## The Allt Essan and Auchessan Hydro schemes in Glen Dochart

## The Auchessan Hydro

## **The Allt Essan Hydro**

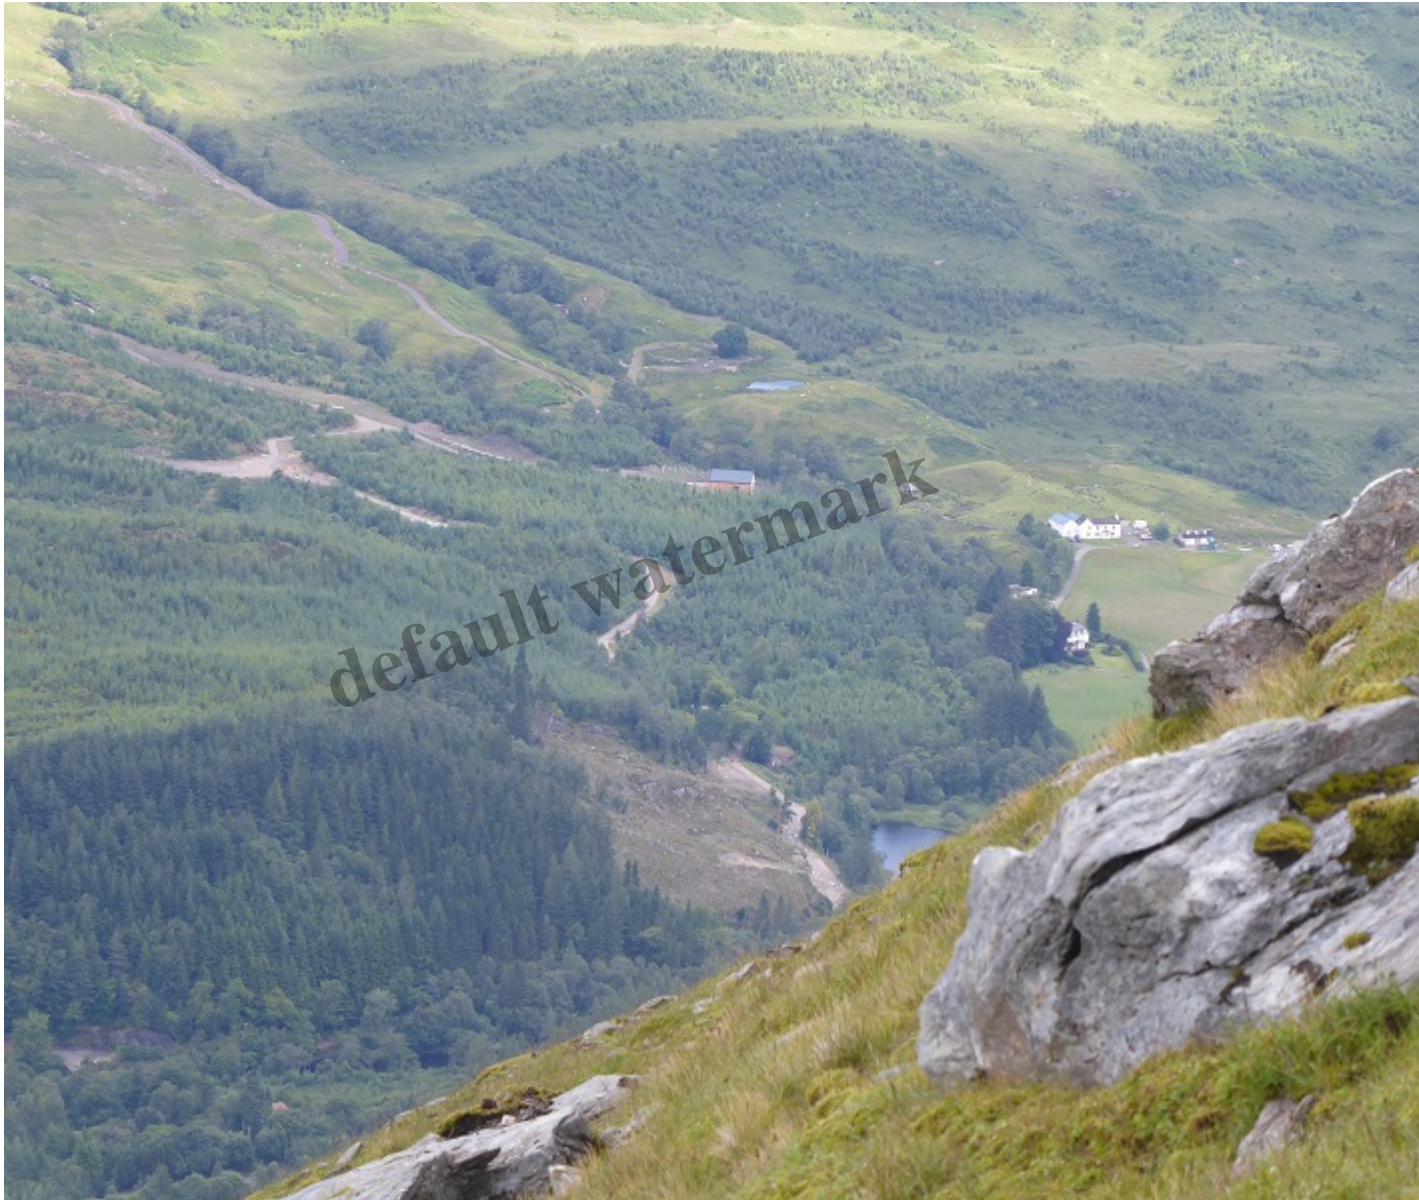
Looking down onto the Allt Essan (power house centre photo and tracks through forestry) and Auchessan (hydro scheme above and left of Allt Essan power house leading to top left corner of photo) hydro schemes from Ben Alder 2017.

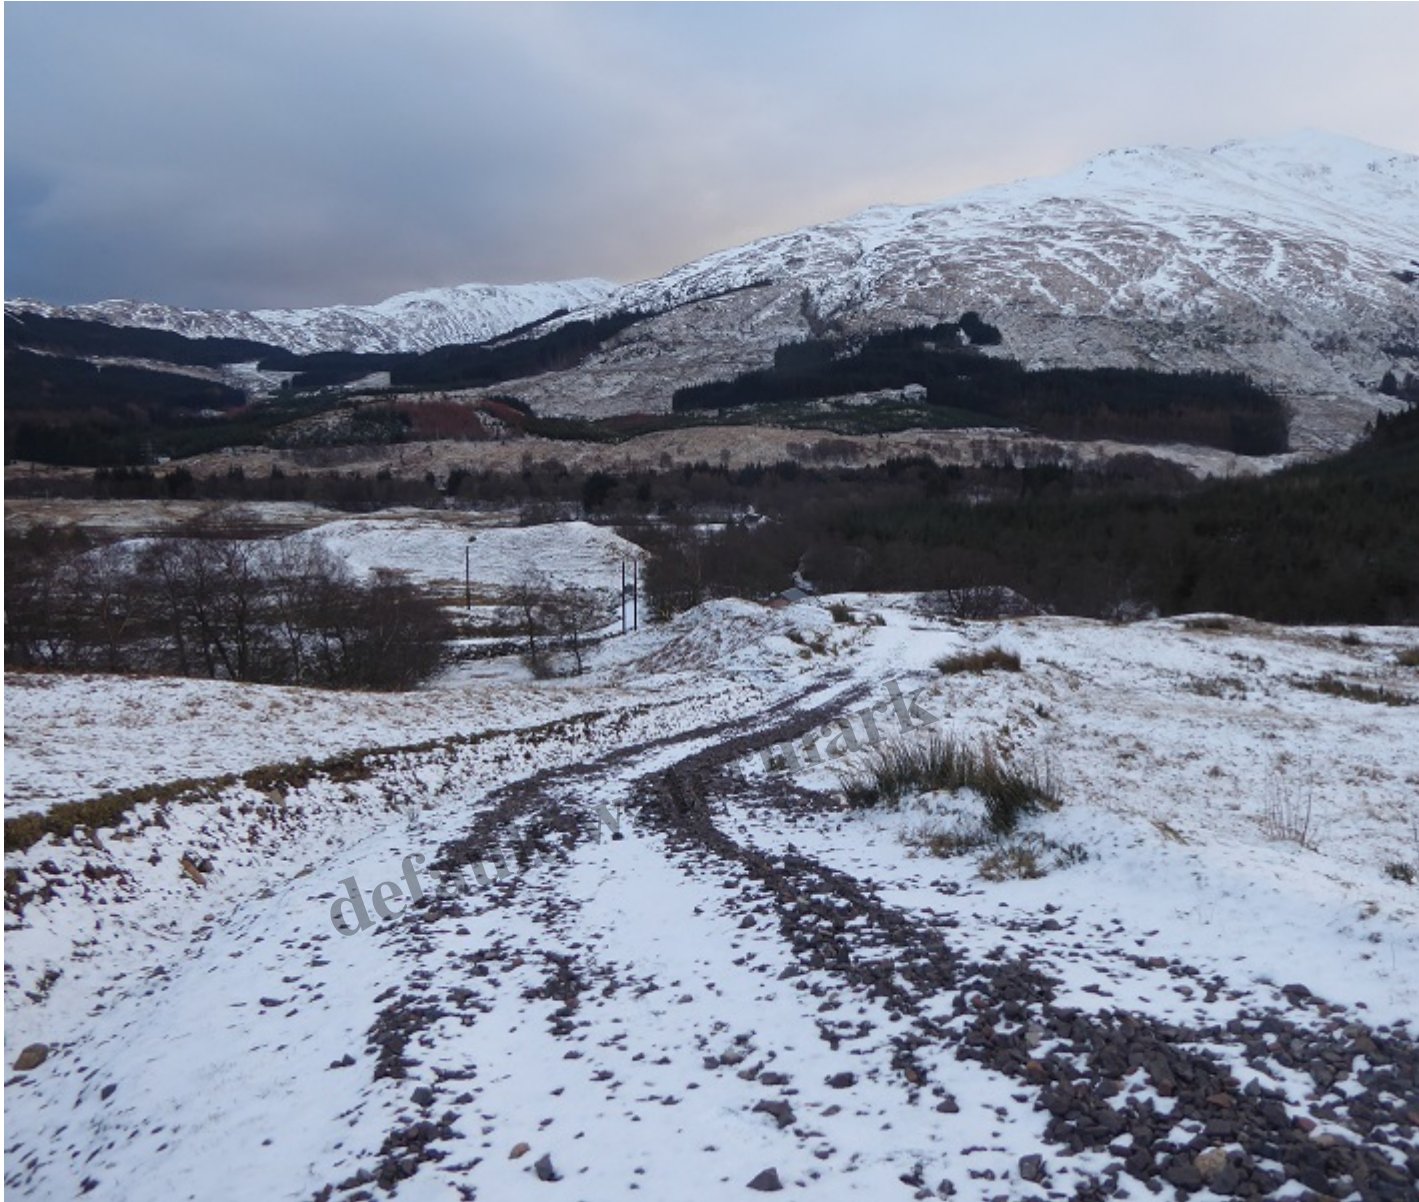
What struck me immediately running up the track, the first section of which had preceded the hydro but has been “upgraded”, by being widened and having new aggregate dumped on the surface, is that it is far too steep:

Looking down track, powerhouse centre with Auchessan Farm behind and Ben More right.

In the lower “upgraded” section of track there has been a failure to retain and use turf to line the left hand side of the track/drainage ditch with a consequence this too will erode. Because the LLTNPA has not published the Construction Method Statement and Landscape Restoration Plan it required as a condition of the planning consent, its not possible to tell if proper plans were ever agreed and whether this is another failure by the LLTNPA to enforce planning conditions. Whatever the case, the design and execution of the work is extremely poor.

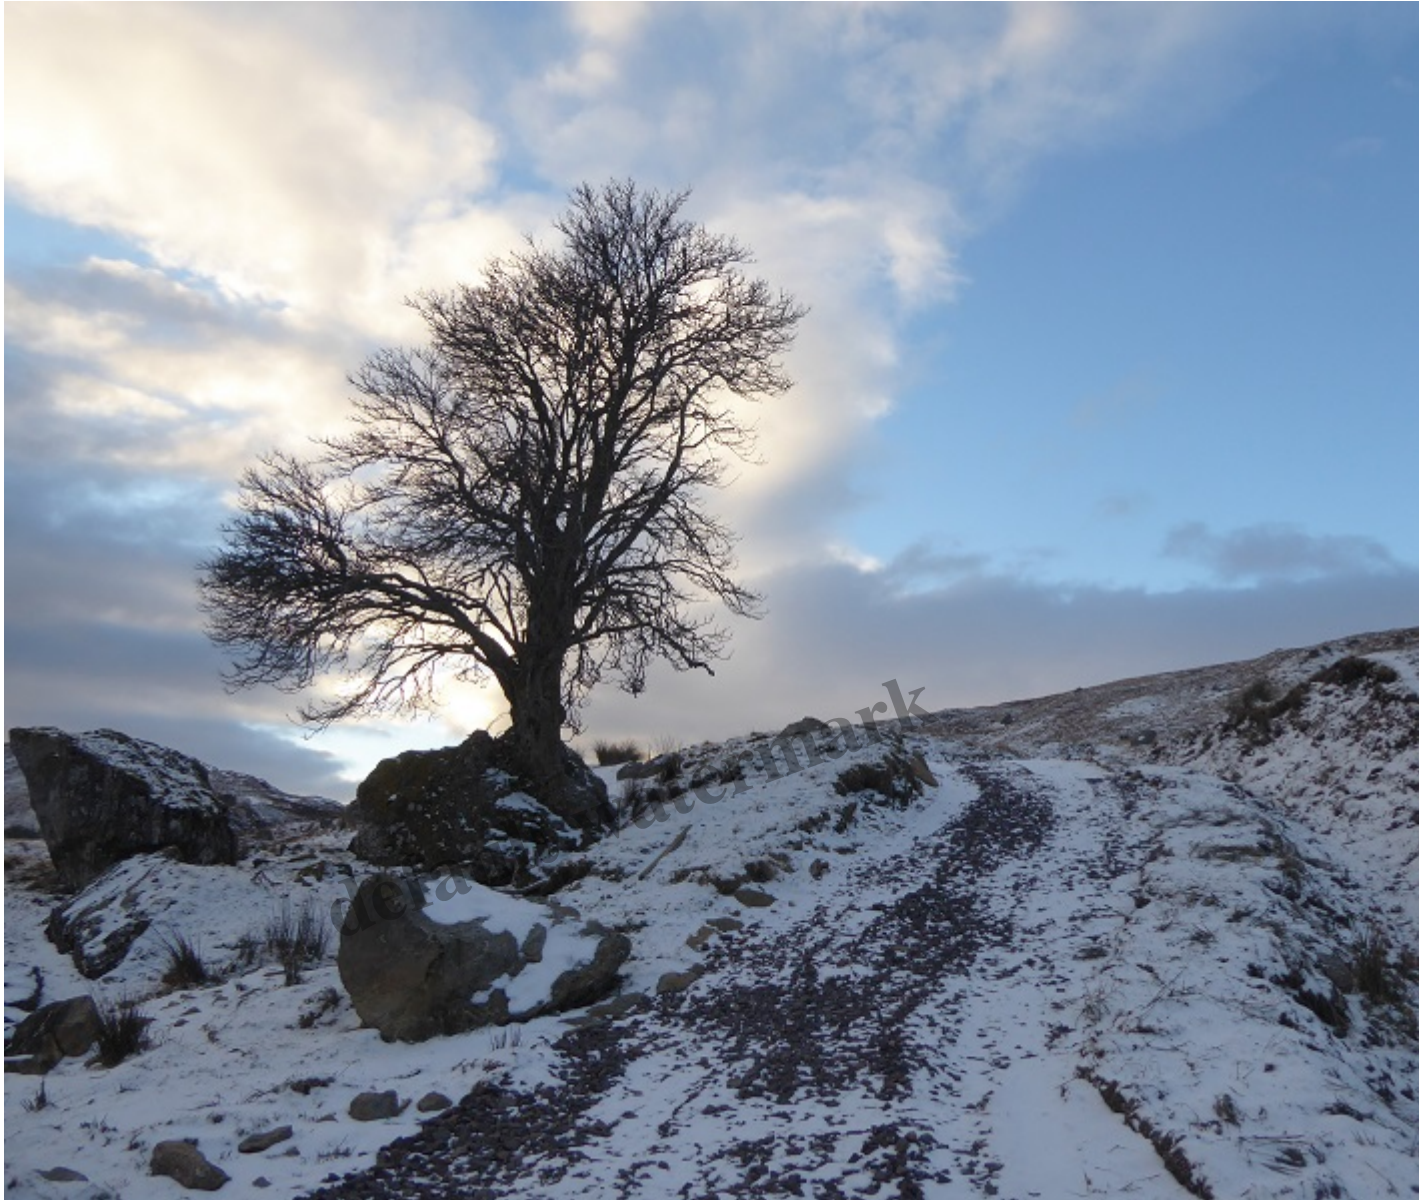
Higher up, while the track was still too steep, a section has been narrowed and the edges finished with per Park Guidance and the planning conditions – but note the bare bank on the right.

While in its Supplementary Guidance on Renewables the LLTNPA refers developers to SNH Guidance on Constructed Tracks in the Scottish Uplands, nowhere does it say anything explicitly about the angle of hill tracks. SNH's guidance states that the angle should not exceed 14 degrees – because the evidence is any steeper than this and tracks erode. The LLTNPA, however, has rarely given any consideration to the steepness of tracks and as a consequence is creating erosion problems for the future (whatever the wider landscape impact).

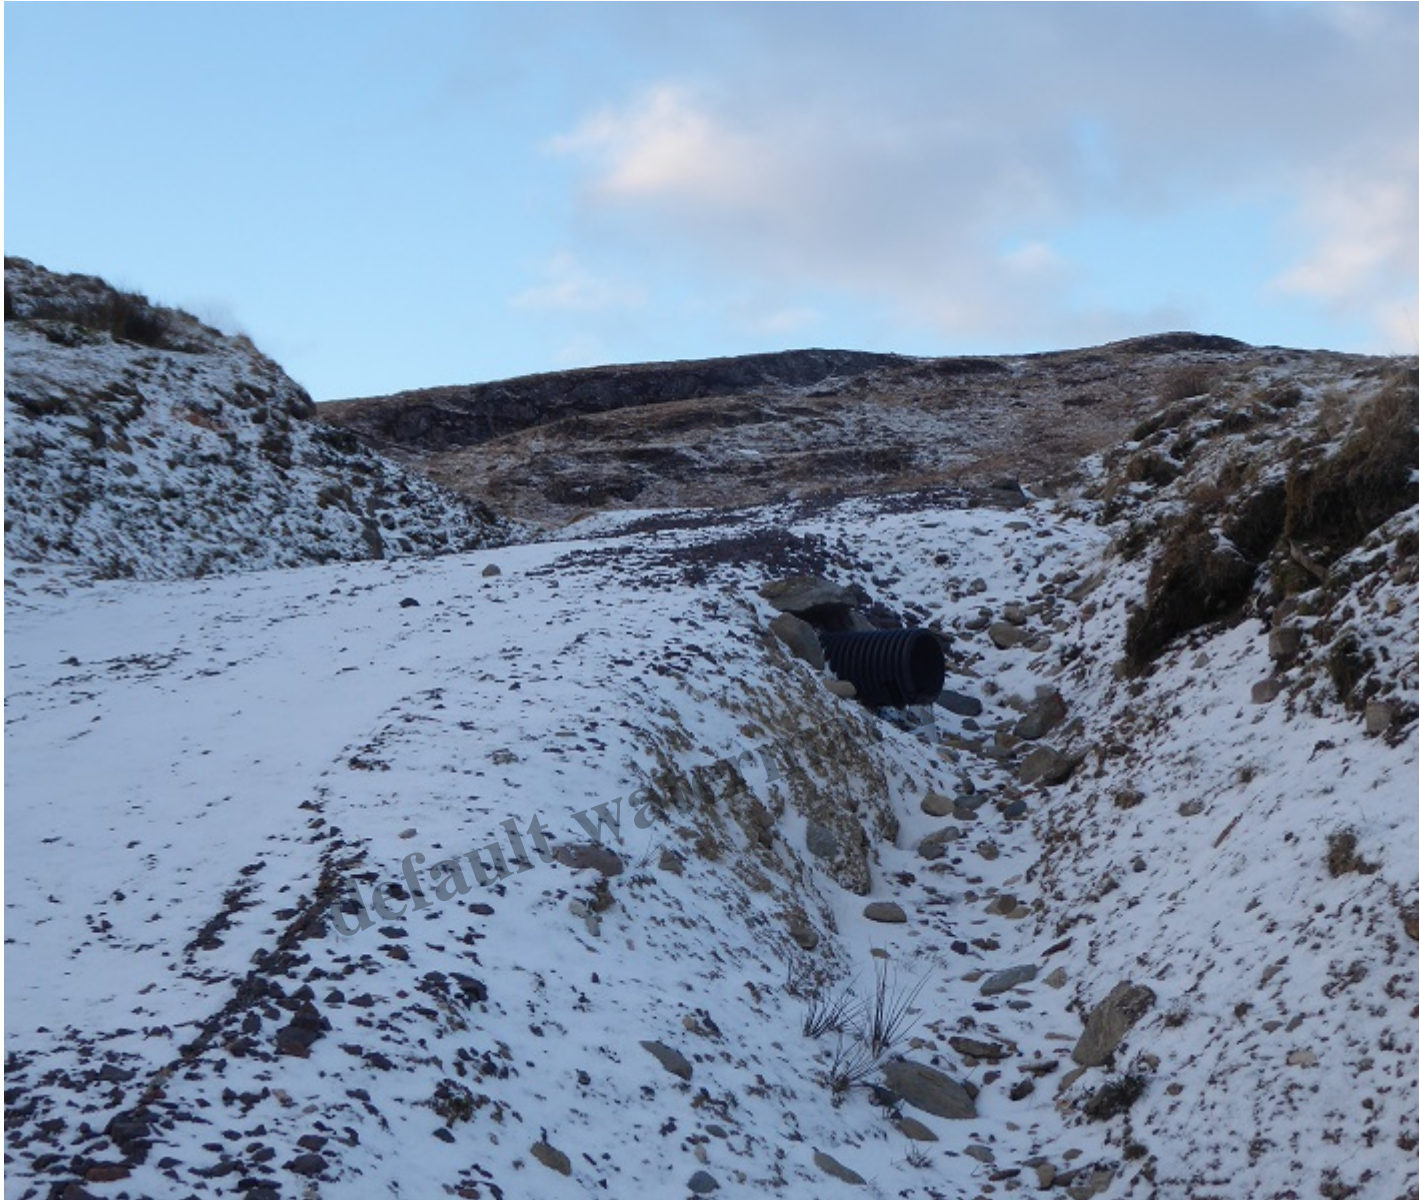
This section of track totally fails to meet the requirements of the LLTNPA's guidance – and note the culvert

None of these recommendations are evident in the photo above or below:

*“Once the track is constructed the batters are bare earth surfaces that can scar the landscape, so in order to reduce their visual impact batters must be graded in order that re-vegetation can occur. Developers should follow best practice techniques:*

- \* Minimise the length of the batter slope by avoiding steep hillsides.*
- \* Ensure that the slope of the batter is shallow enough for vegetation to grow.*
- \* Complete batters at the time of road construction, not retrospectively.*
- \* Preferably cut and put aside turves during construction of the road and then place these on the batters; or leave a prepared (cultivated) batter surface to assist re-vegetation.*
- \* Assist re-vegetation using appropriate techniques (for example the use of heather brash or native grass seed).”* (LLTNPA Supplementary Planning Guidance on Renewables)

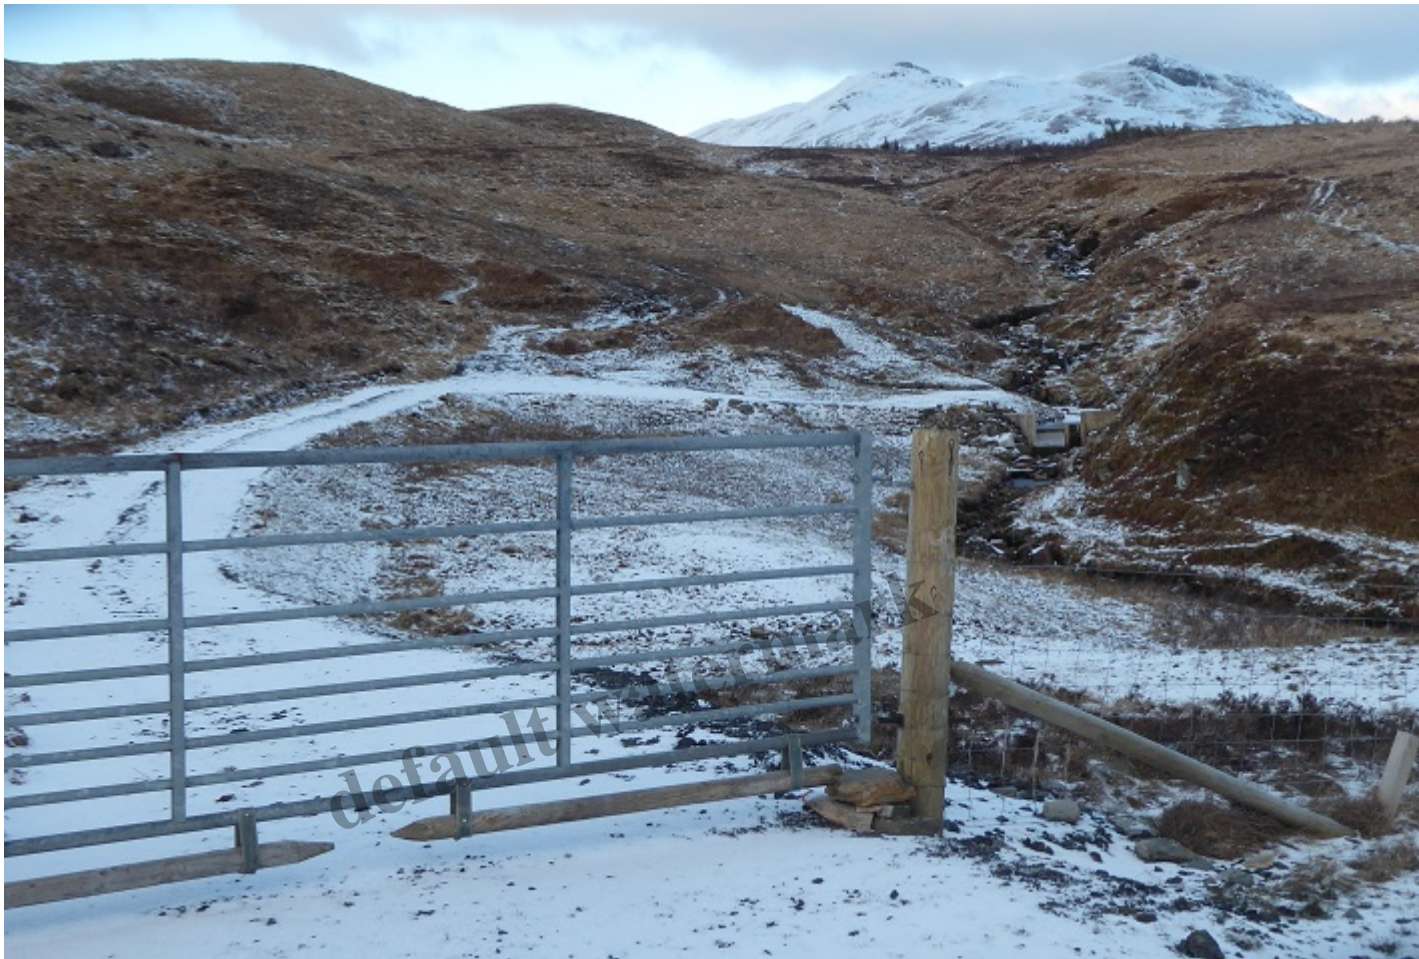
Main hydro intake with Sgiath Chuil behind. Note how the creation of the new track appears to have the creation of a new ATV track behind the gate to the left of the intake dam

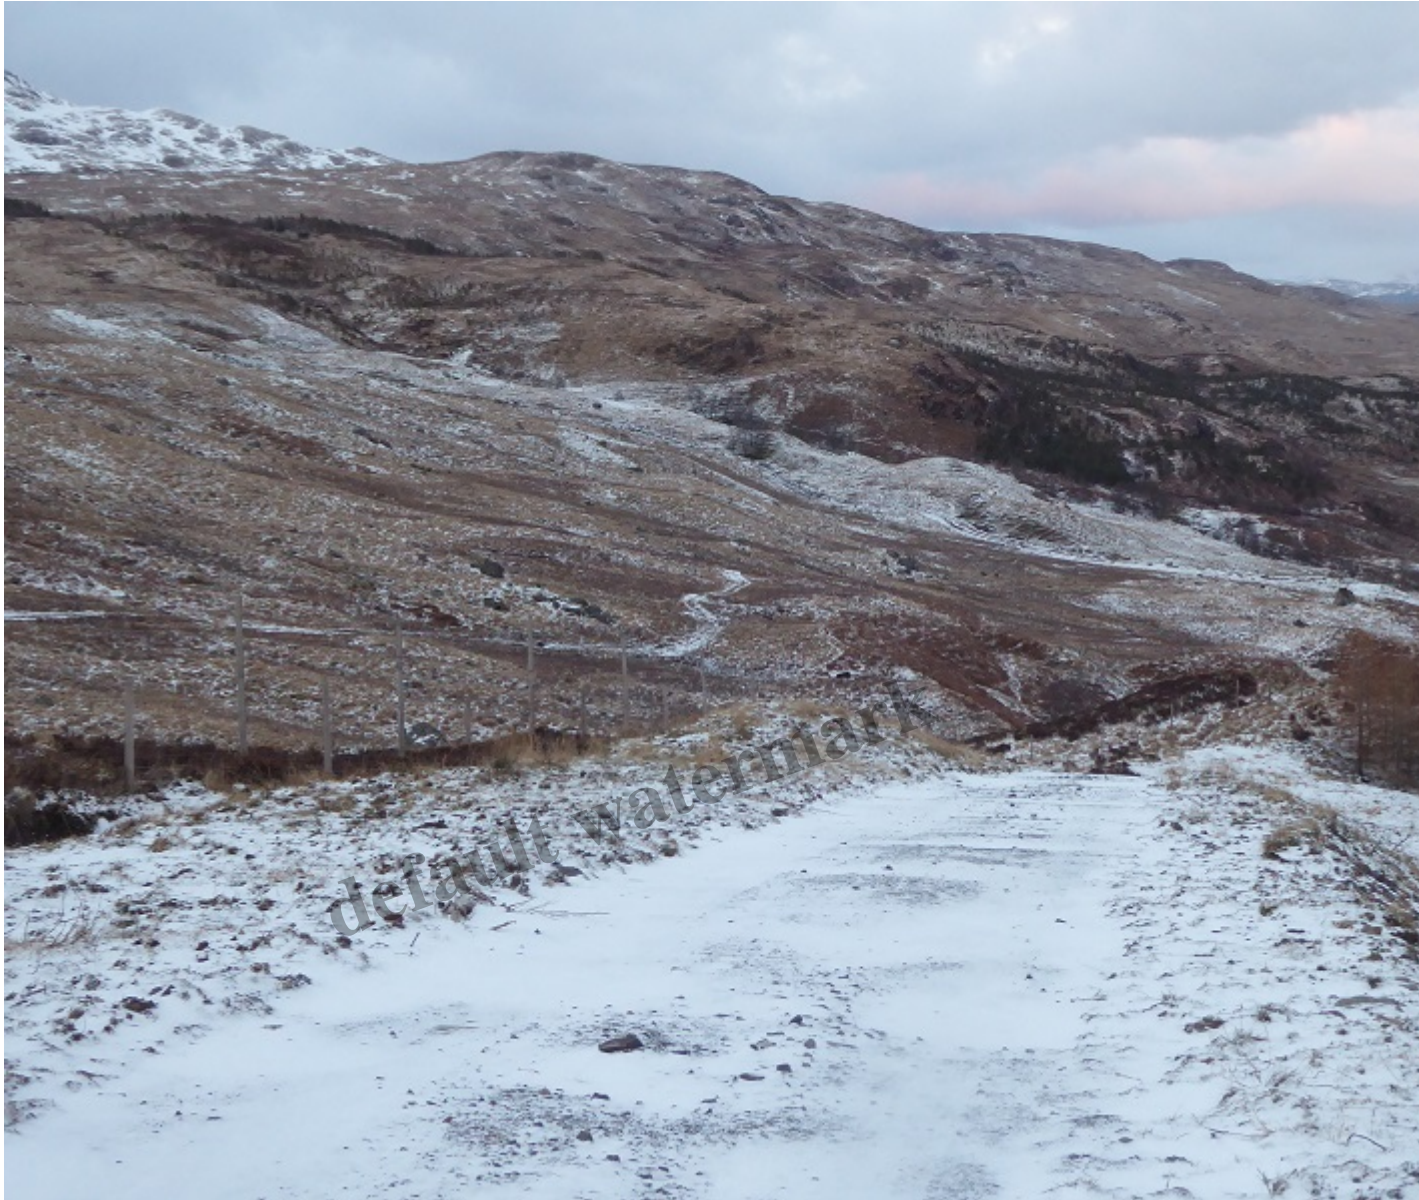
Track city – the Auchessan hydro track in background, Allt Essan hydro track in foreground – following ridge (see below) and the Auchessan ATV track inbetween on the other side of the Allt Essan

So why then does the track follow the ridge by the side of the burn?

How has the LLTNPA now allowed not just one but two tracks leading to the same location?

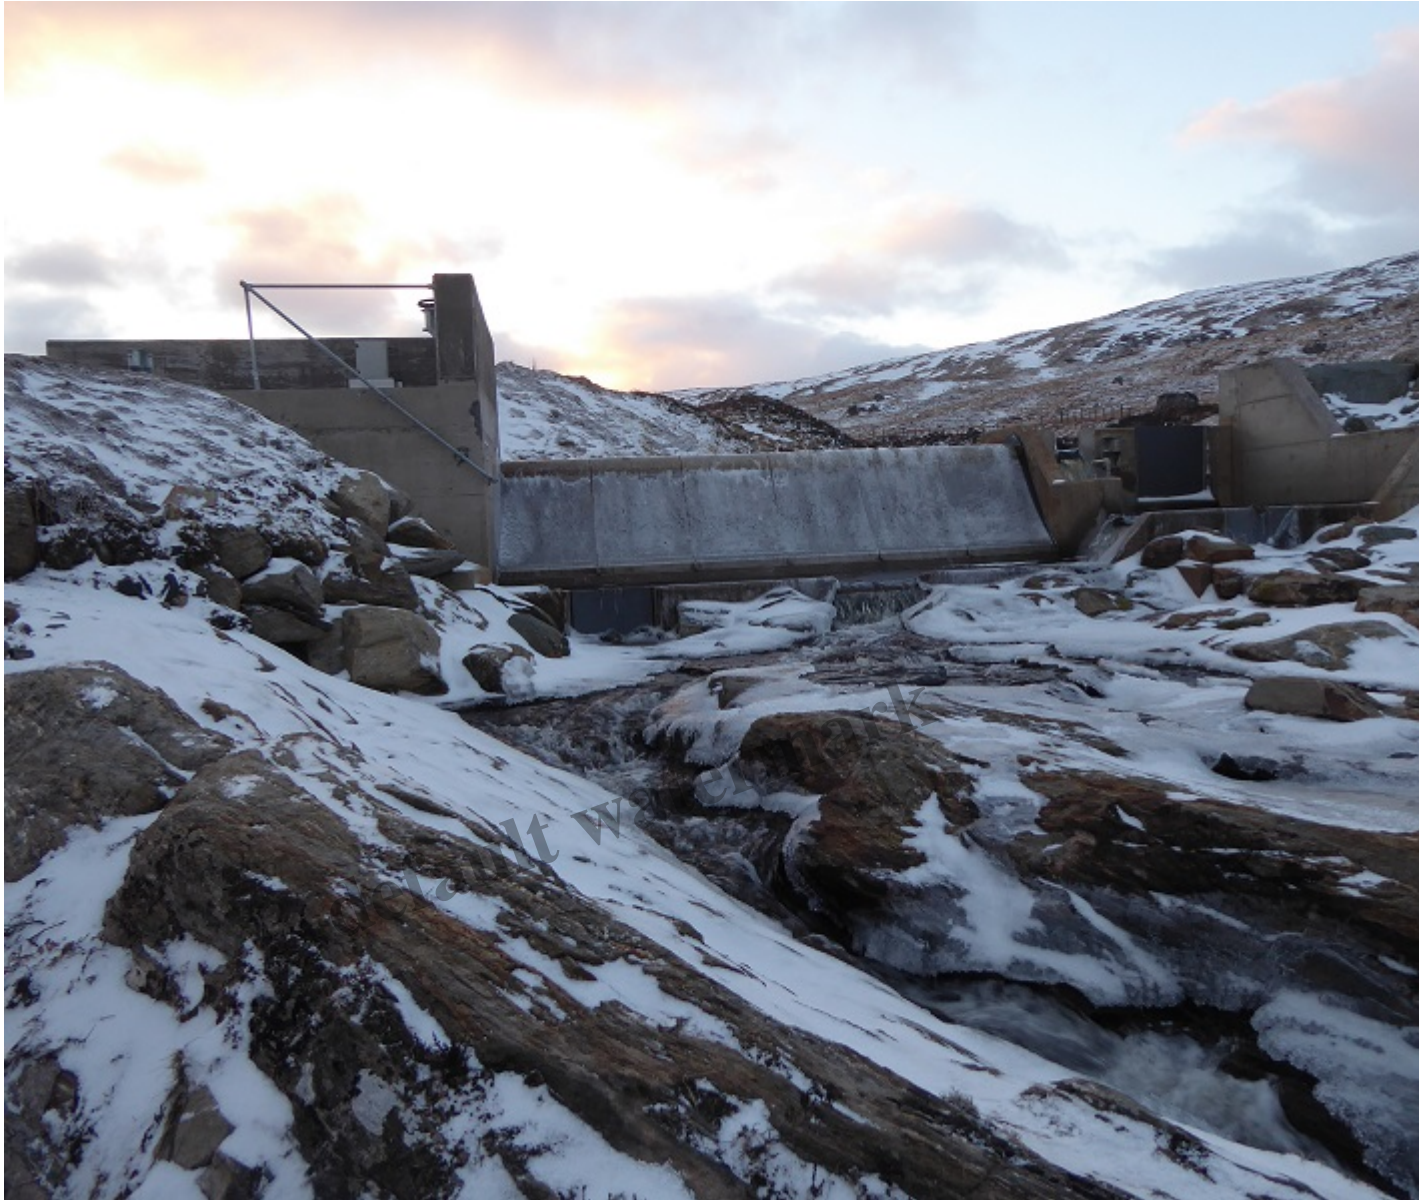
The end result, another industrial looking dam worthy of the 1950s

Little appears to have been done to ameliorate the appearance of the dam as set out in the delegated planning report which stated:

*“Intake design: All visible pipes should be coloured grey to minimise visual impact [Hurrah!]. The wingwalls for the intakes are proposed as being reinforced with boulders in the concrete which could result in a very visible structure. Further detail on the finish should be agreed with the NPA prior to development. Stone facing on wingwalls can discretely hide the wingwalls within a watercourse however without a photomontage of the intakes at the locations it is difficult to adequately advise.”*

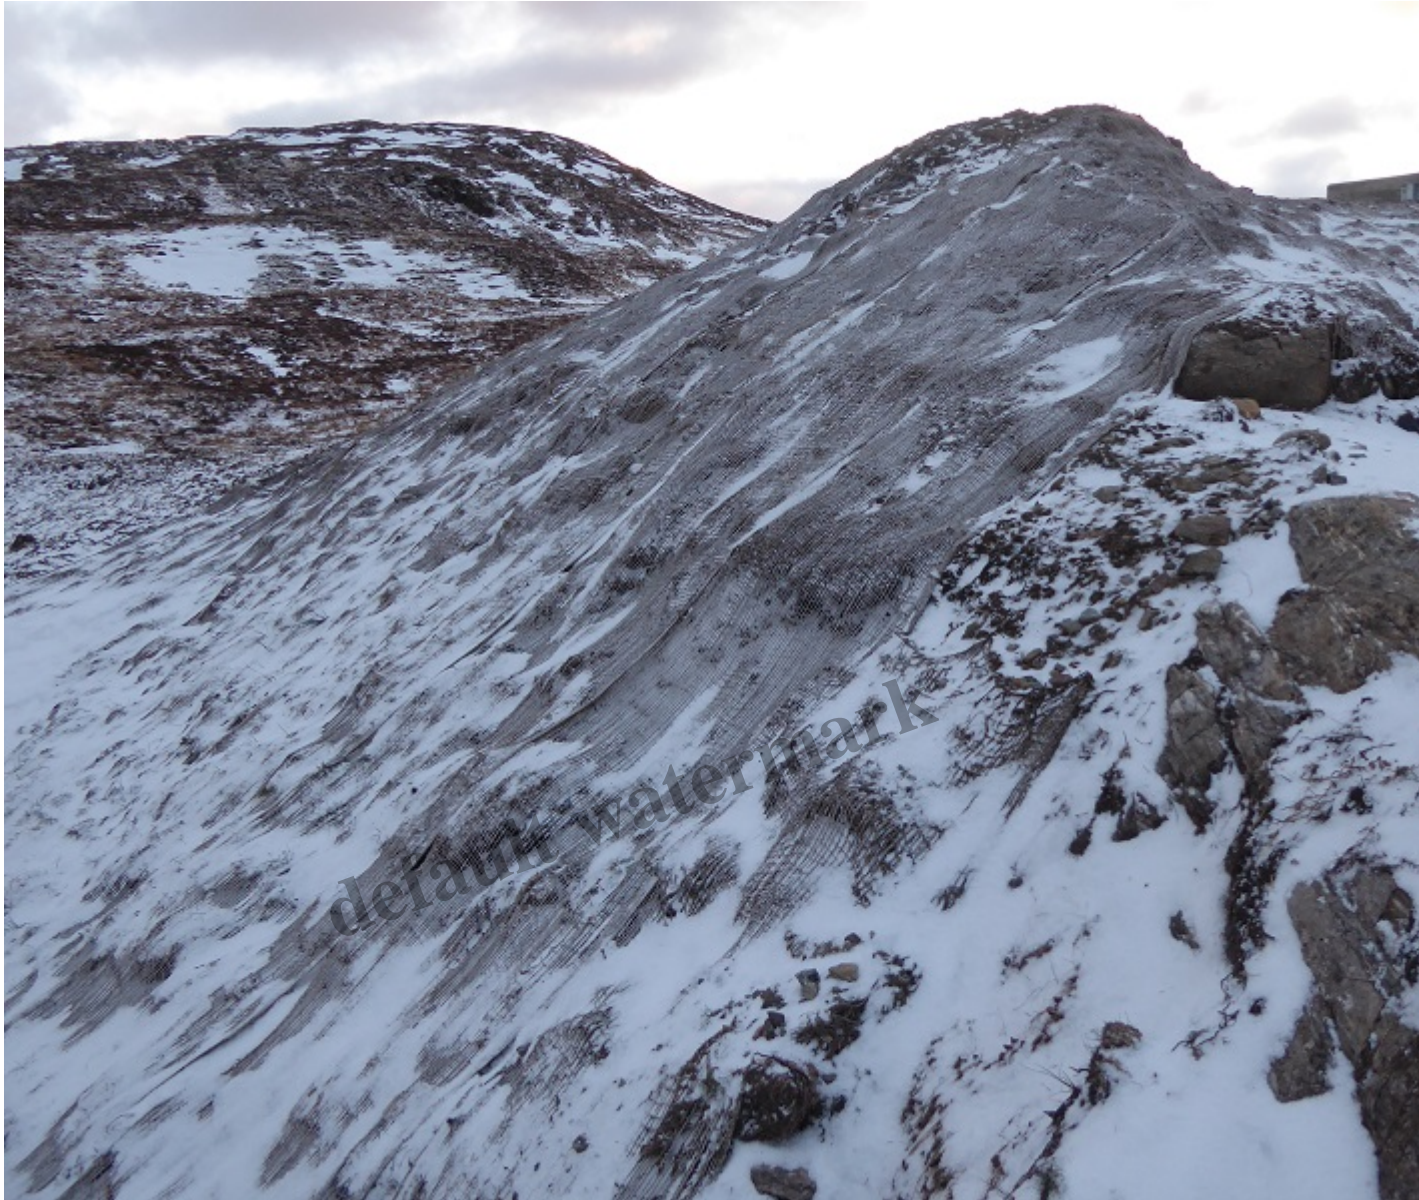
Mound of earth used to conceal intake from below

The earth screen is far too steep-sided, held together by textile and does not fit with the landscape. Here is the LLTNPA Guidance again:

*“If geotextile retention is required, in order to aid re-vegetation as well as successful landscape and visual integration, attention should be paid to the detail and specification of the material applied and its ongoing monitoring and maintenance.”*

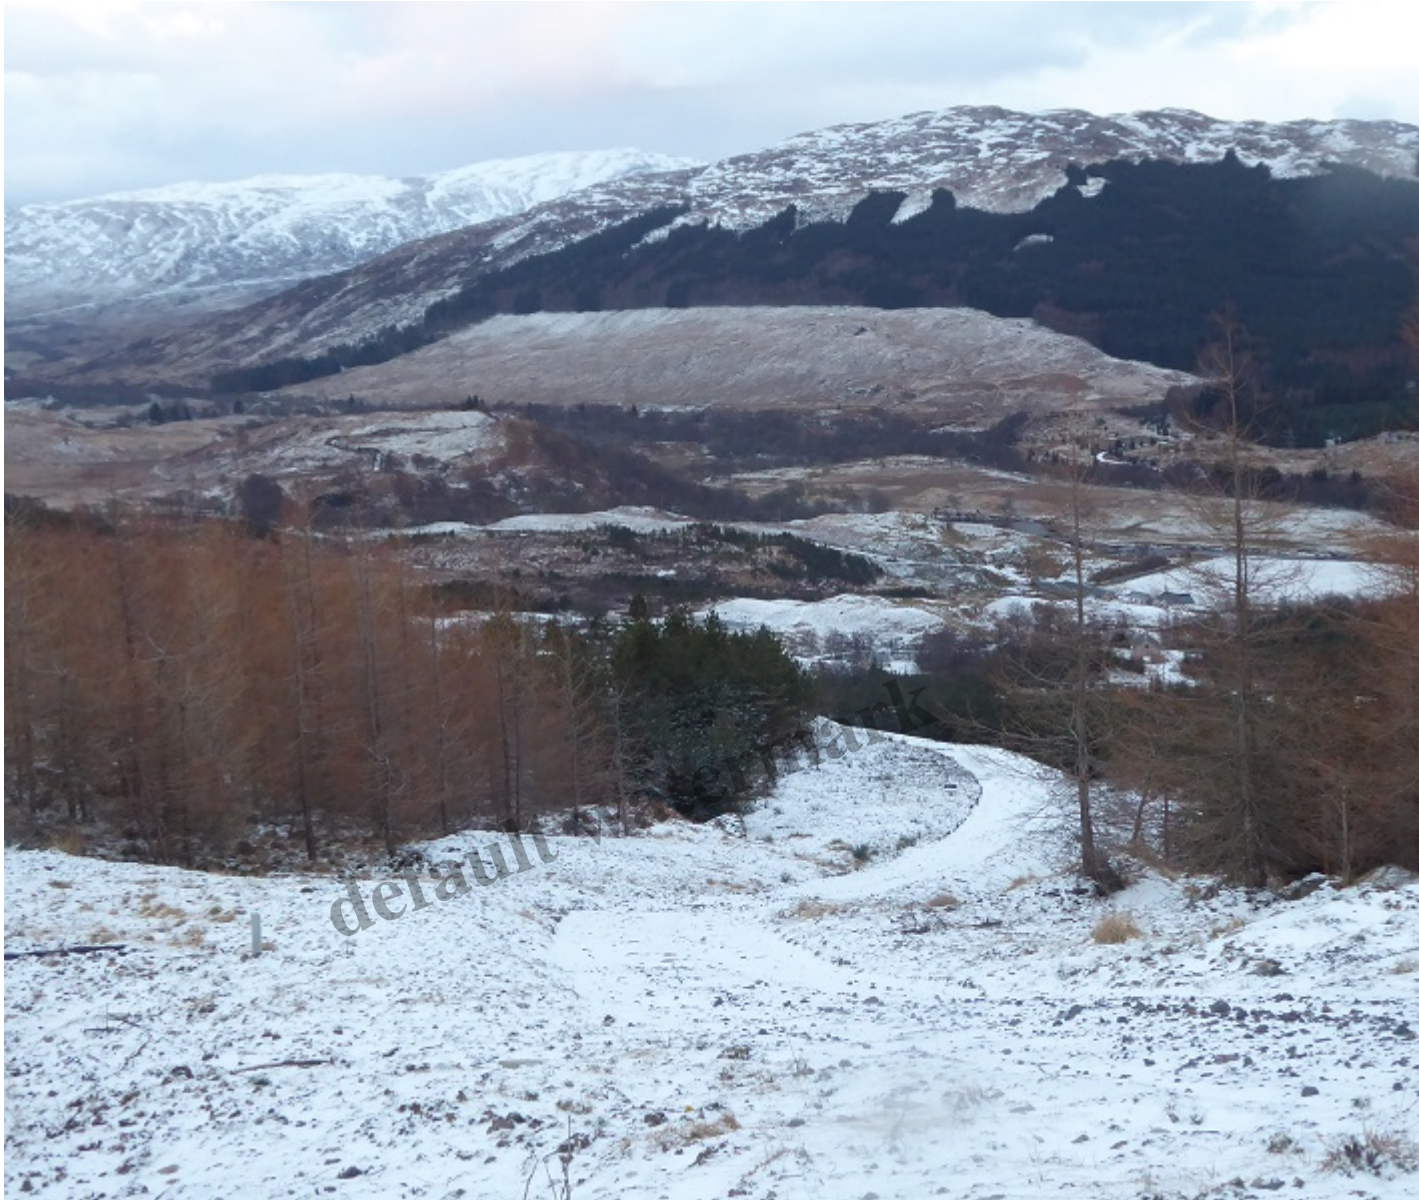
Pipeline on left of track marked by concrete posts

While most of the track runs through forestry, a wide swathe was cut through trees to create the pipeline with the result it is highly visible. Could the LLTNPA not have required a narrower construction corridor? Here is the Park's own Guidance again:

*Where tracks are to be retained, especially in locations which are sensitive in terms of landscape impact, they should be restored from the specification required for construction vehicles and be reduced in width to the minimum required for ongoing quad bike (or similar) access*

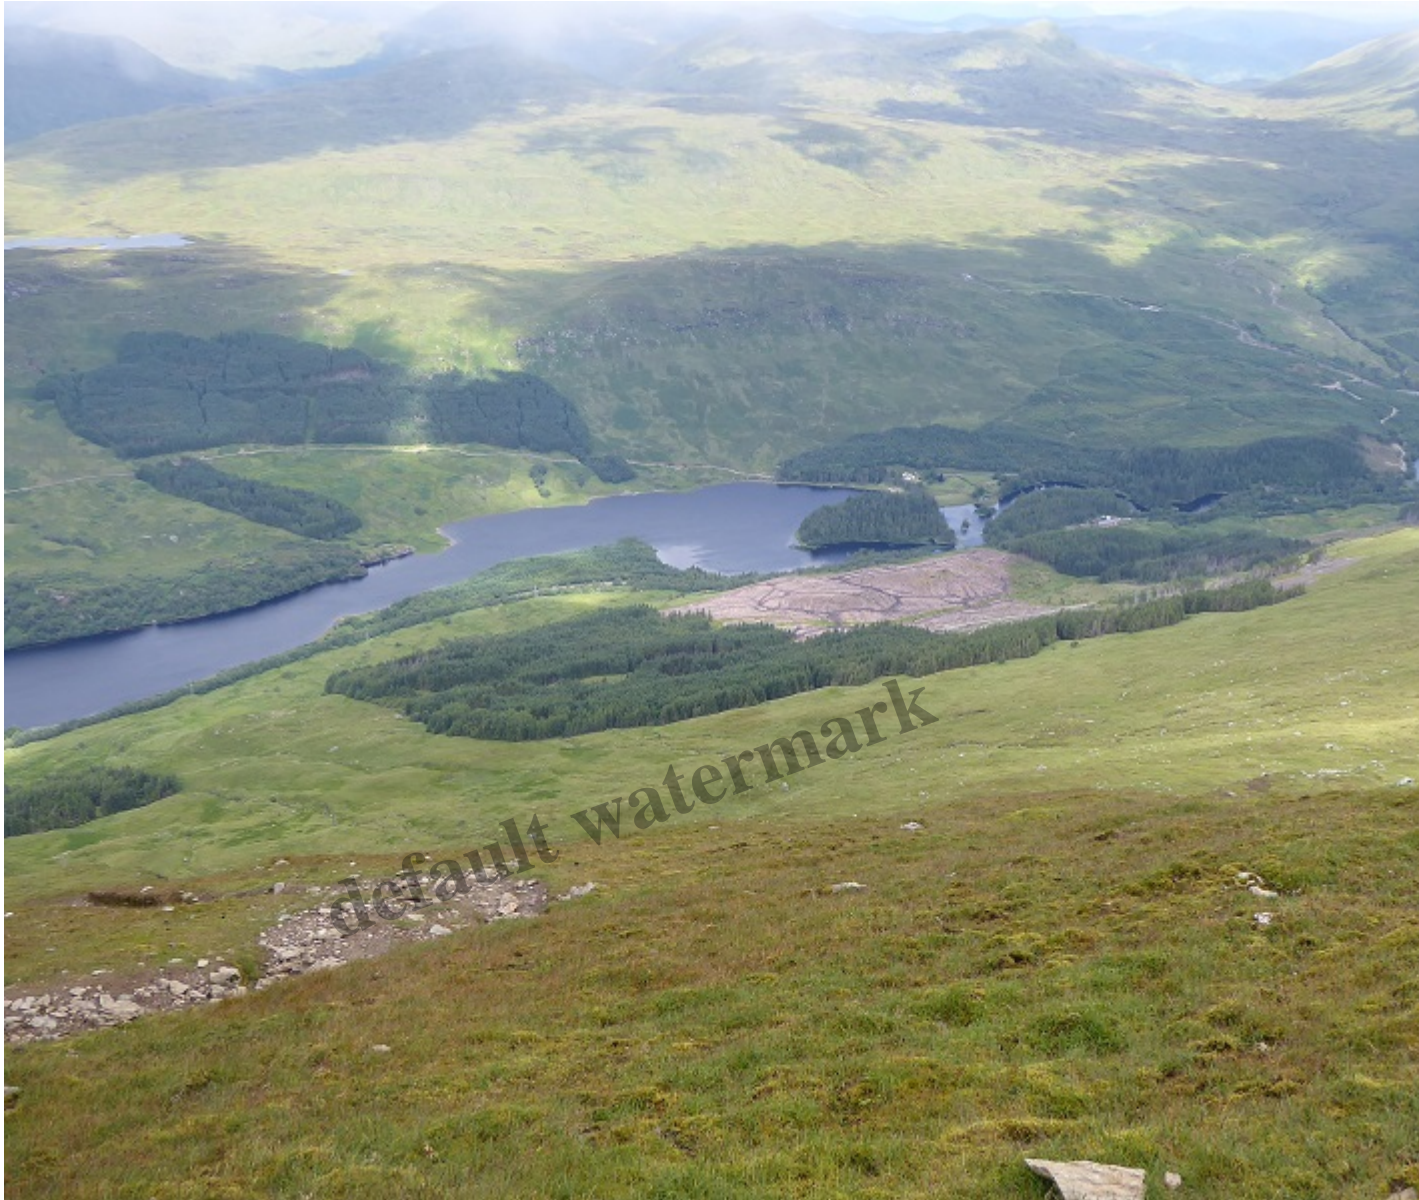
View of Allt Essan and Auchessan hydro tracks (right) from upper slopes of Ben More – note how the track basically follows the ridge and is therefore particularly prominent
