The Allt Essan and Auchessan Hydro schemes in Glen Dochart

March 26, 2018

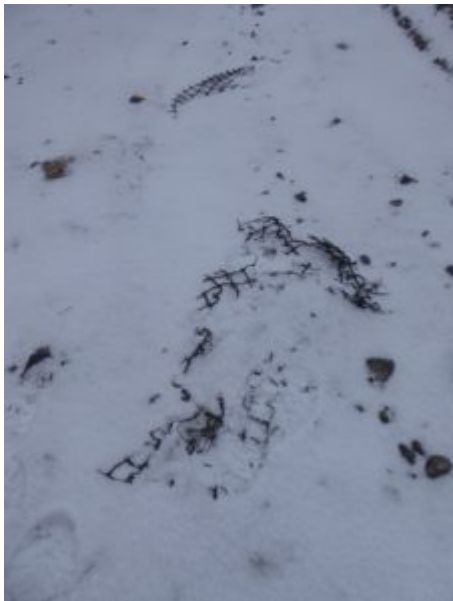
Netting embedded in surface
of track

It got worse as, not long after I started down the new Allt Essan hydro track, I realised much of it and the ground at the sides was being held together with plastic garden netting partially concealed in the snow. The LLTNPA makes no mention of plastic, which does not biodegrade for hundreds of years and then when it does poisons organisms, being used to restore ground in its best practice Guidance on Renewables but it appears to have played a fundamental role in the “restoration” of ground at Allt Essan. Time that Guidance was updated!
