## The Allt Essan and Auchessan Hydro schemes in Glen Dochart

Looking down onto the Allt Essan (power house centre photo and tracks through forestry) and Auchessan (power house above and left of Allt Essan power house leading to top left corner of photo) hydro schemes from Ben Alder. Photo taken in 2017.

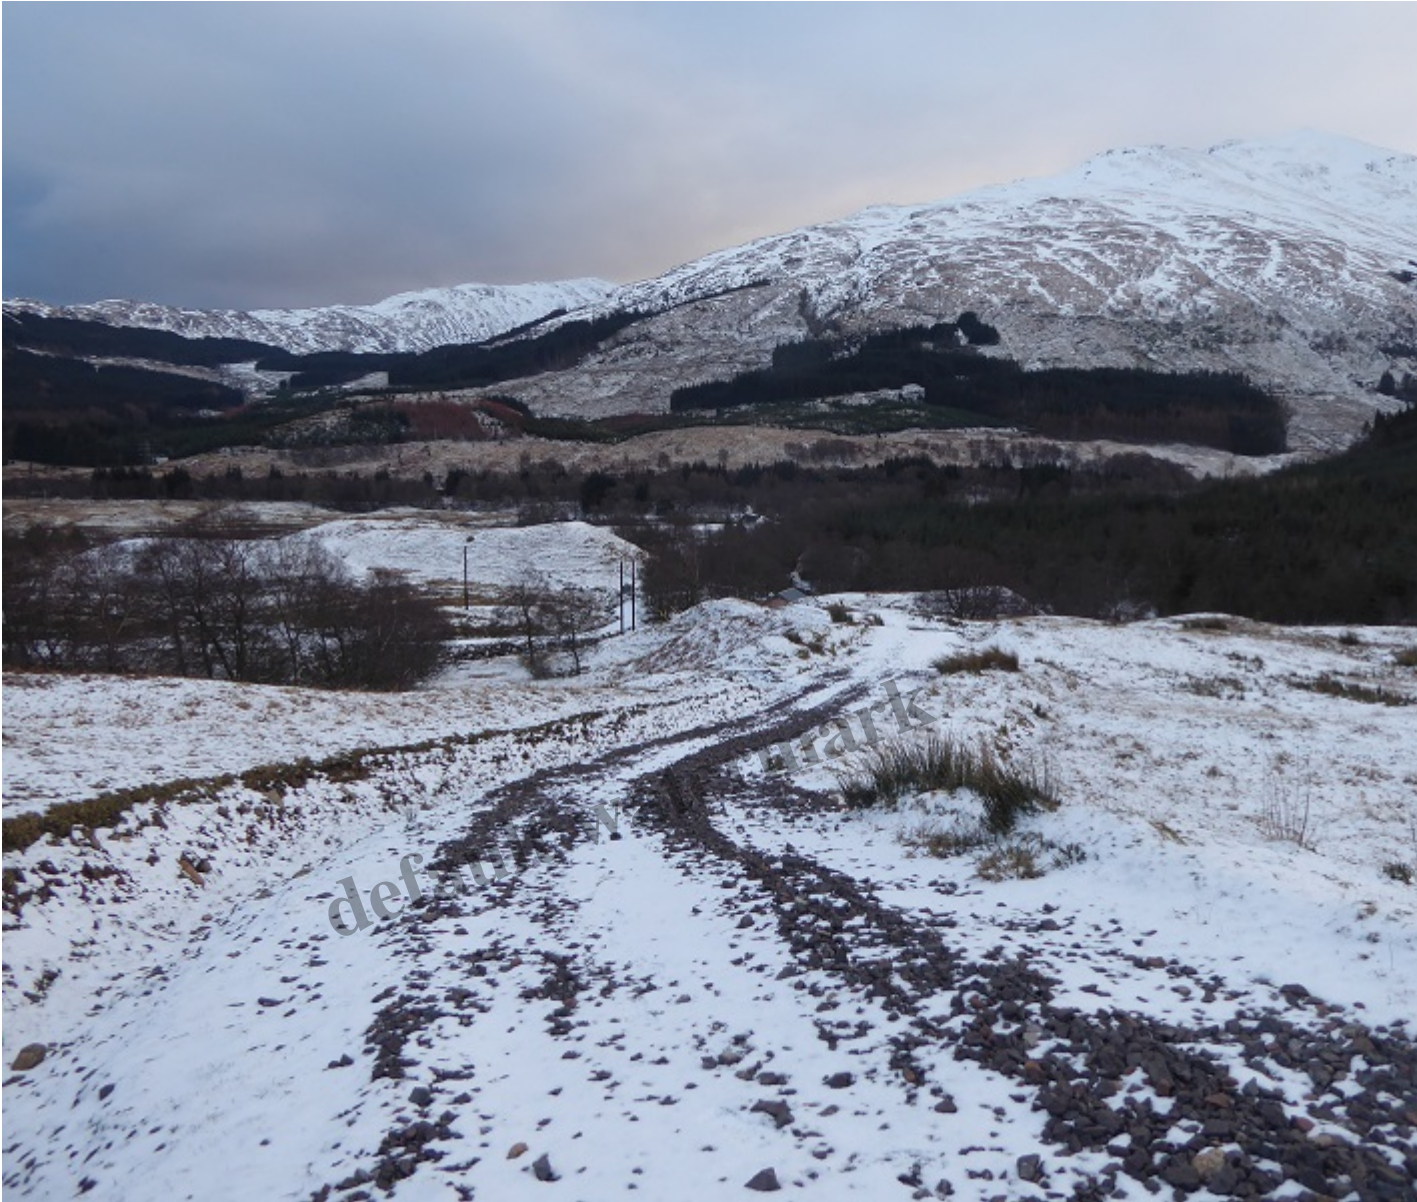
What struck me immediately running up the track, the first section of which had preceded the hydro but has been “upgraded”, by being widened and having new aggregate dumped on the surface, is that it is far too steep:

Looking down track, powerhouse centre with Auchessan Farm behind and Ben More right.

In the lower “upgraded” section of track there has been a failure to retain and use turf to line the left hand side of the track/drainage ditch with a consequence this too will erode. Because the LLTNPA has not published the Construction Method Statement and Landscape Restoration Plan it required as a condition of the planning consent, its not possible to tell if proper plans were ever agreed and whether this is another failure by the LLTNPA to enforce planning conditions. Whatever the case, the design and execution of the work is extremely poor.

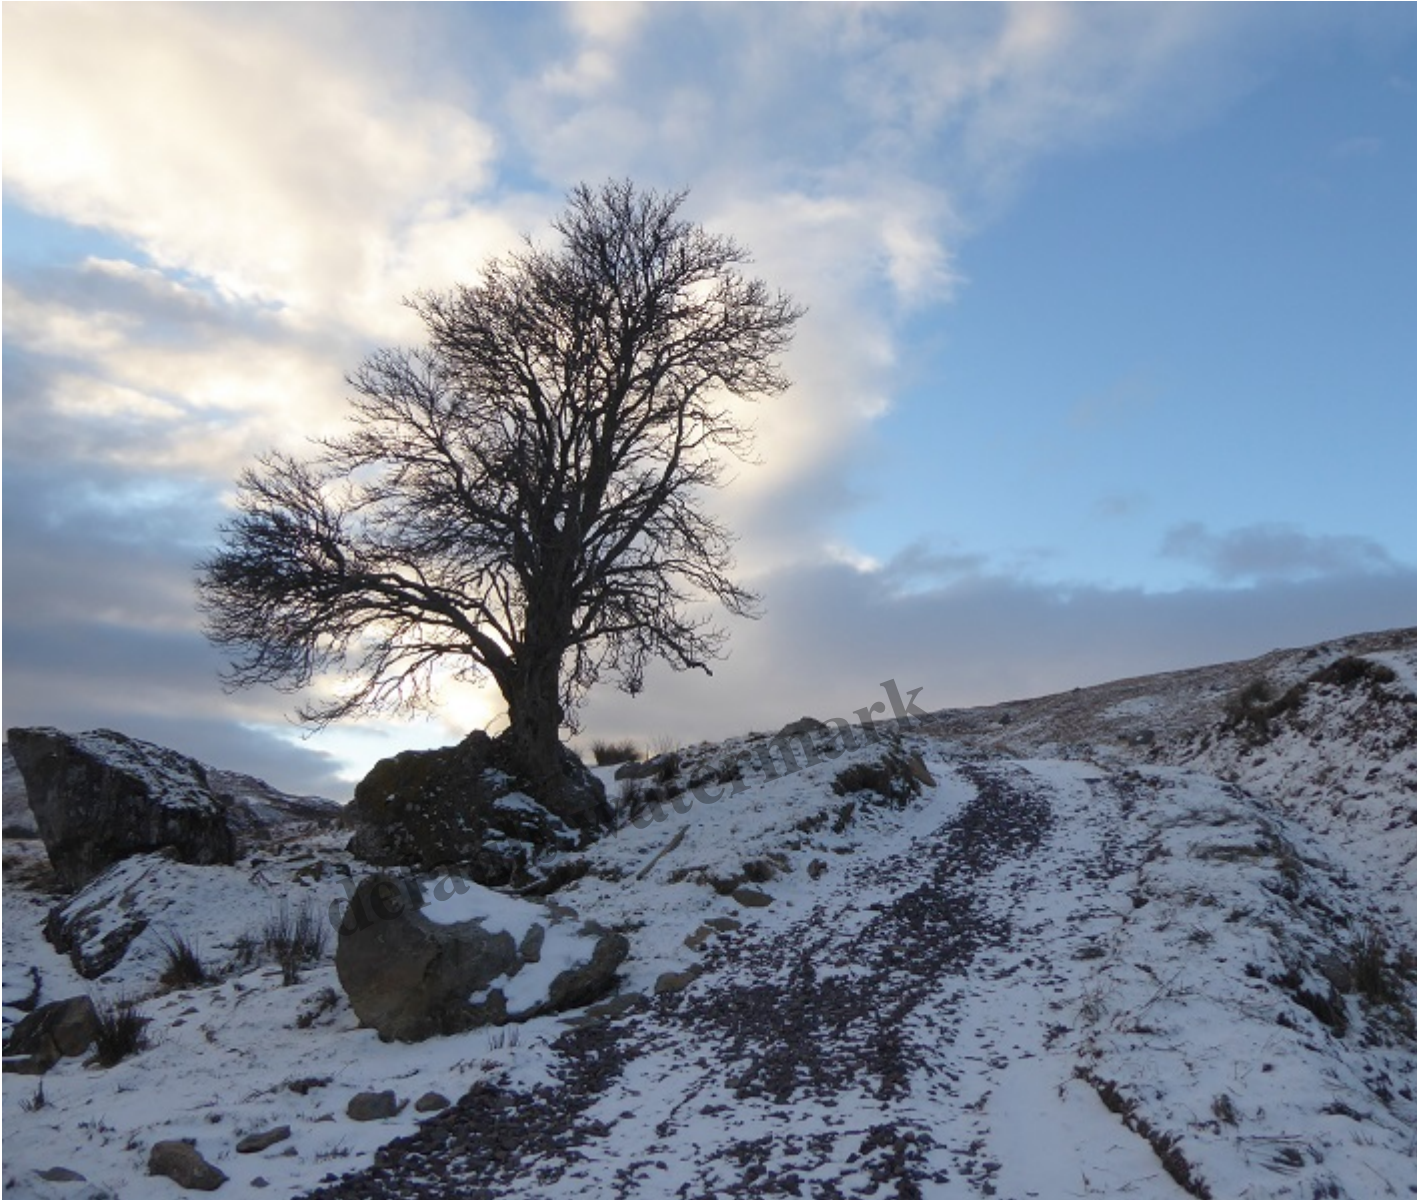
Higher up, while the track was still too steep, a section has been narrowed and the edges finished w per Park Guidance and the planning conditions – but note the bare bank on the right.

While in its Supplementary Guidance on Renewables the LLTNPA refers developers to SNH Guidance on Constructed Tracks in the Scottish Uplands, nowhere does it say anything explicitly about the angle of hill tracks. SNH's guidance states that the angle should not exceed 14 degrees – because the evidence is any steeper than this and tracks erode. The LLTNPA, however, has rarely given any consideration to the steepness of tracks and as a consequence is creating erosion problems for the future (whatever the wider landscape impact).

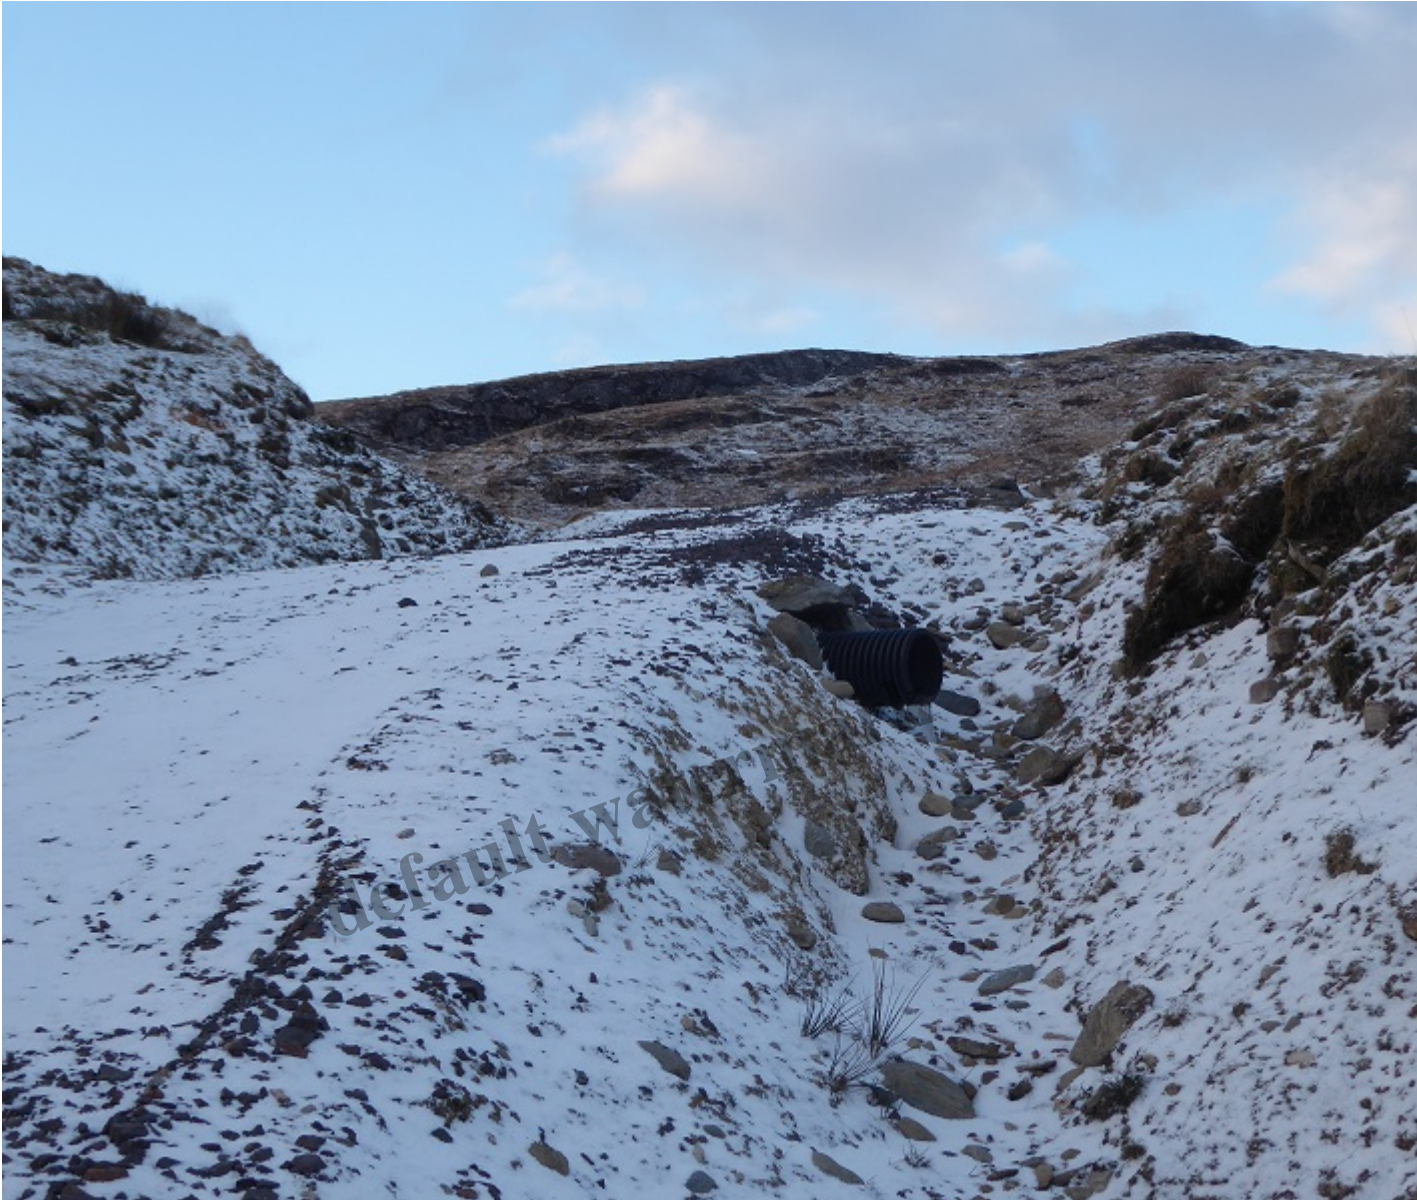
This section of track totally fails to meet the requirements of the LLTNPA's guidance – and note the culvert

None of these recommendations are evident in the photo above or below:

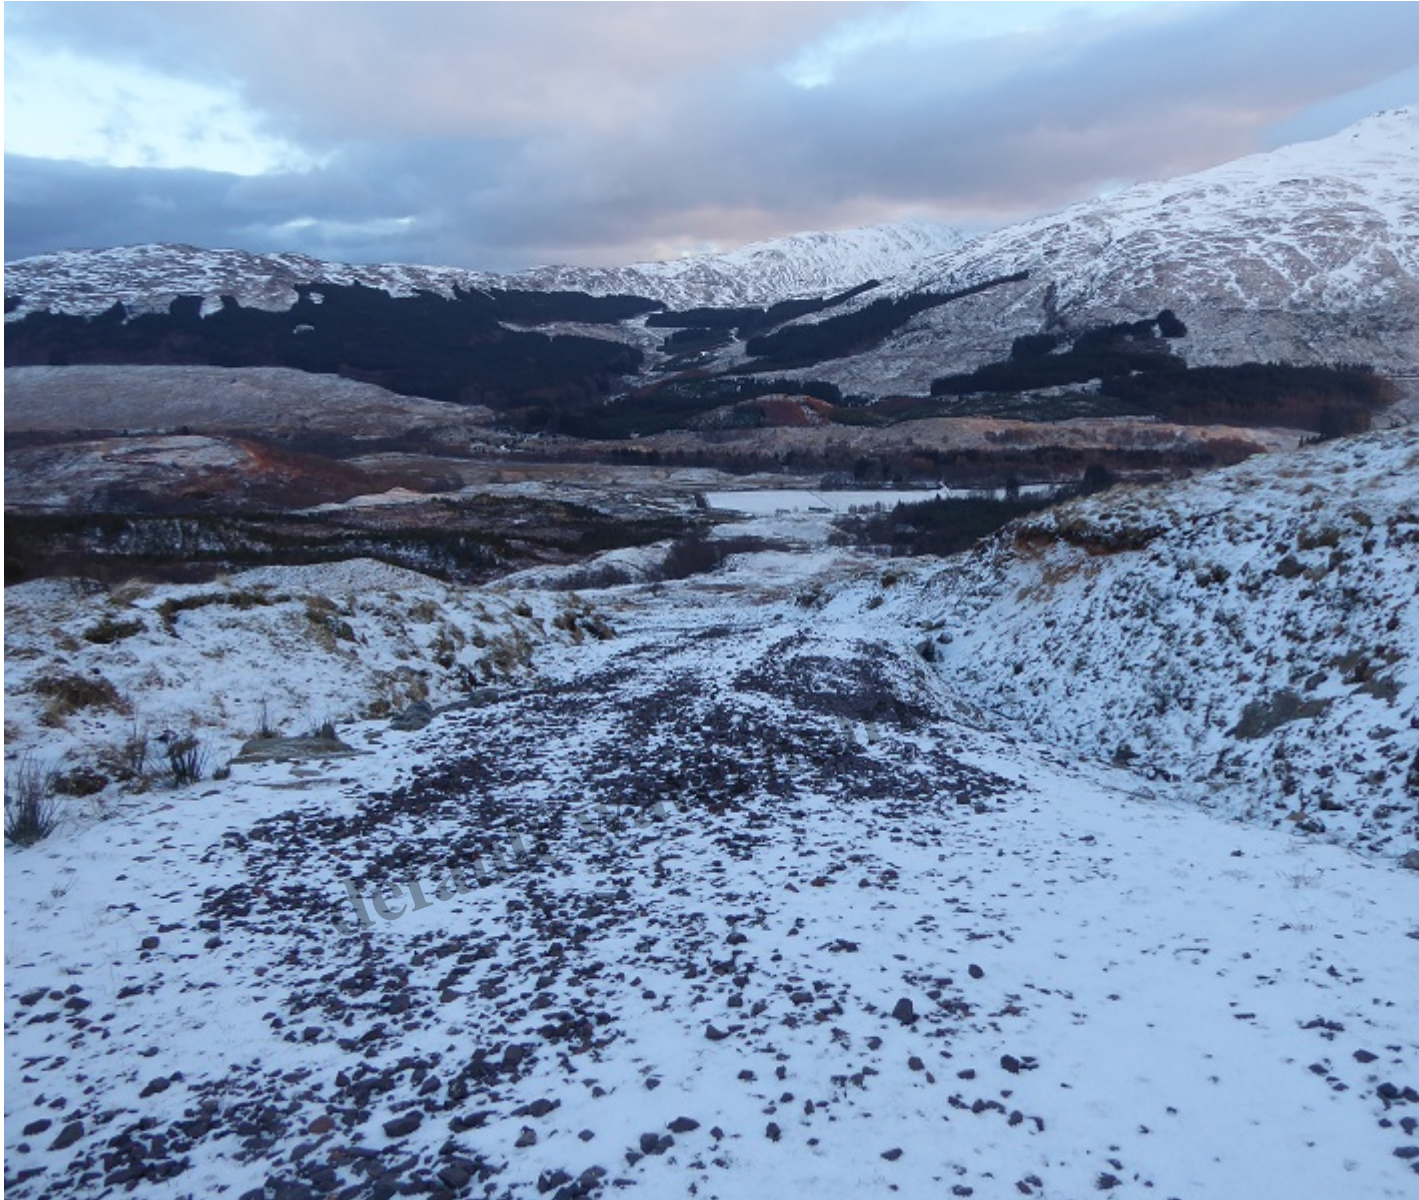
Higher up there was less evidence of any attempt to restore the track properly in contravention of LL guidance which states “*complete batters at time of road construction*”.

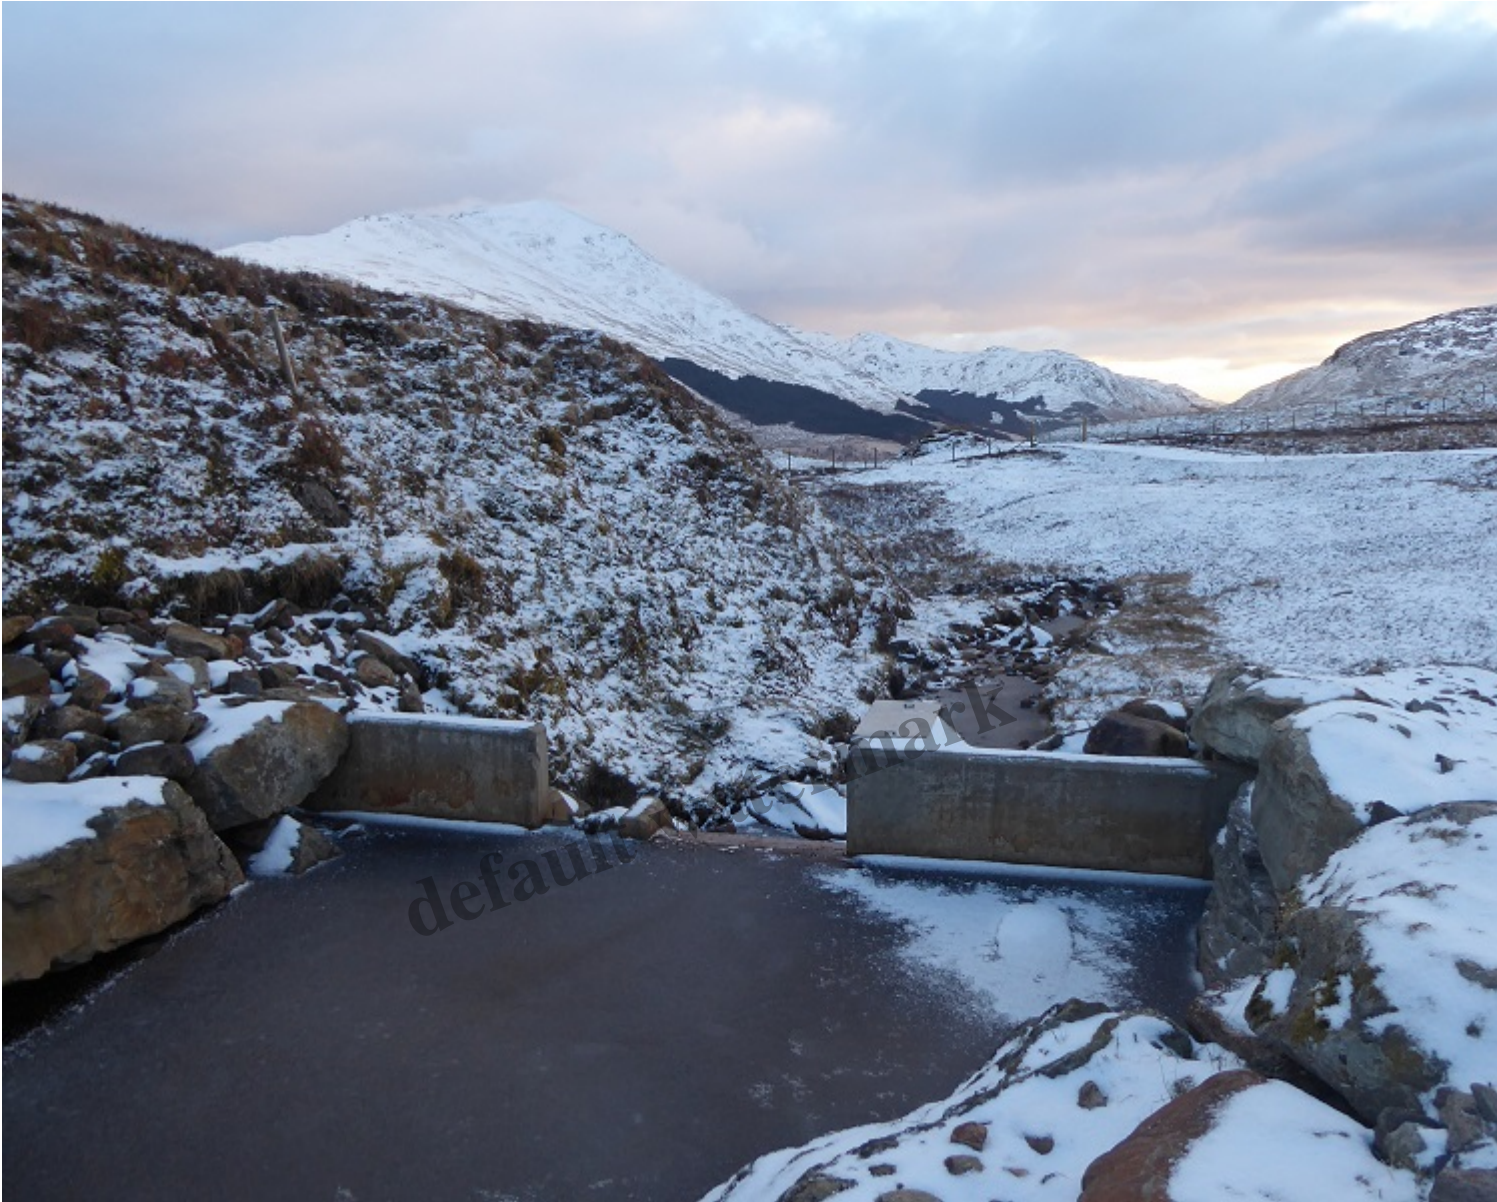
While the main intake is well located being hidden from a distance – the track, top right, is the main issue – it still does not follow LLTNPA guidance:

These boulders will almost certainly never blend in with the landscape

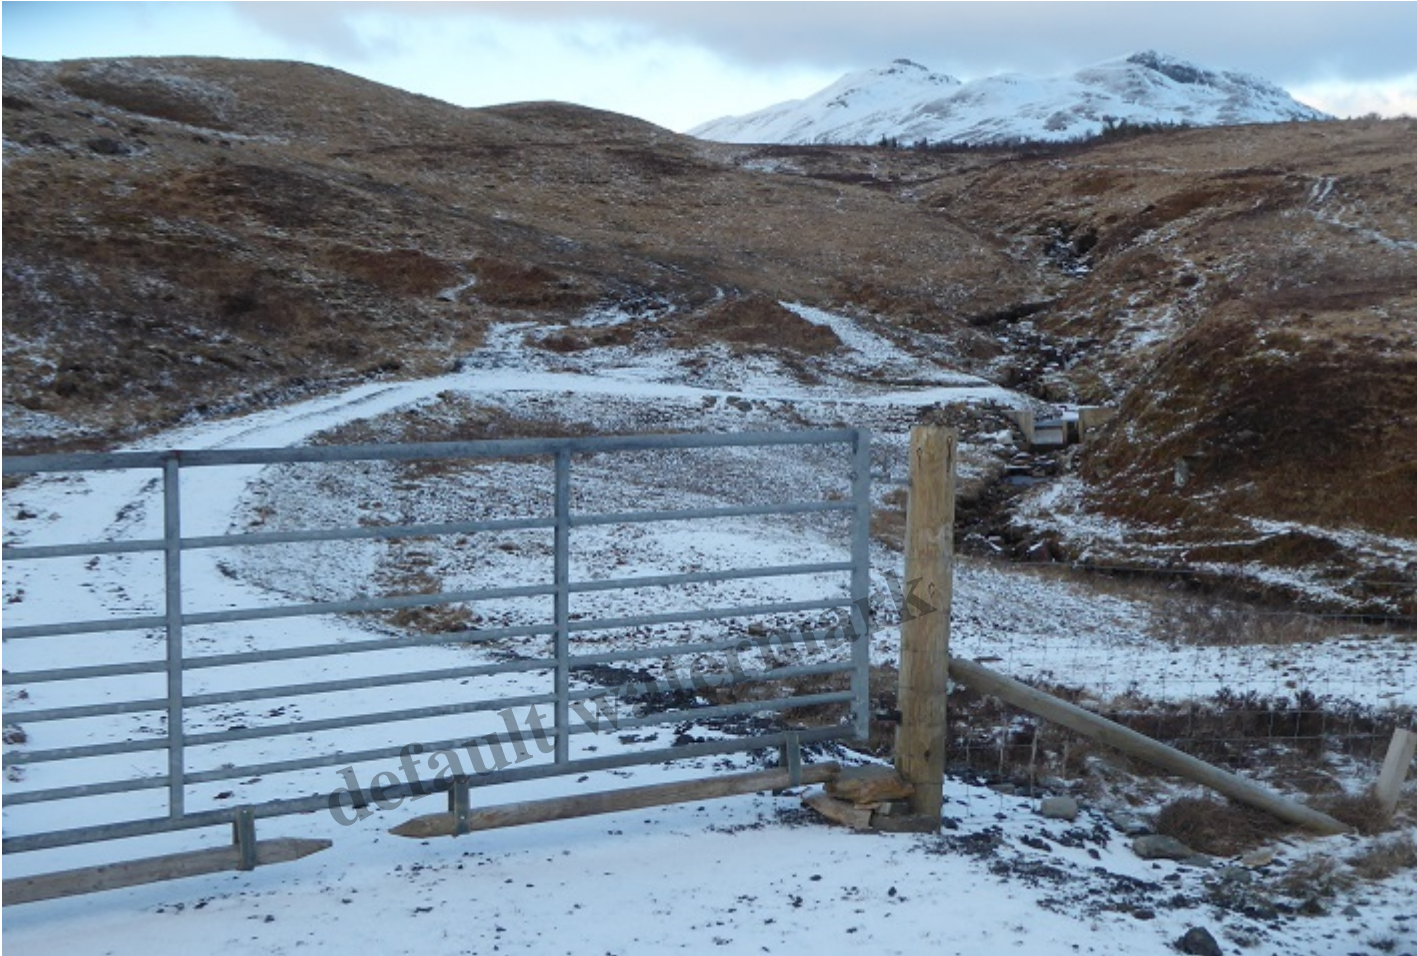
Main hydro intake with Sgiath Chuil behind. Note how the creation of the new track appears to have the creation of a new ATV track behind the gate to the left of the intake dam

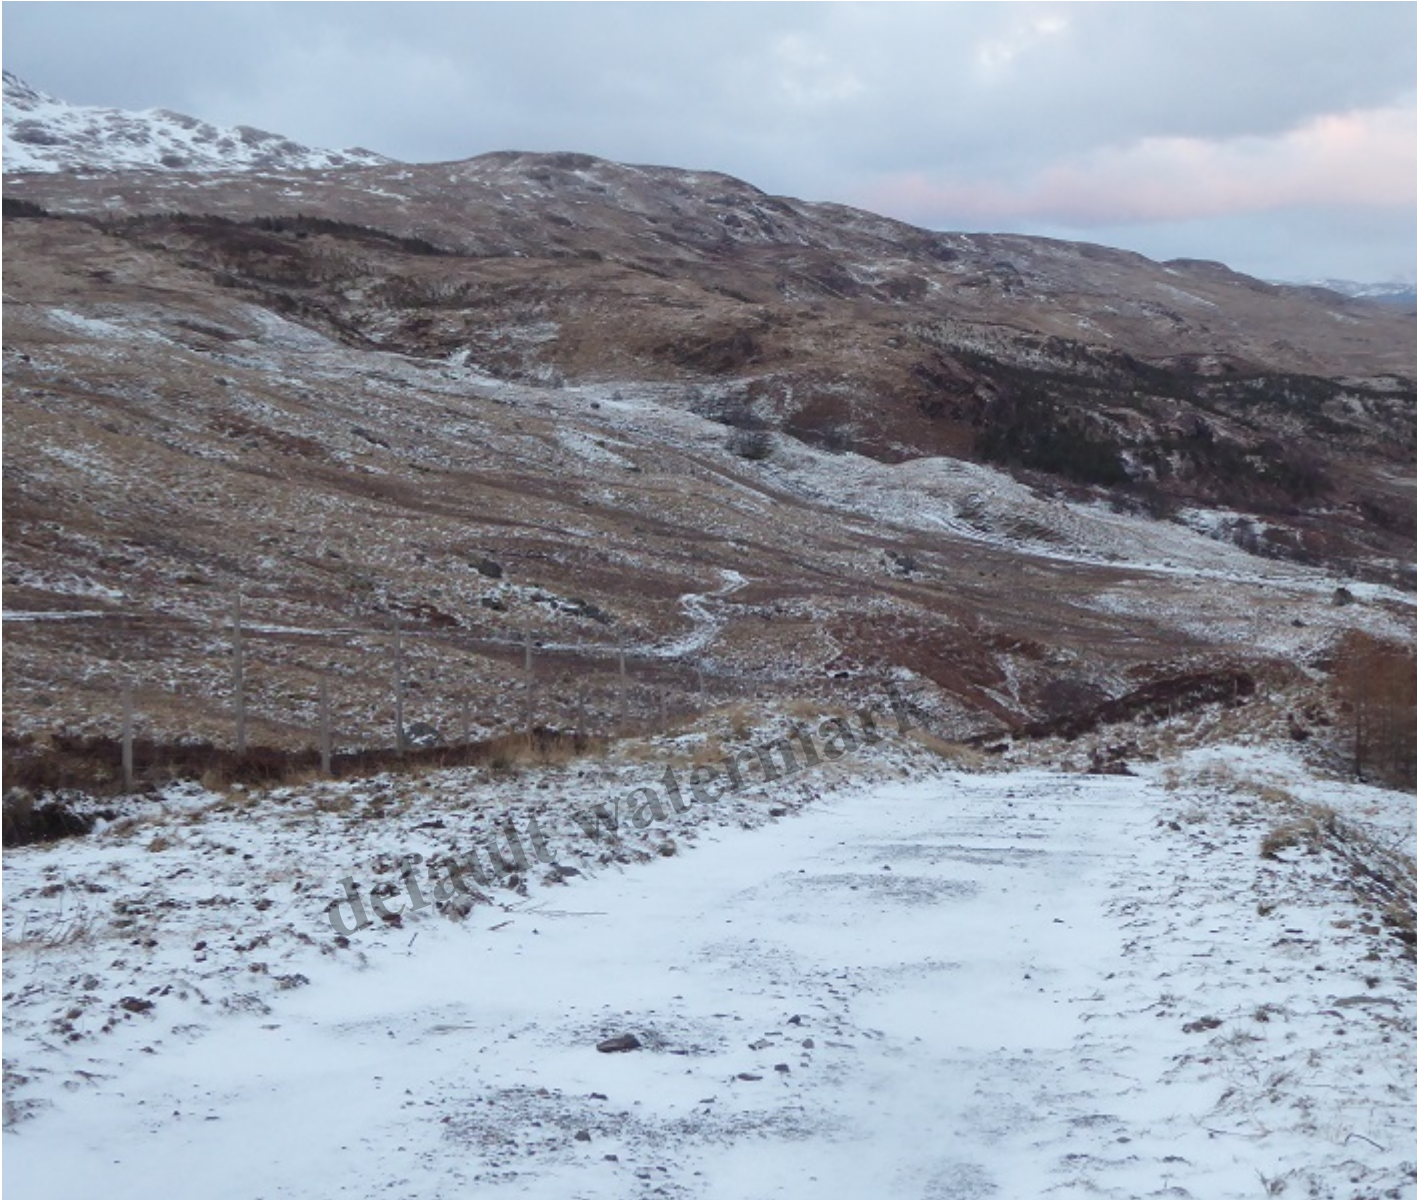
Track city – the Auchessan hydro track in background, Allt Essan hydro track in foreground – following ridge (see below) and the Auchessan ATV track inbetween on the other side of the Allt Essan

So why then does the track follow the ridge by the side of the burn?

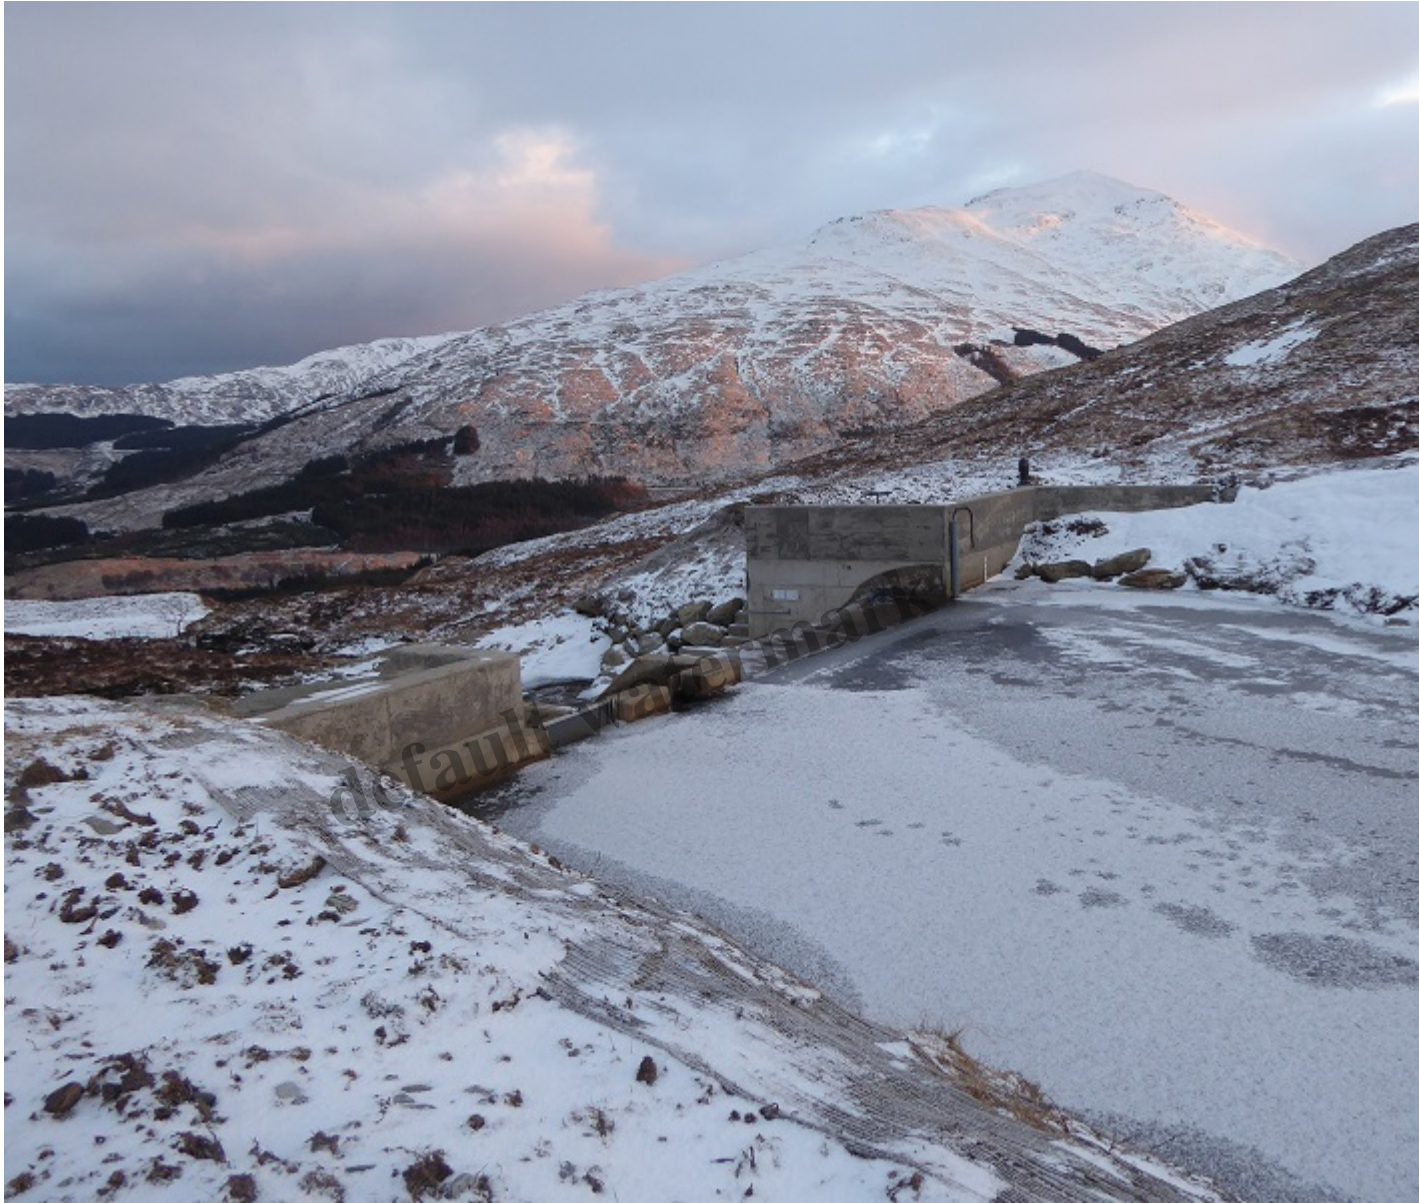
The Allt Essan intake is significantly larger than the Auchessan intake – Ben More behind. Note the use of geotextile material on banks

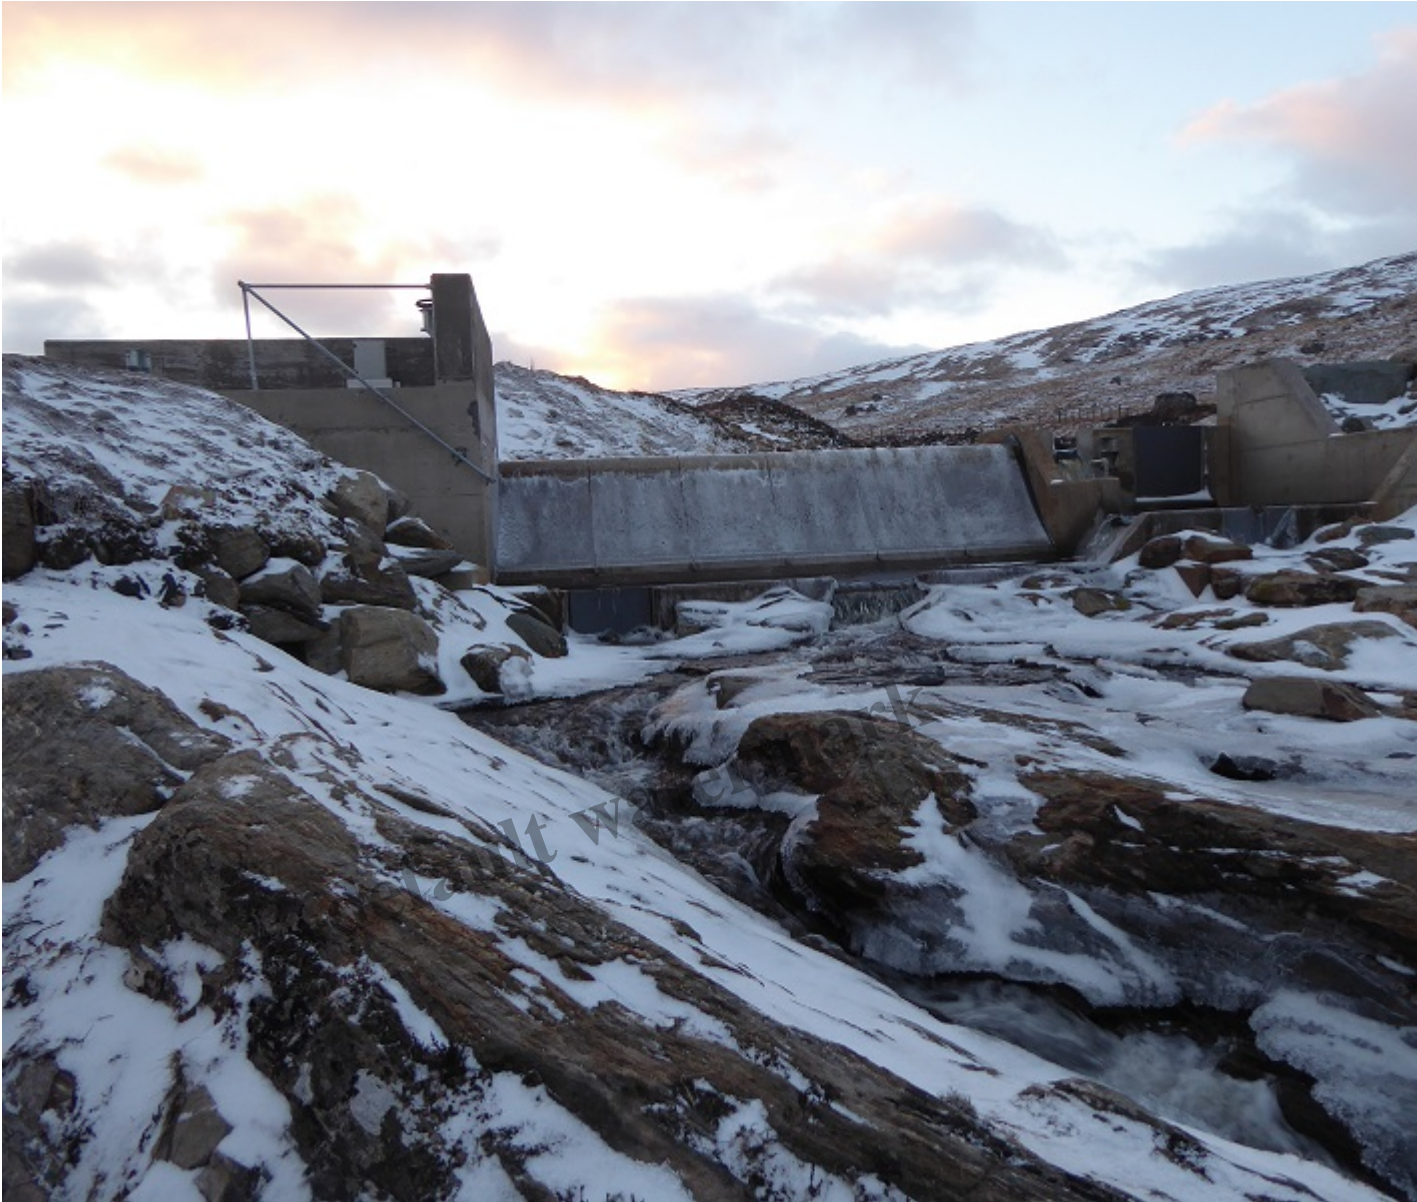
The end result, another industrial looking dam worthy of the 1950s

Little appears to have been done to ameliorate the appearance of the dam as set out in the delegated planning report which stated:

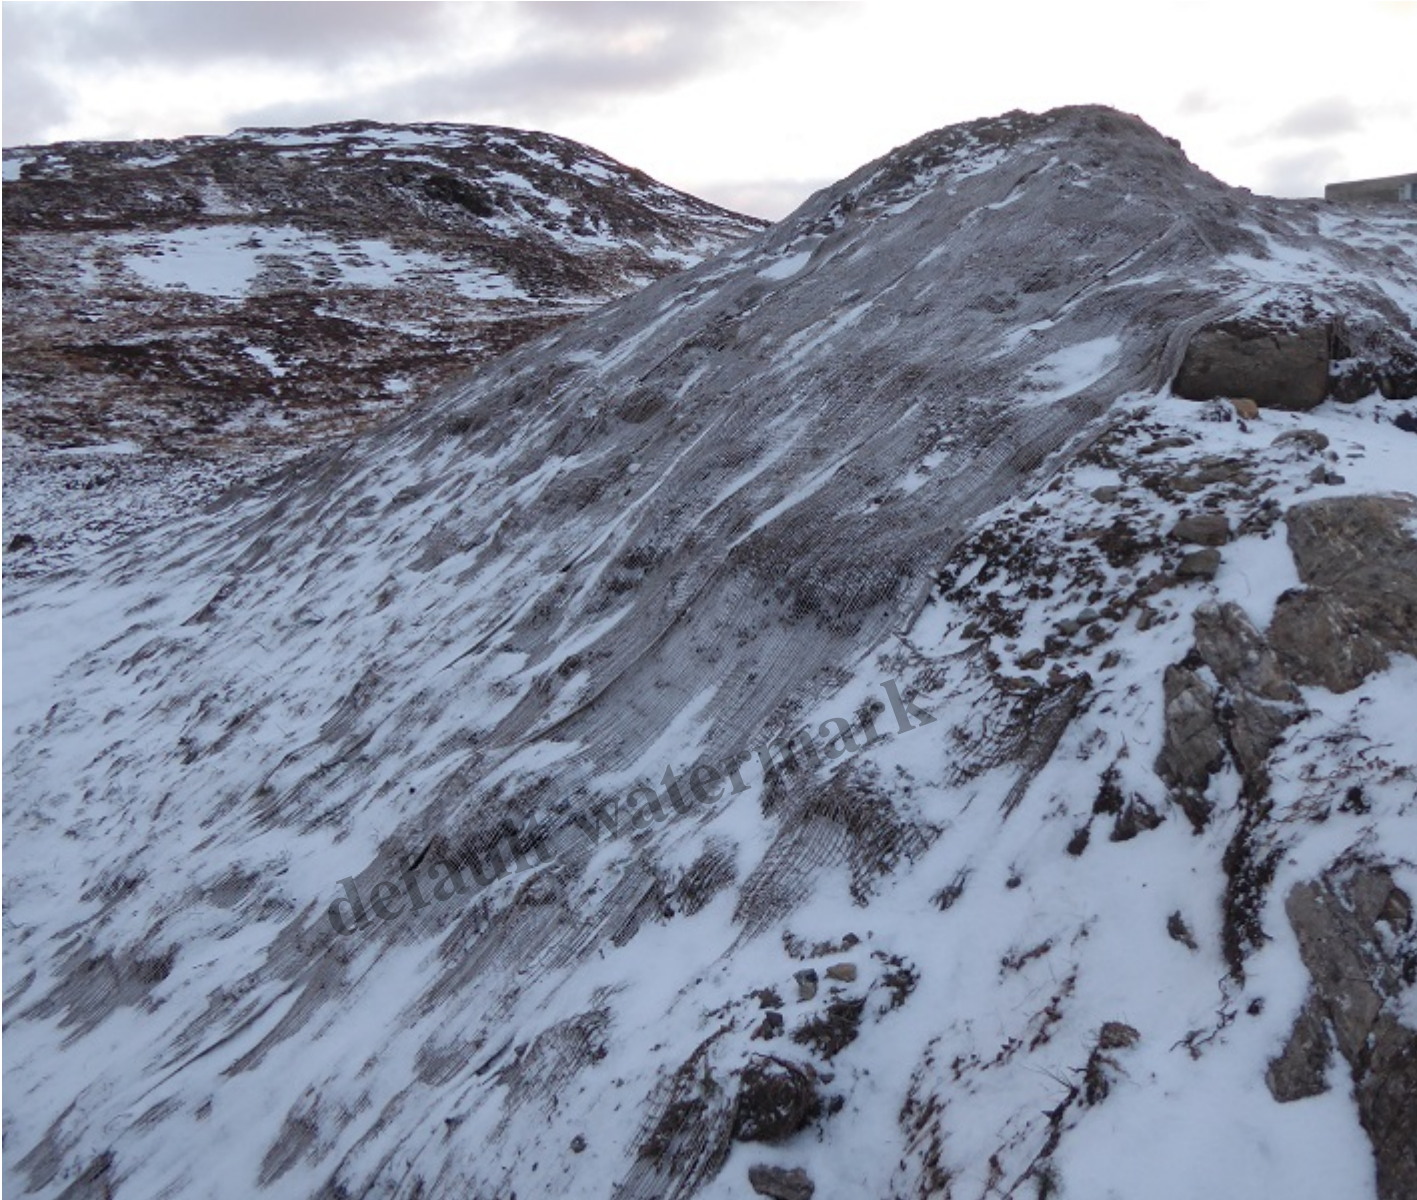
Mound of earth used to conceal intake from below

The earth screen is far too steep-sided, held together by textile and does not fit with the landscape. Here is the LLTNPA Guidance again:

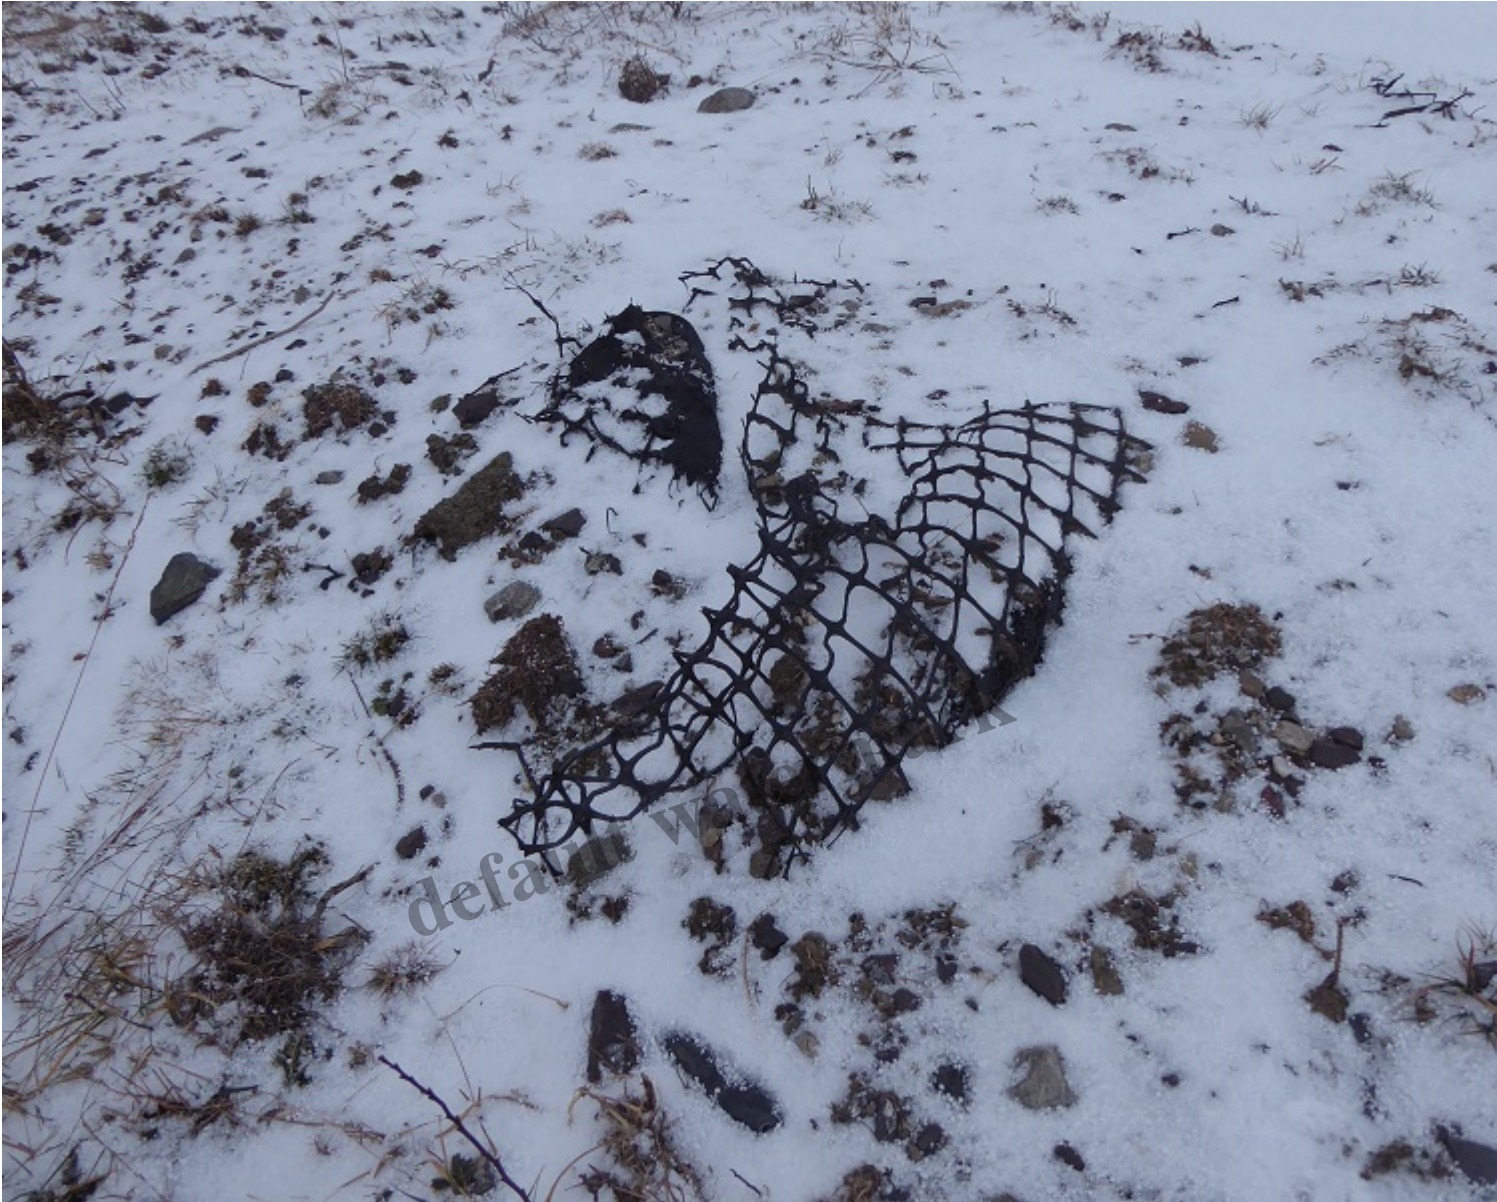
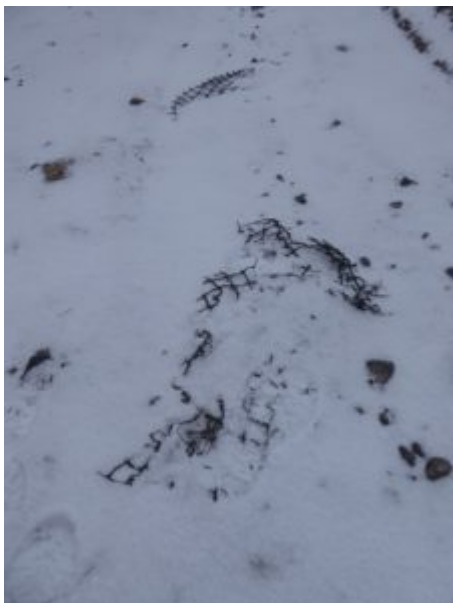
Netting embedded in surface  
of track

It got worse as, not long after I started down the new Allt Essan hydro track, I realised much of it and the ground at the sides was being held together with plastic garden netting partially concealed in the snow. The LLTNPA makes no mention of plastic, which does not biodegrade for hundreds of years and then when it does poisons organisms, being used to restore ground in its best practice Guidance on Renewables but it appears to have played a fundamental role in the “restoration” of ground at Allt Essan. Time that Guidance was updated!

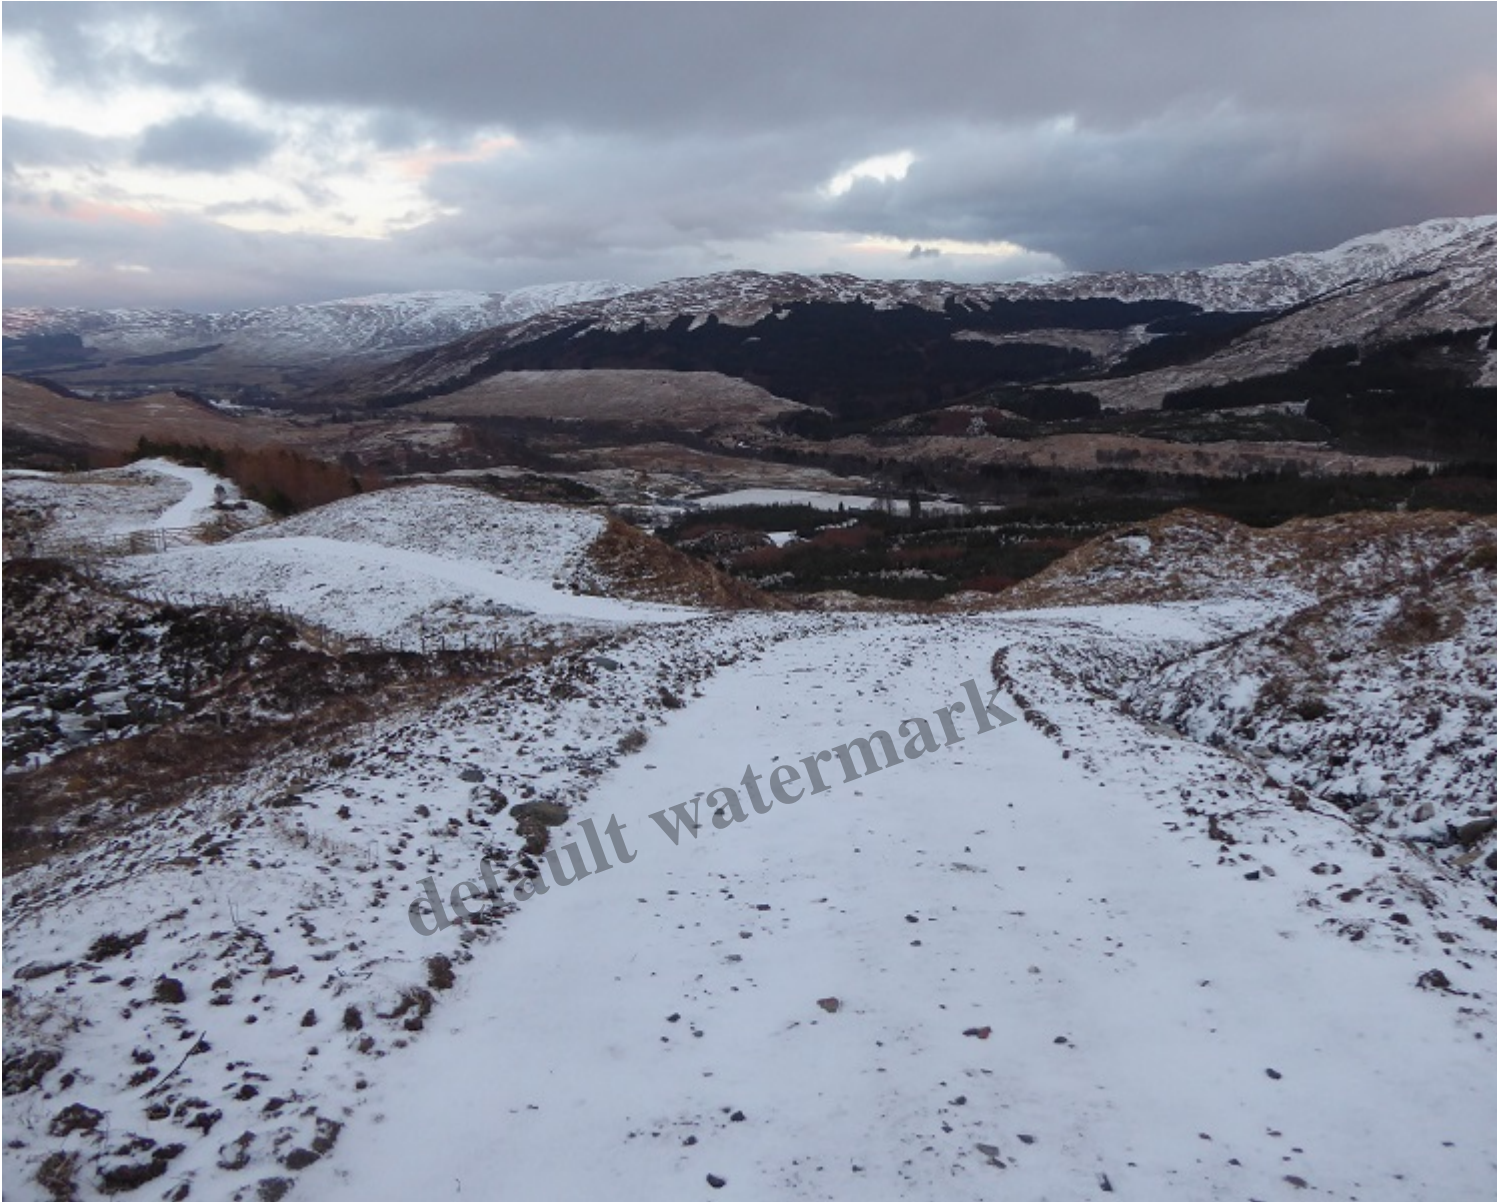
The track below is a motorway which carves its way around and over what was a fine line of moraine.

The Planners were concerned about the visibility of the Allt Essan track from the A85 – it is visible from there in places – but the real impact is for people out for a walk in the surrounding hills. The tracks here have changed the character of the glen. What is the point of Landscape Character Assessments if this is then allowed to happen?
