## The Allt Essan and Auchessan Hydro schemes in Glen Dochart

Looking down onto the Allt Essan (power house centre photo and tracks through forestry) and Auchessan (power house above and left of Allt Essan power house leading to top left corner of photo) hydro schemes from Ben Alder. Photo taken in 2017.

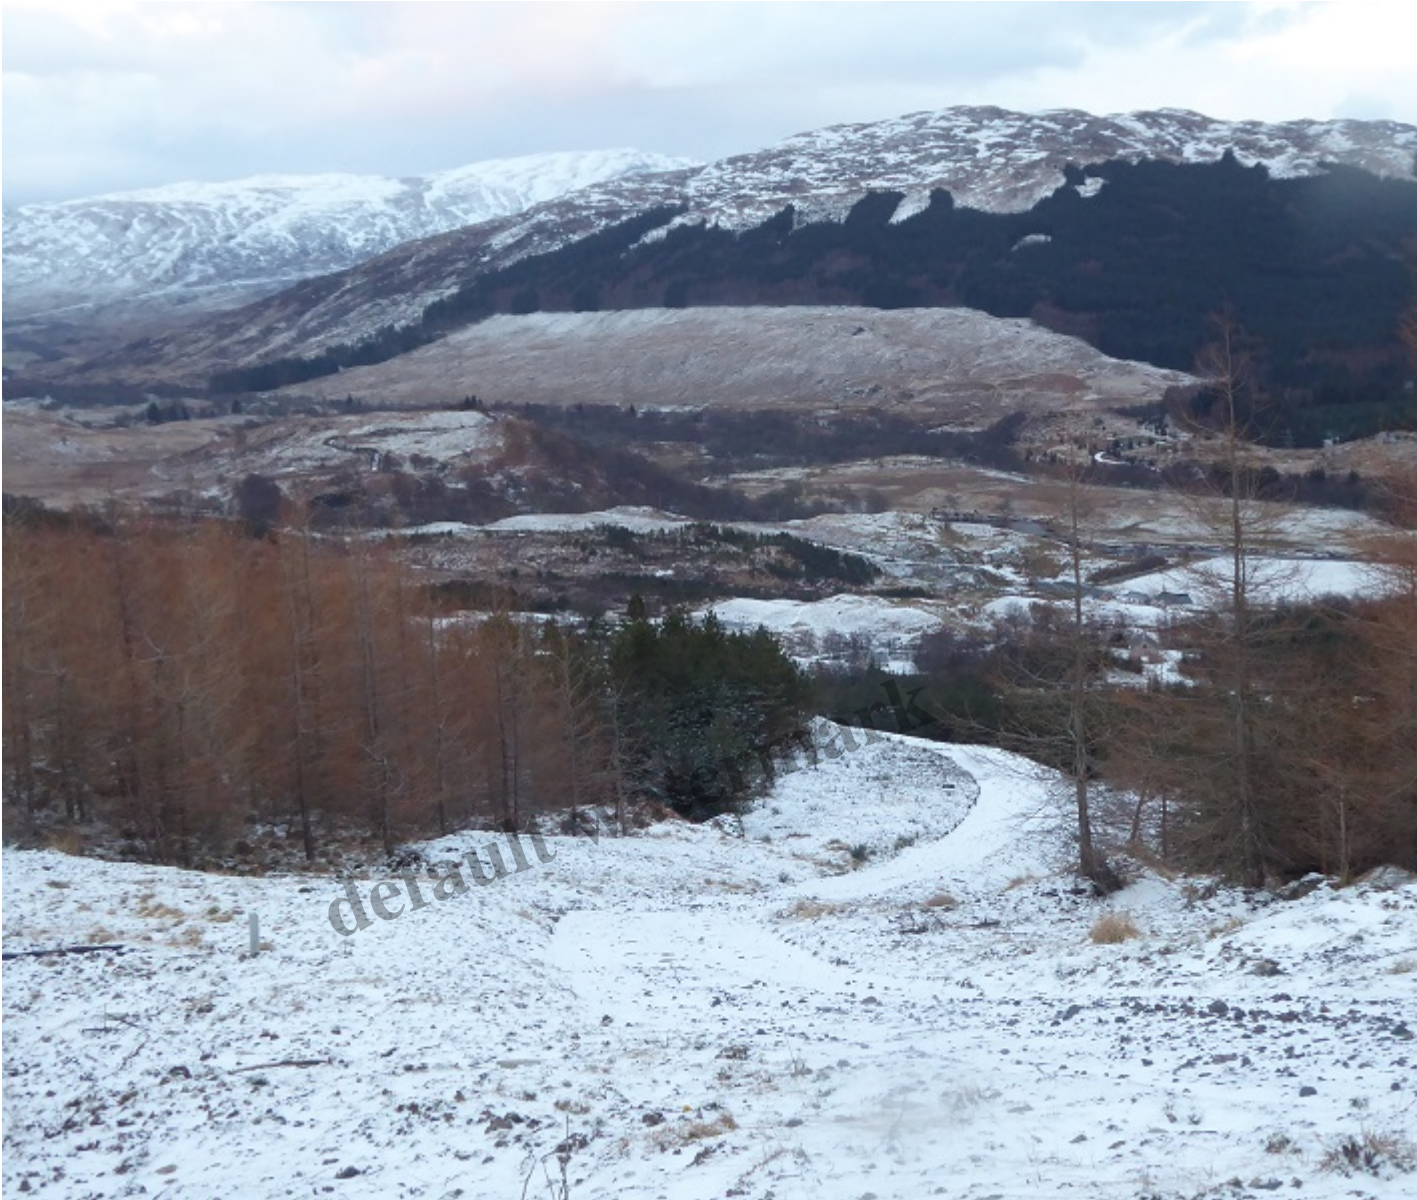
Pipeline on left of track marked by concrete posts

While most of the track runs through forestry, a wide swathe was cut through trees to create the pipeline with the result it is highly visible. Could the LLTNPA not have required a narrower construction corridor? Here is the Park's own Guidance again:

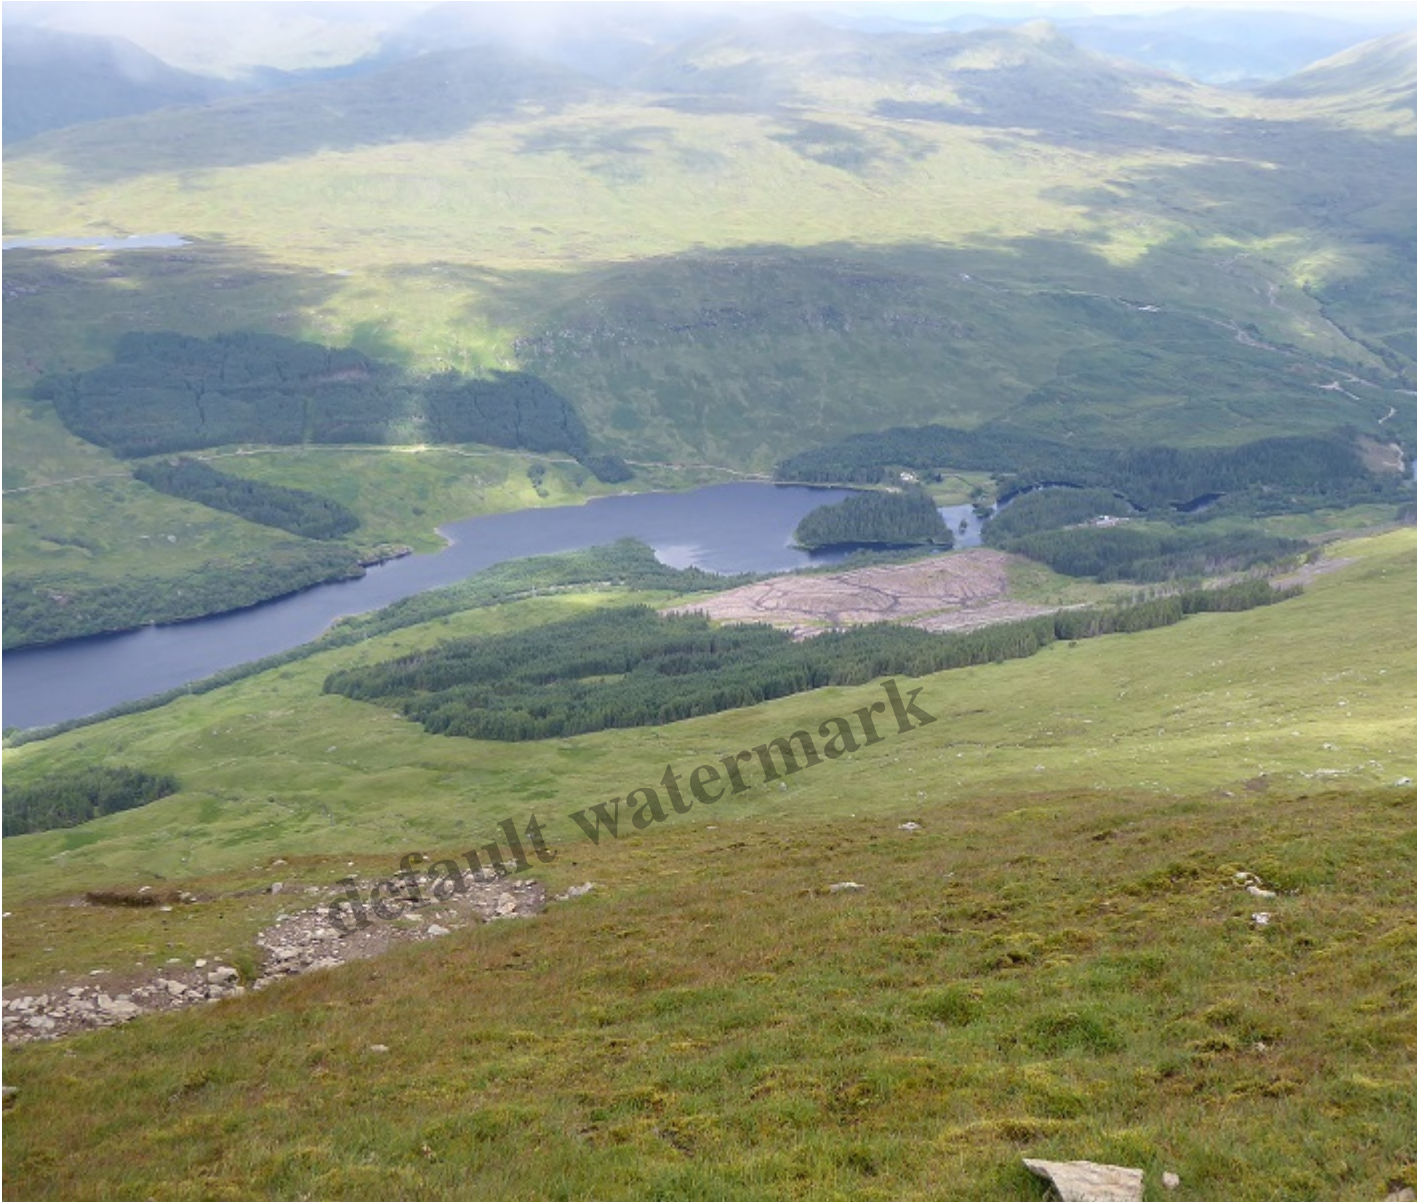
View of Allt Essan and Auchessan hydro tracks (right) from upper slopes of Ben More – note how the track basically follows the ridge and is therefore particularly prominent
