The Allt Essan and Auchessan Hydro schemes in Glen Dochart

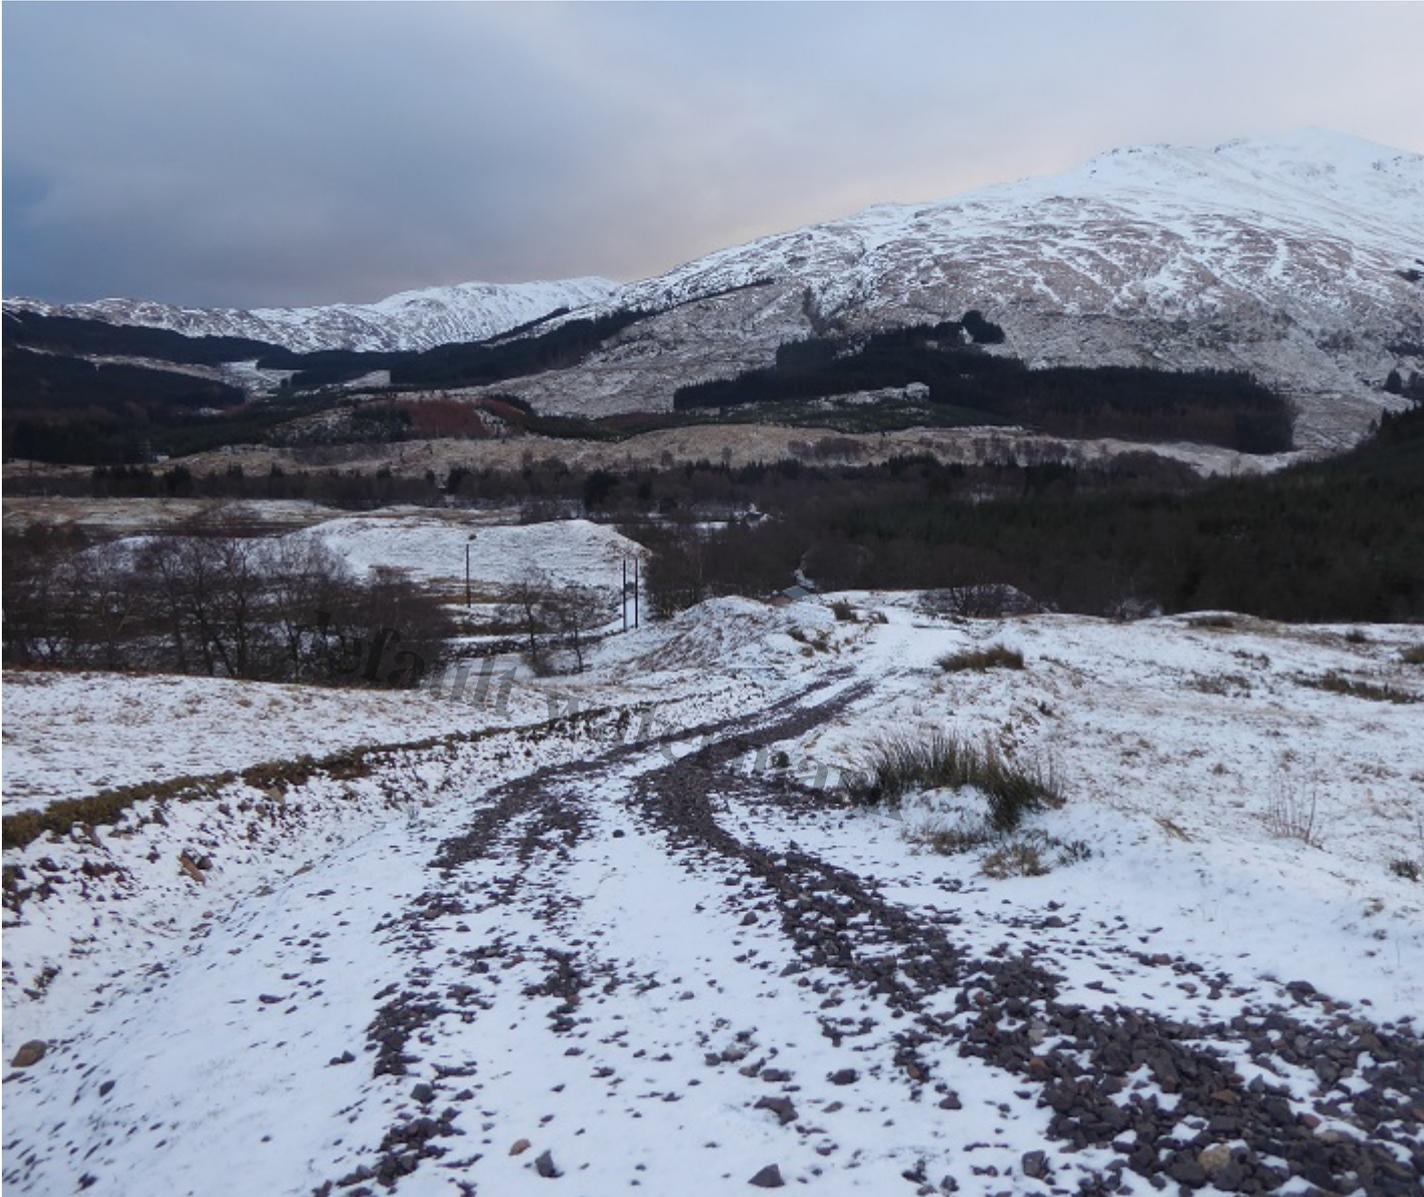
What struck me immediately running up the track, the first section of which had preceded the hydro but has been "upgraded", by being widened and having new aggregate dumped on the surface, is that it is far too steep:

Looking down track, powerhouse centre with Auchessan Farm behind and Ben More right.

In the lower “upgraded” section of track there has been a failure to retain and use turf to line the left hand side of the track/drainage ditch with a consequence this too will erode. Because the LLTNPA has not published the Construction Method Statement and Landscape Restoration Plan it required as a condition of the planning consent, its not possible to tell if proper plans were ever agreed and whether this is another failure by the LLTNPA to enforce planning conditions. Whatever the case, the design and execution of the work is extremely poor.

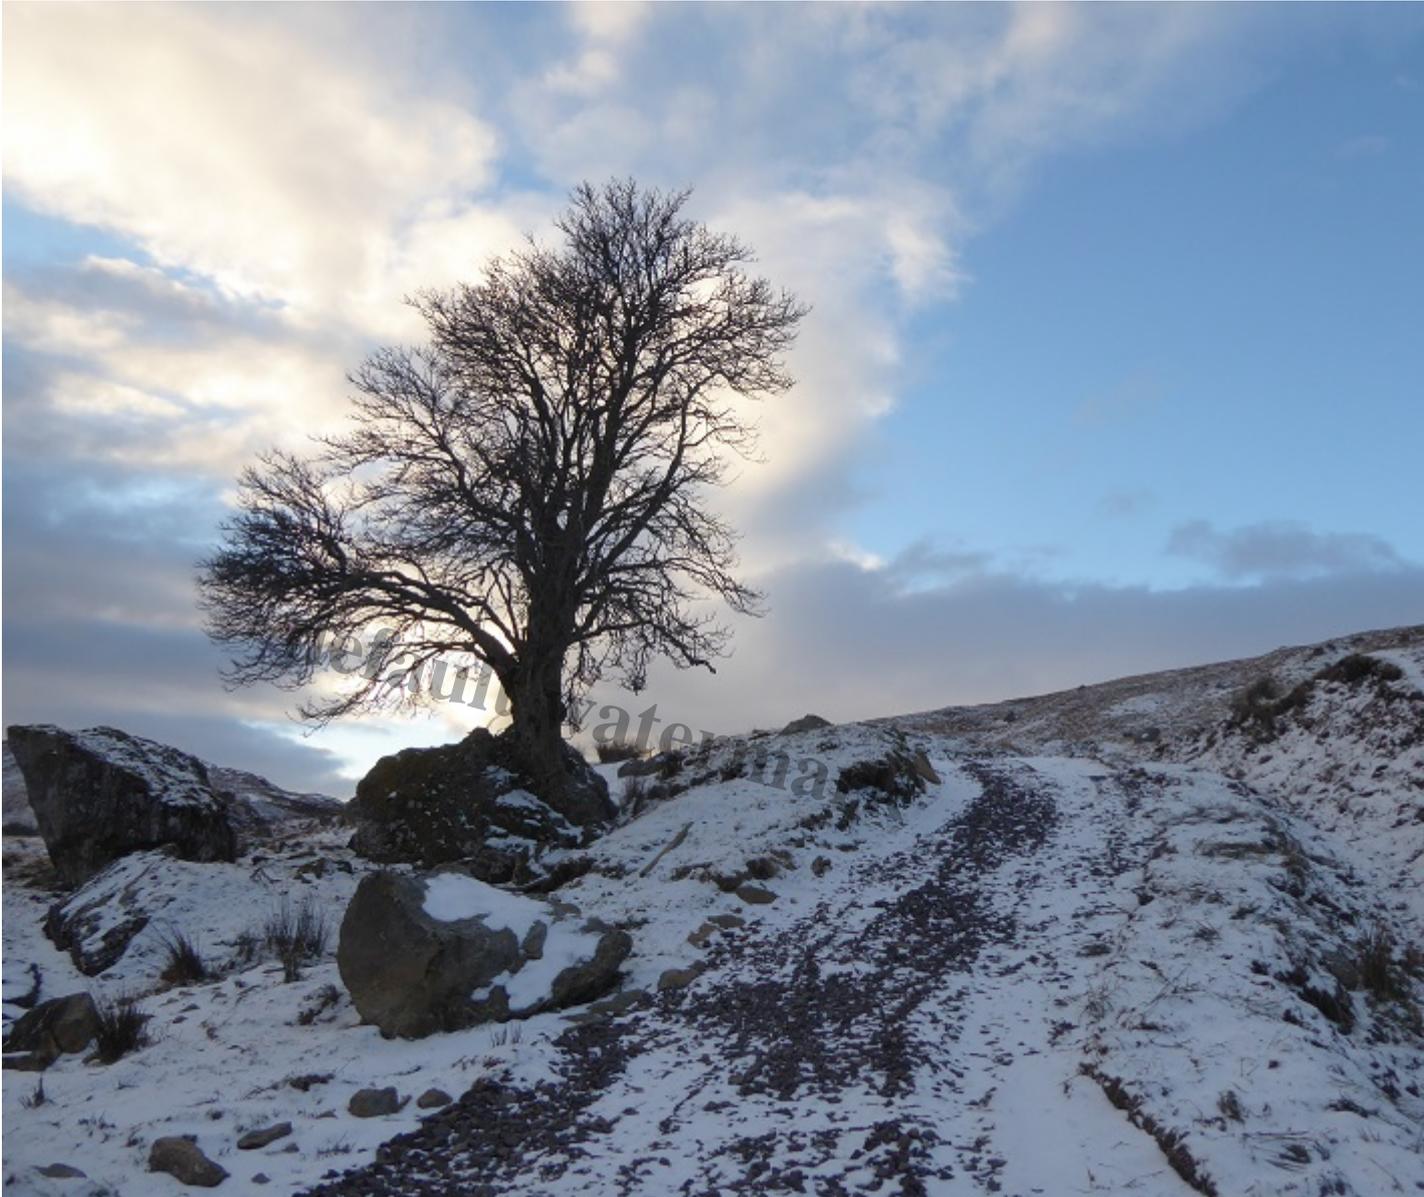
Higher up, while the track was still too steep, a section has been narrowed and the edges finished w as per Park Guidance and the planning conditions â?? but note the bare bank on the right.

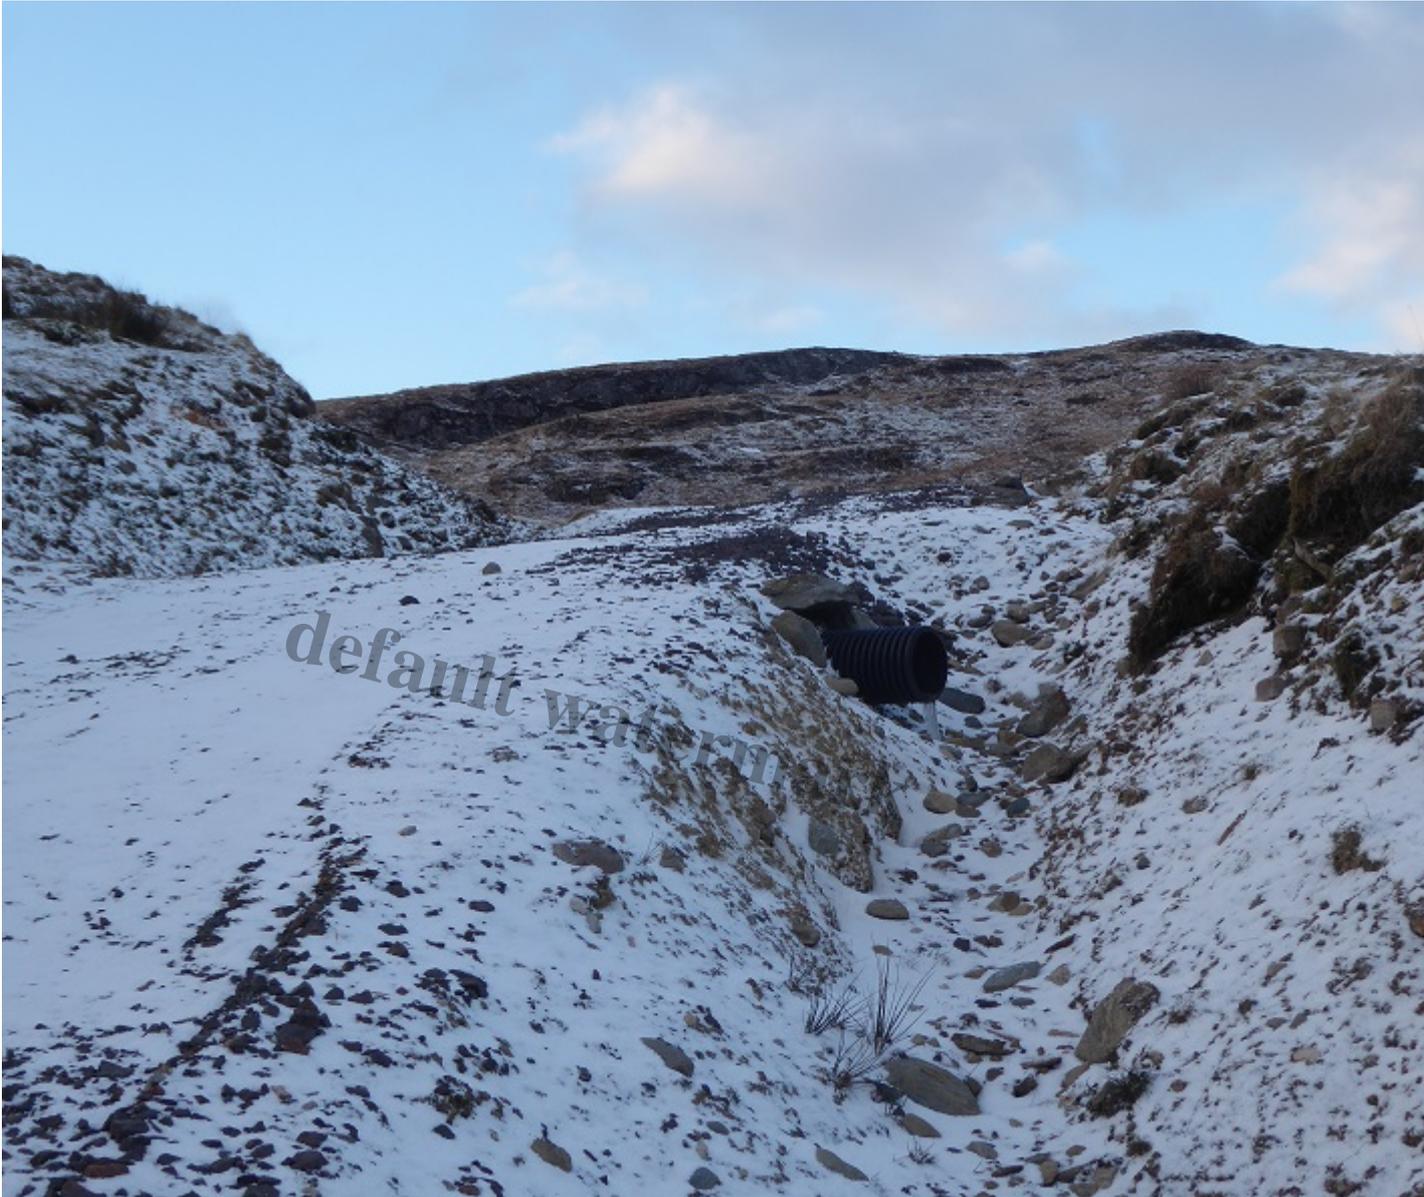
While in its Supplementary Guidance on Renewables the LLTNPA refers developers to SNH Guidance on Constructed Tracks in the Scottish Uplands, nowhere does it say anything explicitly about the angle of hill tracks. SNHâ??s guidance states that the angle should not exceed 14 degrees â?? because the evidence is any steeper than this and tracks erode. The LLTNPA, however, has rarely given any consideration to the steepness of tracks and as a consequence is creating erosion problems for the future (whatever the wider landscape impact).

This section of track totally fails to meet the requirements of the LLTNPA's guidance and not protruding culvert

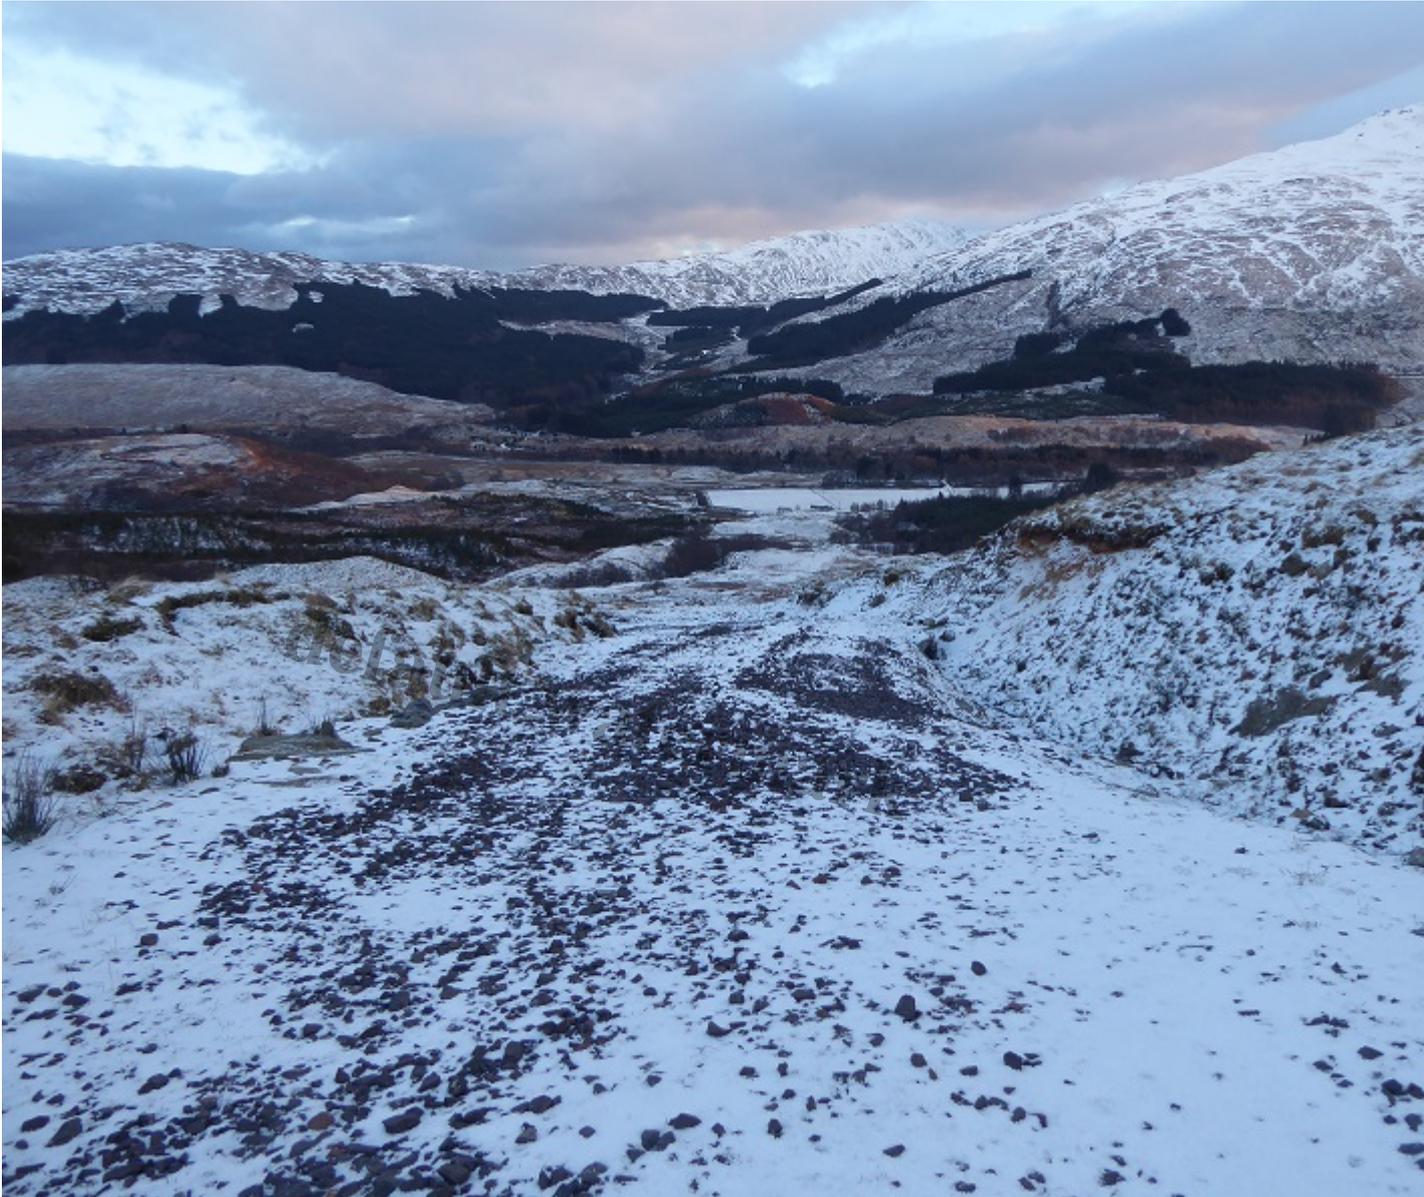
None of these recommendations are evident in the photo above or below:

Higher up there was less evidence of any attempt to restore the track properly in contravention of LL guidance which states *“complete batters at time of road construction”*.

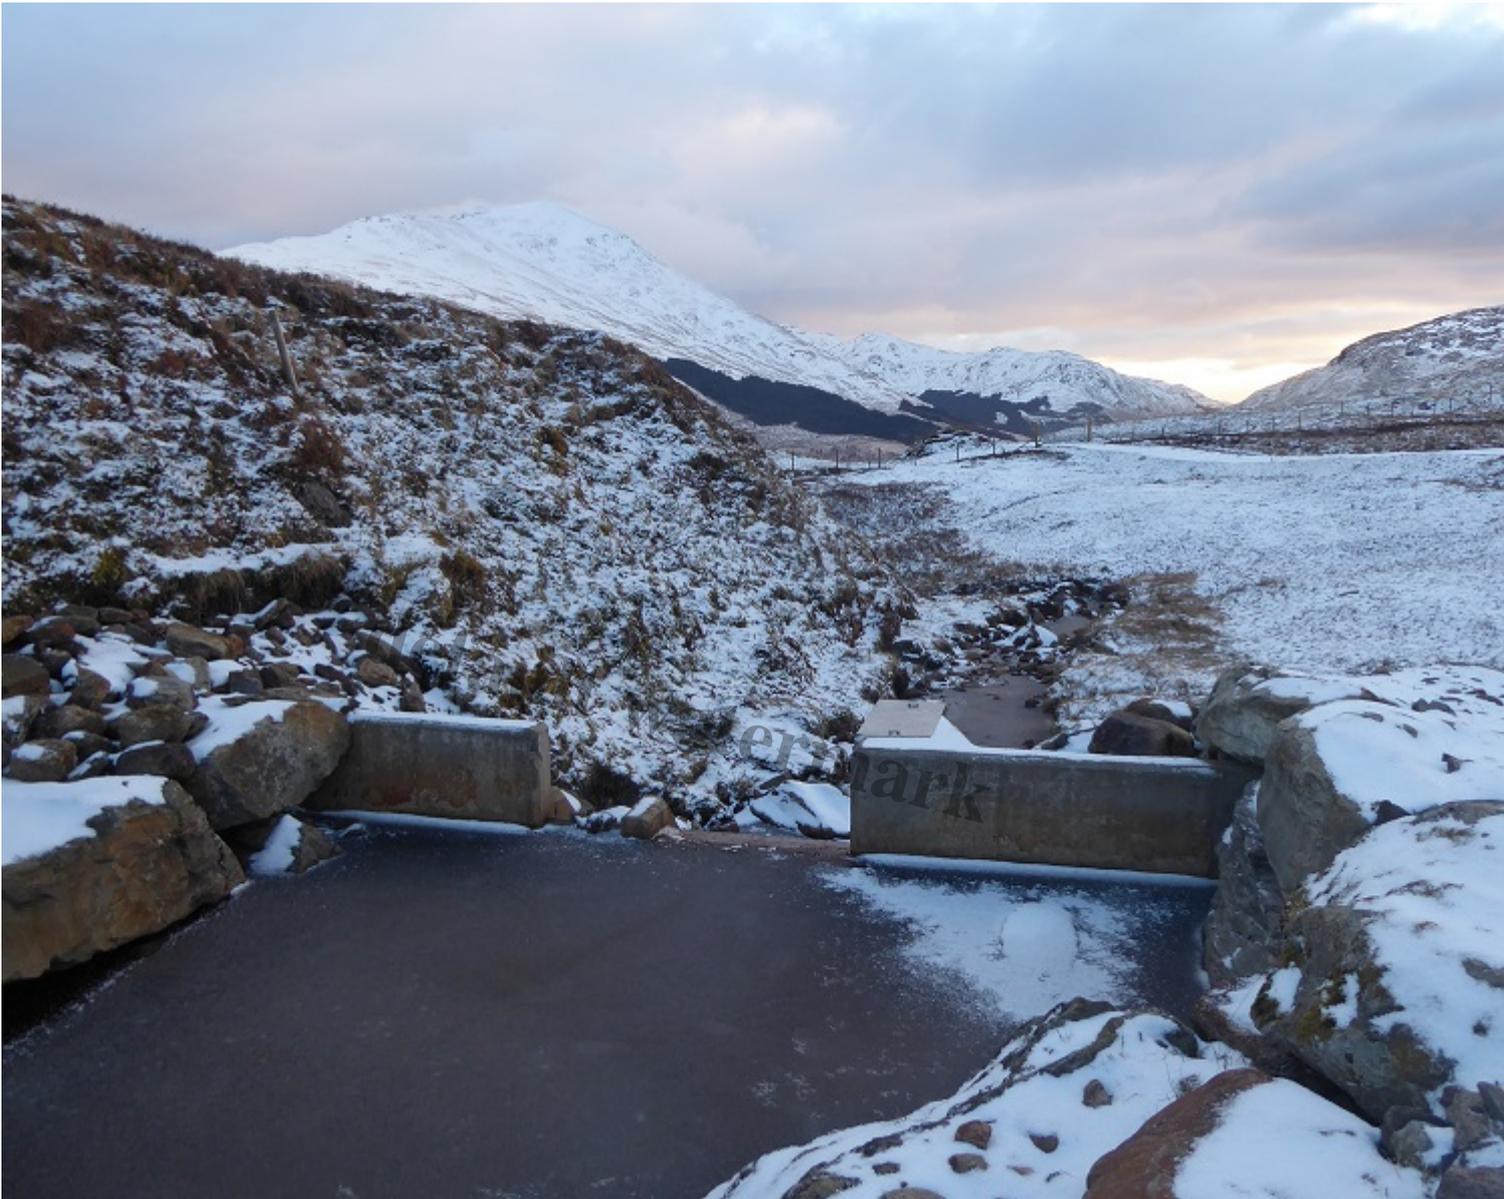
While the main intake is well located being hidden from a distance – the track, top right, is the main issue – it still does not follow LLTNPA guidance:

These boulders will almost certainly never blend in with the landscape

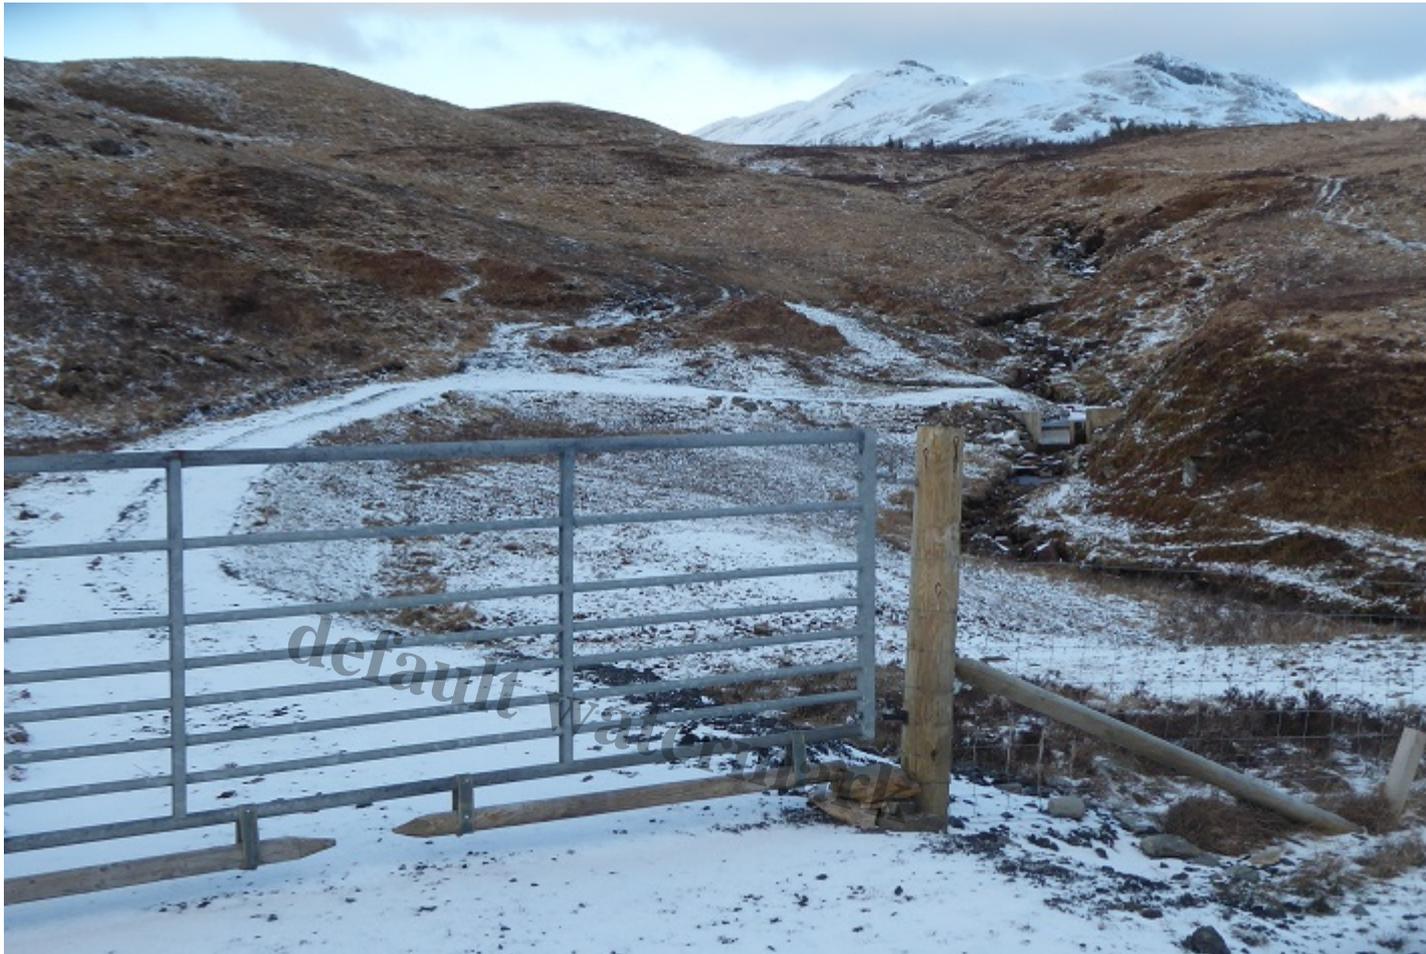
Main hydro intake with Sgiath Chuil behind. Note how the creation of the new track appears to have the creation of a new ATV track behind the gate to the left of the intake dam

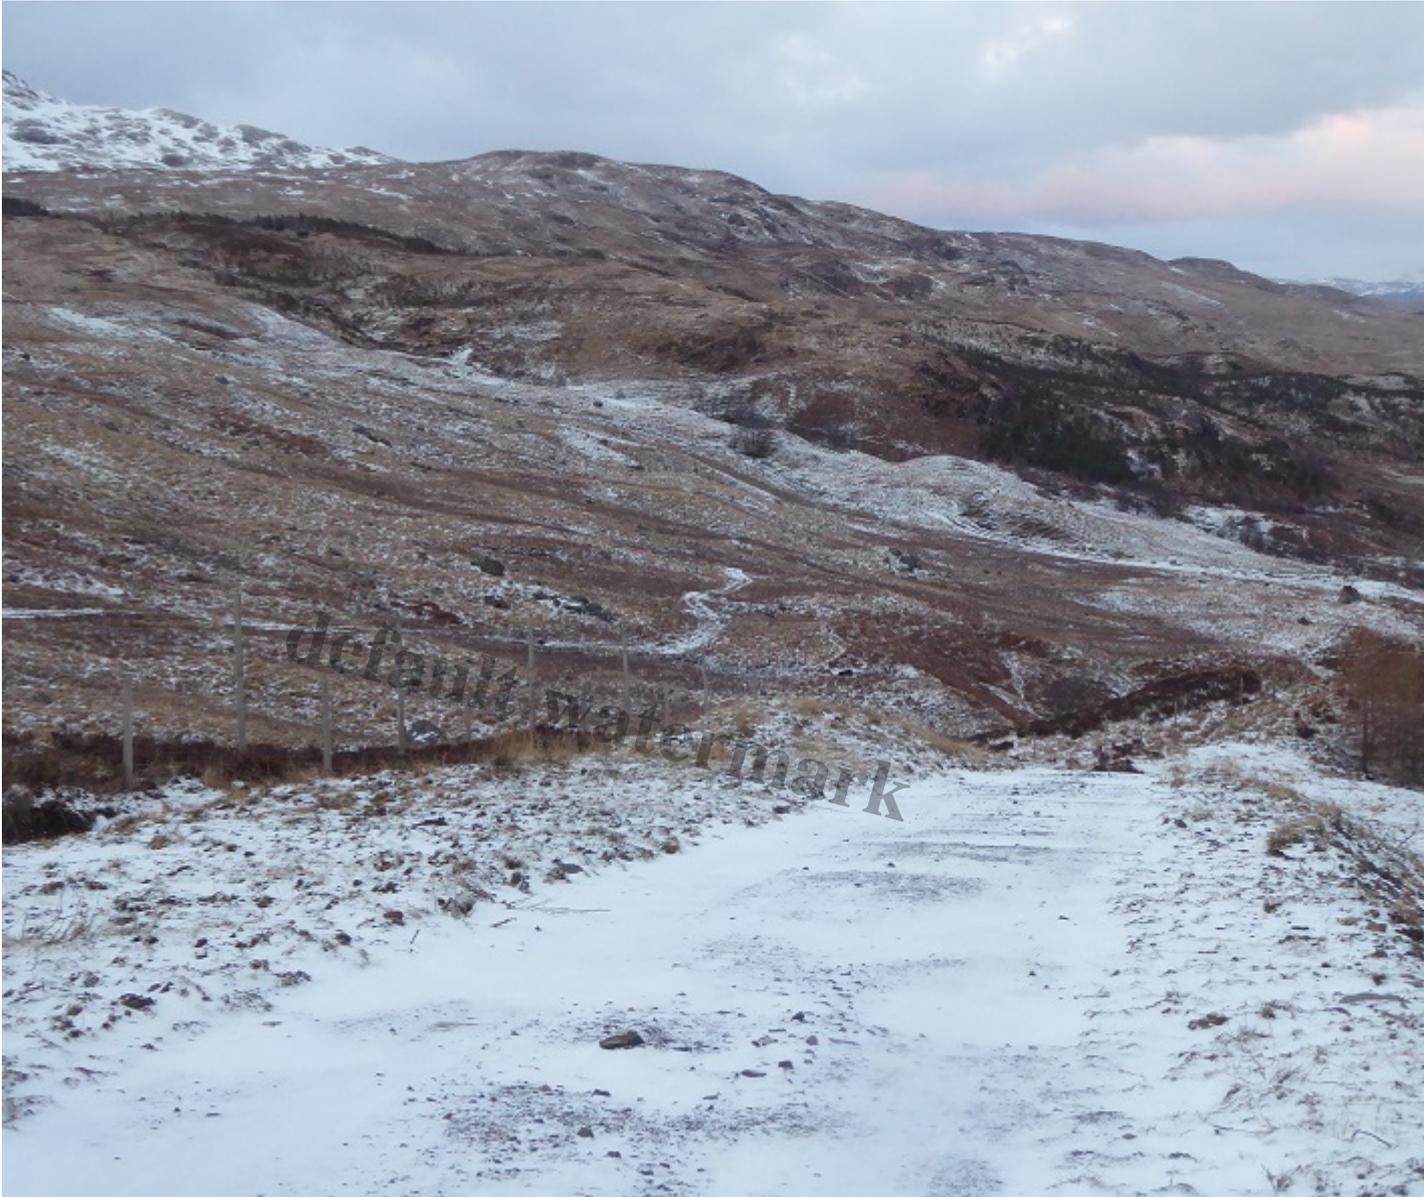
Track city ??? the Auchessan hydro track in background, Allt Essan hydro track in foreground ??? fo
of ridge (see below) and the Auchessan ATV track inbetween on the other side of the Allt Essan

So why then does the track follow the ridge by the side of the burn?

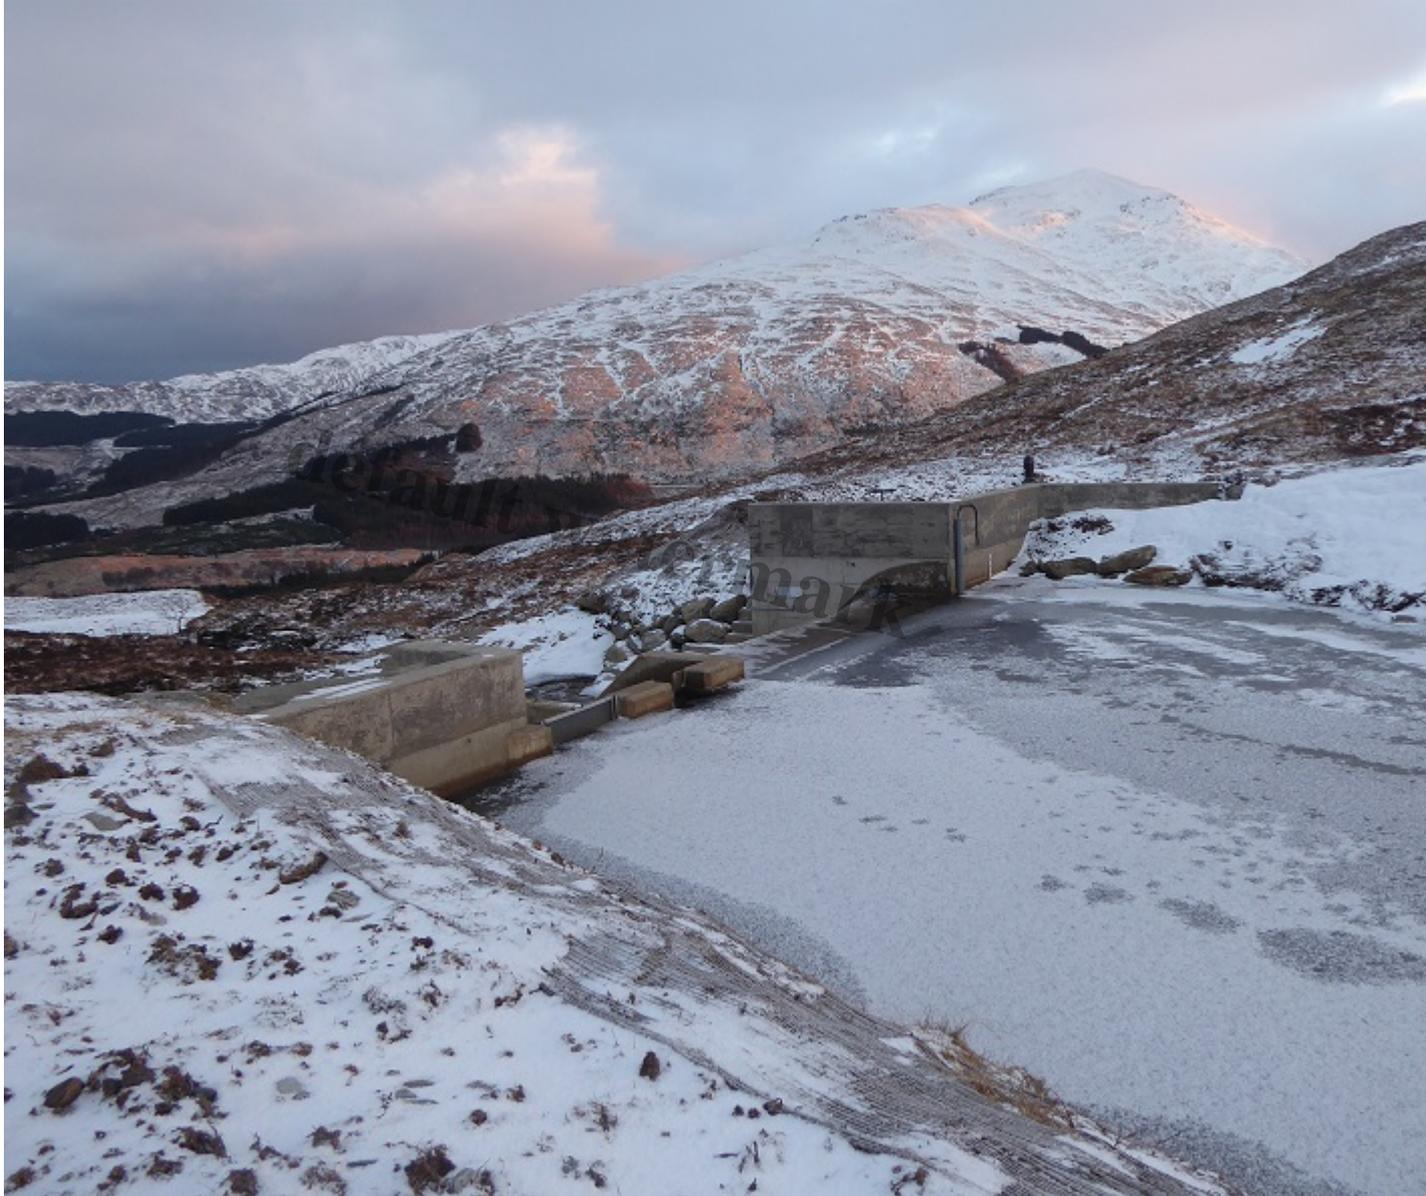
The Allt Essan intake is significantly larger than the Auchessan intake – Ben More behind. Note the geotextile material on banks

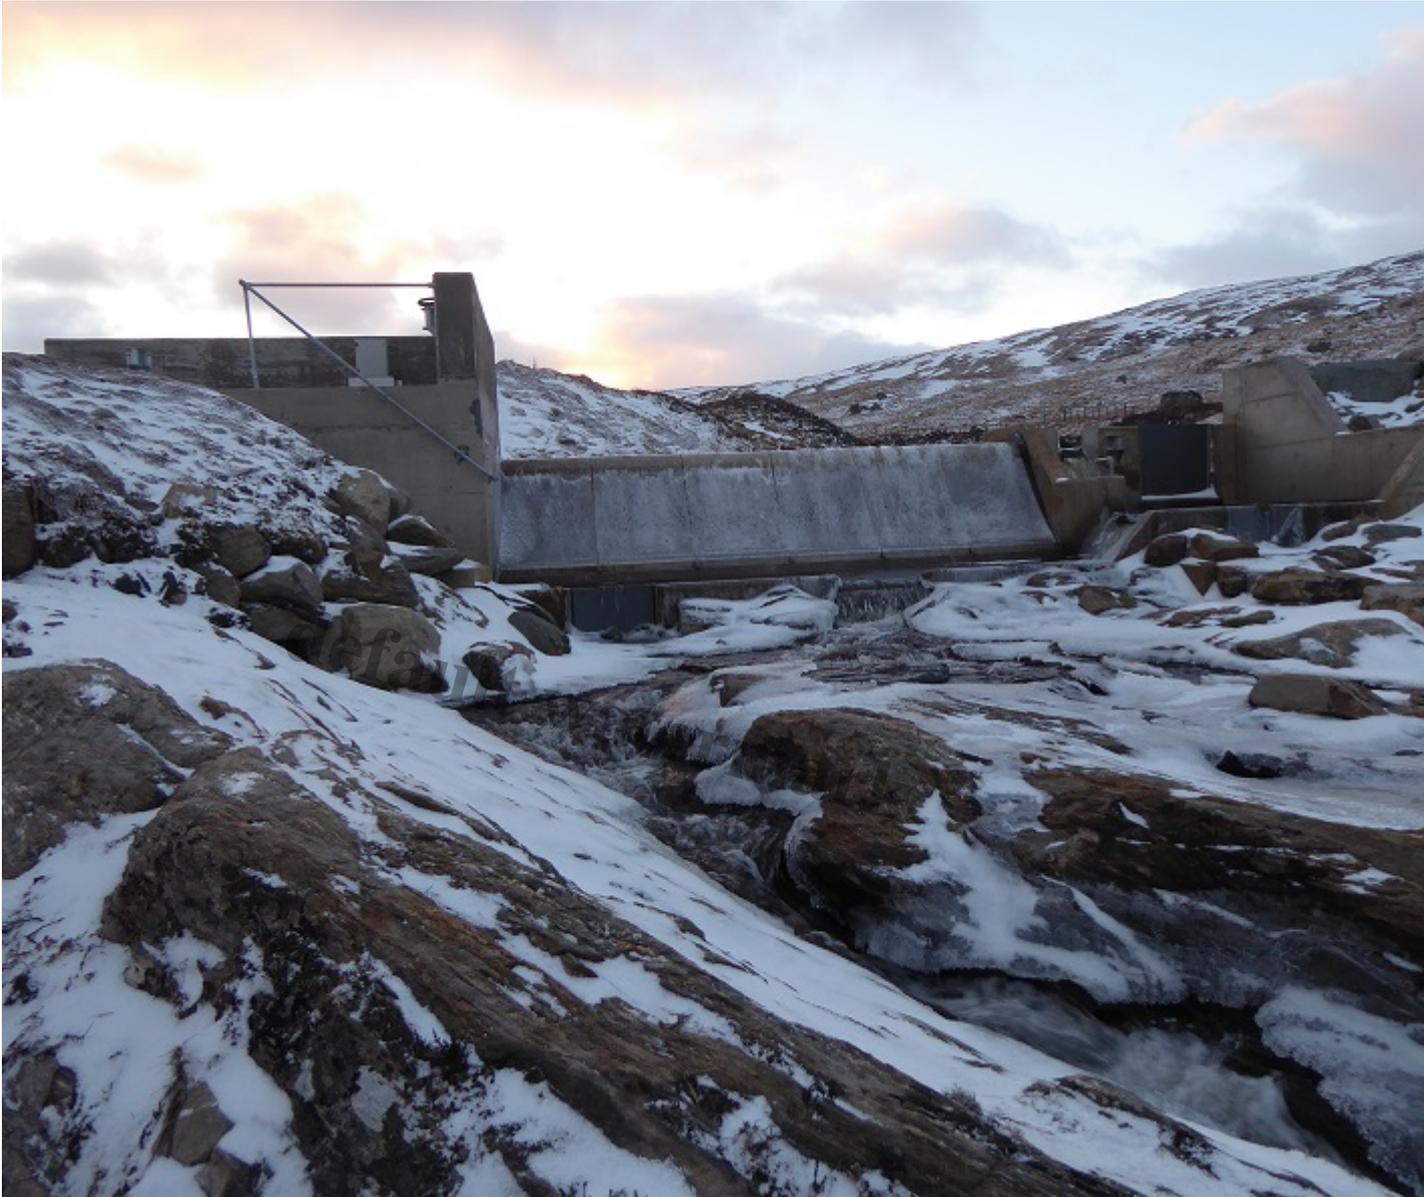
The end result, another industrial looking dam worthy of the 1950s

Little appears to have been done to ameliorate the appearance of the dam as set out in the delegated planning report which stated:

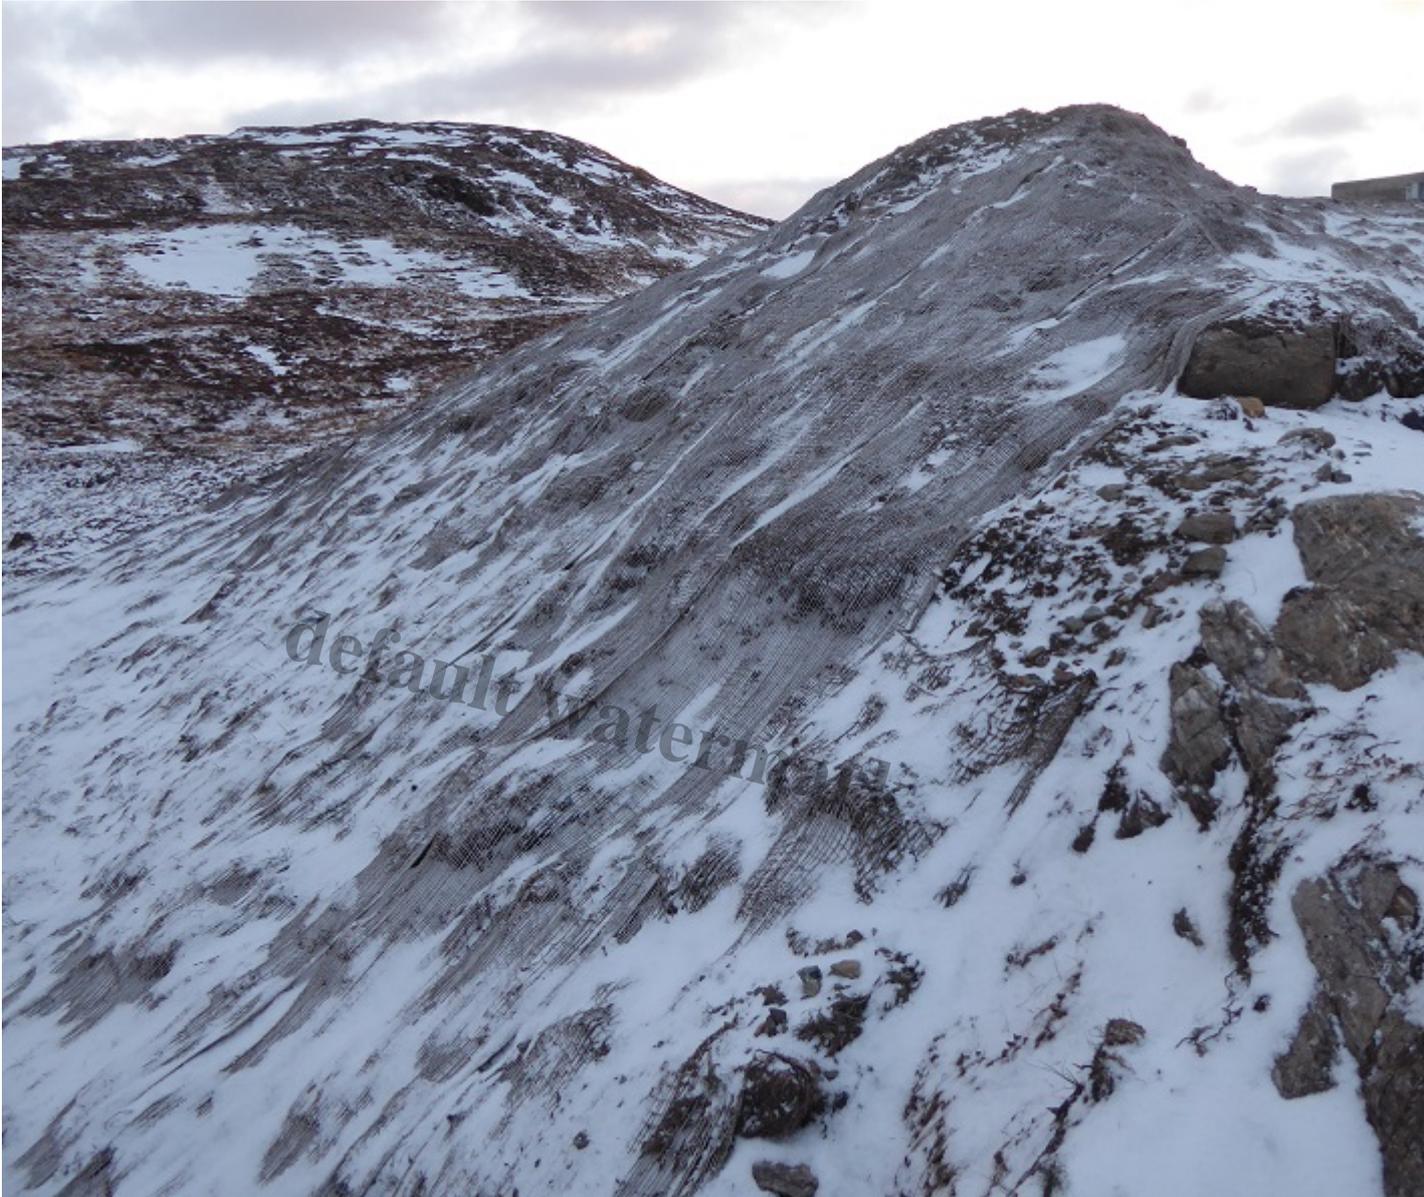
Mound of earth used to conceal intake from below

The earth screen is far too steep-sided, held together by textile and does not fit with the landscape. Here is the LLTNPA Guidance again:

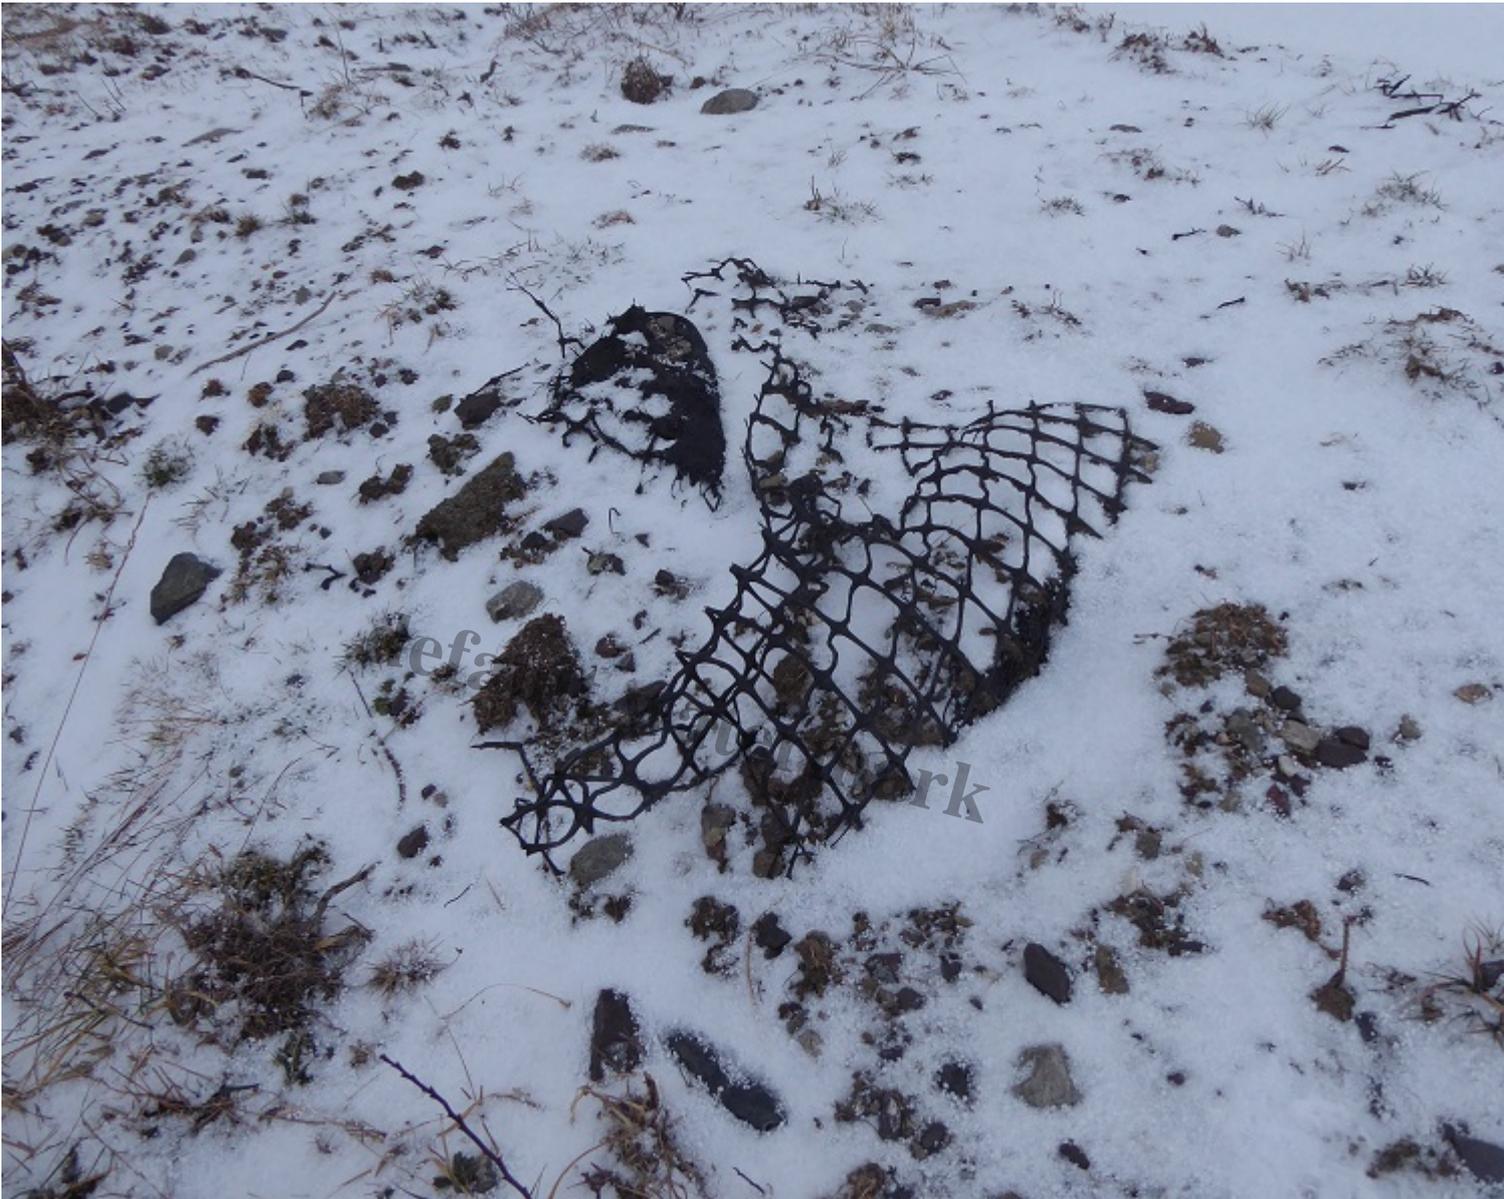
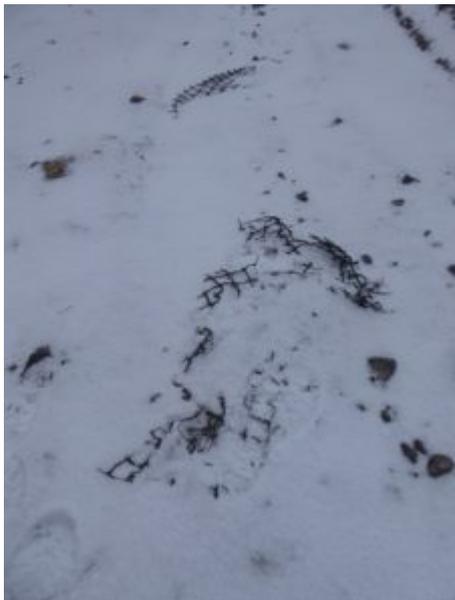
Netting embedded in surface of track

It got worse as, not long after I started down the new Allt Essan hydro track, I realised much of it and the ground at the sides was being held together with plastic garden netting partially concealed in the snow. The LLTNPA makes no mention of plastic, which does not biodegrade for hundreds of years and then when it does poisons organisms, being used to restore ground in its best practice Guidance on Renewables but it appears to have played a fundamental role in the "restoration" of ground at Allt Essan. Time that Guidance was updated!

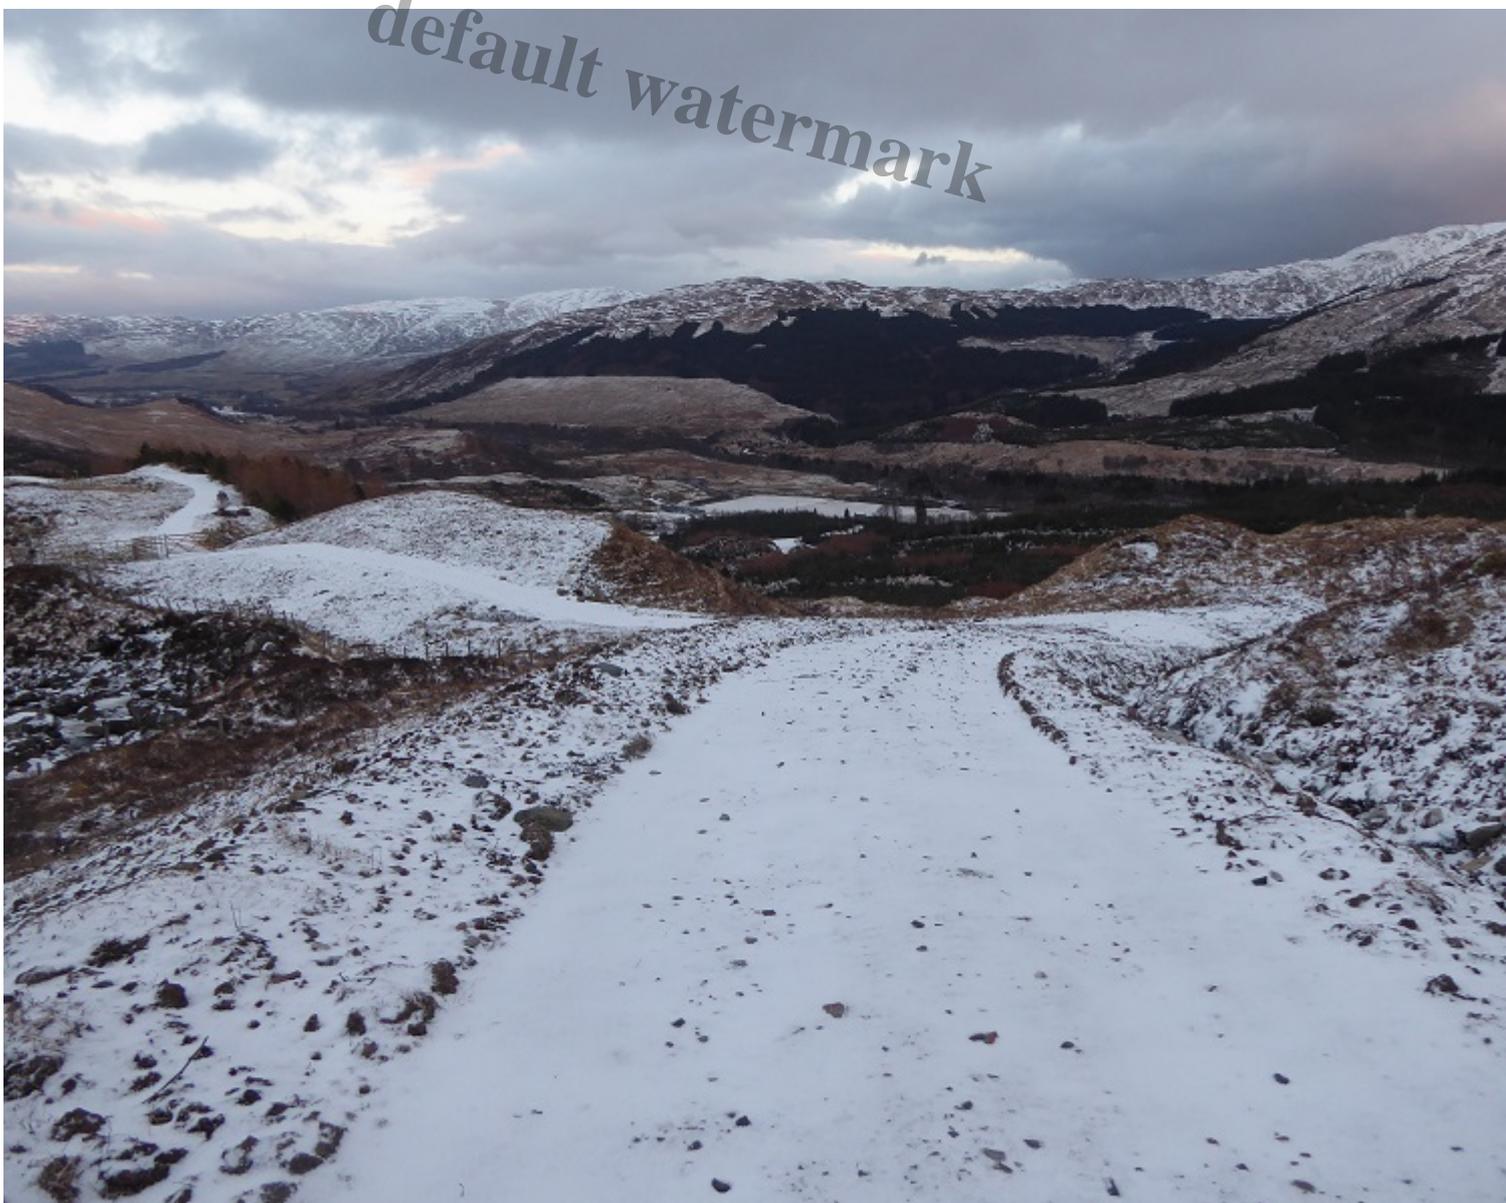
The track below is a motorway which carves its way around and over what was a fine line of moraine.

The Planners were concerned about the visibility of the Allt Essan track from the A85 – it is visible from there in places – but the real impact is for people out for a walk in the surrounding hills. The tracks here have changed the character of the glen. What is the point of Landscape Character Assessments if this is then allowed to happen?
