The Allt Essan and Auchessan Hydro schemes in Glen Dochart

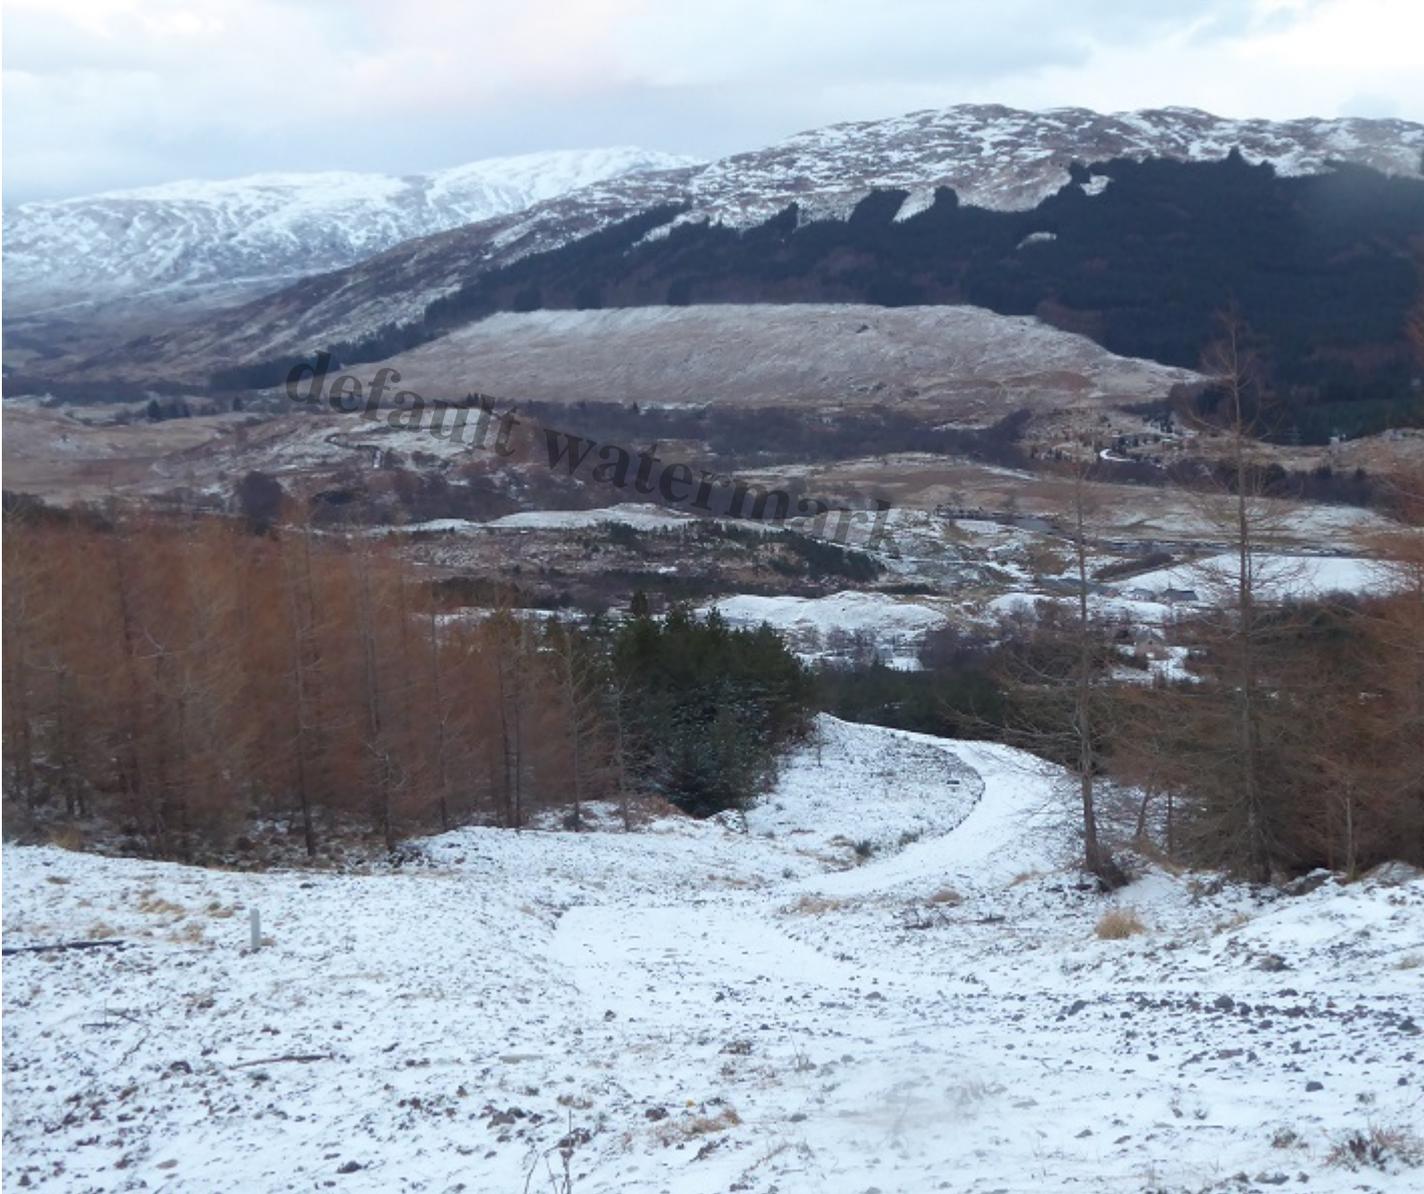
Pipeline on left of track marked by concrete posts

While most of the track runs through forestry, a wide swathe was cut through trees to create the pipeline with the result it is highly visible. Could the LLTNPA not have required a narrower construction corridor? Here is the Park’s own Guidance again:

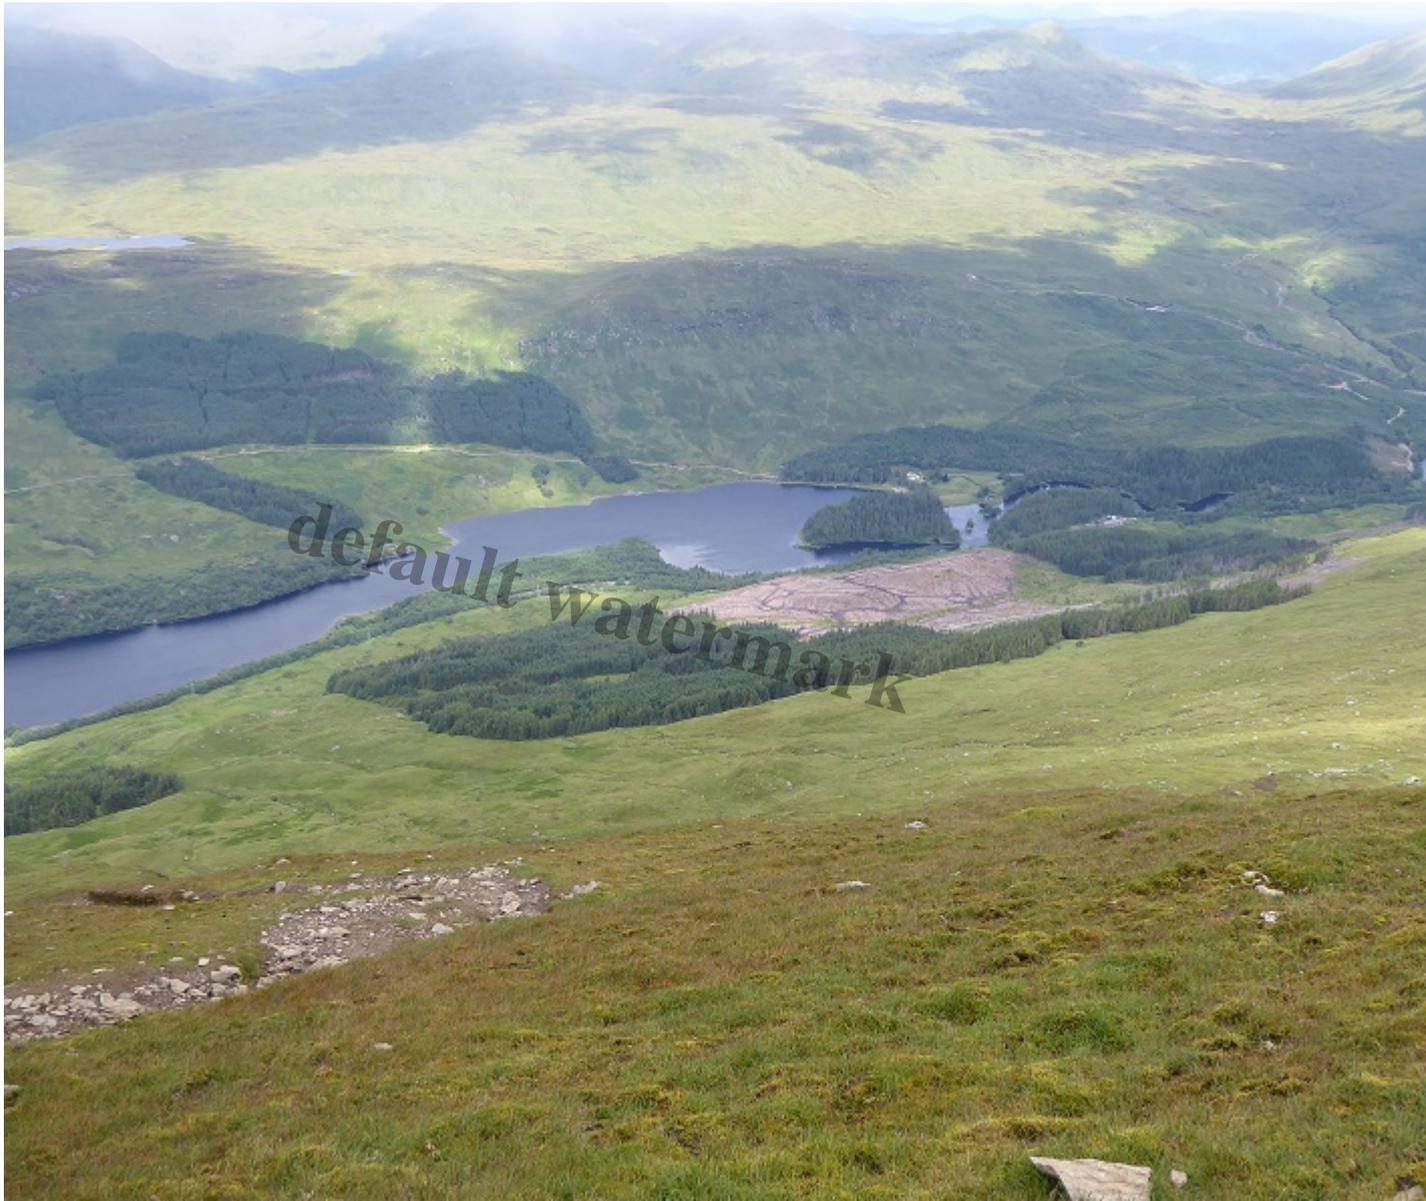
View of Allt Essan and Auchessan hydro tracks (right) from upper slopes of Ben More – note how Essan track basically follows the ridge and is therefore particularly prominent
