Is the Beachen Court Development in the Cairngorms National Park the national “go to” place for water technology?

On 26 April 2018 an Icelandic delegation on a water technology knowledge exchange visit to Scotland visited the SUDS scheme currently being installed on Beachen Court, a housing development under construction in Grantown-on-Spey. A video was posted on the Cairngorms National Park Authority Facebook page on 1 May 2018 ([see here](#)) which portrays this SUDS scheme as best practice but nothing could be further from the truth – instead there are important lessons for CNPA and developers to learn about avoiding the pitfalls into which this scheme has fallen.

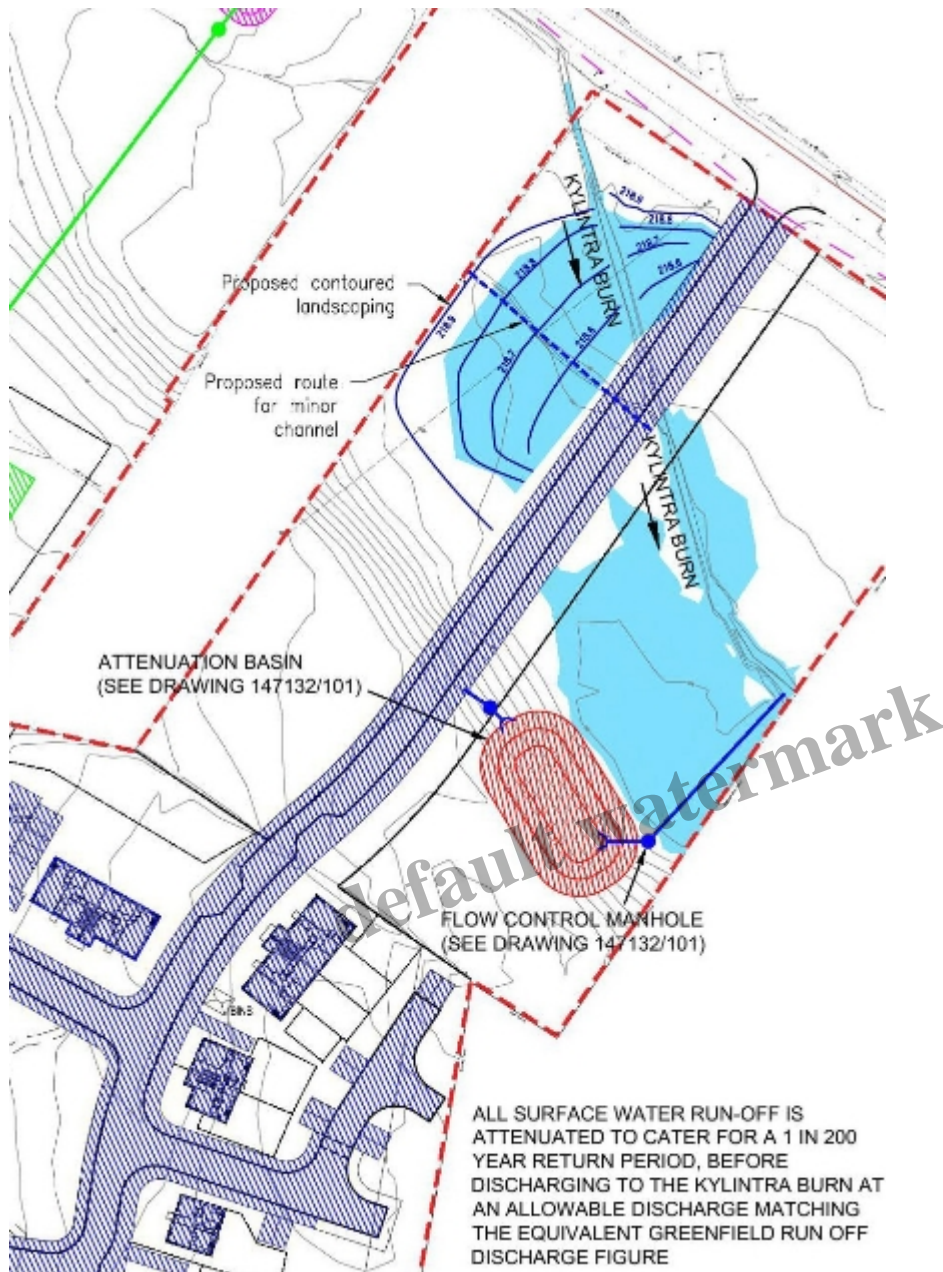
The initial engineering drawing submitted to CNPA around March 2016 in support of the planning application contained several serious design issues e.g. it proposed that a SUDS pond, capacity some 500m³ be located in the middle of the 1:4 slope of river terrace south of the floodplain – a ridiculous proposition:

Plan1: Design drawing proposing siting the SUDS pond on the 1:4 slope

The dimensions of the proposed pond were also incorrect, far too small to provide the stated design capacity. OK, the design engineer made some dreadful mistakes but, just as concerning, when the developer submitted this drawing in support of his application the CNPA as Planning Authority, apparently without thought, put it out for public consultation. CNPA will say it's not their job to question design when there is a statutory consultee to make comments but the faults with the pond were so obvious it would surely have been common sense for CNPA to address them before consultation and avoid wasting consultees' time.

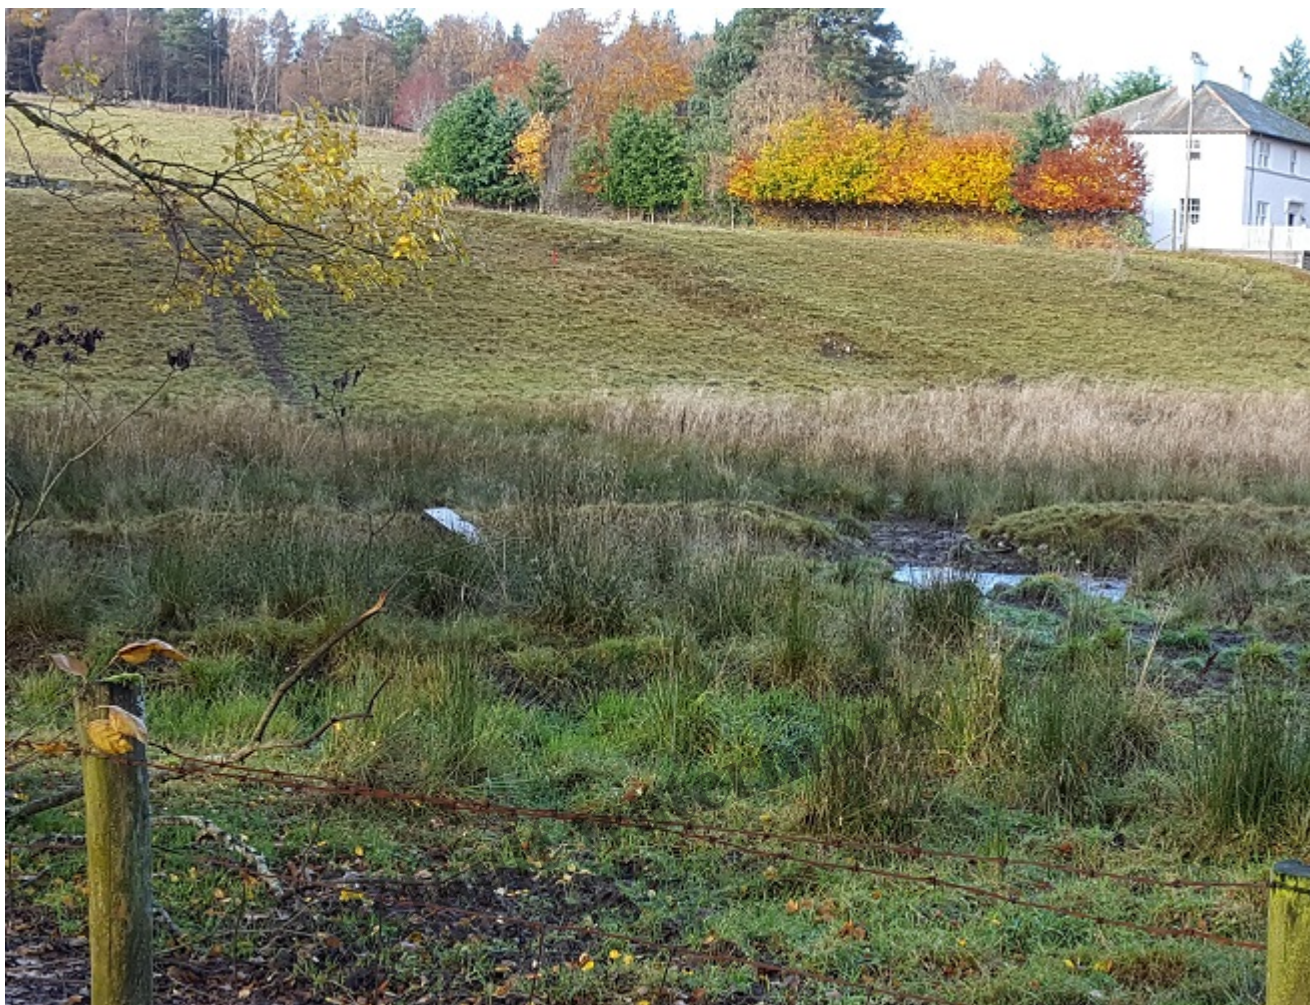
The 1:4 river terrace slope – certainly not the place on which to site a 40m x 20m pond

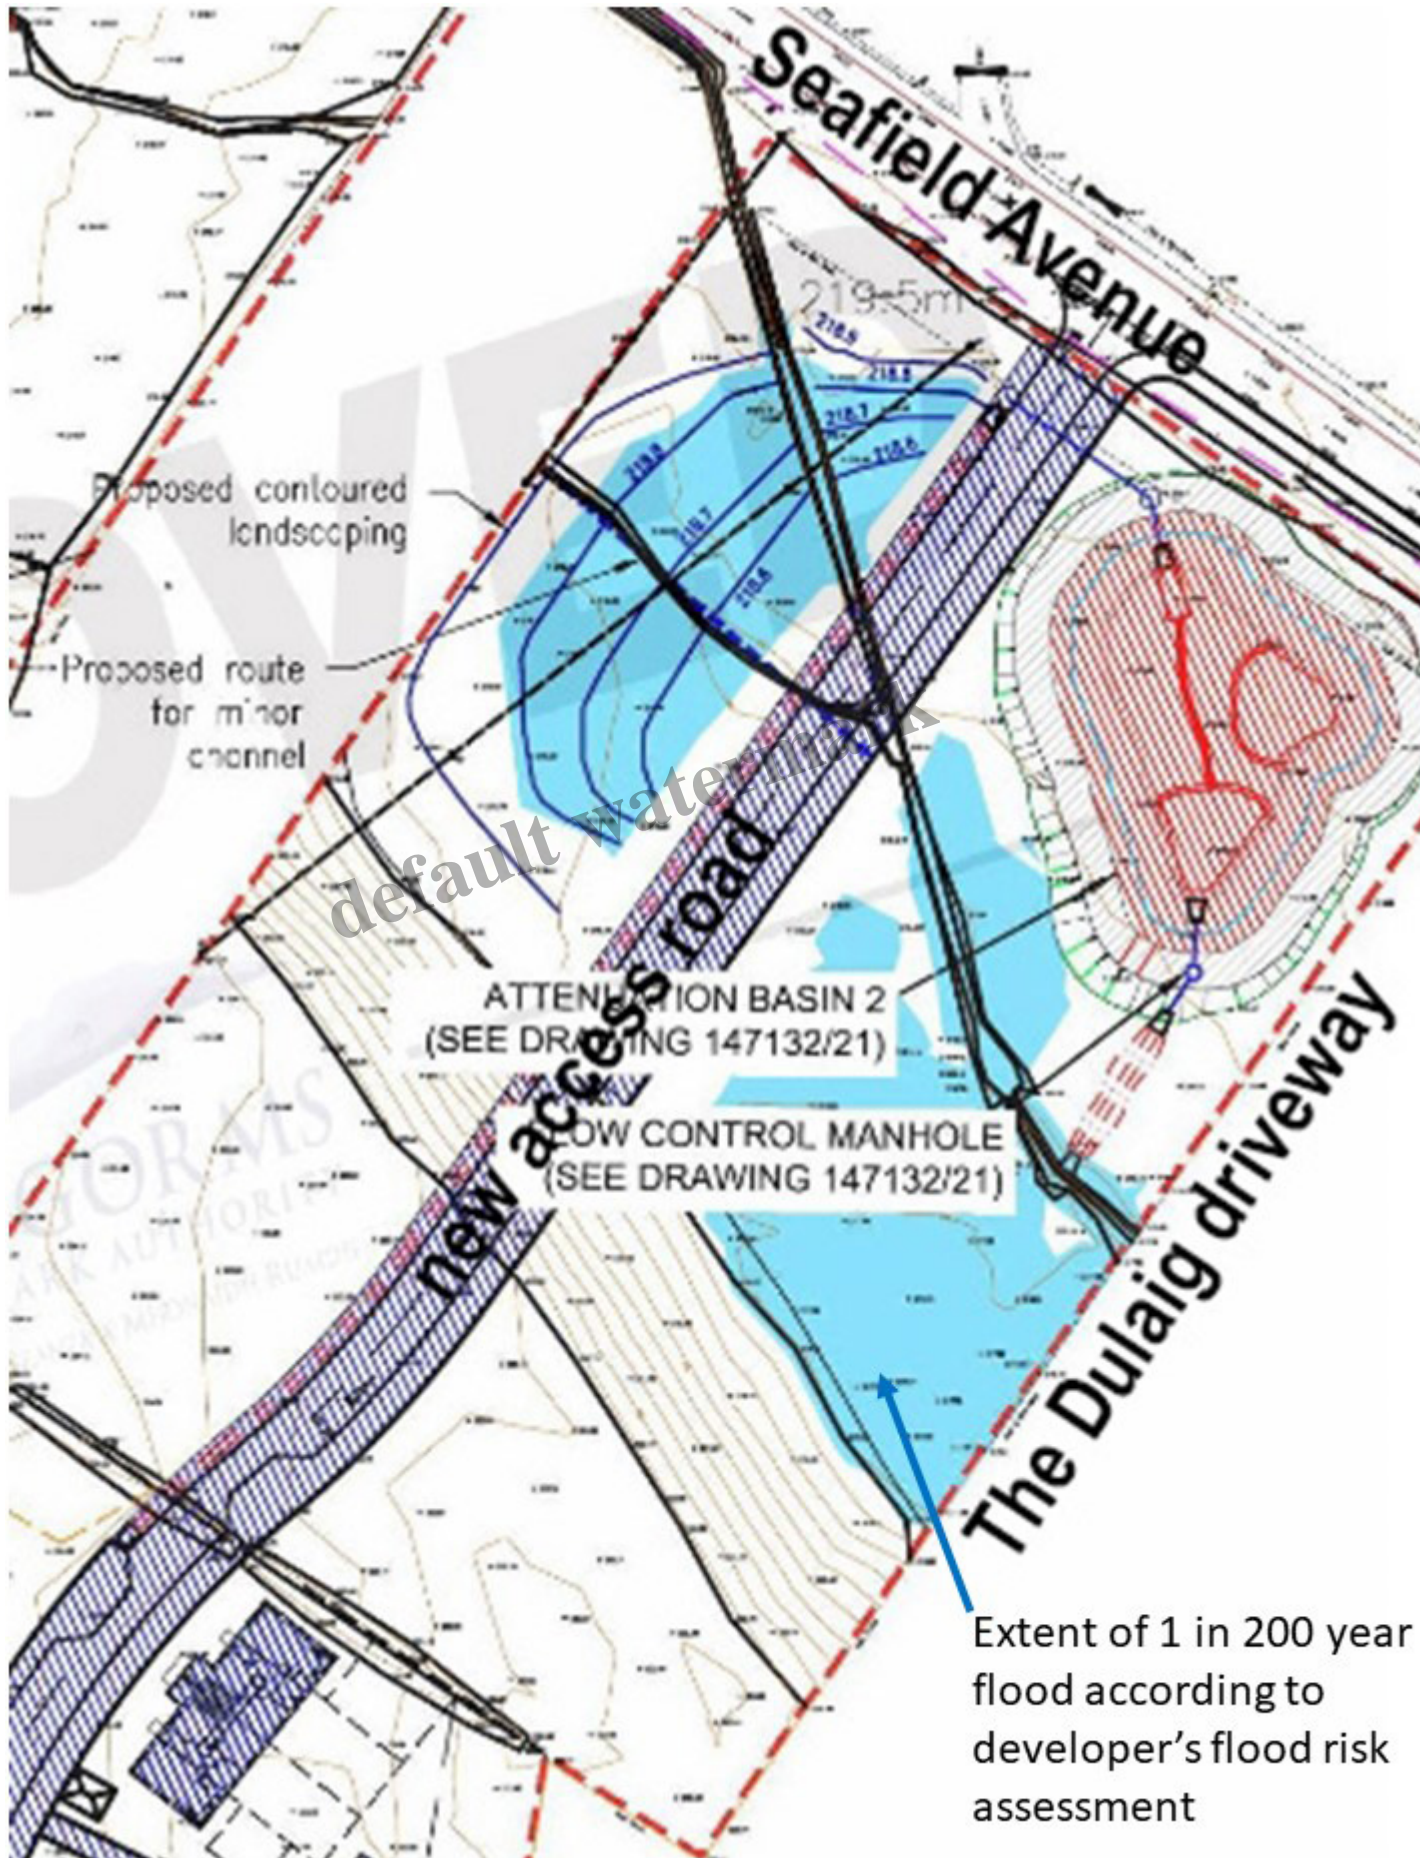
– The size and shape of the SUDS pond is highly constrained by the new access road to the west, Seafeld Avenue to the north, the driveway of The Dulaig to the east and the flood plain of the Kynlra

Burn to the south. There is no room for manoeuvre.

Plan 2: Approved design for the relocated SUDS pond. Note the constraints of new access road, public road (Seafield Avenue), The Dulaig driveway and the Kylintra Burn floodplain

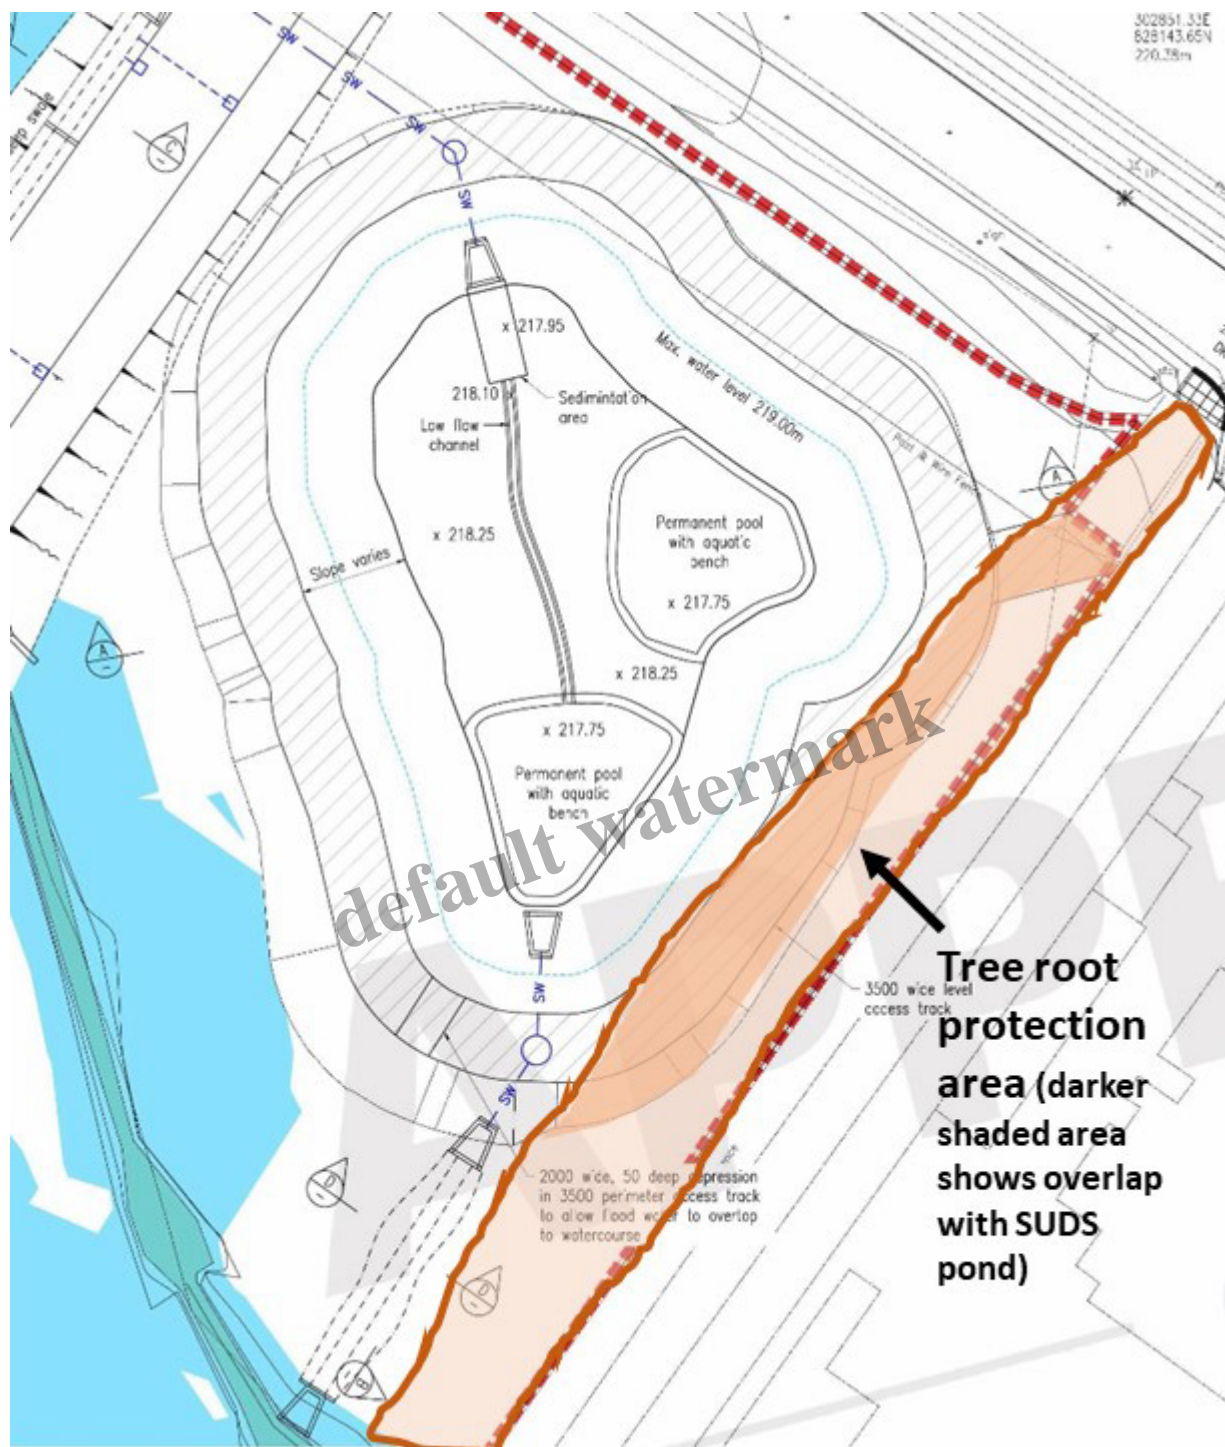
After planning permission had been granted it was discovered that the approved design completely ignored that the mature trees lining our driveway required a tree root protection area – up to 9 metres wide – which stretched into the development site. The design required the eastern embankment of the pond be built right over this tree root protection area.

Plan 3: Plan showing error in locating the SUDS pond to overlap with the required tree root protection area

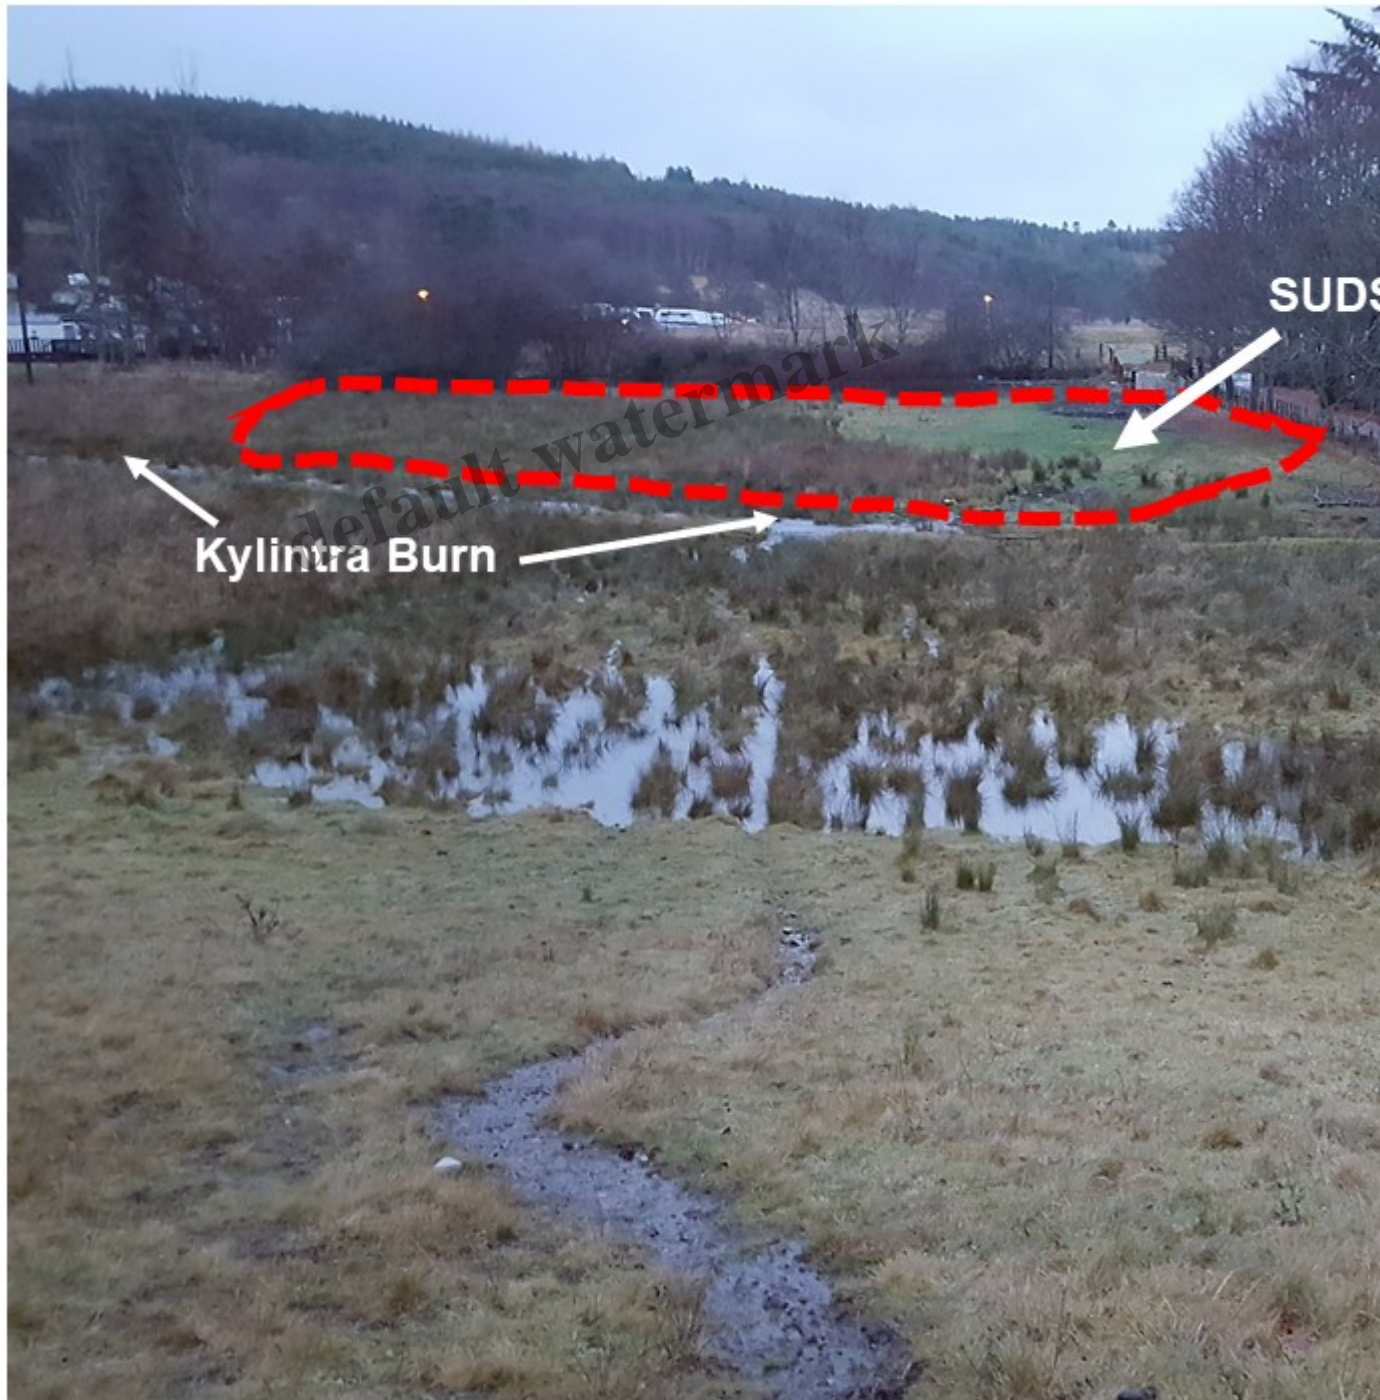
Does the SUDS pond encroach on the area of flood plain required to cope with a 1 in 200 year flood (Plan 2 above)? The Developer's Flood Risk Assessment says it does not, but I have serious doubts about this. In addition I have concerns that the as-built SUDS pond footprint, including embankments, is larger than the approved drawing and thus further encroaches on the already restricted flood plain.

The natural flood plain after a period of heavy rain (Nov.2016).The footprint of the as-built SUDS pond

Note that most of the SUDS pond footprint covers an area which had been long grass and rushes – an indicator of wetland – demonstrating it encroaches on the functioning flood plain

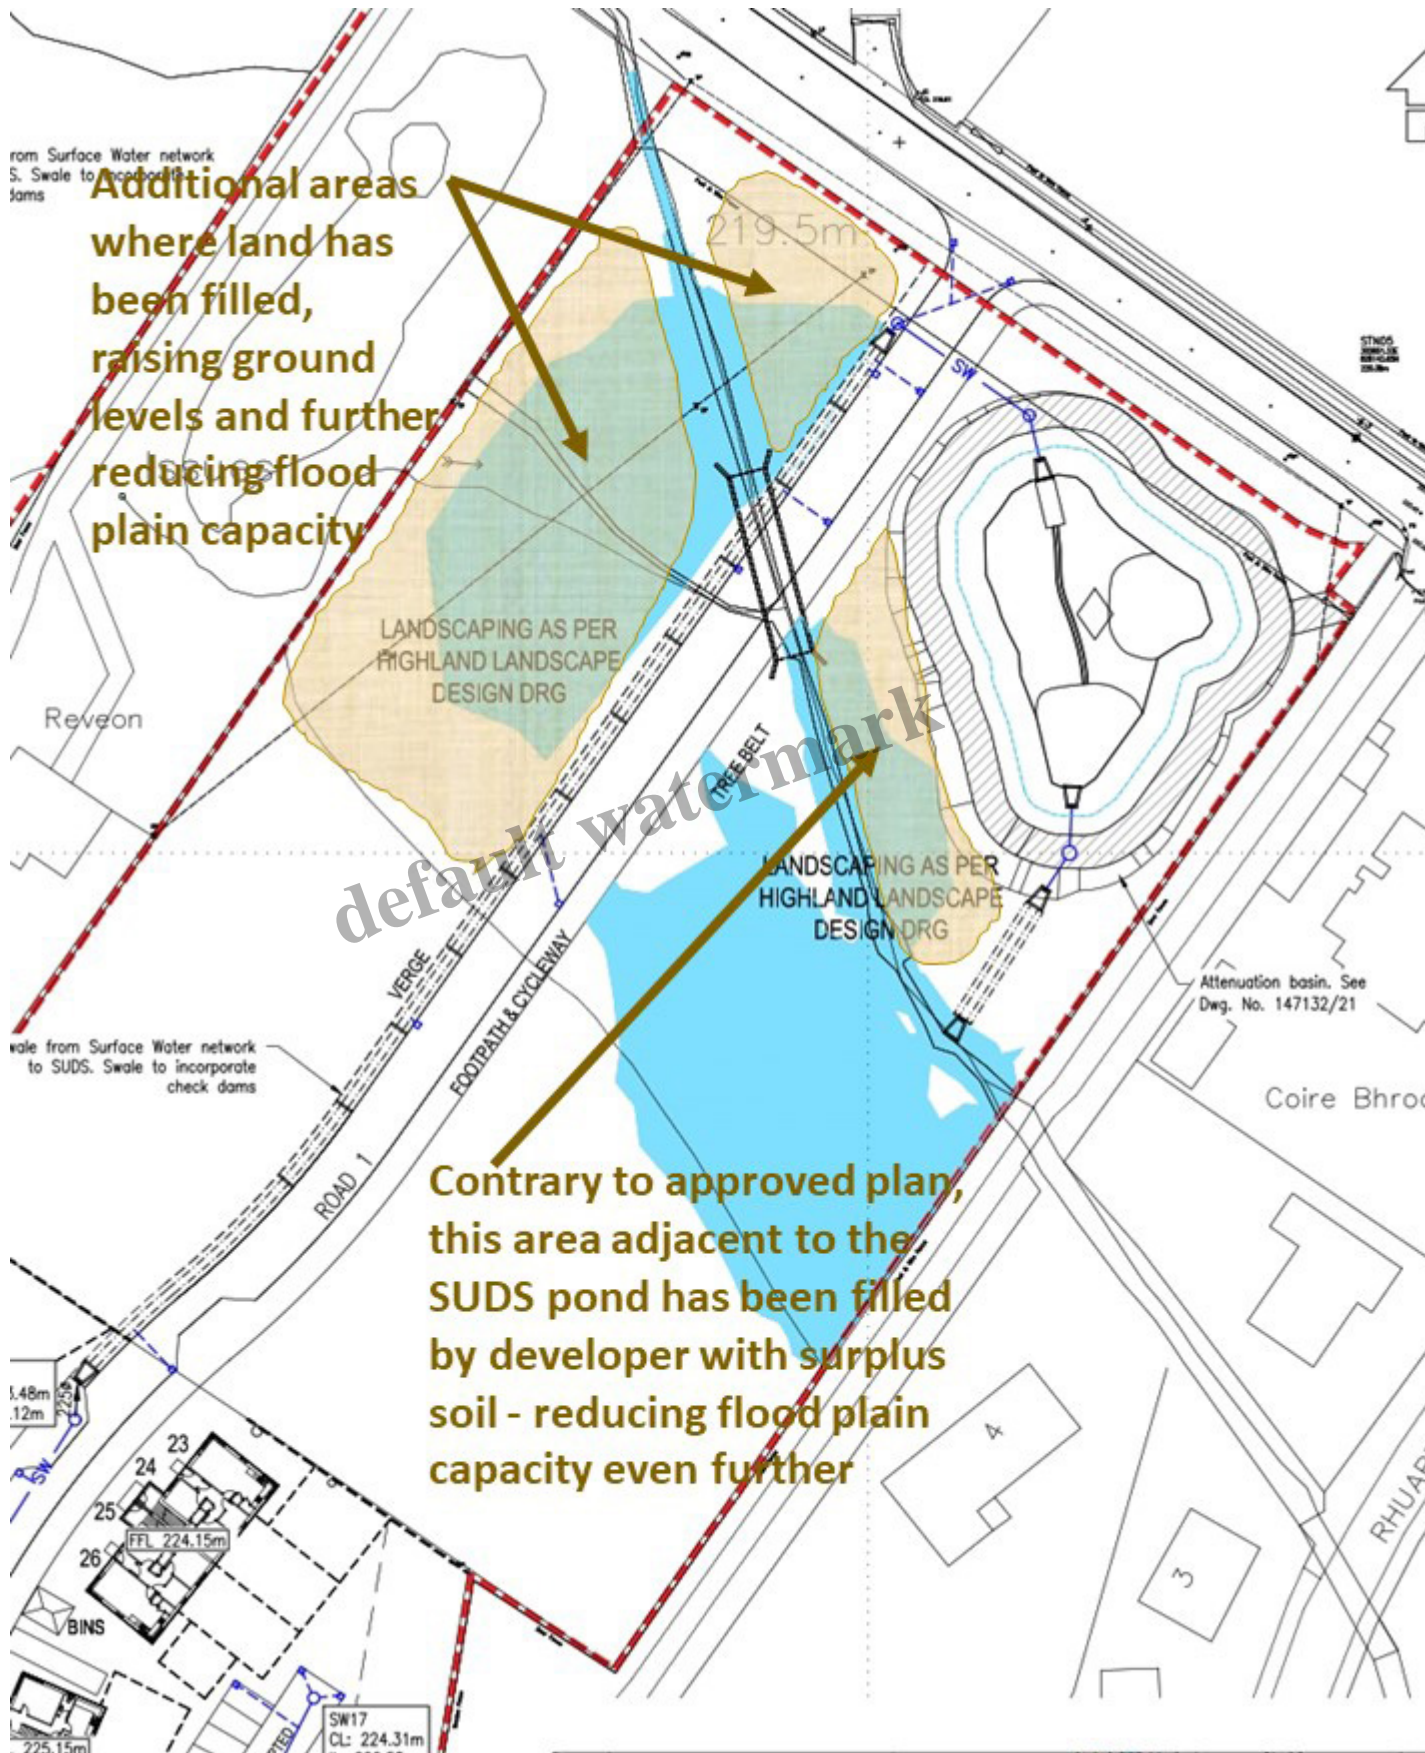
Plan 4: The approved SUDS plan overlaid with the additional unapproved fill area shown in photo 5

below which further reduces flood plain capacity.

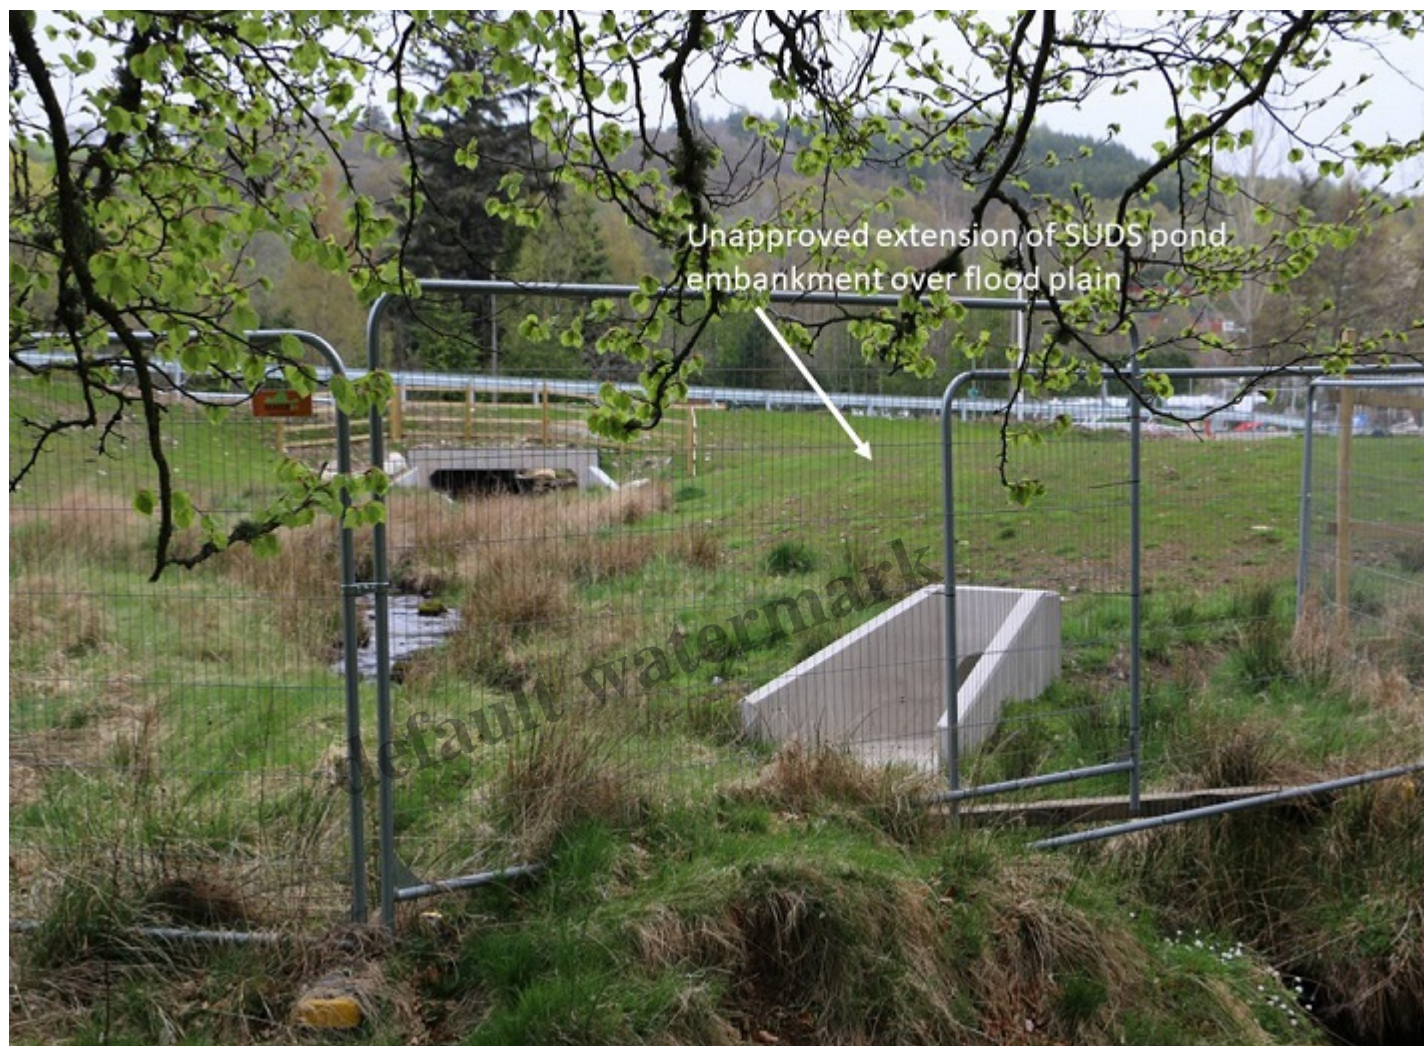
Photo 5

Edge of SUDS pond embankment sloping down to the Kylesha Burn. Compare this with Plan 4 which shows there should be at least 10 metres of flood plain between the embankment and the Burn.

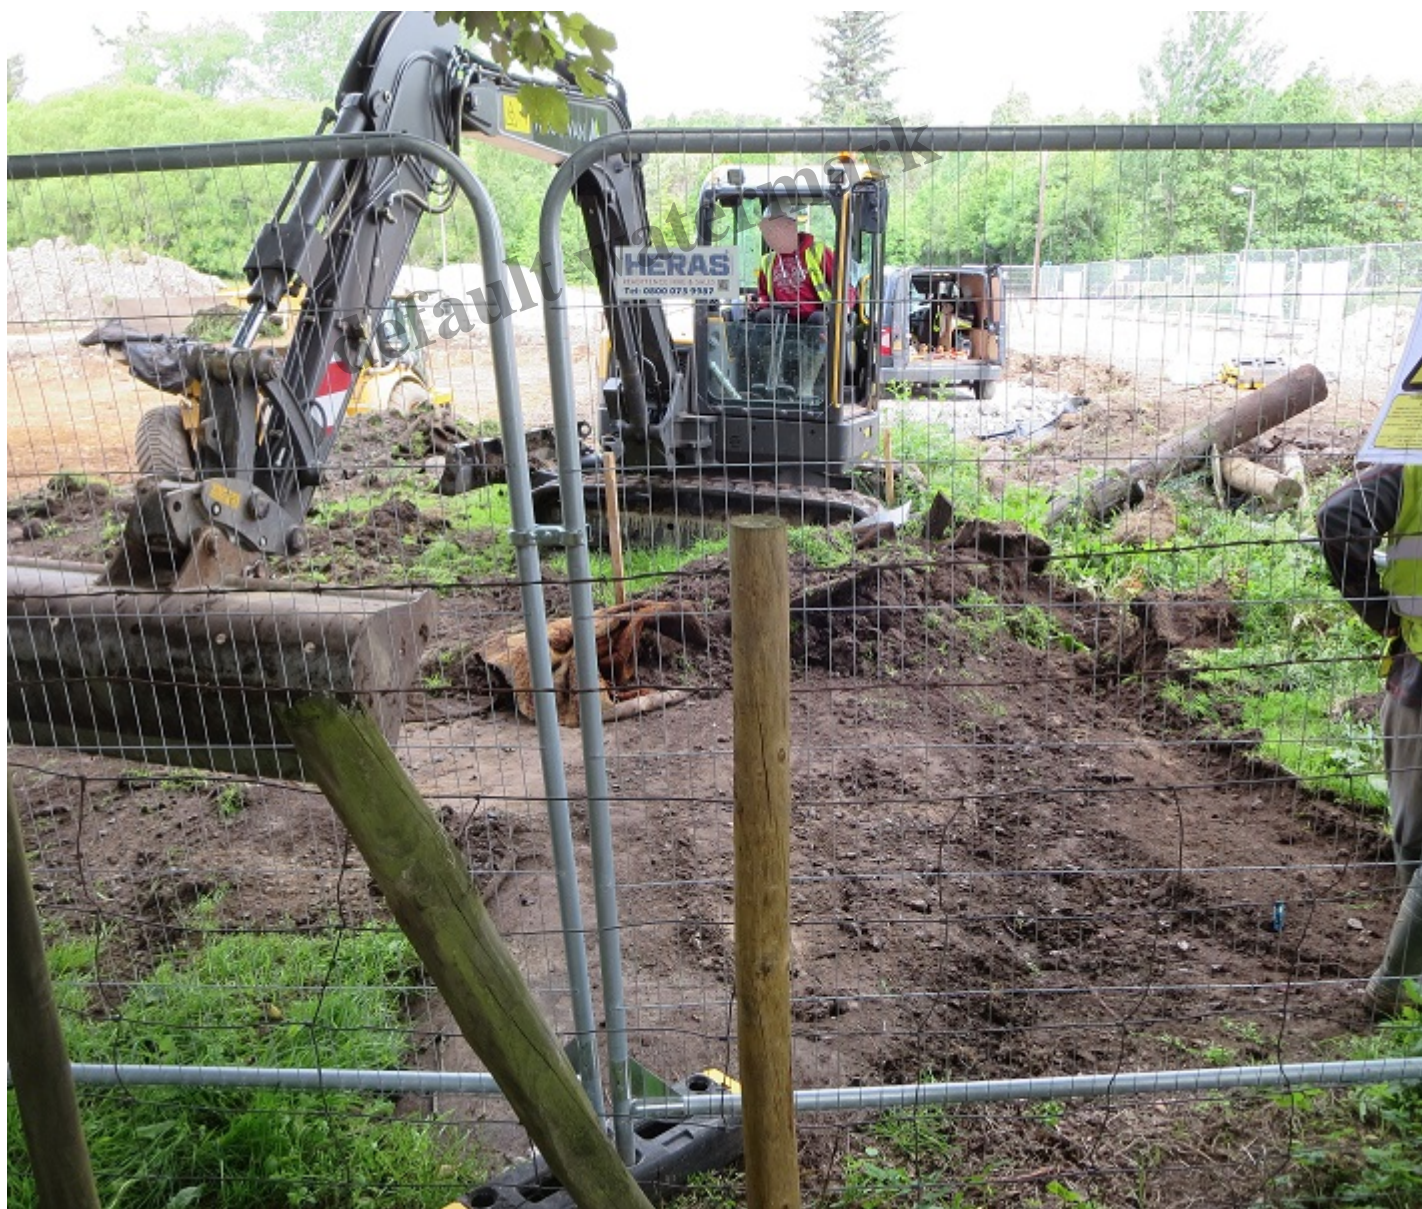
Photo 6

1. Cellweb installation advice states *“Soil compaction from vehicles, machinery and materials is to be strictly prohibited during construction within Root Protection Areas (RPAs).”* and *“Remove surface vegetation using hand held tools or a herbicide”*. Instead surface vegetation was scraped off using a mechanical excavator, potentially damaging the fine roots the trees use for feeding.
2. Cellweb installation advice states *“Permeable surface is always recommended, if this is not possible approx. 100mm thickness of subbase type 1 can be used as running surface”*. Type 1 aggregate was used to varying depths up to 250mm to form the running surface.

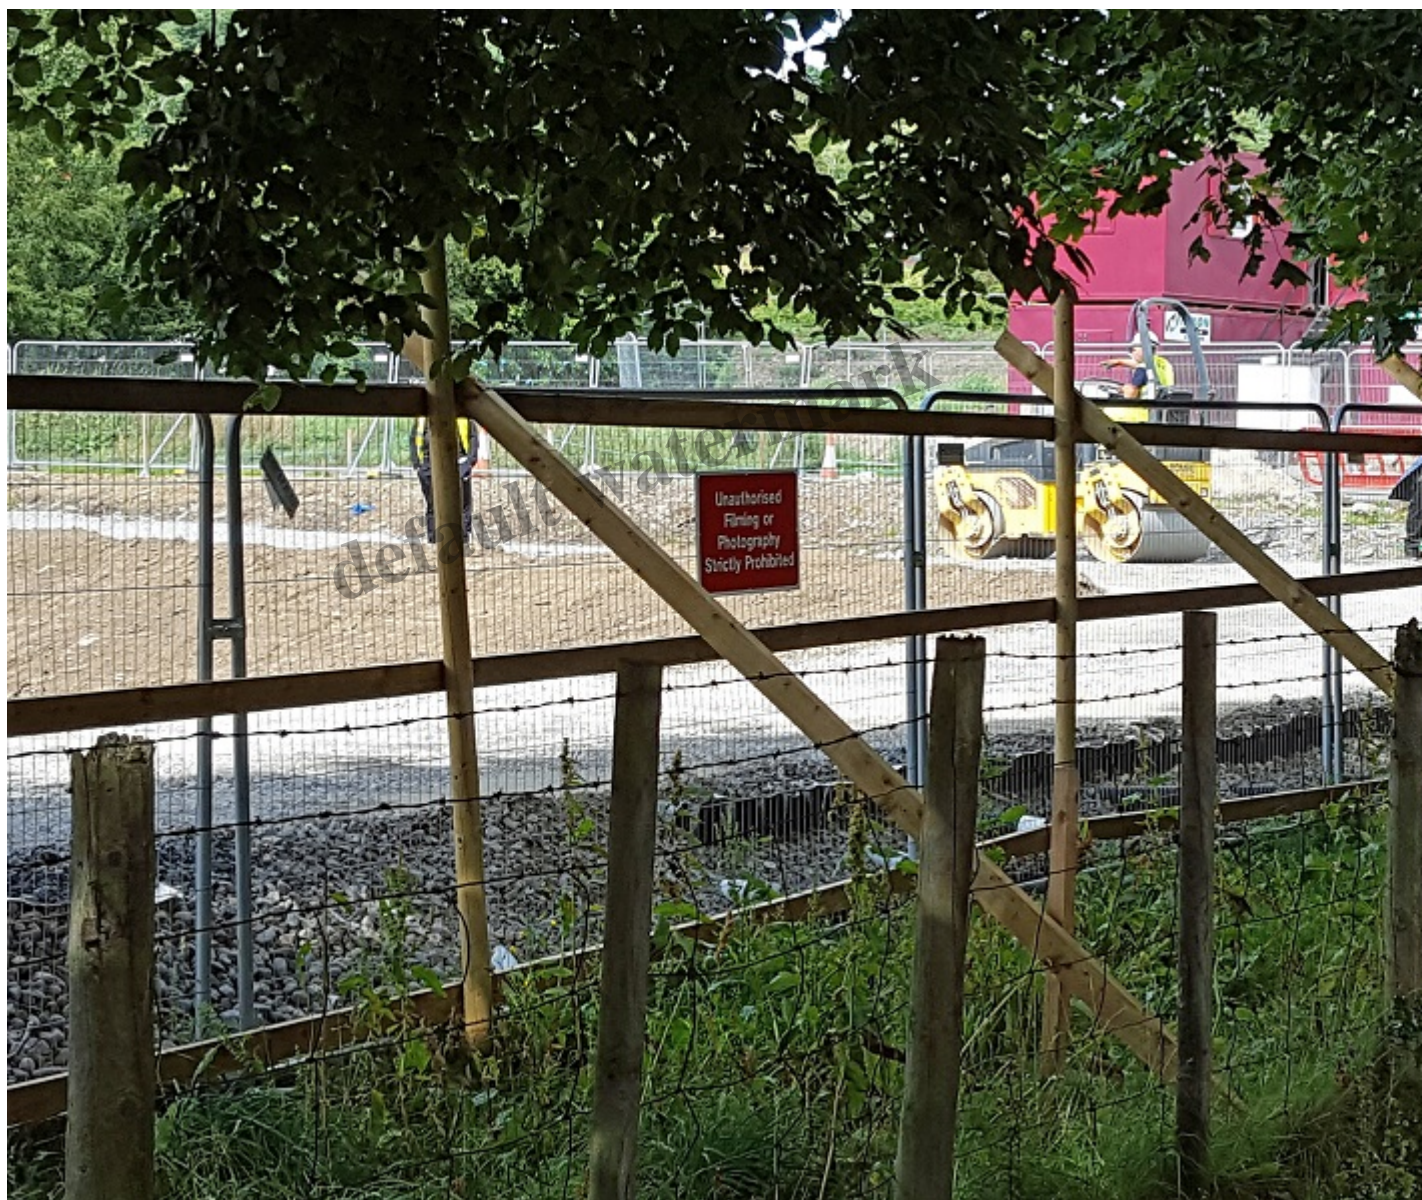
Photo 7

3. Cellweb installation guidance states *“Do not use a whacker plate... or any other form of compaction”* but the Type 1 was compacted with a large vibratory roller (compacted Type 1 reduces oxygen supply to tree roots)

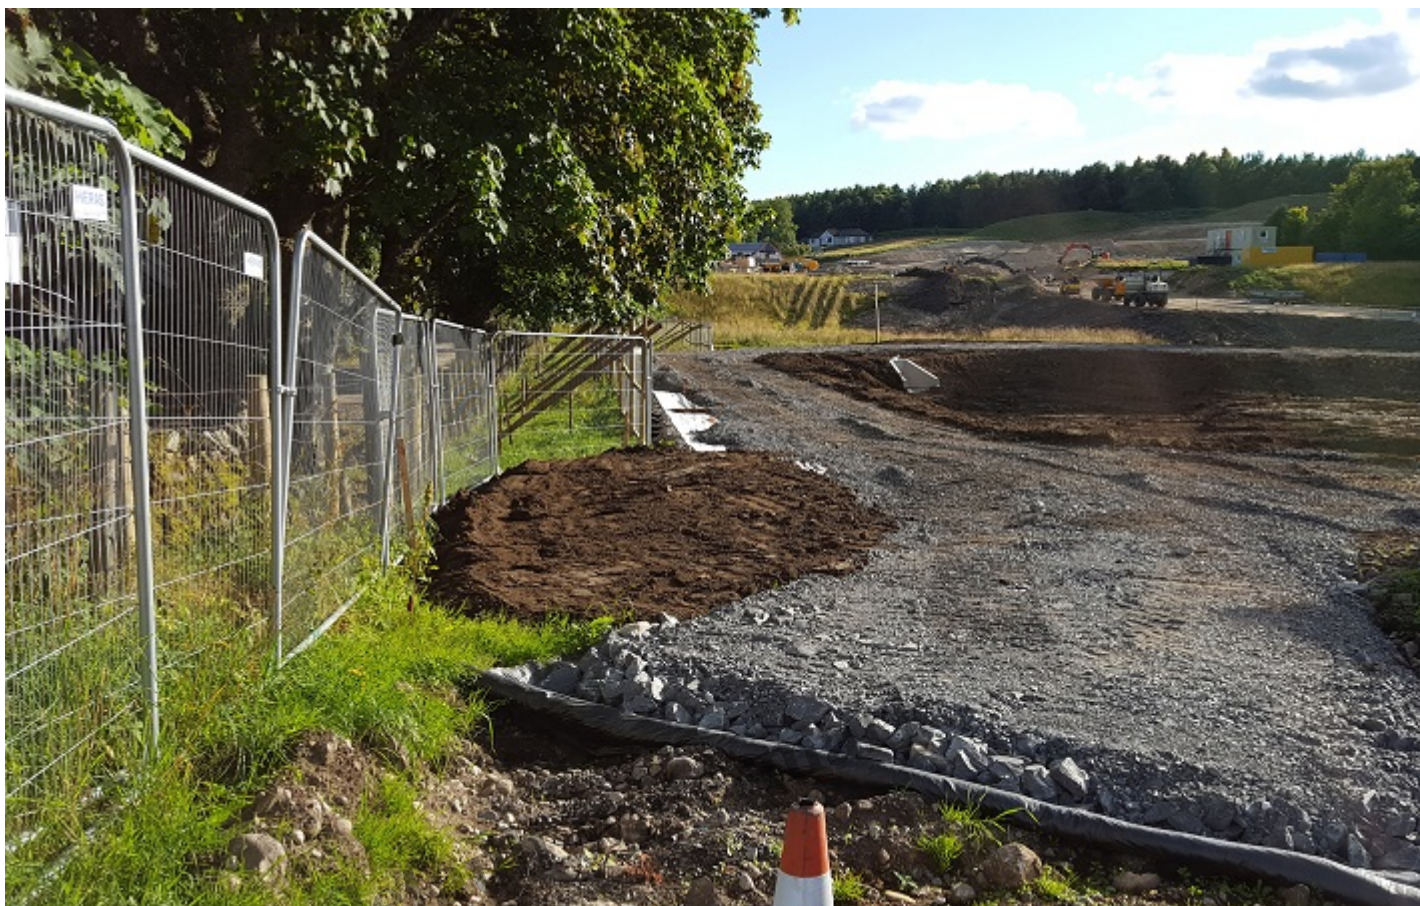
Photo 8

4. A thick layer of topsoil was placed on top of part of the Cellweb® installation – reducing oxygen supply to the tree roots – negating the beneficial effect of the Cellweb®

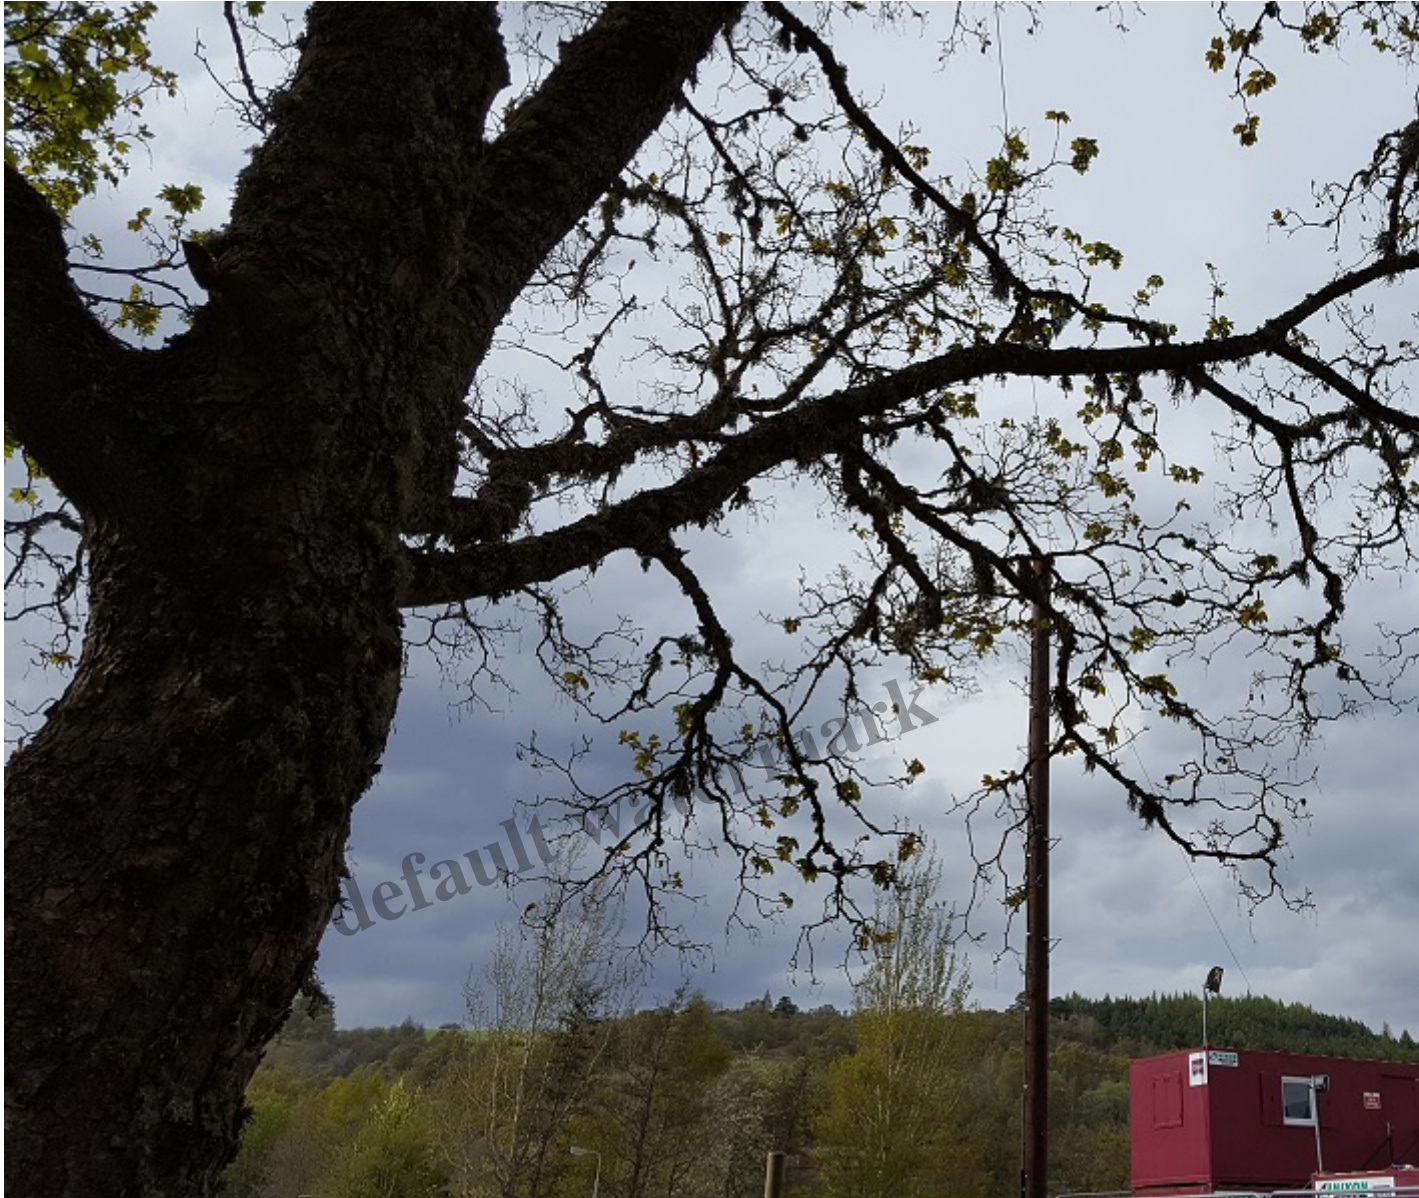
It is now springtime 2018 and the trees are just coming into leaf – a worrying time for our threatened trees. It's a bit early to assess the 100 year old beech, but one of the sycamores which was healthy a year ago is currently looking particularly stressed and is very slow in coming into leaf.

Photo 9 Mature sycamore showing stress with few buds leafing and most of the fine twigs almost leafless.

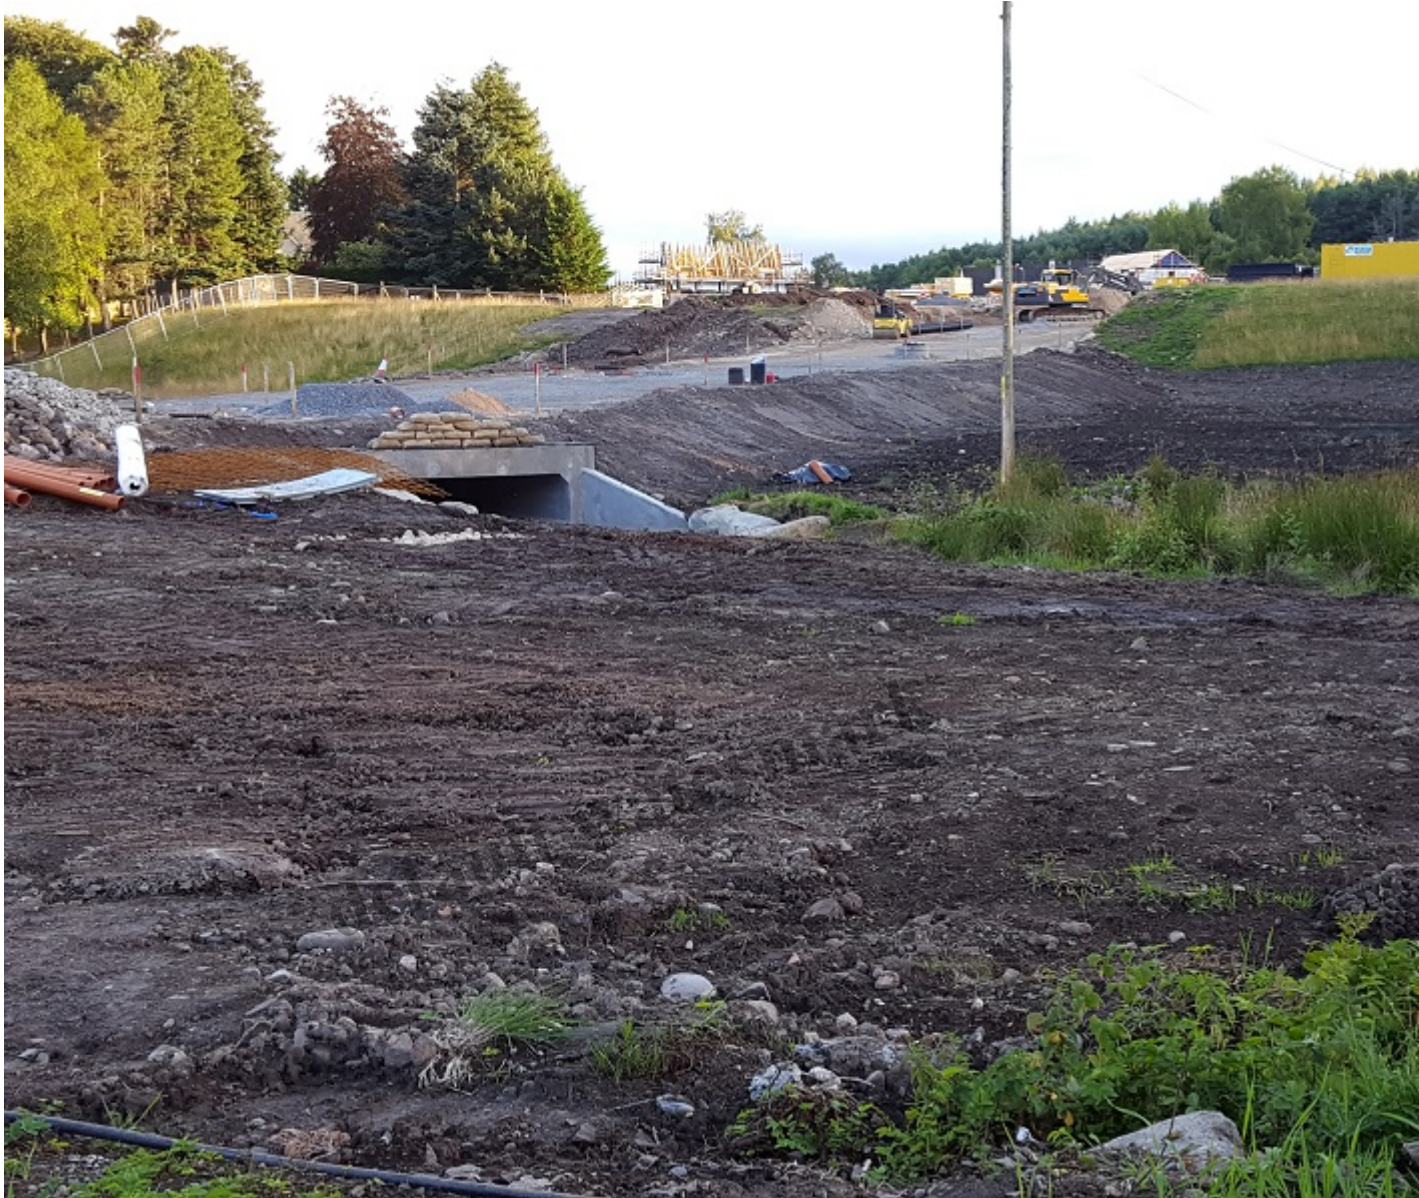
Photo 11 Virtually all of this rich wetland destroyed and levels raised with soil fill (August 2017)
