Is the Beachen Court Development in the Cairngorms National Park the national “go to” place for water technology?

This SUDS scheme looks like many others, but could it really become a national icon and the ‘go to’ place for water technology as claimed by the British organiser of an Icelandic delegation visiting to the Cairngorms National Park? From my knowledge and professional experience of SUDS installations – and from living next door and seeing what has happened day to day – I don’t think so. Rather it presents a great example of how NOT to design and build such schemes.

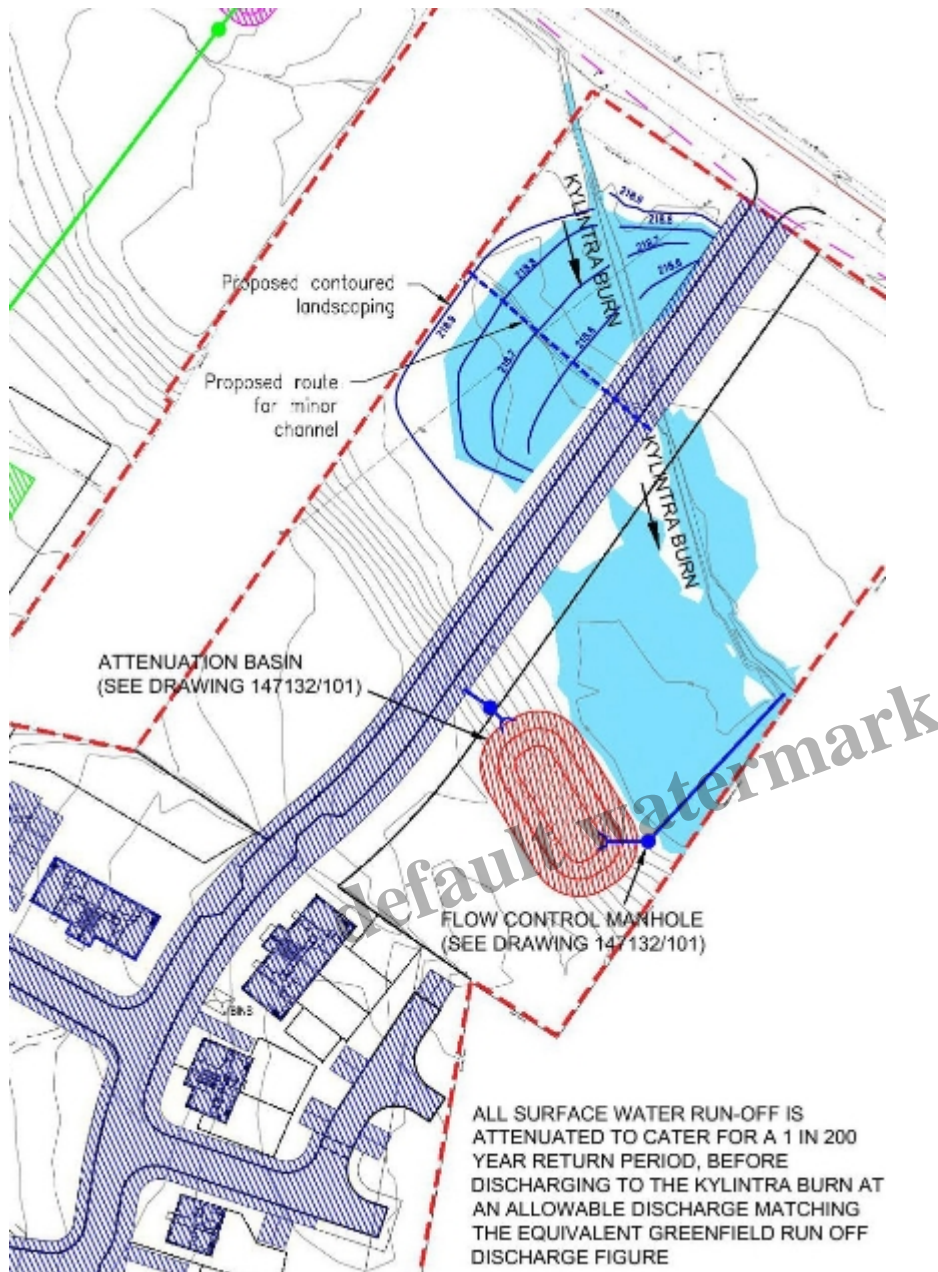
Plan1: Design drawing proposing siting the SUDS pond on the 1:4 slope

The initial engineering drawing submitted to CNPA around March 2016 in support of the planning application contained several serious design issues e.g. it proposed that a SUDS pond, capacity some 500m³ be located in the middle of the 1:4 slope of river terrace south of the floodplain – a ridiculous proposition:

The dimensions of the proposed pond were also incorrect, far too small to provide the stated design capacity. OK, the design engineer made some dreadful mistakes but, just as concerning, when the developer submitted this drawing in support of his application the CNPA as Planning Authority, apparently without thought, put it out for public consultation. CNPA will say it's not their job to question design when there is a statutory consultee to make comments but the faults with the pond were so obvious it would surely have been common sense for CNPA to address them before consultation and avoid wasting consultees' time.

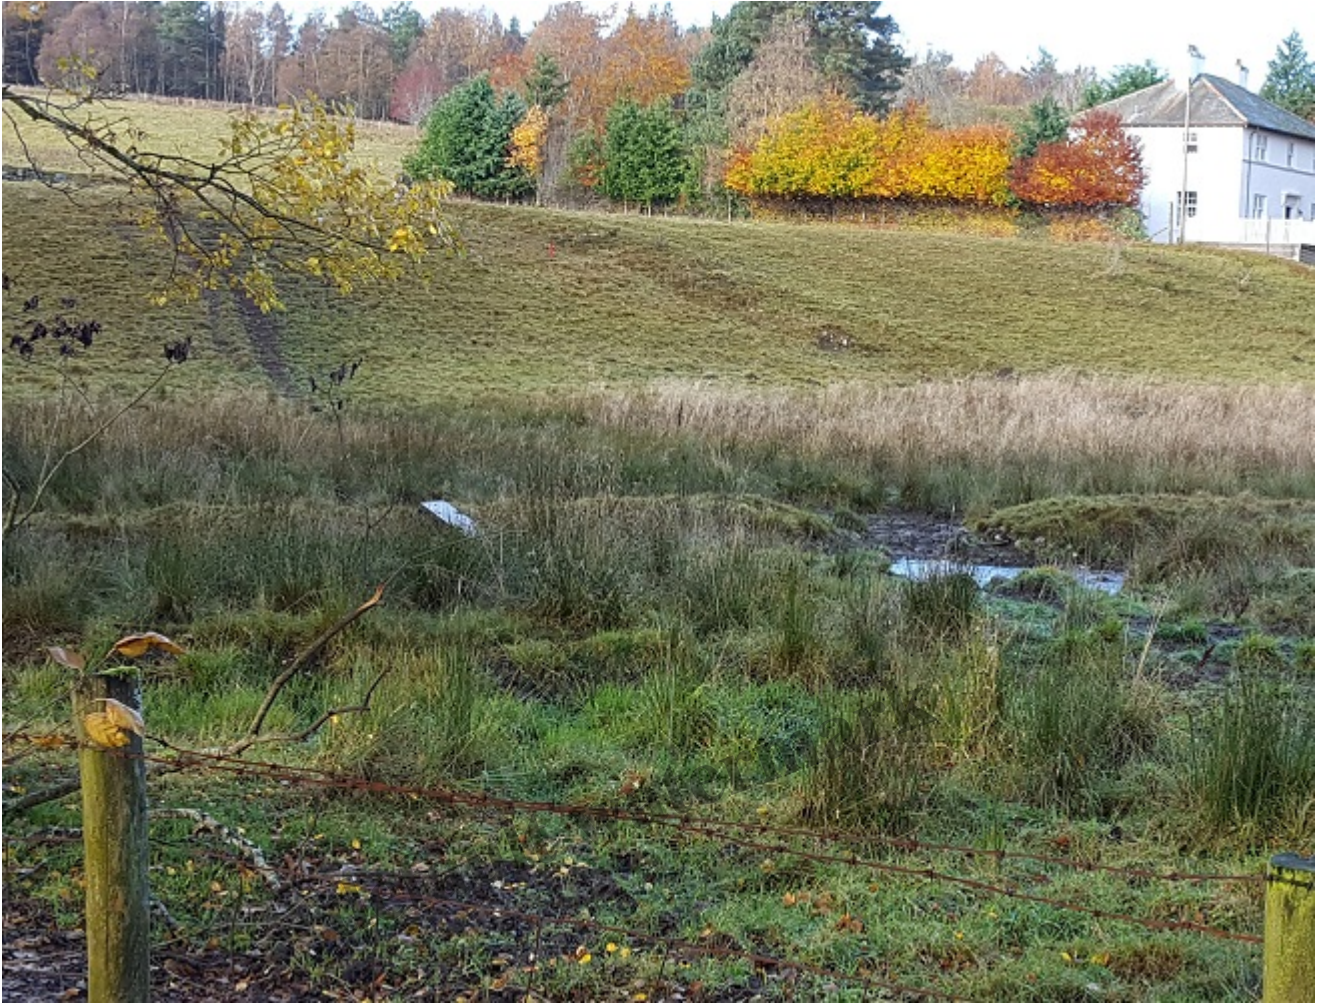
The 1:4 river terrace slope – certainly not the place on which to site a 40m x 20m pond

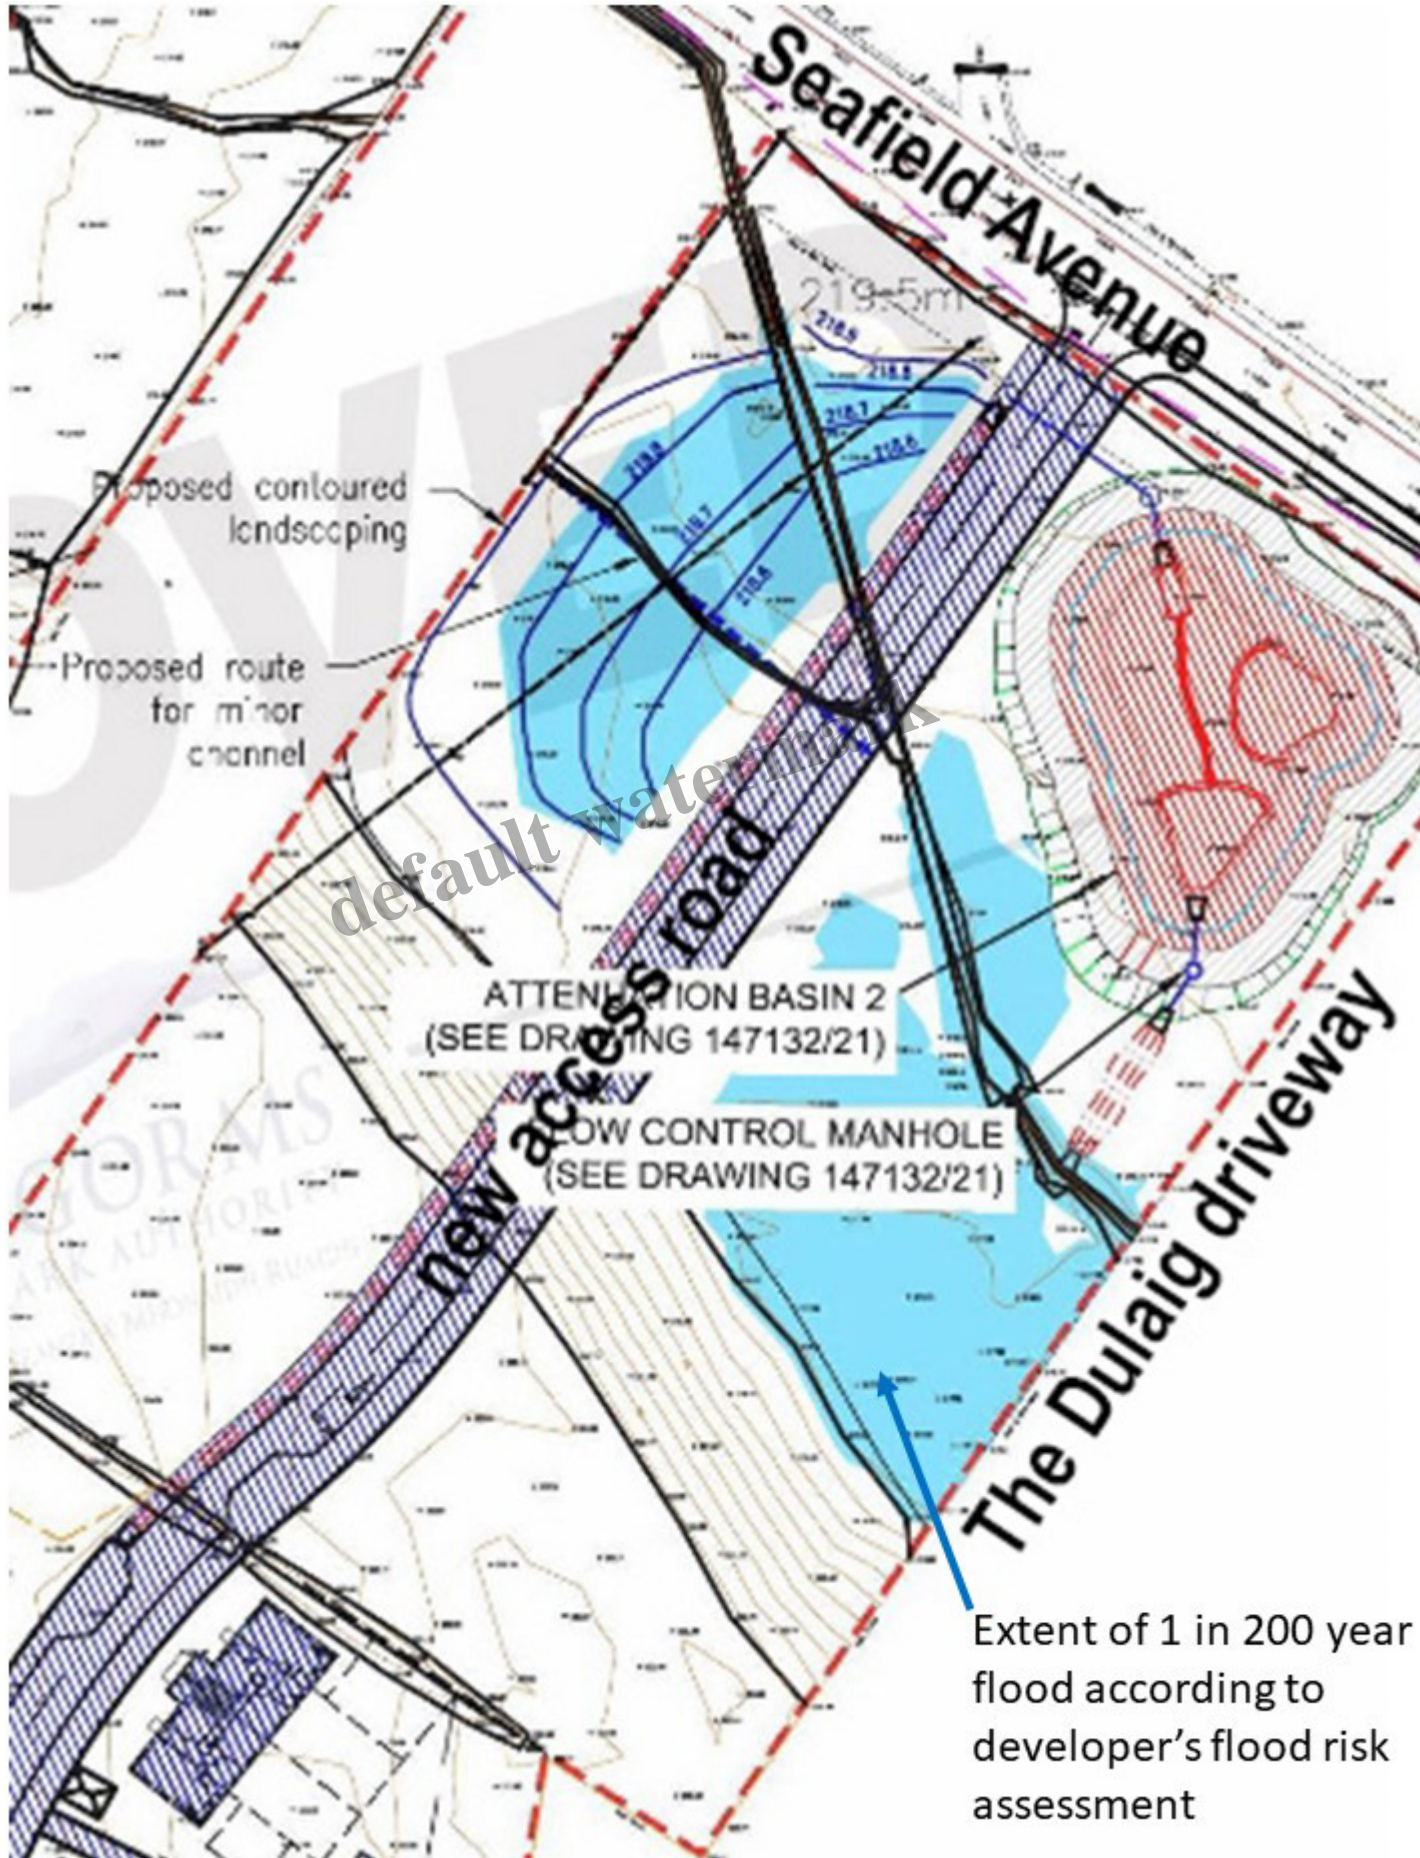
Plan 2: Approved design for the relocated SUDS pond. Note the constraints of new access road, public road (Seafield Avenue), The Dulaig driveway and the Kylintra Burn floodplain

Following criticism on consultation the plan was amended to show the SUDS pond relocated onto the floodplain area of the Kylintra Burn. The size appeared to offer the design capacity and other errors were corrected. Statutory consultees seemed relatively content with the new design which was included in the planning application approved by the CNPA Planning Committee in October 2016, however significant problems remained e.g.:-

– The size and shape of the SUDS pond is highly constrained by the new access road to the west, Seafield Avenue to the north, the driveway of The Dulaig to the east and the flood plain of the Kylintra

Burn to the south. There is no room for manoeuvre.

Extent of 1 in 200 year flood according to developer's flood risk assessment

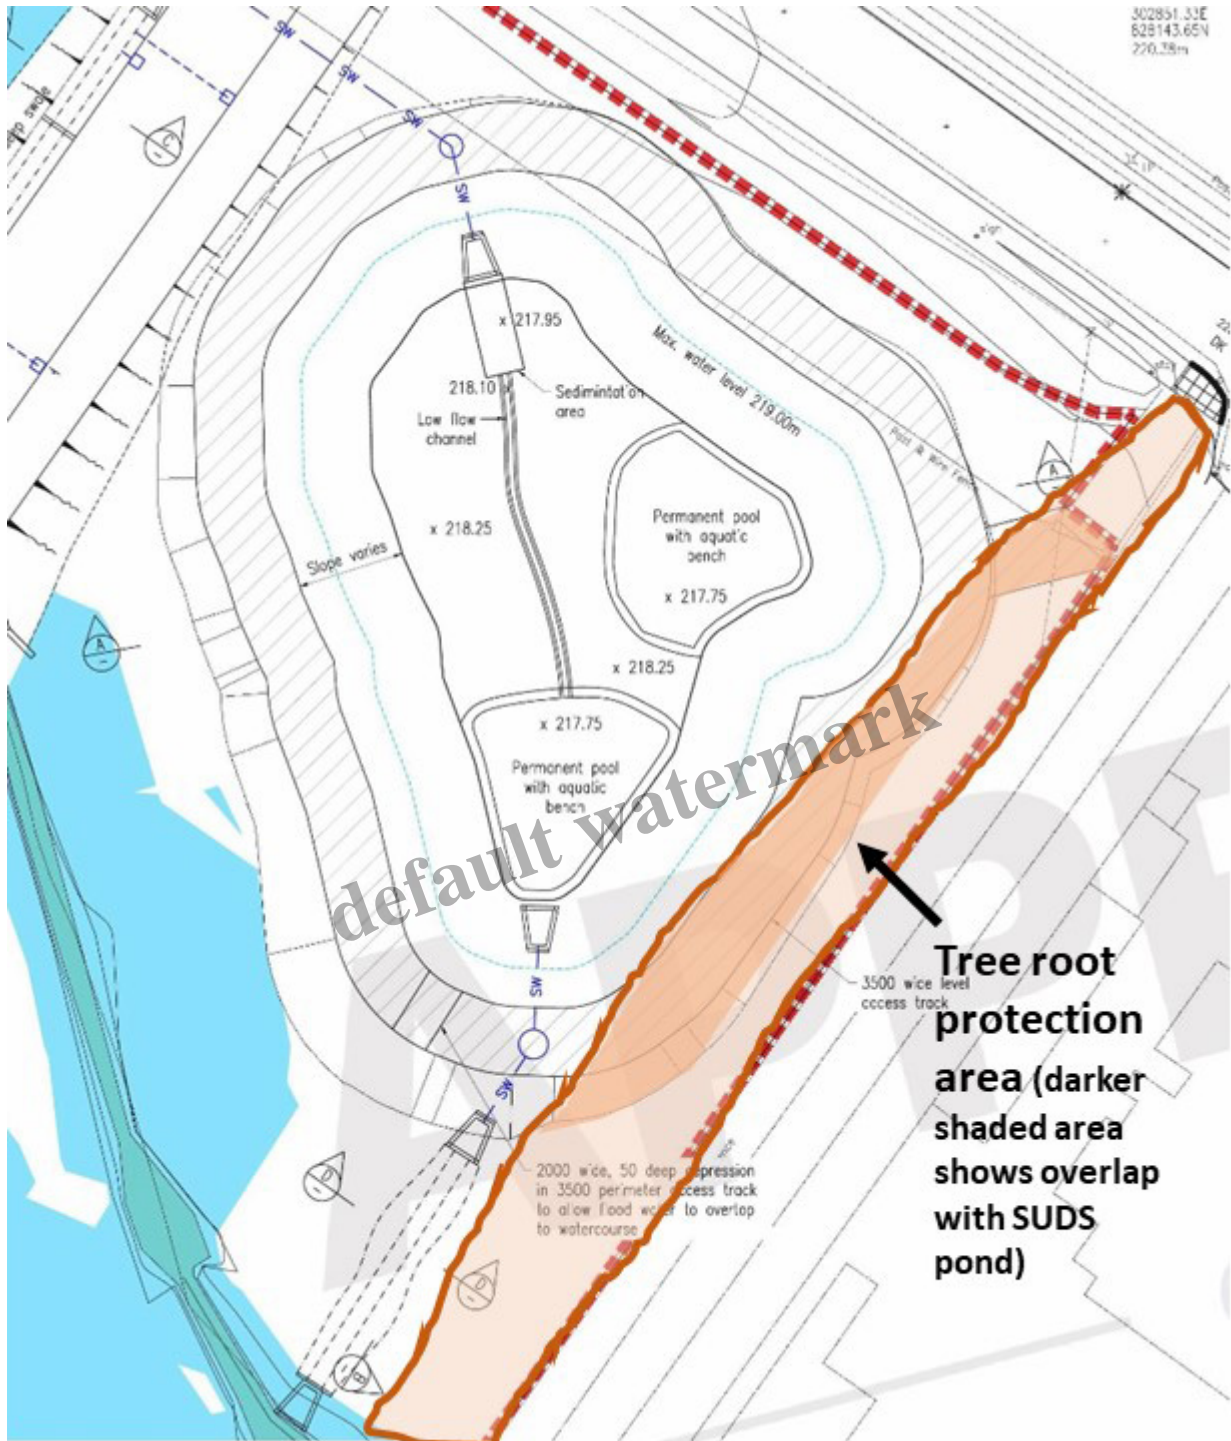
Plan 3: Plan showing error in locating the SUDS pond to overlap with the required tree root protection area

After planning permission had been granted it was discovered that the approved design completely ignored that the mature trees lining our driveway required a tree root protection area – up to 9 metres wide – which stretched into the development site. The design required the eastern embankment of the pond be built right over this tree root protection area.

The paper trail is a bit unclear but it appears that CNPA was certainly aware of the tree problem in late April 2017, just as development site work was commencing. Why was this problem not picked up earlier? In my opinion it was due to bad – or non-existent – project management and because the drawing showing the relocated SUDS pond was too schematic i.e. it shows the dimensions of the pond but not its position relative to the surrounding fixed structures. This is a learning point for the planners.

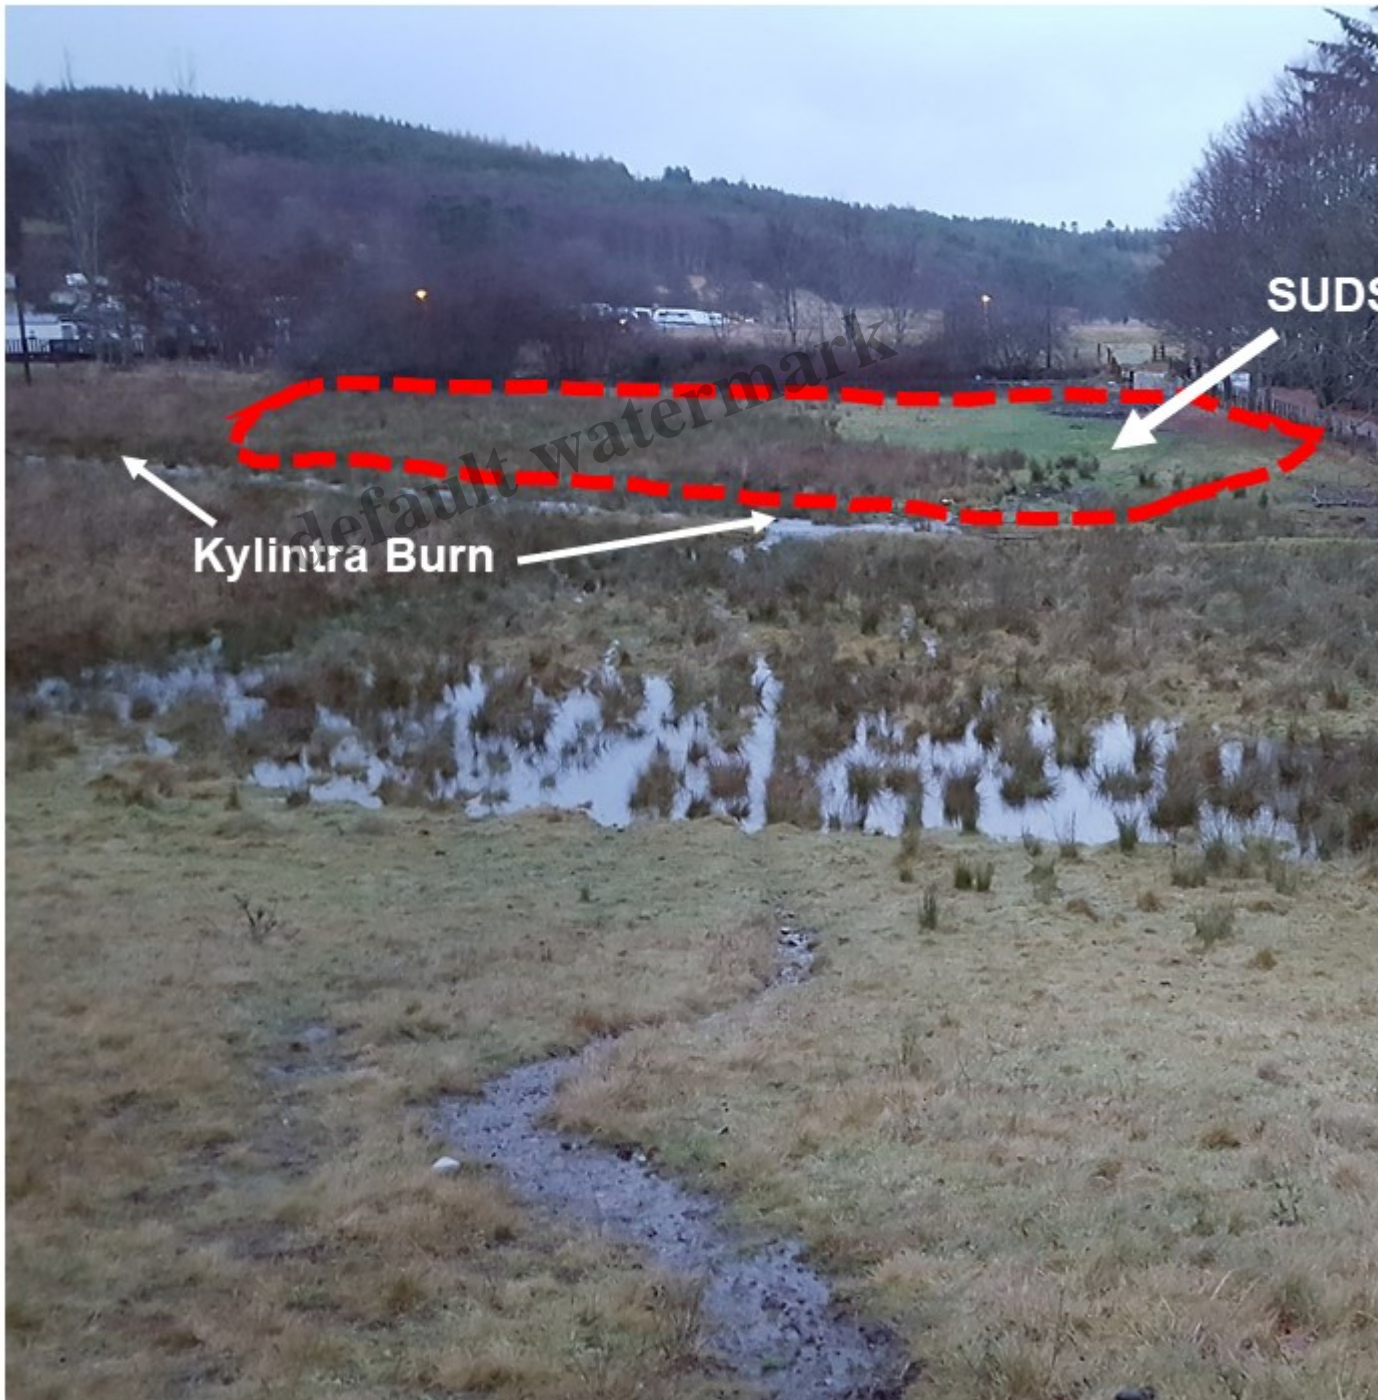
Does the SUDS pond encroach on the area of flood plain required to cope with a 1 in 200 year flood (Plan 2 above)? The Developer's Flood Risk Assessment says it does not, but I have serious doubts about this. In addition I have concerns that the as-built SUDS pond footprint, including embankments, is larger than the approved drawing and thus further encroaches on the already restricted flood plain.

The natural flood plain after a period of heavy rain (Nov.2016).The footprint of the as-built SUDS pond

Note that most of the SUDS pond footprint covers an area which had been long grass and rushes – an indicator of wetland – demonstrating it encroaches on the functioning flood plain

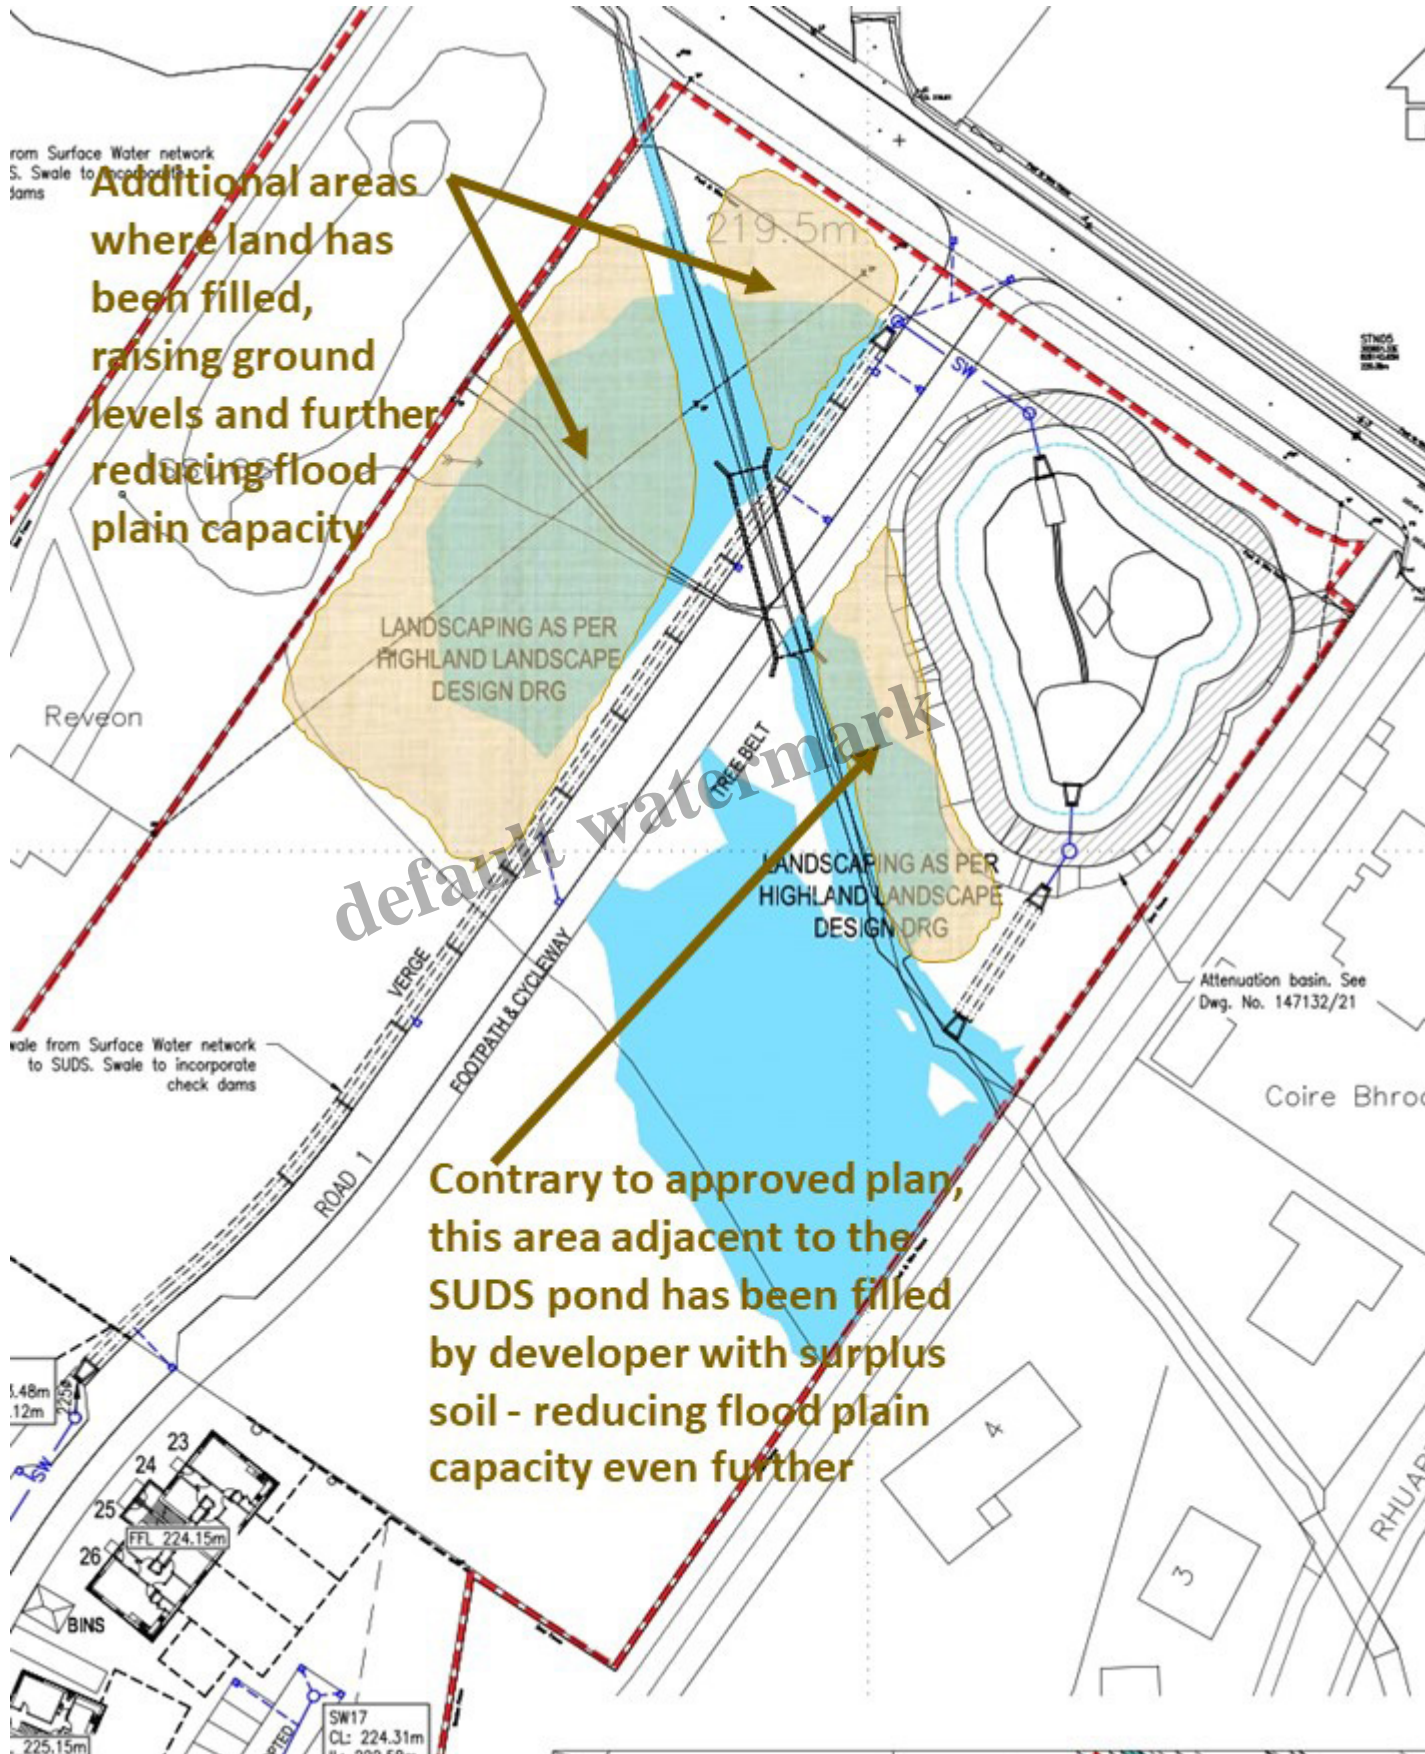
Plan 4: The approved SUDS plan overlaid with the additional unapproved fill area shown in photo 5

below which further reduces flood plain capacity.

Note too the large areas of flood plain filled in on the opposite side of the new access road (illustrated in photos 10 and 11 below)

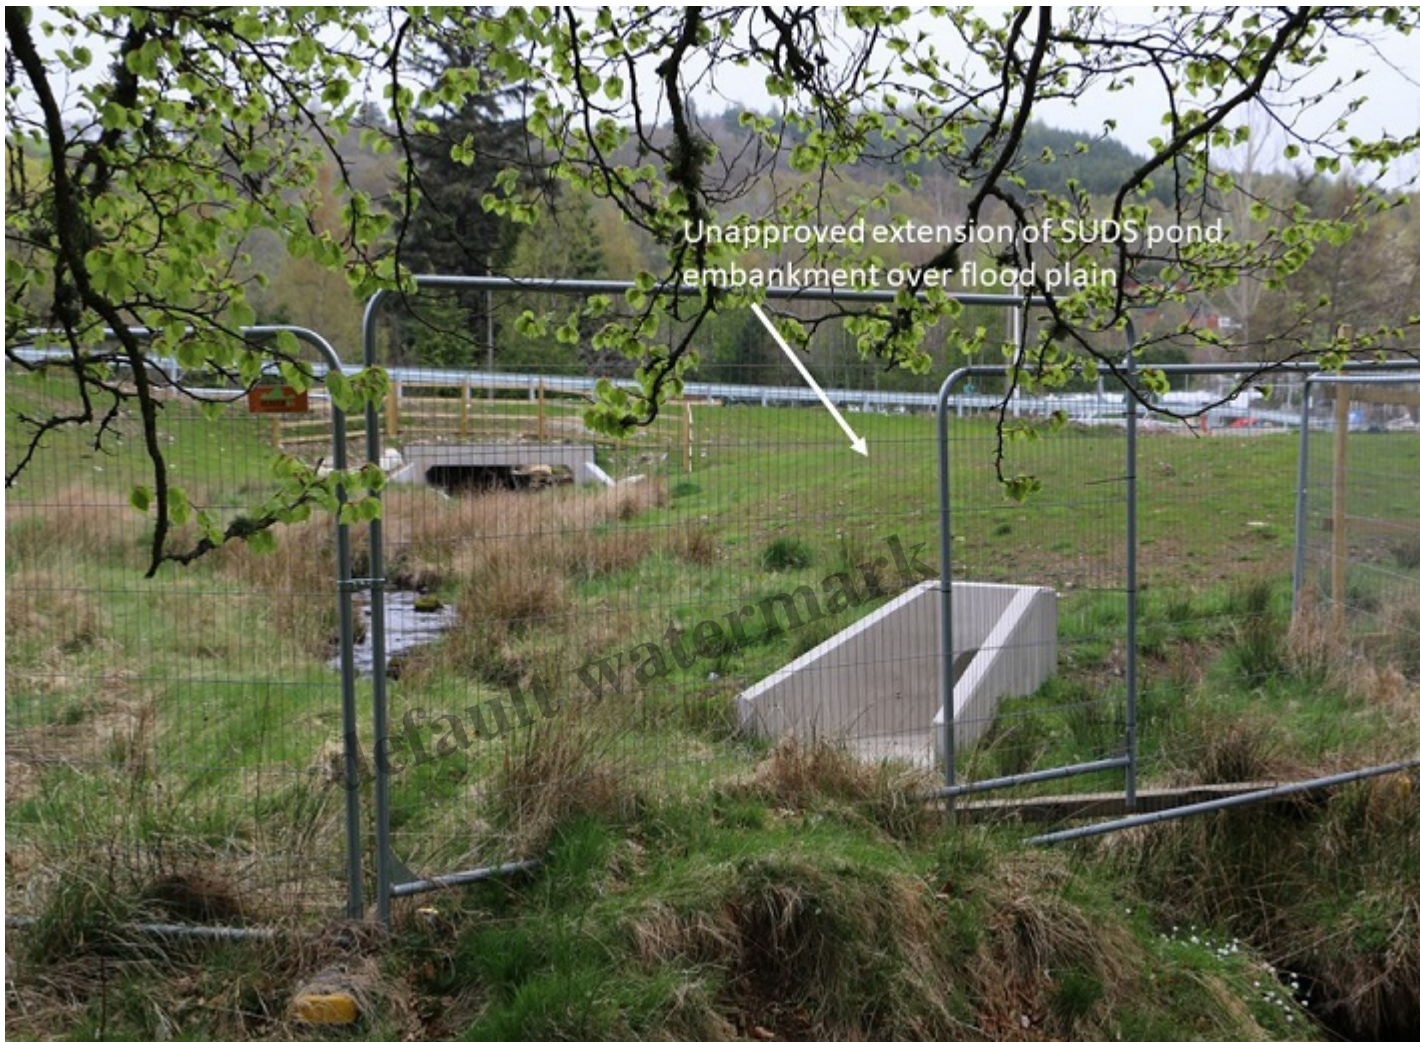
Photo 5

Edge of SUDS pond embankment sloping down to the Kylesha Burn. Compare this with Plan 4 which shows there should be at least 10 metres of flood plain between the embankment and the Burn.

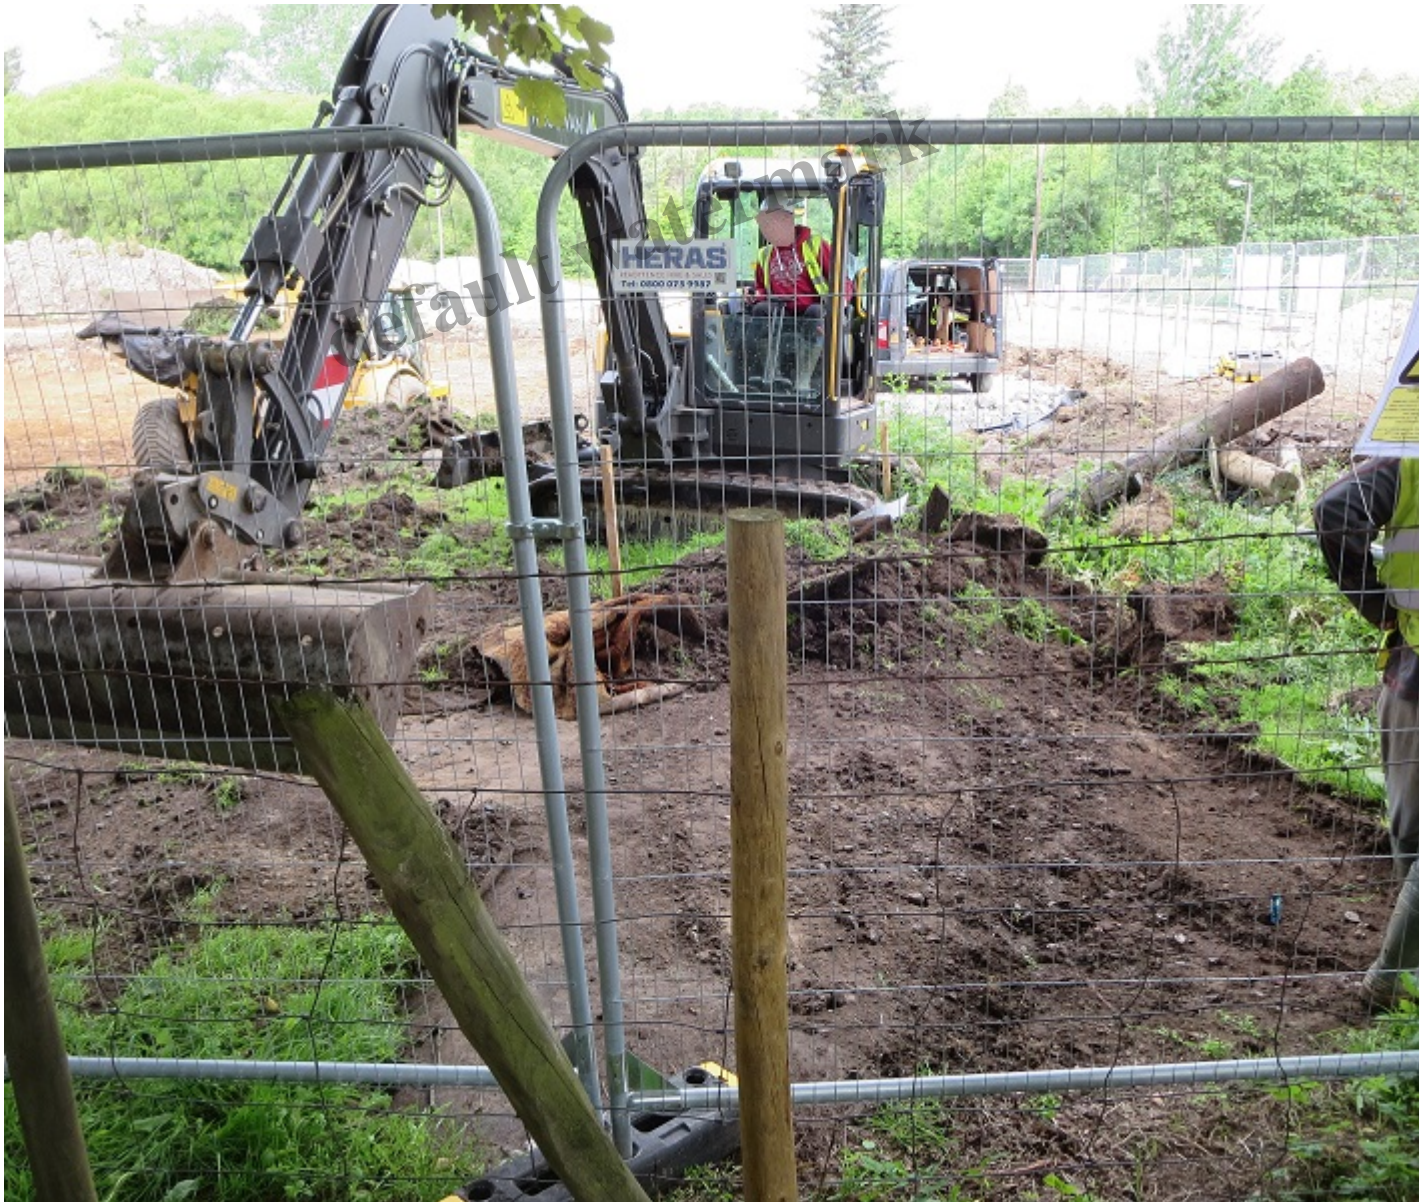
Photo 6

1. Cellweb installation advice states “*Soil compaction from vehicles, machinery and materials is to be strictly prohibited during construction within Root Protection Areas (RPAs).*” and “*Remove surface vegetation using hand held tools or a herbicide*”. Instead surface vegetation was scraped off using a mechanical excavator, potentially damaging the fine roots the trees use for feeding.
2. Cellweb installation advice states “*Permeable surface is always recommended, if this is not possible approx. 100mm thickness of subbase type 1 can be used as running surface*”. Type 1 aggregate was used to varying depths up to 250mm to form the running surface.

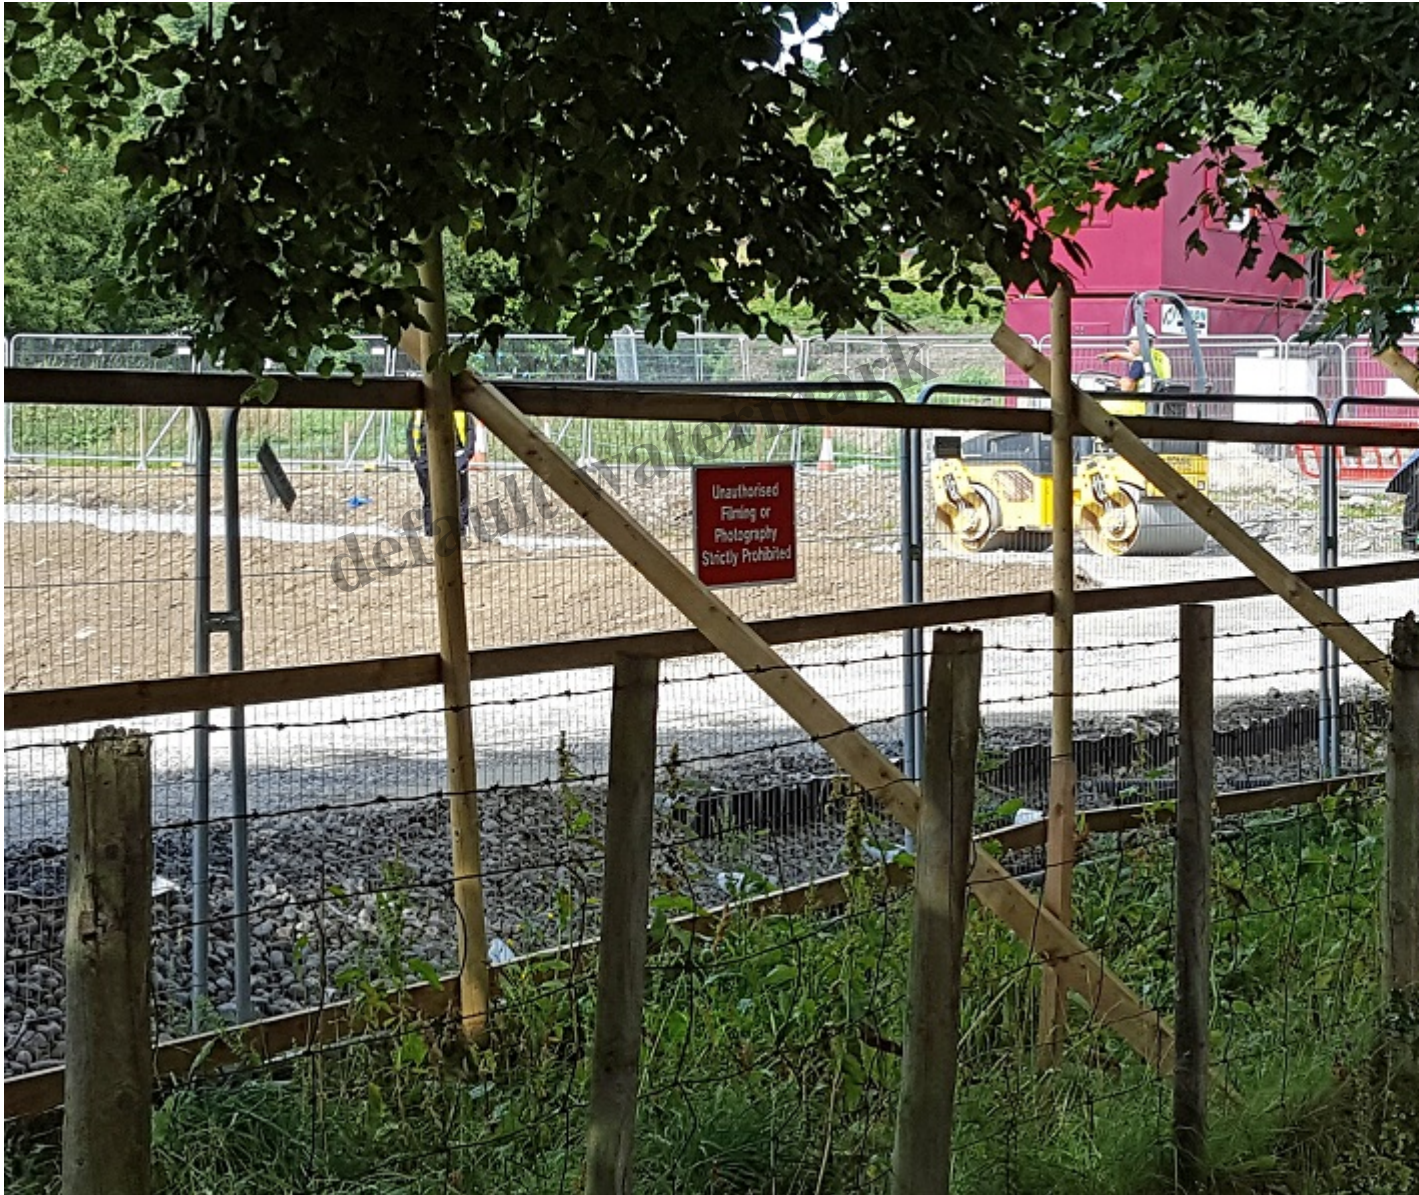
Photo 7

3. Cellweb installation guidance states “*Do not use a whacker plate... or any other form of compaction*” but the Type 1 was compacted with a large vibratory roller (compacted Type 1 reduces oxygen supply to tree roots)

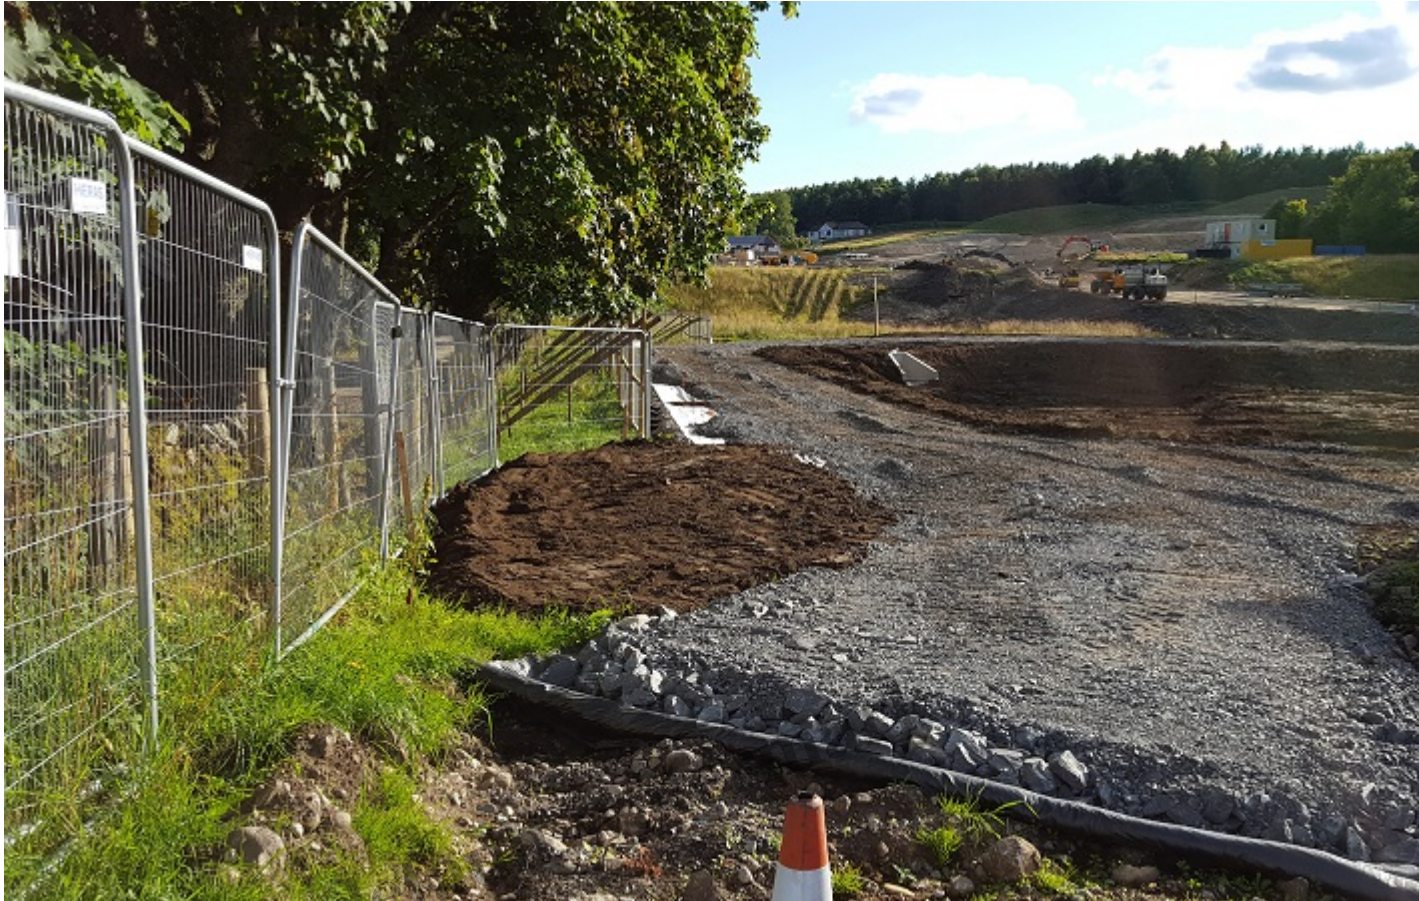
Photo 8

4. A thick layer of topsoil was placed on top of part of the Cellweb® installation – reducing oxygen supply to the tree roots – negating the beneficial effect of the Cellweb®

“Where professional advice has been given to the housing developer regarding tree protection this appears to have been followed in part but with significant modifications introduced during the performance of the works on site. Deviation from current nationally recognised guidance and manufacturers installation instructions coupled with weak planning enforcement has resulted in an inadequate protection for the trees at The Dulaig.”

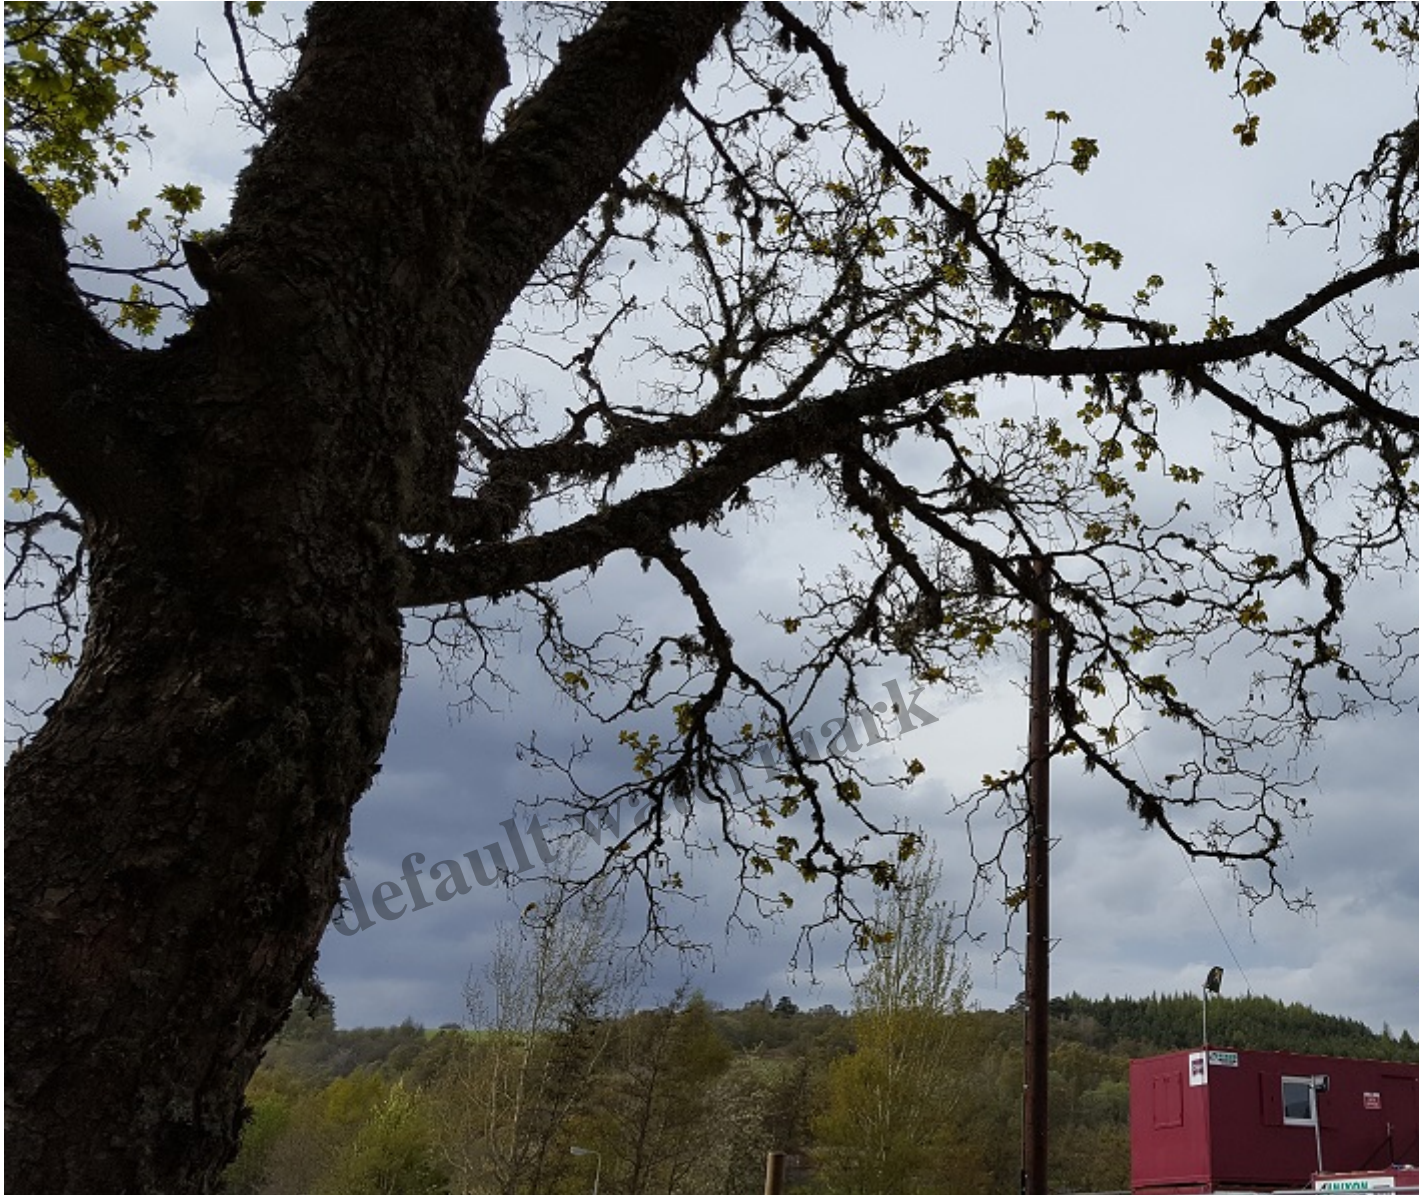
It is now springtime 2018 and the trees are just coming into leaf – a worrying time for our threatened trees. It’s a bit early to assess the 100 year old beech, but one of the sycamores which was healthy a year ago is currently looking particularly stressed and is very slow in coming into leaf.

Photo 9 Mature sycamore showing stress with few buds leafing and most of the fine twigs almost leafless.

Neighbouring sycamores are almost in full leaf.

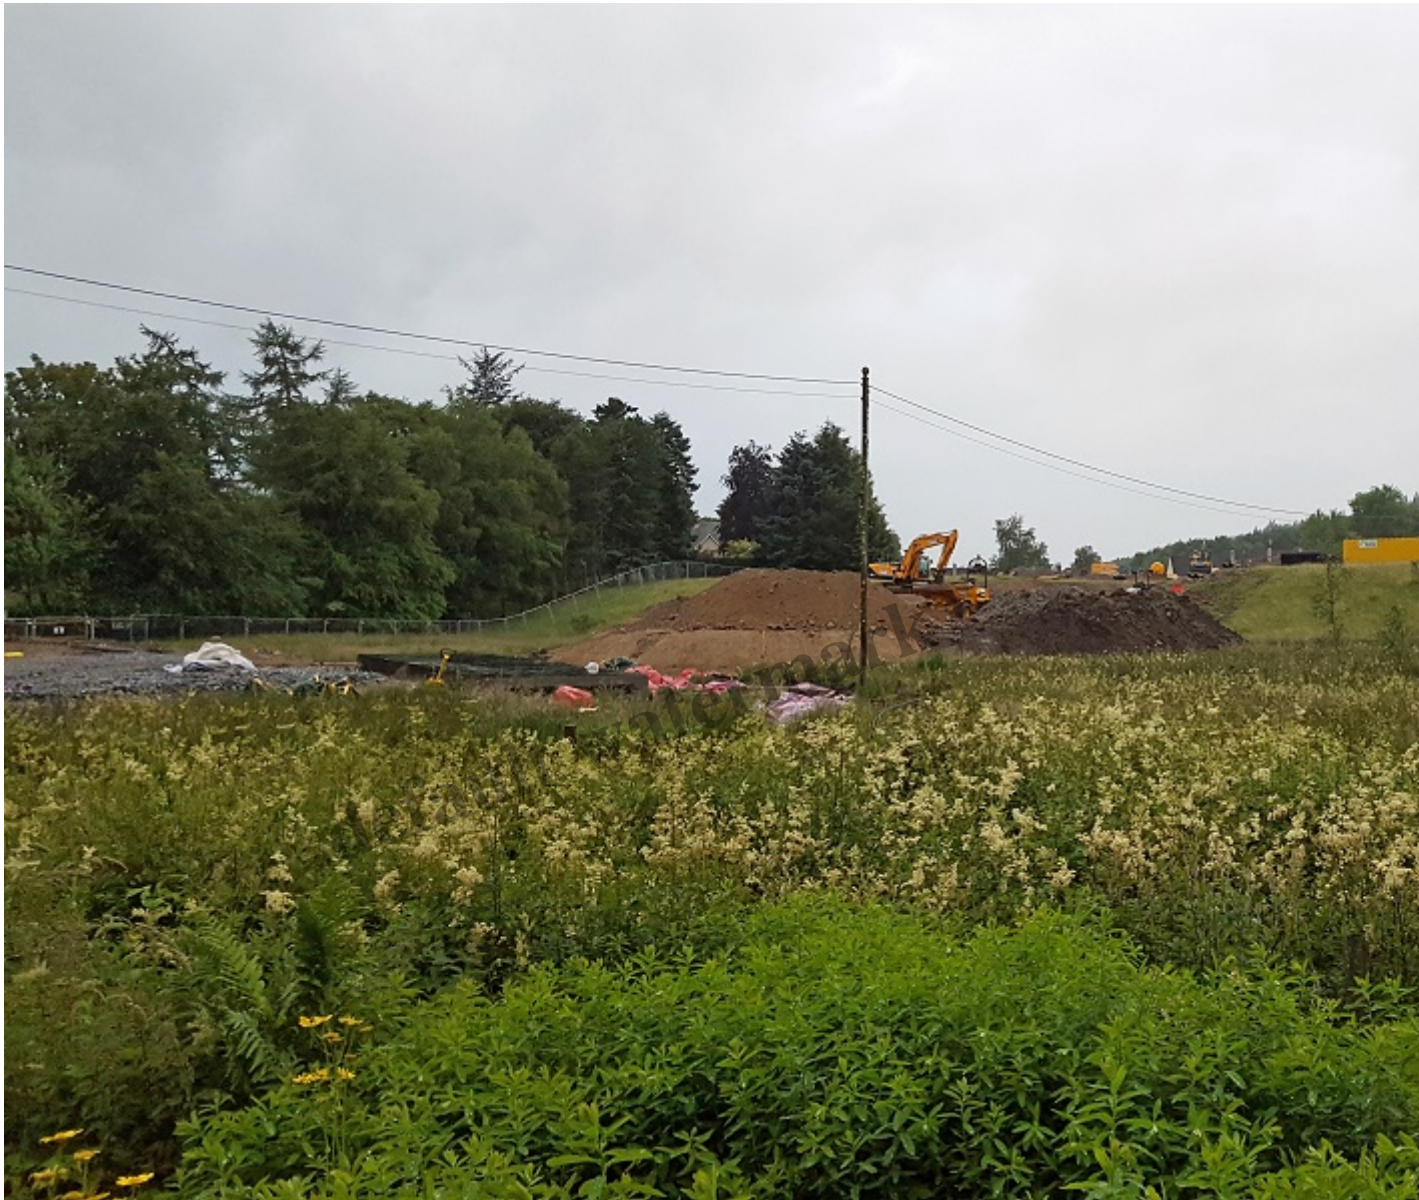
Photo 10

Meadowsweet rich wetland (July 2017) with access road construction underway to the left
