Is the Beachen Court Development in the Cairngorms National Park the national “go to” place for water technology?

This SUDS scheme looks like many others, but could it really become a national icon and the ‘go to’ place for water technology as claimed by the British organiser of an Icelandic delegation visiting to the Cairngorms National Park? From my knowledge and professional experience of SUDS installations – and from living next door and seeing what has happened day to day – I don’t think so. Rather it presents a great example of how NOT to design and build such schemes.

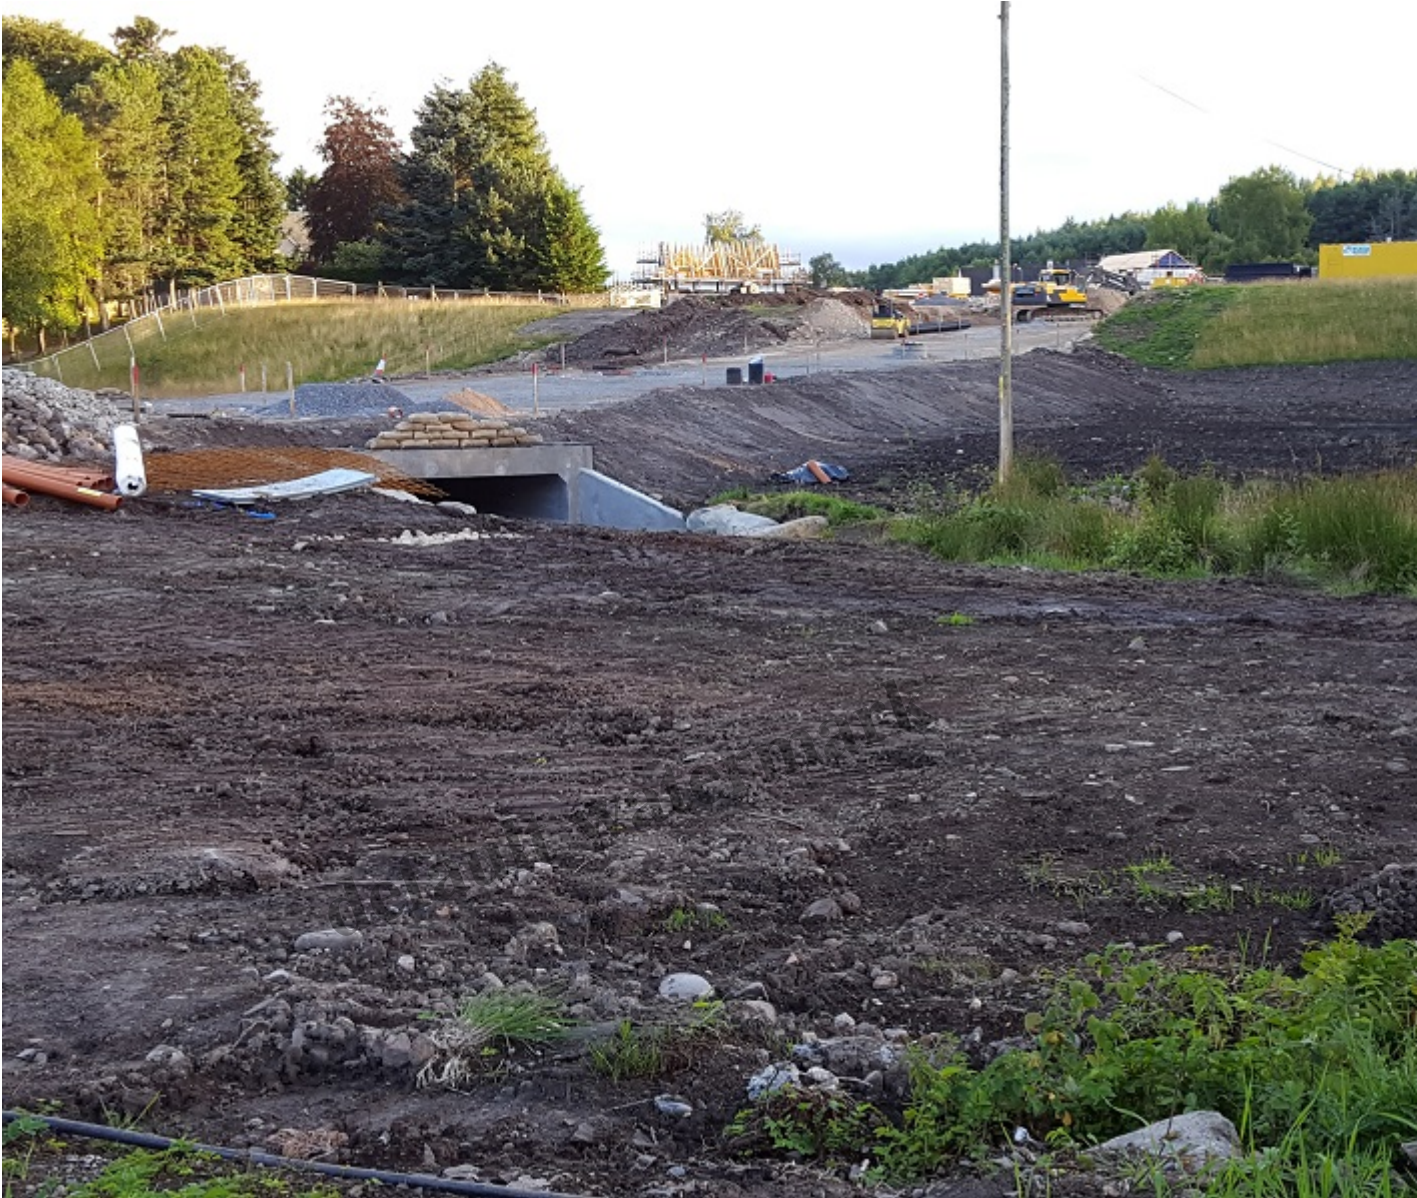
Photo 11 Virtually all of this rich wetland destroyed and levels raised with soil fill (August 2017)

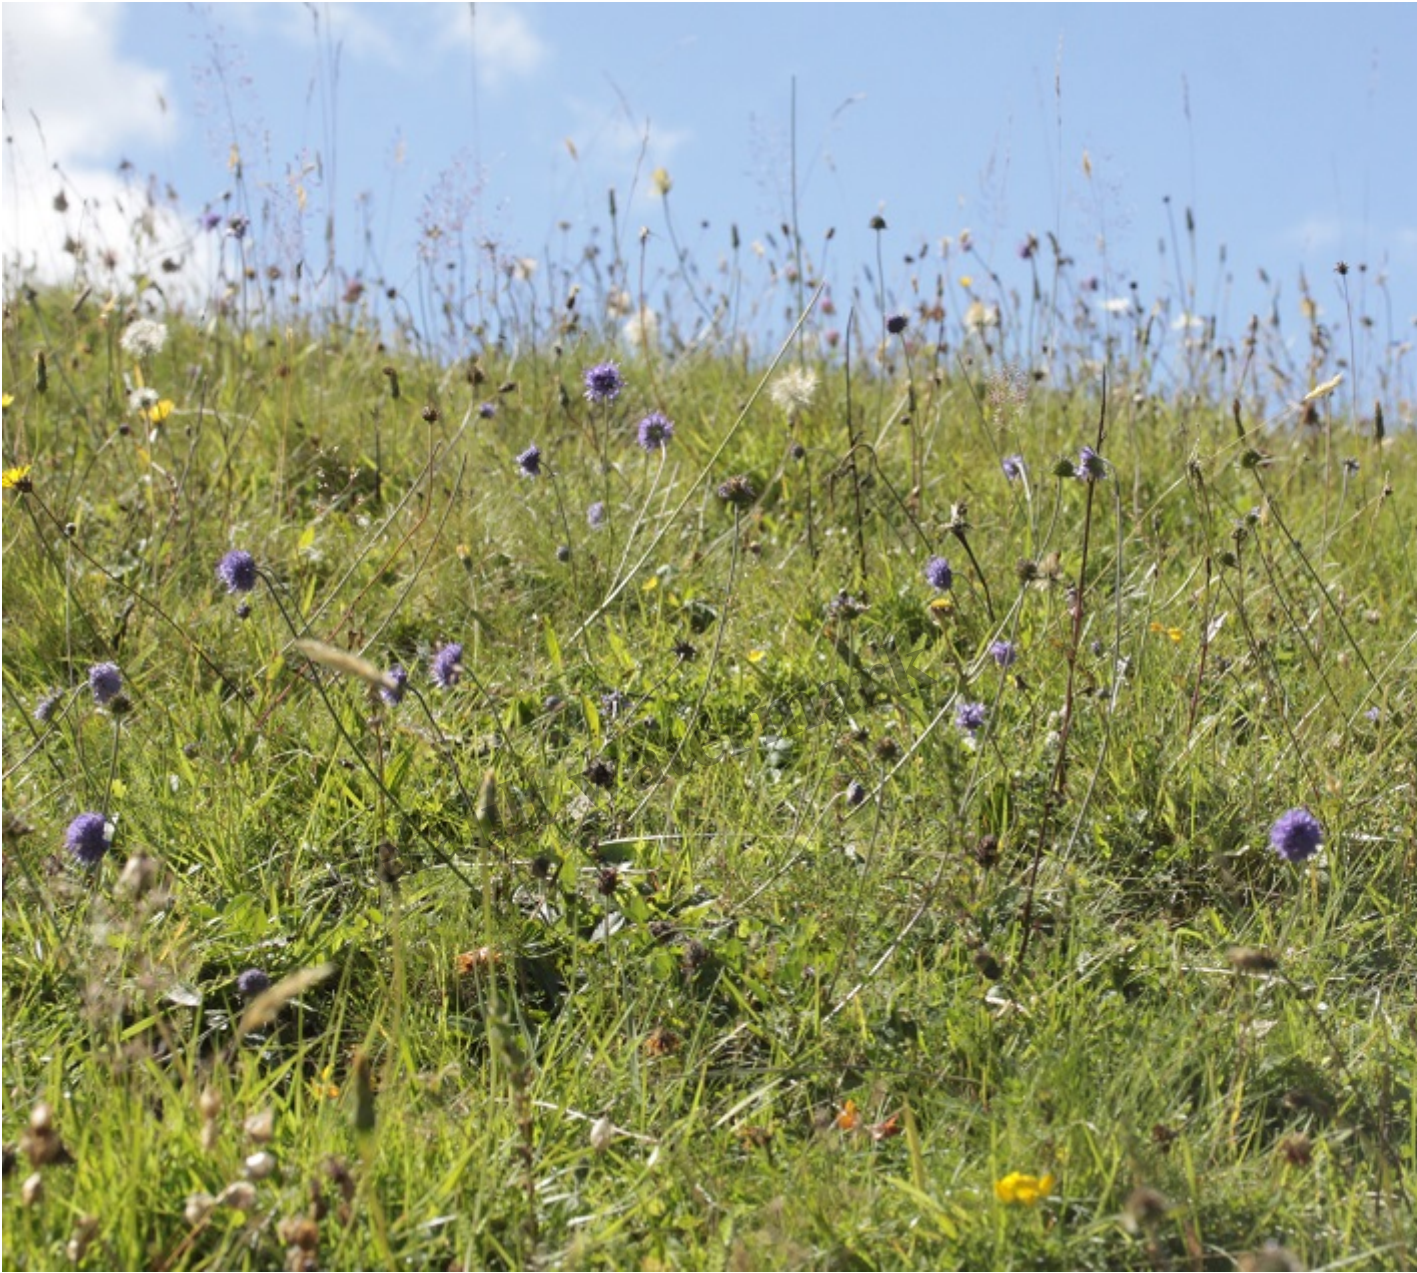
There are further unnecessary losses caused by storing and spreading surplus soil on the flower rich old river terrace that supported field gentian, insect-friendly plants such as birds-foot trefoil and especially devil's bit scabious, as well as being a high interest for grassland fungi. An indication of the value of this area for pollinators such as bees is that mating conopid flies (thick headed flies) have

The wild flower rich river terrace (Photo Credit Badenoch and Strathspey Conservation Group)
