## The impact of hydro tracks on the landscape – the Allt a Chuillinn scheme in Glen Falloch

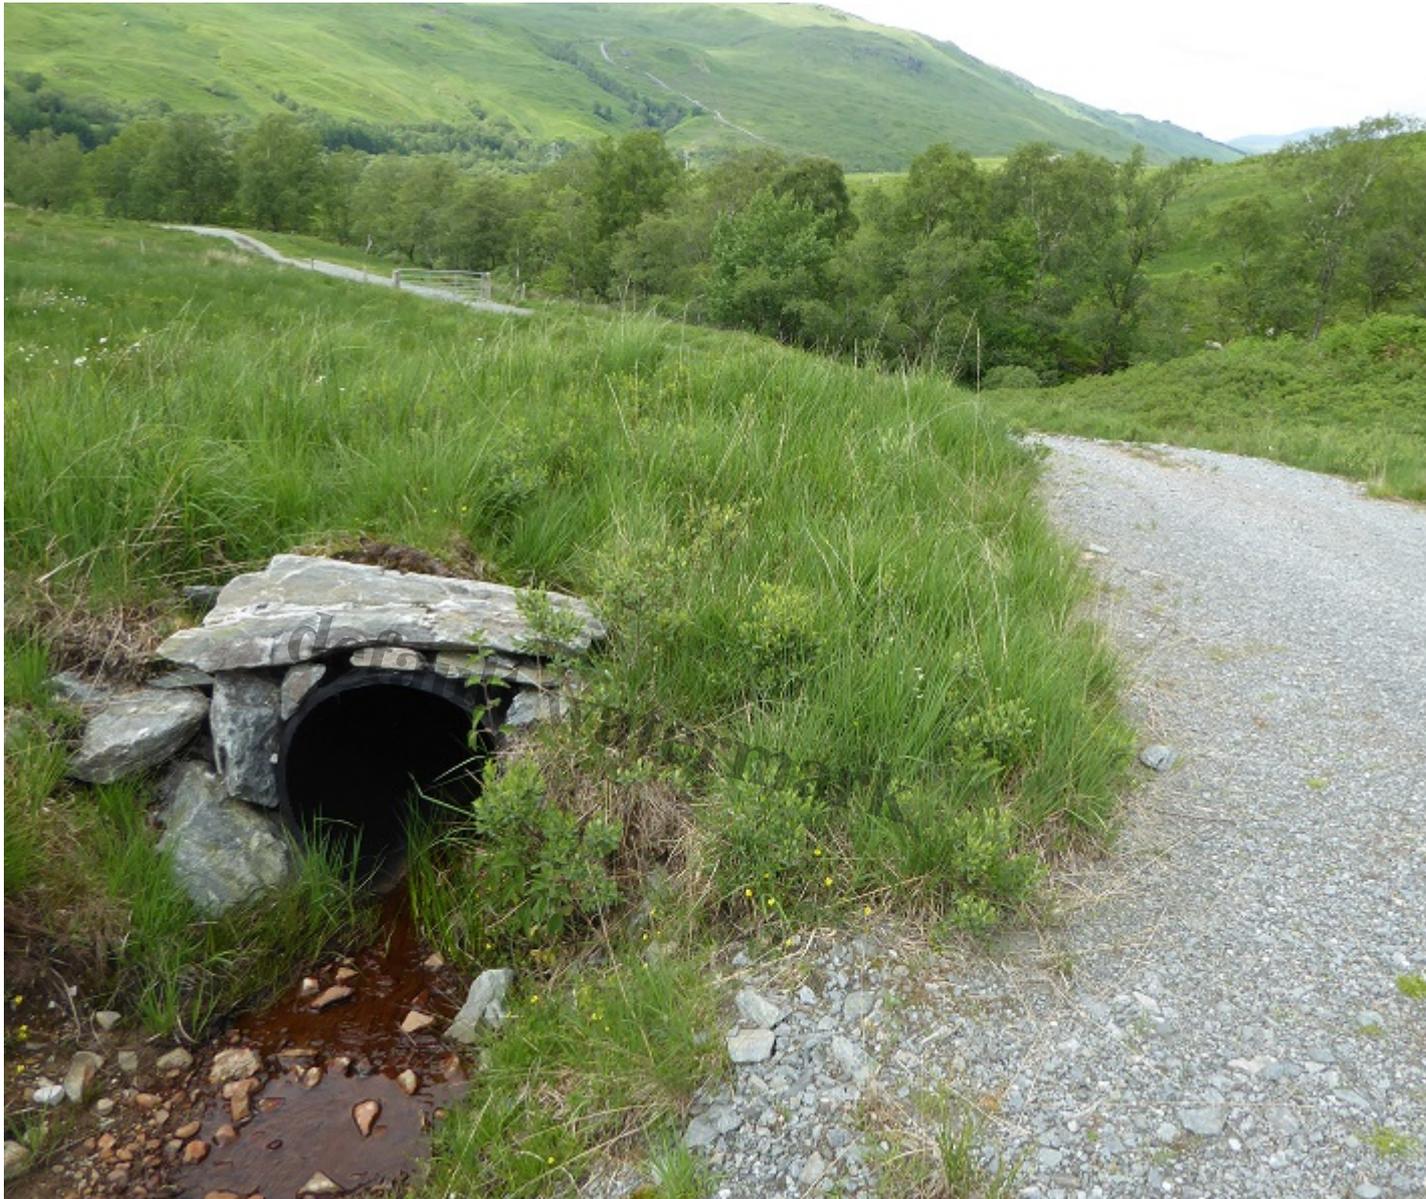
The lower section of the track along the Allt a' Chuillinn

In terms of landscaping, all the culverts have been finished with natural materials and there are none of the protruding plastic pipes so evident in other schemes – which the LLTNPA excuses on the grounds that those schemes have not yet been ‘finished’.

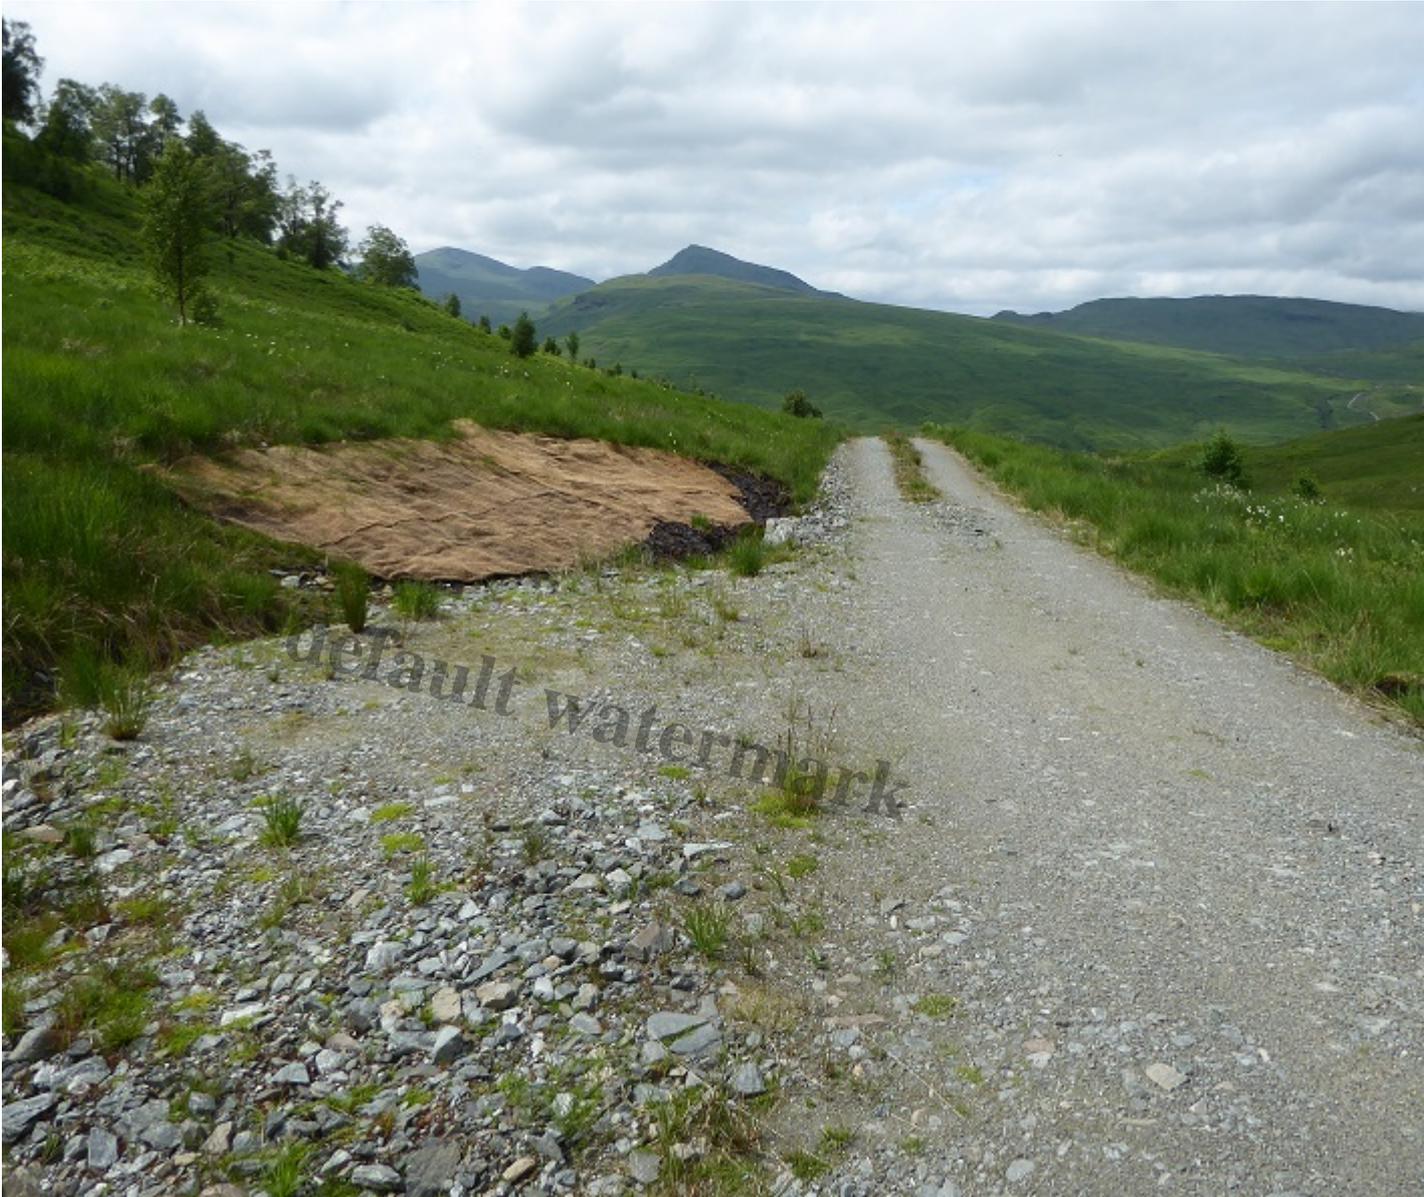
Matting being used to try and restore areas of bare peat

There is even evidence of use of specialised restoration techniques in areas where insufficient vegetation was saved and stored properly for replacing over peat and other soils. The passing place in the foreground, however, is an eyesore which is completely unnecessary on a track which is barred by locked gates ([see here](#)) while its edges are poorly restored. At each passing place on the track, the vegetated strip down the centre has failed to take, presumably from vehicles swerving onto the passing place, thus increasing the visual impact.

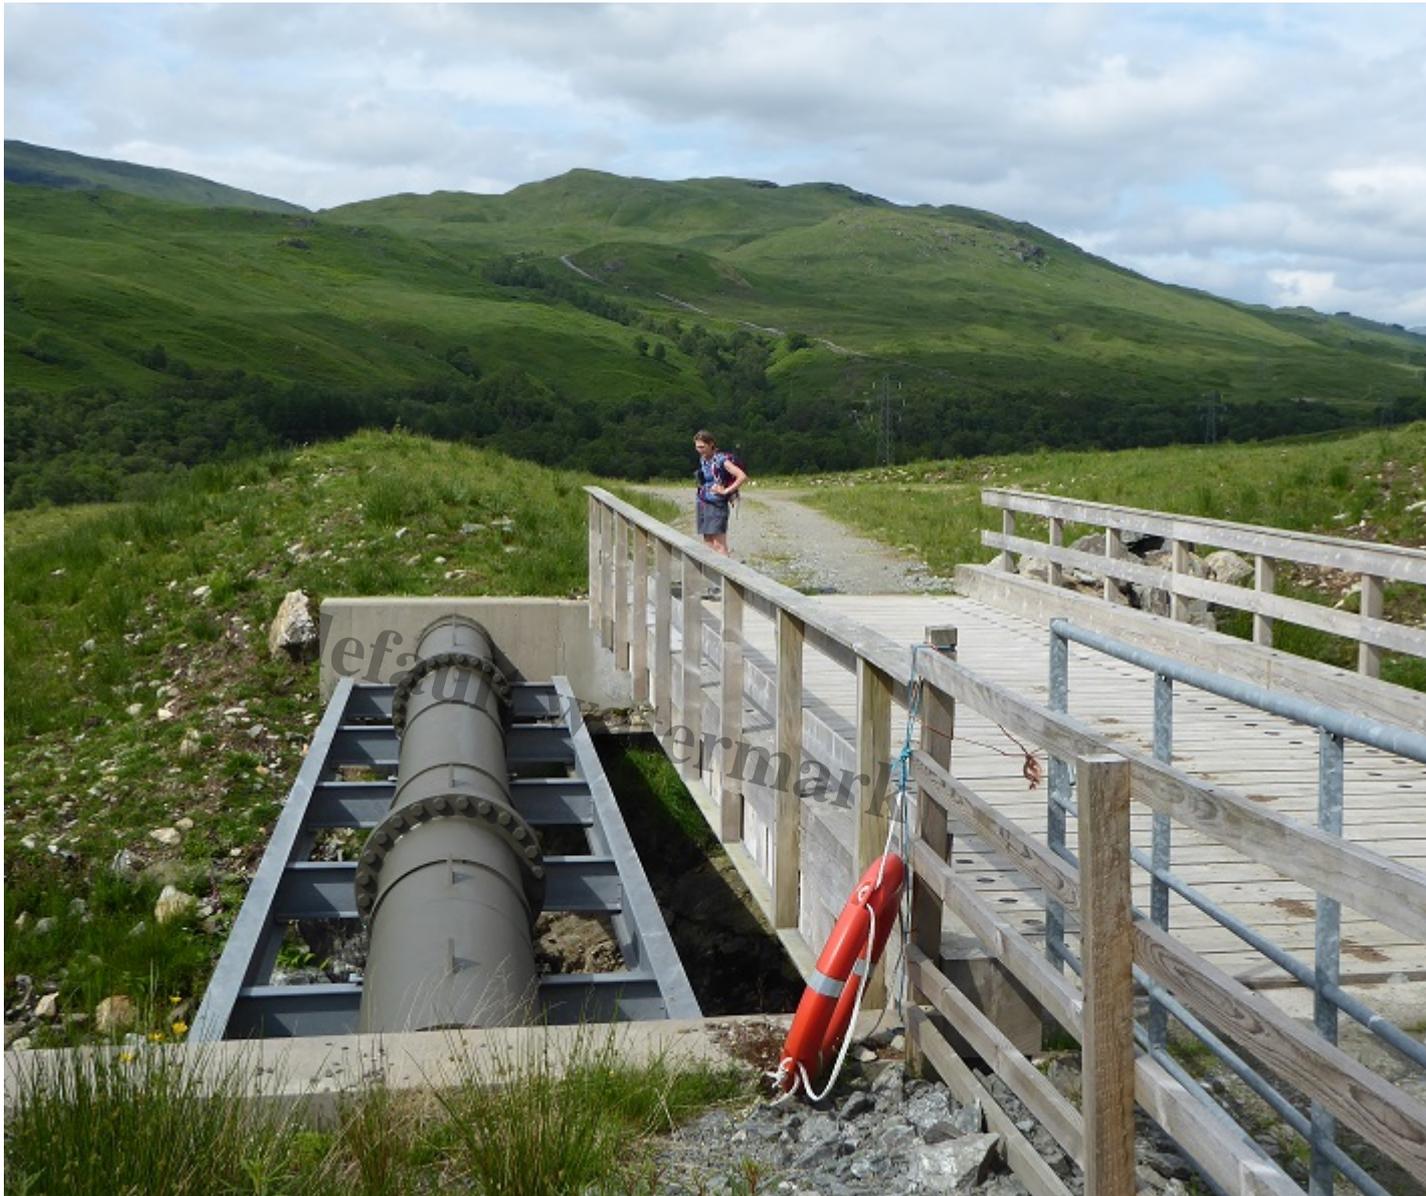
The bridge where the water from the hydro intakes is carried back across the Allt a Chuillinn. The Eas Dubh track, which penetrates the Ben Lui Wild Land Area behind.

Although I was pleased to see the bright blue penstock has been painted ([see here](#)), its still an eyesore and its hard to understand why it would not have been hidden under the new road bridge as the LLTNPA's own good practice guidance recommends.

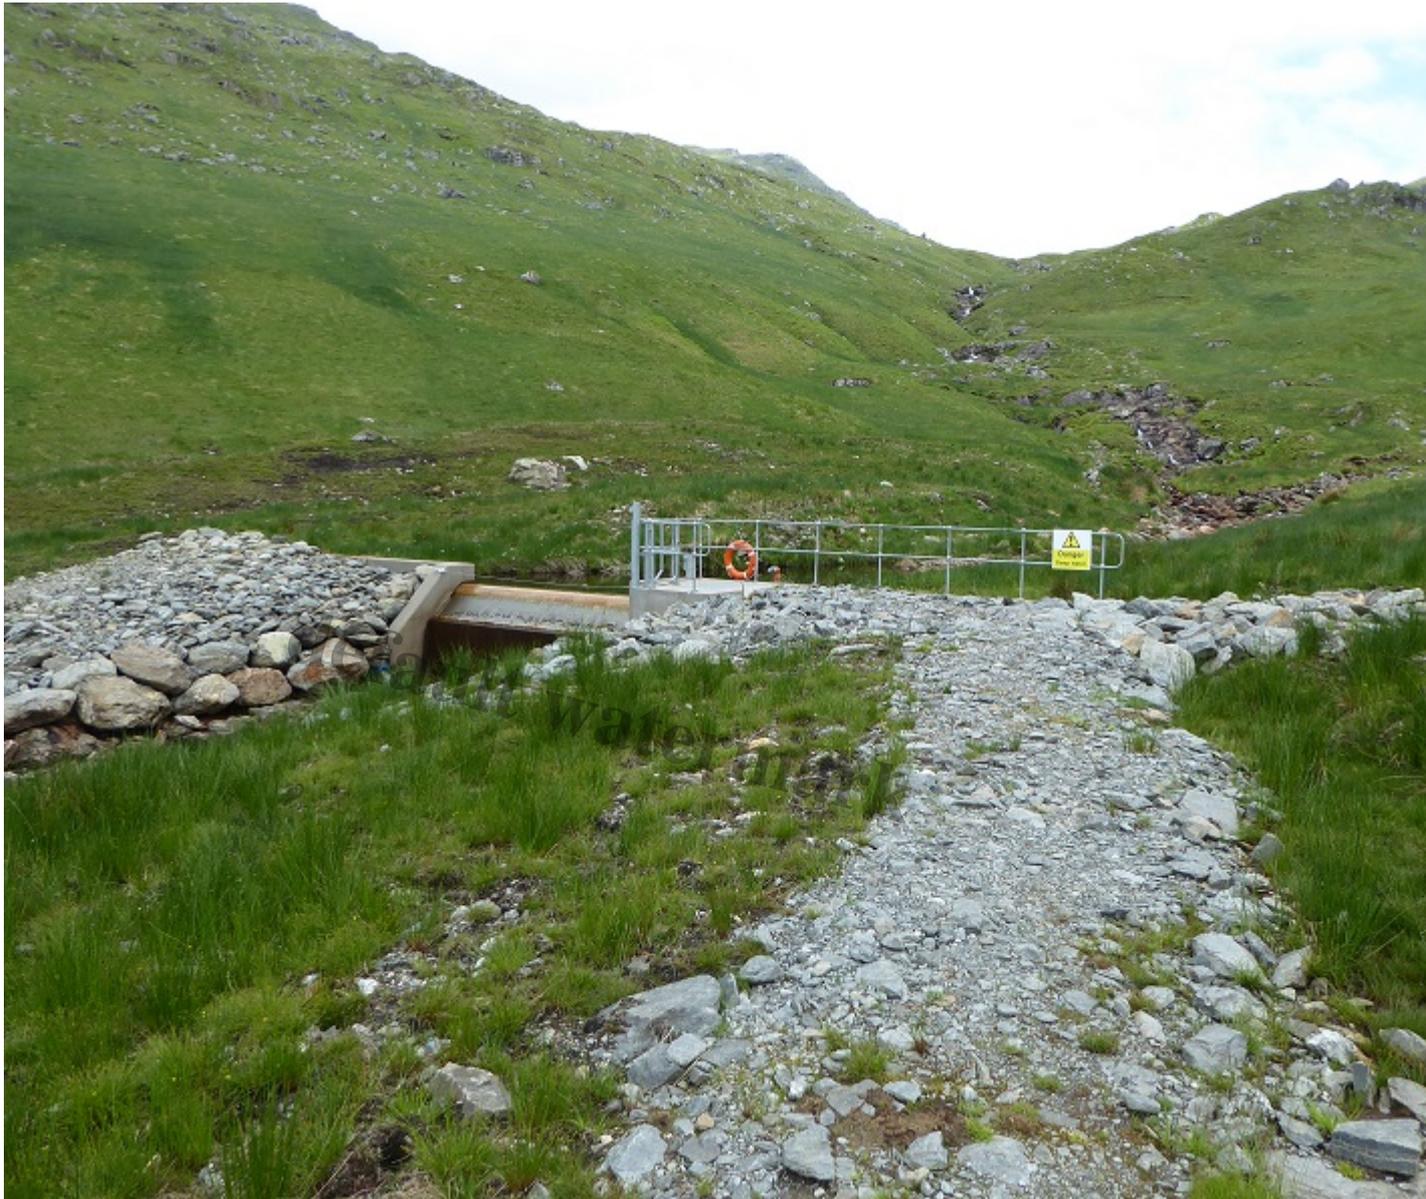
The main intake on the Allt a Chuillinn hydro scheme looking up towards Coire a Chuillinn which forms a designated Wild Land Area

The finishing at the intakes is another matter â?? the ugliness jars against the wild land behind.

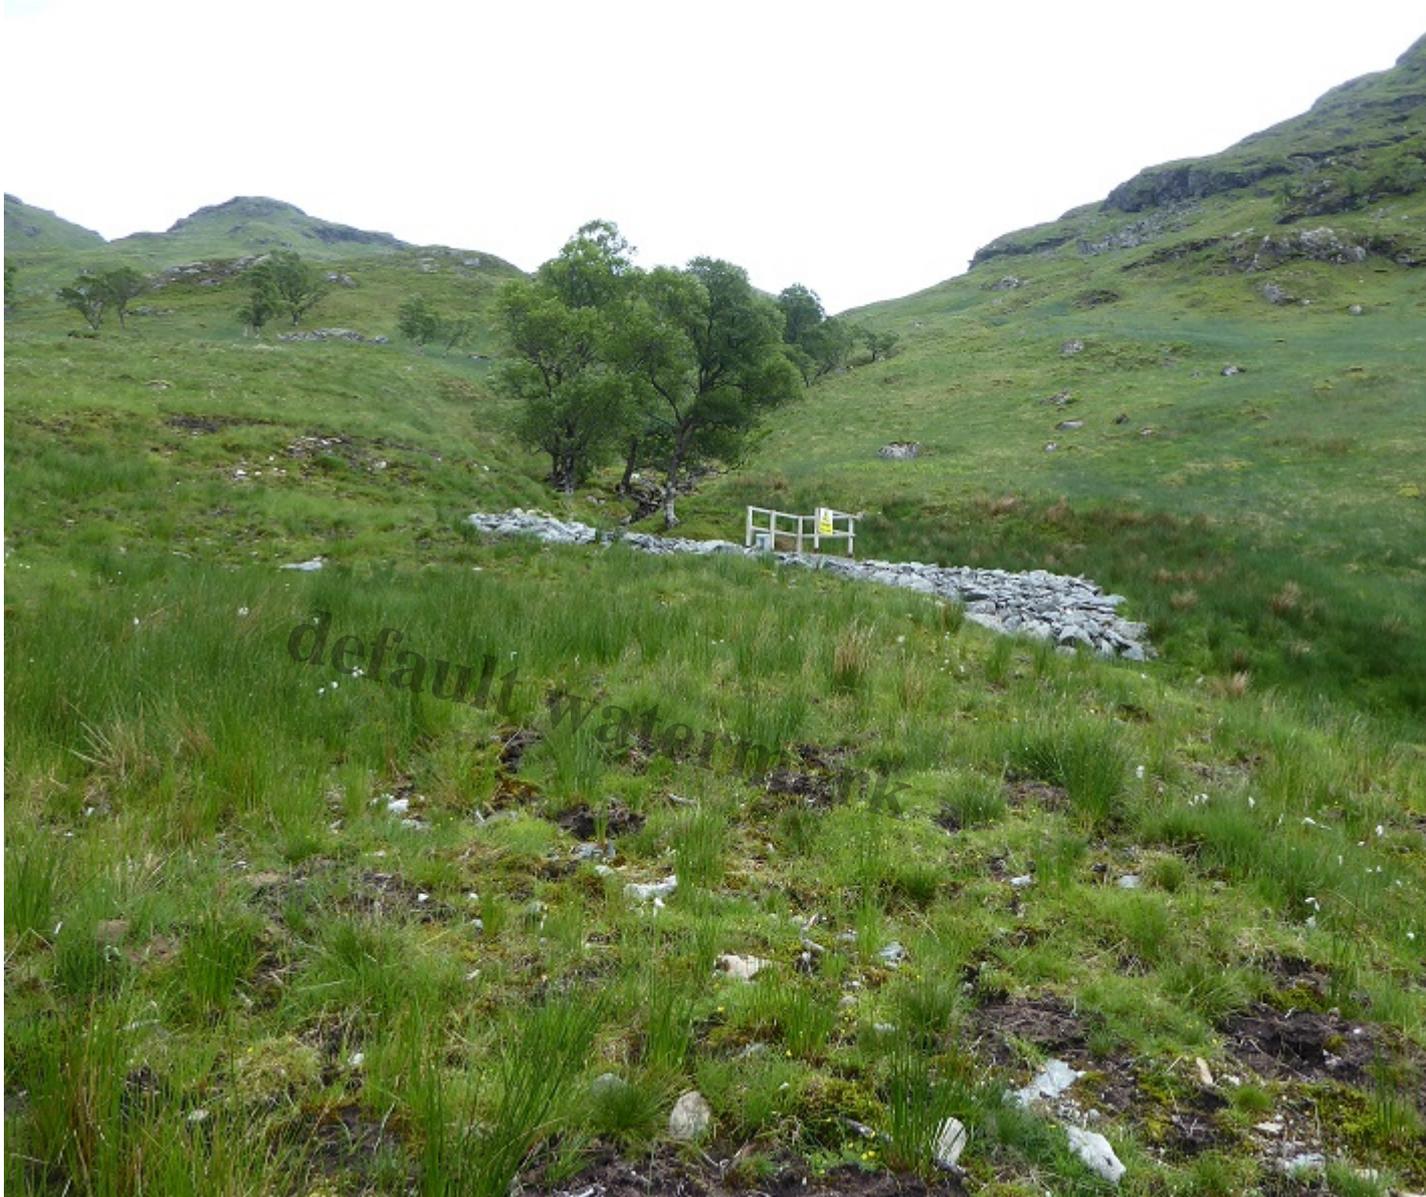
pipe which leads down from the second intake

While there is no track up the second intake and the ground above the pipe is

recovering quite well, its location is all too evident from the spill of boulders which contrasts with the surrounding grassland. Why wooden restraining rails were used here and not at the main intake, as per the LLTNPA own good practice guidance, is unclear and the penstock has been left bright blue. The equally bright yellow danger signs warn people of the danger of pools, health and safety gone mad, when most of the side burns and the Allt aâ??Chuillin itself contain similar pools.

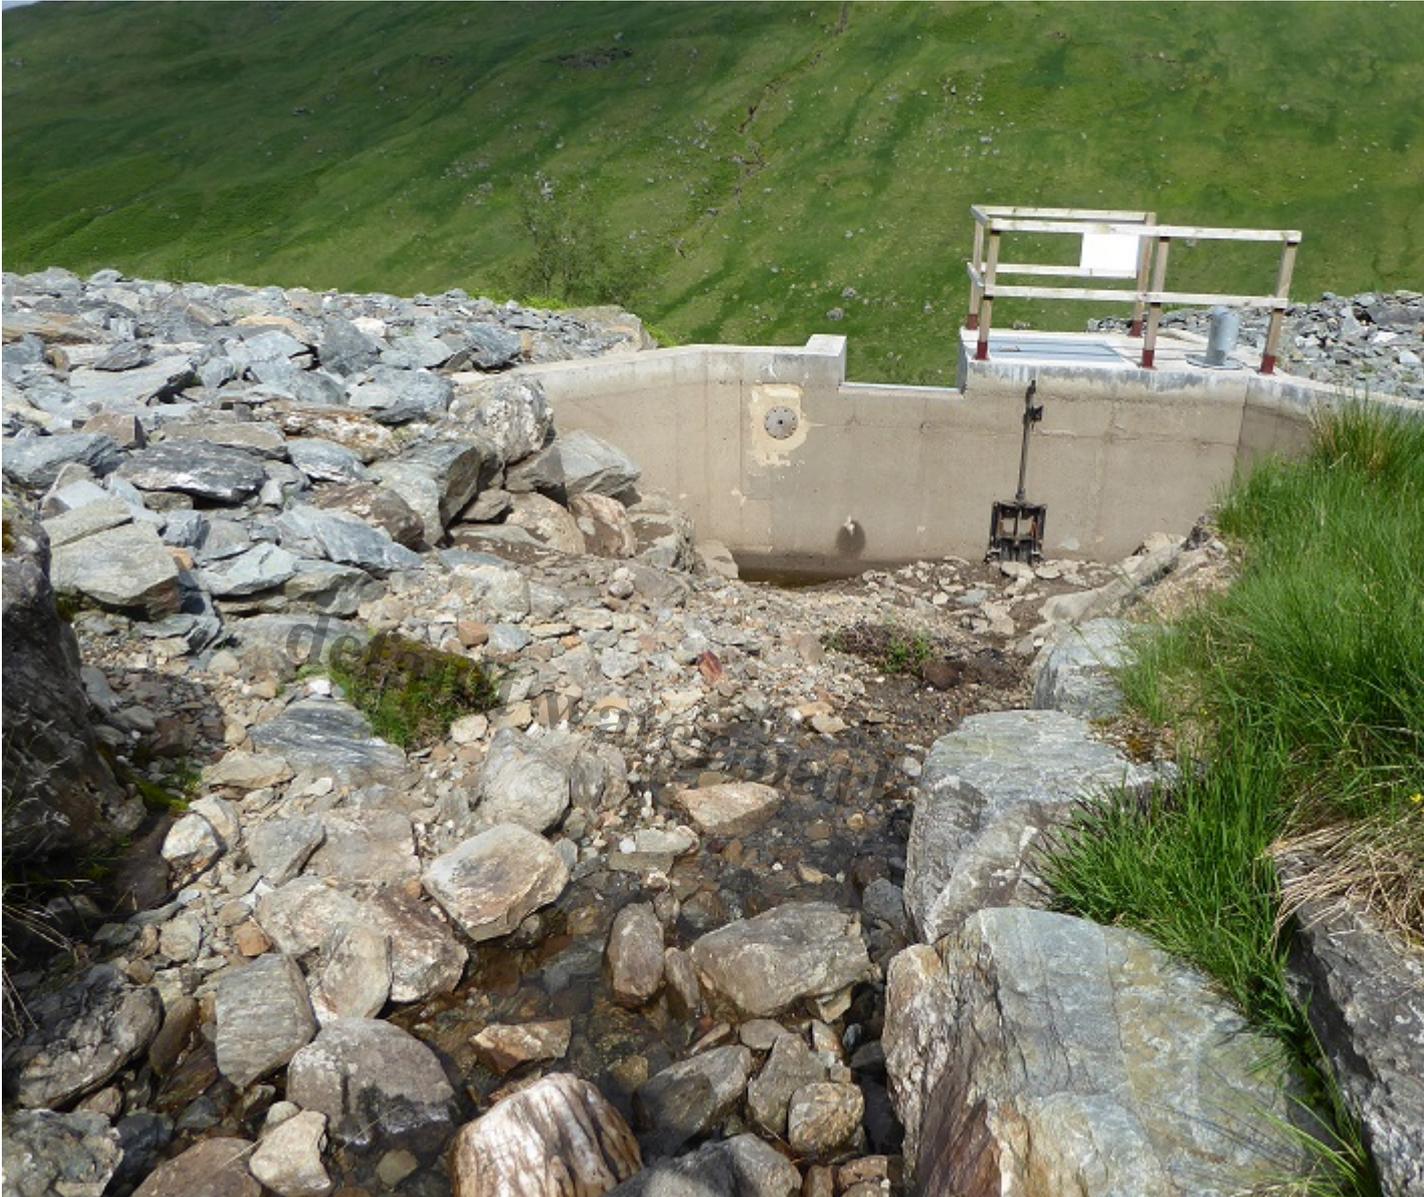
The third intake from above with flowing water visible in the foreground

At the third intake, I was surprised by the complete lack of water. At first I thought this was due to the very dry period â?? I visited 10 days ago â?? but above the intake the burn was running before disappearing into the ground a few metres above the intakeâ?!

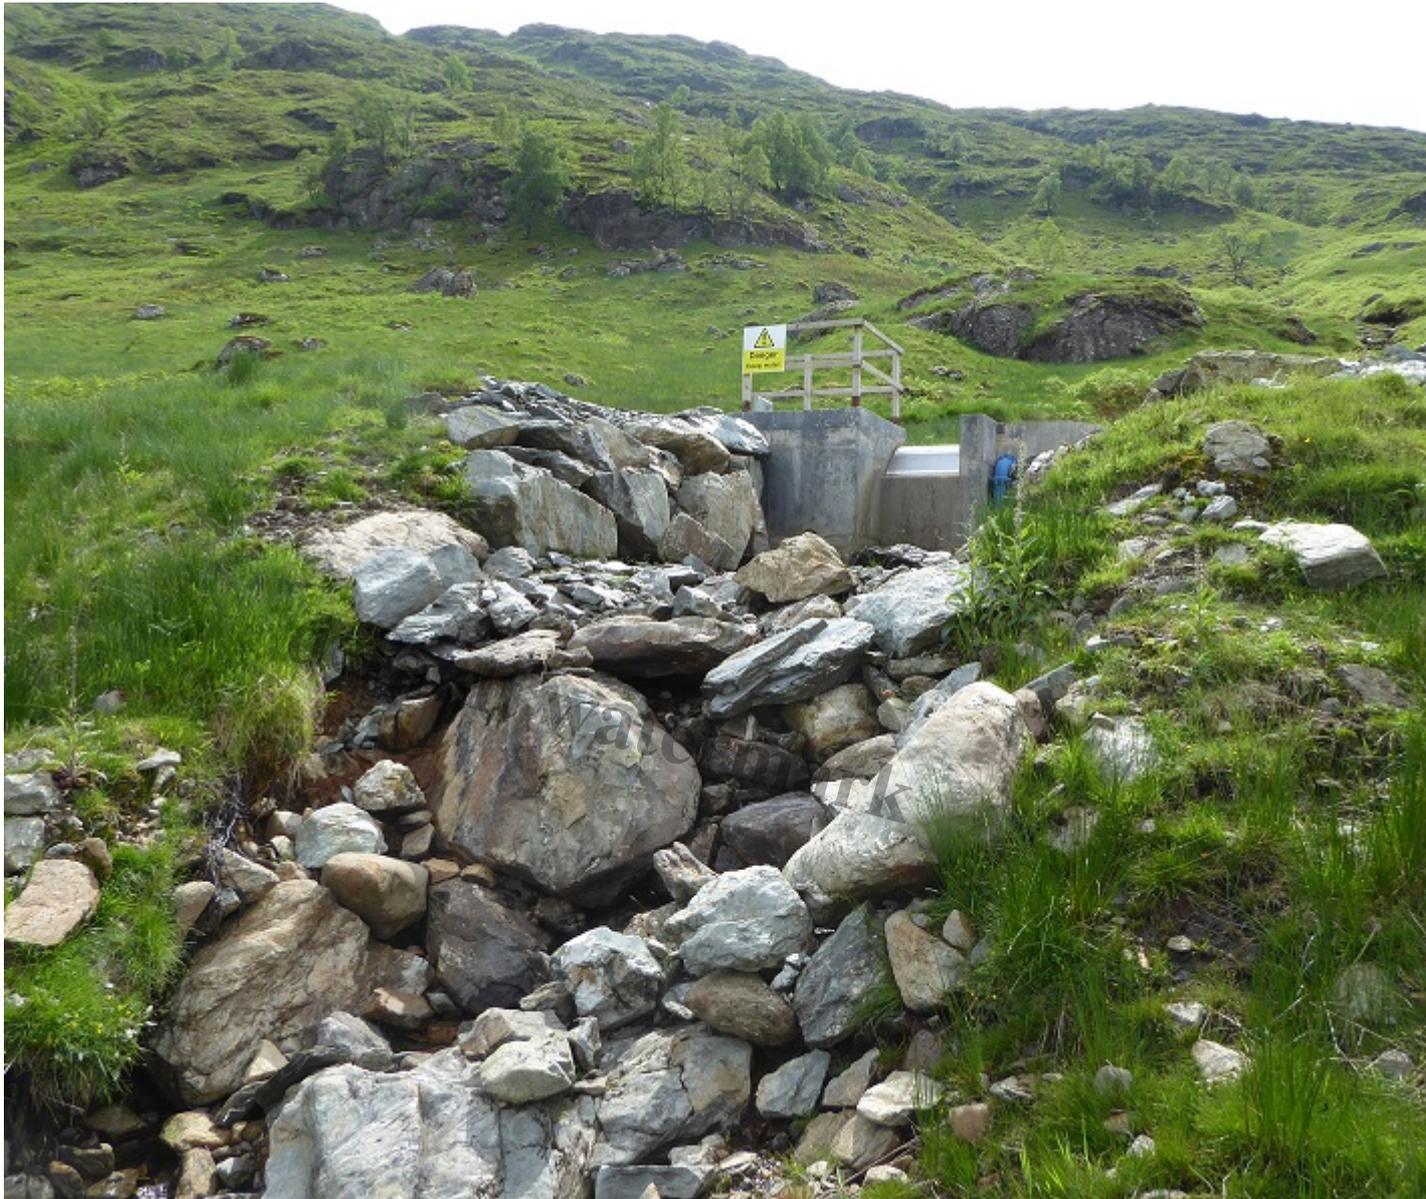
Below the third intake, blue pipe, warning signs and all the burn started flowing again in bottom

and then re-appearing a few metres below it. This looks like a pretty significant engineering failure and I suspect the intake pool will only fill when the burn is in spate. If Glen Falloch Estates want to repair this intake bringing in heavy machinery along the track would undo much of the restoration work which has been done there! Because of this, if the estate do want to fix this hydro intake, the LLTNPA should insist that heavy machinery is brought in by a large helicopter.

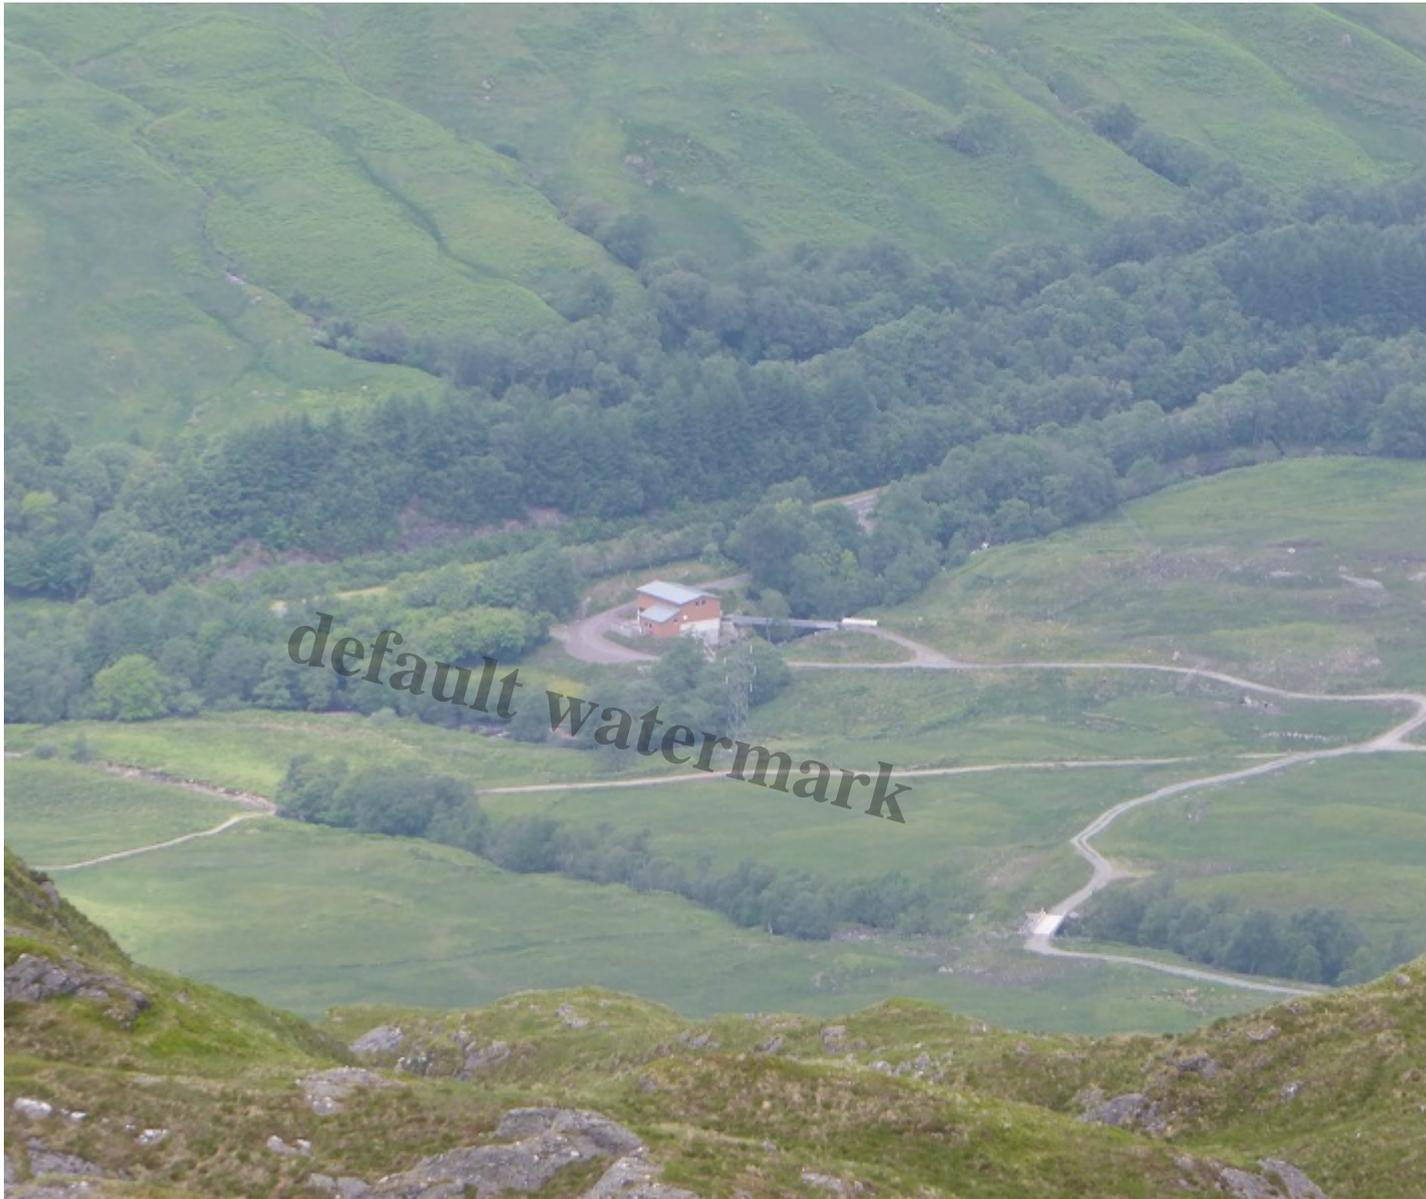
The Derrydarroch hydro scheme from Ben Glas with the Allt a Chuillinn track and bridge bottom right. Highland Way runs across the crossroads - note how its much narrower than the new - restored

While the A82 and West Highland line are hidden in trees, the new tracks provide a stark contrast to the surrounding landscape.

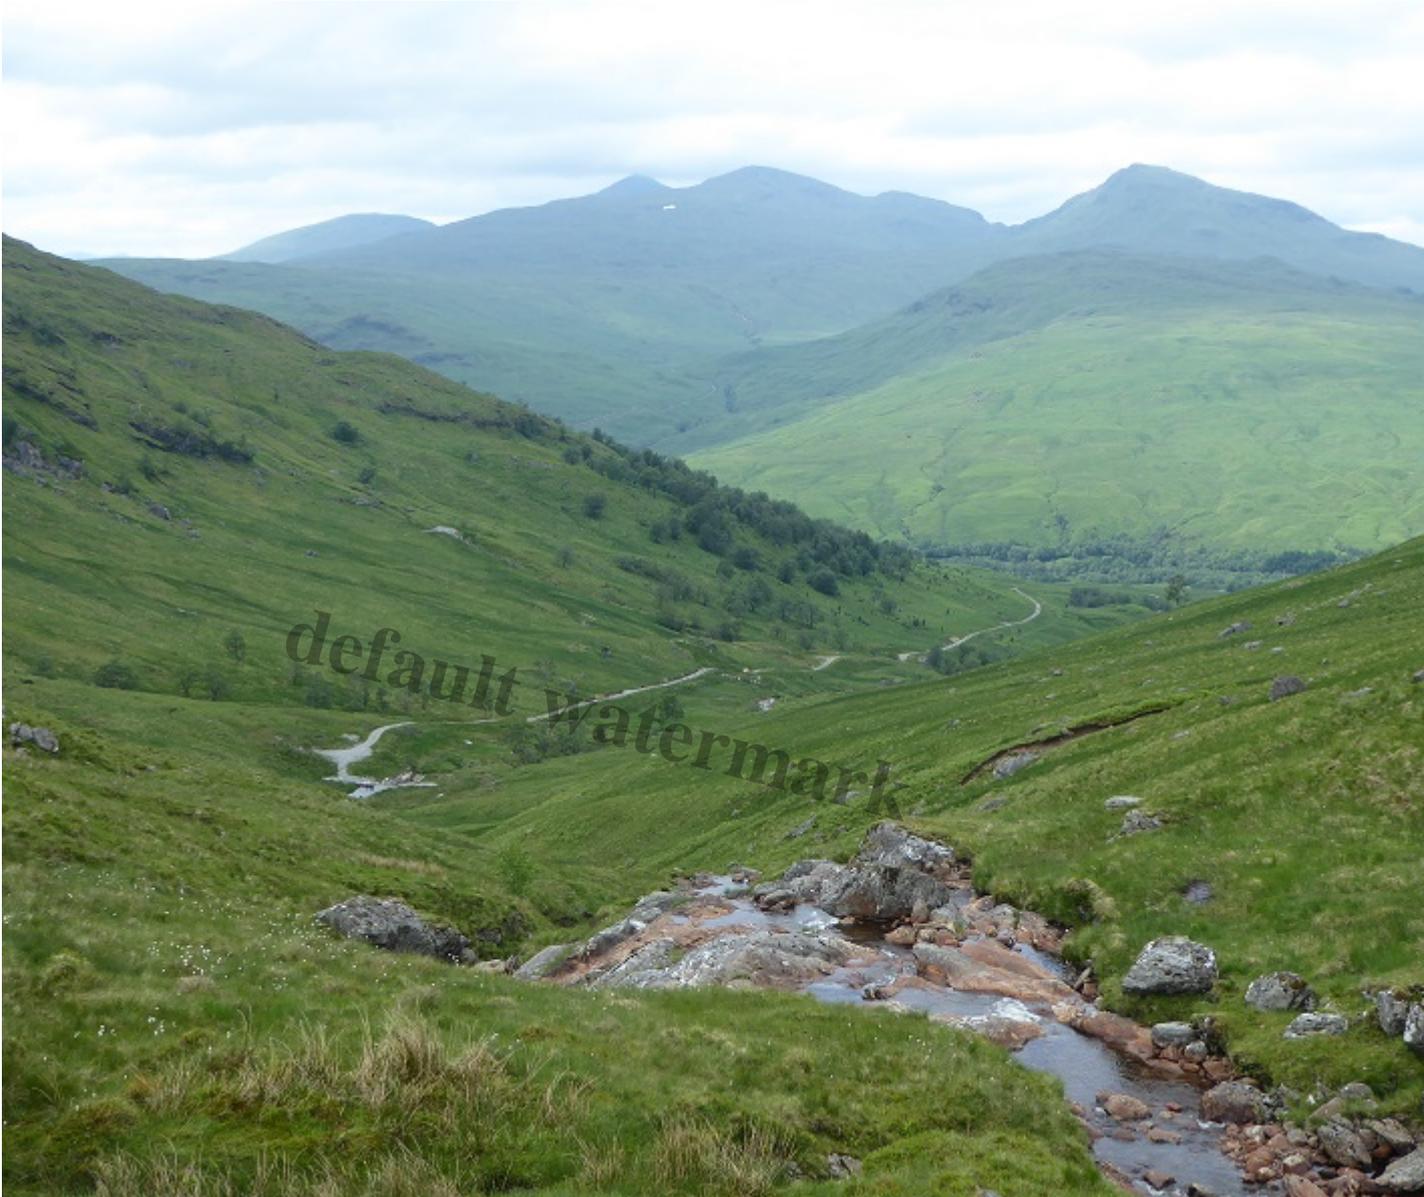
The Ben Lui hills behind the Allt a Chuillinn track – first intake centre left, third intake on hillside re

Imagine this view without the track – that is how this glen looked before the hydro scheme was installed and would have looked like if the LLTNPA had kept the original planning requirements which were for all the access tracks to the hydro intakes should be removed. These requirements, set by the LLTNPA Board at the time, were reversed by staff when they approved subsequent applications from Glen Falloch estate to retain the main tracks. The removal of the construction track to the third intake shows what the view would have looked like if the track had been removed. Some improved landscaping around the 3rd intake and you would not know it was there although for the present it forms another blot on the landscape.

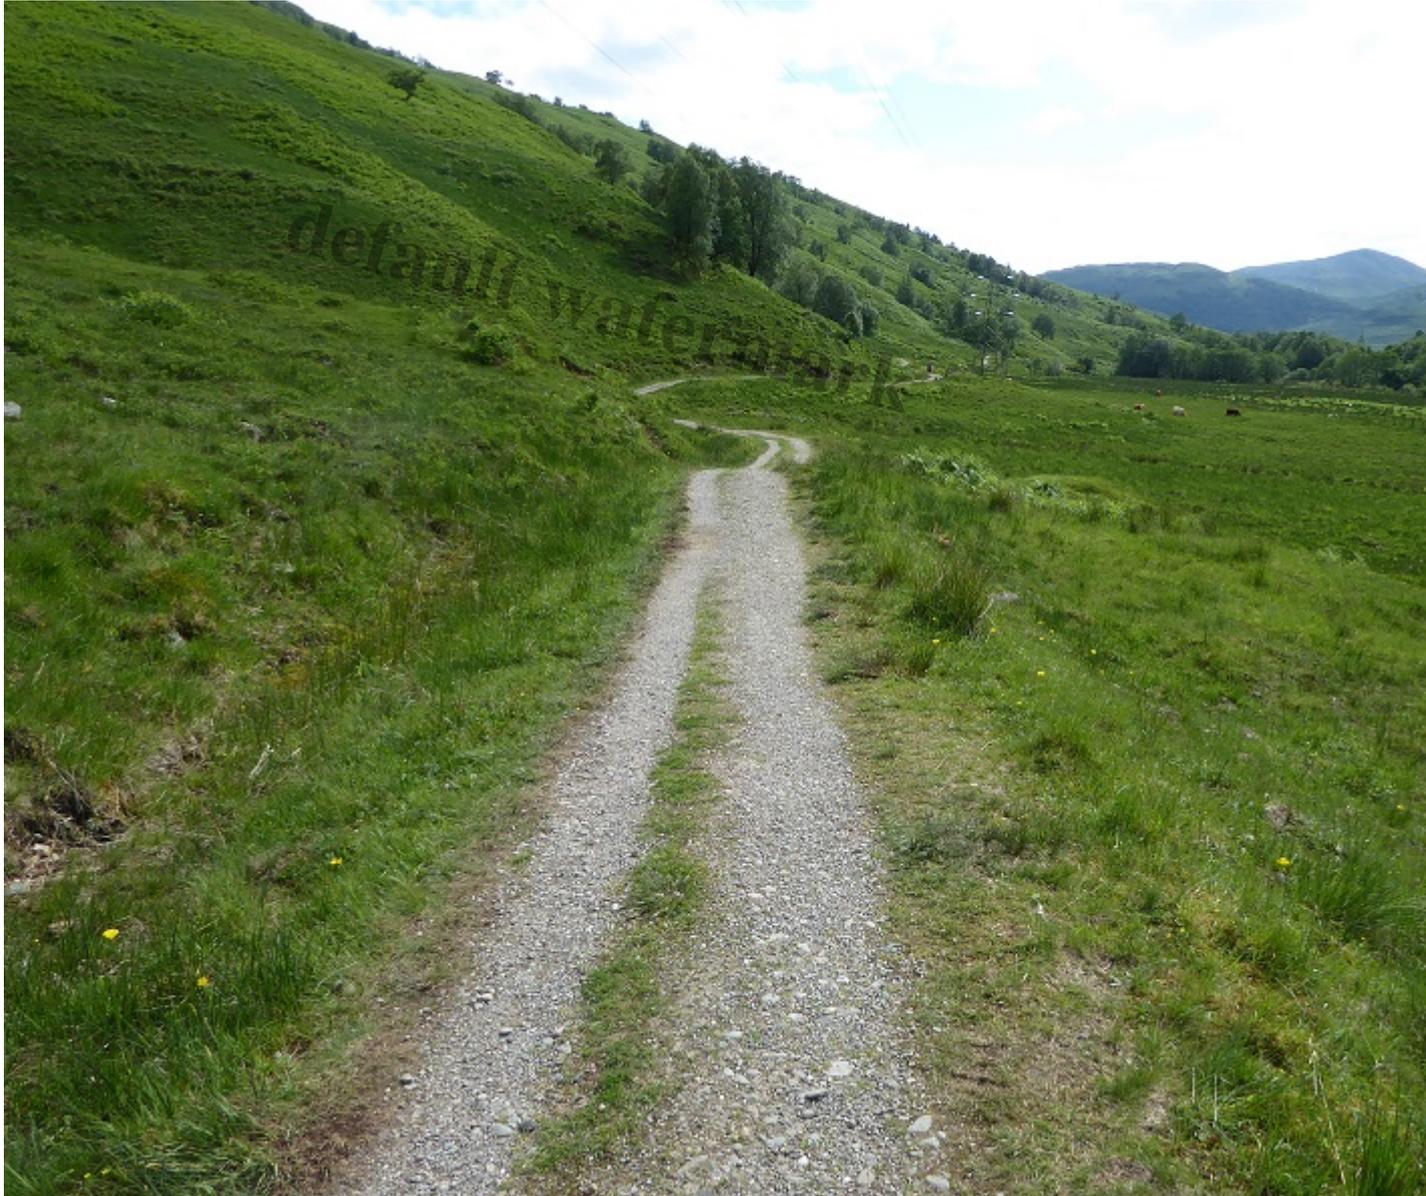
The West Highland Way west of the new Derrydarroch crossroads is much narrower than the new hwy at about 1.5m wide note the pylon, together tracks and pylons have a huge impact on the experience walking the West Highland Way
