The impact of hydro tracks on the landscape – the Allt a Chuillinn scheme in Glen Falloch

June 18, 2018

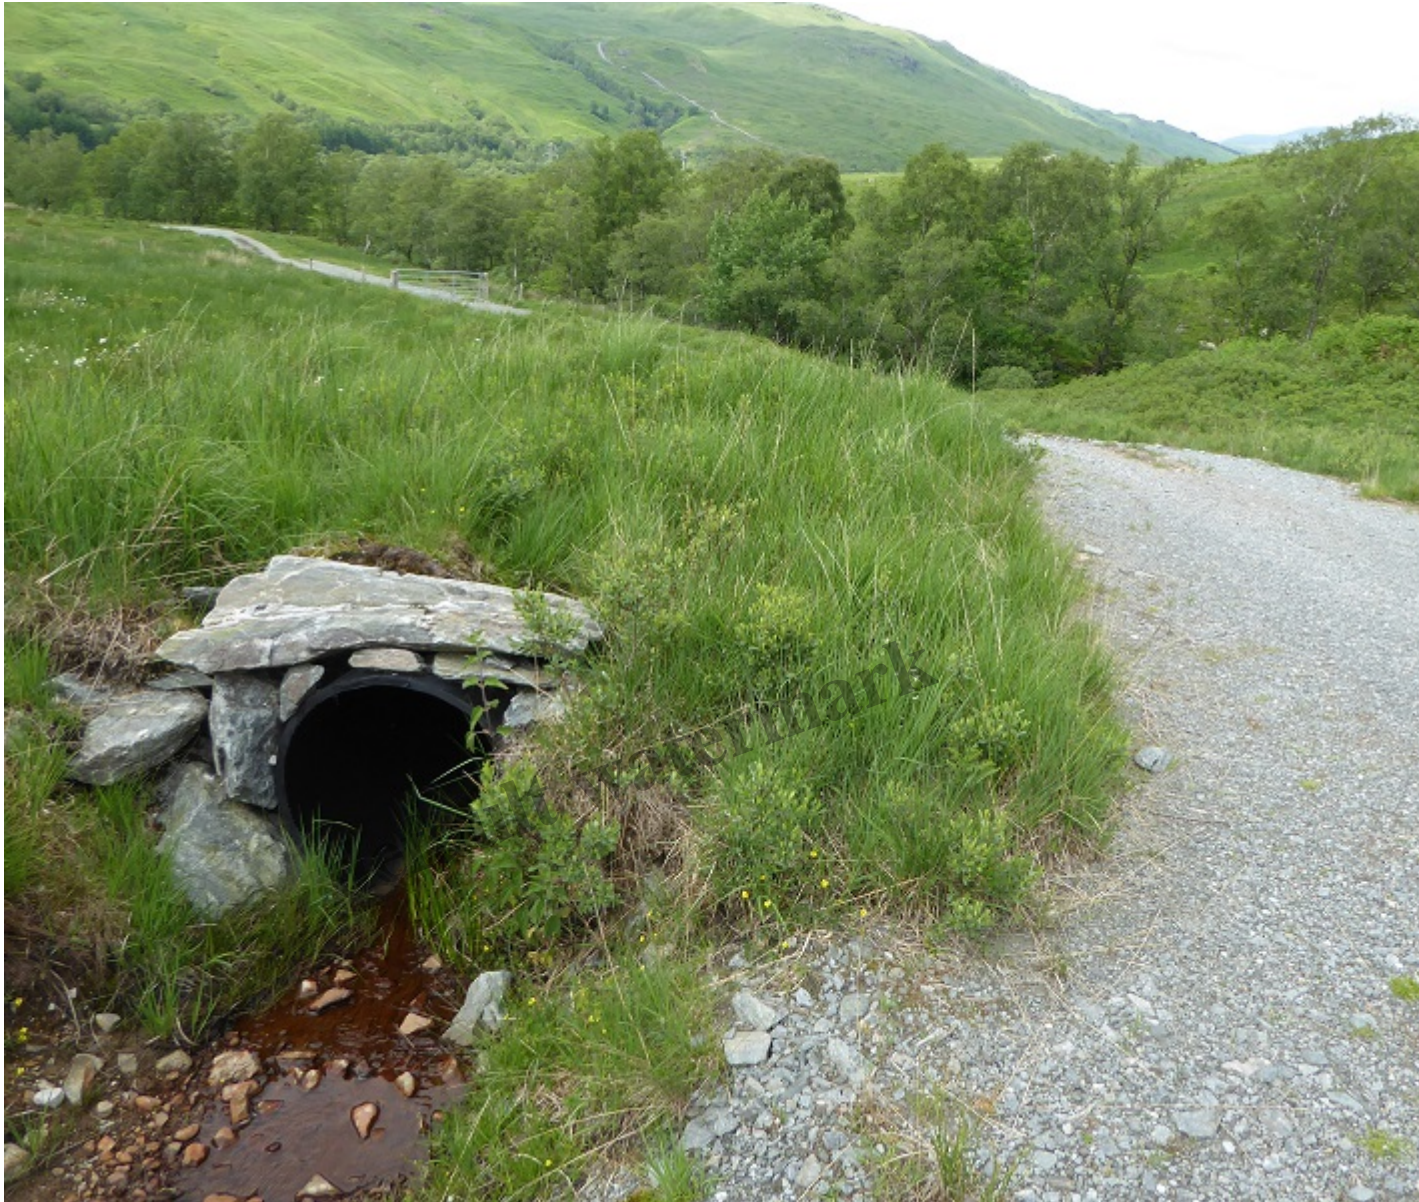
The lower section of the track along the Allt a'Chuillinn

In terms of landscaping, all the culverts have been finished with natural materials and there are none of the protruding plastic pipes so evident in other schemes – which the LLTNPA excuses on the grounds that those schemes have not yet been “finished”.

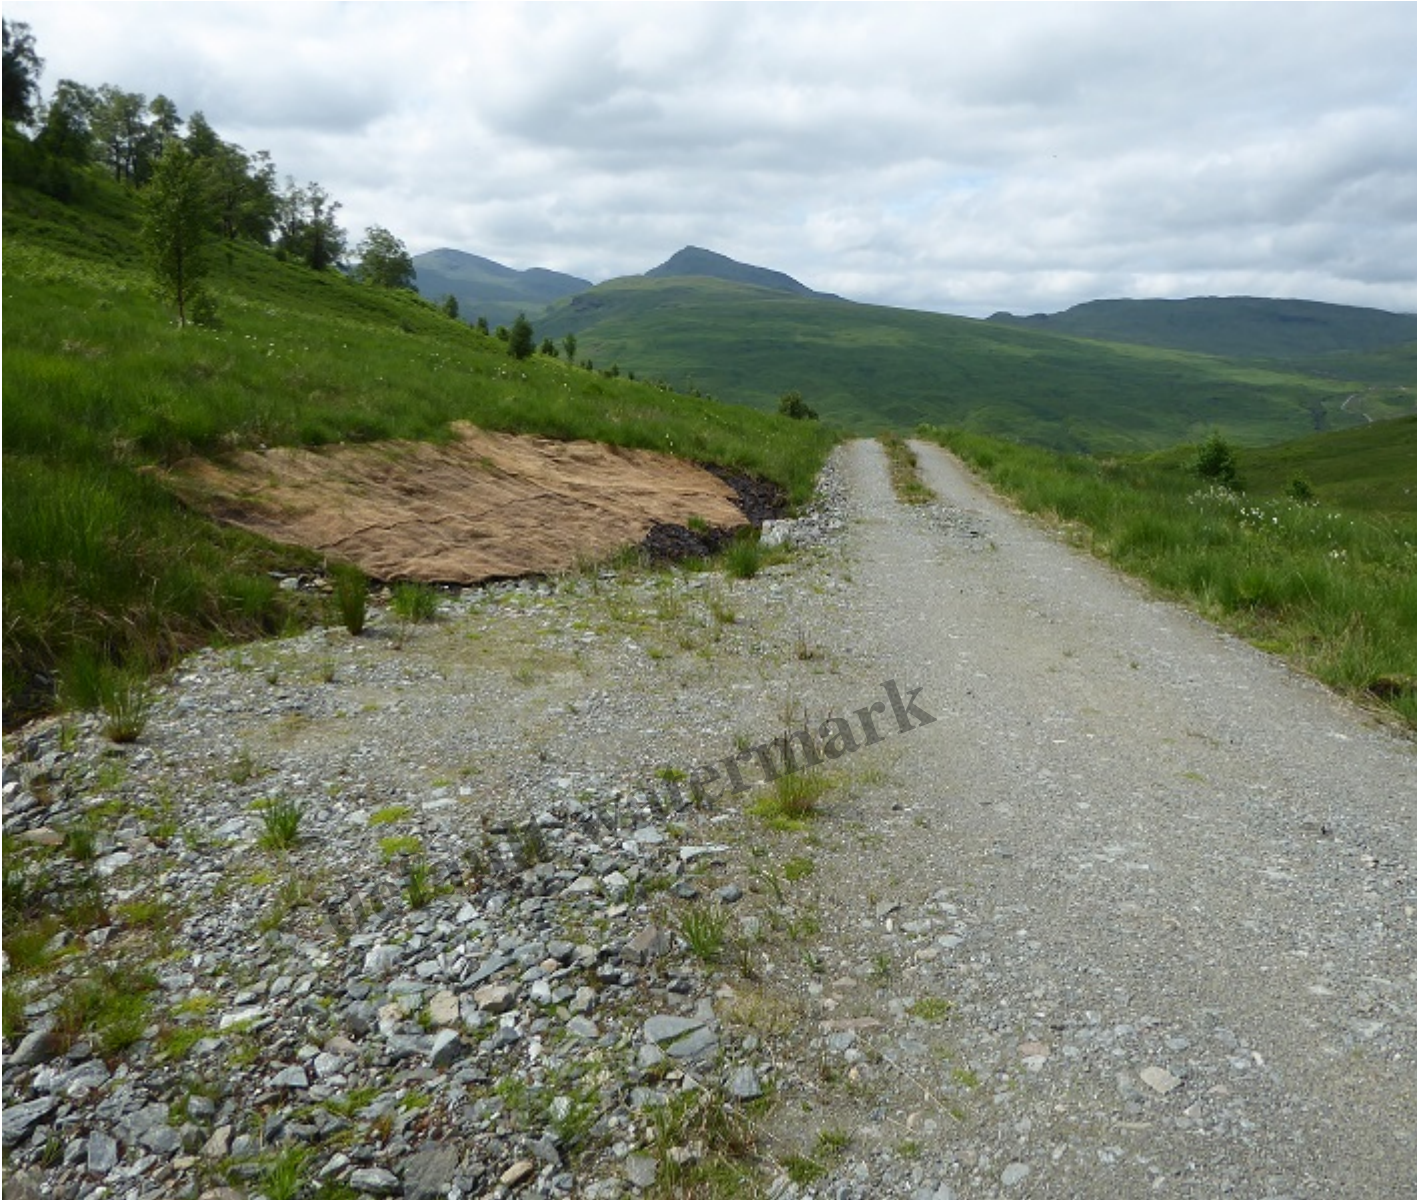
Matting being used to try and restore areas of bare peat

There is even evidence of use of specialised restoration techniques in areas where insufficient vegetation was saved and stored properly for replacing over peat and other soils. The passing place in the foreground, however, is an eyesore which is completely unnecessary on a track which is barred by locked gates ([see here](#)) while its edges are poorly restored. At each passing place on the track, the vegetated strip down the centre has failed to take, presumably from vehicles swerving onto the passing place, thus increasing the visual impact.

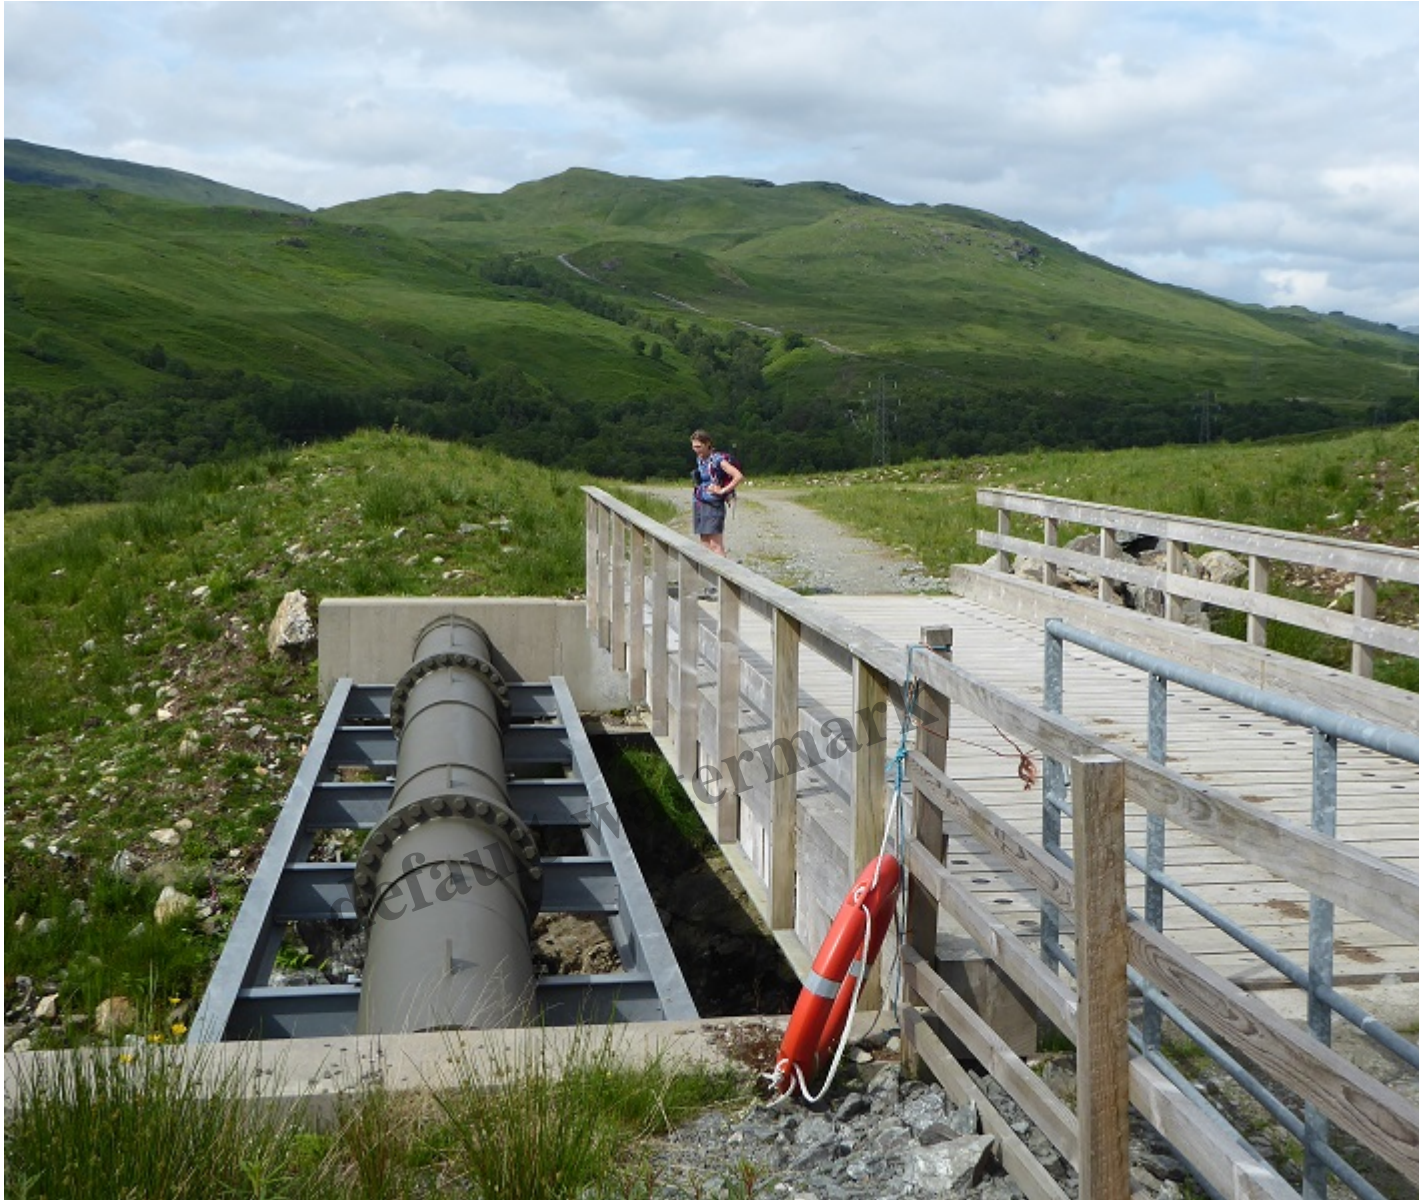
The bridge where the water from the hydro intakes is carried back across the Allt a Chuillinn. The Eas Dubh track, which penetrates the Ben Lui Wild Land Area behind.

Although I was pleased to see the bright blue penstock has been painted ([see here](#)), its still an eyesore and its hard to understand why it would not have been hidden under the new road bridge as the LLTNPA's own good practice guidance recommends.

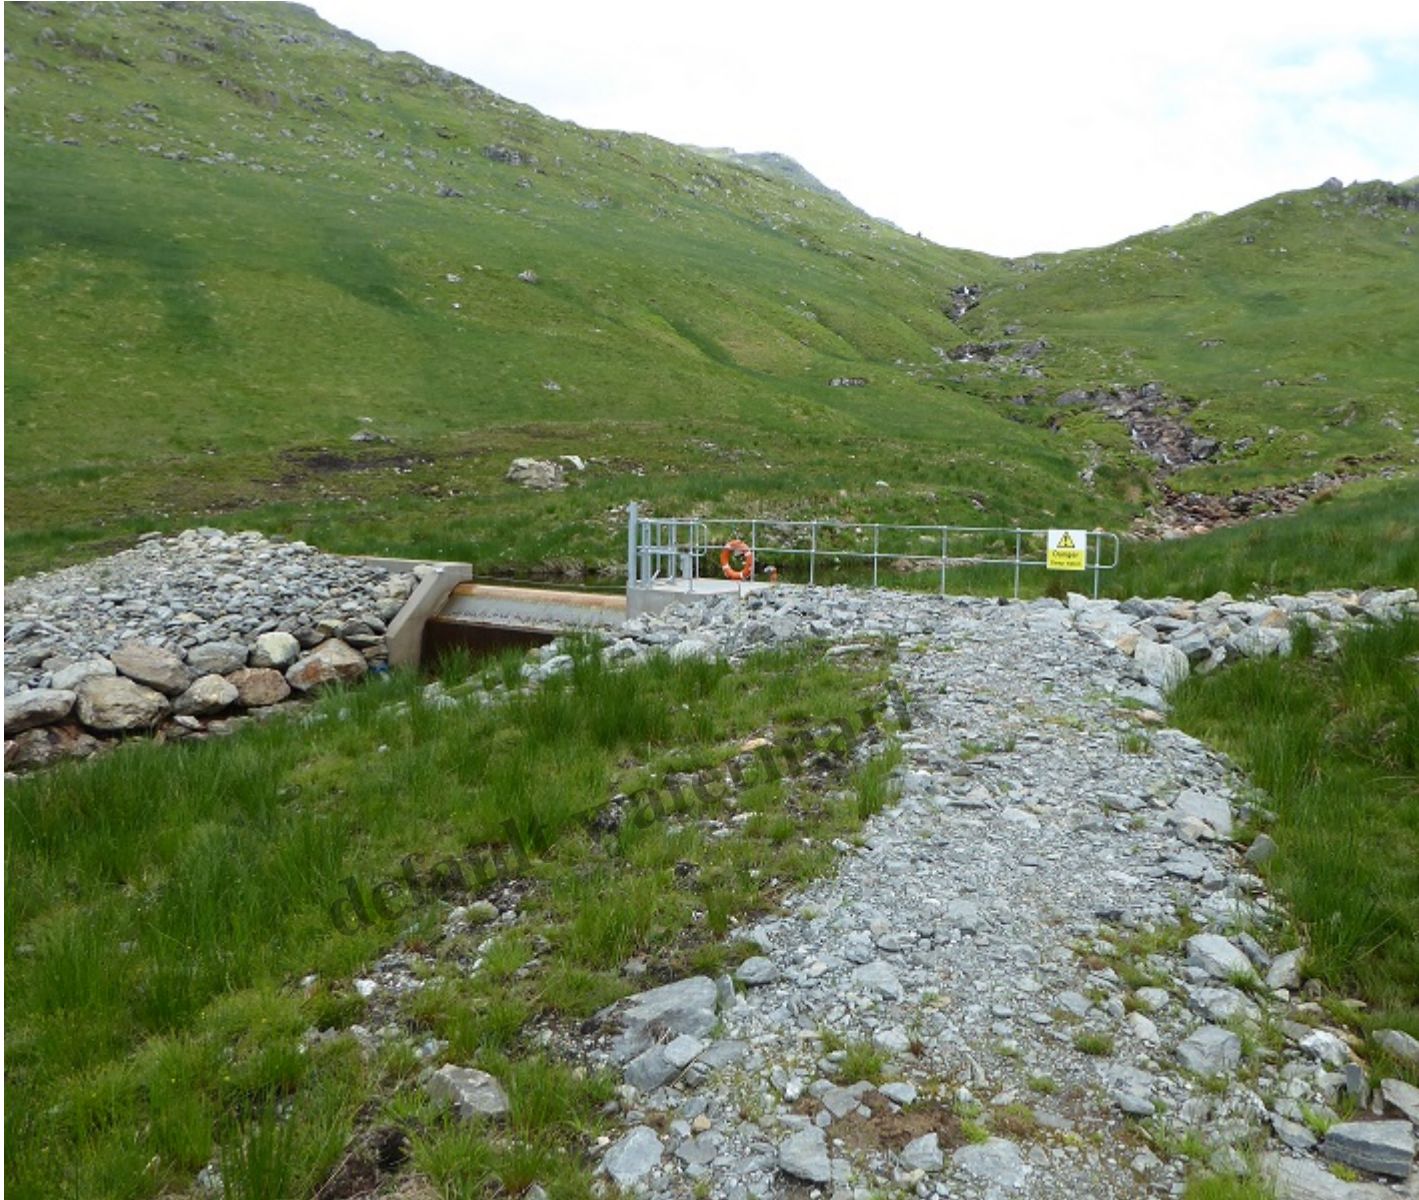
The main intake on the Allt a Chuillinn hydro scheme looking up towards Coire a Chuillinn which forms a designated Wild Land Area

The finishing at the intakes is another matter – the ugliness jars against the wild land behind.

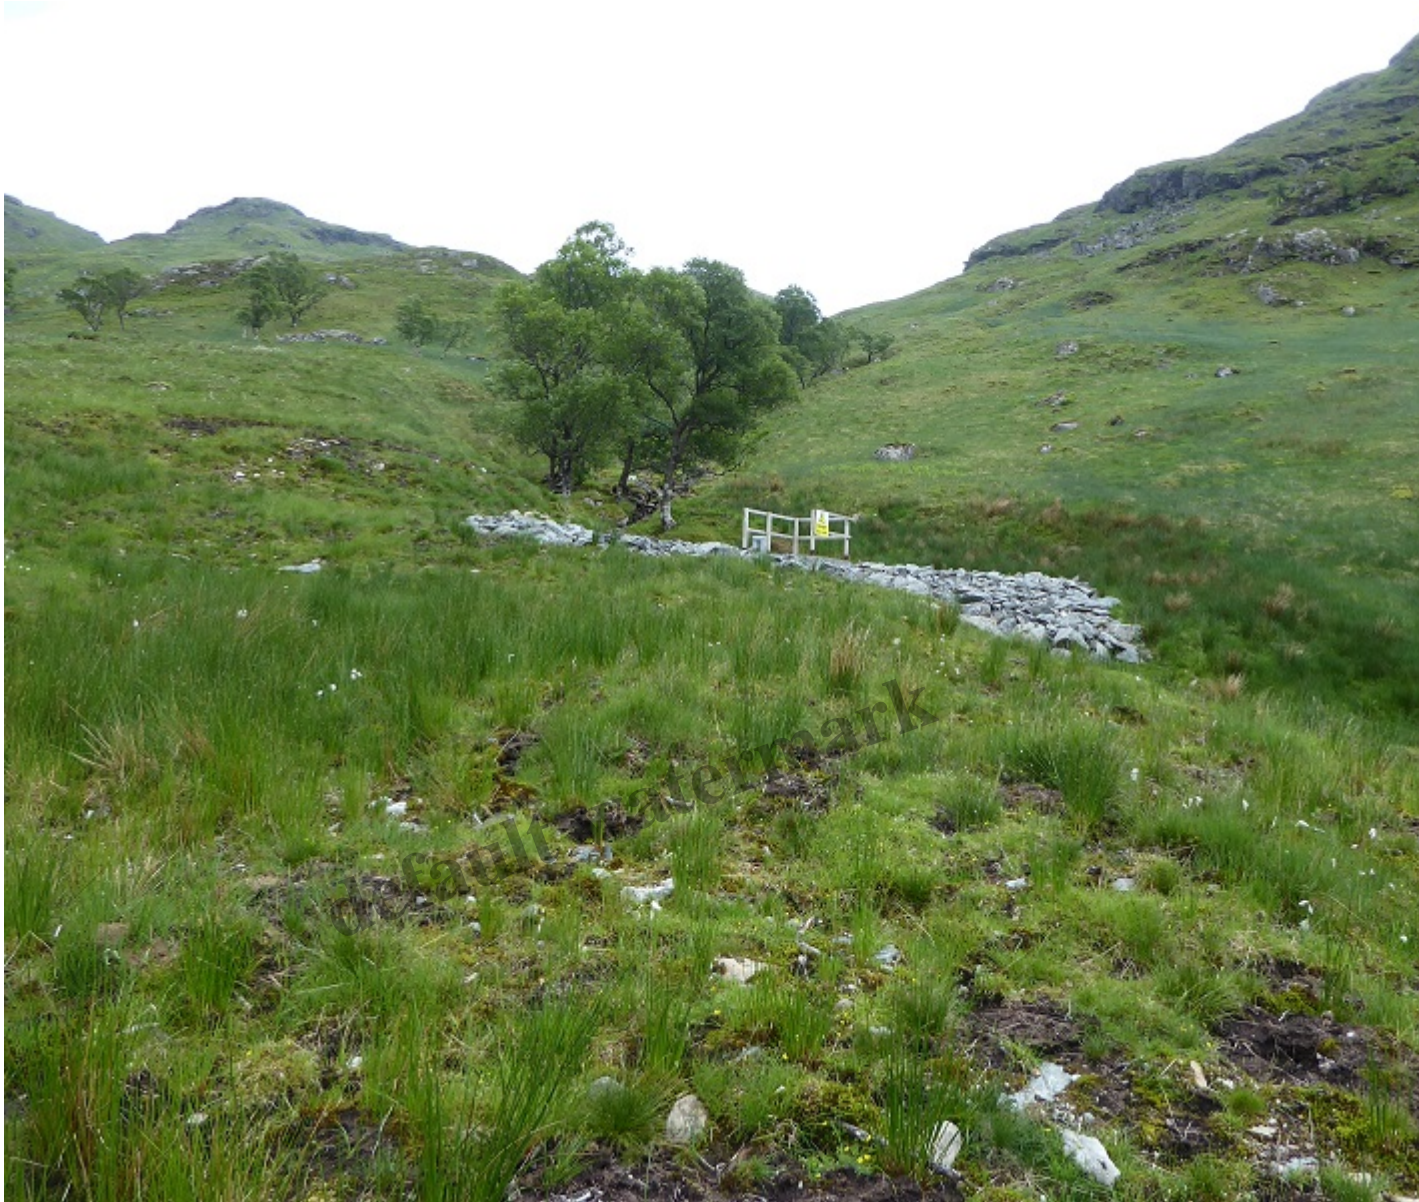
View along the pipe which leads down from the second intake

While there is no track up the second intake and the ground above the pipe is

recovering quite well, its location is all too evident from the spill of boulders which contrasts with the surrounding grassland. Why wooden restraining rails were used here and not at the main intake, as per the LLTNPA own good practice guidance, is unclear and the penstock has been left bright blue. The equally bright yellow danger signs warn people of the danger of pools, health and safety gone mad, when most of the side burns and the Allt a'Chuilin itself contain similar pools.

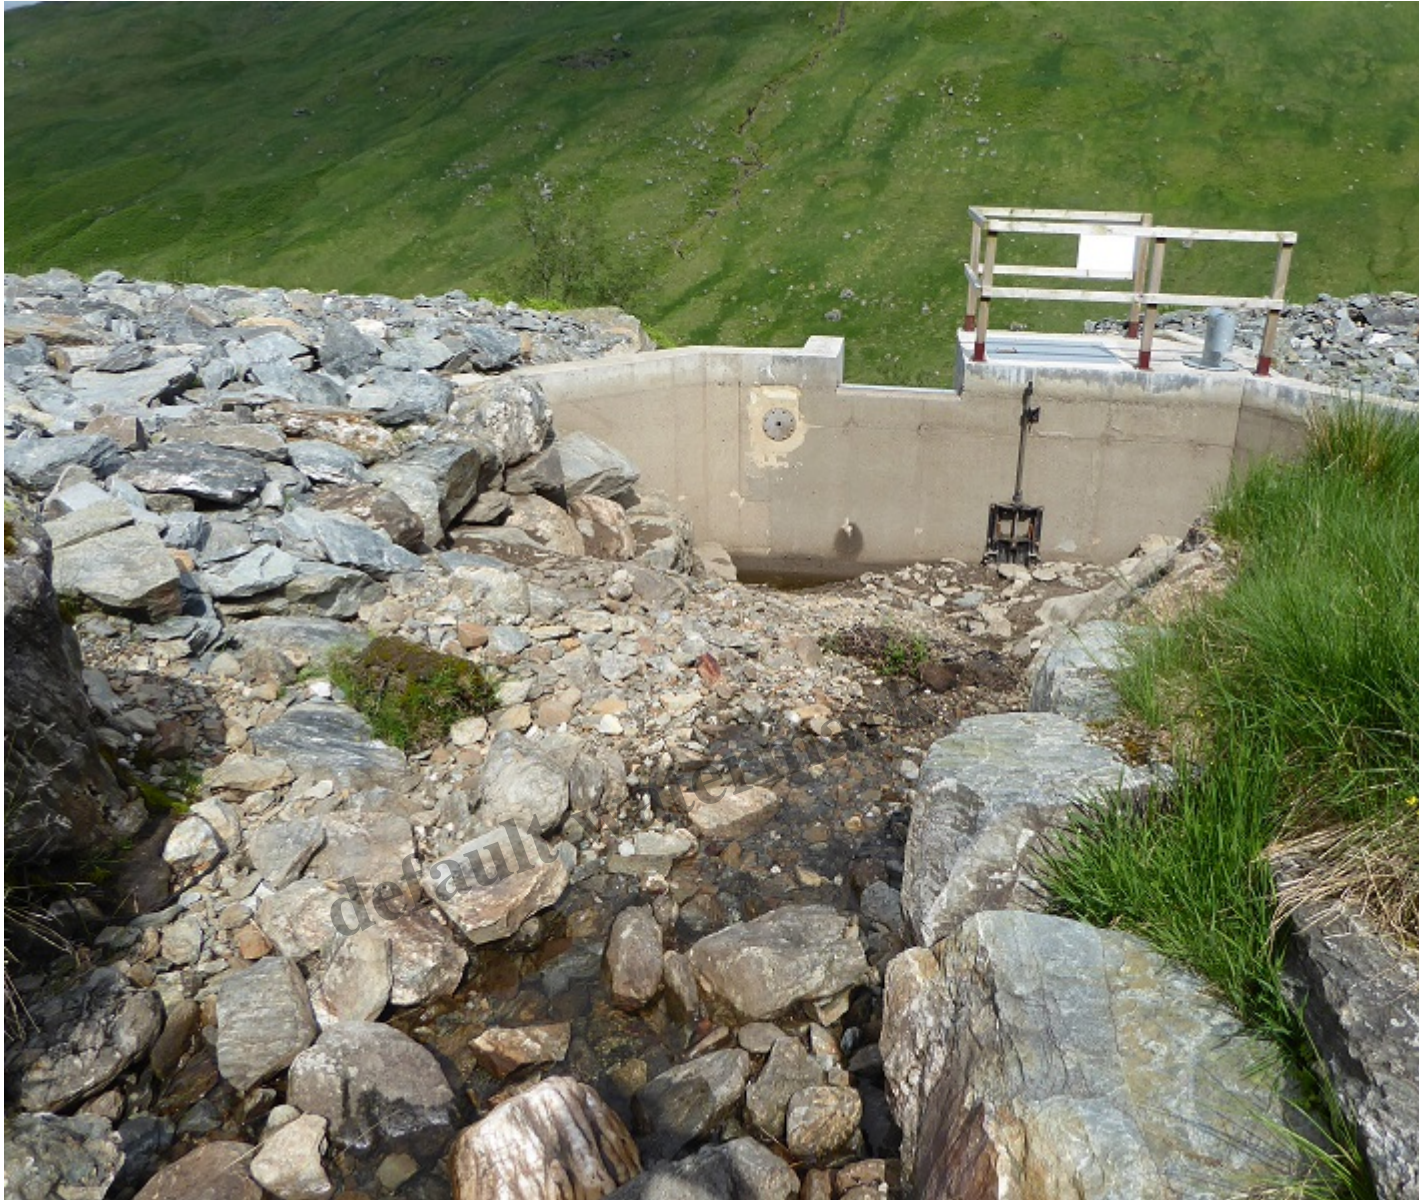
The third intake from above with flowing water visible in the foreground

At the third intake, I was surprised by the complete lack of water. At first I thought this was due to the very dry period – I visited 10 days ago – but above the intake the burn was running before disappearing into the ground a few metres above the intake.....

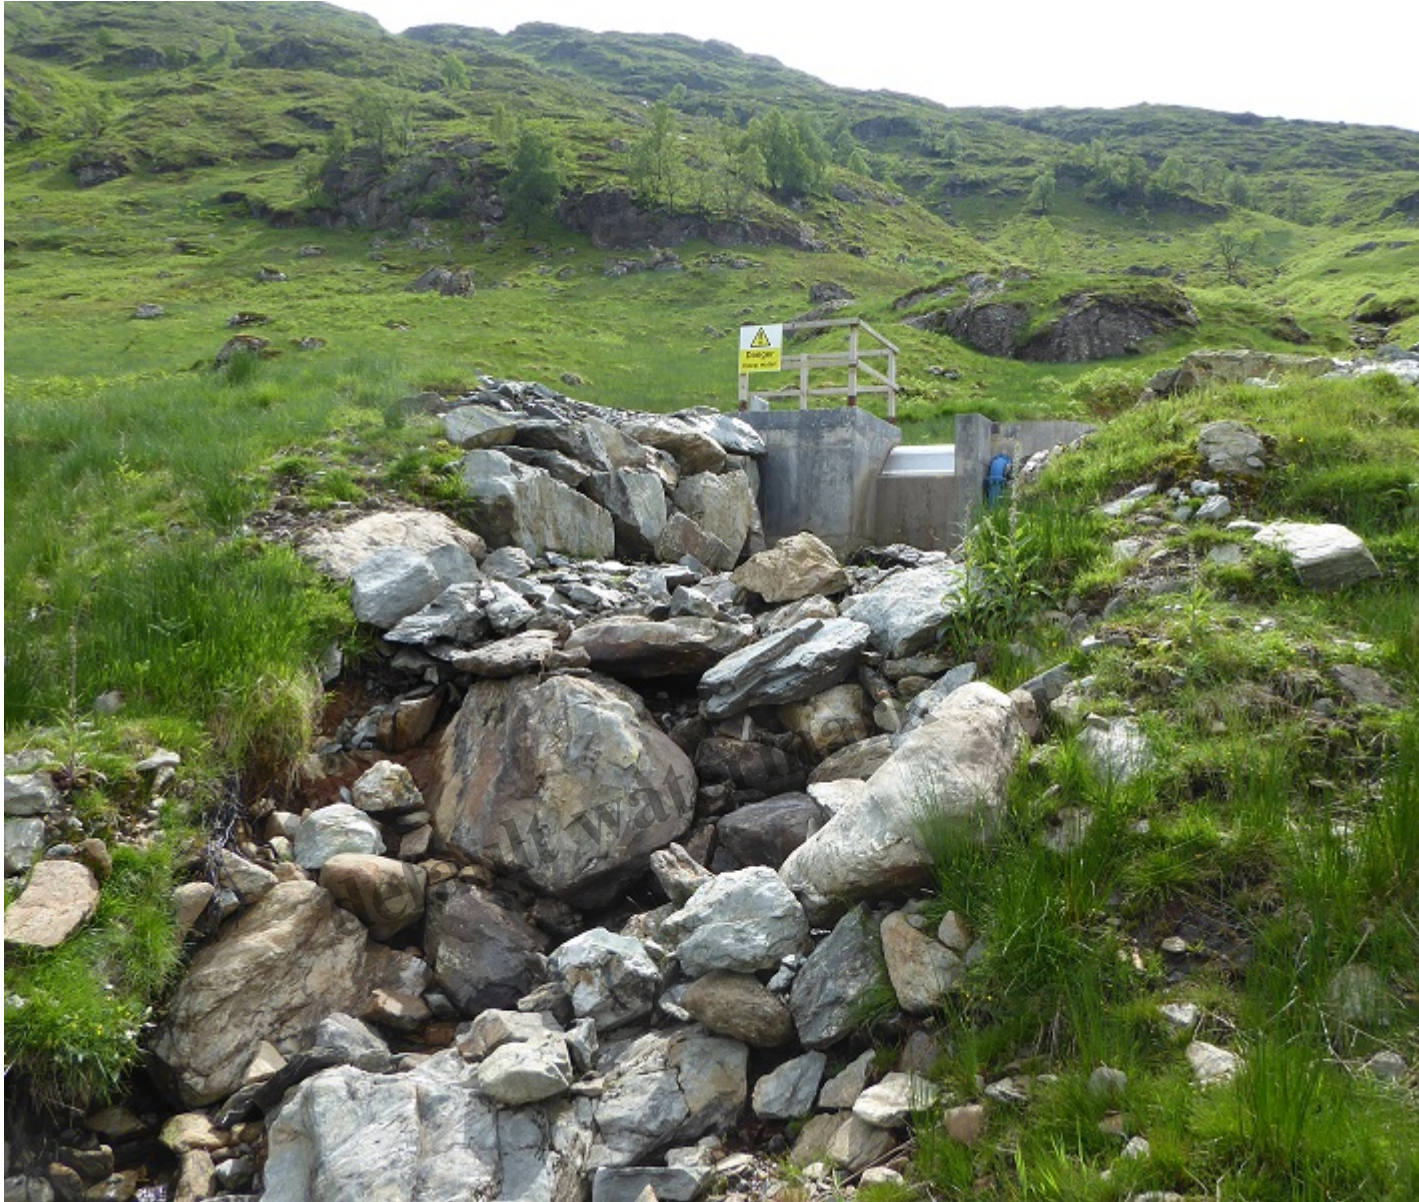
Below the third intake, blue pipe, warning signs and all – the burn started flowing again in bottom left

.....and then re-appearing a few metres below it. This looks like a pretty significant engineering failure and I suspect the intake pool will only fill when the burn is in spate. If Glen Falloch Estates want to repair this intake bringing in heavy machinery along the track would undo much of the restoration work which has been done there! Because of this, if the estate do want to fix this hydro intake, the LLTNPA should insist that heavy machinery is brought in by a large helicopter.

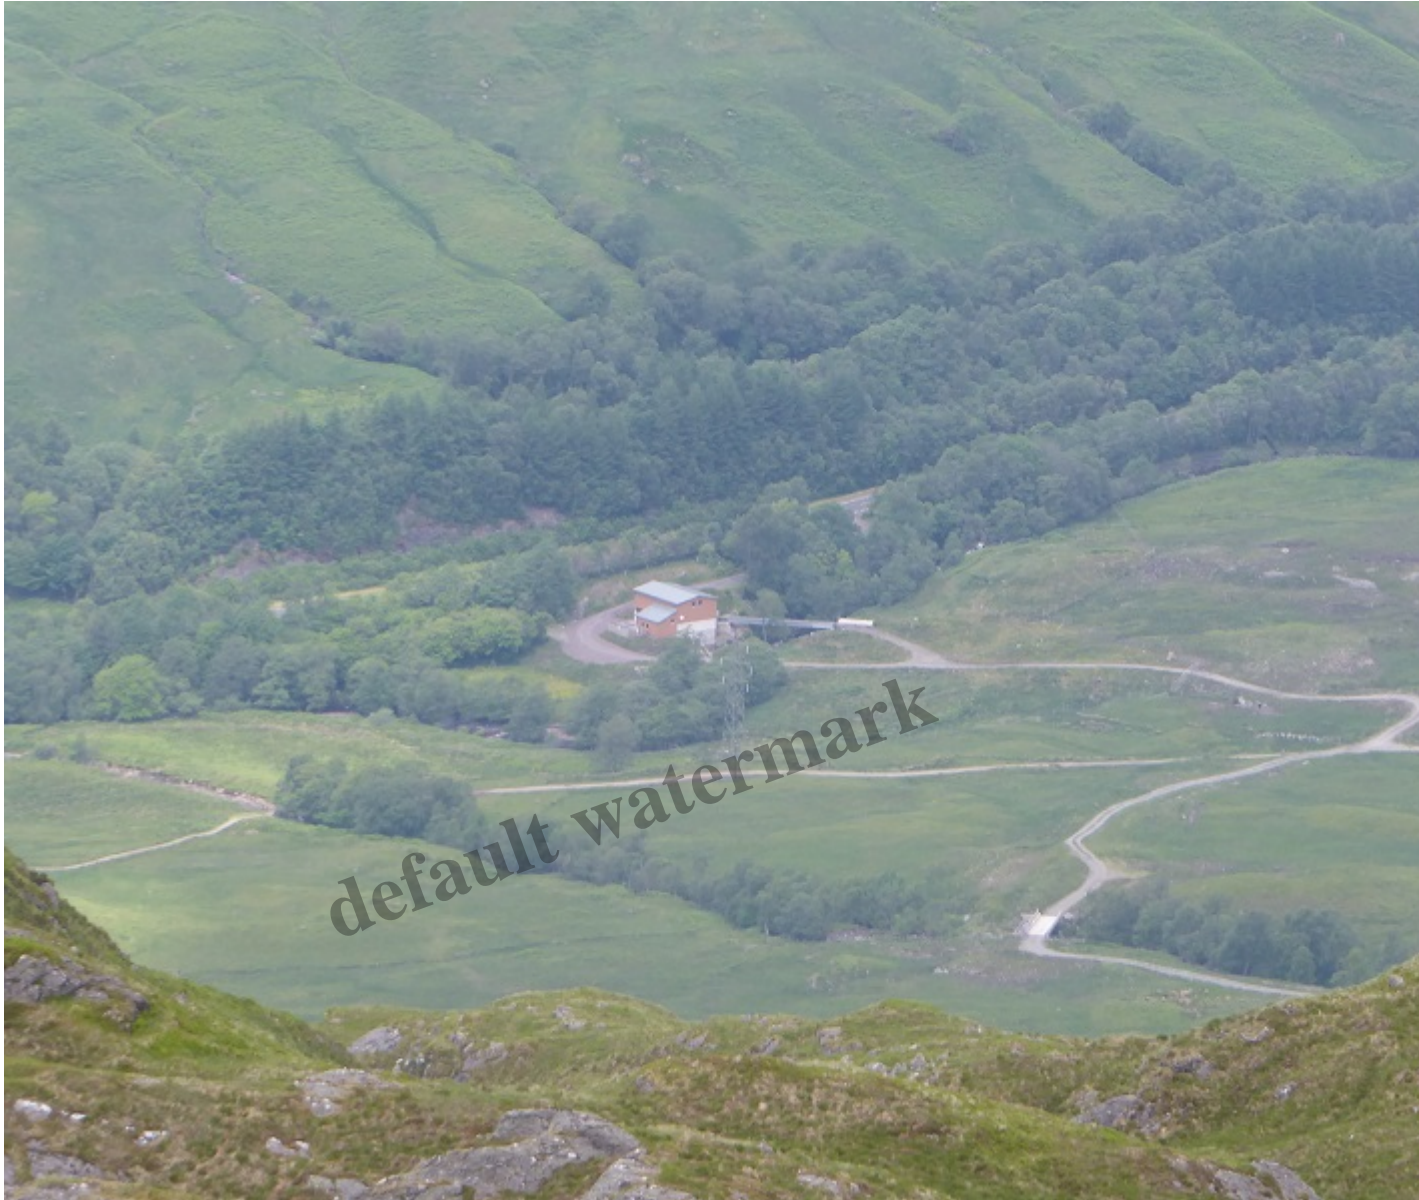
The Derrydarroch hydro scheme from Ben Glas with the Allt a Chuillinn track and bridge bottom right. Highland Way runs across the crossroads – note how its much narrower than the new “restored” track.

While the A82 and West Highland line are hidden in trees, the new tracks provide a stark contrast to the surrounding landscape.

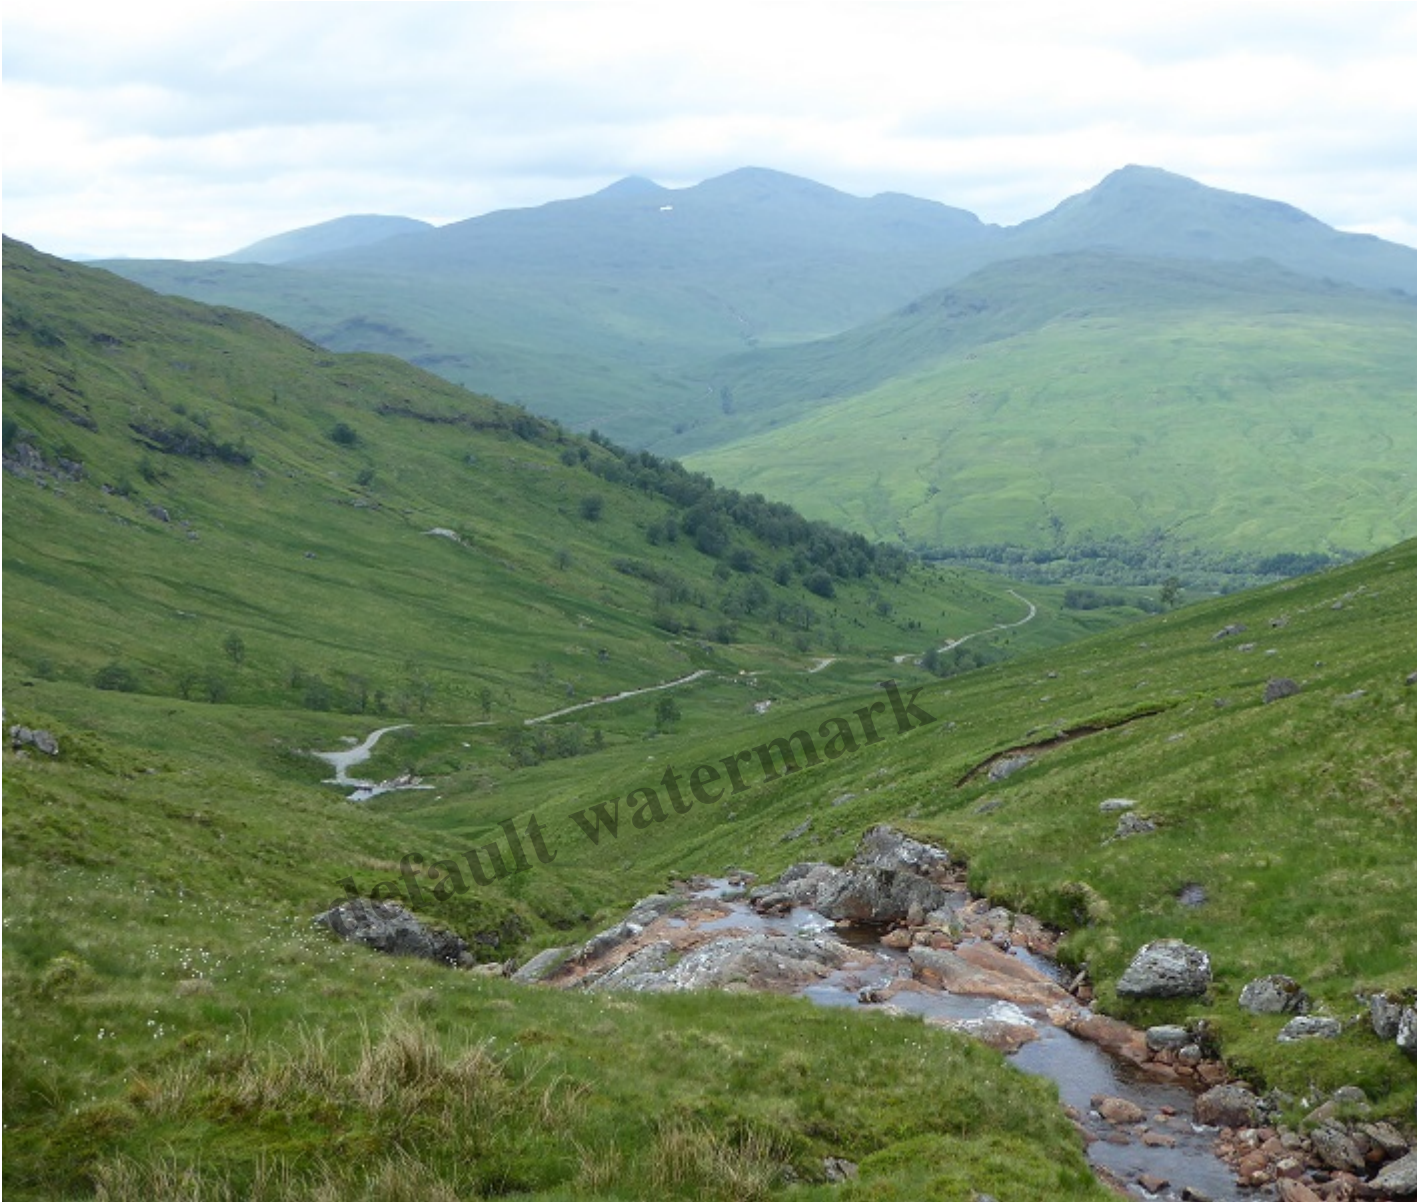
The Ben Lui hills behind the Allt a Chuillinn track – first intake centre left, third intake on hillside rear

Imagine this view without the track – that is how this glen looked before the hydro scheme was installed and would have looked like if the LLTNPA had kept the original planning requirements which were for all the access tracks to the hydro intakes should be removed. These requirements, set by the LLTNPA Board at the time, were reversed by staff when they approved subsequent applications from Glen Falloch estate to retain the main tracks. The removal of the construction track to the third intake shows what the view would have looked like if the track had been removed. Some improved landscaping around the 3rd intake and you would not know it was there although for the present it forms another blot on the landscape.

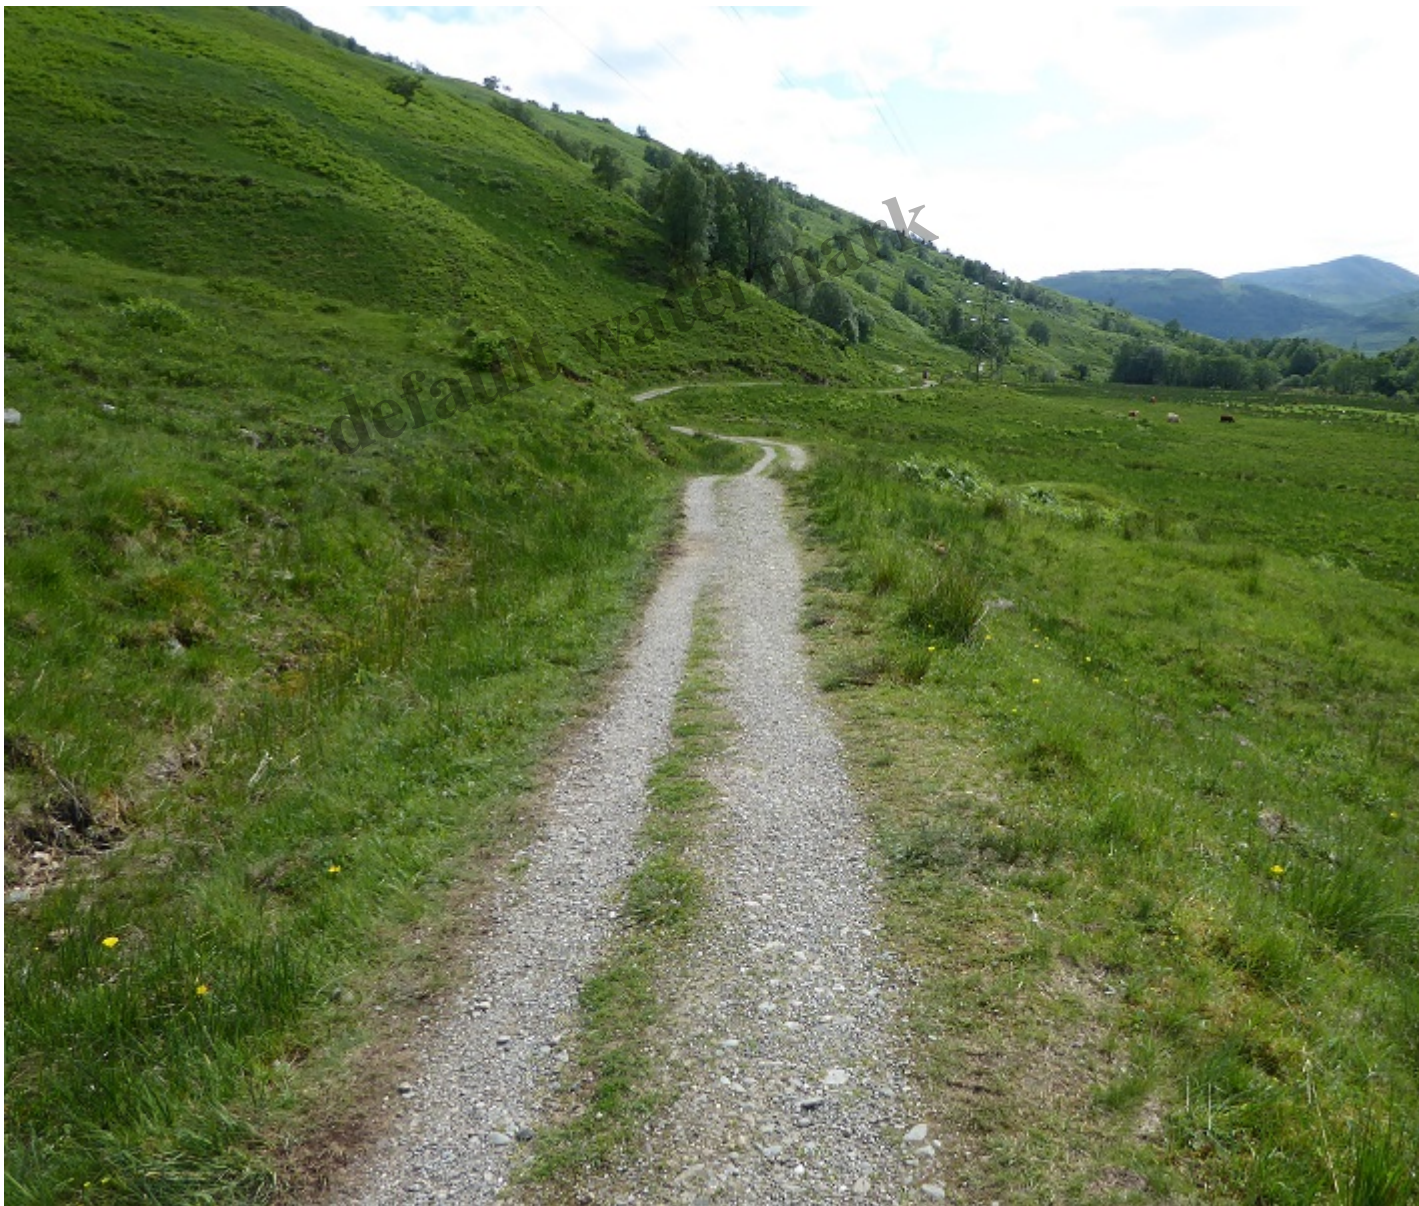
The West Highland Way west of the new Derrydarroch crossroads is much narrower than the new h... at about 1.5m wide – note the pylon, together tracks and pylons have a huge impact on the experien

Walking back along the West Highland Way to our start point, I was struck not just by how narrow it is but that it is used by estate vehicles until close to the top of the gorge above the Falls of Falloch.
