The impact of hydro tracks on the landscape – the Allt a Chuillinn scheme in Glen Falloch

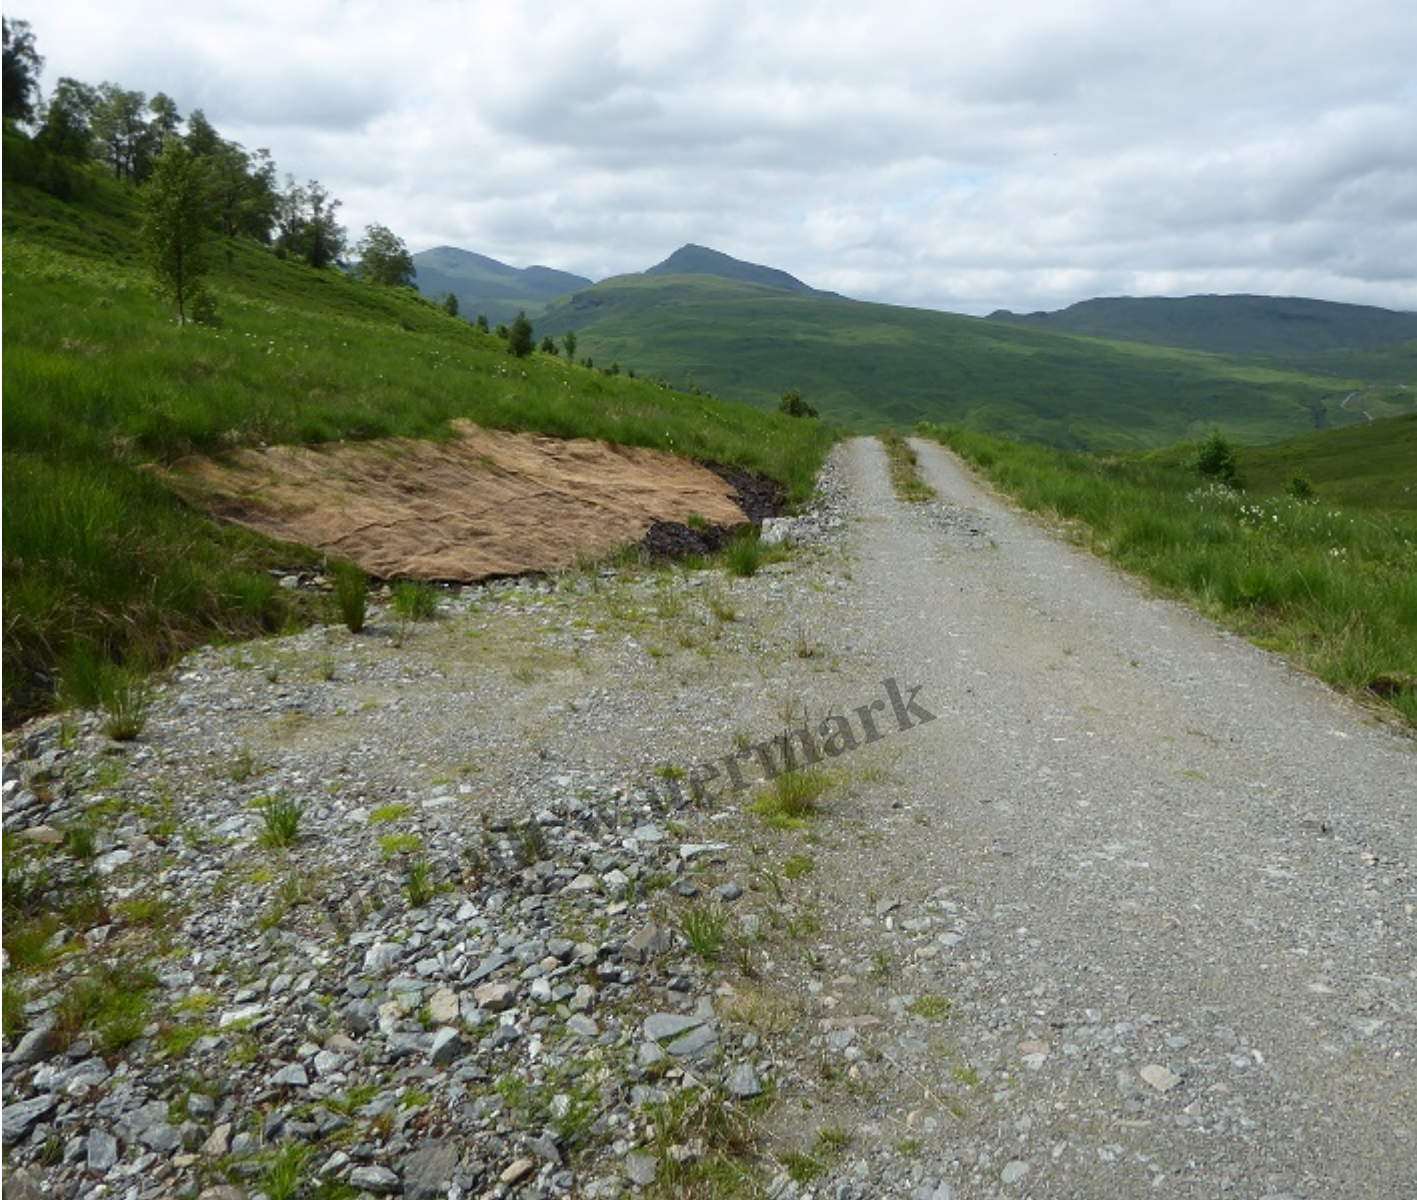
Matting being used to try and restore areas of bare peat

There is even evidence of use of specialised restoration techniques in areas where insufficient vegetation was saved and stored properly for replacing over peat and other soils. The passing place in the foreground, however, is an eyesore which is completely unnecessary on a track which is barred by locked gates ([see here](#)) while its edges are poorly restored. At each passing place on the track, the vegetated strip down the centre has failed to take, presumably from vehicles swerving onto the passing place, thus increasing the visual impact.

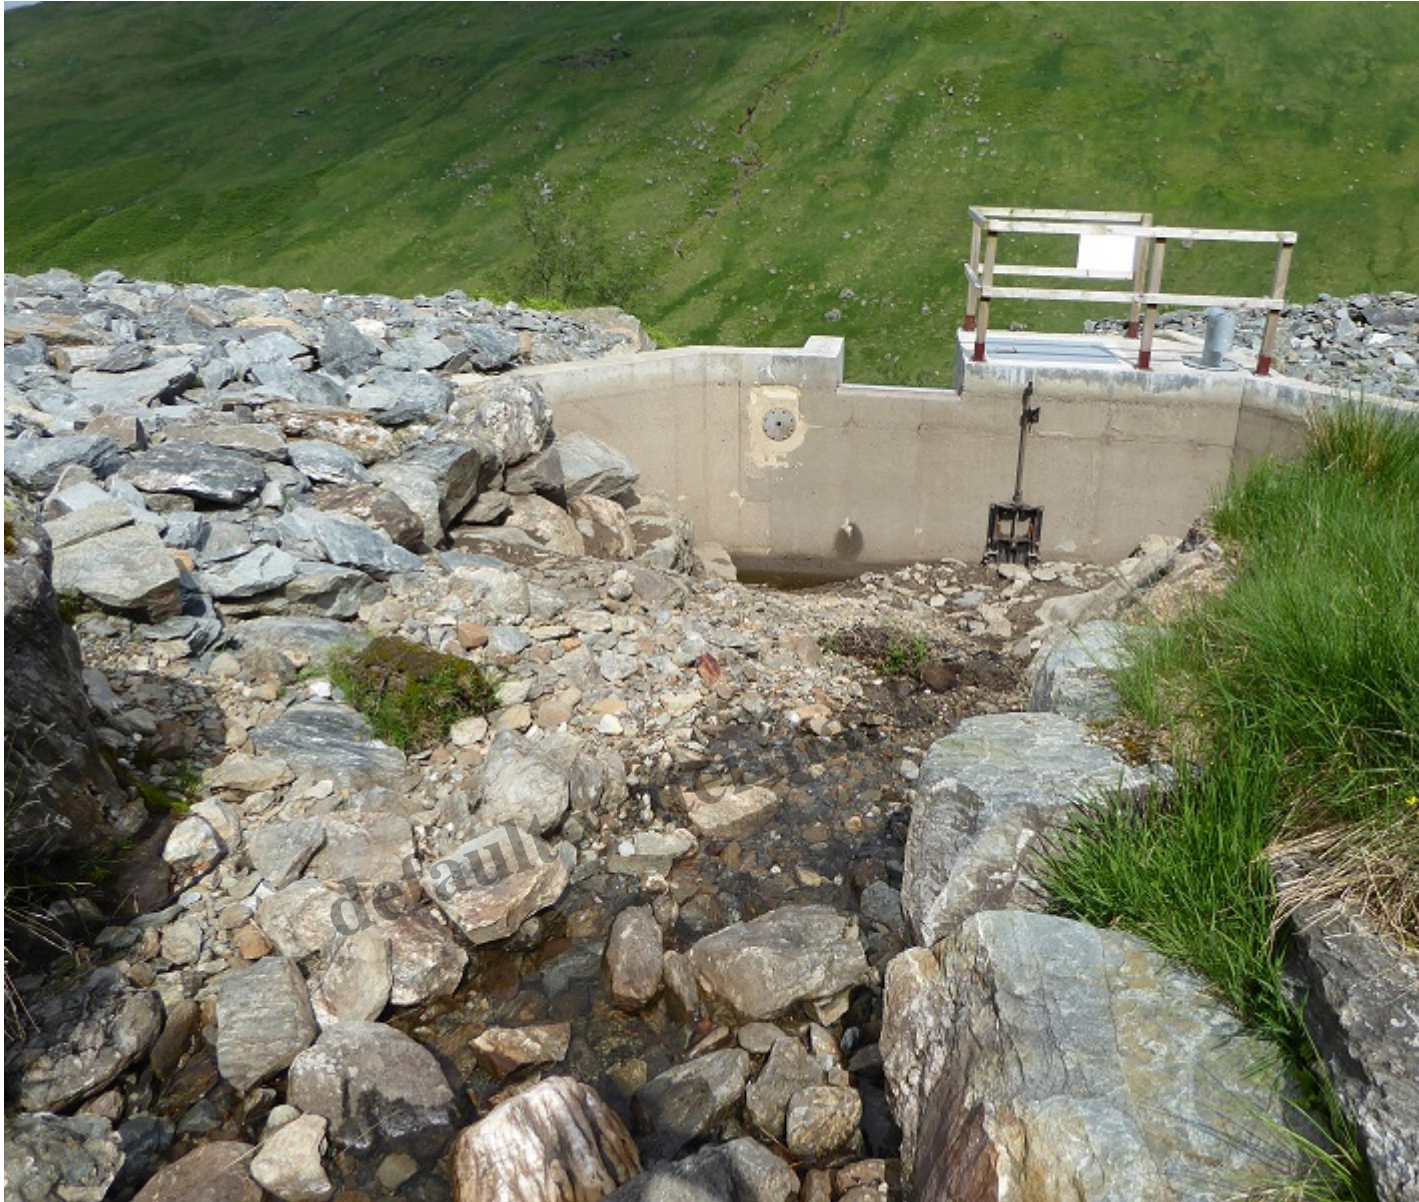
The third intake from above with flowing water visible in the foreground

At the third intake, I was surprised by the complete lack of water. At first I thought this was due to the very dry period – I visited 10 days ago – but above the intake the burn was running before disappearing into the ground a few metres above the intake.....

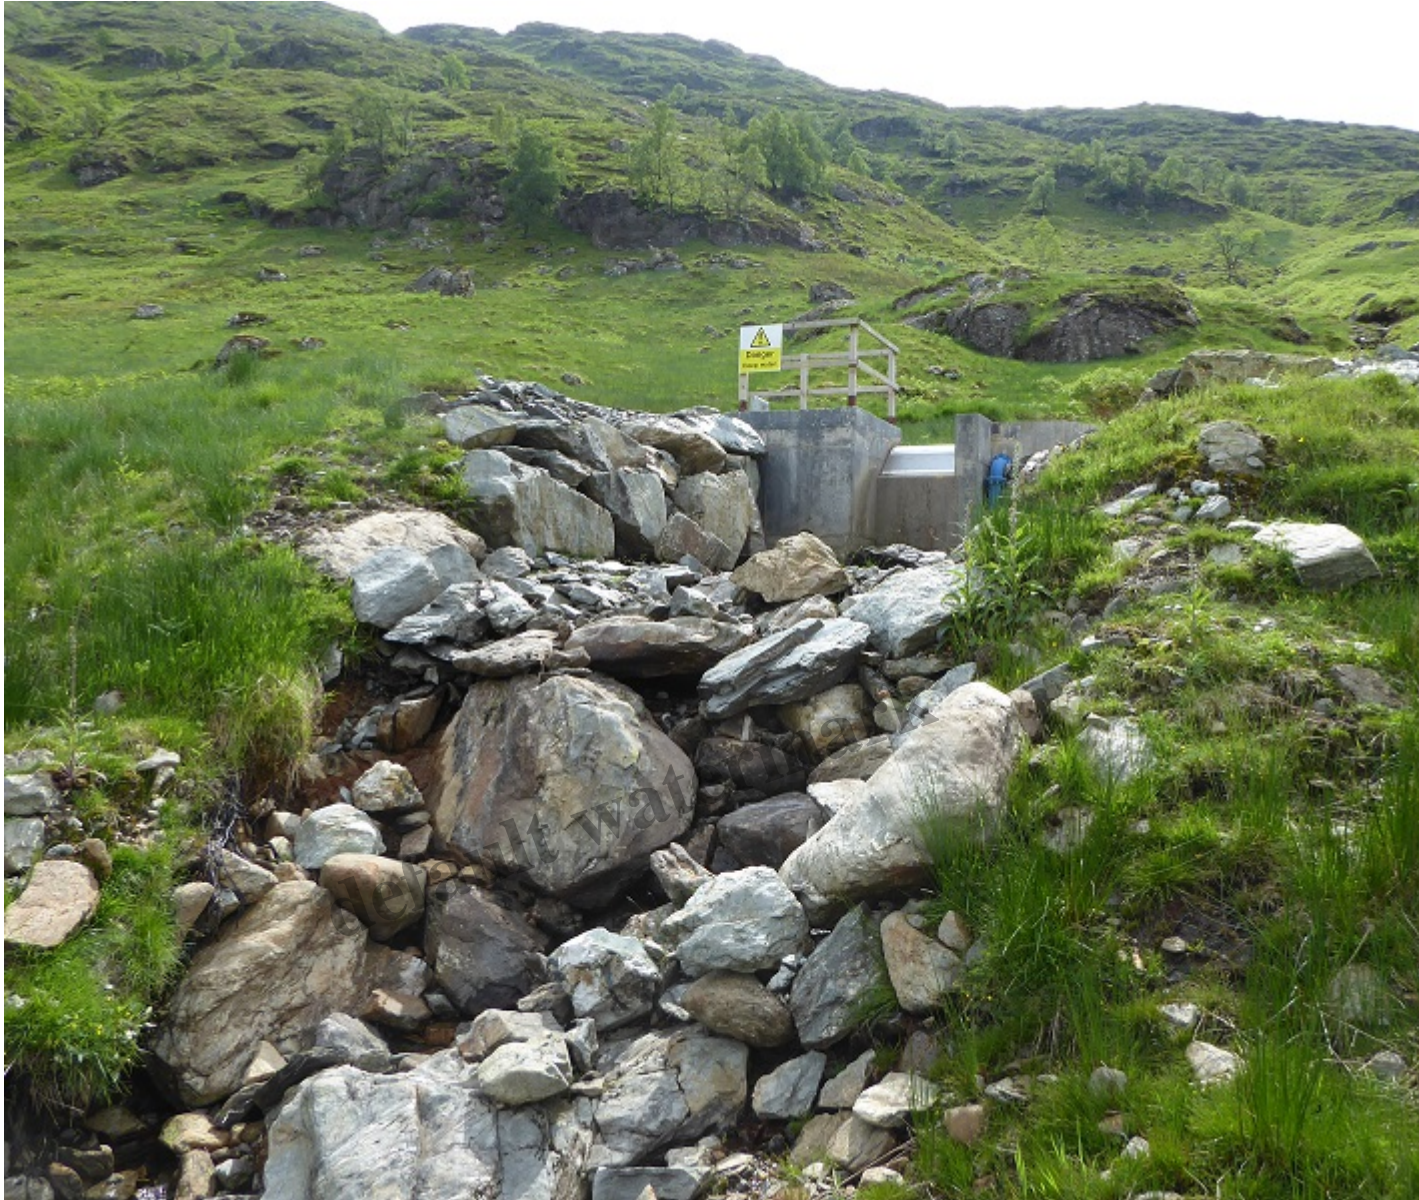
Below the third intake, blue pipe, warning signs and all – the burn started flowing again in bottom left

.....and then re-appearing a few metres below it. This looks like a pretty significant engineering failure and I suspect the intake pool will only fill when the burn is in spate. If Glen Falloch Estates want to repair this intake bringing in heavy machinery along the track would undo much of the restoration work which has been done there! Because of this, if the estate do want to fix this hydro intake, the LLTNPA should insist that heavy machinery is brought in by a large helicopter.
