Glen Falloch – the destruction caused by the Eas Eonan hydro scheme

Approved plan from LLTNPA planning portal for the access tracks at Eas Eonan is Intake 2 for the Derrydarroch hydro schemes, the other intakes being south of the River Falloch

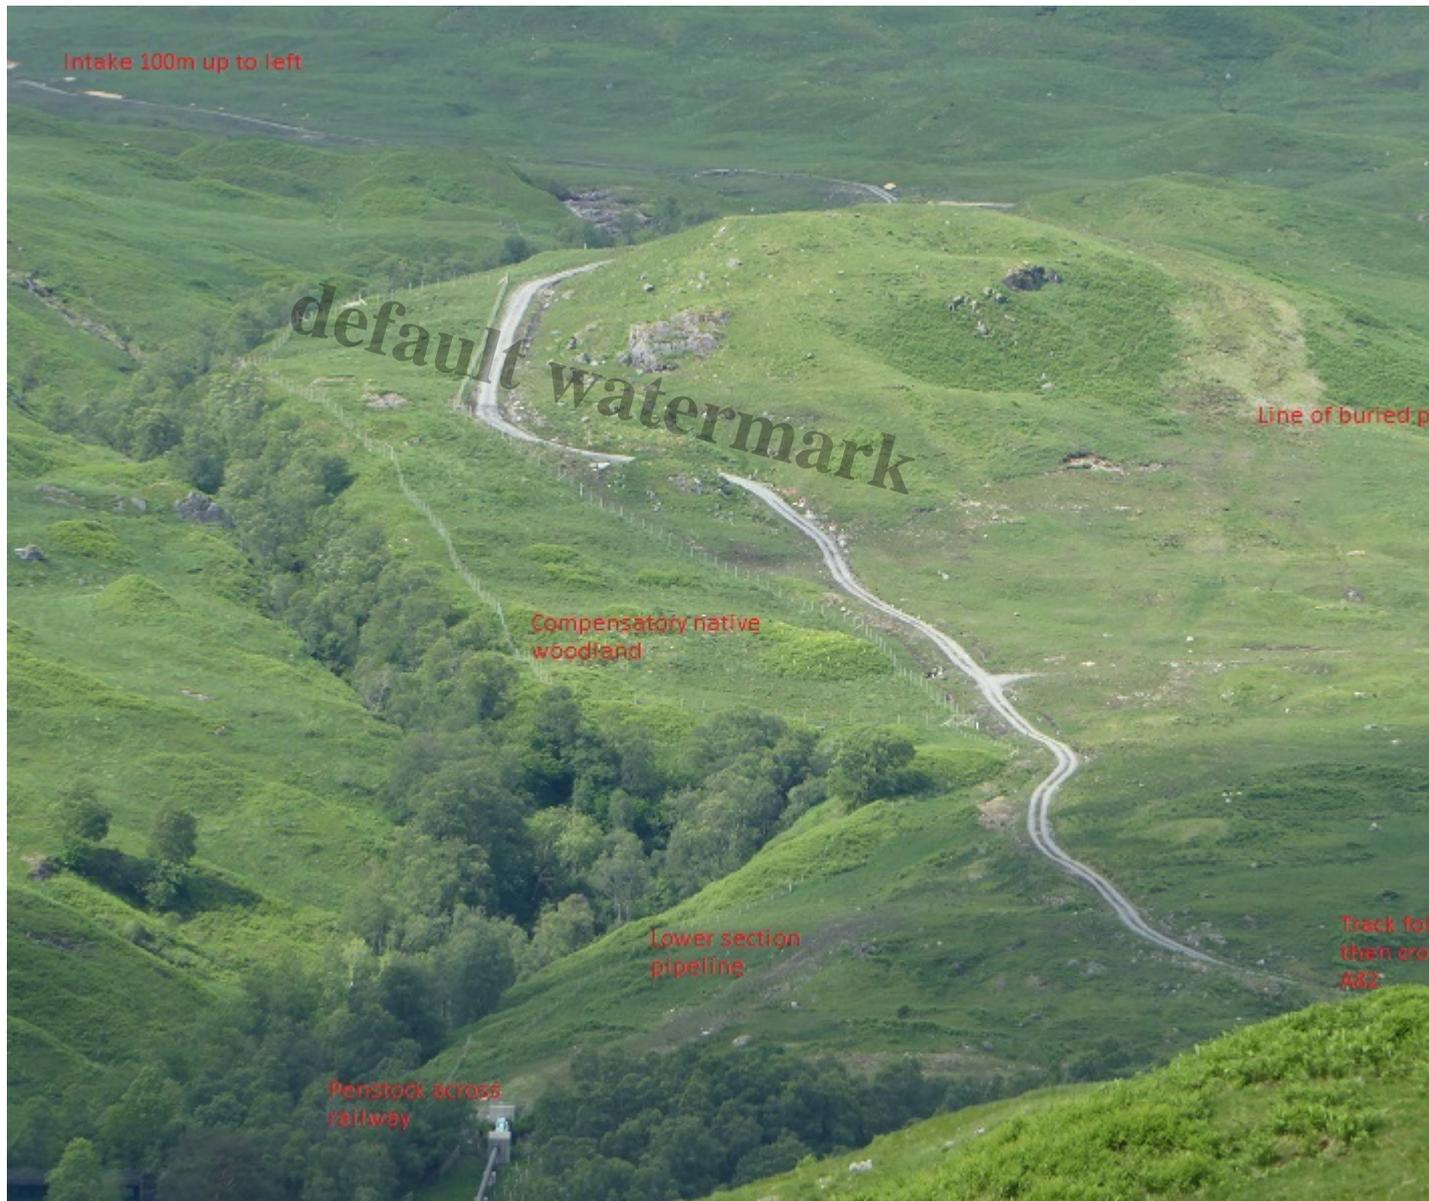
Birds eye view of central section of Eas Eonan scheme June 2018 showing the landscape impact of The line of the buried pipe has been accentuated by the dry weather.

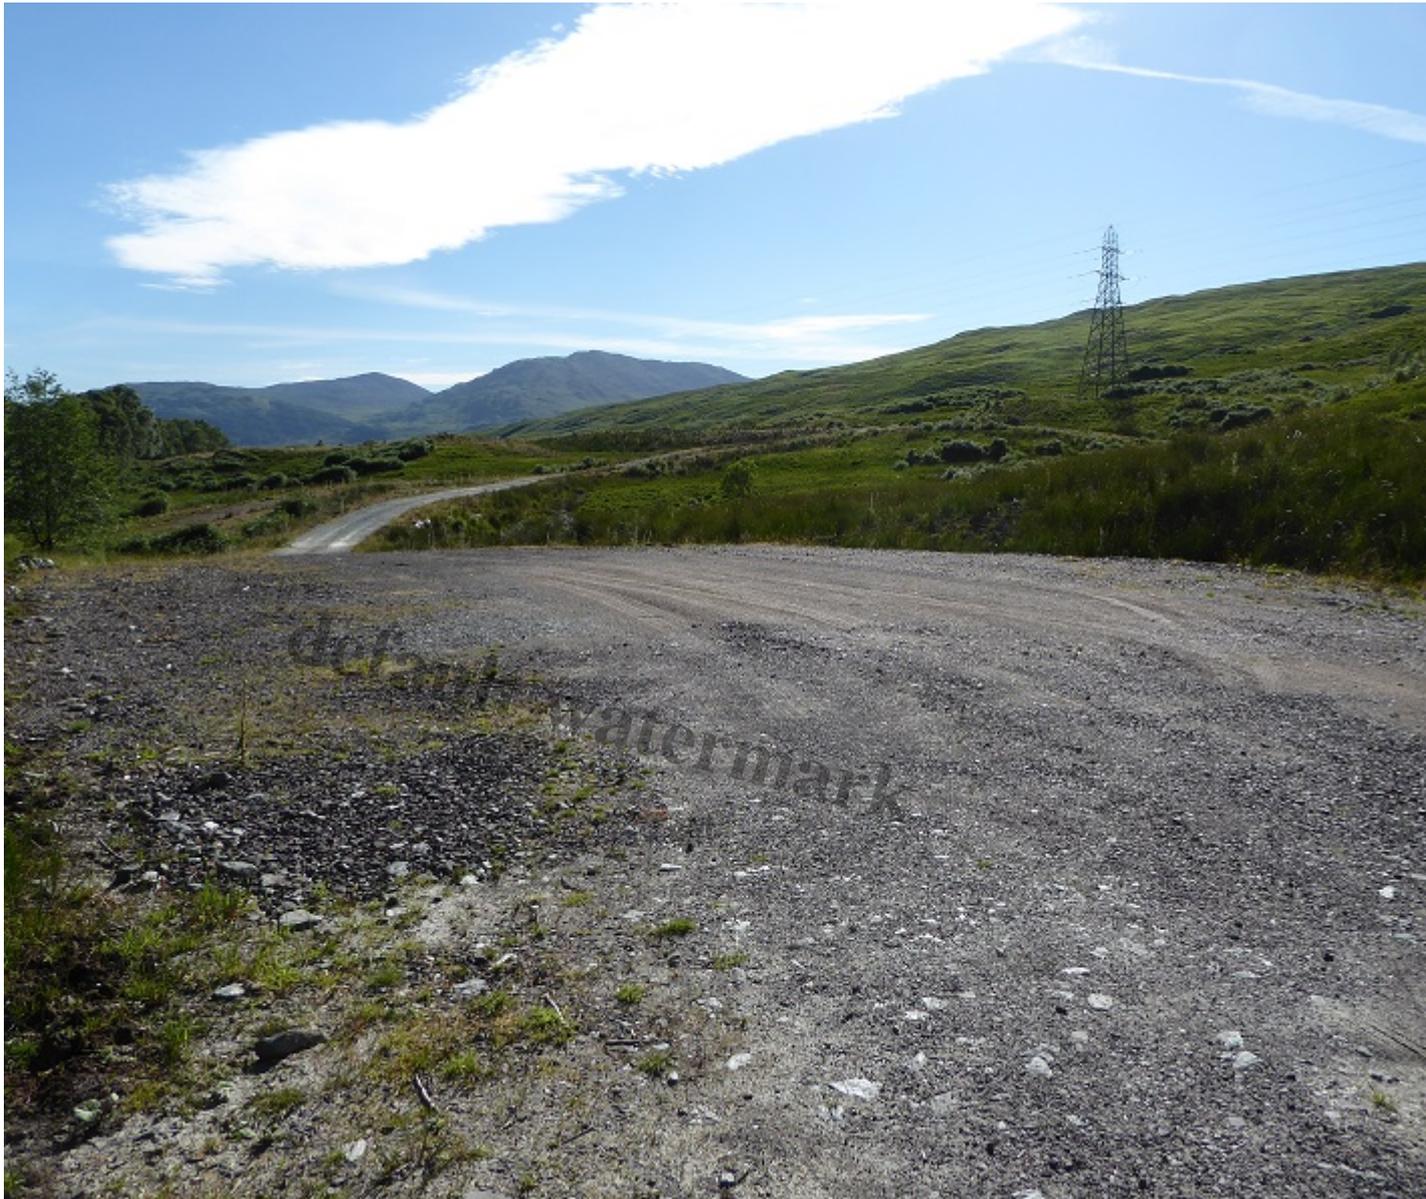
The start of the Eas Eonan track. There had been a short section of track from the A82 up to about t previously. The large working area appears to have been created for the hydro construction and not

At the Eas Eonan the main landscape issues relating to the original consent relate to laydown areas used for construction (see photo above) and the intake.

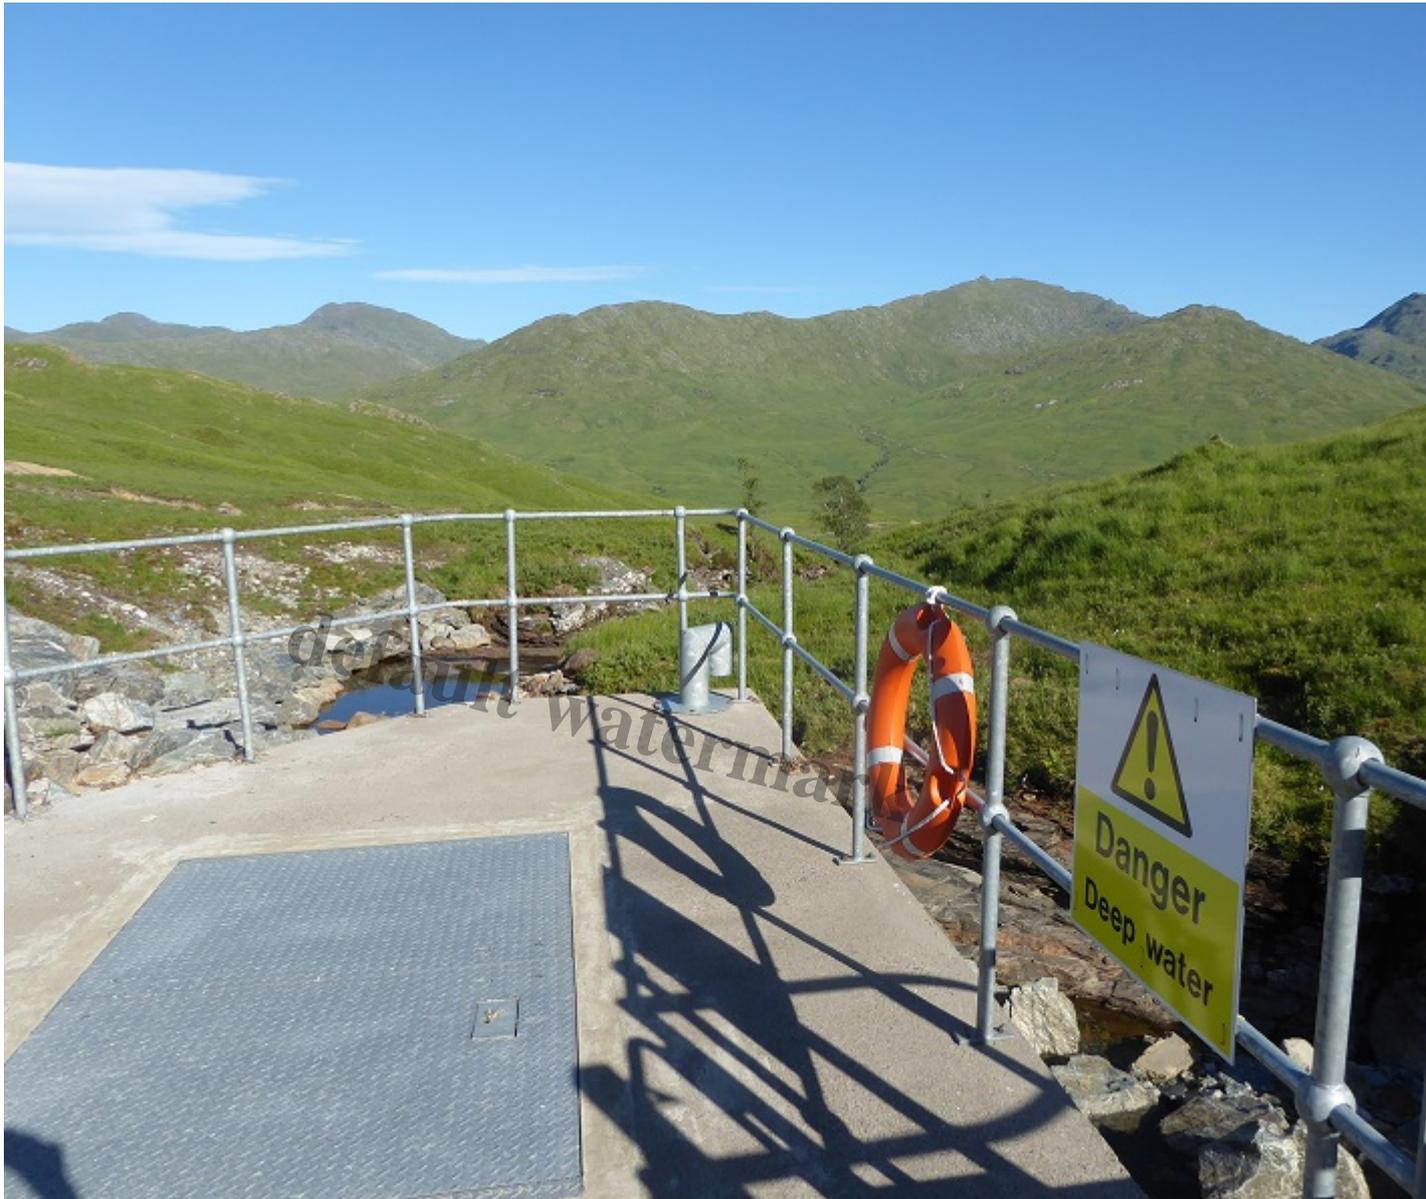
The intake and top section of track (left) lie within the Ben Lui Wild Land Area. While most of the track south side of Glen Falloch are obscured from this angle, a section of the Allt Andoran track, which was under planning permission at the same time, is visible to the right of the tree.

The intake has completely changed the character of a section of the burn, a price worth paying perhaps for more sustainable electricity? However, under the terms of the original decision, the view from the intake once the scheme had been restored would still have been wild. All the transport infrastructure along the bottom of Glen Falloch is hidden from this viewpoint and, looking out from the intake, the landscape unspoilt. Now, however, you can see two tracks.

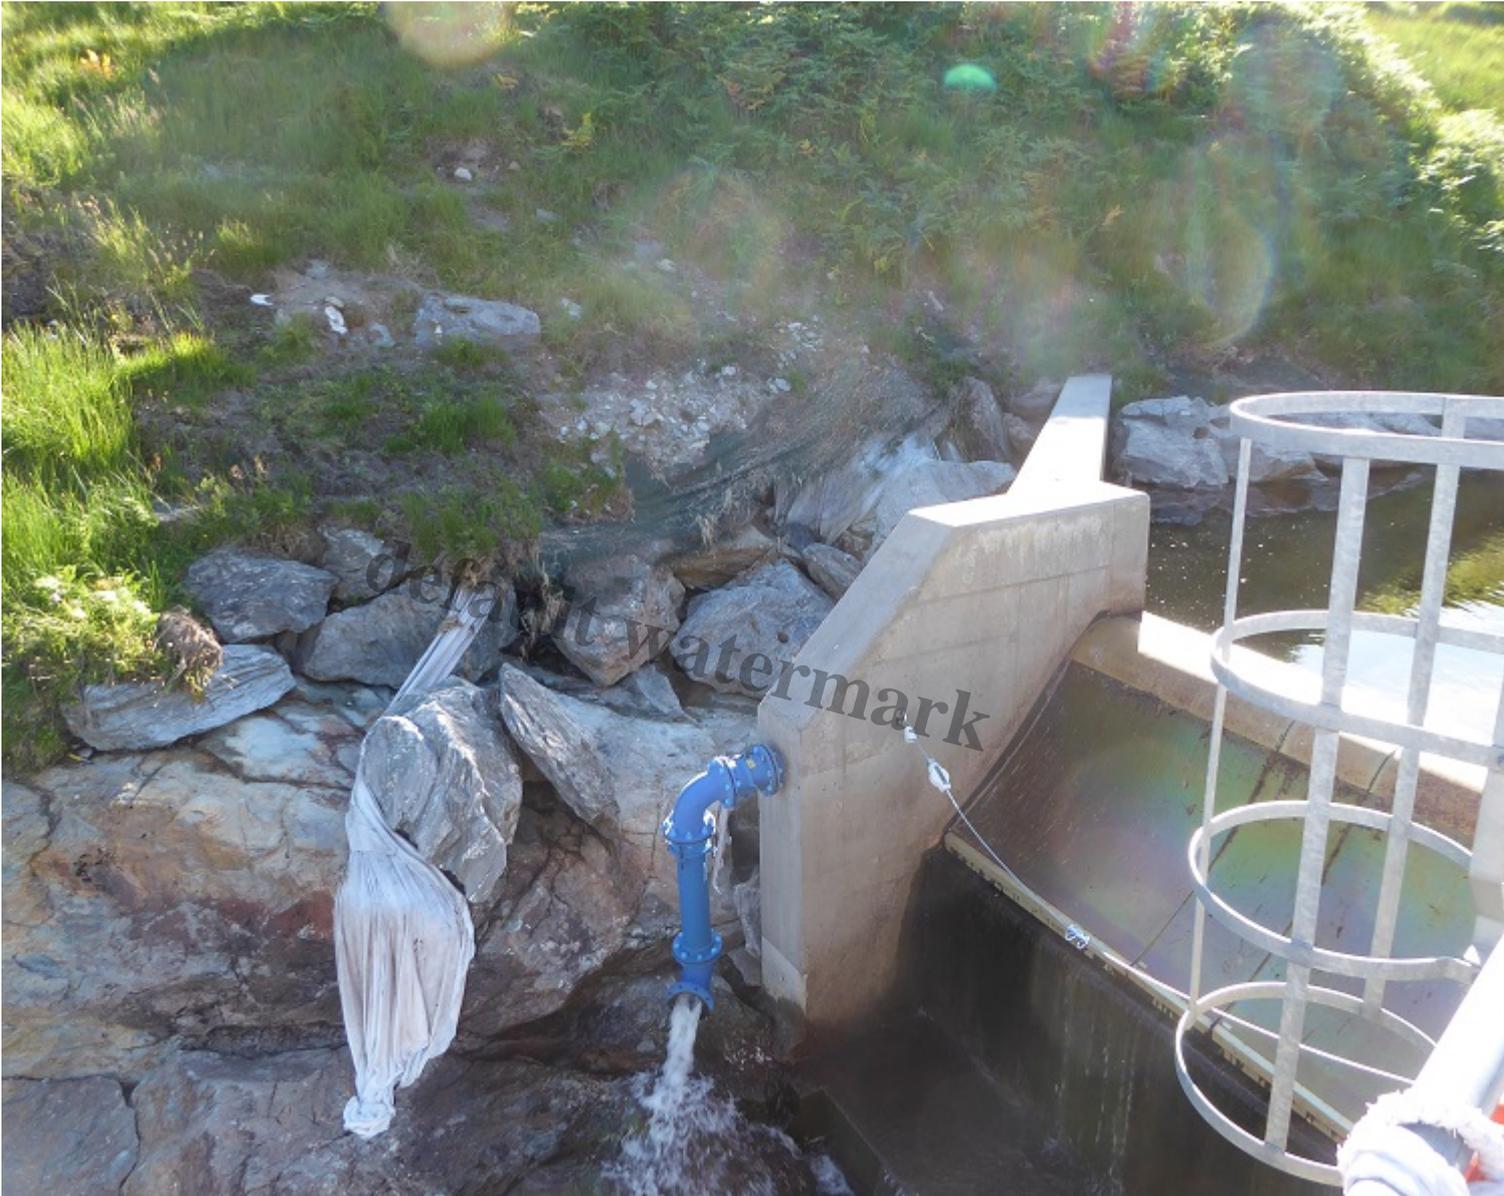
Due to poor design and finishing the visual impact of the intake itself is far more than it needed to be. Many of these issues could still be fixed. A pot of paint, so that pipes and other ironwork were in

George Paton, a reader who formerly worked on hydro and other construction projects in the Highlands, informed me a couple of months ago that wooden railings, which are promoted as best practice in the LLTNPA renewables guidance, don't meet health and safety requirements. That probably explains why wooden railings are only seen on the smallest intakes. However, instead of ignoring the challenges created by Health and Safety, why isn't the LLTNPA working with engineers to find other solutions and then revising its policy? Would not a stone wall and stone facing of the outer dam walls, with material taken from some of the stone spoil littering the edge of the scheme not help Eas Eonan intake blend better into the landscape?

natural colours, as required by the LLTNPA's renewables policy would be a start.

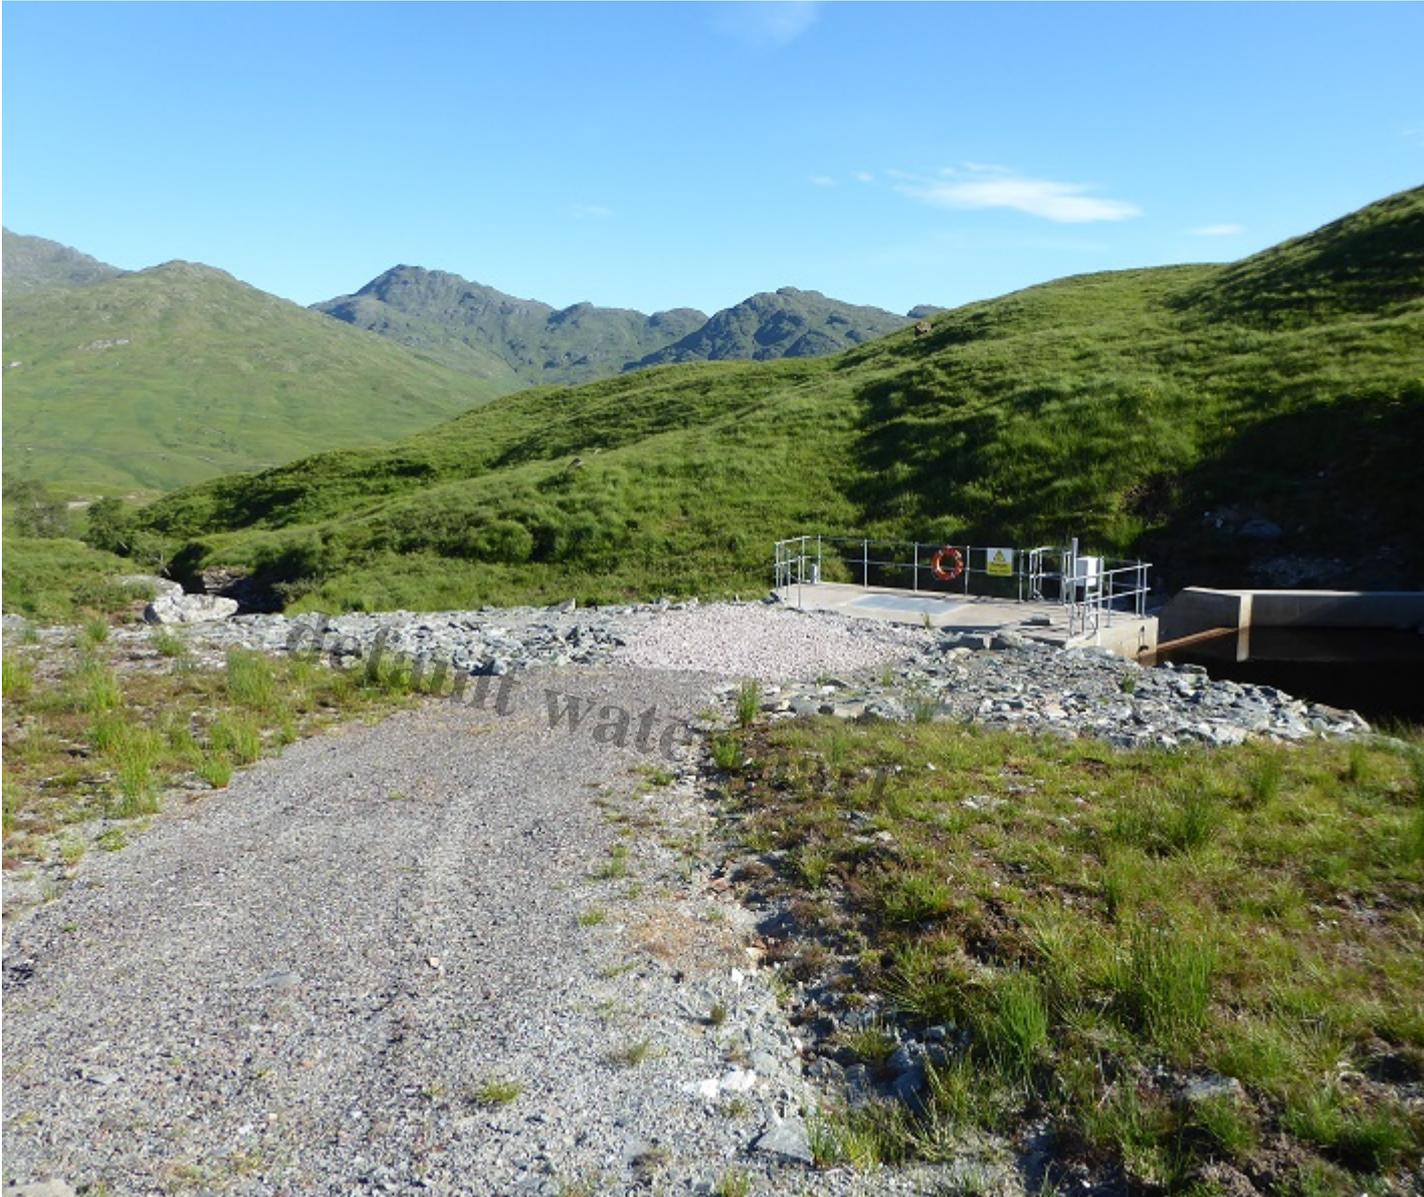
The location of the intake is quite concealed but the landscape impact has been considerably increased by the rip rap bouldering visible on either side of the track which has been treated as hardstanding for vehicles.

And why isn't the LLTNPA conducting a public debate with civil engineers on how they could avoid the adverse impacts of rip rap bouldering which turn what could be quite attractive pools into ugly scars?

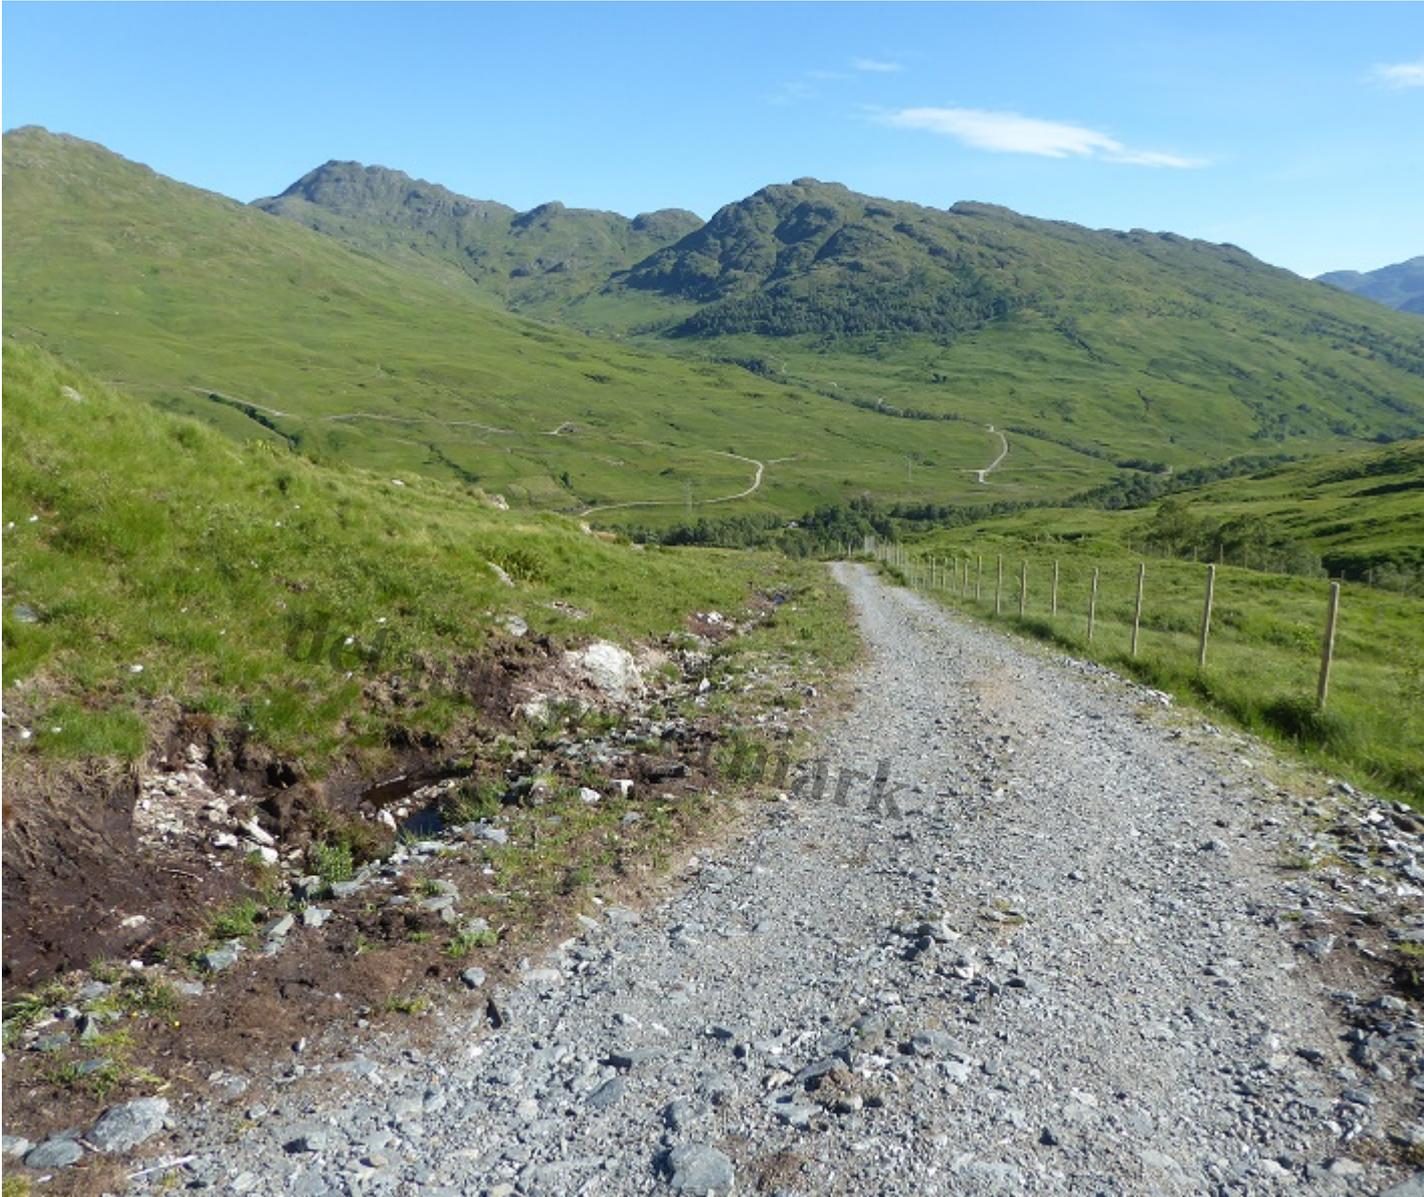
View of Derrydarroch access tracks, Allt Andoran on left, Allt a Chuillin on right, with lower section of track left middle ground. Photo taken from just above steepest section of track from one of many unmarked sections of ground now used for estate management purposes.

It is likely that a permanent track will erode the perception of wildness of this open hill slope; in particular the upper section in core wildness area and the point at which the track approaches the intake and the upper glen where there is intervisibility with Ben Dubcraig. Here the perception of wildness is more apparent and any extensive or adverse development will add to the cumulative impacts of the Glen Falloch schemes. (Extract from Planning Officer's report).

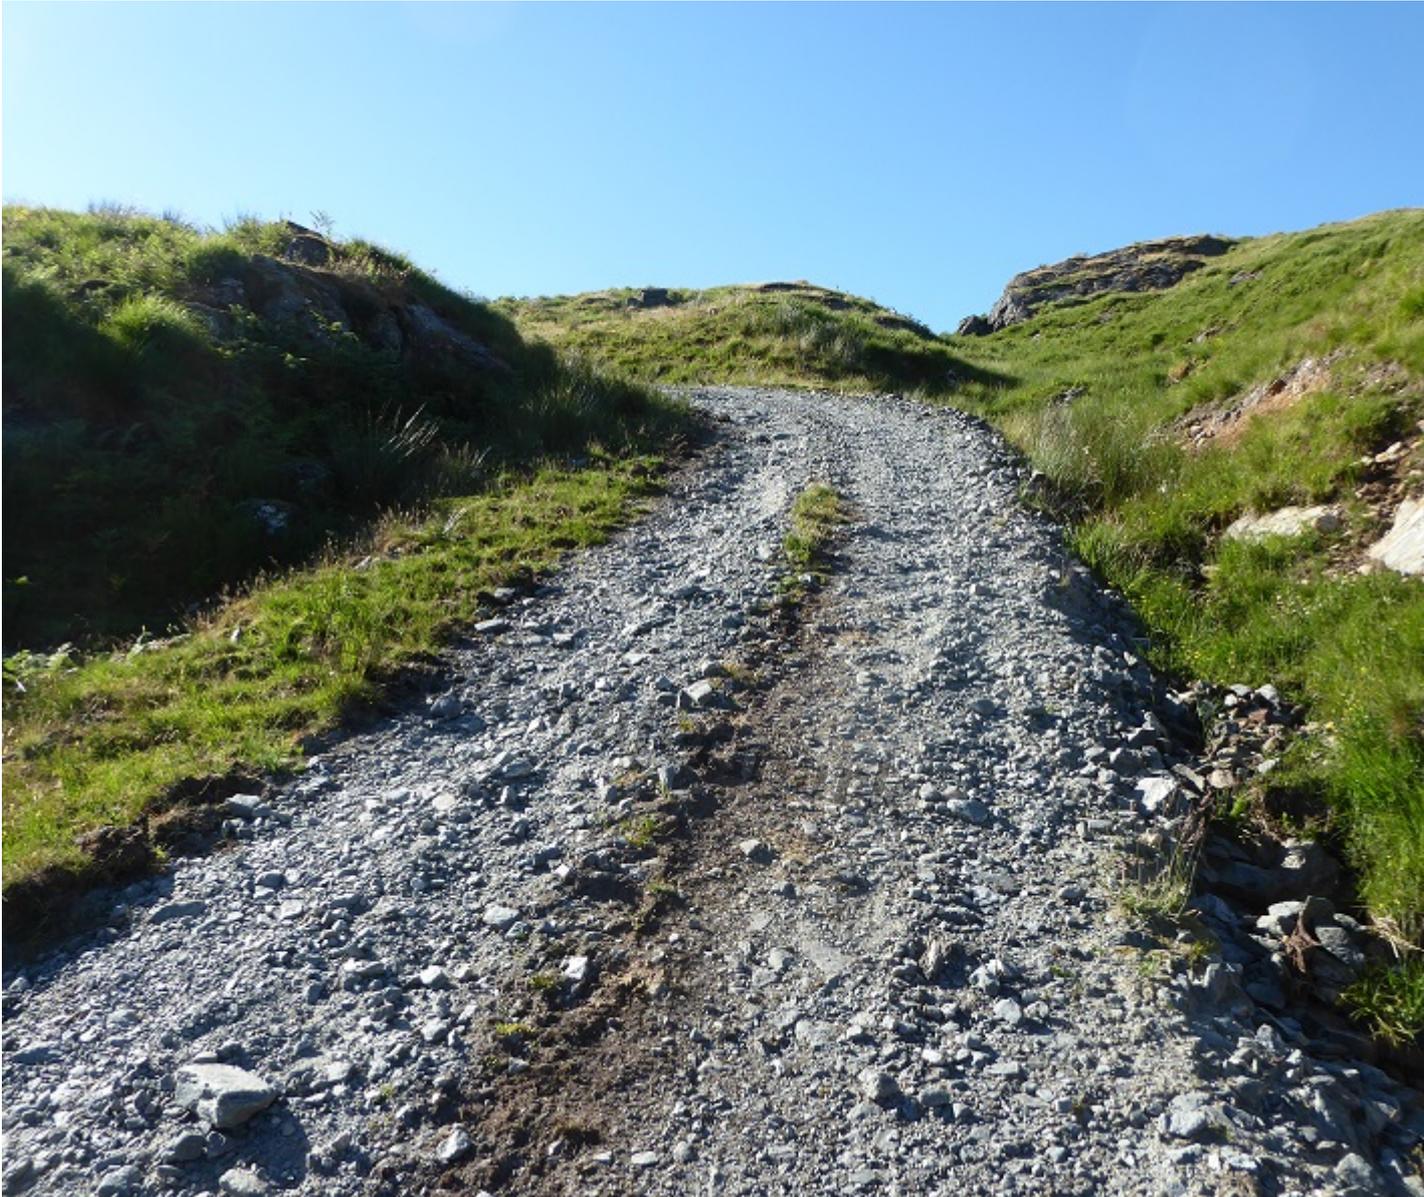
The steep constrained section of track referred to in the planning report is already subject to serious SNH Guidance is that no tracks should be steeper than 14 degrees but unfortunately the LLTNPA has required landowners to meet this standard and is as a consequence storing up problems which are predictable.

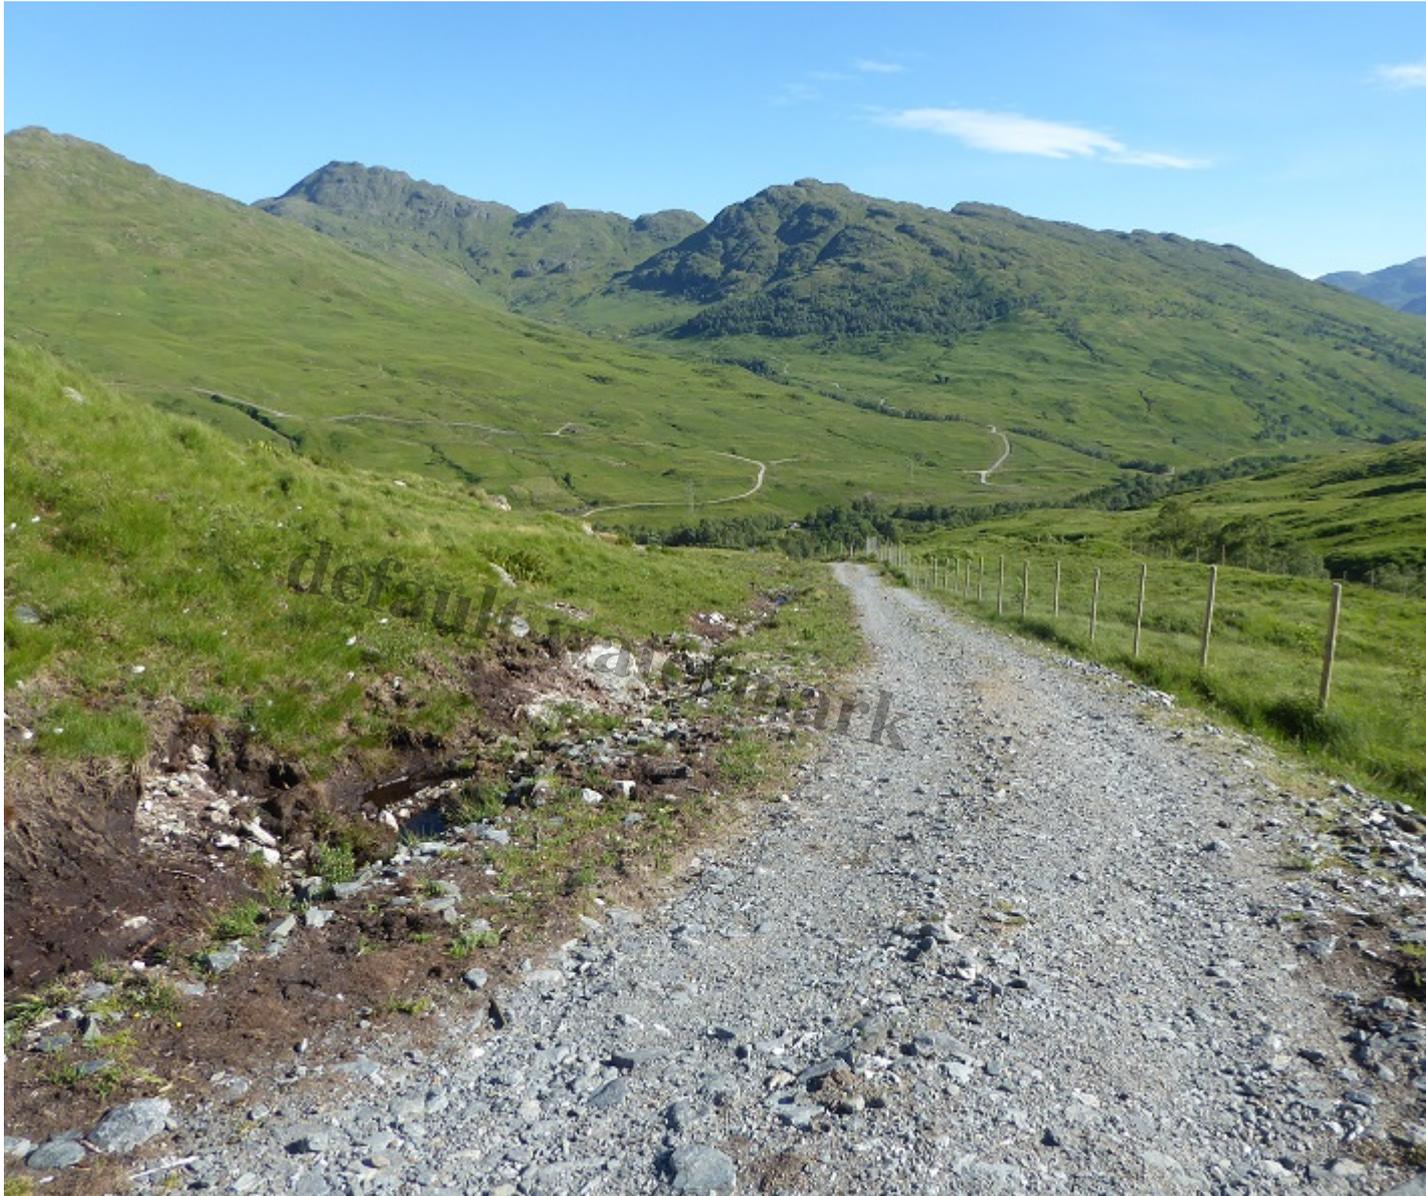
The main mitigation measure agreed for the Eas Eonan scheme was an area of woodland planting visible behind fence on right of track

You cannot cover up major lines running straight along the hillside without landscape scale reforestation and it's a moot point whether trees would grow in some of the wetter parts of the glen. The new planted area will do little to conceal the track. This scar is here for the long-term unless the LLTNPA is forced to think again.

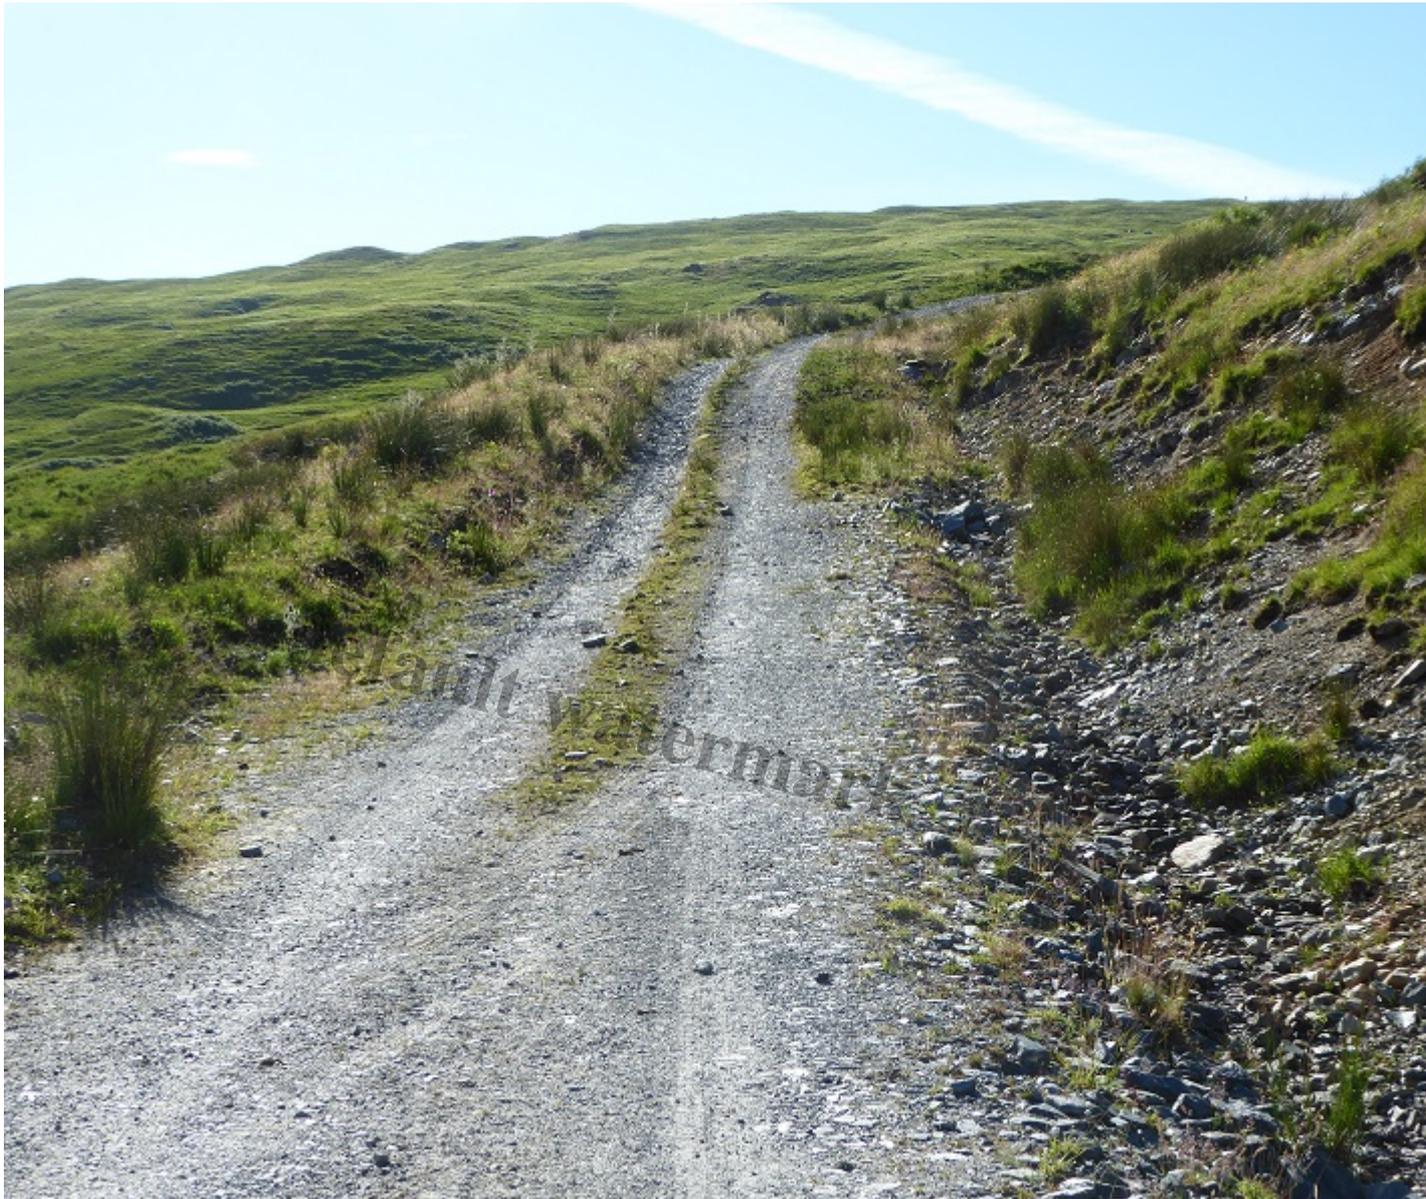
While there is an intermittent line of vegetation running down the middle of the track, as required by guidance, restoration of banks has been far more problematic (this on lower section of track as it sta

The impact of the track has been increased by a problem the Planning Officer identified, the way the track has been cut into the hillside,

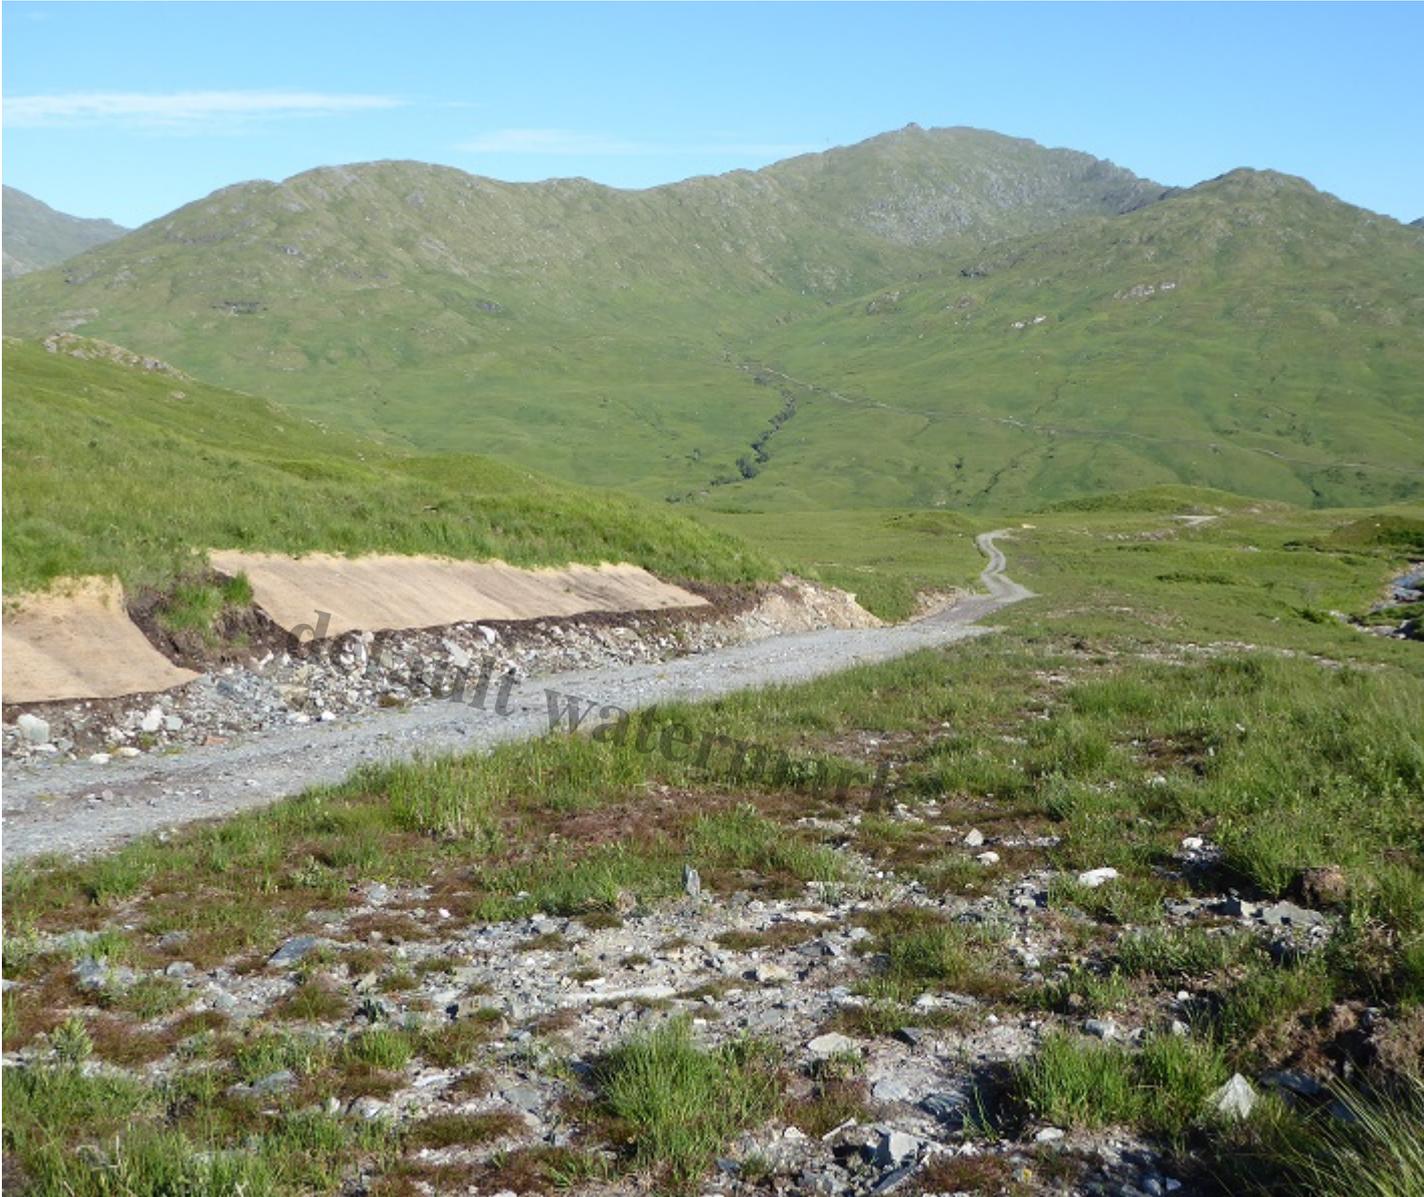
Matting is now being to restore some of the damage. The bare ground in foreground consists of matting in to construct the track.

The original planning consent required that the track would be removed and the landscape returned to its original form. That has now been abandoned and the impact of the track has been accentuated by the creation of steep banks and retention of flat areas next to the track (its far cheaper to simply try and cover up part of the aggregate used to construct the track than to remove or re-landscape it).

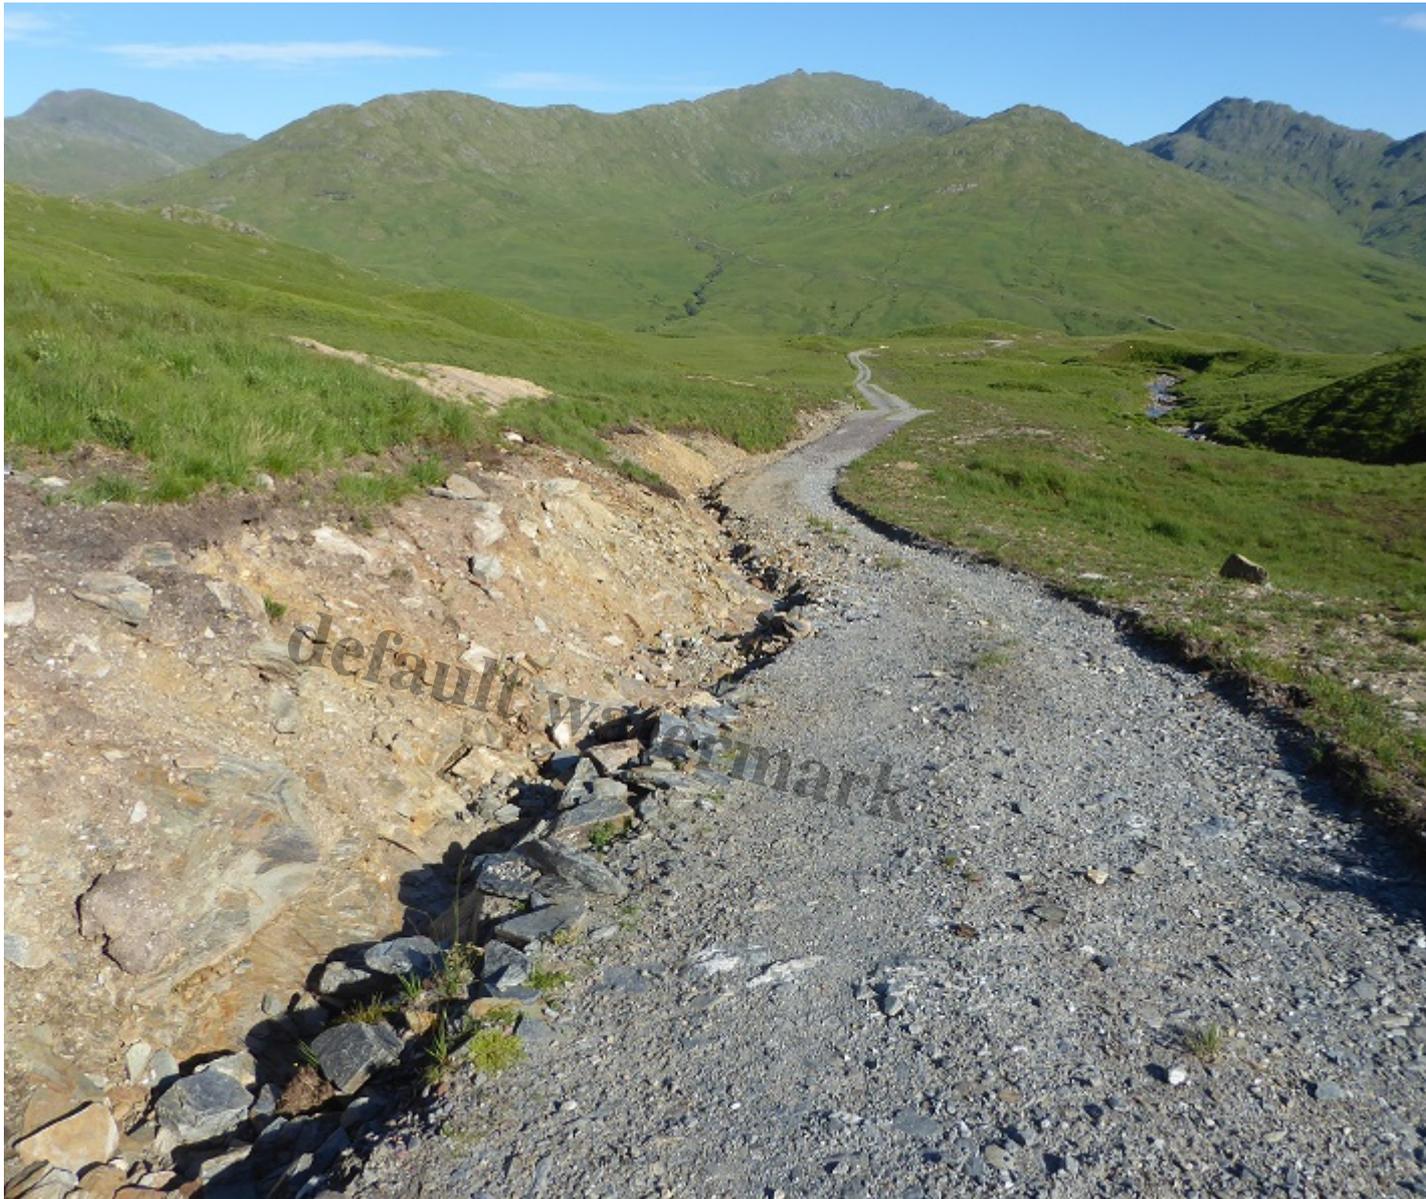
Photo taken from just below area of matting in photo above

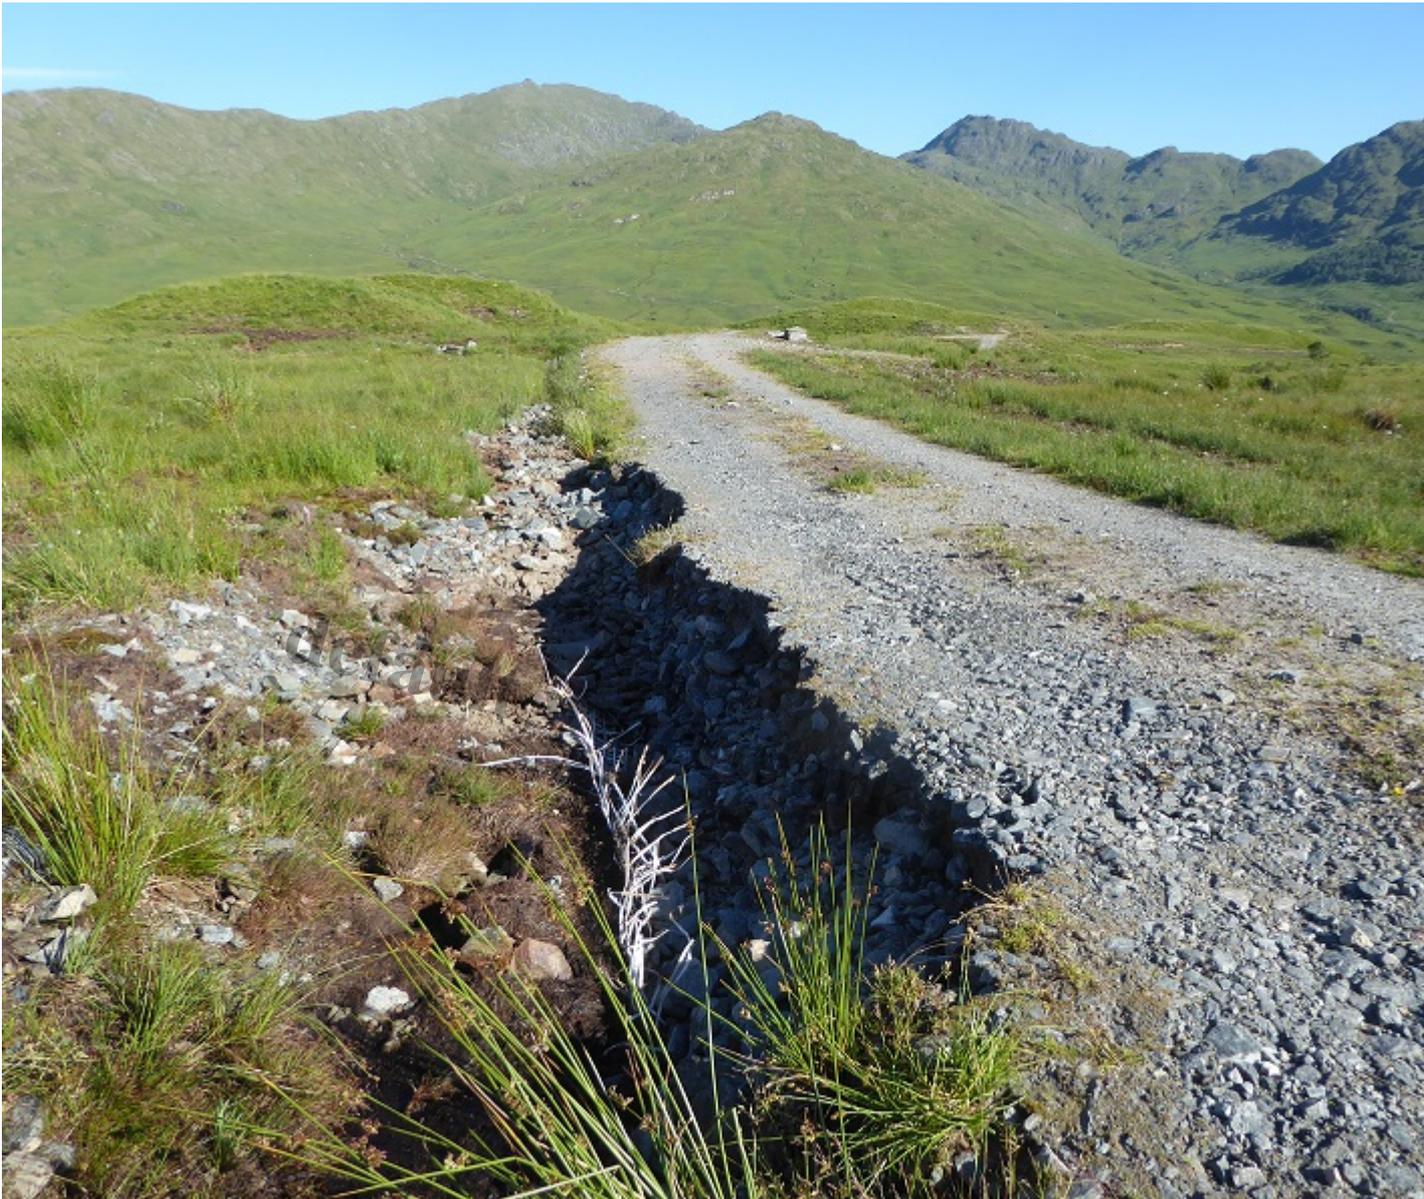
More erosion!
