Glen Falloch – the destruction caused by the Eas Eonan hydro scheme

Approved plan from LLTNPA planning portal for the access tracks at Eas Eonan is Intake 2 for the Derrydarroch hydro schemes, the other intakes being south of the River Falloch

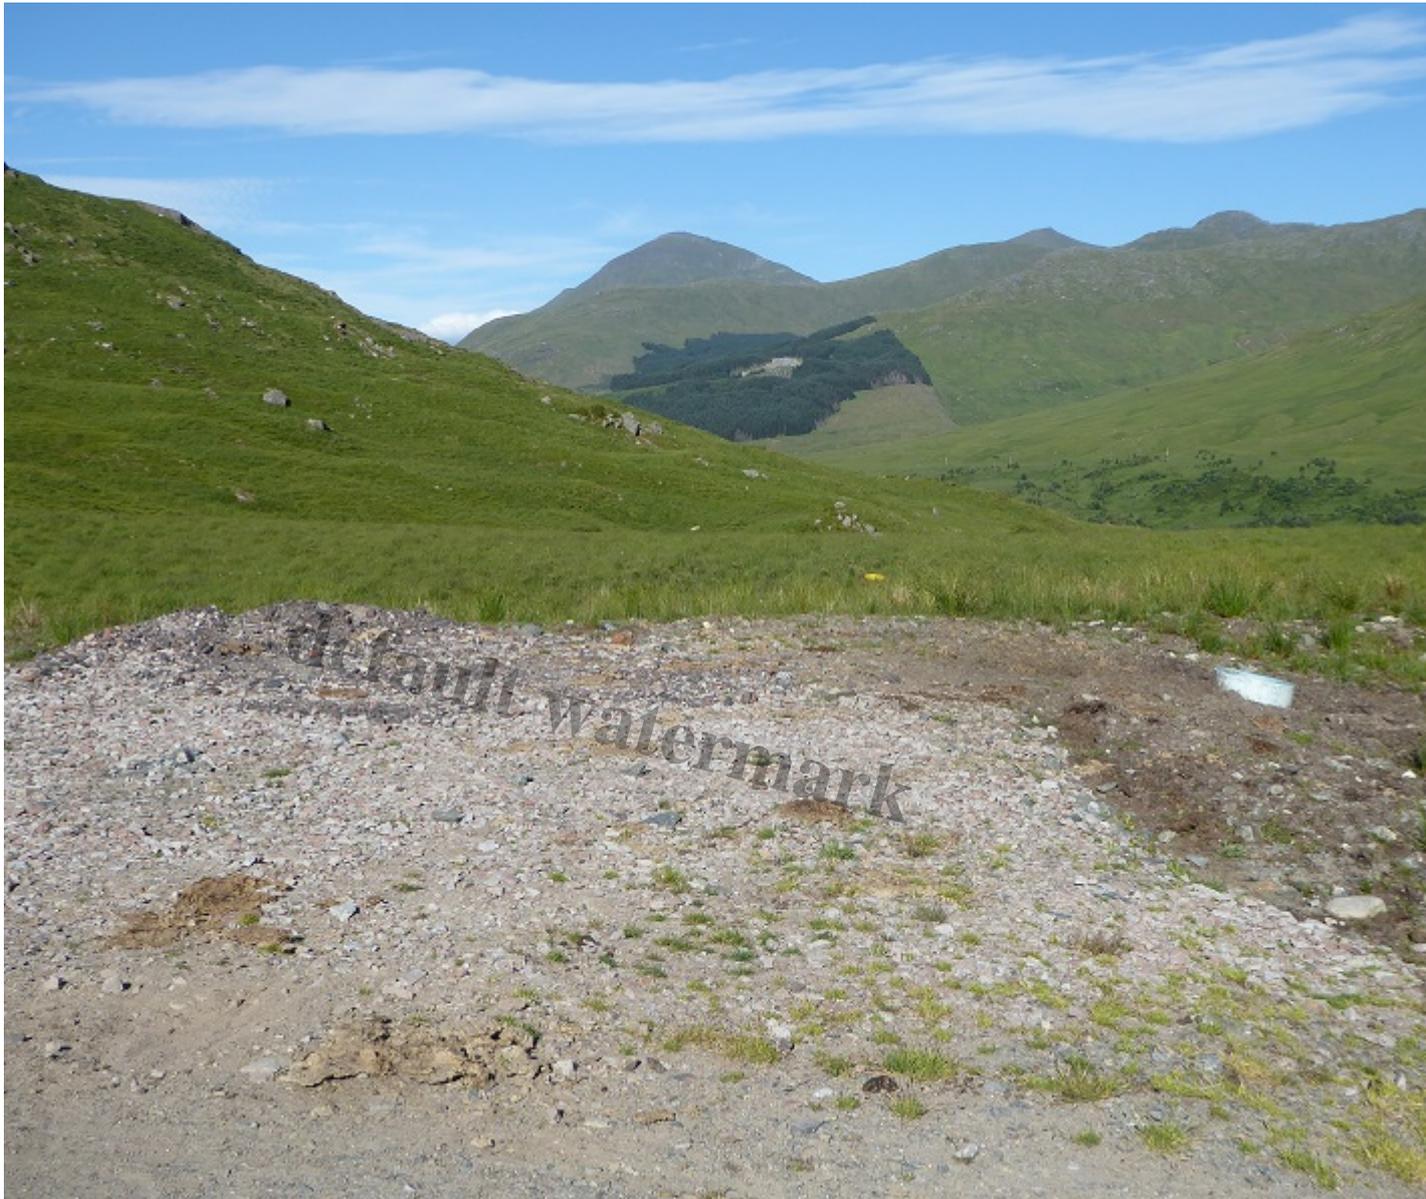
Upper section of track looking towards Ben More

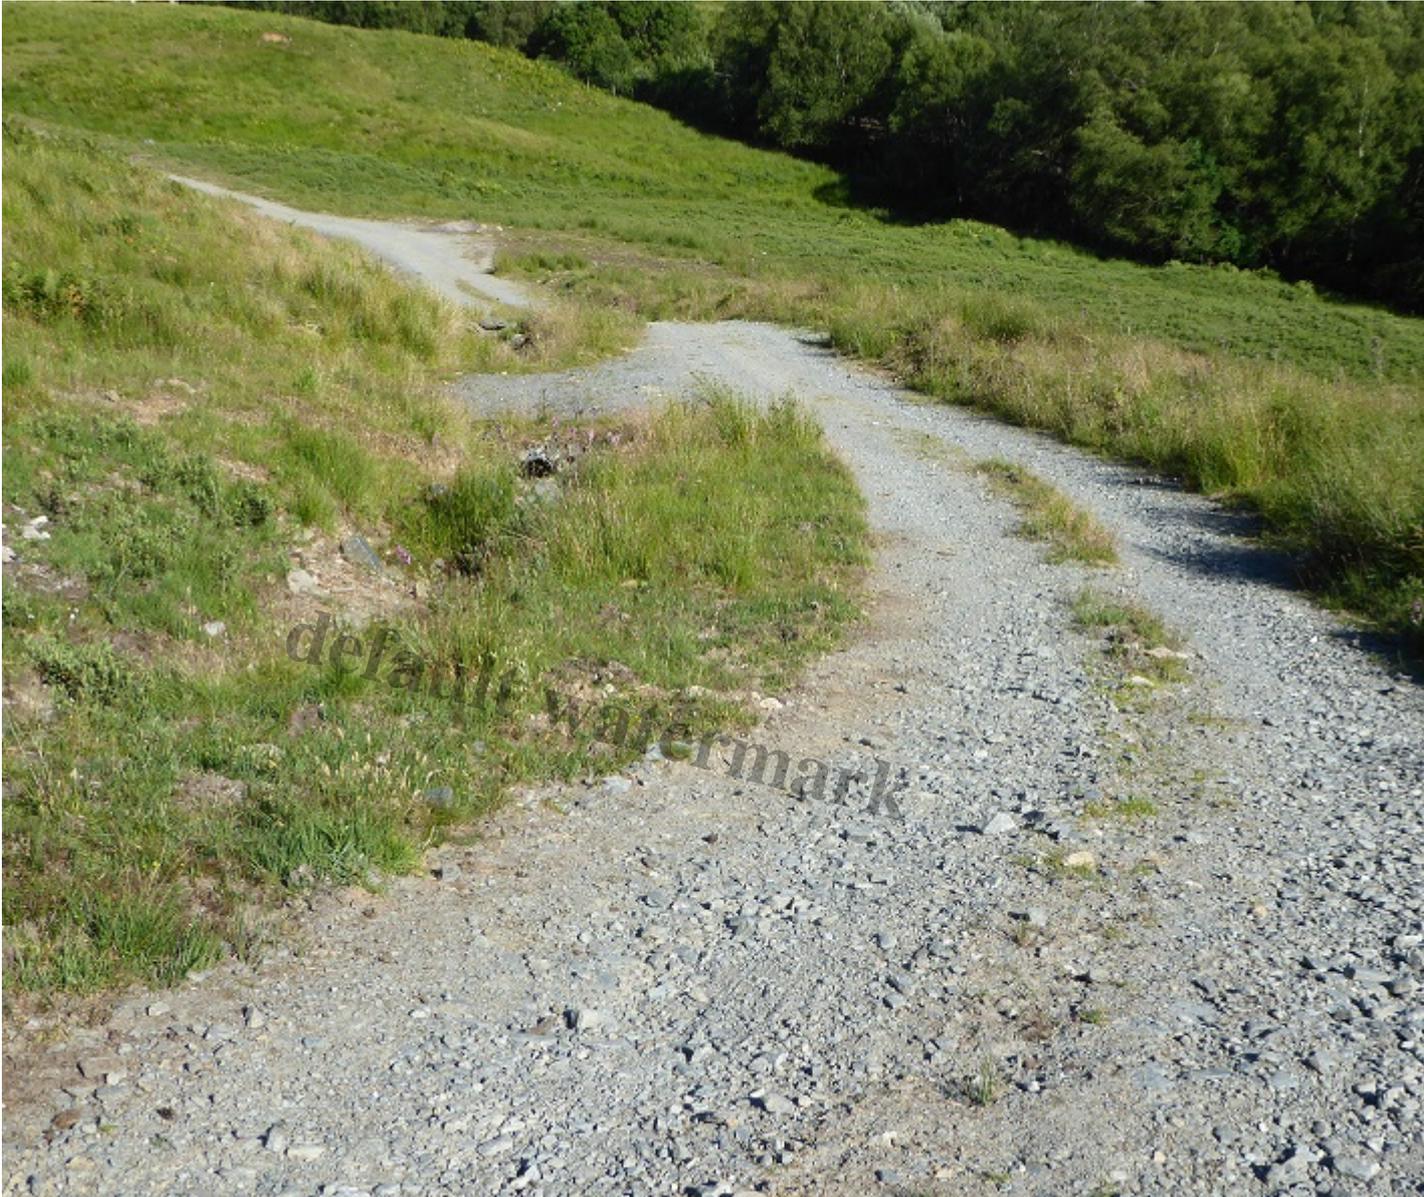
What is the justification for these passing places?

Until the Construction Method Statement is made public its not possible to tell whether the LLTNPA agreed to all these passing places or not. What is clear they increase the landscape impact of the track. They will also have made restoration cheaper. Indeed, one interesting question underlying the landscape impact of hydro schemes across Scotland is the increase in profits to landowners and developers that has resulted from planners allowing them first to cut out the cost of construction track removal and then cutting corners when it comes to restoration. Every time a developer has asked to keep a track the LLTNPA should have been asking them how much money they would save/be taken out of the area as a consequence.

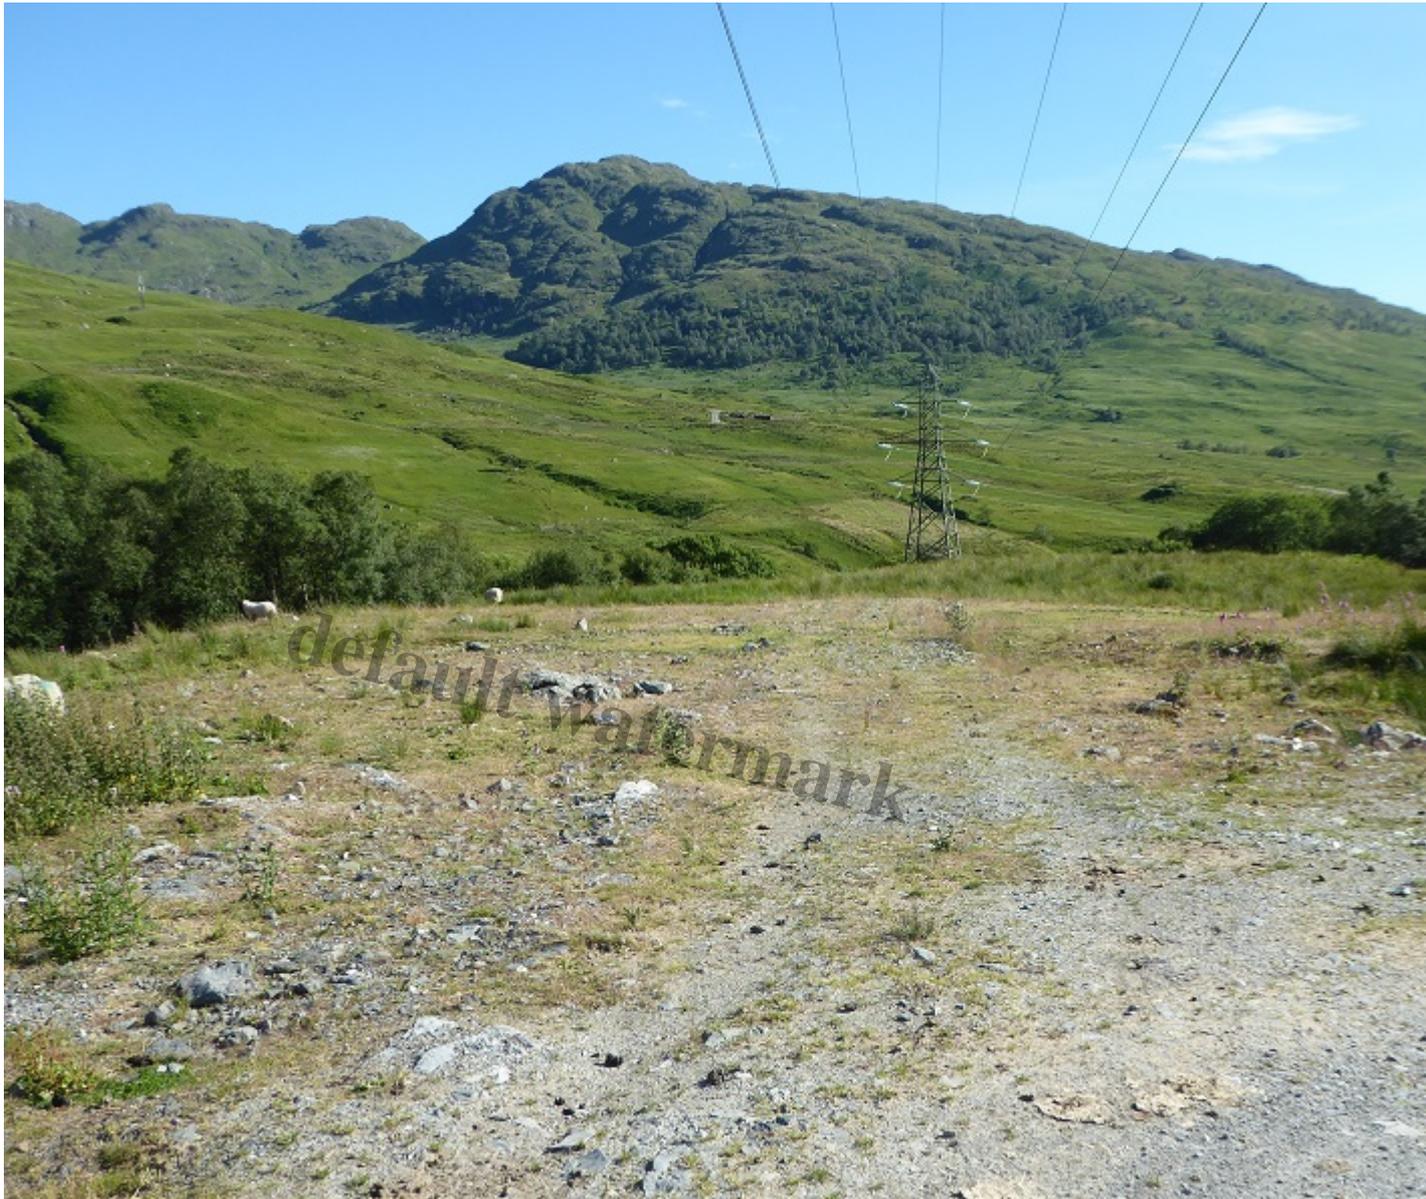
Another restoration failure, where the pipeline diverges from the track to follow the powerline across and River Falloch to the powerhouse.
