Glen Falloch – the destruction caused by the Eas Eonan hydro scheme

Birds eye view of central section of Eas Eonan scheme June 2018 showing the landscape impact of The line of the buried pipe has been accentuated by the dry weather.

early July. It forms part of the Derrydarroch Hydro Scheme.

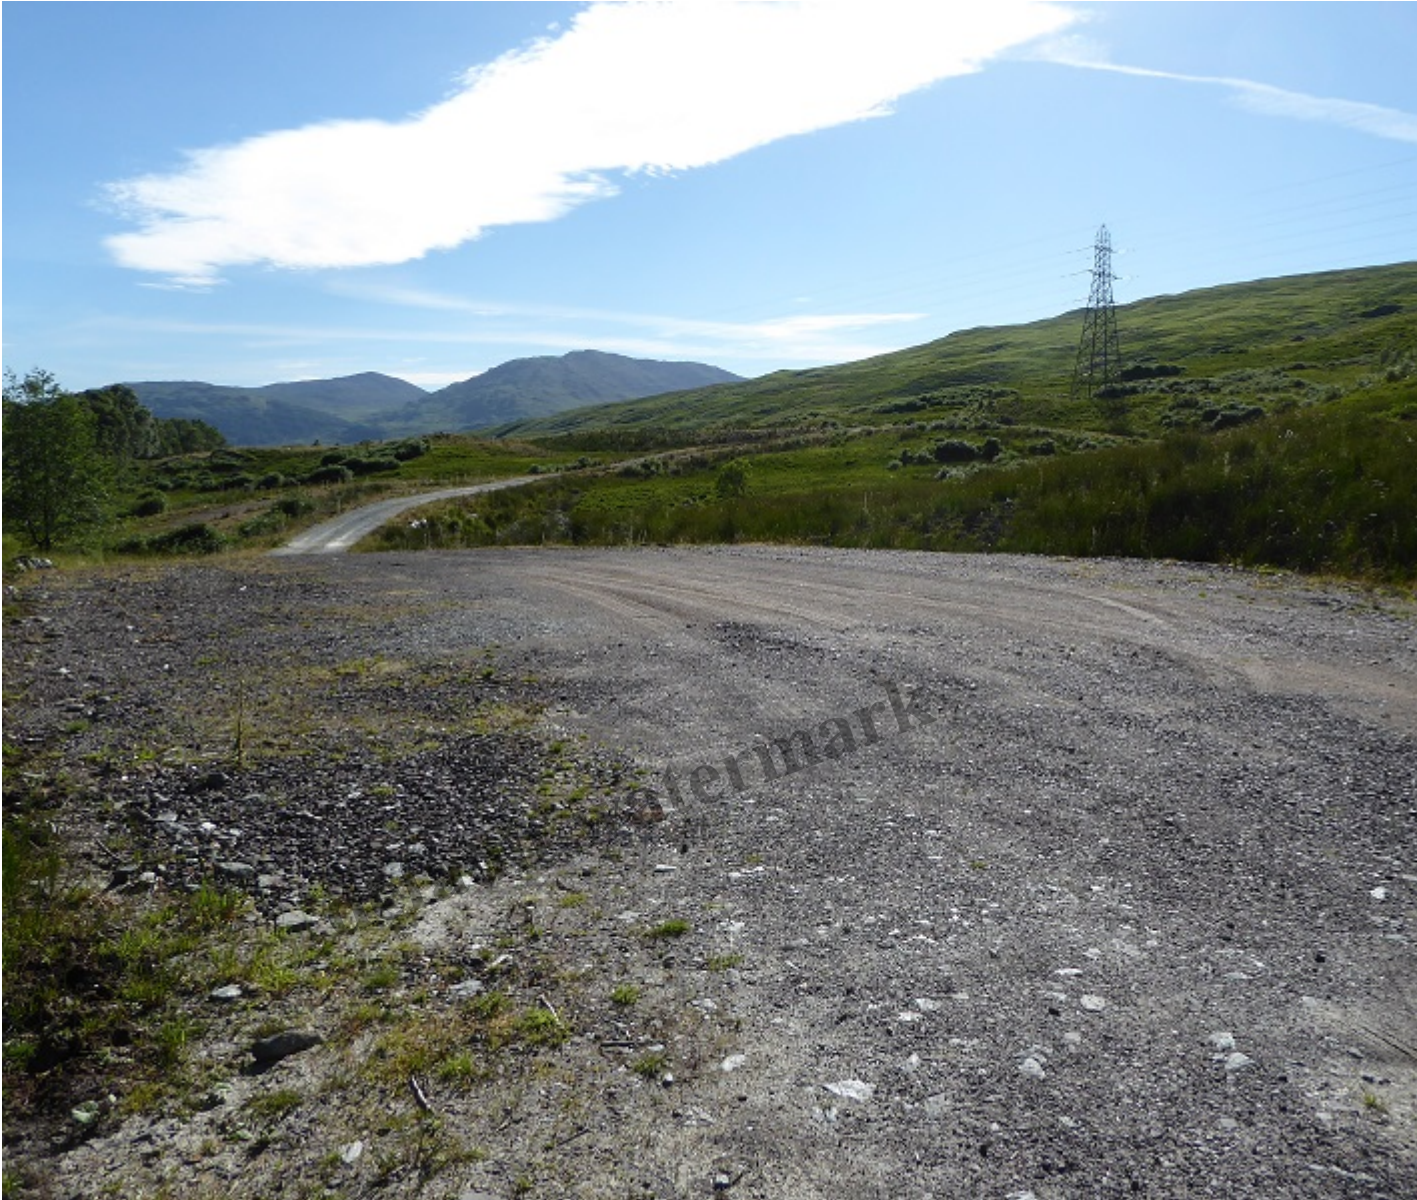
The start of the Eas Eonan track. There had been a short section of track from the A82 up to about t previously. The large working area appears to have been created for the hydro construction and not

At the Eas Eonan the main landscape issues relating to the original consent relate to laydown areas used for construction (see photo above) and the intake.

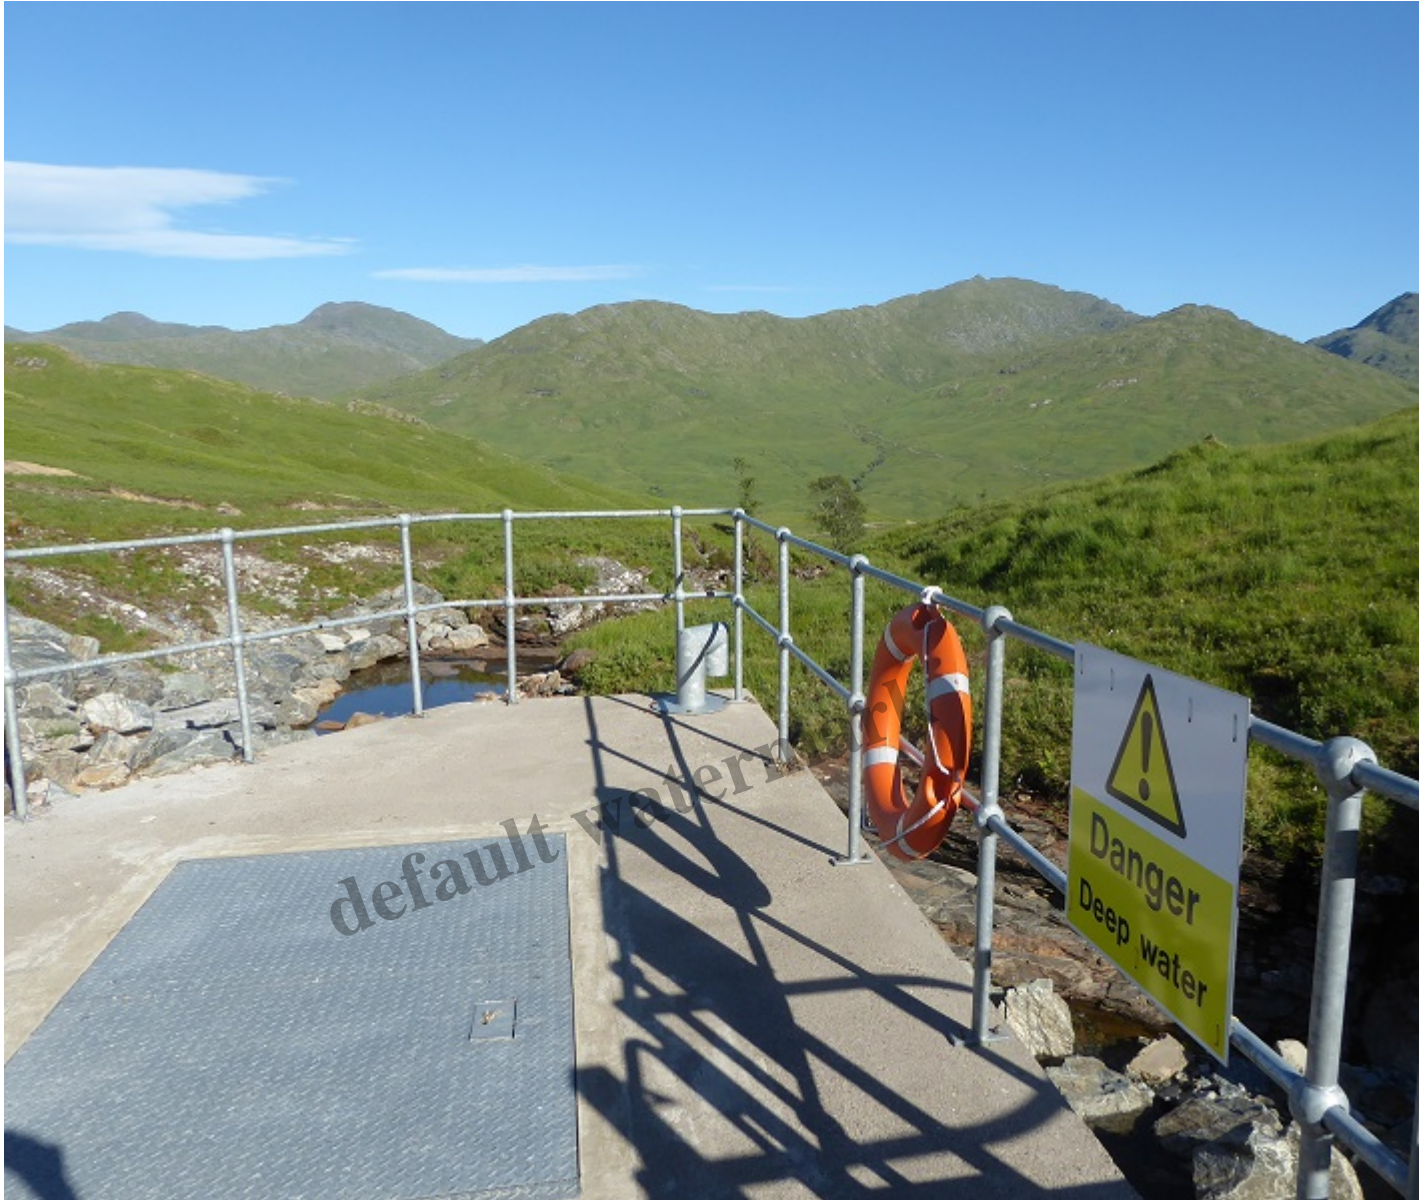
The intake and top section of track (left) lie within the Ben Lui Wild Land Area. While most of the track south side of Glen Falloch are obscured from this angle, a section of the Allt Andoran track, which was granted planning permission at the same time, is visible to the right of the tree.

The intake has completely changed the character of a section of the burn, a price worth paying perhaps for more sustainable electricity? However, under the terms of the original decision, the view from the intake once the scheme had been restored would still have been wild. All the transport infrastructure along the bottom of Glen Falloch is hidden from this viewpoint and, looking out from the intake, the landscape unspoilt. Now, however, you can see two tracks.

Due to poor design and finishing the visual impact of the intake itself is far more than it needed to be.

Many of these issues could still be fixed. A pot of paint, so that pipes and other ironwork were in natural colours, as required by the LLTNPA's renewables policy would be a start.

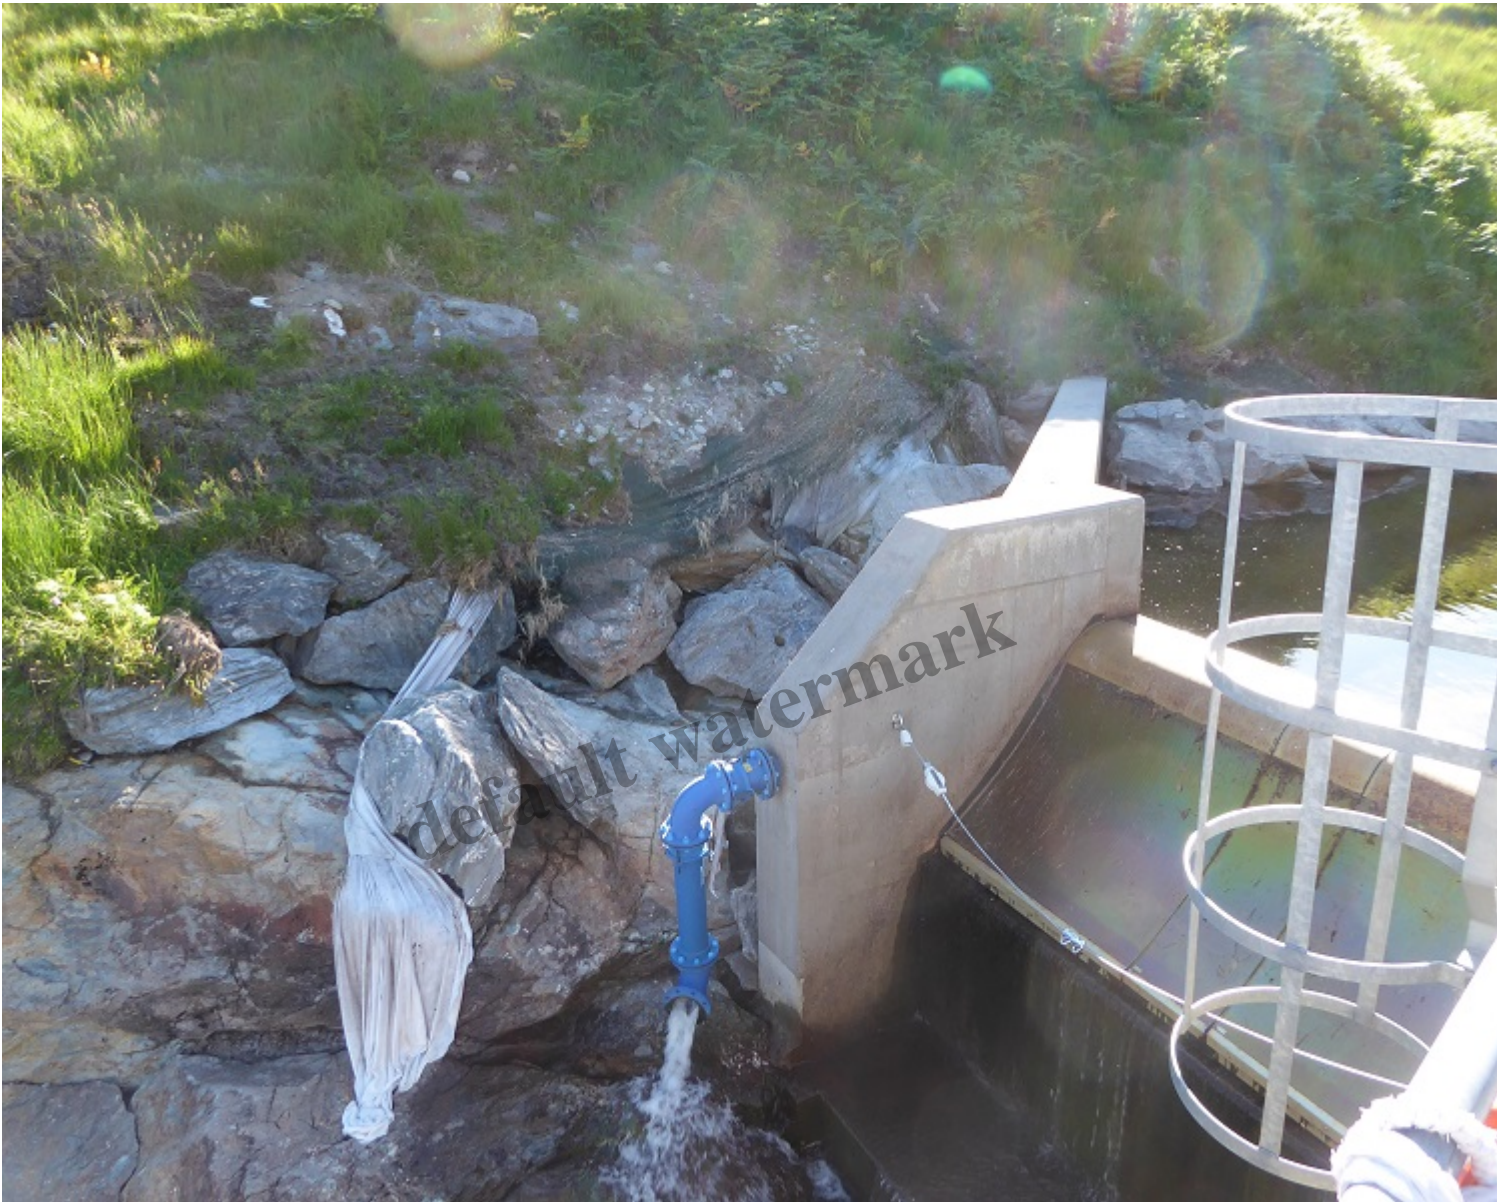
George Paton, a reader who formerly worked on hydro and other construction projects in the Highlands, informed me a couple of months ago that wooden railings, which are promoted as best practice in the LLTNPA renewables guidance, don't meet health and safety requirements. That probably explains why wooden railings are only seen on the smallest intakes. However, instead of ignoring the challenges created by Health and Safety, why isn't the LLTNPA working with engineers to find other solutions and then revising its policy? Would not a stone wall and stone facing of the outer dam walls, with material taken from some of the stone spoil littering the edge of the scheme not help Eas Eonan intake blend better into the landscape?

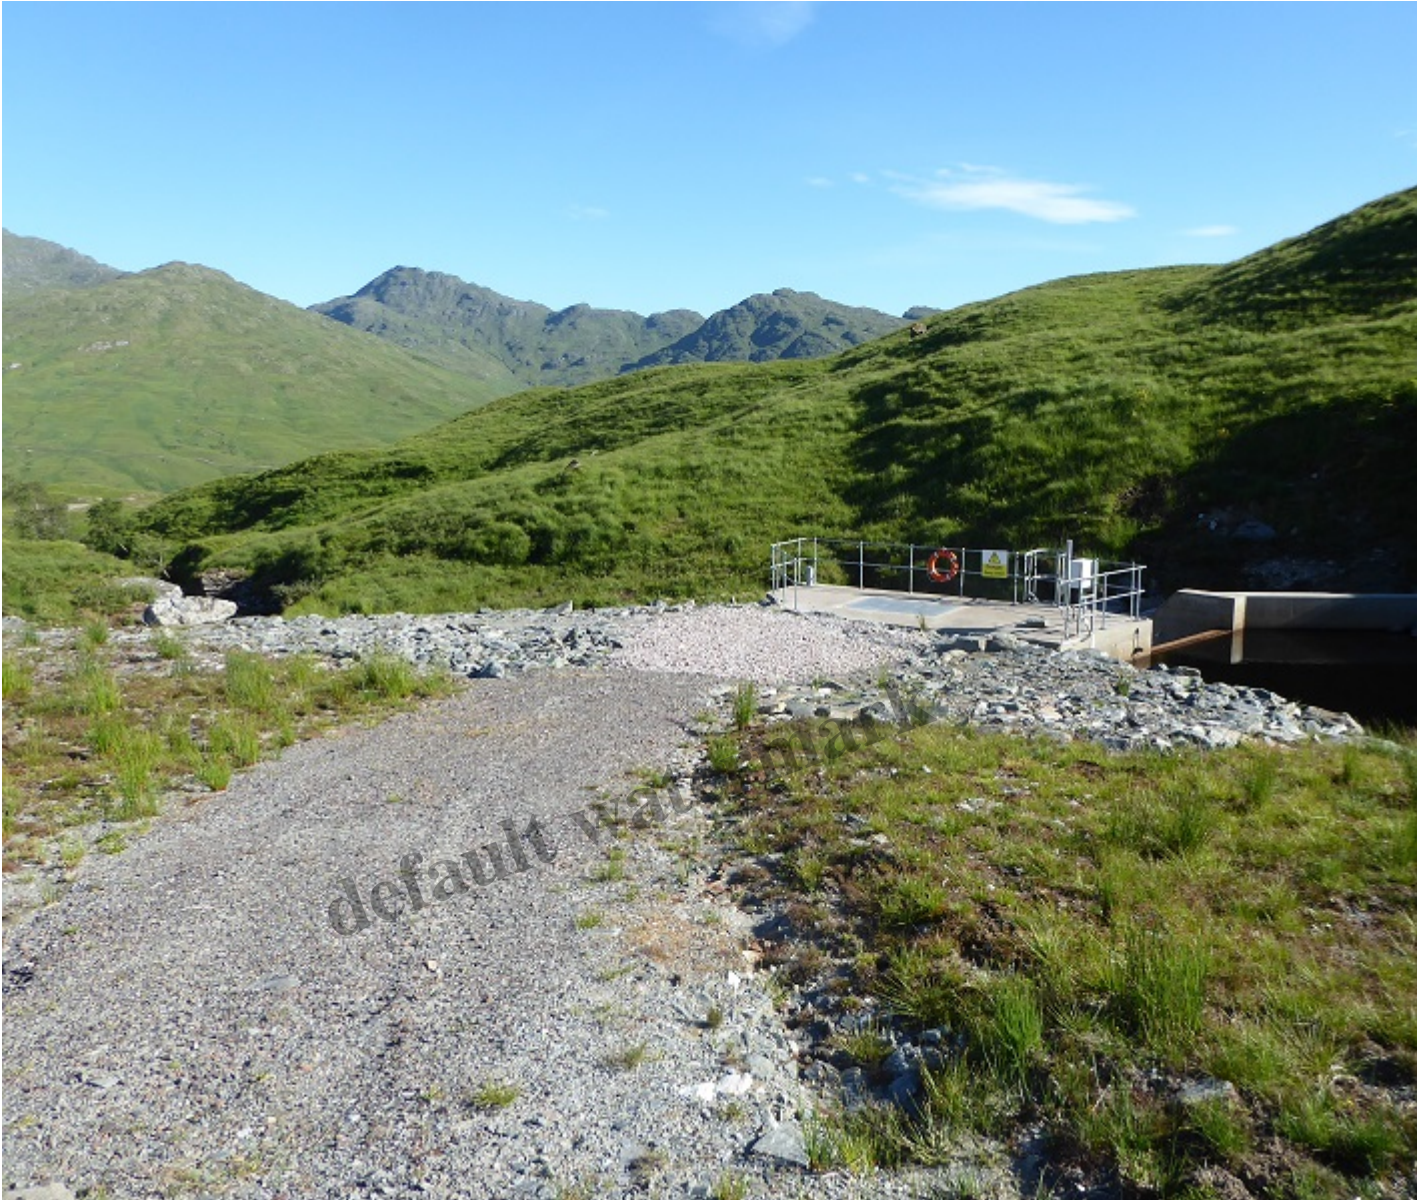
The location of the intake is quite concealed but the landscape impact has been considerably increased by the rip rap bouldering visible on either side of the track which has been treated as hardstanding for vehicles.

And why isn't the LLTNPA conducting a public debate with civil engineers on how they could avoid the adverse impacts of rip rap bouldering which turn what could be quite attractive pools into ugly scars?

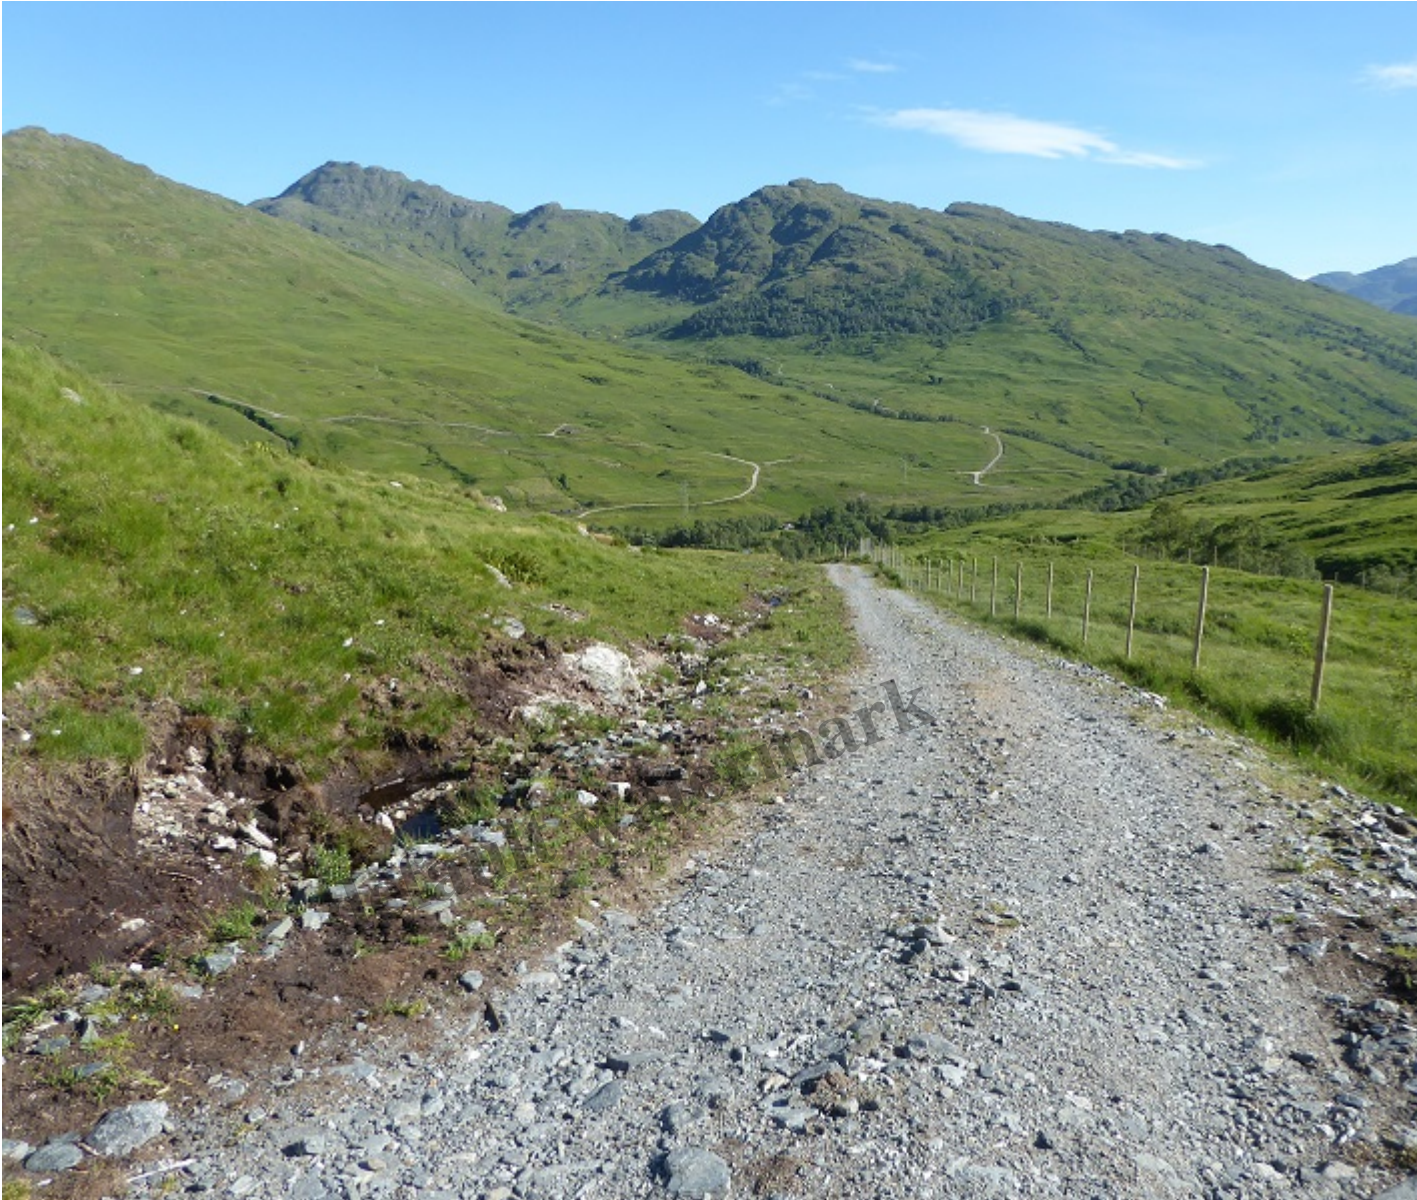
View of Derrydarroch access tracks, Allt Andoran on left, Allt a Chuillin on right, with lower section of track left middle ground. Photo taken from just above steepest section of track from one of many unmarked sections of ground now used for “estate management” purposes.

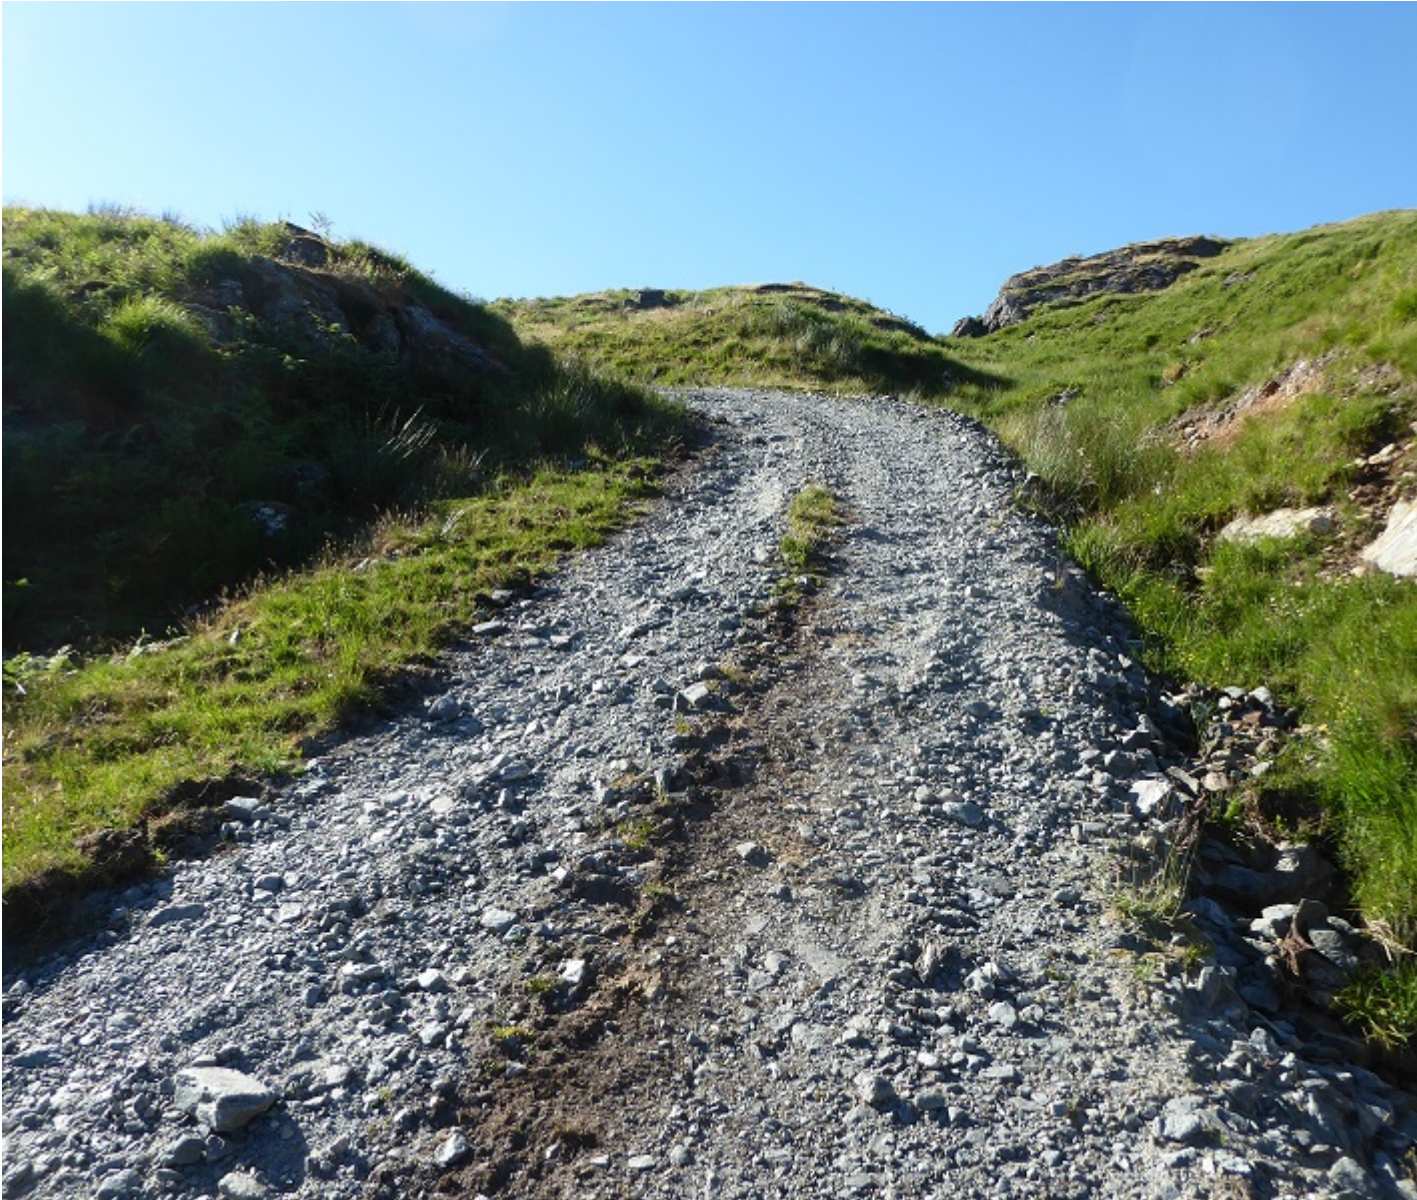
The steep constrained section of track referred to in the planning report is already subject to serious SNH Guidance is that no tracks should be steeper than 14 degrees but unfortunately the LLTNPA has required landowners to meet this standard and is as a consequence storing up problems which are predictable.

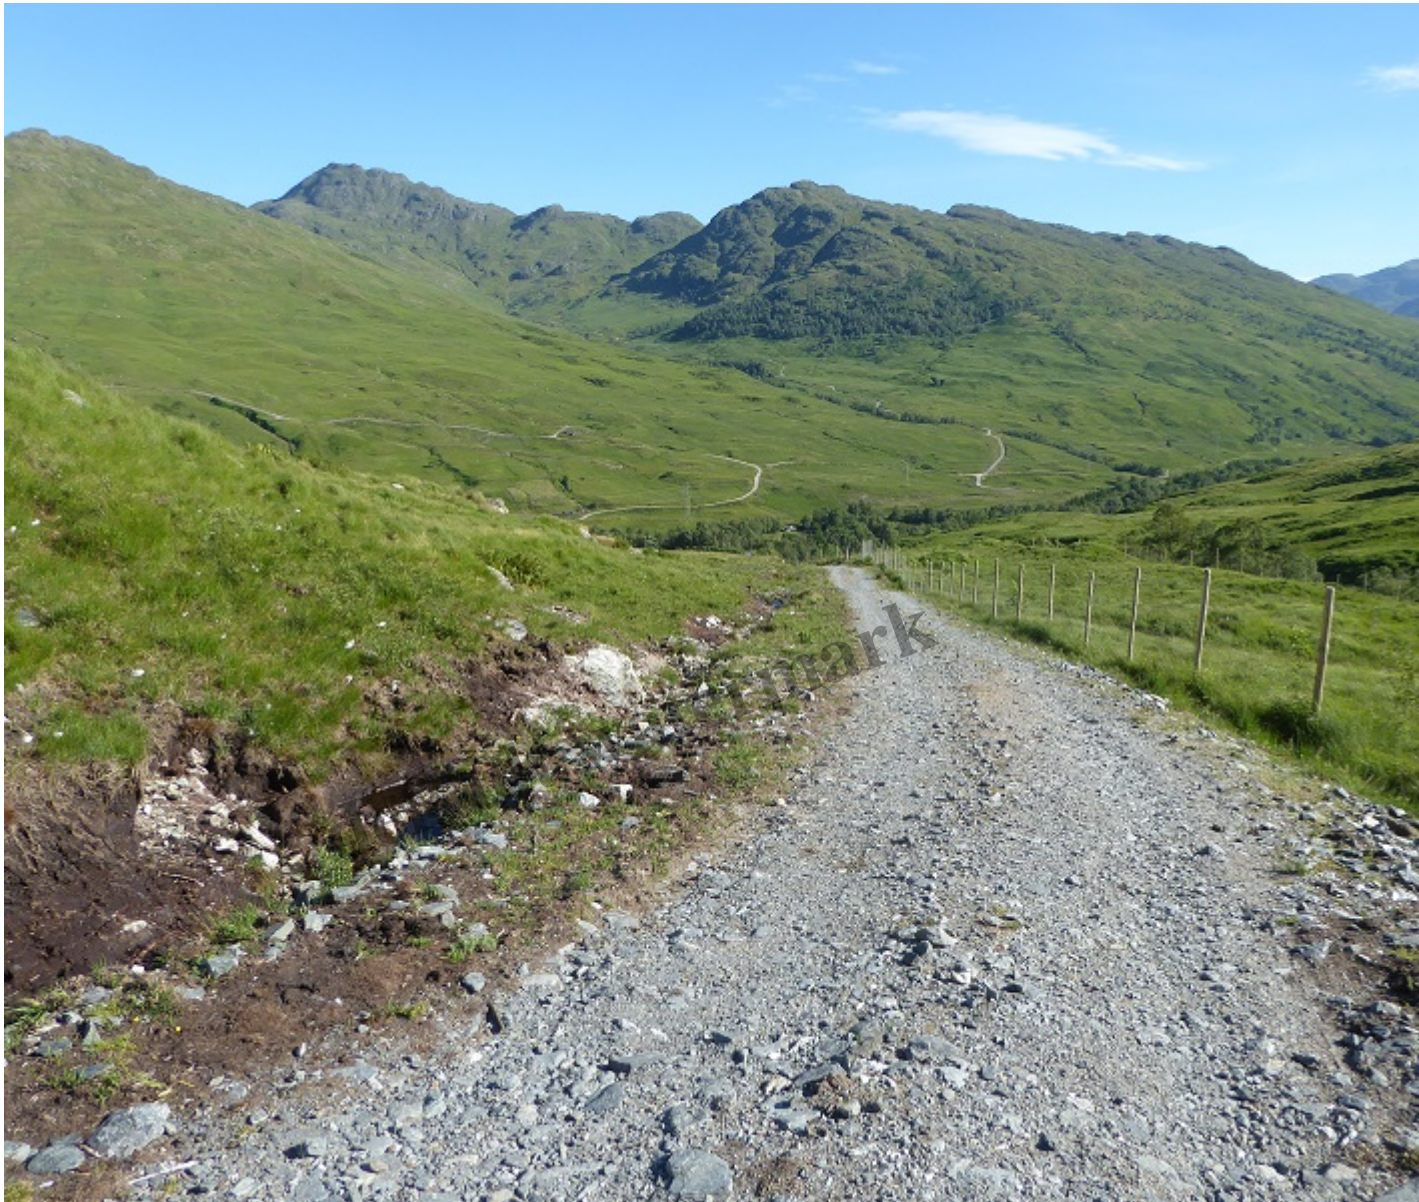
The main mitigation measure agreed for the Eas Eonan scheme was an area of woodland planting v
seen behind fence on right of track

You cannot cover up major lines running straight along the hillside without landscape scale reforestation and its a moot point whether trees would grow in some of the wetter parts of the glen. The new planted area will do little to conceal the track. This scar is here for the long-term unless the LLTNPA is forced to think again.

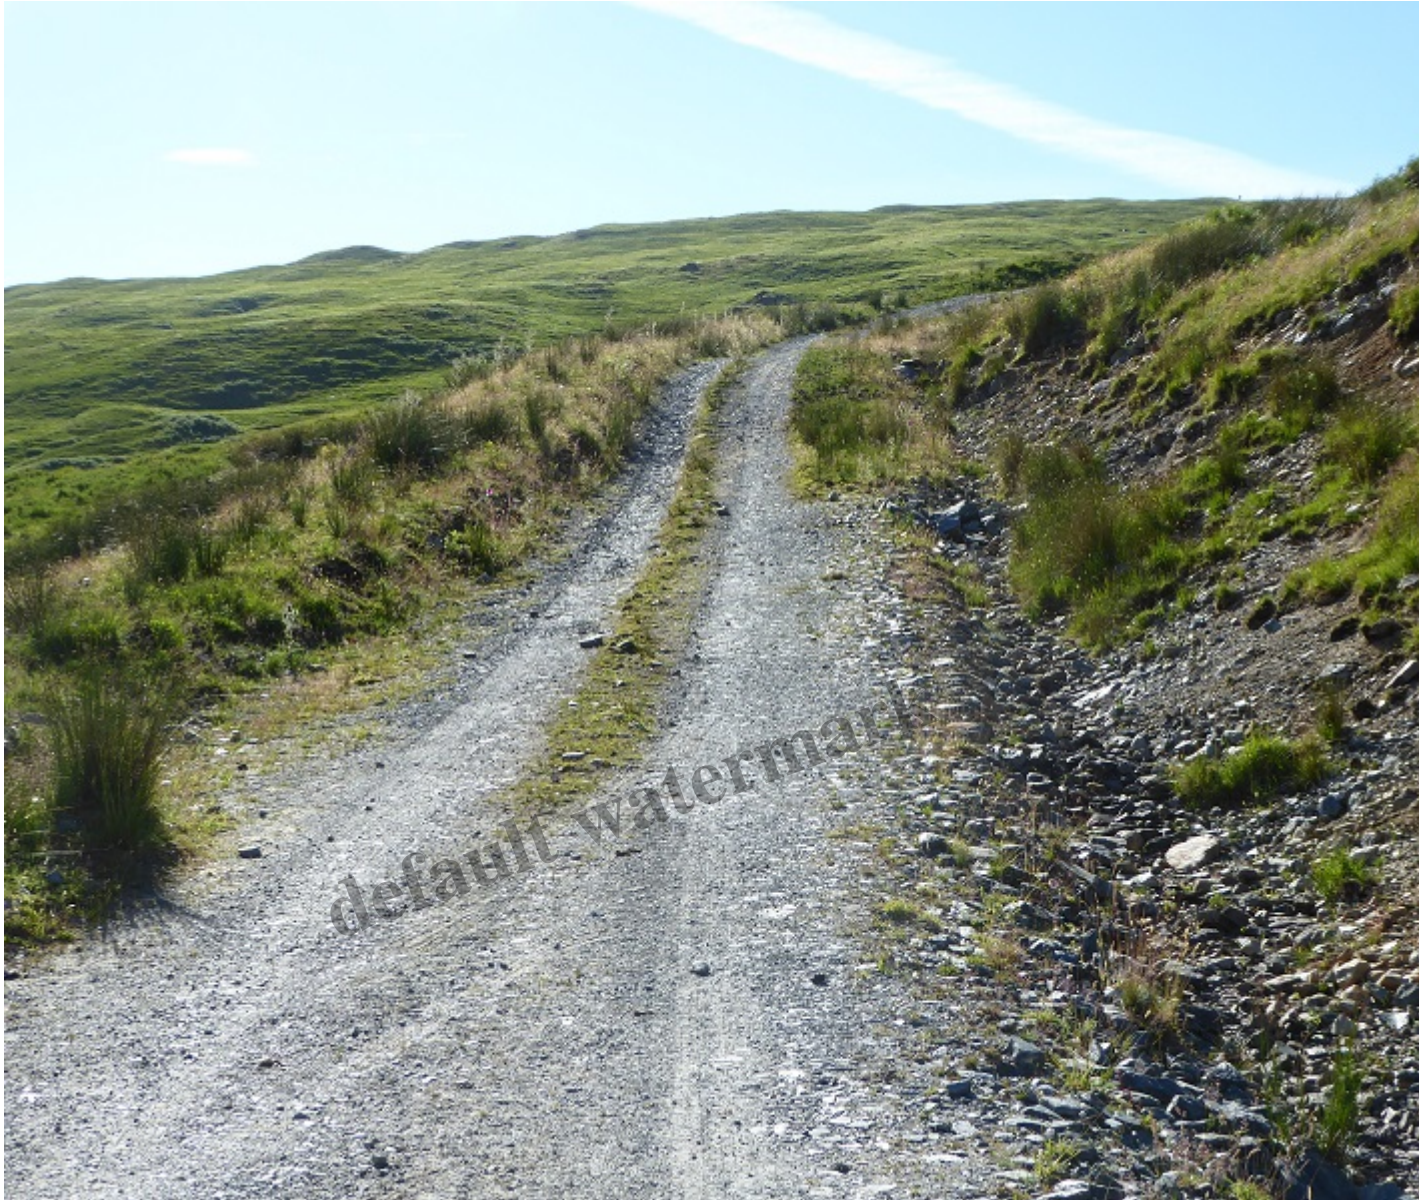
While there is an intermittent line of vegetation running down the middle of the track, as required by guidance, restoration of banks has been far more problematic (this on lower section of track as it sta

The impact of the track has been increased by a problem the Planning Officer identified, the way the track has been cut into the hillside,

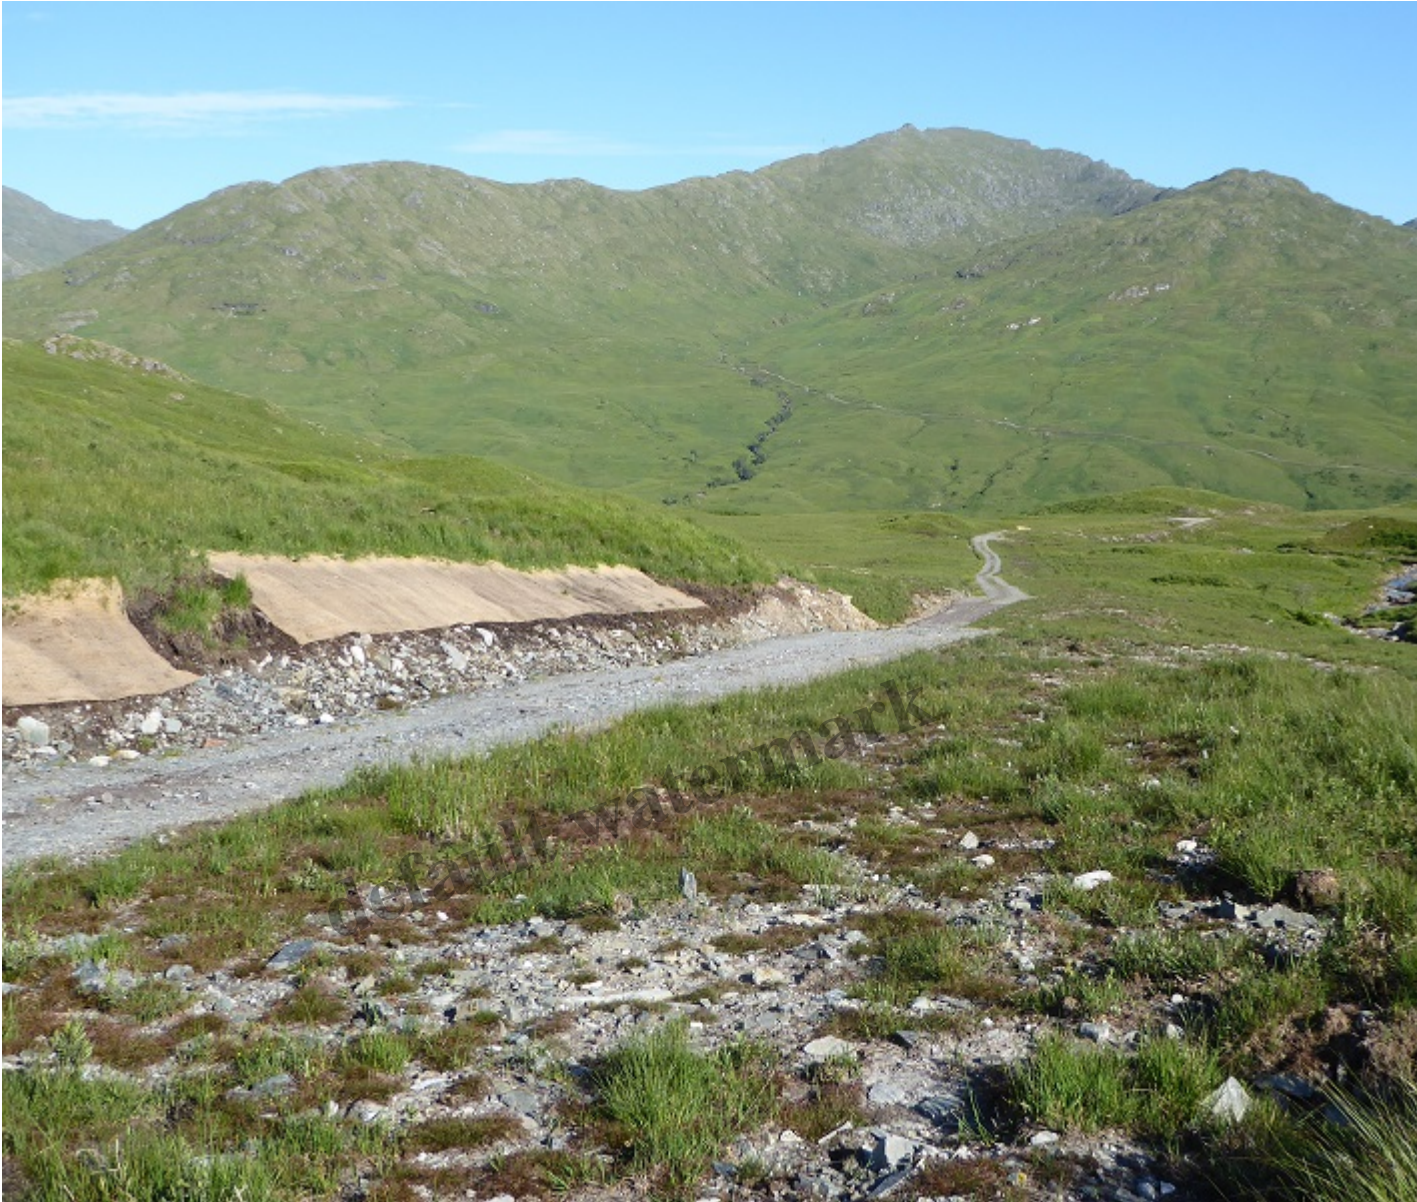
Matting is now being to restore some of the damage. The bare ground in foreground consists of matting in to construct the track.

The original planning consent required that the track would be removed and the landscape returned to its original form. That has now been abandoned and the impact of the track has been accentuated by the creation of steep banks and retention of flat areas next to the track (its far cheaper to simply try and cover up part of the aggregate used to construct the track than to remove or re-landscape it).

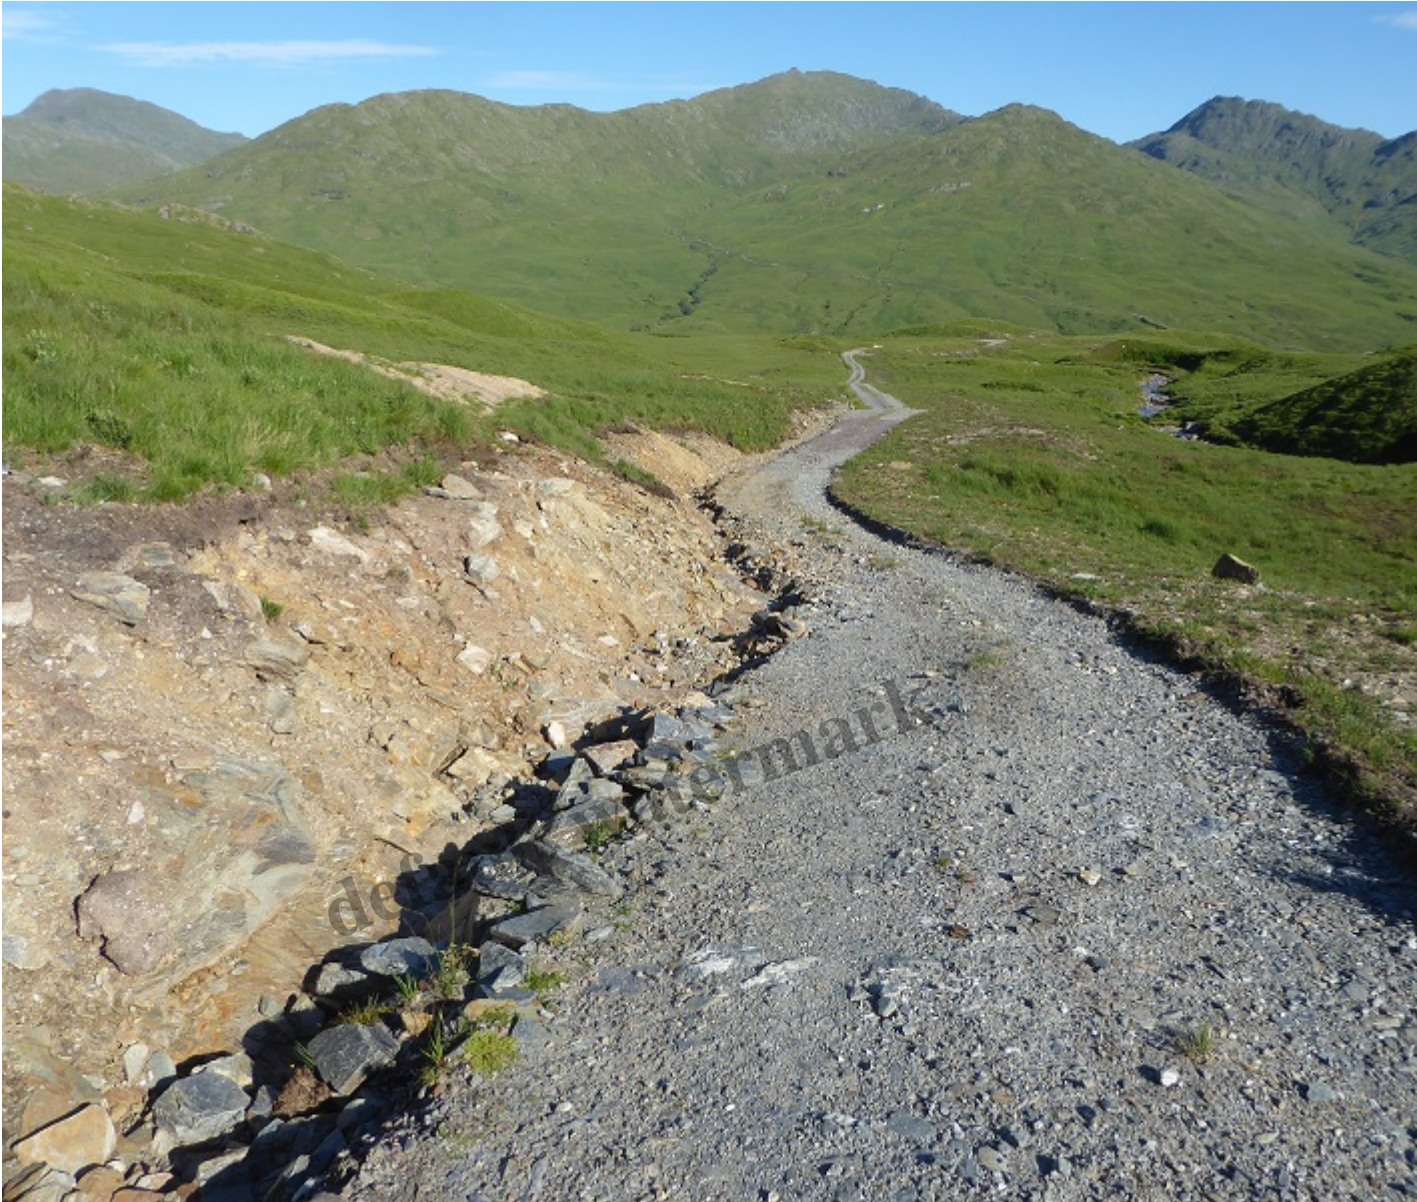
Photo taken from just below area of matting in photo above

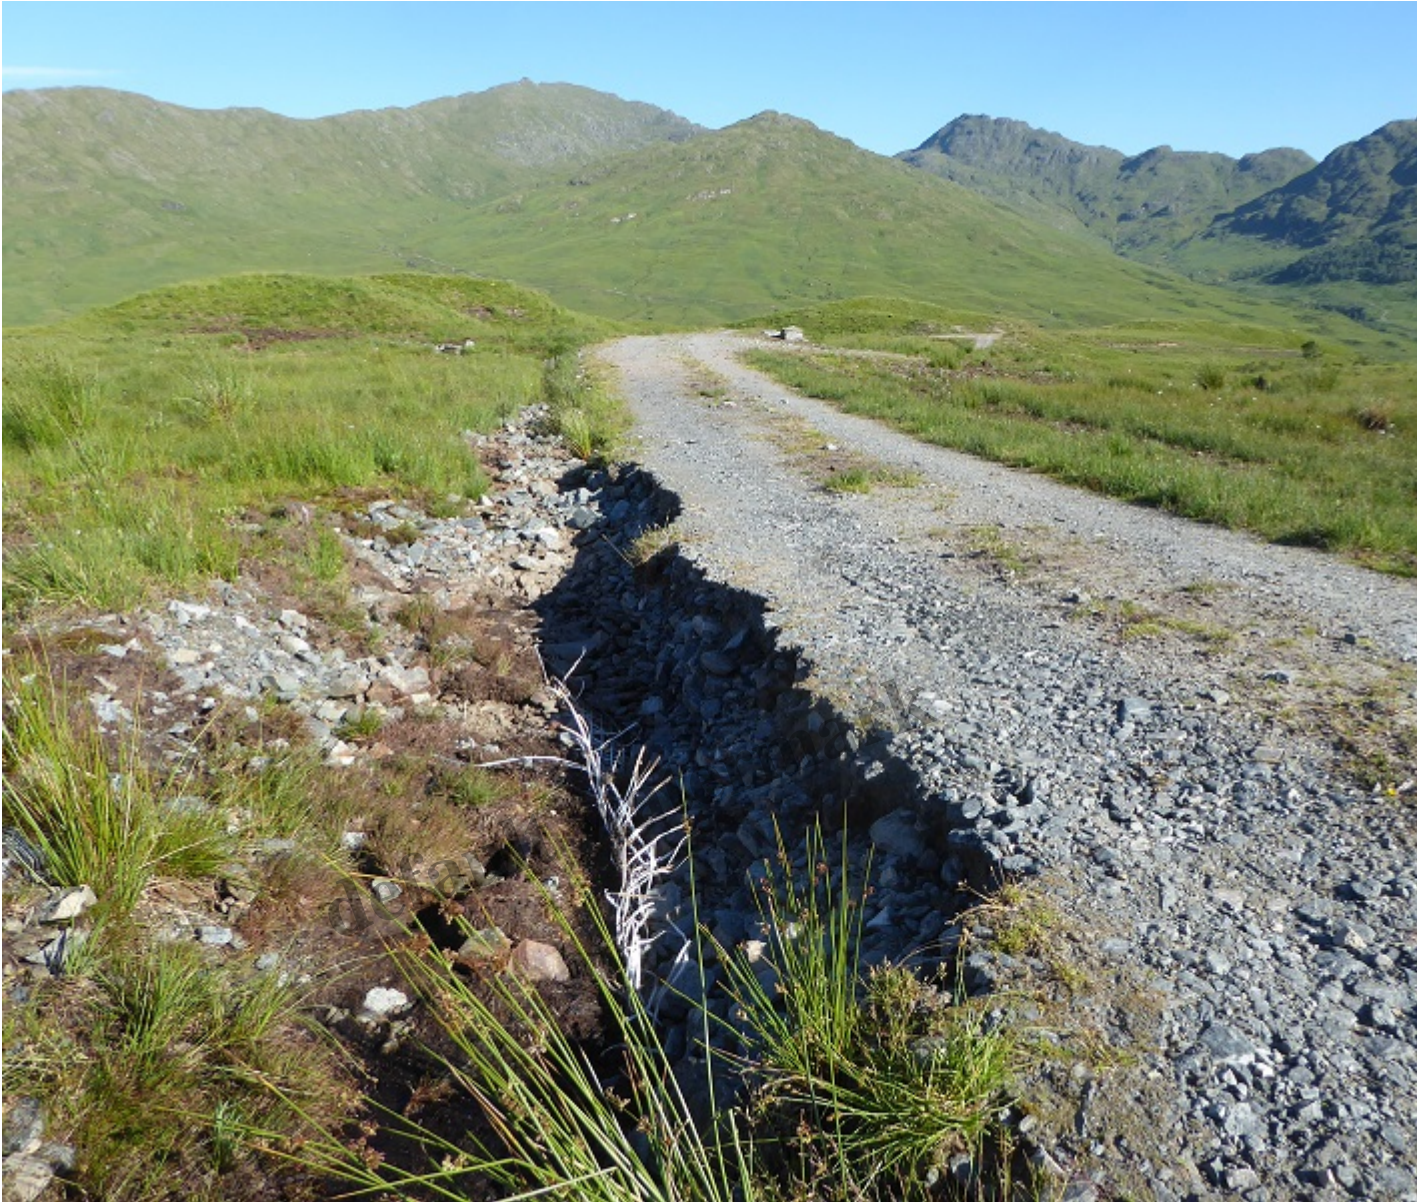
More erosion!

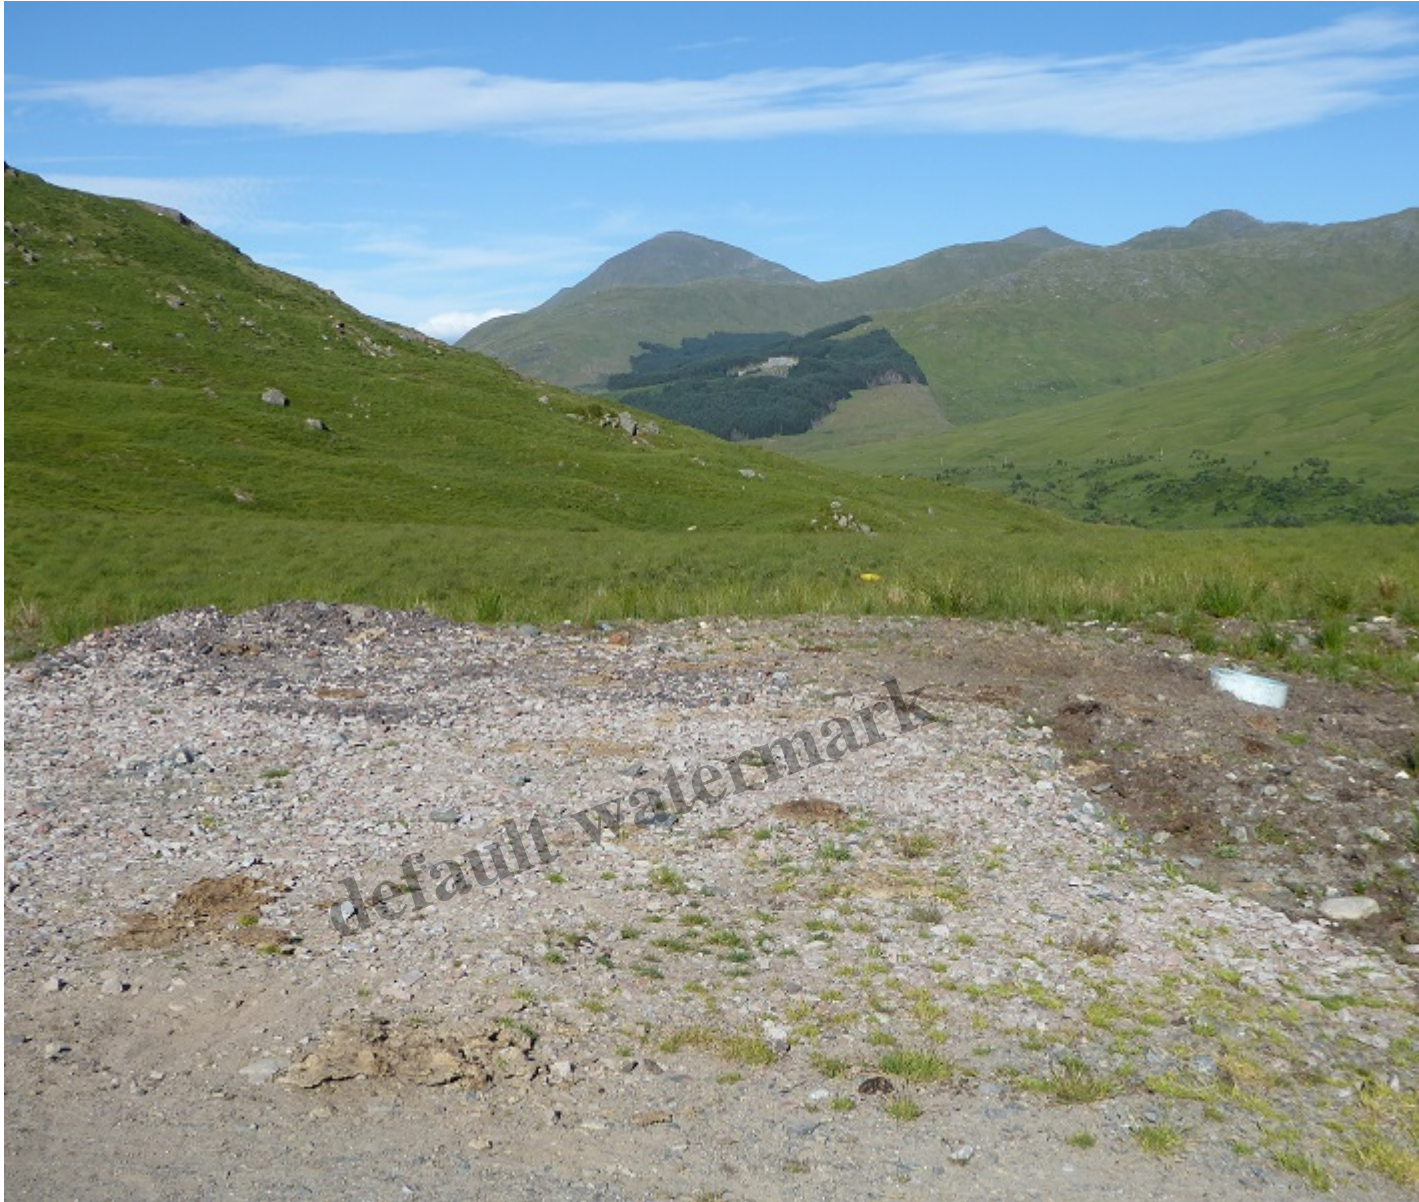
Upper section of track looking towards Ben More
