Glen Falloch – the destruction caused by the Eas Eonan hydro scheme

Birds eye view of central section of Eas Eonan scheme June 2018 showing the landscape impact of The line of the buried pipe has been accentuated by the dry weather.

early July. It forms part of the Derrydarroch Hydro Scheme.

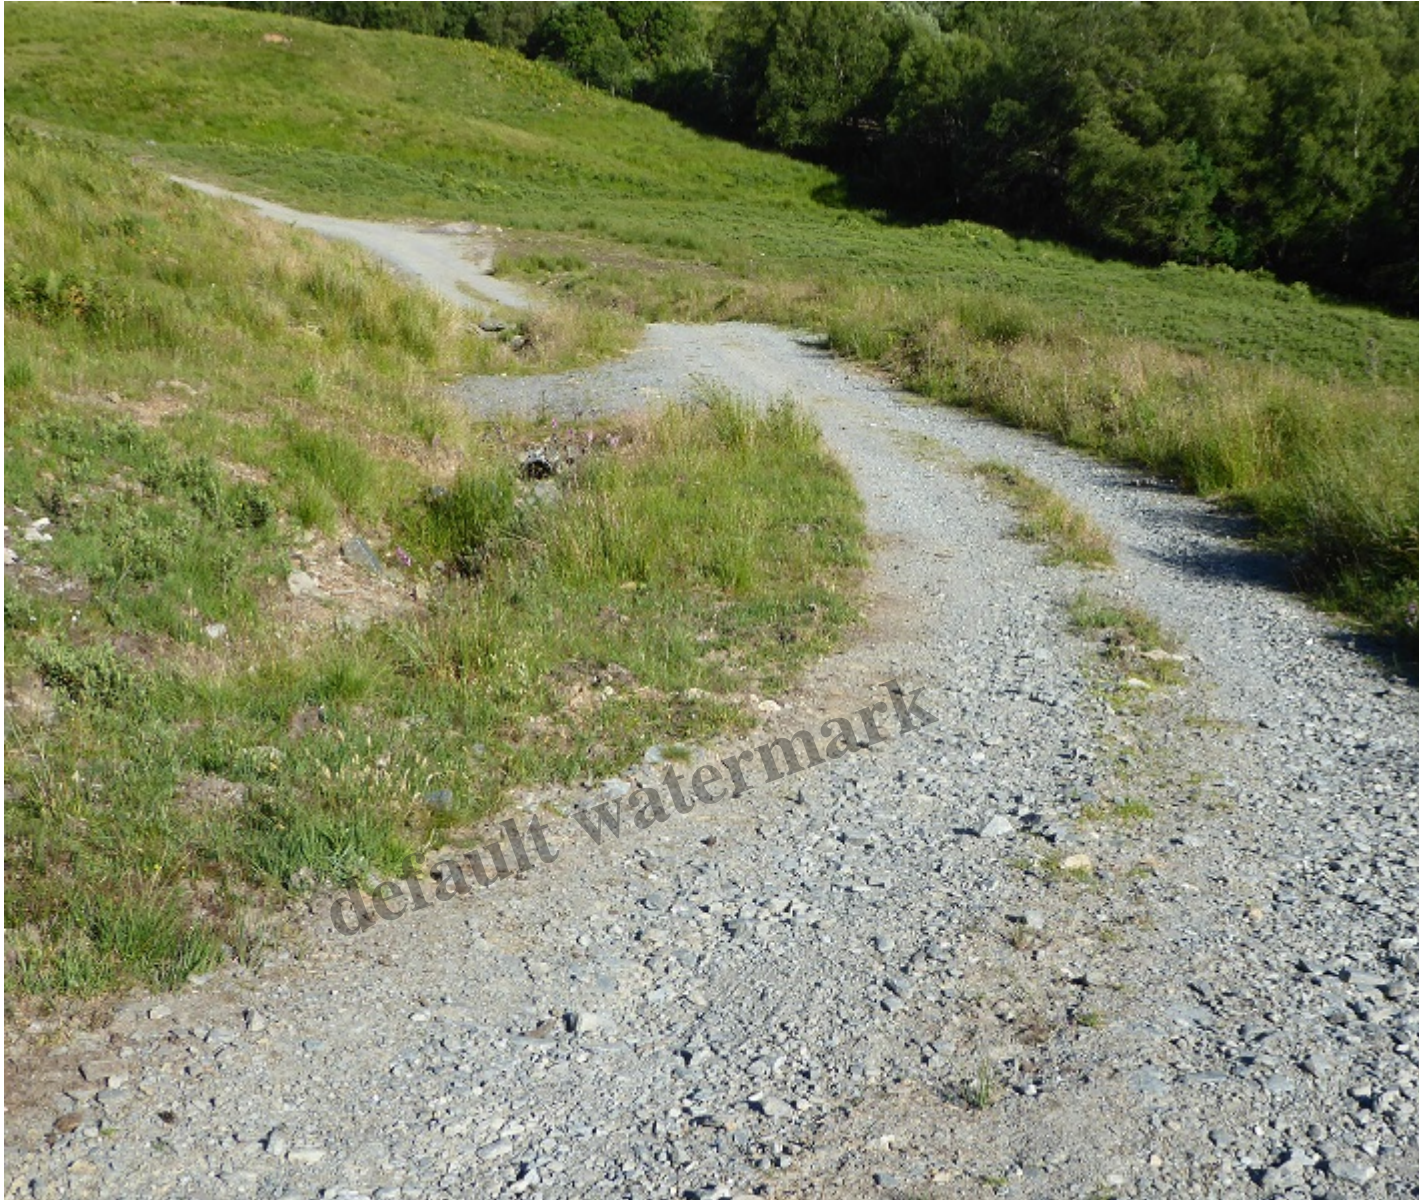
What is the justification for these passing places?

Until the Construction Method Statement is made public its not possible to tell whether the LLTNPA agreed to all these passing places or not. What is clear they increase the landscape impact of the track. They will also have made restoration cheaper. Indeed, one interesting question underlying the landscape impact of hydro schemes across Scotland is the increase in profits to landowners and developers that has resulted from planners allowing them first to cut out the cost of construction track removal and then cutting corners when it comes to restoration. Every time a developer has asked to keep a track the LLTNPA should have been asking them how much money they would save/be taken out of the area as a consequence.

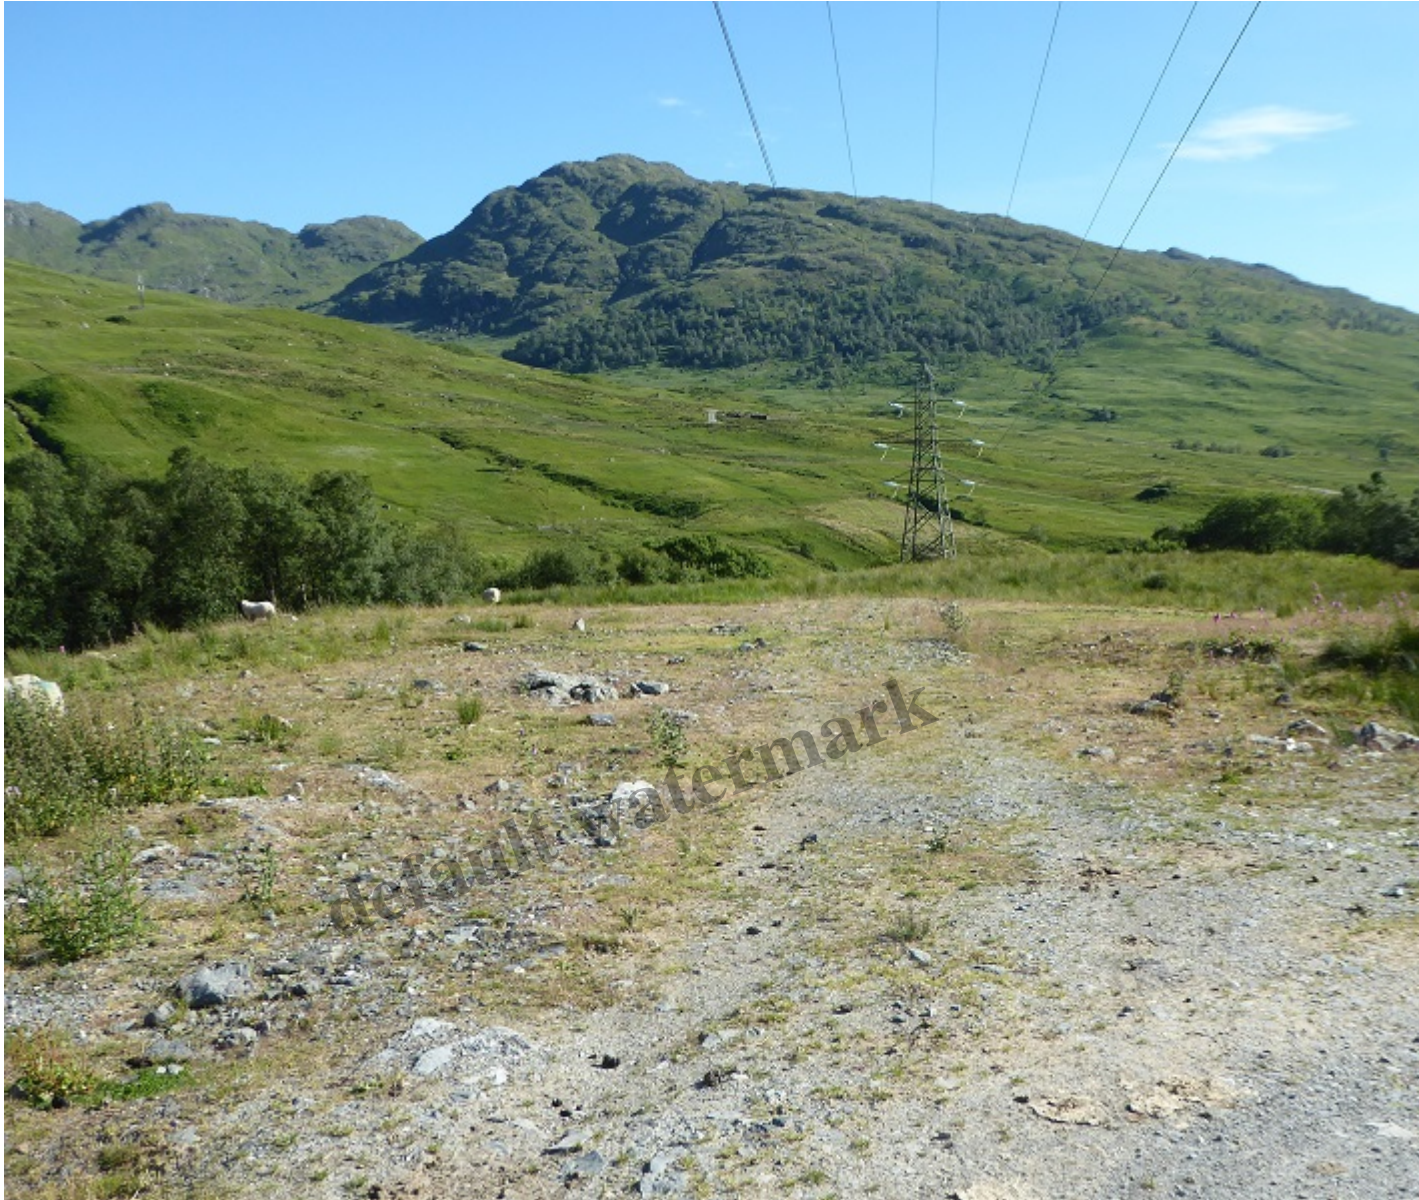
Another restoration failure, where the pipeline diverges from the track to follow the powerline across and River Falloch to the powerhouse.
