Glen Falloch – the destruction caused by the Eas Eonan hydro scheme

August 2, 2018

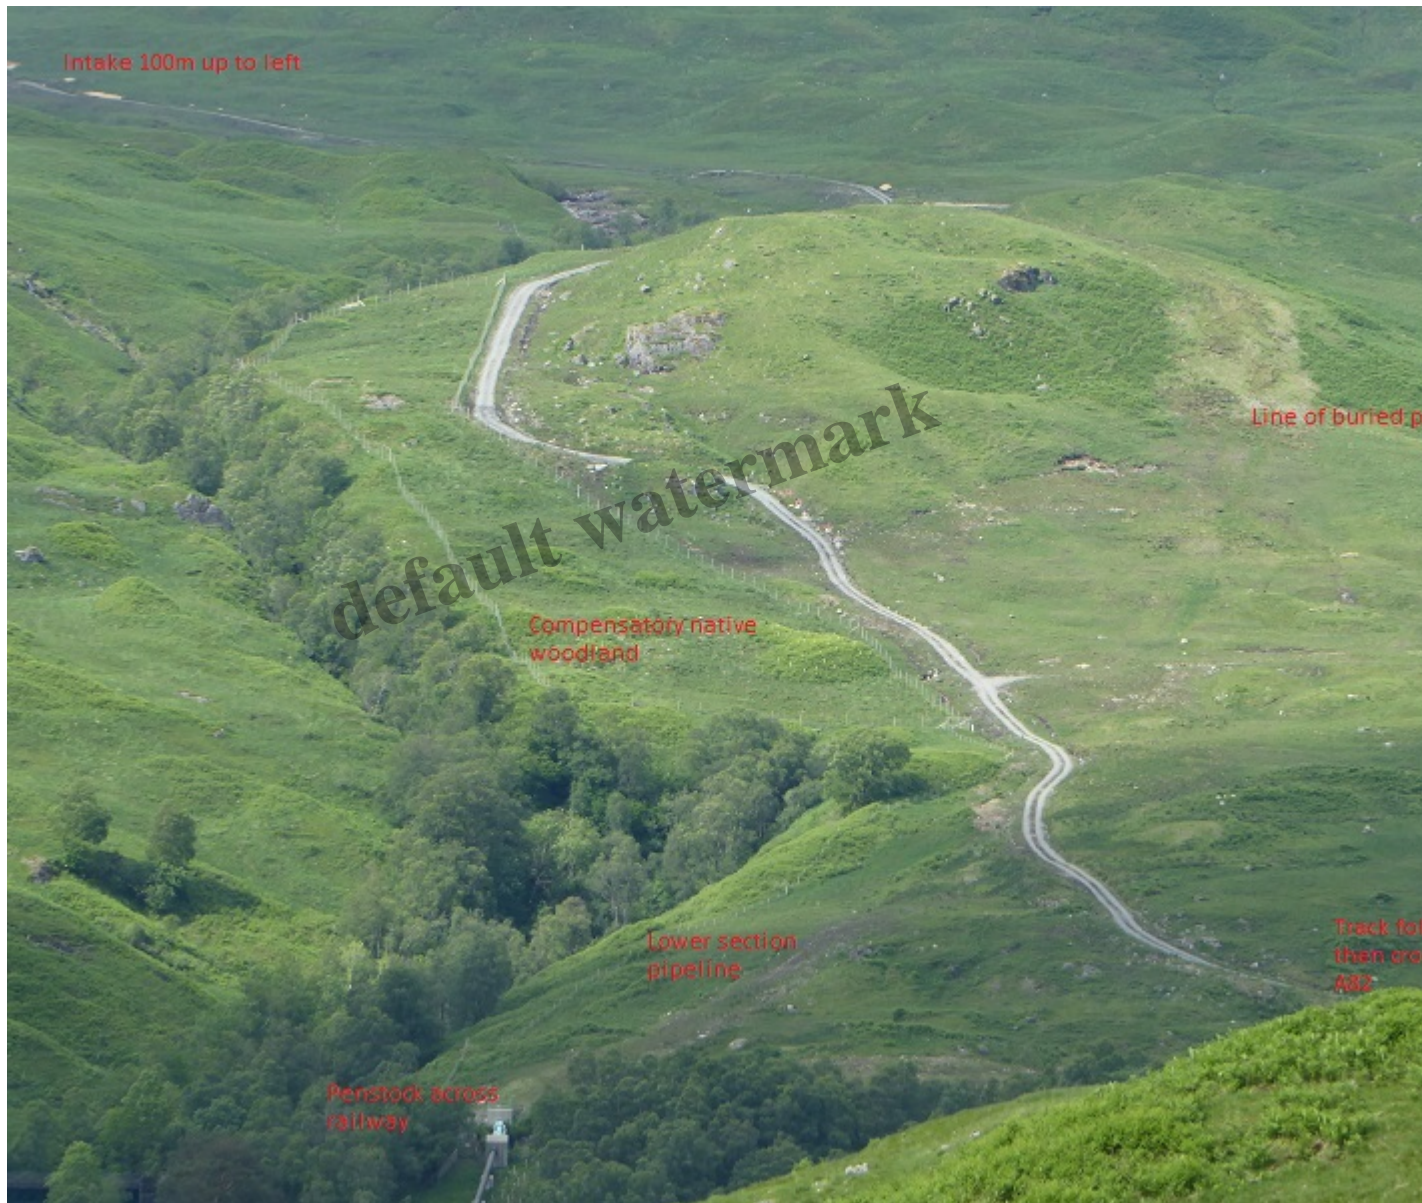
Birds eye view of central section of Eas Eonan scheme June 2018 showing the landscape impact of The line of the buried pipe has been accentuated by the dry weather.

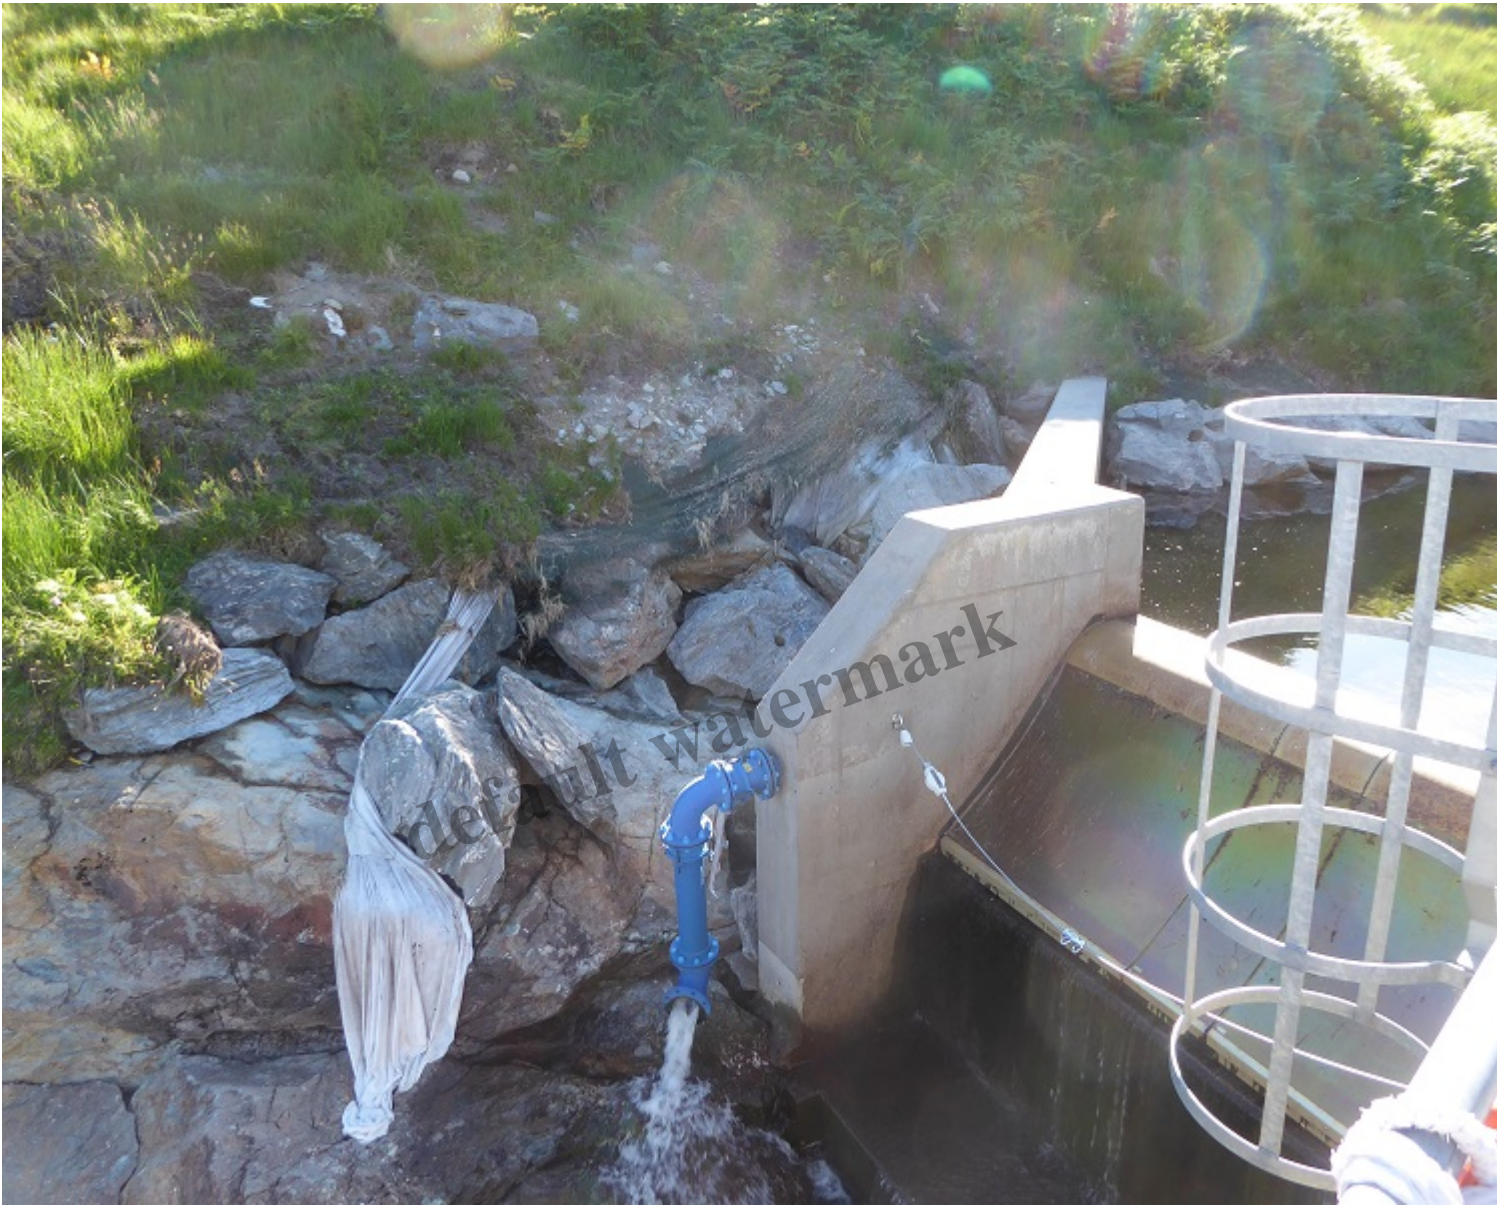
George Paton, a reader who formerly worked on hydro and other construction projects in the Highlands, informed me a couple of months ago that wooden railings, which are promoted as best practice in the LLTNPA renewables guidance, don't meet health and safety requirements. That probably explains why wooden railings are only seen on the smallest intakes. However, instead of ignoring the challenges created by Health and Safety, why isn't the LLTNPA working with engineers to find other solutions and then revising its policy? Would not a stone wall and stone facing of the outer dam walls, with material taken from some of the stone spoil littering the edge of the scheme not help Eas Eonan intake blend better into the landscape?

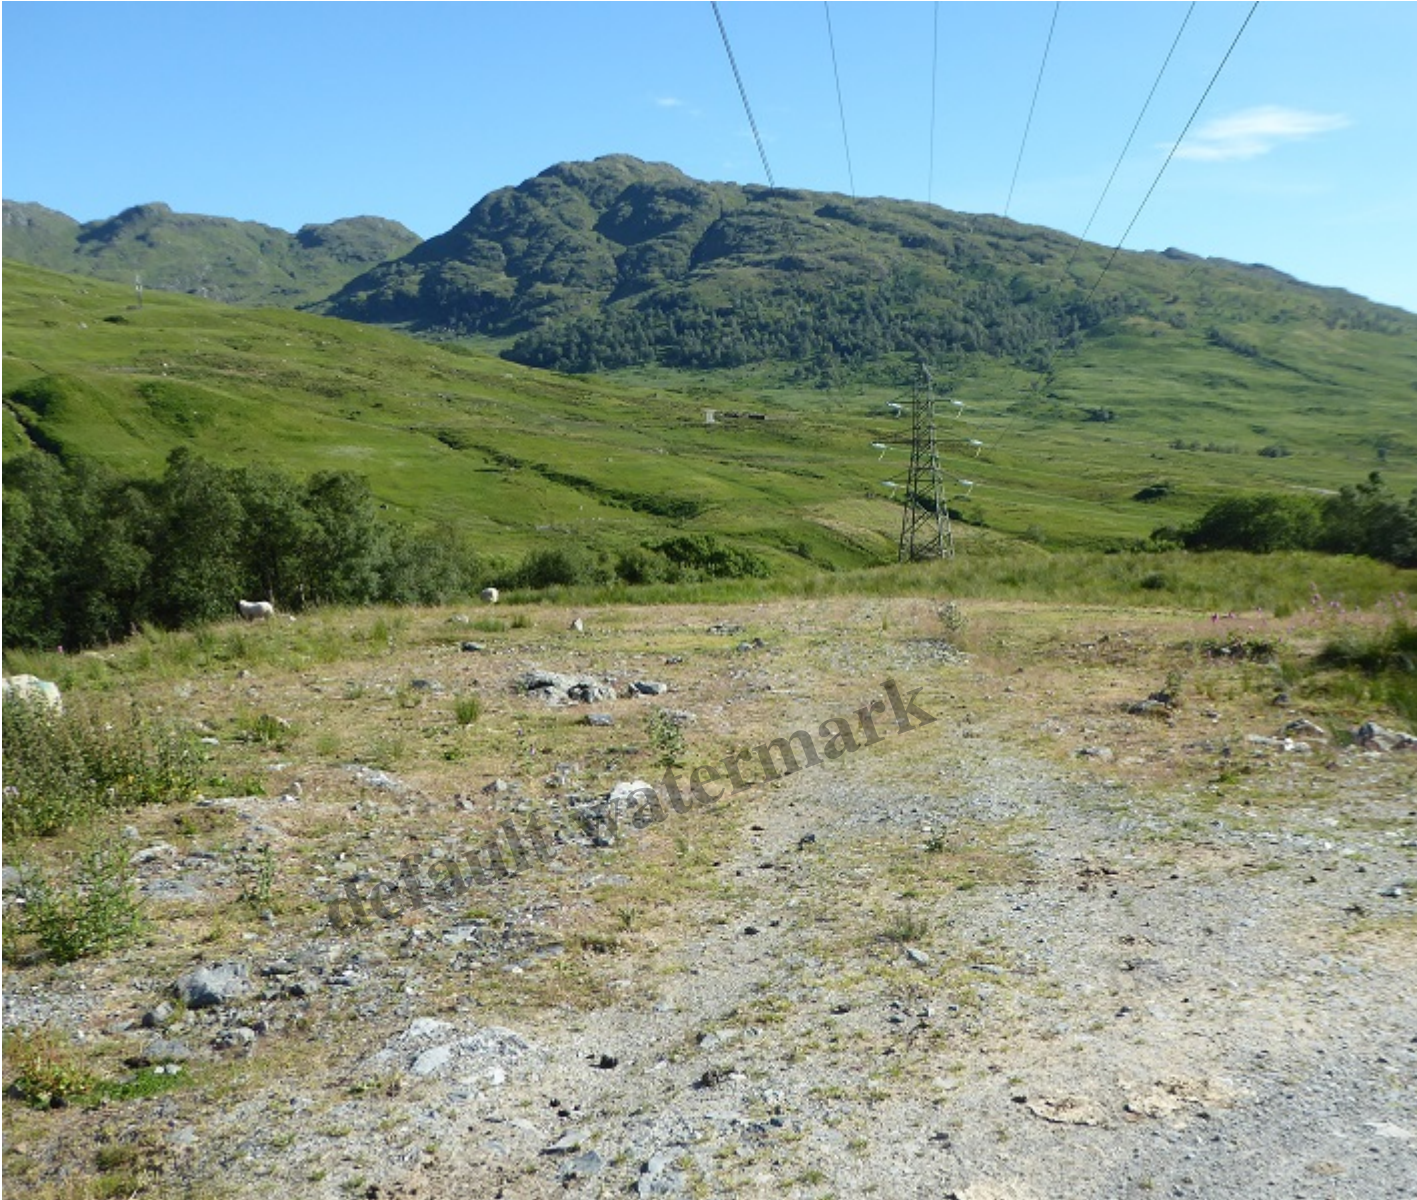
Another restoration failure, where the pipeline diverges from the track to follow the powerline across and River Falloch to the powerhouse.
