Glen Falloch – the destruction caused by the Eas Eonan hydro scheme

August 2, 2018

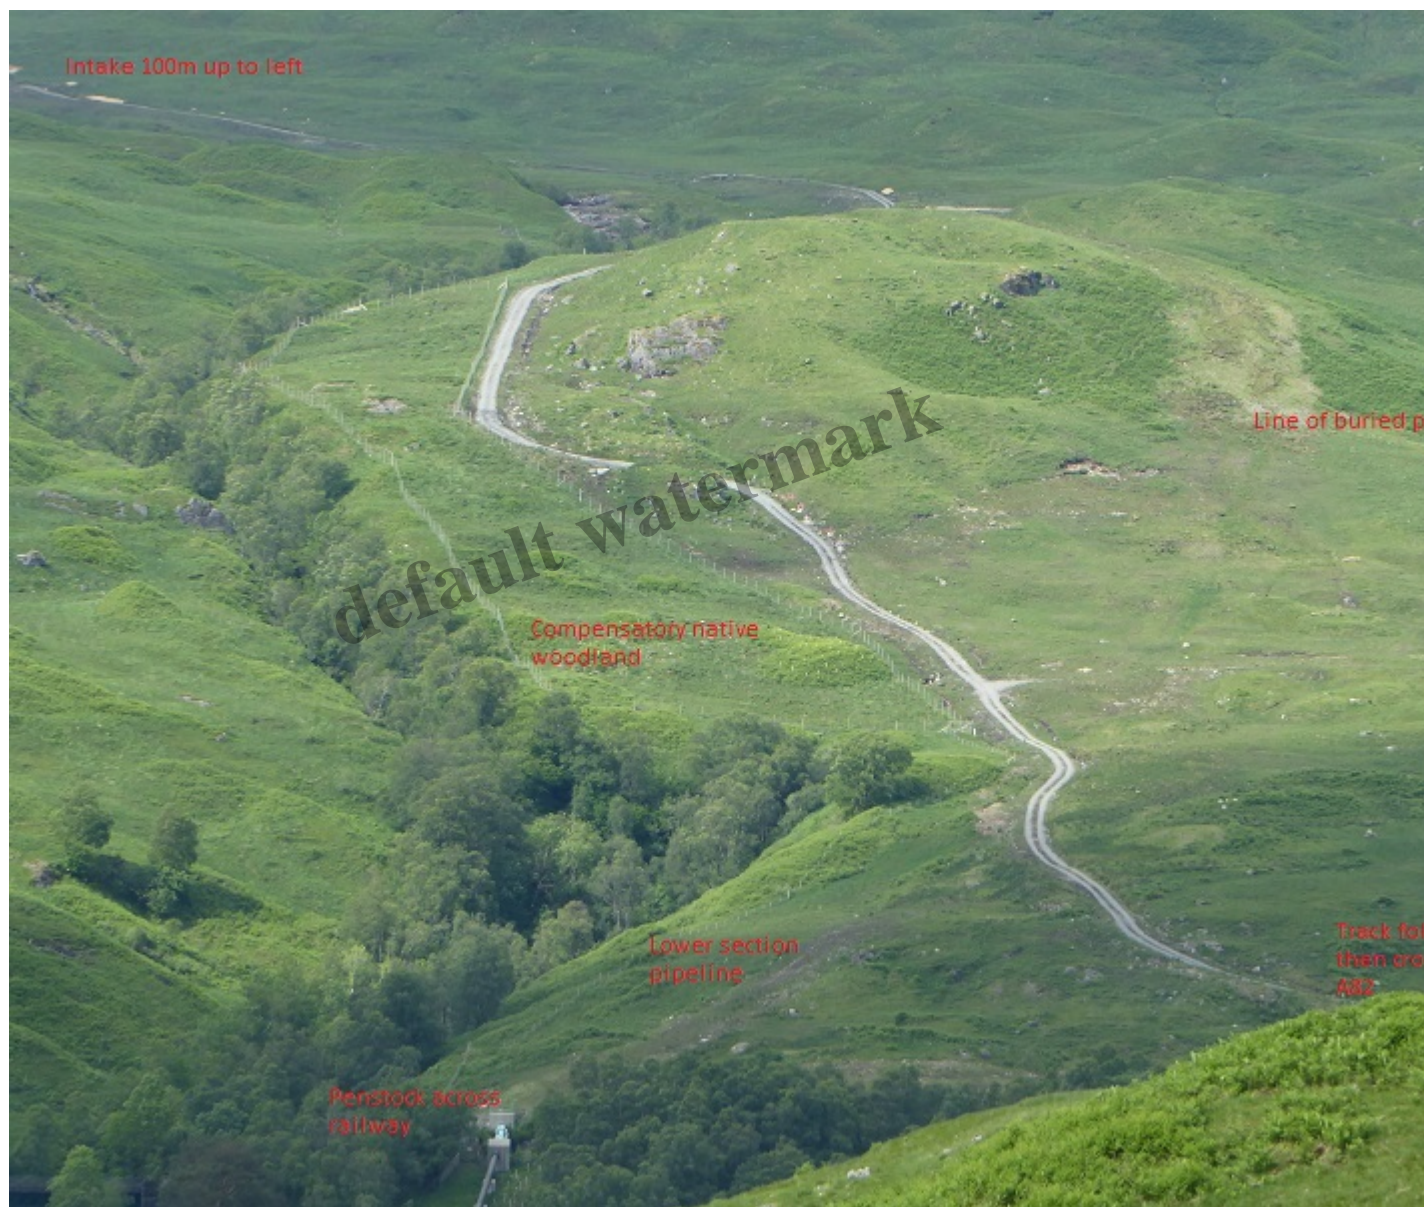
Birds eye view of central section of Eas Eonan scheme June 2018 showing the landscape impact of The line of the buried pipe has been accentuated by the dry weather.

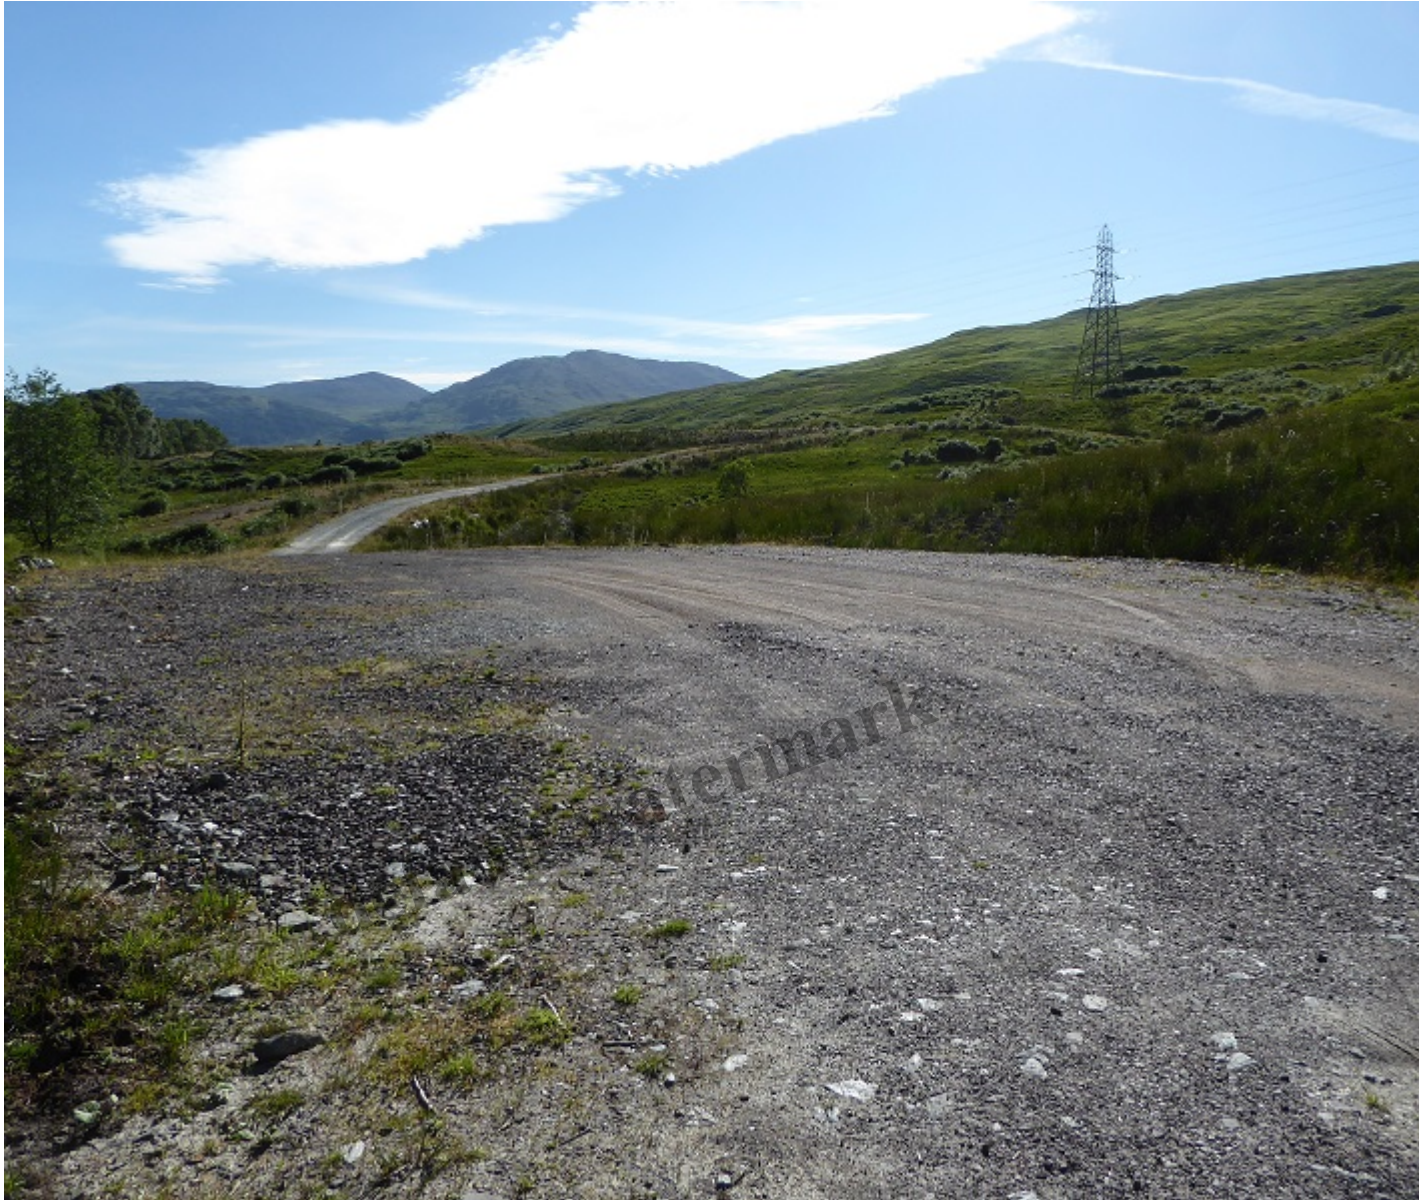
The start of the Eas Eonan track. There had been a short section of track from the A82 up to about t previously. The large working area appears to have been created for the hydro construction and not

At the Eas Eonan the main landscape issues relating to the original consent relate to laydown areas used for construction (see photo above) and the intake.

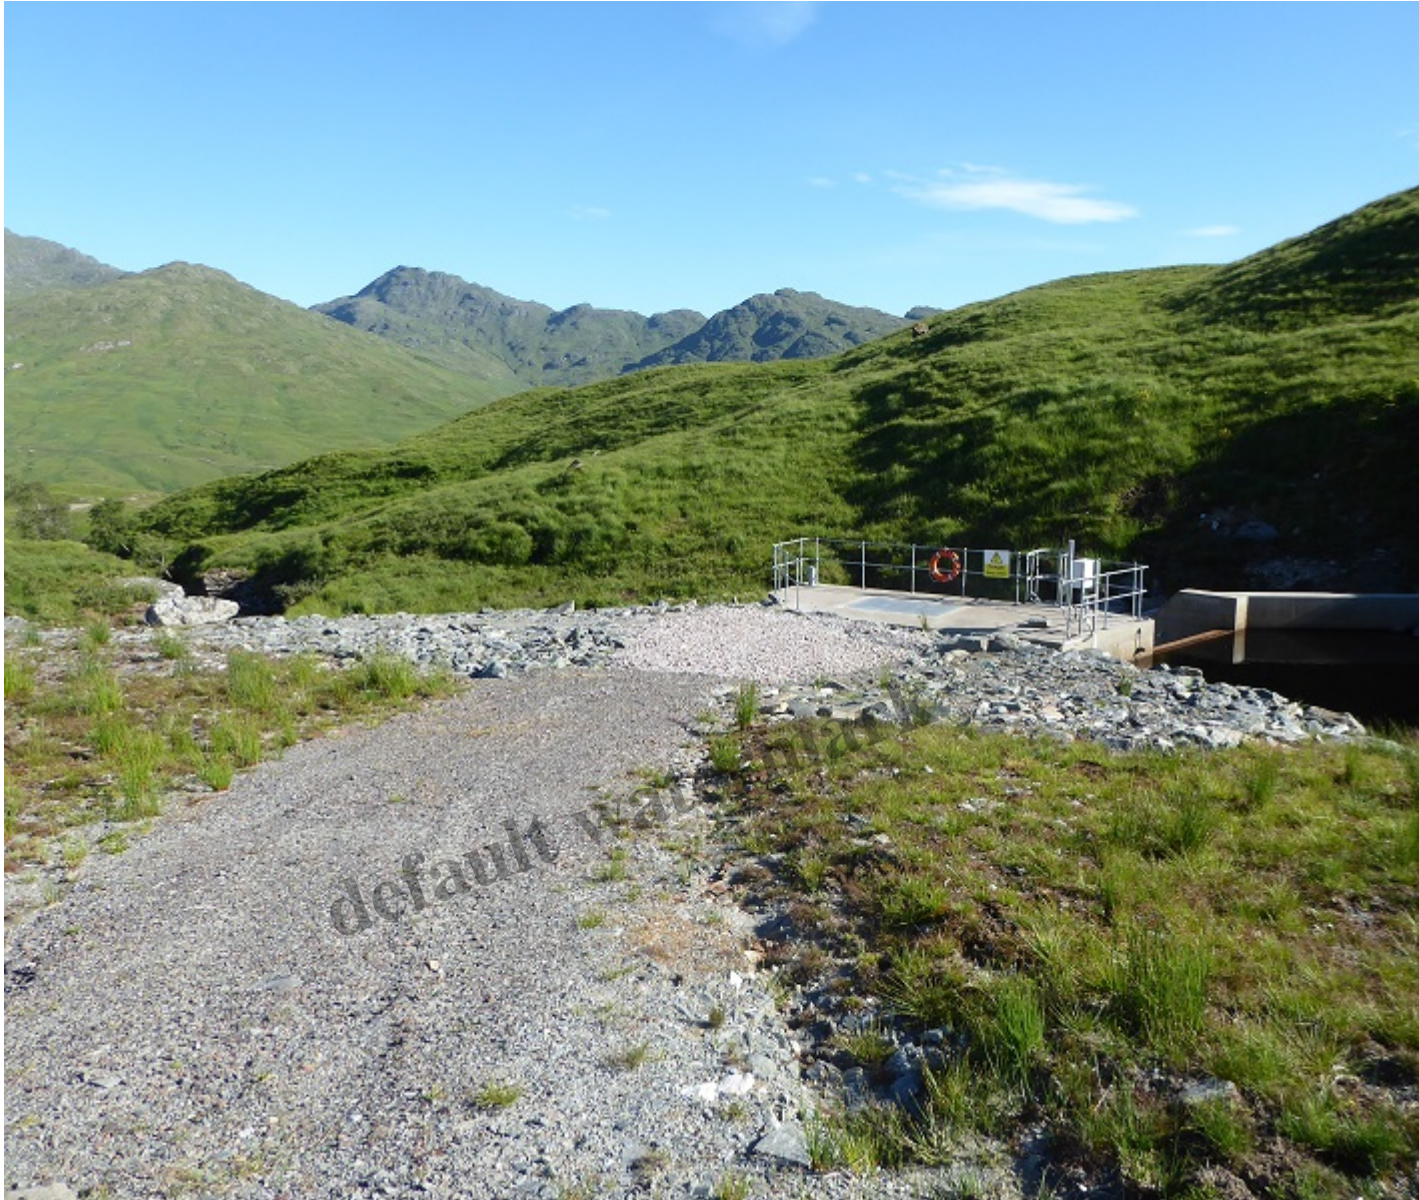
The location of the intake is quite concealed but the landscape impact has been considerably increased by the rip rap bouldering visible on either side of the track which has been treated as hardstanding for vehicles.

And why isn't the LLTNPA conducting a public debate with civil engineers on how they could avoid the adverse impacts of rip rap bouldering which turn what could be quite attractive pools into ugly scars?

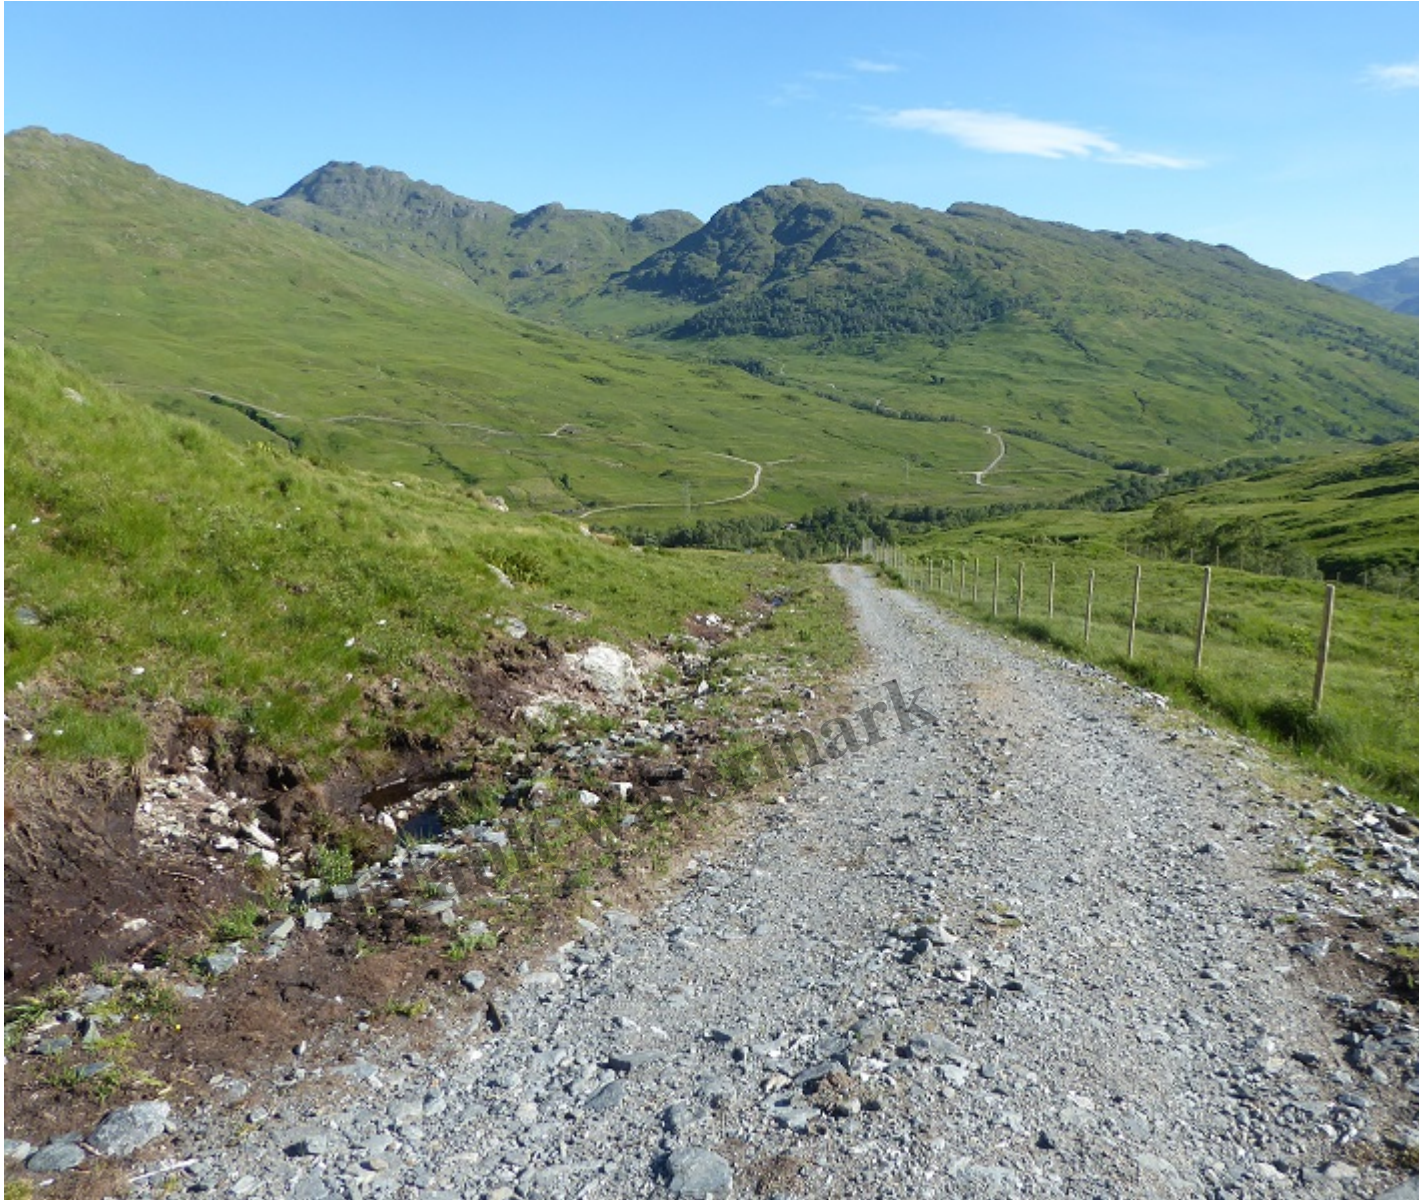
View of Derrydarroch access tracks, Allt Andoran on left, Allt a Chuillin on right, with lower section of track left middle ground. Photo taken from just above steepest section of track from one of many unmarked sections of ground now used for “estate management” purposes.

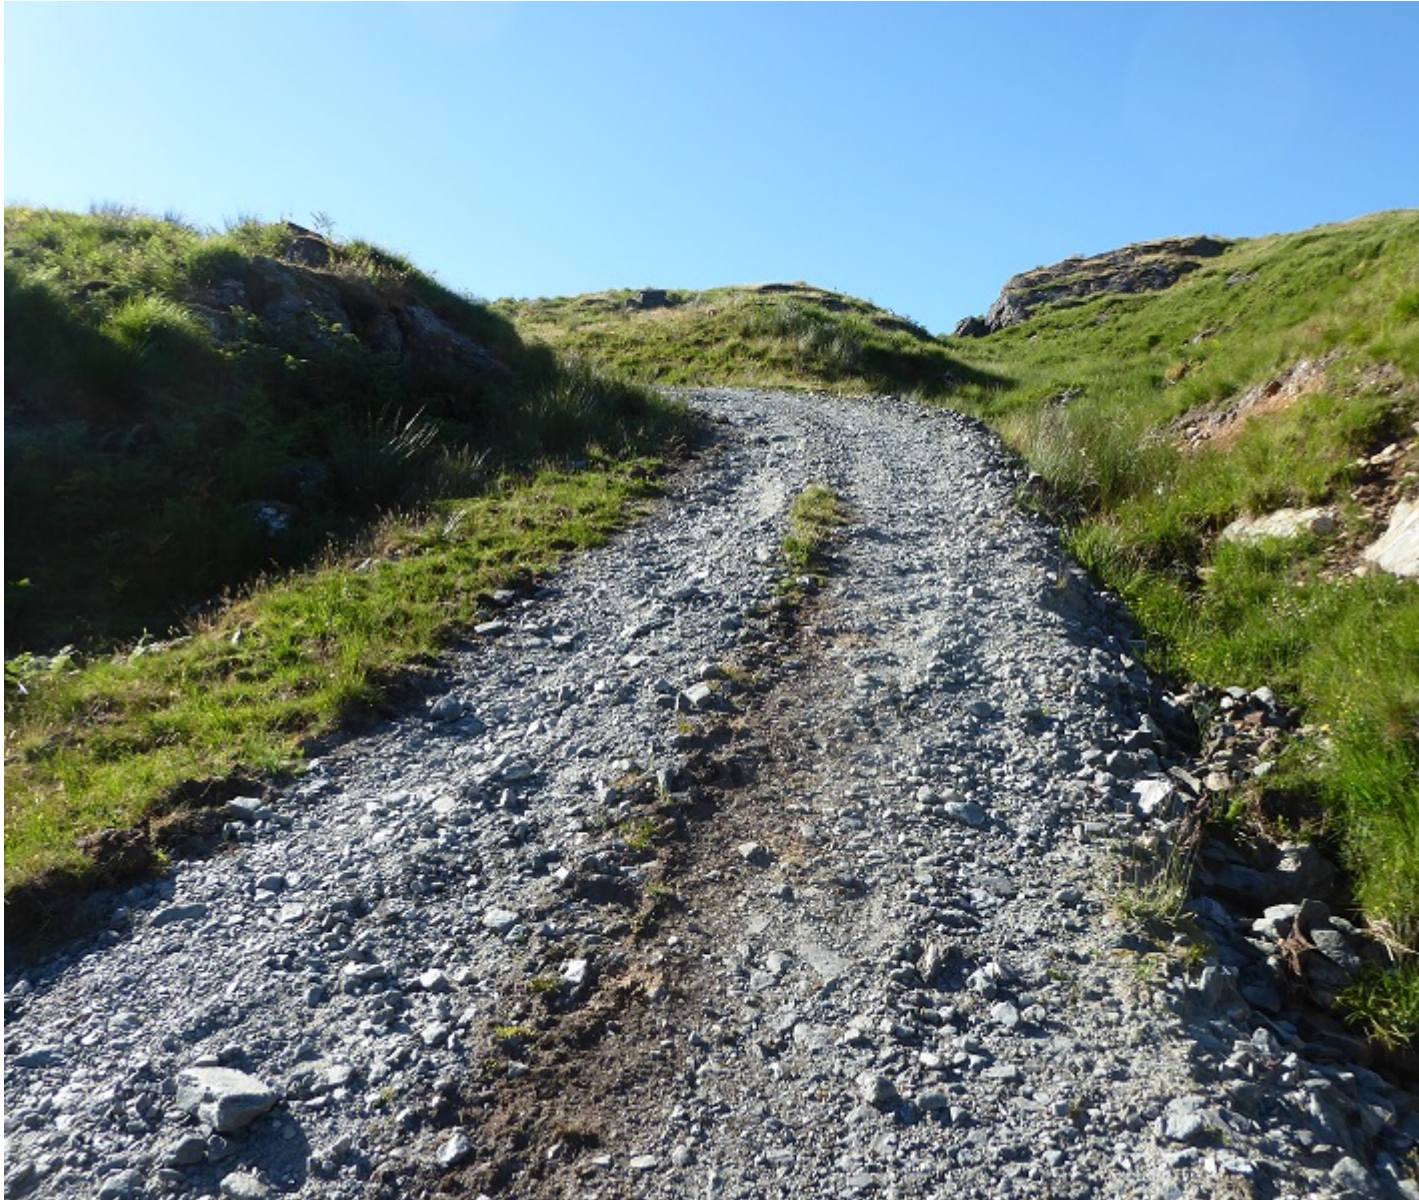
The steep constrained section of track referred to in the planning report is already subject to serious SNH Guidance is that no tracks should be steeper than 14 degrees but unfortunately the LLTNPA has required landowners to meet this standard and is as a consequence storing up problems which are predictable.

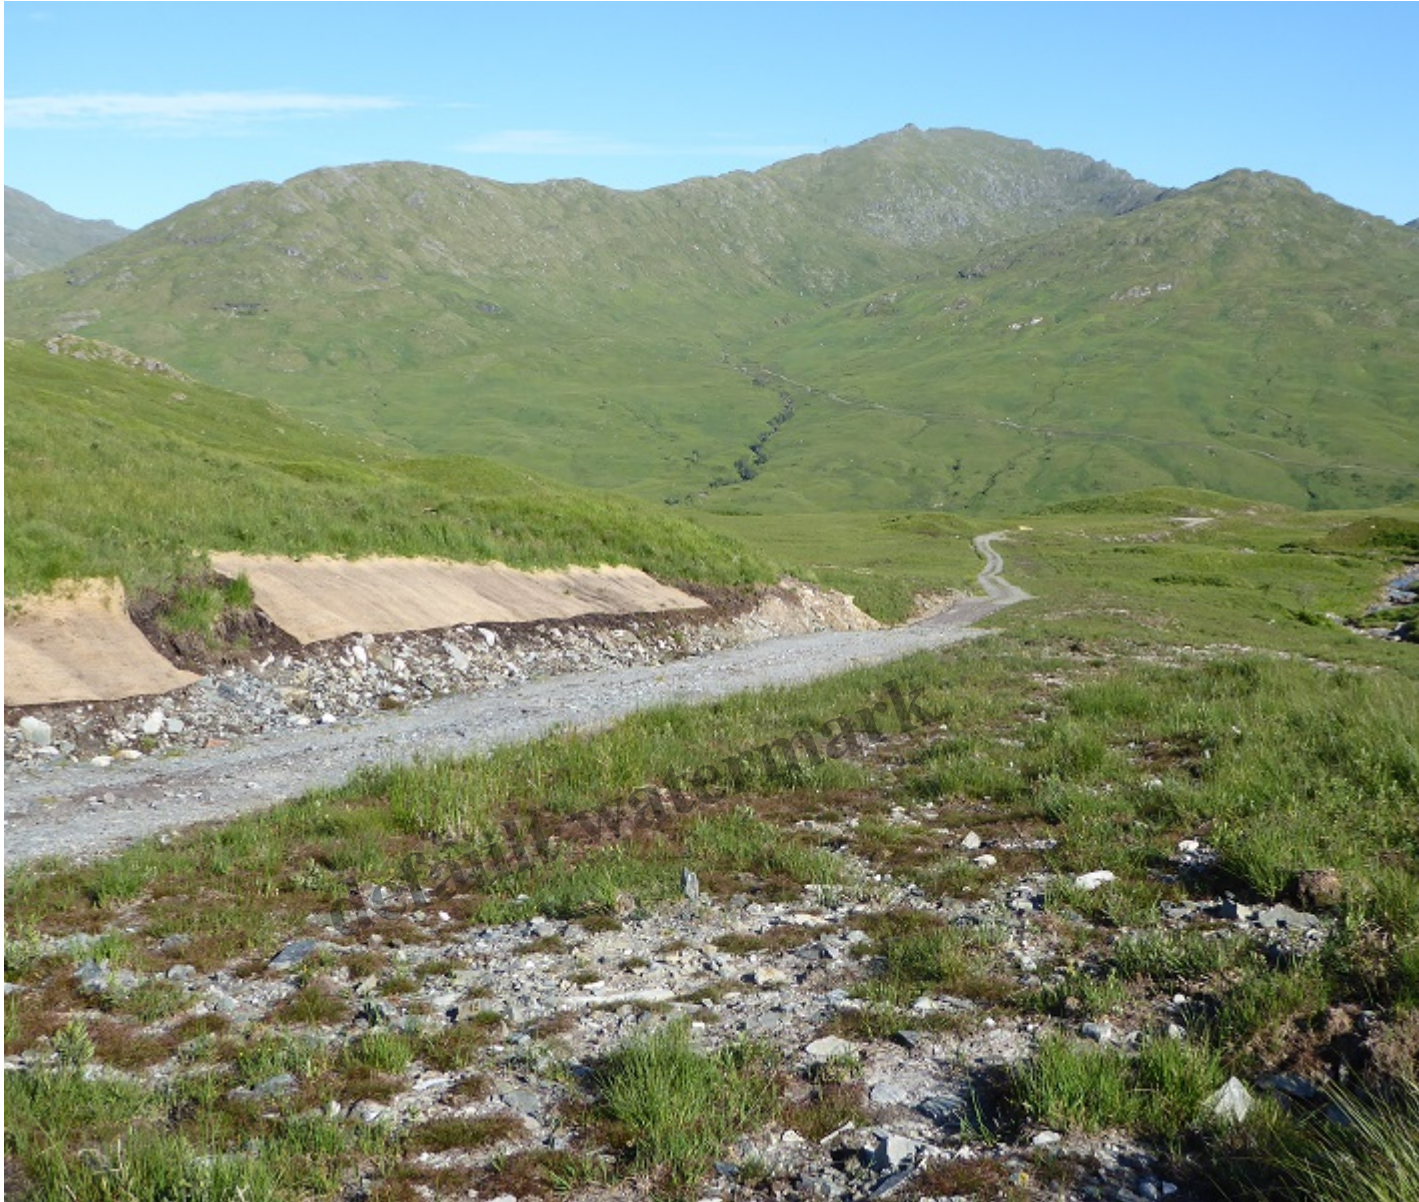
Matting is now being to restore some of the damage. The bare ground in foreground consists of matting in to construct the track.

The original planning consent required that the track would be removed and the landscape returned to its original form. That has now been abandoned and the impact of the track has been accentuated by the creation of steep banks and retention of flat areas next to the track (its far cheaper to simply try and cover up part of the aggregate used to construct the track than to remove or re-landscape it).

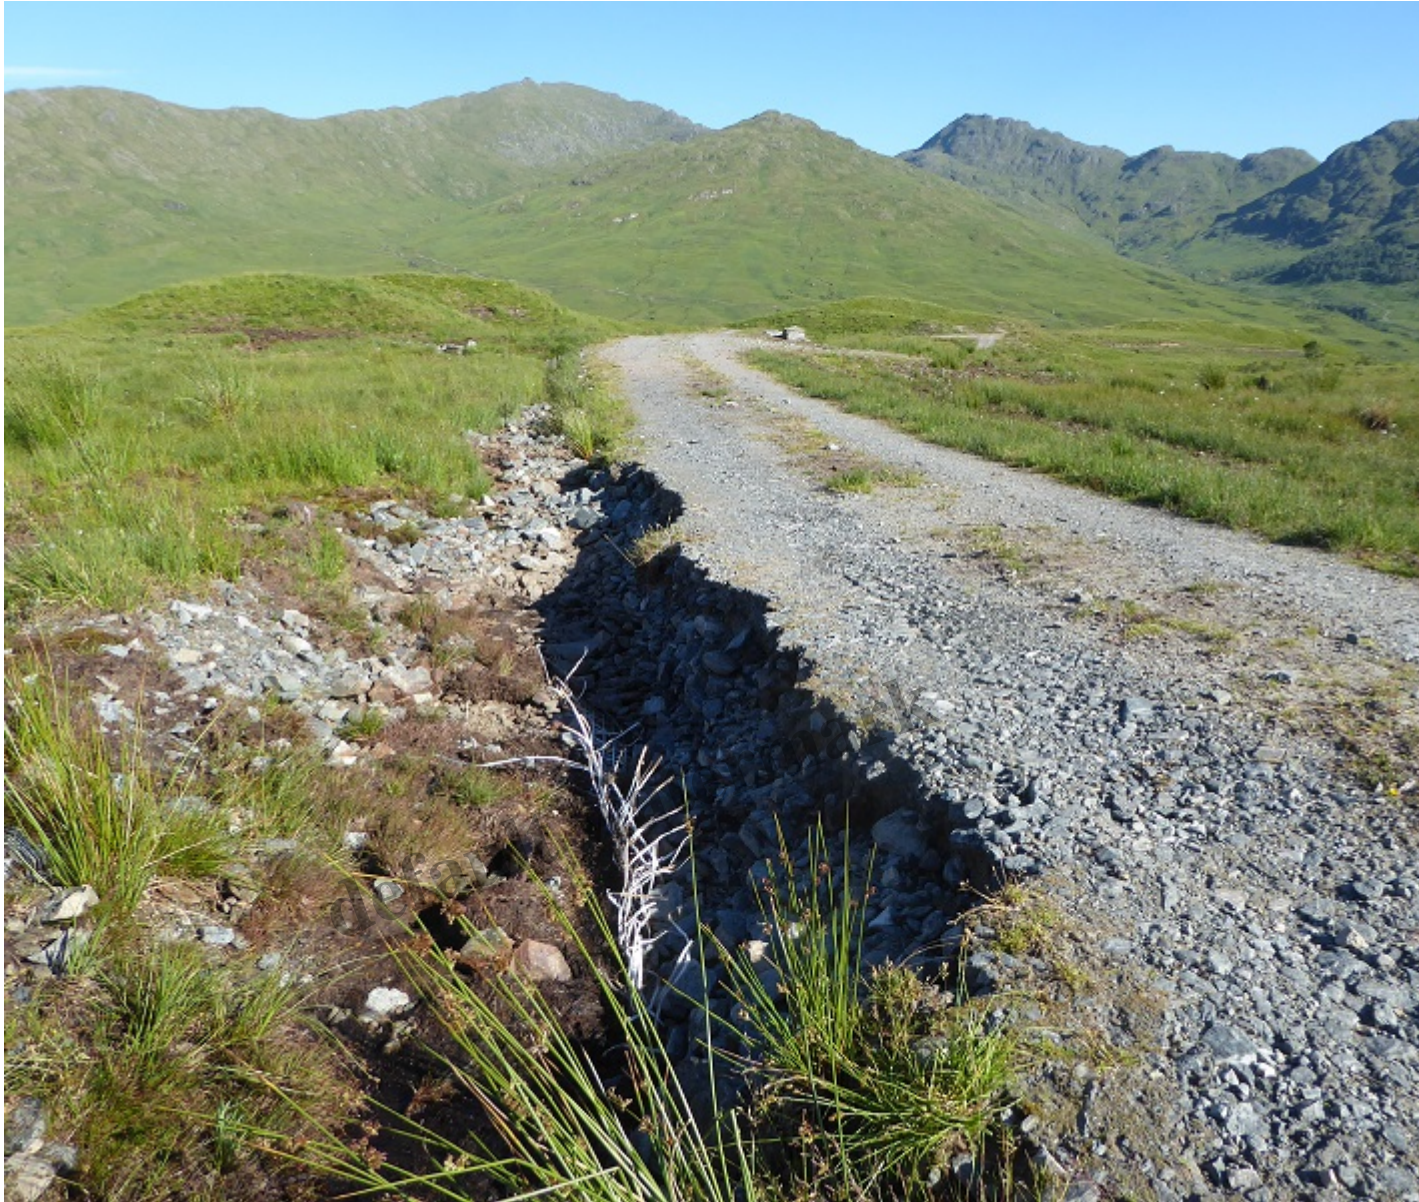
More erosion!

What is this if not a long drainage ditch?

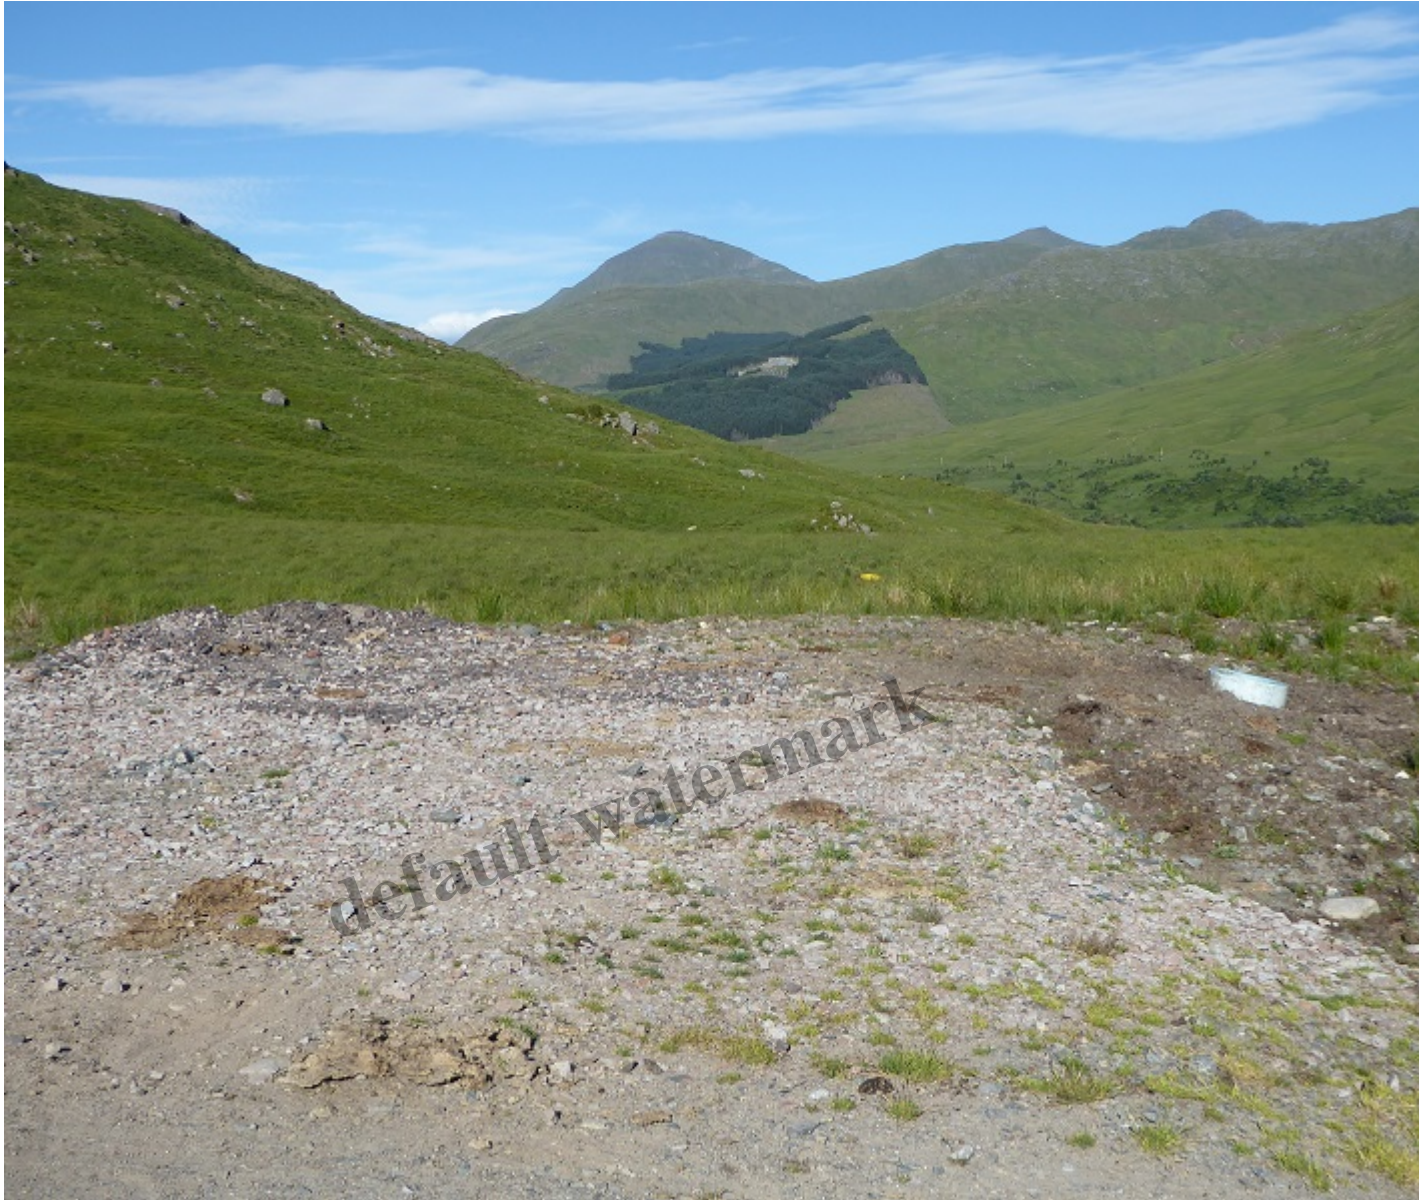
Upper section of track looking towards Ben More

And everywhere you look parking bays/areas of unrestored track:
