The Keltie Water hydro scheme and Scottish quality awards for planning

Background to the Keltie Water hydro scheme

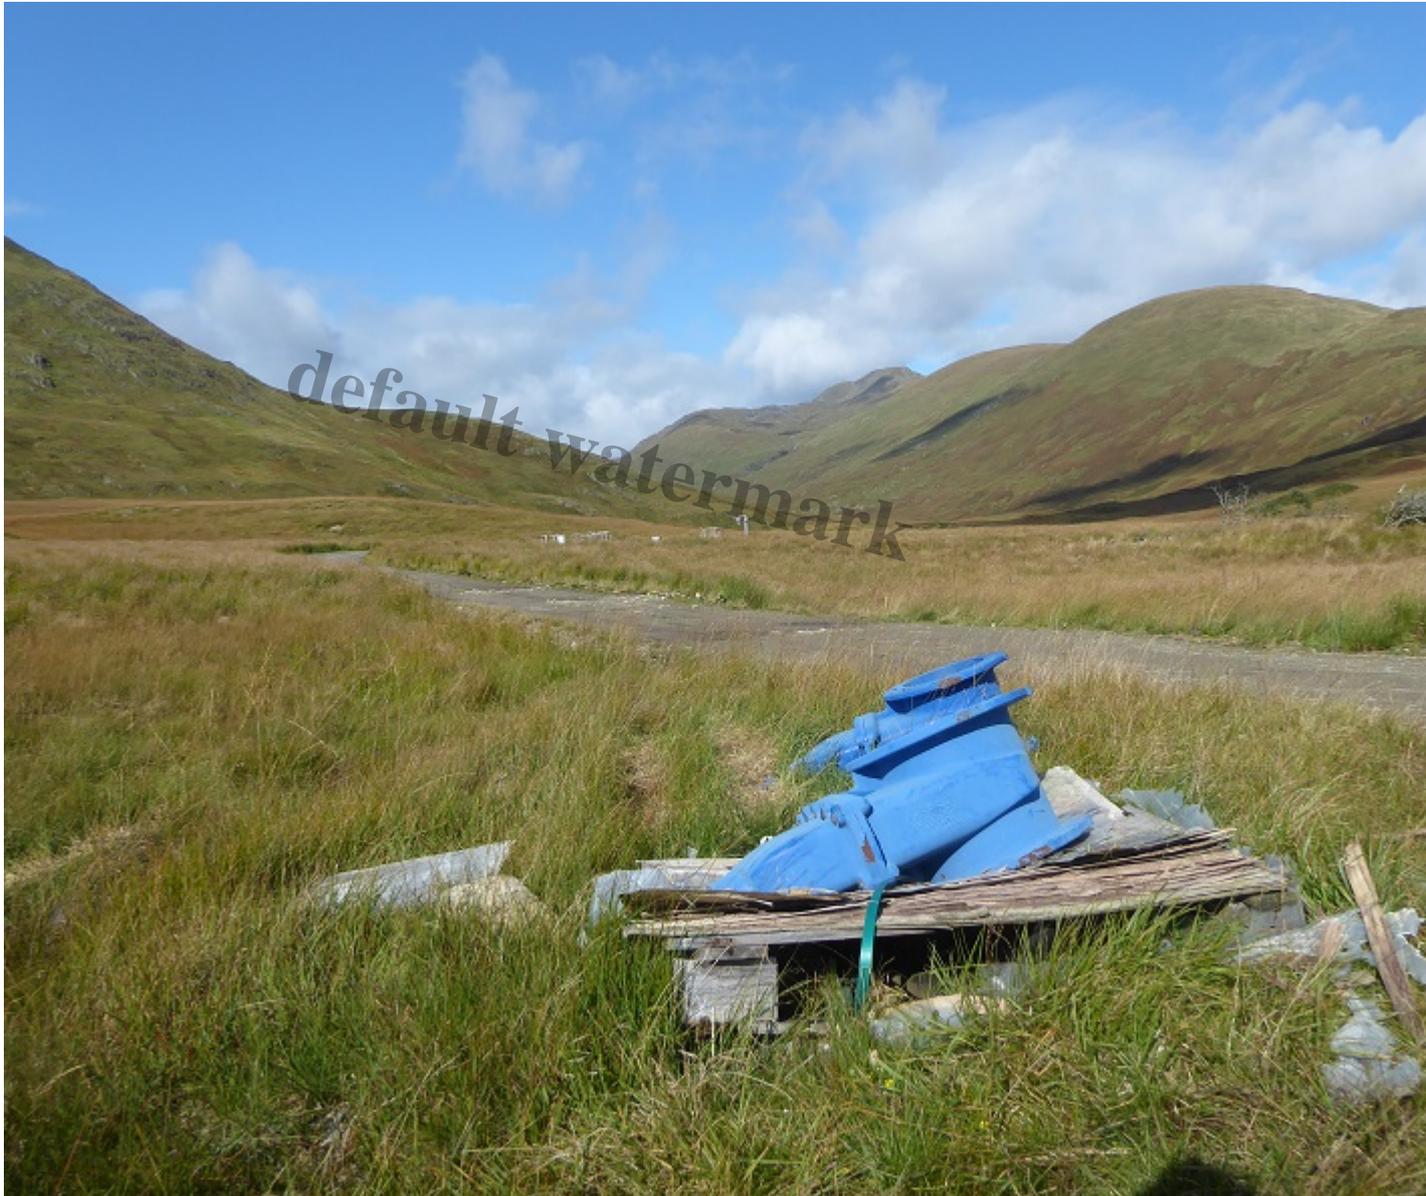
Kelty Water hydro rubbish, with the main intake marked by the metalwork in the middle ground and S behind

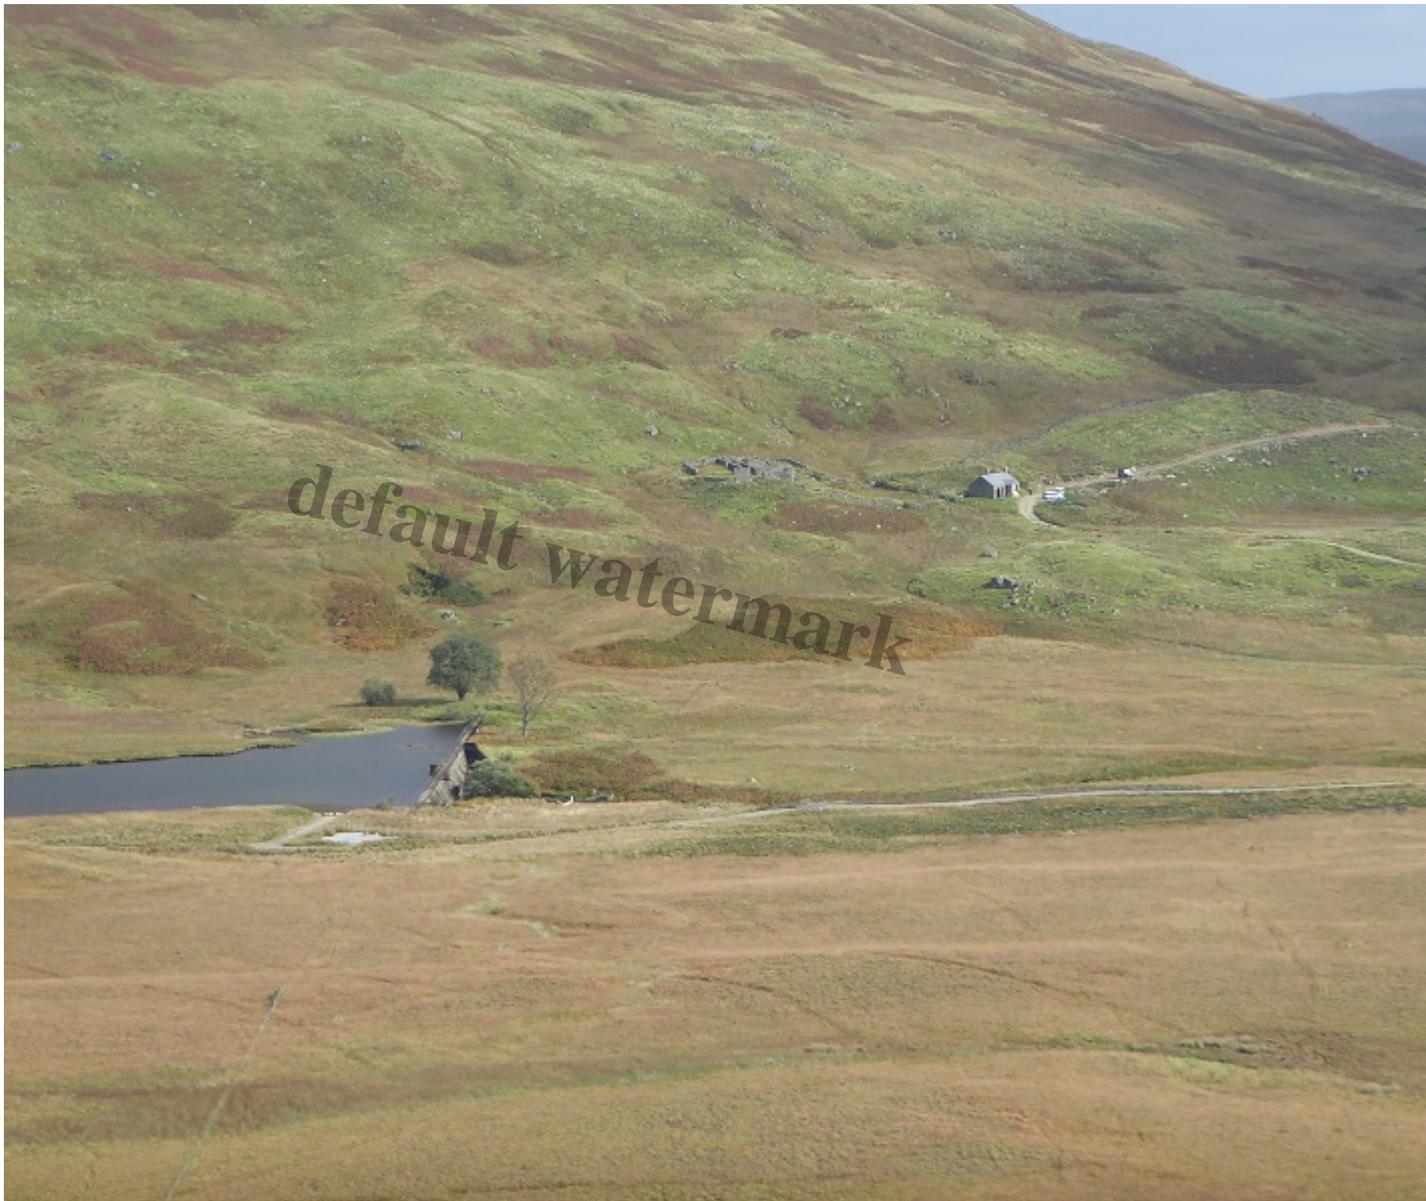
The patch of concrete in front of the dam covers the intake chamber which is now below ground and hardly visible from a distance. Note the two vehicles at Arivurichardich.

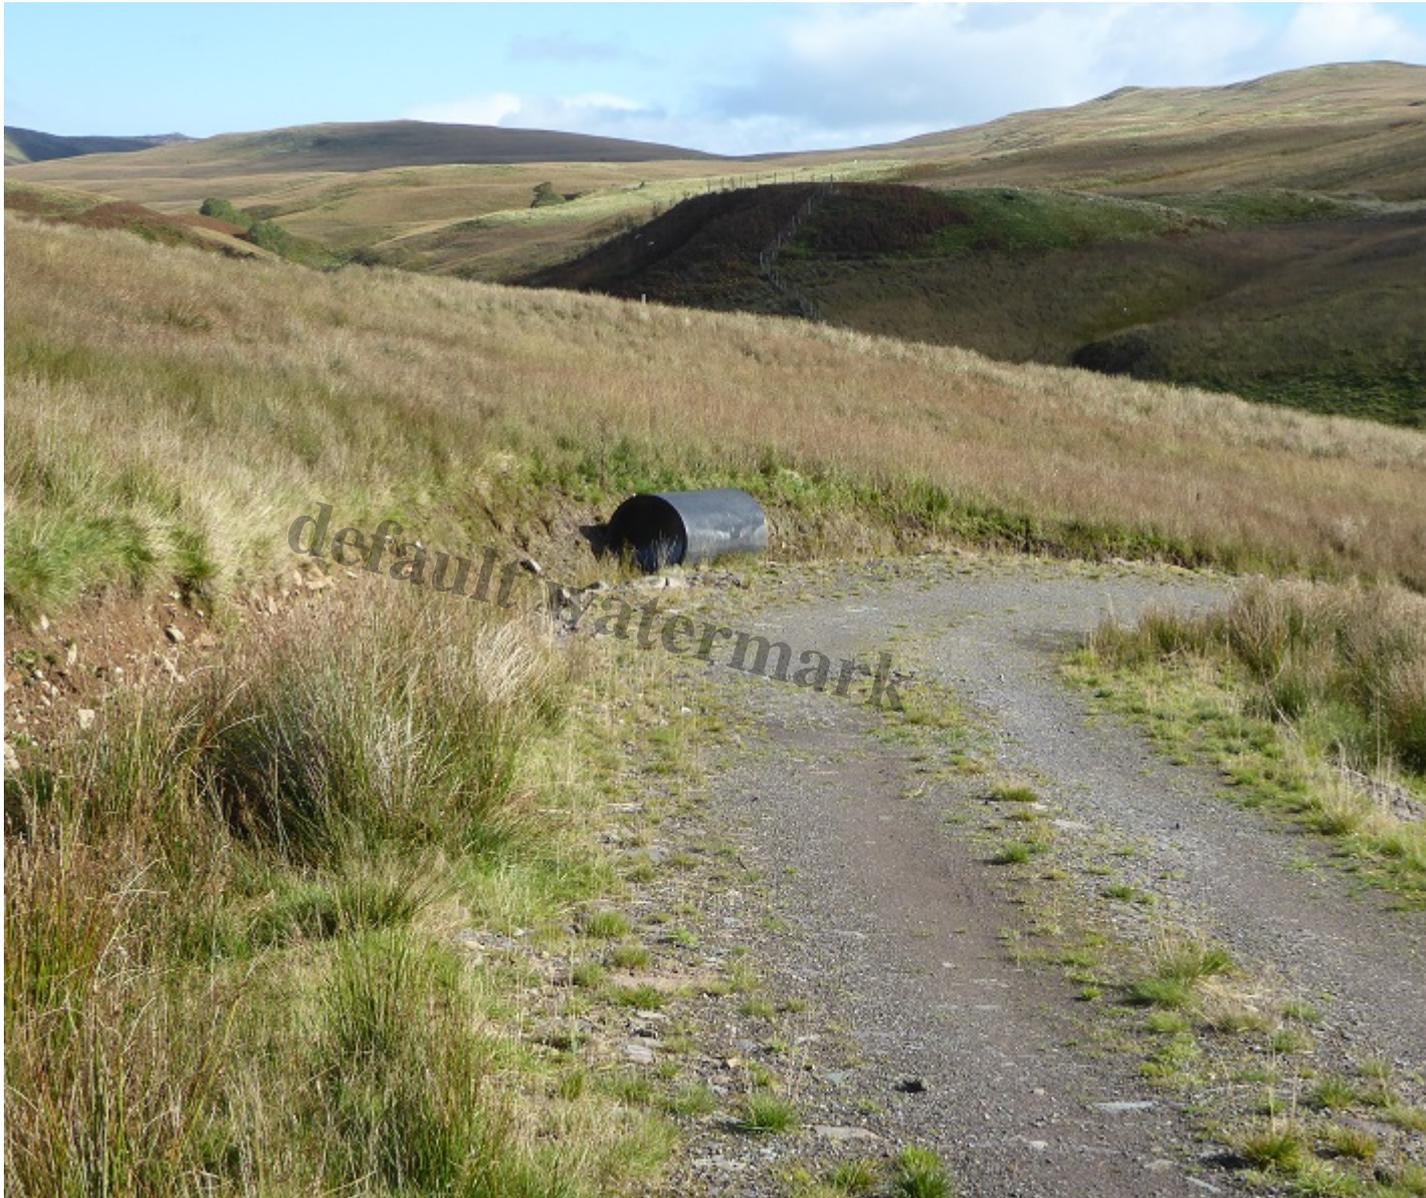
Pipe being used as a drain on access road to power house

They are still there! Whatâ??s more LLTNPA Park staff must have passed them while filming the video and turned the camera the other way!

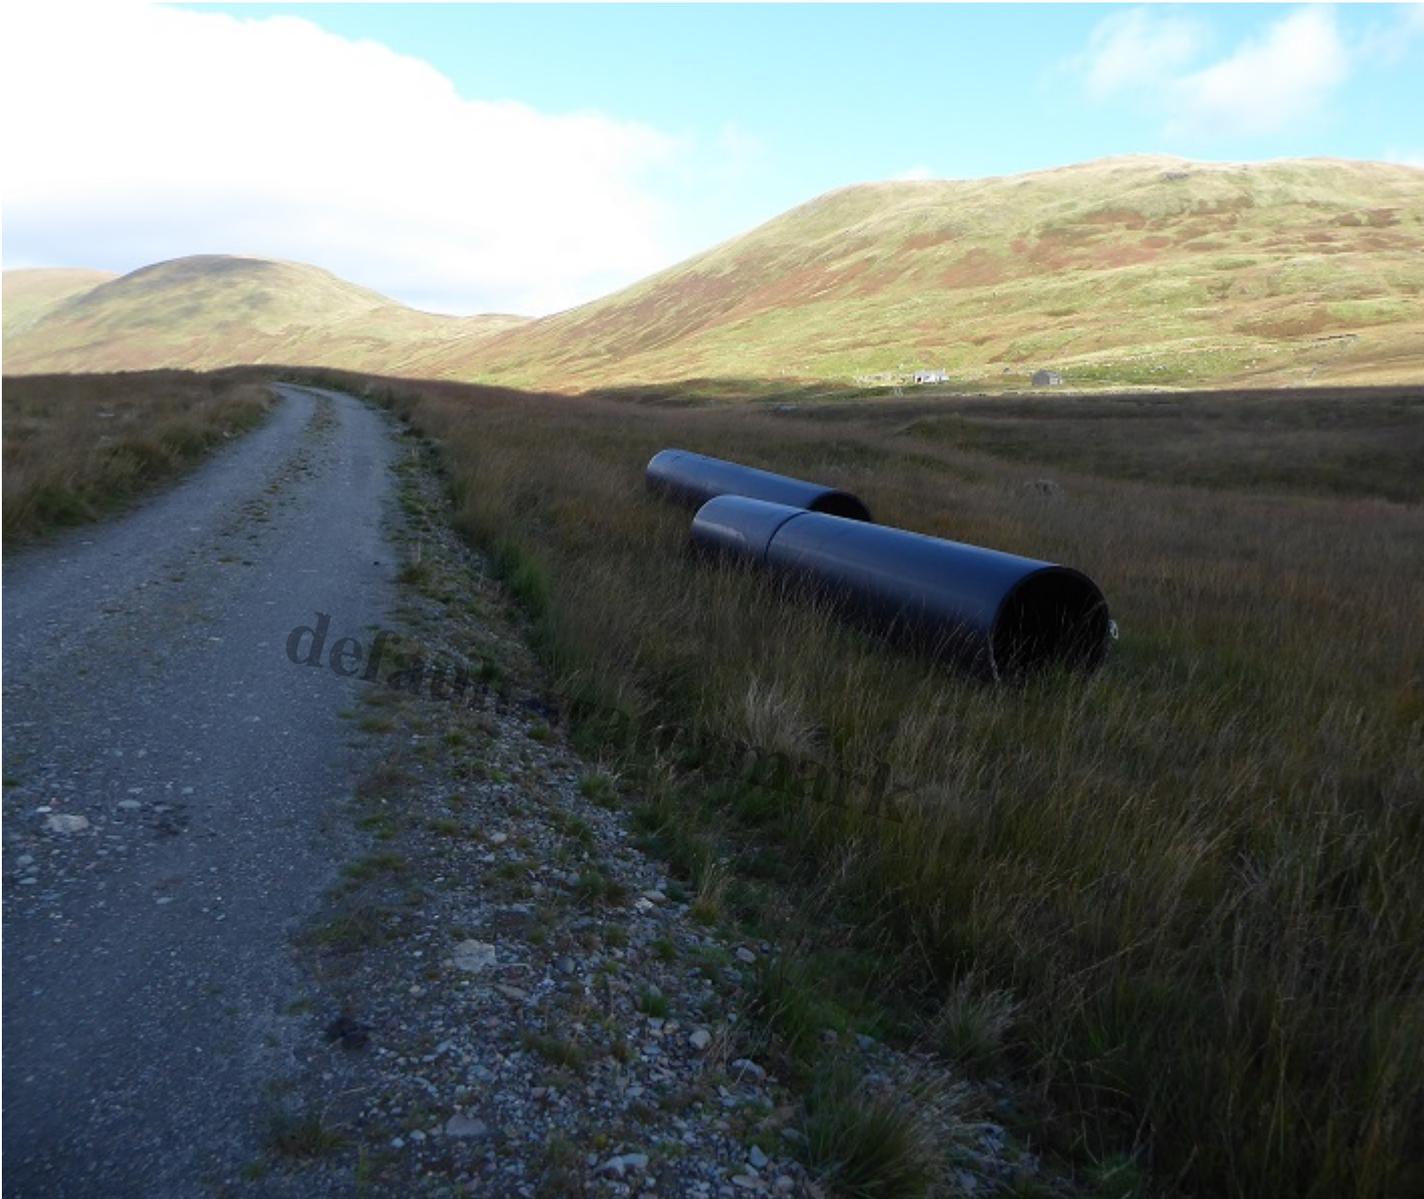
Larger sections of abandoned surplus pipe with Meall Odhar behind â?? its never called fly tipping w
is dunped by a landowner.

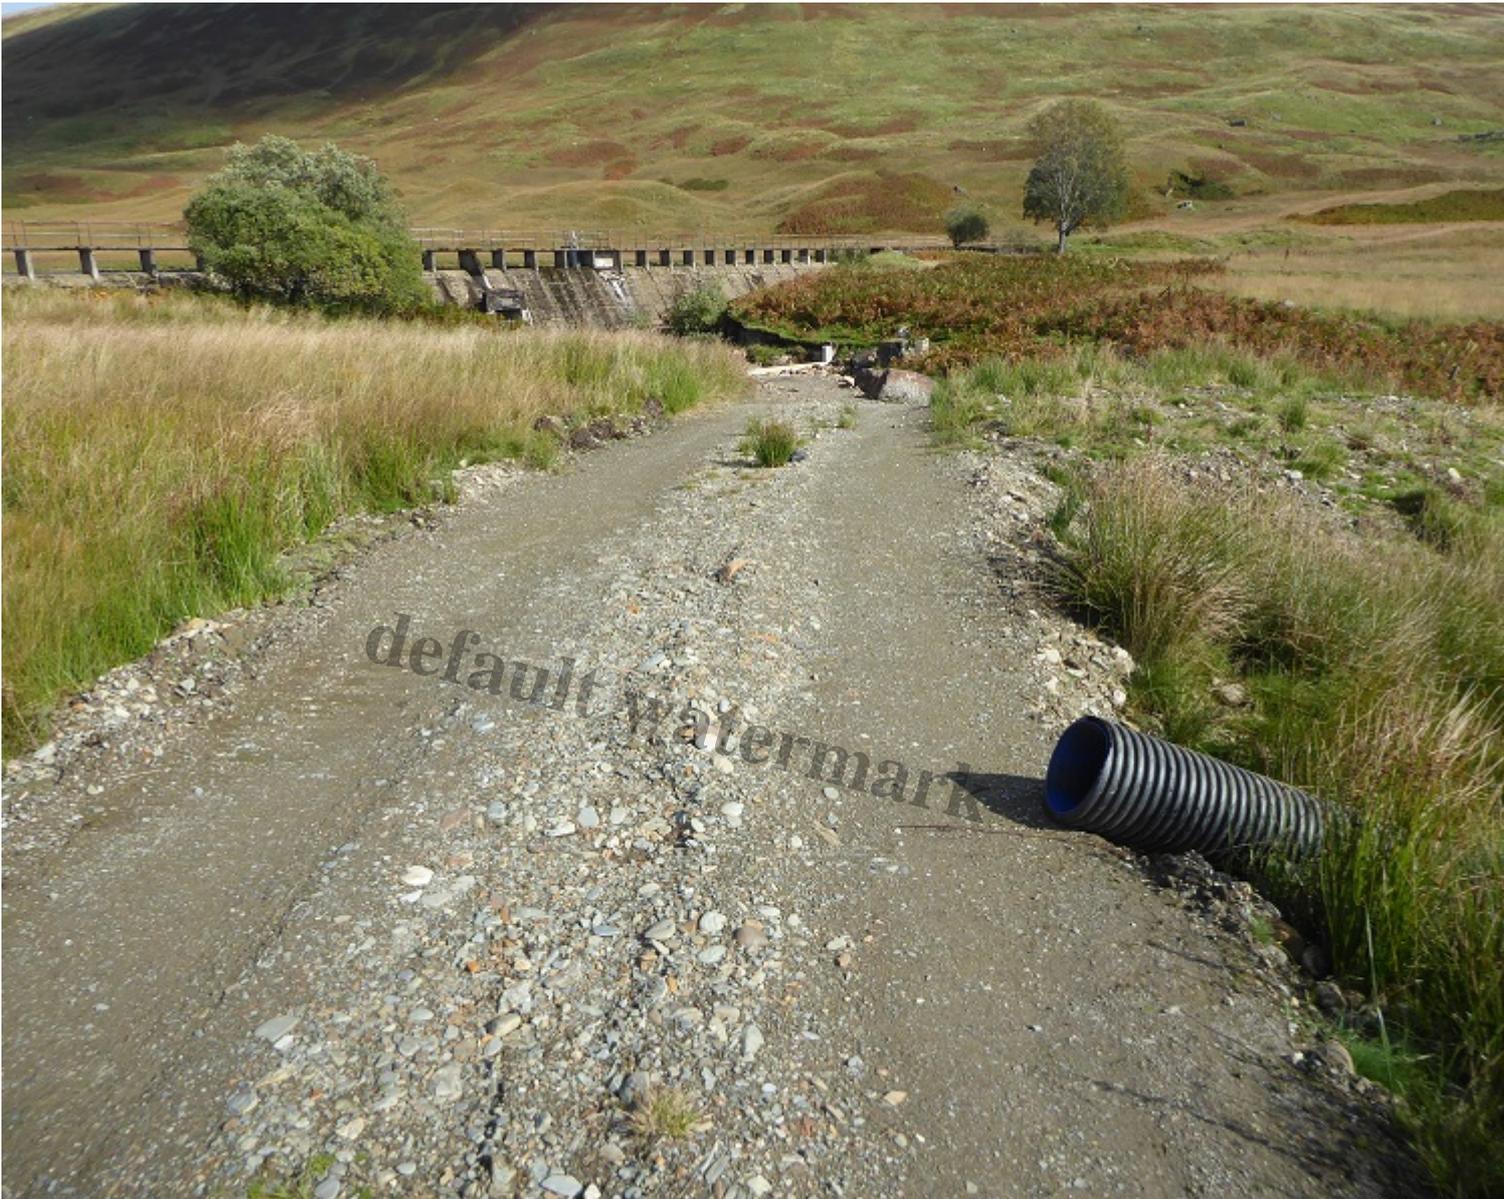
Two years after the hydro opened in 2016 maybe this section of pipe is still work in progress?

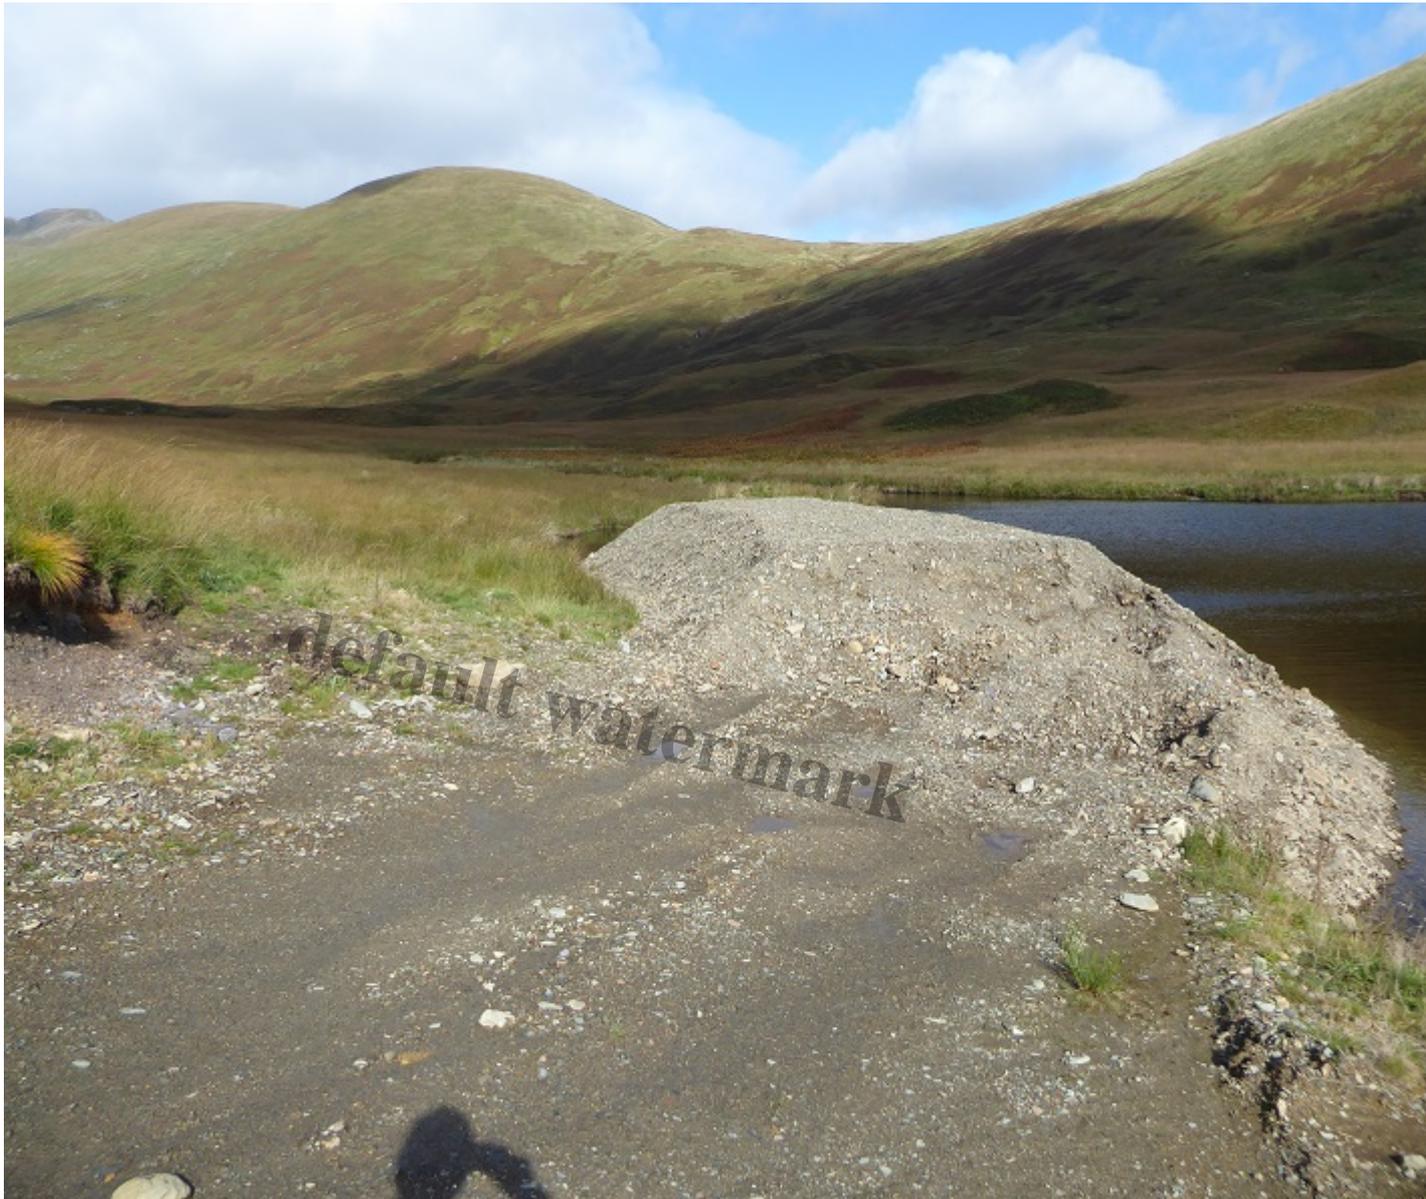
The planning consent allowed gravel to be excavated from the reservoir to construct the new tracks

Or if you want something different how about this large heap of gravel and extension of track beyond the dam which has this been allowed to remain by the reservoir?

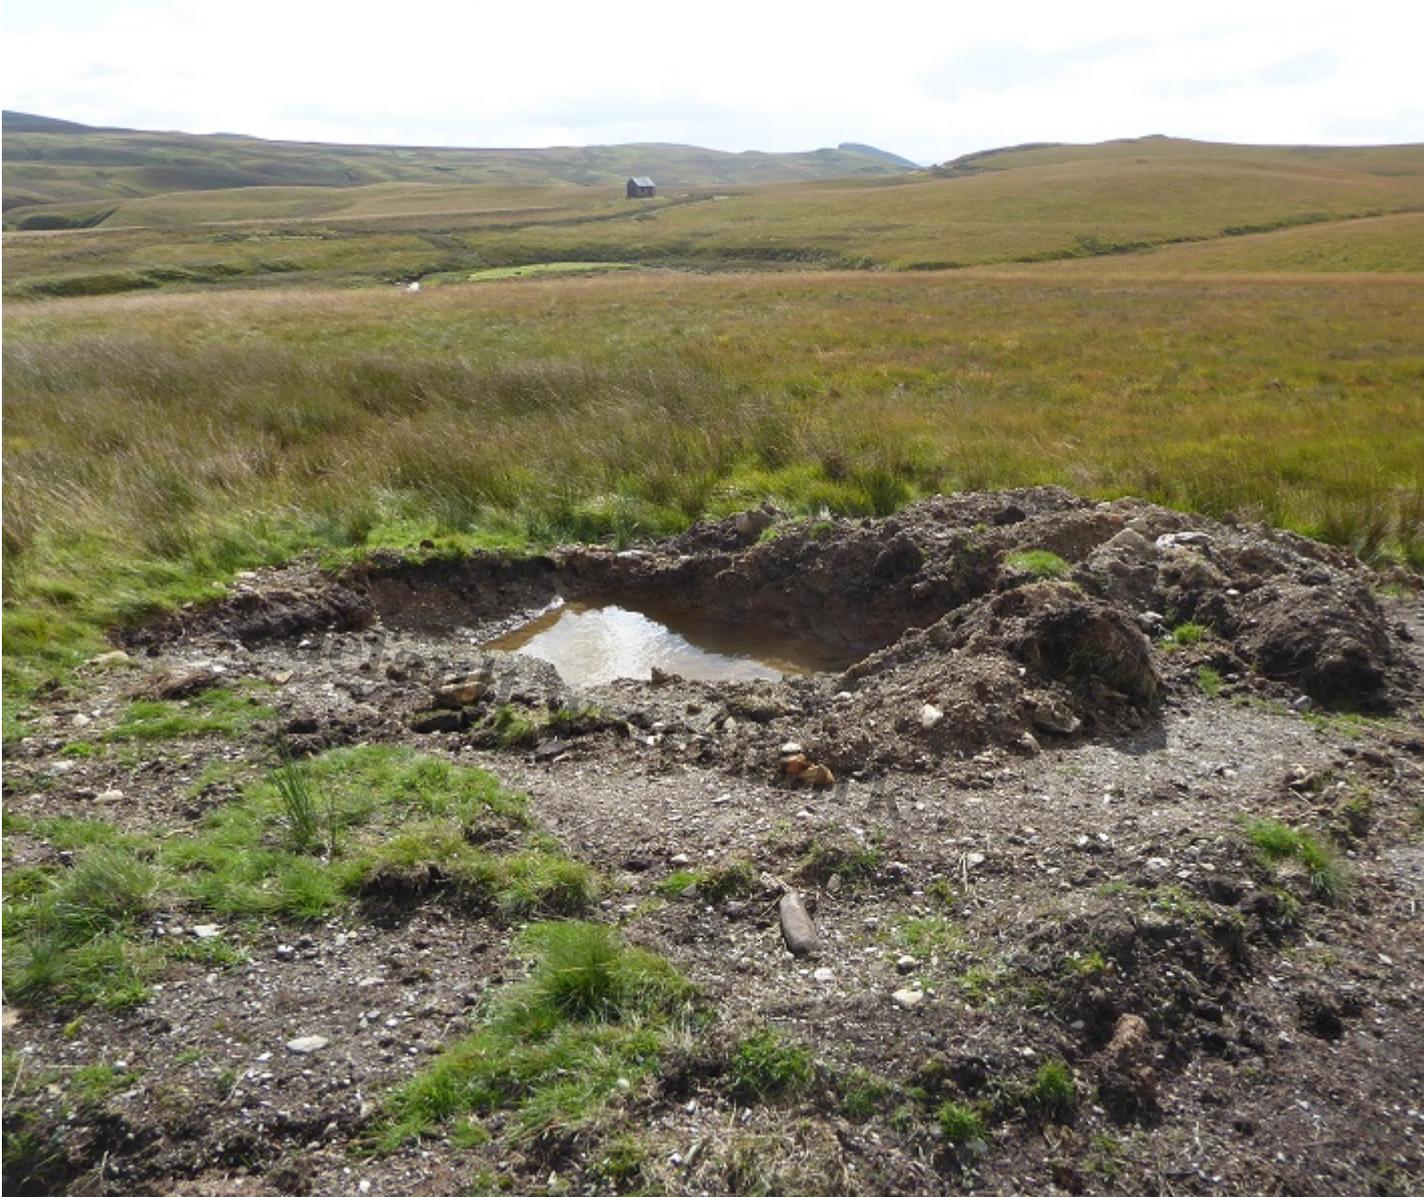
Hole by pipeline to secondary intake â?? again work in progress?? â?? with the former Scottish Water building behind

This is all relatively small stuff, snagging if you like, but should have been very easy to sort out. If this is such an excellent example of partnership working, why hasn't the LLTNPA lifted the phone to the Drummond Estates, who own the land, and the developer and got them to sort this out? If I had been the Director of Planning I would have damn well made sure it was all sorted BEFORE the submission for a planning award. Its typical of the brass neck of those in charge of the LLTNPA that they put themselves in for this award without bothering to sort any of this â?? its very hard not to draw the conclusion that they simply don't care. That's not good for people who are supposed to be the custodians of our National Park.

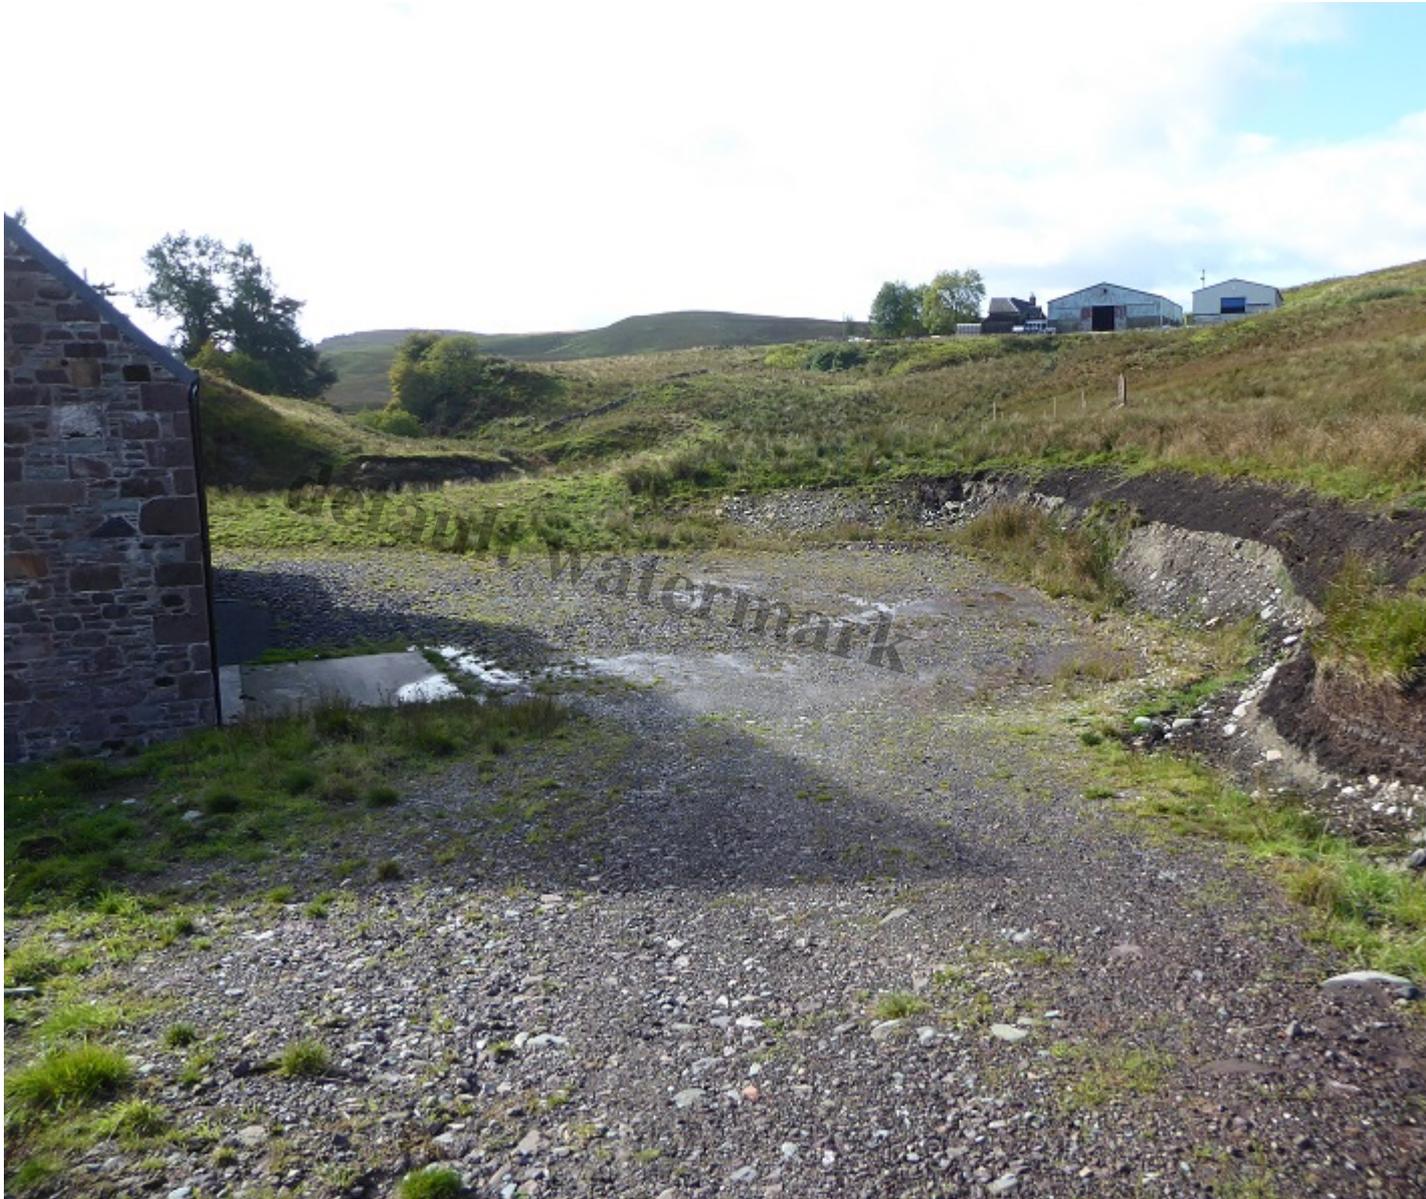
Power house on left, beautifully built and quite a contrast to the farm buildings right, but spoiled by the restoration around it. Note the unrestored peat bank with glacial till below – a good section for study students.

The LLTNPA has quoted the location and construction of the power house as one of the quality aspects of the scheme. There is no argument about the power house itself which is beautifully built – like many in the Park – the issue is the surrounding area. While the LLTNPA required trees to be planted round the powerhouse to help conceal it, the turning areas itself appears to have just been left without any thought about what space was required or how its appearance could be improved. Why is it that our planners and developers can produce good looking buildings but are often so poor at restoring the landscape around?

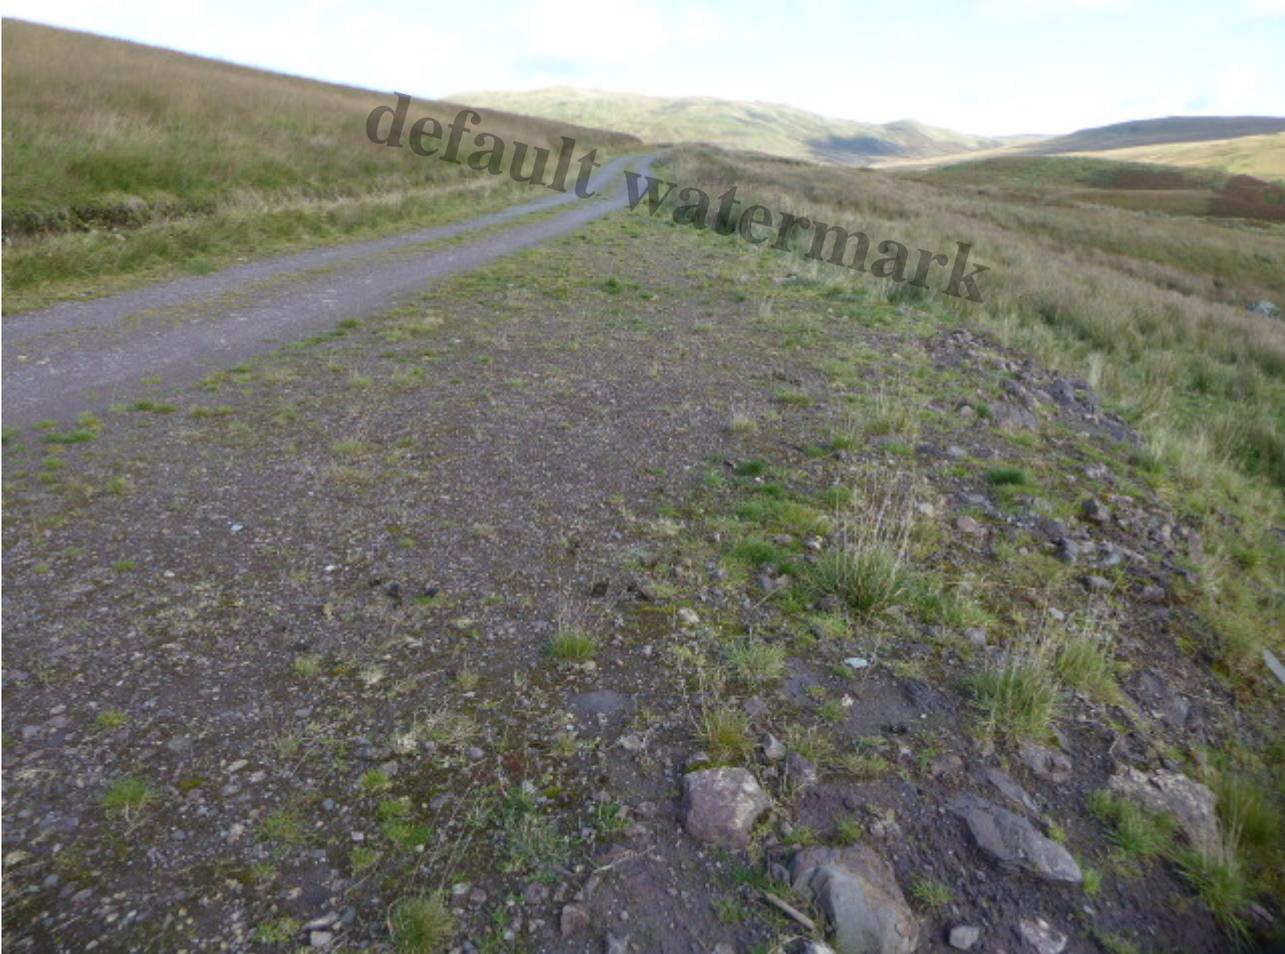
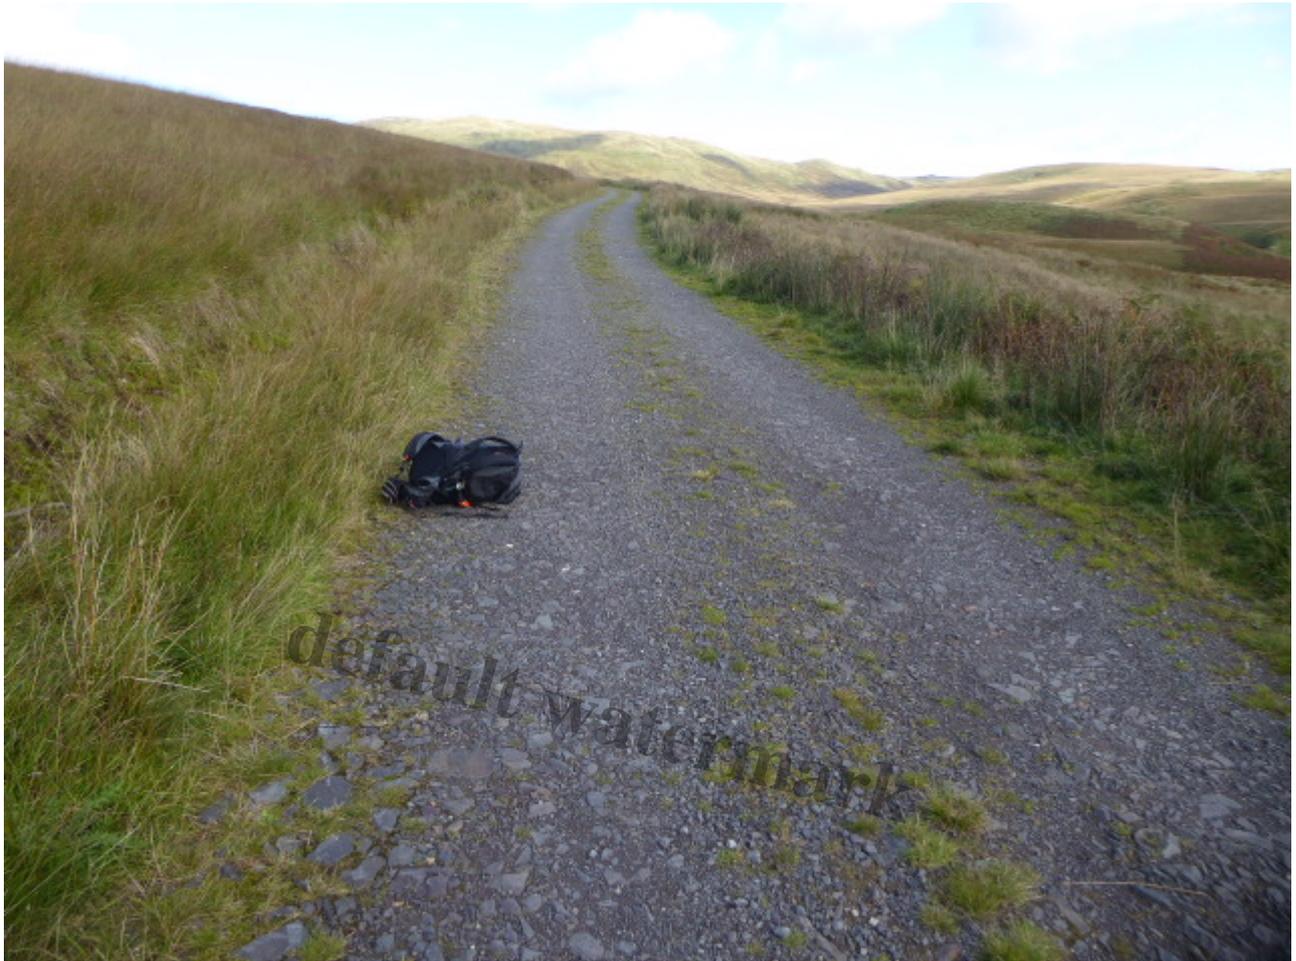
In my first post, I had commented how Drummond Estate had applied for the track to be 2.5m wide but the planning officer had required the tracks to be kept to 2m, except on the bends (in line with LLTNPA policy although its not clear from the consent letter if this condition applied to sections of track which needed to be upgraded to take the construction vehicles):

This straight section of track is wider than necessary, about 2.5m \hat{a} ?? contrary to the planning condition which I think was right

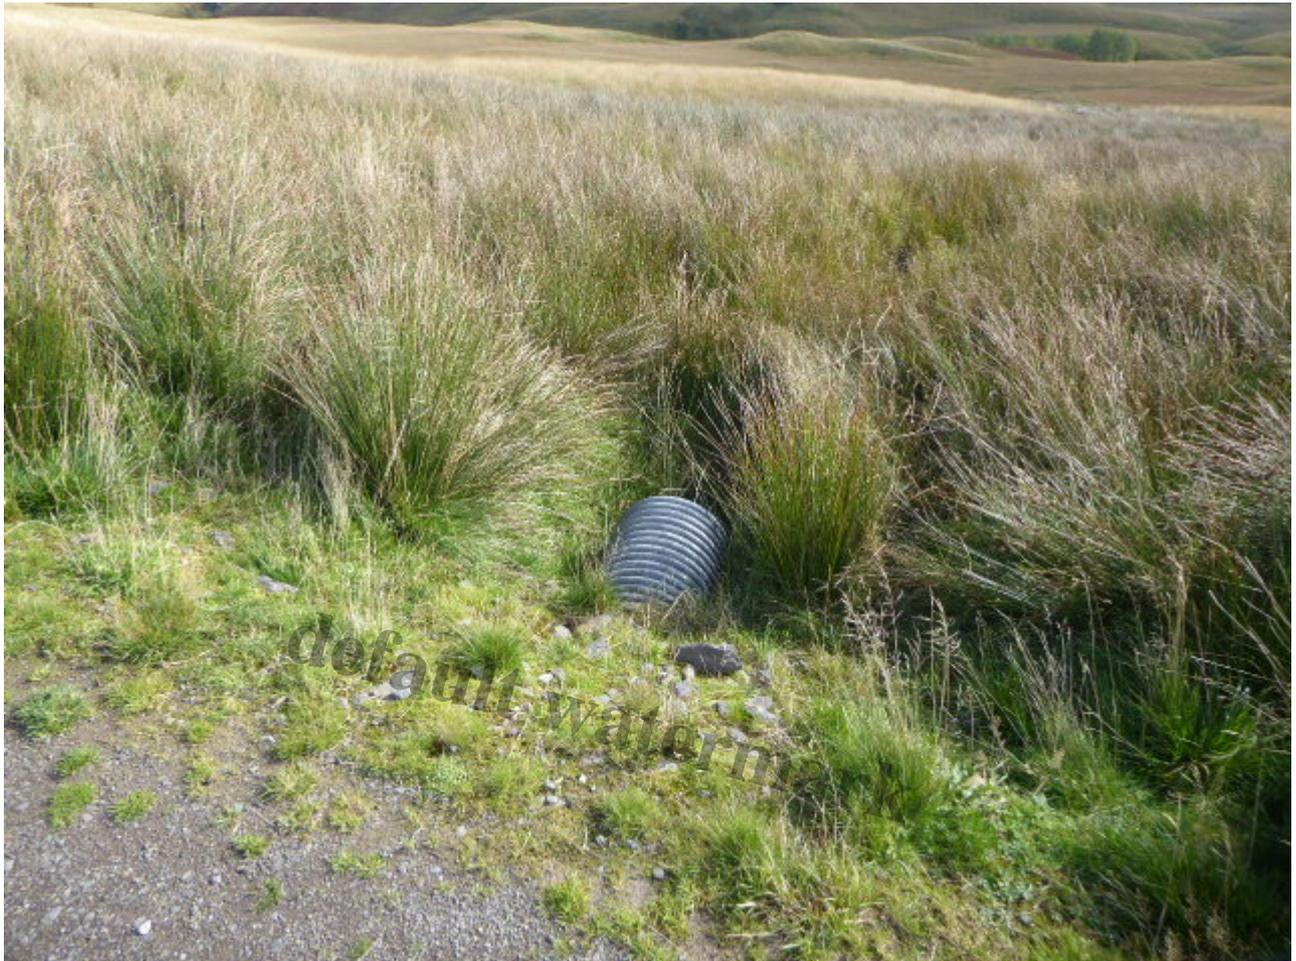
While most of the new culverts had been hidden, this one wasnâ??t

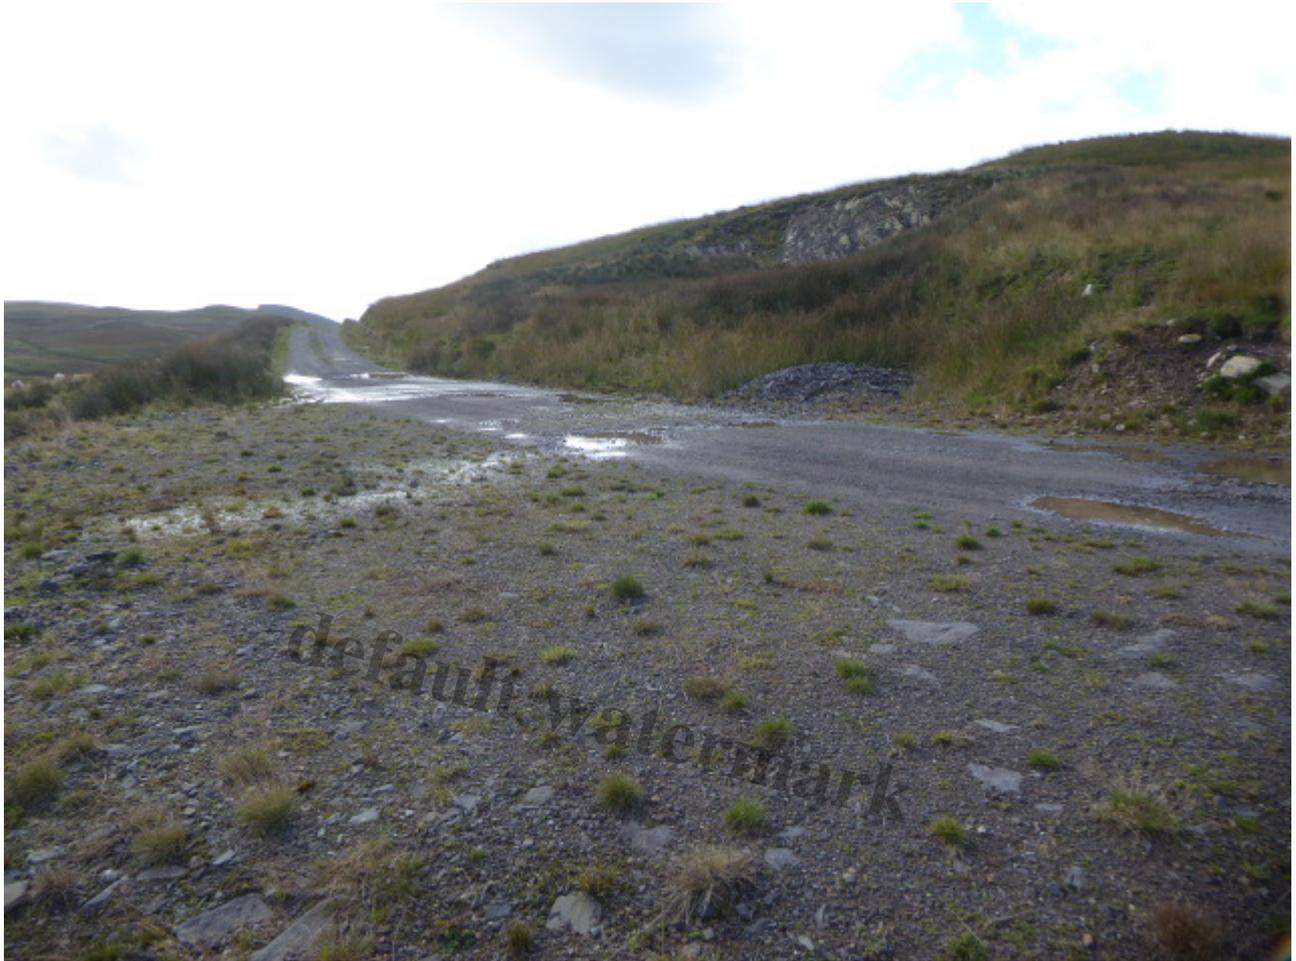
One of the worst sections of upgraded track was by a borrow pit, which also had not been restored properly:

Unrestored ground with heap of aggregate behind and only partially restored borrow pit behind.

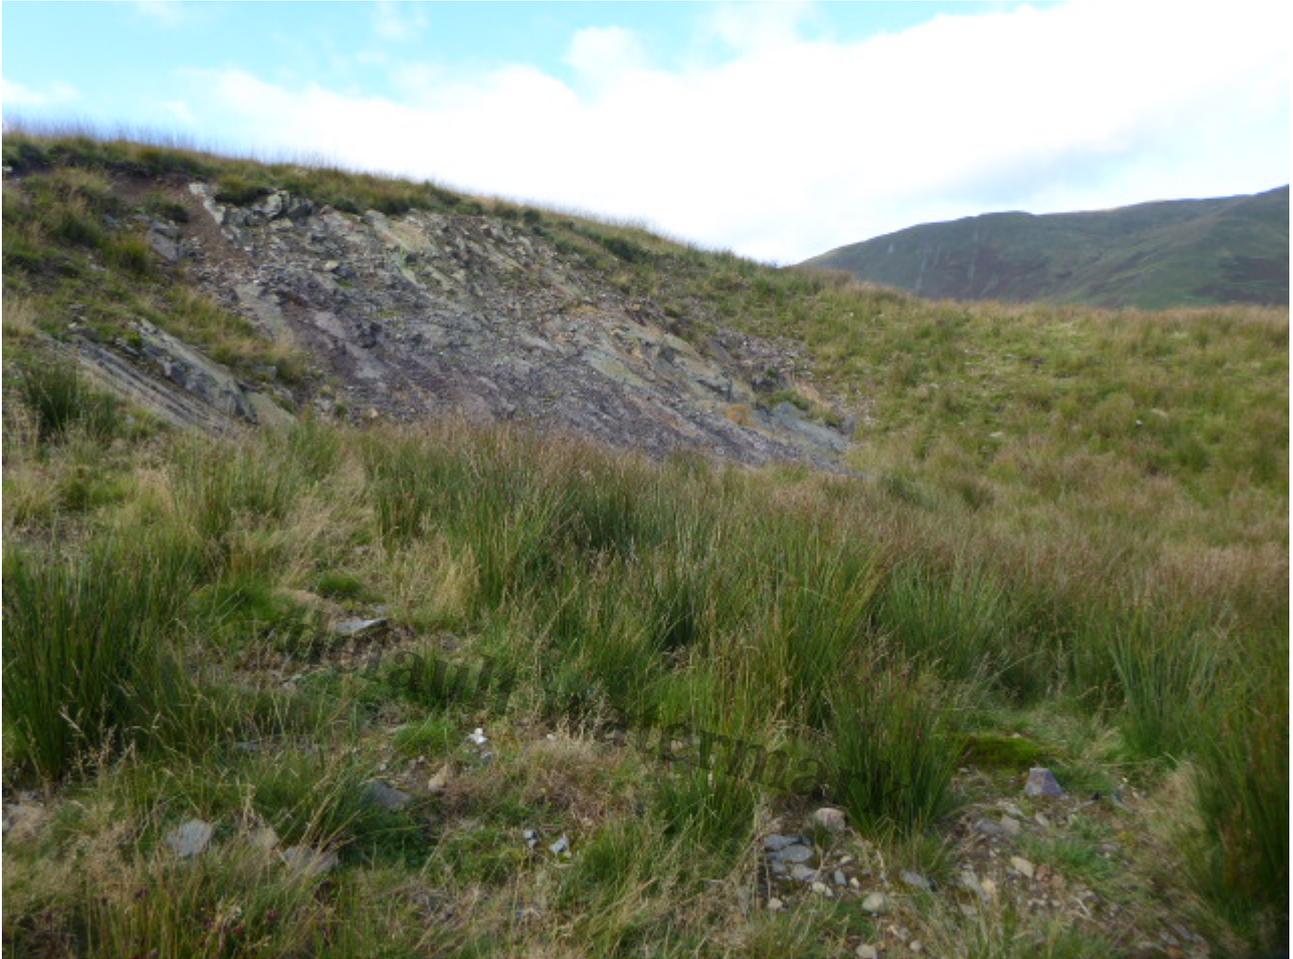
Unrestored section of borrow pit – note how soft rush has colonised and now dominates the ground which has been restored. LLTNPA officers wrote a further delegated report ([see here](#)) agreeing another borrow pit could be retained because sand martins had started to nest there, so on what basis has LLTNPA agreed with the estate that this section of ground need not be restored?

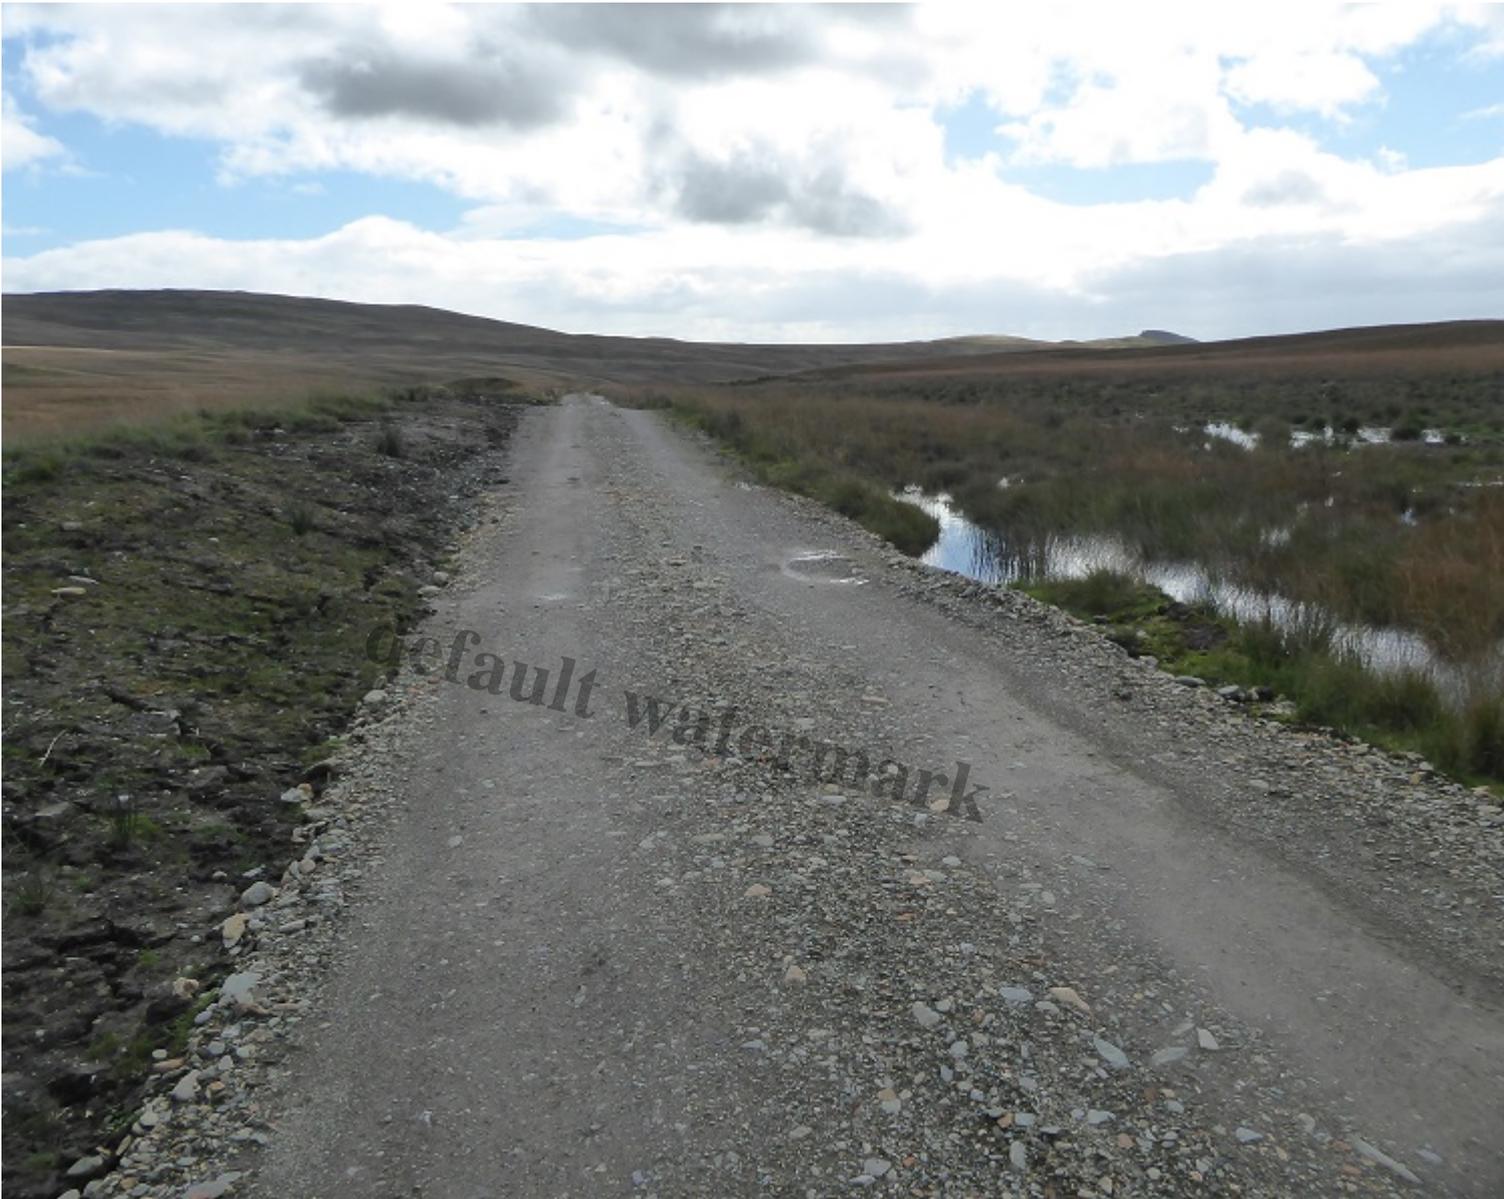
Its not just that the new section of track is more than the 2m stipulated, the track itself appears to have altered the drainage, making the area on the right where the pipeline is buried even wetter, while rush now dominates the vegetation.
