The Keltie Water hydro scheme and Scottish quality awards for planning

Background to the Keltie Water hydro scheme

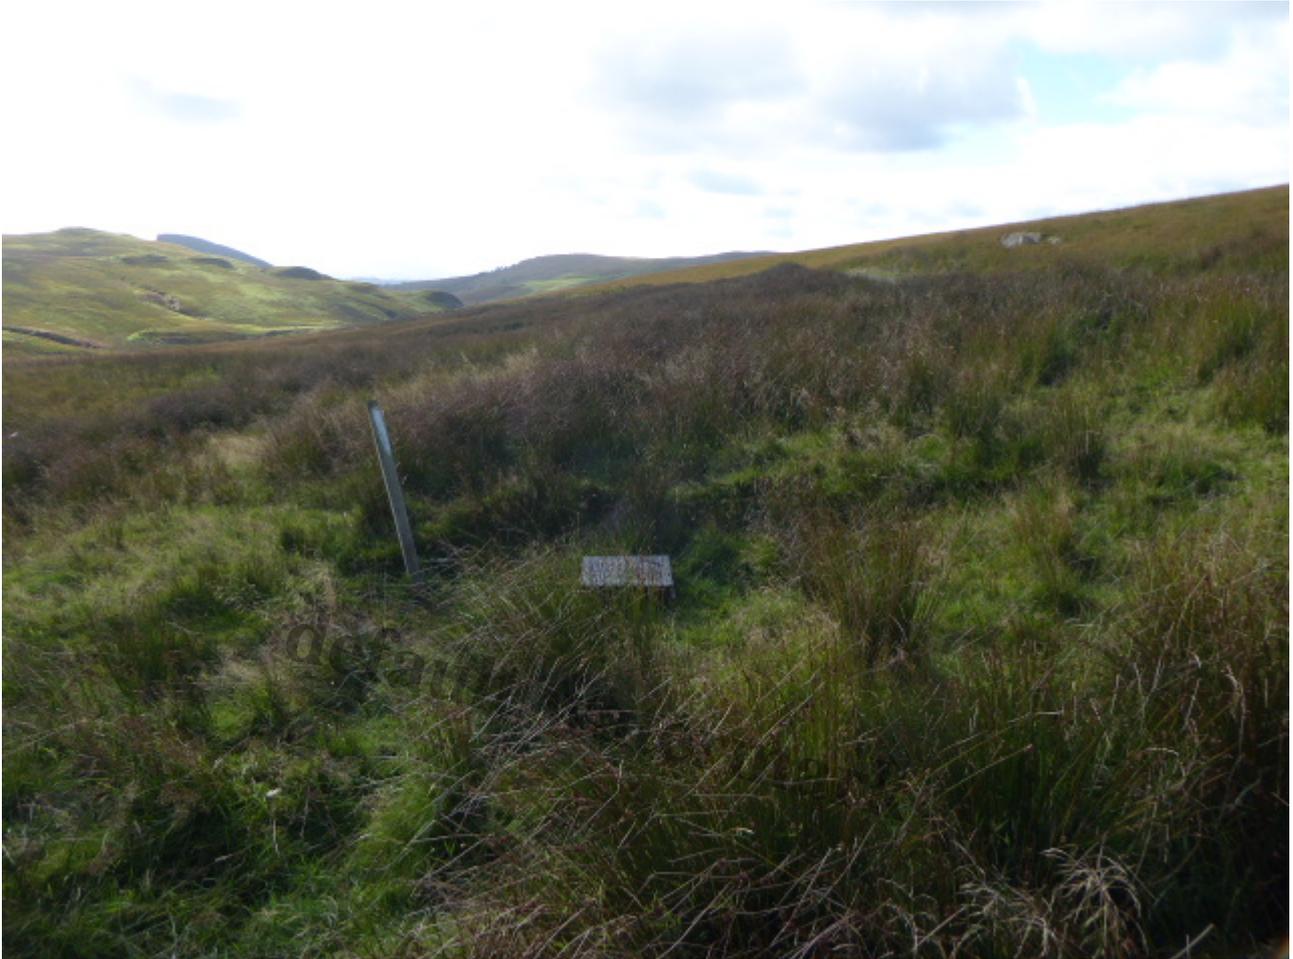
Swathe of soft rush forming a dark band along the top the ground where the pipeline construction took place

On Saturday I was puzzling about how the band of soft rush marking the new pipeline fitted with other areas of rush and then it clicked: the other areas of extensive rush below the new pipe mark the construction of the former Scottish Water pipeline. The rush therefore appears likely to become a more or less permanent landscape and ecological feature. It really is time that that some proper research on the long-term vegetation impacts of hydro schemes was commissioned and our National Parks could be taking a lead on this.

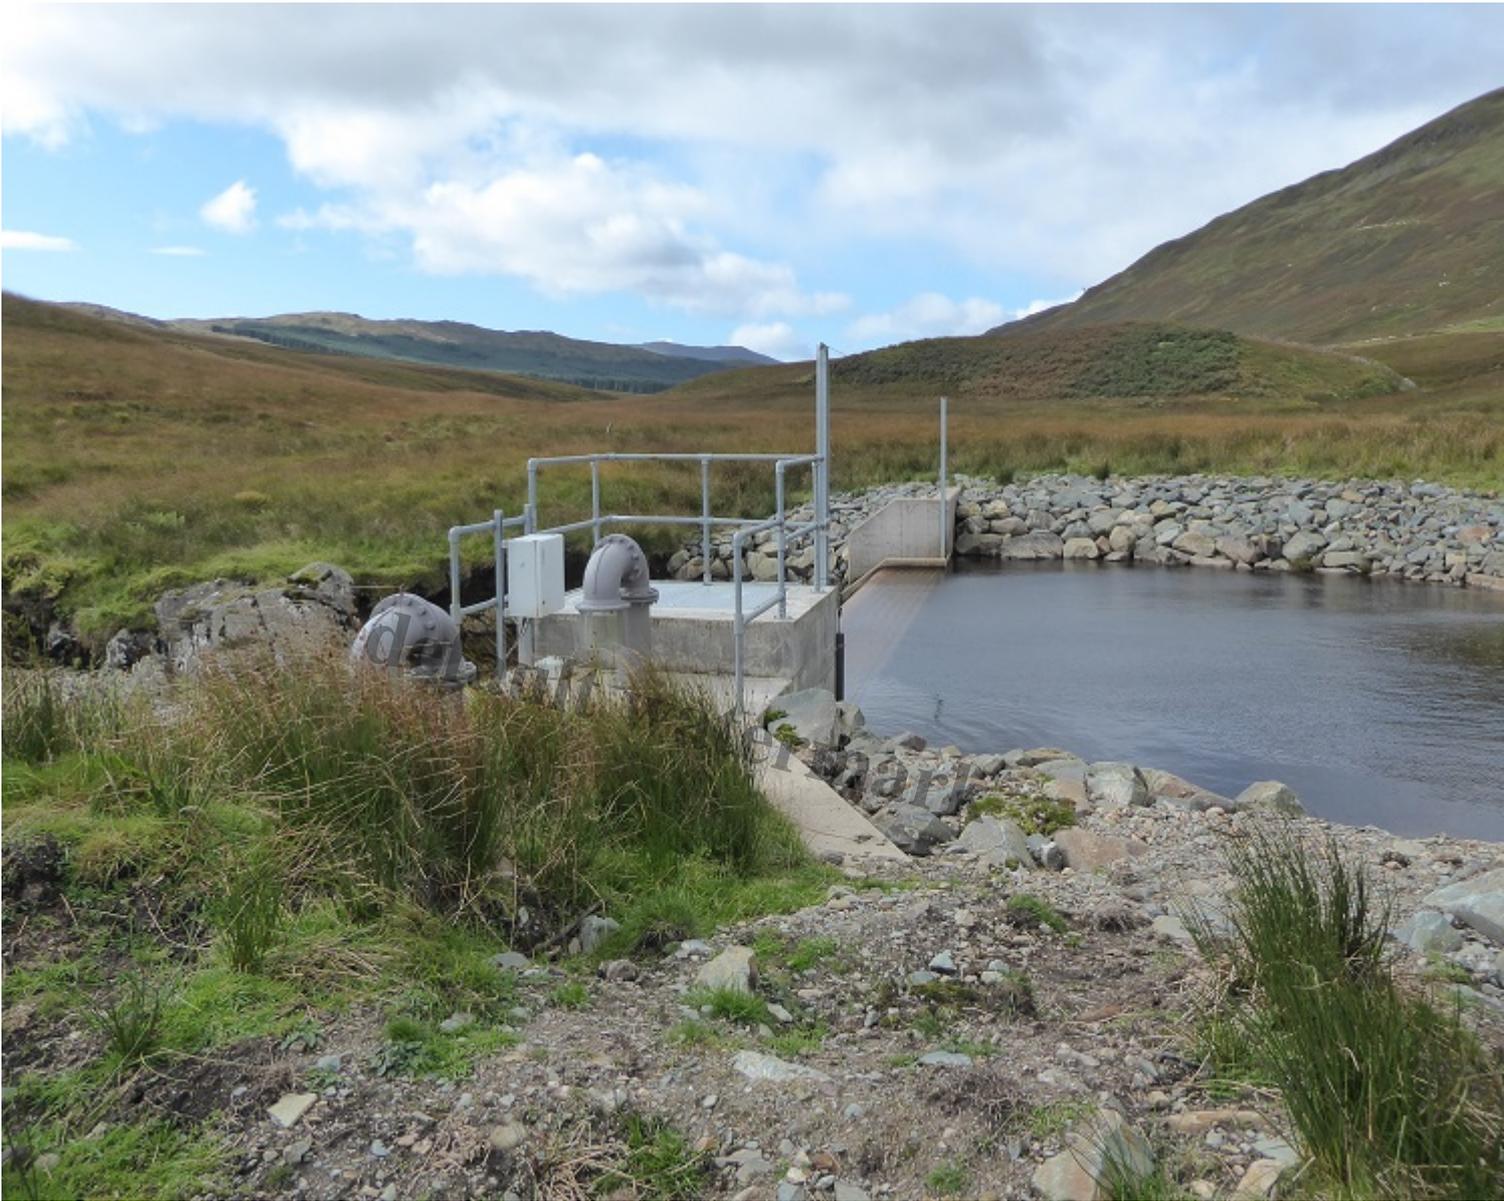
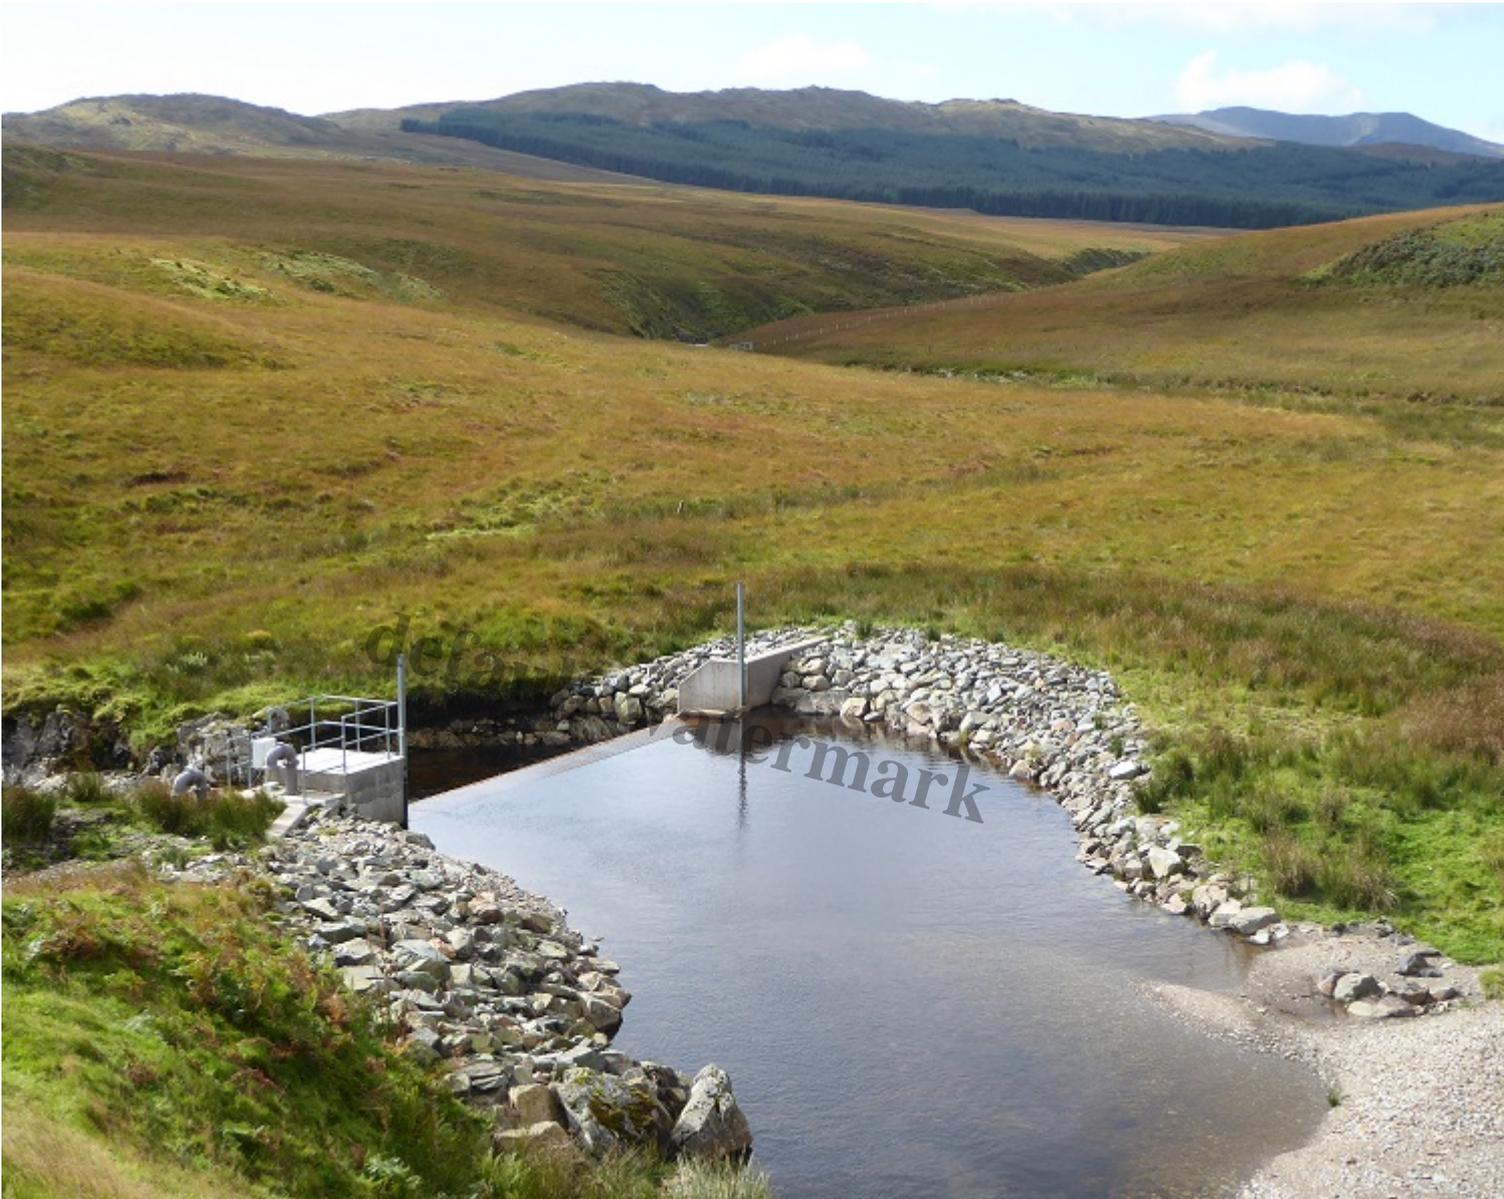
Also evident are the usual problems of poor landscaping around new intake dams. The actual landscape impact at the secondary intake is far greater than suggested in the plans:

The original photomontage failed to show either the new section of access track or the rip rap bouldering which is unlikely to revegetate

The planning consent rightly required *“Landscape mitigation measures proposed at the intakes and outfall (this should include details of ground profiling to screen higher areas of the wing walls)”* but the result, as in most other LLTNPA hydro schemes, leaves much to be desired. Had the LLTNPA and Drummond Estates worked out a solution which would avoid the need for these artificial banks of boulders that might have been a step forward justifying a quality award.

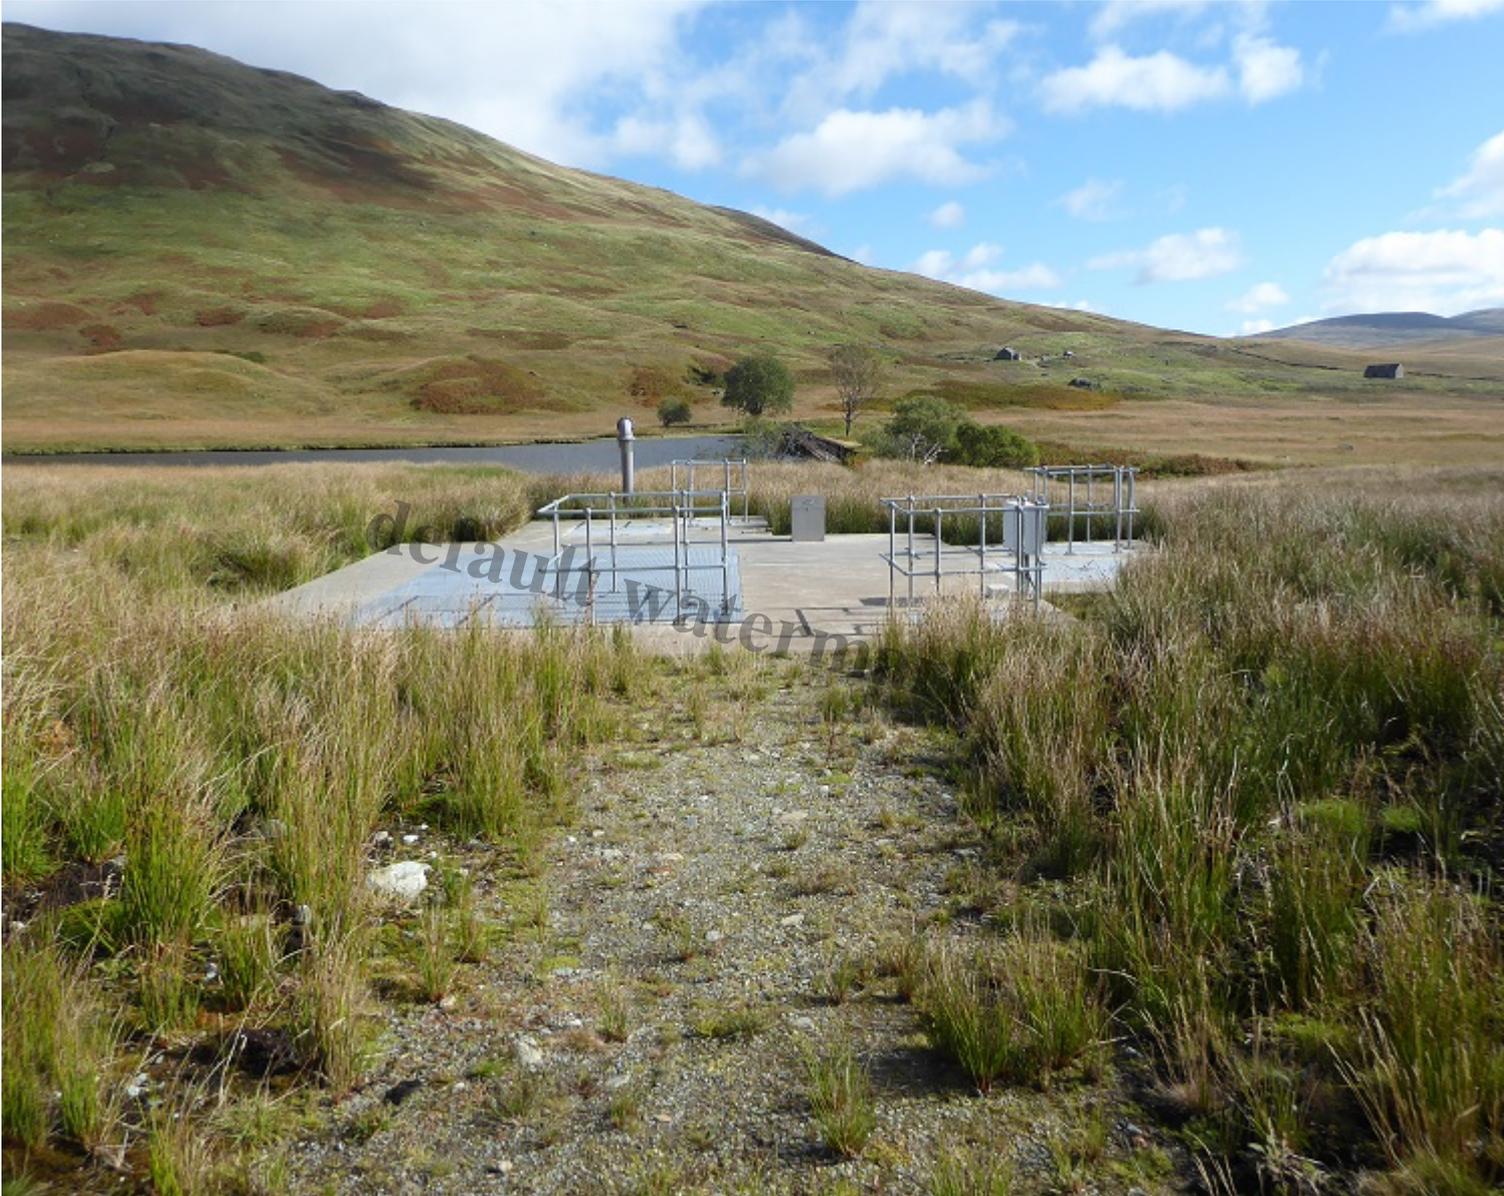
While the buried intake tank at the main intake is ugly from close up (could it not have been screened by a stone wall?) the new structure is far less intrusive visually than the original plans as a result of the water being abstracted by a pipe from the middle of the reservoir. An innovative solution that could possibly be used in other cases where there are large intake pools.

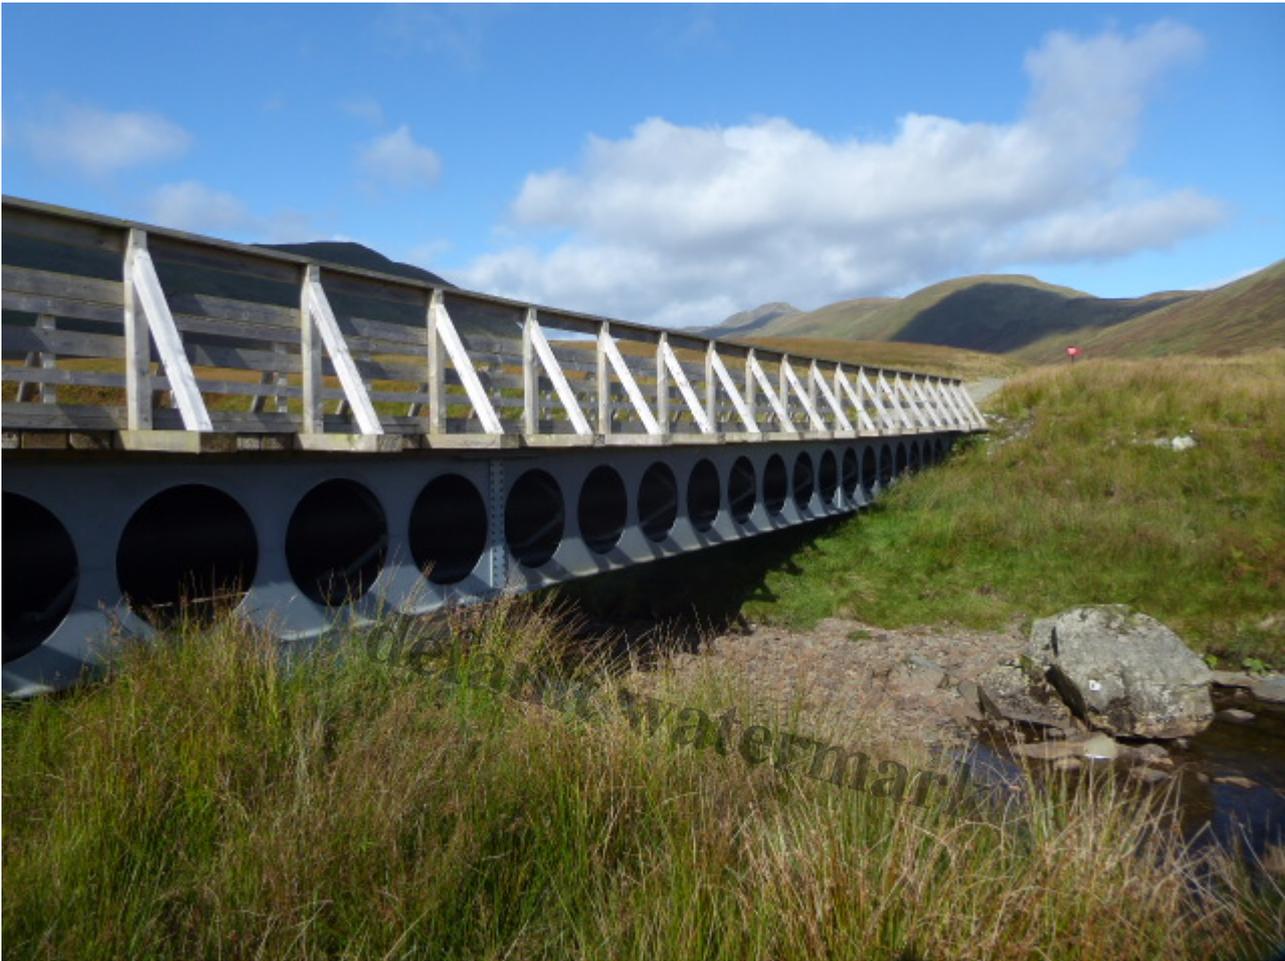
It was also good to see the Park's own guidance being followed with the pipeline well concealed below the first bridge. While this and the second bridge which replaced the one swept away in 2004 has made access easier for walkers – the track is part of the core path network – I am sceptical about the LLTNPA's claims this was done for walkers. On my visit I spotted six estate vehicles which had used the bridges – the most I have ever seen – and I suspect the estate's primary motivation for installing the bridges was for estate management rather than recreational purposes.
