## The Keltie Water hydro scheme and Scottish quality awards for planning

## **Background to the Keltie Water hydro scheme**

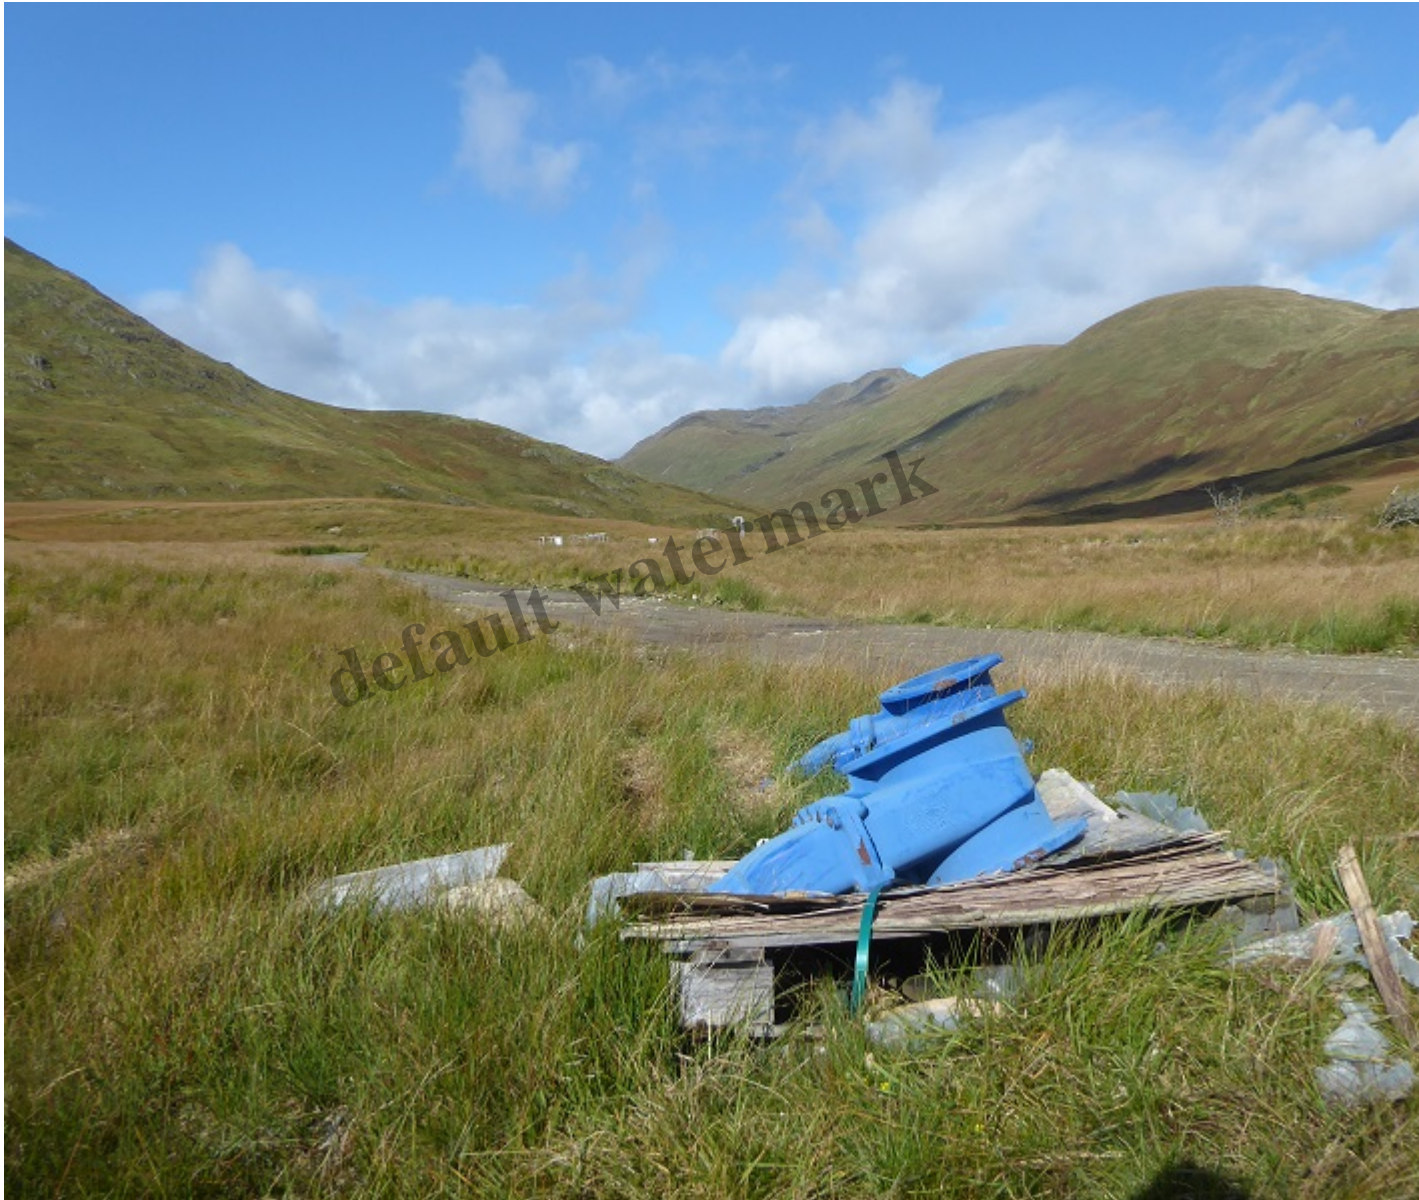
Kelty Water hydro rubbish, with the main intake marked by the metalwork in the middle ground and S Chroin behind

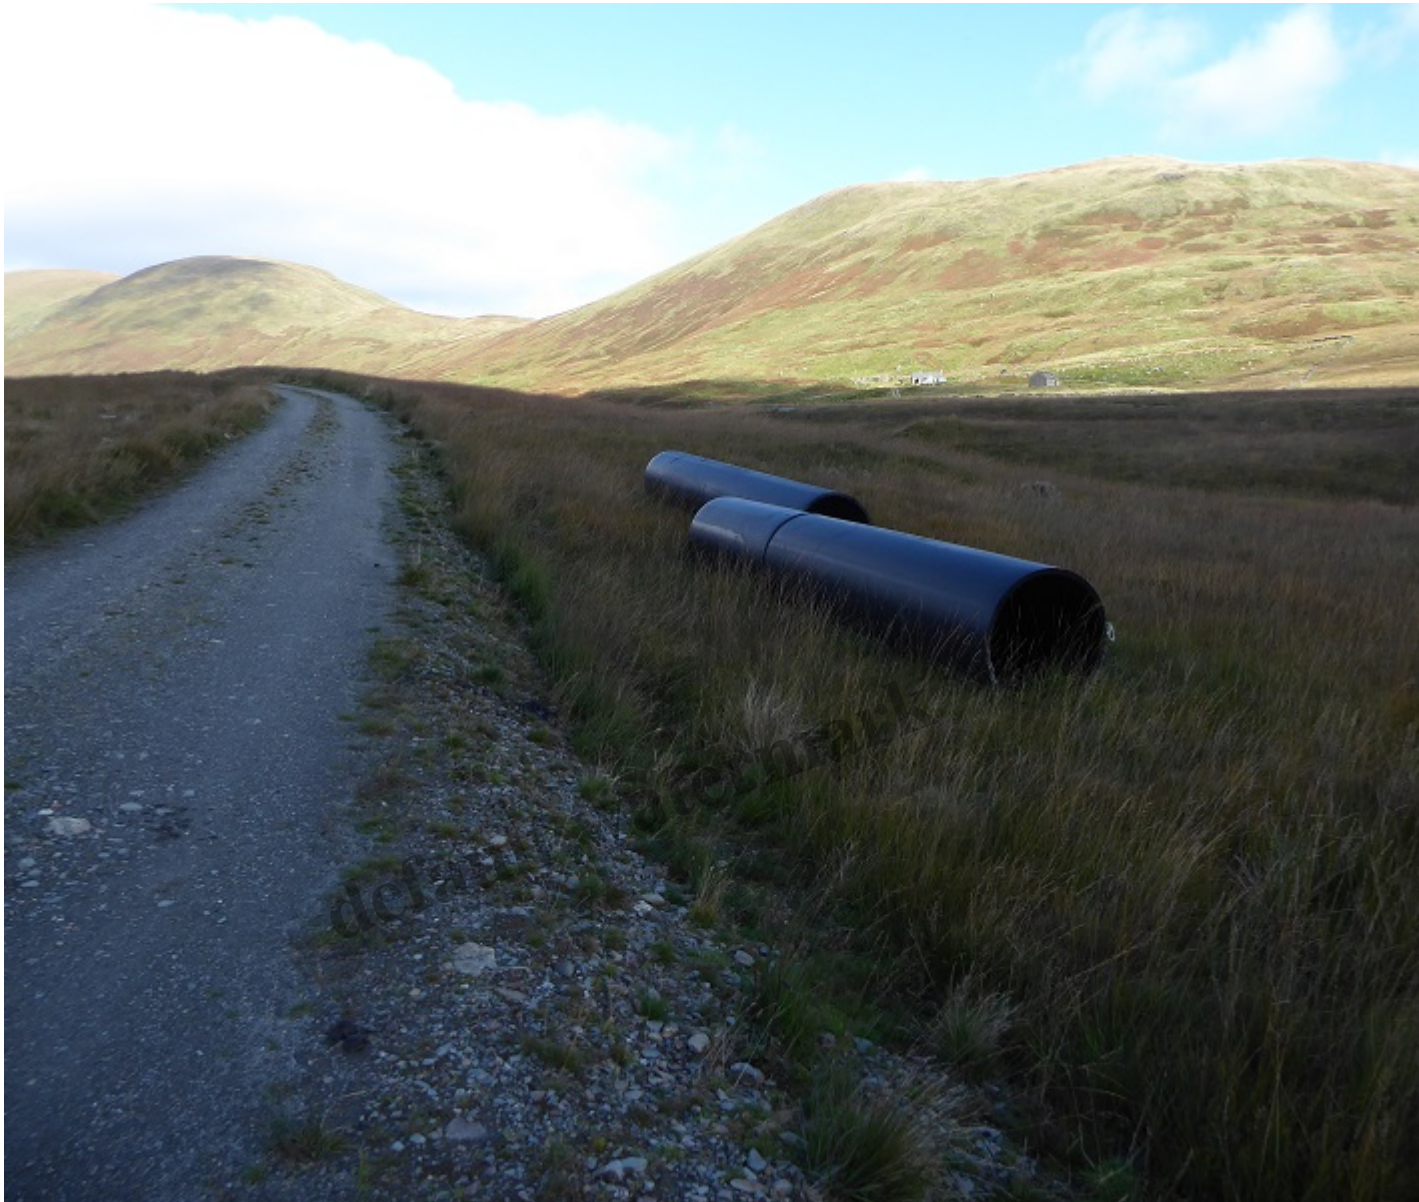
Larger sections of abandoned surplus pipe with Meall Odhar behind – its never called fly tipping when dumped by a landowner.

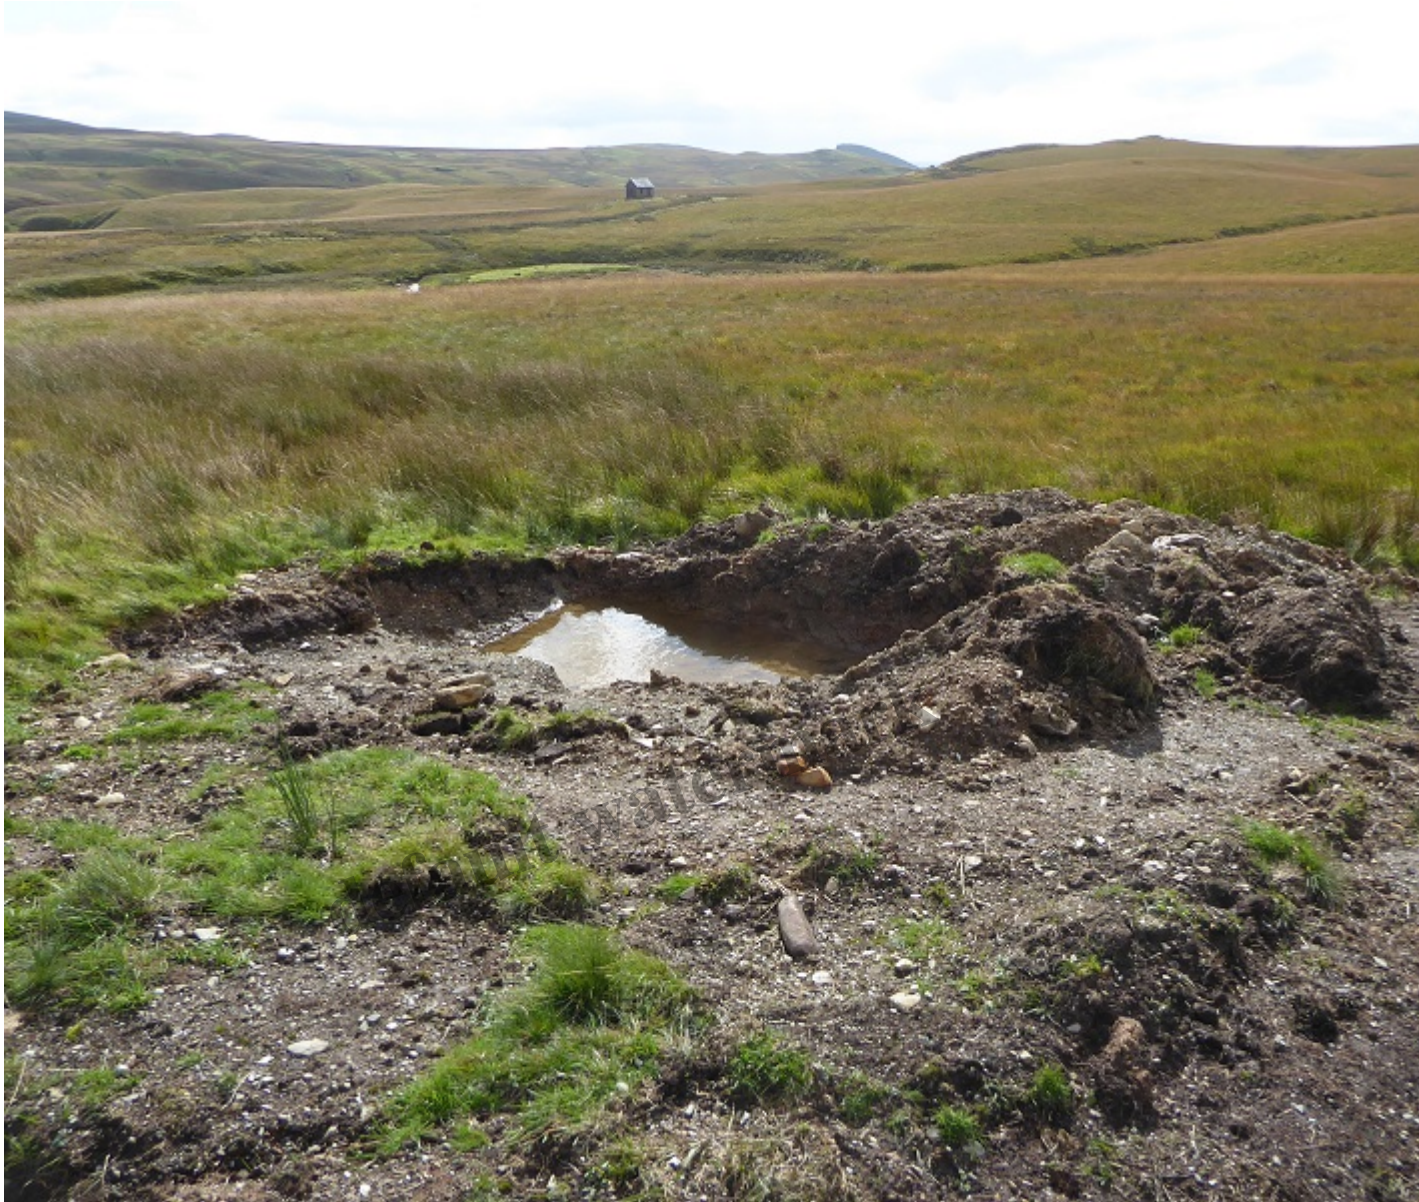
Hole by pipeline to secondary intake – again work in progress?? – with the former Scottish Water pip building behind

This is all relatively small stuff, snagging if you like, but should have been very easy to sort out. If this is such an excellent example of partnership working, why hasn't the LLTNPA lifted the phone to the Drummond Estates, who own the land, and the developer and got them to sort this out? If I had been the Director of Planning I would have damn well made sure it was all sorted BEFORE the submission for a planning award. Its typical of the brass neck of those in charge of the LLTNPA that they put themselves in for this award without bothering to sort any of this – its very hard not to draw the conclusion that they simply don't care. That's not good for people who are supposed to be the custodians of our National Park.

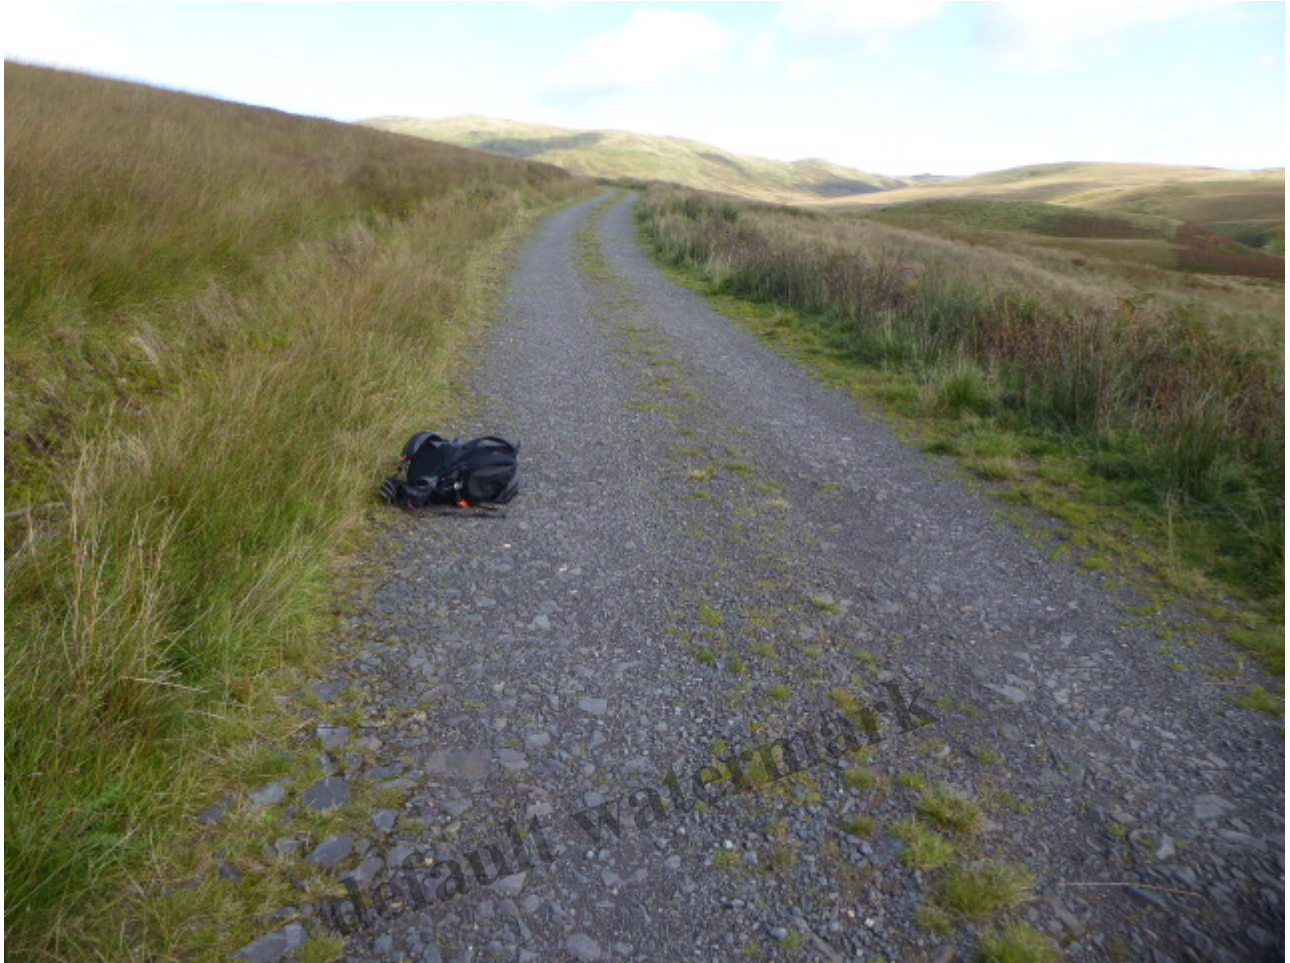
This straight section of track is wider than necessary, about 2.5m – contrary to the planning condition which I think was right

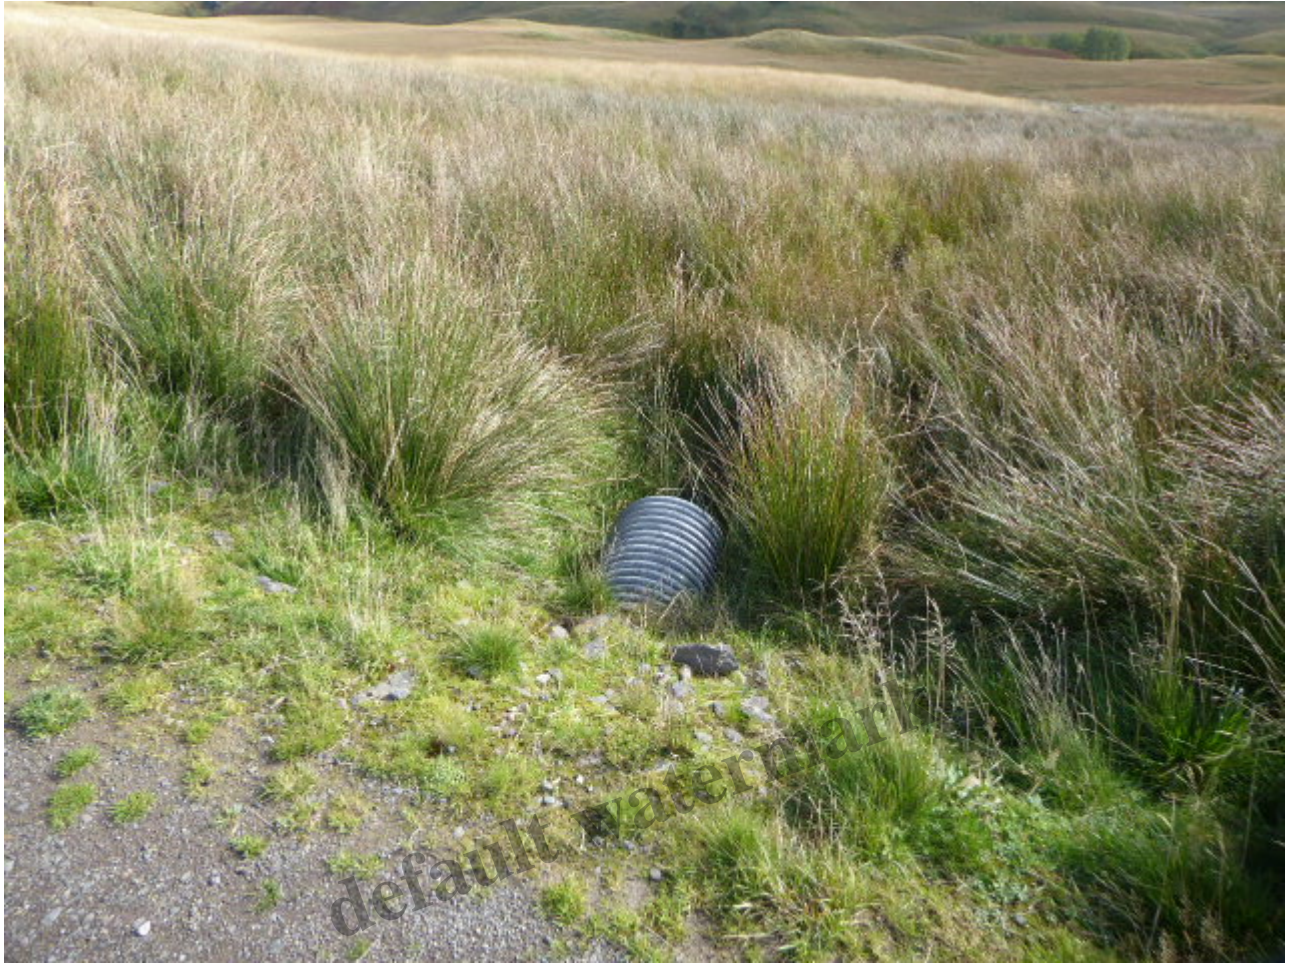
While most of the new culverts had been hidden, this one wasn't

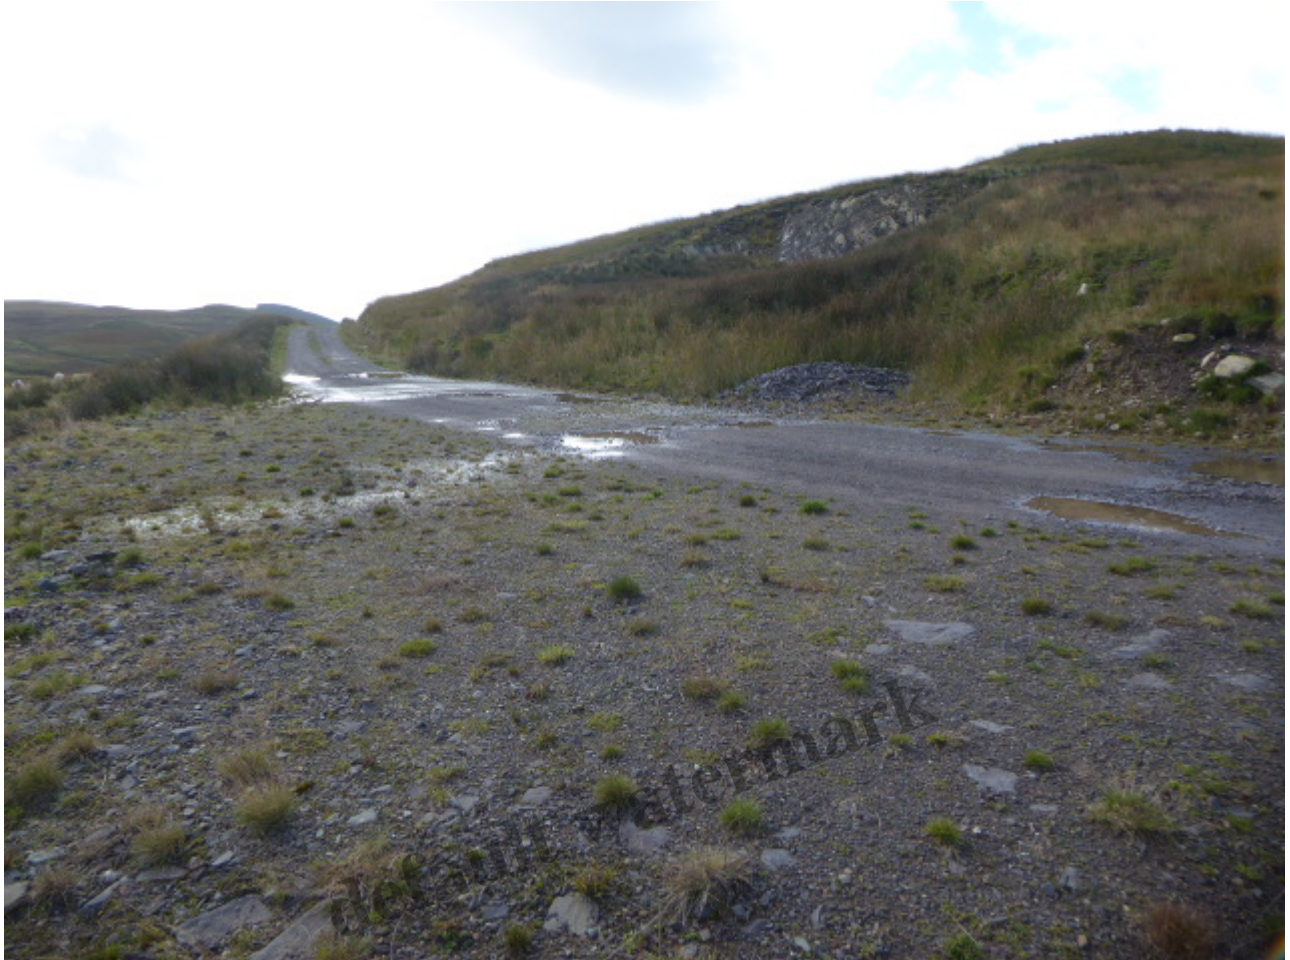
Unrestored ground with heap of aggregate behind and only partially restored borrow pit behind.

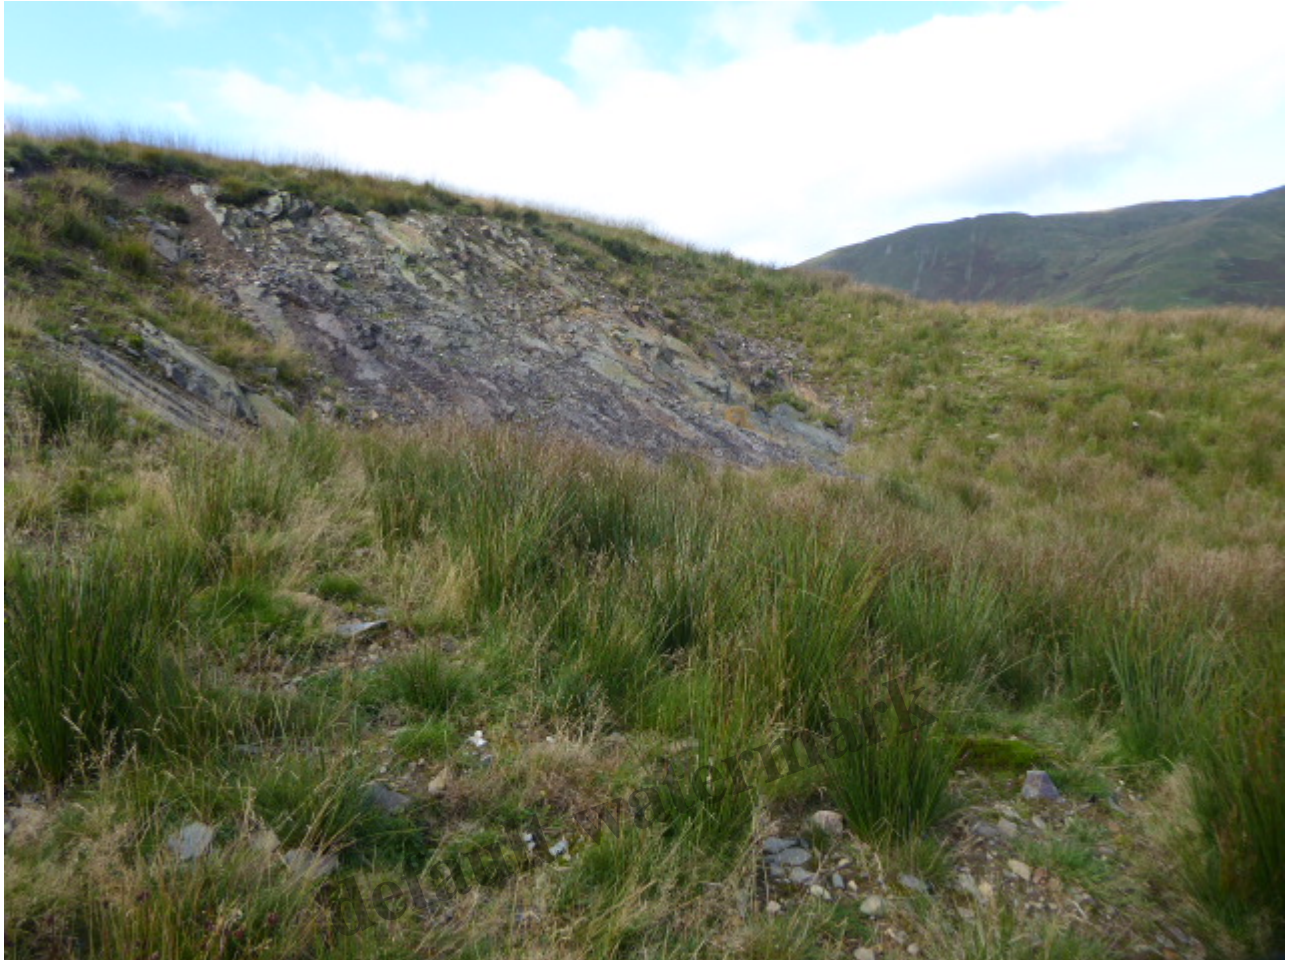
Unrestored section of borrow pit – note how soft rush has colonised and now dominates the ground which has been restored. LLTNPA officers wrote a further delegated report ([see here](#)) agreeing another borrow pit could be retained because sand martins had started to nest there, so on what basis has LLTNPA agreed with the estate that this section of ground need not be restored?

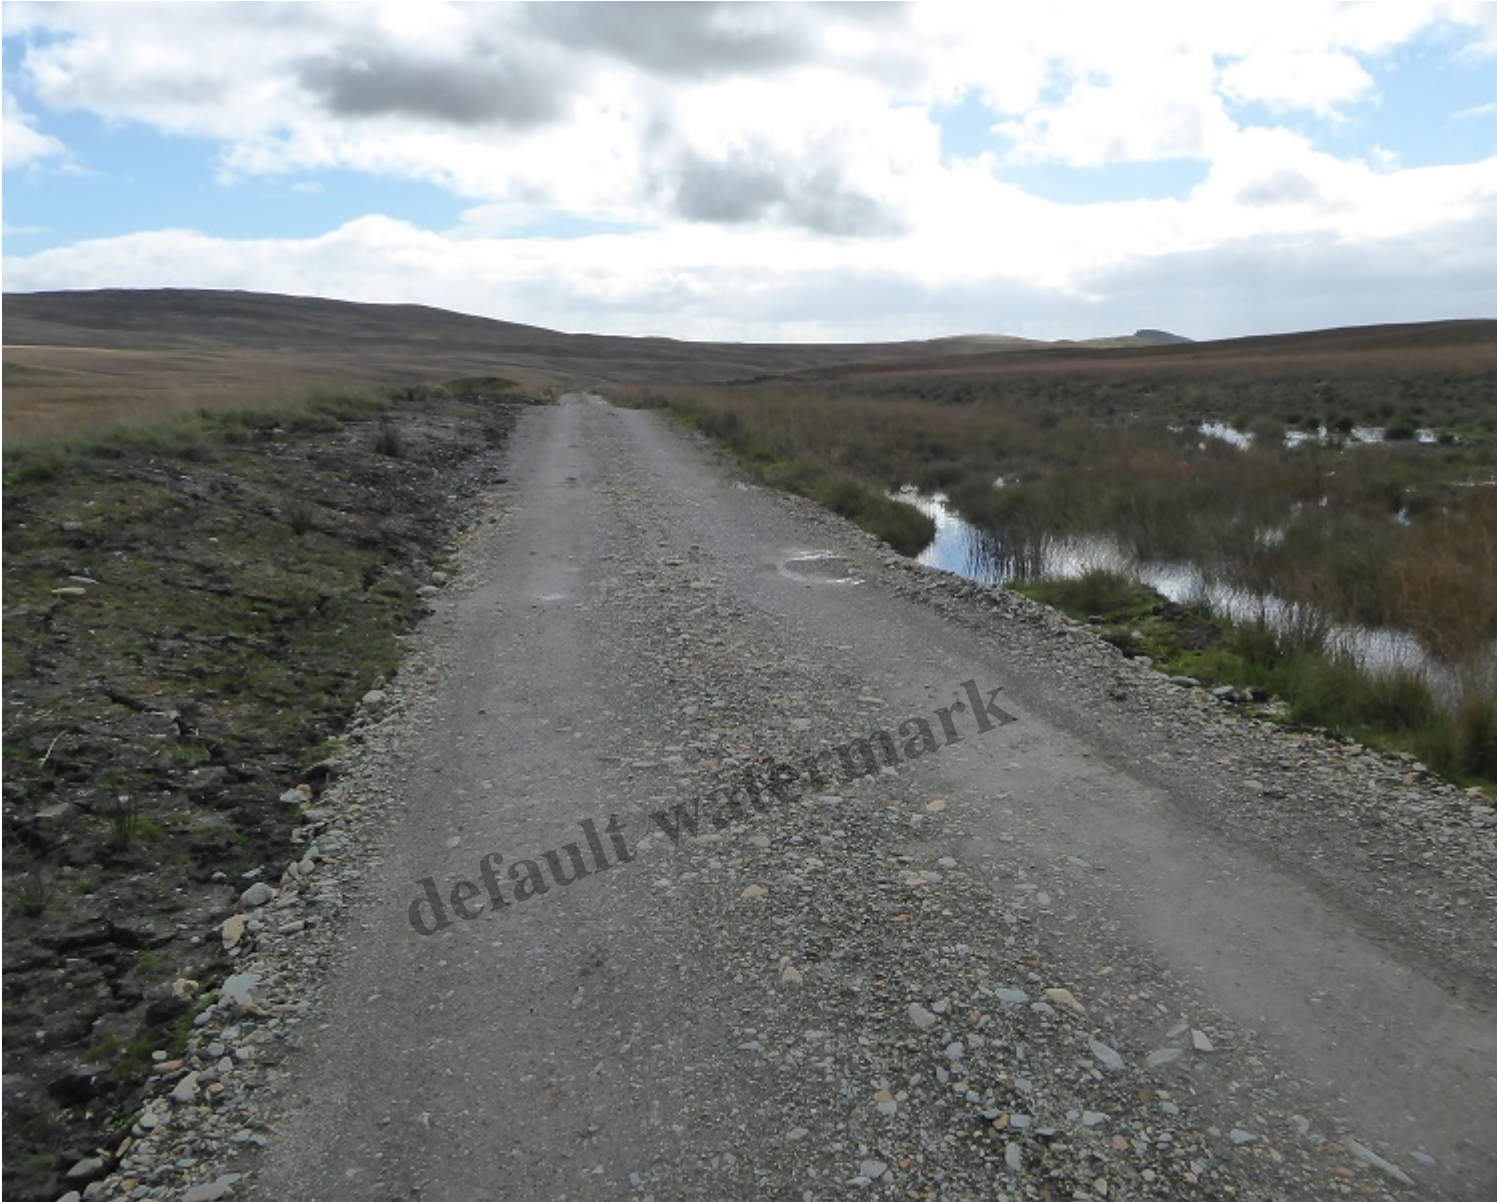
Its not just that the new section of track is more than the 2m stipulated, the track itself appears to have altered the drainage, making the area on the right where the pipeline is buried even wetter, while rush now dominates the vegetation.

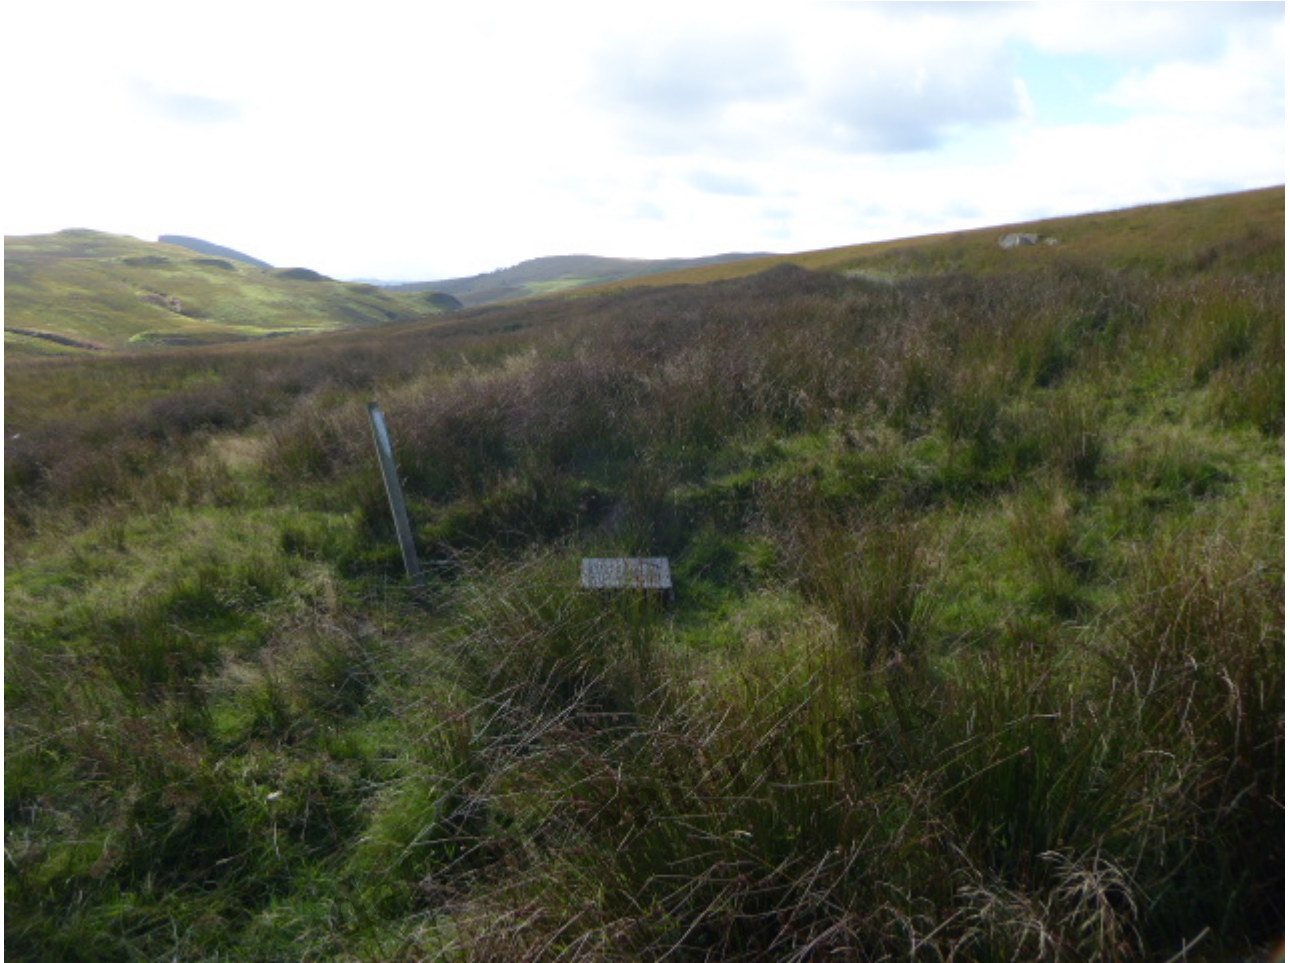
Swathe of soft rush forming a dark band along the top the ground where the pipeline construction took place

On Saturday I was puzzling about how the band of soft rush marking the new pipeline fitted with other areas of rush and then it clicked: the other areas of extensive rush below the new pipe mark the construction of the former Scottish Water pipeline. The rush therefore appears likely to become a more or less permanent landscape and ecological feature. It really is time that that some proper research on the long-term vegetation impacts of hydro schemes was commissioned and our National Parks could be taking a lead on this.

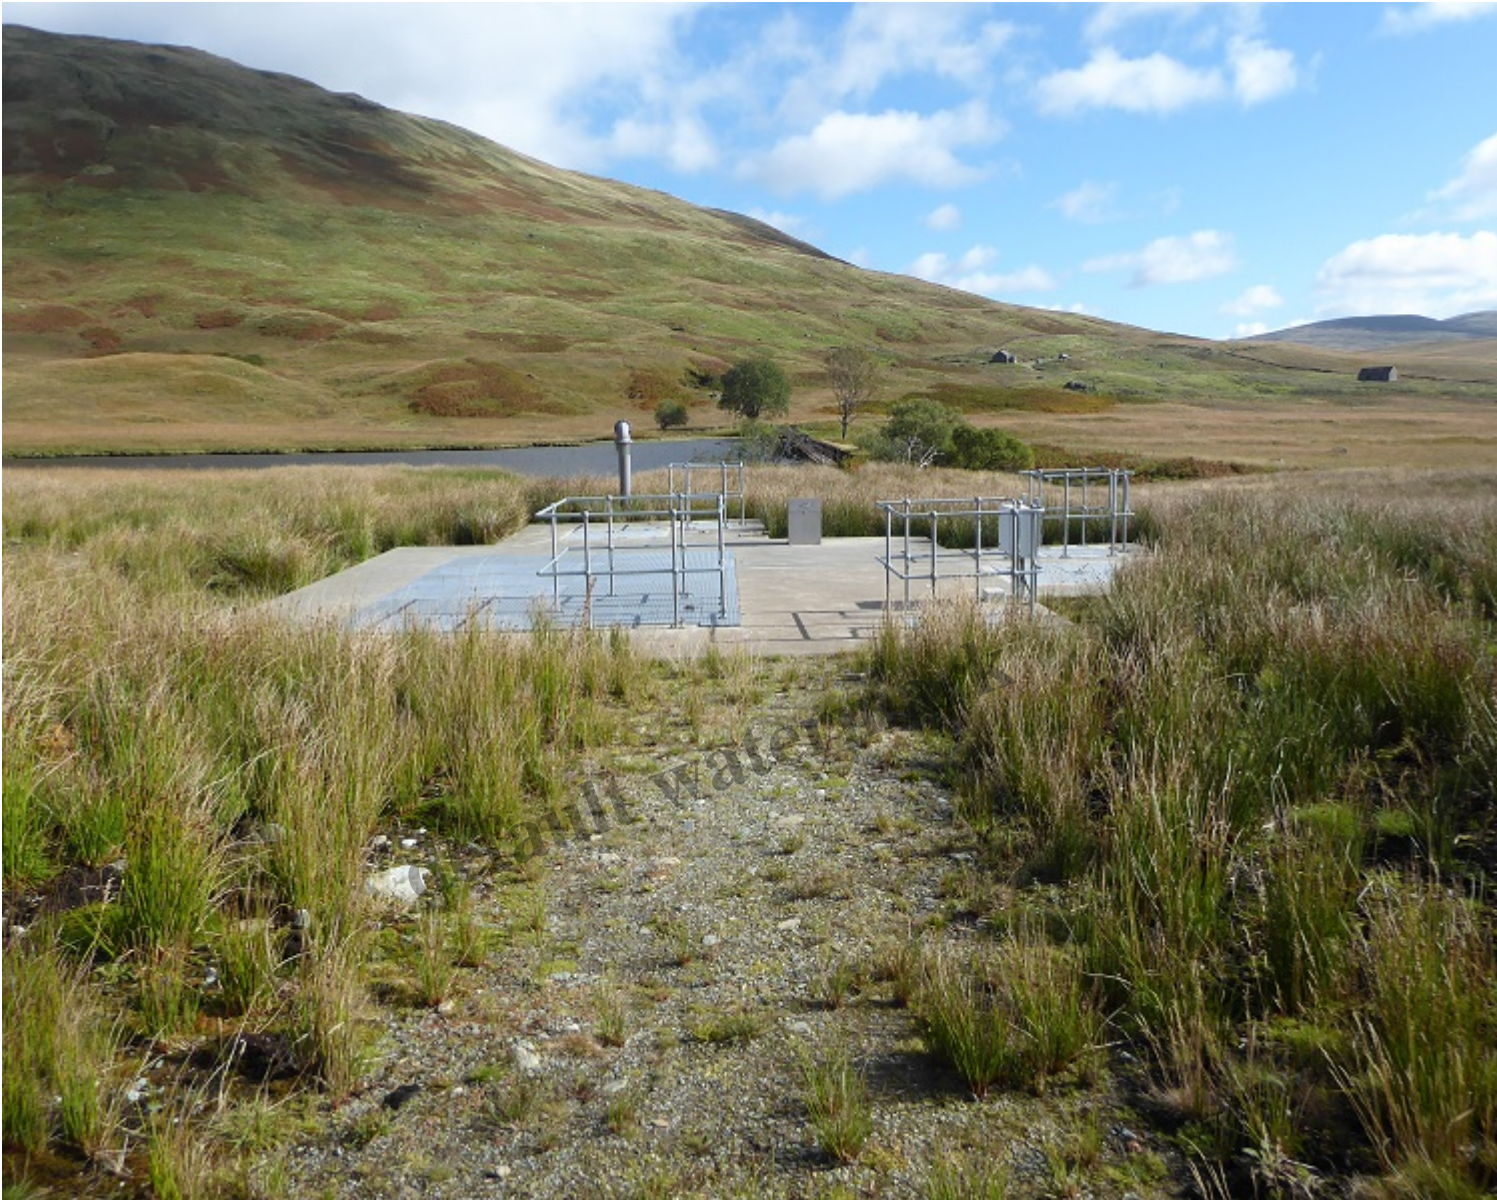
While the buried intake tank at the main intake is ugly from close up (could it not have been screened by a stone wall?) the new structure is far less intrusive visually than the original plans as a result of the water being abstracted by a pipe from the middle of the reservoir. An innovative solution that could possibly be used in other cases where there are large intake pools.

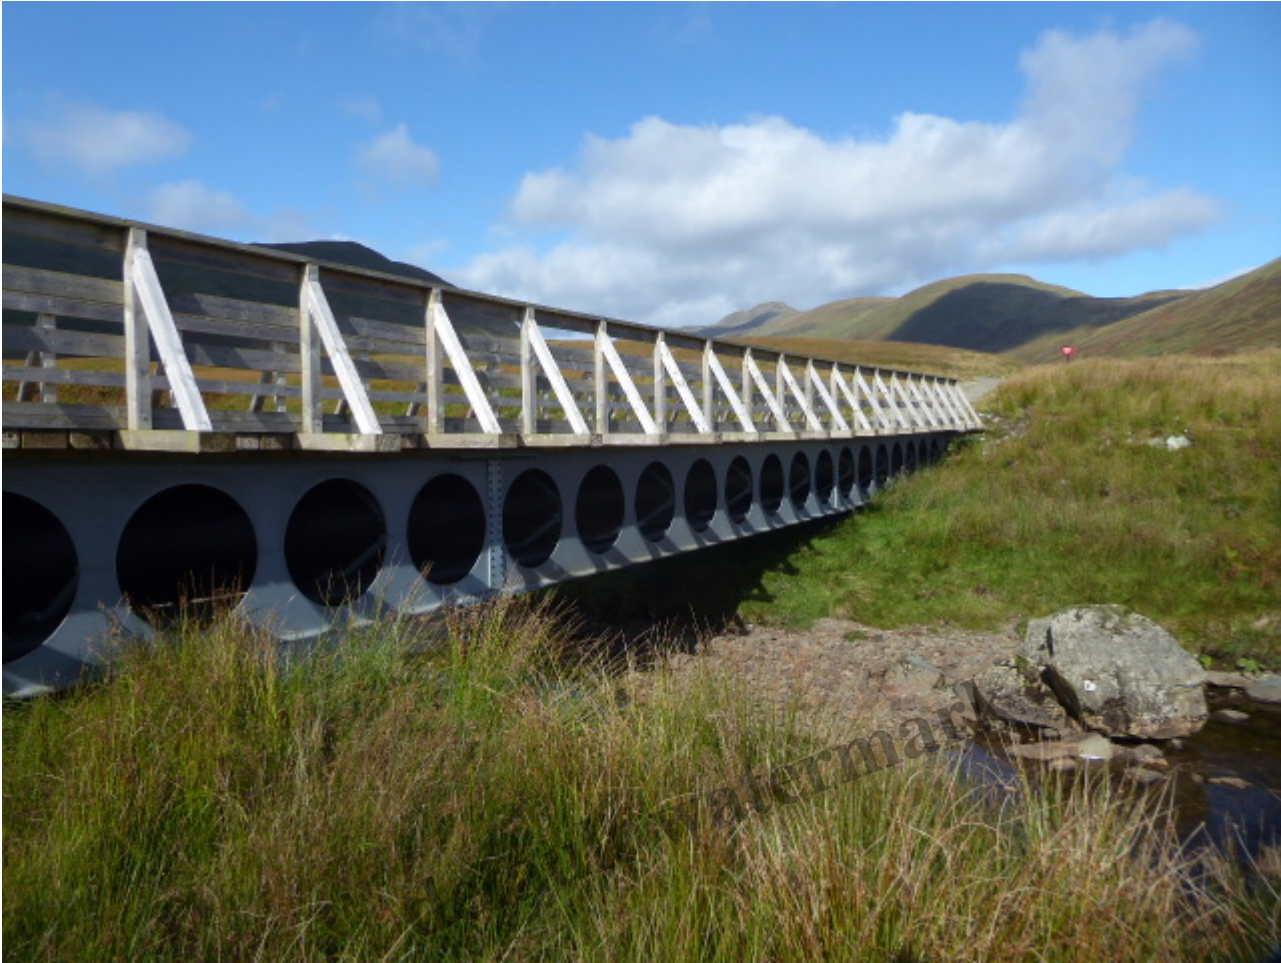
It was also good to see the Park's own guidance being followed with the pipeline well concealed below the first bridge. While this and the second bridge which replaced the one swept away in 2004 has made access easier for walkers – the track is part of the core path network – I am sceptical about the LLTNPA's claims this was done for walkers. On my visit I spotted six estate vehicles which had used the bridges – the most I have ever seen – and I suspect the estate's primary motivation for installing the bridges was for estate management rather than recreational purposes.

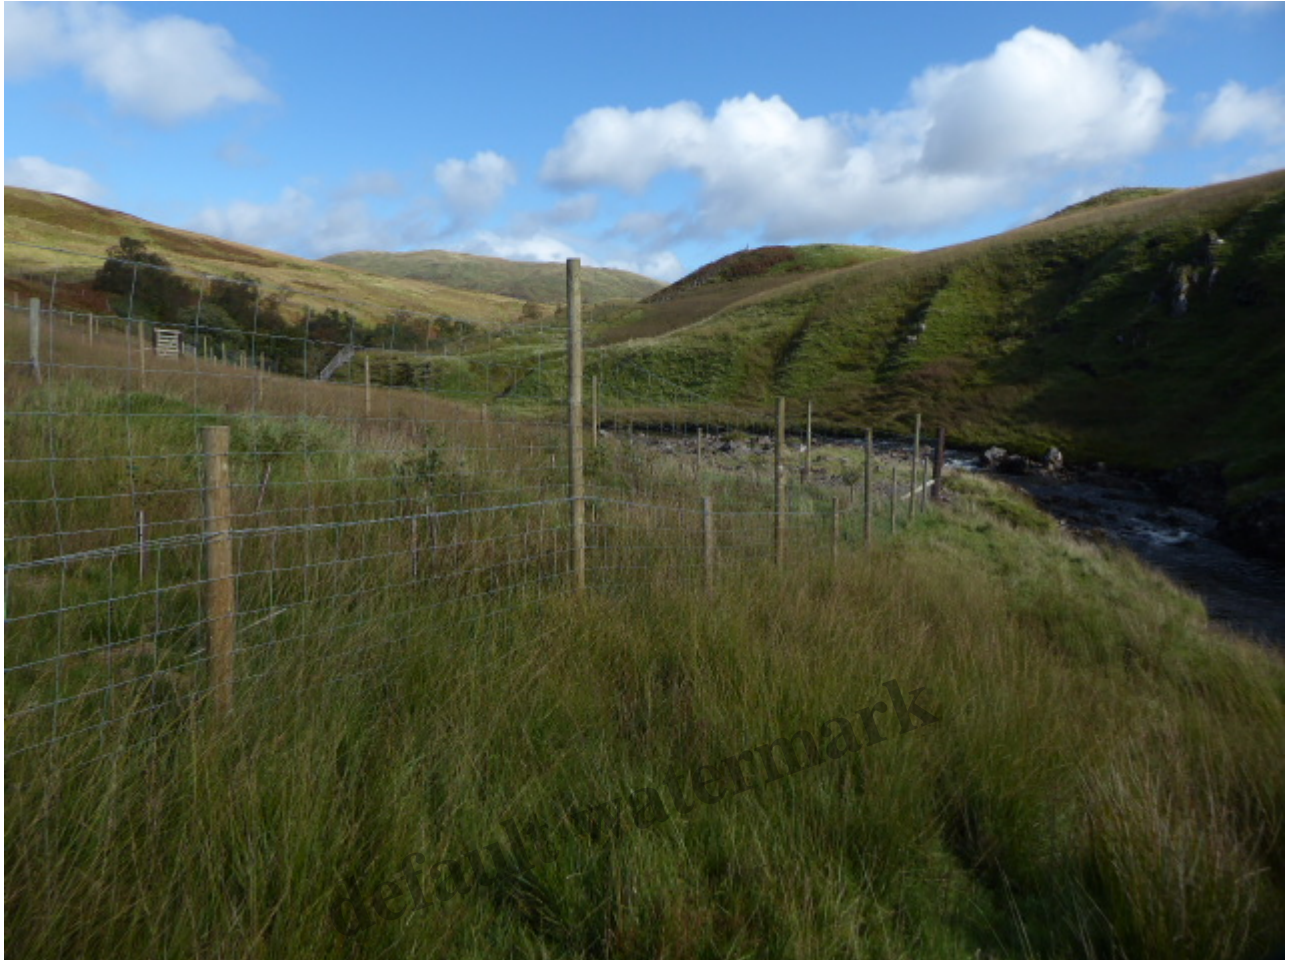
New woodland enclosure north of power house with existing native woodland beyond

As for the small fenced enclosures of new native woodland, which the LLTNPA claims as a success, well that is pretty common in hydro schemes and I think the question the LLTNPA should be asking is whether this is sufficient to justify/compensate for all the rush?
