The Keltie Water hydro scheme and Scottish quality awards for planning

Background to the Keltie Water hydro scheme

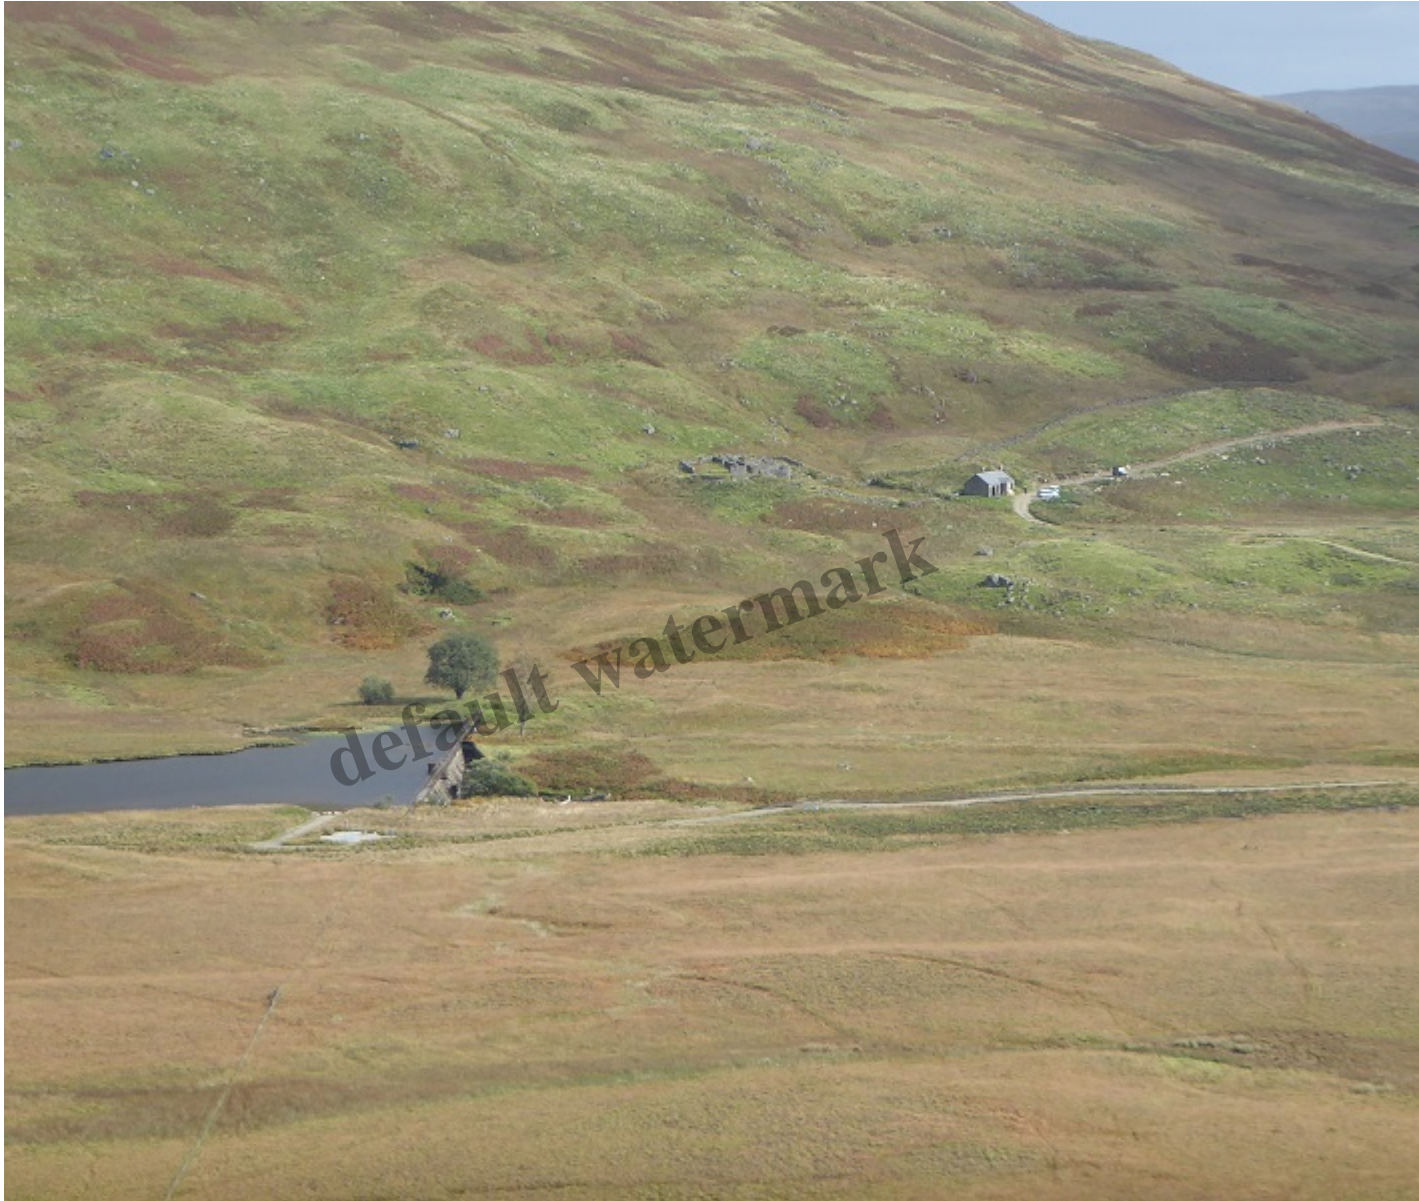
The patch of concrete in front of the dam covers the intake chamber which is now below ground – a of design – and hardly visible from a distance. Note the two vehicles at Arivurichardich.

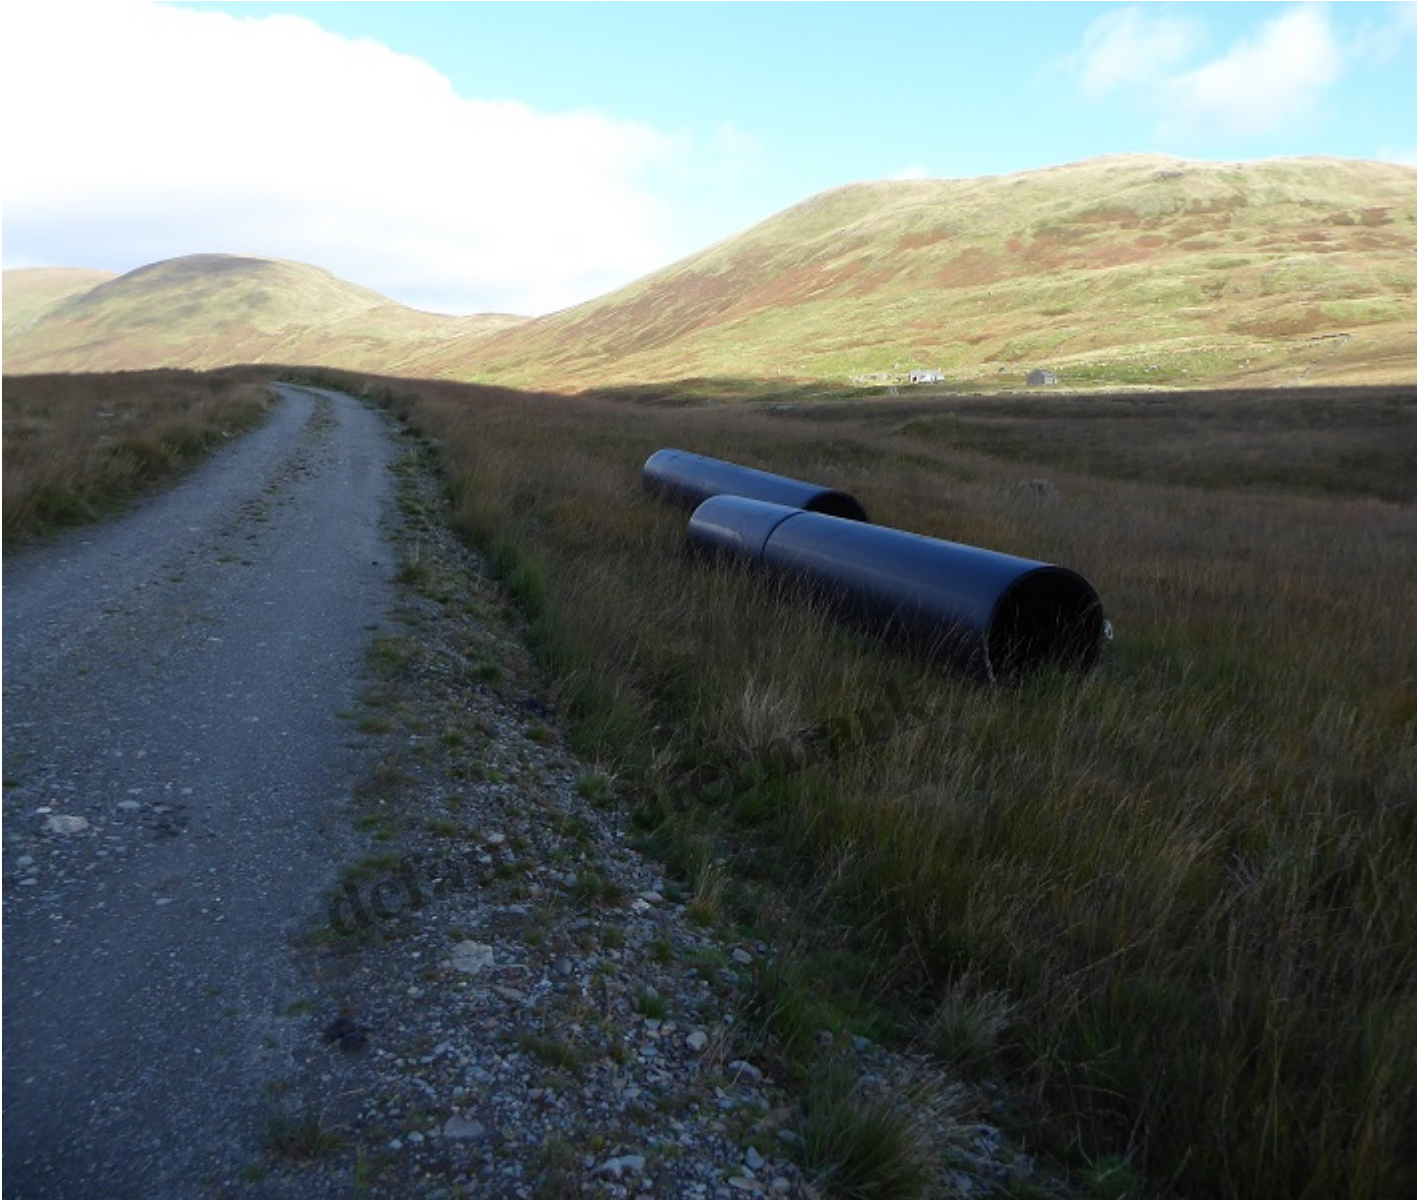
Larger sections of abandoned surplus pipe with Meall Odhar behind – its never called fly tipping when dumped by a landowner.

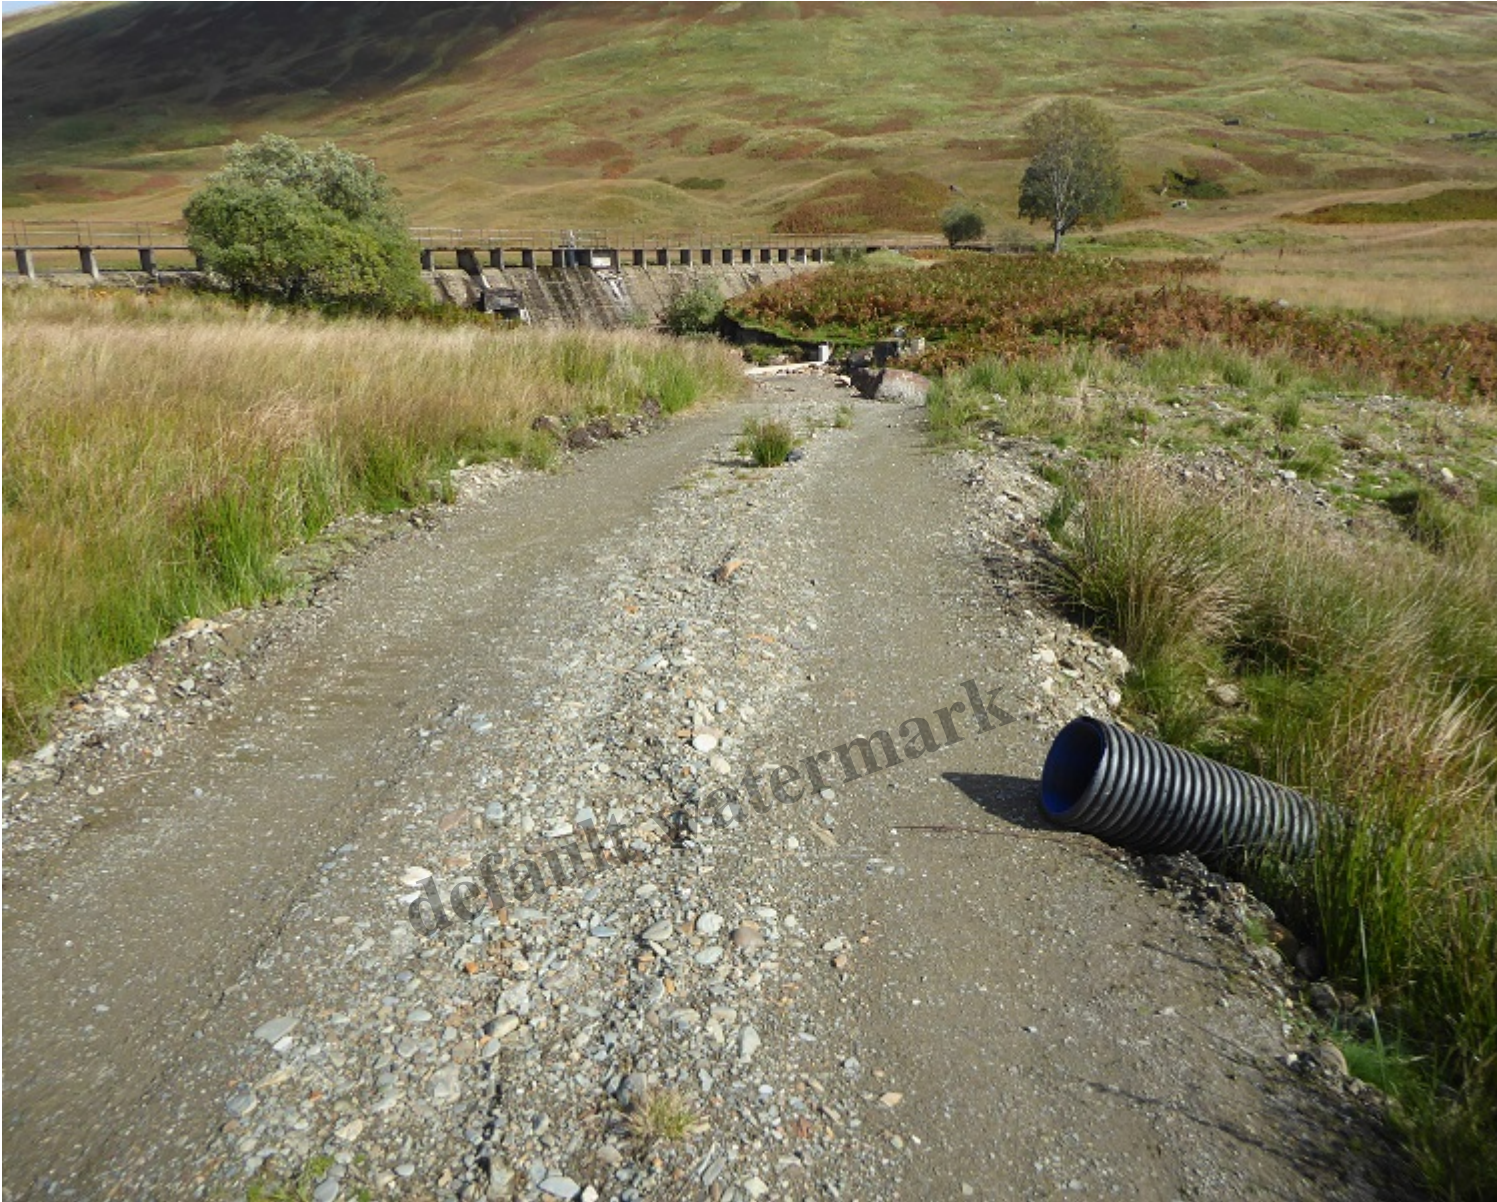
Two years after the hydro opened in 2016 maybe this section of pipe is still work in progress?

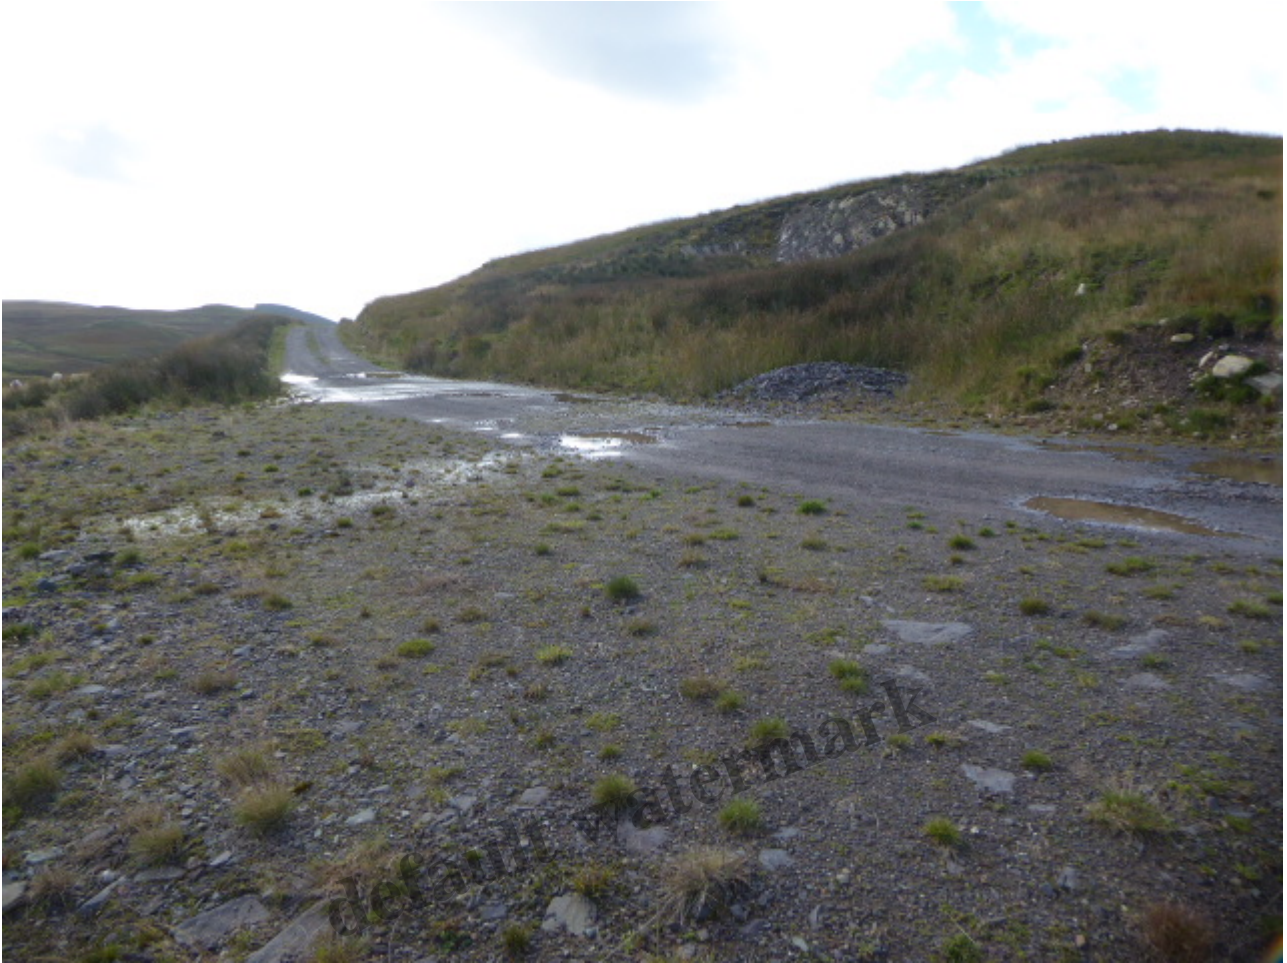
Unrestored ground with heap of aggregate behind and only partially restored borrow pit behind.

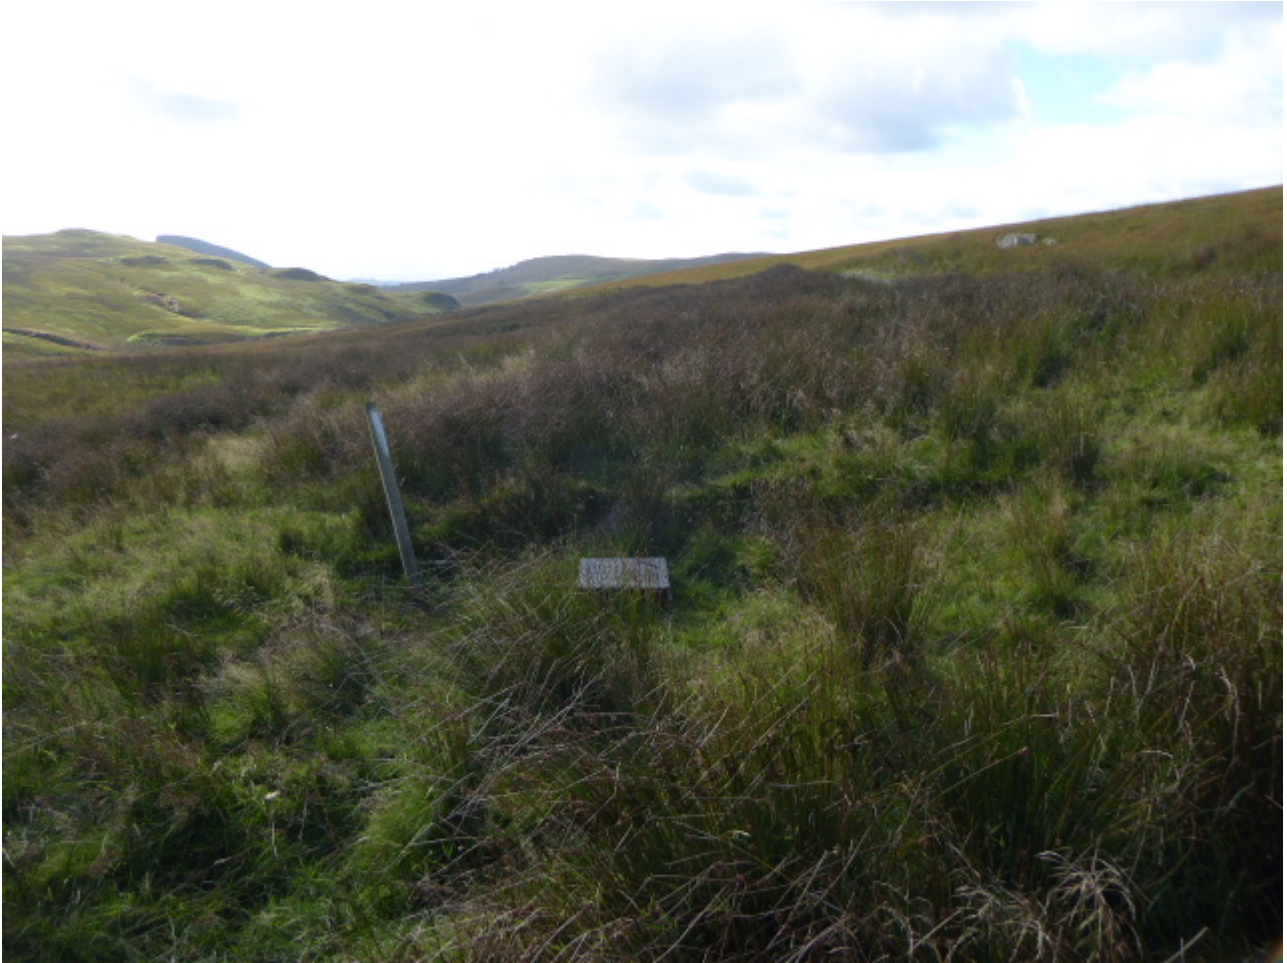
Swathe of soft rush forming a dark band along the top the ground where the pipeline construction took place

On Saturday I was puzzling about how the band of soft rush marking the new pipeline fitted with other areas of rush and then it clicked: the other areas of extensive rush below the new pipe mark the construction of the former Scottish Water pipeline. The rush therefore appears likely to become a more or less permanent landscape and ecological feature. It really is time that that some proper research on the long-term vegetation impacts of hydro schemes was commissioned and our National Parks could be taking a lead on this.
