The Keltie Water hydro scheme and Scottish quality awards for planning

Background to the Keltie Water hydro scheme

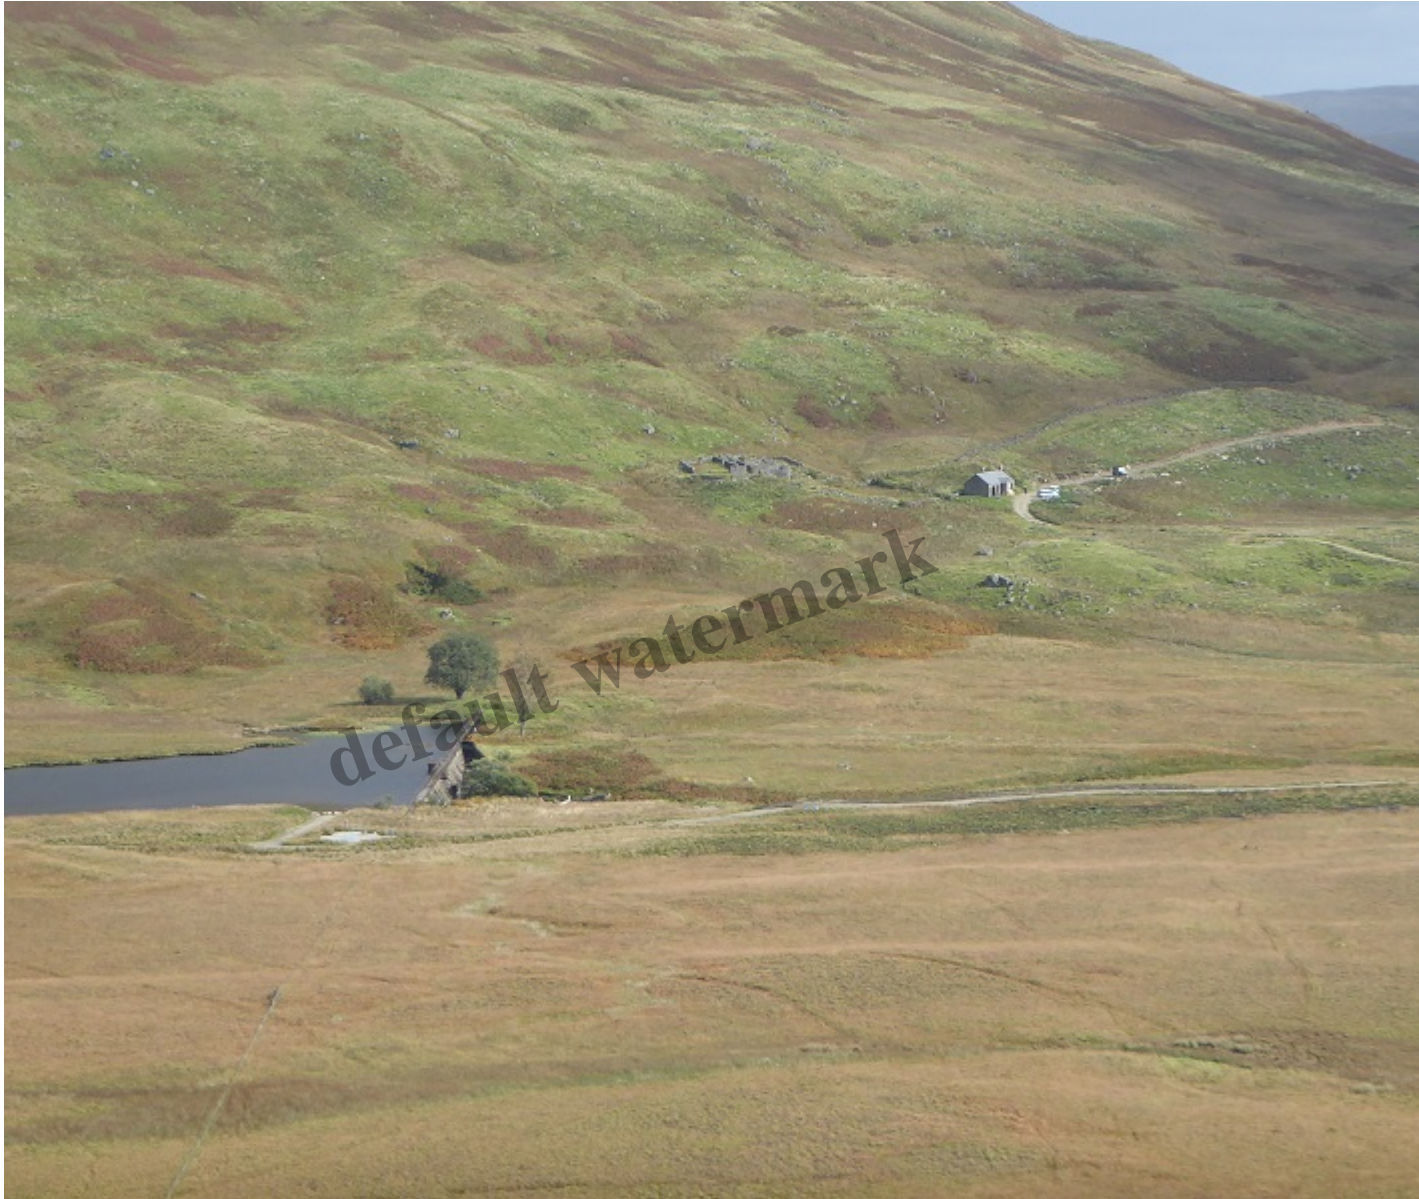
The patch of concrete in front of the dam covers the intake chamber which is now below ground – a of design – and hardly visible from a distance. Note the two vehicles at Arivurichardich.

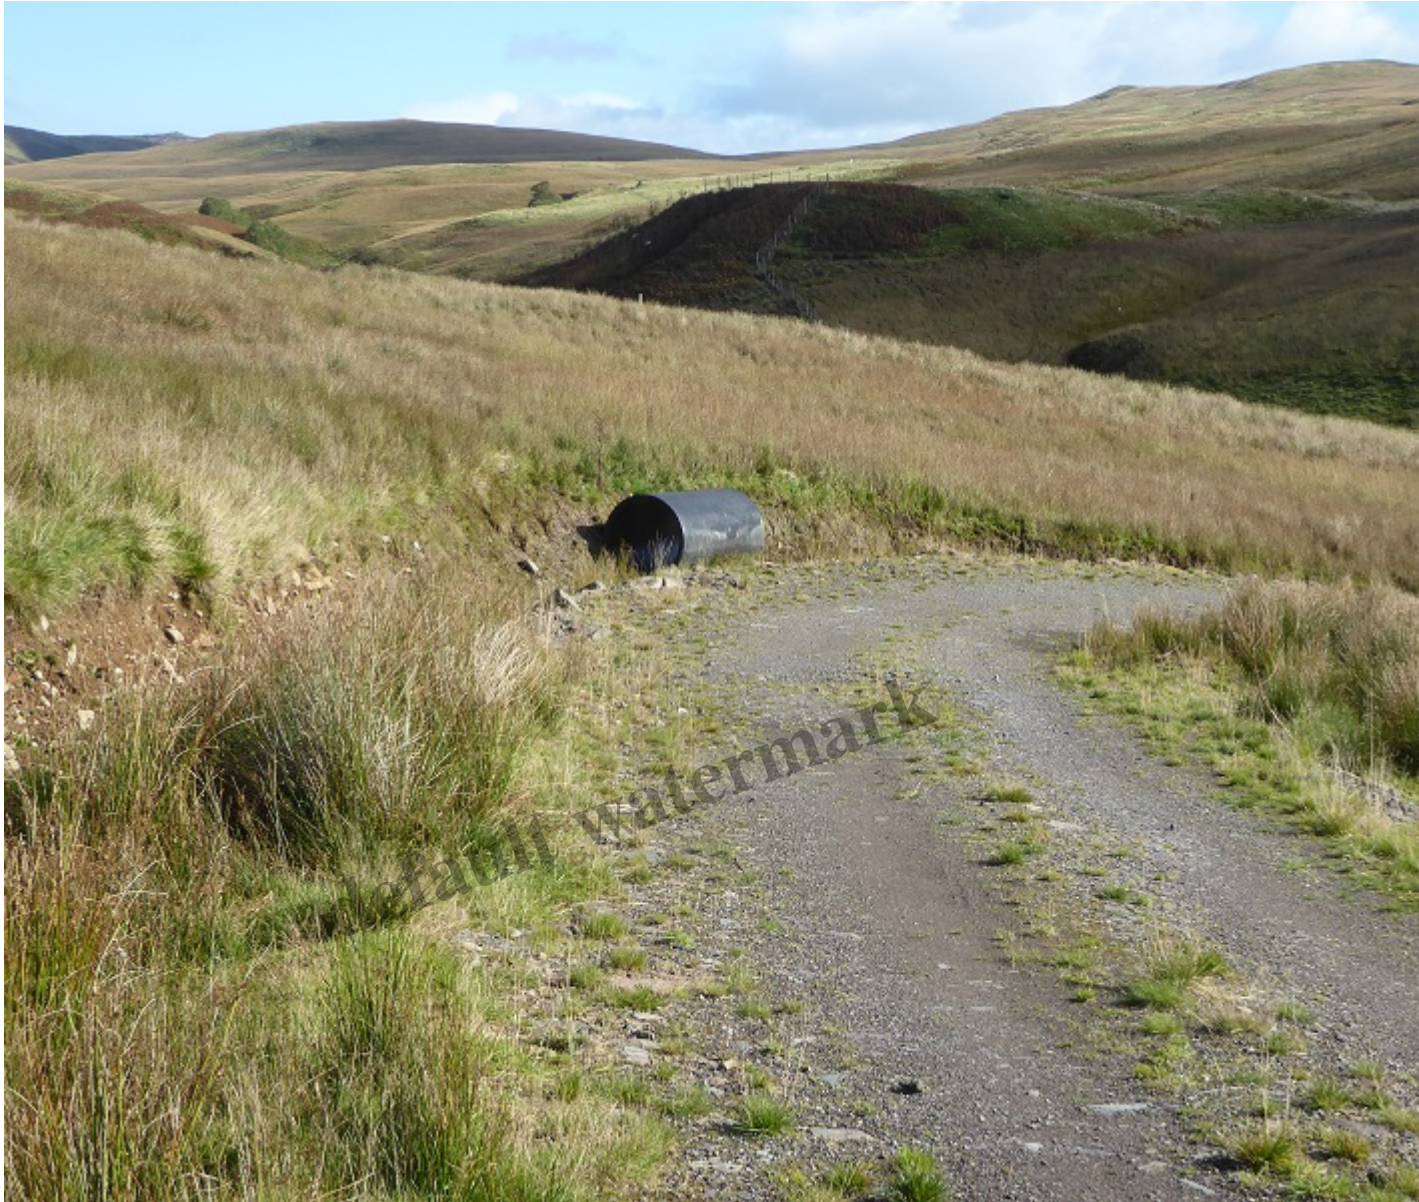
Pipe being used as a drain on access road to power house

They are still there! What's more LLTNPA Park staff must have passed them while filming the video and turned the camera the other way!

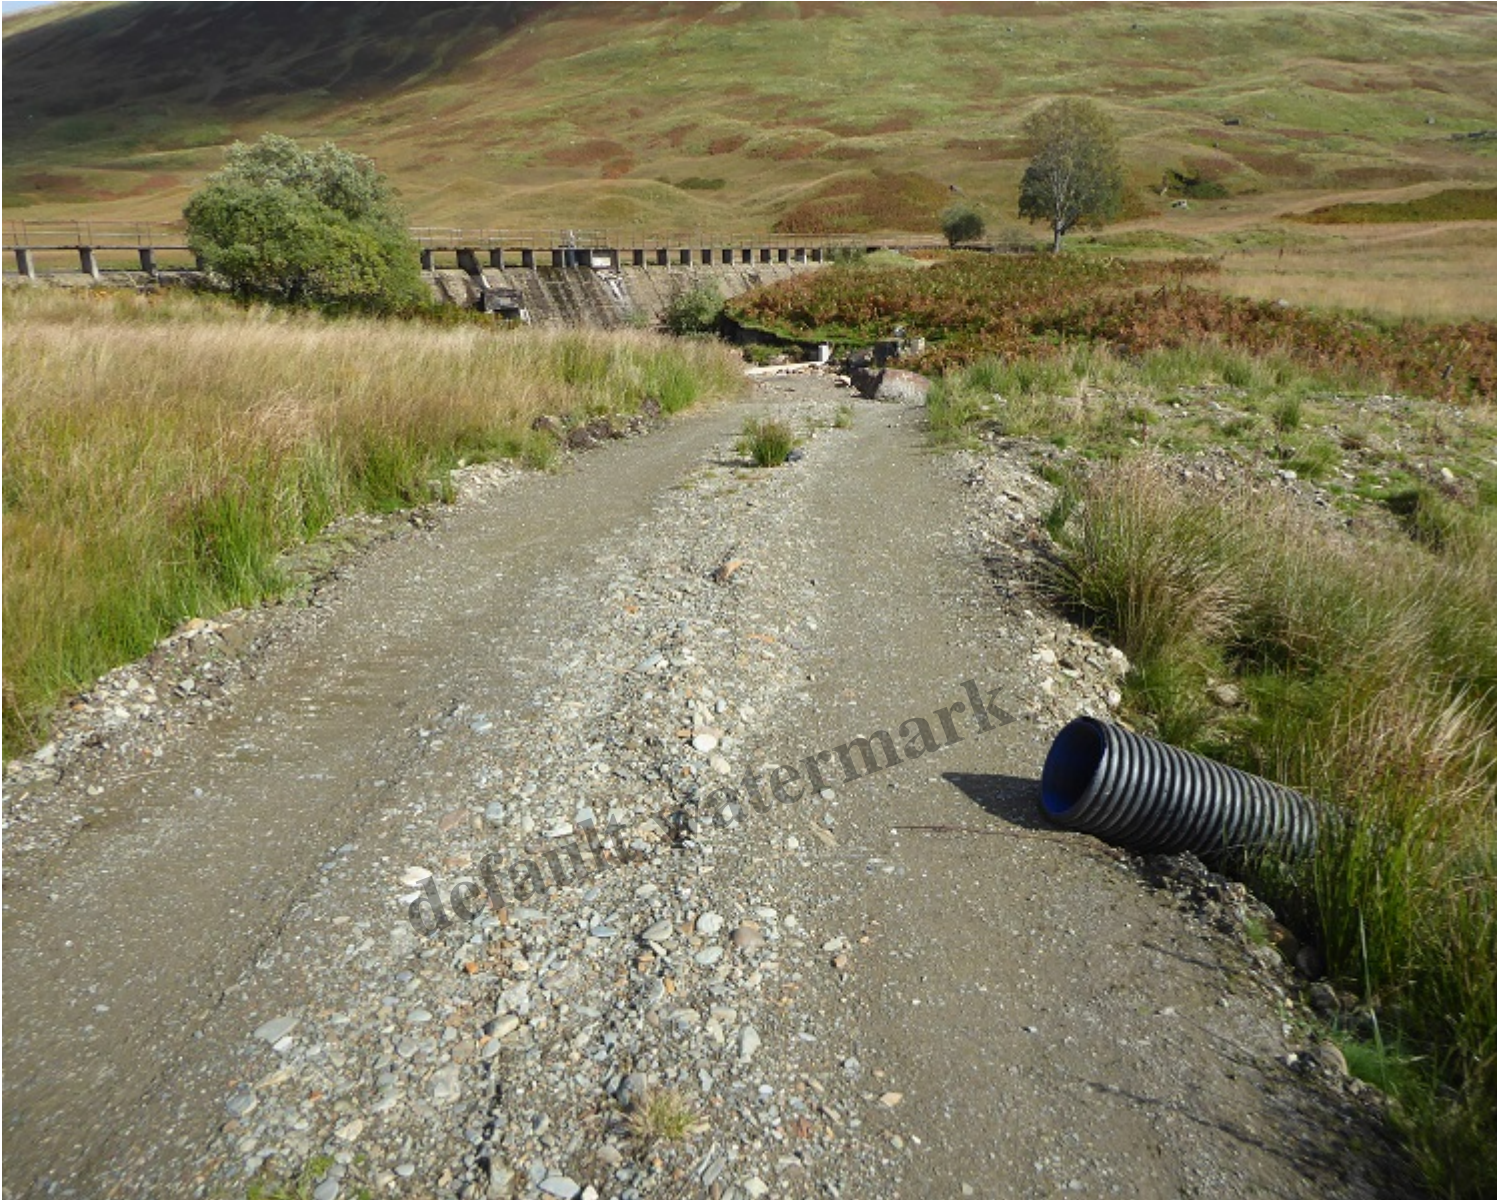
Two years after the hydro opened in 2016 maybe this section of pipe is still work in progress?

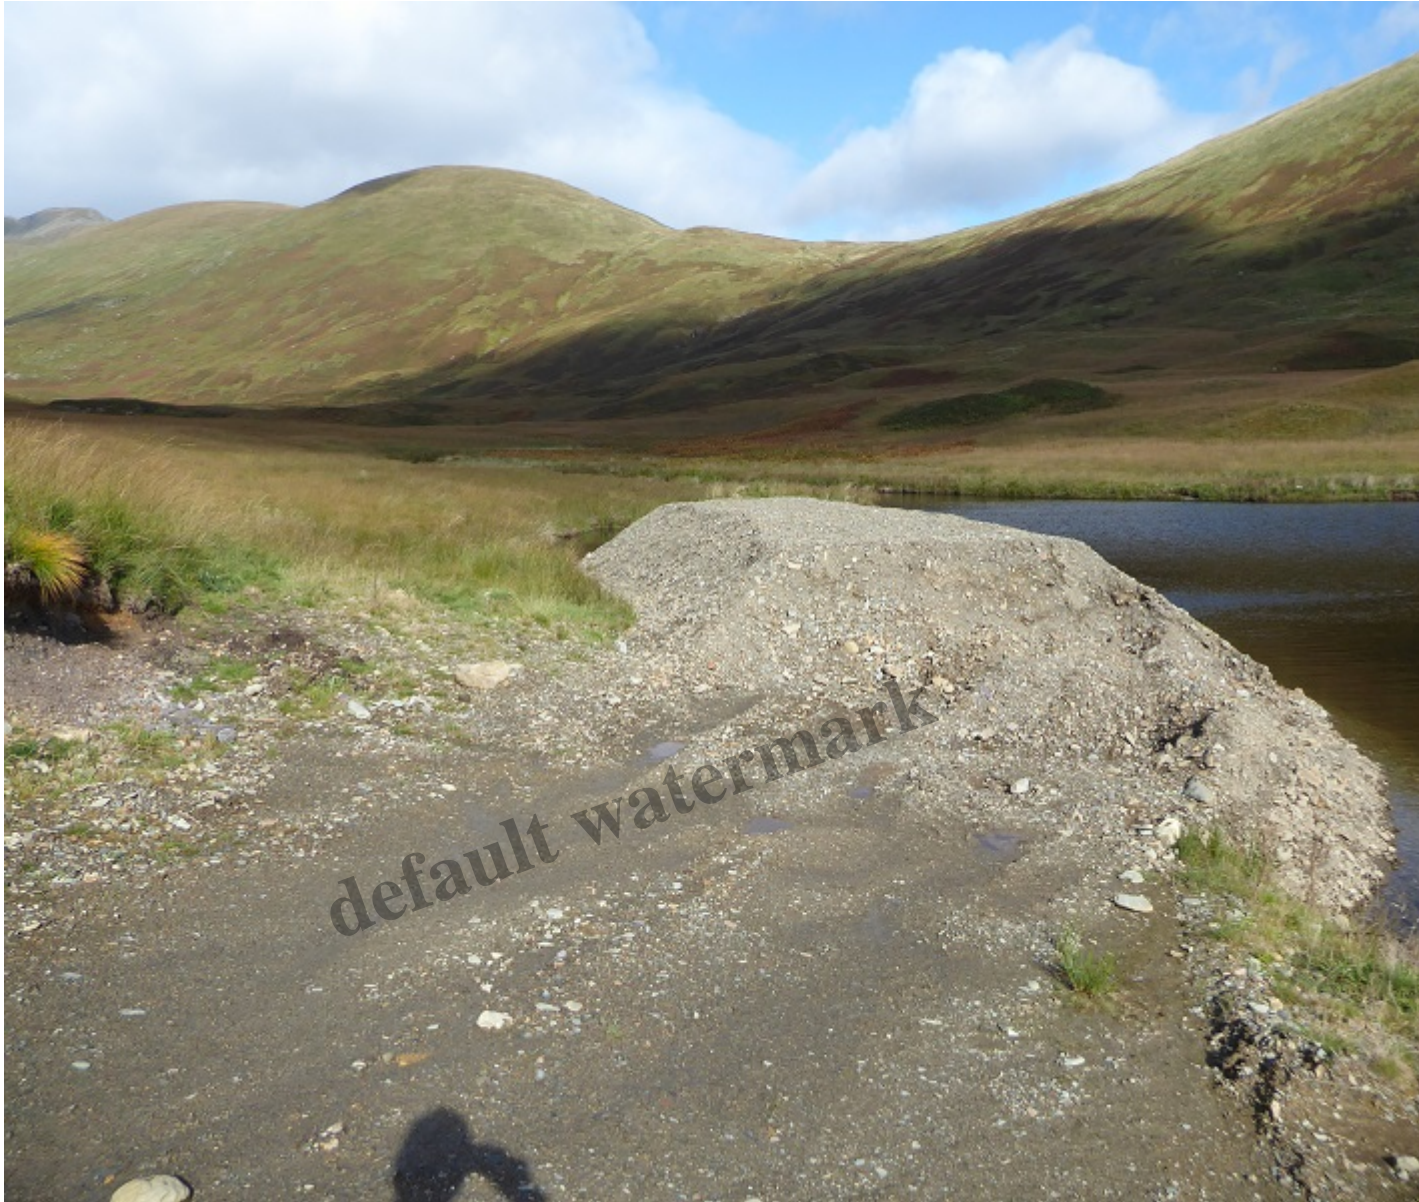
The planning consent allowed gravel to be excavated from the reservoir to construct the new tracks

Or if you want something different how about this large heap of gravel and extension of track beyond the dam which has this been allowed to remain by the reservoir?

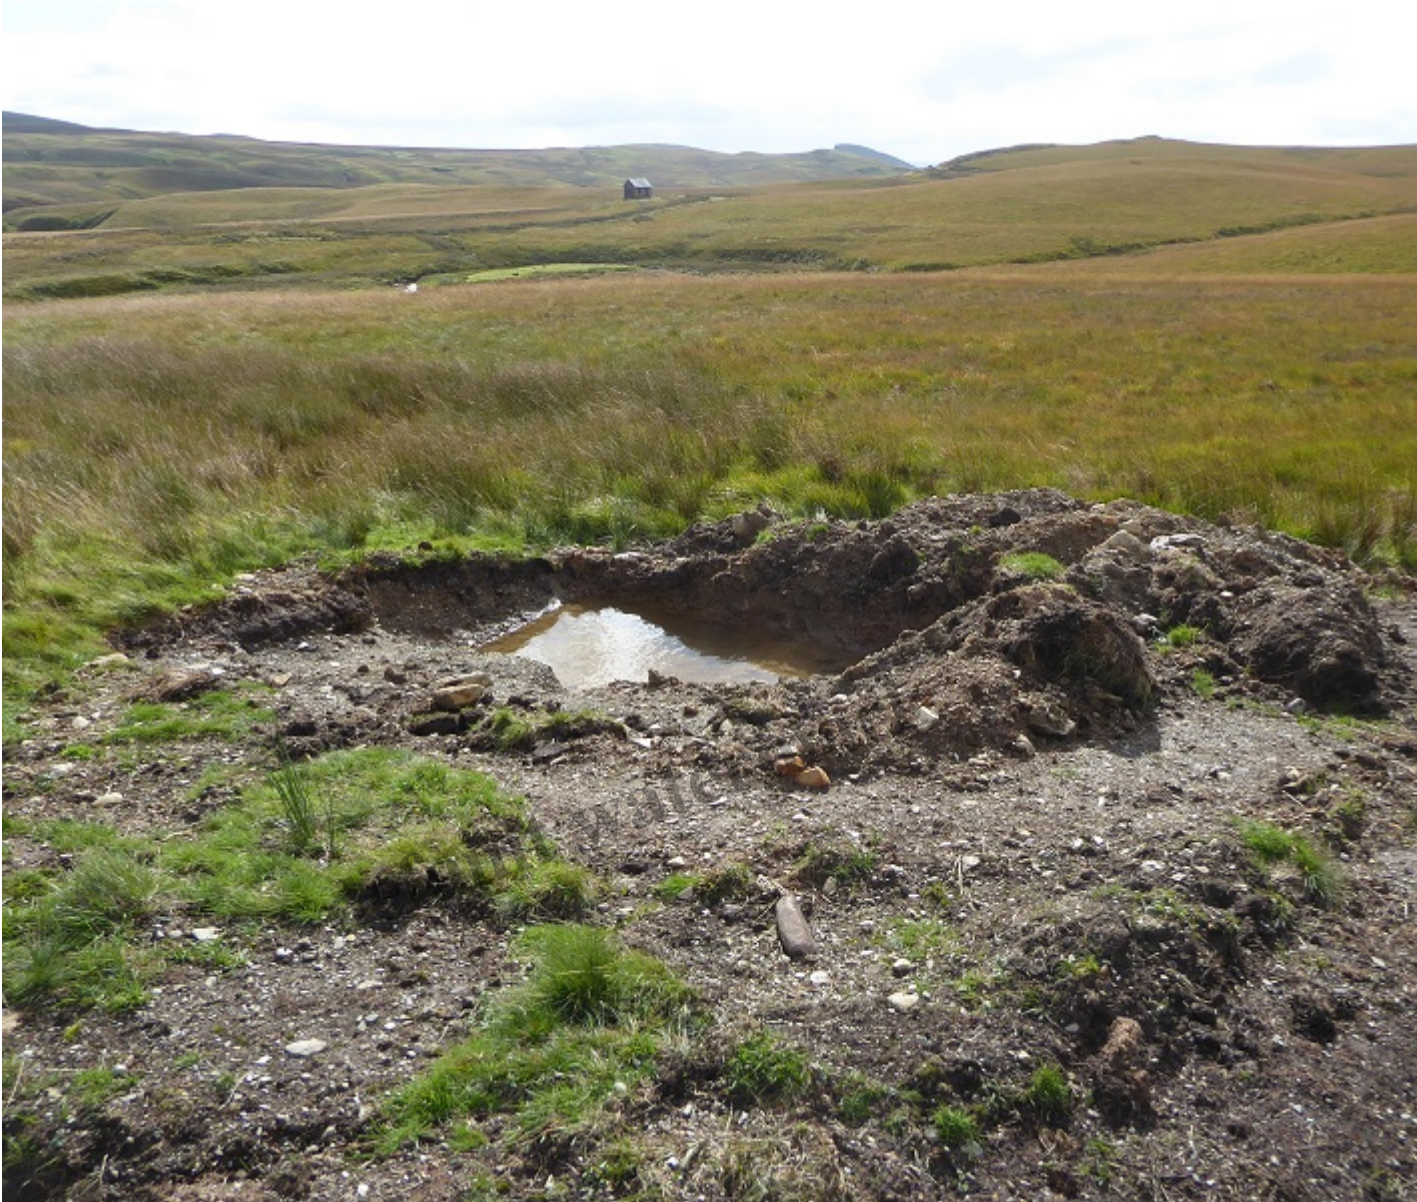
Hole by pipeline to secondary intake – again work in progress?? – with the former Scottish Water pip building behind

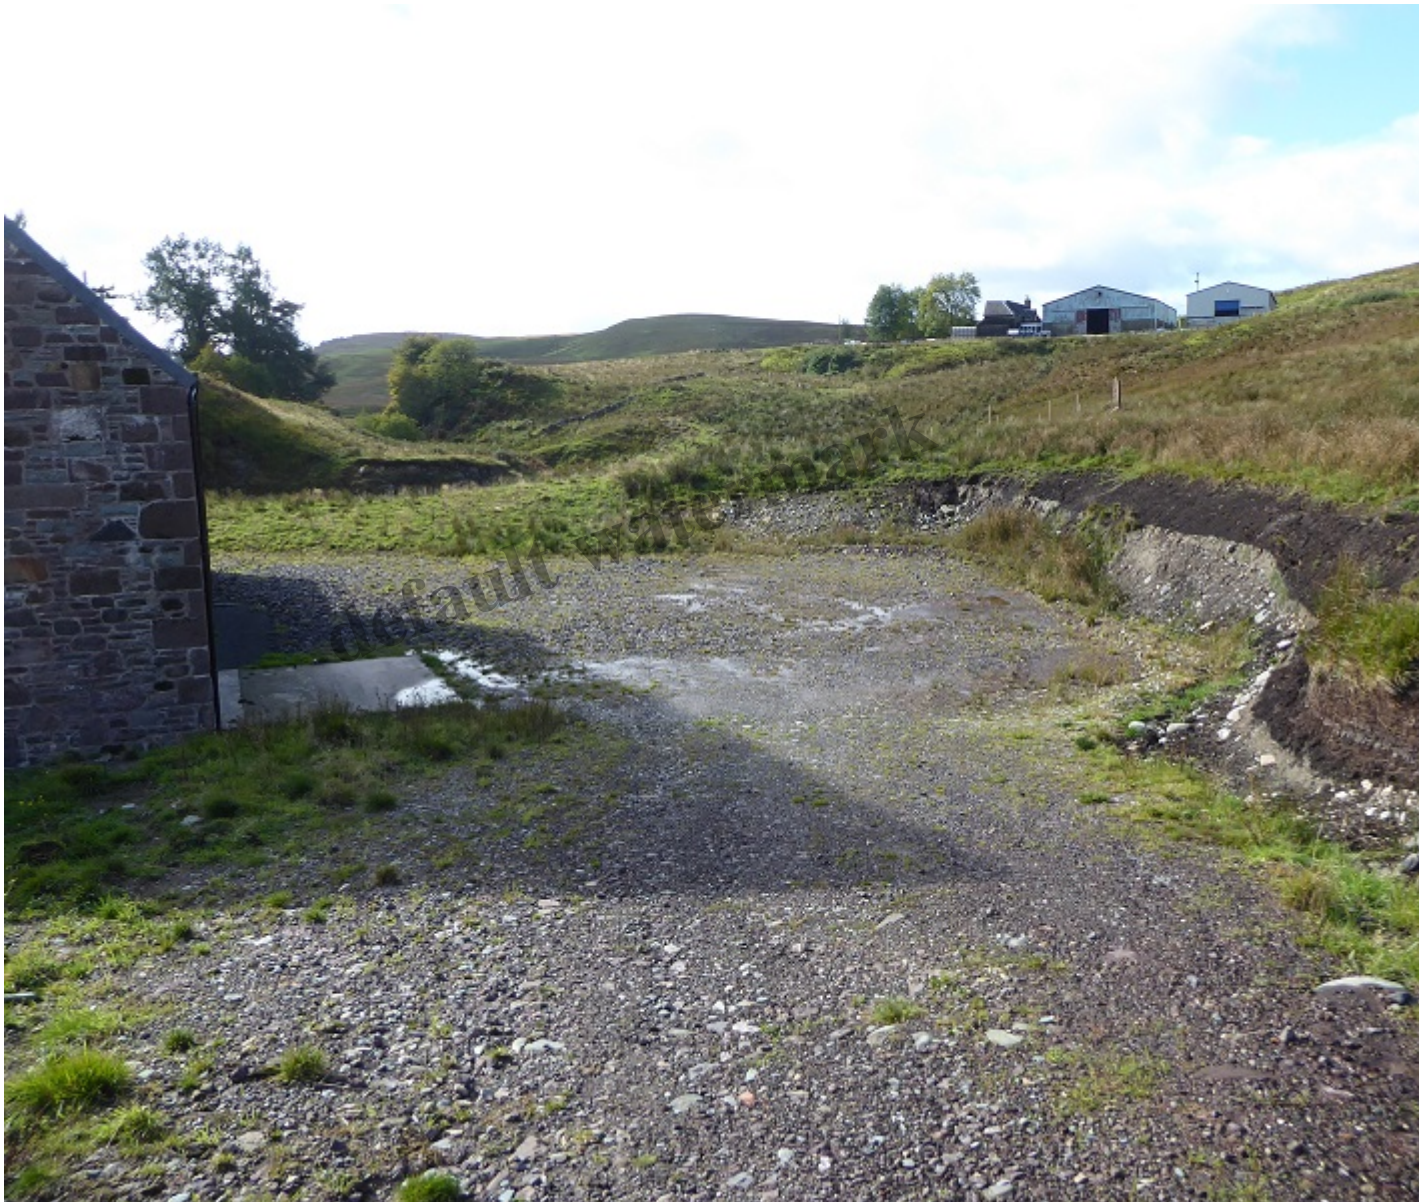
Power house on left, beautifully built and quite a contrast to the farm buildings right, but spoiled by the restoration around it. Note the unrestored peat bank with glacial till below – a good “section” for field students.

The LLTNPA has quoted the location and construction of the power house as one of the quality aspects of the scheme. There is no argument about the power house itself which is beautifully built – like many in the Park – the issue is the surrounding area. While the LLTNPA required trees to be planted round the powerhouse to help conceal it, the turning areas itself appears to have just been left

without any thought about what space was required or how its appearance could be improved. Why is it that our planners and developers can produce good looking buildings but are often so poor at restoring the landscape around?

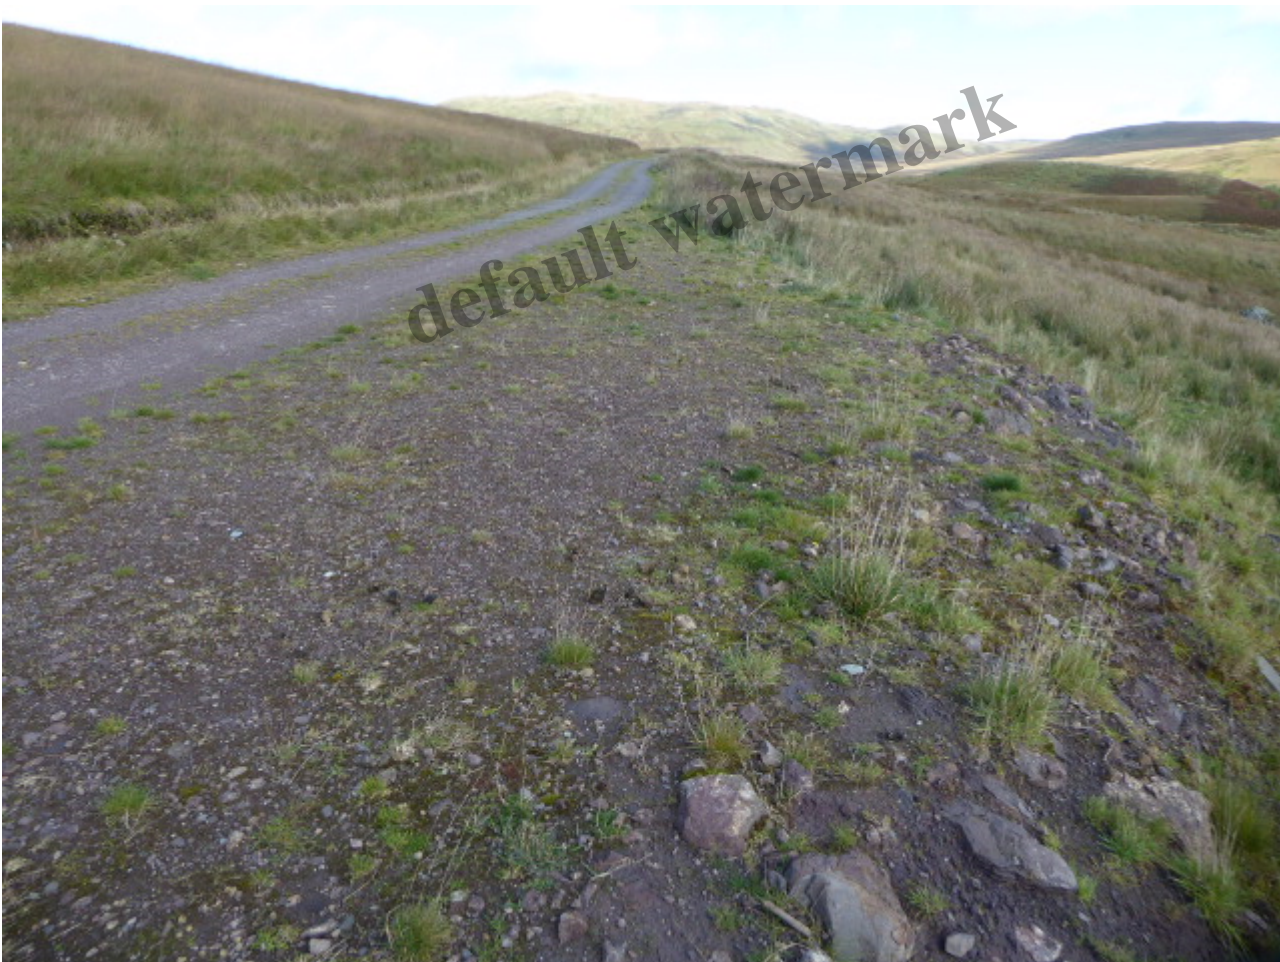
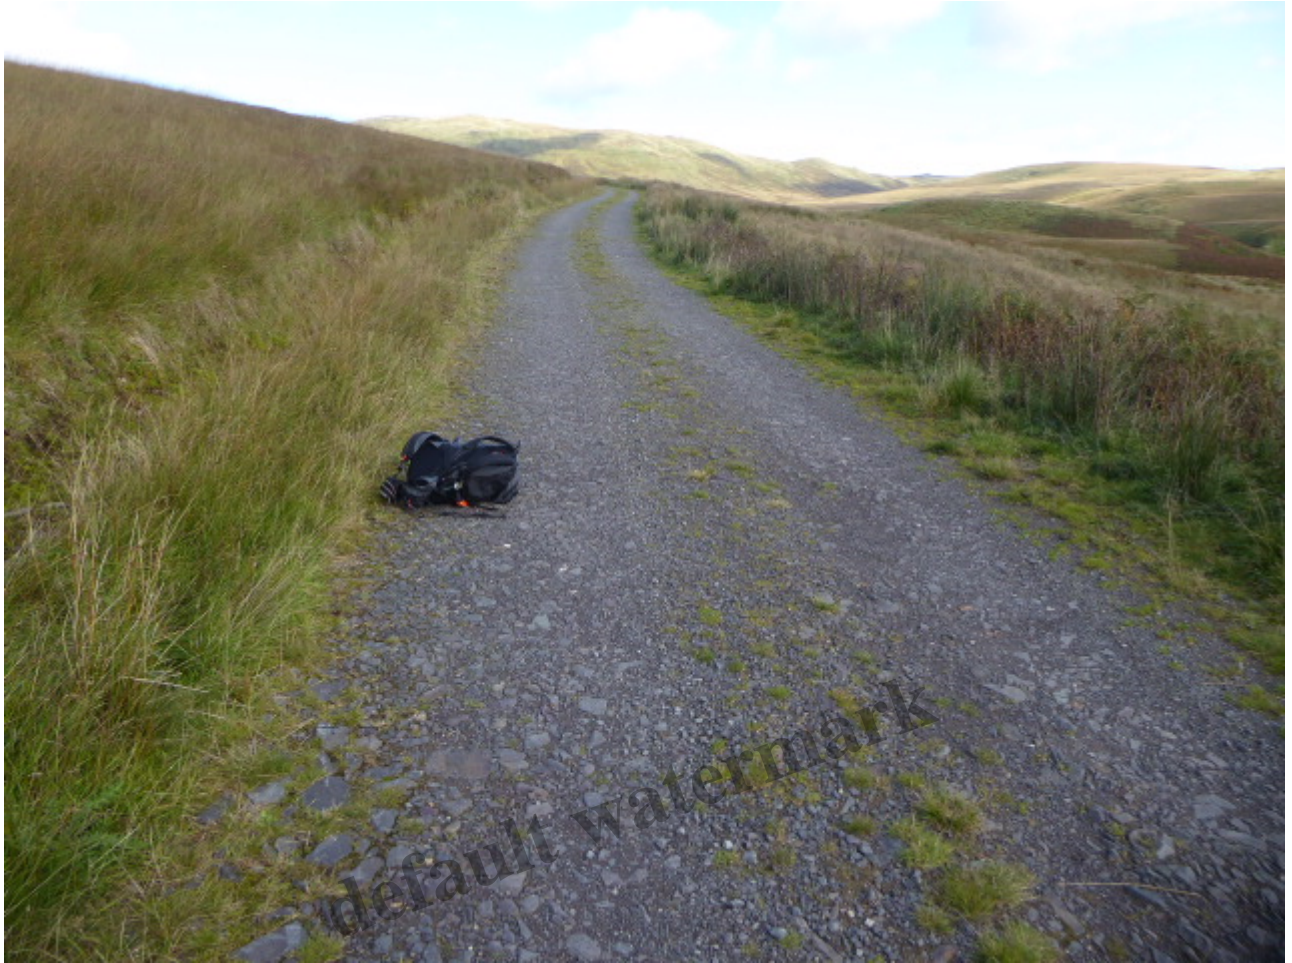
This straight section of track is wider than necessary, about 2.5m – contrary to the planning condition which I think was right

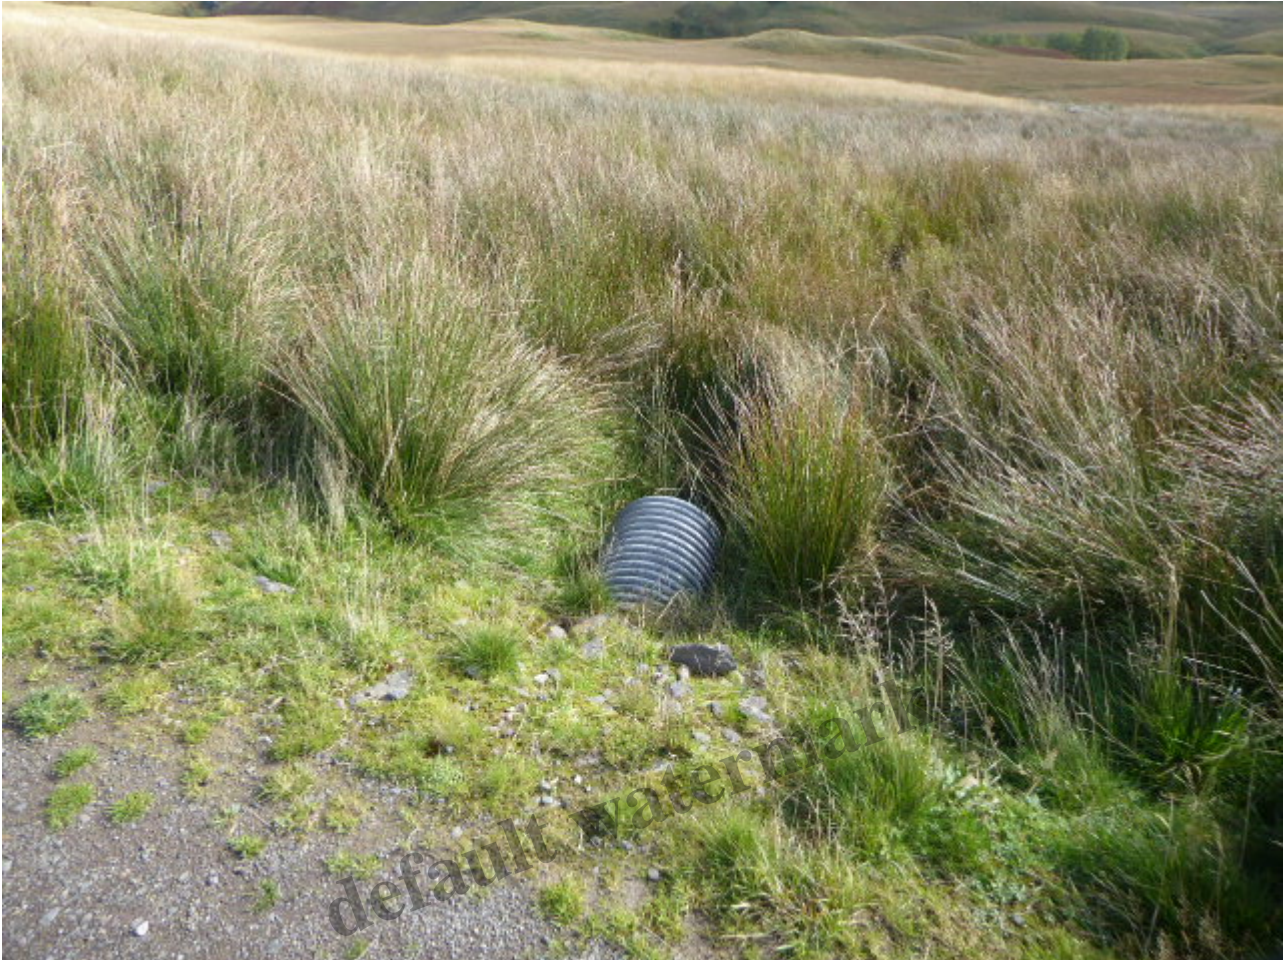
While most of the new culverts had been hidden, this one wasn't

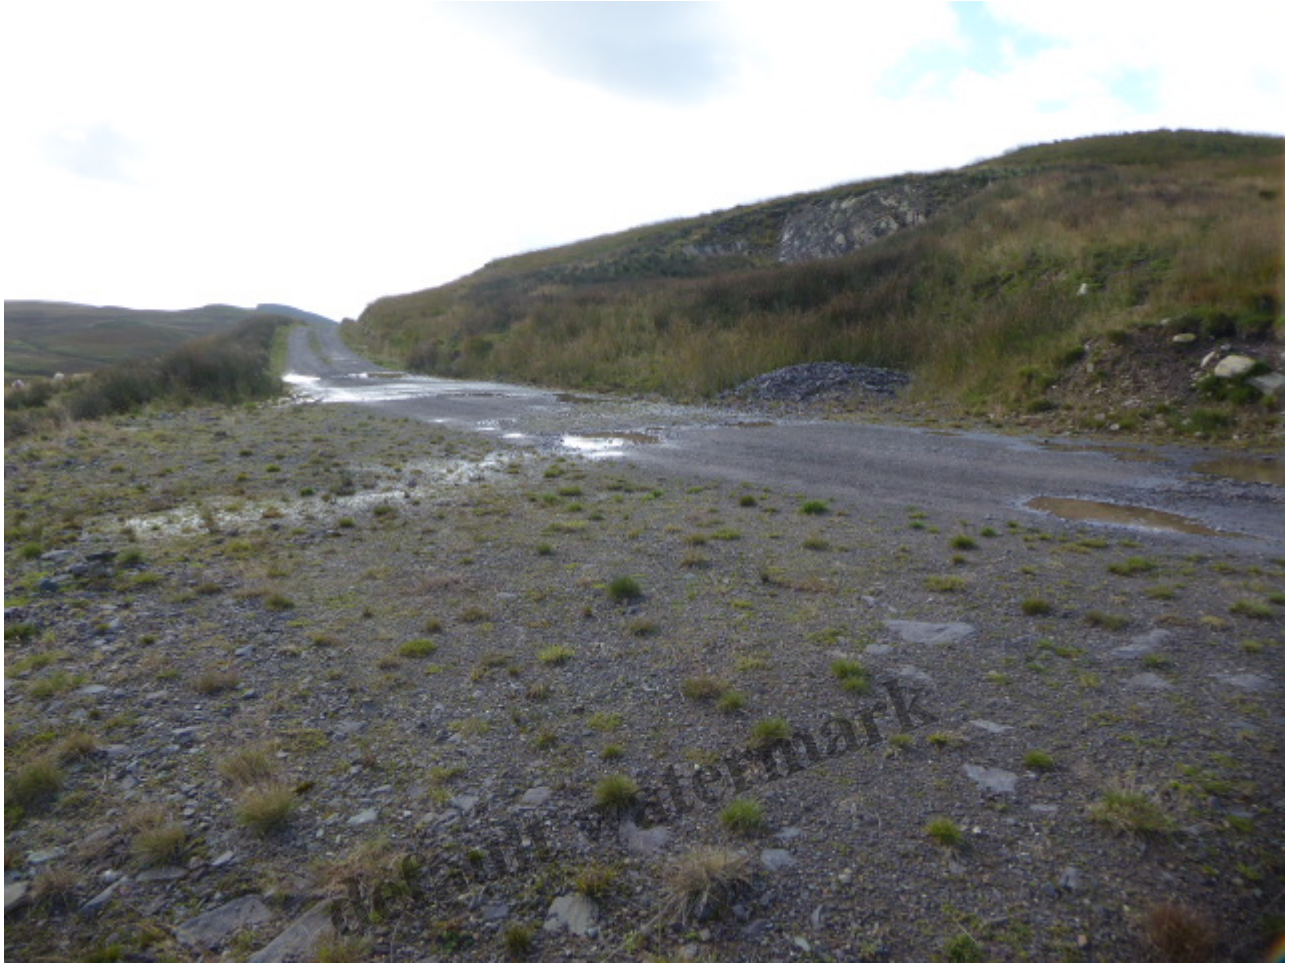
Unrestored ground with heap of aggregate behind and only partially restored borrow pit behind.

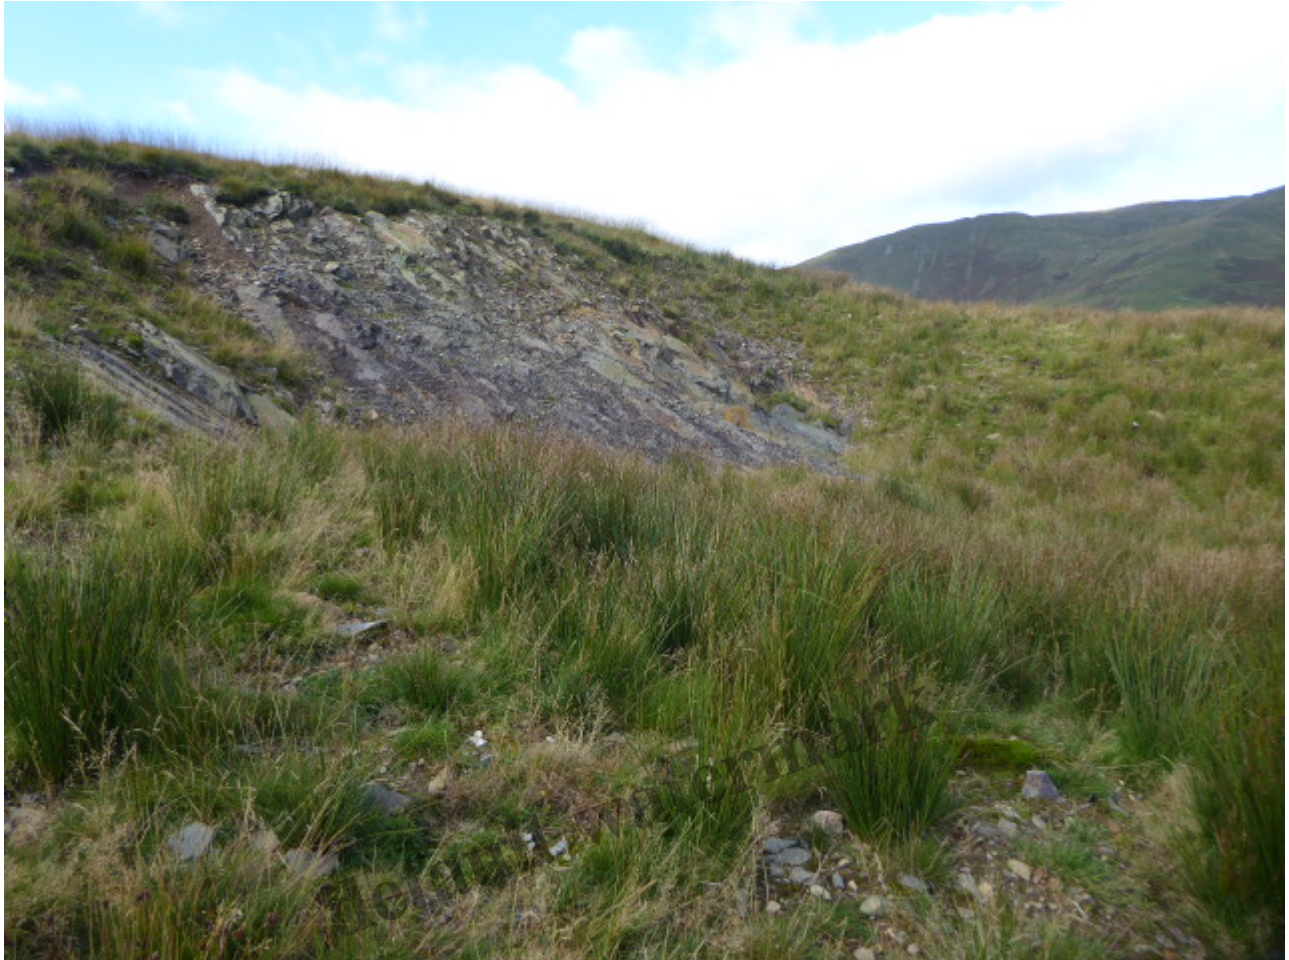
Unrestored section of borrow pit – note how soft rush has colonised and now dominates the ground which has been restored. LLTNPA officers wrote a further delegated report ([see here](#)) agreeing another borrow pit could be retained because sand martins had started to nest there, so on what basis has LLTNPA agreed with the estate that this section of ground need not be restored?

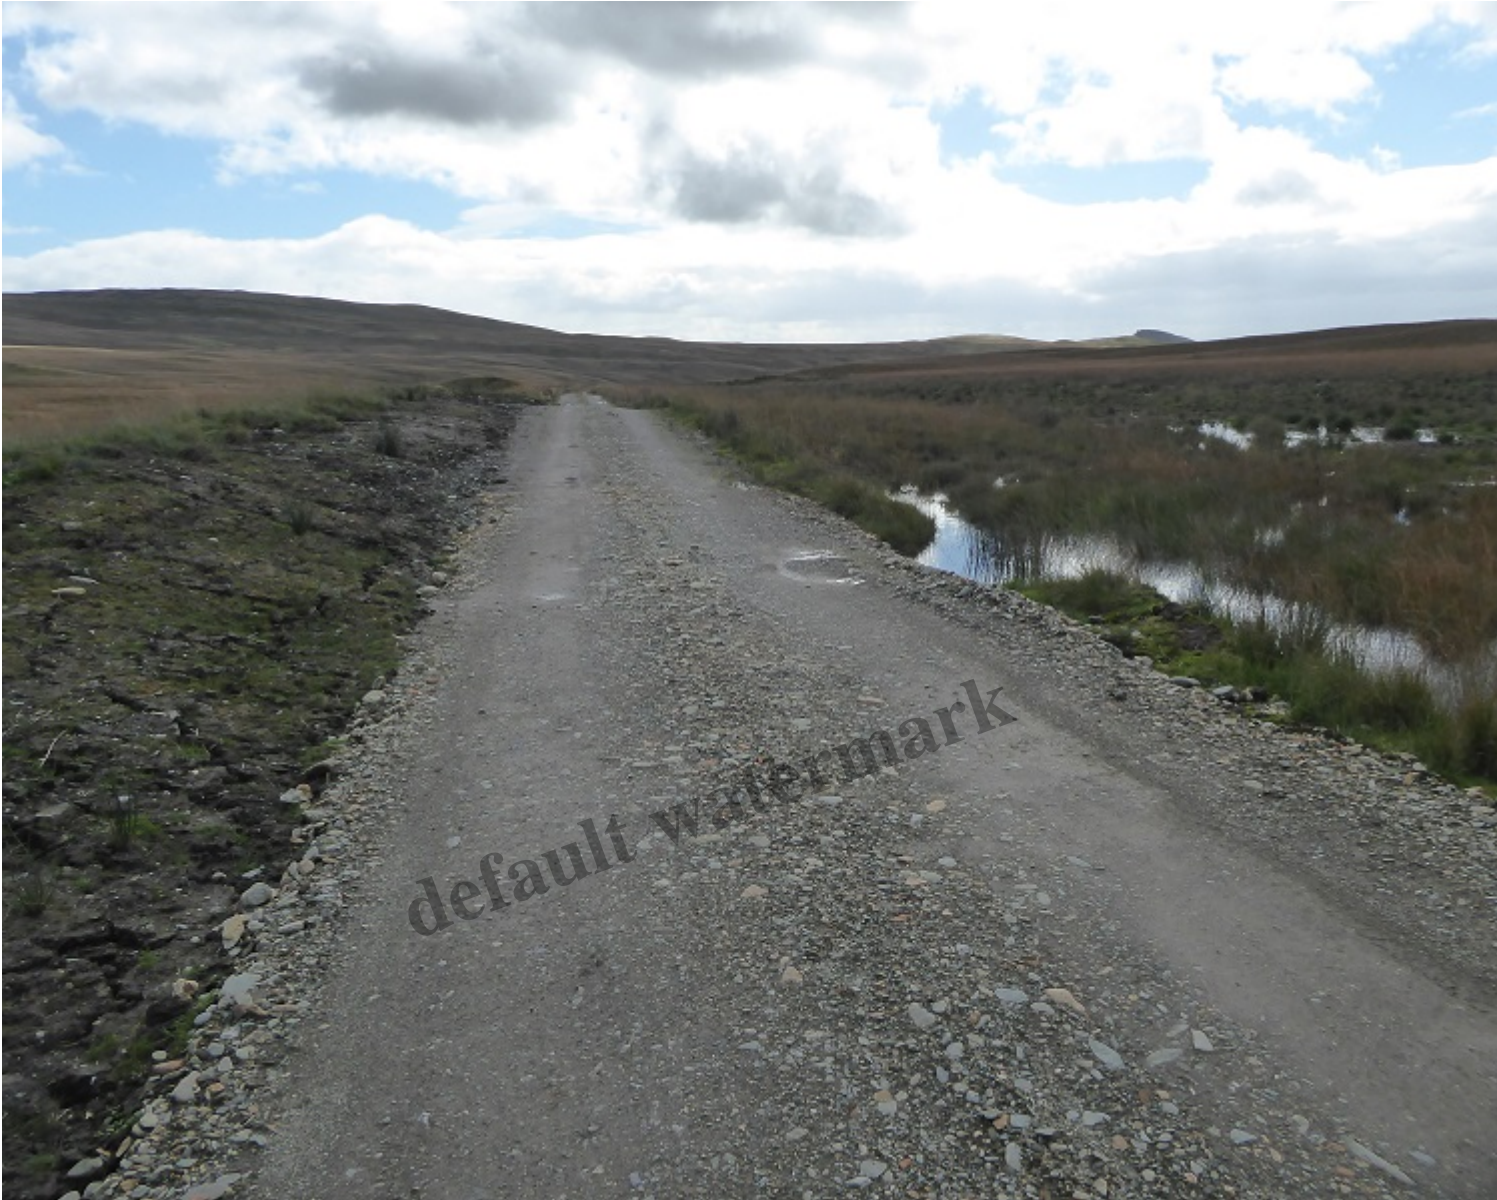
Its not just that the new section of track is more than the 2m stipulated, the track itself appears to have altered the drainage, making the area on the right where the pipeline is buried even wetter, while rush now dominates the vegetation.

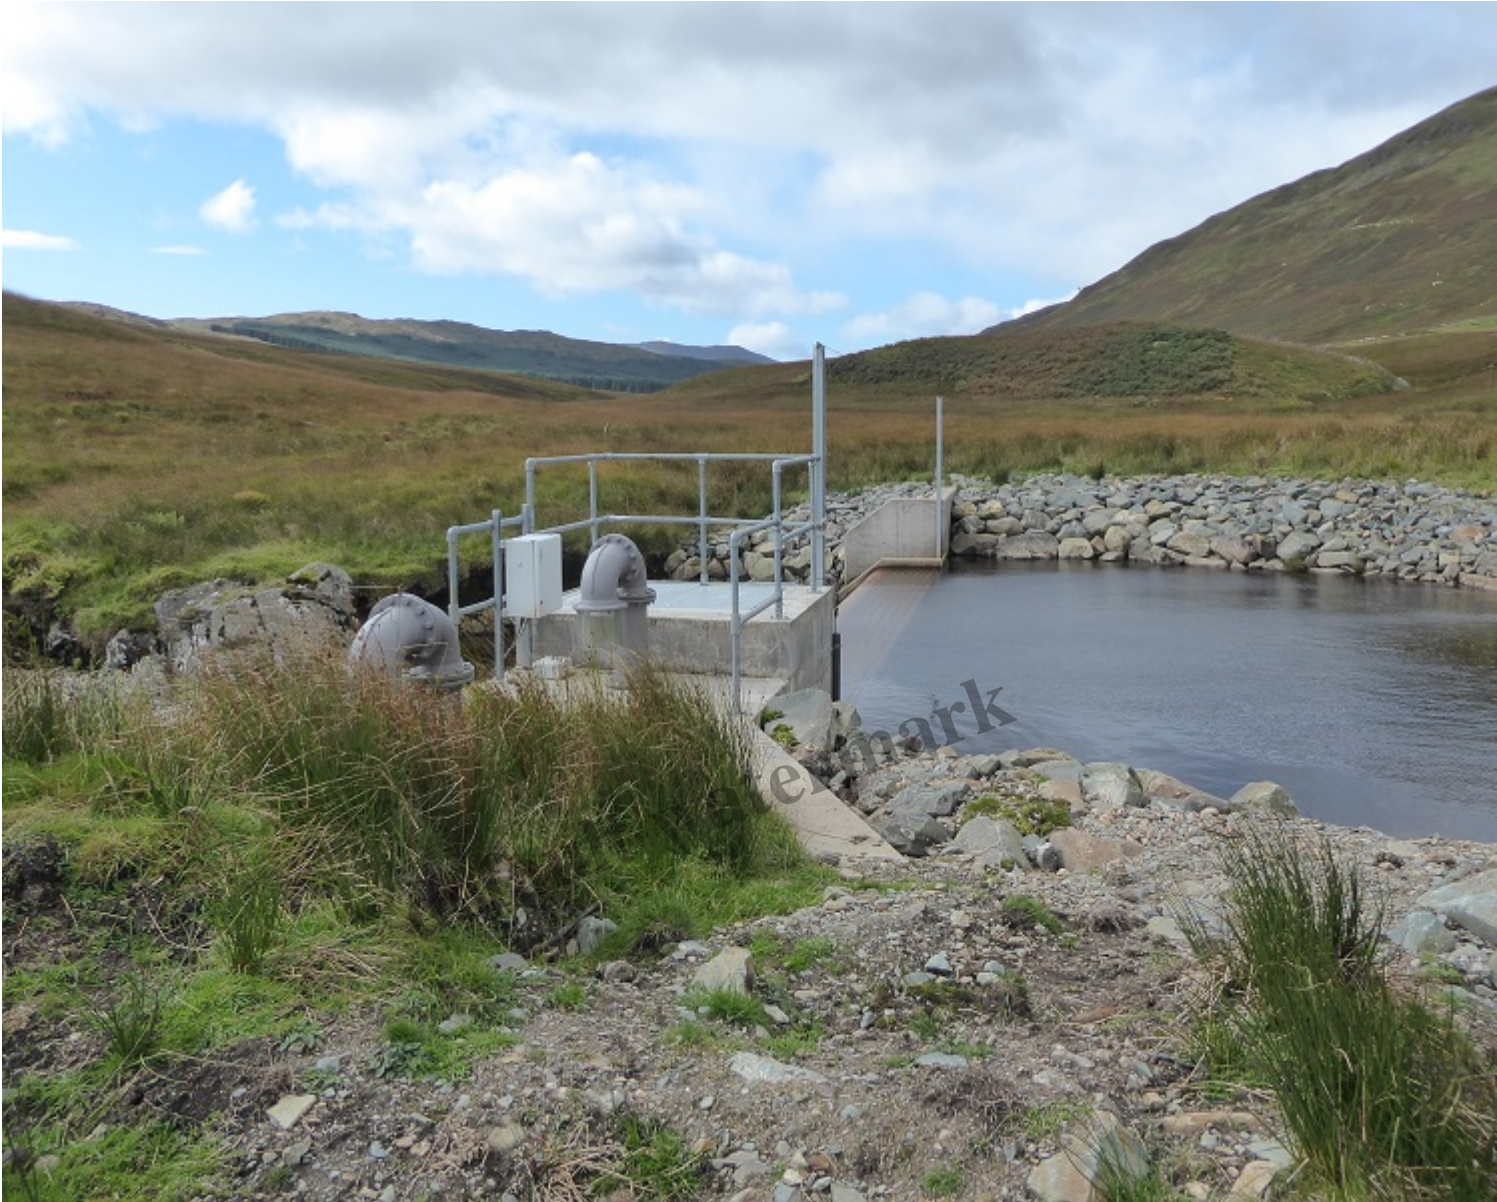
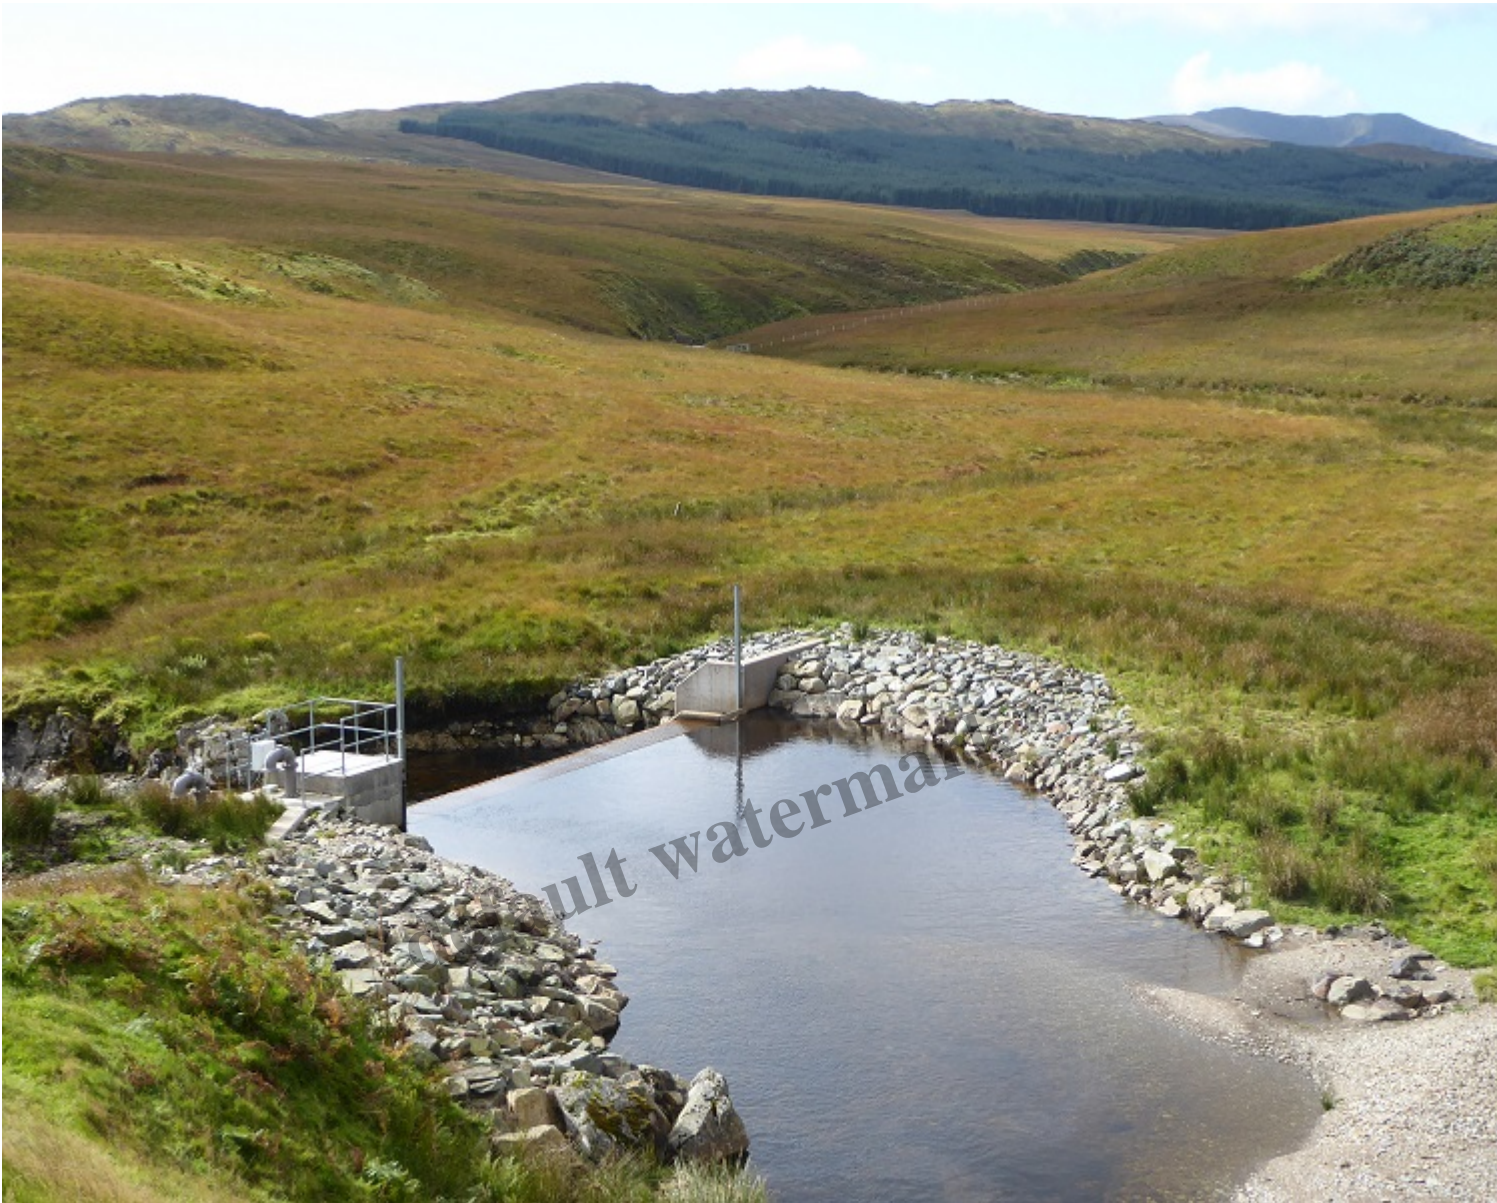
The original photomontage failed to show either the new section of access track or the rip rap bouldering which is unlikely to revegetate

The planning consent rightly required “*Landscape mitigation measures proposed at the intakes and outfall (this should include details of ground profiling to screen higher areas of the wing walls)*” but the result, as in most other LLTNPA hydro schemes, leaves much to be desired. Had the LLTNPA and Drummond Estates worked out a solution which would avoid the need for these artificial banks of boulders that might have been a step forward justifying a quality award.
