The Keltie Water hydro scheme and Scottish quality awards for planning

Background to the Keltie Water hydro scheme

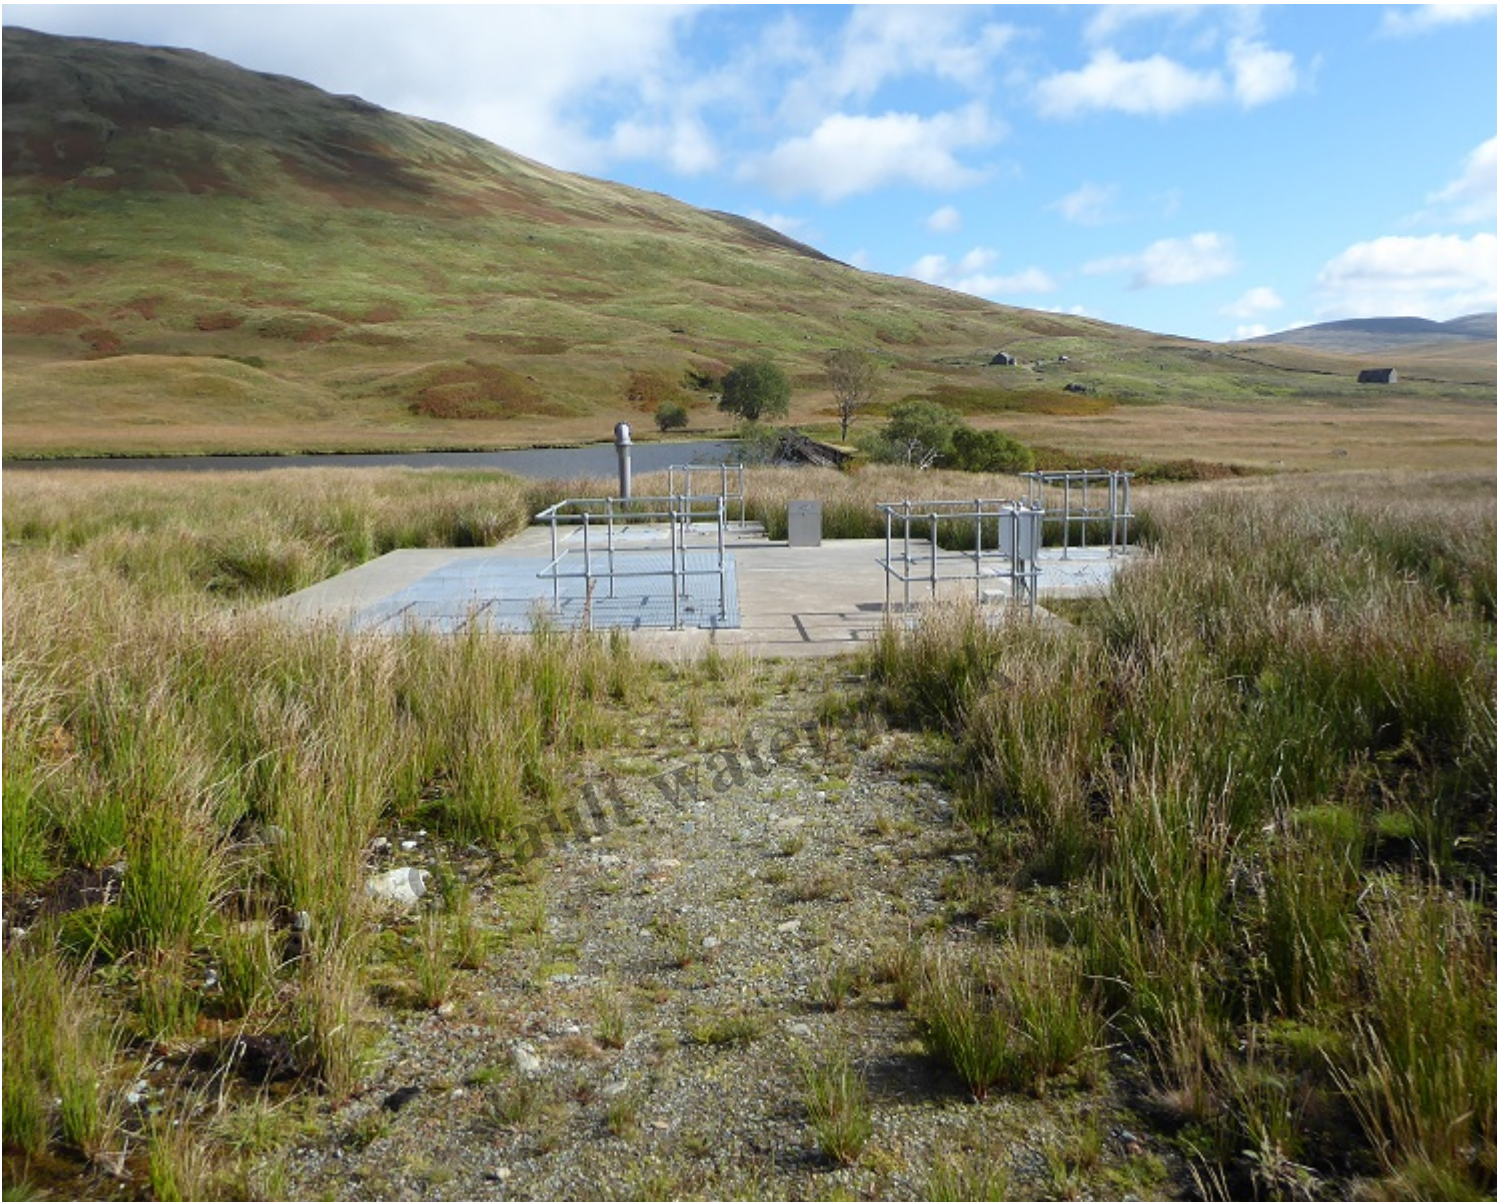
While the buried intake tank at the main intake is ugly from close up (could it not have been screened by a stone wall?) the new structure is far less intrusive visually than the original plans as a result of the water being abstracted by a pipe from the middle of the reservoir. An innovative solution that could possibly be used in other cases where there are large intake pools.
