LLTNPA's "Success shared"? – the Ardchullarie and Anie hydro schemes

The Ardchullarie hydro scheme

The Anie hydro scheme

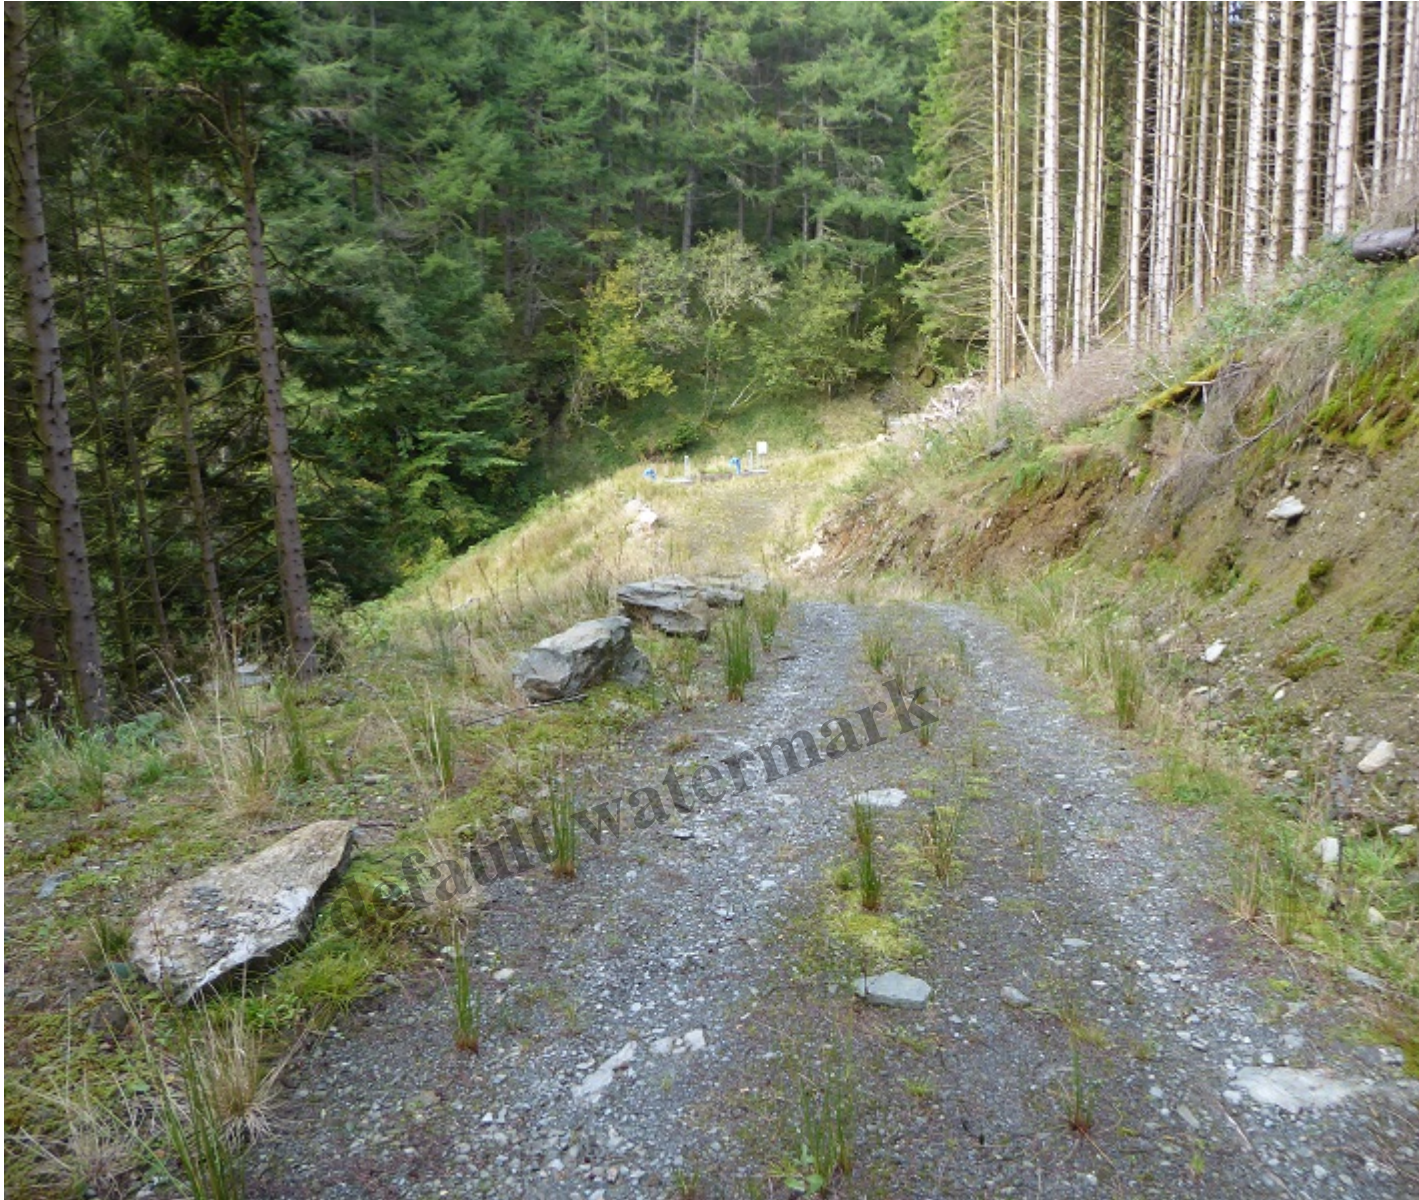
Shallow batter? Use of vegetation to restore batter? Appropriate use of boulders? Good landscaping

You would struggle to find ANY evidence of that award winning good practice advice being implemented here.

While the bare slopes and ground photographed by Jane Meek in early 2017 have started to re-vegetate, what recovery has taken place appears to have happened naturally without any of the good practice techniques advocated by the LLTNPA. The revegetation is partial and the steep slope remains very vulnerable to erosion:

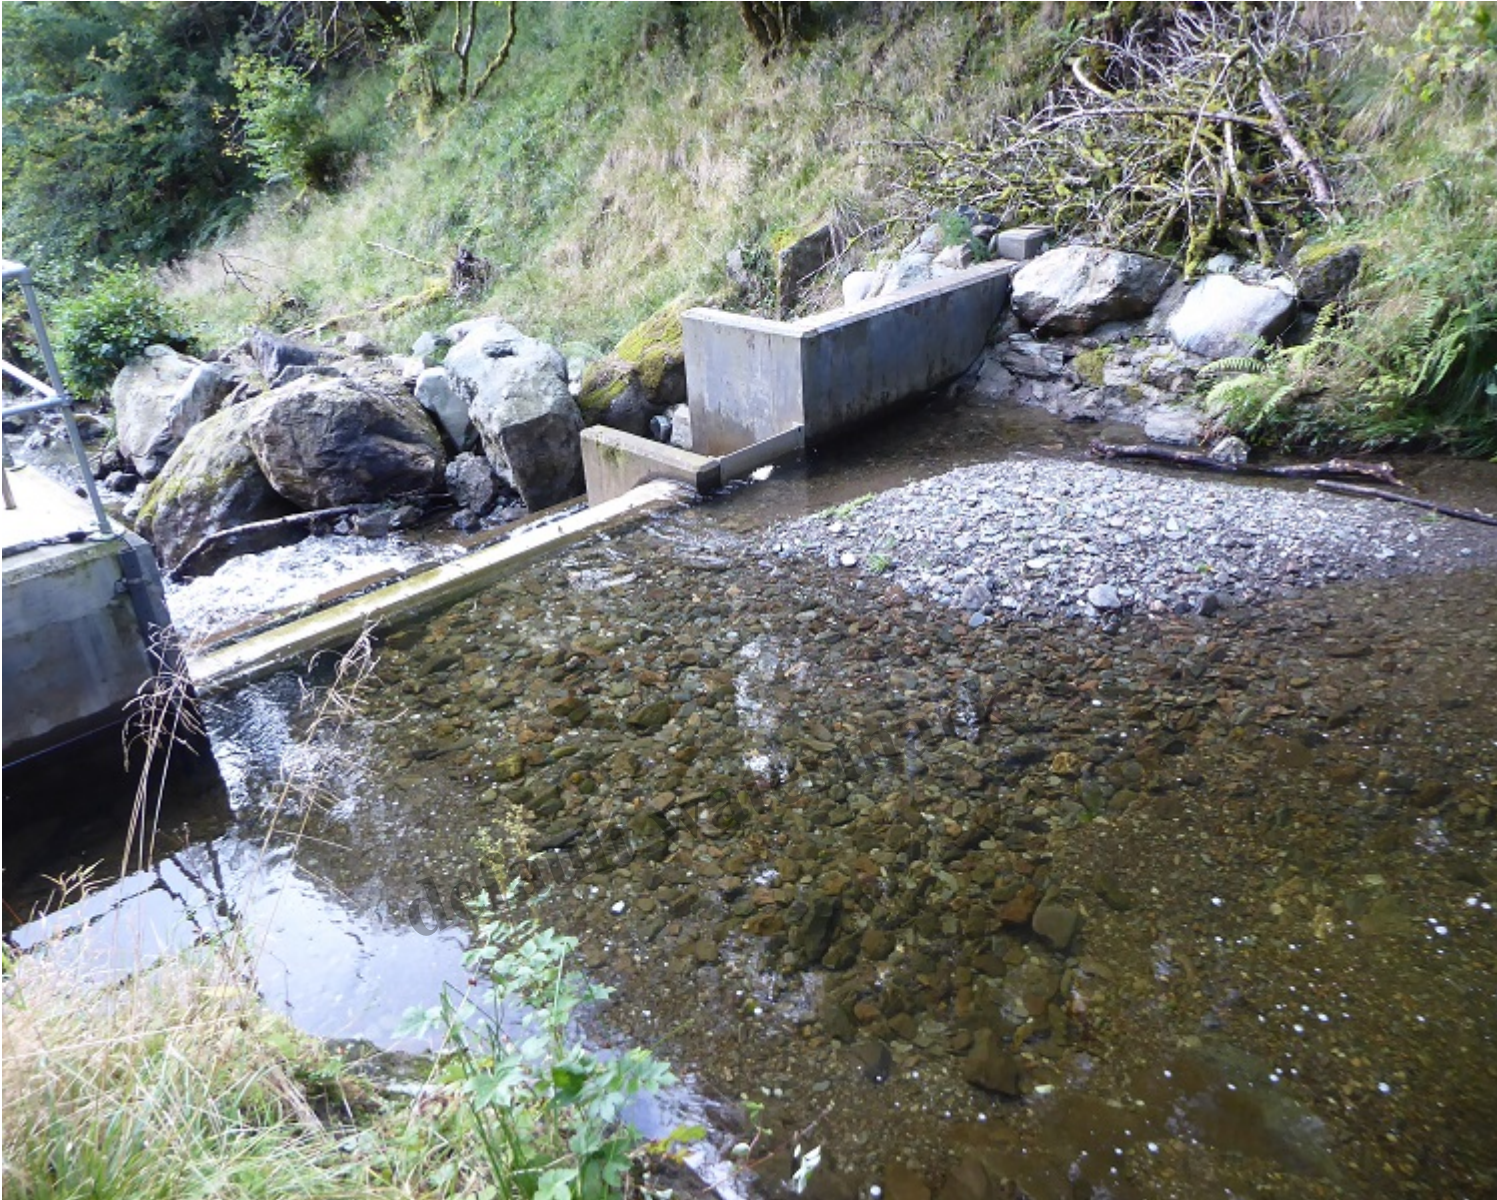
What most interested me most though about Ardchullarie was the intake dam and not just because of the LLTNPA’s guidance on wing walls, which as usual has been mostly ignored:

What was striking is how the intake pool is filling in:

That would appear easier said than done. The intake is clearly forming a barrier to stones as they are eroded and swept down the burn. The impact of this, both on the ecology of these burns and on the functioning of the hydro, is something the LLTNPA should be commissioning research on. My suspicion is, however, that one reason access tracks are being retained and the temporary access track has not been restored is to enable diggers to be brought in to re-excavate intake pools every few years.

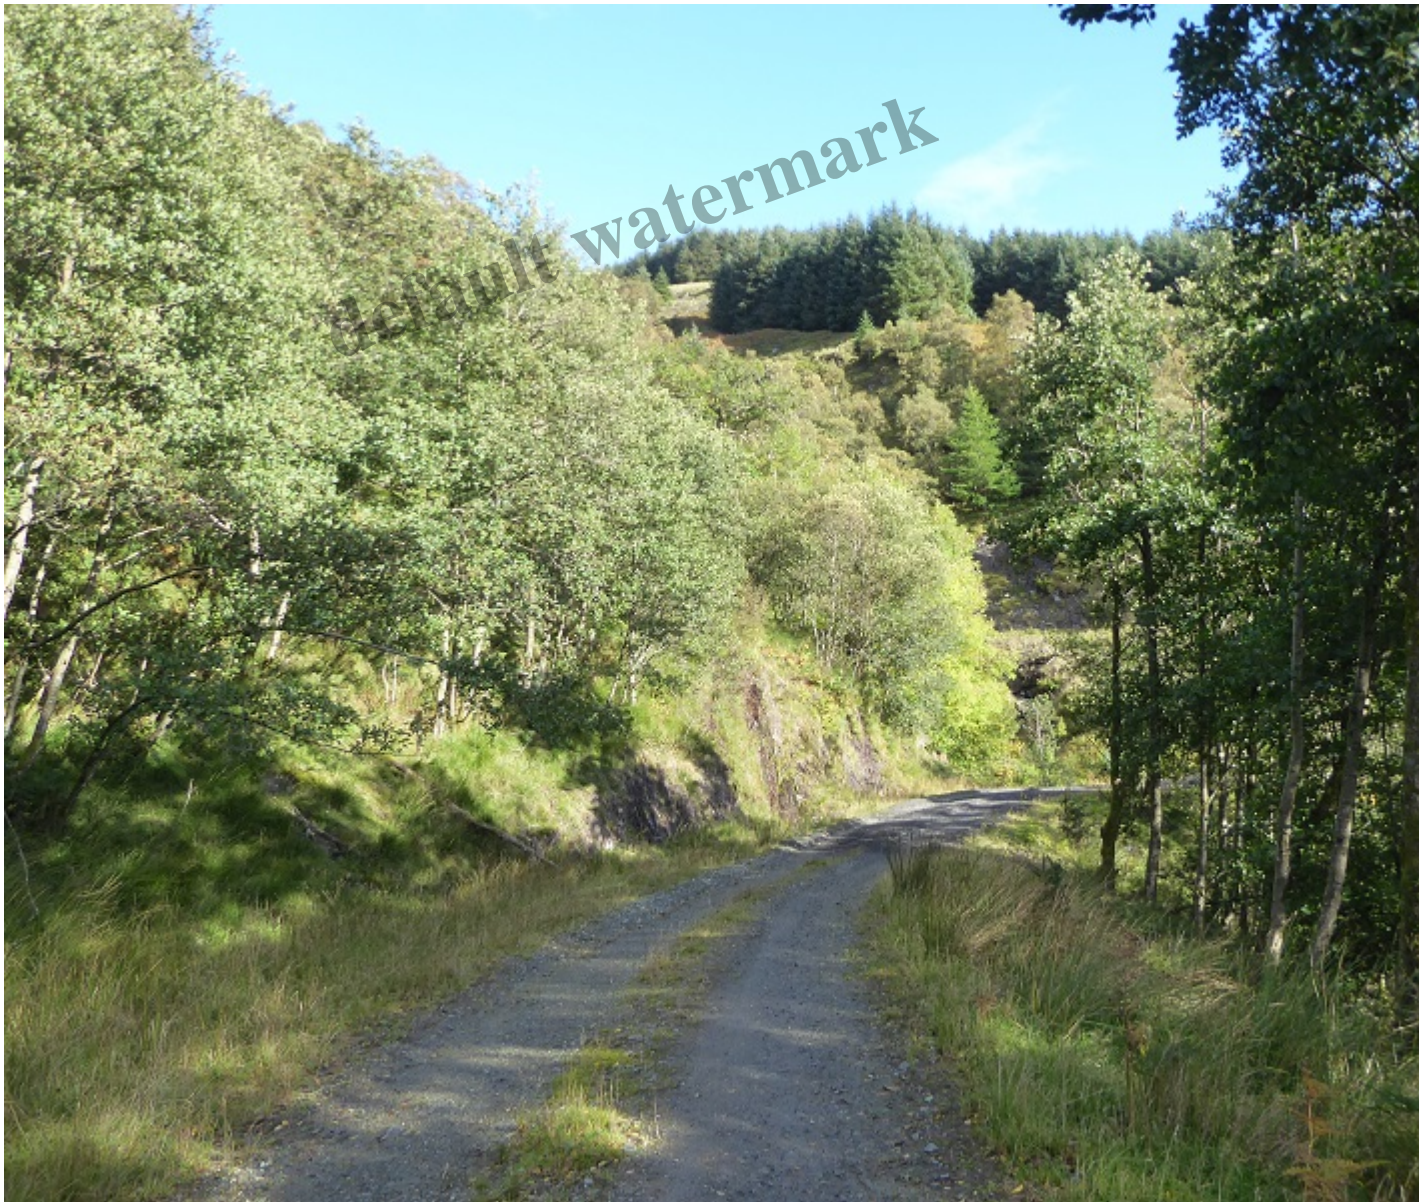
The Anie hydro intake is located at the bend in the track in native woodland on the Ancient Woodland

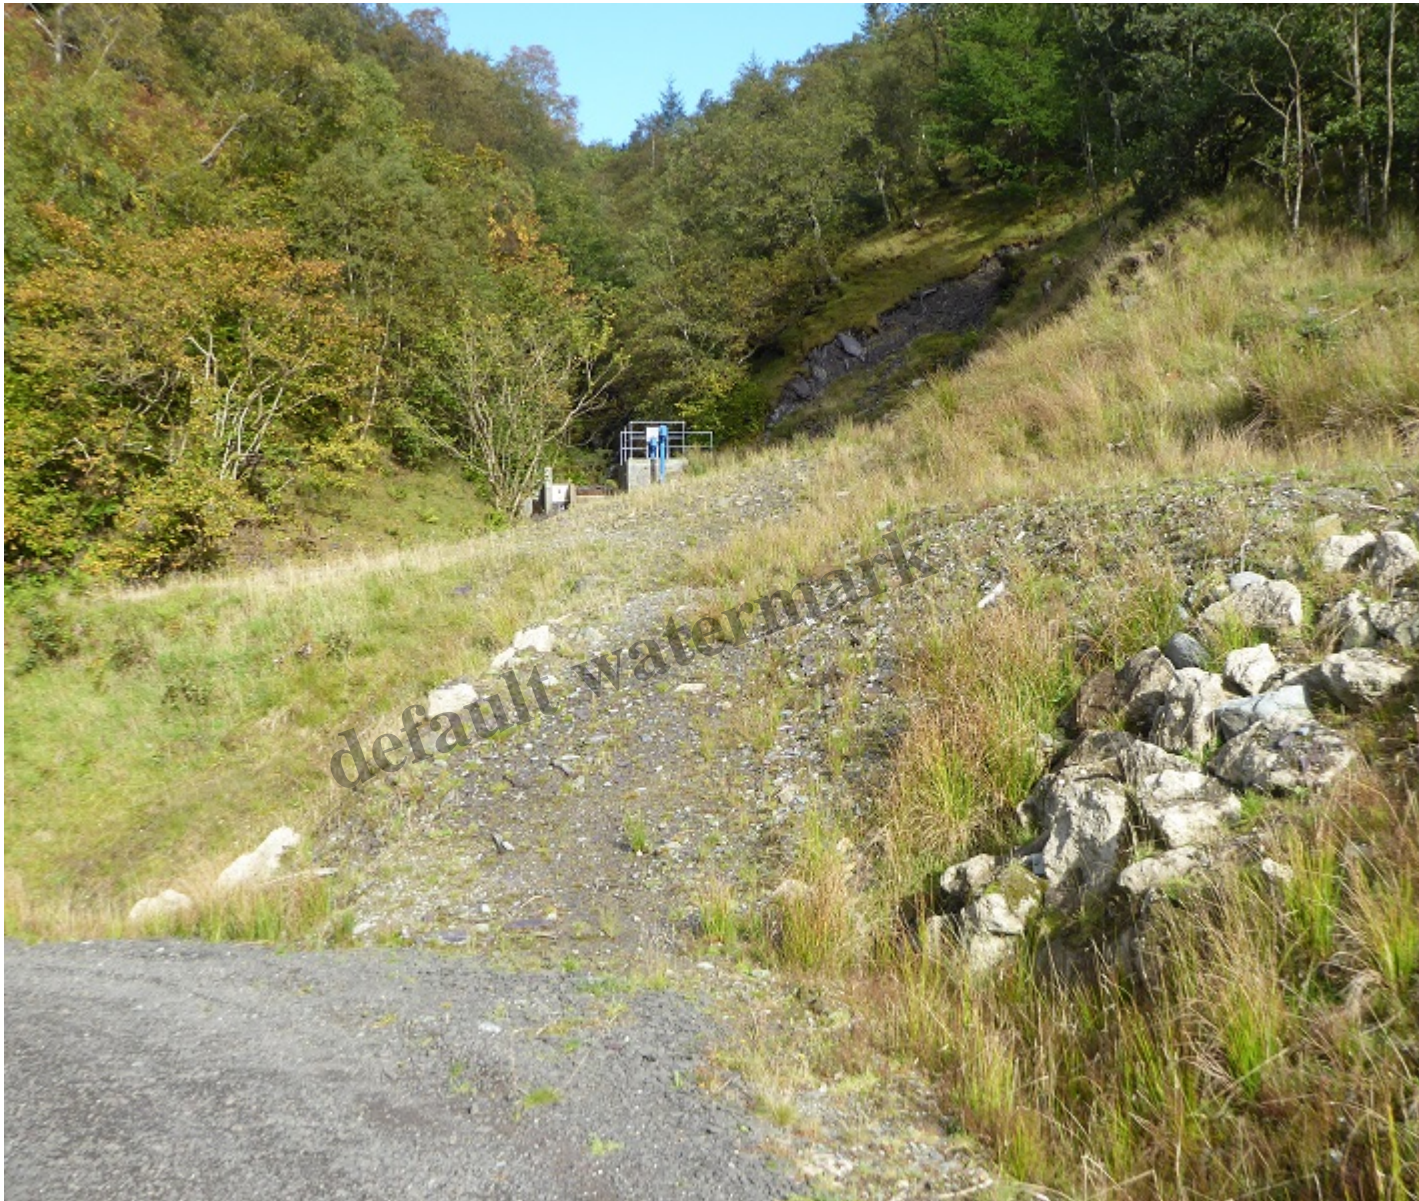
Note the unrestored temporary construction track marked by white stones on left and steep bare bank right of intake

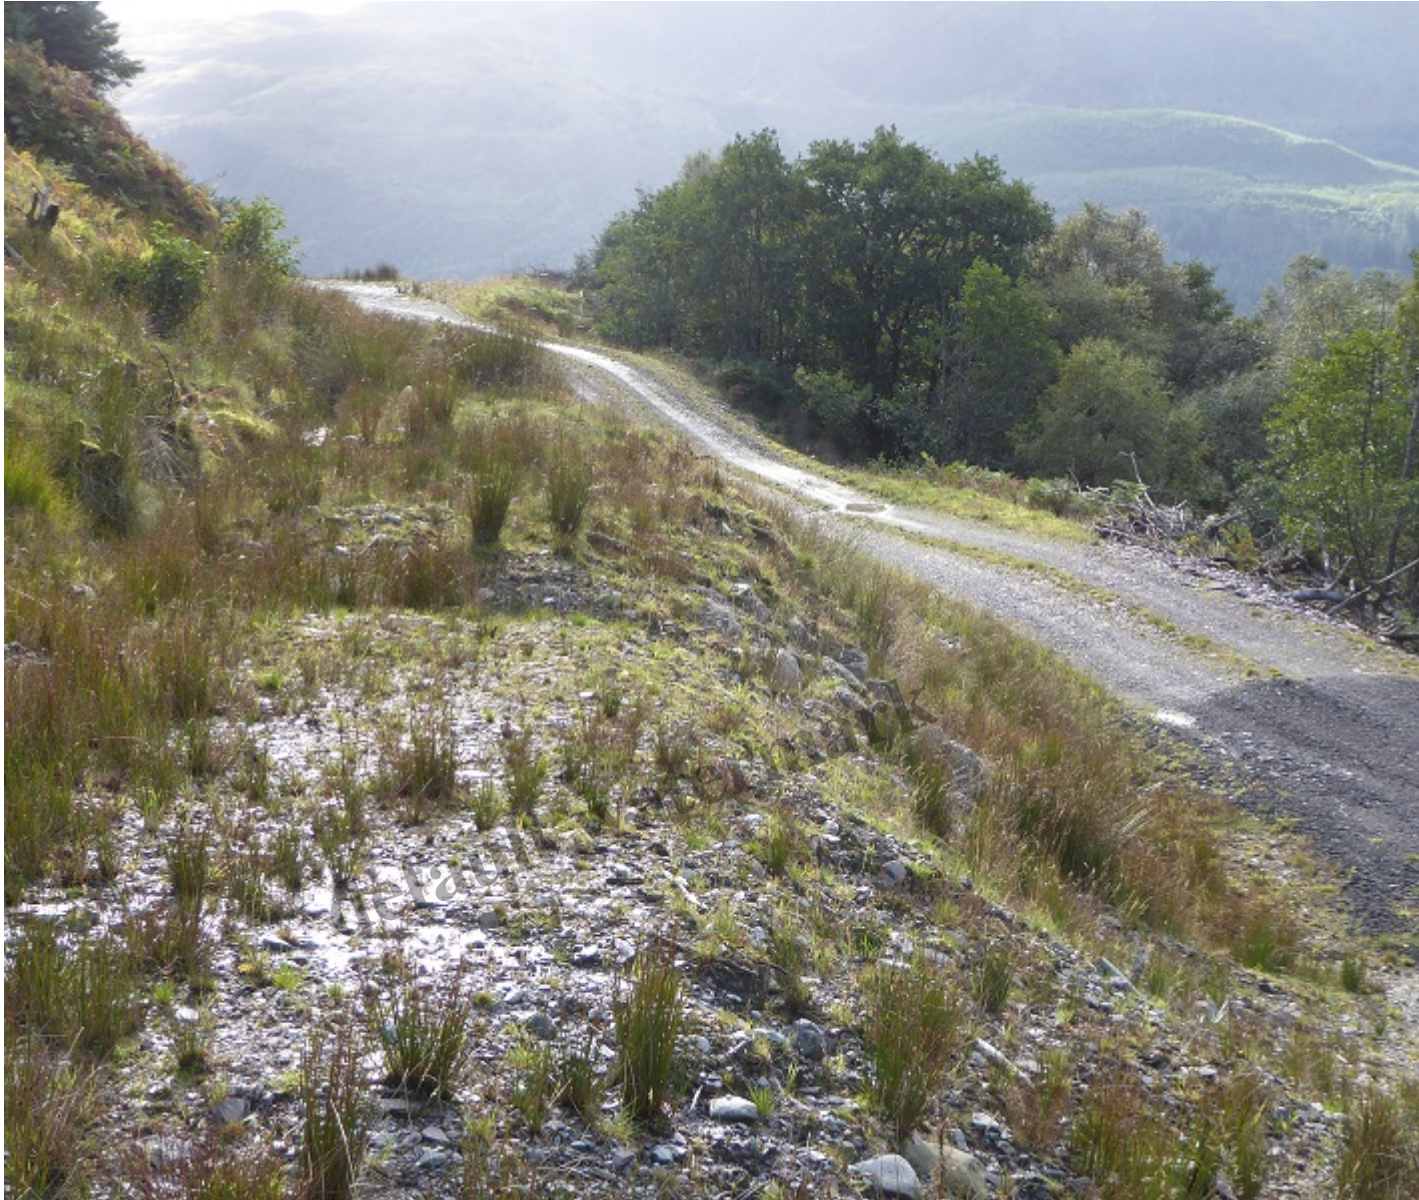
Failure to restore landscape or vegetation above the pipeline (which crosses under the road in the middle distance) *“The National Park will wish to see ecological integrity retained and where possible enhanced. For example tracks and pipelines should avoid fragmentation of woodland.”* (Good Practice Guidance)

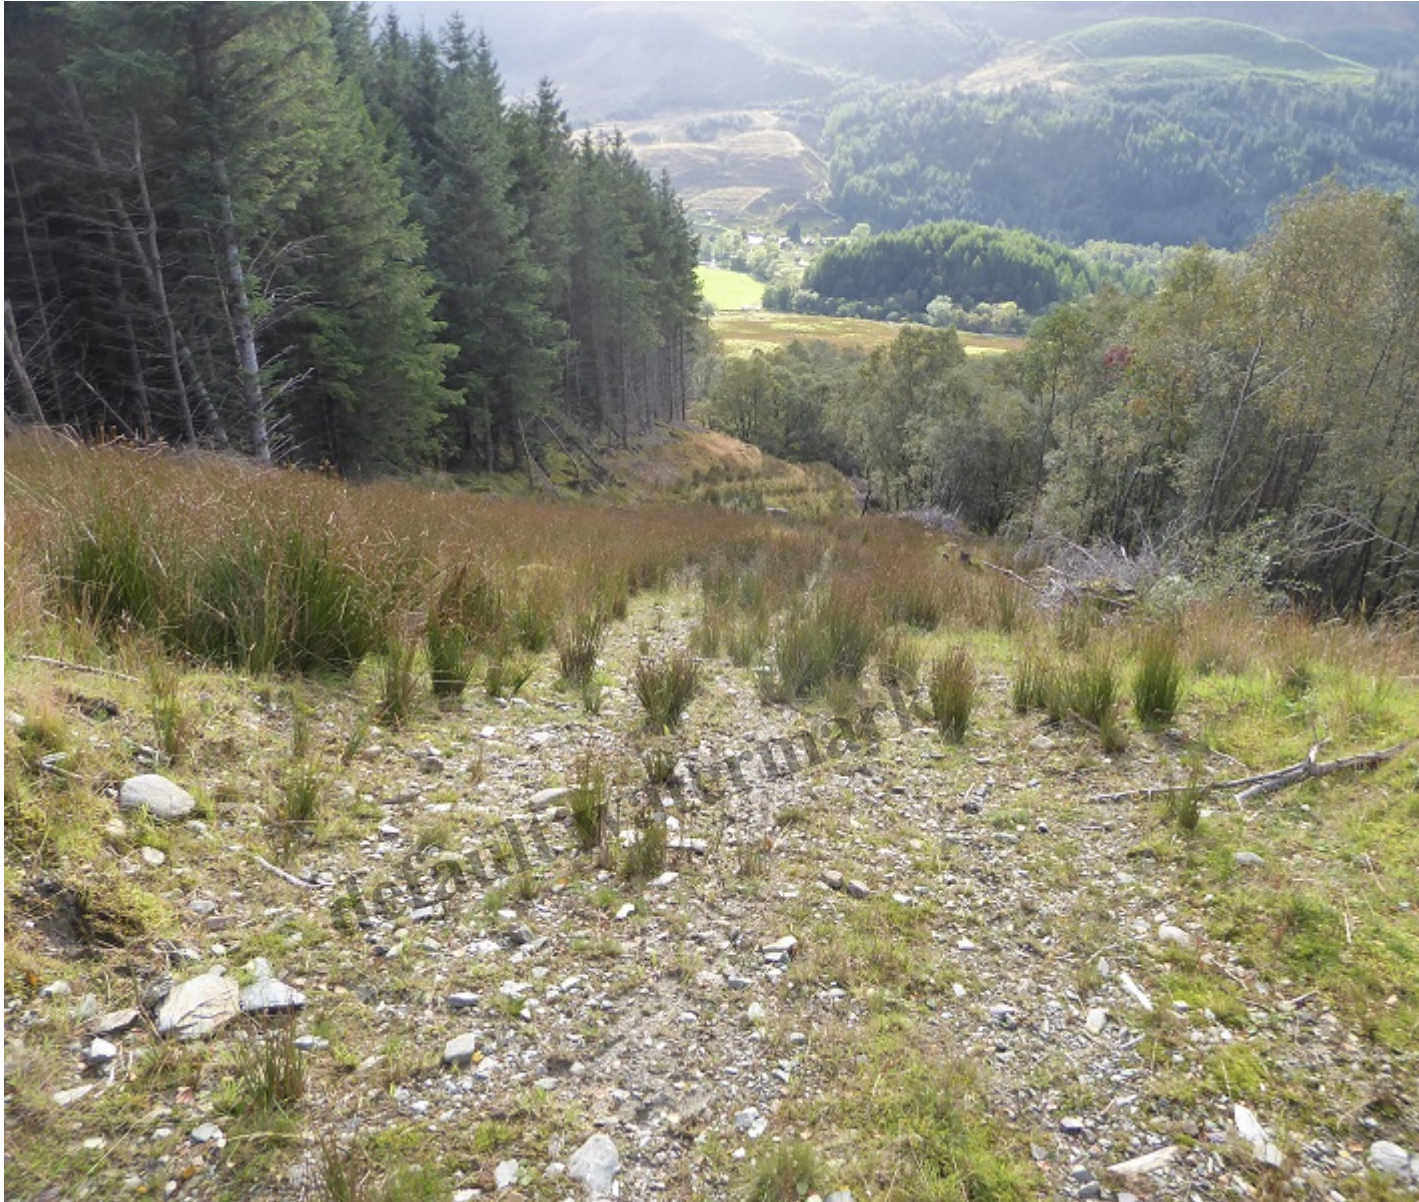
More restoration failure of the pipeline below the forest track

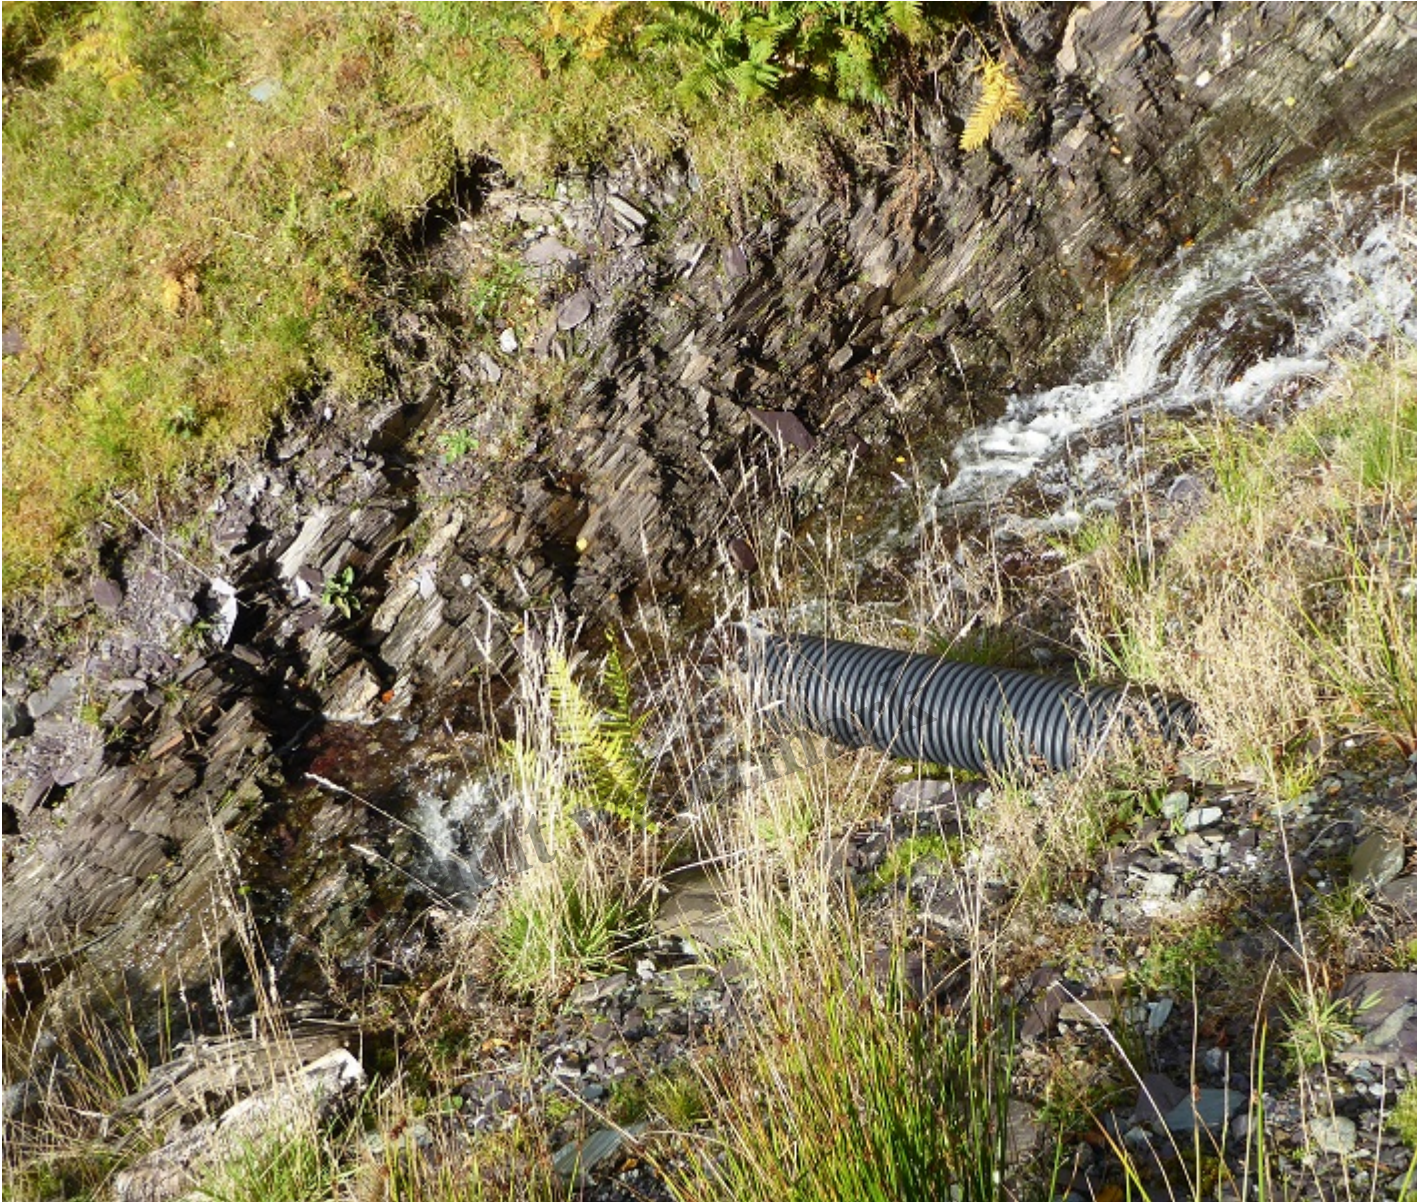
The seemingly inevitable protruding culvert – this one just below the intake
