LLTNPA's Success shared at the Ardchullarie and Anie hydro schemes

The Ardchullarie hydro scheme

The Anie hydro scheme

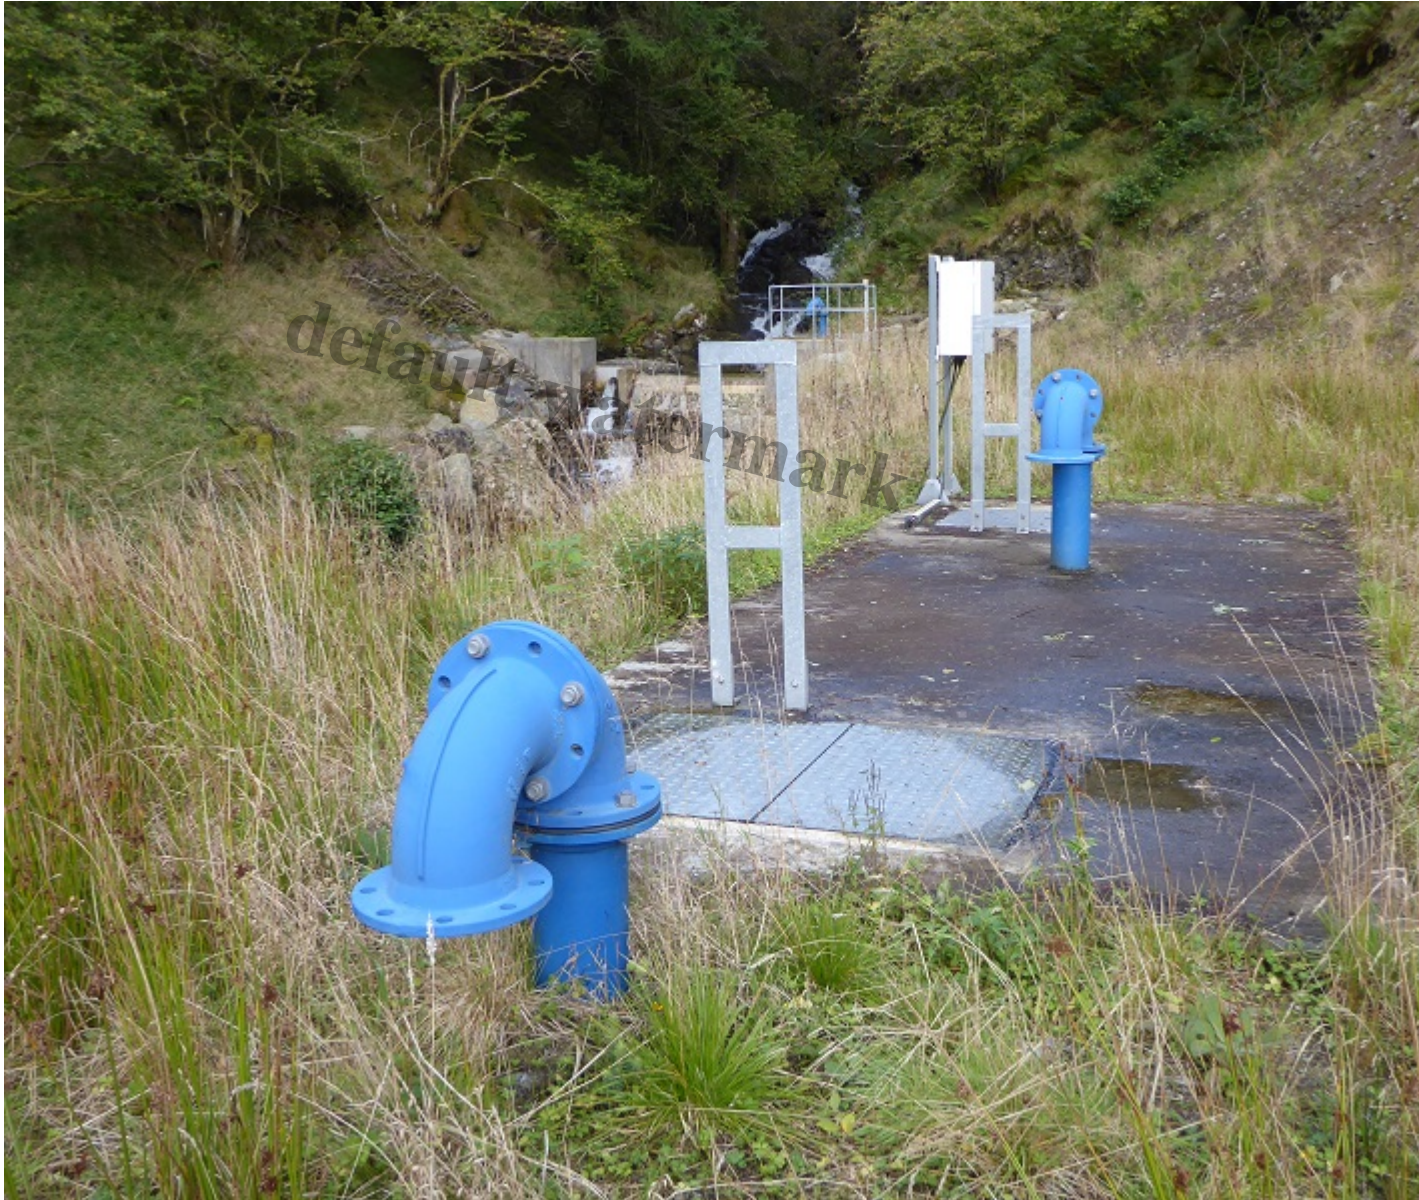
Ardchullarie Intake – Introduce as few different materials and colours as possible. A muted galvanneal grey / green colour will blend in with most upland environments. (LLTNPA Good Practice Guidelines for renewables)

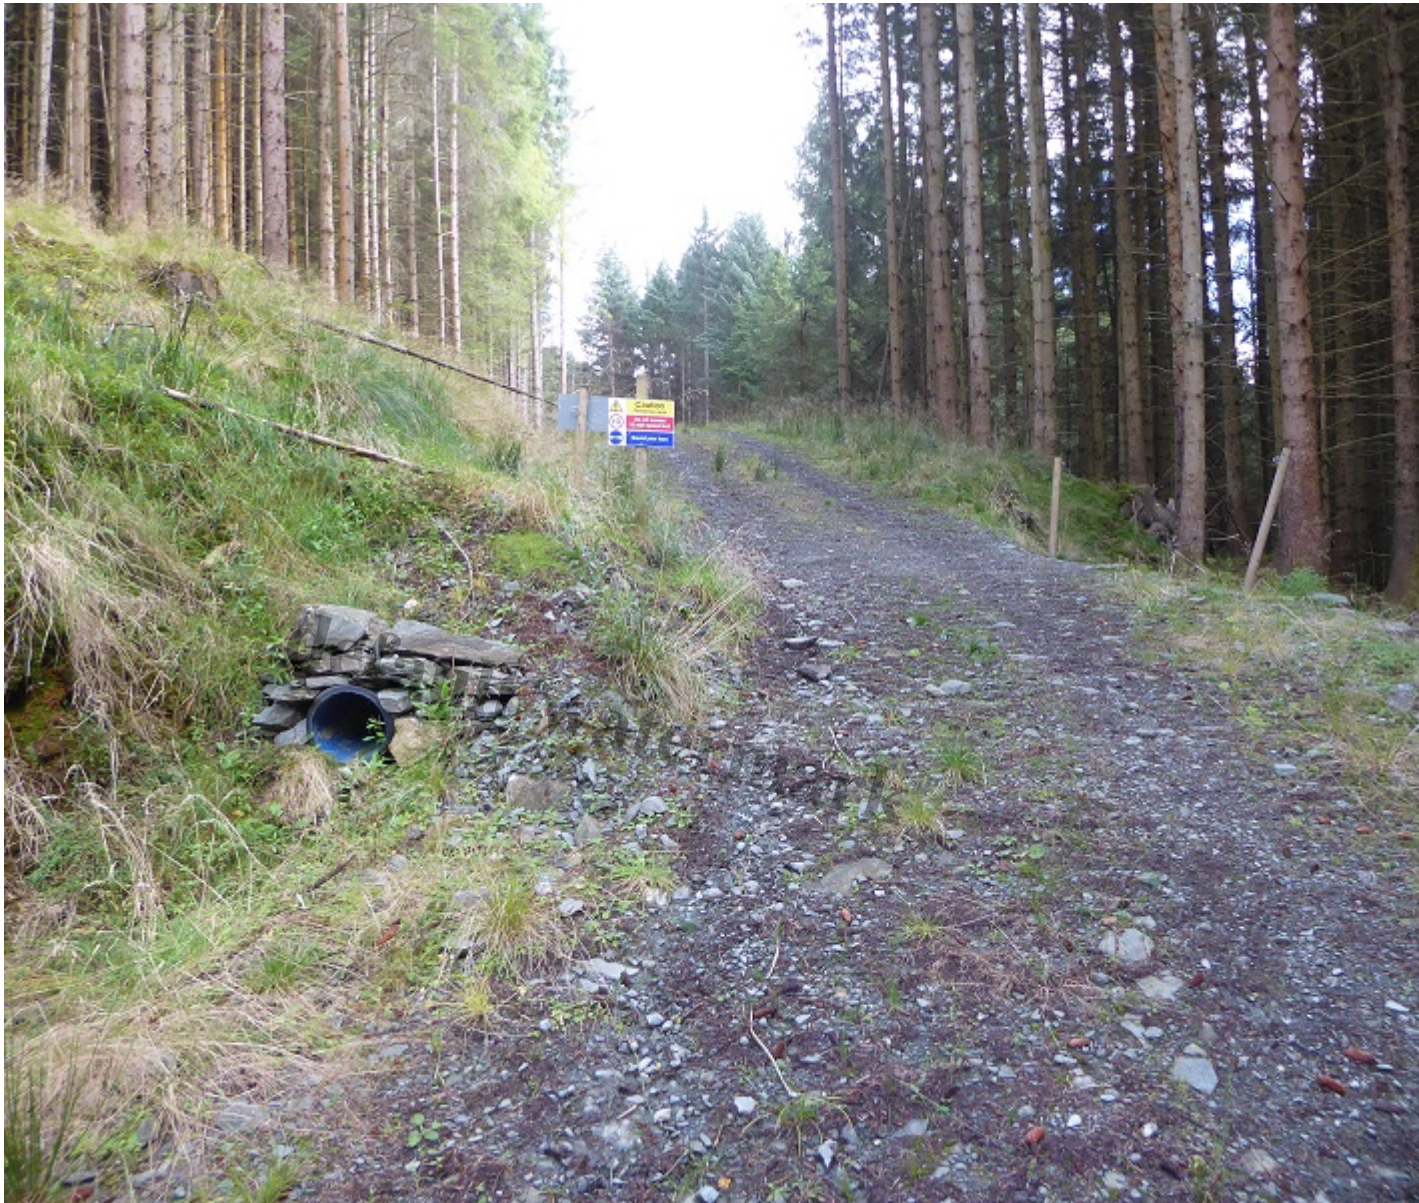
The intersection of the walker's path and new track - note the finished culvert which runs under the track. The signs advise vehicles to look out for walkers.

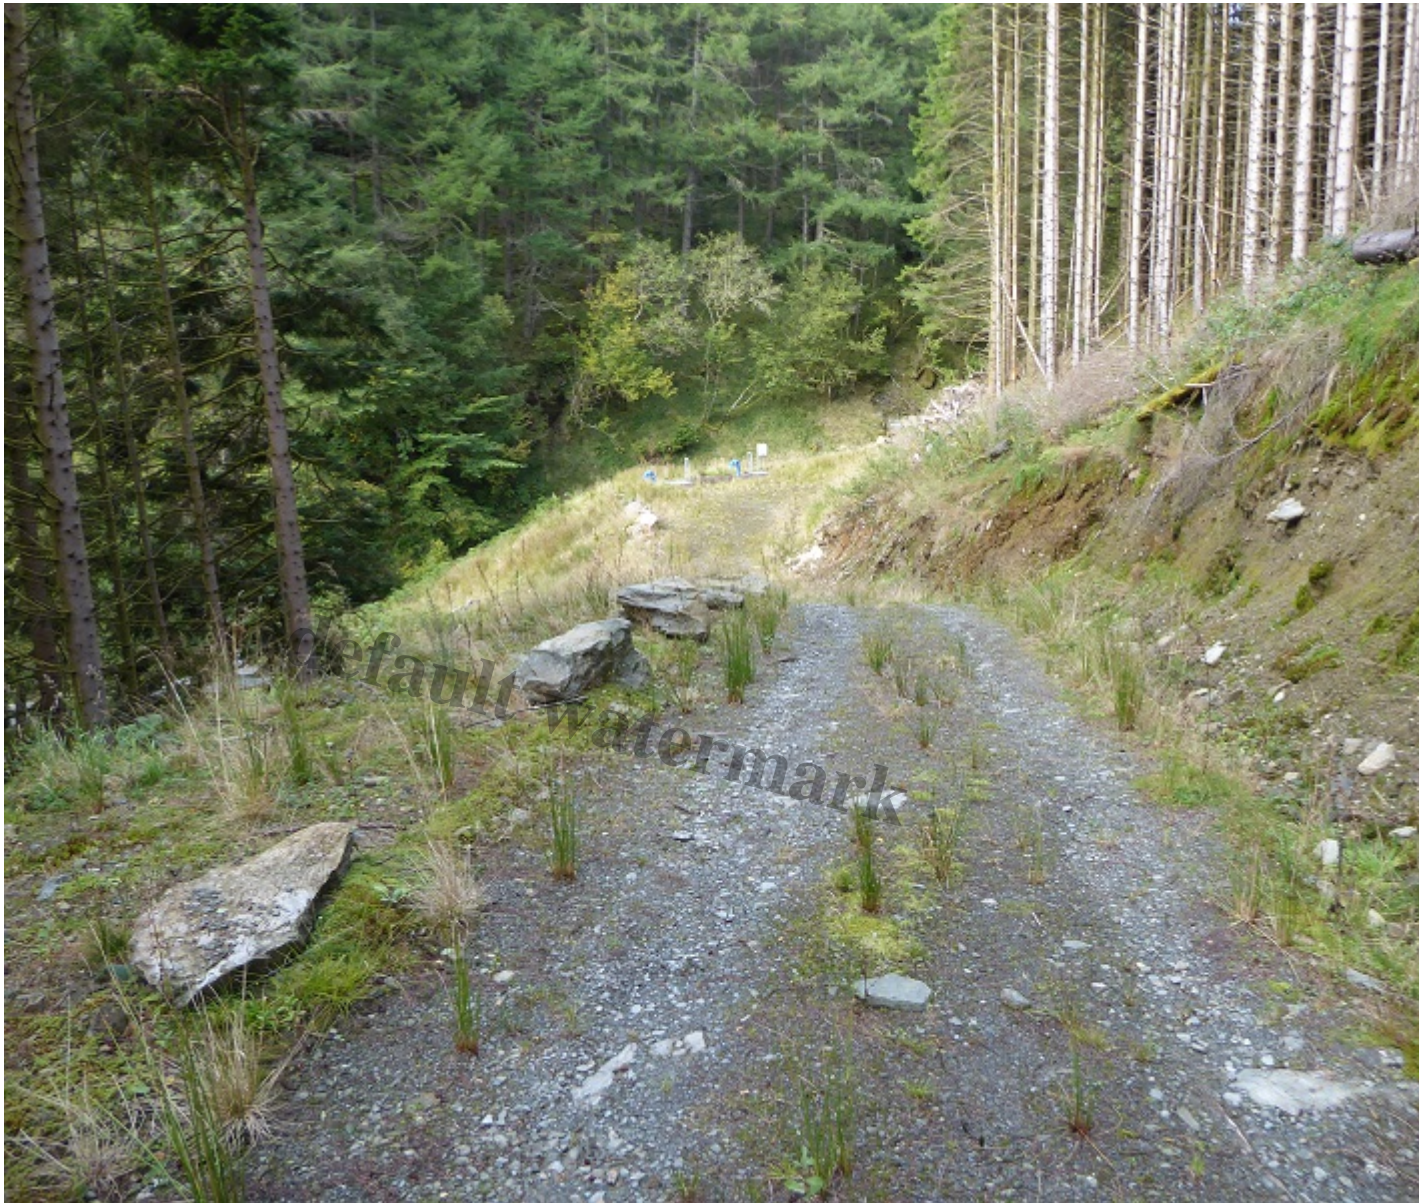
Shallow batter? Use of vegetation to restore batter? Appropriate use of boulders? Good landscaping

You would struggle to find ANY evidence of that award winning good practice advice being implemented here.

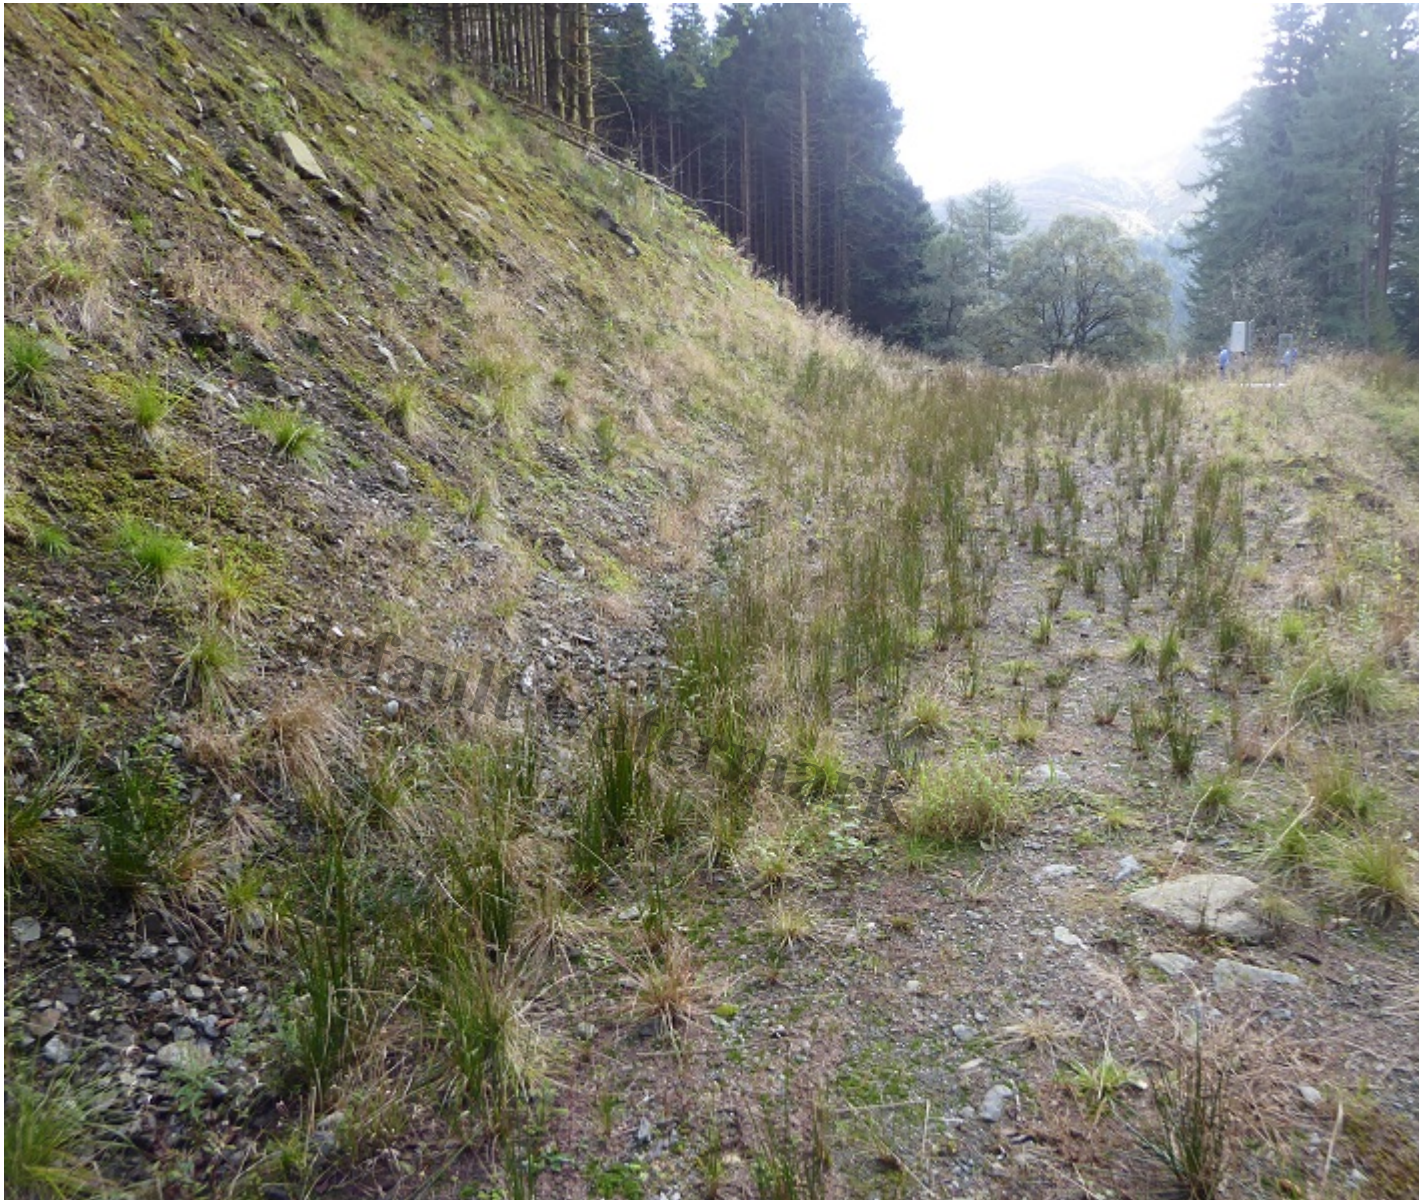
Looking west from the intake along the short section of construction track which was supposed to be removed. The slope on the right had been bare early in 2017. Note how soft rush is colonising the flatter area of the track.

Had this section of temporary track been removed, instead of just being left to grow over, there would have been sufficient material to restore the landscape, including the oversteep uniform slope on the left.

That’s not happened here. Instead, the abandoned track adds to the desolation created by industrial forestry practices.

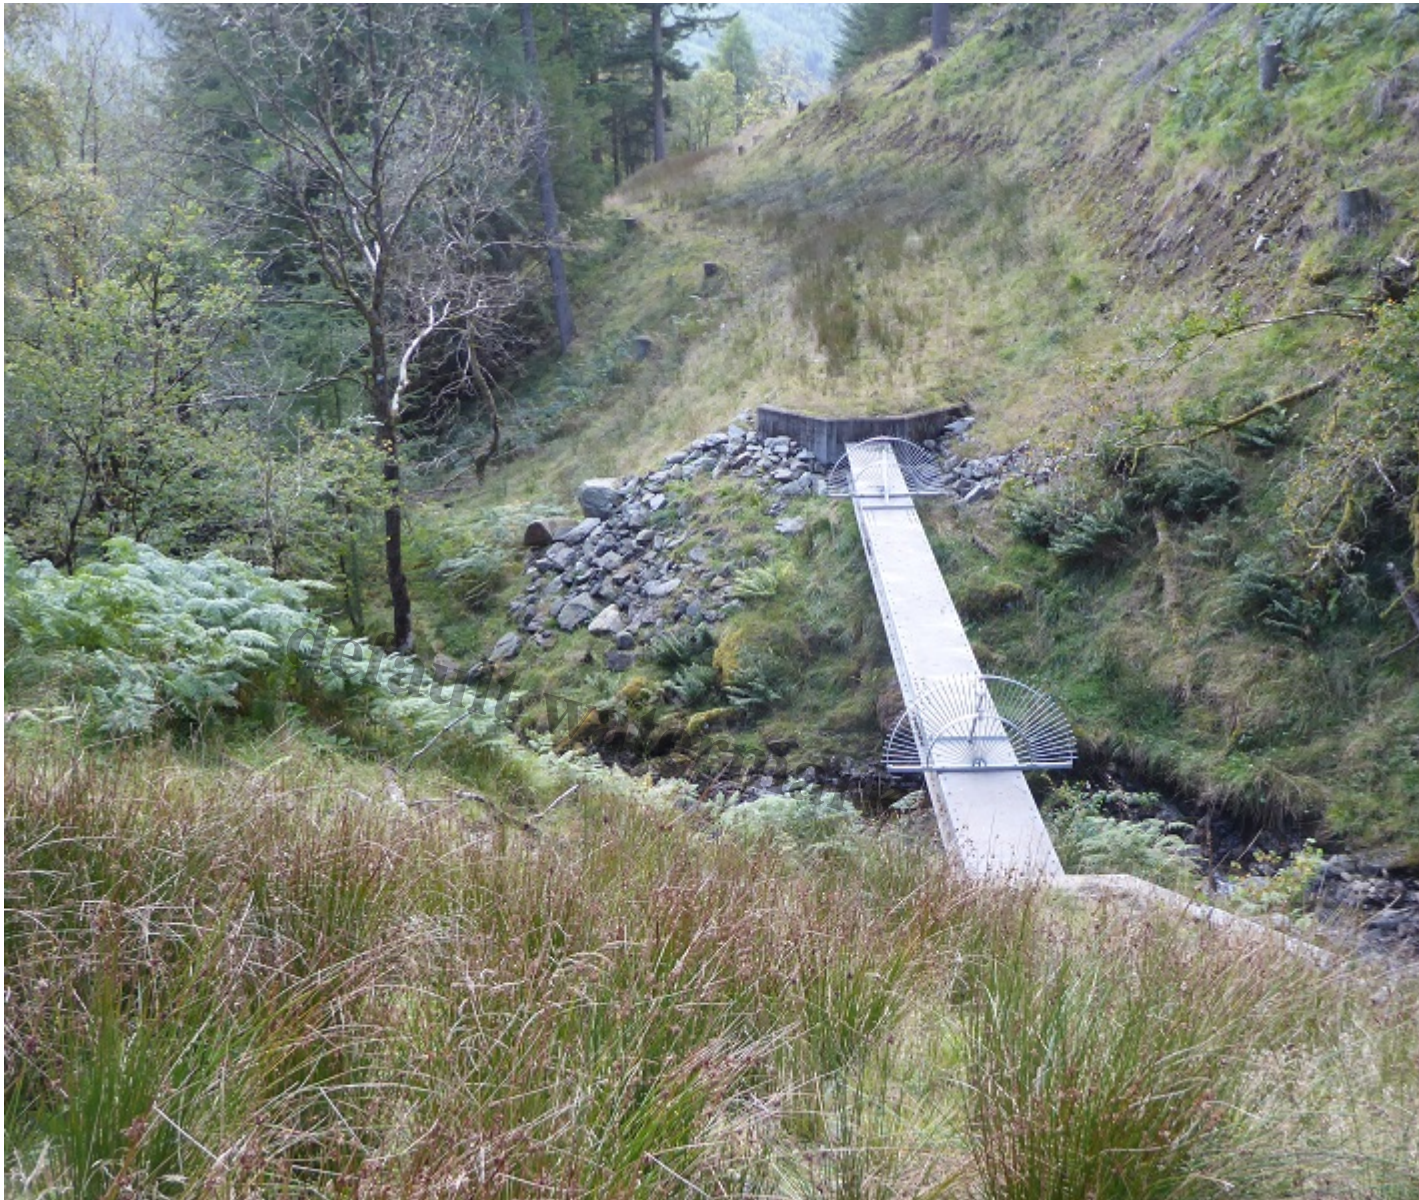
The pipe bridge and boulders look much as they did eighteen months ago. Had the ground above the bridge been properly restored, there would have been no permanent shelf cut across the hillside with the overhanging uphill batter which will take years to re-vegetate.

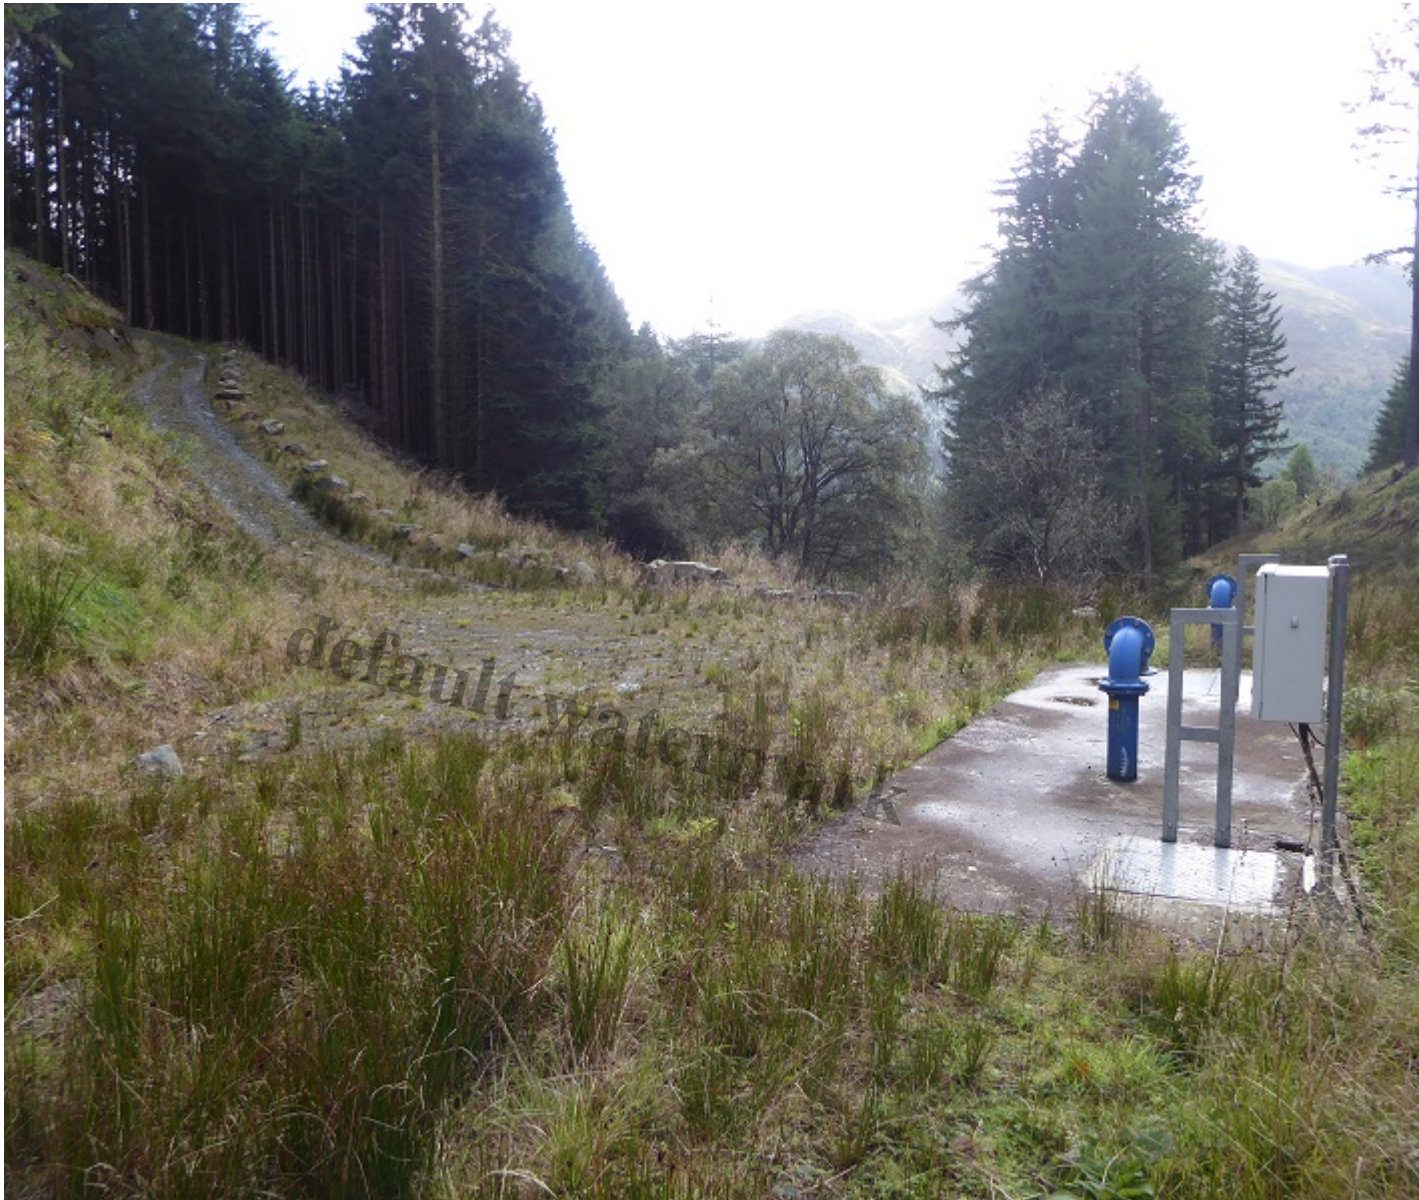
•••Keep measuring devices and gauges low in profile. Use a mute galvanised finish rather than a highly reflective or coloured finish which will reflect light and draw attention to the structure (LLTNPA guidance). The section of track planning staff agreed could remain permanently starts from in front of the dam and runs up the hill.

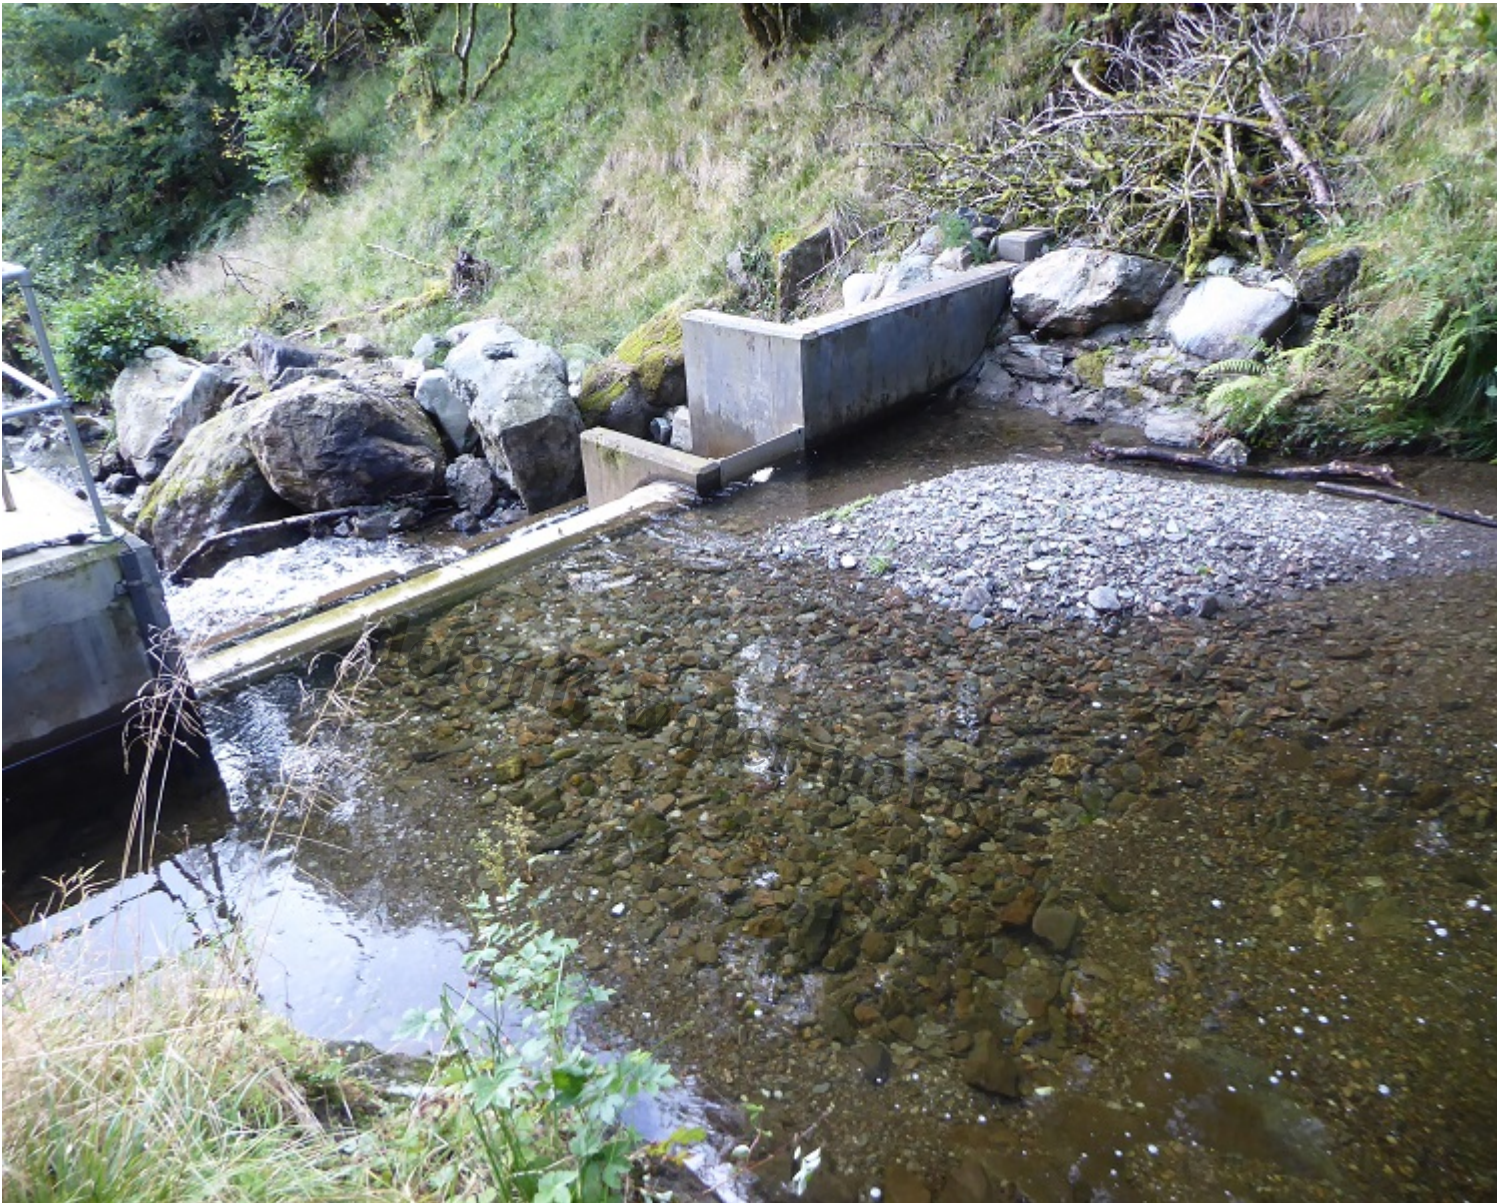
What was striking is how the intake pool is filling in:

That would appear easier said than done. The intake is clearly forming a barrier to stones as they are eroded and swept down the burn. The impact of this, both on the ecology of these burns and on the functioning of the hydro, is something the LLTNPA should be commissioning research on. My suspicion is, however, that one reason access tracks are being retained and the temporary access track has not been restored is to enable diggers to be brought in to re-excavate intake pools every few years.

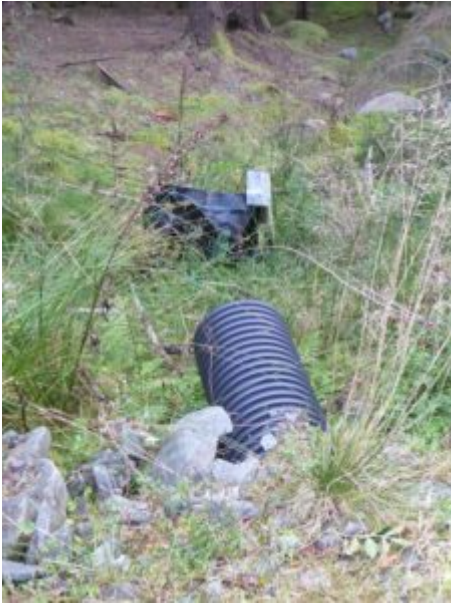
Protruding culvert on new section access track

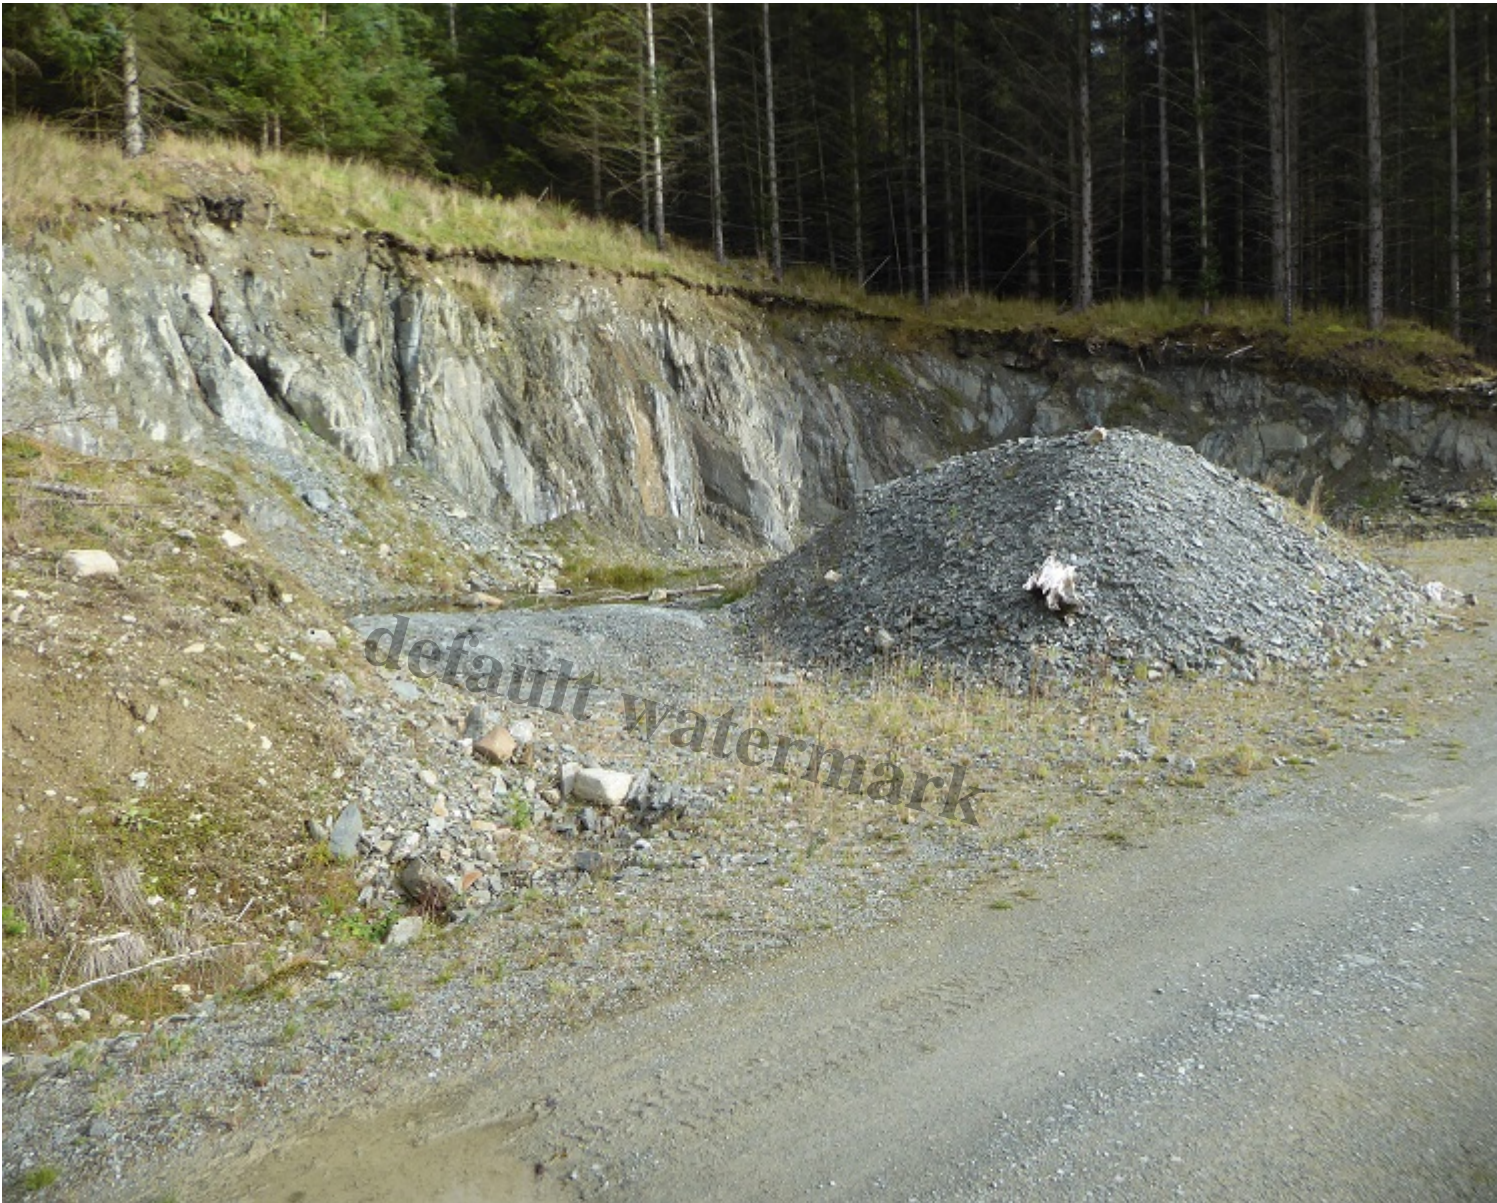
Past the new section of track heading south, there is an old forestry borrow pit which appears to have been used to source materials to build it. LLTNPA good practice guidance has again been totally ignored:

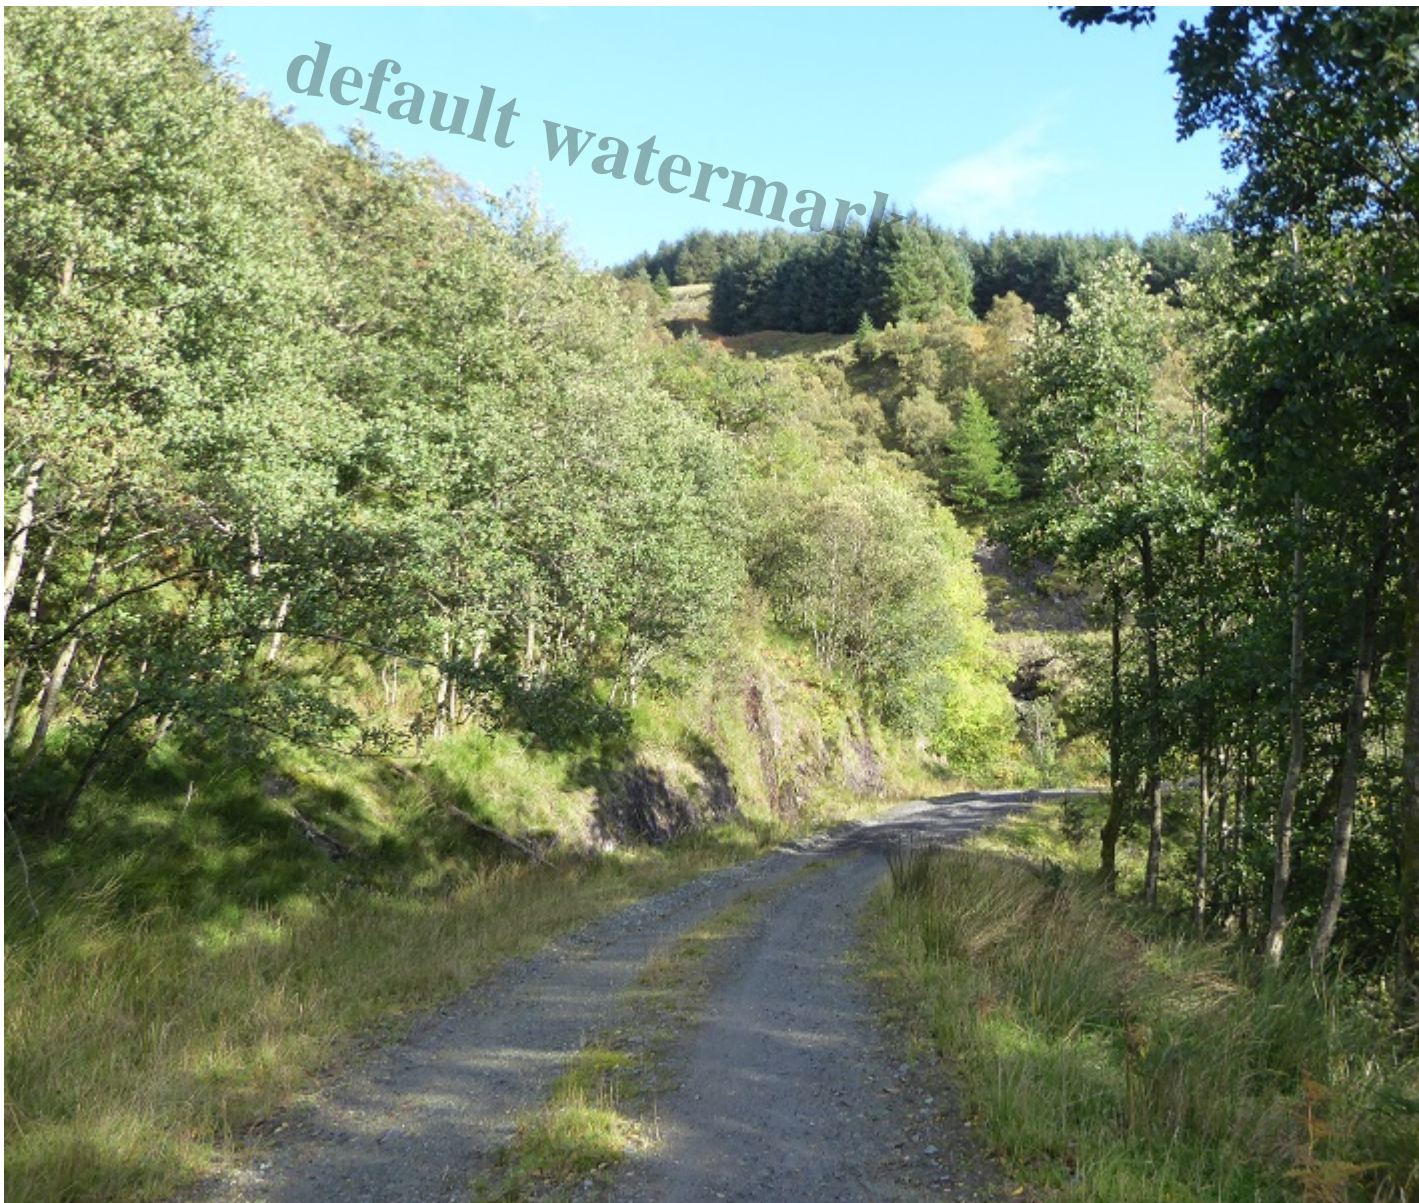
The Anie hydro intake is located at the bend in the track in native woodland on the Ancient Woodland

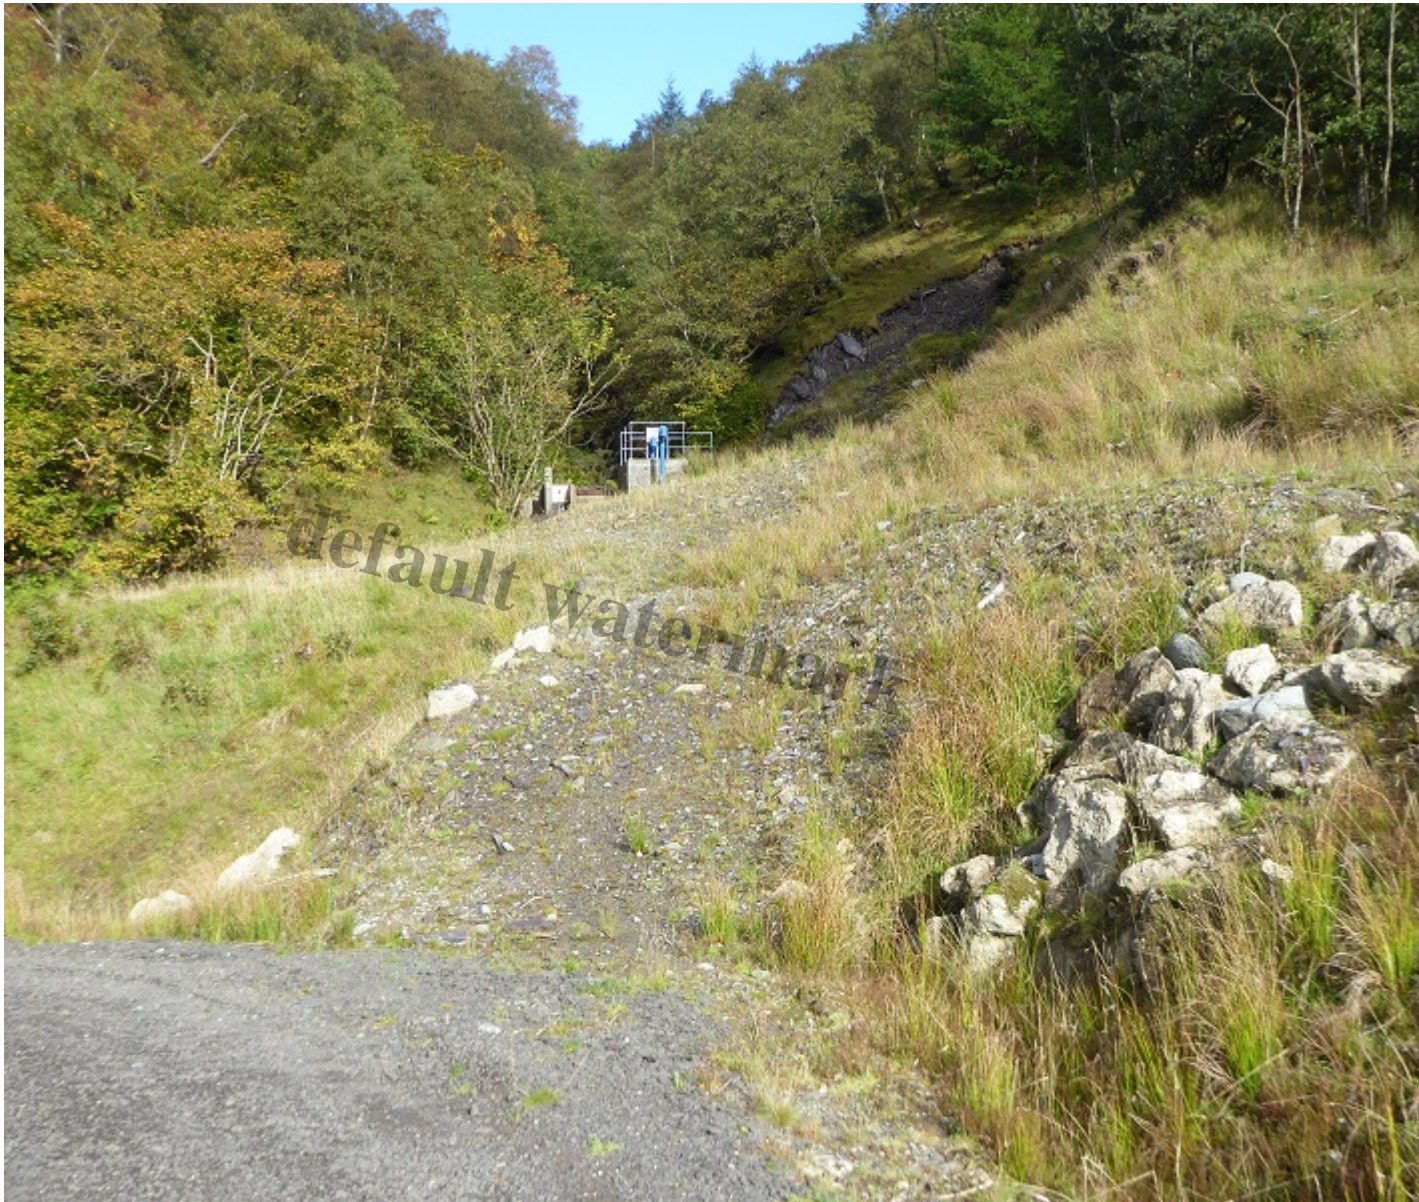
Note the unrestored temporary construction track marked by white stones on left and steep bare bank right of intake

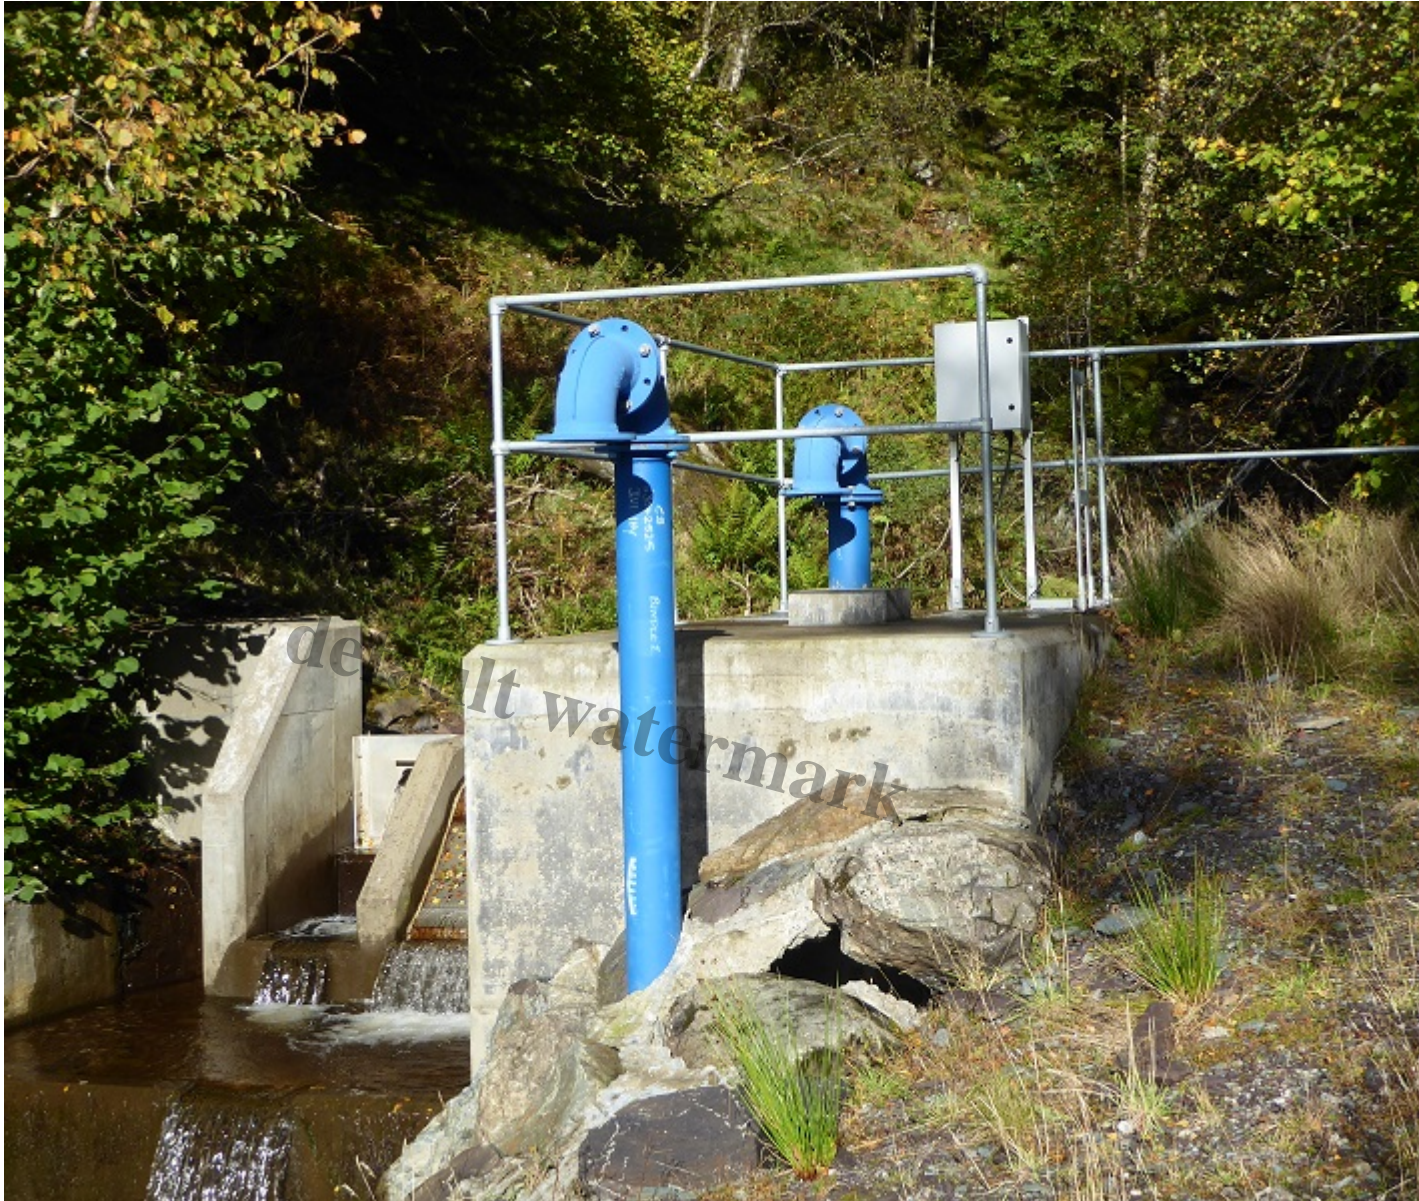
More blue pipes and bare concrete structures

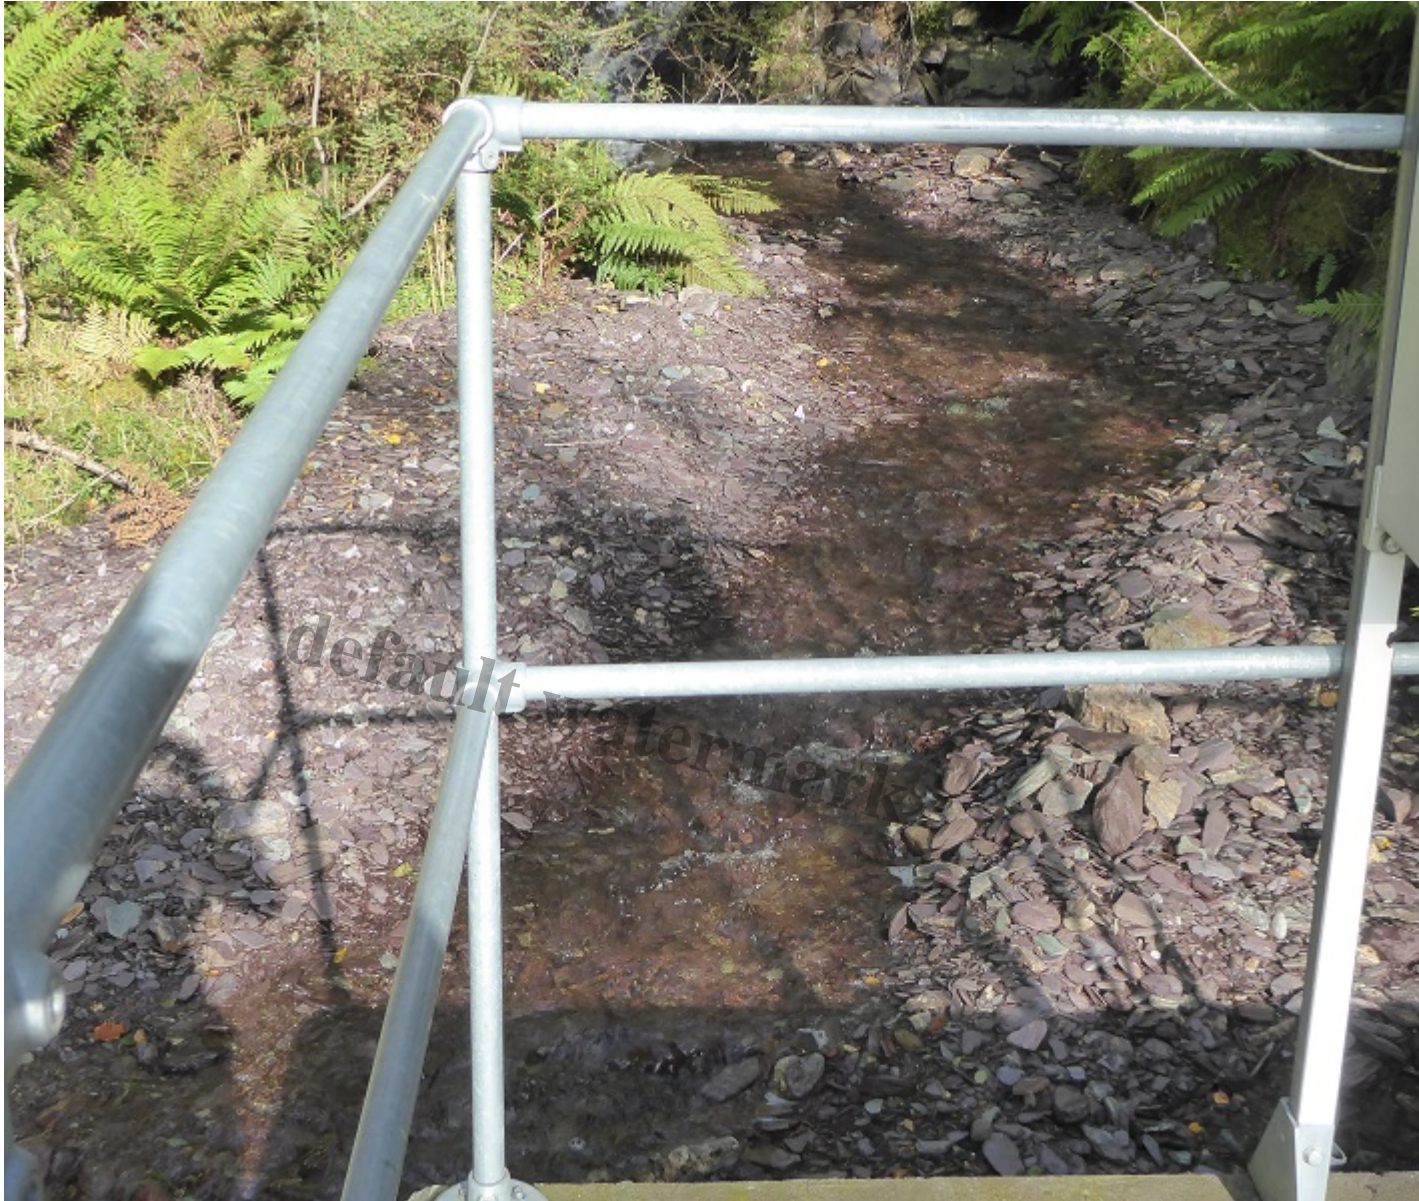
Infilling intake pool
