LLTNPA's Success shared at the Ardchullarie and Anie hydro schemes

The Ardchullarie hydro scheme

The Anie hydro scheme

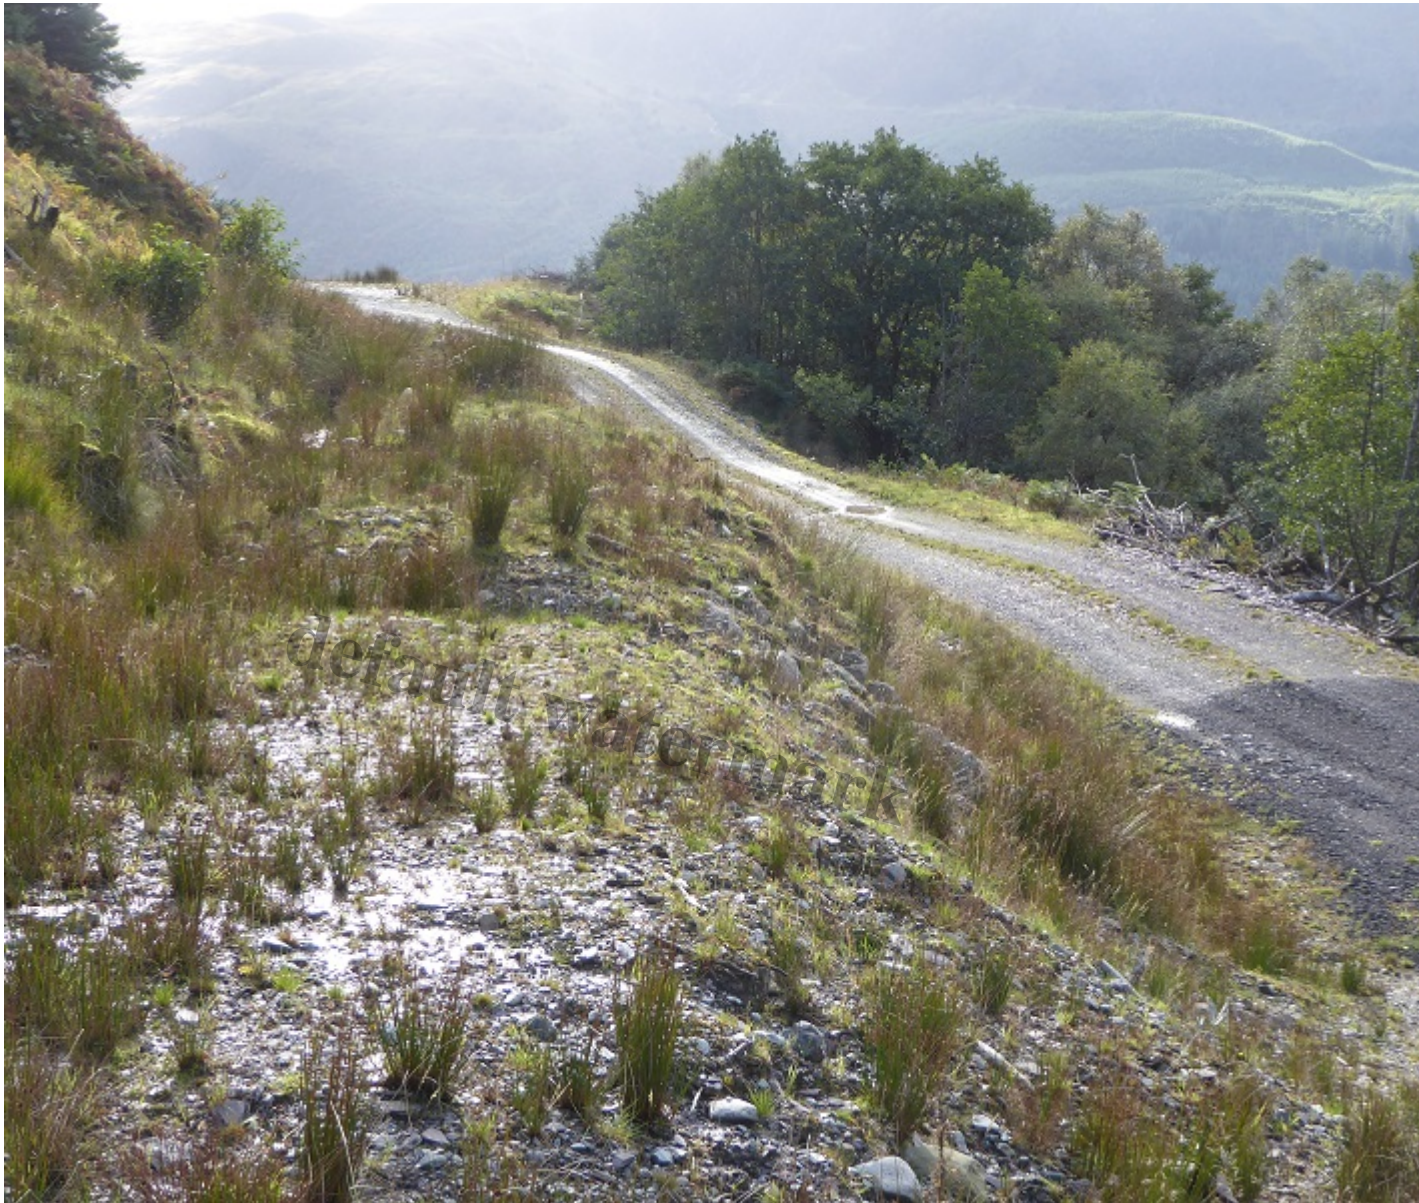
Failure to restore landscape or vegetation above the pipeline (which crosses under the road in the middle distance) *“The National Park will wish to see ecological integrity retained and where possible enhanced. For example tracks and pipelines should avoid fragmentation of woodland.”* (Good Practice Guidance)

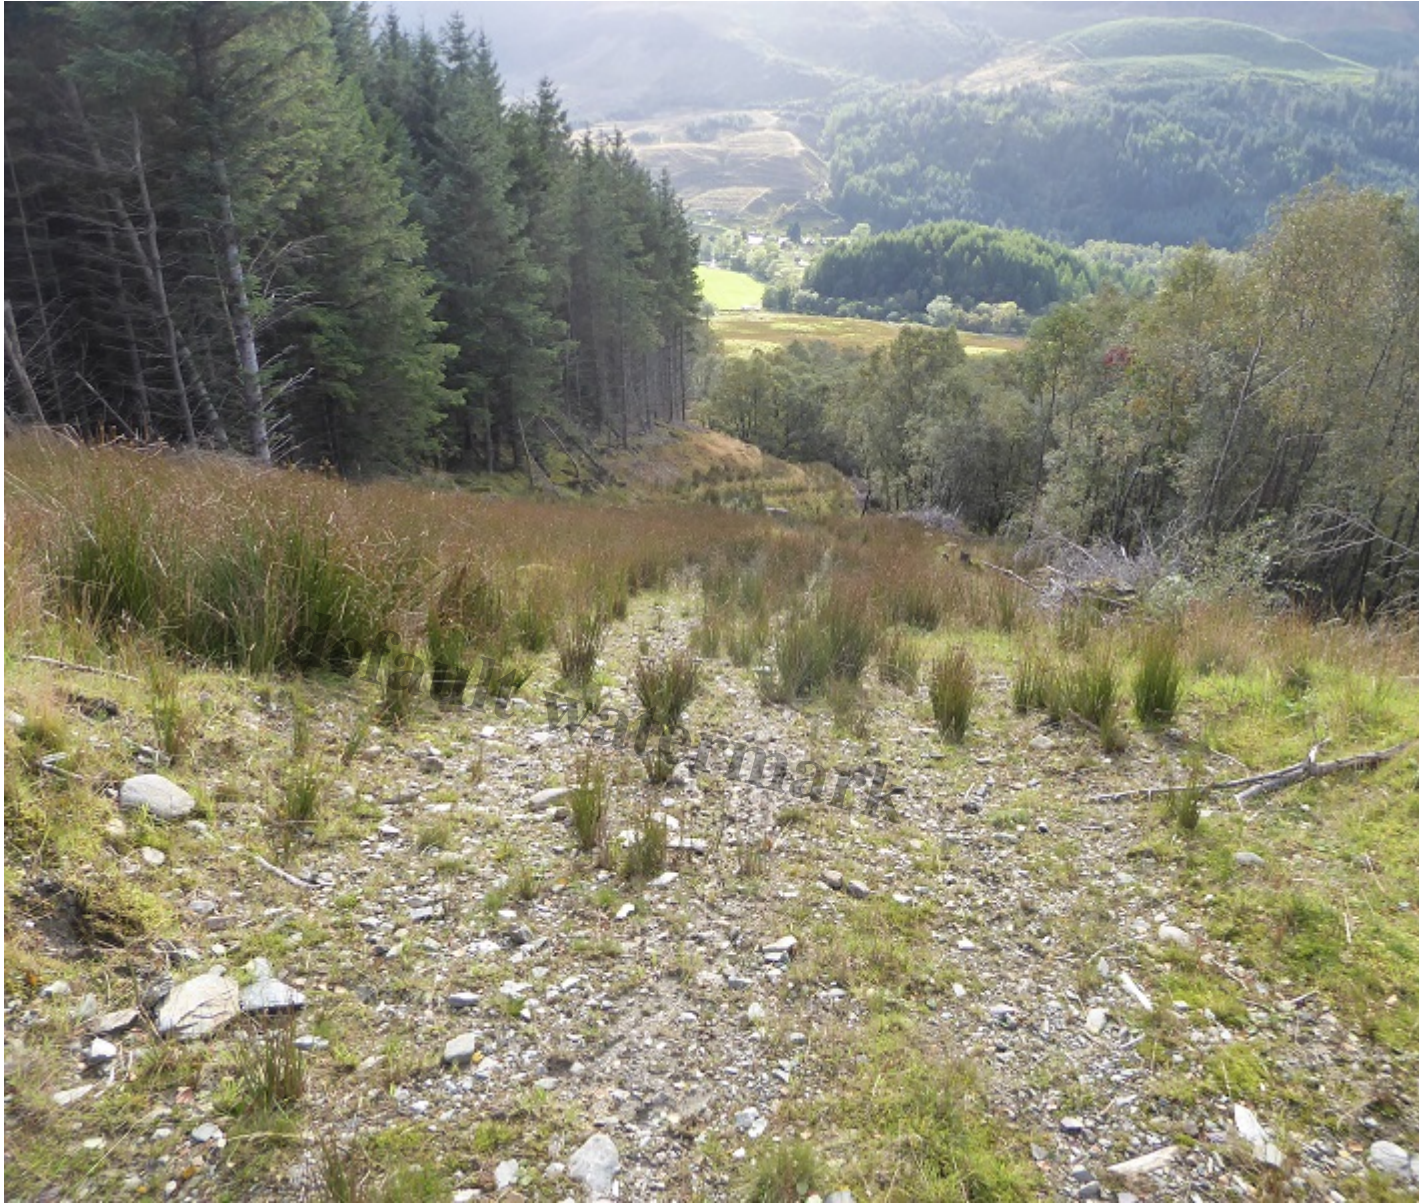
More restoration failure of the pipeline below the forest track

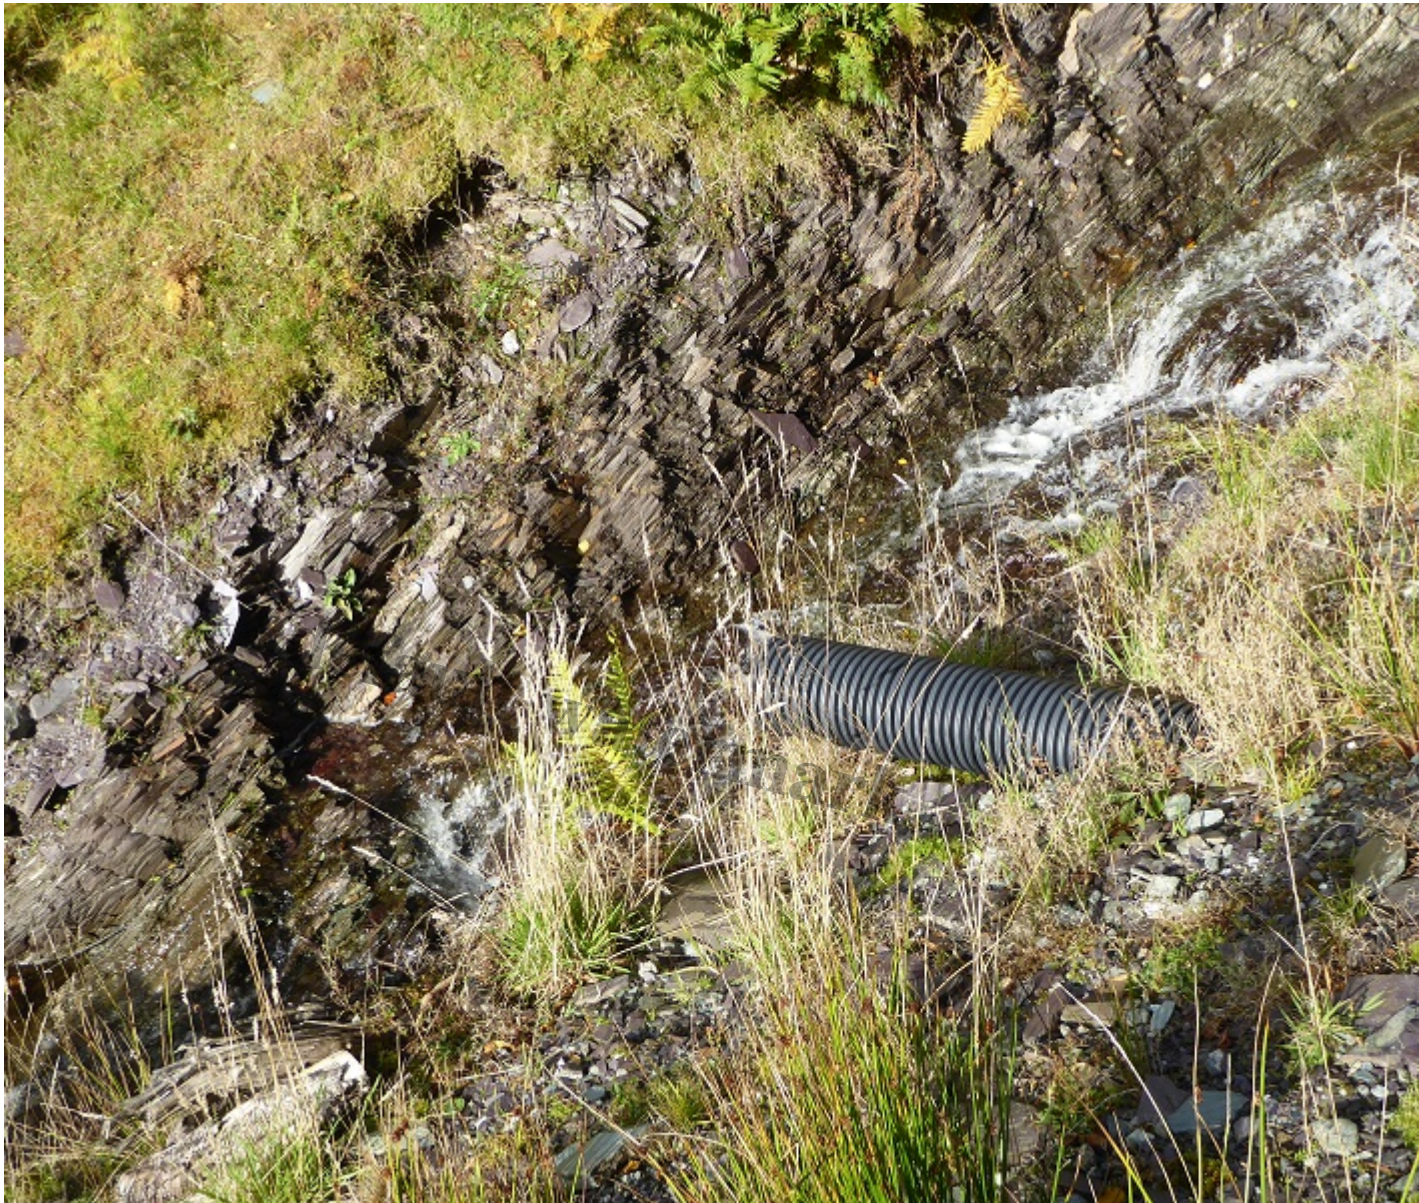
The seemingly inevitable protruding culvert – this one just below the intake

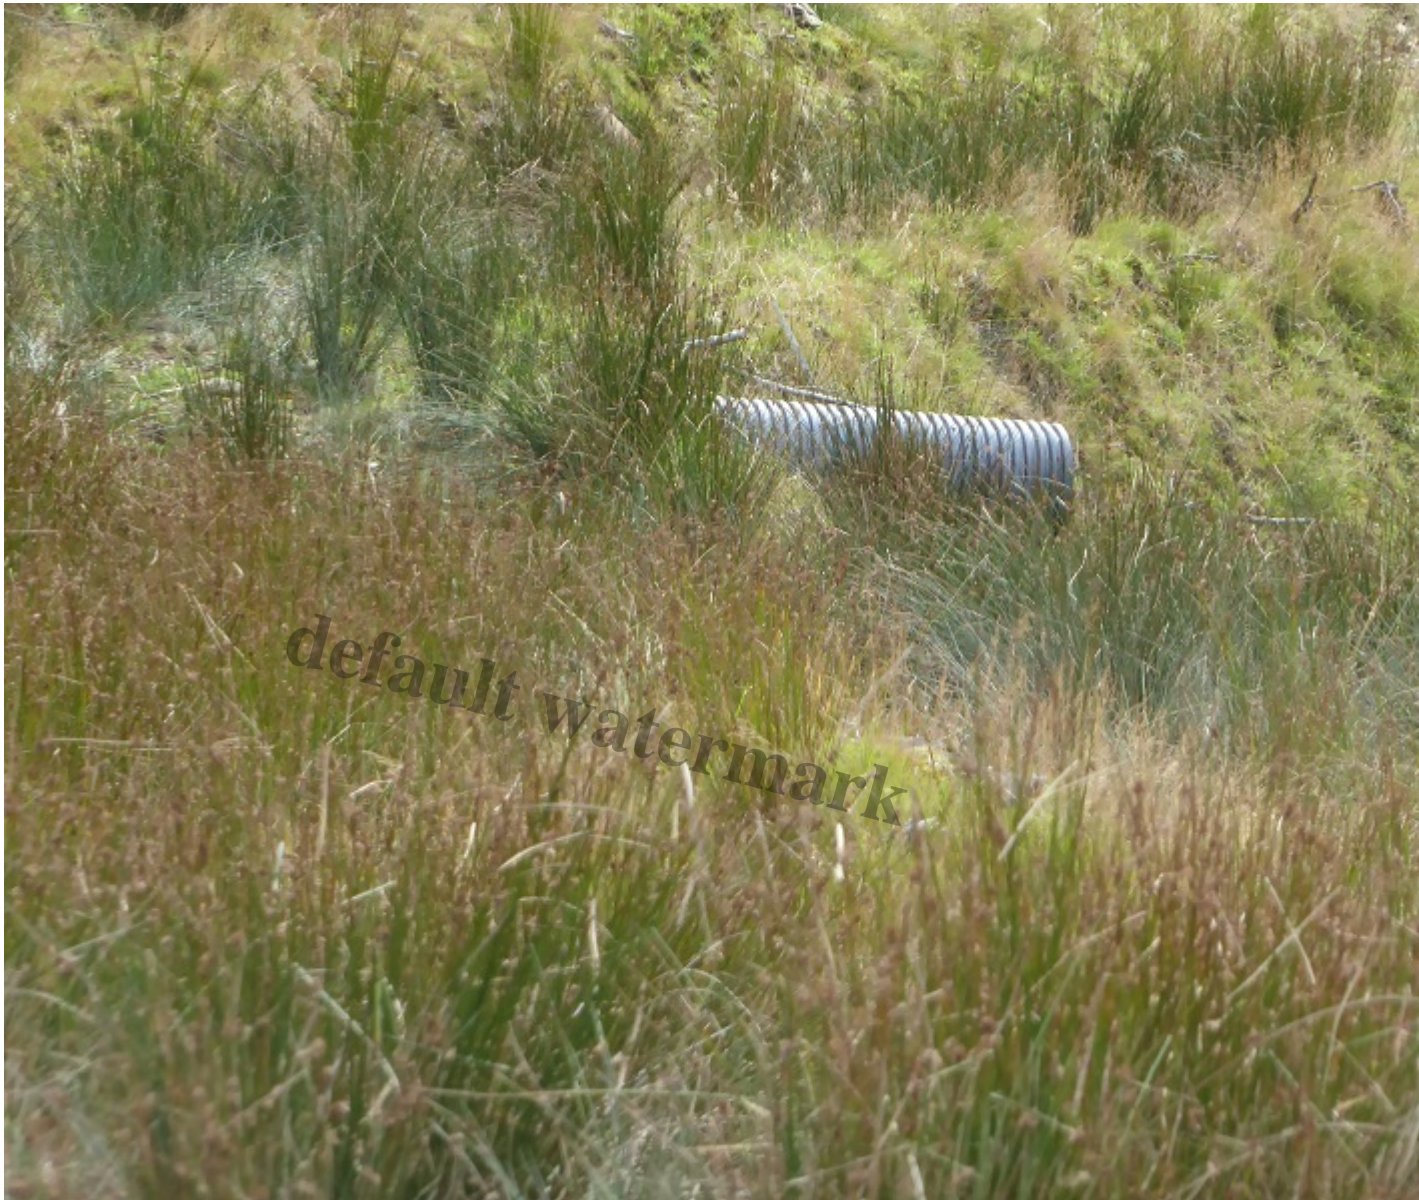
And another further down the pipelineâ?!
