## LLTNPA's "Success shared"? – the Ardchullarie and Anie hydro schemes

## **The Ardchullarie hydro scheme**

## **The Anie hydro scheme**

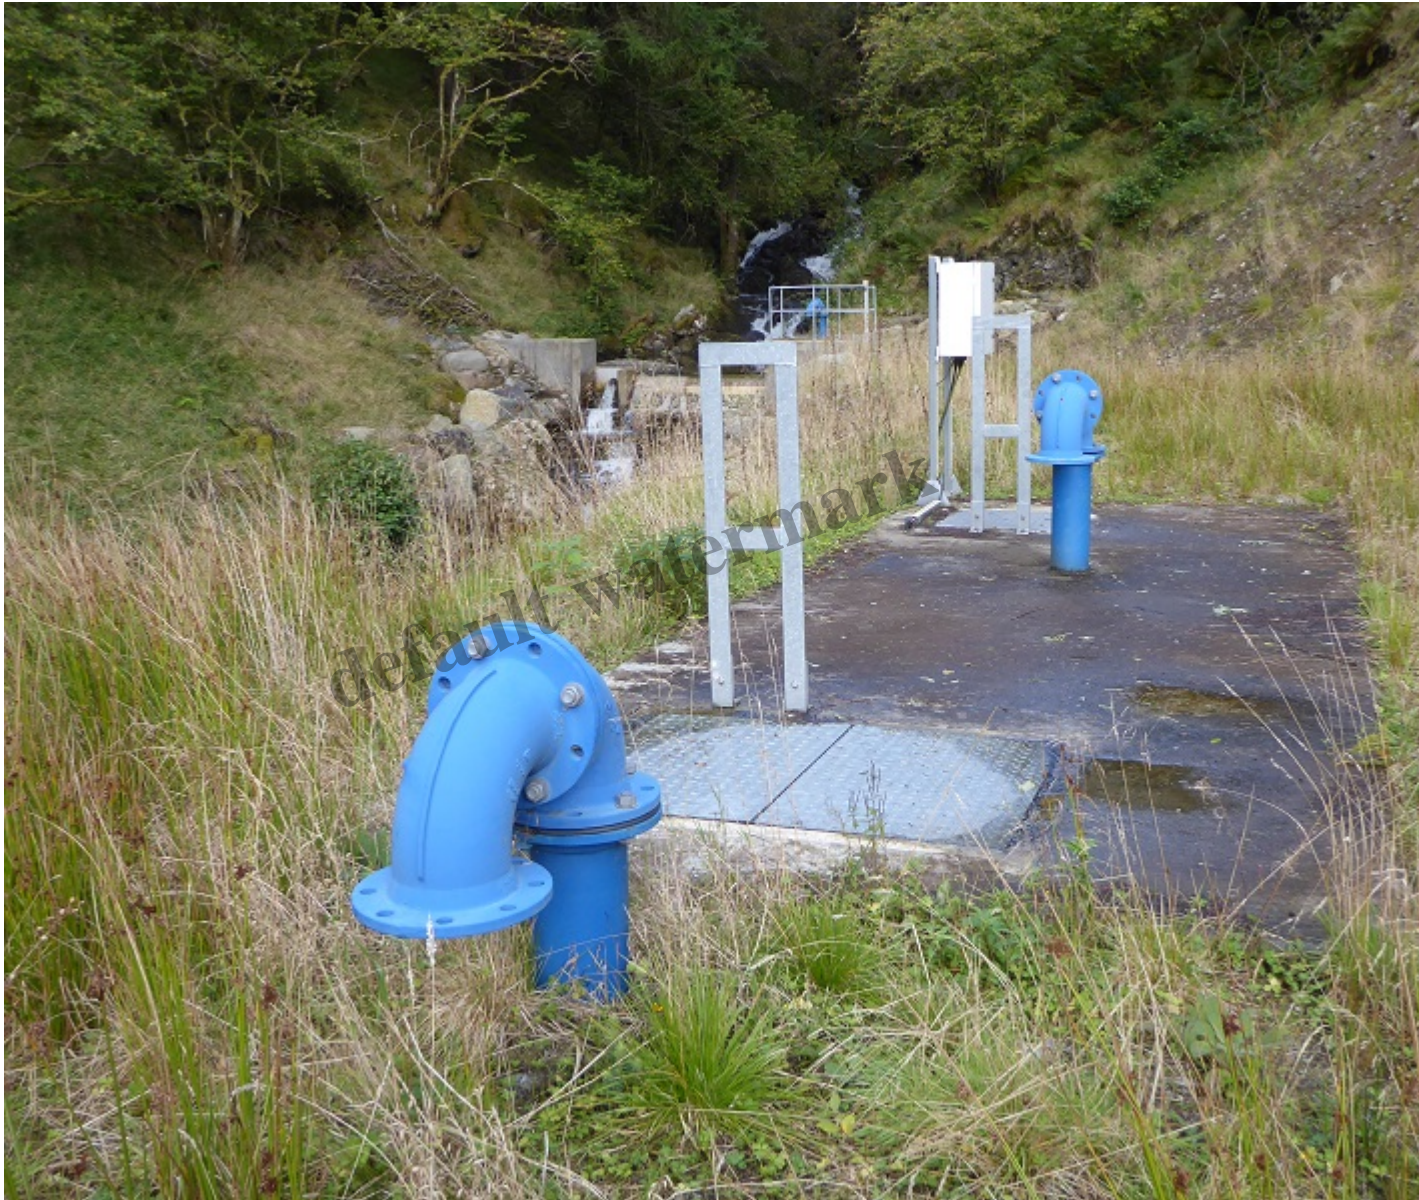
Ardchullarie Intake "Introduce as few different materials and colours as possible. A mute galvanised mute grey / green colour will blend in with most upland environments." (LLTNPA Good Practice Guide renewables)

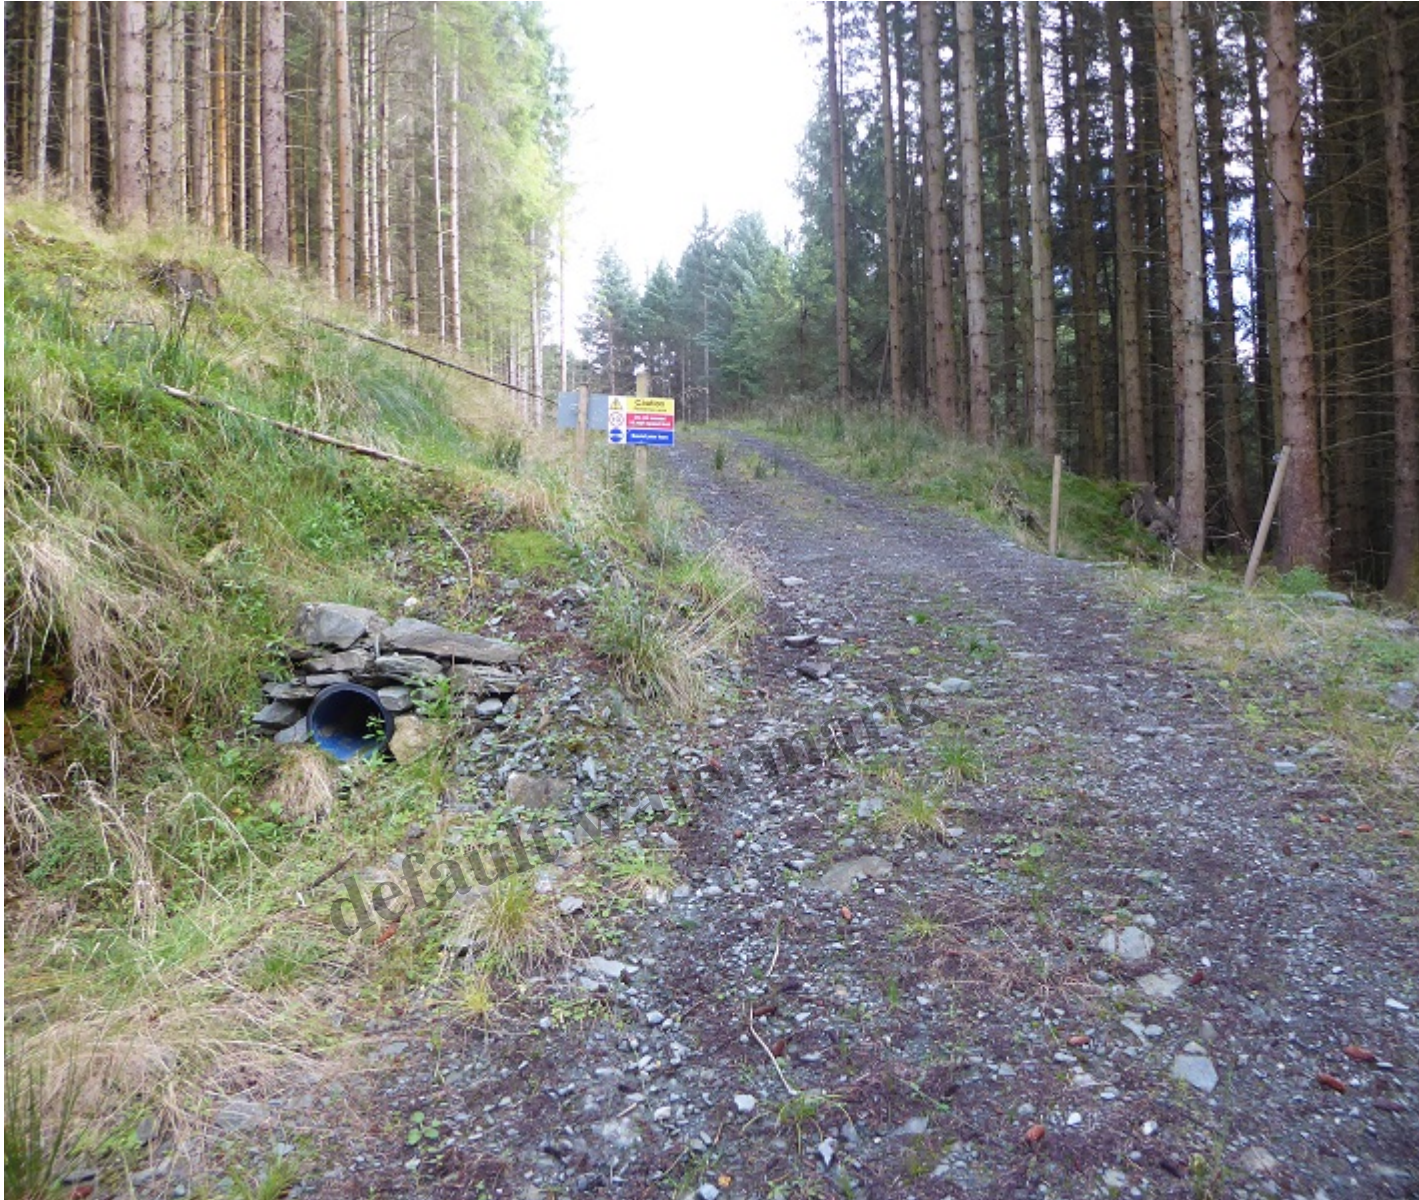
The intersection of the walker's path and new track – note the finished culvert which runs under the path. Signs advise vehicles to look out for walkers.

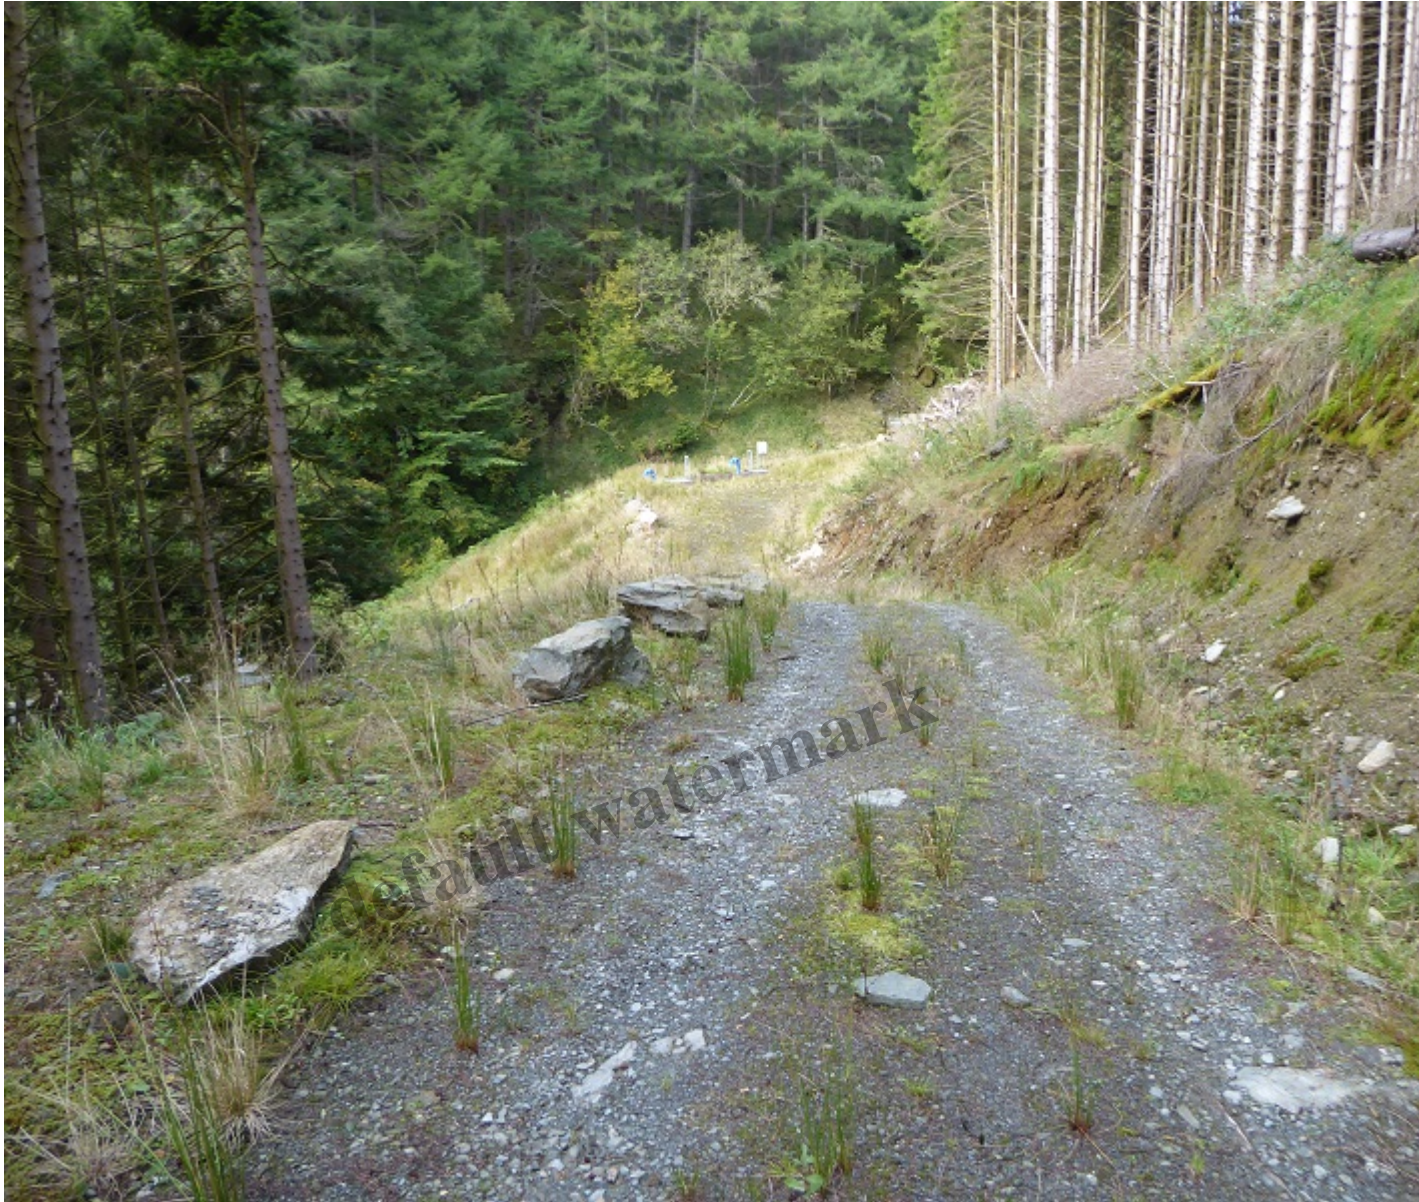
Shallow batter? Use of vegetation to restore batter? Appropriate use of boulders? Good landscaping

You would struggle to find ANY evidence of that award winning good practice advice being implemented here.

While the bare slopes and ground photographed by Jane Meek in early 2017 have started to re-vegetate, what recovery has taken place appears to have happened naturally without any of the good practice techniques advocated by the LLTNPA. The revegetation is partial and the steep slope remains very vulnerable to erosion:

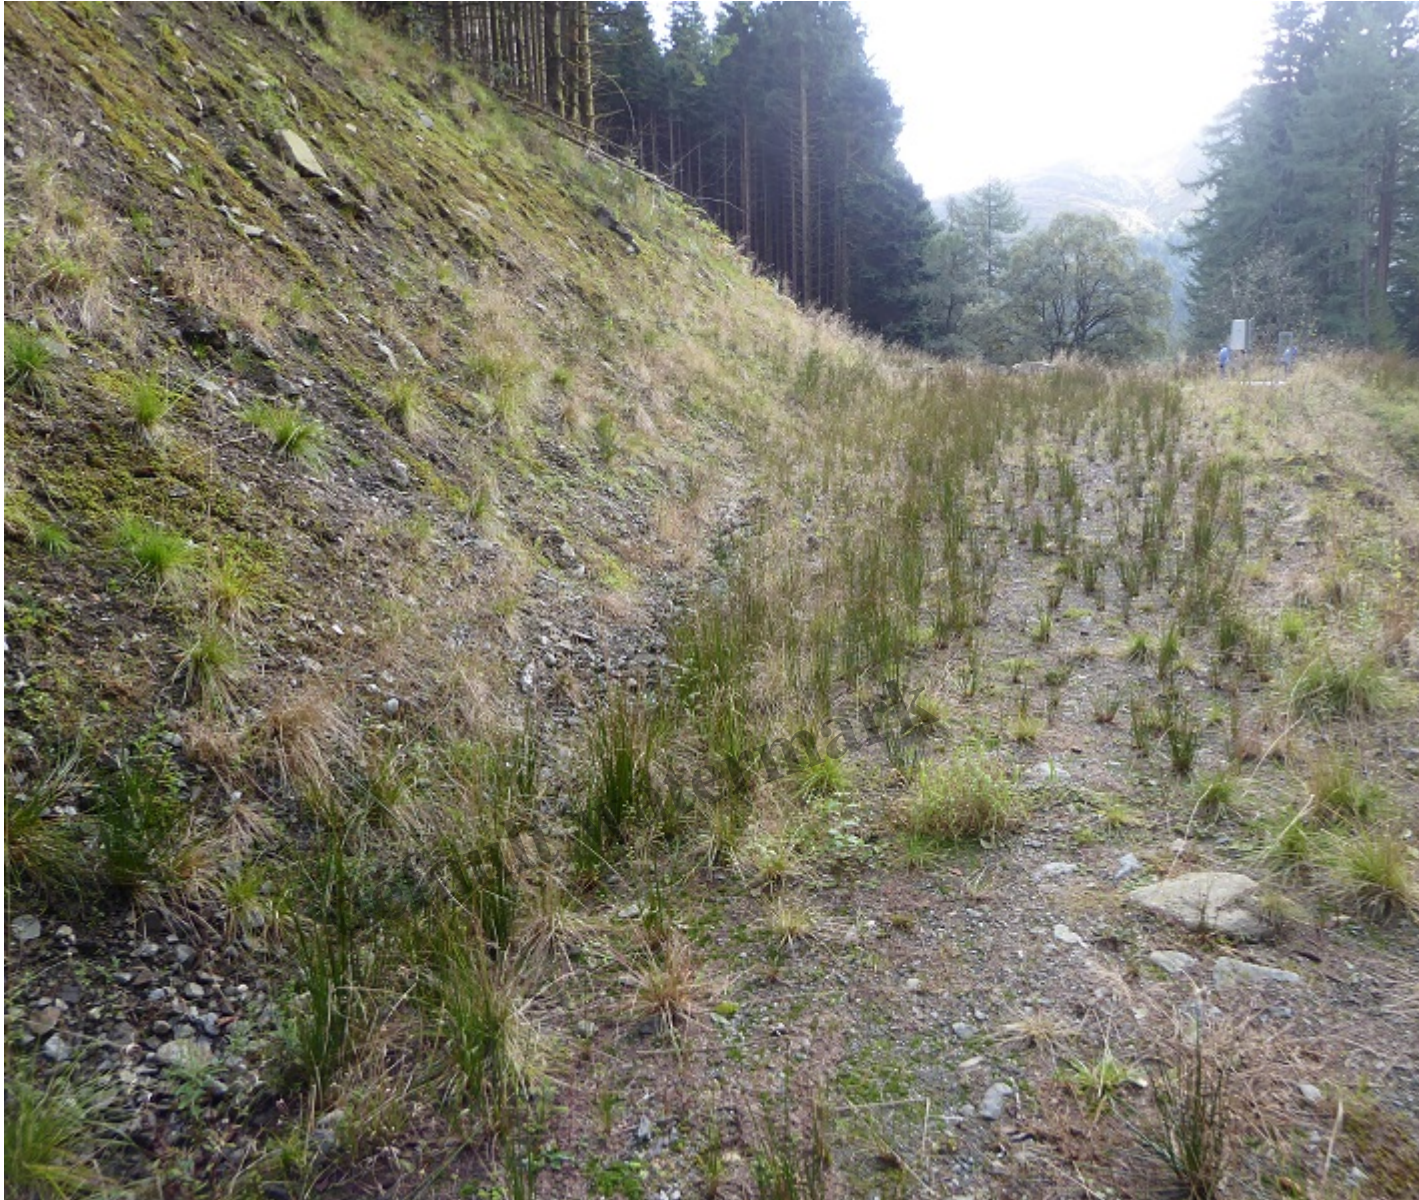
Looking west from the intake along the short section of construction track which was supposed to be removed. The slope on the right had been bare early in 2017. Note how soft rush is colonising the flatter area formerly occupied by the track.

Had this section of temporary track been removed, instead of just being left to grow over, there would have been sufficient material to restore the landscape, including the oversteep uniform slope on the left.

That’s not happened here. Instead, the abandoned track adds to the desolation created by industrial forestry practices.

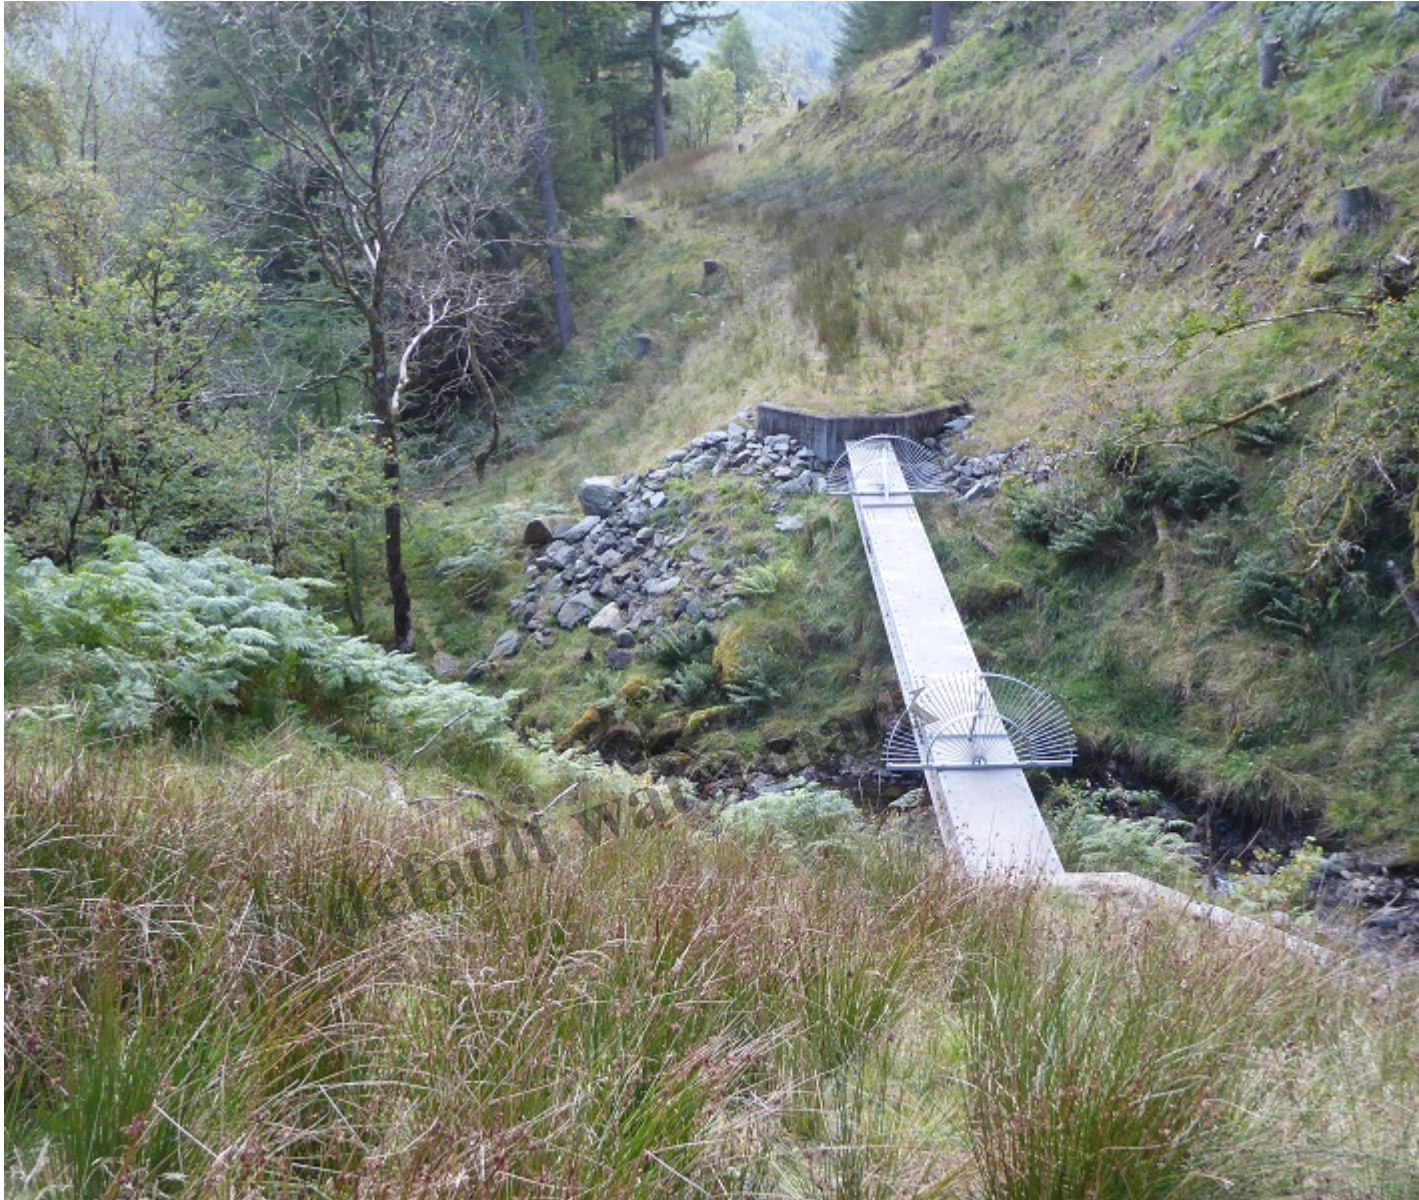
The pipe bridge and boulders look much as they did eighteen months ago. Had the ground above the bridge been properly restored, there would have been no permanent shelf cut across the hillside with the overhanging uphill batter which will take years to re-vegetate.

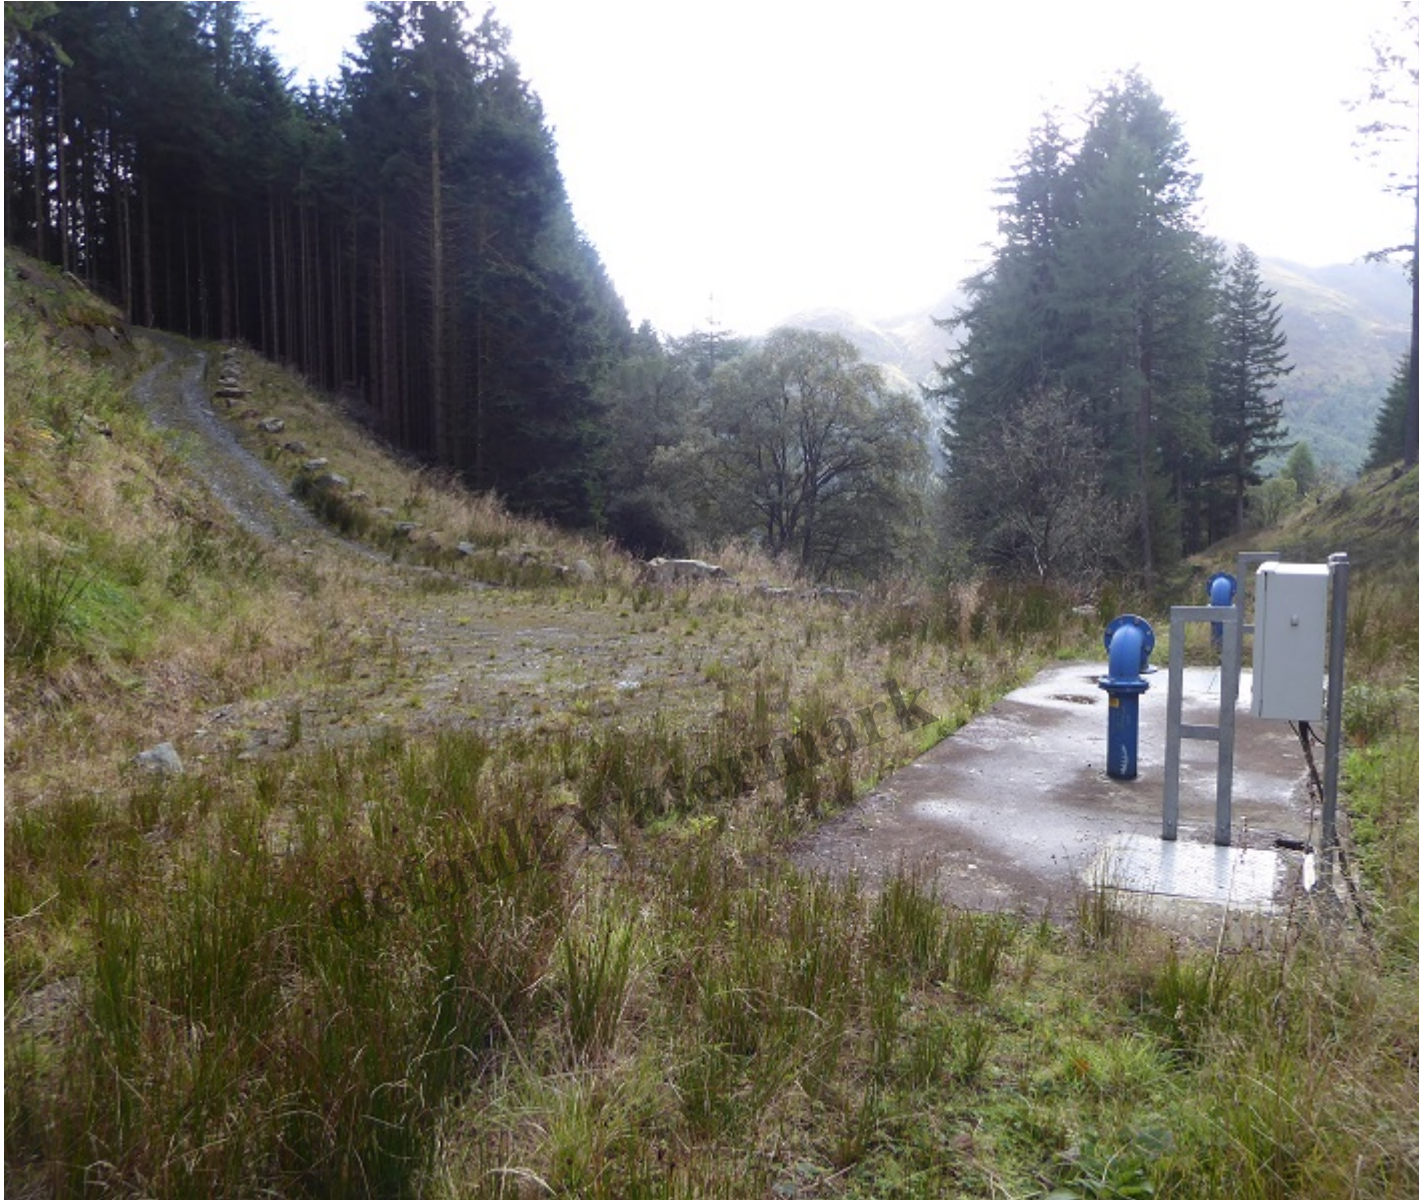
“Keep measuring devices and gauges low in profile. Use a mute galvanised finish rather than a high or coloured finish which will reflect light and draw attention to the structure” (LLTNPA good practice guide). The section of track planning staff agreed could remain permanently starts from in front of the rush at the hill.

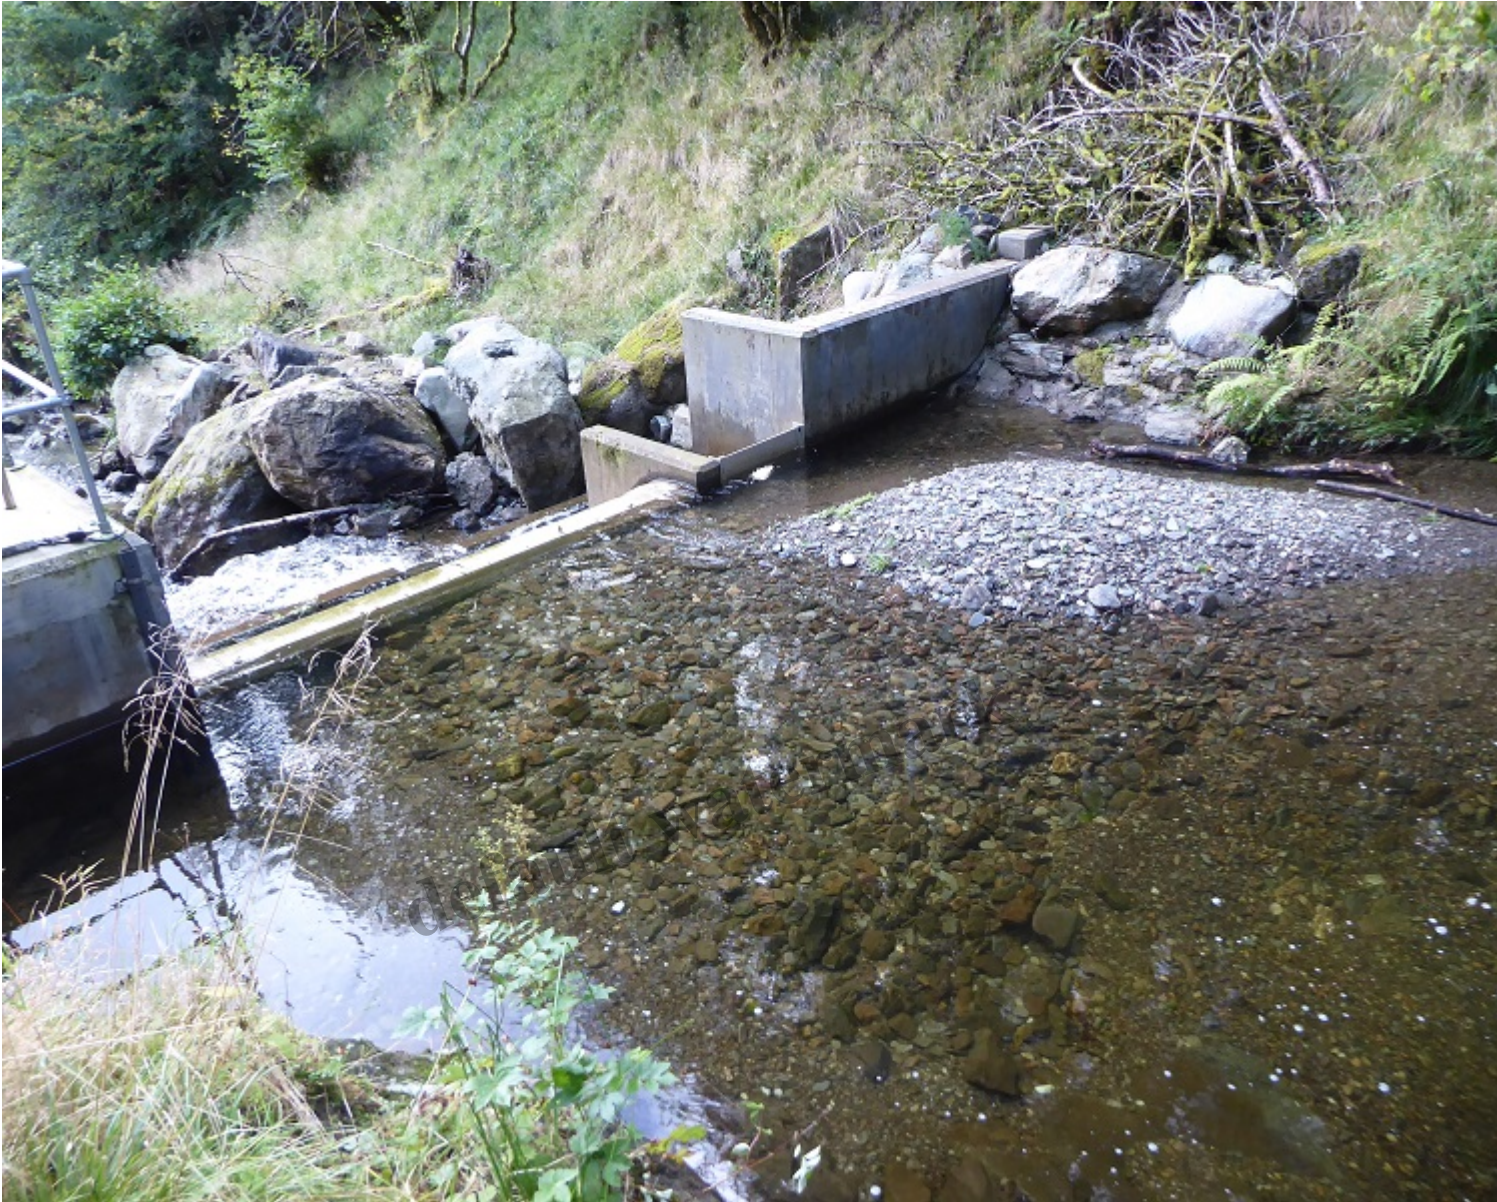
What was striking is how the intake pool is filling in:

That would appear easier said than done. The intake is clearly forming a barrier to stones as they are eroded and swept down the burn. The impact of this, both on the ecology of these burns and on the functioning of the hydro, is something the LLTNPA should be commissioning research on. My suspicion is, however, that one reason access tracks are being retained and the temporary access track has not been restored is to enable diggers to be brought in to re-excavate intake pools every few years.

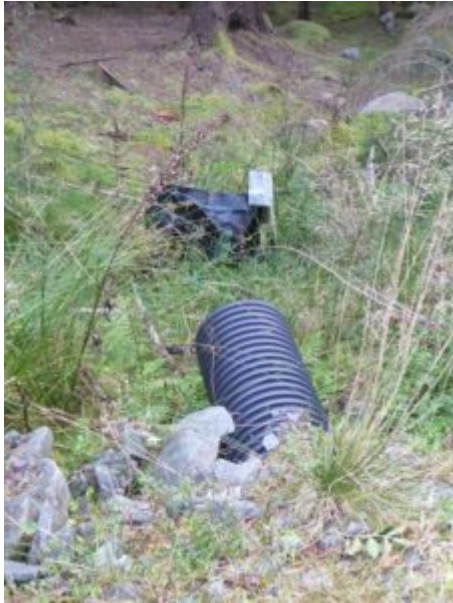
Protruding culvert on new  
section access track

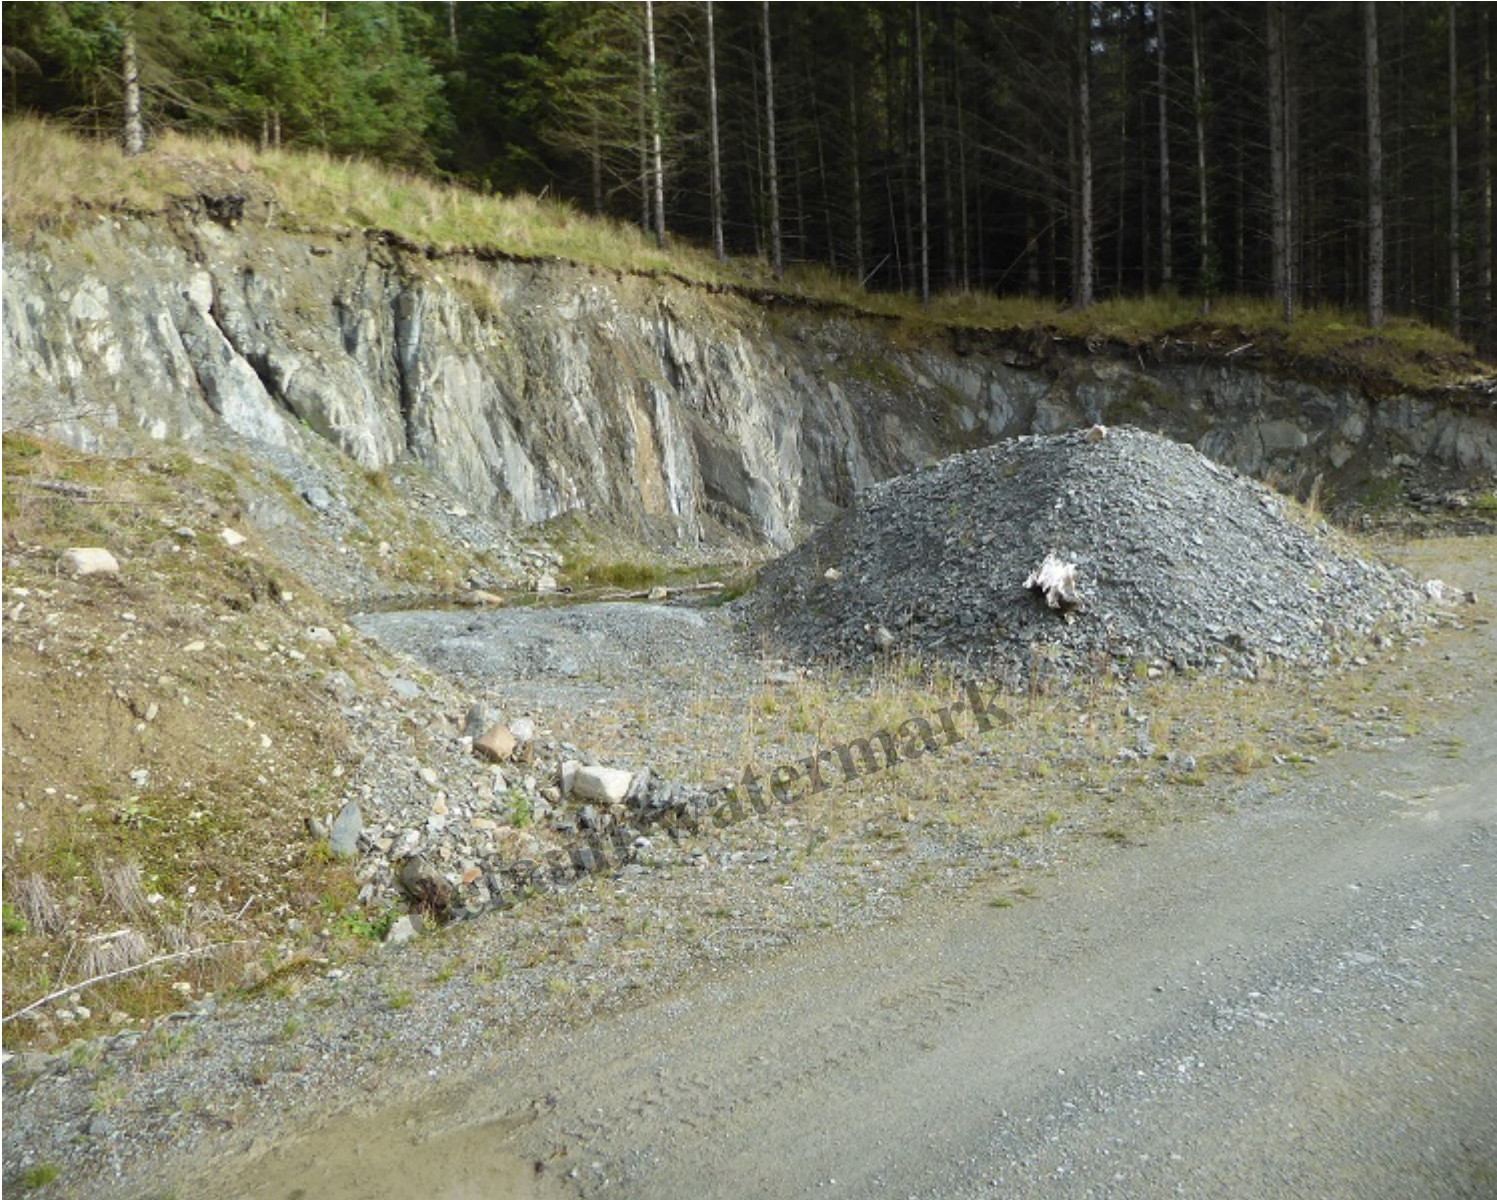
Past the new section of track heading south, there is an old forestry borrow pit which appears to have been used to source materials to build it. LLTNPA good practice guidance has again been totally ignored:

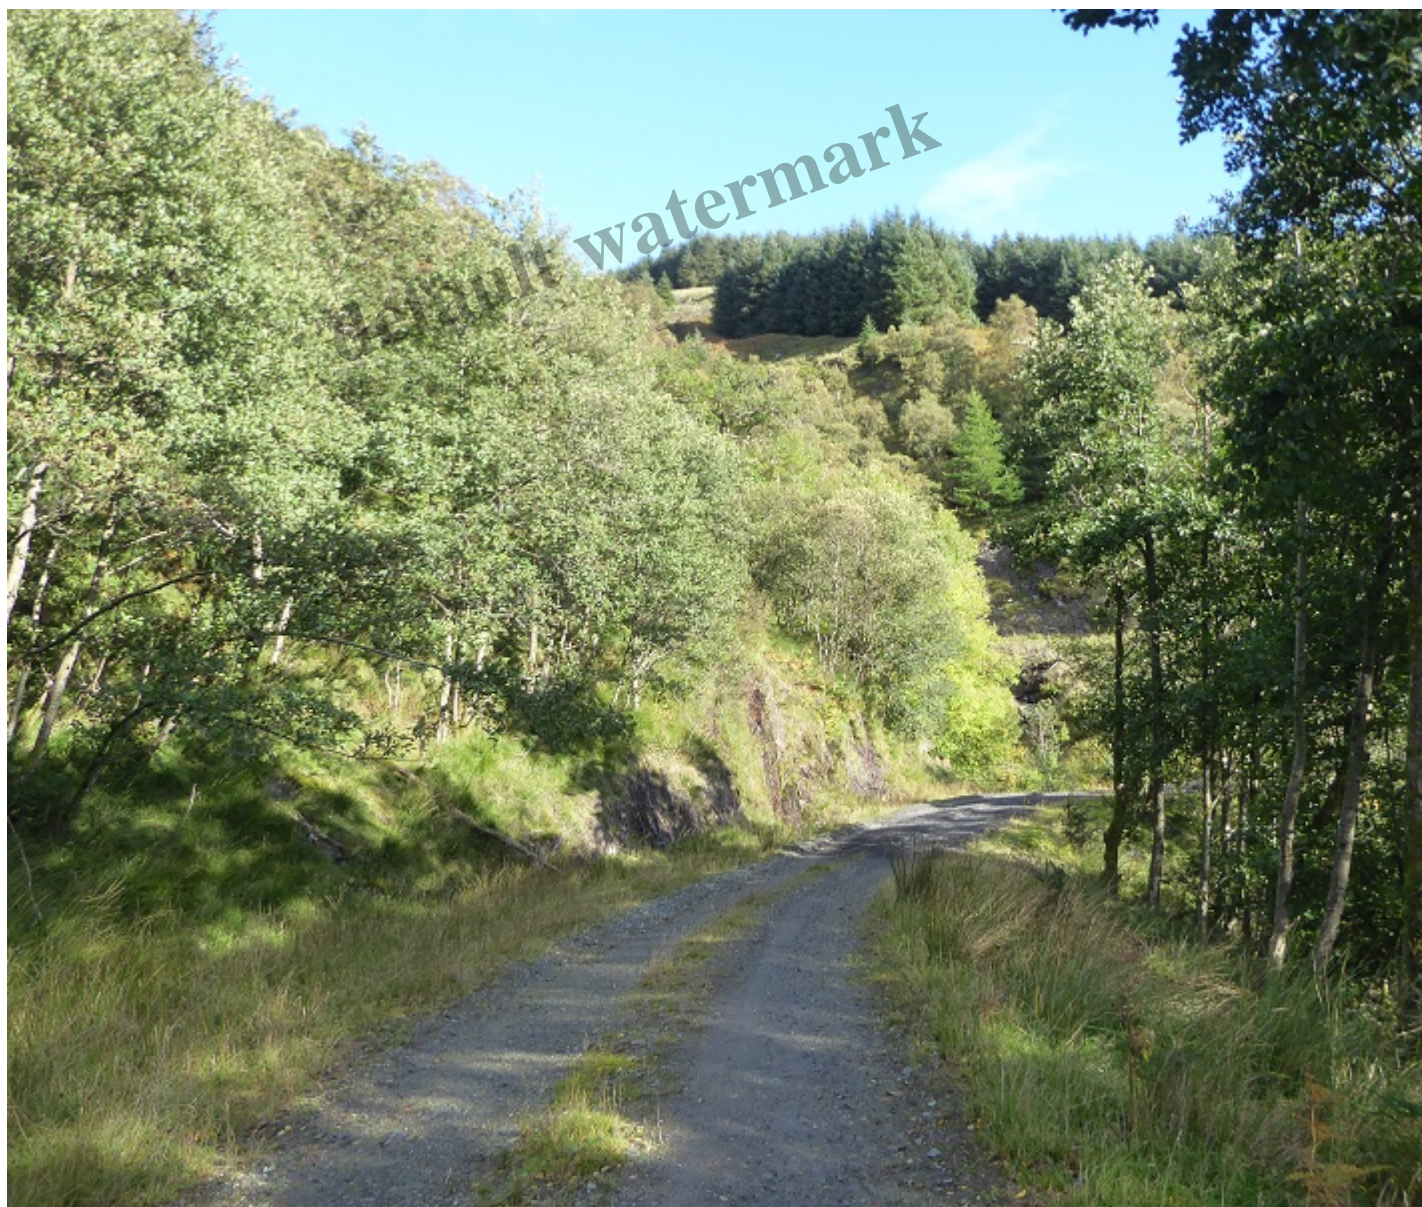
The Anie hydro intake is located at the bend in the track in native woodland on the Ancient Woodland

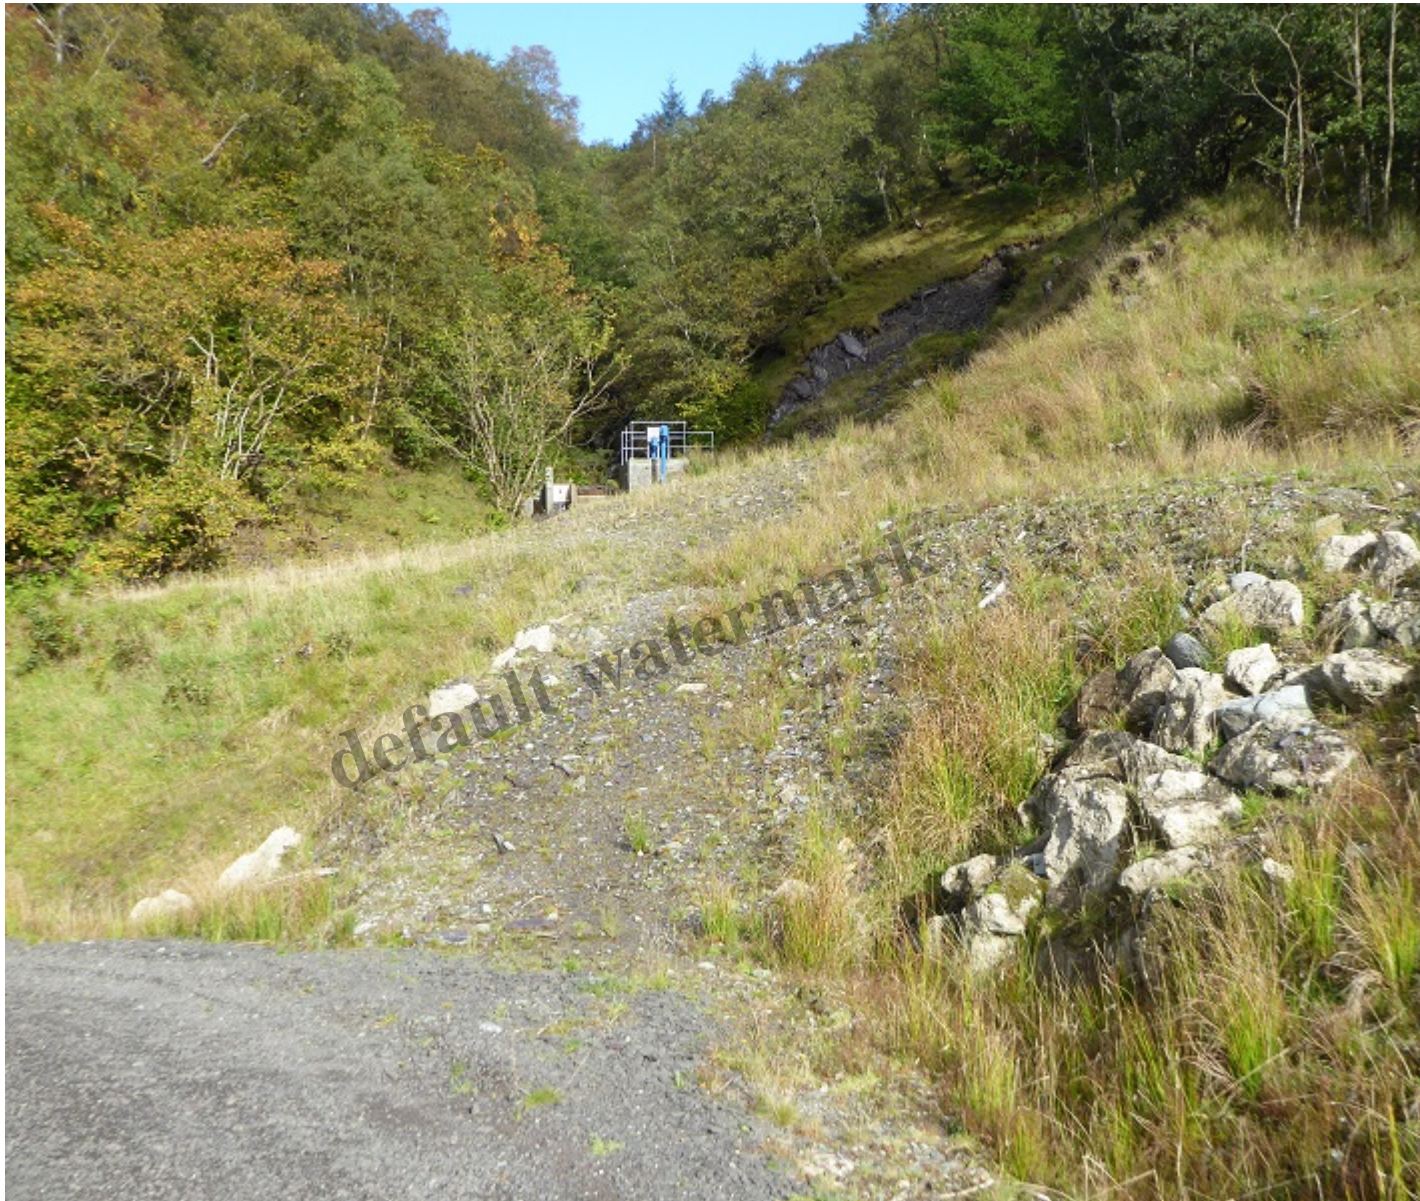
Note the unrestored temporary construction track marked by white stones on left and steep bare bank right of intake

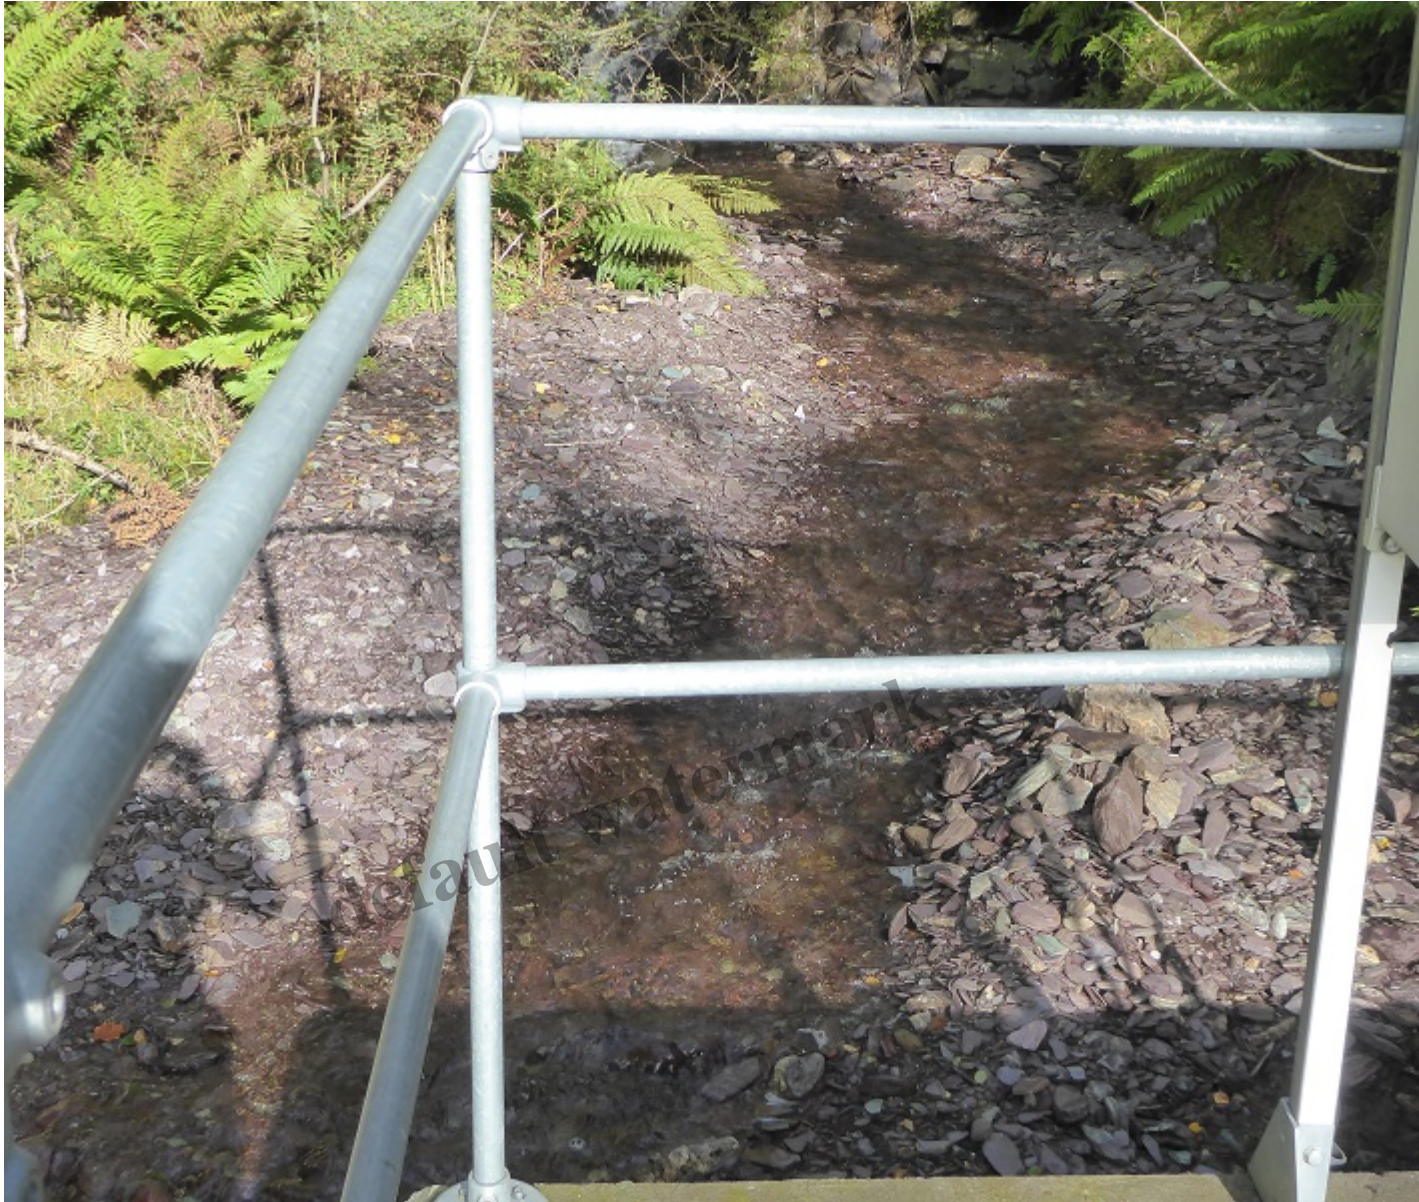
Infilling intake pool

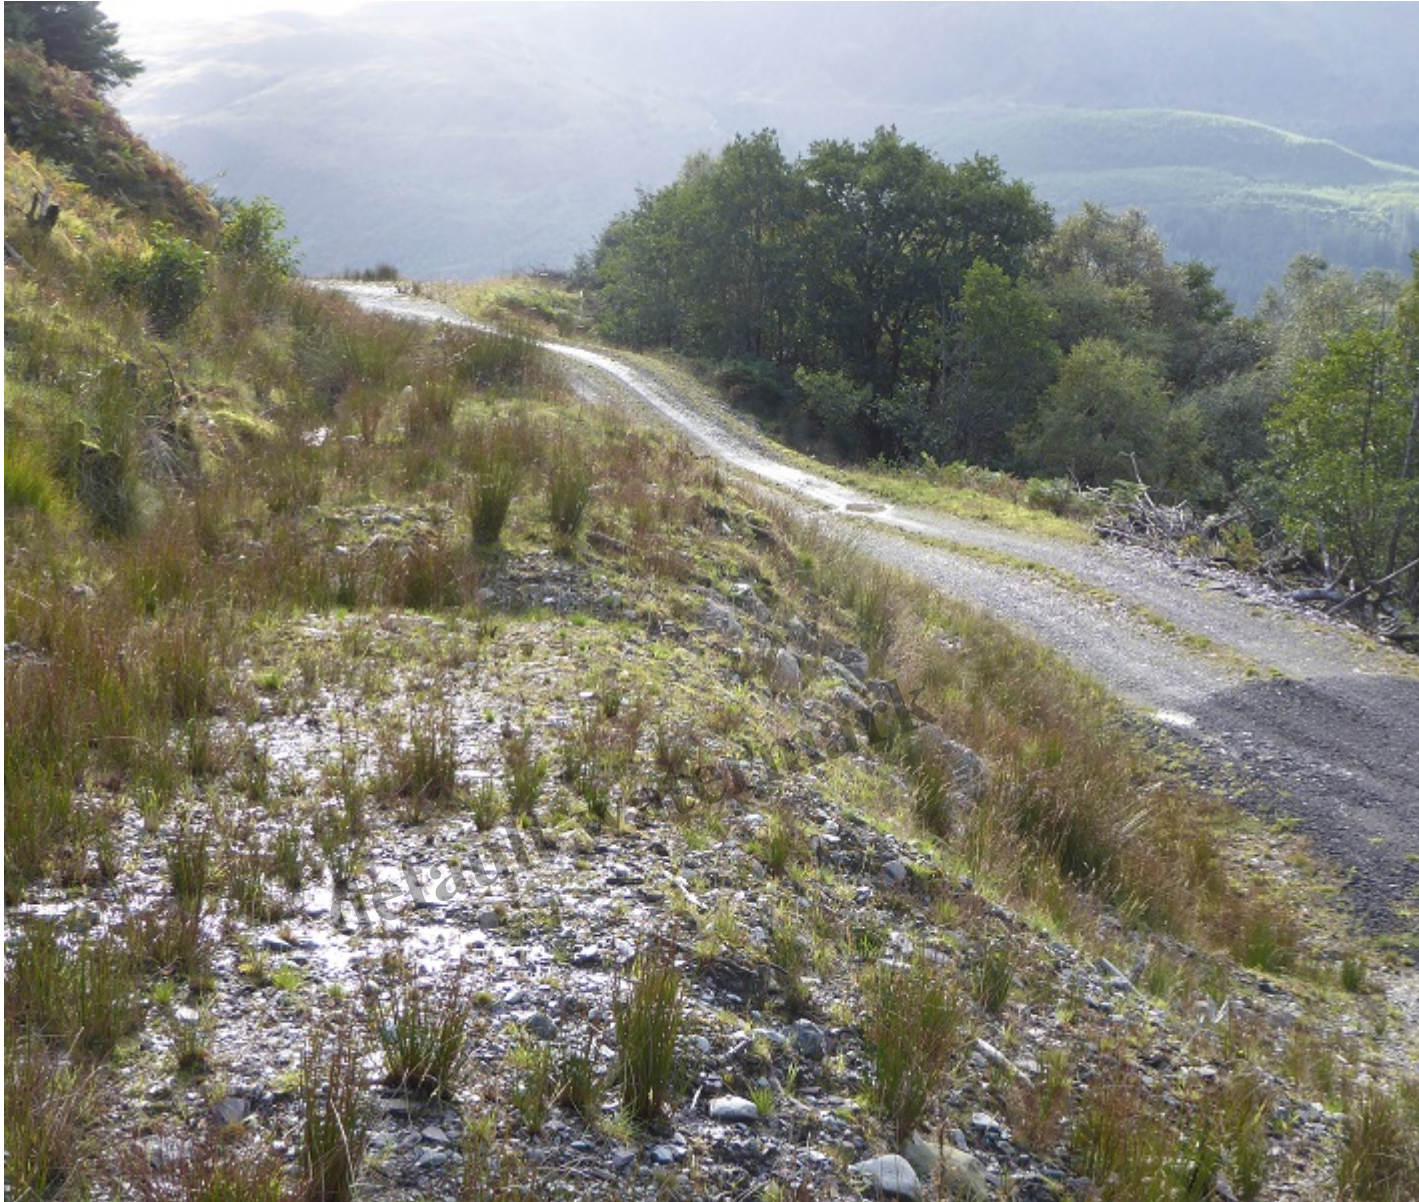
Failure to restore landscape or vegetation above the pipeline (which crosses under the road in the m distance) *“The National Park will wish to see ecological integrity retained and where possible enhance example tracks and pipelines should avoid fragmentation of woodland.”* (Good Practice Guidance)
