## LLTNPA's "Success shared"? – the Ardchullarie and Anie hydro schemes

## **The Ardchullarie hydro scheme**

## **The Anie hydro scheme**

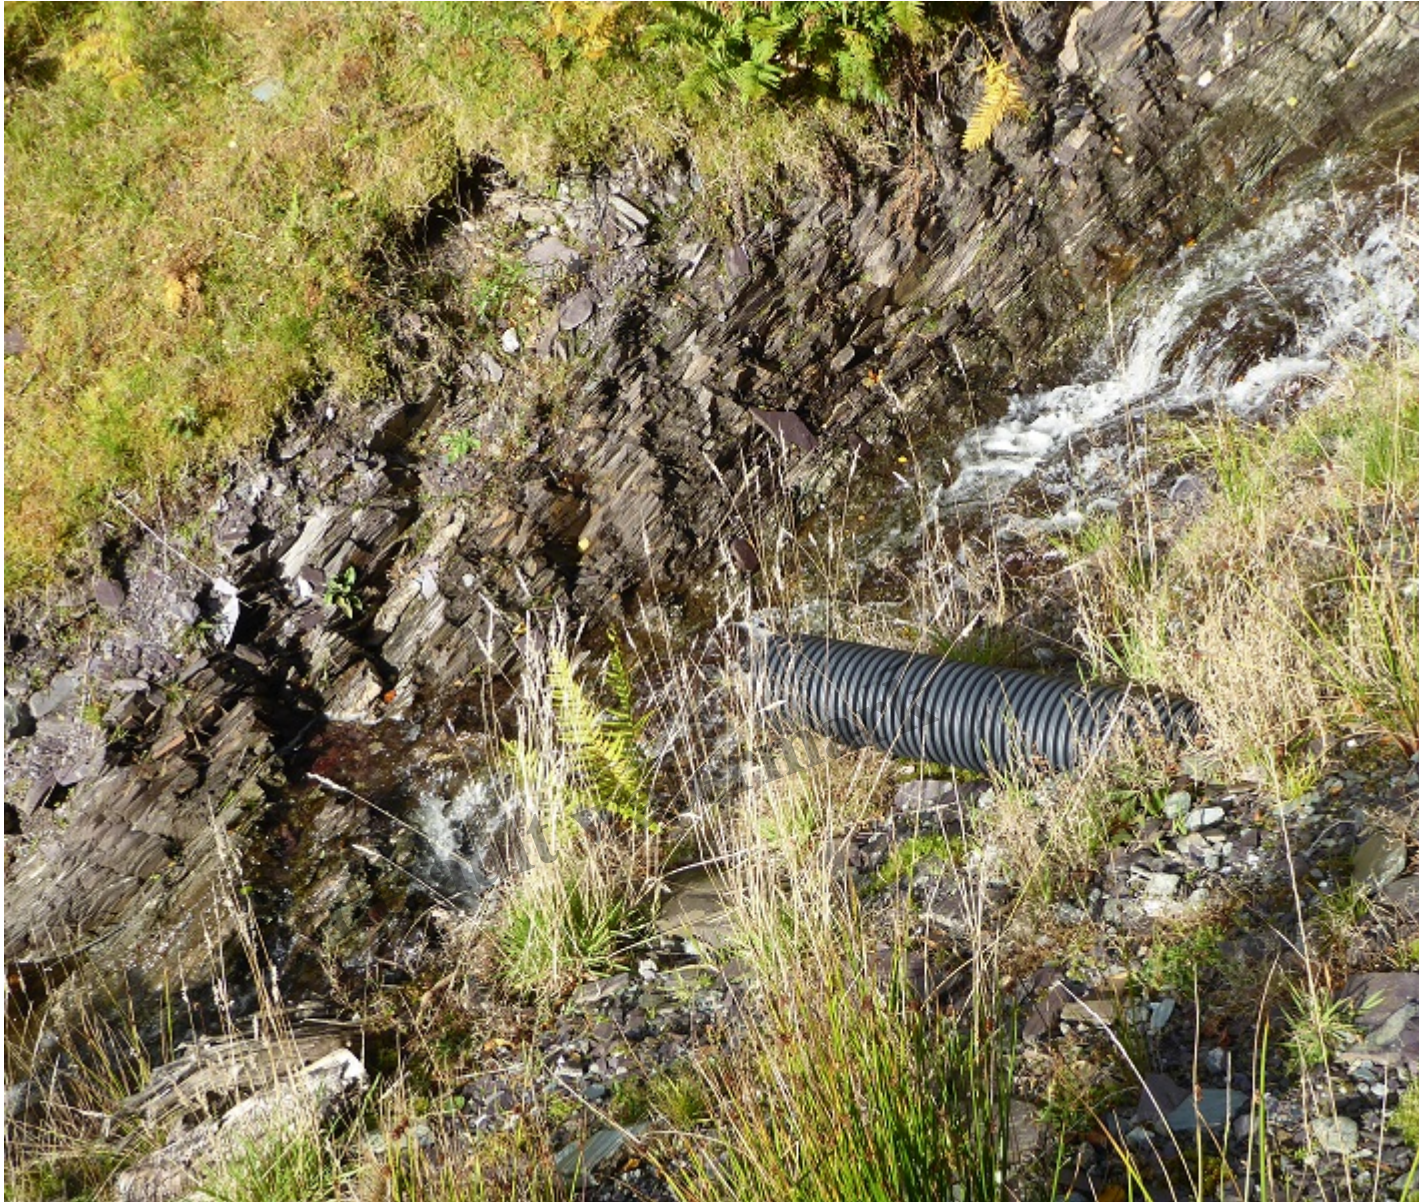
The seemingly inevitable protruding culvert – this one just below the intake

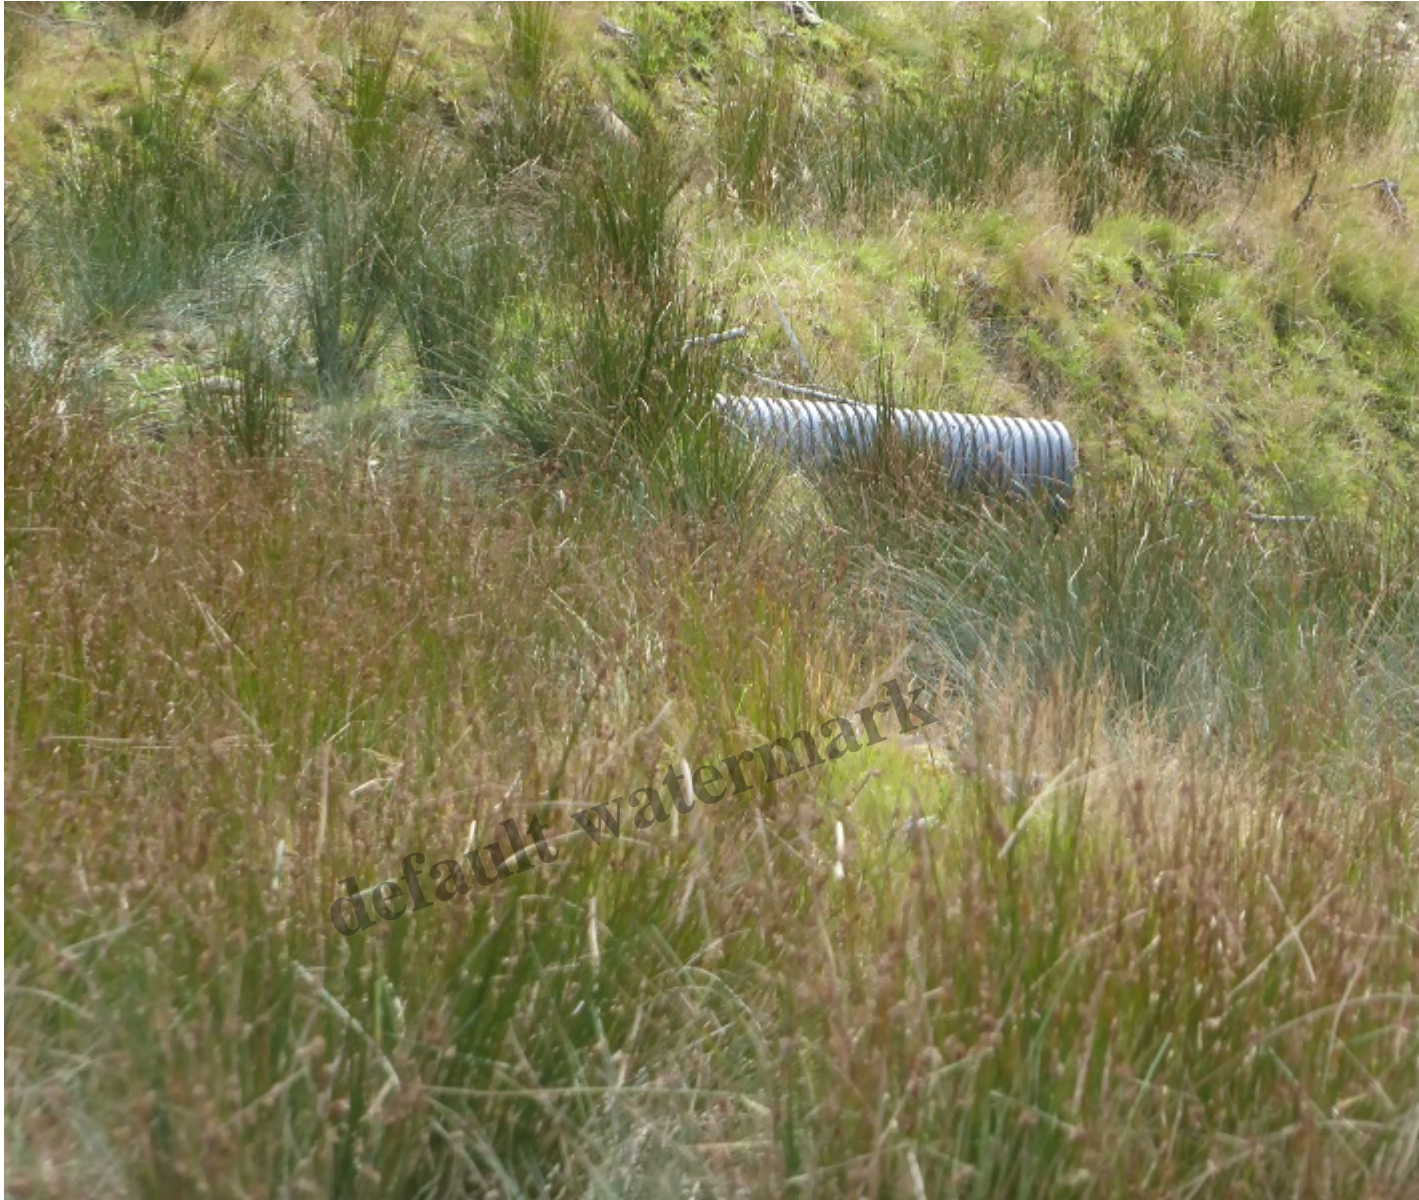
And another further down the pipeline.....
