LLTNPA's "Success shared"? – the Ardchullarie and Anie hydro schemes

The Ardchullarie hydro scheme

The Anie hydro scheme

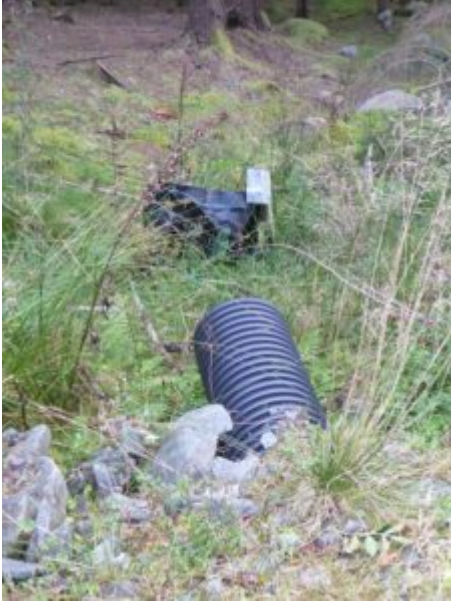
Protruding culvert on new section access track

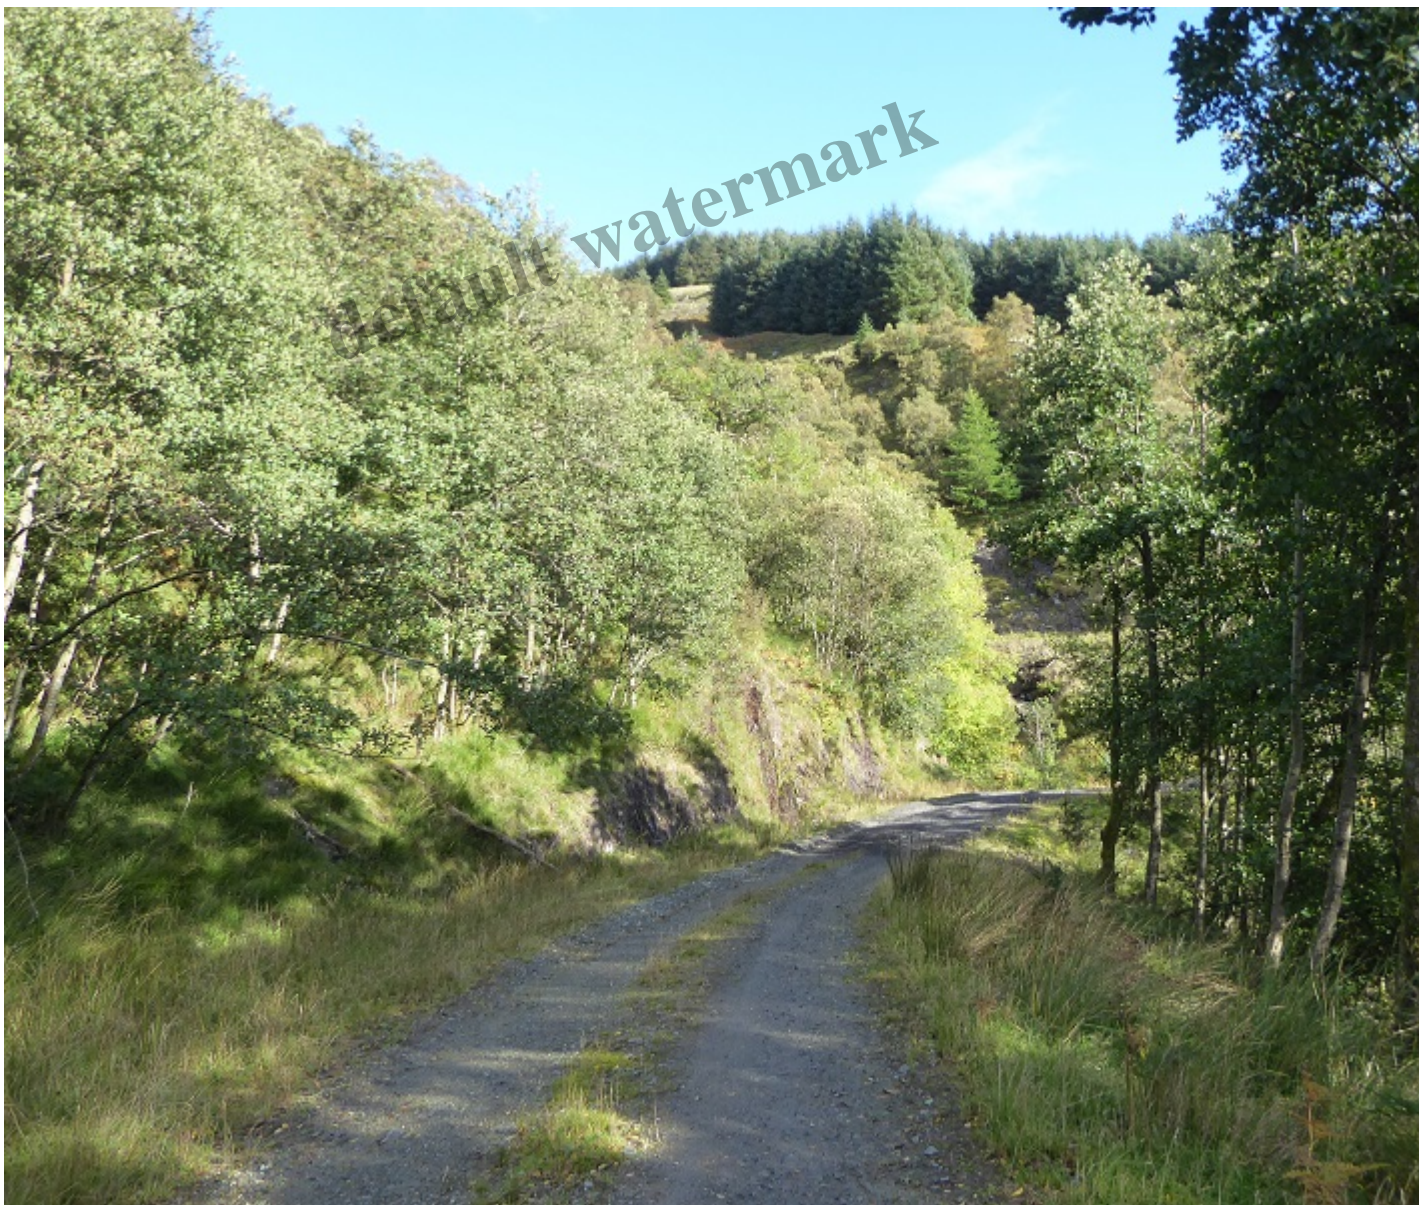
The Anie hydro intake is located at the bend in the track in native woodland on the Ancient Woodland

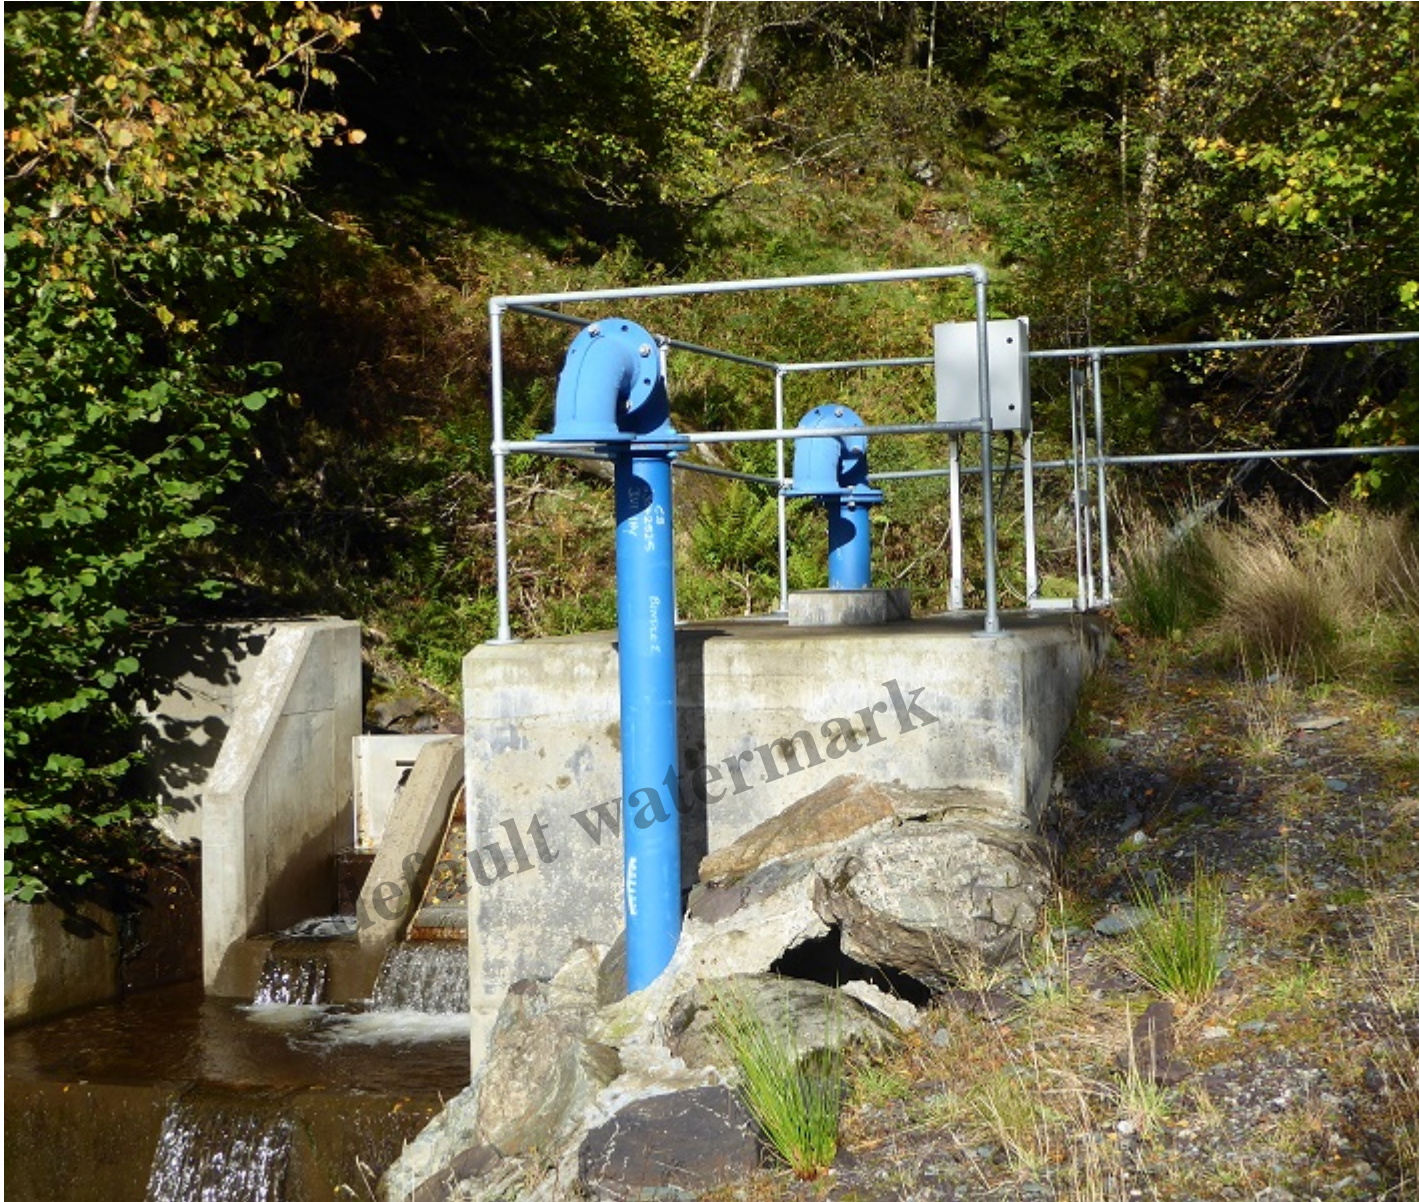
More blue pipes and bare concrete structures
