LLTNPA's "Success shared"? – the Ardchullarie and Anie hydro schemes

The Ardchullarie hydro scheme

The Anie hydro scheme

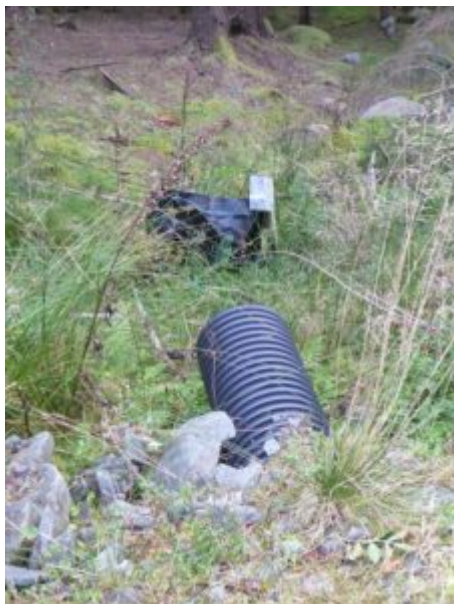
Protruding culvert on new
section access track
