## HIE/Natural Retreats' failure to maintain ski infrastructure at Cairngorm

## Rusted and corroded bolts Ptarmigan t-bar – recommendations to fix these in 2015, 2016 and 2017 Bratney

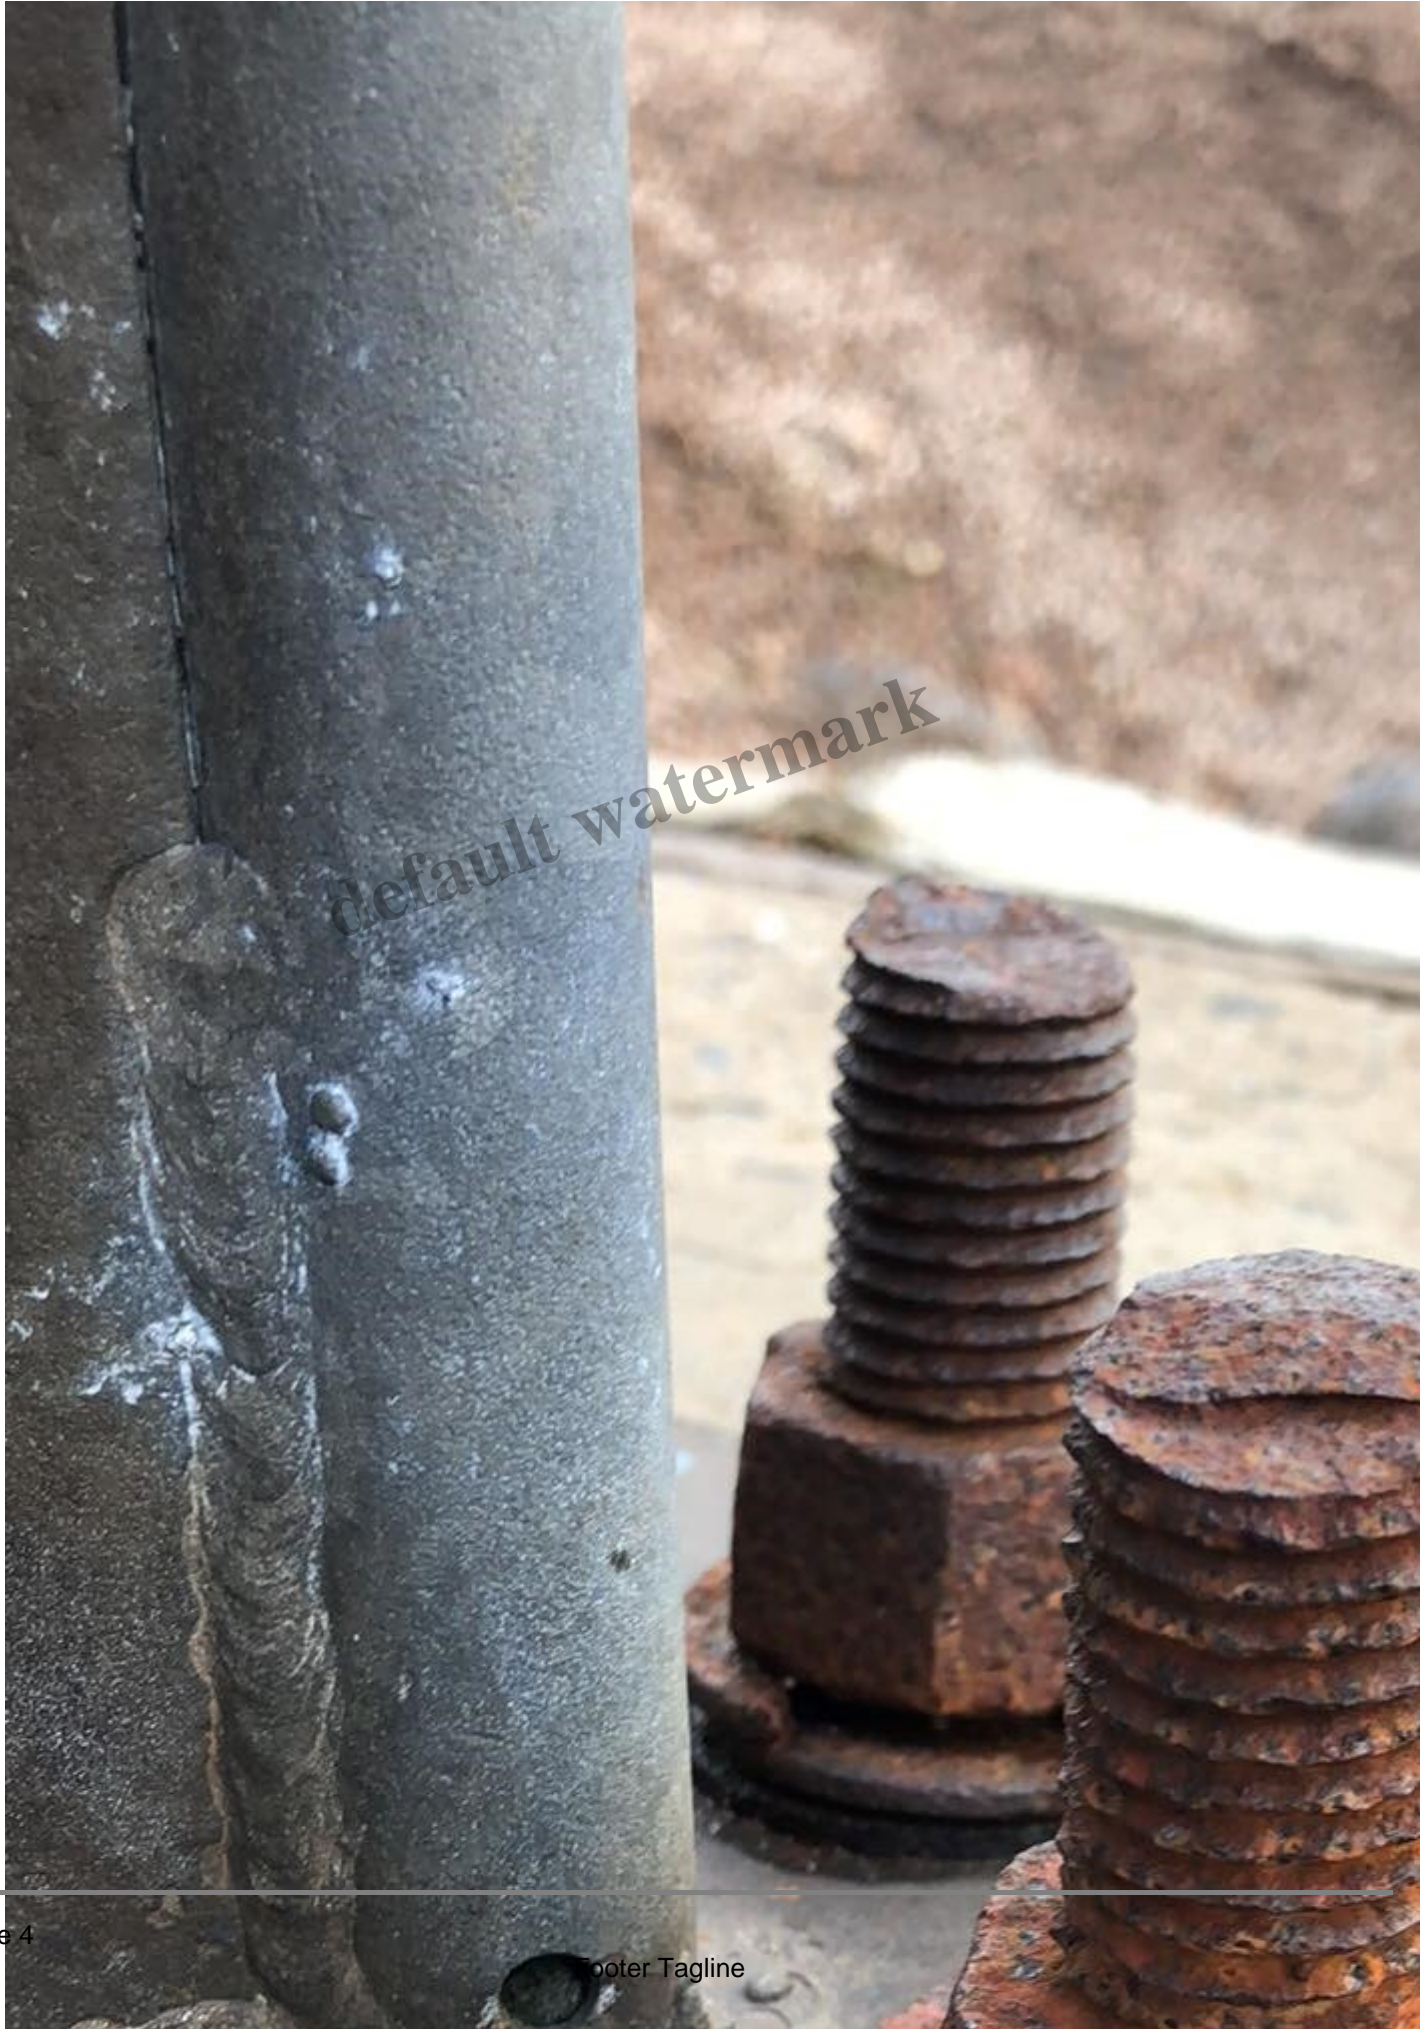
Bolts pylon 1 – and see top picture. Photo credit Alan Bratney

**2015:** *“Pylon 1; bolts grade 4. It is probably not possible to service these. This pylon should be monitored for signs of distress.”*

**2016:** *“Pylon 1; bolts grade 4 plus failed washer.”*

**2017:** **“\*\*\*Pylon 1; bolts grade 4. Missing washer on one bolt, so this is ineffective meaning second bolt has twice the stress, this could fail under load. Action required.\*\*\*”**

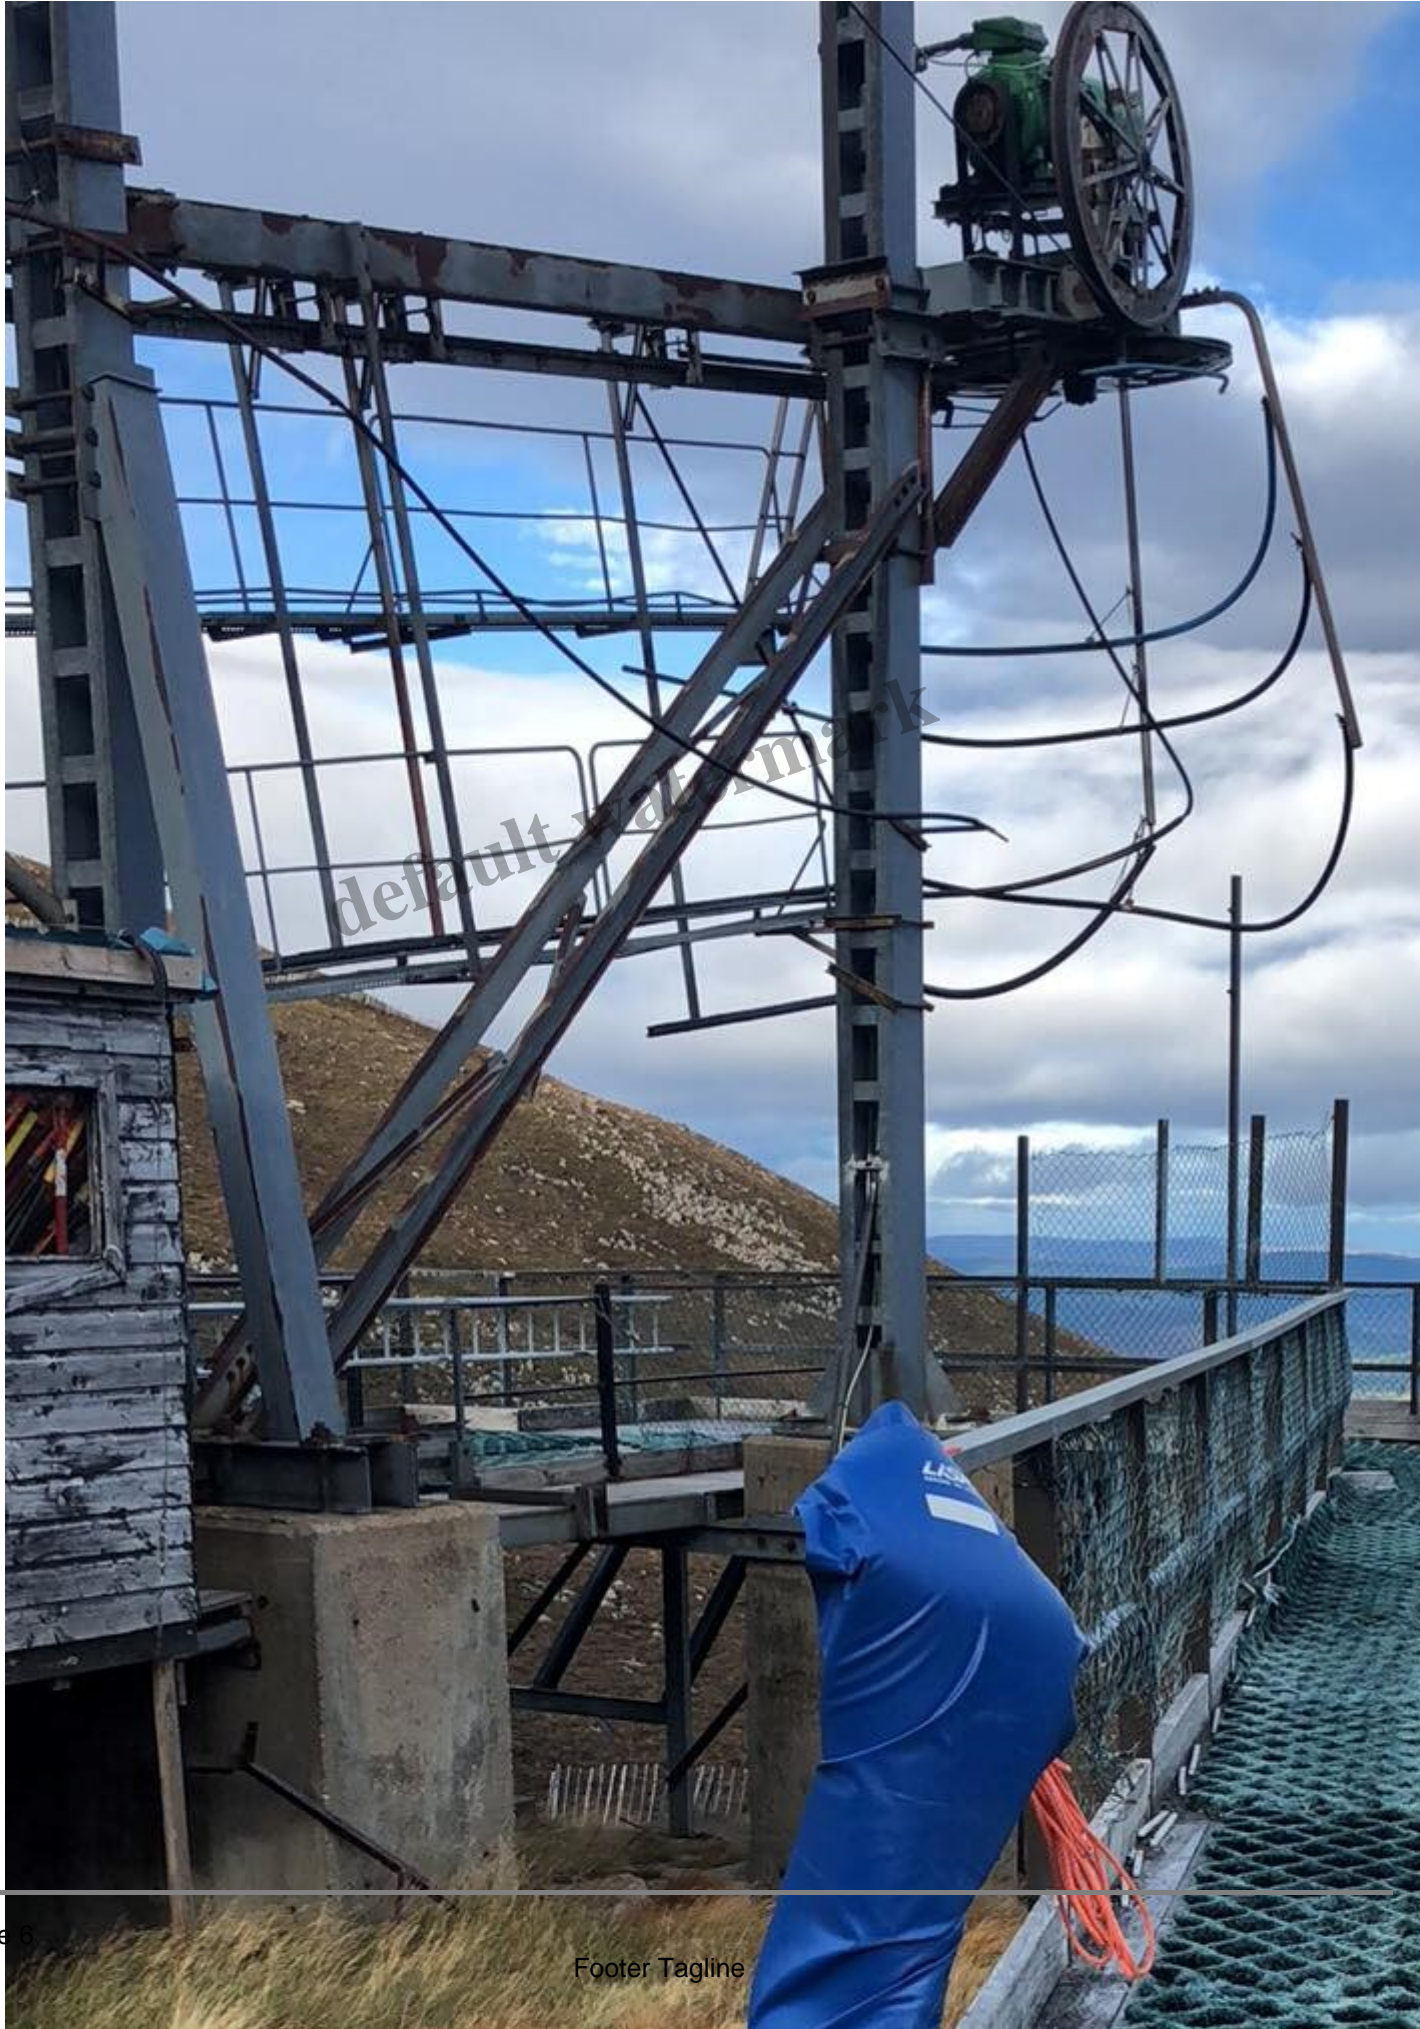
**2015:** *“The lower platform should be inspected and assessed for its suitability as a public access platform.”*

Comment: despite some remedial work having been done during September 2018, the loading area remains in a dilapidated condition

West Wall poma20th October 2018 – photo credit Alan Bratley

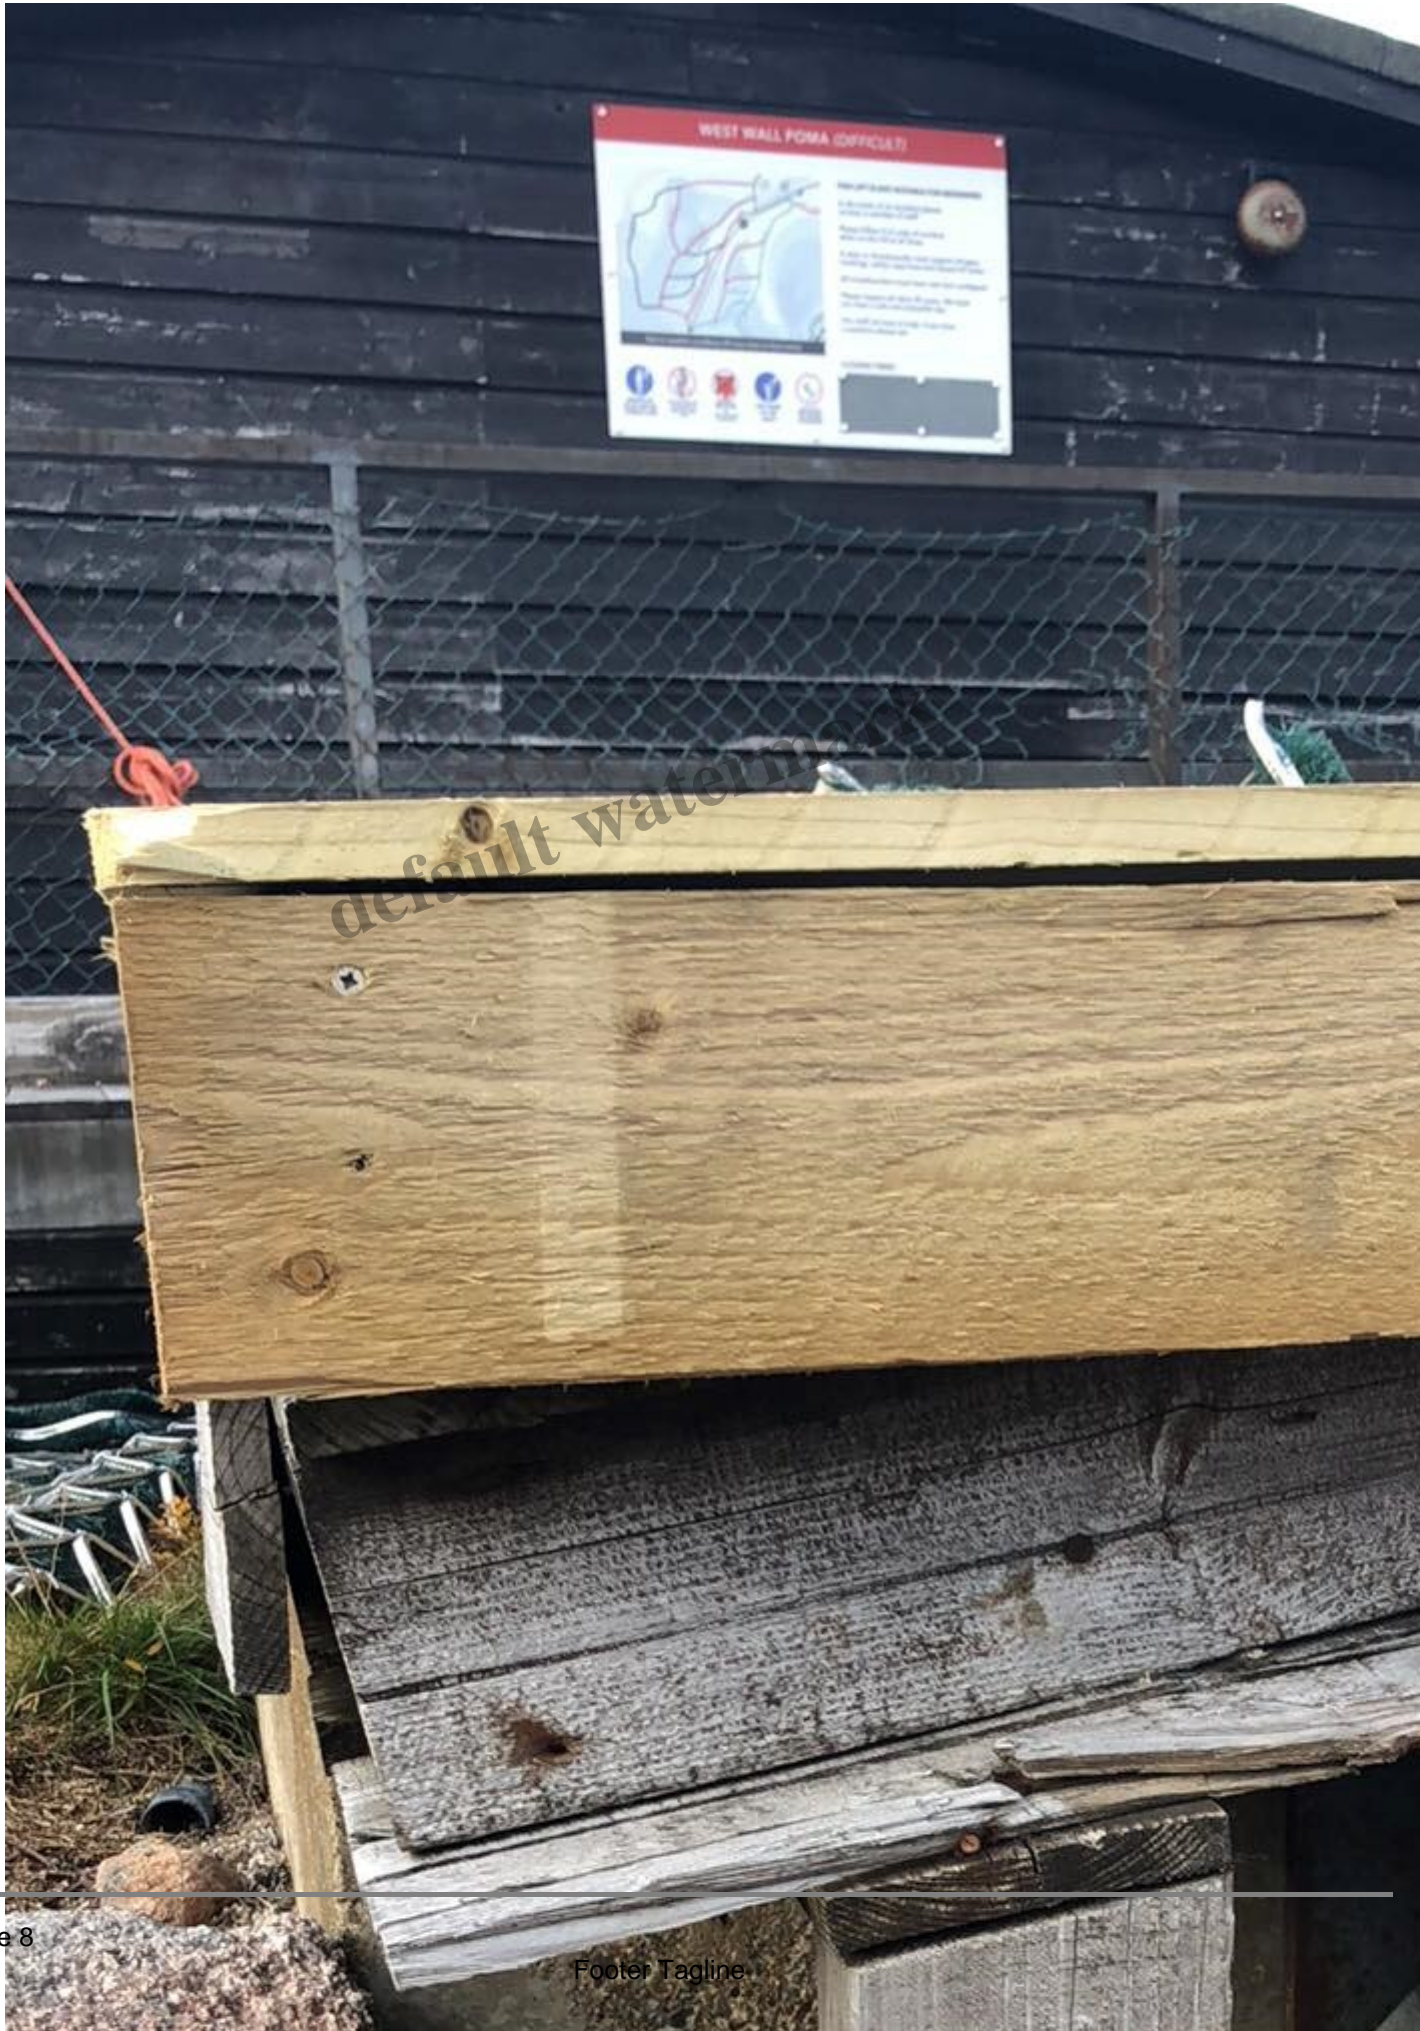
West Wall poma 20 October 2018 – Photo Credit Alan Bratney

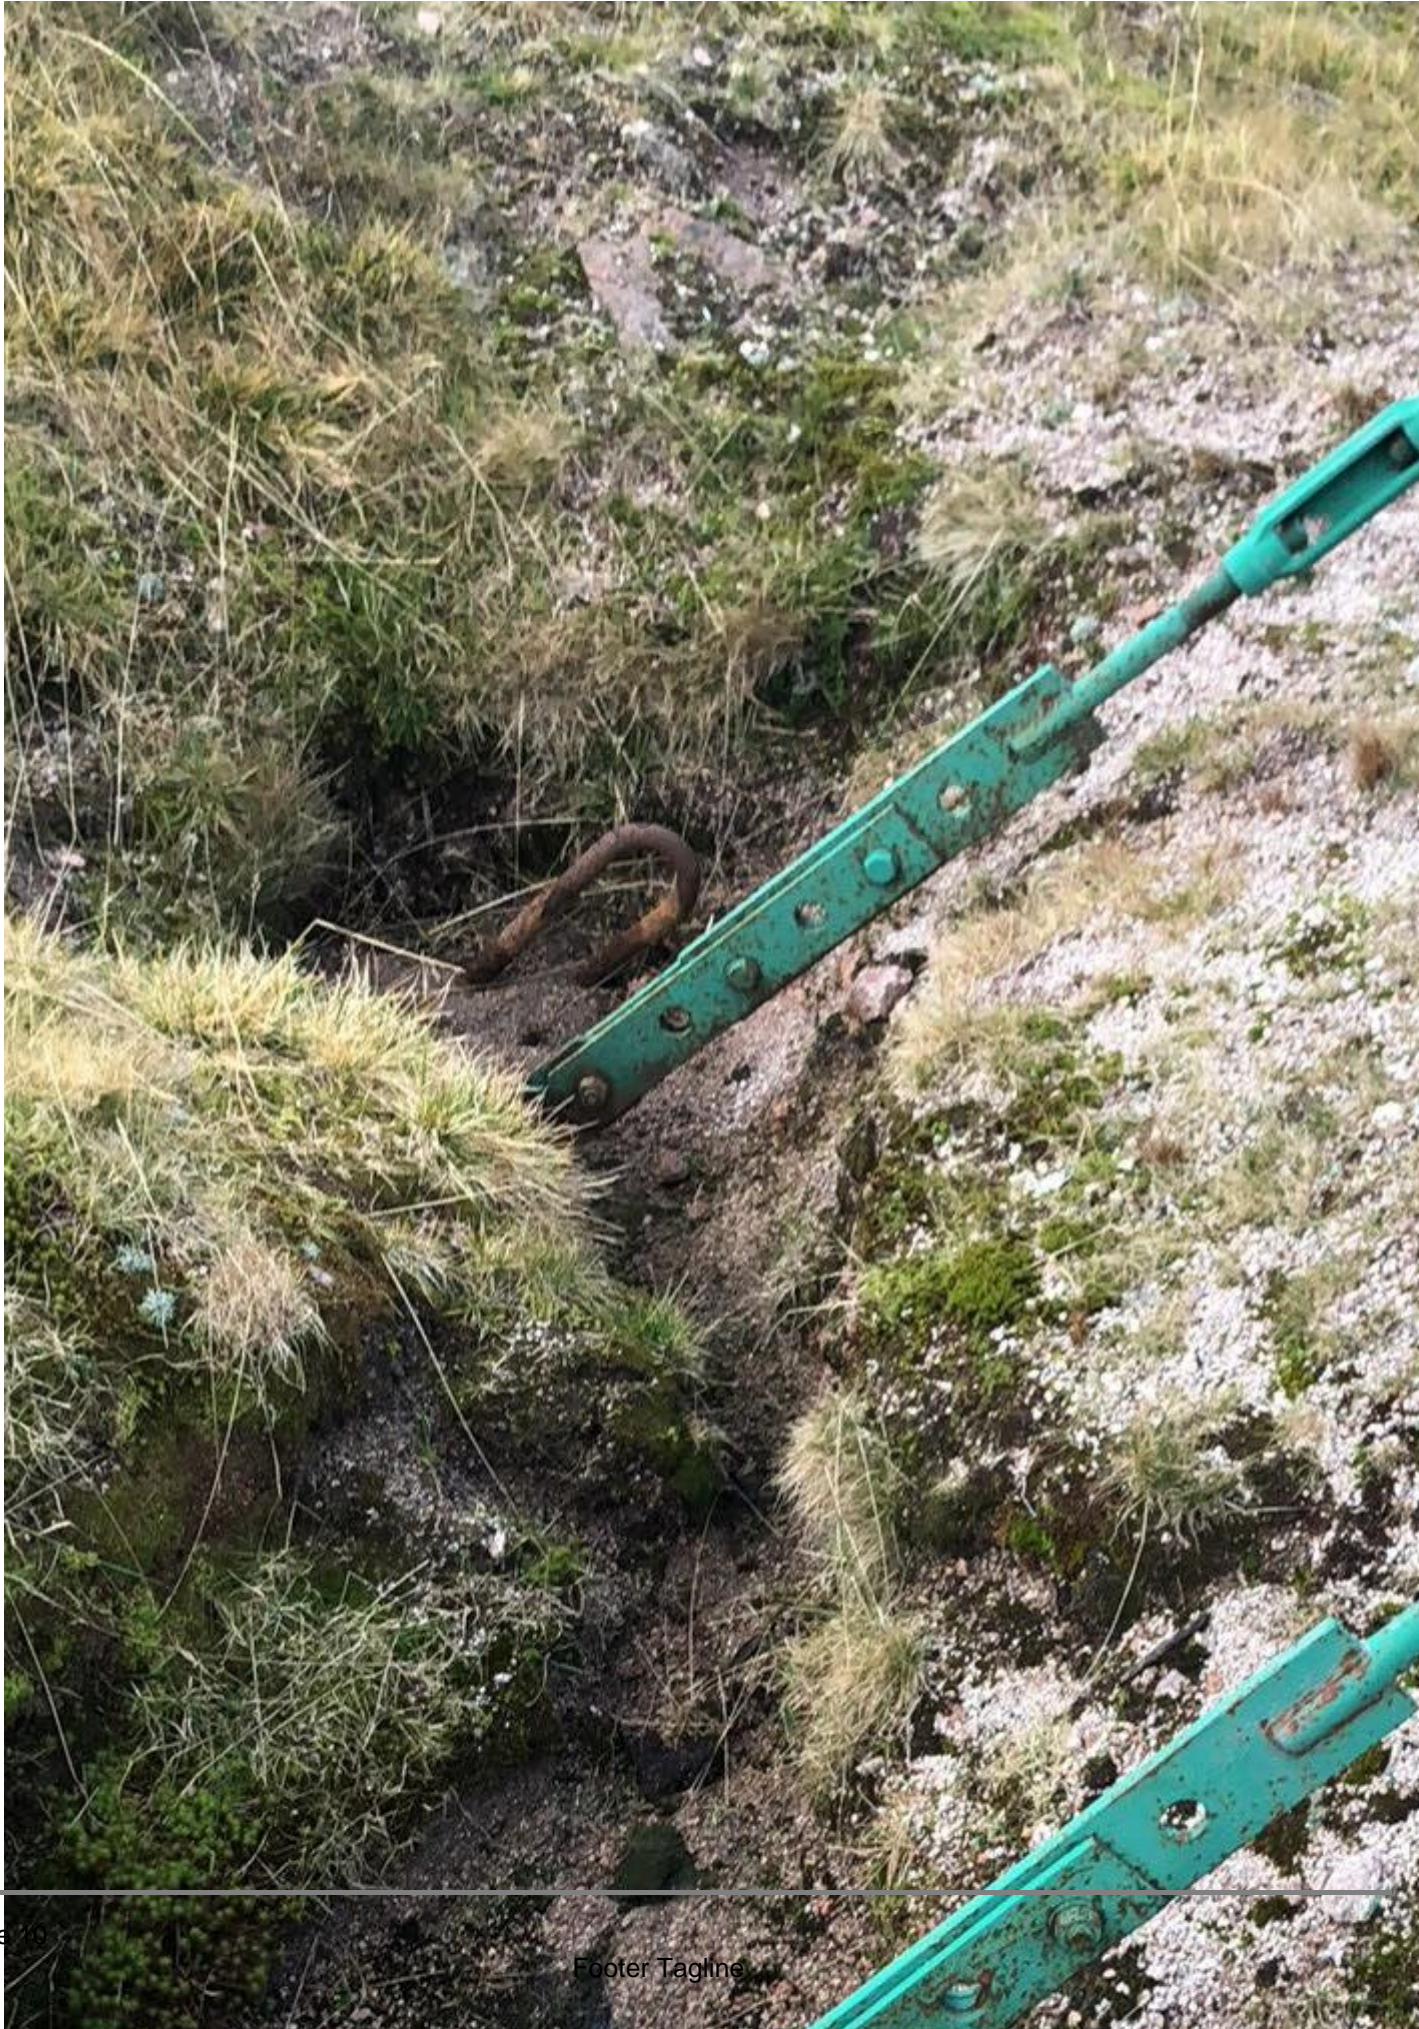
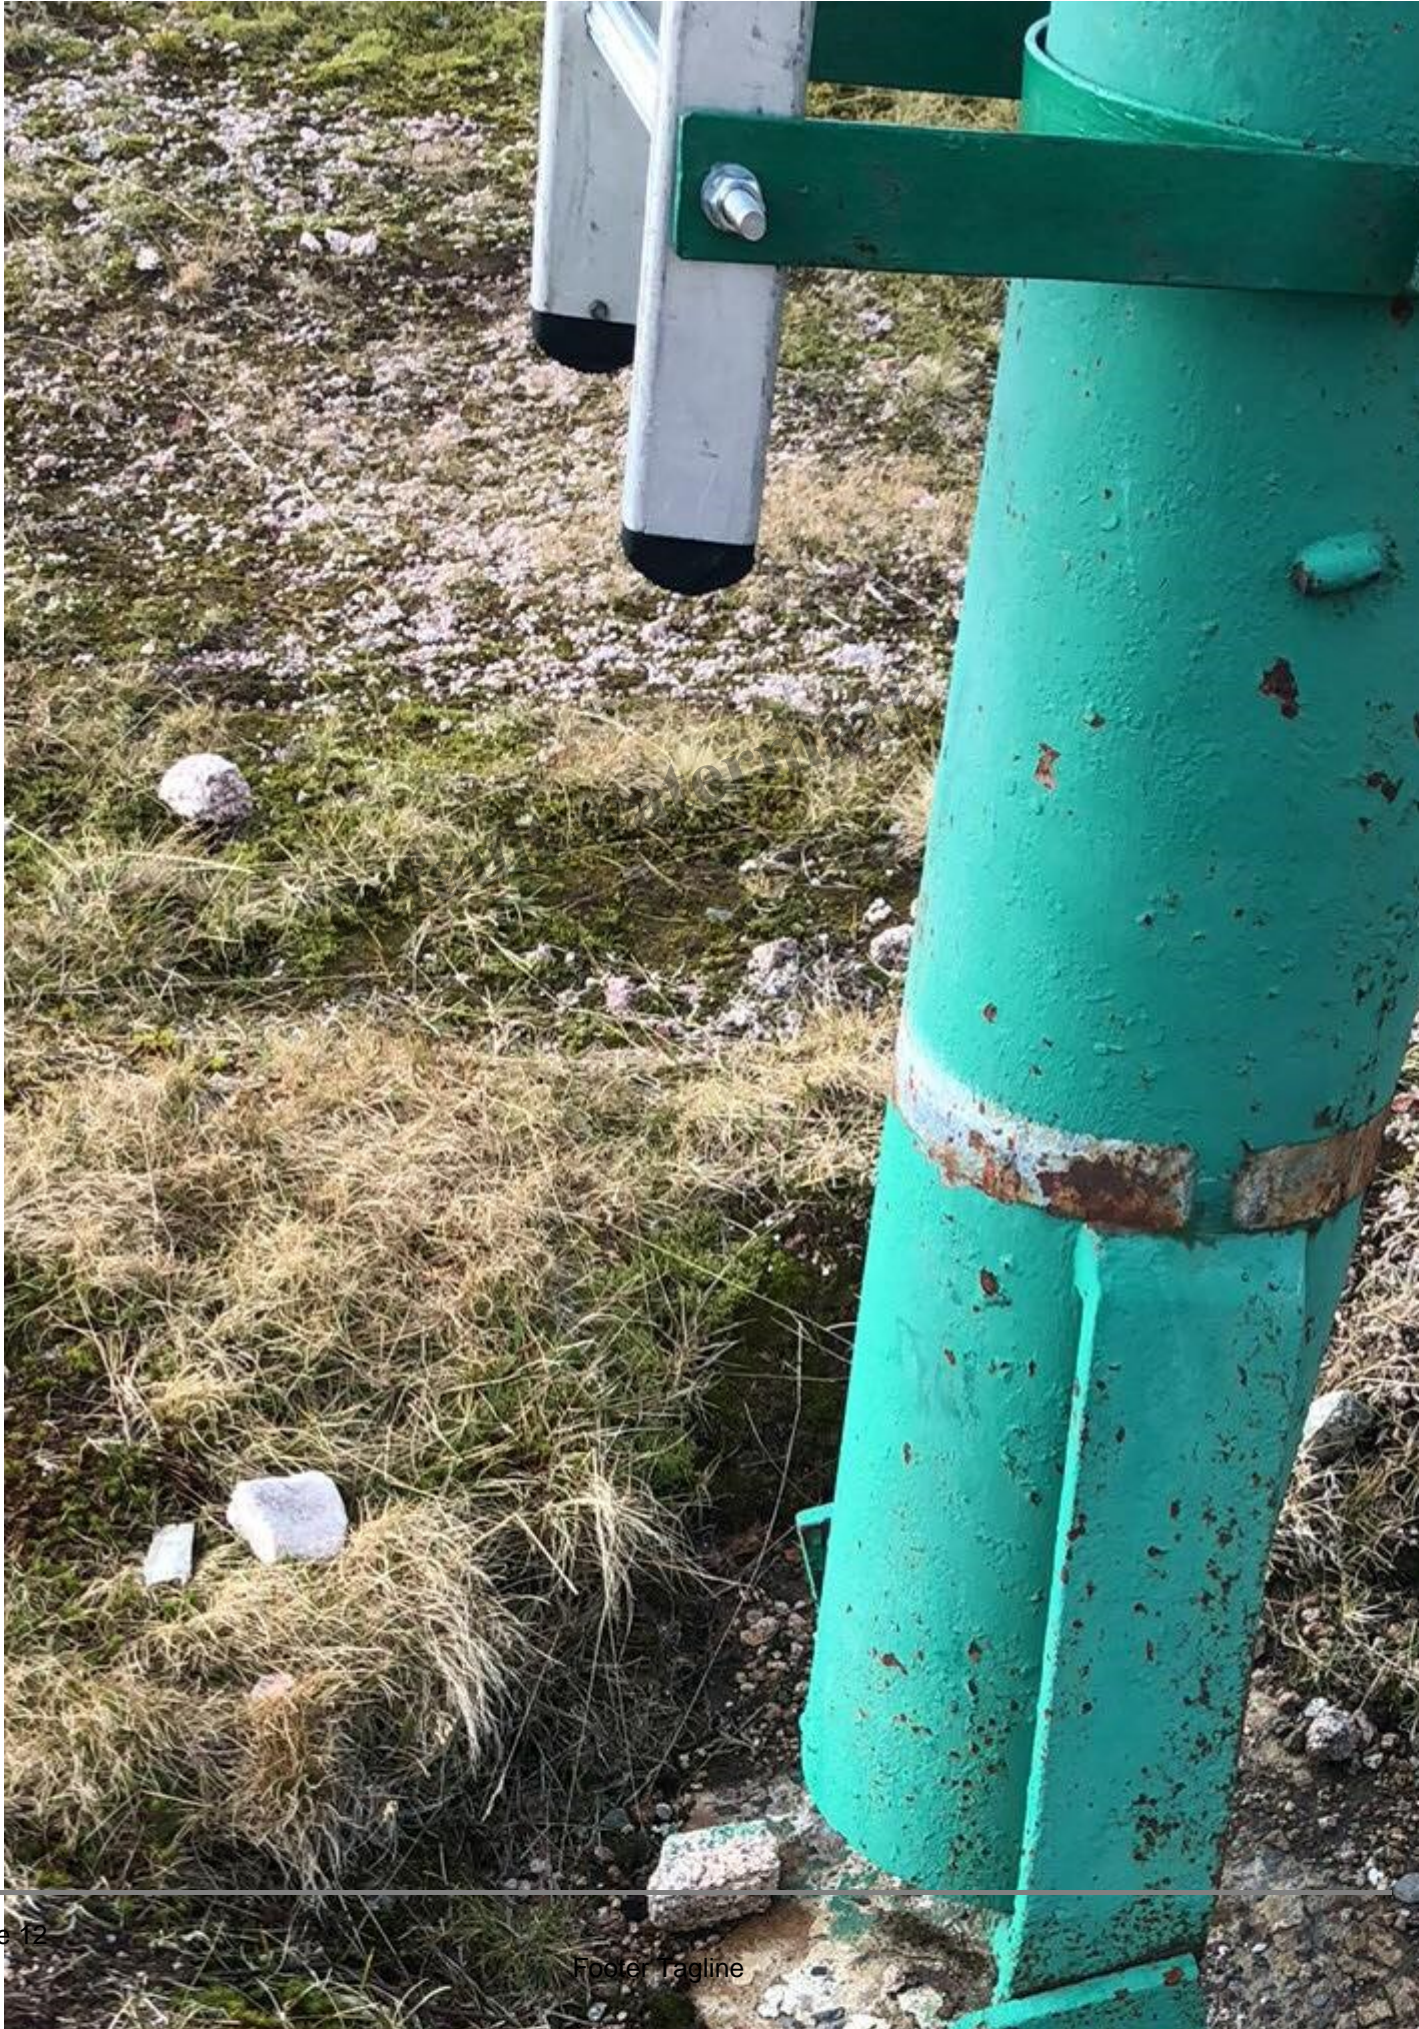
*Top station anchorages are buried to varying extents. **All steel work should be exposed and inspected for corrosion.** Ground levels should be maintained to give free drainage and air circulation. Paint system is failing.”*

*“Top station anchorages are buried to varying extents. **All steel work should be exposed and inspected for corrosion.** Ground levels should be maintained to give free drainage and air circulation. Paint system is failing – **clean and repaint. There is significant corrosion and \*\*plans should be put in place to replace\*\***– a more detailed inspection is recommended once it is fully exposed.”*

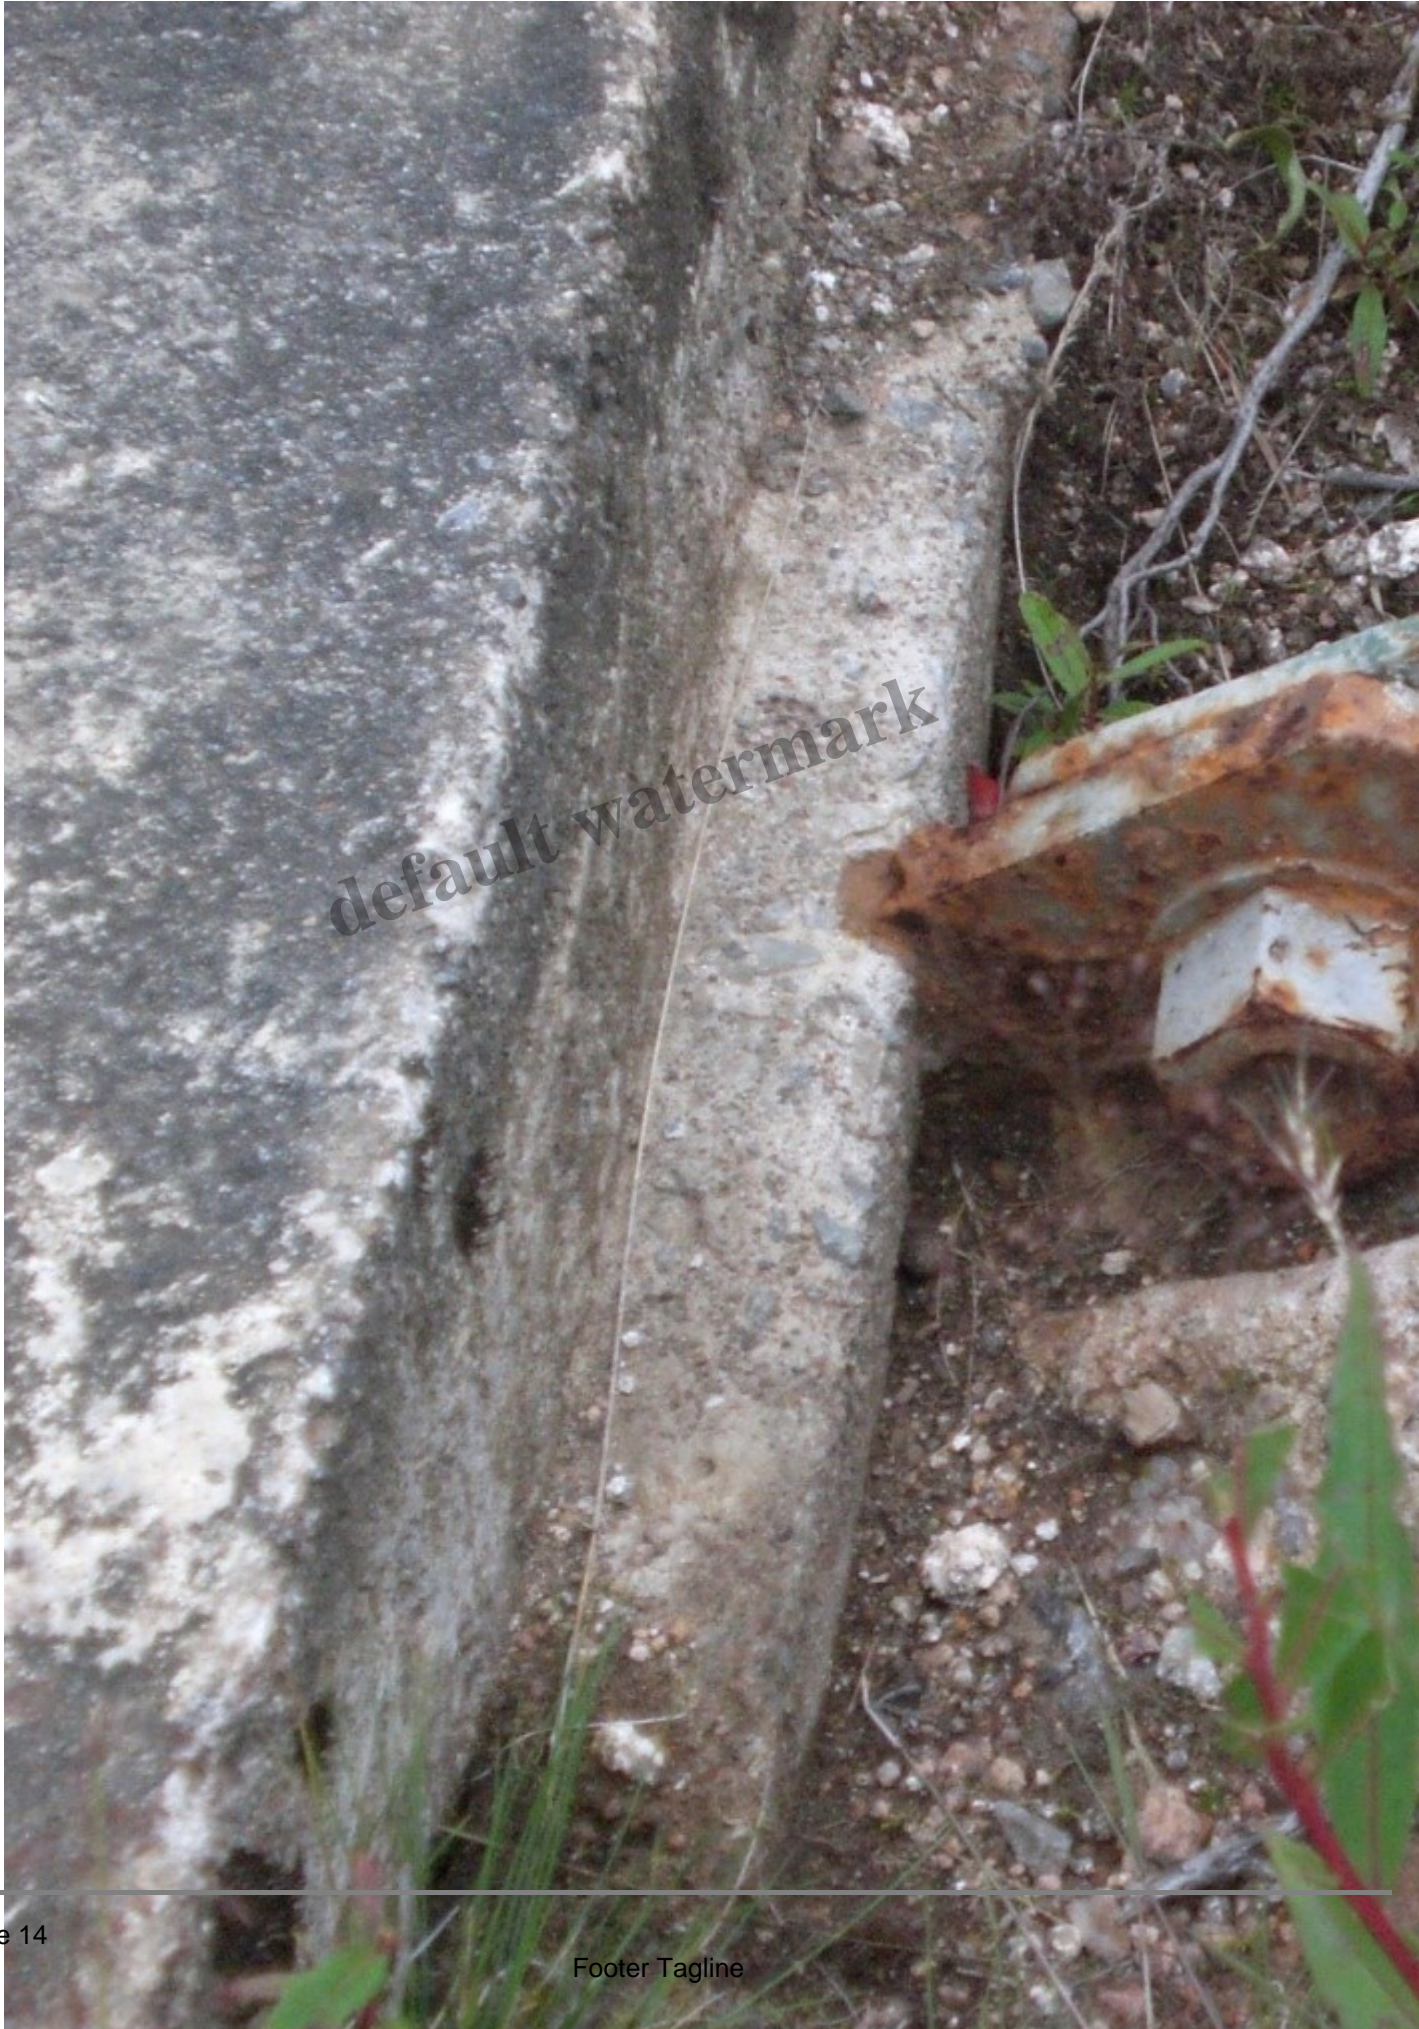
Bolts are generally grade 2/3 however **\*\*pylon 1 bolts are grade 3/4\*\*.**

Bolt car park t-bar Photo Credit Alan Bratney
