HIE/Natural Retreats' failure to maintain ski infrastructure at Cairngorm

Following my post on the dilapidated state of the day lodge (see [here](#)) and the closure of the funicular on safety grounds, today I submitted to Highlands and Islands Enterprise and Fergus Ewing, the Scottish Minister responsible, a report on HIE/Natural Retreats' response to the Conditions Reports with respect to the Concrete Support Structures for the surface Tows on Cairn Gorm Mountain as prepared by ADAC Structures.

ADAC produced reports on 16 November 2015, 22 December 2016 and 20 July 2017 which have been obtained through FOI. Cross-referencing those reports enables identification of maintenance work that has not been undertaken by the operator in response to specific recommendations within those reports and I have been able to verify this through checking the position on the ground.

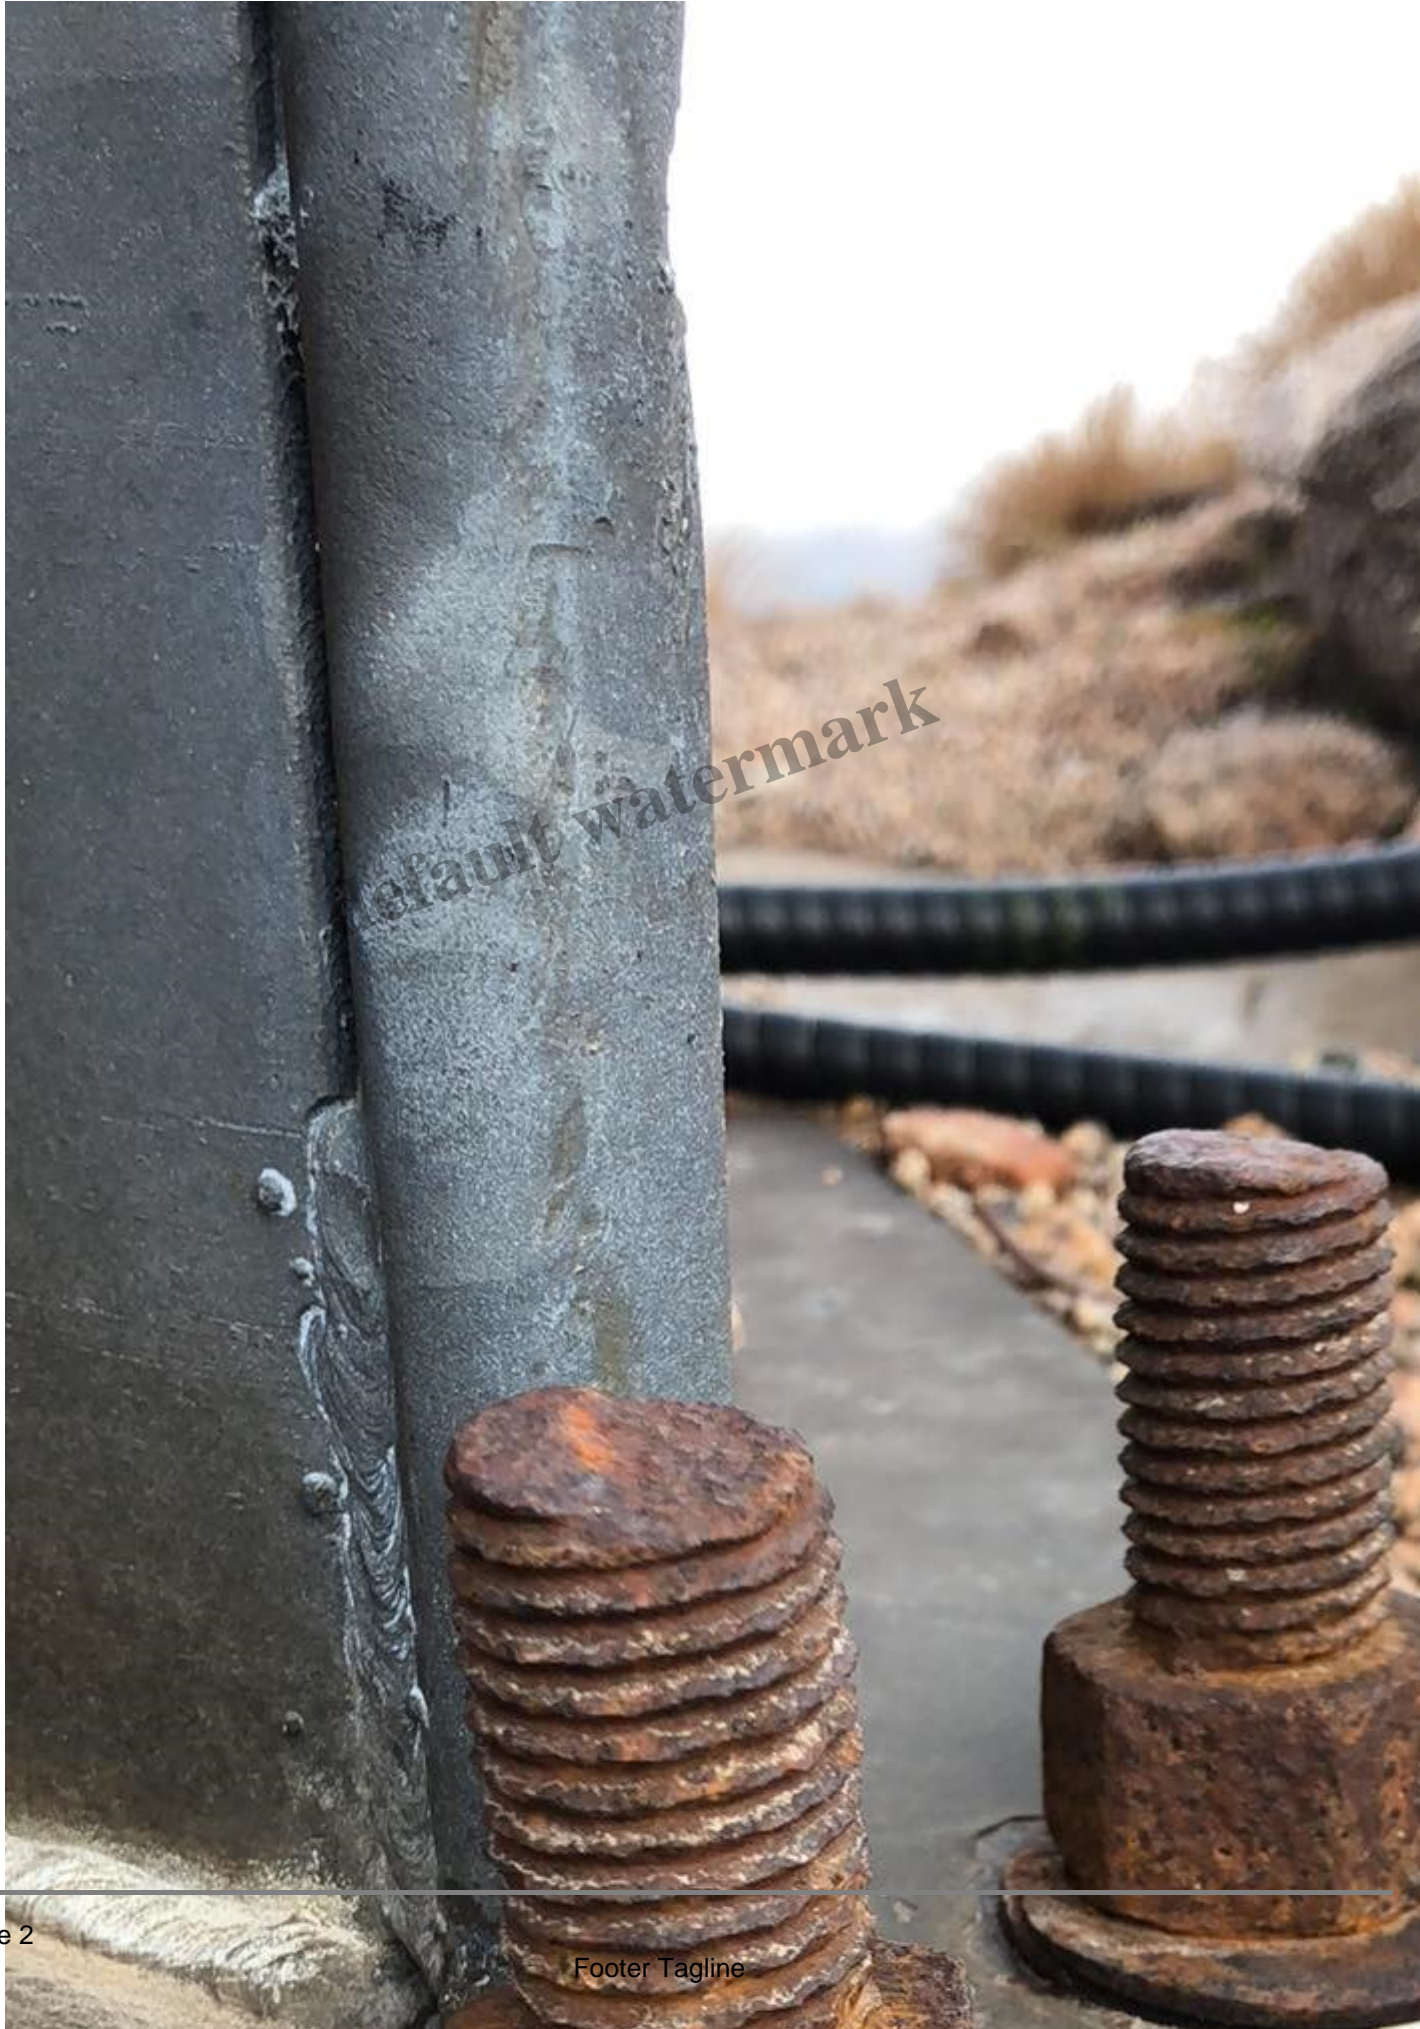
Rusted and corroded bolts Ptarmigan t-bar – recommendations to fix these in 2015, 2016 and 2017 Bratney

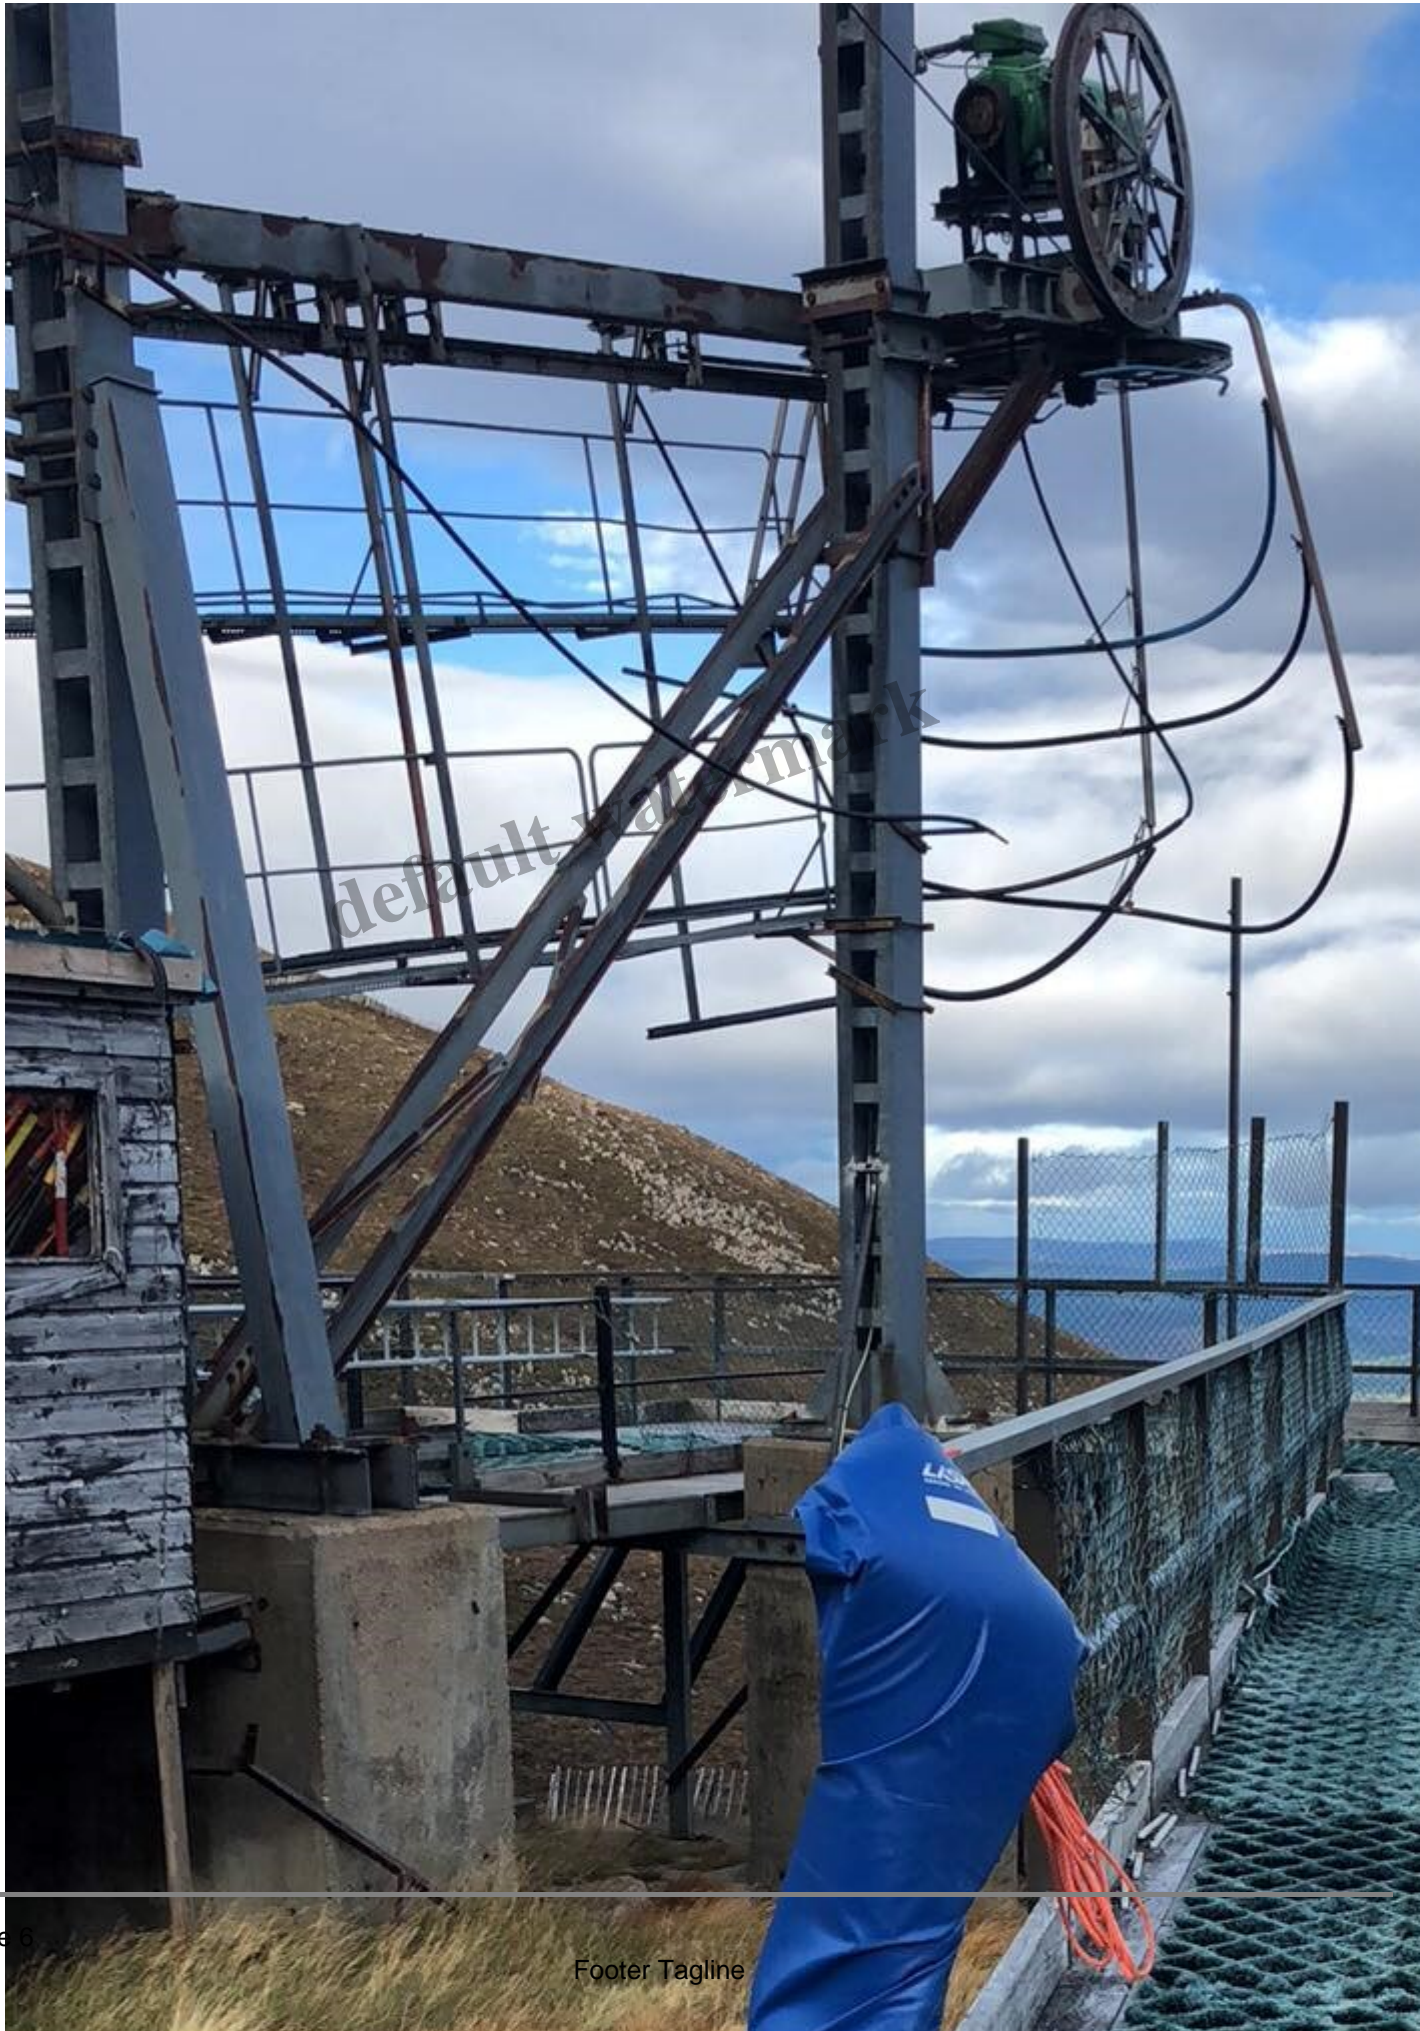
2015: *“The lower platform should be inspected and assessed for its suitability as a public access platform.”*

2016: *“The lower platform should be inspected and assessed for its suitability as a public access platform.”*

2017: *“The lower platform should be inspected and assessed for its suitability as a public access platform.”*

Comment: despite some remedial work having been done during September 2018, the loading area remains in a dilapidated condition

West Wall poma20th October 2018 – photo credit Alan Bratney

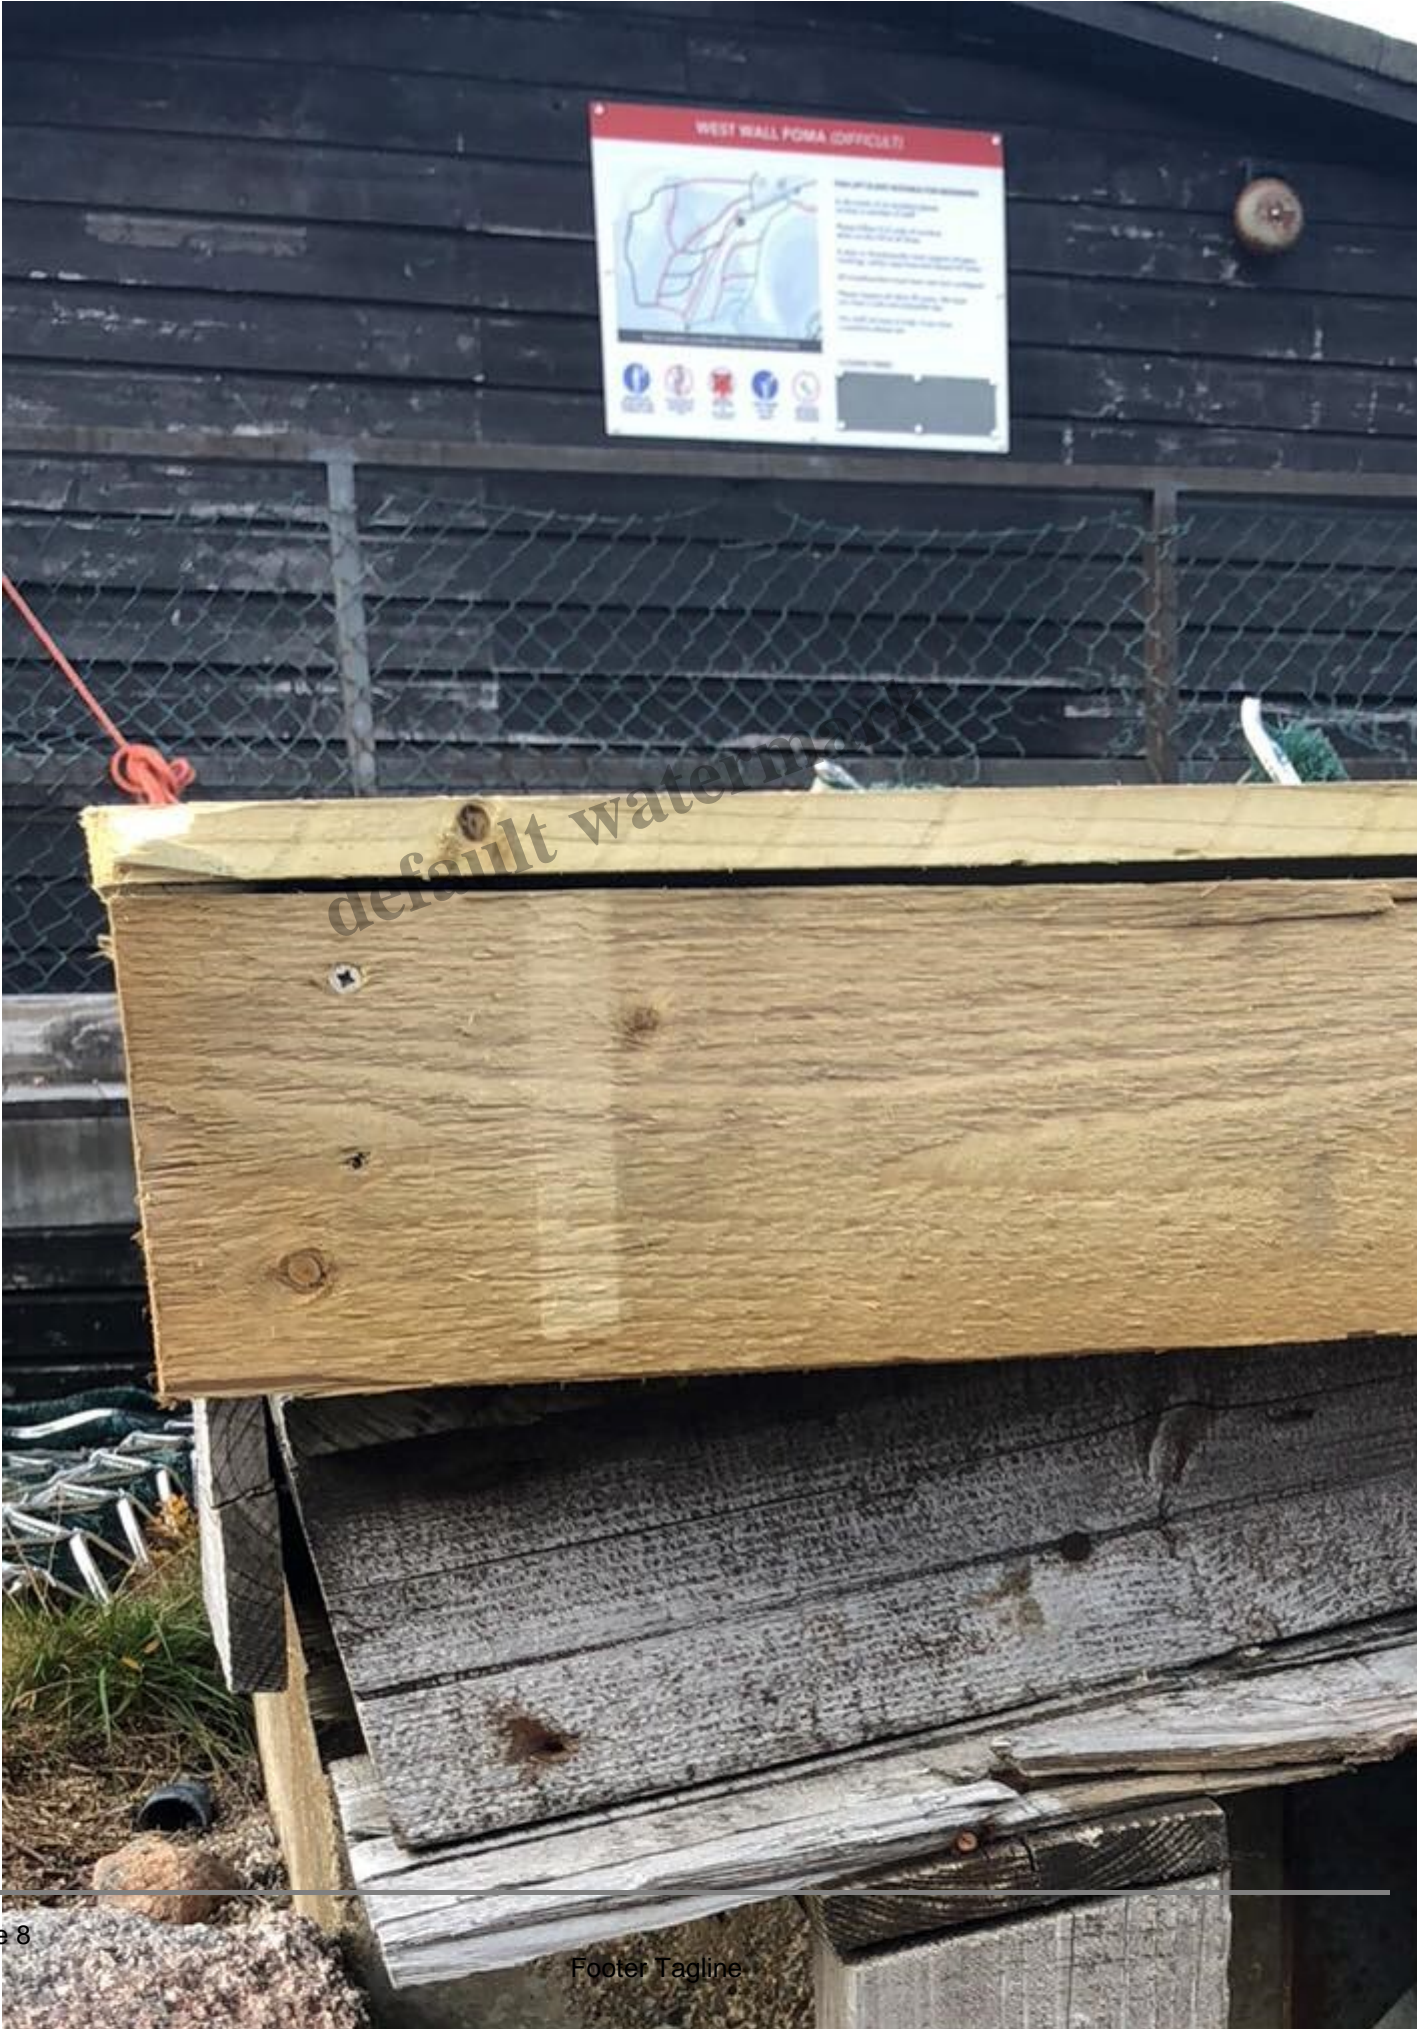
West Wall poma 20 October 2018 – Photo Credit Alan Bratney
