HIE/Natural Retreatsâ?? failure to maintain ski infrastructure at Cairngorm

Following my post on the dilapidated state of the day lodge (see [here](#)) and the closure of the funicular on safety grounds, today I submitted to Highlands and Islands Enterprise and Fergus Ewing, the Scottish Minister responsible, a report on HIE/Natural Retreats' response to the Conditions Reports with respect to the Concrete Support Structures for the surface Tows on Cairn Gorm Mountain as prepared by ADAC Structures.

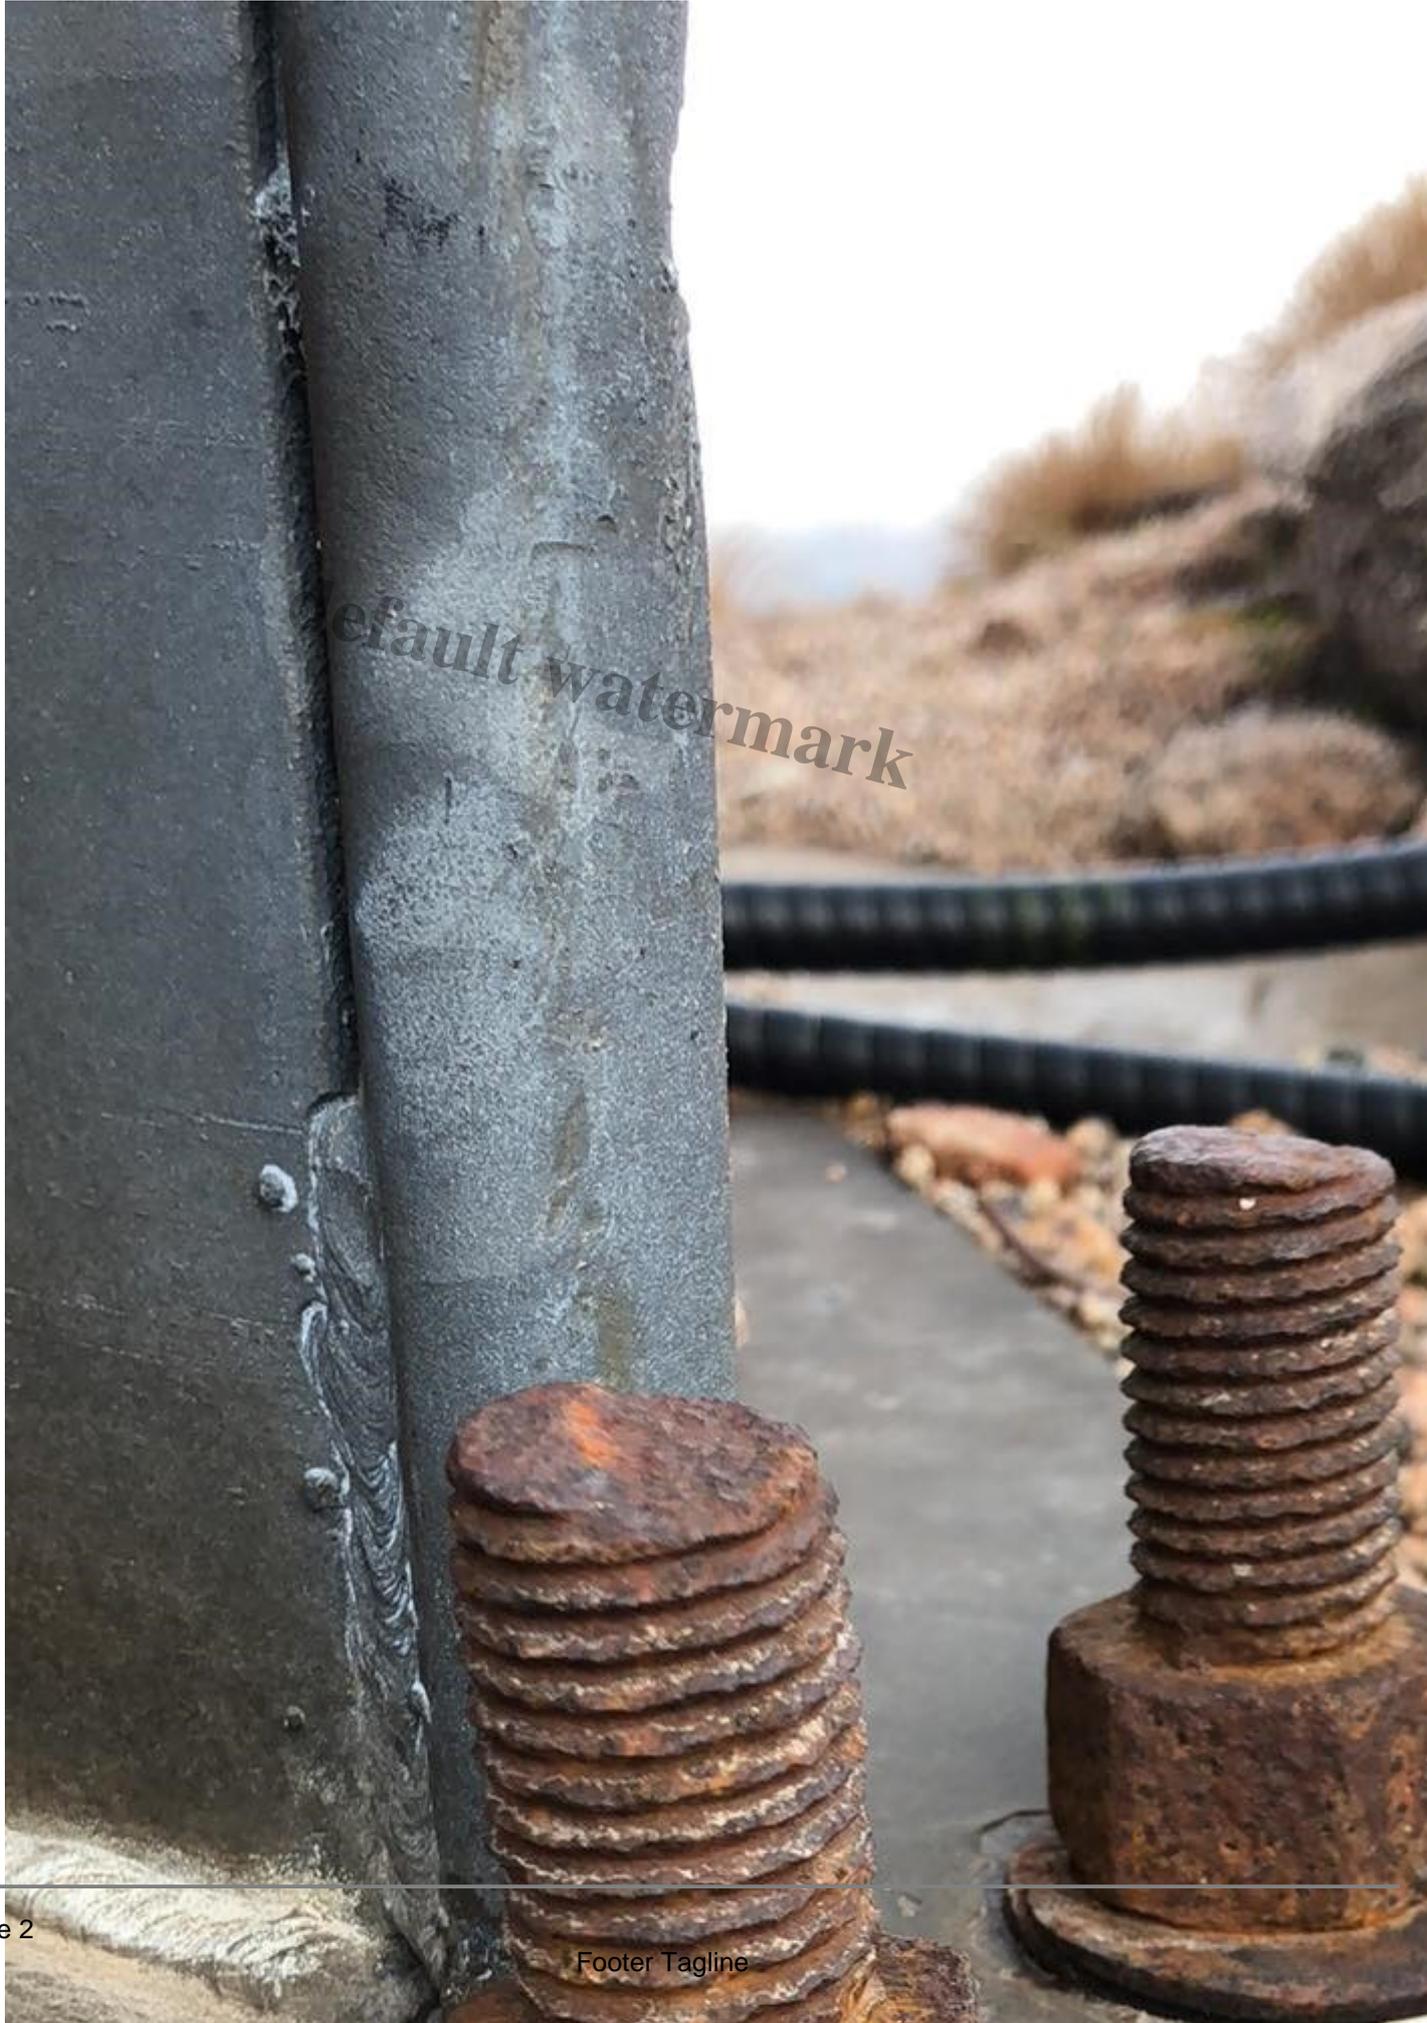
Rusted and corroded bolts Ptarmigan t-bar - recommendations to fix these in 2015, 2016 and 2017
Bratney

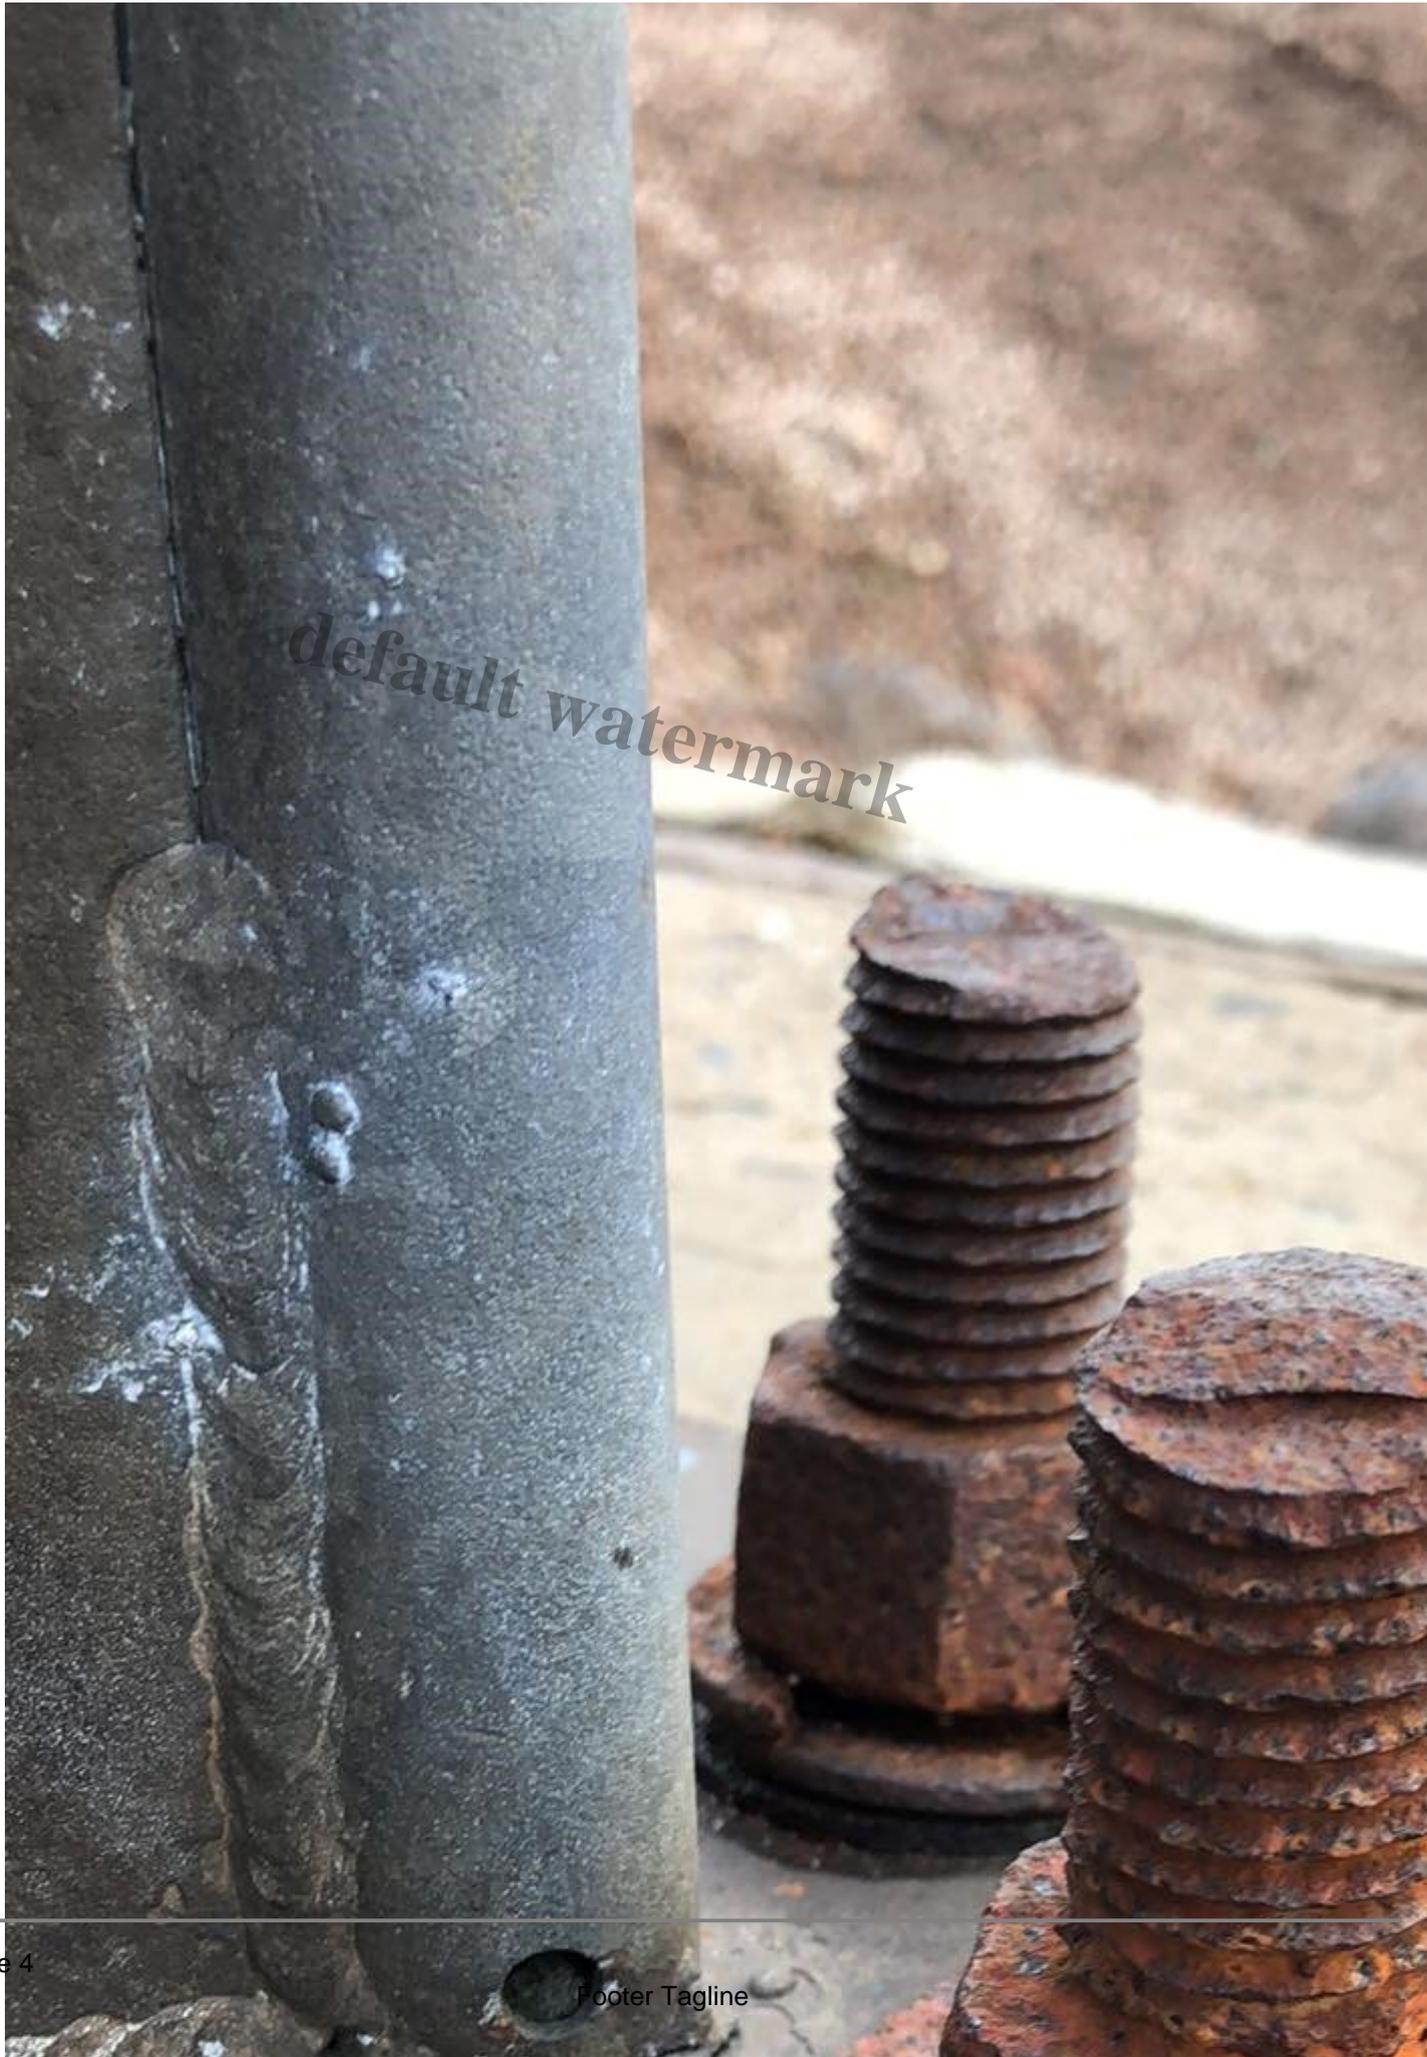
Bolts pylon 1 and see top picture. Photo credit Alan Bratney

2015: Pylon 1; bolts grade 4. It is probably not possible to service these. This pylon should be monitored for signs of distress.

2016: Pylon 1; bolts grade 4 plus failed washer.

2017: **Pylon 1; bolts grade 4. Missing washer on one bolt, so this is ineffective meaning second bolt has twice the stress, this could fail under load. Action required.**

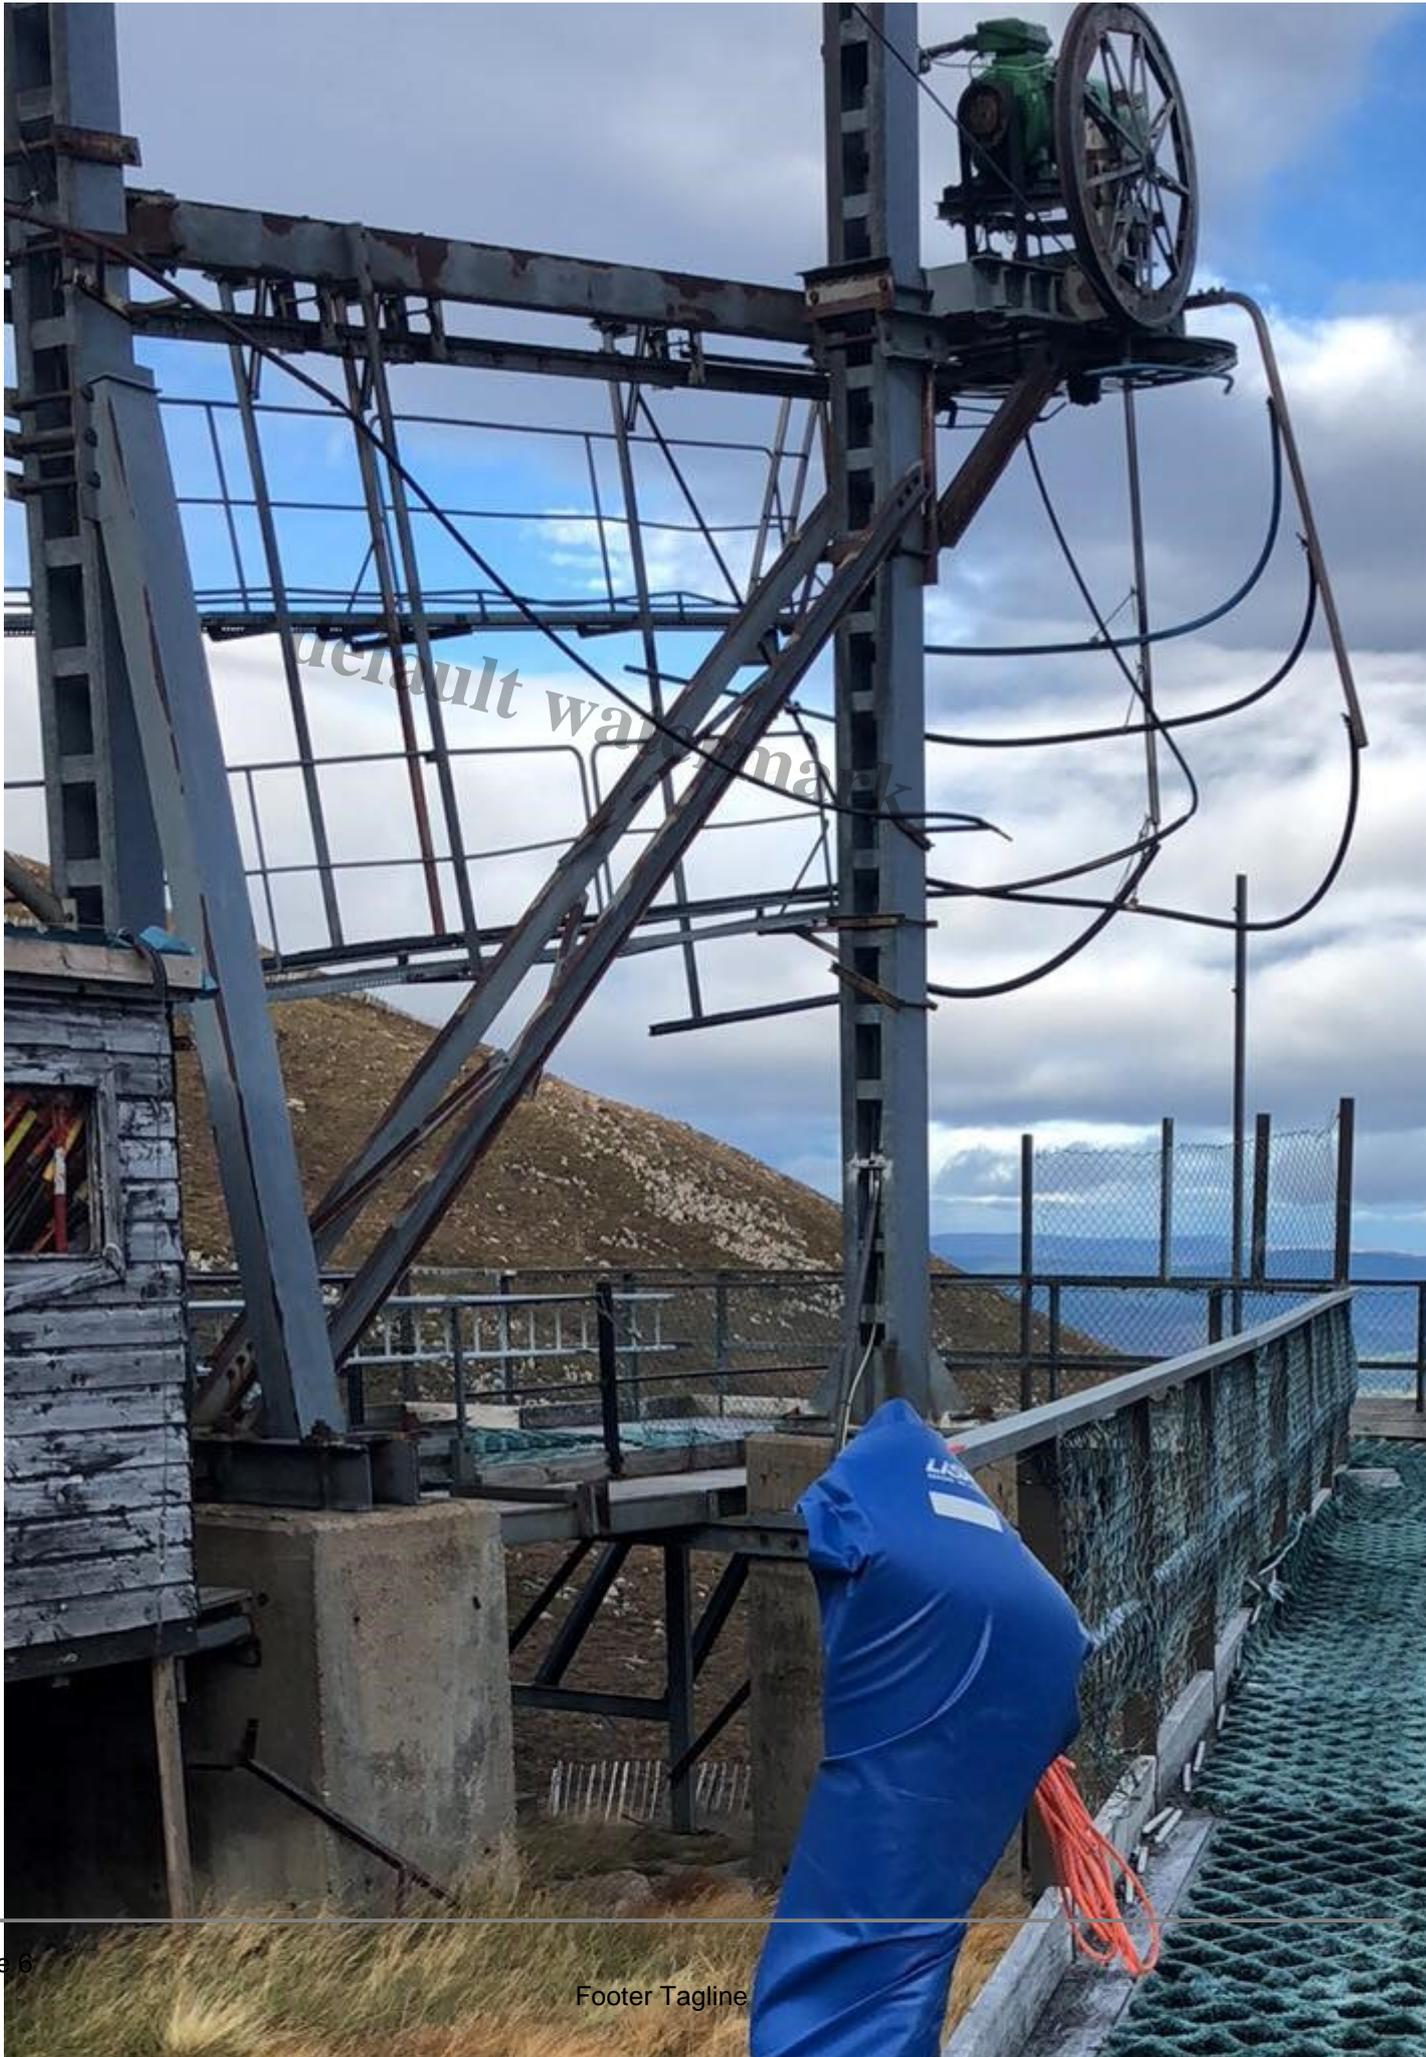
West Wall poma20th October 2018 â?? photo credit Alan Bratney

Comment: despite some remedial work having been done during September 2018, the loading area remains in a dilapidated condition

2015: The lower platform should be inspected and assessed for its suitability as a public access platform.

2016: The lower platform should be inspected and assessed for its suitability as a public access platform.

2017: The lower platform should be inspected and assessed for its suitability as a public access platform.

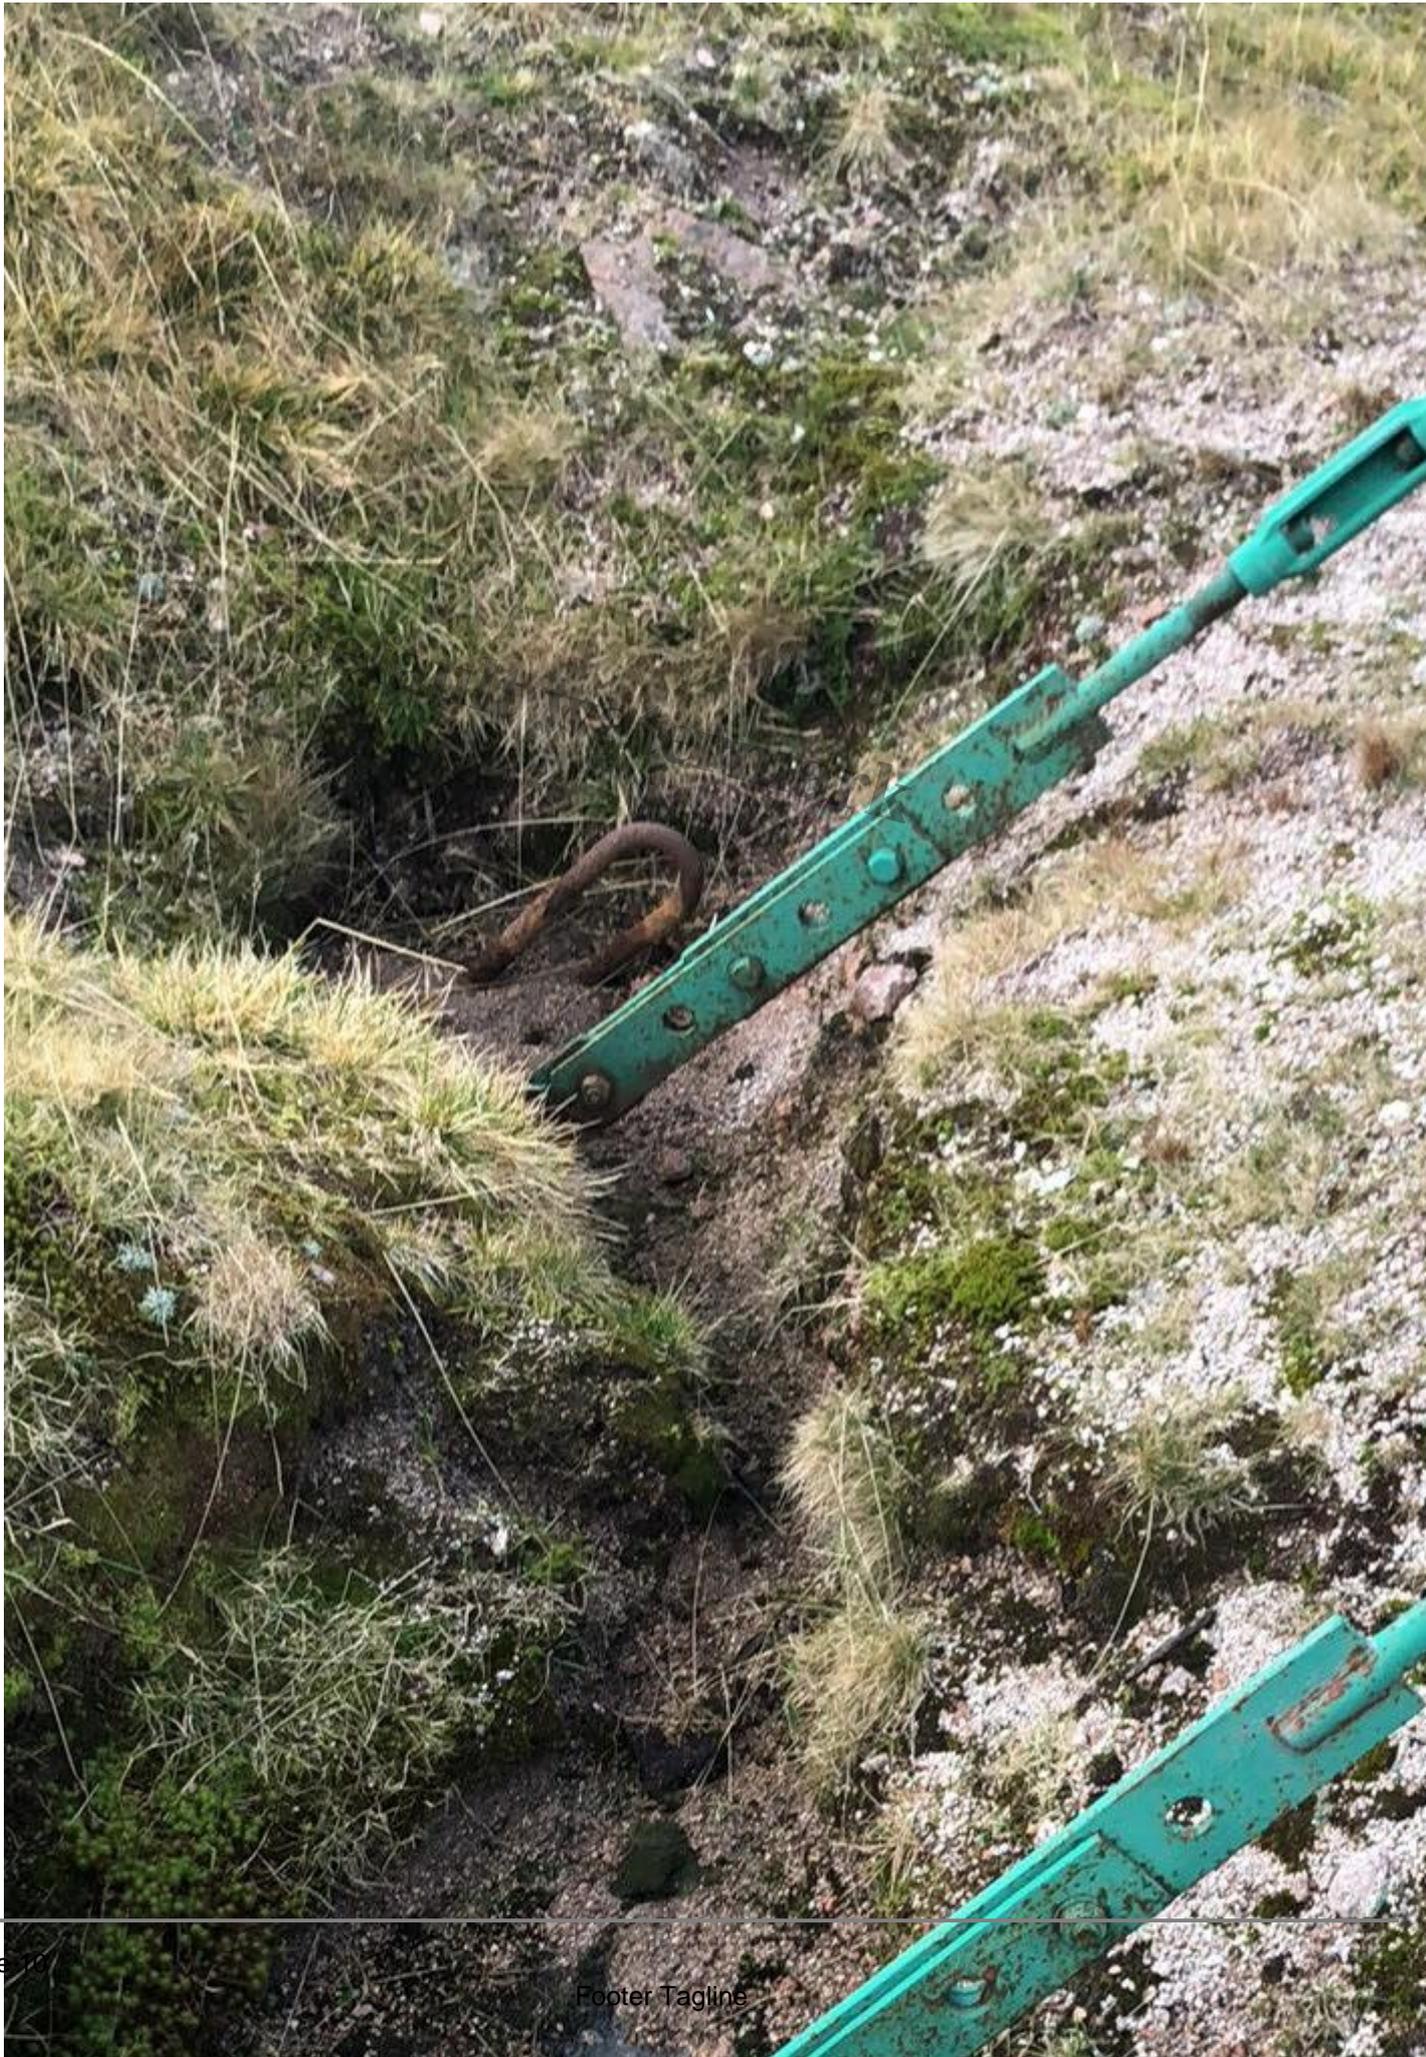
Photo credit Alan Bratney

â??Top station anchorages are buried to varying extents. **All steel work should be exposed and inspected for corrosion.** Ground levels should be maintained to give free drainage and air circulation. Paint system is failing â?? **clean and repaint. There is significant corrosion and **plans should be put in place to replace**â?? a more detailed inspection is recommended once it is fully exposed.â?•**

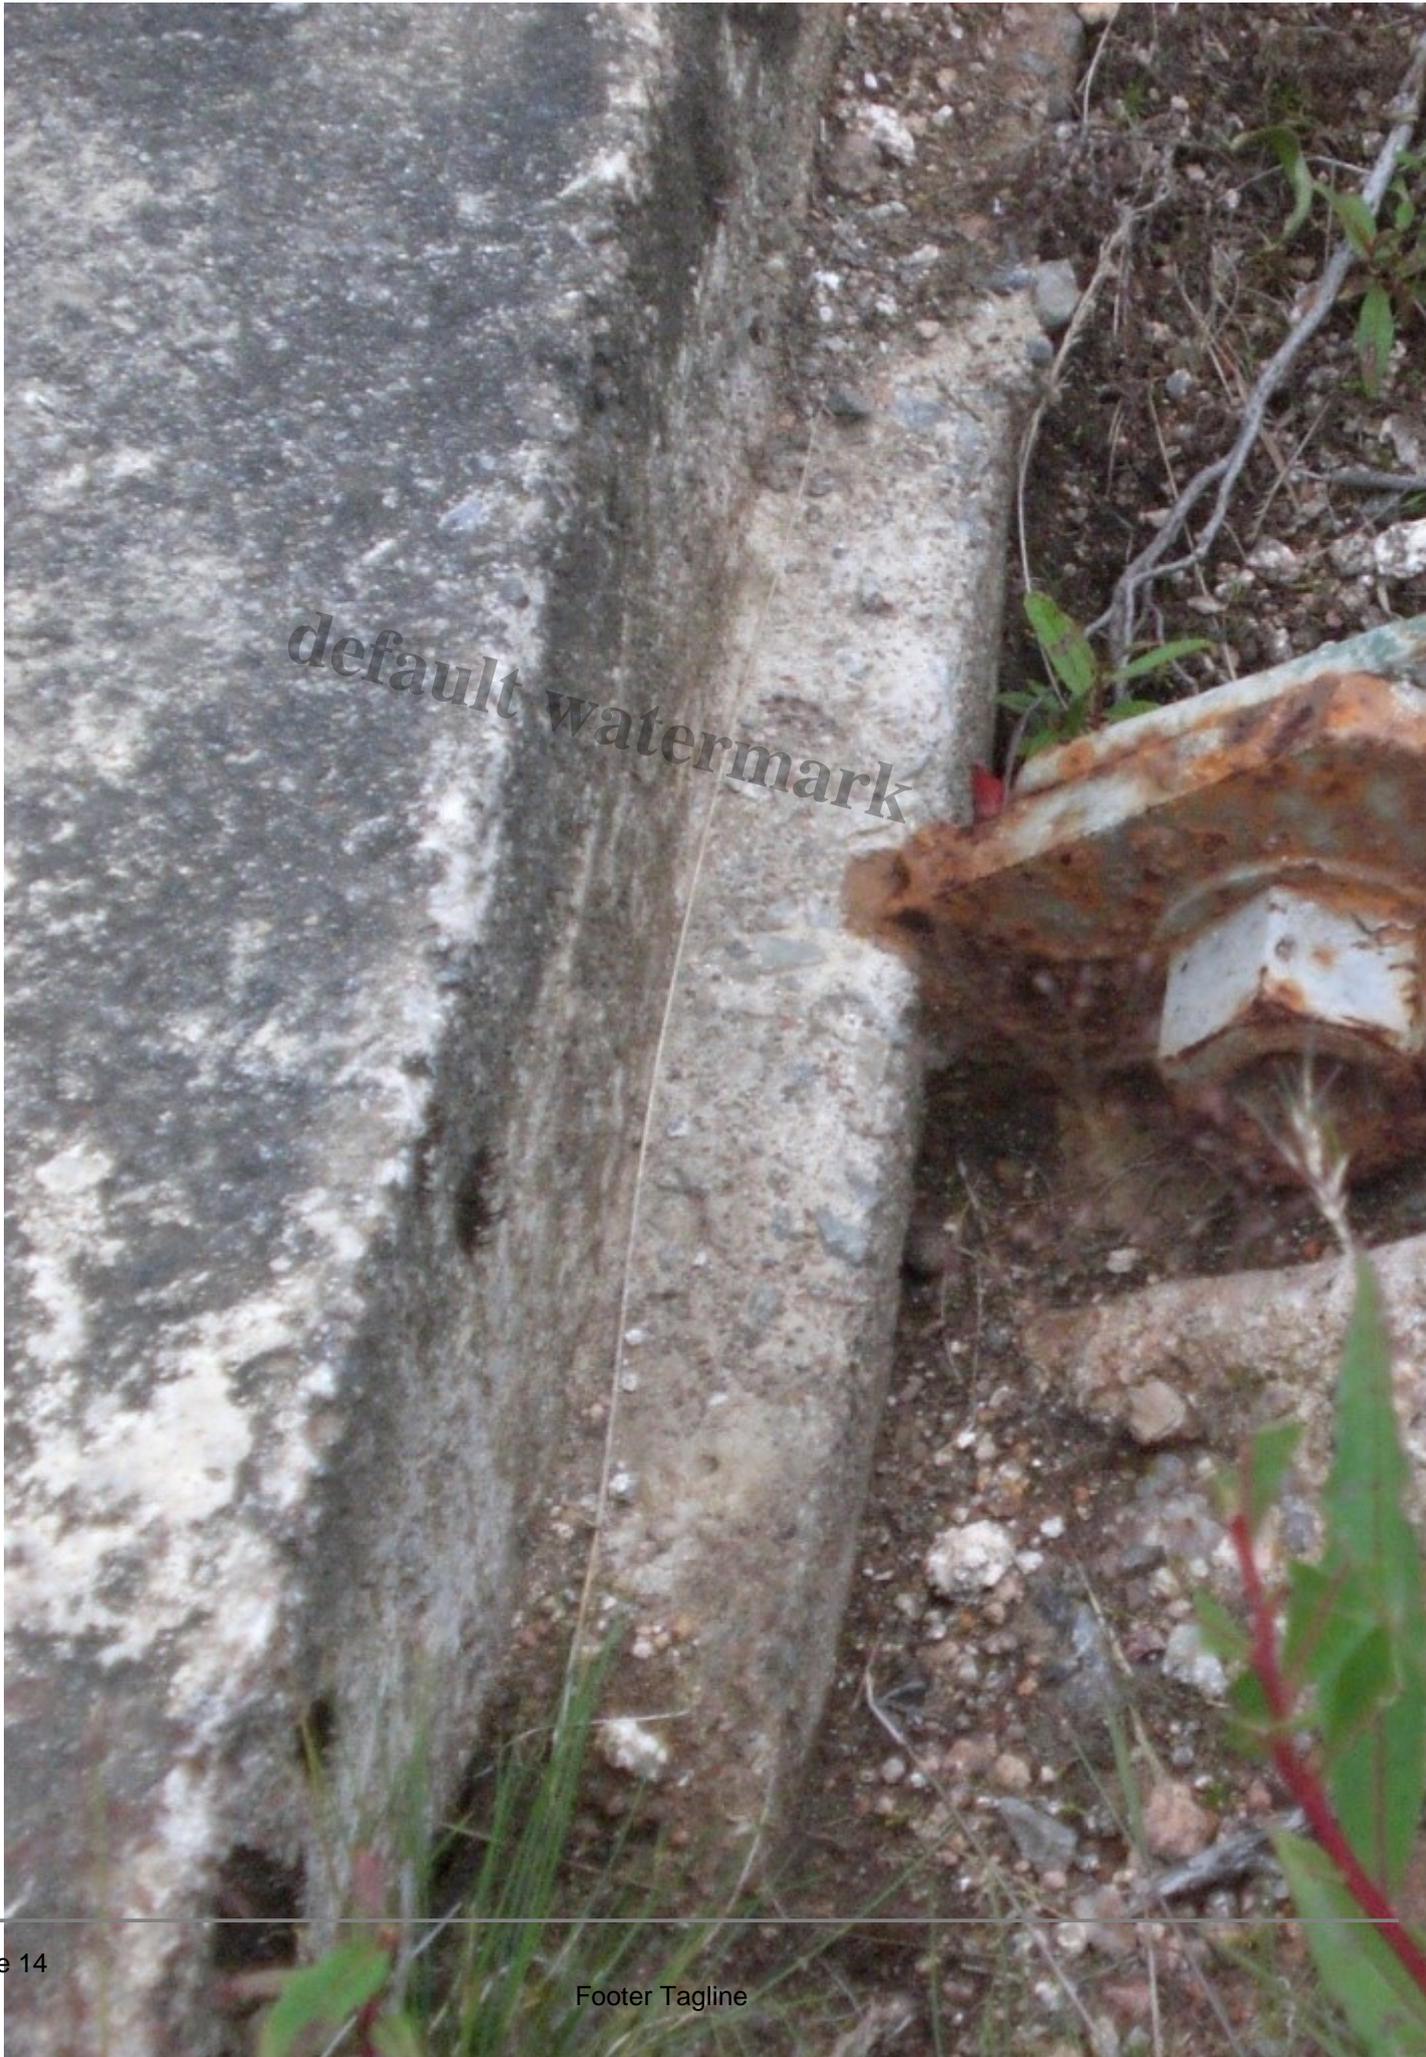
Bolt car park t-bar Photo Credit Alan Bratney

Bolts are generally grade 2/3 however ****pylon 1 bolts are grade 3/4**.**
