The hill and hydro roads disaster at the head of Glen Prosen

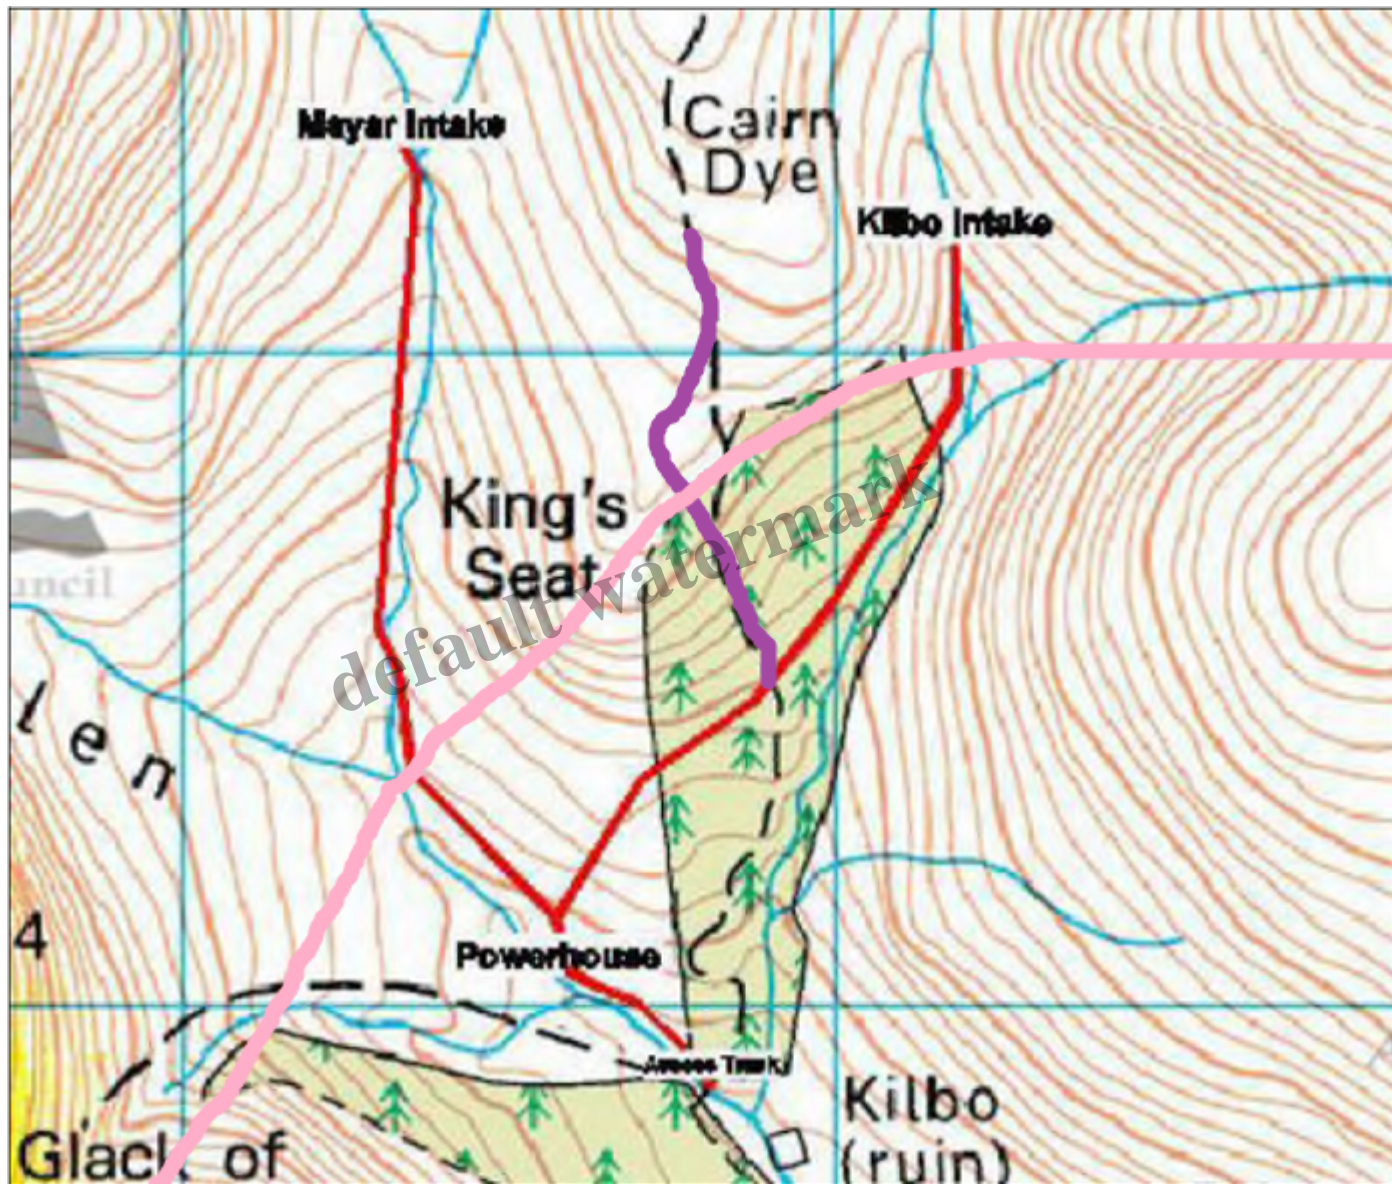
Figure 2. Site Plan

Extract from Planning Report, with the red denoting the two pipelines/construction tracks. I have added two further lines: the purple demarcates the approx line of the track constructed without planning permission; the pink the approx boundary of the Lochnagar-Mt Keen Wild Land Area which came into affect in 2014 (after planning permission was granted).

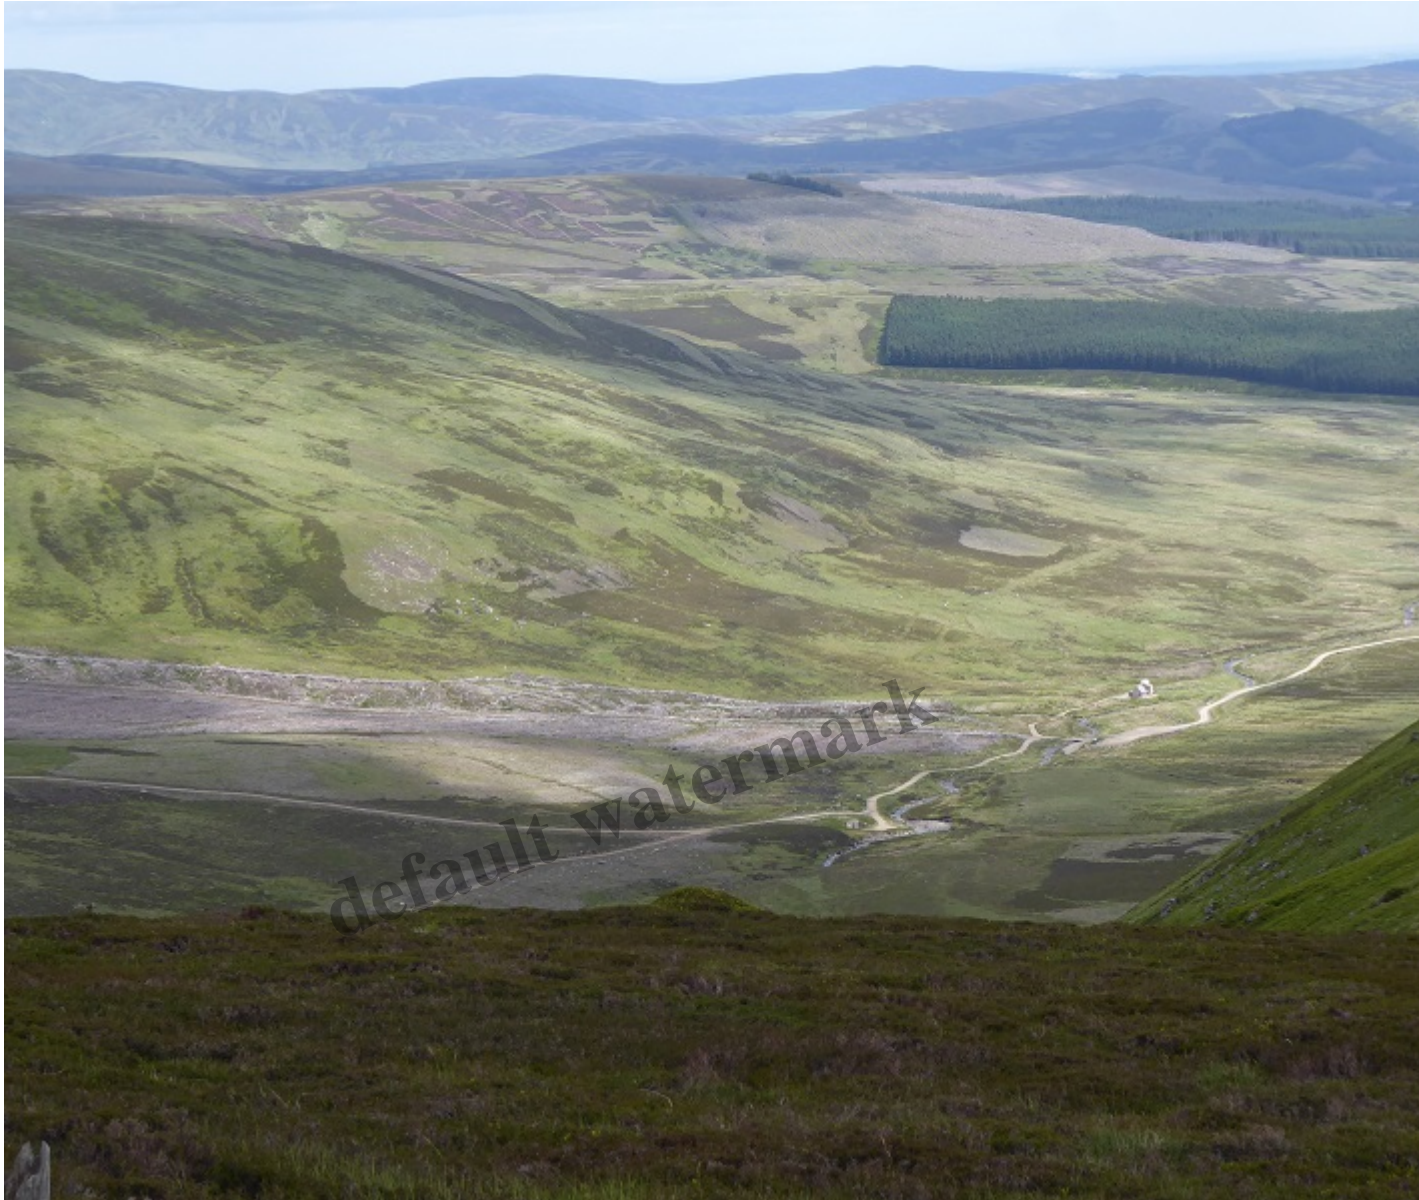
Looking down on the start of the two new hydro roads – the fork marks where the two pipelines meet head of Glen Prosen in June 2016. The location of the powerhouse can be seen just right of centre

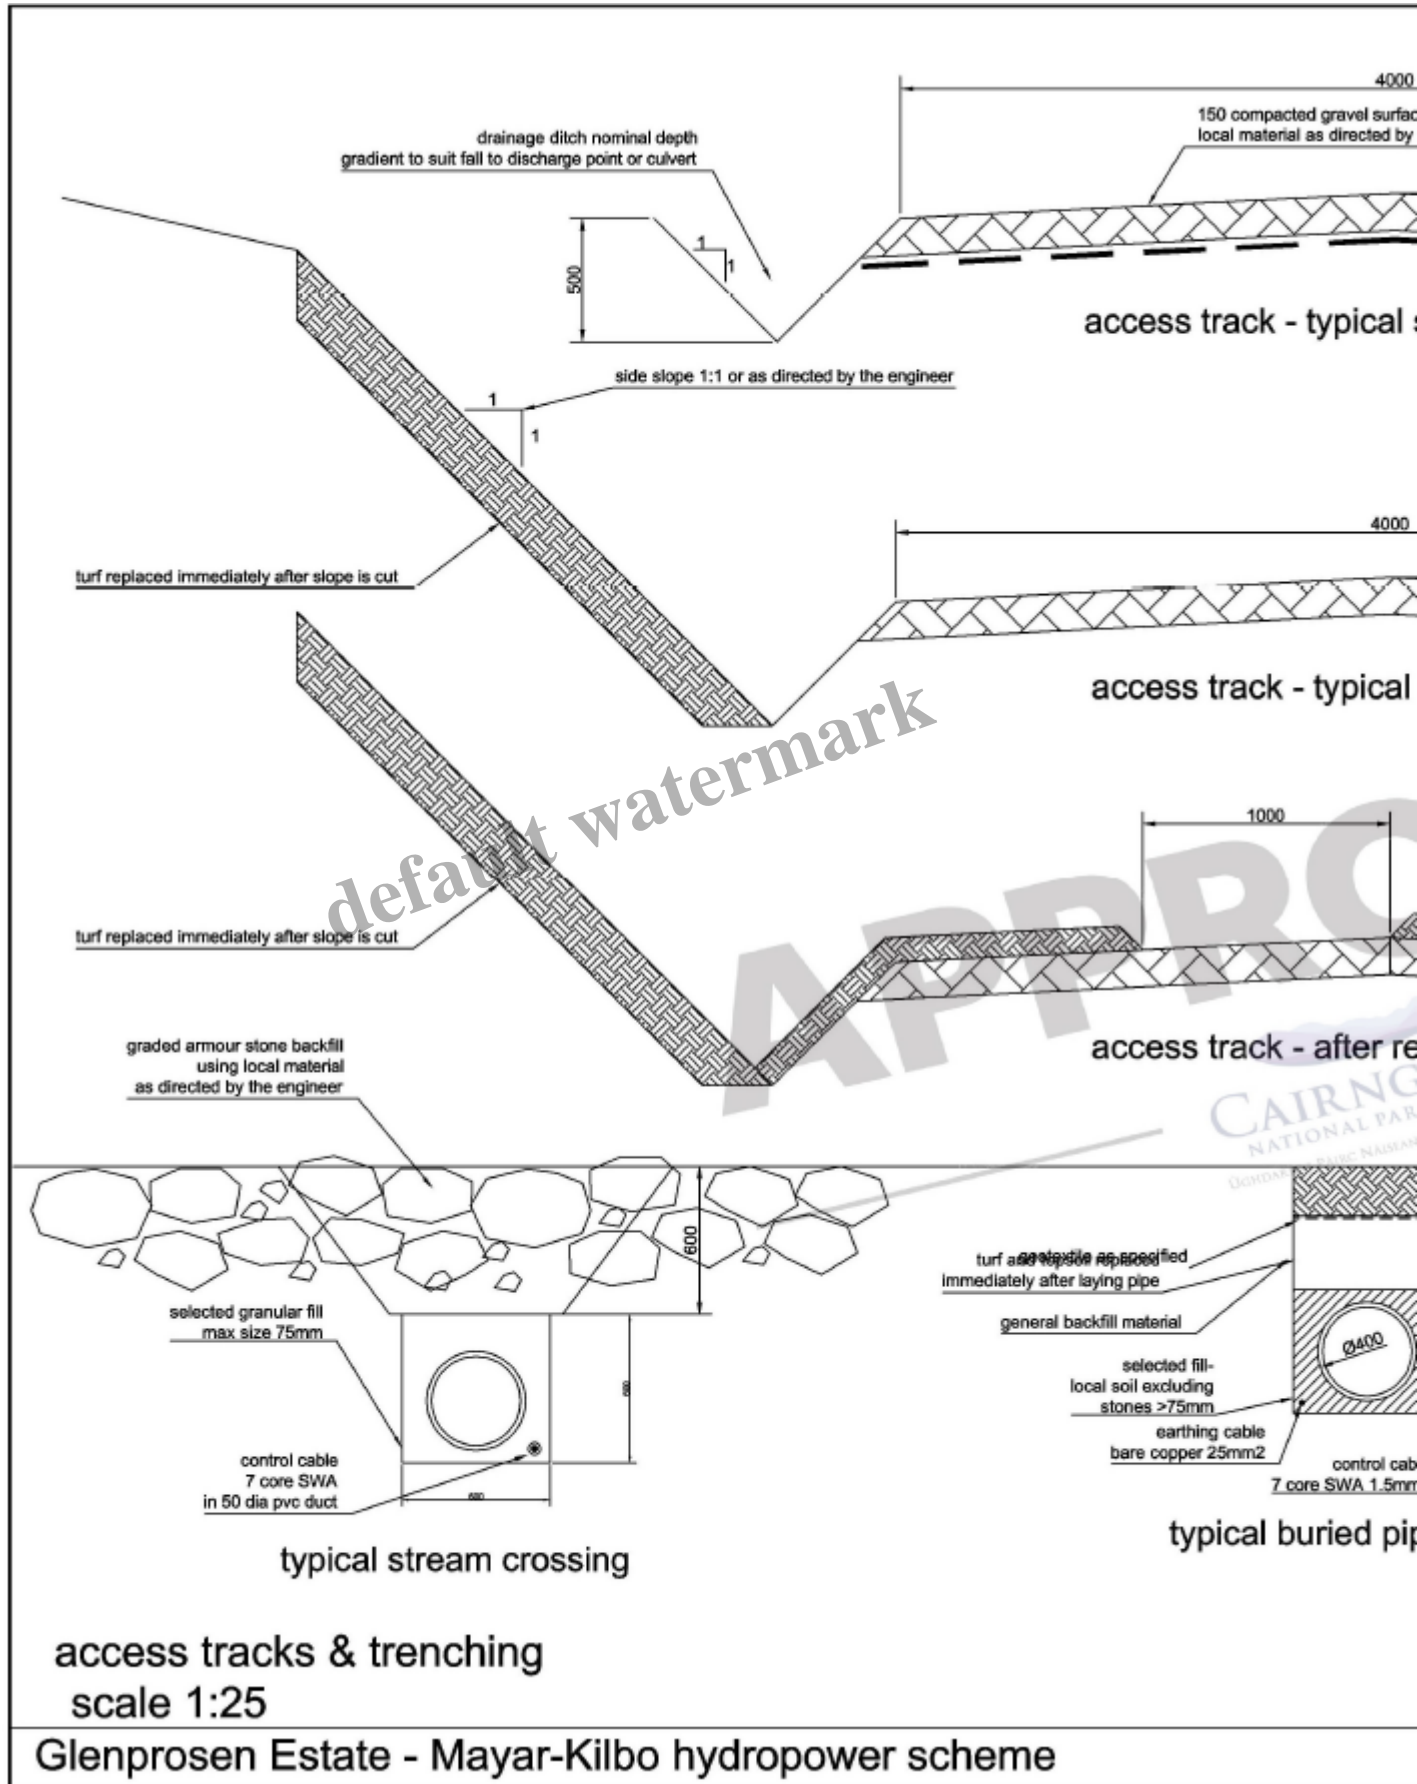
The first diagram shows the hydro construction tracks being four metres wide and the surface being being reduced to 1m wide for quad bike use after construction.

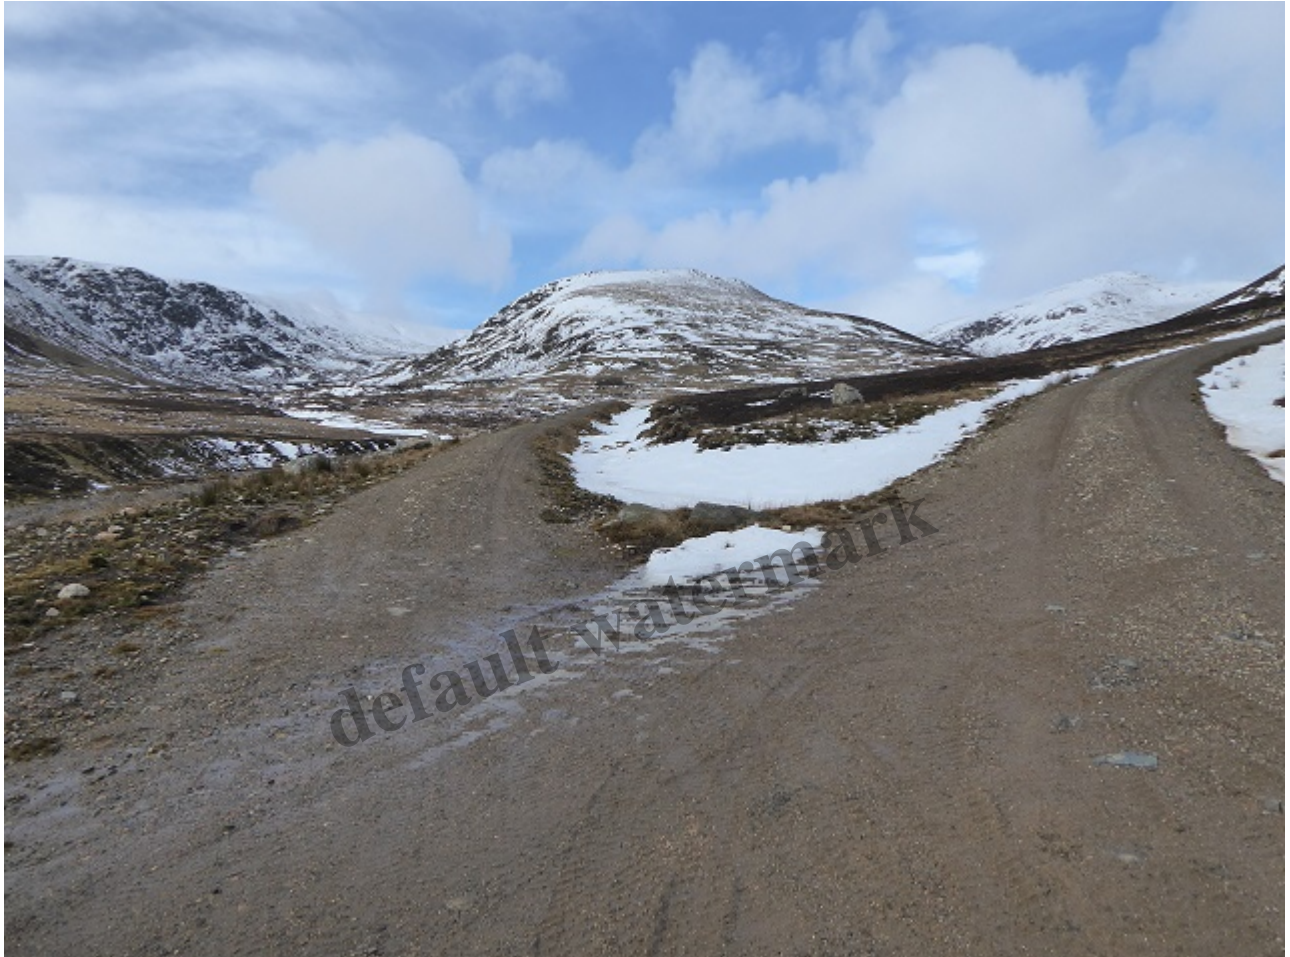
The fork in the roads above the powerhouse, the left to the Mayar intake and the right to the Kilbo intake.

Both roads are far wider than necessary for landrover use – as you can see from the tyre marks – let alone for quad bike or ATV use.

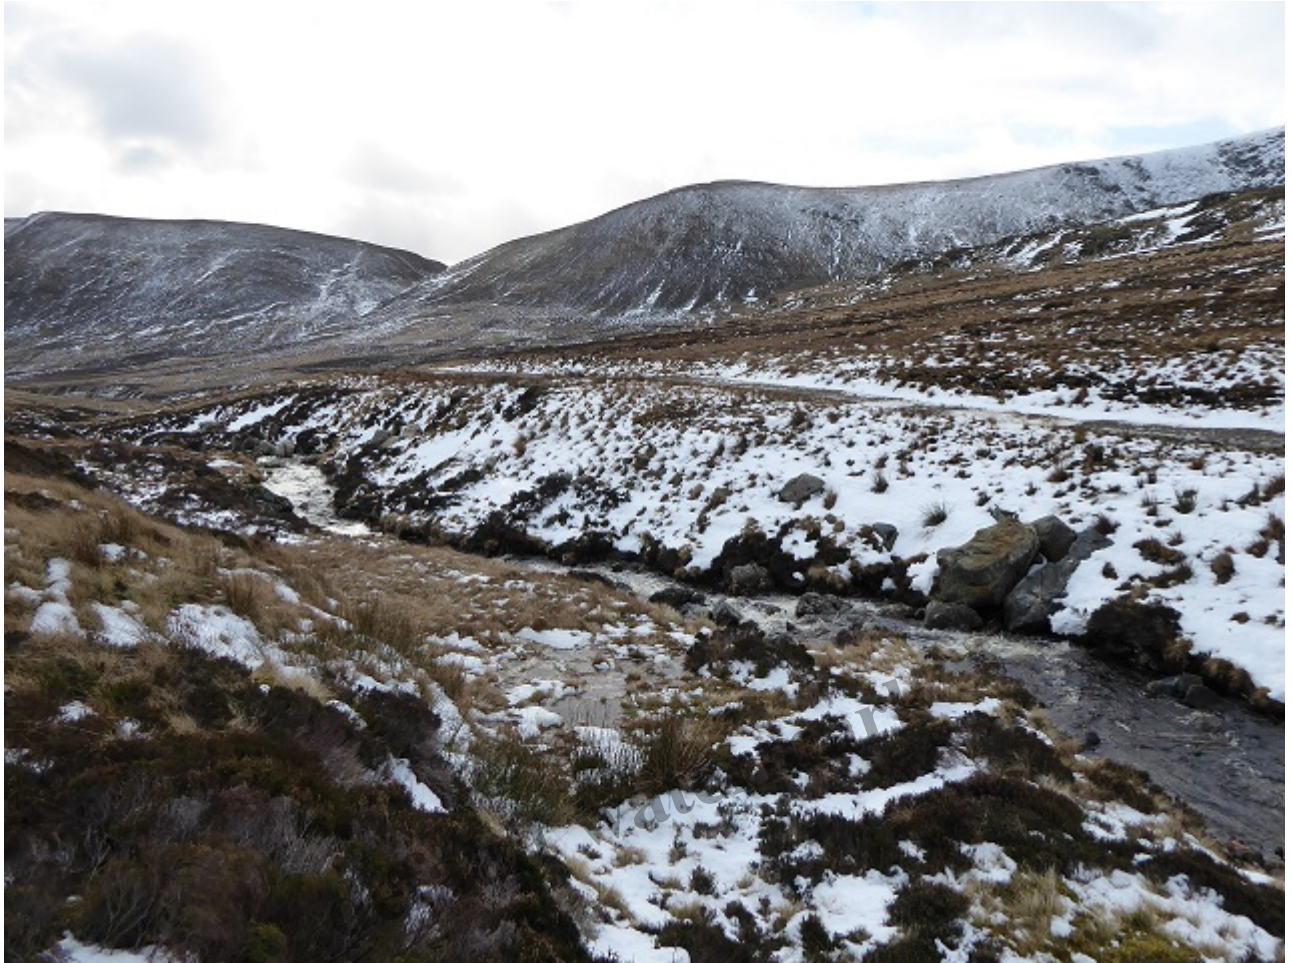
View of the road up to the Mayar intake above where it crosses the burn

This road is highly visible from various angles. Part of the problem is the excessive width. Had it been reduced to 1m width it would be far less visible. It also however forms a straight cut across the landscape, unlike most footpaths, and this accentuates the impact.

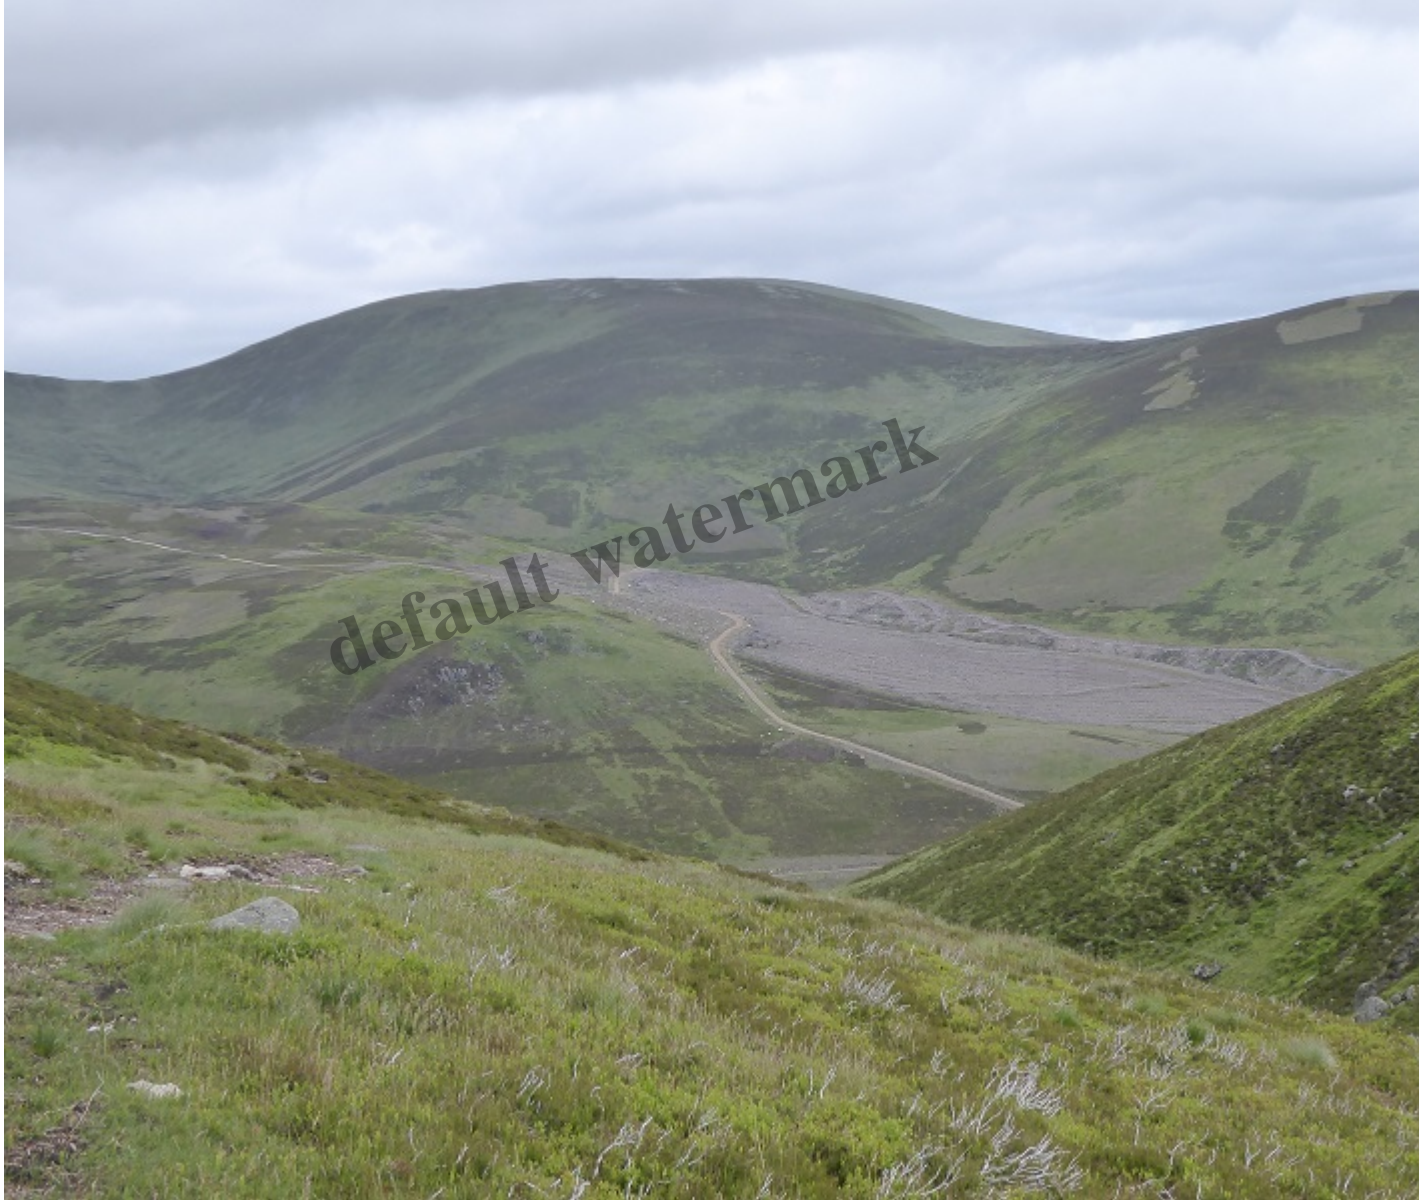
The road to the Kilbo intake below Driesh with the unlawful new grouse moor track visible to the left.

Part of the reason the Kilbo road is so visible is it takes a high line across the hillside.

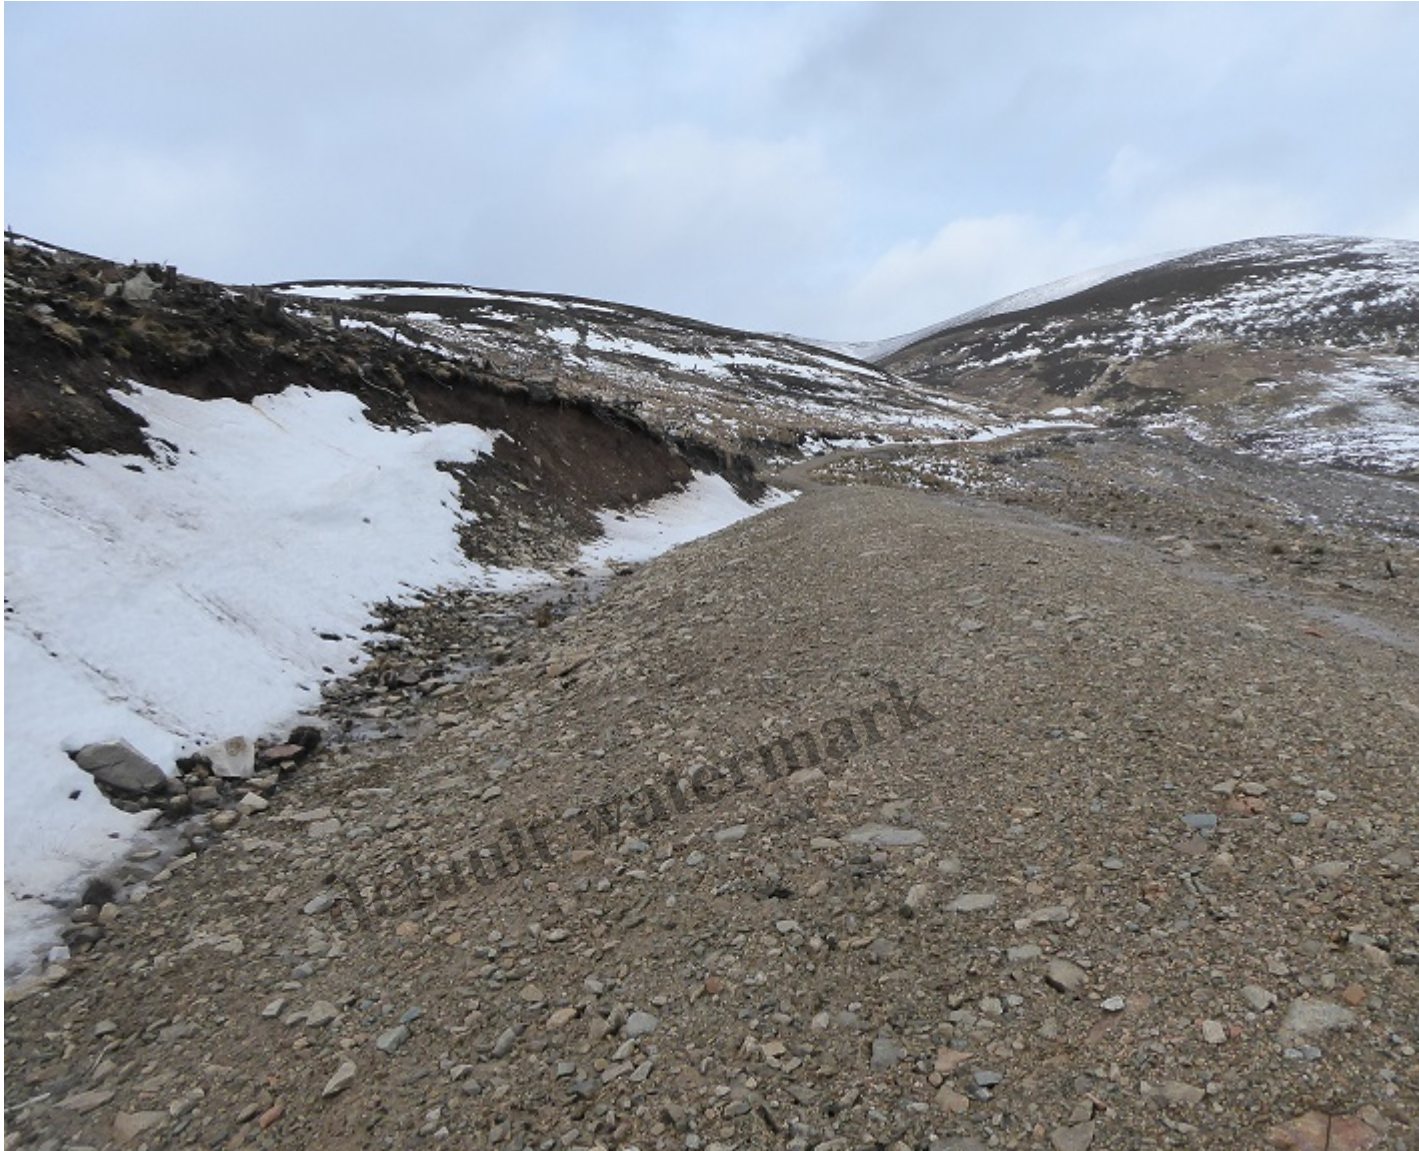
View up towards the Mayar intake from just above the junction with the new grouse moor road. The part of the road is so steeply sloping on both sides that it would be difficult to drive a vehicle along

Prior to the construction of the hydro scheme, the King's Seat forestry plantation (as shown on map above) was felled. Forest roads don't need planning approval but come under the Prior Notification system and part of the reason for this terrible section of track would appear to be that it was constructed to forestry specifications. These allow wider roads for felling than the 4m construction track agreed by the CNPA. However, whatever the origins, this road has been used to construct the hydro scheme and the CNPA required this to be reduced in width to 1m.

One might have hoped that, given the disgraceful state of the upper part of the Kilbo Road that the CNPA would have taken prompt enforcement action. I will now be asking them to do so for both hydro tracks.

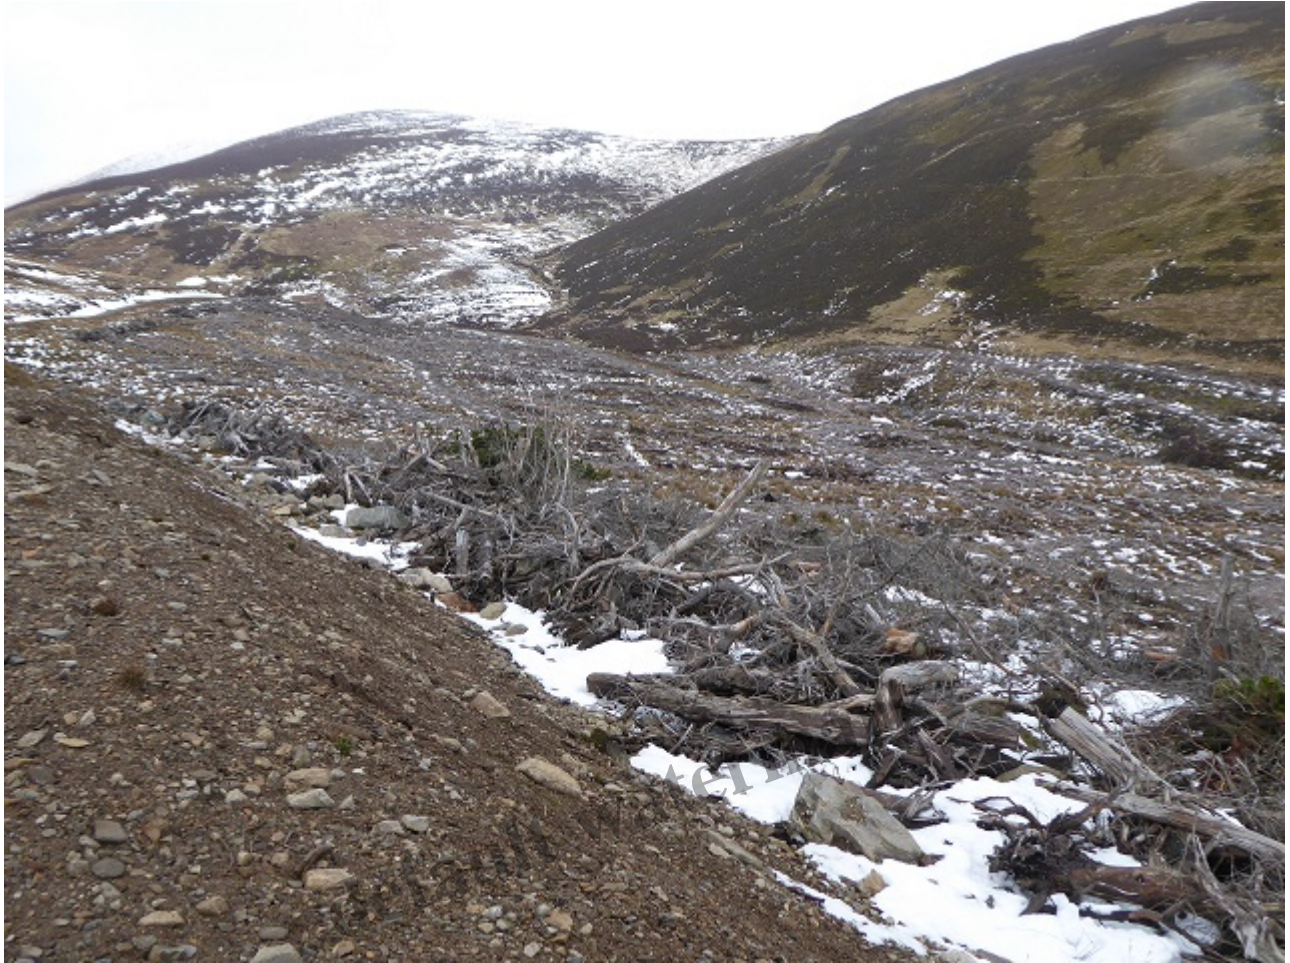
Close up of downhill side of cutting

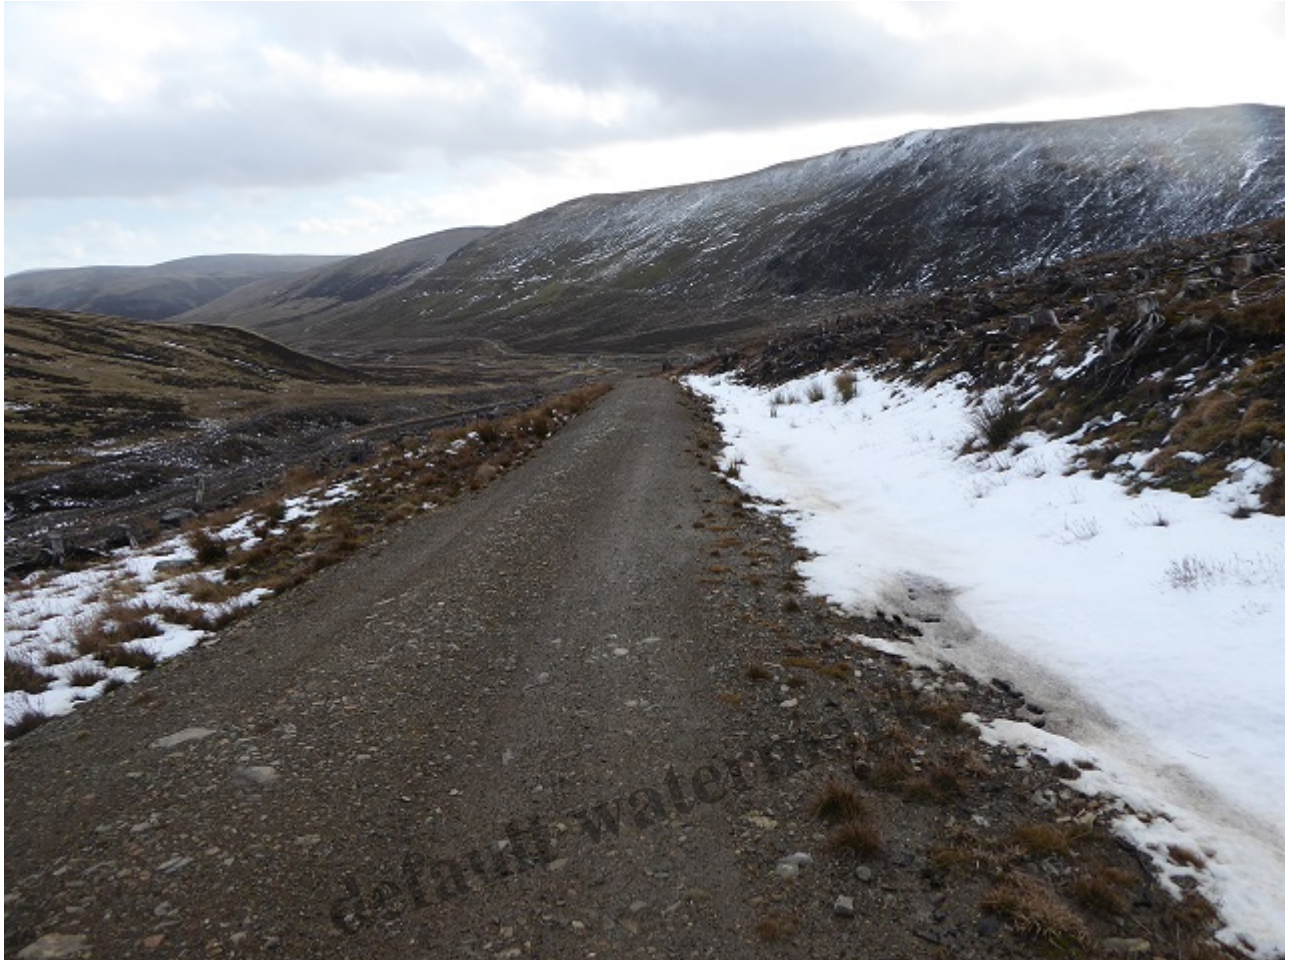
Looking down the first section of the new road, with the Kilbo hydro road visible below and two left and the old road to the head of Glen Prosen in the background beyond

It appears that the Glen Prosen Estate has used the hydro scheme construction tracks as an opportunity to construct a new road up Cairn Dye. This appears to have obliterated the historic Kilbo Path and means that there are now not just two but three hill roads within one small area at the head of the glen. There is no planning application for this and the road is not listed under those that have been developed under the Prior Notification scheme. It therefore appears unlawful.

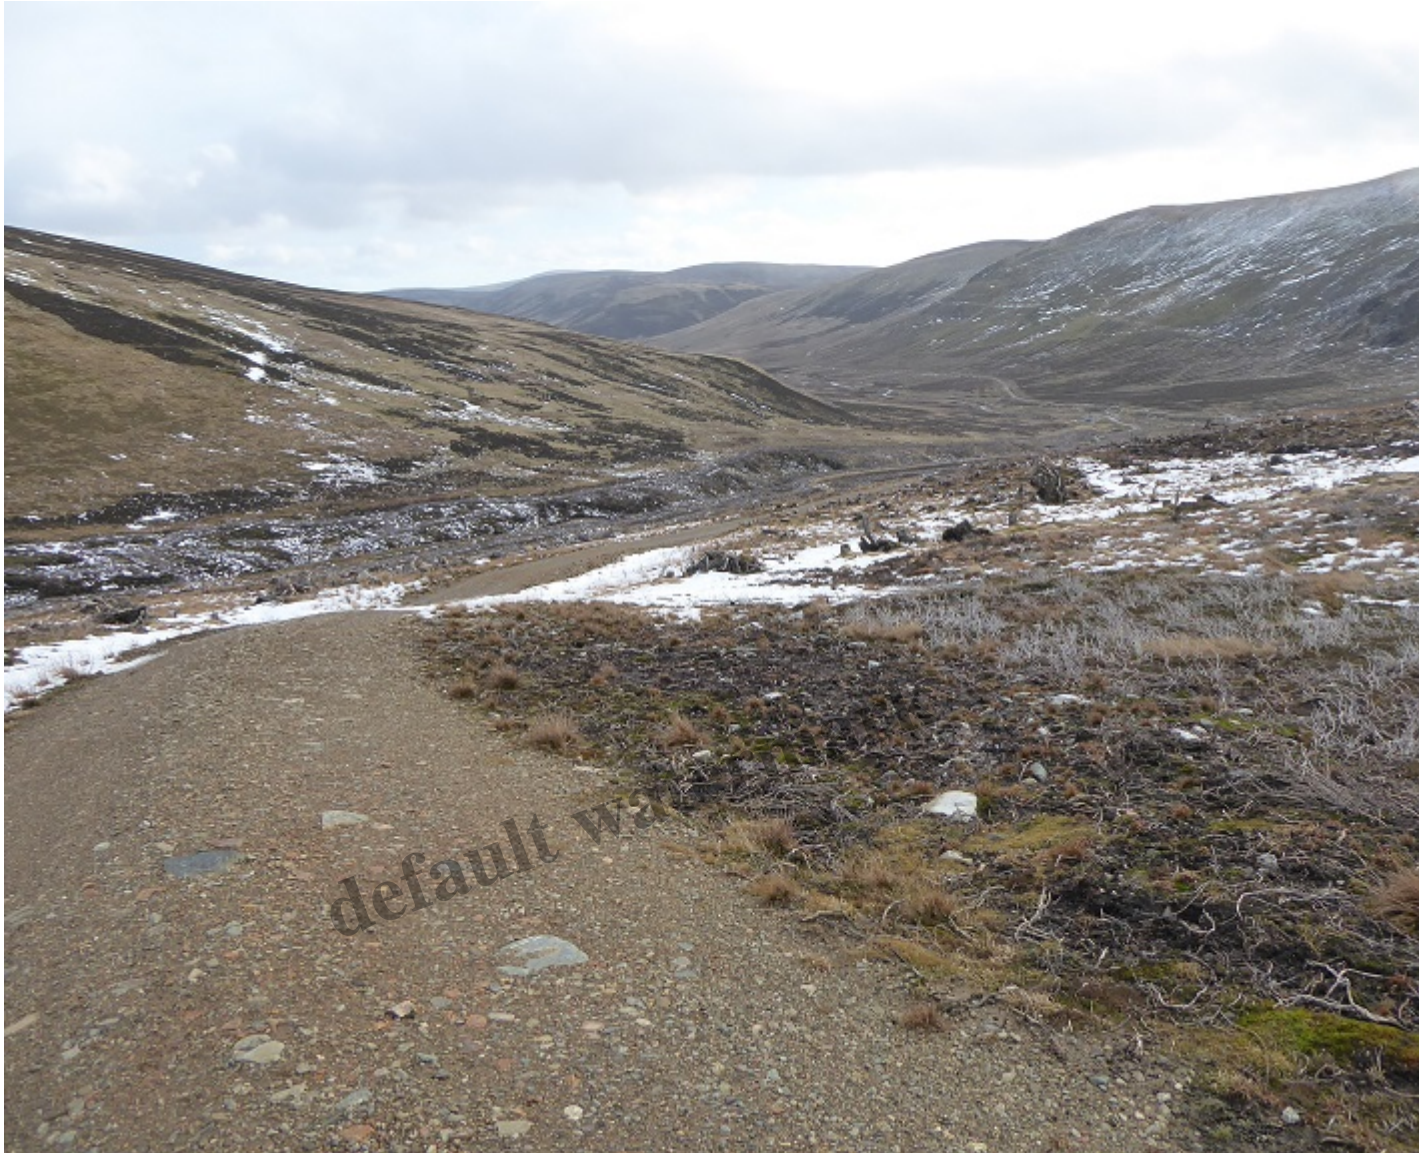
Muirburn by side of road just above forest plantation

Its symptomatic of current inconsistencies in our approach to land-use that the ground here is being damaged by muirburn when along the Kilbo Burn the CNPA made this requirement for the hydro scheme:

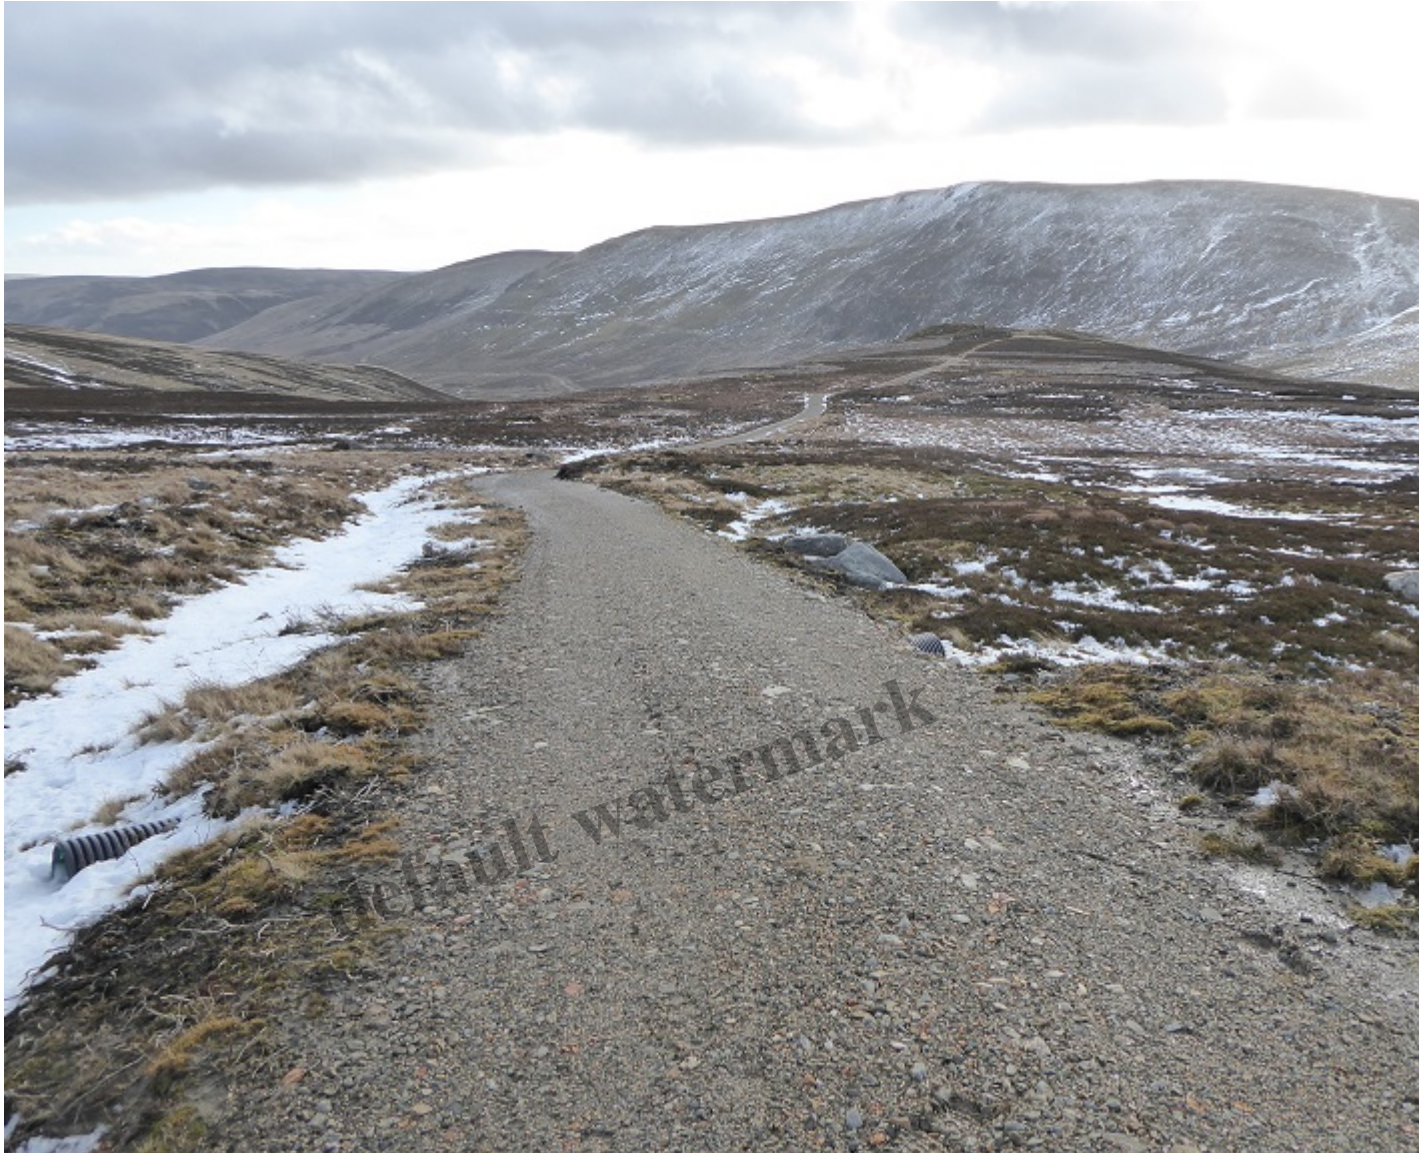
Looking down the new road along the Glen Dye ridge – note the plastic culvert left indicating the degree of construction that has taken place

The road is far far wider than that consented for the hydro roads and there is now no sign of the green central strip that the CNPA now regards as good practice for landrover tracks.

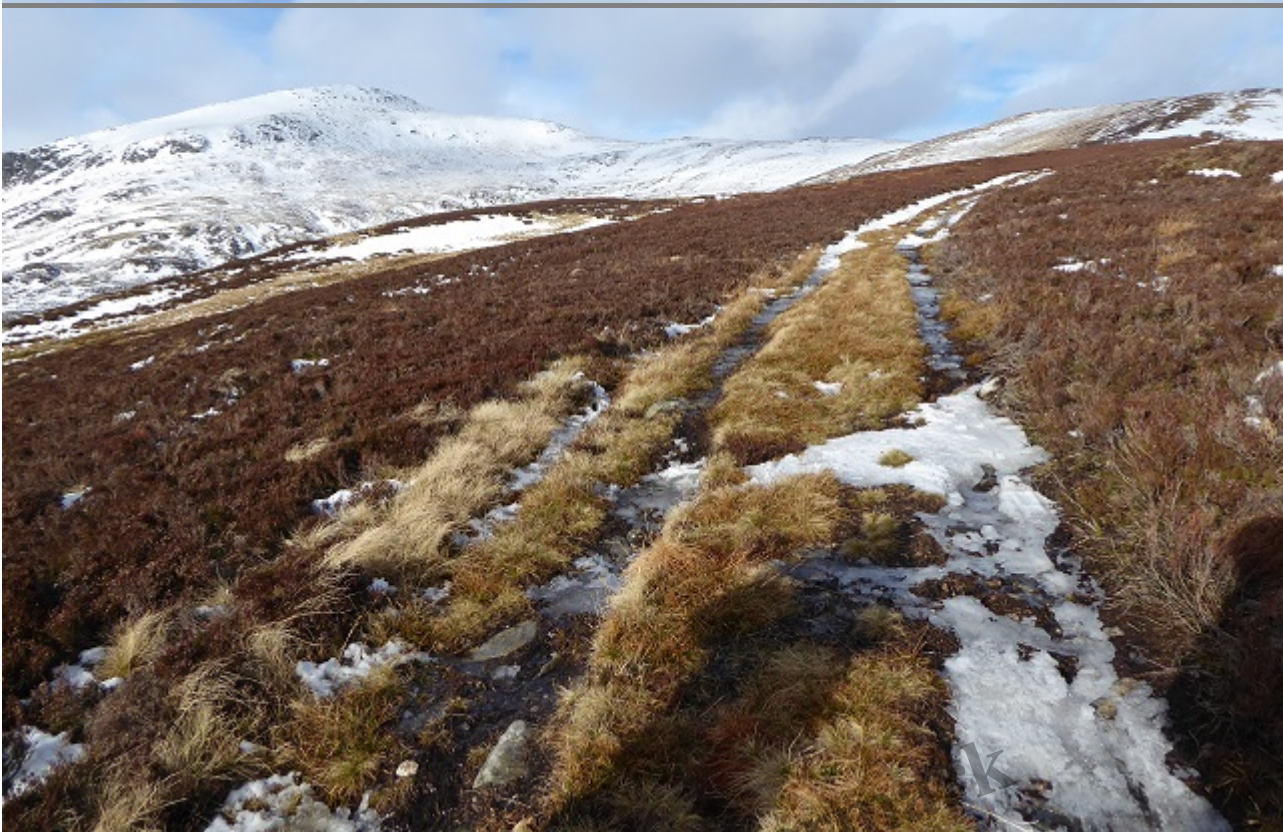
The vehicle

use has however clearly impacted on the vegetation, converting heather to grasses, thus forming a line across the landscape. This illustrates why footpaths generally have less landscape impact and are preferable to roads with green strips down the middle. If the Glen Prosen Estate accepted 1m wide tracks for quad bike use below it's hard to see how they can justify using any other vehicles here.

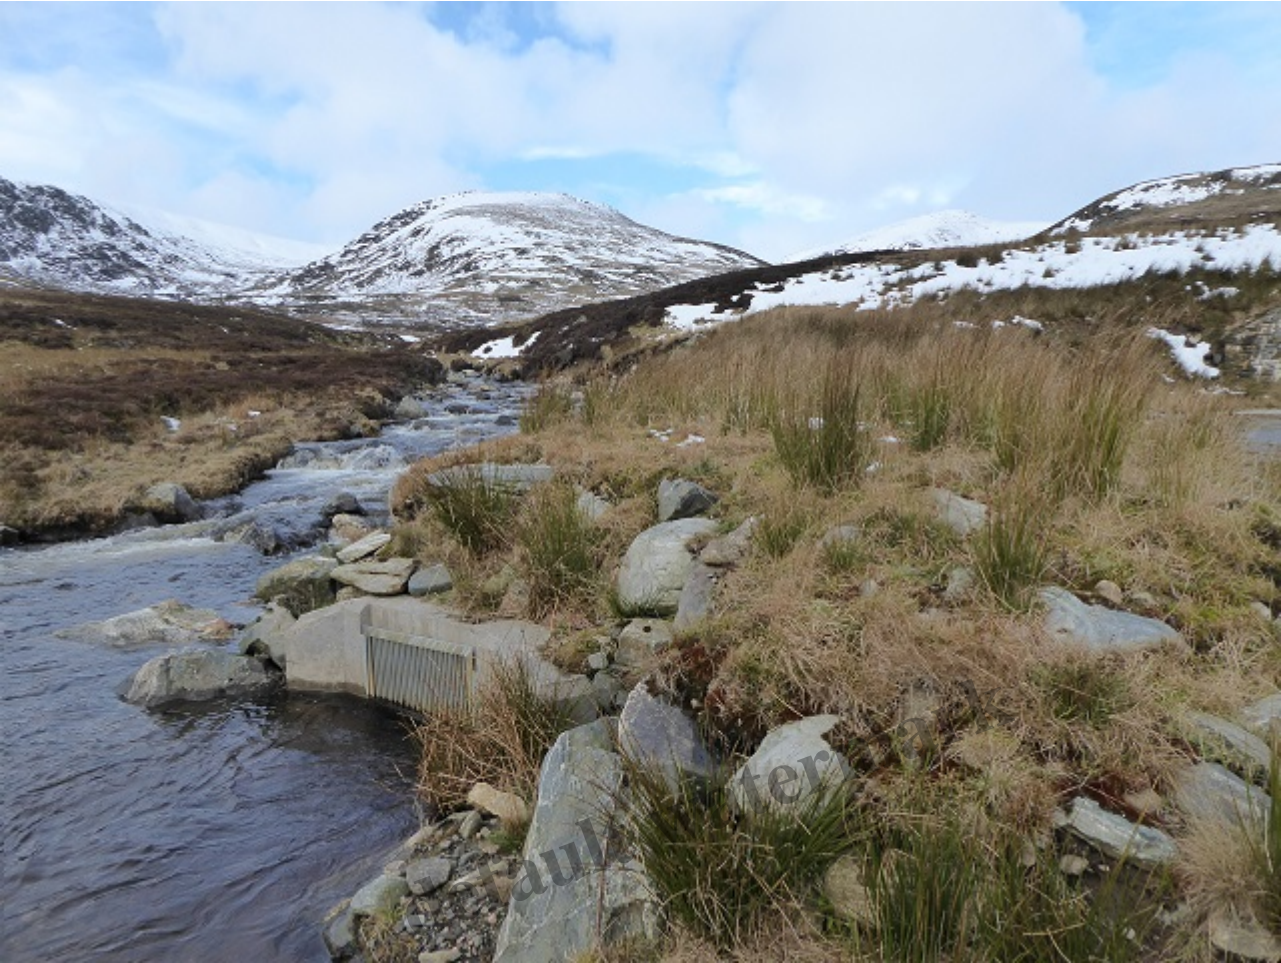
The outrace has been very sensitively landscaped

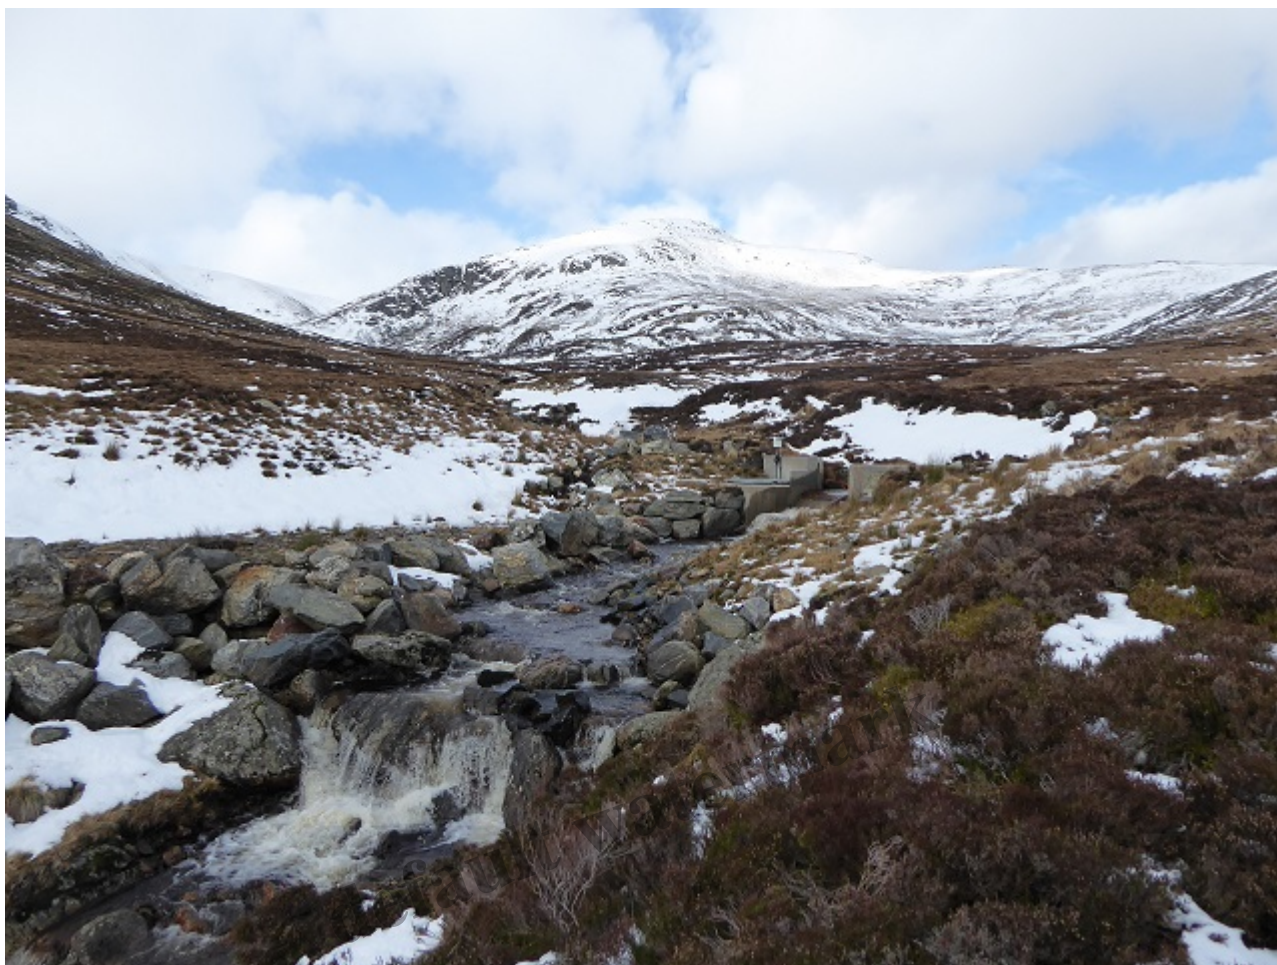
Mayar Intake with Mayar beyond

The Mayar intake is not just well located, it shows how rip rap bouldering to reinforce the sides of streams can be done sensitively so it appears almost natural (unlike the dreadful examples in Glen Falloch in the Loch Lomond and Trossachs National Park [\(see here for example\)](#)).
