The hill and hydro roads disaster at the head of Glen Prosen

The landscape impact of the two new hydro roads

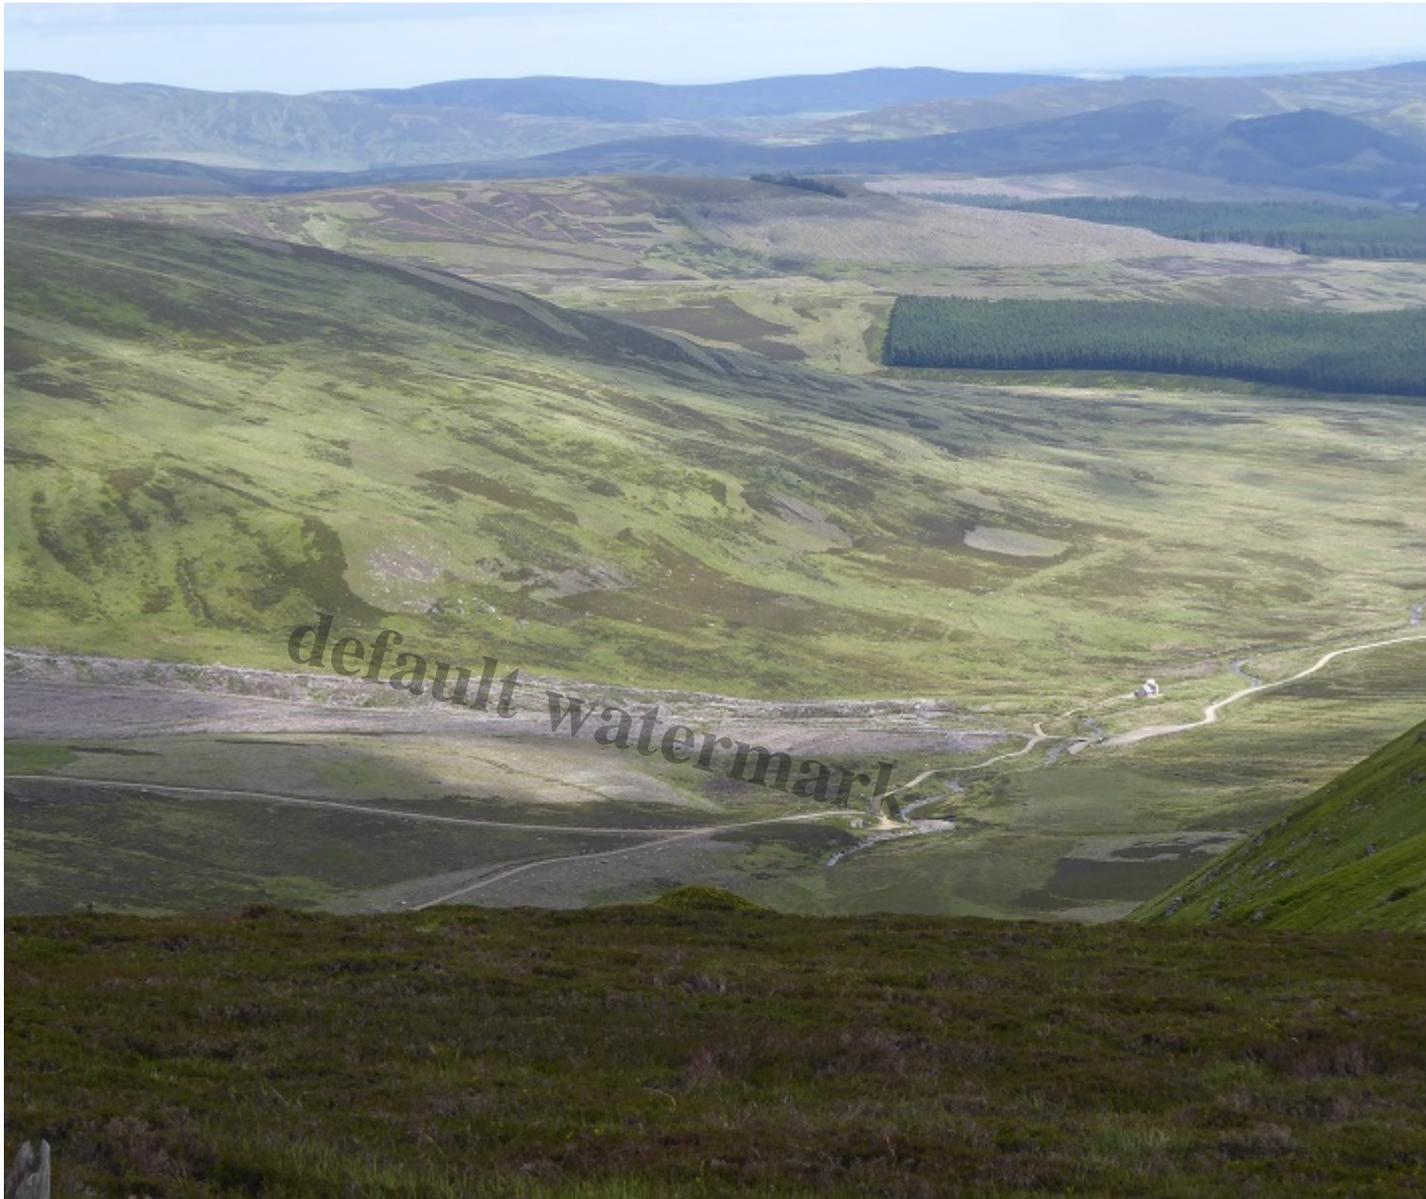
Looking down on the start of the two new hydro roads – the fork marks where the two pipelines meet at the head of Glen Prosen in June 2016. The location of the powerhouse can be seen just right of center.

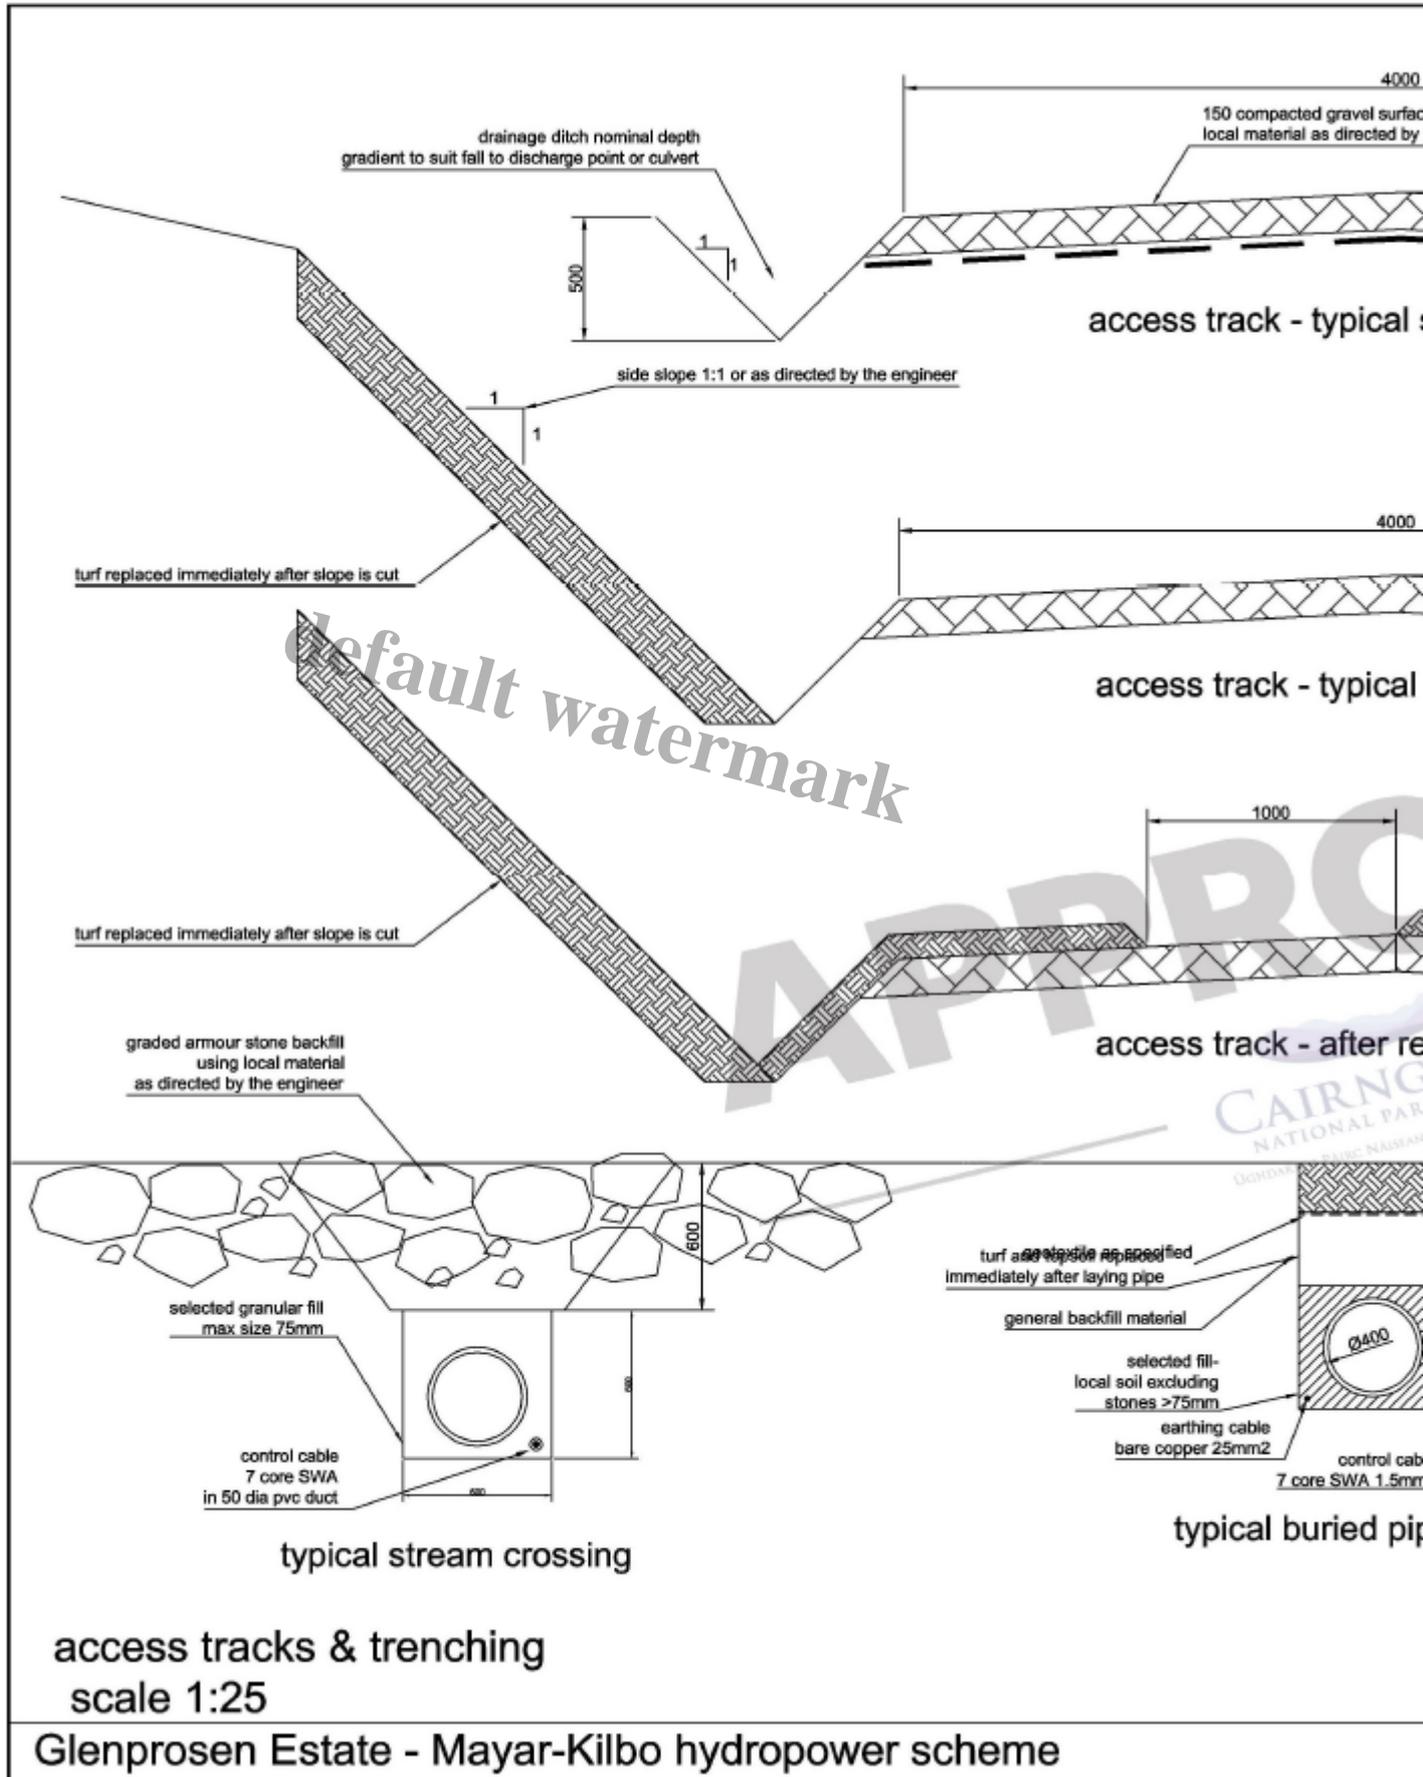
The first diagram shows the hydro construction tracks being four metres wide and the surface being reduced to 1m wide for quad bike use after construction.

The specification has been ignored, with more imported material than that originally proposed and far more limited restoration of the track width:

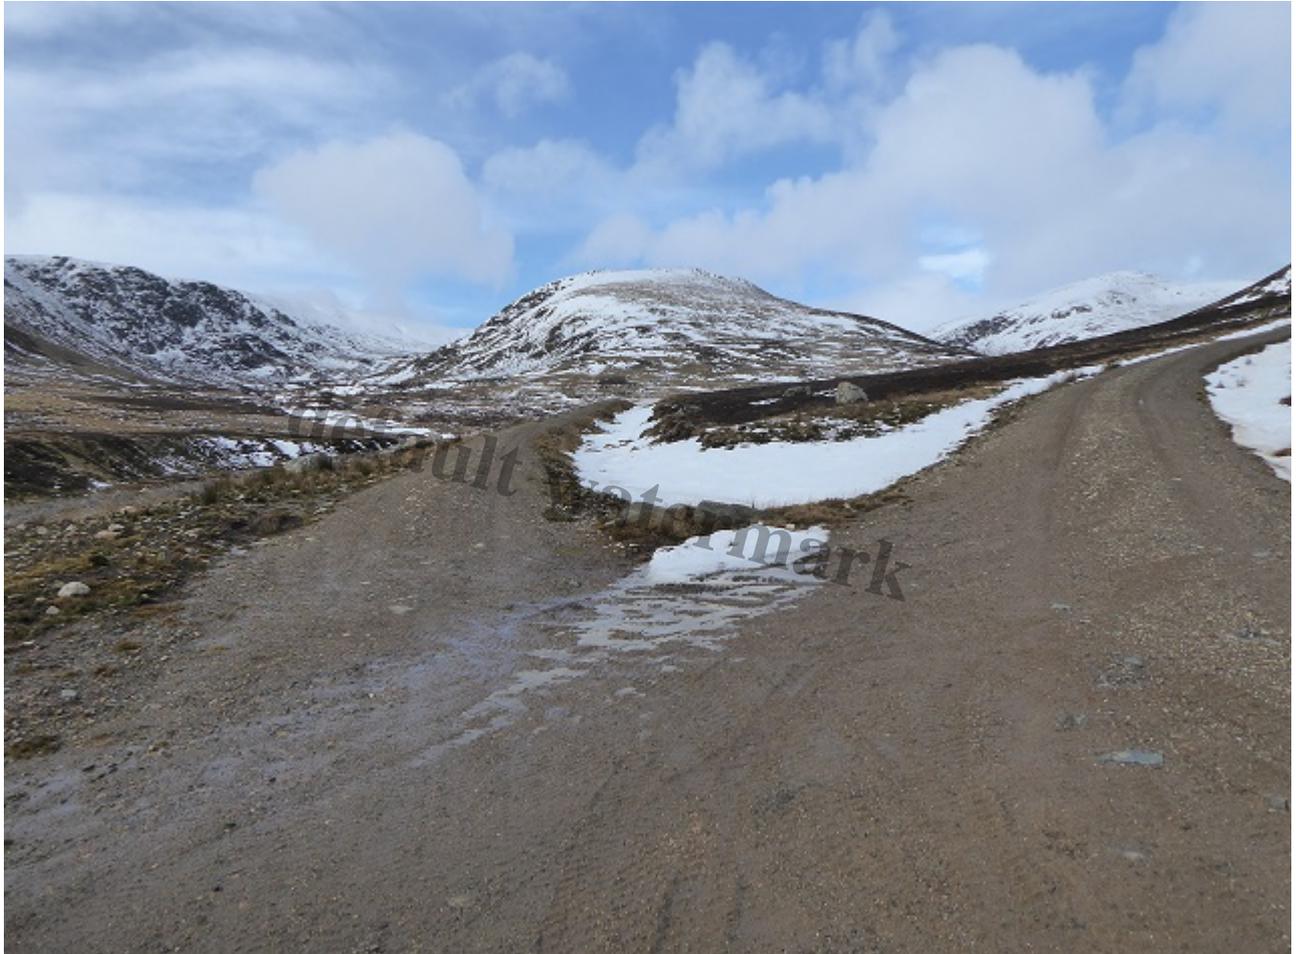
The fork in the roads above the powerhouse, the left to the Mayar intake and the right to the Kilbo intake.

Both roads are far wider than necessary for landrover use as you can see from the tyre marks let alone for quad bike or ATV use.

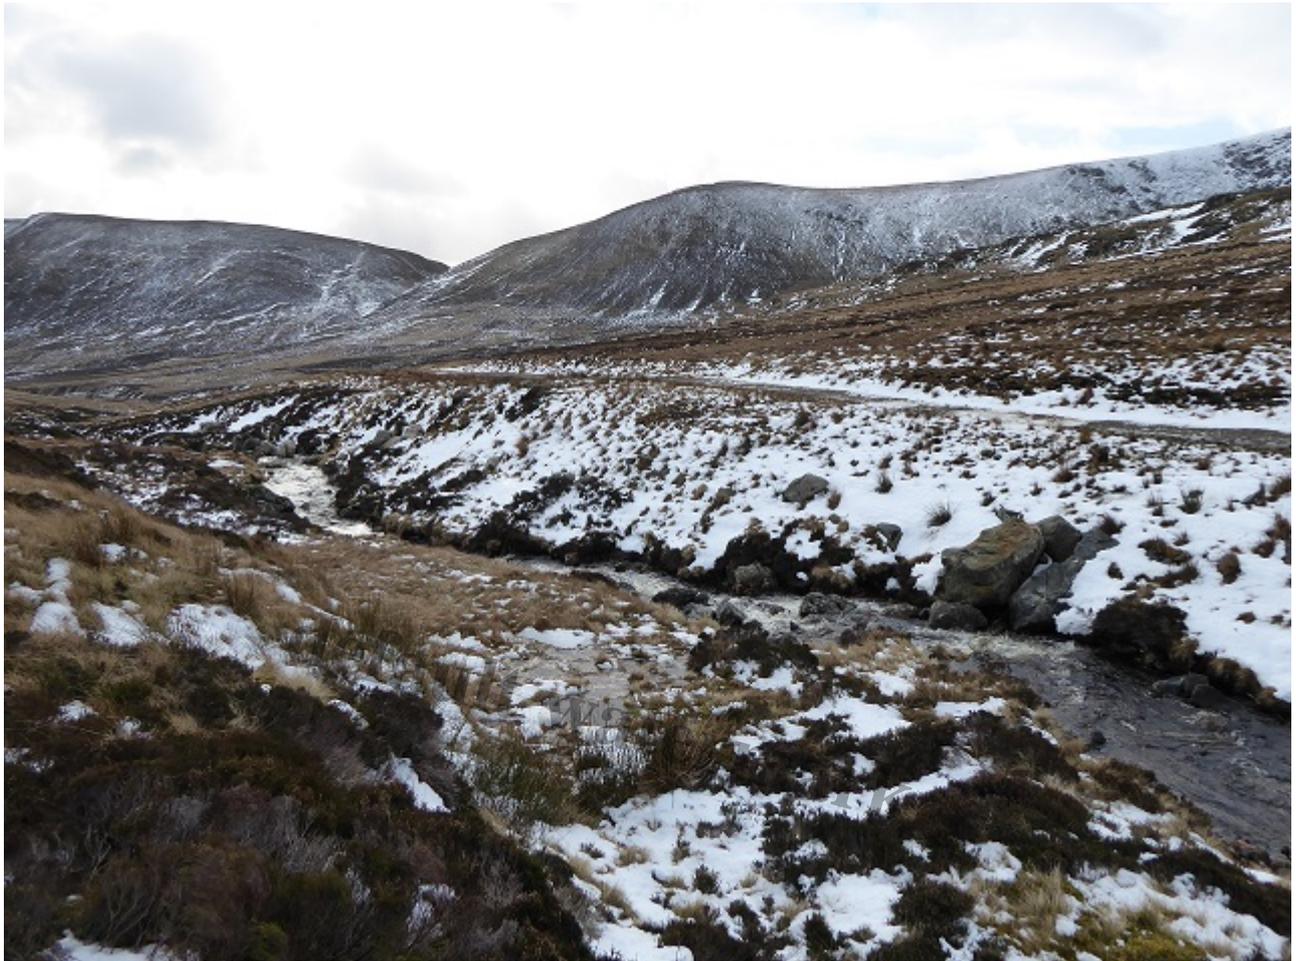
View of the road up to the Mayar intake above where it crosses the burn

This road is highly visible from various angles. Part of the problem is the excessive width. Had it been reduced to 1m width it would be far less visible. It also however forms a straight cut across the landscape, unlike most footpaths, and this accentuates the impact.

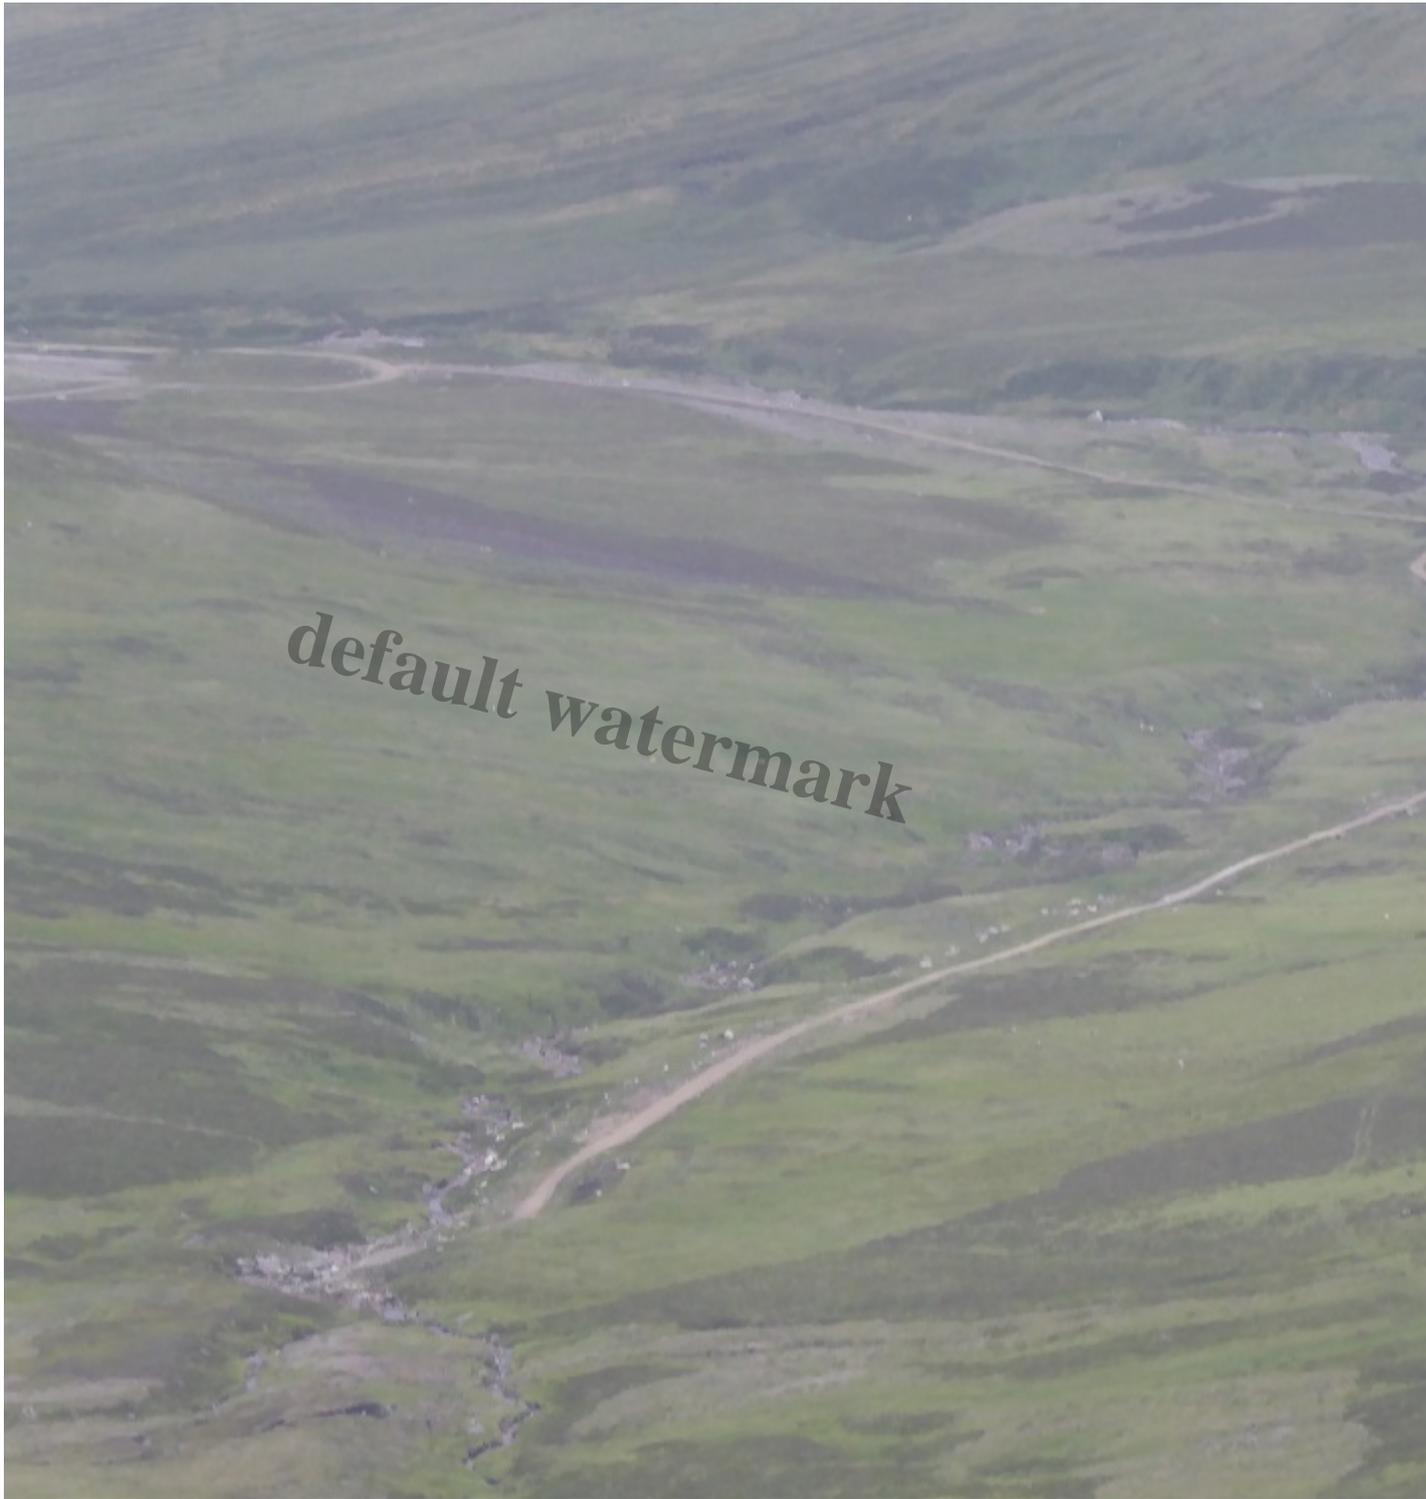
Another view down on the Kilbo access road taken from summit of Mayar through telephoto lens Jun

Even in 2016 it was very hard to see the line of the buried pipeline. That has been done very well, including where it crosses back under the burn, and was constructed without using new imported materials. While the vegetation by the road has recovered further since this photo, the problem is that a new road has been created. As the photos shows its far too wide and straight.

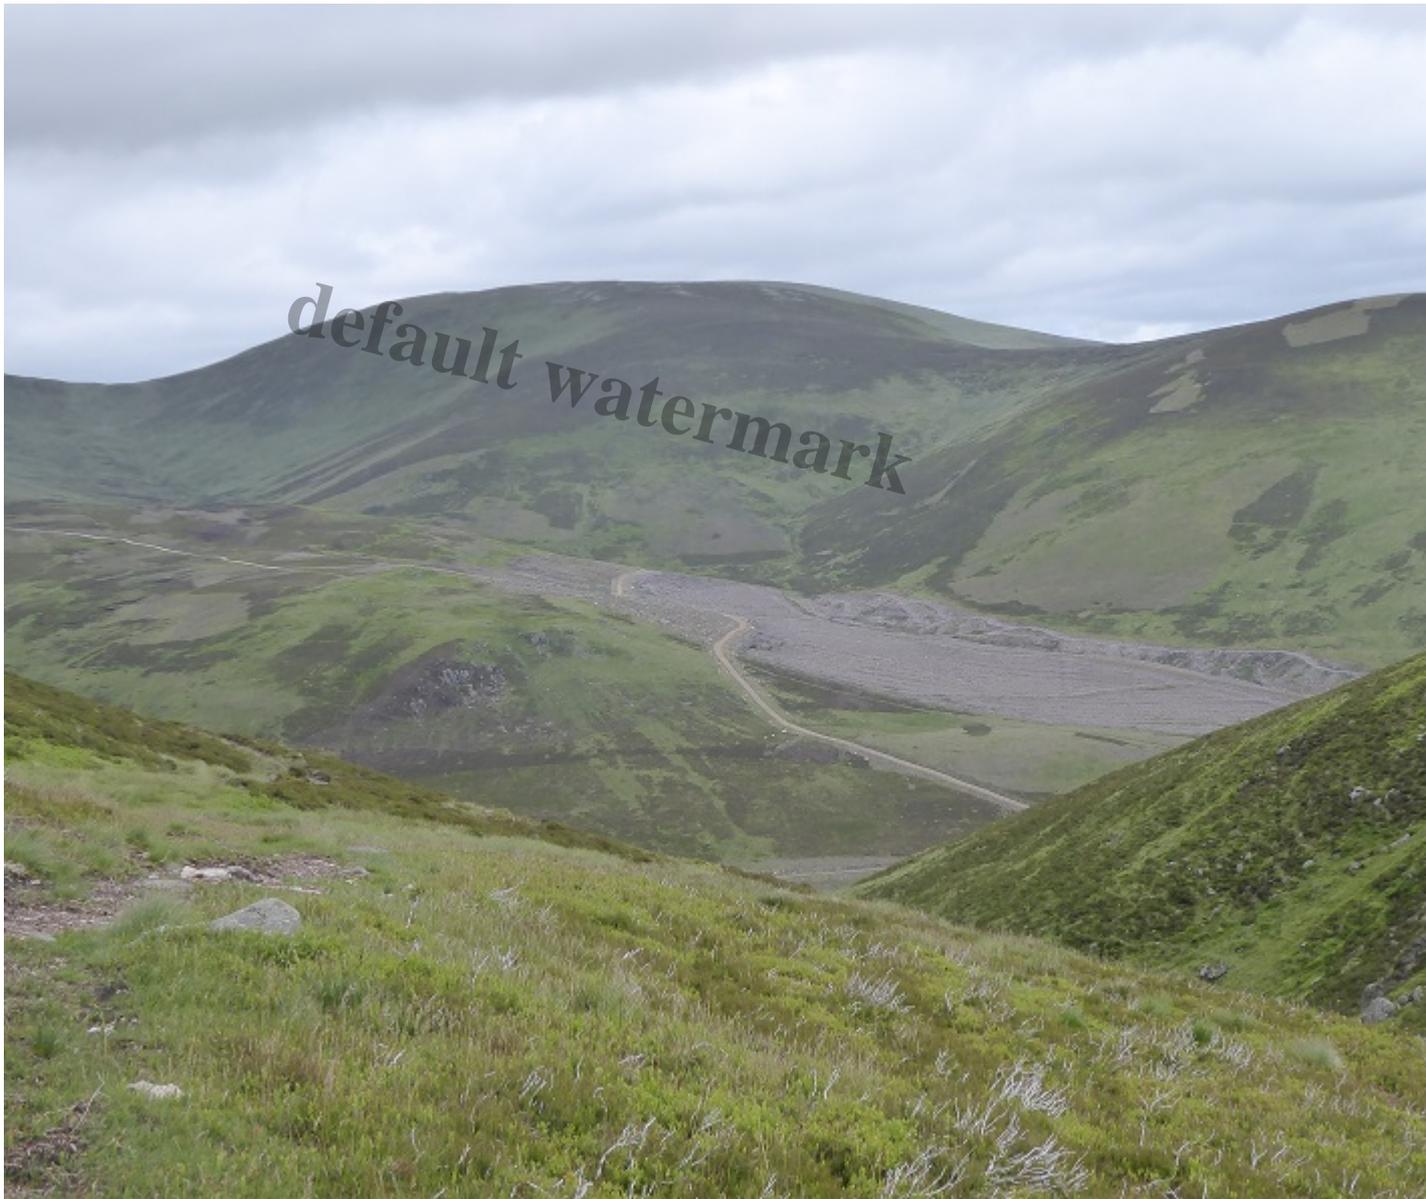
The road to the Kilbo intake below Driesh with the unlawful new grouse moor track visible to the left.

Part of the reason the Kilbo road is so visible is it takes a high line across the hillside.

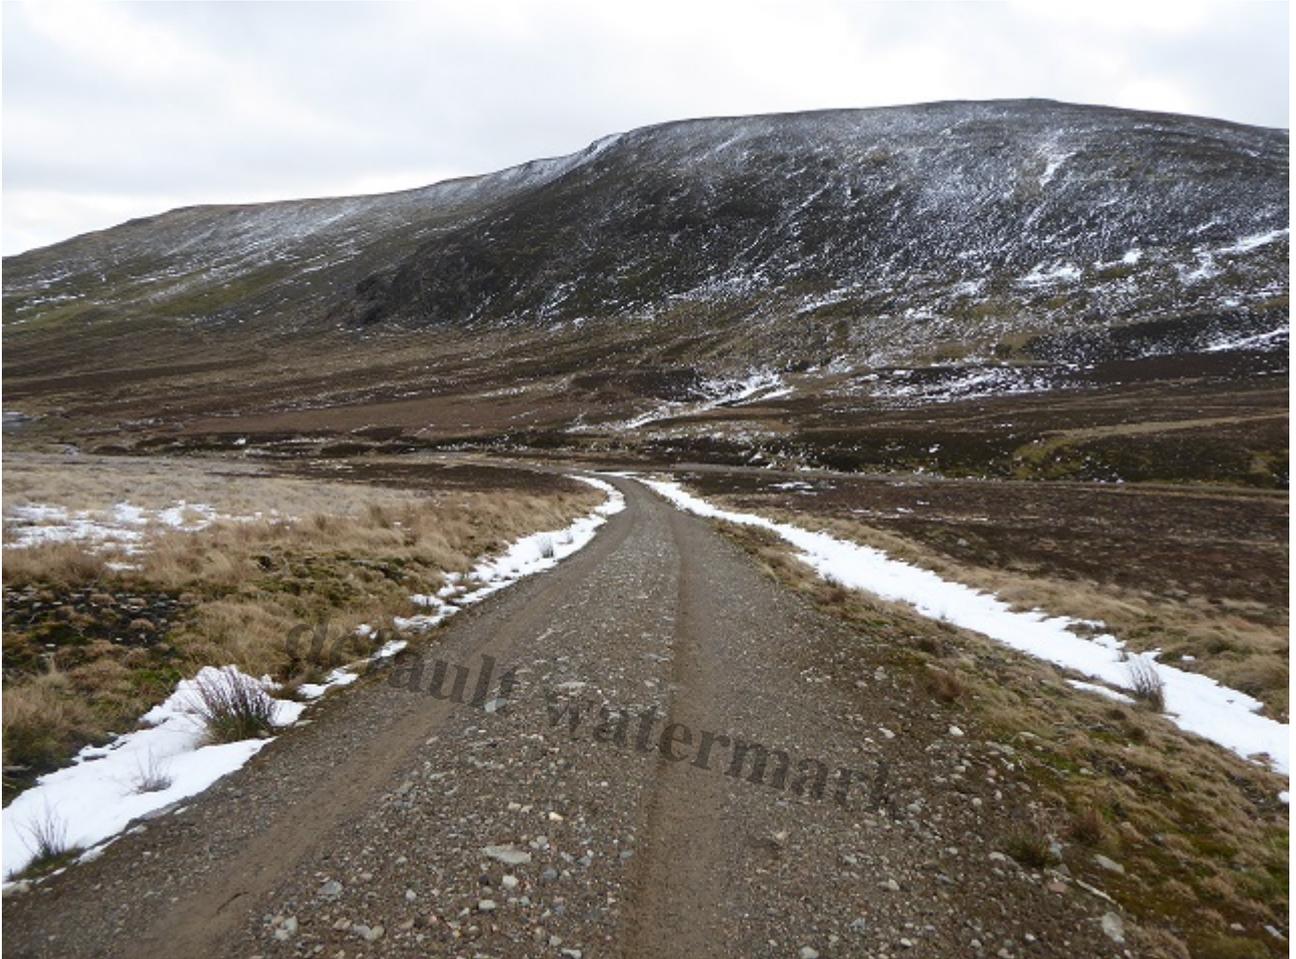
Looking down the Kilbo road towards the hydro road junction showing how it has been raised above the surrounding ground

Couple the line with the width of the road and the way its been raised above the surrounding ground and you have a highly prominent landscape scar.

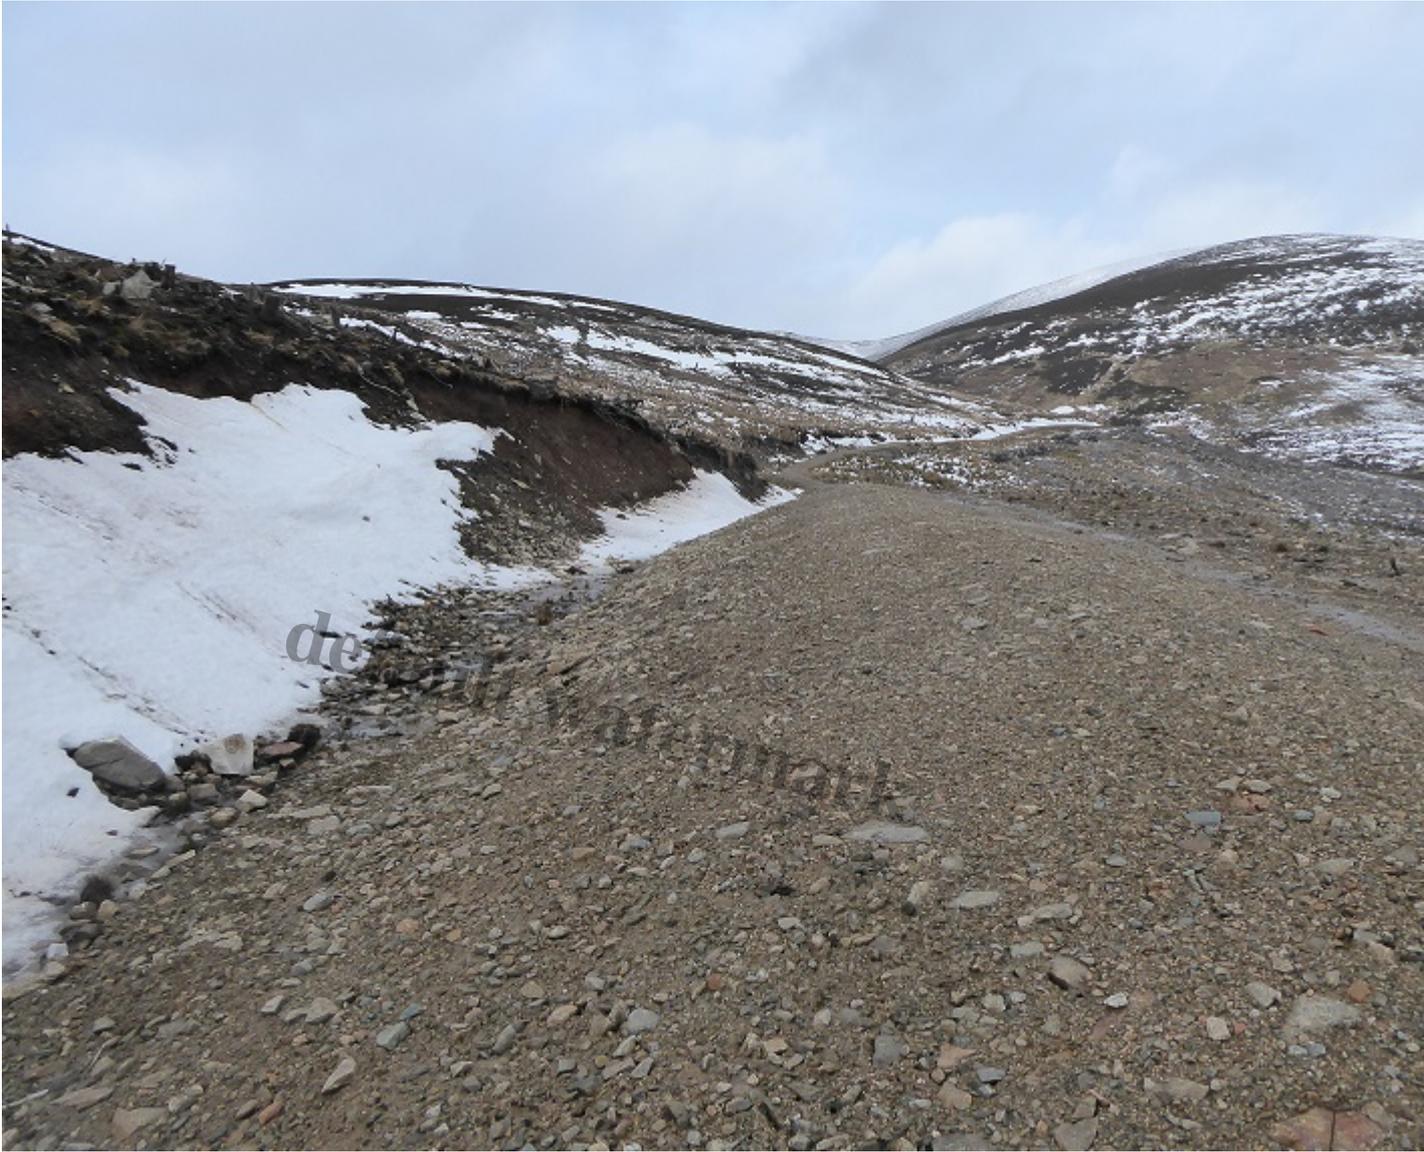
View up towards the Mayar intake from just above the junction with the new grouse moor road. The of the road is so steeply sloping on both sides that it would be difficult to drive a vehicle along

Prior to the construction of the hydro scheme, the Kingâ??s Seat forestry planation (as shown on map above) was felled. Forest roads donâ??t need planning approval but come under the Prior Notification system and part of the reason for this terrible section of track would appear to be that it was constructed to forestry specifications. These allow wider roads for felling than the 4m construction track agreed by the CNPA. However, whatever the origins, this road has been used to construct the hydro scheme and the CNPA required this to be reduce in width to 1m.

One might have hoped that, given the disgraceful state of the upper part of the Kilbo Road that the CNPA would have taken prompt enforcement action. I will now be asking them to do so for both hydro tracks.

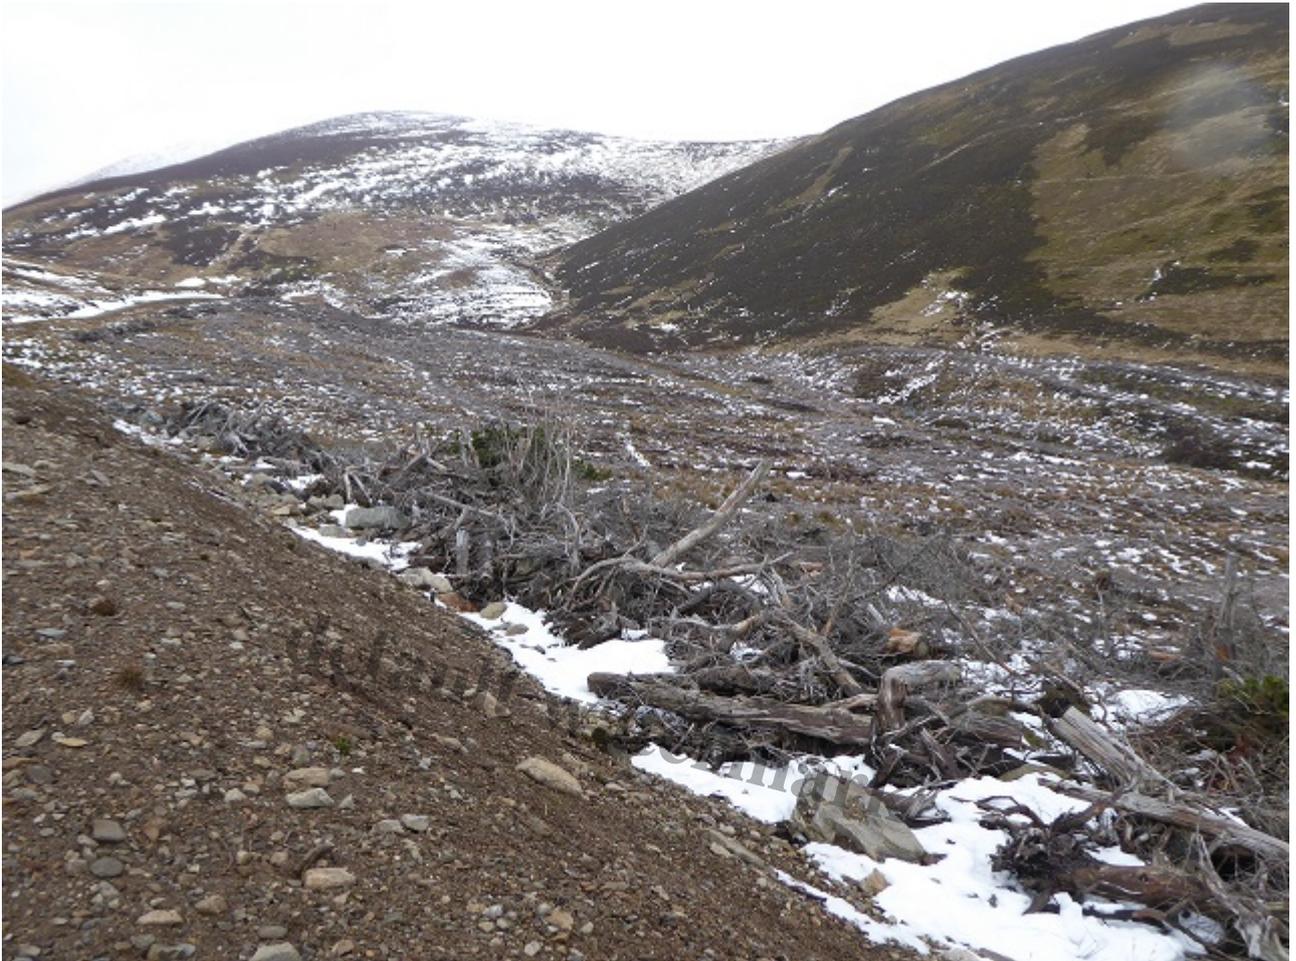
Close up of downhill side of cutting

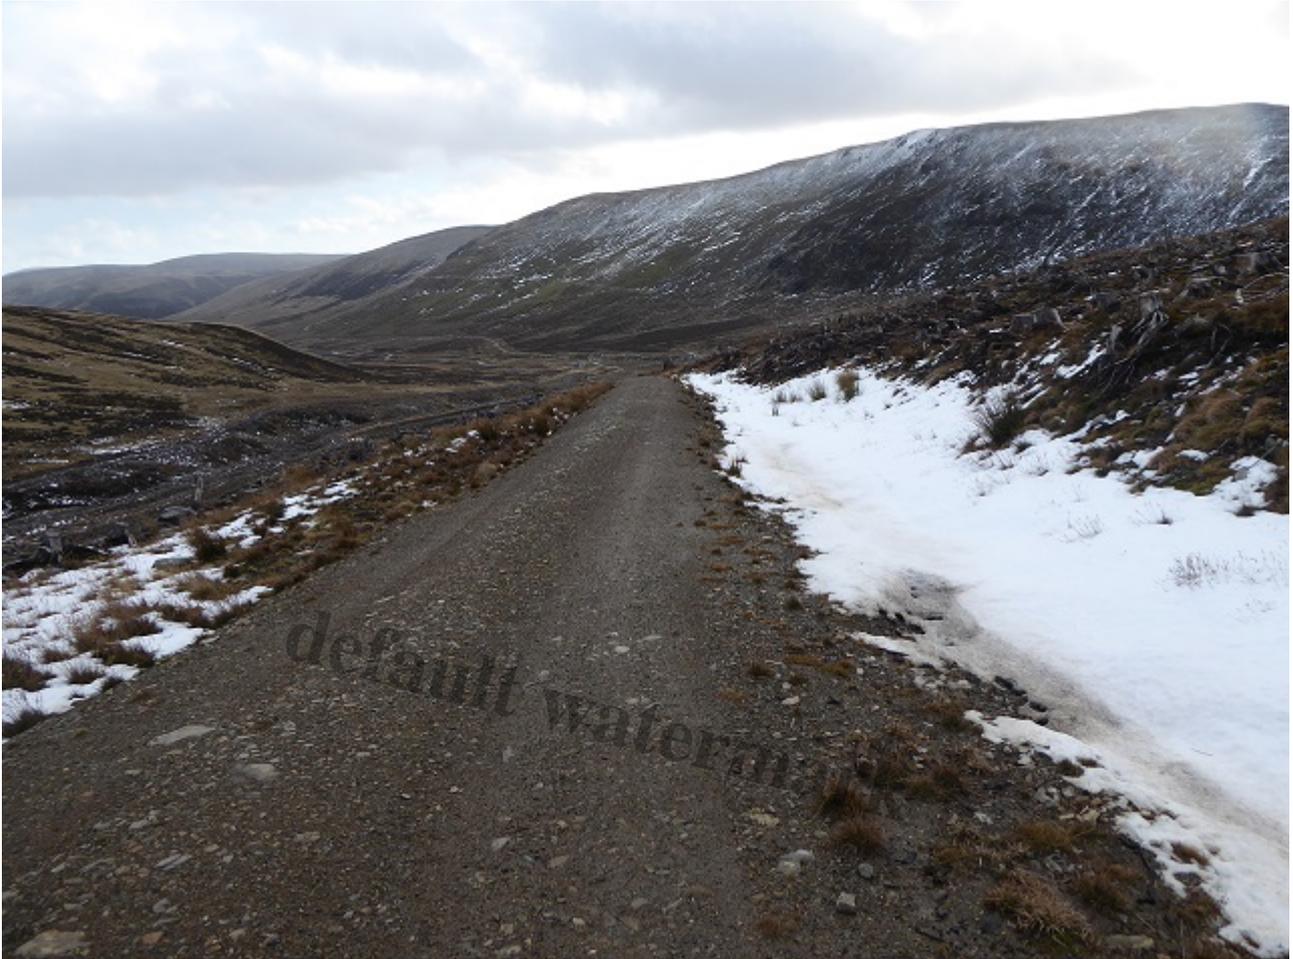
Looking down the first section of the new road, with the Kilbo hydro road visible below and two left and the old road to the head of Glen Prosen in the background beyond

It appears that the Glen Prosen Estate has used the hydro scheme construction tracks as an opportunity to construct a new road up Cairn Dye. This appears to have obliterated the historic Kilbo Path and means that there are now not just two but three hill roads within one small area at the head of the glen. There is no planning application for this and the road is not listed under those that have been developed under the Prior Notification scheme. It therefore appears unlawful.

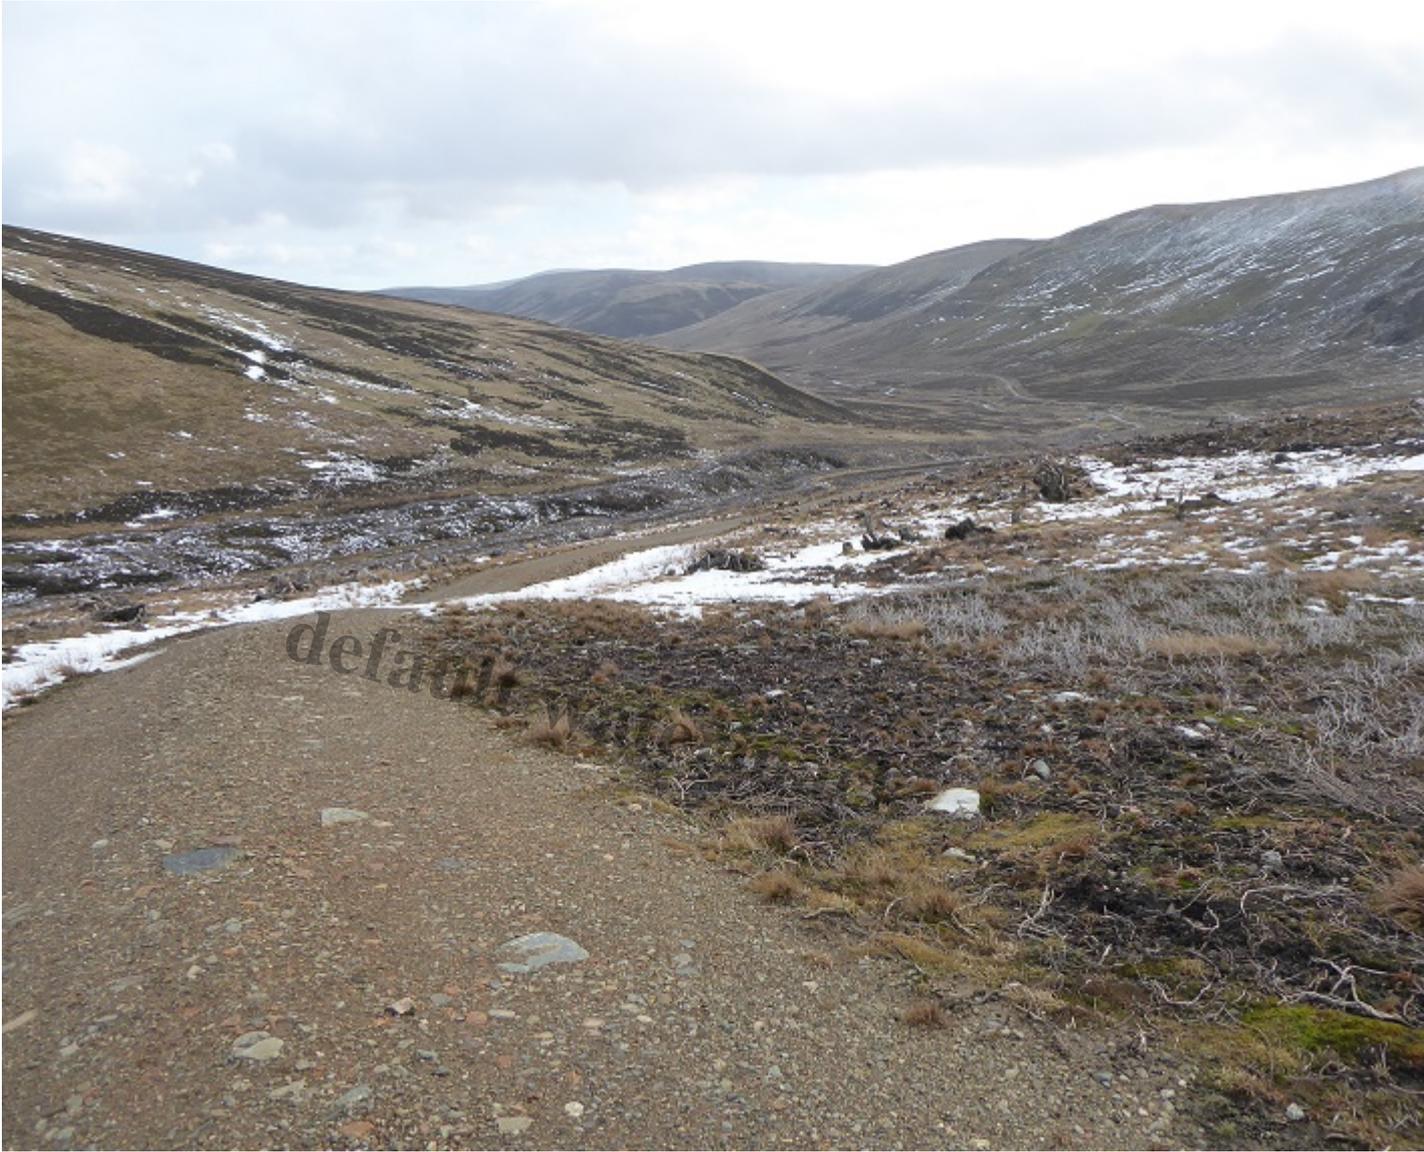
Muirburn by side of road just above forest plantation

Its symptomatic of current inconsistencies in our approach to land-use that the ground here is being damaged by muirburn when along the Kilbo Burn the CNPA made this requirement for the hydro scheme:

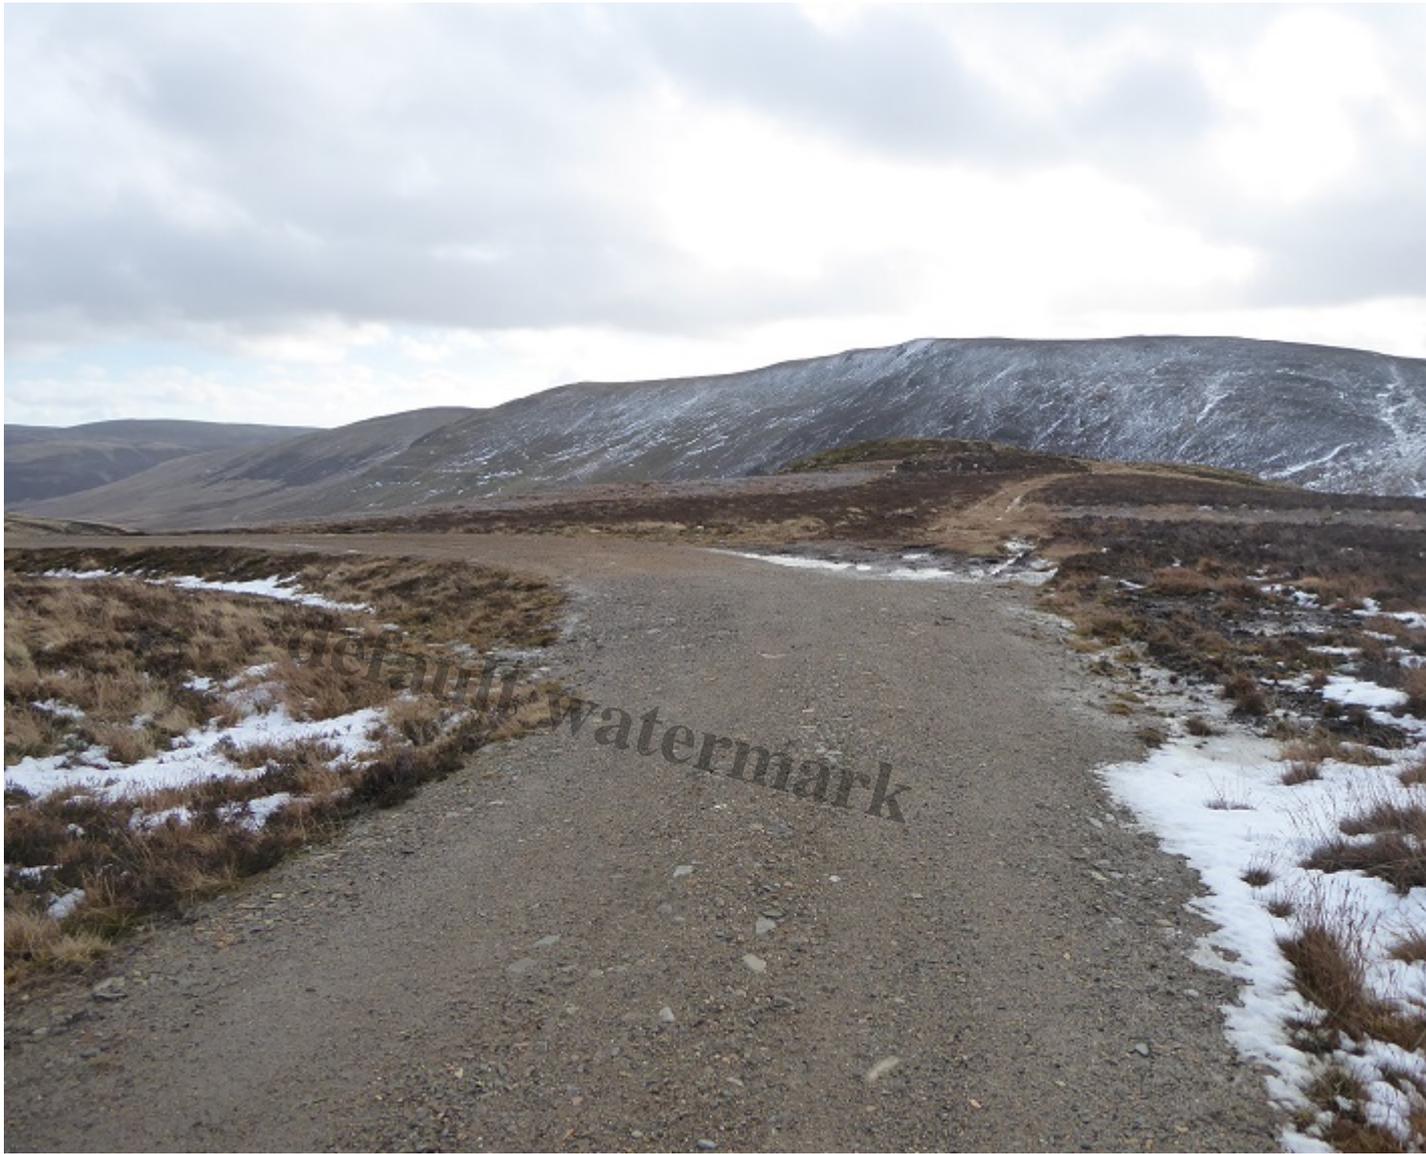
On Cairn Dye, looking south, with former landrover track clearly visible

The estate appears to have driven vehicles here for many years but they took a different less steep route up onto Cairn Dye and that old route had far less landscape impact.

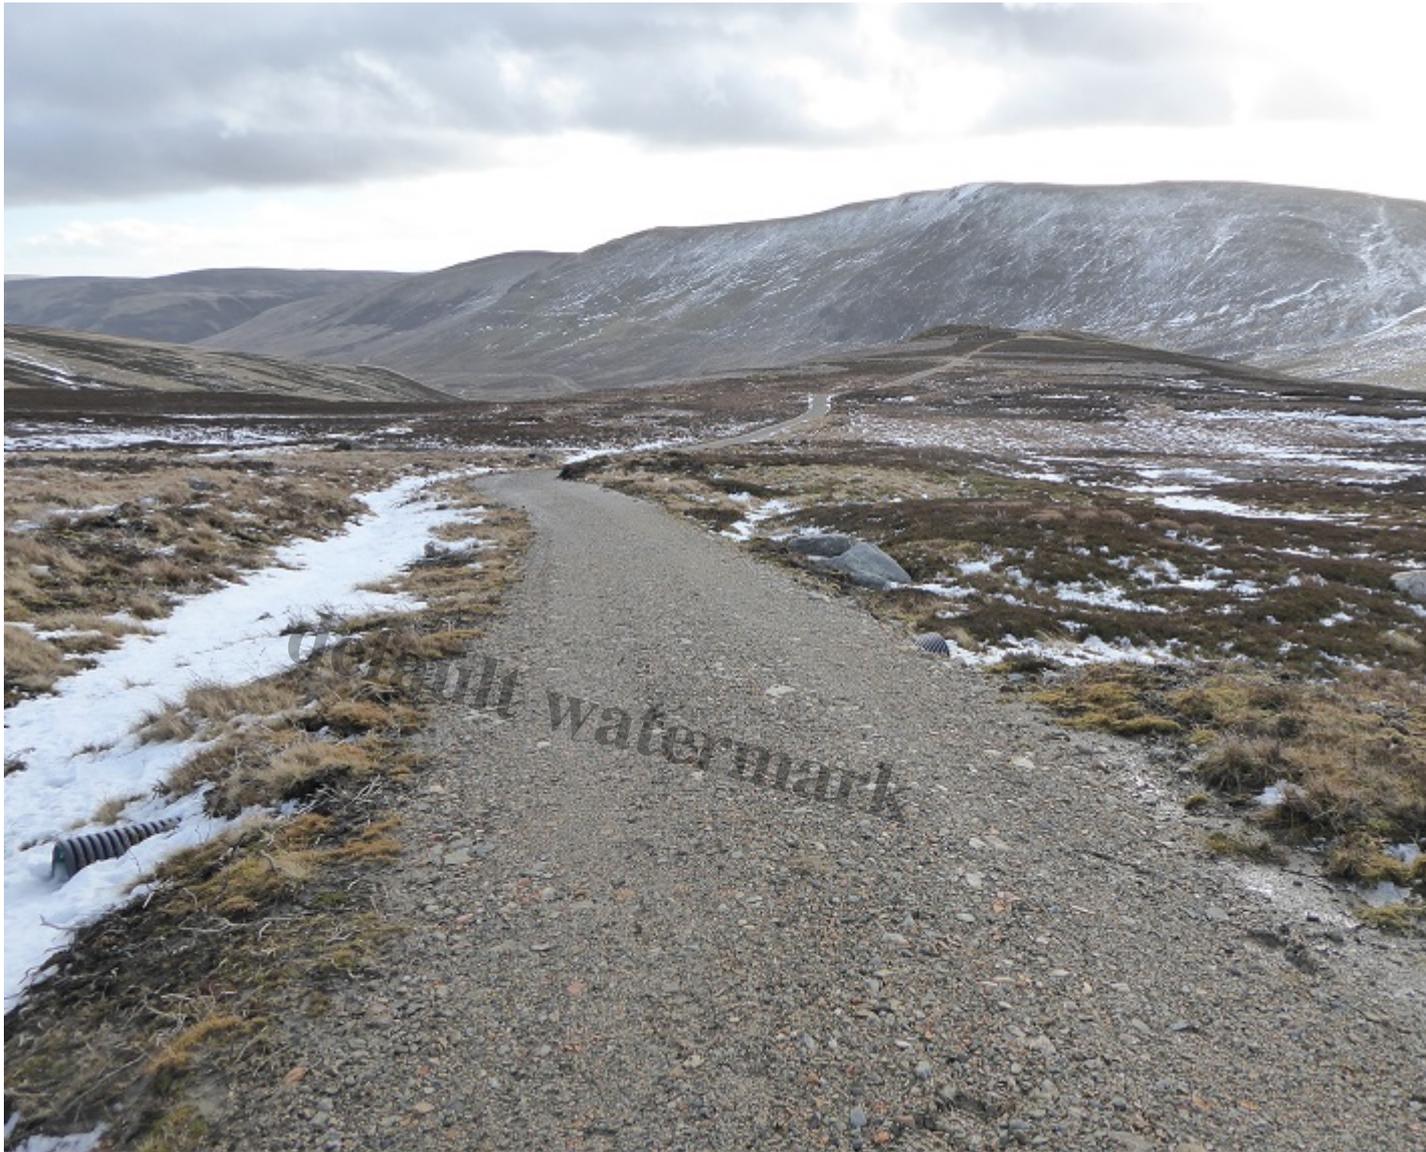
Looking down the new road along the Glen Dye ridge – note the plastic culvert left indicating the completion of construction that has taken place

The road is far far wider than that consented for the hydro roads and there is now no sign of the green central strip that the CNPA now regards as good practice for landrover tracks.
