The hill and hydro roads disaster at the head of Glen Prosen

The landscape impact of the two new hydro roads

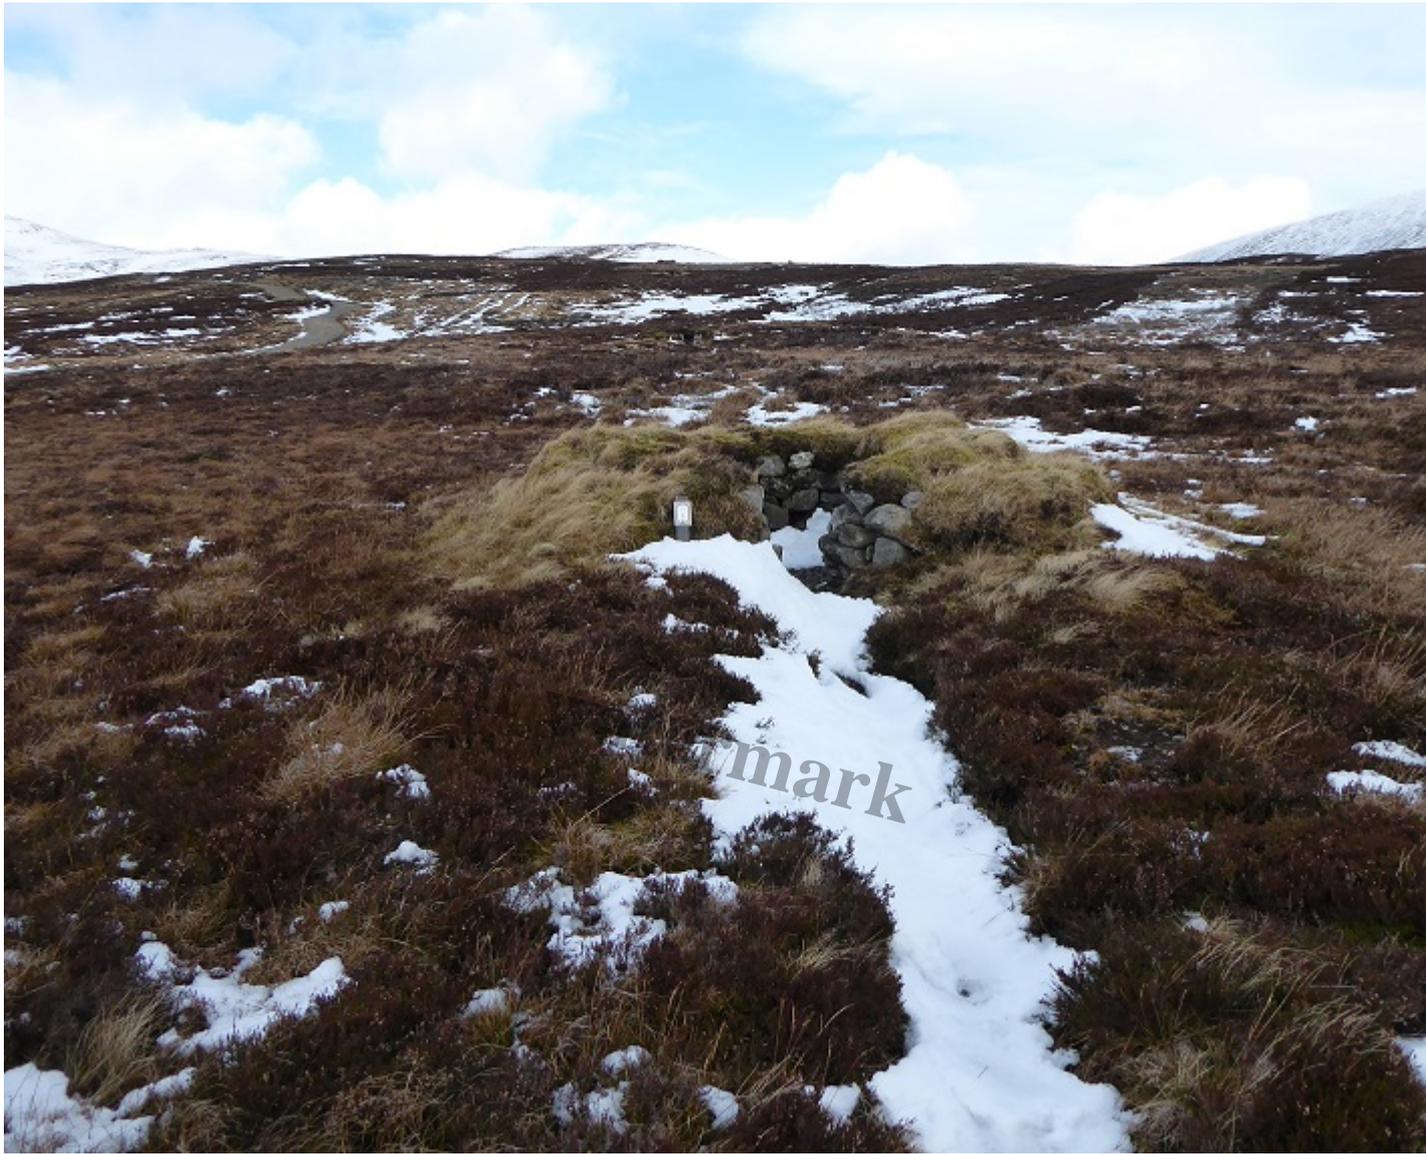
Grouse butt access road on left, further butts beyond

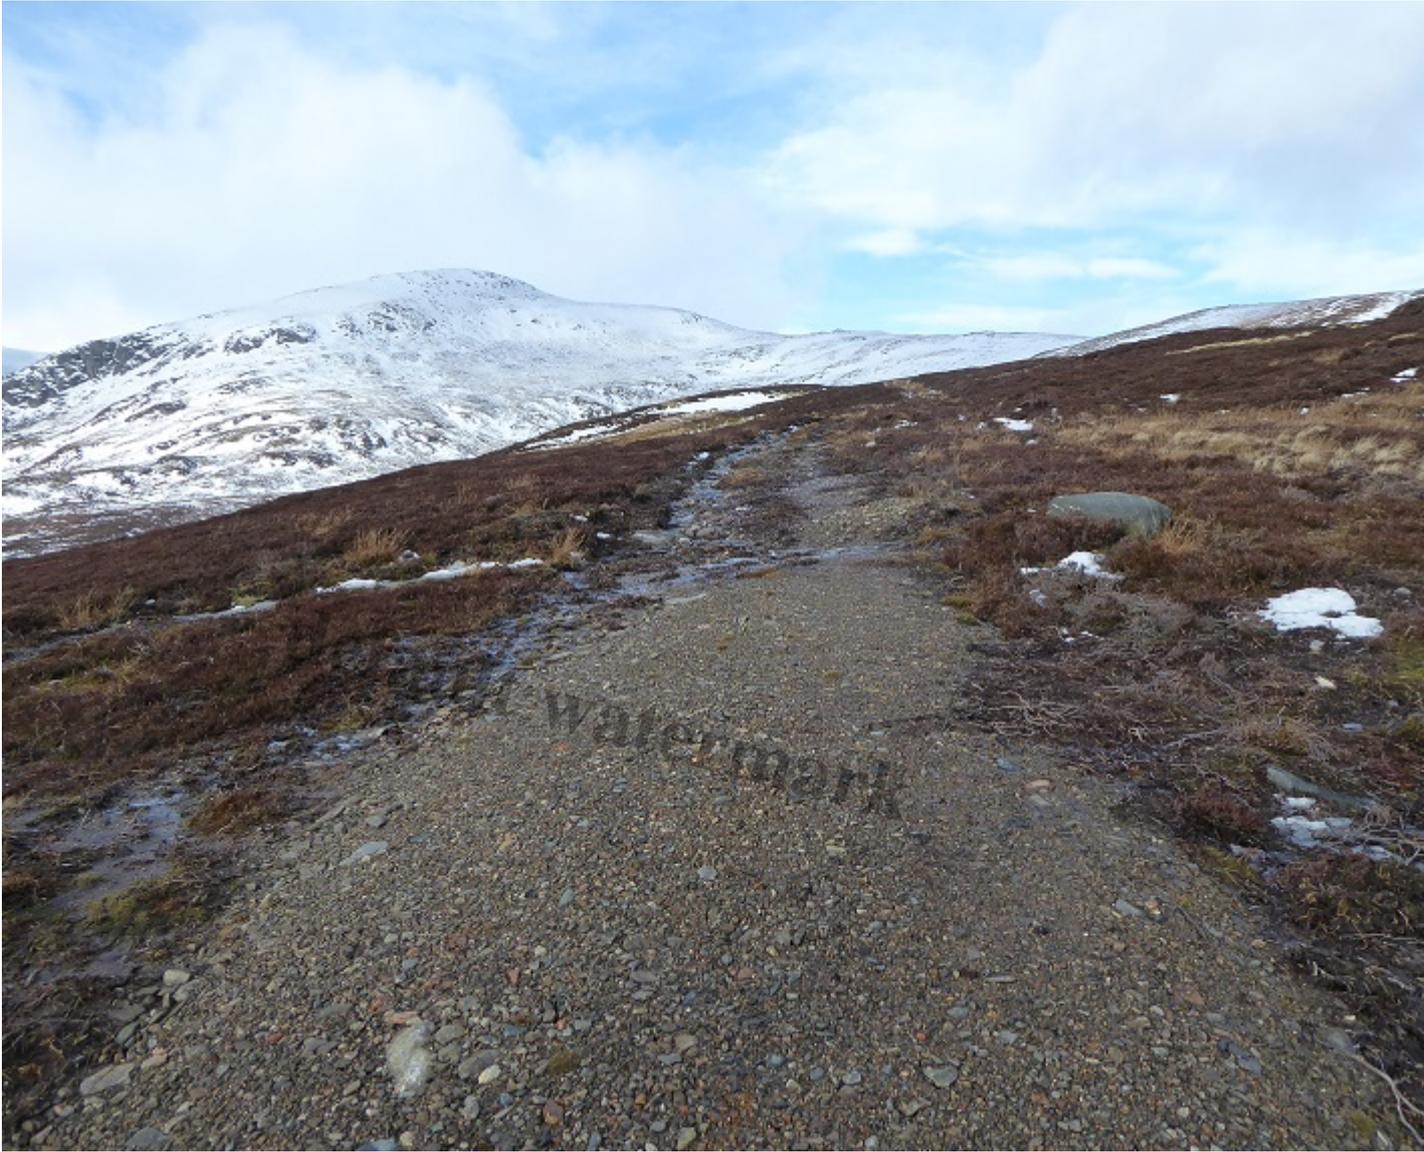
End of the new road, Mayar beyond. The landrover track continues on up towards the Mayar-Driesh

The landscape impact of the landrover track is far less than the new road because it is narrower and restricted to tyre lines so effectively has a vegetated strip down the middle:

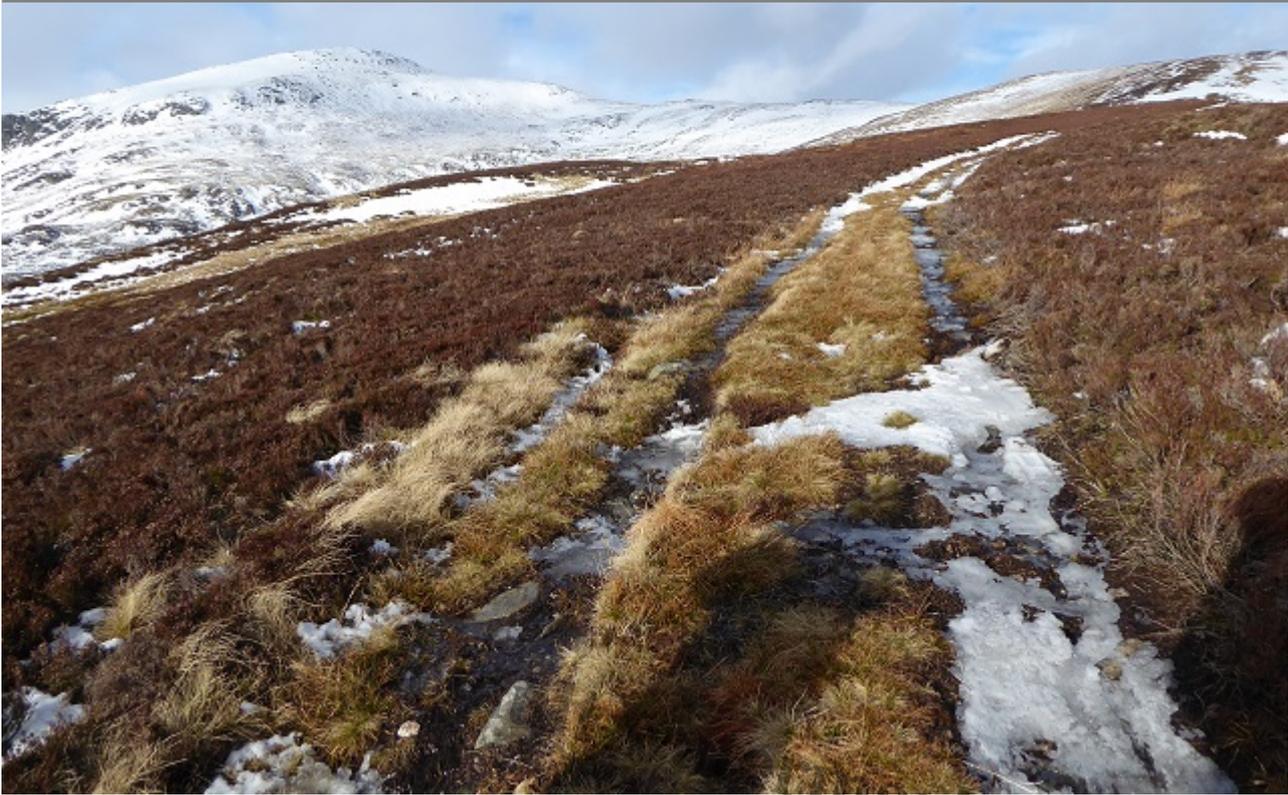
The vehicle

use has however clearly impacted on the vegetation, converting heather to grasses, thus forming a line across the landscape. This illustrates why footpaths generally have less landscape impact and are preferable to roads with green strips down the middle. If the Glen Prosen Estate accepted 1m wide tracks for quad bike use below it's hard to see how they can justify using any other vehicles here.

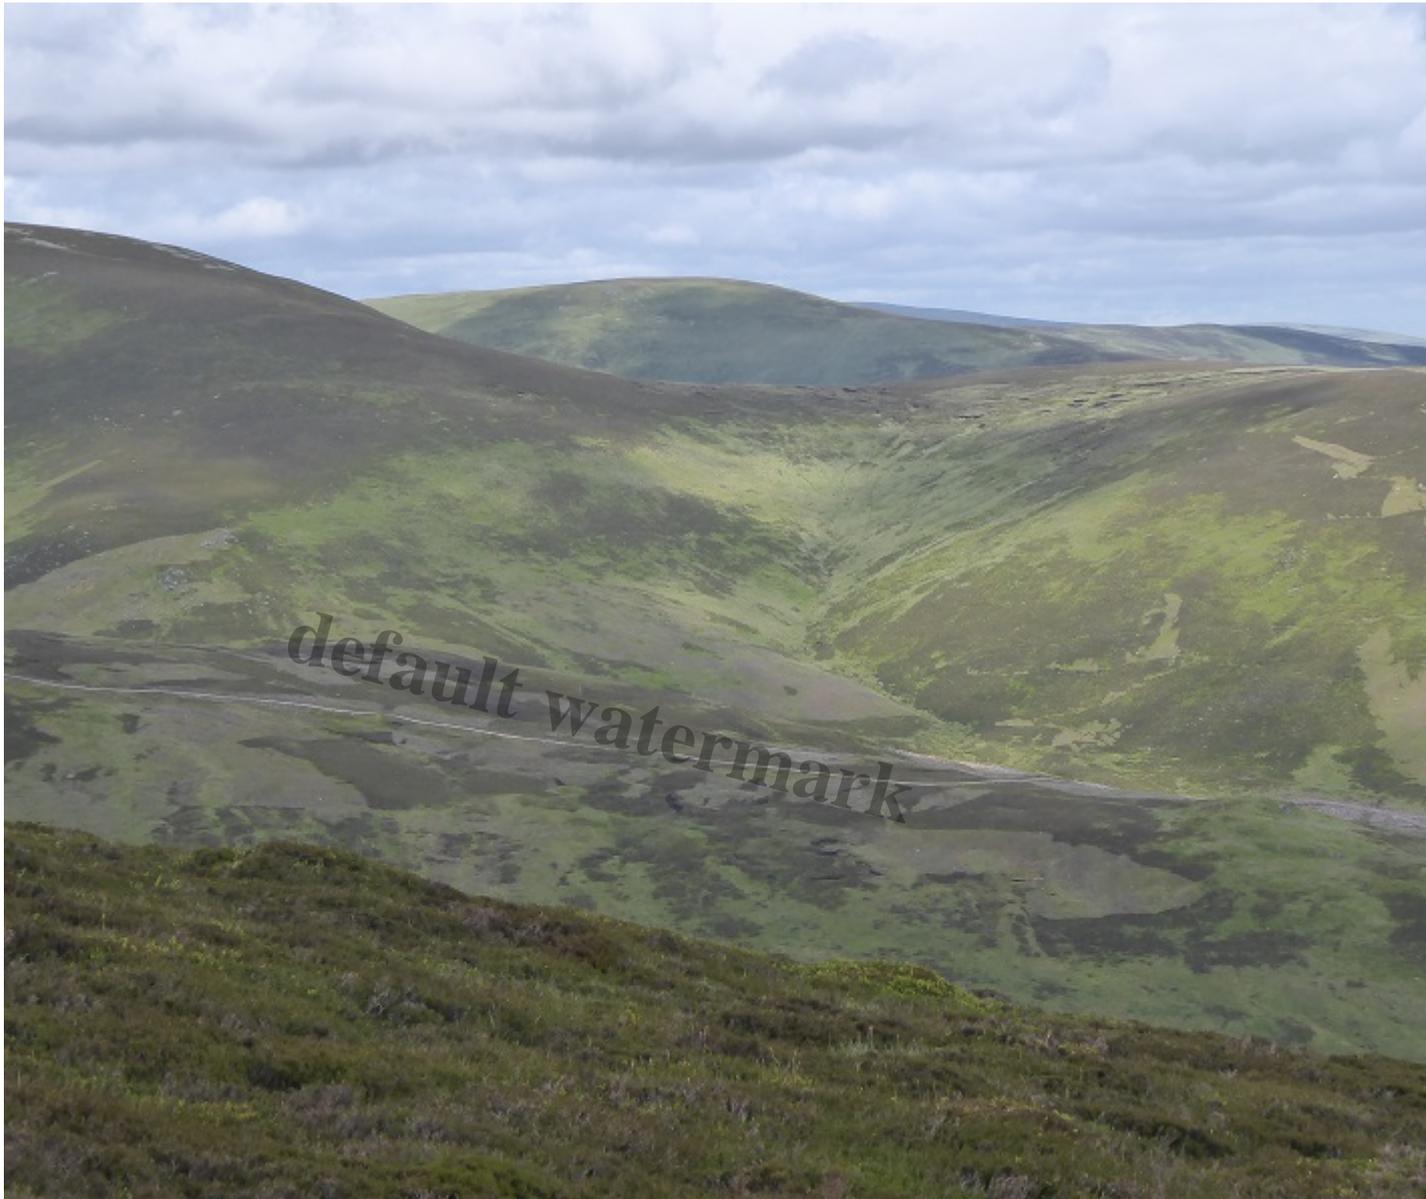
The Cairn Dye road viewed from Bawhelps June 2006 with Hunt Hill (on right) and Little Driesh (on left). The hydro roads are tucked into glens on either side and not visible from this particular viewpoint.

The consequences for the landscape have been significant and the track is highly visible from the high ground around the head of the glen. With two hydro roads in place on either side there can be no justification for this road. The upper part is also within the Lochnagar-Mt Keen Wild Land Area and seems likely to have been constructed after SNH's maps and descriptions of Wild Land Areas were published in 2014:

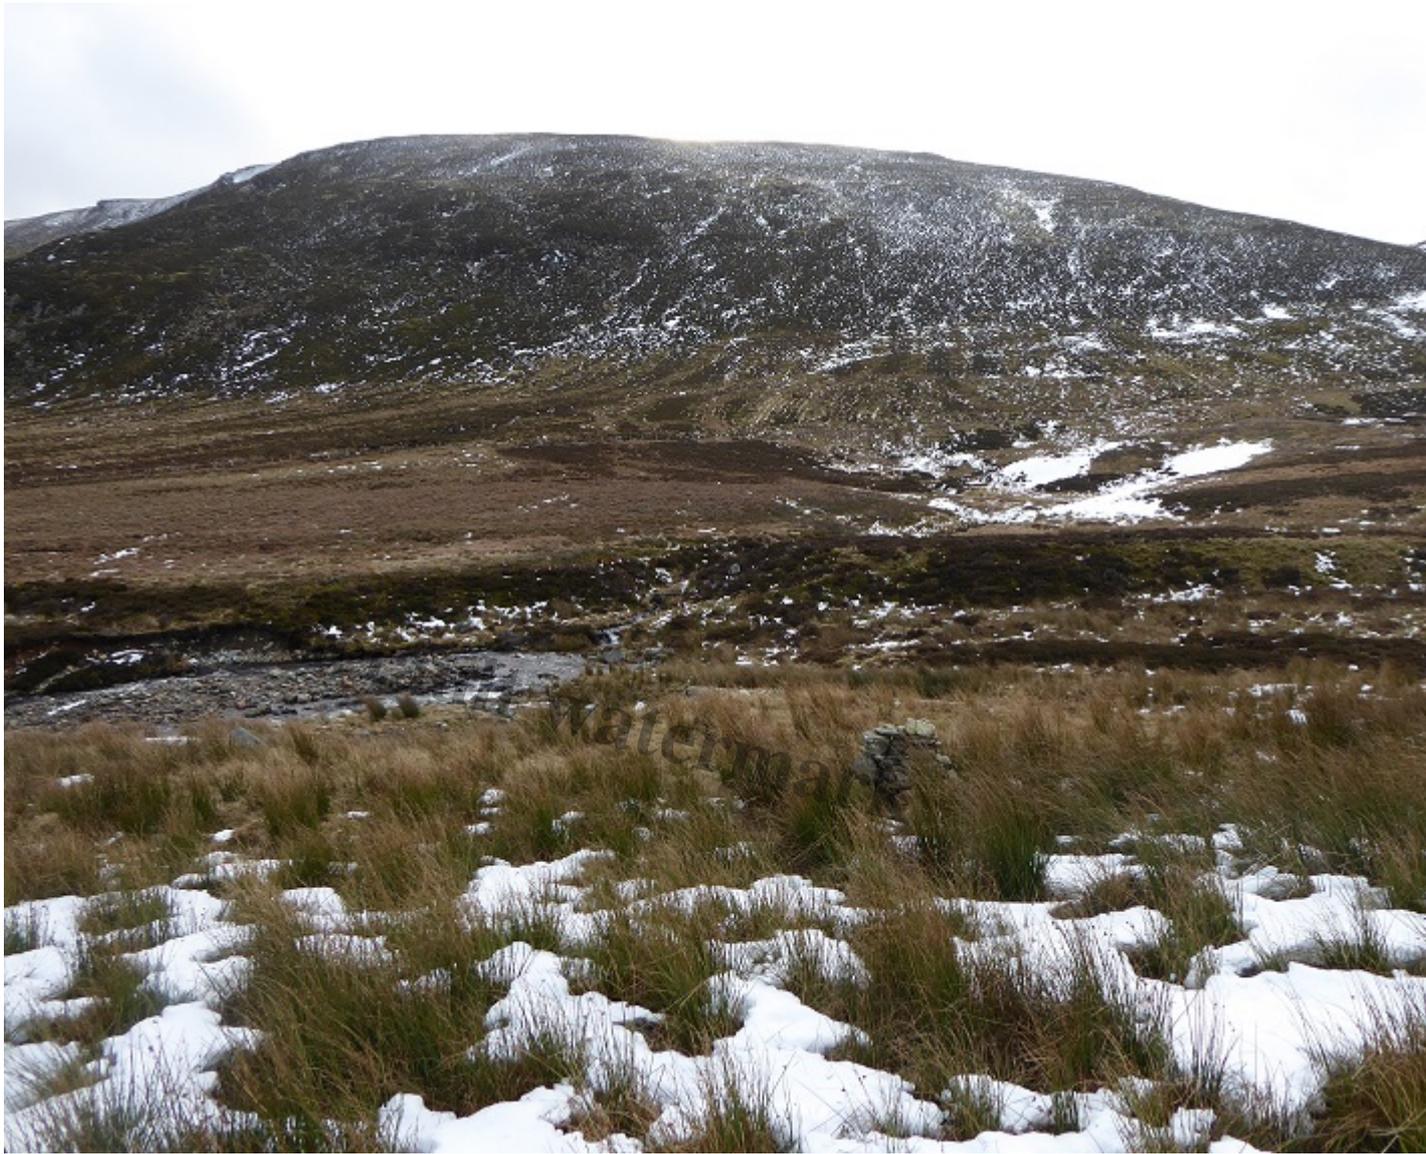
View of powerhouse from above â?? the cairn is presumably to alert people not to walk over the edge

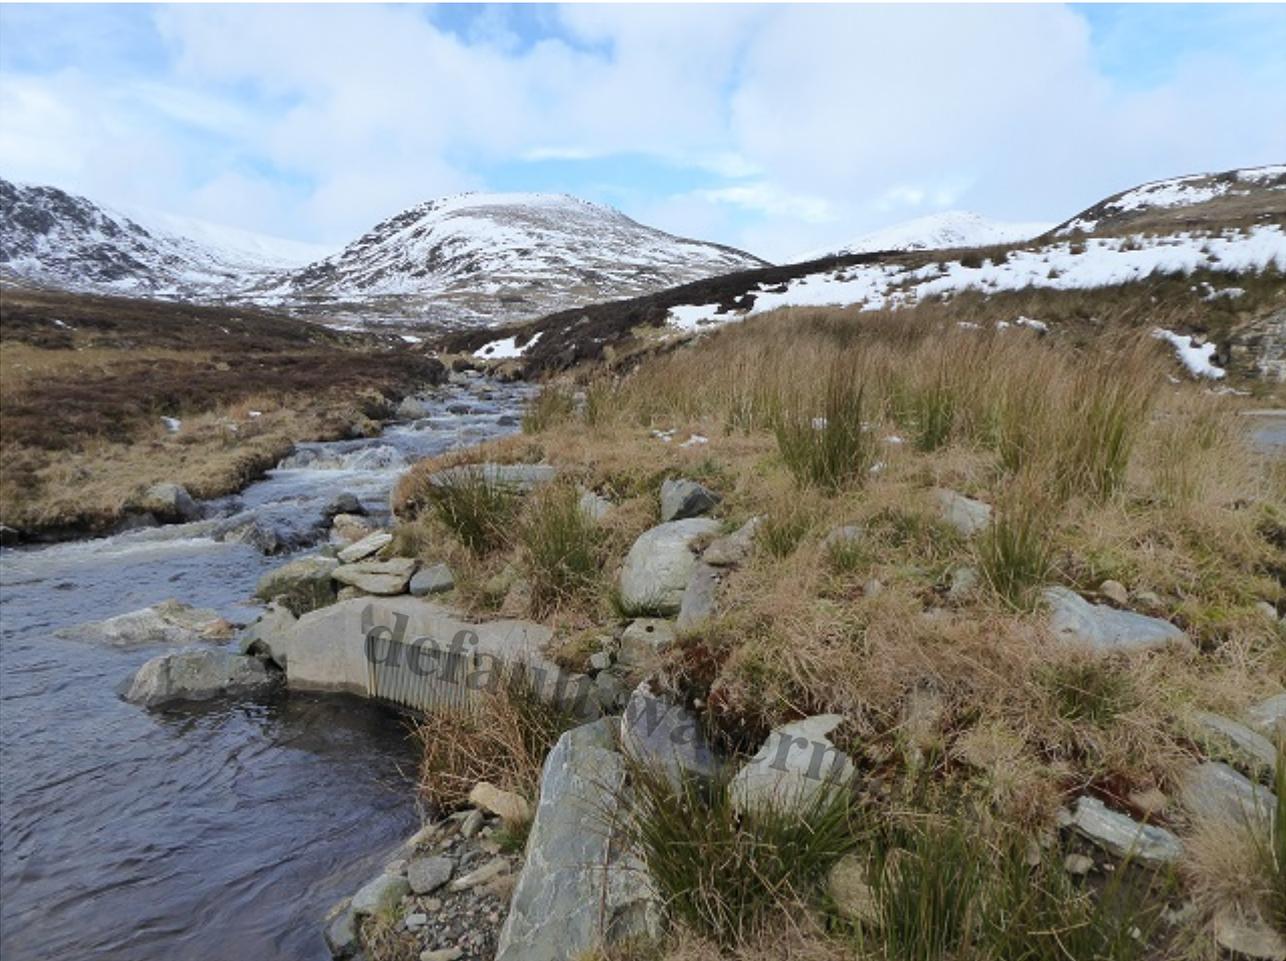
The outrace has been very sensitively landscaped

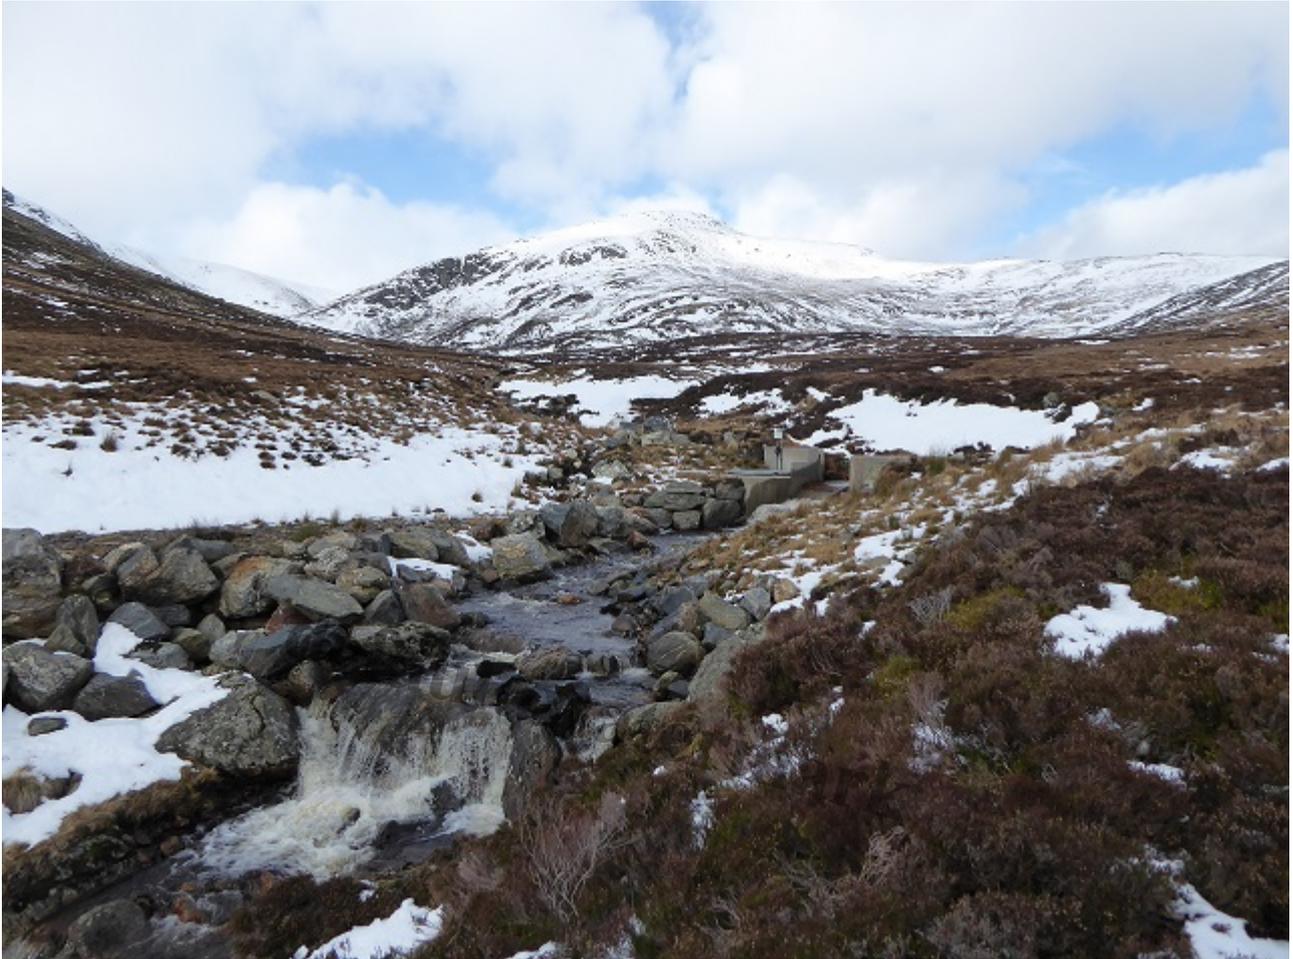
Mayar Intake with Mayar beyond

The Mayar intake is not just well located, it shows how rip rap bouldering to reinforce the sides of streams can be done sensitively so it appears almost natural (unlike the dreadful examples in Glen Falloch in the Loch Lomond and Trossachs National Park [\(see here for example\)](#)).
