## The hill and hydro roads disaster at the head of Glen Prosen

**The landscape impact of the two new hydro roads**

## **The new grouse moor track**

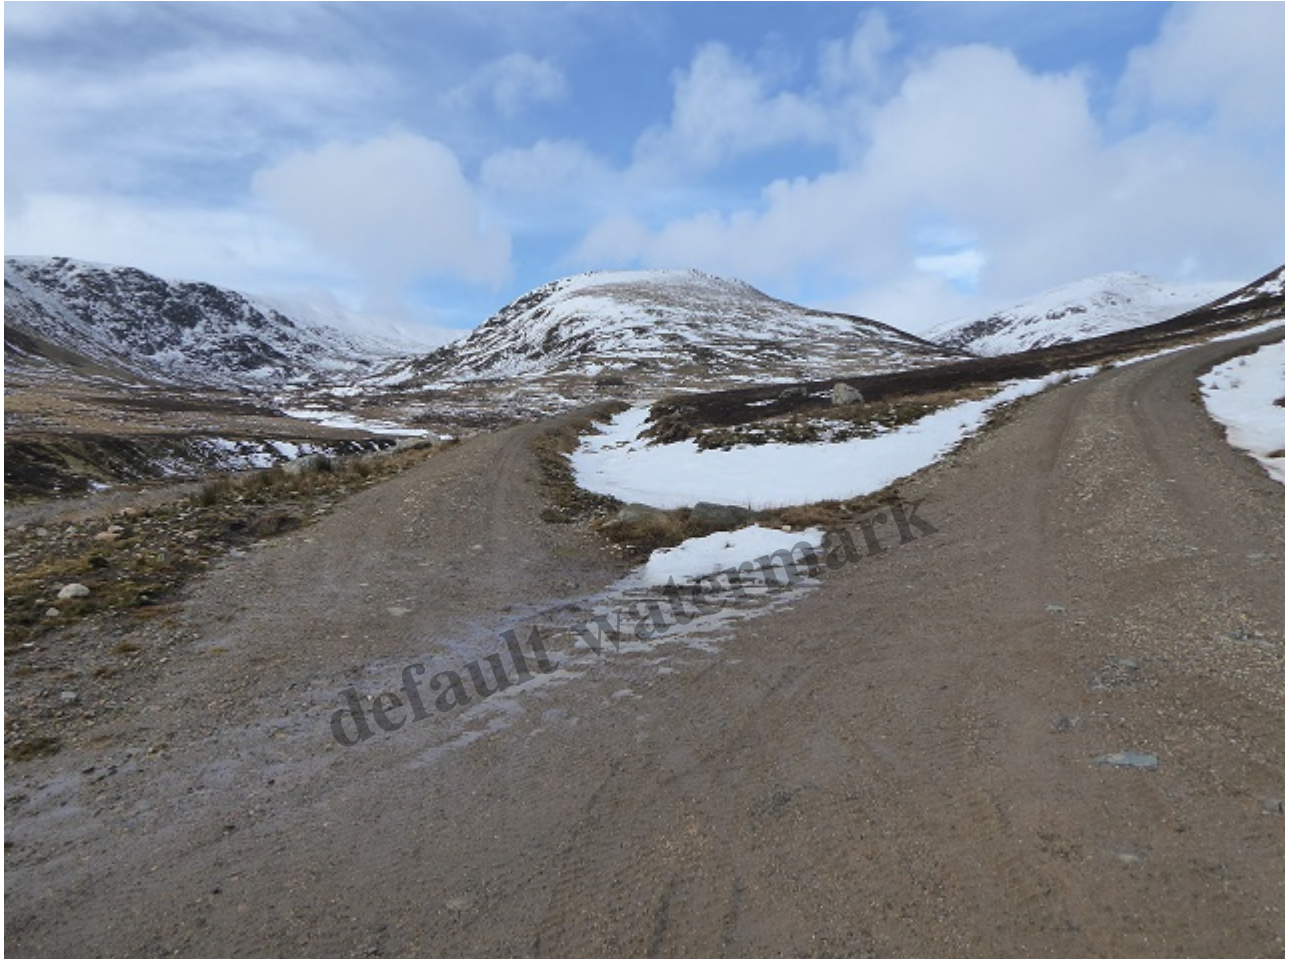
The fork in the roads above the powerhouse, the left to the Mayar intake and the right to the Kilbo intake.

Both roads are far wider than necessary for landrover use – as you can see from the tyre marks – let alone for quad bike or ATV use.

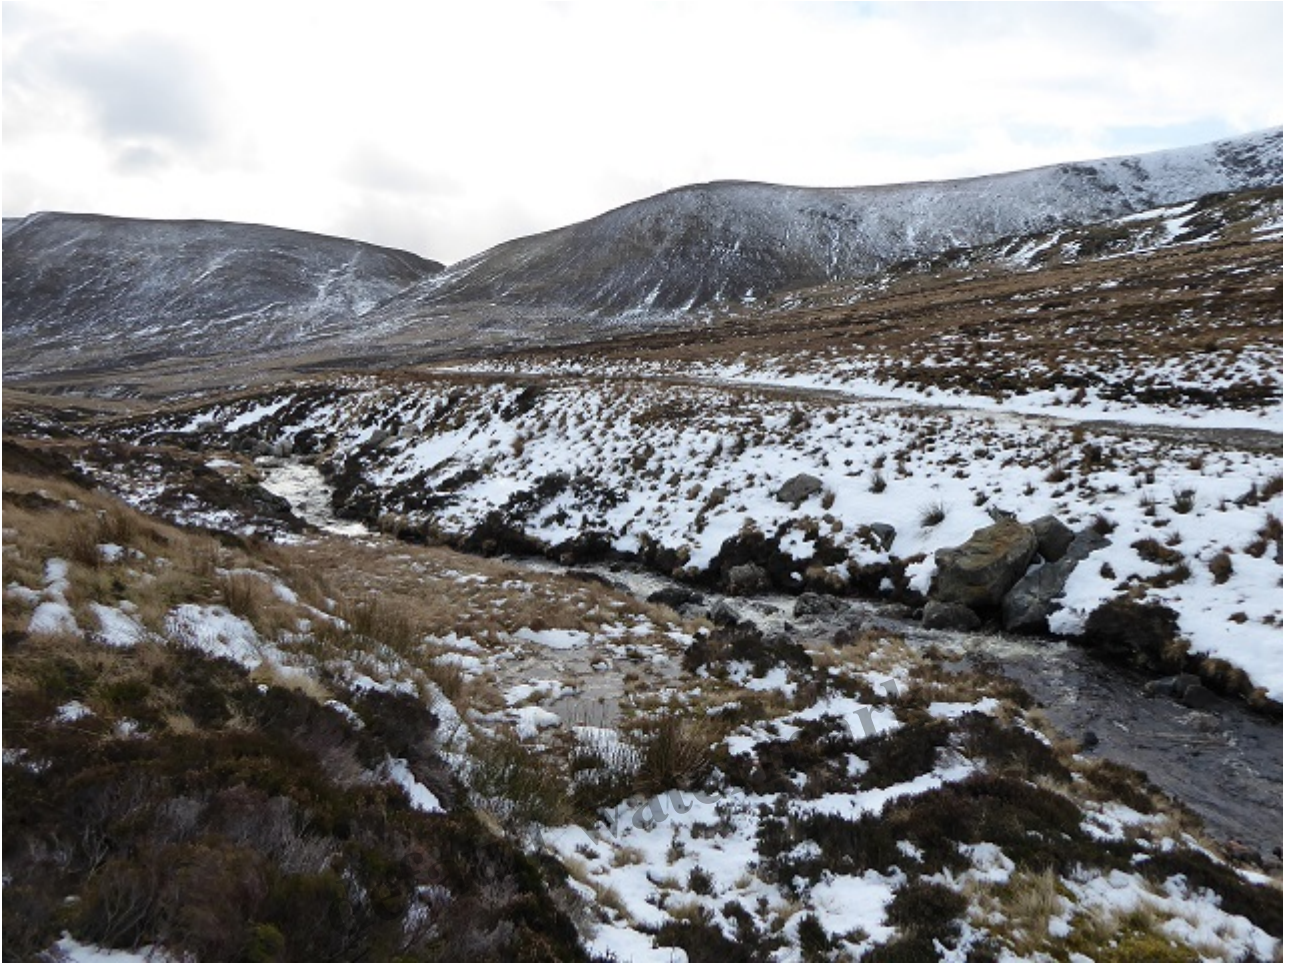
View of the road up to the Mayar intake above where it crosses the burn

This road is highly visible from various angles. Part of the problem is the excessive width. Had it been reduced to 1m width it would be far less visible. It also however forms a straight cut across the landscape, unlike most footpaths, and this accentuates the impact.

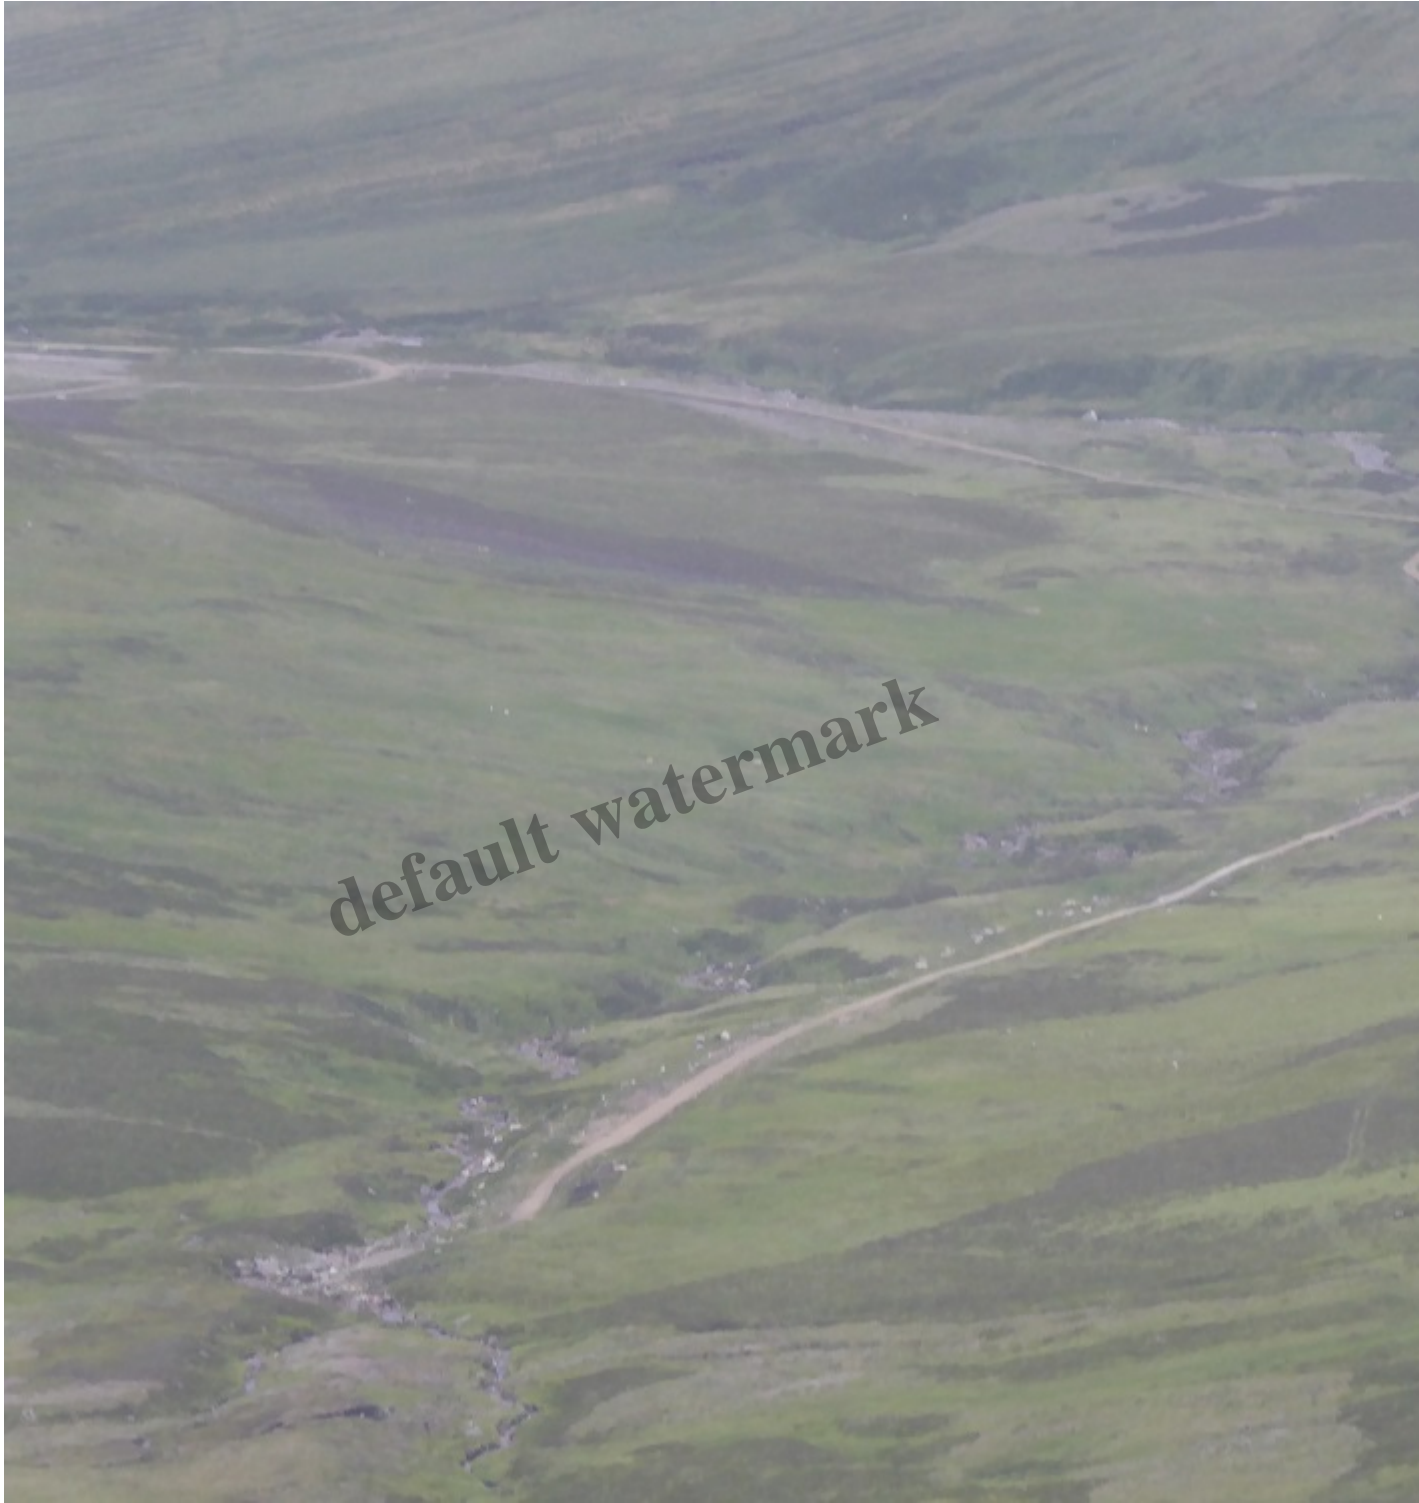
Another view down on the Kilbo access road taken from summit of Mayar through telephoto lens Jun

Even in 2016 it was very hard to see the line of the buried pipeline. That has been done very well, including where it crosses back under the burn, and was constructed without using new imported materials. While the vegetation by the road has recovered further since this photo, the problem is that a new road has been created. As the photos shows its far too wide and straight.

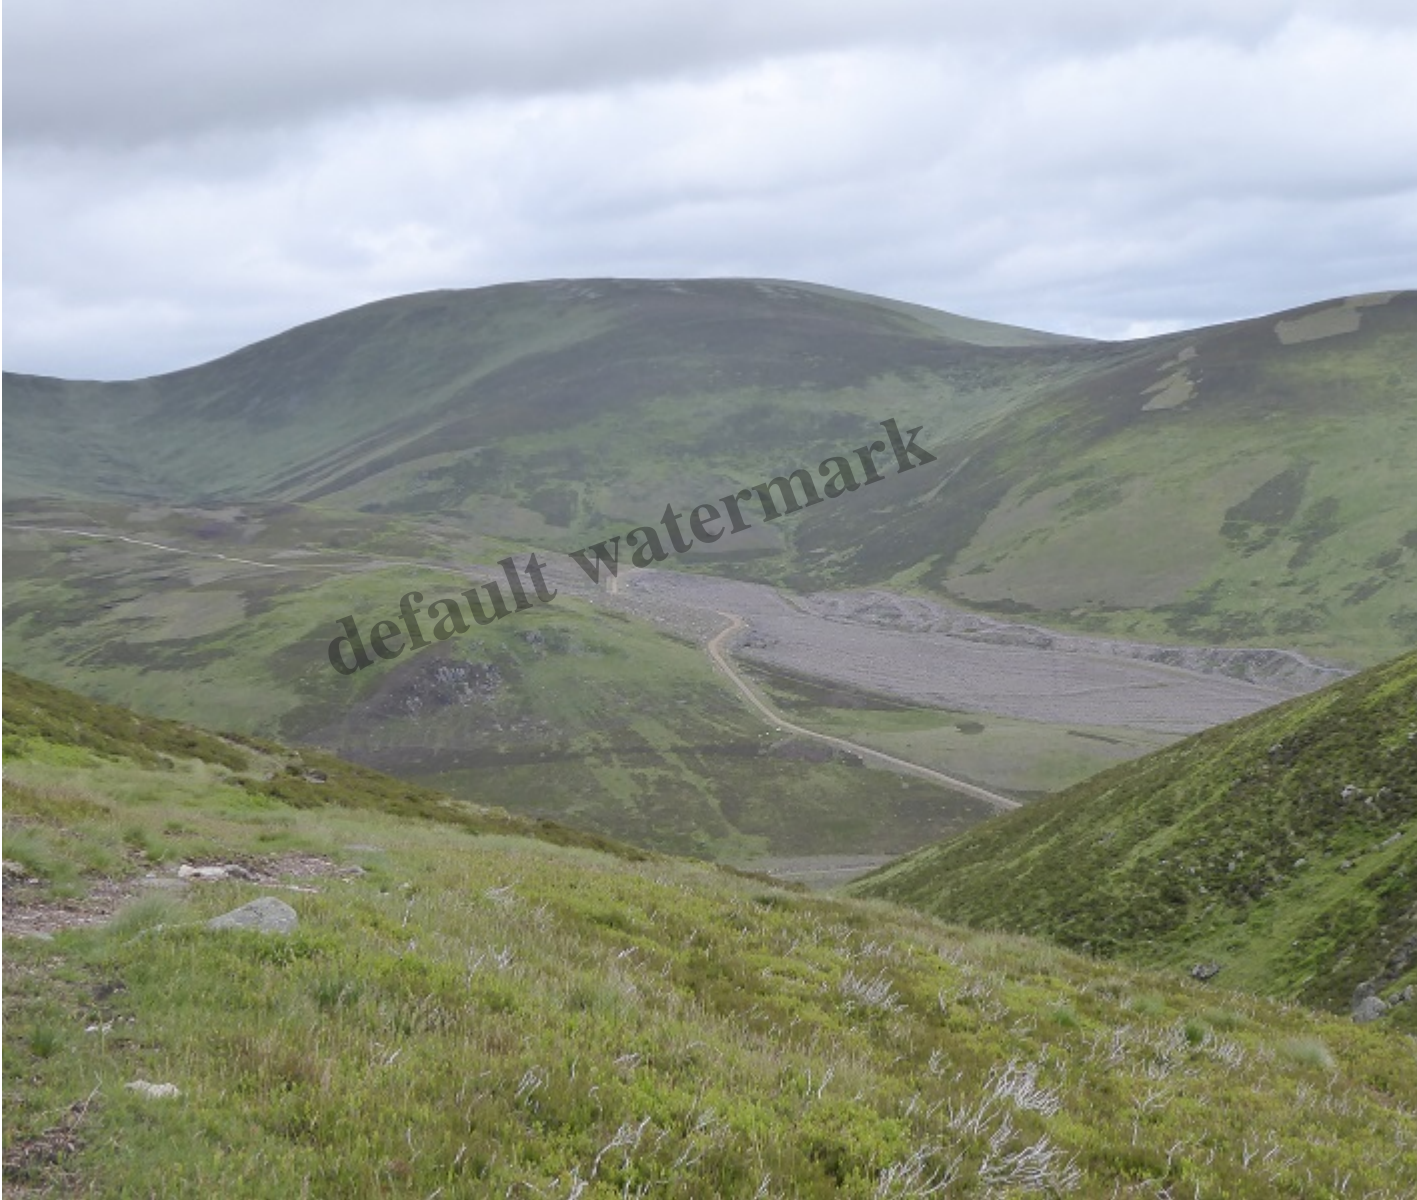
The road to the Kilbo intake below Driesh with the unlawful new grouse moor track visible to the left.

Part of the reason the Kilbo road is so visible is it takes a high line across the hillside.

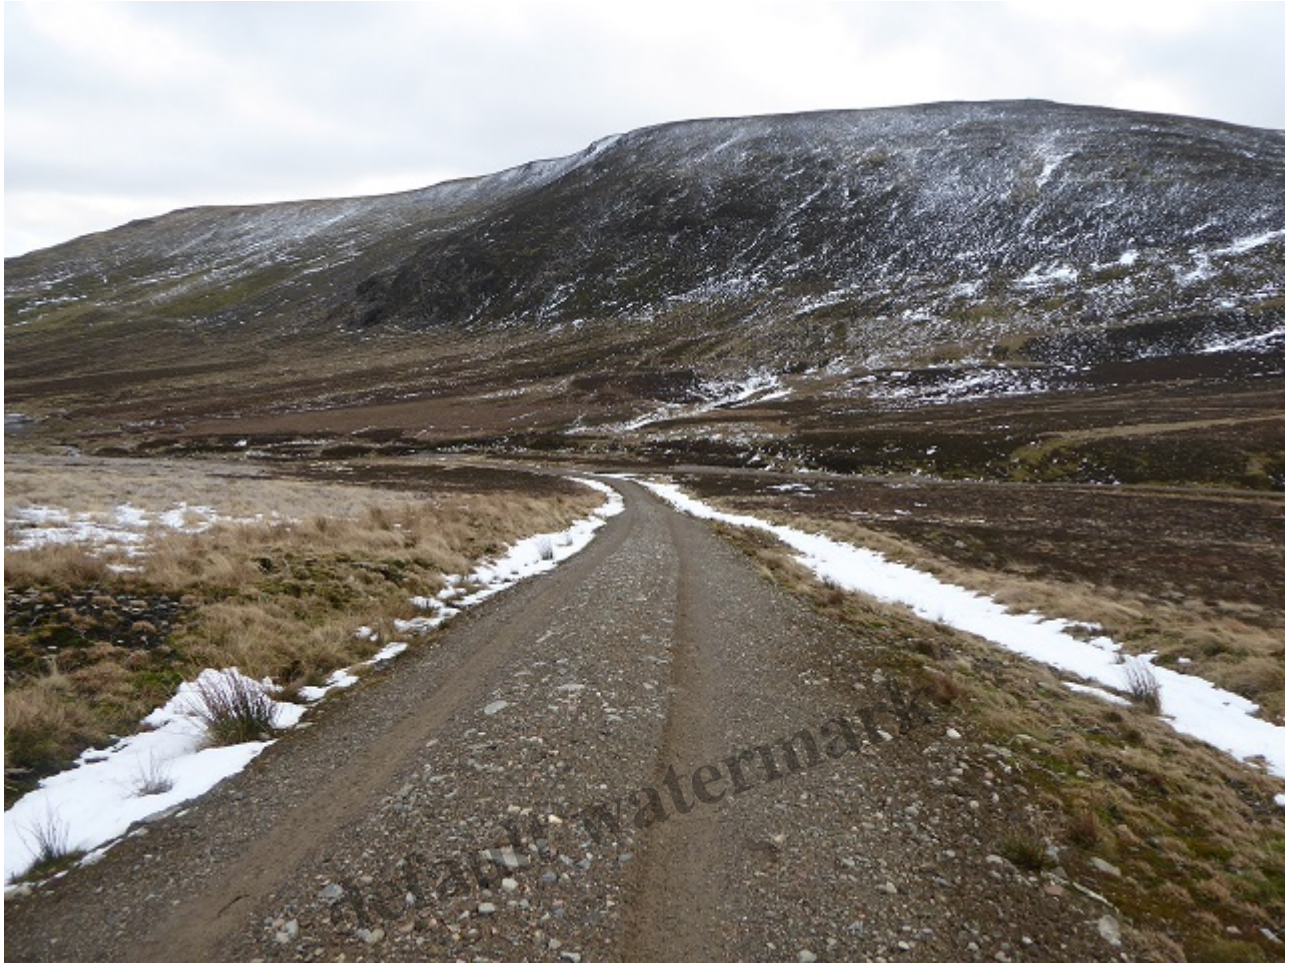
Looking down the Kilbo road towards the hydro road junction showing how it has been raised above the surrounding ground

Couple the line with the width of the road and the way its been raised above the surrounding ground and you have a highly prominent landscape scar.

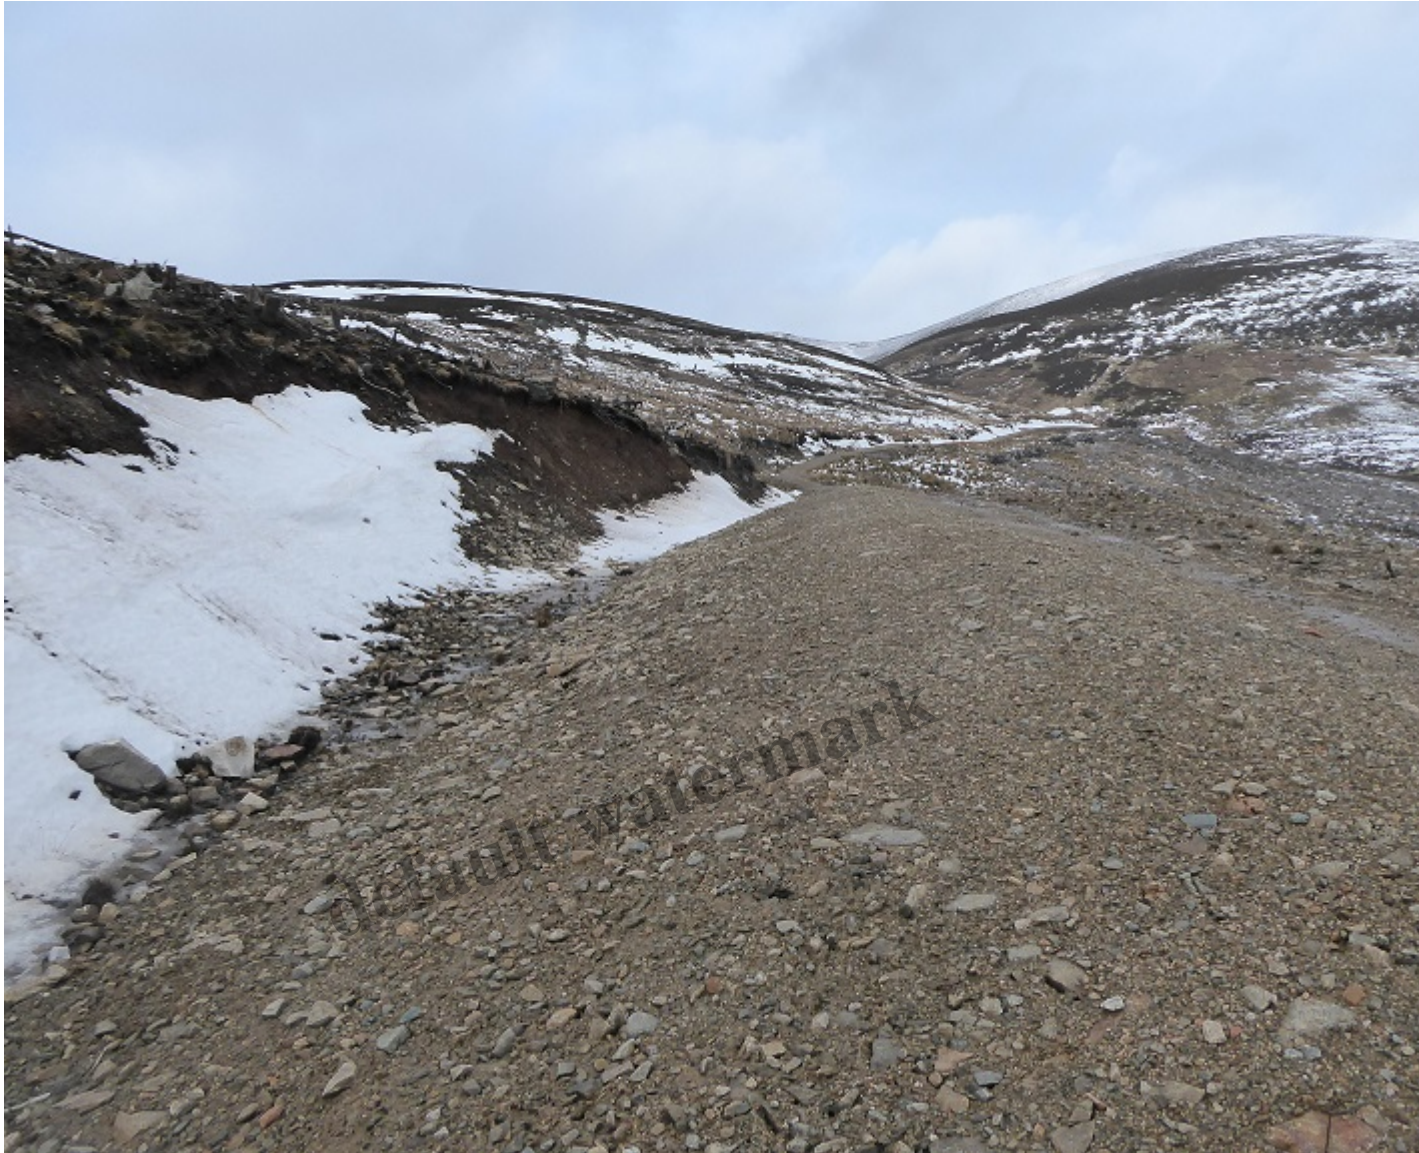
View up towards the Mayar intake from just above the junction with the new grouse moor road. The part of the road is so steeply sloping on both sides that it would be difficult to drive a vehicle along

Prior to the construction of the hydro scheme, the King's Seat forestry plantation (as shown on map above) was felled. Forest roads don't need planning approval but come under the Prior Notification system and part of the reason for this terrible section of track would appear to be that it was constructed to forestry specifications. These allow wider roads for felling than the 4m construction track agreed by the CNPA. However, whatever the origins, this road has been used to construct the hydro scheme and the CNPA required this to be reduce in width to 1m.

One might have hoped that, given the disgraceful state of the upper part of the Kilbo Road that the CNPA would have taken prompt enforcement action. I will now be asking them to do so for both hydro tracks.

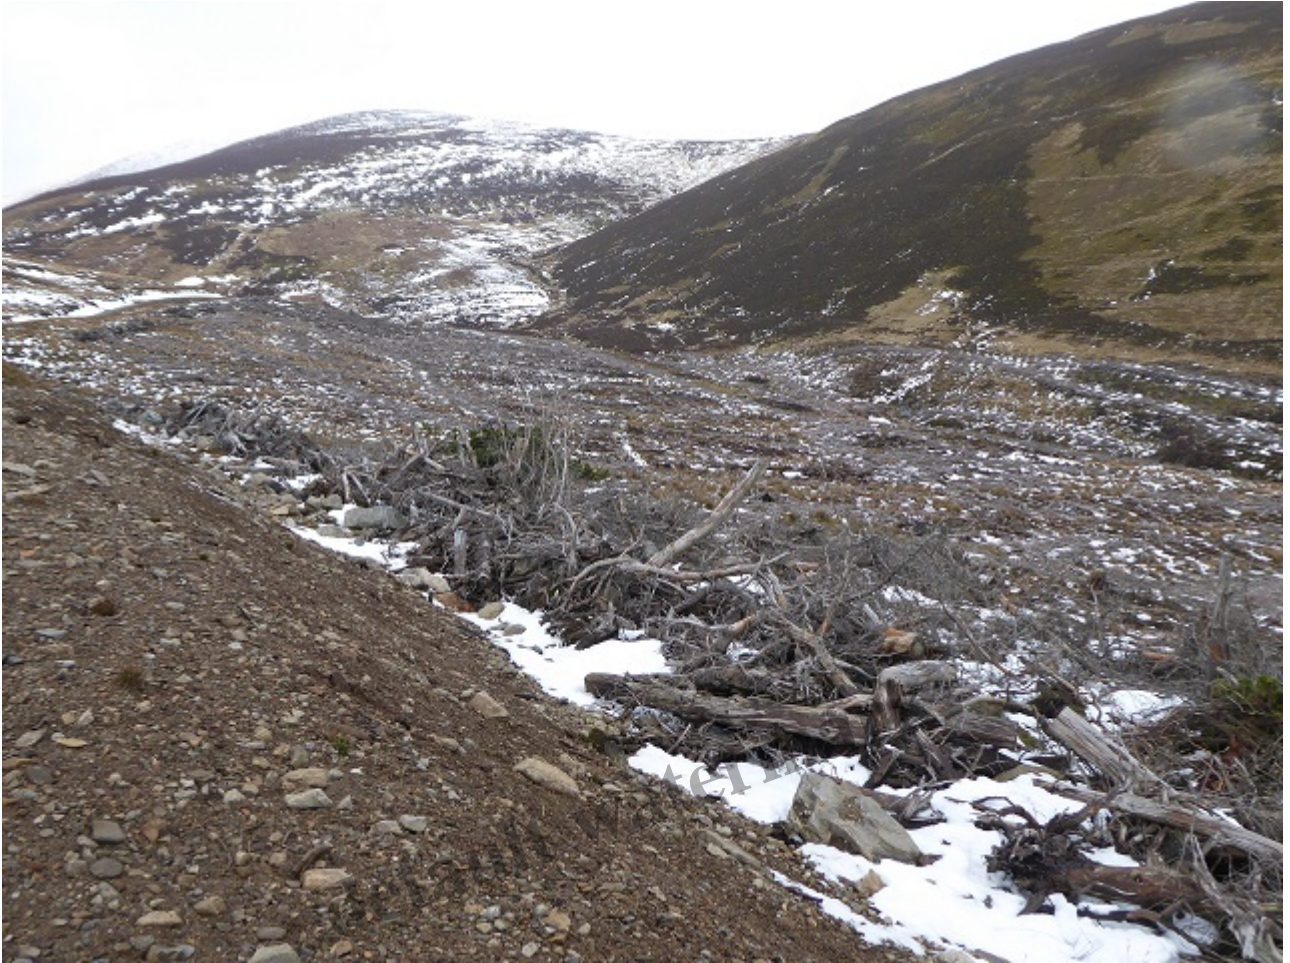
Close up of downhill side of cutting

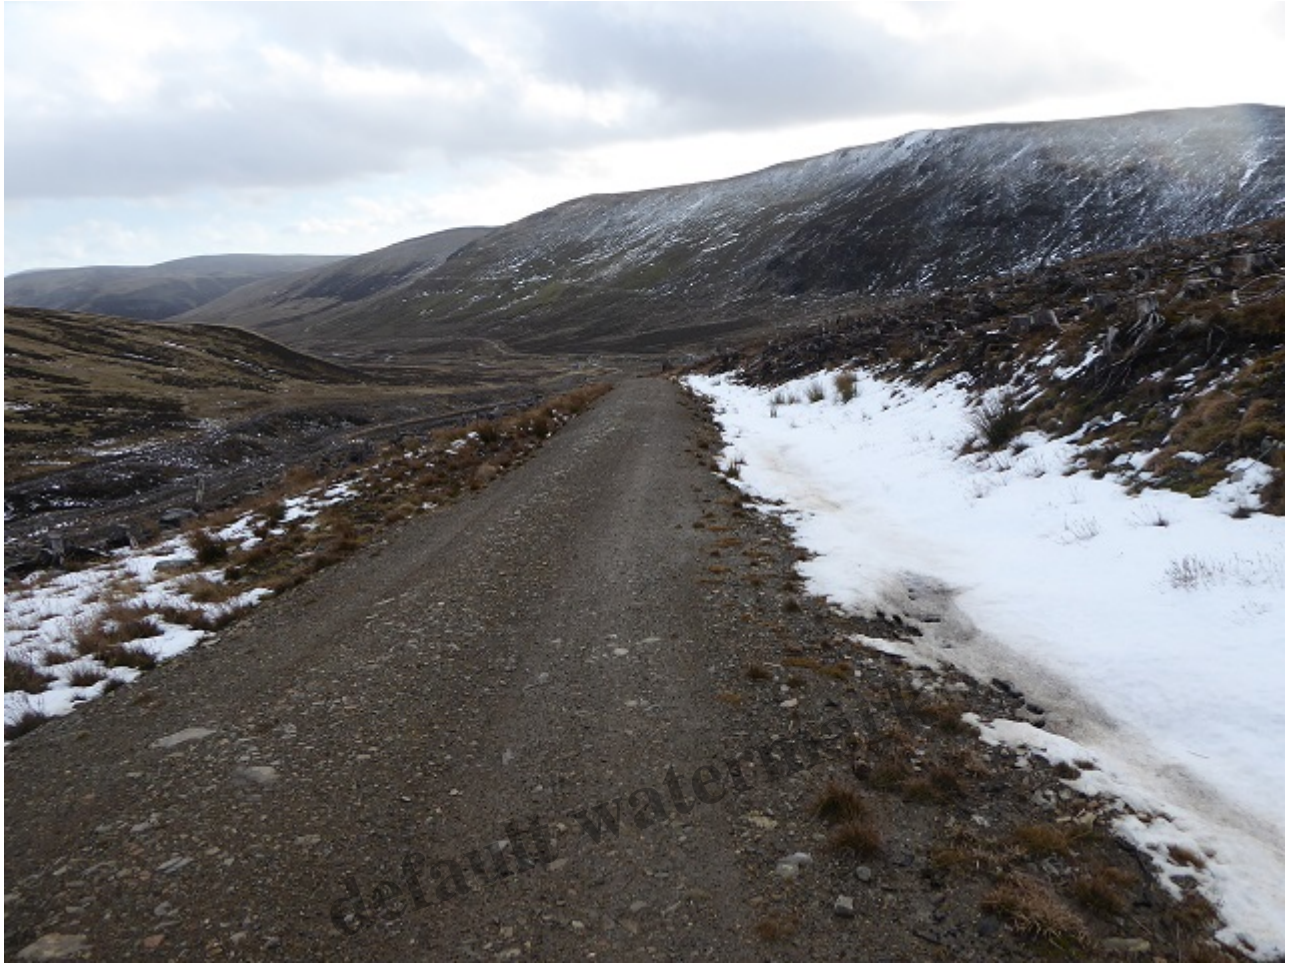
Looking down the first section of the new road, with the Kilbo hydro road visible below and two left and the old road to the head of Glen Prosen in the background beyond

It appears that the Glen Prosen Estate has used the hydro scheme construction tracks as an opportunity to construct a new road up Cairn Dye. This appears to have obliterated the historic Kilbo Path and means that there are now not just two but three hill roads within one small area at the head of the glen. There is no planning application for this and the road is not listed under those that have been developed under the Prior Notification scheme. It therefore appears unlawful.

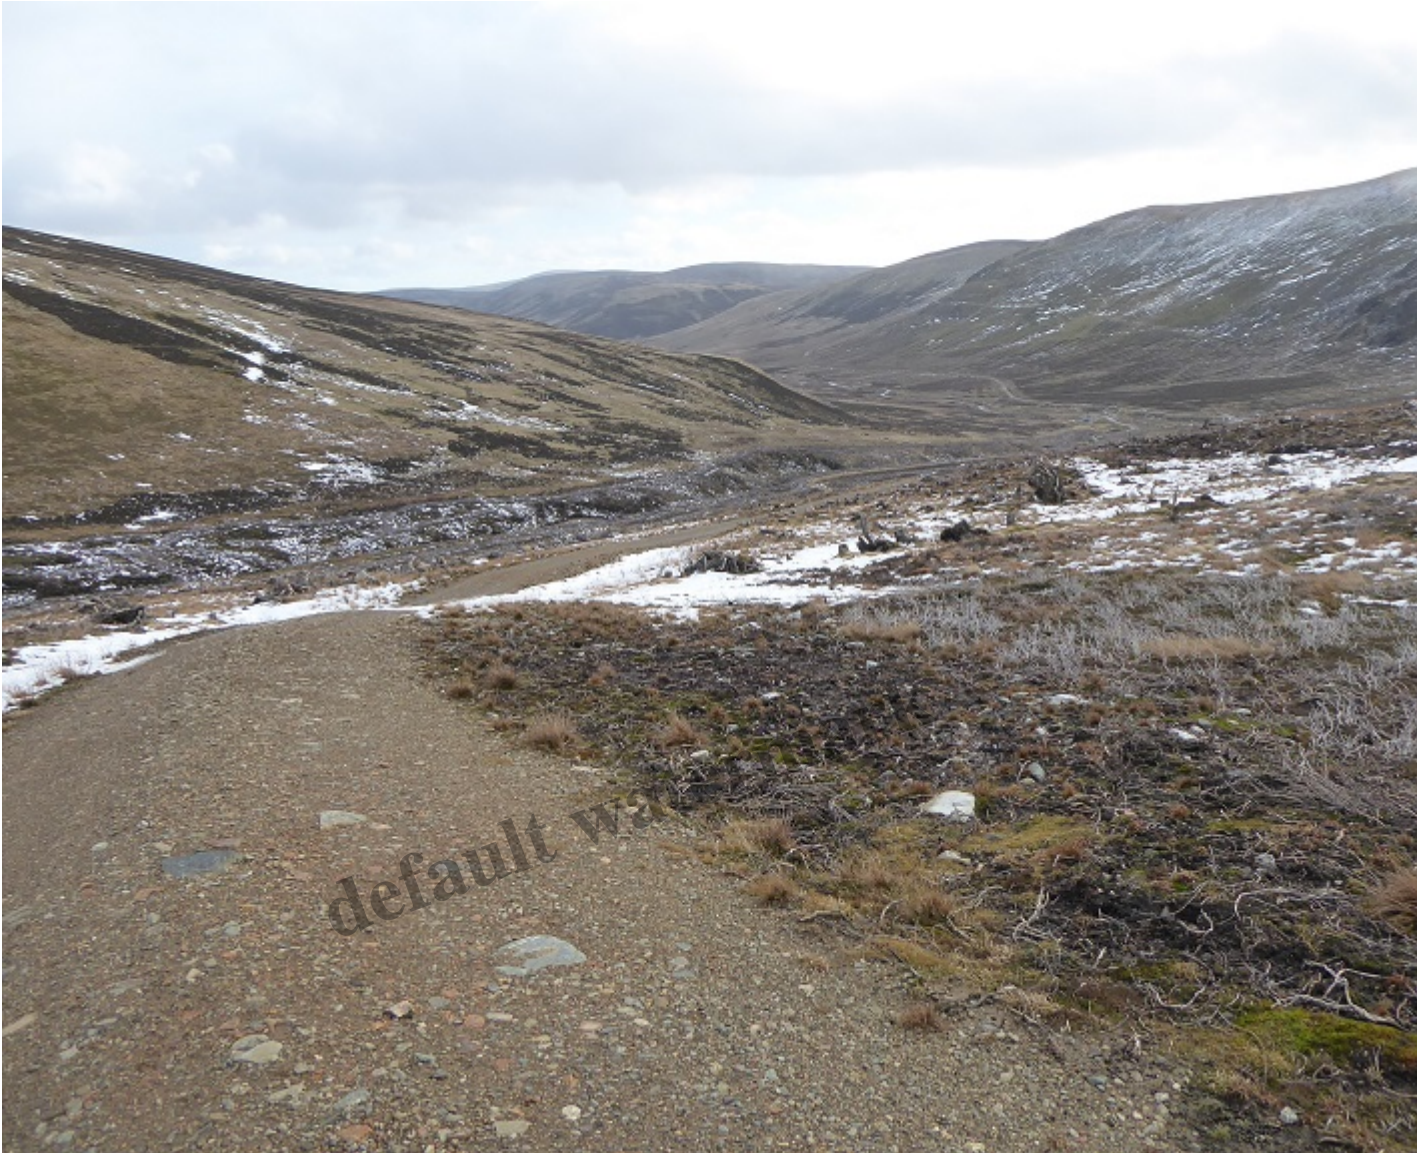
Muirburn by side of road just above forest plantation

Its symptomatic of current inconsistencies in our approach to land-use that the ground here is being damaged by muirburn when along the Kilbo Burn the CNPA made this requirement for the hydro scheme:

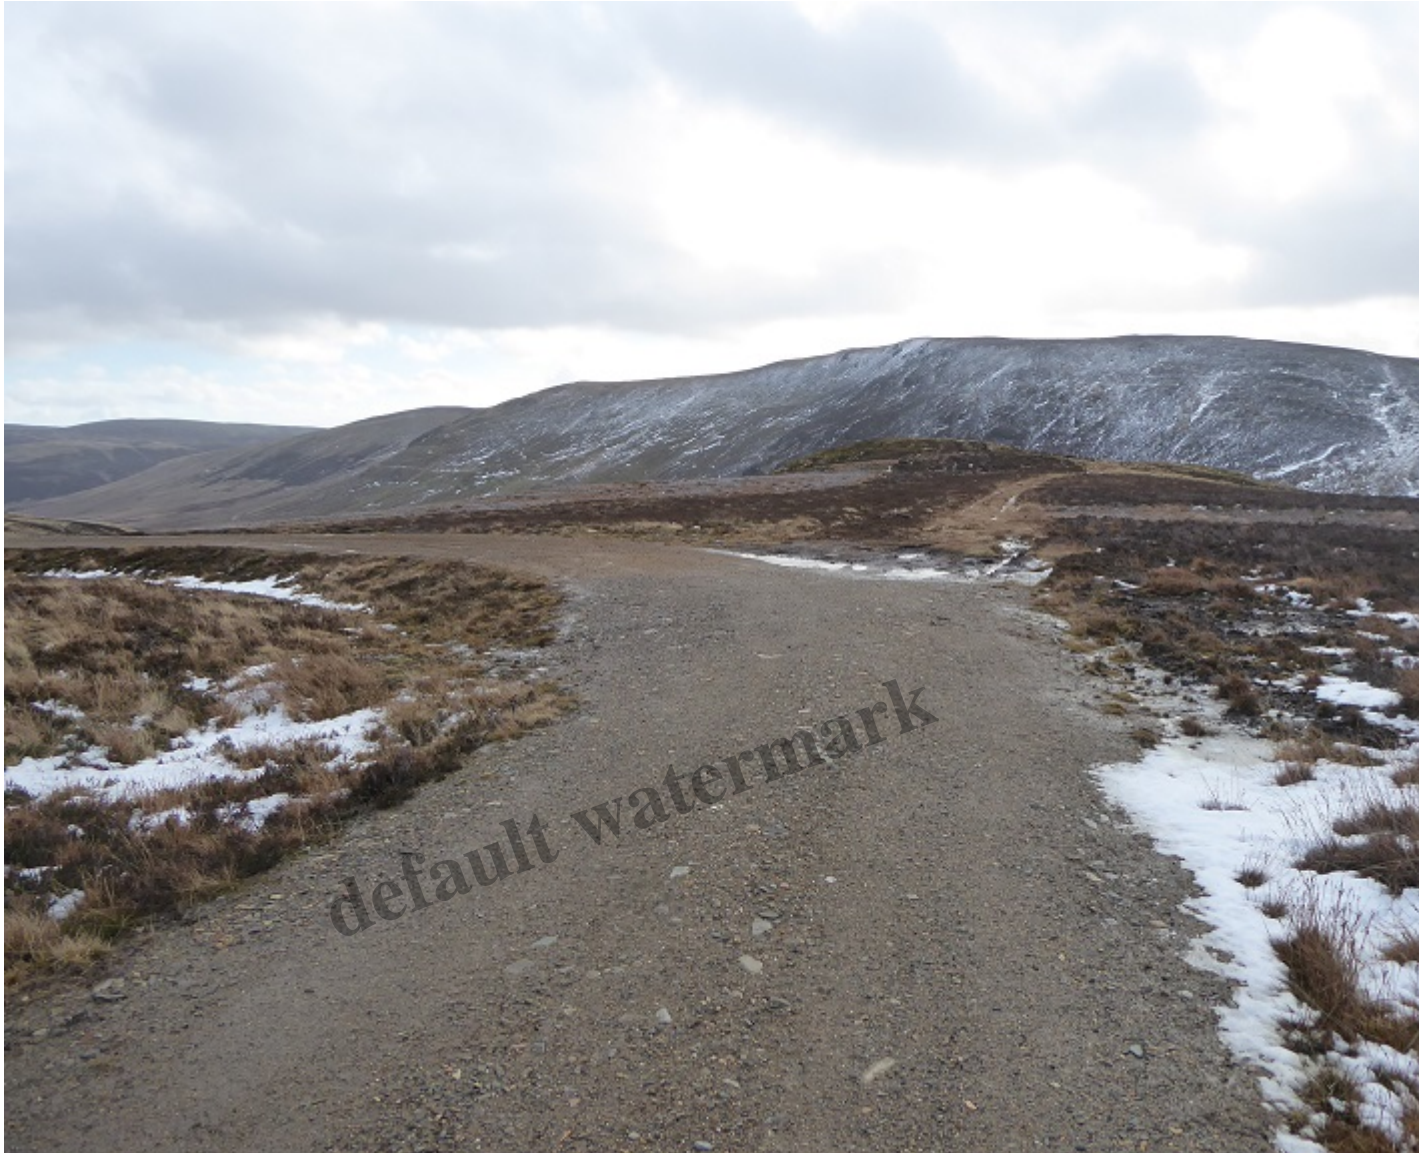
On Cairn Dye, looking south, with former landrover track clearly visible

The estate appears to have driven vehicles here for many years but they took a different less steep route up onto Cairn Dye and that old route had far less landscape impact.

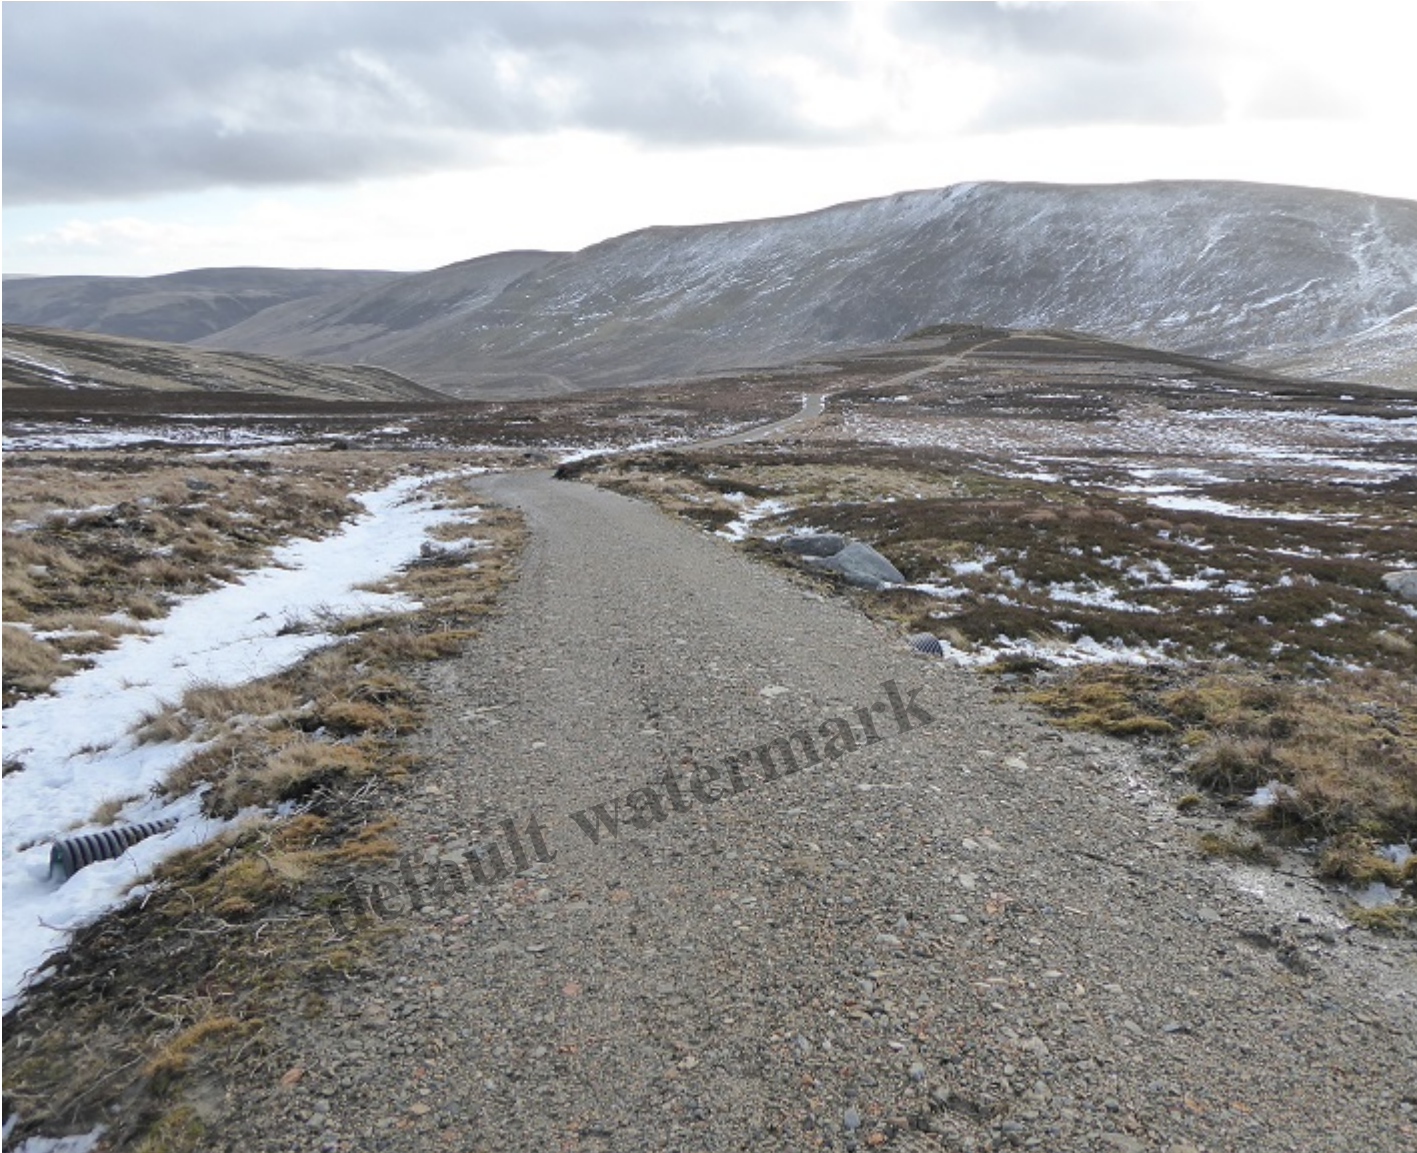
Looking down the new road along the Glen Dye ridge – note the plastic culvert left indicating the degradation of construction that has taken place

The road is far far wider than that consented for the hydro roads and there is now no sign of the green central strip that the CNPA now regards as good practice for landrover tracks.

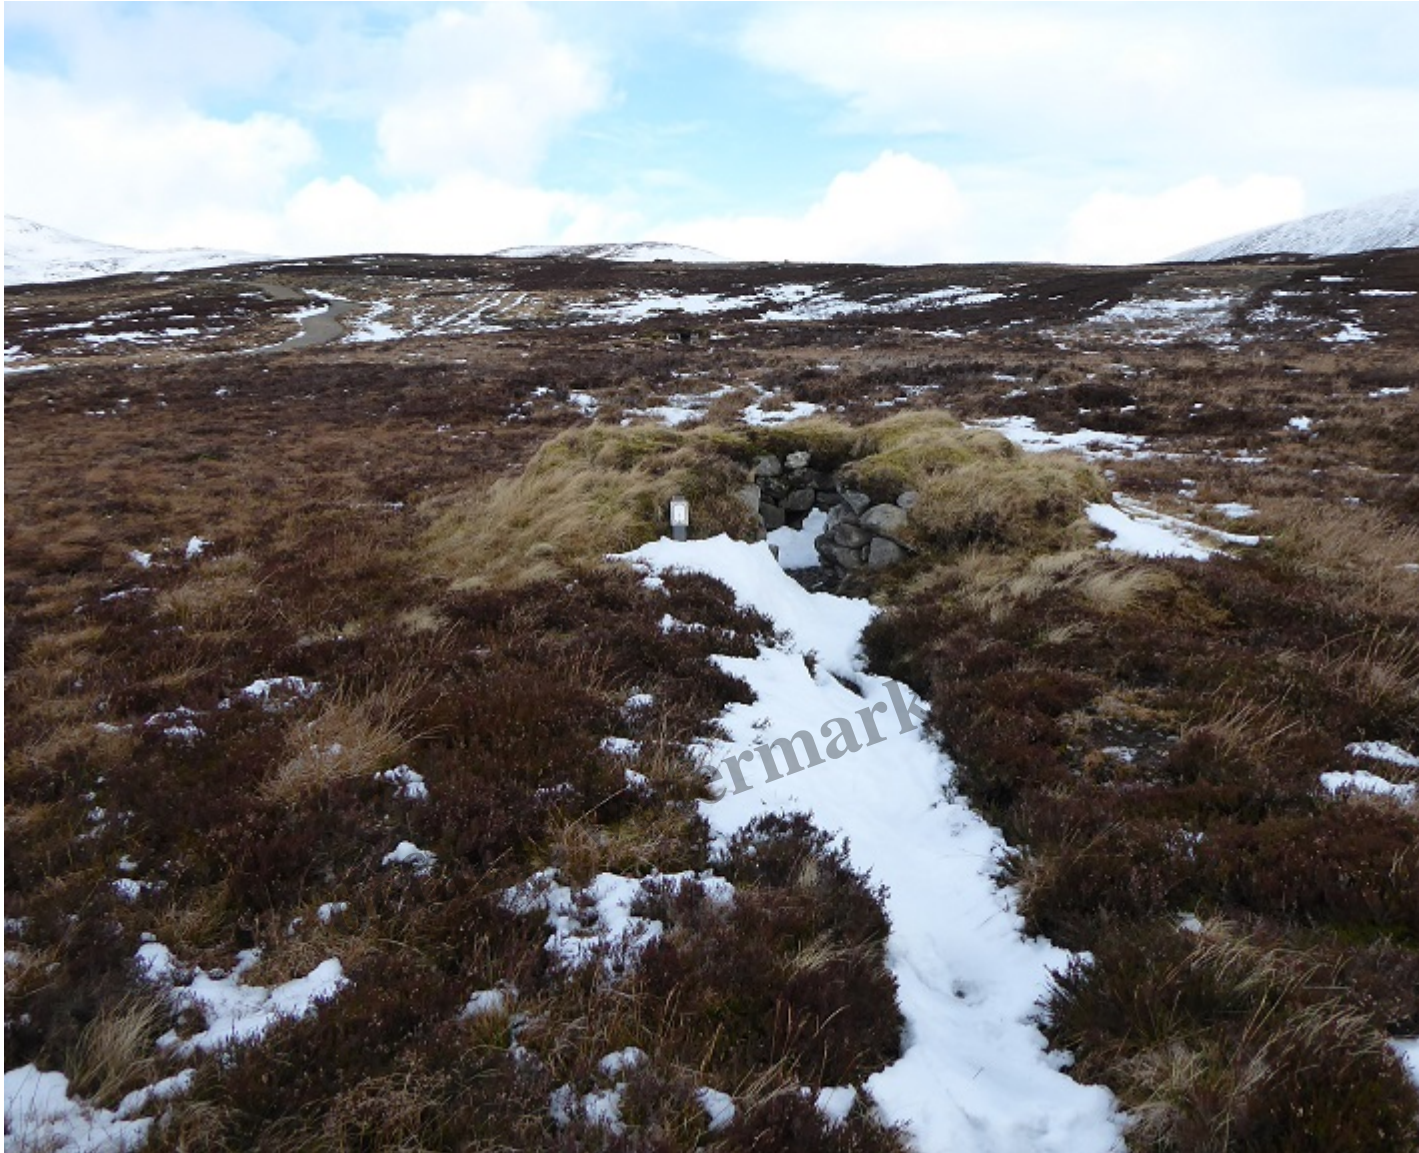
Grouse butt access road on left, further butts beyond

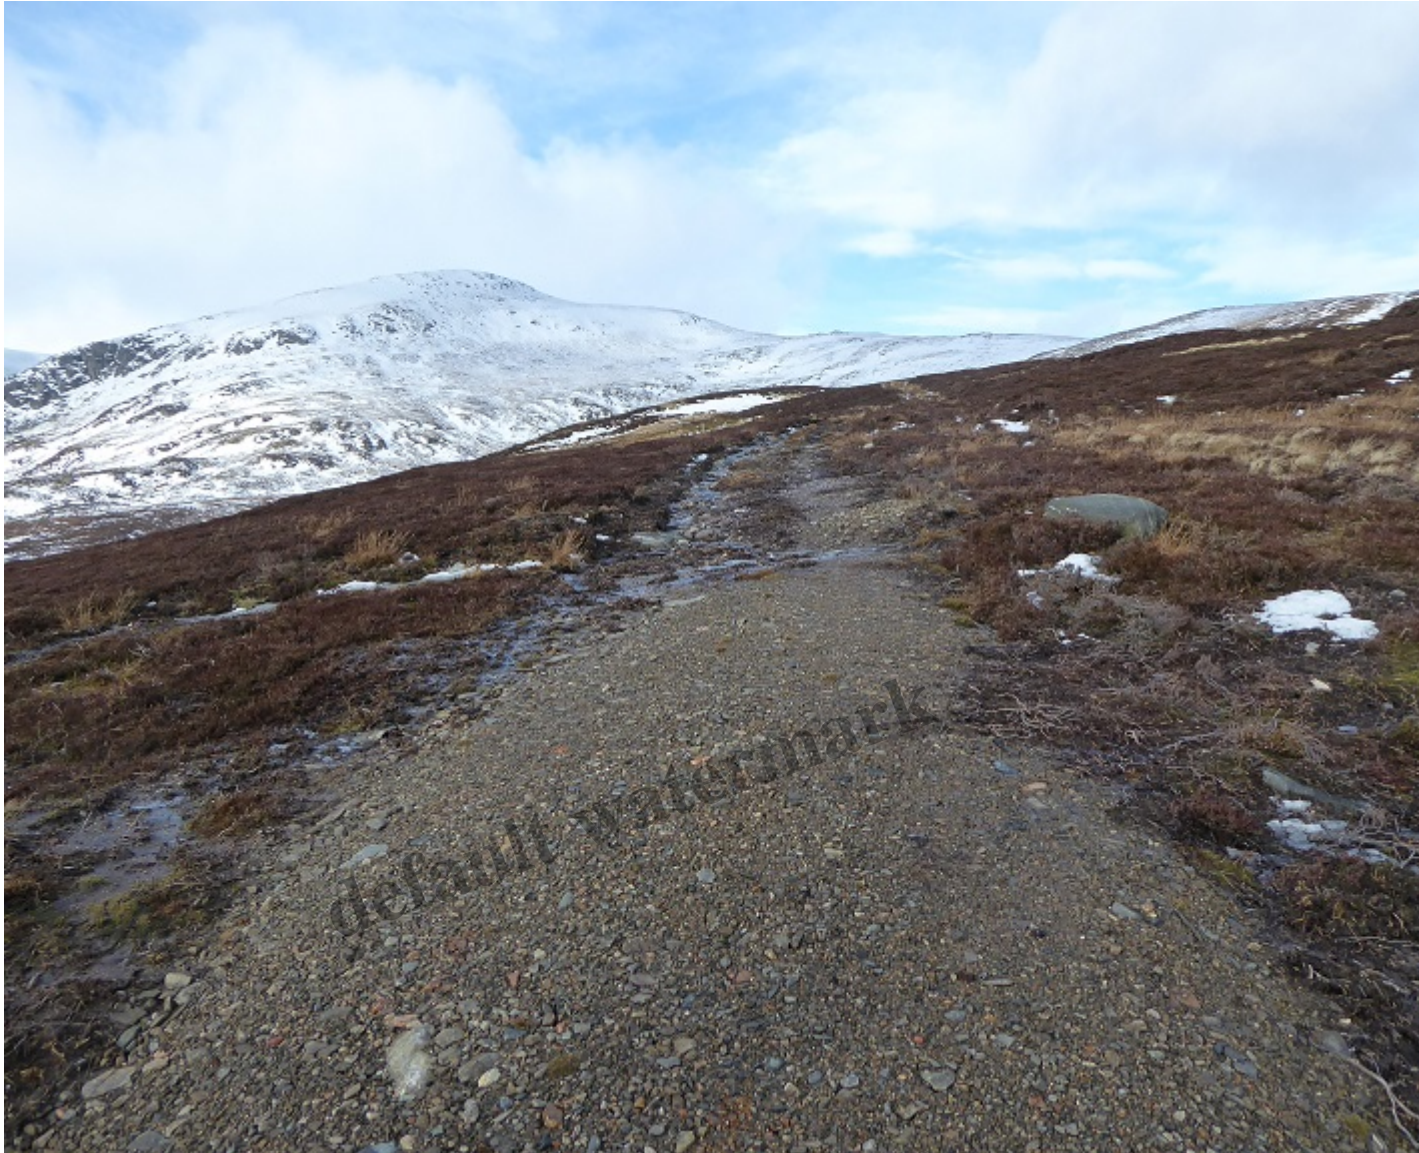
End of the new road, Mayar beyond. The landrover track continues on up towards the Mayar-Driesh

The landscape impact of the landrover track is far less than the new road because it is narrower and restricted to tyre lines so effectively has a vegetated strip down the middle:

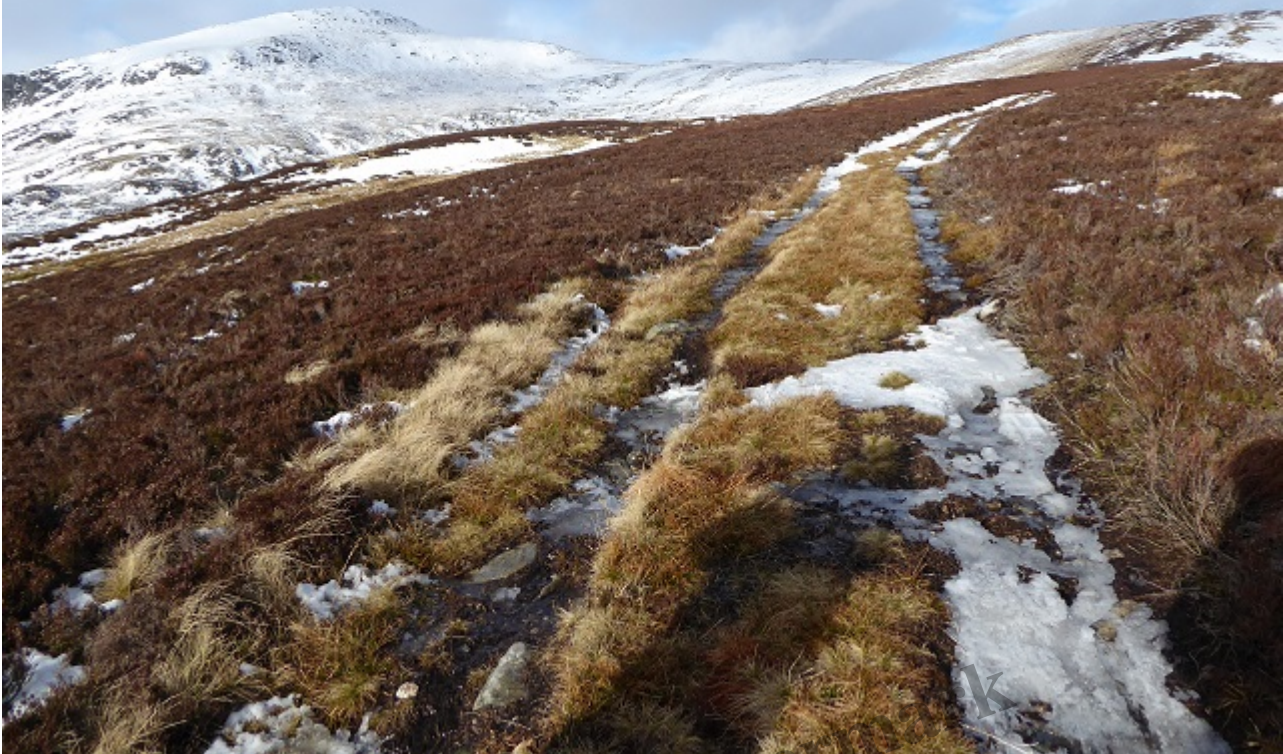
The vehicle

use has however clearly impacted on the vegetation, converting heather to grasses, thus forming a line across the landscape. This illustrates why footpaths generally have less landscape impact and are preferable to roads with green strips down the middle. If the Glen Prosen Estate accepted 1m wide tracks for quad bike use below it's hard to see how they can justify using any other vehicles here.
