## The hill and hydro roads disaster at the head of Glen Prosen

**The landscape impact of the two new hydro roads**

## **The new grouse moor track**

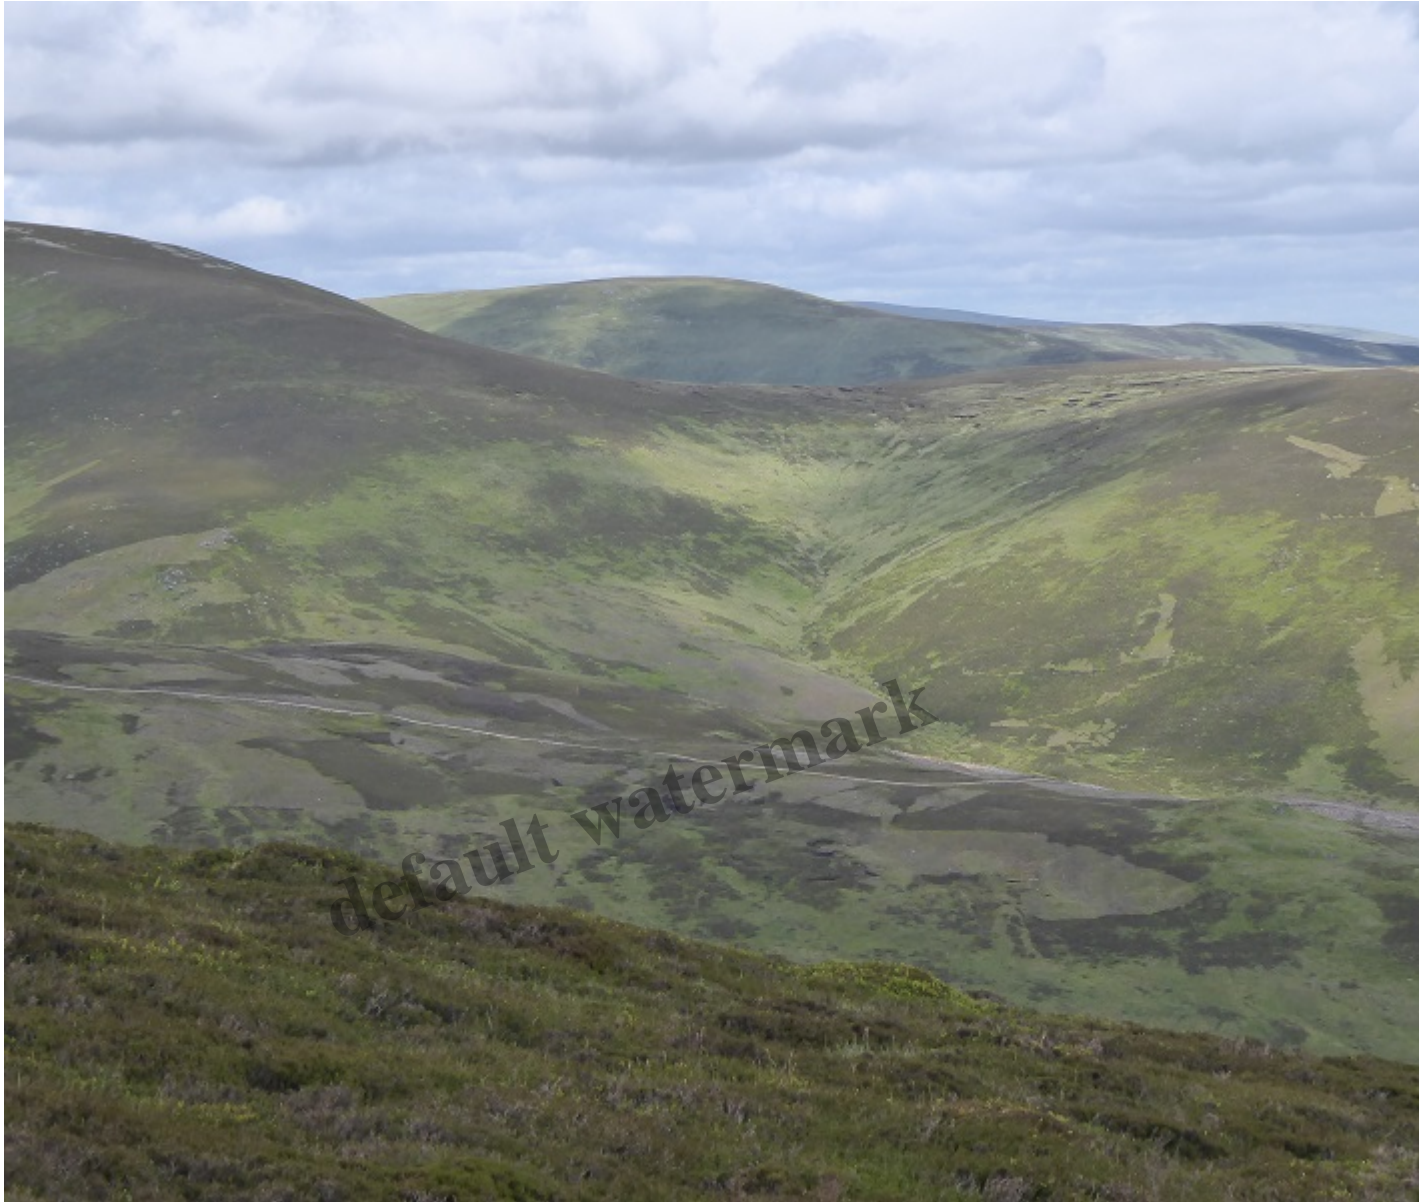
The Cairn Dye road viewed from Bawhelps June 2006 with Hunt Hill (on right) and Little Driesh (on left). The hydro roads are tucked into glens on either side and not visible from this particular viewpoint.

The consequences for the landscape have been significant and the track is highly visible from the high ground around the head of the glen. With two hydro roads in place on either side there can be no justification for this road. The upper part is also within the Lochnagar-Mt Keen Wild Land Area and seems likely to have been constructed after SNH's maps and descriptions of Wild Land Areas were published in 2014:

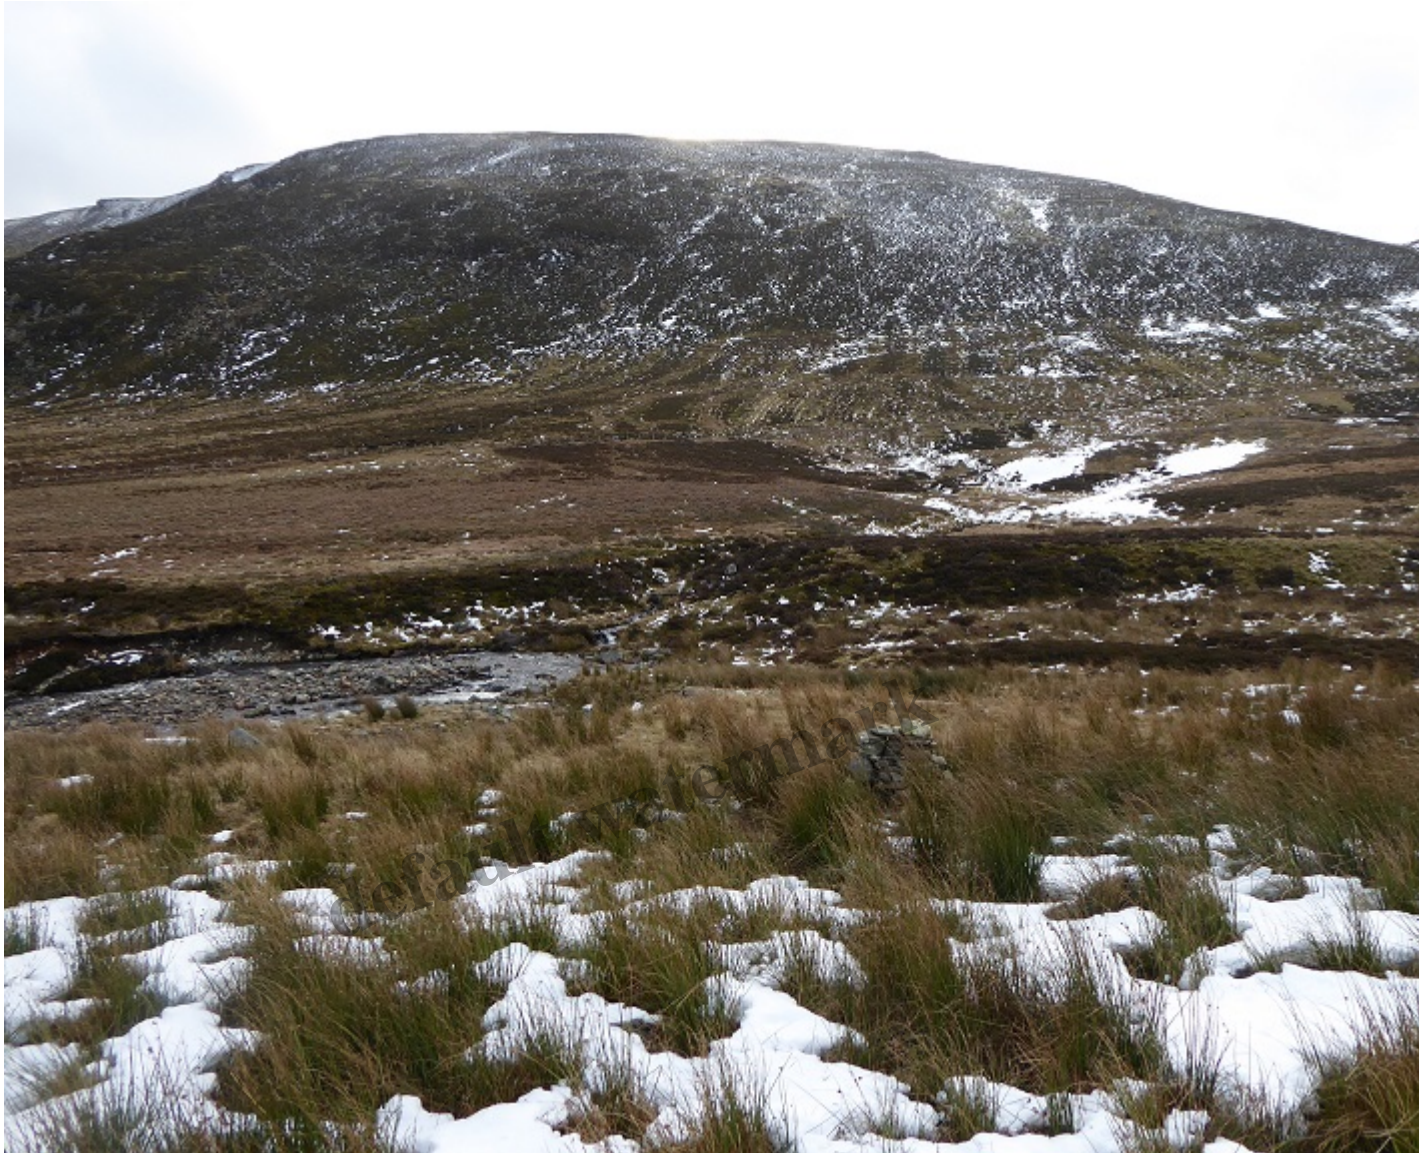
View of powerhouse from above – the cairn is presumably to alert people not to walk over the edge!

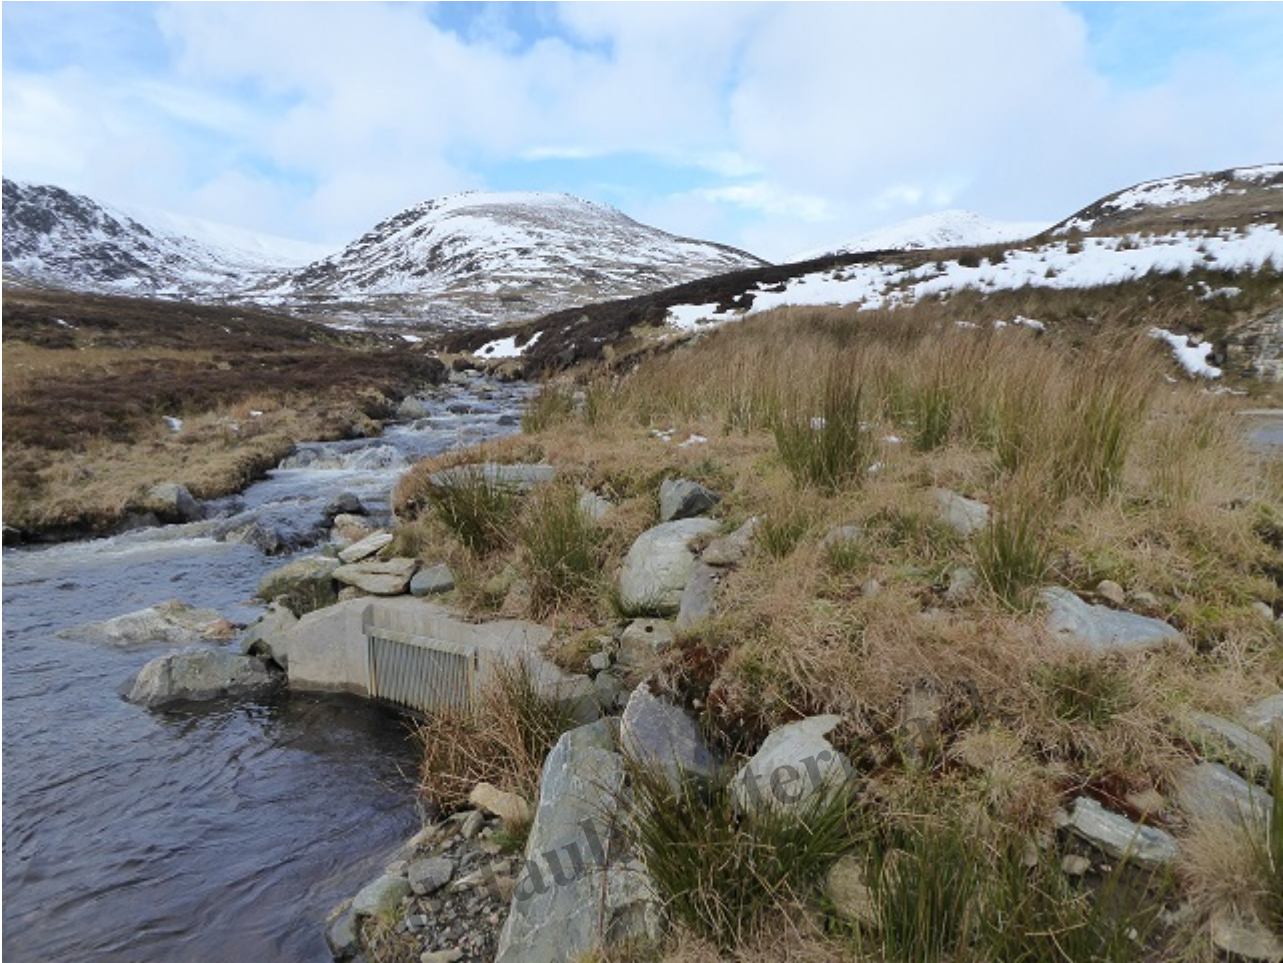
The outrace has been very sensitively landscaped

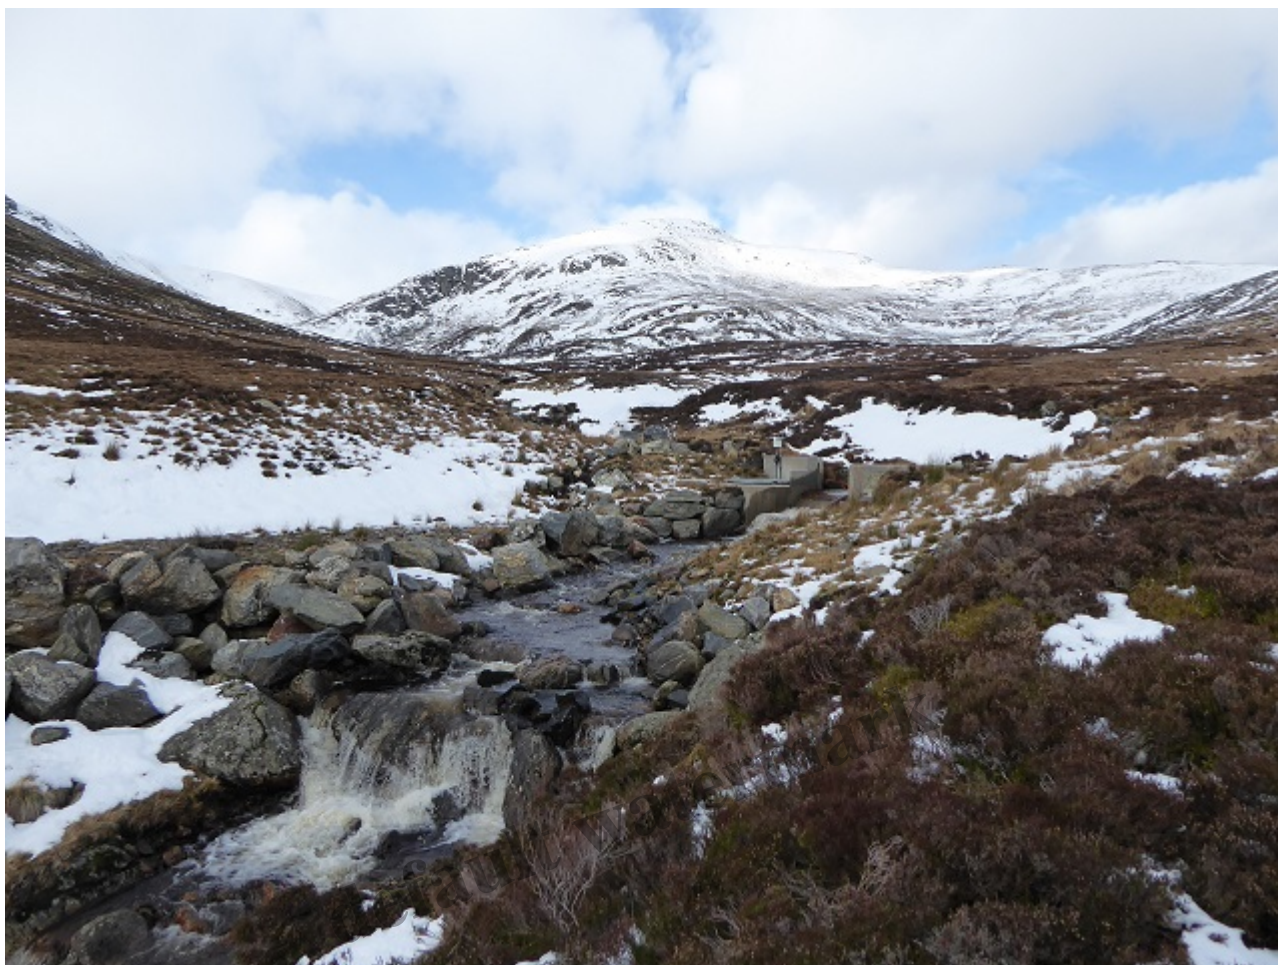
Mayar Intake with Mayar beyond

The Mayar intake is not just well located, it shows how rip rap bouldering to reinforce the sides of streams can be done sensitively so it appears almost natural (unlike the dreadful examples in Glen Falloch in the Loch Lomond and Trossachs National Park [\(see here for example\)](#)).
