Hydro schemes and the failure of the planning system in the Loch Lomond and Trossachs National Park

The Upper Glen Falloch hydro scheme

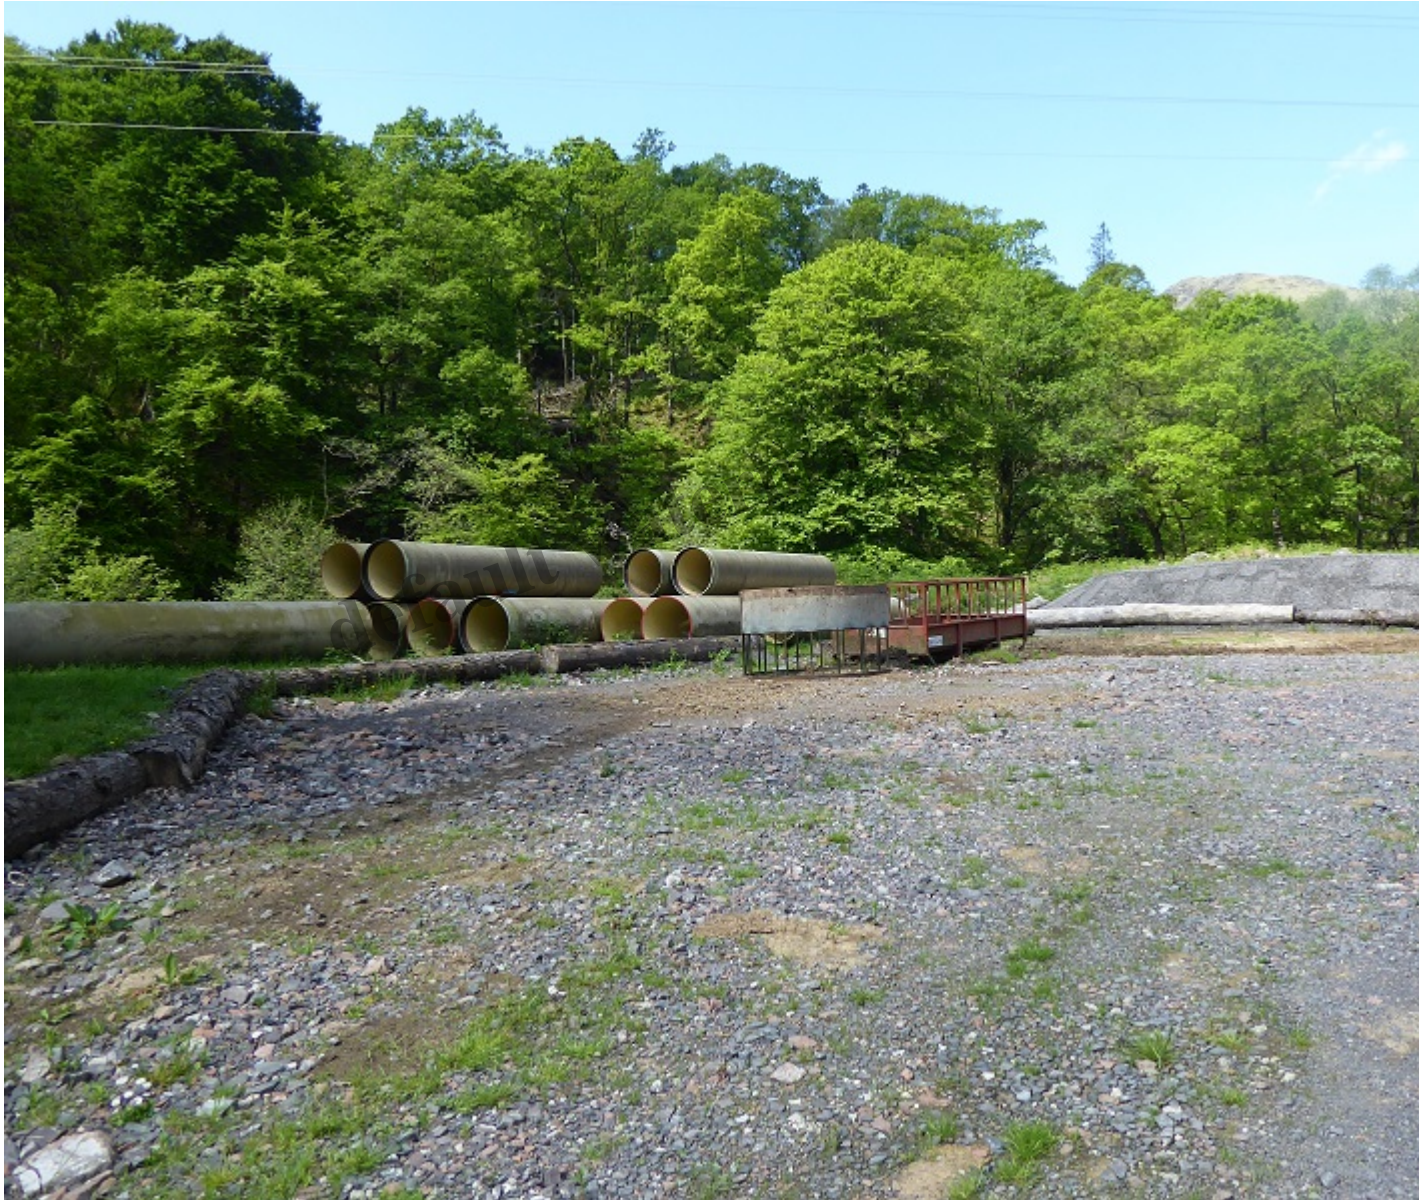
Abandoned hydro pipes and unrestored laydown area from Allt Fionn hydro scheme in Glen Falloch. LLTNPA received a Scottish Quality Award in planning for this scheme back in 2015 – the pipes are still there in 2019!

I responded to James Stuart with a further email ([see here for full text](#)) pointing out that the abandoned detritus at the Allt Fionn hydro scheme (photo above), which HAD received a planning quality award five years ago, was even worse. I also raised the need for the LLTNPA to conduct an audit of all the 45 or so hydro schemes constructed in the National Park and offered to come to the Board and speak about this. While James Stuart's reply ([see here](#)) was effectively a brush off and written in the usual quango speak, it did admit that the Park's Planning team is not properly resourced:

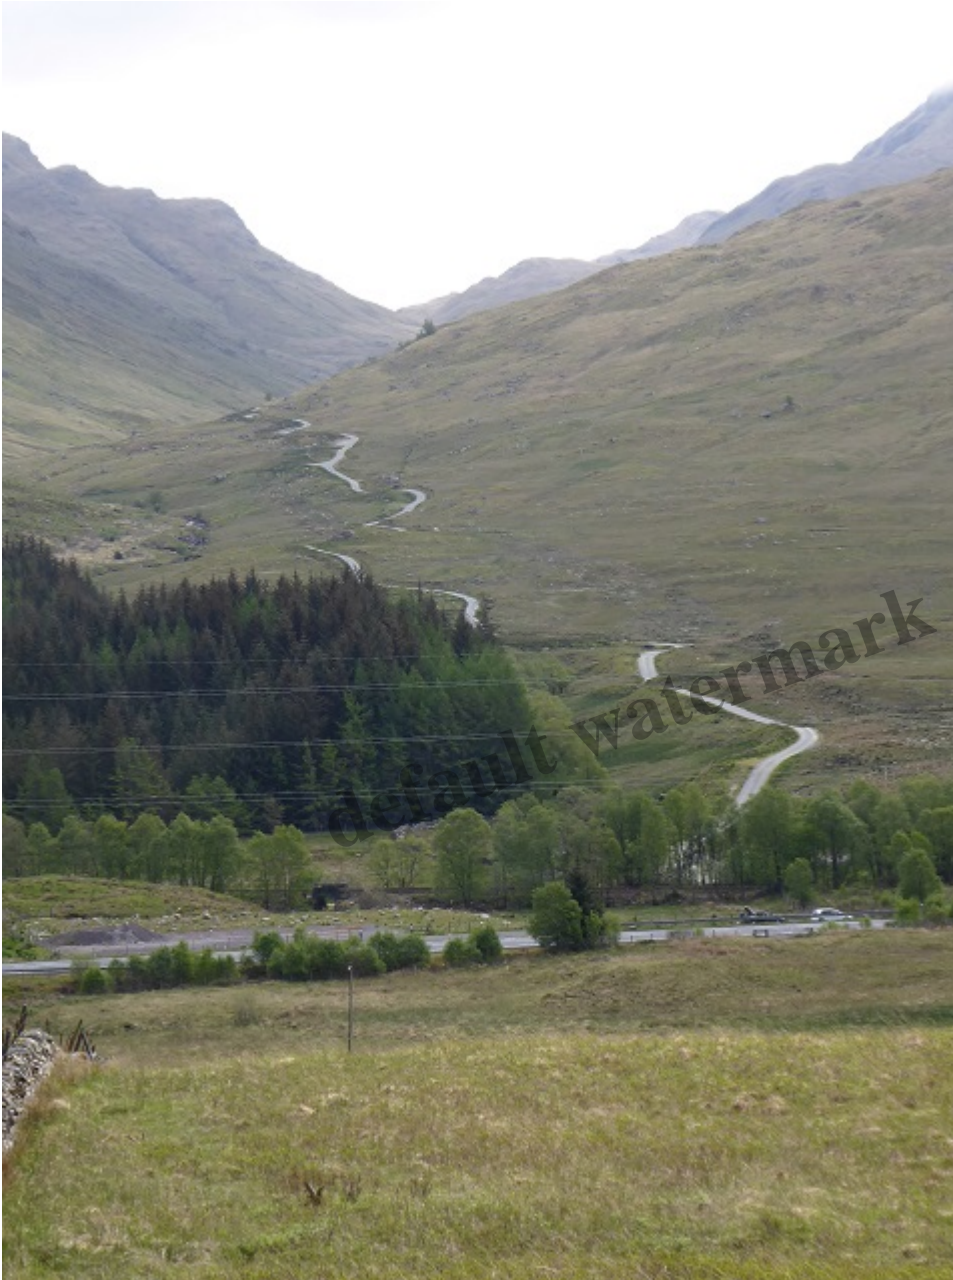
The first two sections of the upper Glen Falloch hydro road viewed from just below the West Highland Way

The hydro scheme has had a major landscape impact on Upper Glen Falloch. Most of this side glen was previously wild and unspoilt as is befitting for a National Park. Its wild character has been effectively destroyed through the widening and extension of the road and the disastrously designed and executed intake pool. While prior to the hydro scheme there was a road up the first section of the glen, the original planning application, which was approved by the Scottish Government on the advice on the National Park Authority, allowed it to be doubled in length. A further planning application for the temporary construction track from the road end to the intake to made permanent was then approved by the LLTNPA.

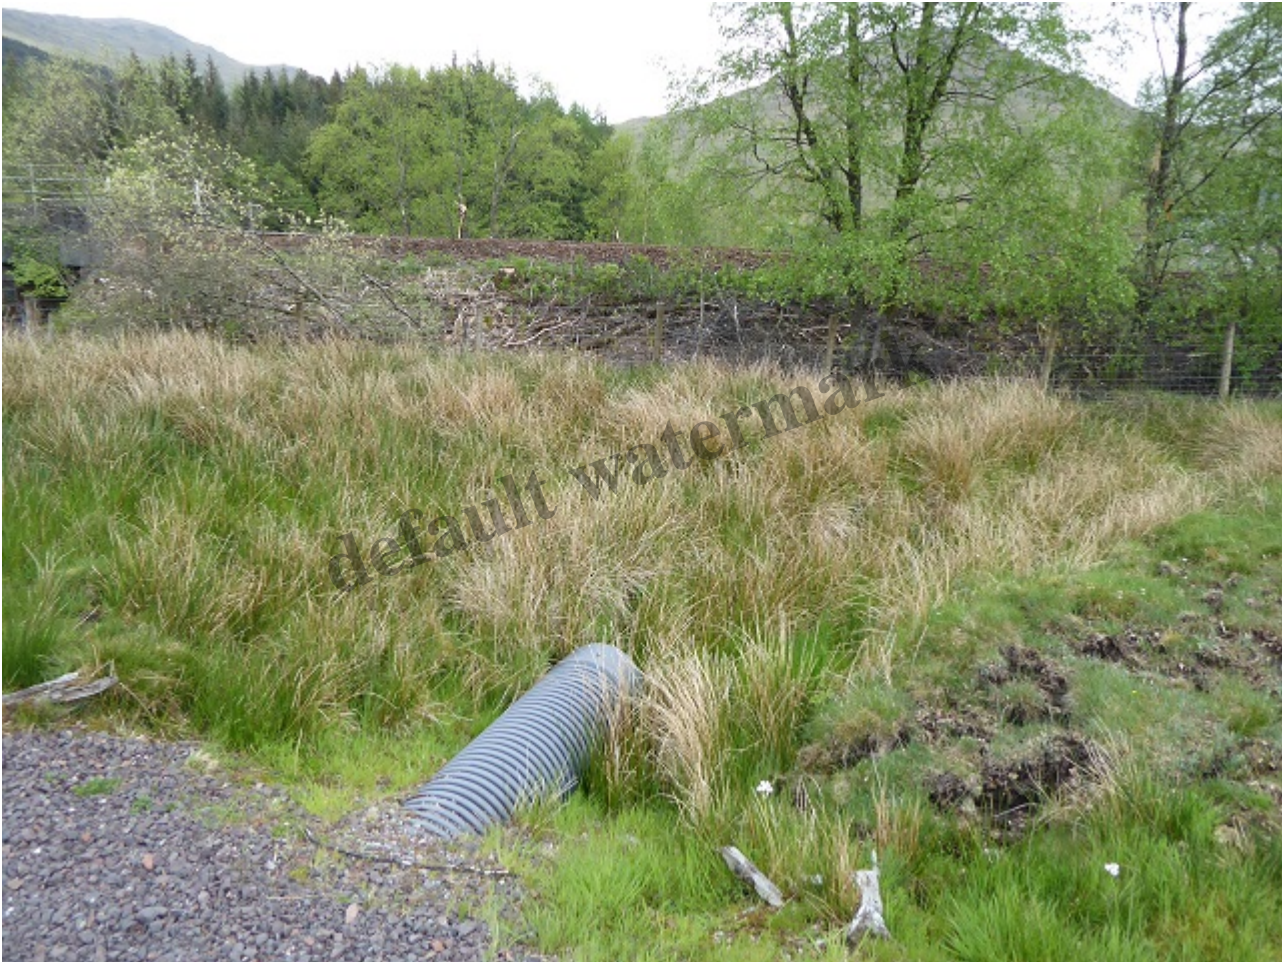
Protruding culvert on new section of footpath between the layby commonly used to access An Caisteal and Beinn a Chroin and the river Falloch

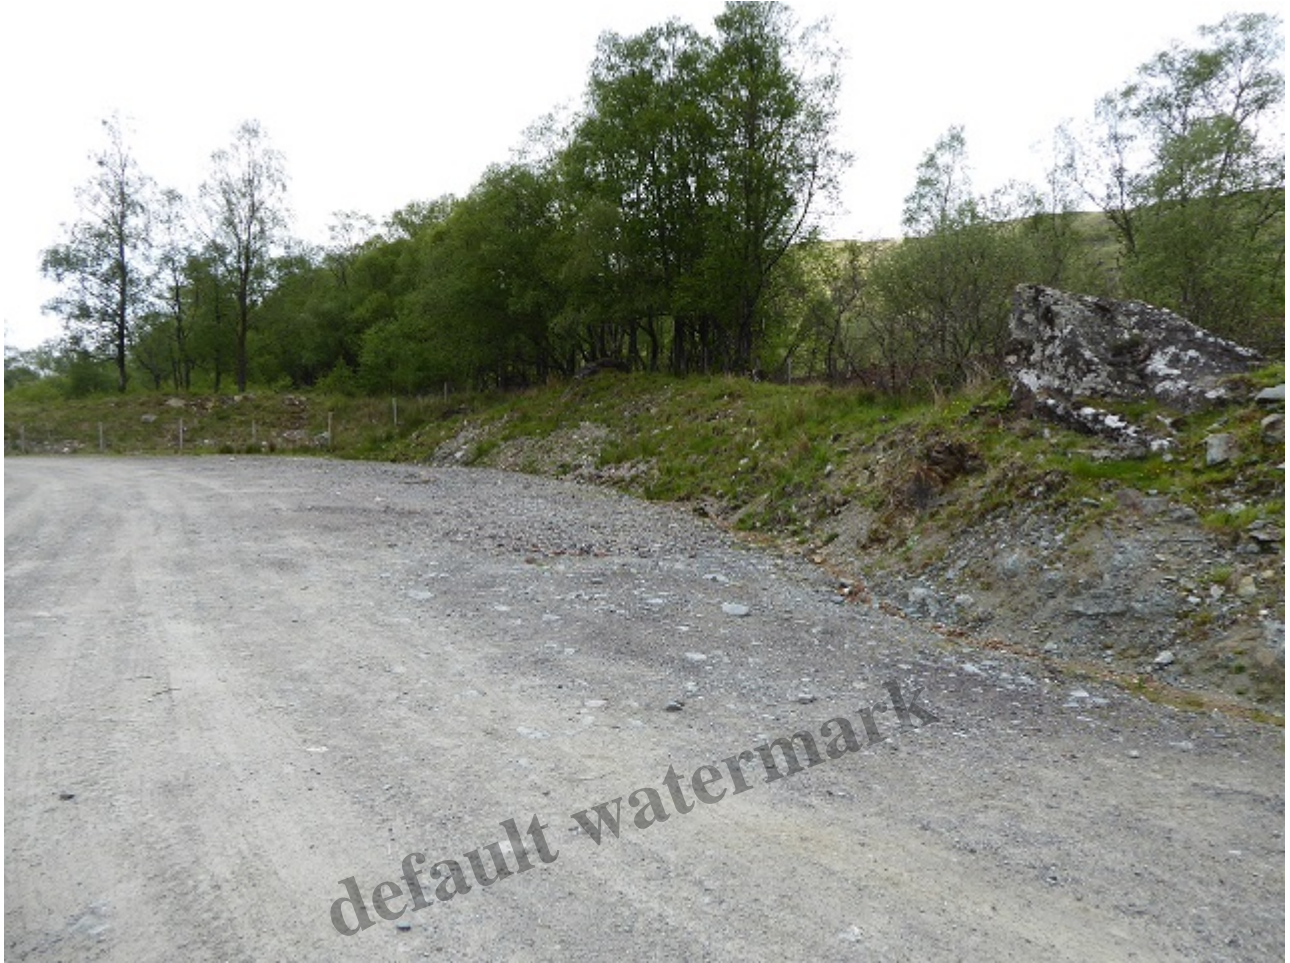
The hydro access road between the railway and river Falloch

Why has the start of the access road been left like this? The answer appears to be that its cheaper for the landowner and developer not to restore ground affected by construction and the LLTNPA has failed to take effective enforcement action. Unfortunately its not possible for the public to find out what the LLTNPA has tried to fix because it does not publish such information on the planning portal. This is not what one should expect for a National Park and does not meet the standards set out in the Park's own best practice guidance on renewables ([SPG-Renewables-final](#)).

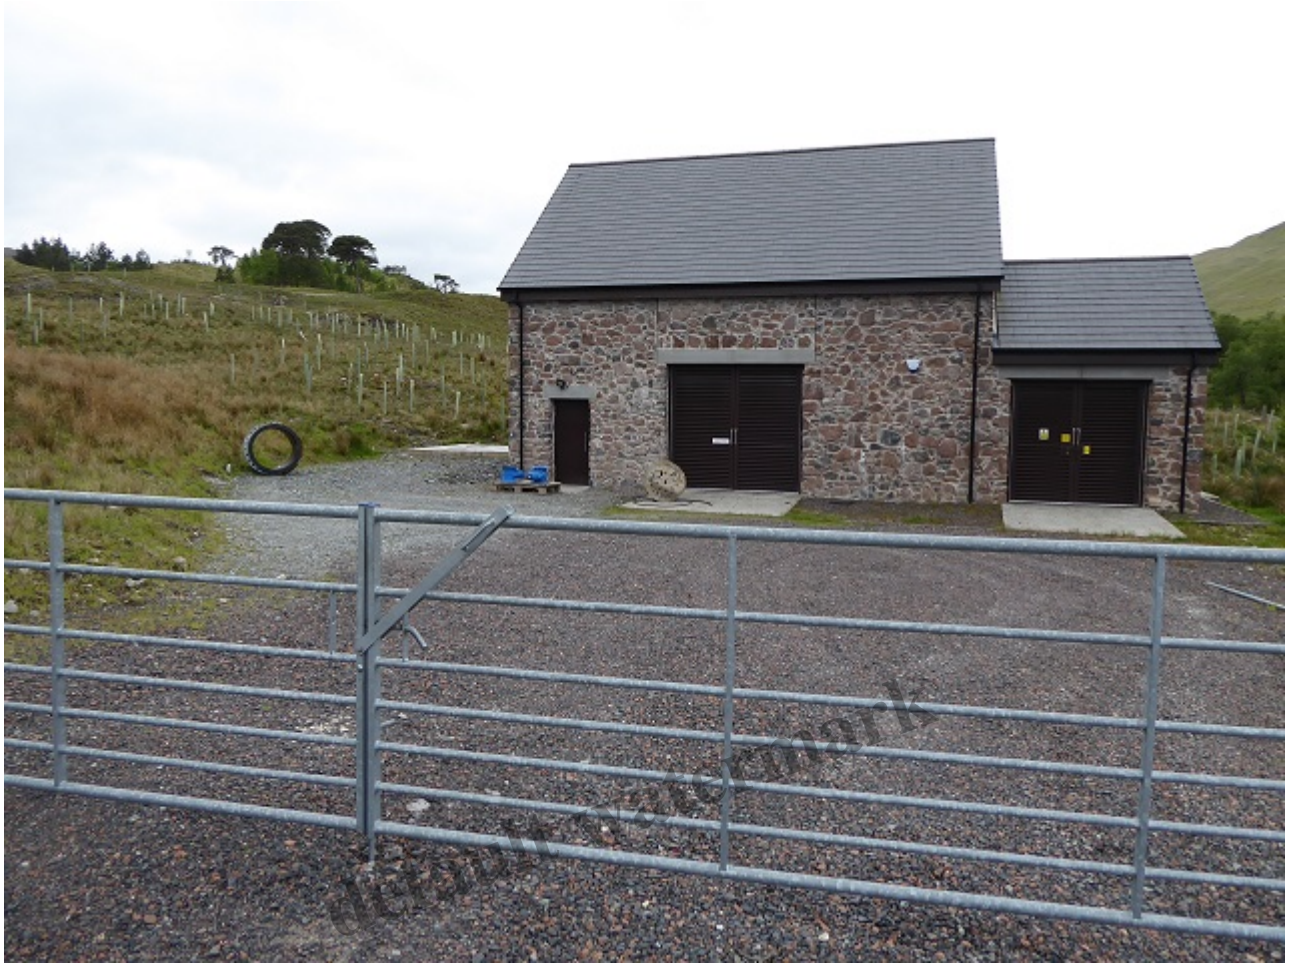
Only one dumped section of spare pipe unlike the schemes nominated for Scottish Planning Quality Awards! Glen Falloch Caledonian pine forest remnant visible behind.

The landscaping of the powerhouse leaves lots to be desired. The vehicle area is unnecessarily large, contrary to the Park's best practice guidance, again because its cheaper for developers to cover ground with imported stone than to restore it. An opportunity to allow the Glen Falloch native pinewood to regenerate naturally, as recommended in the Park's draft Trees and Woodland Strategy ([see here](#)), has been lost and instead a fenced area around the powerhouse planted.

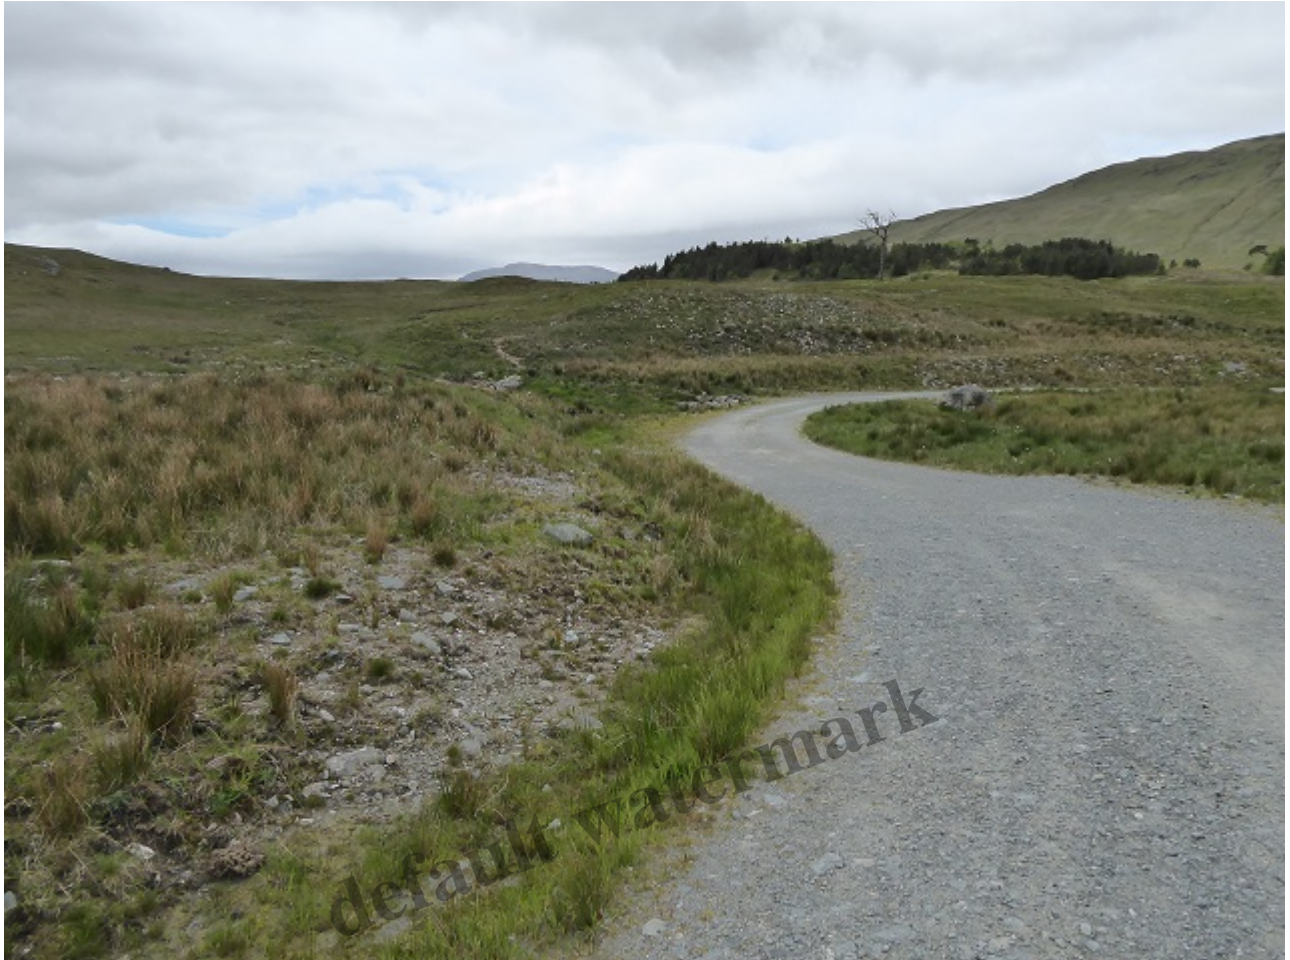
Dead pine visible in front of (fence) native pinewood illustrating that the forest not so long ago extended up the glen to the hydro track. Mineral soils, created by the construction of the hydro, are clearly visible on the left of the track.

A much greater opportunity to allow the native pinewood to expand back up the glen and hide the eyesore of the first section of road has also been lost.

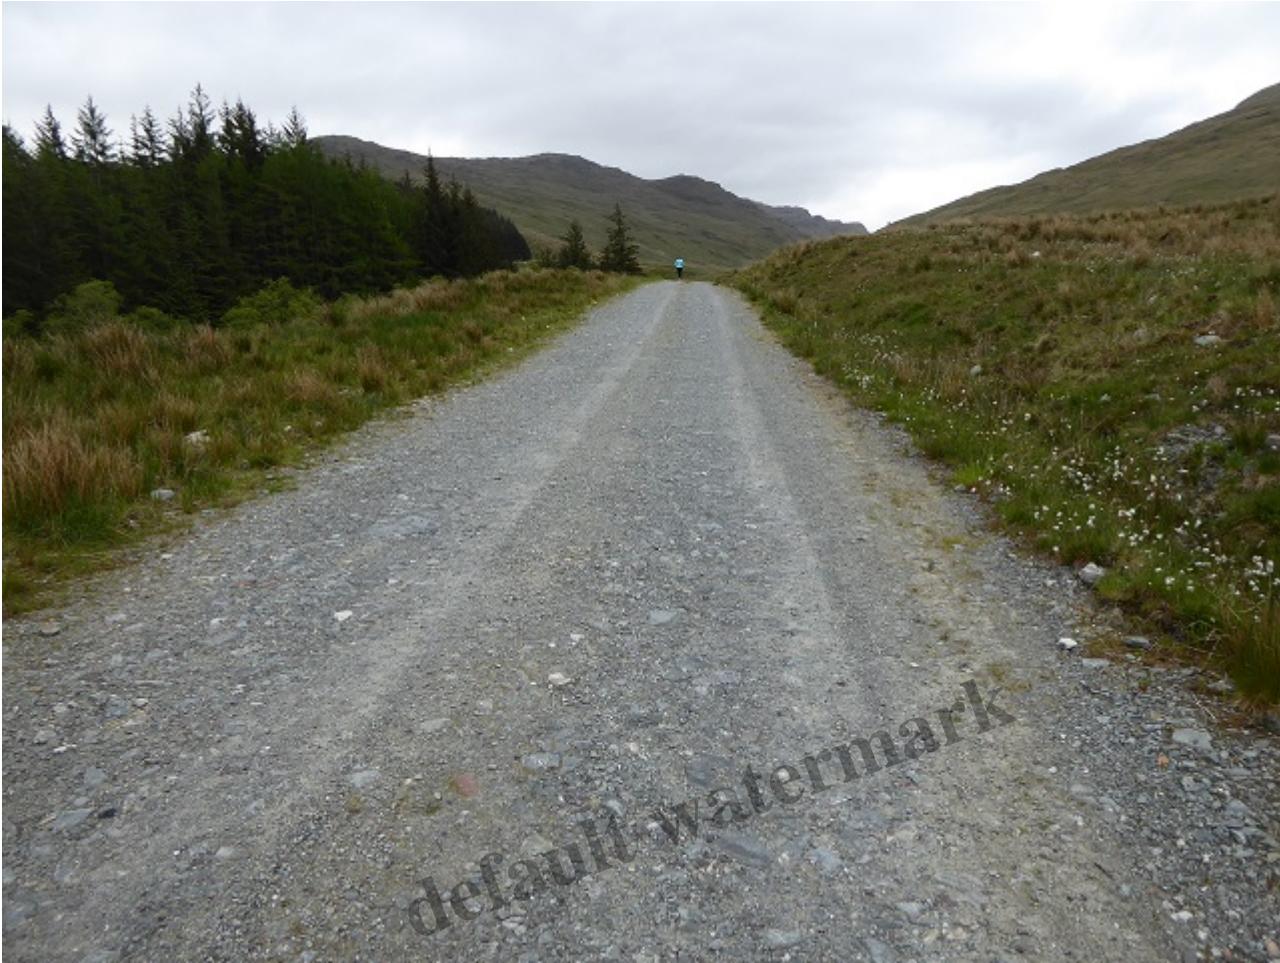
While efforts have been made to restore some of the edge of the road, its still much wider than the 2.5m maximum recommended in the Park's best practice guidance. As a consequence vehicles drive anywhere which effectively prevents a central grass strip, which would help reduce the visual impact, from developing.

- 5. Where existing tracks were widened, the LLTNPA needs to ensure that all the restoration meets the standards set out in its good practice guidance. Tracks which are broader than the maximum and unfinished culverts for example should not be tolerated.*

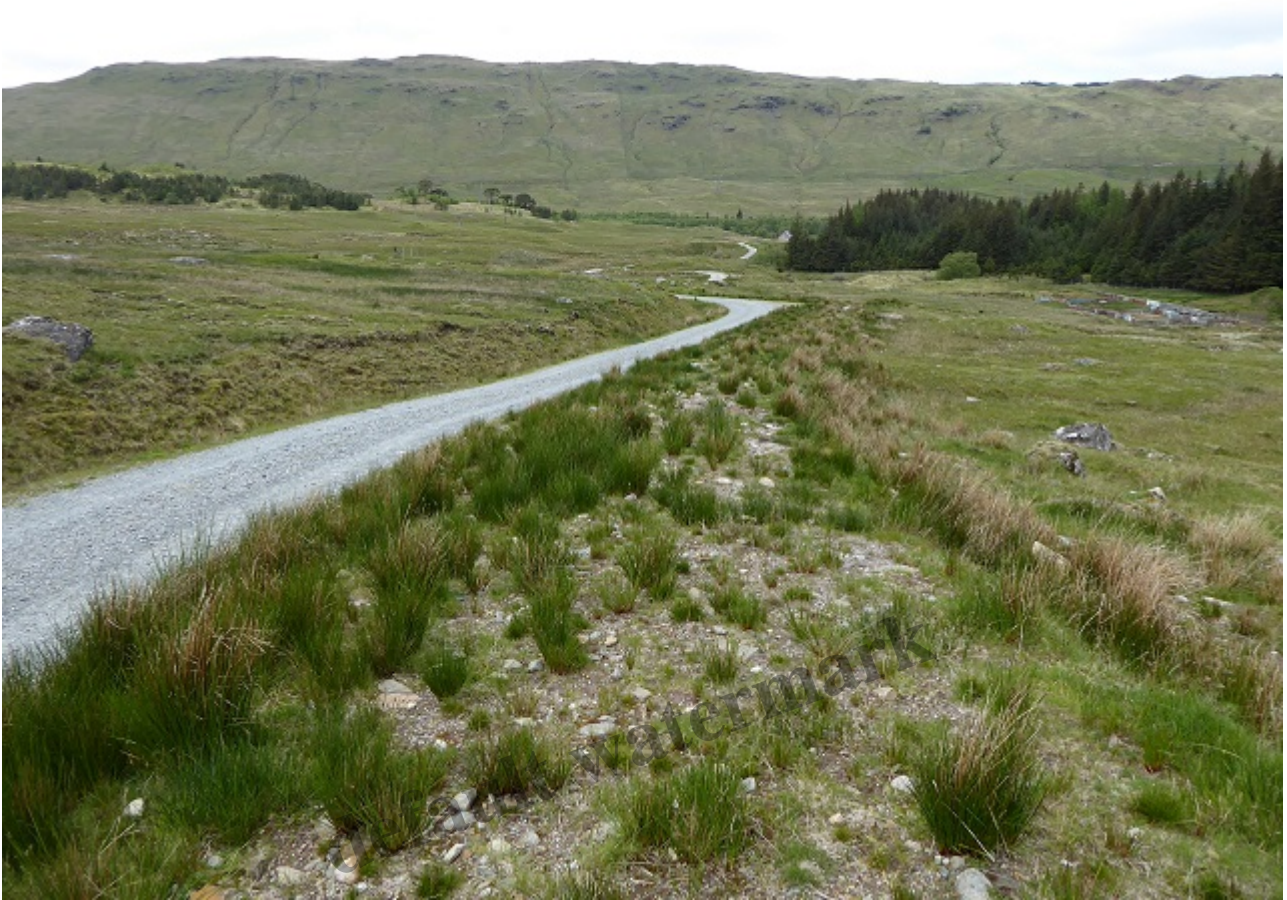
Looking back north along the road to the powerhouse.

Instead of retaining the vegetation and turf which was excavated during the creation on the construction track and using it to restore the ground, the newly exposed mineral soils have been left bare, grazed and as consequence colonised by a broad band of rush. Arguably, that's the worst ecological outcome possible. Either rough grazing or pinewood regeneration would have been far more preferable. At Keltie Water the broad band of rush above the former water pipeline is still there despite the pipeline now having been decommissioned. This suggests the impact of poor restoration on the vegetation is likely to be permanent. The LLTNPA should be commissioning research on this rather than ignoring the issue.

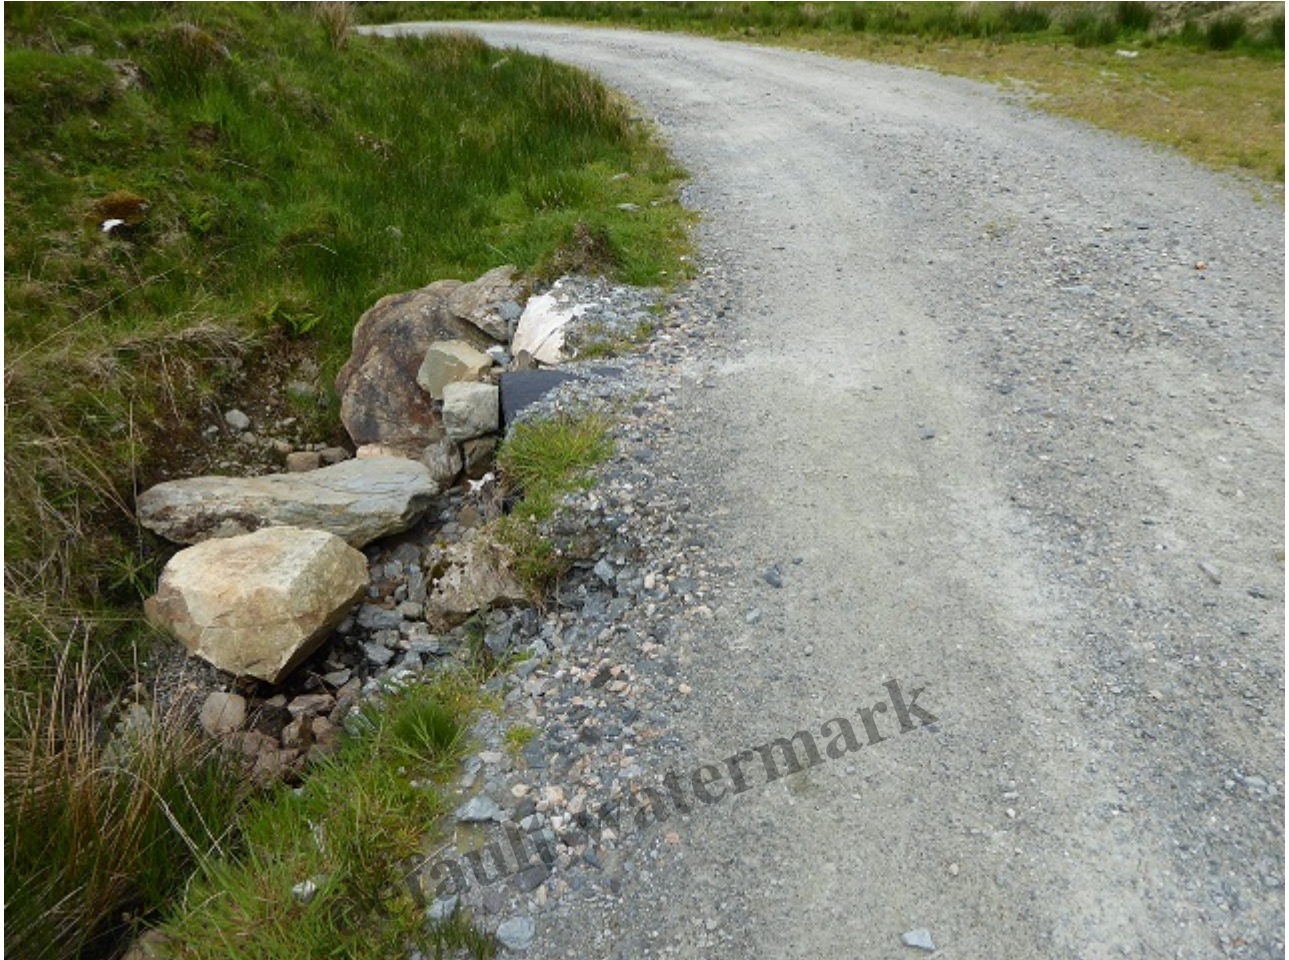
Collapse stone revetement by culvert. Note how the edge of the road in front of the culvert is now eroding into the burn.

While there had been an attempt to improve the finishing to the culverts under the road since my last visit, some of the work was of poor quality and had already collapsed.

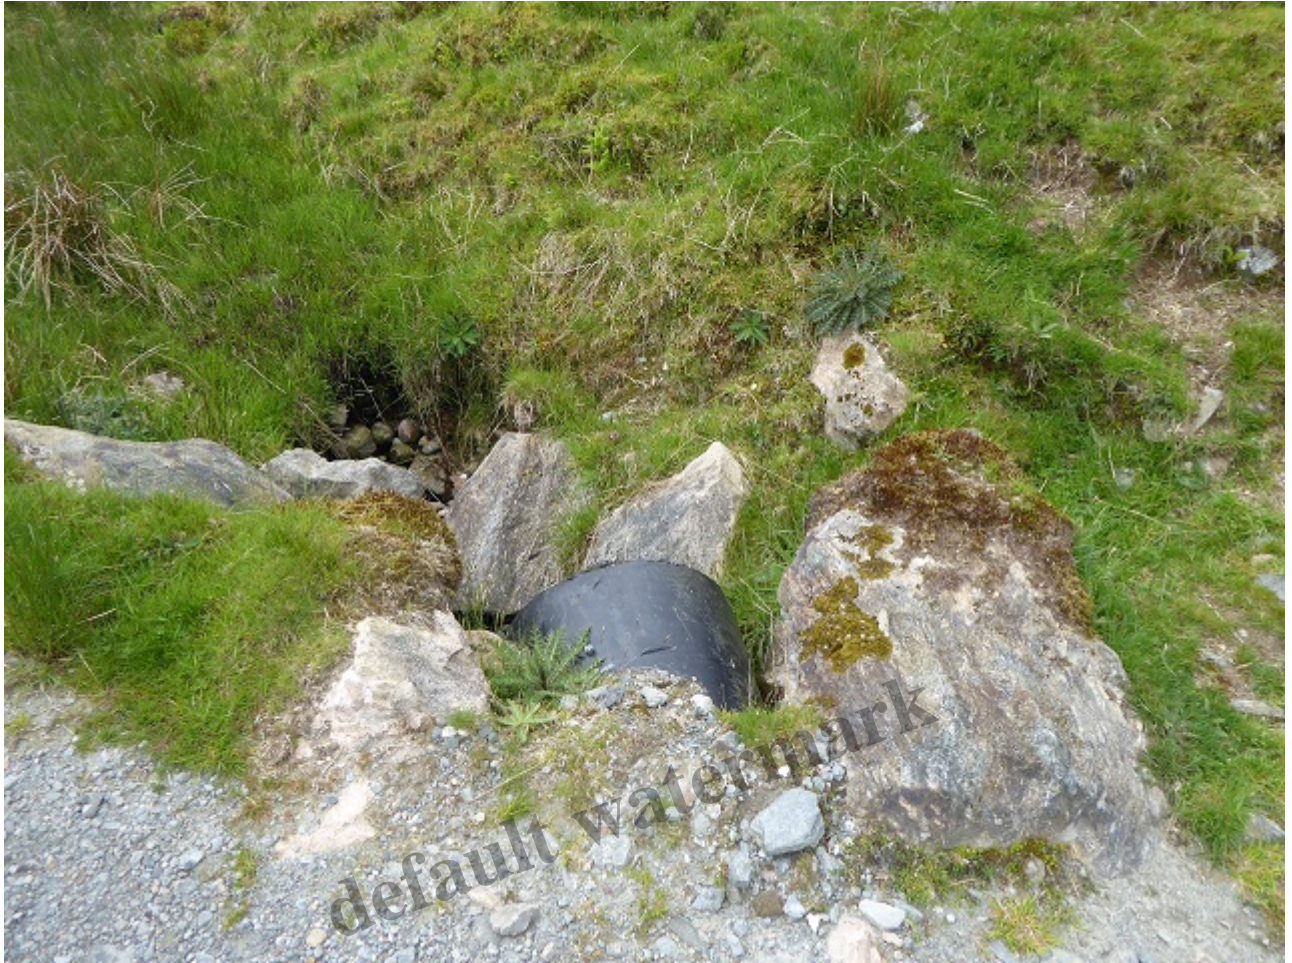
Another collapsed culvert headstone

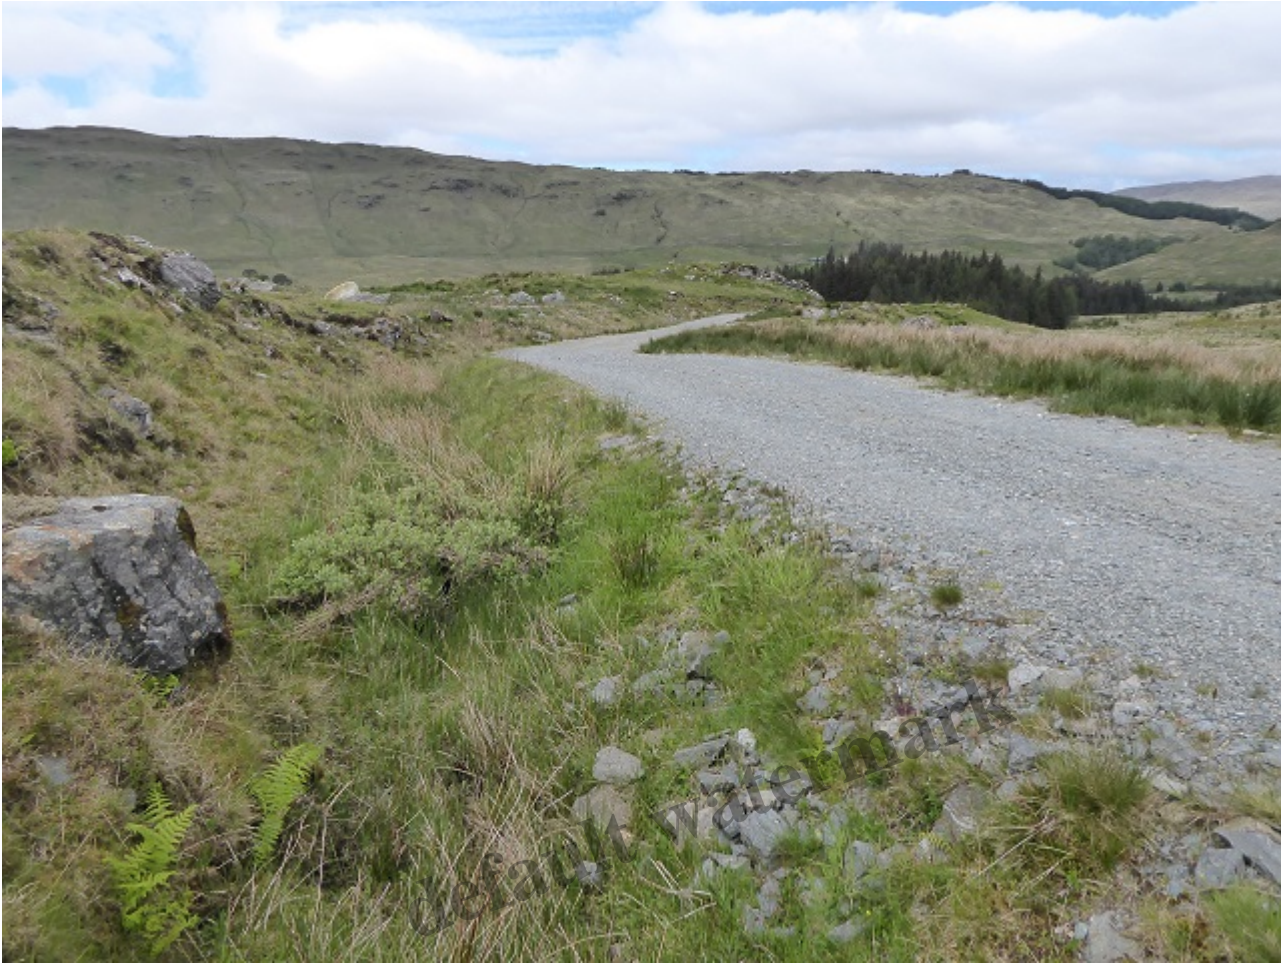
On the positive side, many sections of the drainage ditch at the side of the track had been restored and were covered in quite dense vegetation which will help reduce future erosion. This is one aspect of the Upper Falloch scheme which is rarely seen elsewhere and should be highly commended.

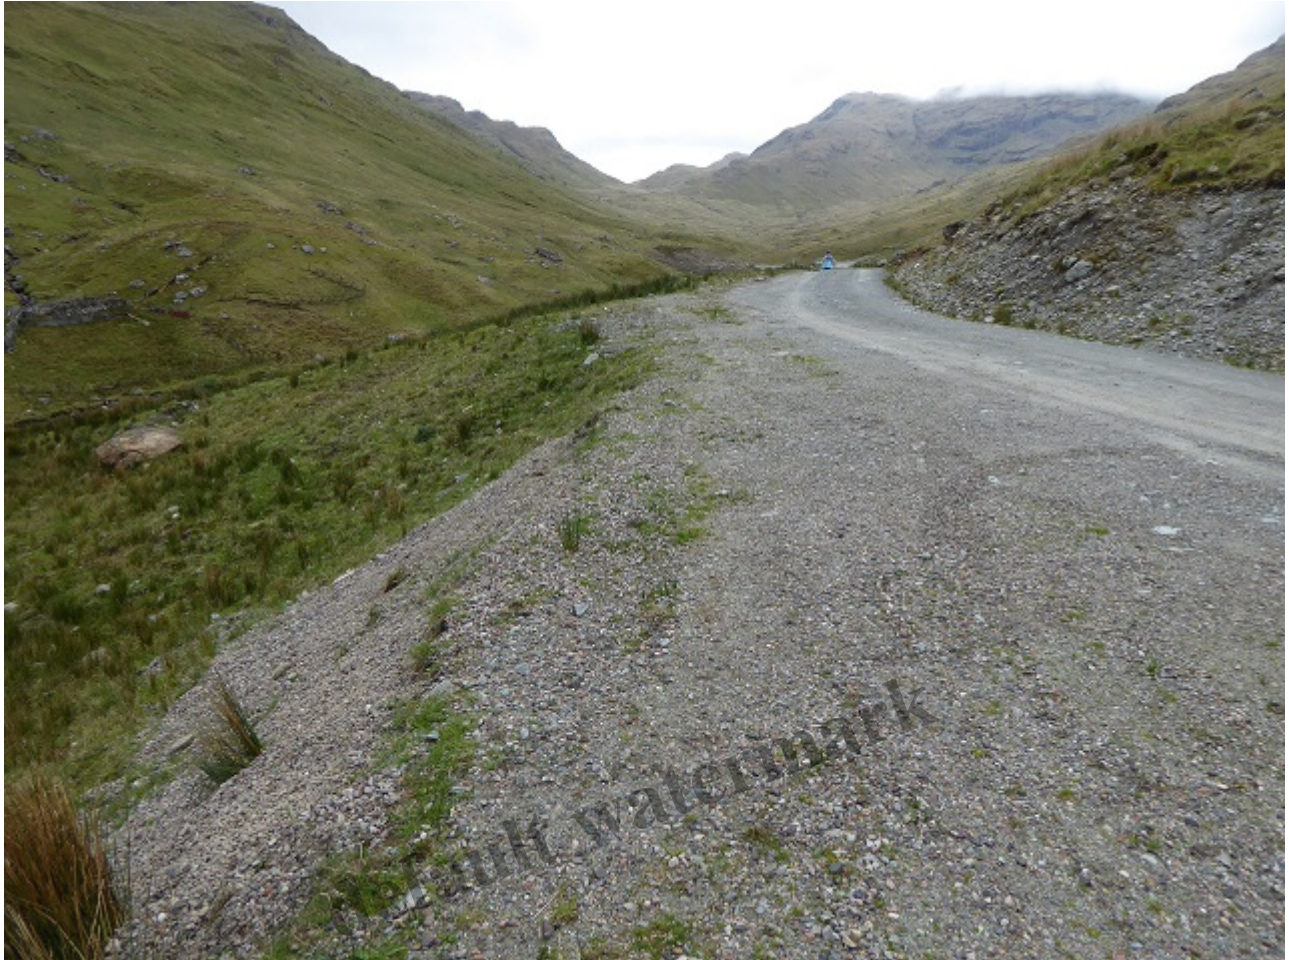
Spare material appears to have been dumped over the side of the track. Note the bare batter on the right where there has also been no attempt at restoration.

This section of the road was subject to the separate planning application to the LLTNPA (agreed in 2013) and they are therefore are solely responsible (i.e there was no Scottish Government involvement),

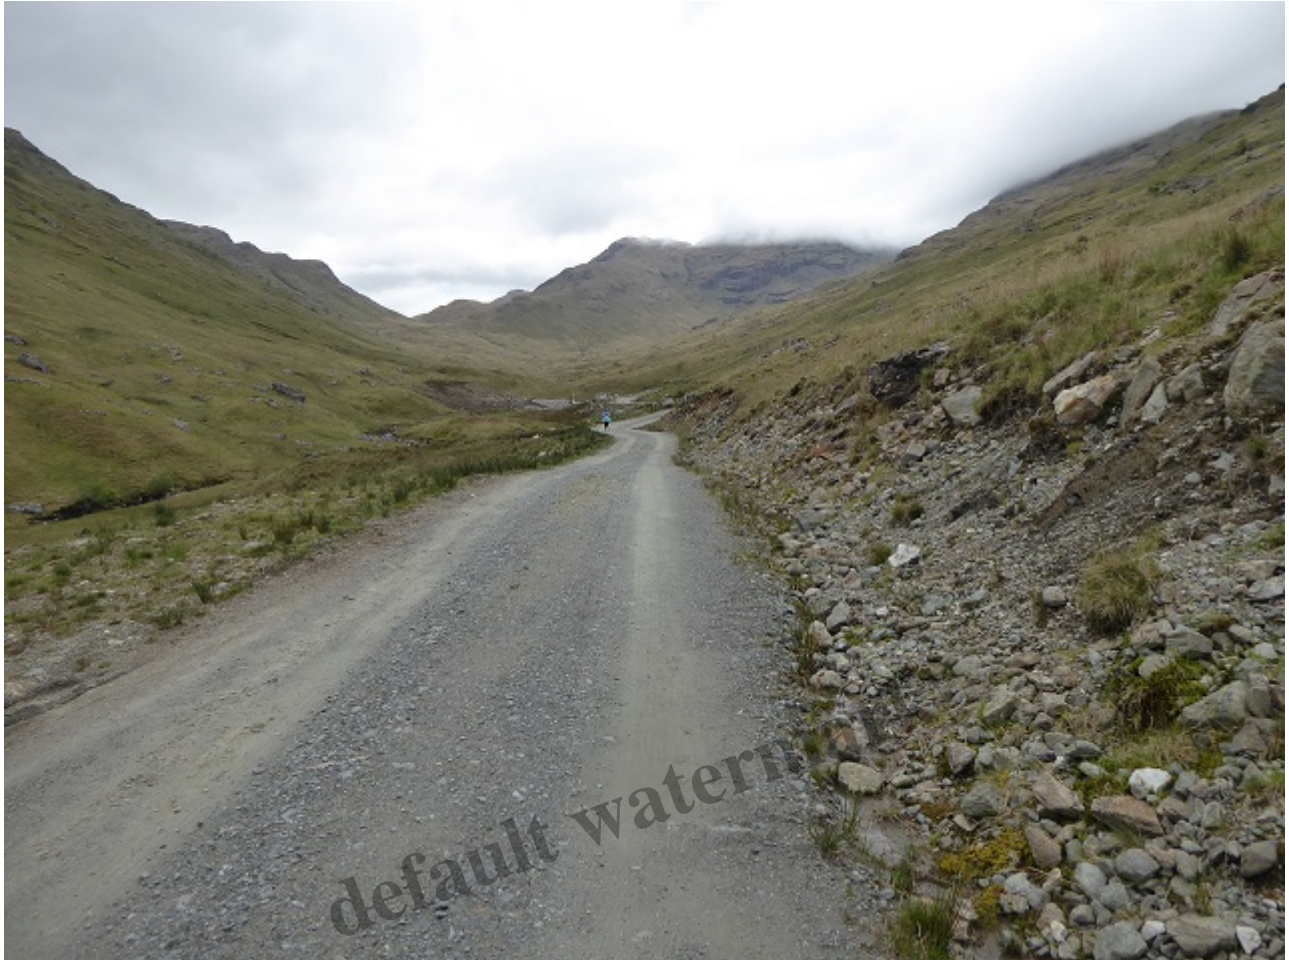
Looking towards hydro intake and Beinn a Chroin along final section of road. Note stones eroding out of unrestored bank on right.

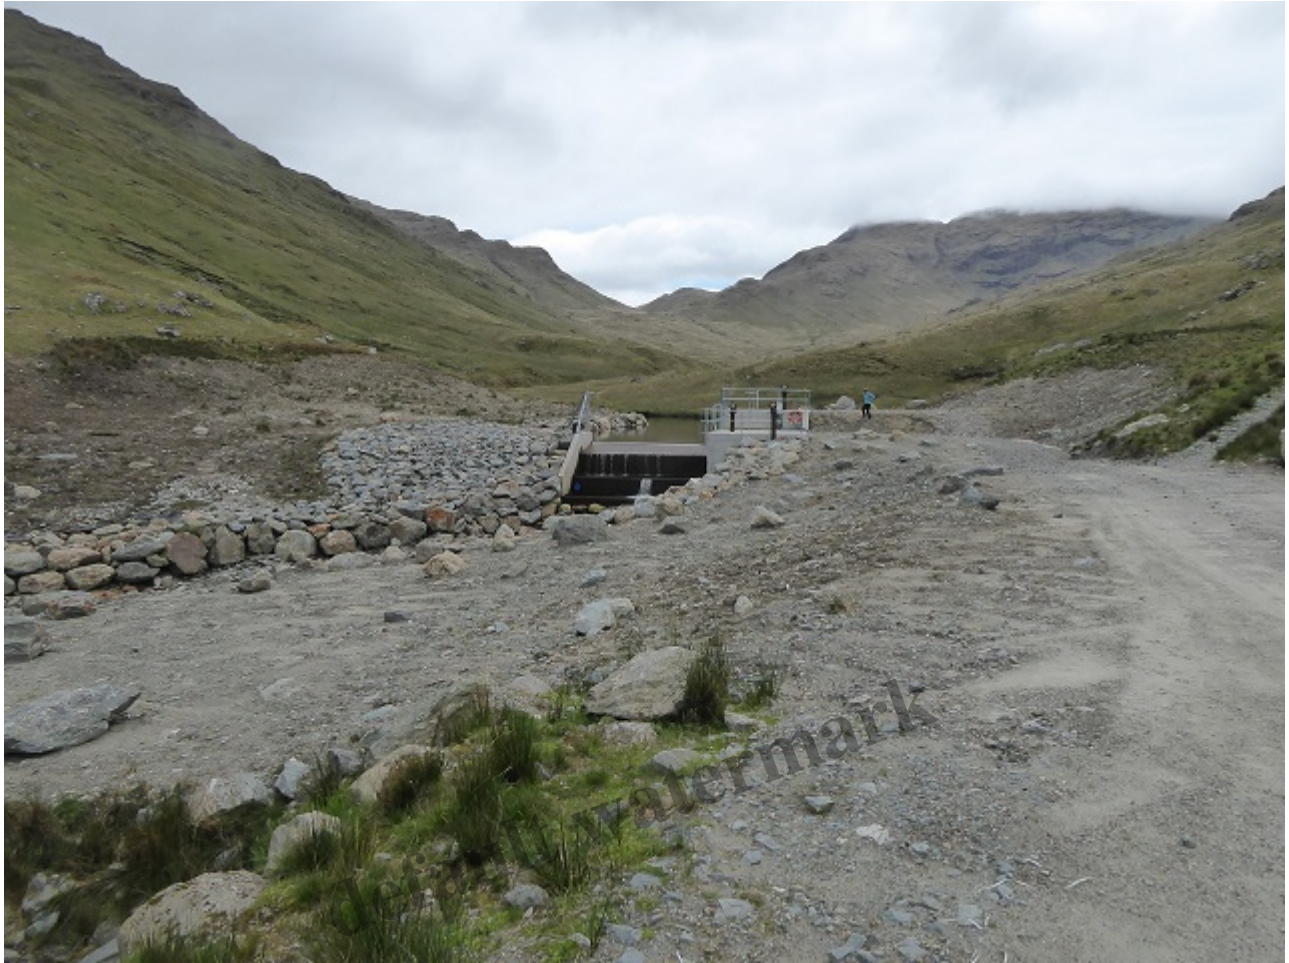
There were no boulders scattered over the bare area to the left of the road in 2017

This has resulted in some changes to the landscaping since 2017, though whether this will be any improvement is questionable. The bare area is likely to turn into a giant patch of rush. This again results from the failure of the LLTNPA and the Ecological and Landscape Clerks of Works to ensure that turf and vegetation was properly stored at the time of the original construction for restoration purposes. Had it been, it could have been relifted and then replaced over this large bare patch

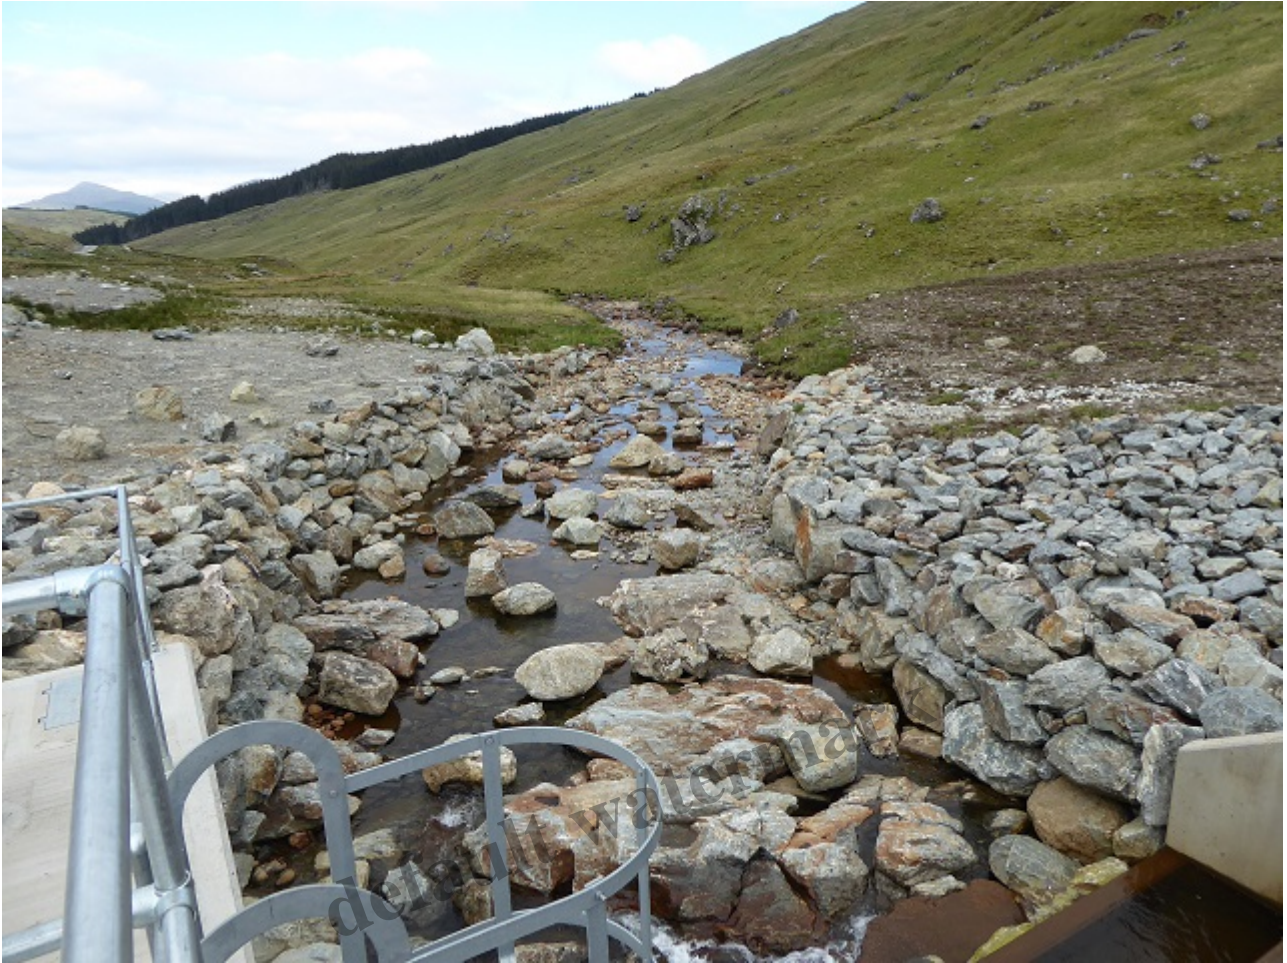
The fundamental issue, however, is the extent of the rip-rap bouldering which has been used to shore up the banks of the intake and the banks of what remains of the once proud river below.

View downstream from hydro intake. The scattered boulders on the bare patch appear to be “landscaping”.

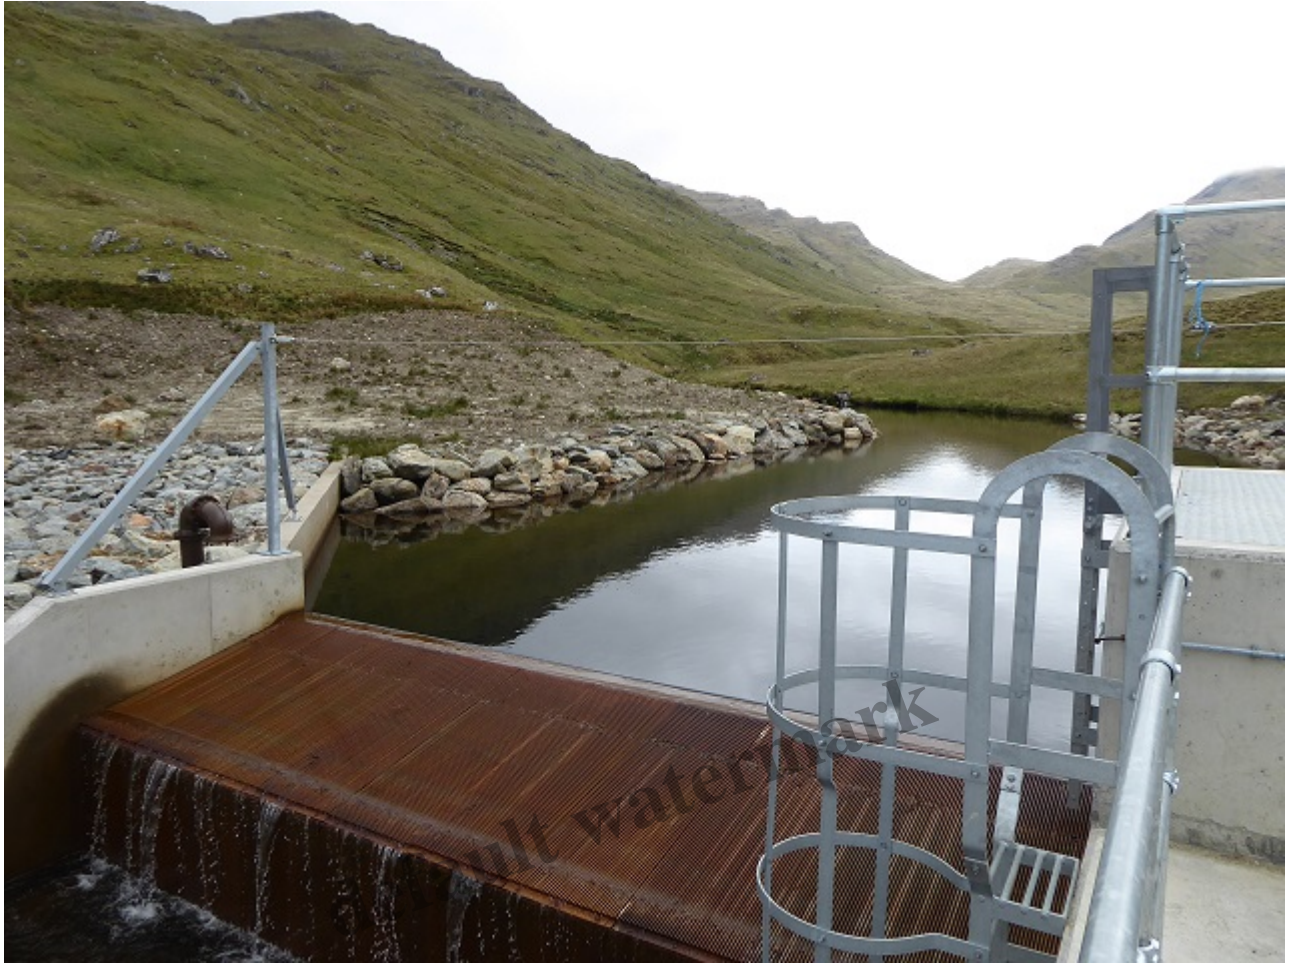
View upstream from hydro intake – at least the pipe on the left has been painted brown!
