Hydro schemes and the failure of the planning system in the Loch Lomond and Trossachs National Park

The Upper Glen Falloch hydro scheme

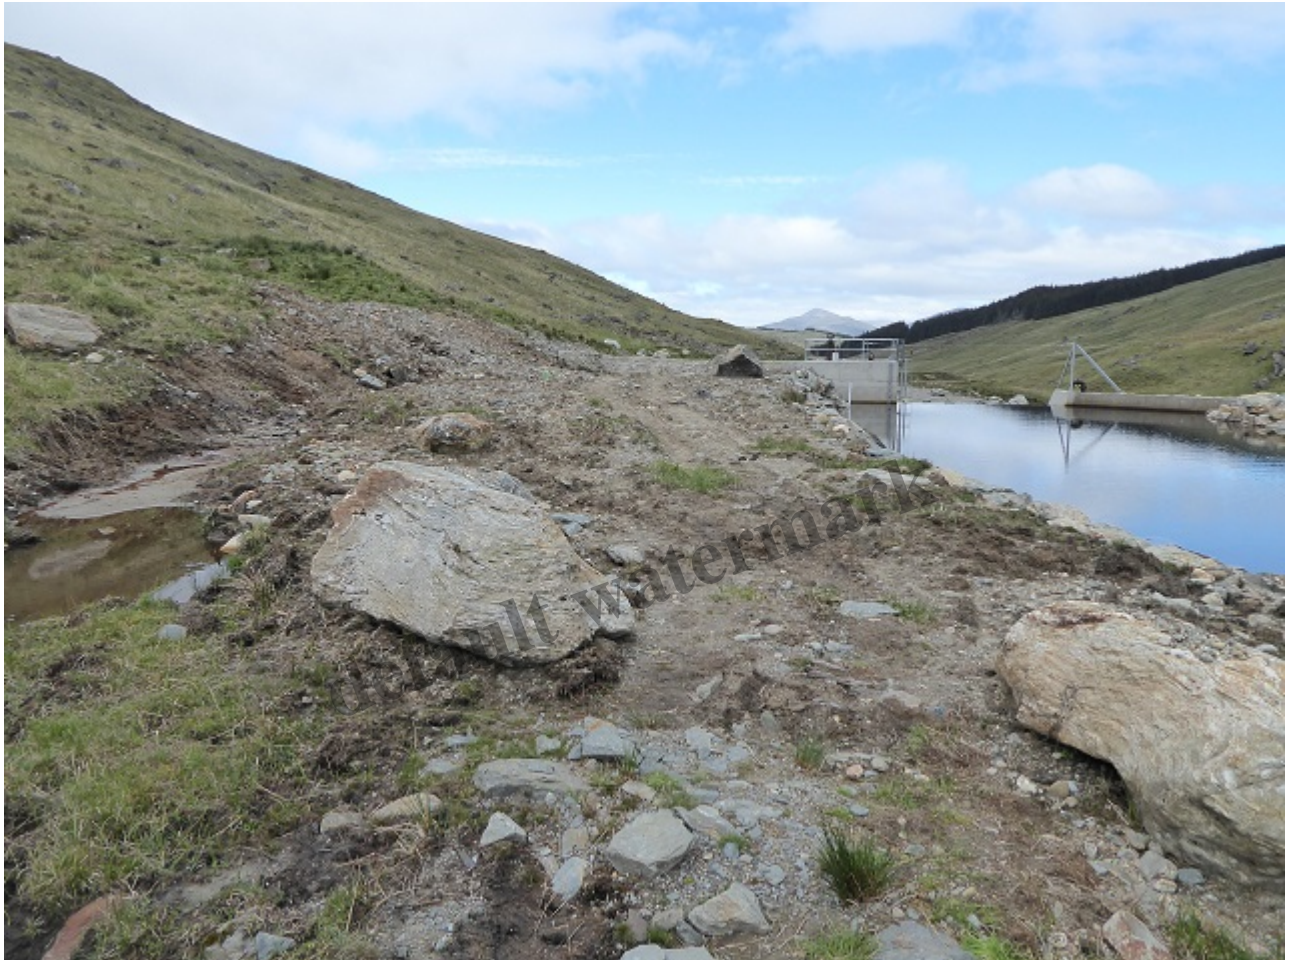
View back down intake. The extent of the visible rip rap bouldering above the intake appears to be less than in 2017, a slight improvement. Soil and vegetation appears to have been taken from bank on left to help restore the ground. Note how the two boulders have been carefully spaced to allow ATVs to travel further up the glen, creating more vehicular damage. Unfortunately, vehicles have then been driven across this destroying much of the restoration work.

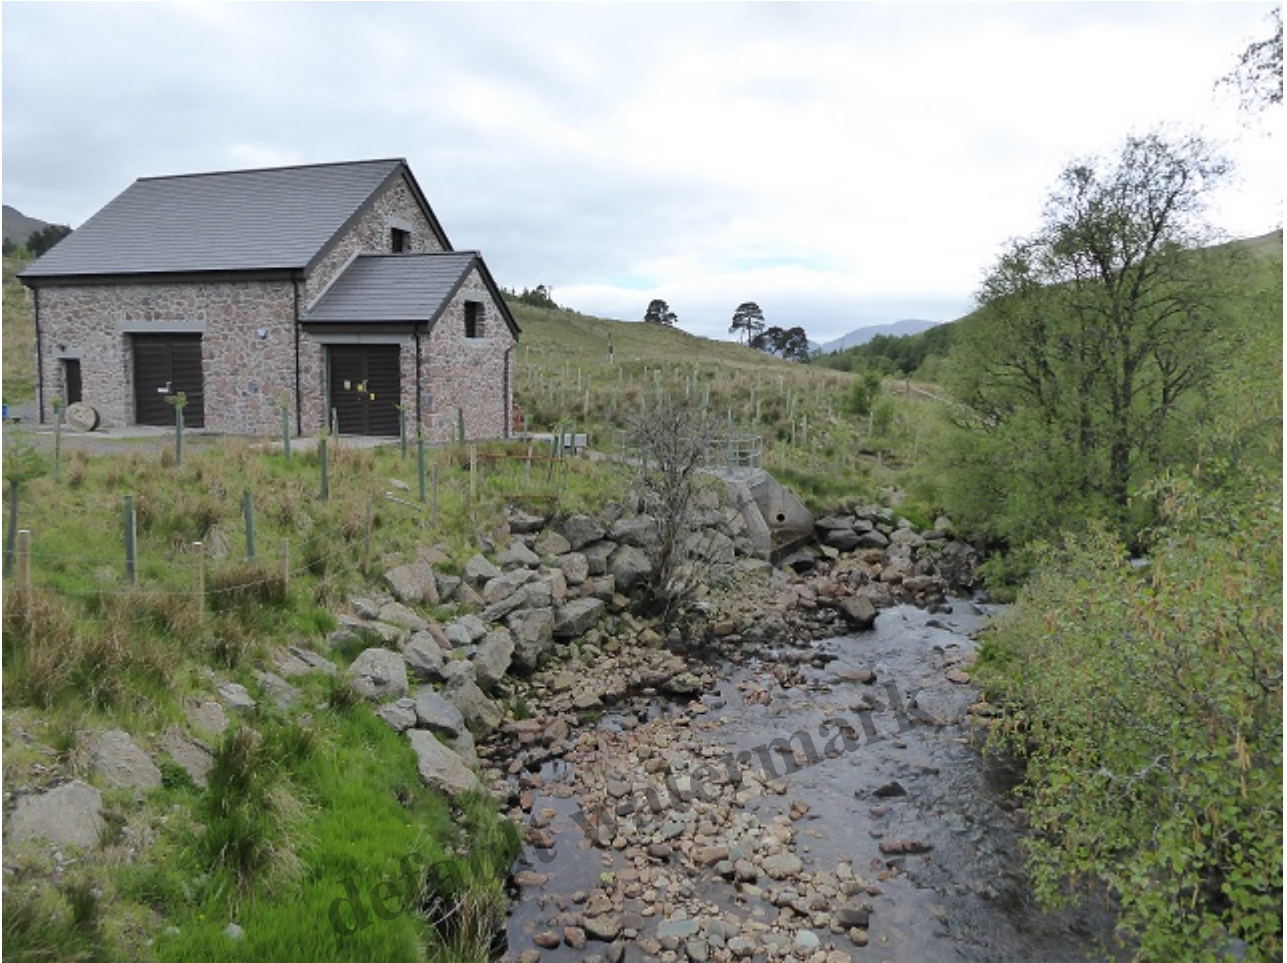
Hydro outflow on the day of my visit – dry!
