Hydro schemes and the failure of the planning system in the Loch Lomond and Trossachs National Park

The Upper Glen Falloch hydro scheme

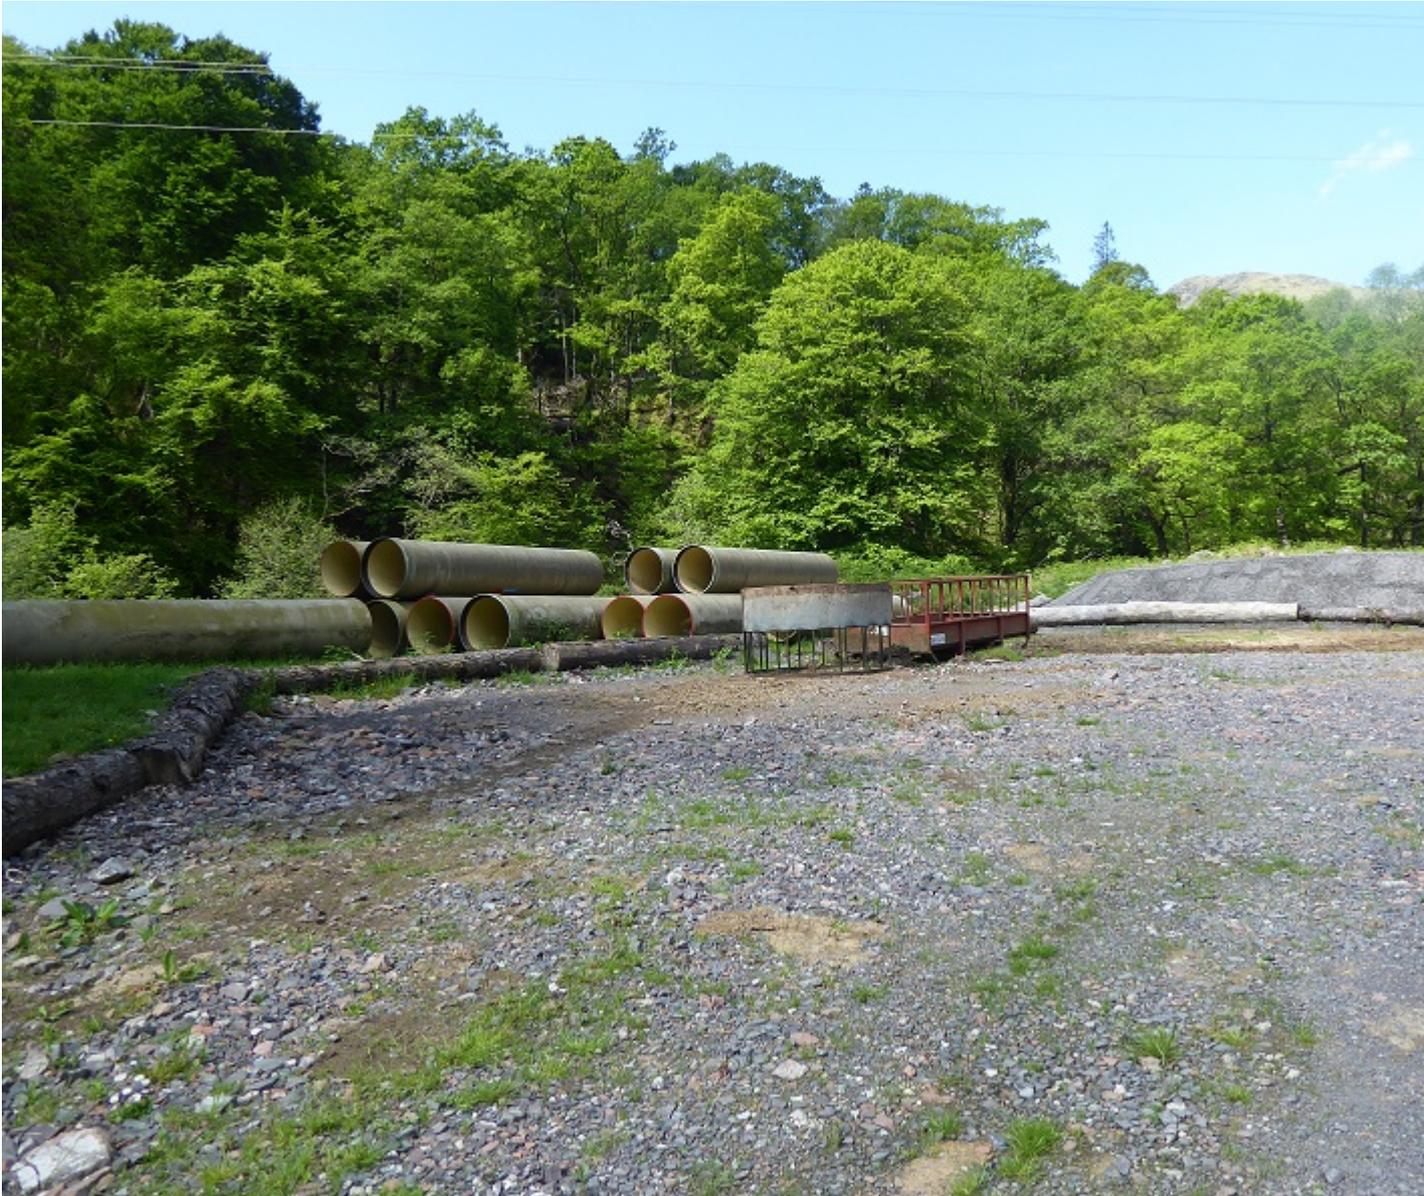
Abandoned hydro pipes and unrestored laydown area from Allt Fionn hydro scheme in Glen Falloch. LLTNPA received a Scottish Quality Award in planning for this scheme back in 2015 – the pipes are still there in 2019!

I responded to James Stuart with a further email ([see here for full text](#)) pointing out that the abandoned detritus at the Allt Fionn hydro scheme (photo above), which HAD received a planning quality award five years ago, was even worse. I also raised the need for the LLTNPA to conduct an audit of all the 45 or so hydro schemes constructed in the National Park and offered to come to the Board and speak about this. While James Stuartâ??s reply ([see here](#)) was effectively a brush off and written in the usual quango speak, it did admit that the Parkâ??s Planning team is not properly resourced:

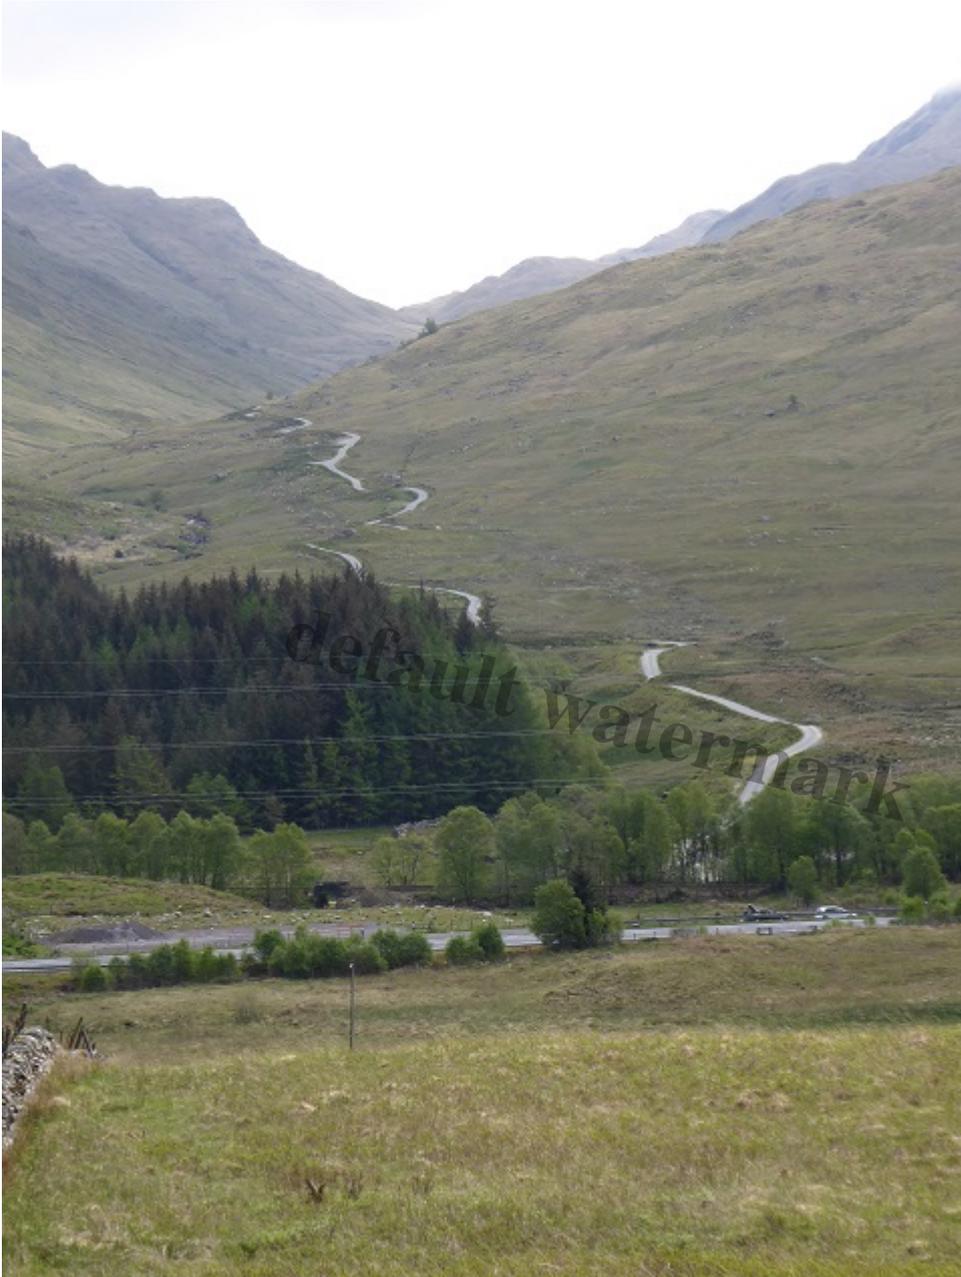
The first two sections of the upper Glen Falloch hydro road viewed from just below the West Highland Way

The hydro scheme has had a major landscape impact on Upper Glen Falloch. Most of this side glen was previously wild and unspoilt as is befitting for a National Park. Its wild character has been effectively destroyed through the widening and extension of the road and the disastrously designed and executed intake pool. While prior to the hydro scheme there was a road up the first section of the glen, the original planning application, which was approved by the Scottish Government on the advice of the National Park Authority, allowed it to be doubled in length. A further planning application for the temporary construction track from the road end to the intake to be made permanent was then approved by the LLTNPA.

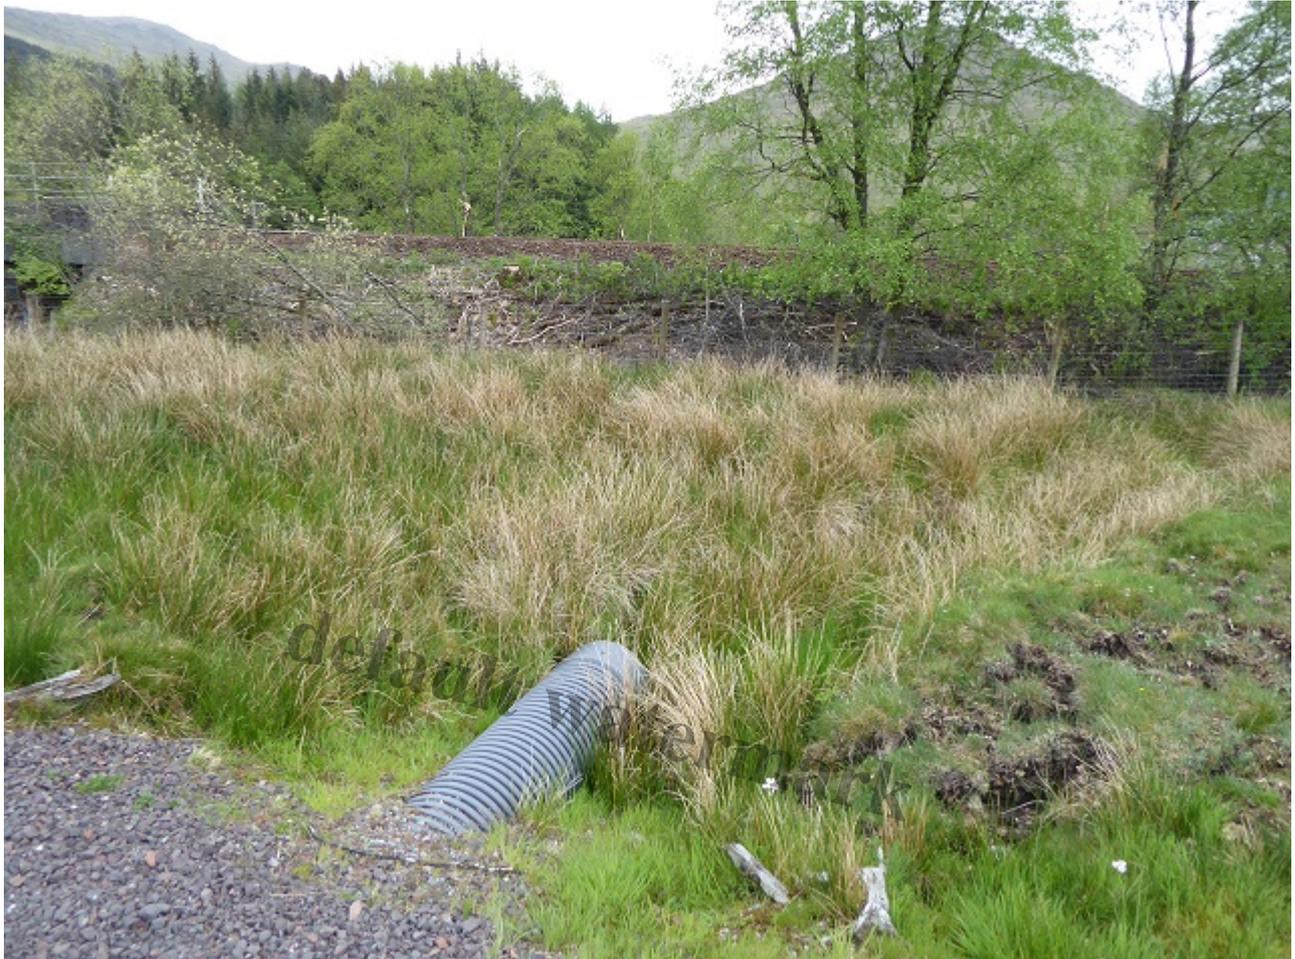
Protruding culvert on new section of footpath between the layby commonly used to access An Caisteal and Beinn a Chroin and the river Falloch

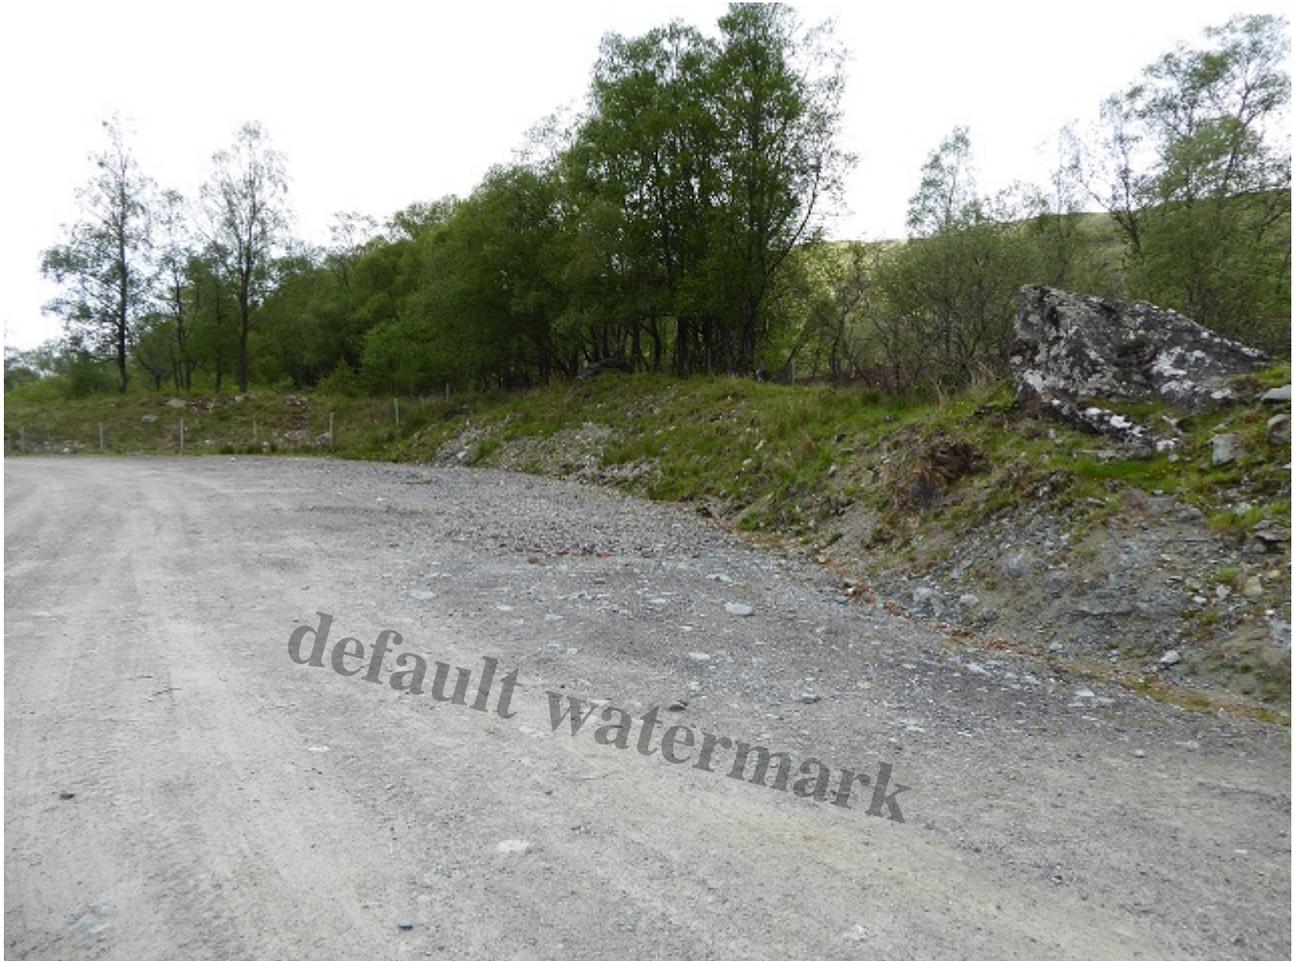
The hydro access road between the railway and river Falloch

Why has the start of the access road been left like this? The answer appears to be that its cheaper for the landowner and developer not to restore ground affected by construction and the LLTNPA has failed to take effective enforcement action. Unfortunately its not possible for the public to find out what the LLTNPA has tried to fix because it does not publish such information on the planning portal. This is not what one should expect for a National Park and does not meet the standards set out in the Park's own best practice guidance on renewables ([SPG-Renewables-final](#)).

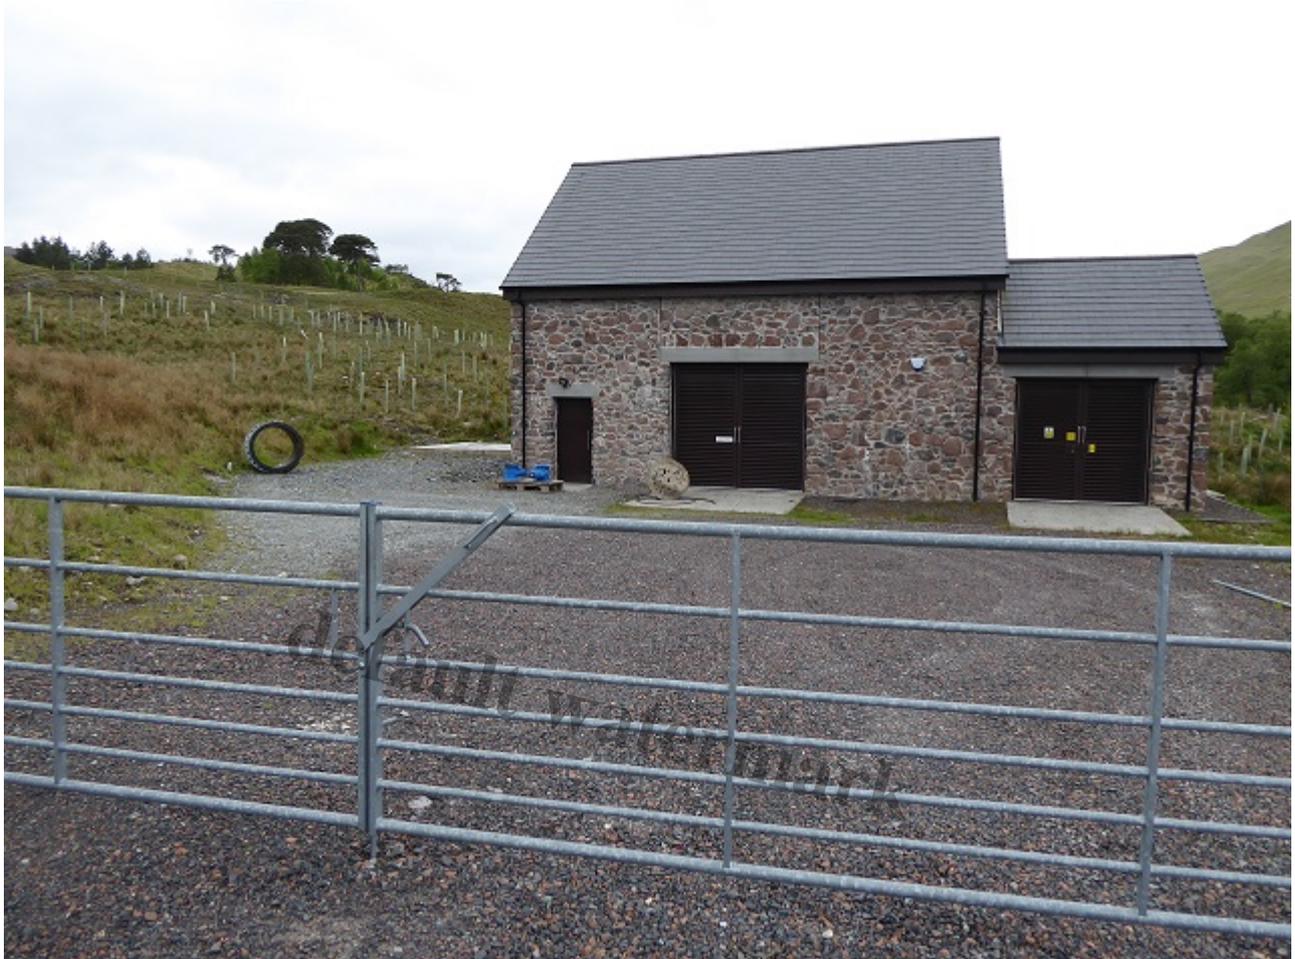
Only one dumped section of spare pipe unlike the schemes nominated for Scottish Planning Quality Awards! Glen Falloch Caledonian pine forest remnant visible behind.

The landscaping of the powerhouse leaves lots to be desired. The vehicle area is unnecessarily large, contrary to the Park's best practice guidance, again because it's cheaper for developers to cover ground with imported stone than to restore it. An opportunity to allow the Glen Falloch native pinewood to regenerate naturally, as recommended in the Park's draft Trees and Woodland Strategy ([see here](#)), has been lost and instead a fenced area around the powerhouse planted.

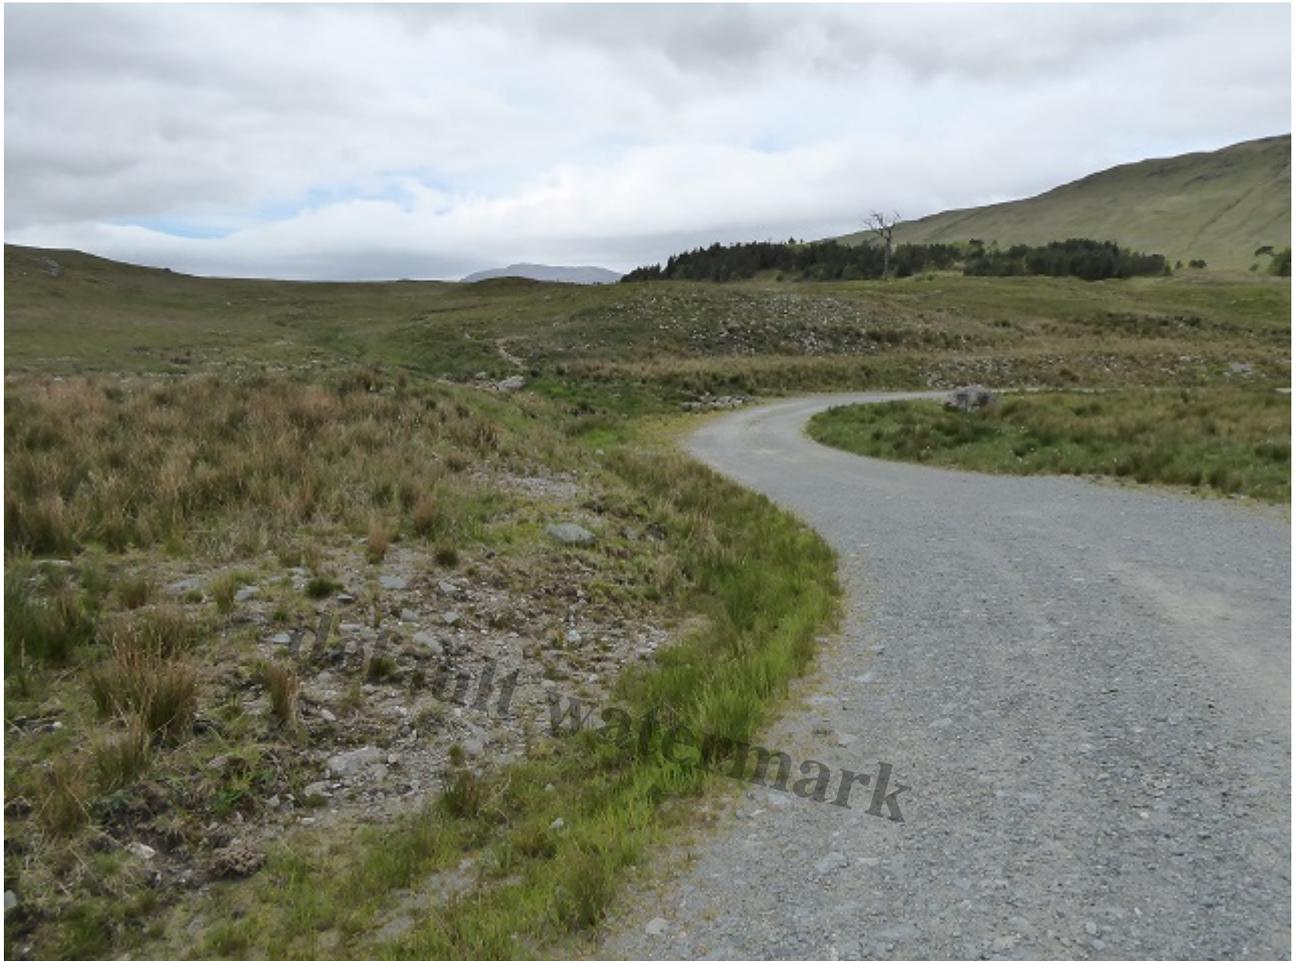
Dead pine visible in front of (fence) native pinewood illustrating that the forest not so long ago extended up the glen to the hydro track. Mineral soils, created by the construction of the hydro, are clearly visible on the left of the track.

A much greater opportunity to allow the native pinewood to expand back up the glen and hide the eyesore of the first section of road has also been lost.

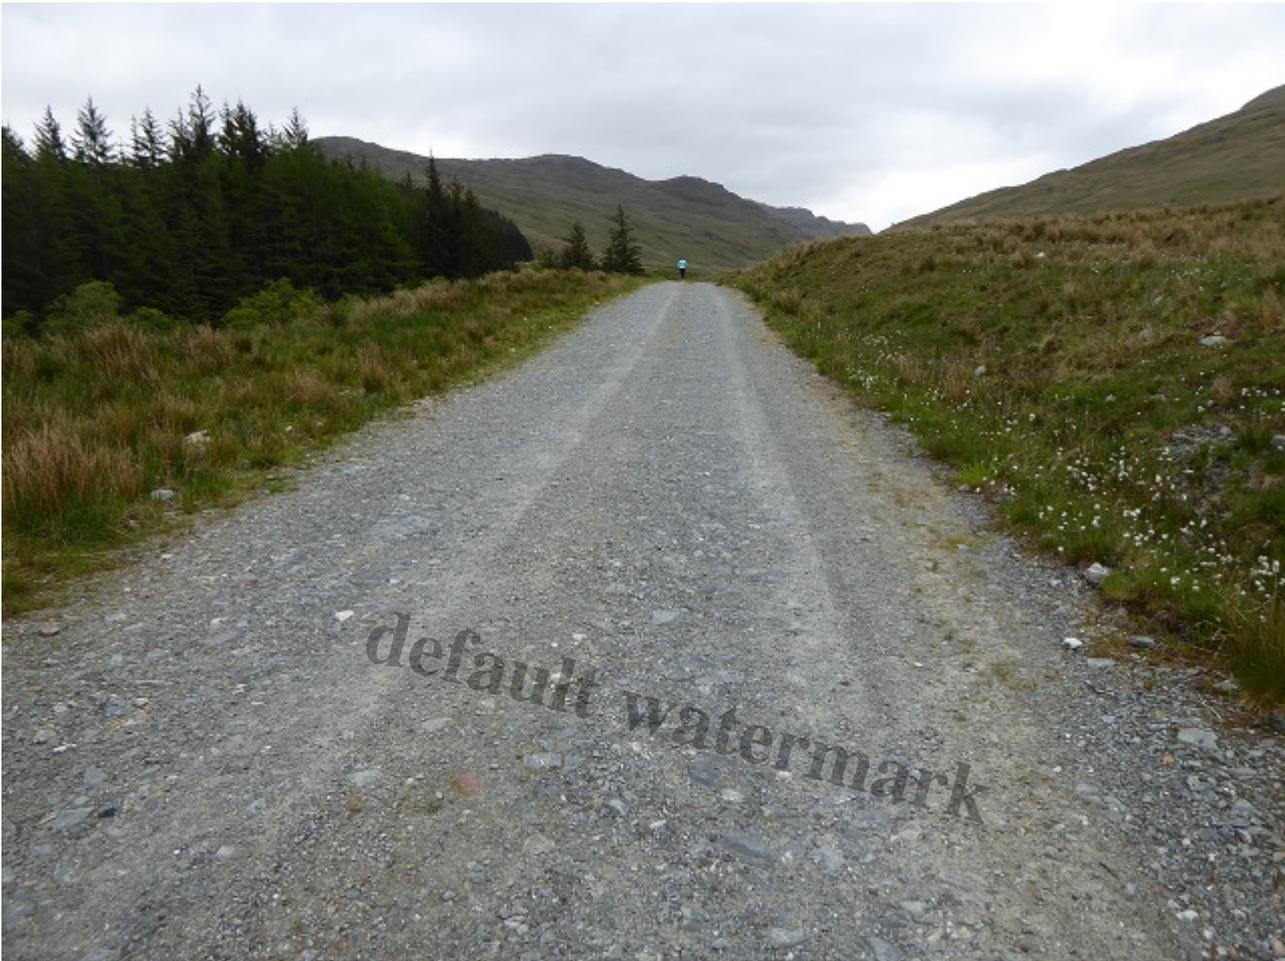
While efforts have been made to restore some of the edge of the road, its still much wider than the 2.5m maximum recommended in the Park's best practice guidance. As a consequence vehicles drive anywhere which effectively prevents a central grass strip, which would help reduce the visual impact, from developing.

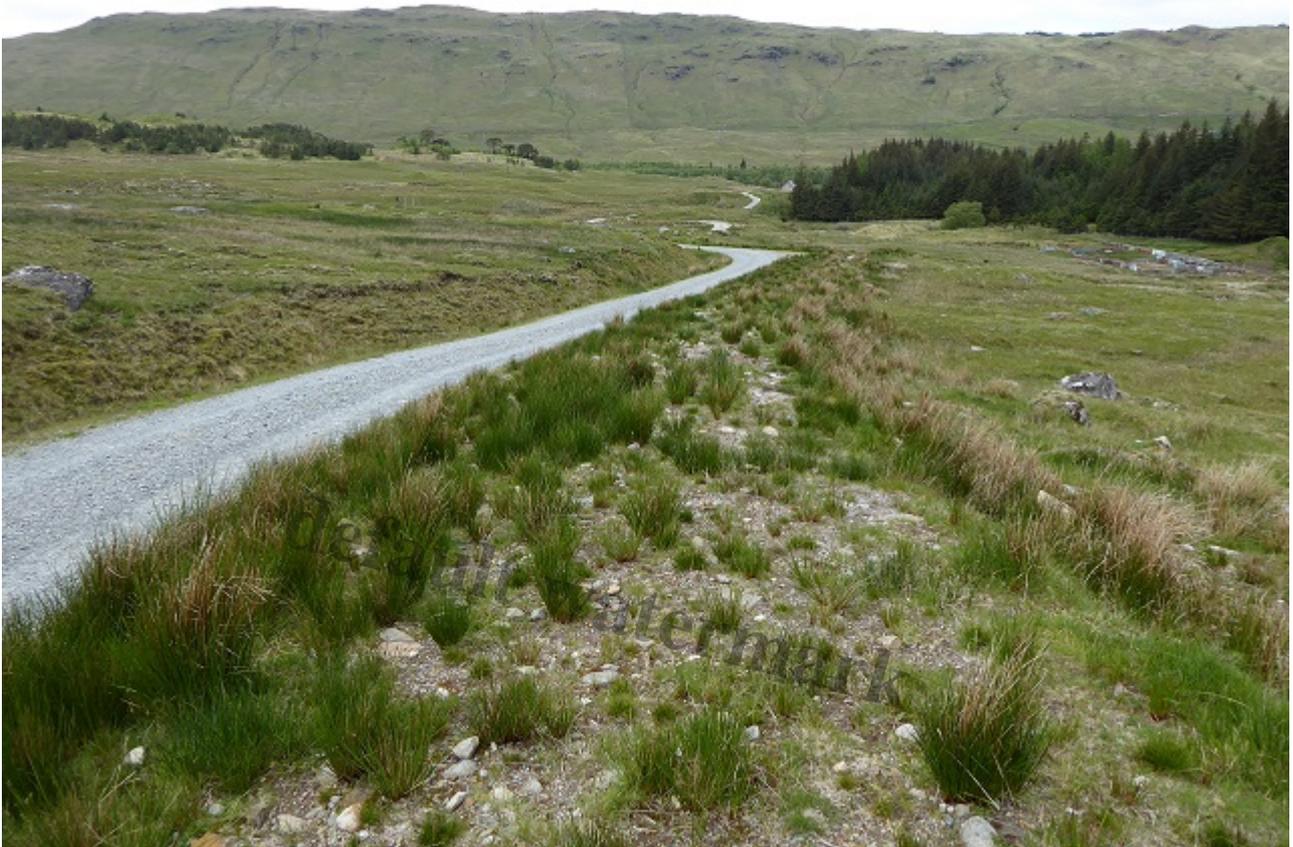
Looking back north along the road to the powerhouse.

Instead of retaining the vegetation and turf which was excavated during the creation on the construction track and using it to restore the ground, the newly exposed mineral soils have been left bare, grazed and as consequence colonised by a broad band of rush. Arguably, that's the worst ecological outcome possible. Either rough grazing or pinewood regeneration would have been far more preferable. At Keltie Water the broad band of rush above the former water pipeline is still there despite the pipeline now having been decommissioned. This suggests the impact of poor restoration on the vegetation is likely to be permanent. The LLTNPA should be commissioning research on this rather than ignoring the issue.

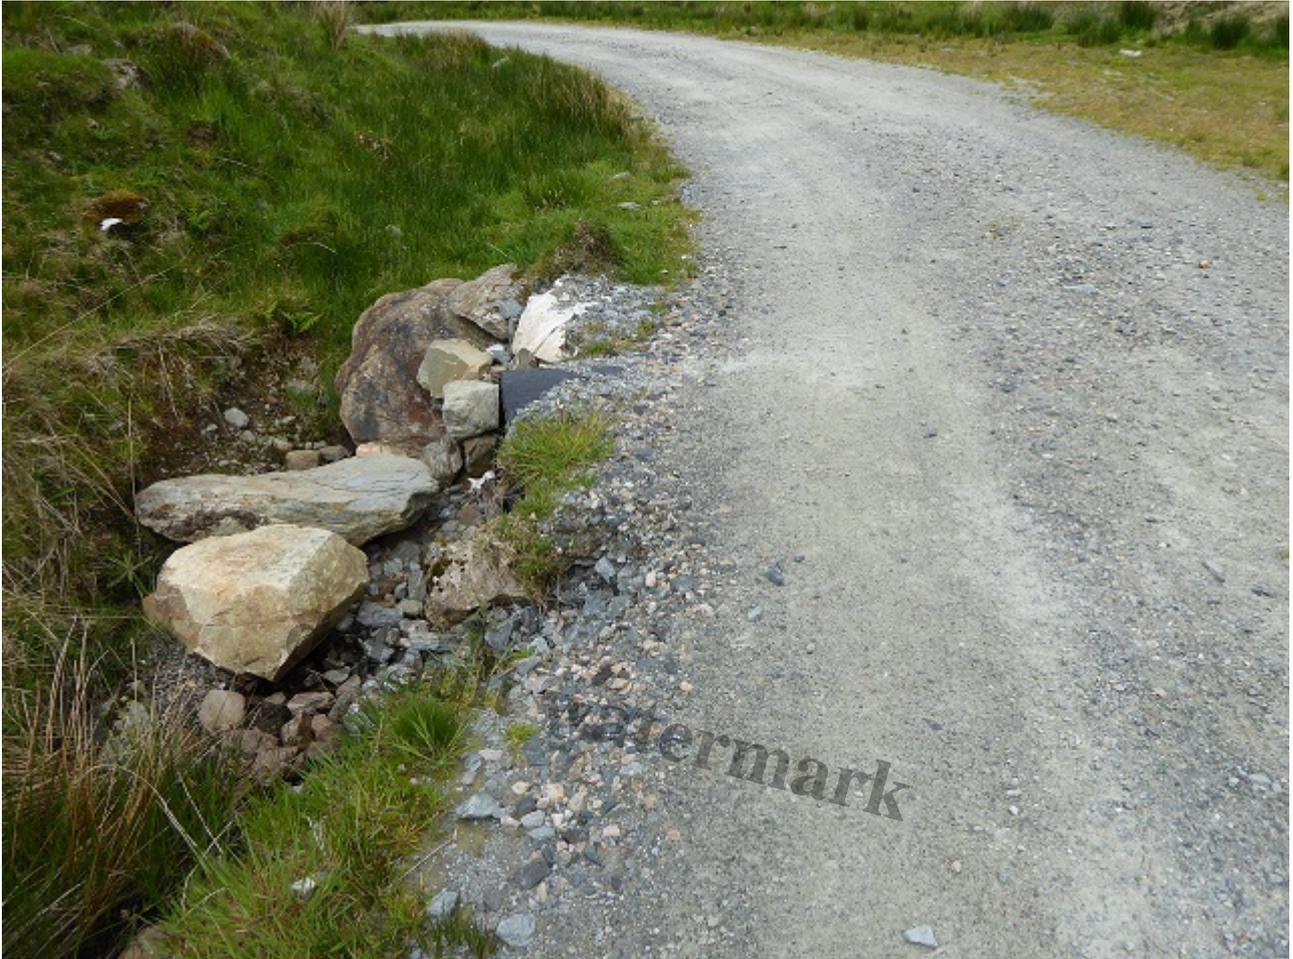
Collapse stone revetement by culvert. Note how the edge of the road in front of the culvert is now eroding into the burn.

While there had been an attempt to improve the finishing to the culverts under the road since my last visit, some of the work was of poor quality and had already collapsed.

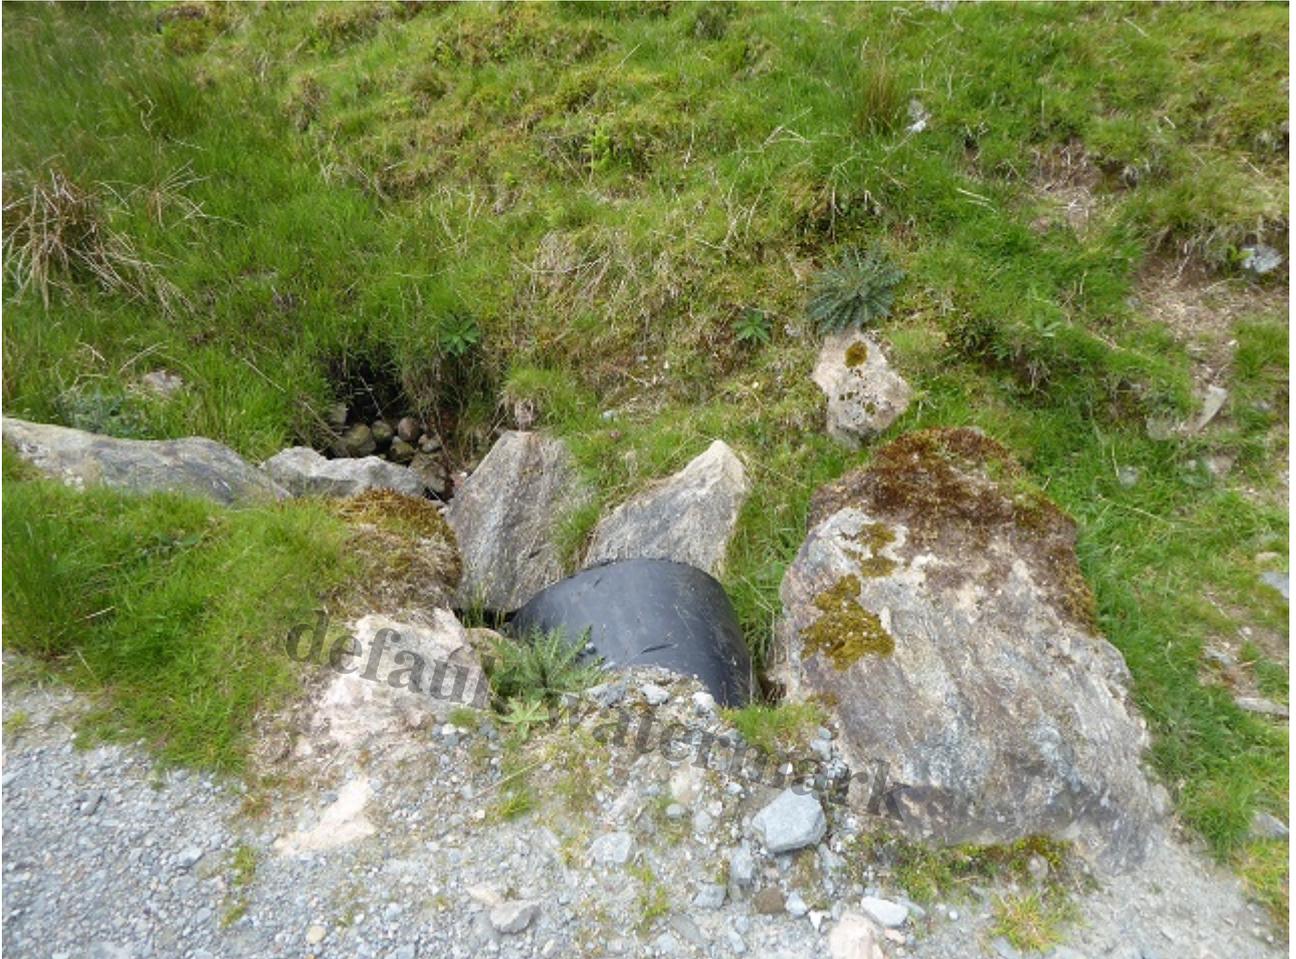
Another collapsed culvert headstone

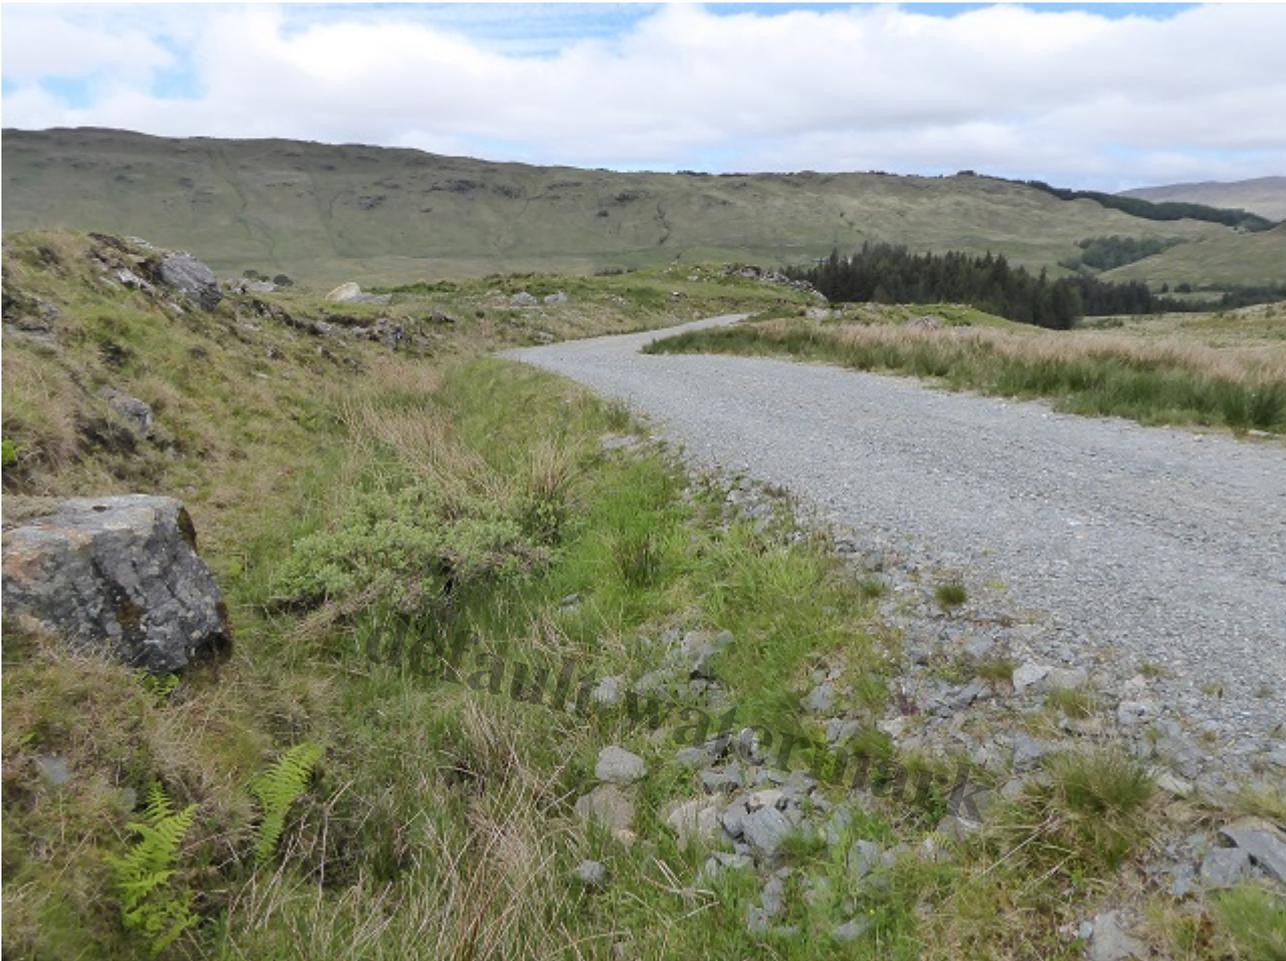
On the positive side, many sections of the drainage ditch at the side of the track had been restored and were covered in quite dense vegetation which will help reduce future erosion. This is one aspect of the Upper Falloch scheme which is rarely seen elsewhere and should be highly commended.

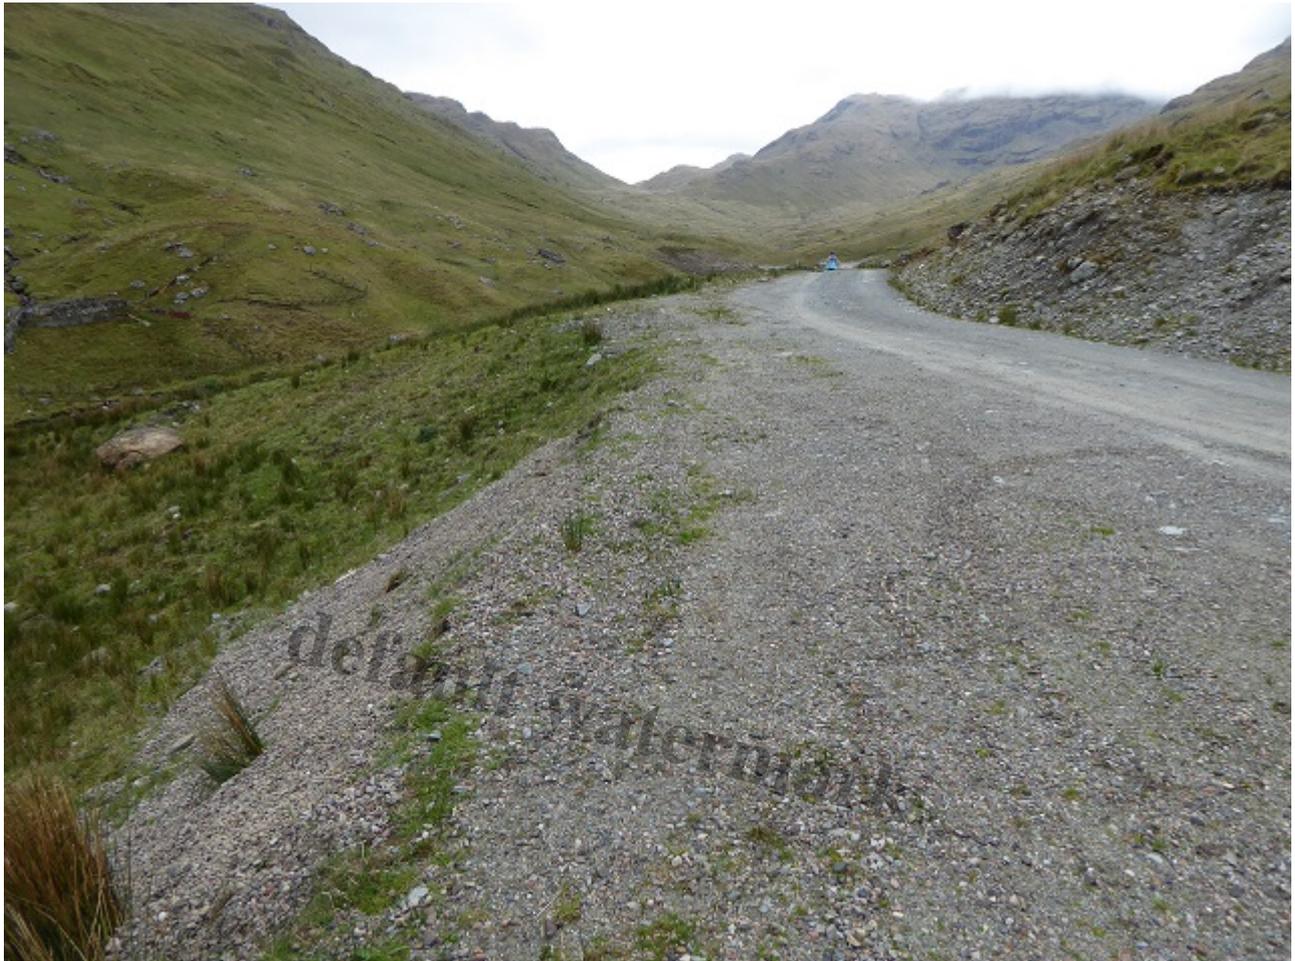
Spare material appears to have been dumped over the side of the track. Note the bare batter on the right where there has also been no attempt at restoration.

This section of the road was subject to the separate planning application to the LLTNPA (agreed in 2013) and they are therefore are solely responsible (i.e there was no Scottish Government involvement),

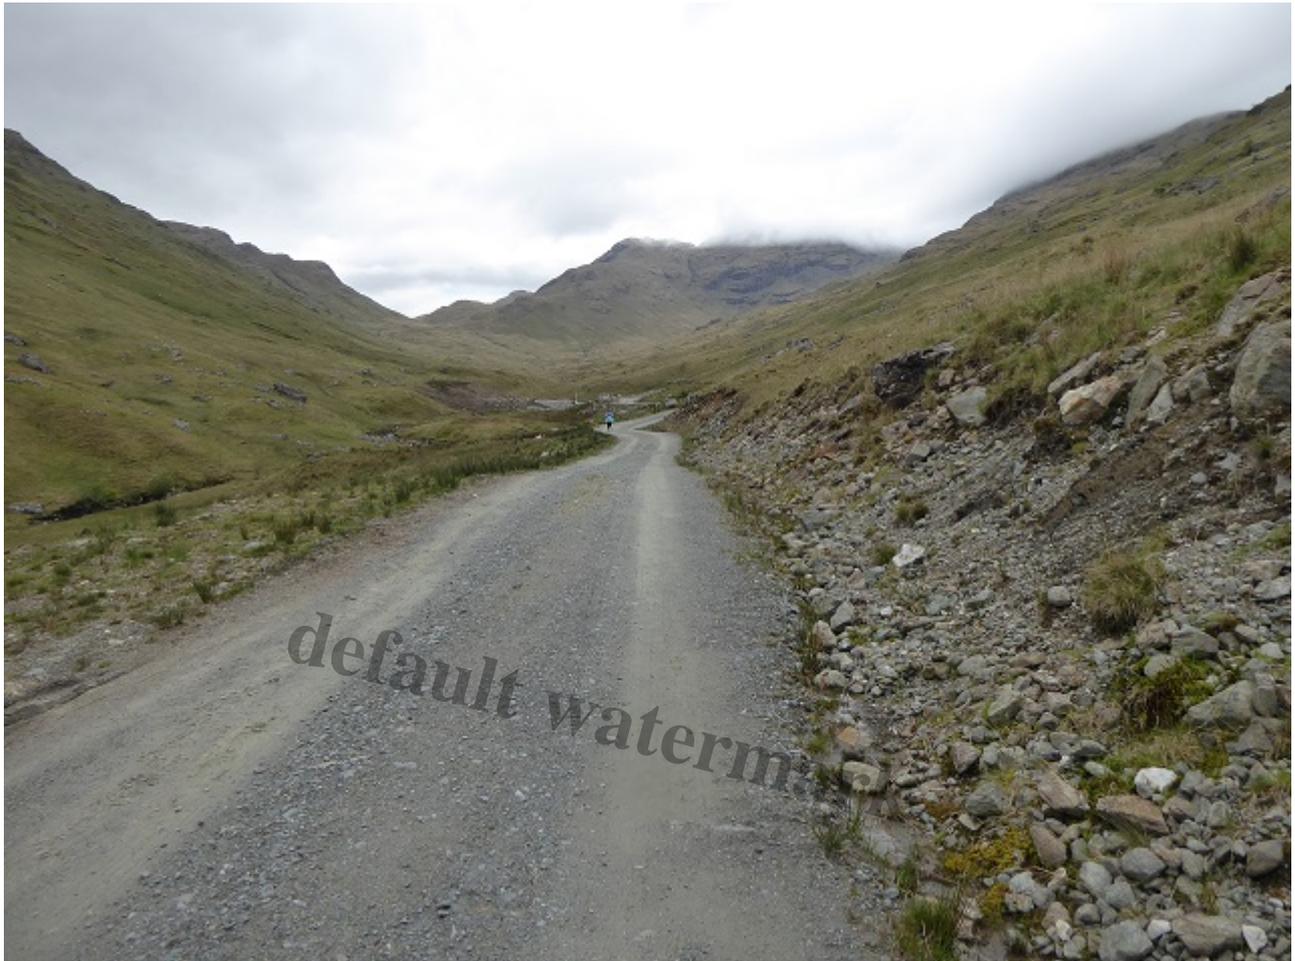
Looking towards hydro intake and Beinn a Chroin along final section of road. Note stones eroding out of unrestored bank on right.

The hydro intake and surrounding area is an even greater disaster. The hydro was not functioning to full capacity because of a design flaw so last year the LLTNPA granted planning permission for the size of the stilling chamber *to improve the hydraulic efficiency of the structure*• ([see here](#)). This required extensive engineering works, including diverting the river again and meant that the recolonisation of vegetation that had taken place on the site, such as it was, had to start all over again.

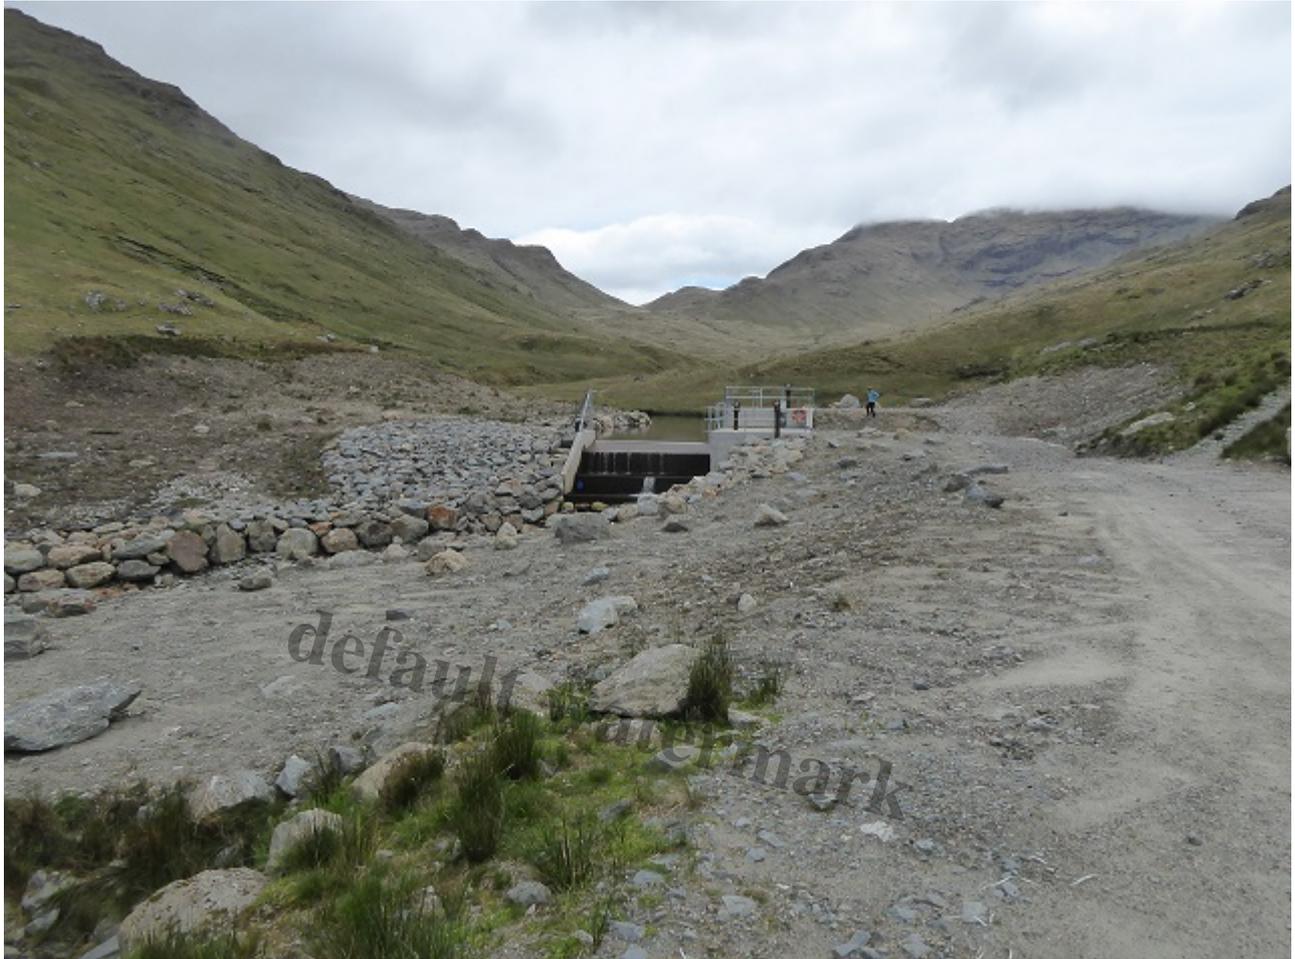
There were no boulders scattered over the bare area to the left of the road in 2017

This has resulted in some changes to the landscaping since 2017, though whether this will be any improvement is questionable. The bare area is likely to turn into a giant patch of rush. This again results from the failure of the LLTNPA and the Ecological and Landscape Clerks of Works to ensure that turf and vegetation was properly stored at the time of the original construction for restoration purposes. Had it been, it could have been relifted and then replaced over this large bare patch

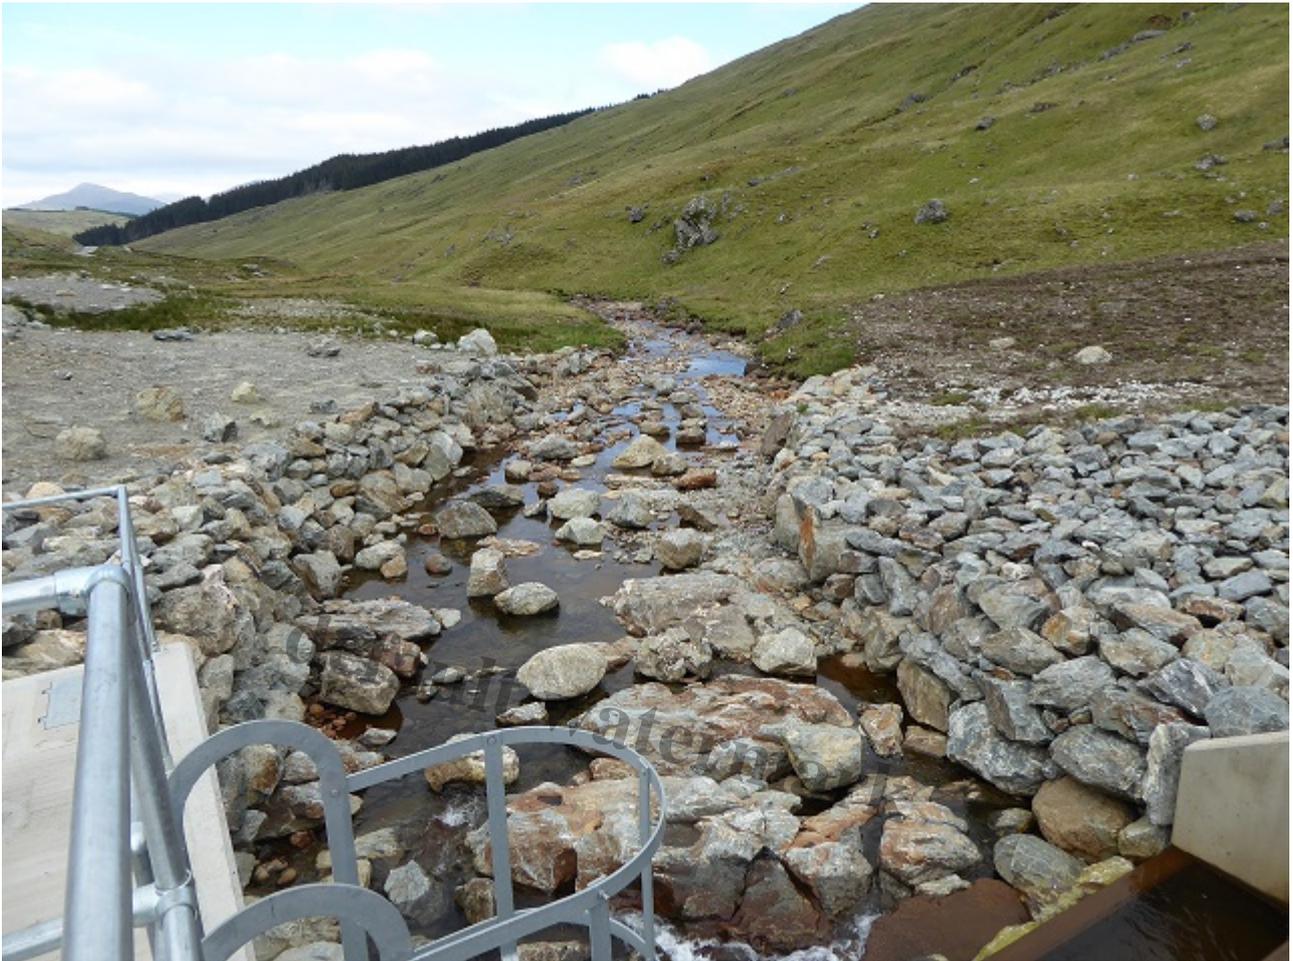
The fundamental issue, however, is the extent of the rip-rap bouldering which has been used to shore up the banks of the intake and the banks of what remains of the once proud river below.

View downstream from hydro intake. The scattered boulders on the bare patch appear to be "landscaping".

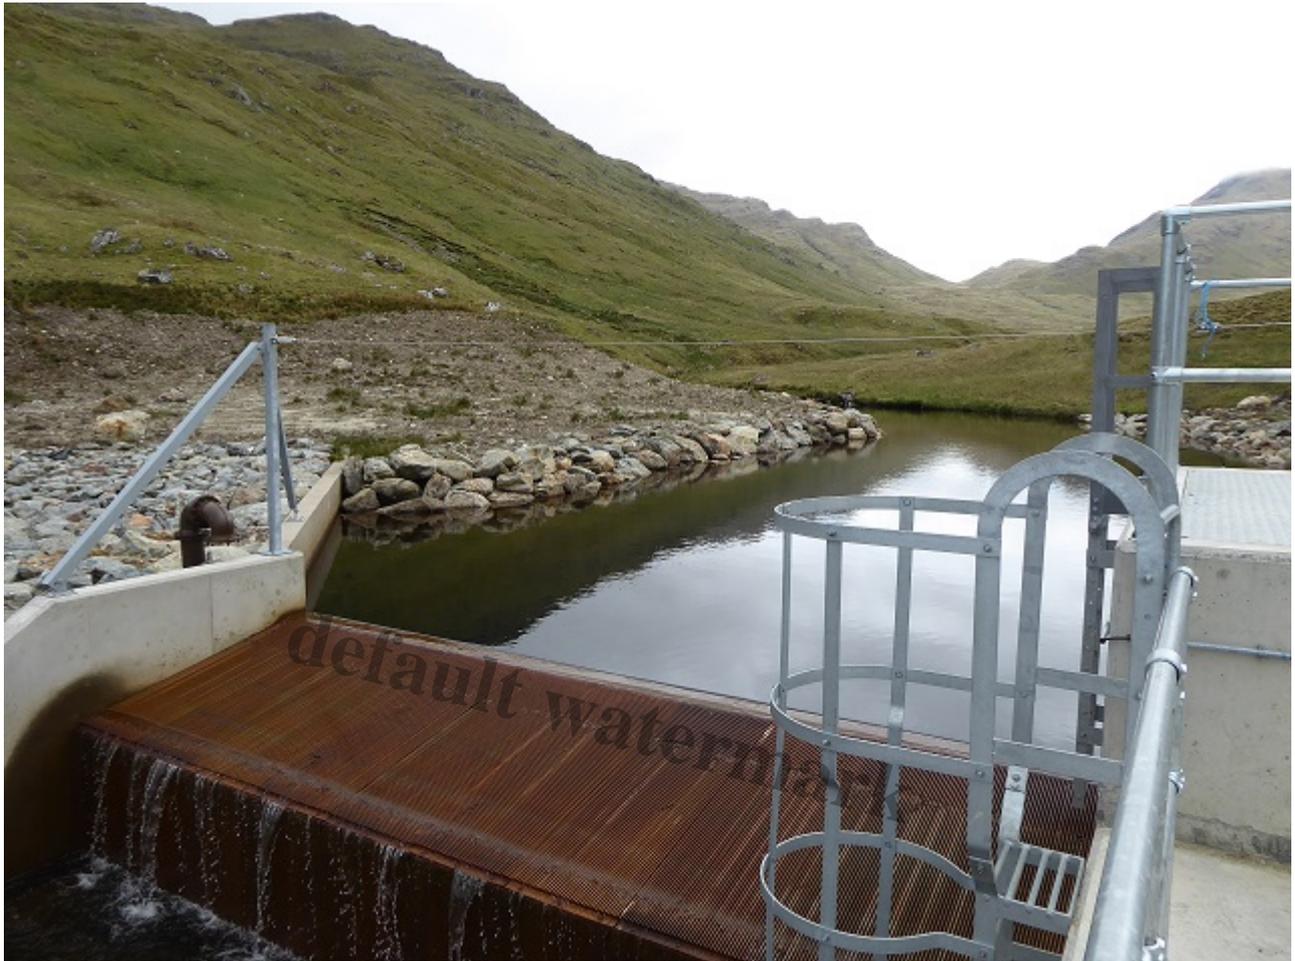
View upstream from hydro intake – at least the pipe on the left has been painted brown!

This is not, strictly speaking, a run of river hydro scheme at all but a small new reservoir that has been constructed without any regard for the landscape. Here is a graphic, from the Planning Application, of how it was meant to look:
