Hydro schemes and the failure of the planning system in the Loch Lomond and Trossachs National Park

The Upper Glen Falloch hydro scheme

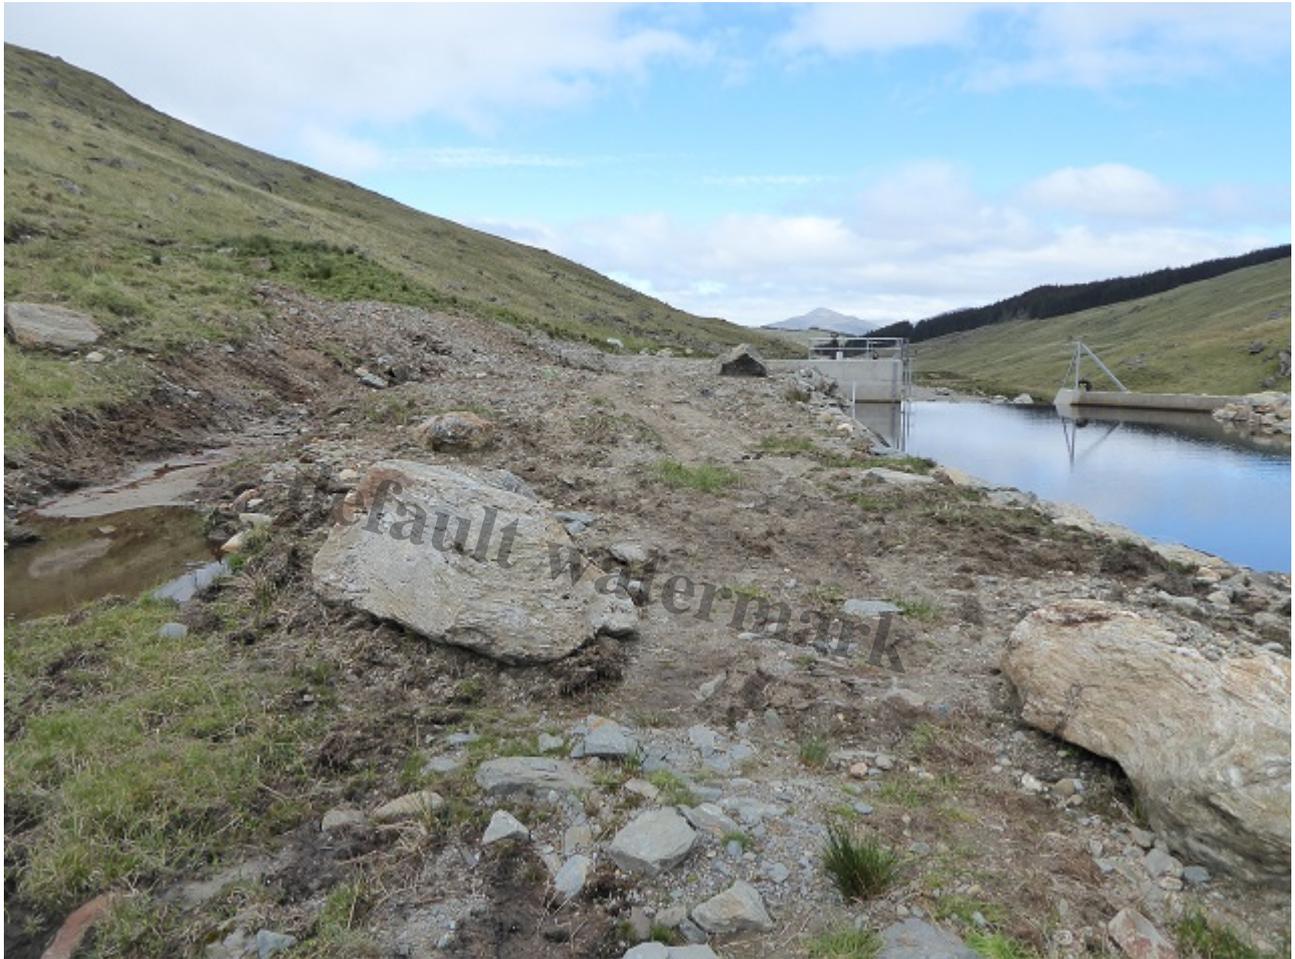
View back down intake. The extent of the visible rip rap bouldering above the intake appears to be less than in 2017, a slight improvement. Soil and vegetation appears to have been taken from bank on left to help restore the ground. Note how the two boulders have been carefully spaced to allow ATVs to travel further up the glen, creating more vehicular damage. Unfortunately, vehicles have then been driven across this destroying much of the restoration work.

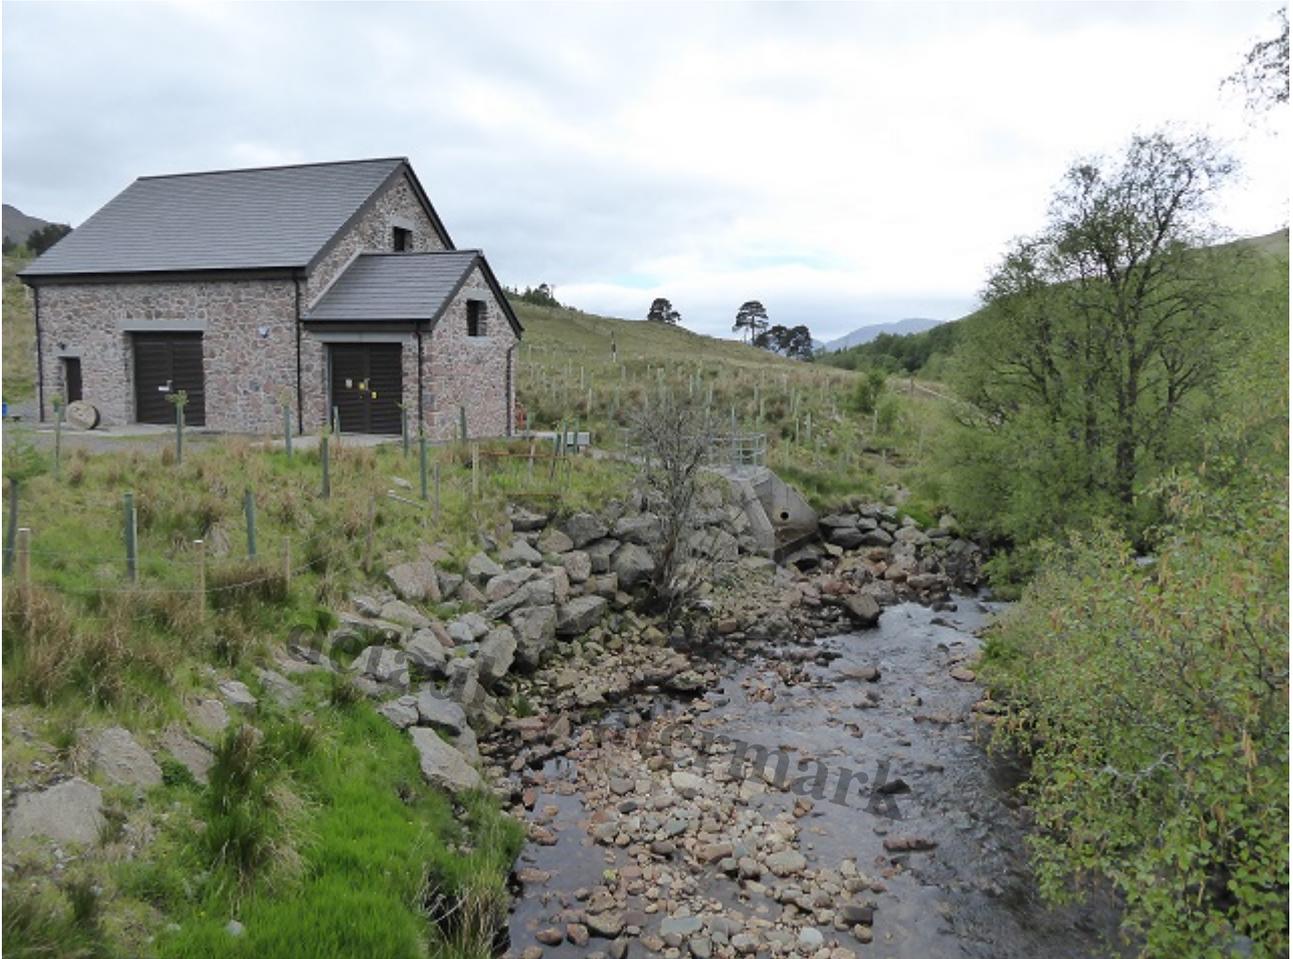
Hydro outflow on the day of my visit â?? dry!
