Hydro schemes and the failure of the planning system in the Loch Lomond and Trossachs National Park

The Upper Glen Falloch hydro scheme

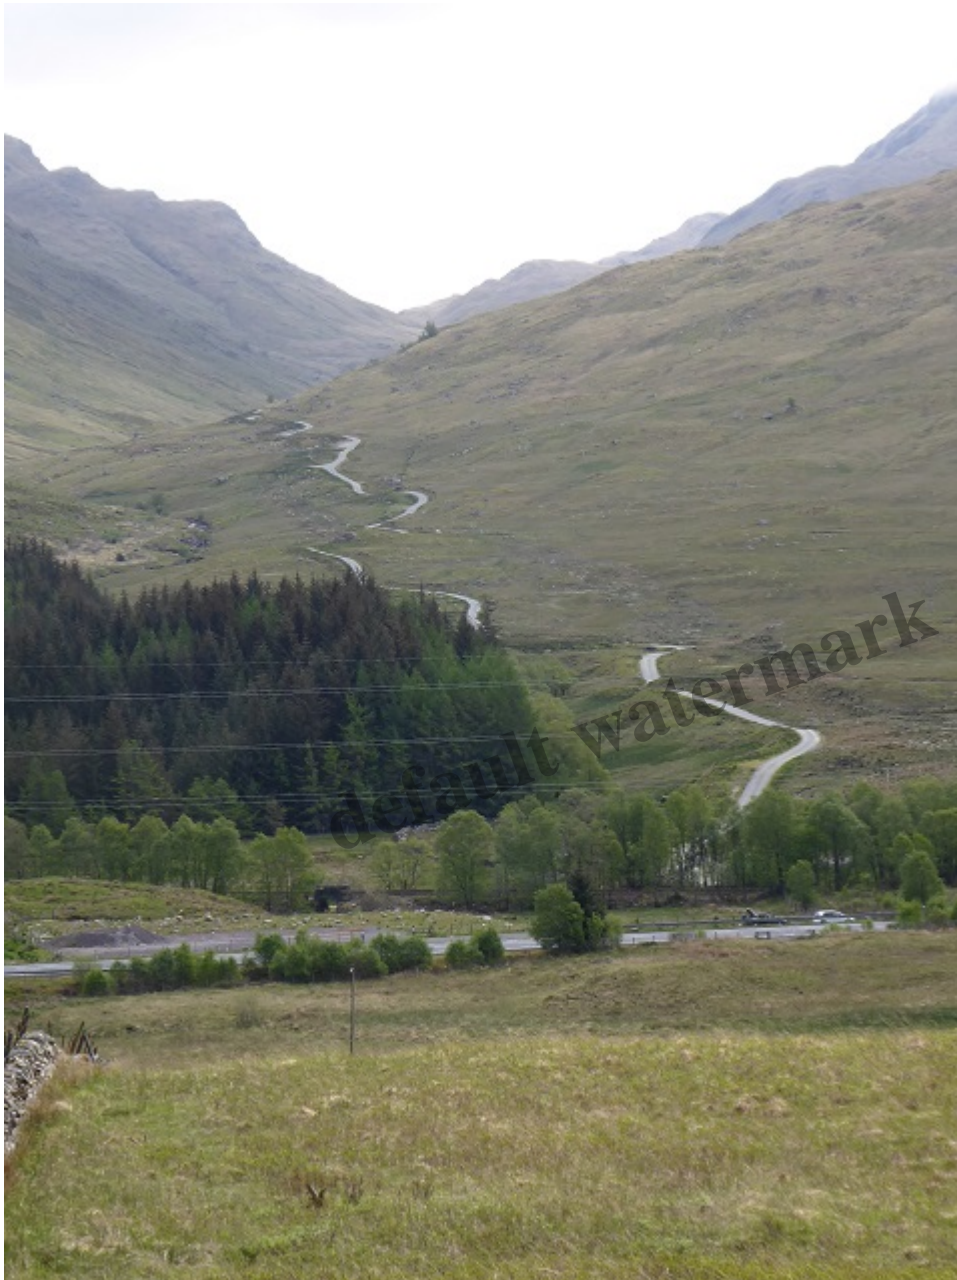
The first two sections of the upper Glen Falloch hydro road viewed from just below the West Highland Way

The hydro scheme has had a major landscape impact on Upper Glen Falloch. Most of this side glen was previously wild and unspoilt as is befitting for a National Park. Its wild character has been effectively destroyed through the widening and extension of the road and the disastrously designed and executed intake pool. While prior to the hydro scheme there was a road up the first section of the glen, the original planning application, which was approved by the Scottish Government on the advice of the National Park Authority, allowed it to be doubled in length. A further planning application for the temporary construction track from the road end to the intake to be made permanent was then approved by the LLTNPA.

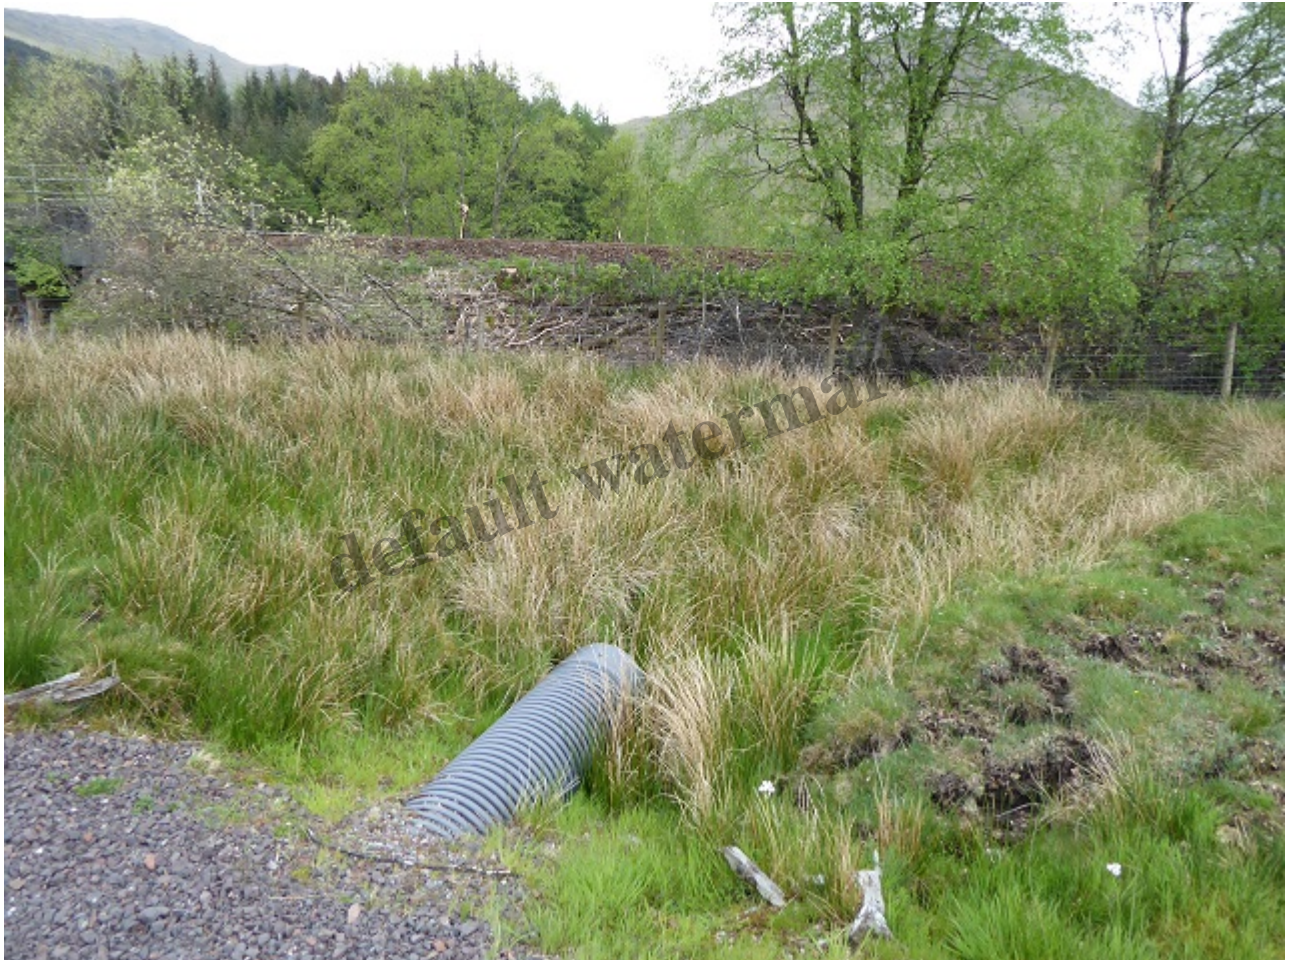
Protruding culvert on new section of footpath between the layby commonly used to access An Caisteal and Beinn a Chroin and the river Falloch

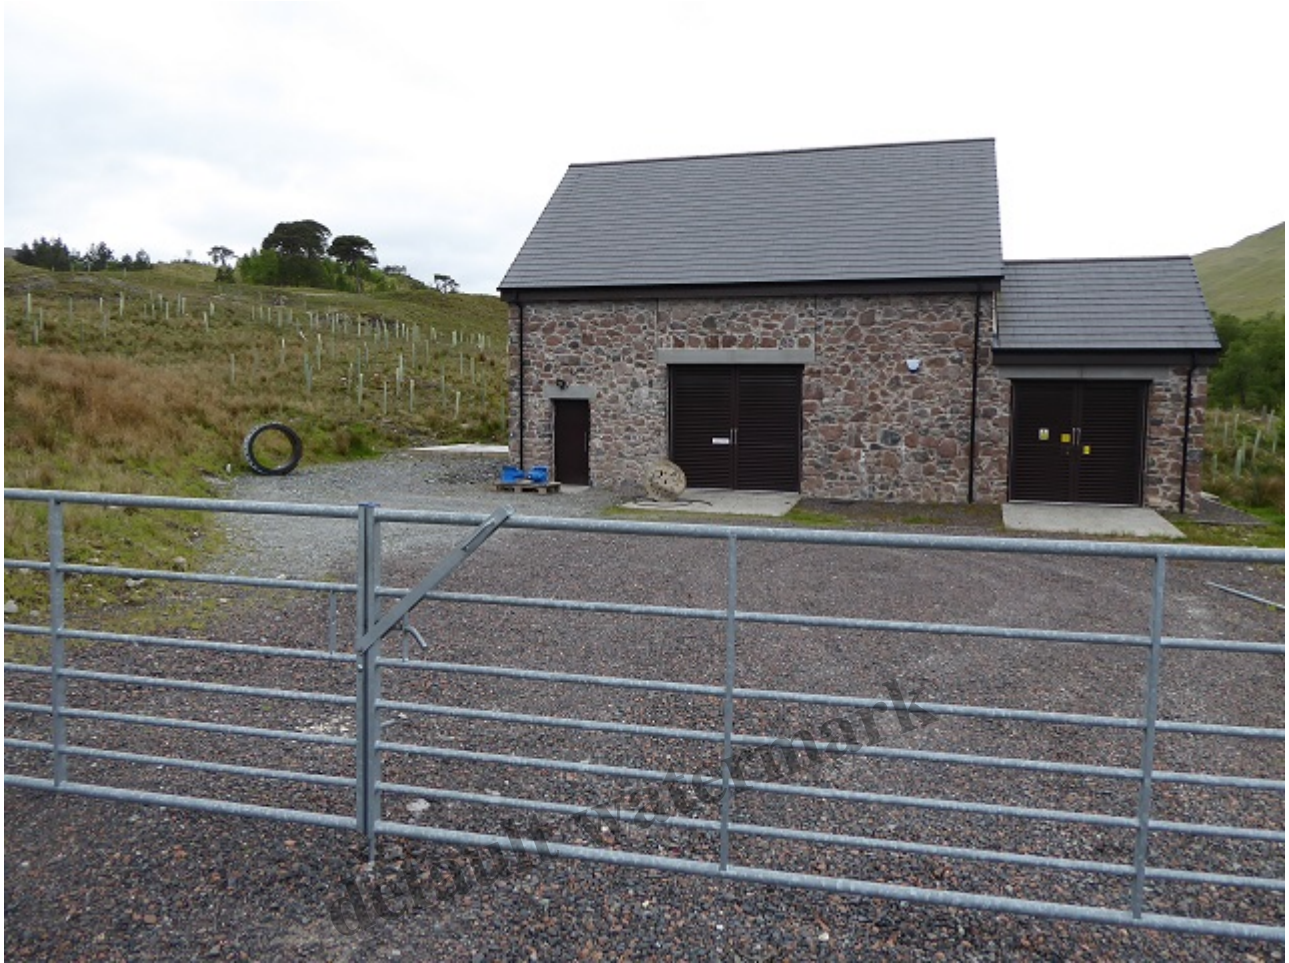
Only one dumped section of spare pipe unlike the schemes nominated for Scottish Planning Quality Awards! Glen Falloch Caledonian pine forest remnant visible behind.

The landscaping of the powerhouse leaves lots to be desired. The vehicle area is unnecessarily large, contrary to the Park's best practice guidance, again because its cheaper for developers to cover ground with imported stone than to restore it. An opportunity to allow the Glen Falloch native pinewood to regenerate naturally, as recommended in the Park's draft Trees and Woodland Strategy ([see here](#)), has been lost and instead a fenced area around the powerhouse planted.

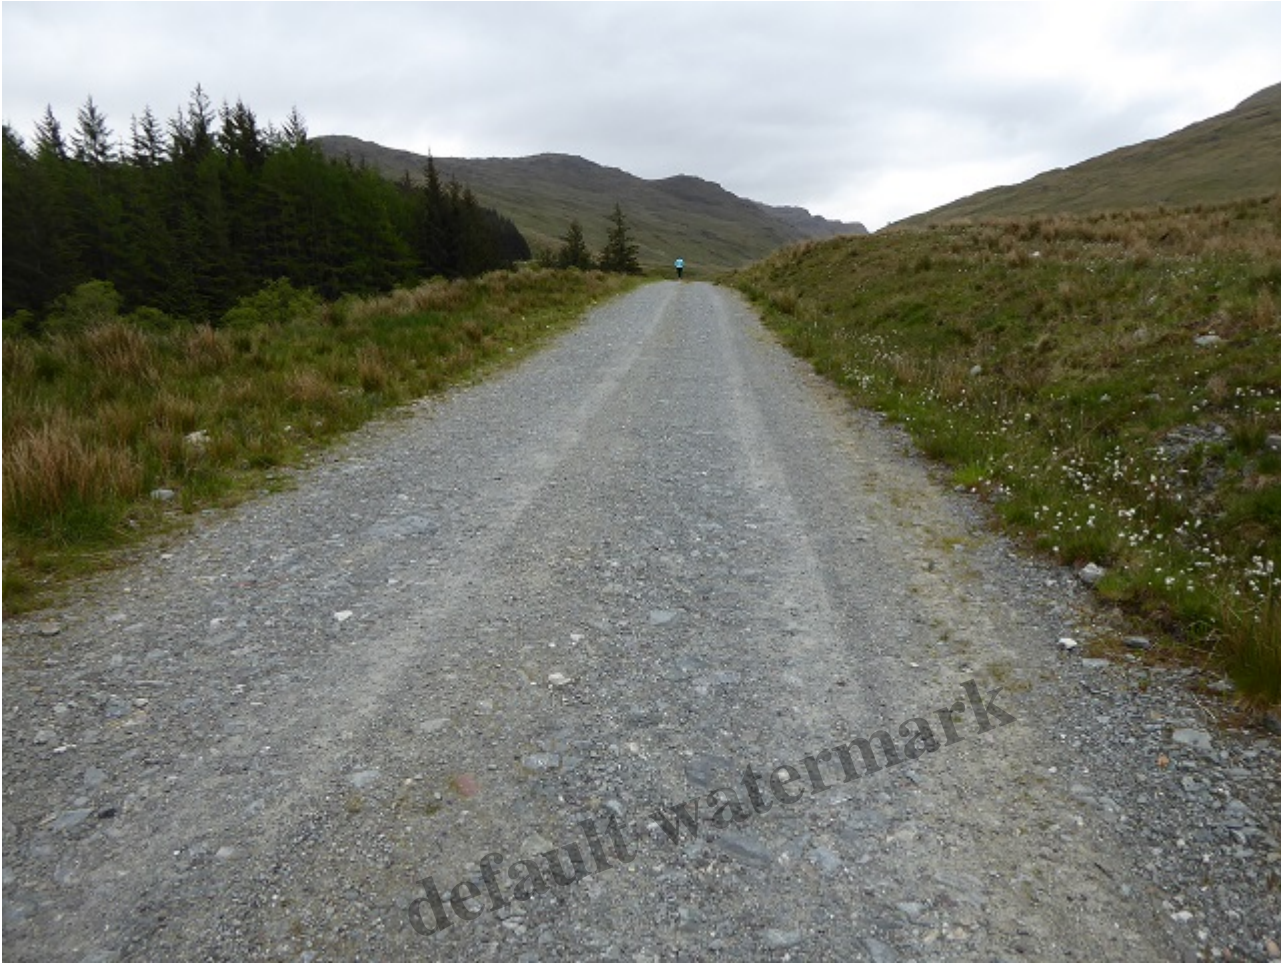
While efforts have been made to restore some of the edge of the road, its still much wider than the 2.5m maximum recommended in the Park's best practice guidance. As a consequence vehicles drive anywhere which effectively prevents a central grass strip, which would help reduce the visual impact, from developing.

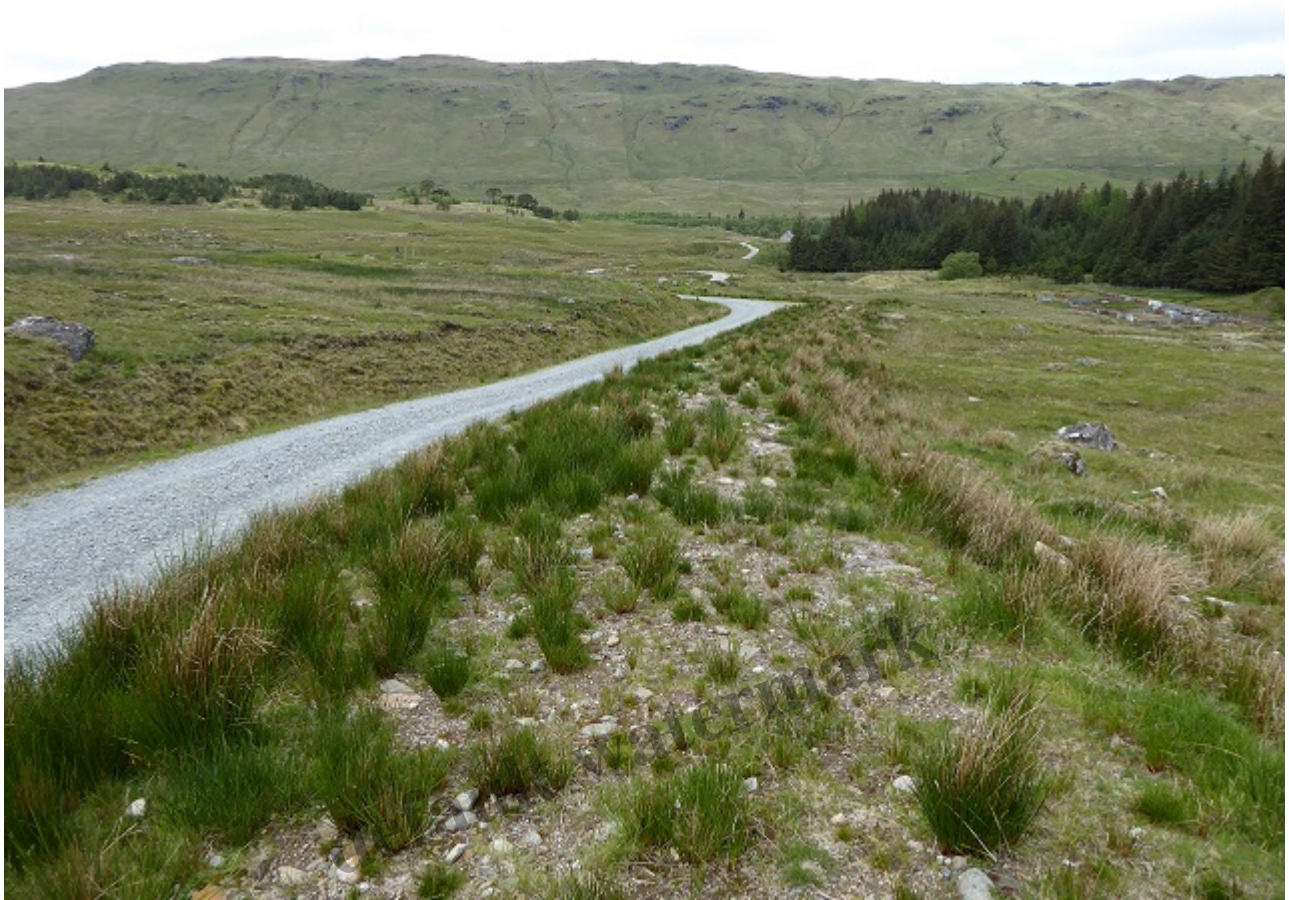
Looking back north along the road to the powerhouse.

Instead of retaining the vegetation and turf which was excavated during the creation on the construction track and using it to restore the ground, the newly exposed mineral soils have been left bare, grazed and as consequence colonised by a broad band of rush. Arguably, that's the worst ecological outcome possible. Either rough grazing or pinewood regeneration would have been far more preferable. At Keltie Water the broad band of rush above the former water pipeline is still there despite the pipeline now having been decommissioned. This suggests the impact of poor restoration on the vegetation is likely to be permanent. The LLTNPA should be commissioning research on this rather than ignoring the issue.

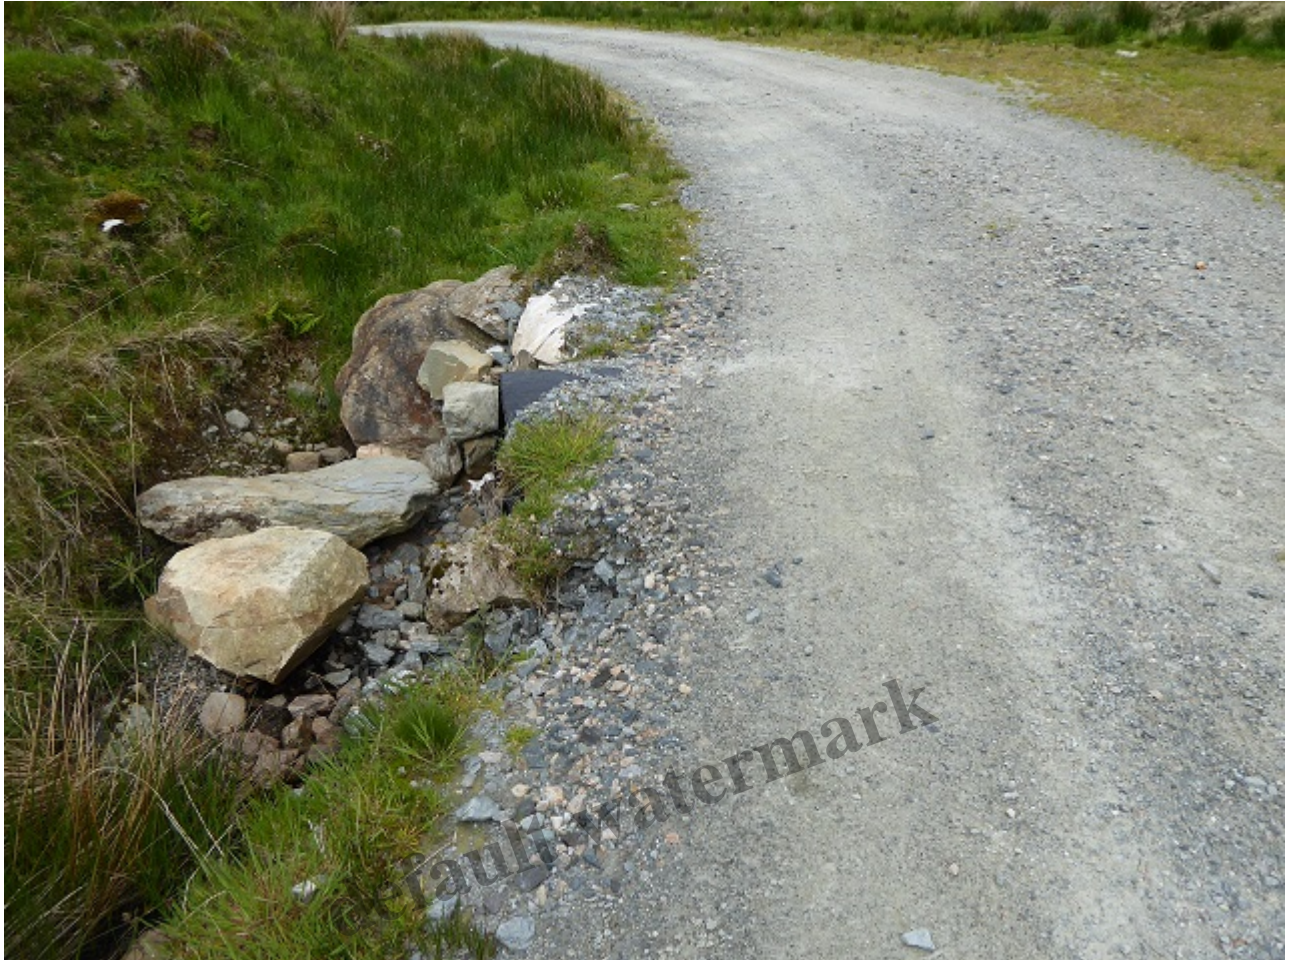
Collapse stone revetement by culvert. Note how the edge of the road in front of the culvert is now eroding into the burn.

While there had been an attempt to improve the finishing to the culverts under the road since my last visit, some of the work was of poor quality and had already collapsed.

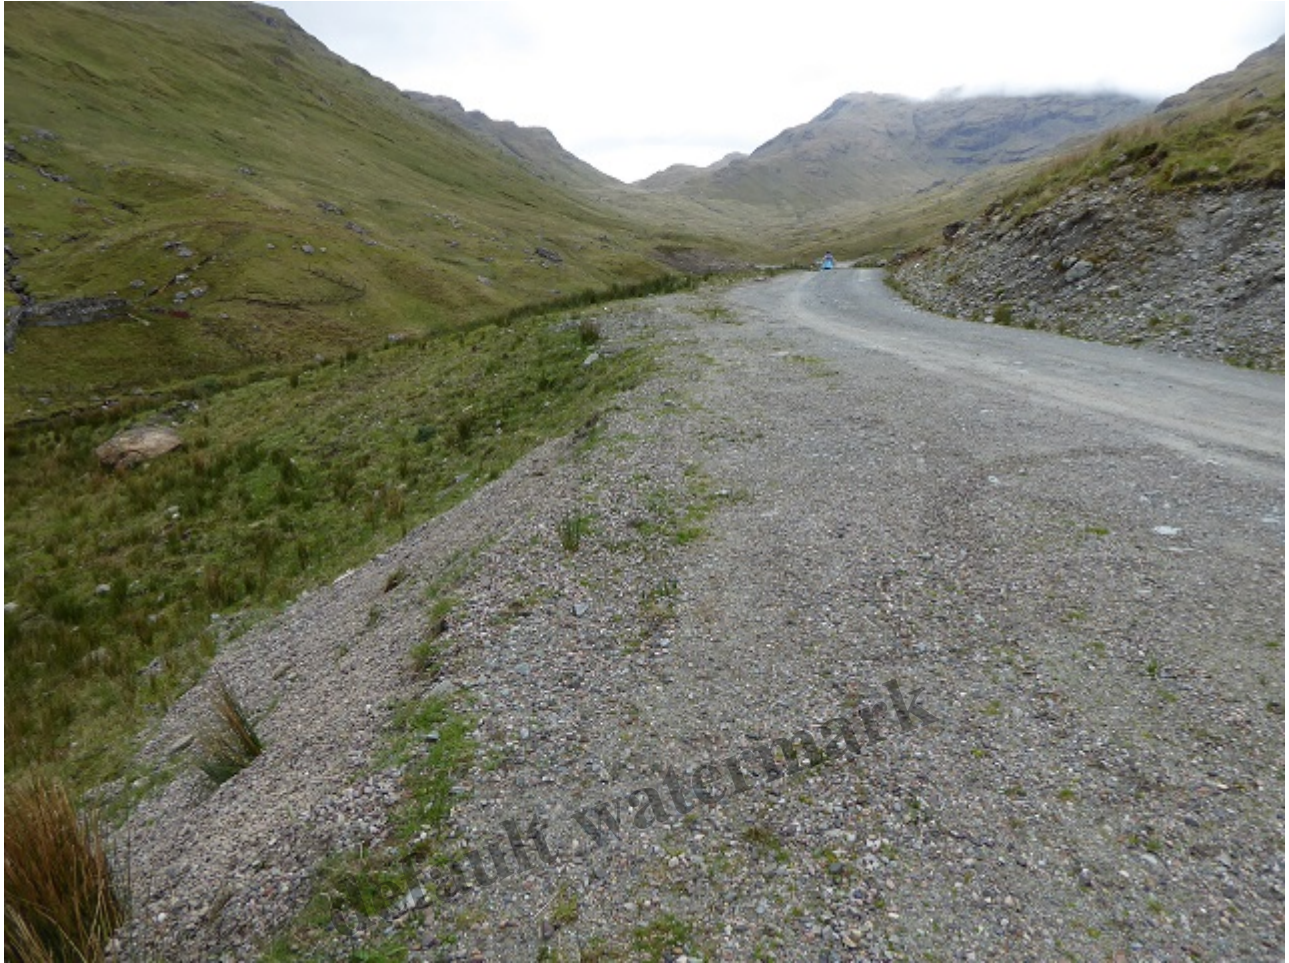
Spare material appears to have been dumped over the side of the track. Note the bare batter on the right where there has also been no attempt at restoration.

This section of the road was subject to the separate planning application to the LLTNPA (agreed in 2013) and they are therefore are solely responsible (i.e there was no Scottish Government involvement),

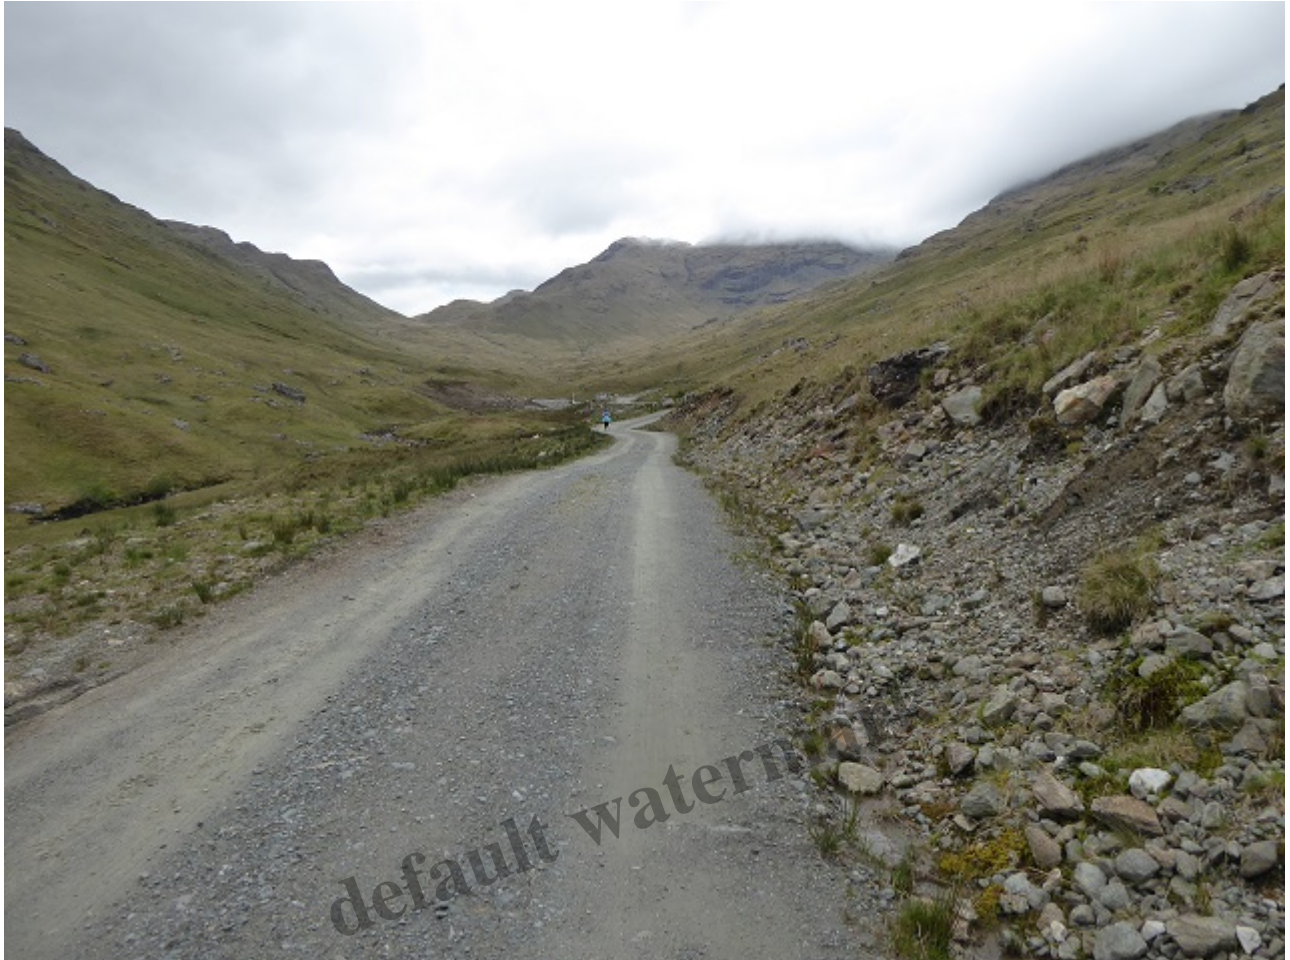
Looking towards hydro intake and Beinn a Chroin along final section of road. Note stones eroding out of unrestored bank on right.

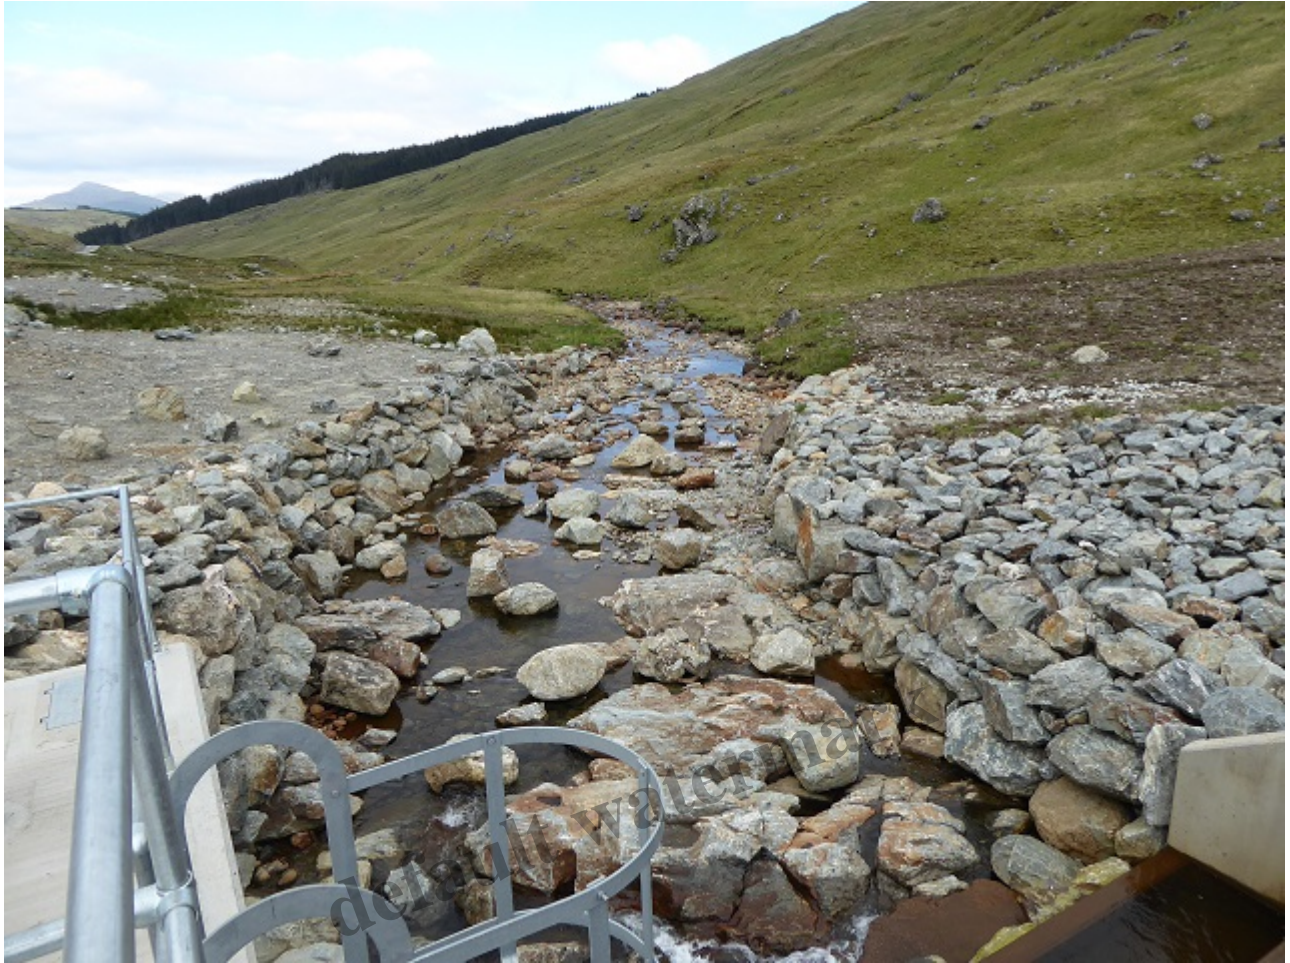
The fundamental issue, however, is the extent of the rip-rap bouldering which has been used to shore up the banks of the intake and the banks of what remains of the once proud river below.

View downstream from hydro intake. The scattered boulders on the bare patch appear to be “landscaping”.

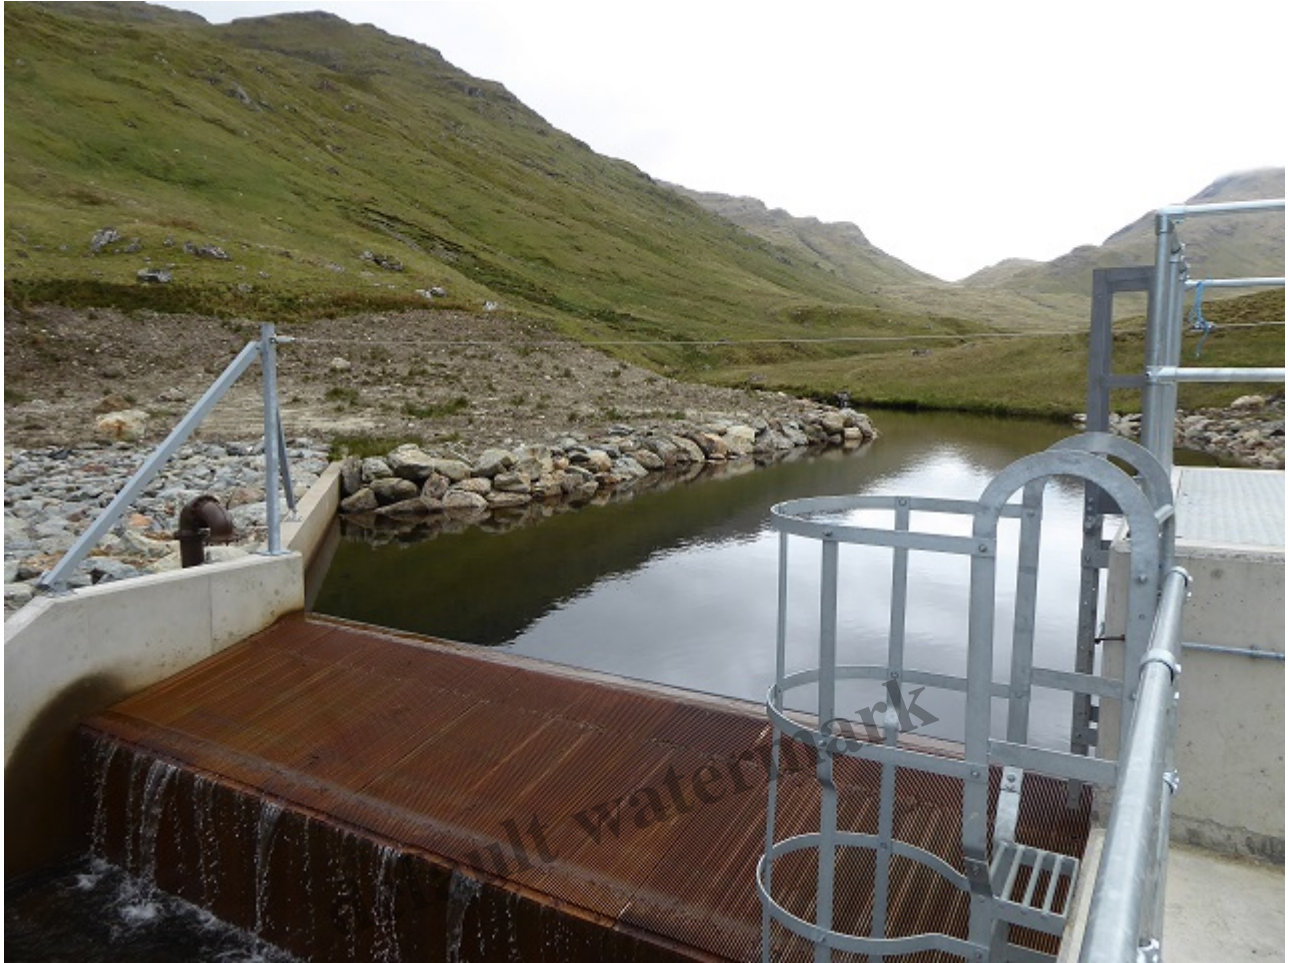
View upstream from hydro intake – at least the pipe on the left has been painted brown!

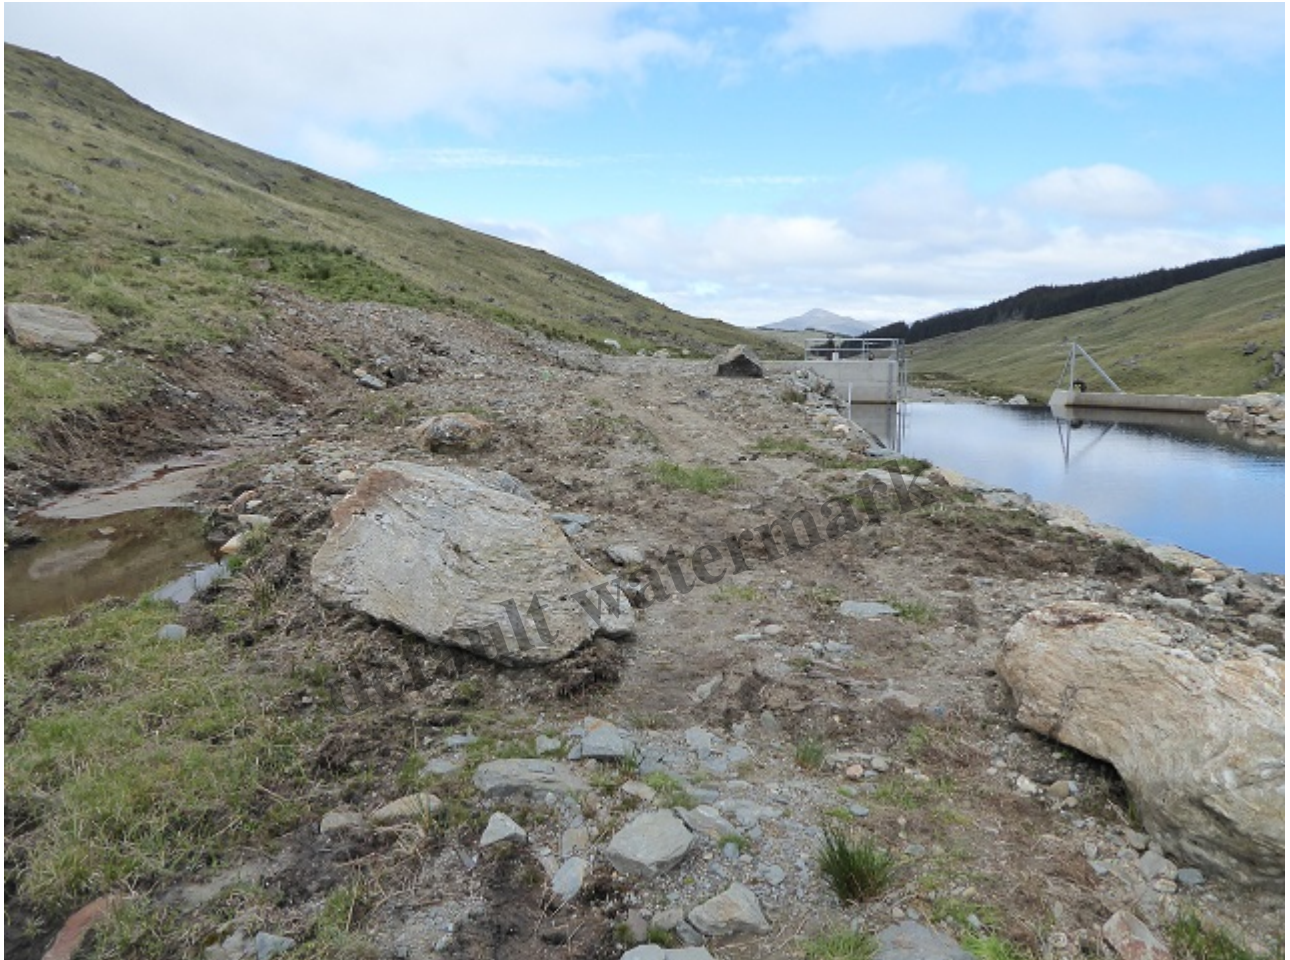
View back down intake. The extent of the visible rip rap bouldering above the intake appears to be less than in 2017, a slight improvement. Soil and vegetation appears to have been taken from bank on left to help restore the ground. Note how the two boulders have been carefully spaced to allow ATVs to travel further up the glen, creating more vehicular damage. Unfortunately, vehicles have then been driven across this destroying much of the restoration work.

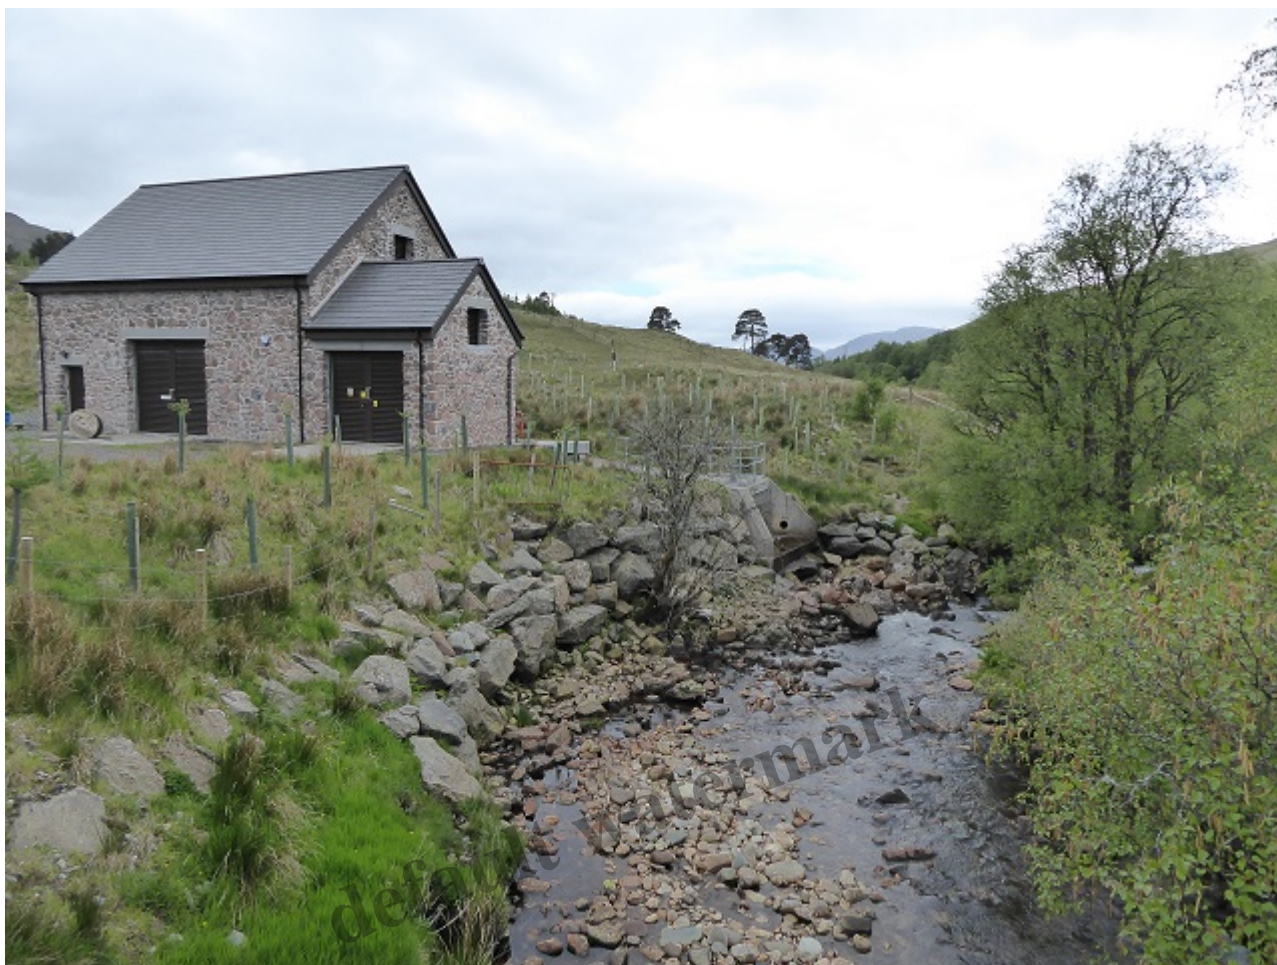
Hydro outflow on the day of my visit – dry!

The final salt in the wound is that despite the frequent failure of these hydro schemes to produce any electricity – a consequence of the west of Scotland’s “flashy” rivers which rise and fall with the rain – they are nevertheless highly profitable to landowners and developers because of what the public pay through our electricity bills. Hence why it was worth re-engineering the scheme last year to increase its capacity.
