The Donich Water hydro scheme and industrial forestry – out of sight, out of mind?

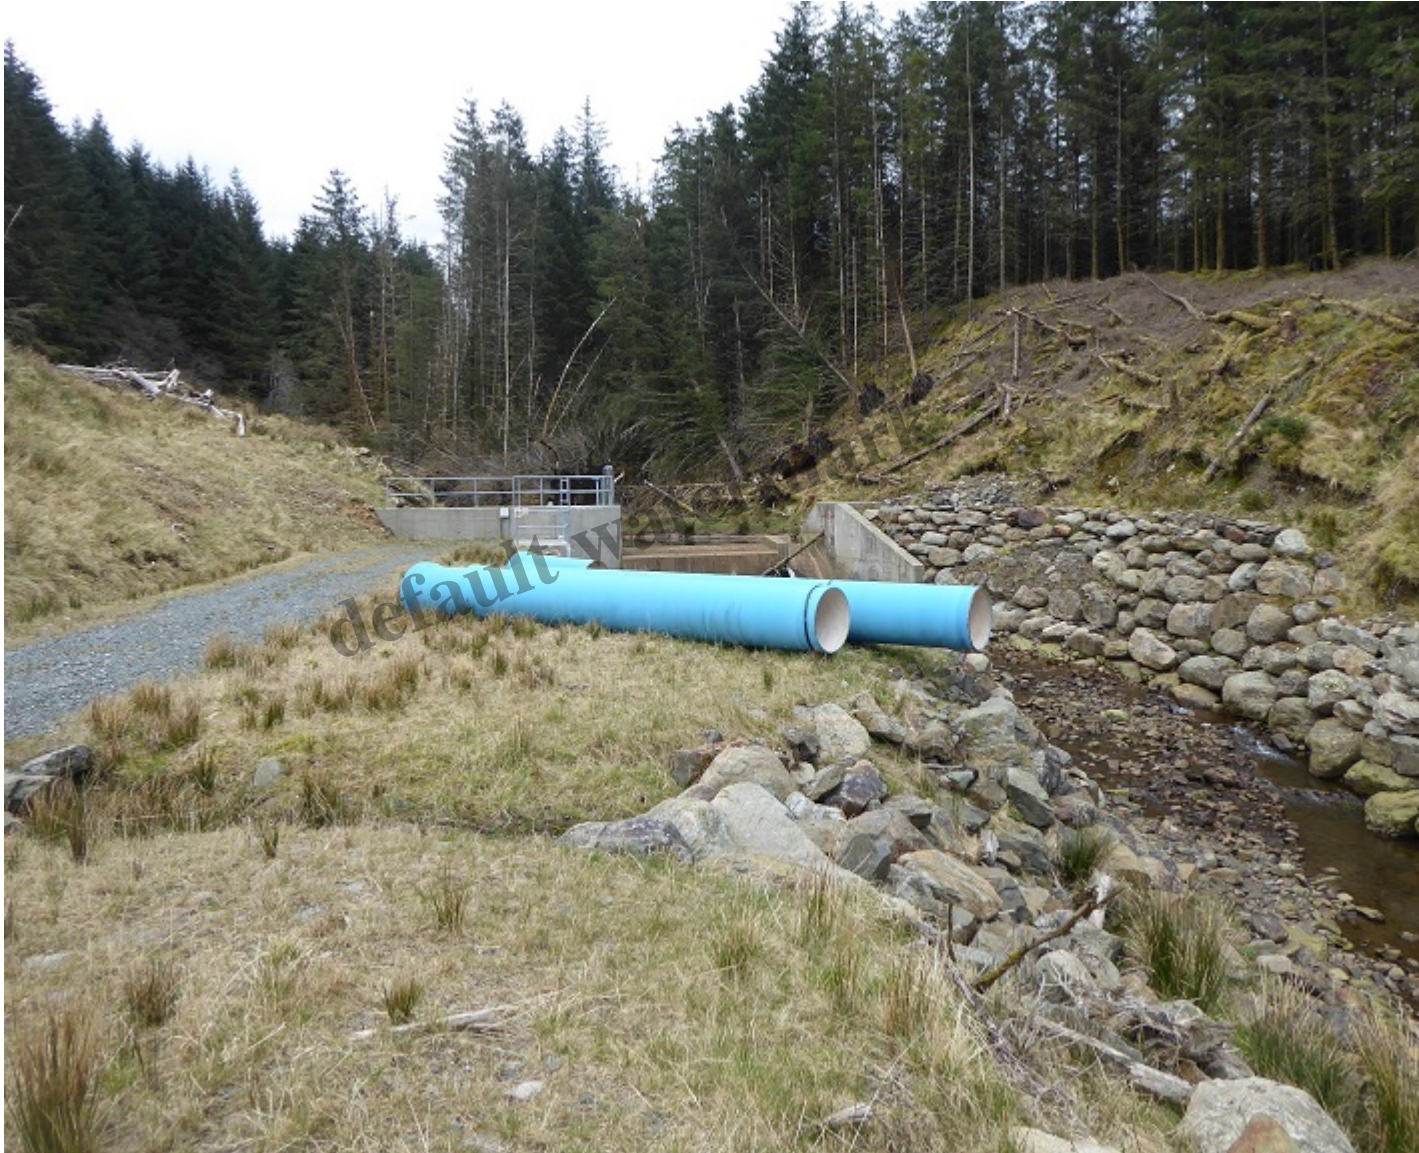
Almost three years after the Donich Water hydro scheme was commissioned, the spare penstock has not been removed, a symptom of the Park's failure to ensure basic planning standards are met. The forestry, bare wing walls and rip rap bouldering add to the landscape mess.

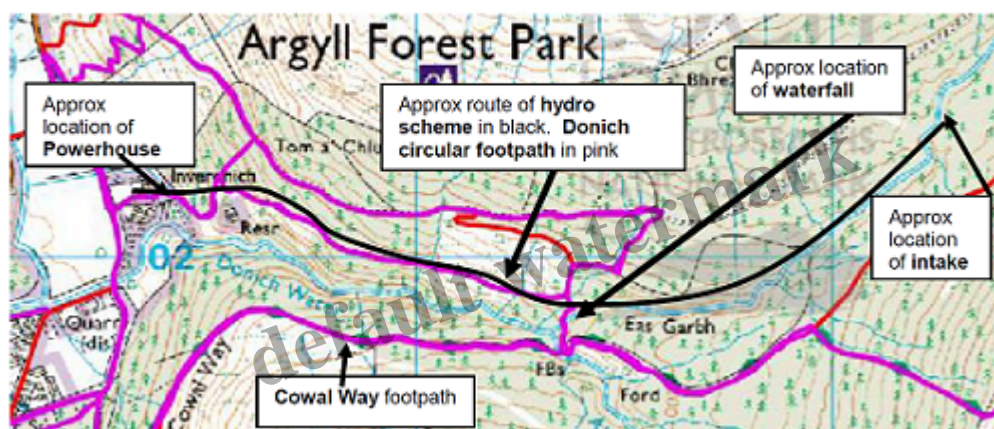
Fig 2: footpaths, waterfall and hydro scheme

Extract from planning application showing paths, waterfall and pipeline

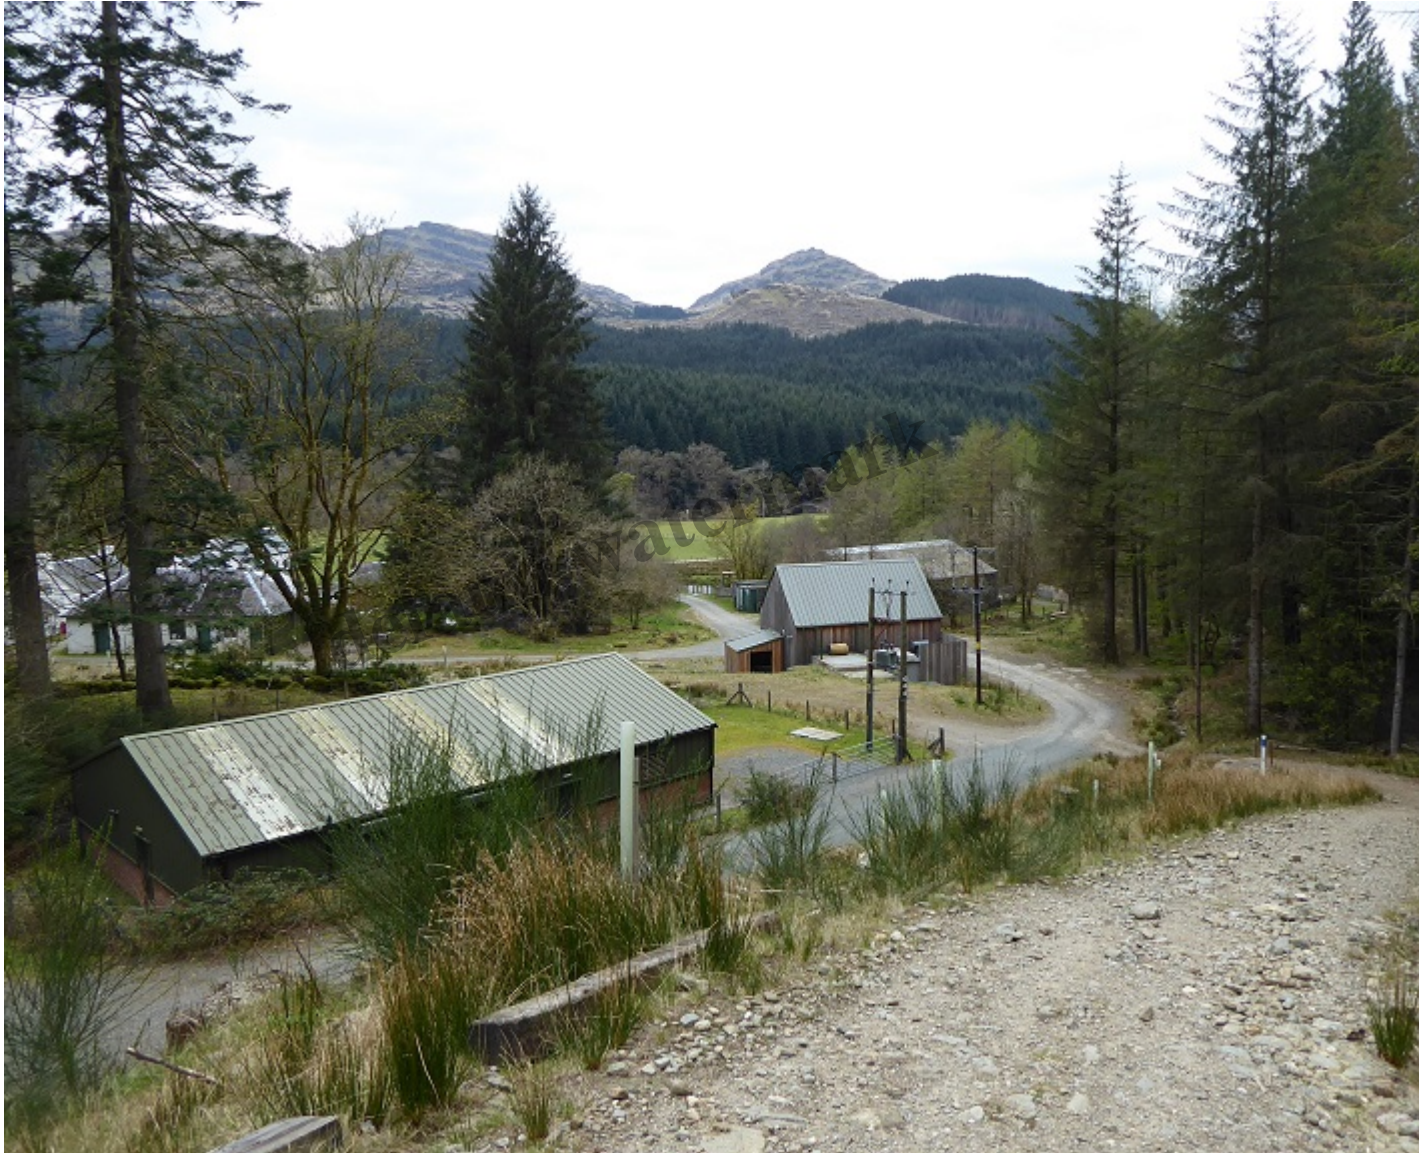
Powerhouse just right of centre, Beinn Bheula behind on left

Local residents had also expressed concerns about the noise that would be emitted from the powerhouse and subjected the specification of the building to detailed scrutiny. Their concerns were dismissed by Environmental Health and Planning Staff:

Following the discharge of the condition, residents living adjacent to the powerhouse building wrote to A&BC Environmental Health expressing concerns that the findings of the report were not representative of actual noise levels. The letter contested that noise levels generated by the powerhouse were in excess of what had been recorded for the report and deemed acceptable in line with Condition 13.

The applicant has submitted this application in response to concerns from neighbours. The extension has been designed to direct noise from the powerhouse away from nearby properties into an uninhabited area. The principle of the extension is supported by Overarching Policy 2 of the Local Development Plan as it has been designed to improve the amenity of residents.”

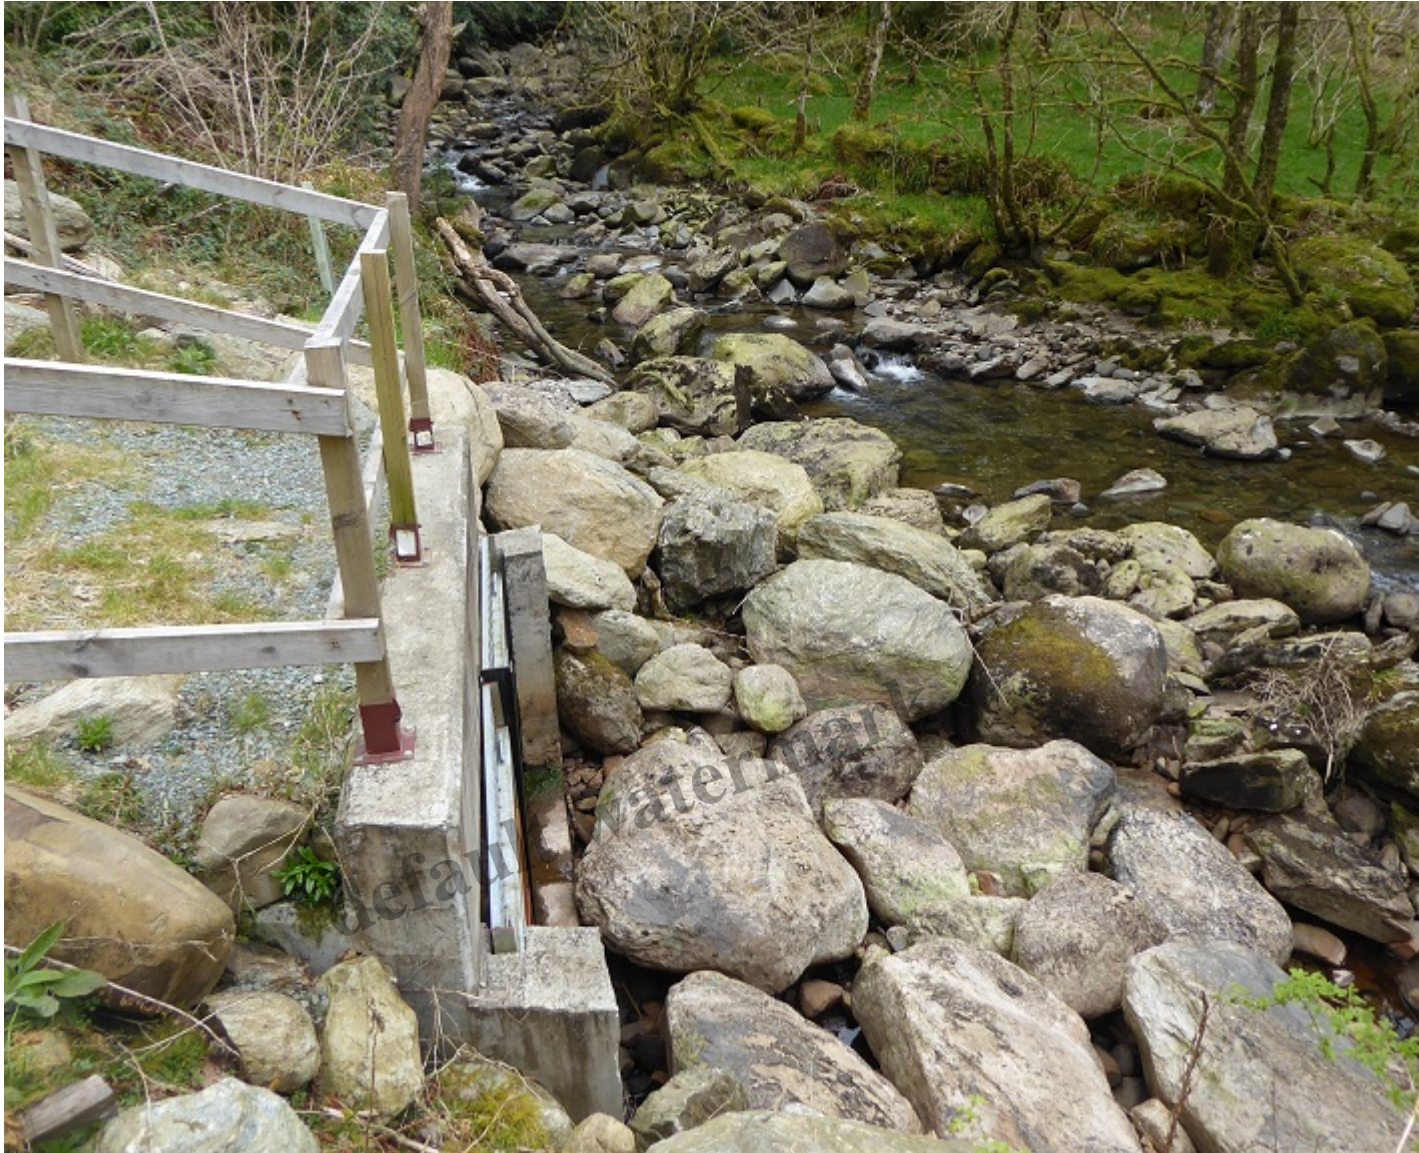
Tailrace – where the water from the powerhouse would re-enter the river if the scheme was operating.

Unfortunately on the day I visited it was impossible to judge whether noise was still an issue because, as is quite common with our “flashy” west of Scotland rivers, the river flow was too low to produce any electricity.

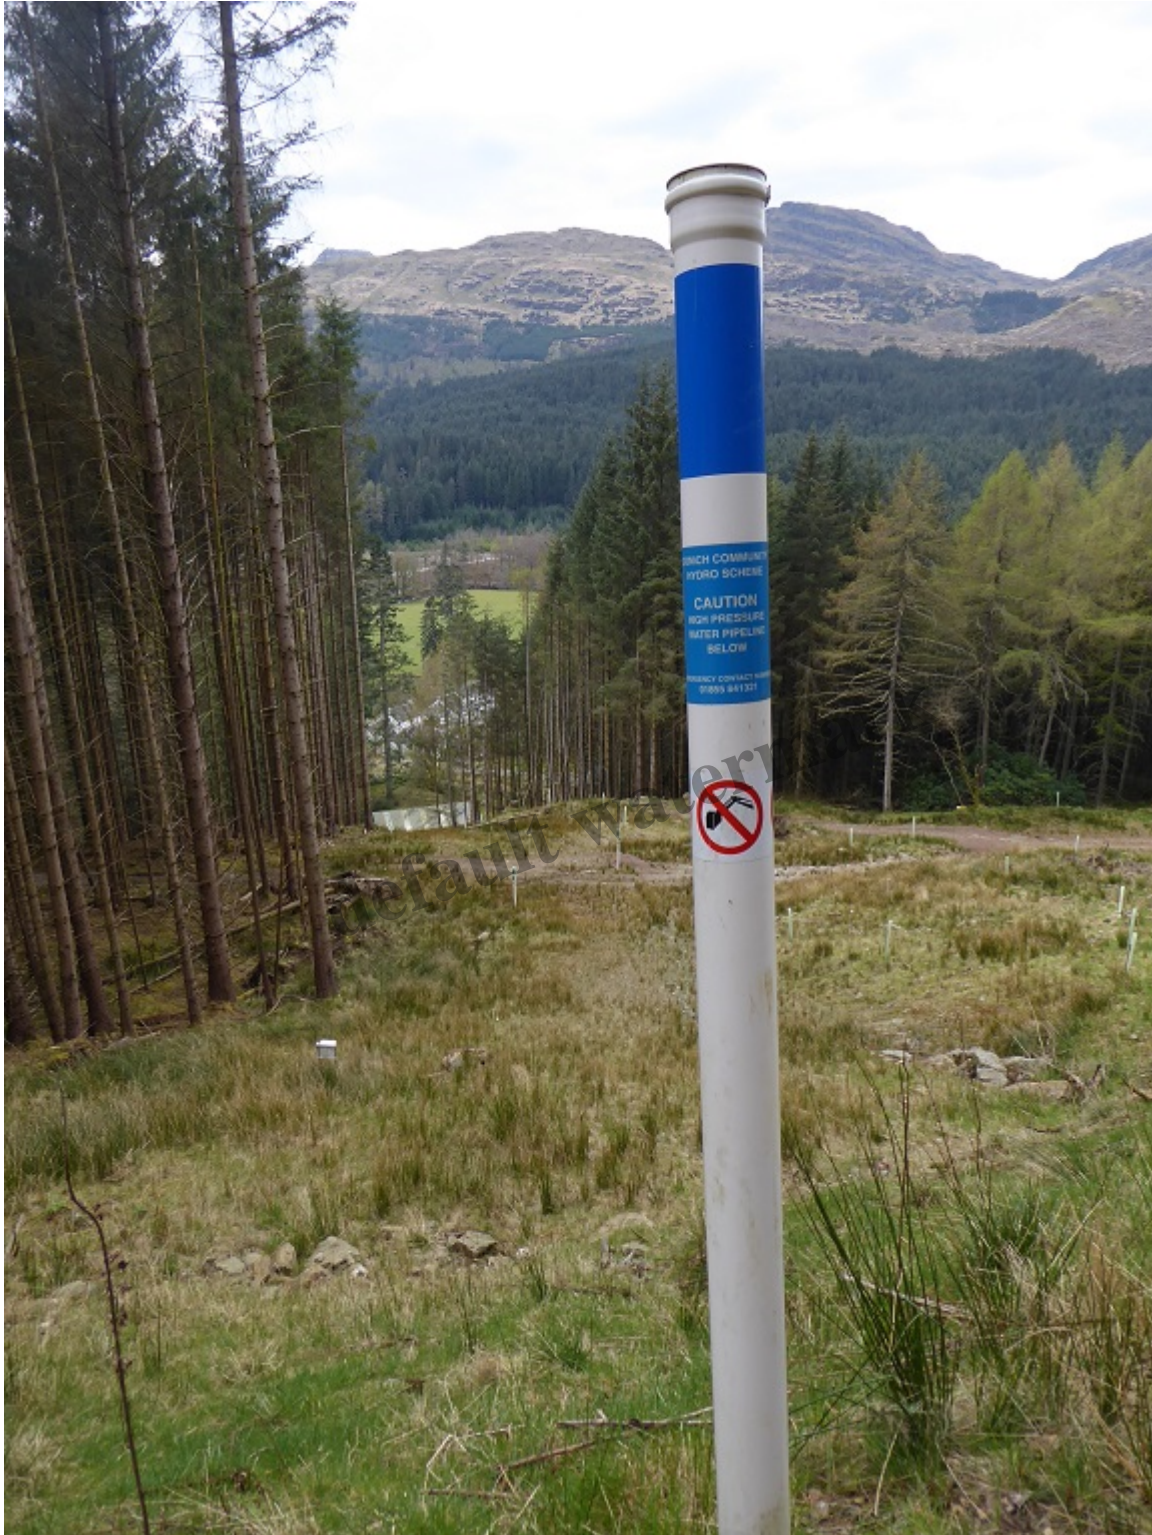
While the path existed before the hydro scheme was approved, trees were felled to make way for the steepest section of pipeline above the powerhouse

30 months after construction, the vegetation above the steepest section of the pipeline has hardly recovered. There appears to have been only minimal attempts at restoration, with a few trees planted. In most hydro schemes within the National Park, the most effective restoration work has involved the

ground above pipelines. In this case too the LLTNPA required the land to be restored, requiring a turve management plan for example, but appears to have done nothing to enforce this. It appears that because this land is within industrial forestry and owned by the Forestry Commission/Forest and Land Scotland the LLTNPA has not enforced its usual standards.

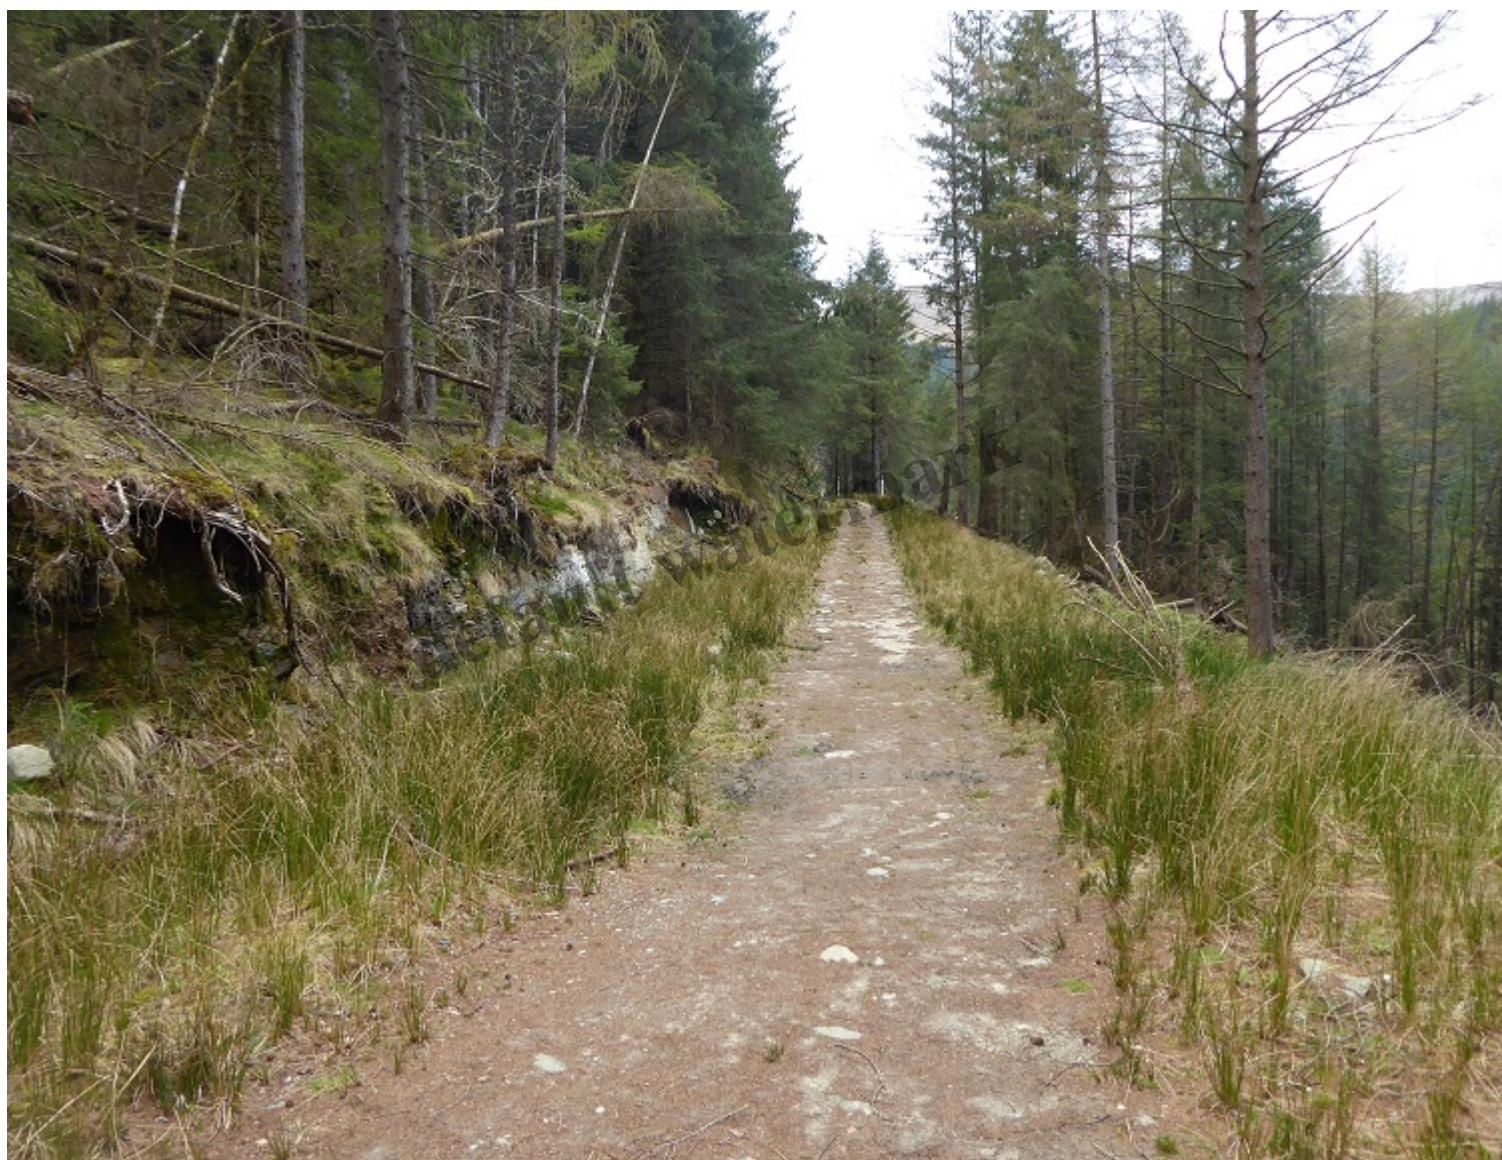
After the steep section, the pipeline follows the line of the core path. No attempt has been made to restore the prominent bench which has now been cut across the hillside. It has been left to revegetate itself and consequently has been colonised with rush. Some of the steep bank on the left may have been created by the original path but its contrary to the Park's best practice guidance, being too steep to vegetate, and there has been no attempt to restore it. An opportunity to improve the walking experience – an open woodland ride with grasses and flowers would be good for butterflies etc – has been lost and the “restored” path has very little to commend it.

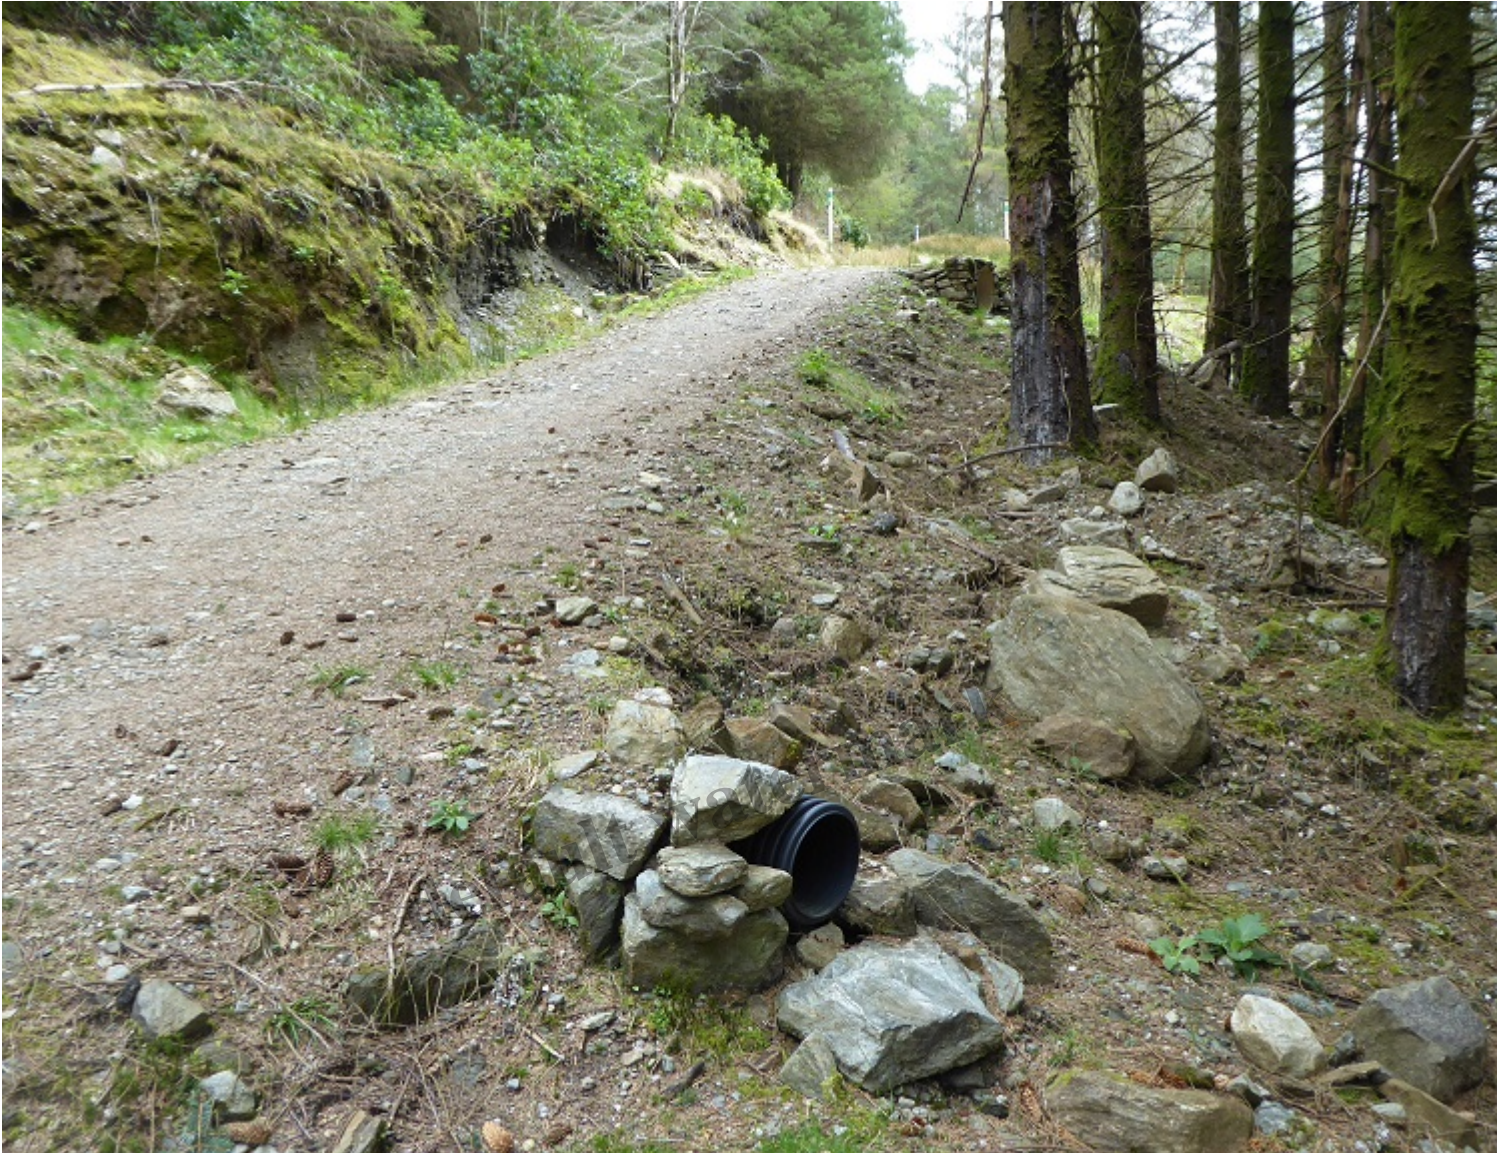
The quality of the culvert finishing was very poor and in this case the stone facing had already collapsed revealing the plastic pipe.

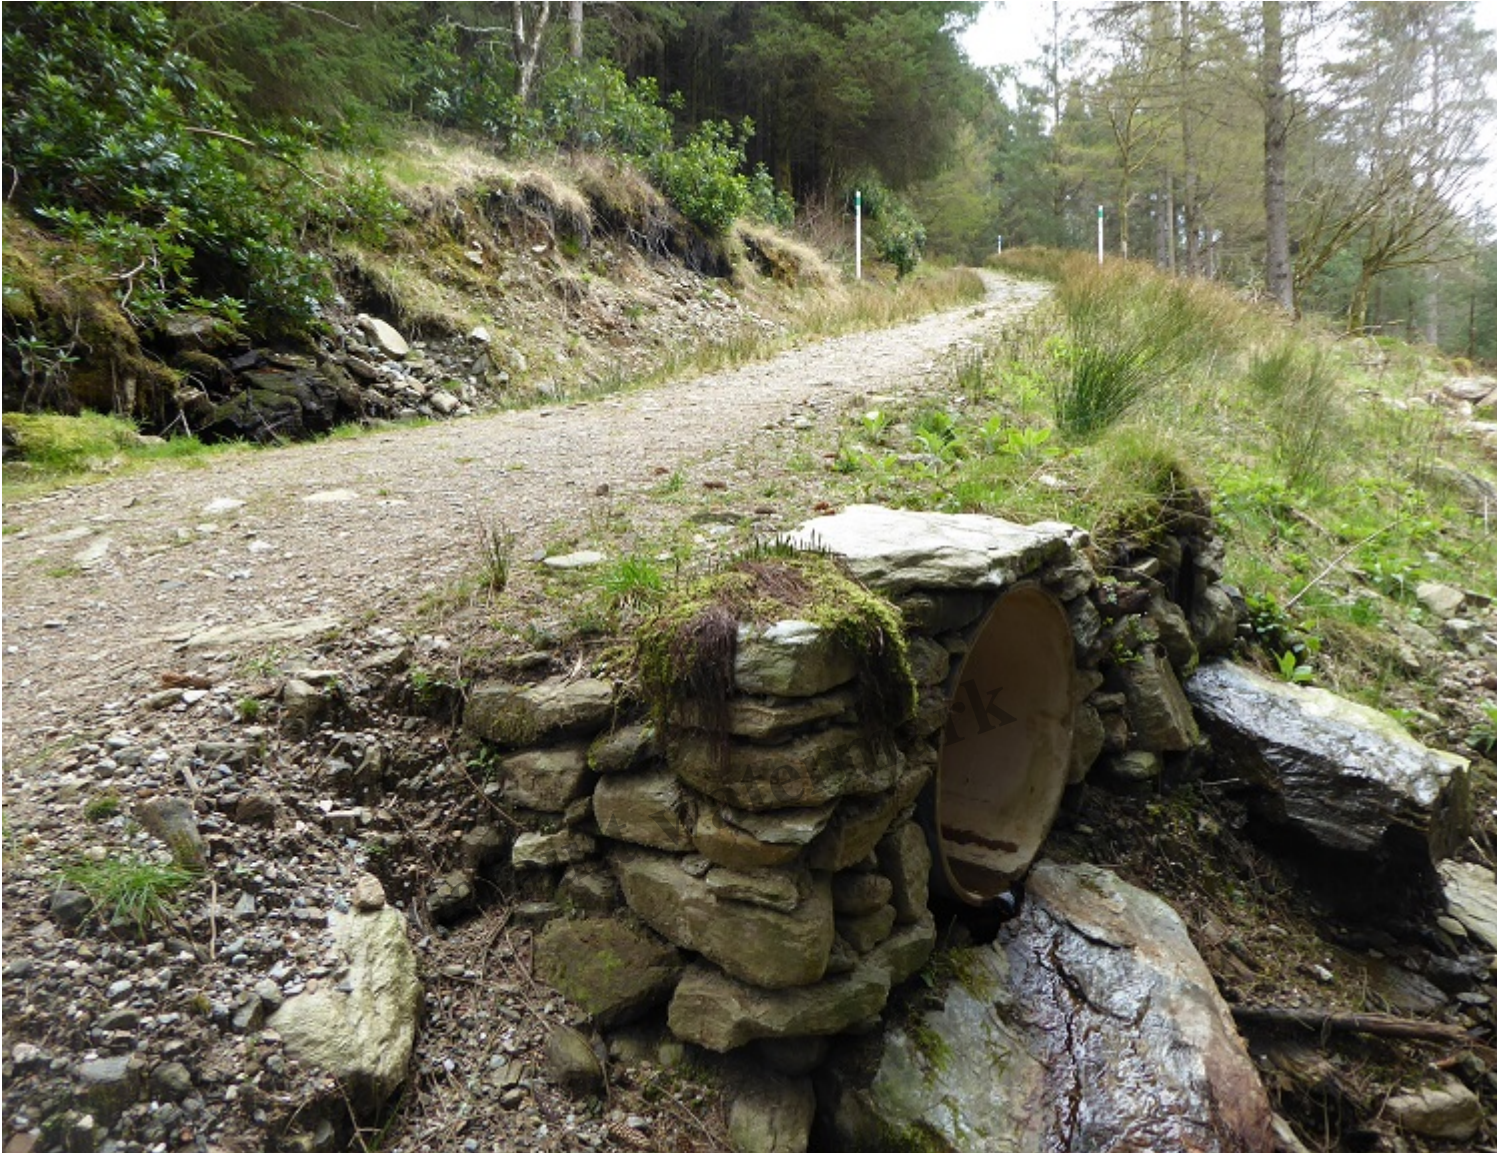
Its hard to see this culvert wall facing, built without any foundations, surviving long either. Note the bare banks and multiple pipe markers behind. Are these the standards we should expect in a National Park?

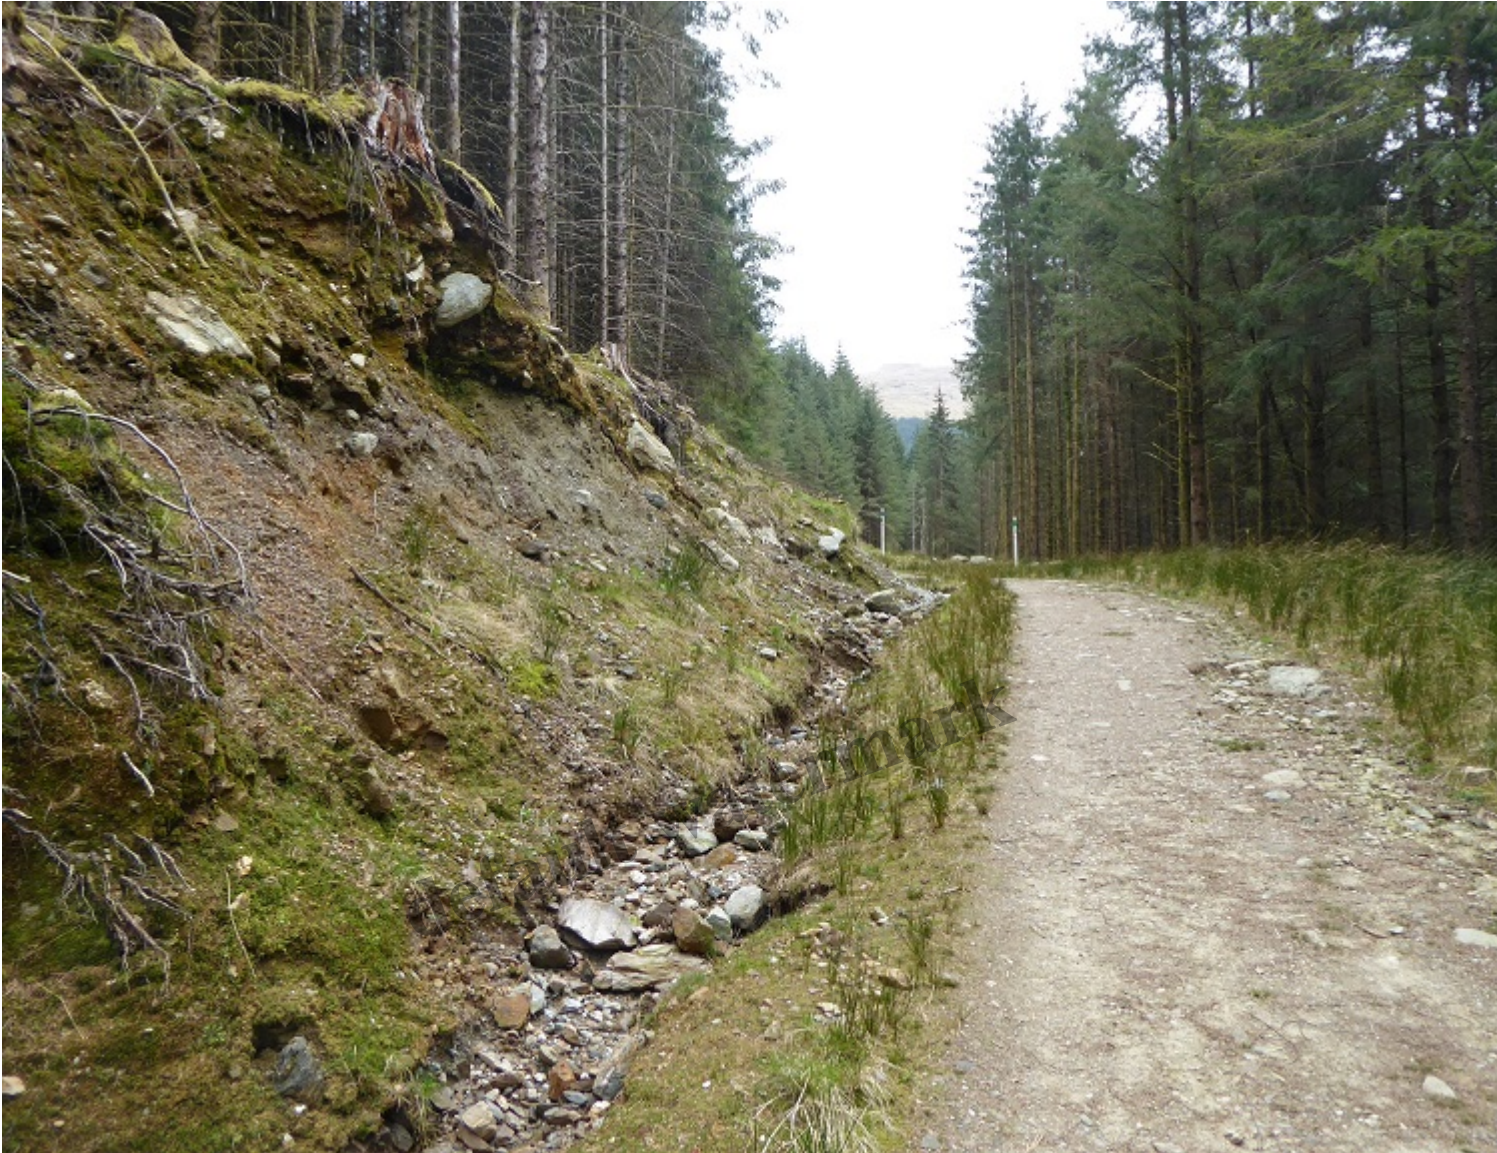
Further along the cuttings are even worse. Does no-one in Forestry and Land Scotland or the LLTNPA consider what sort of recreational experience this offers?

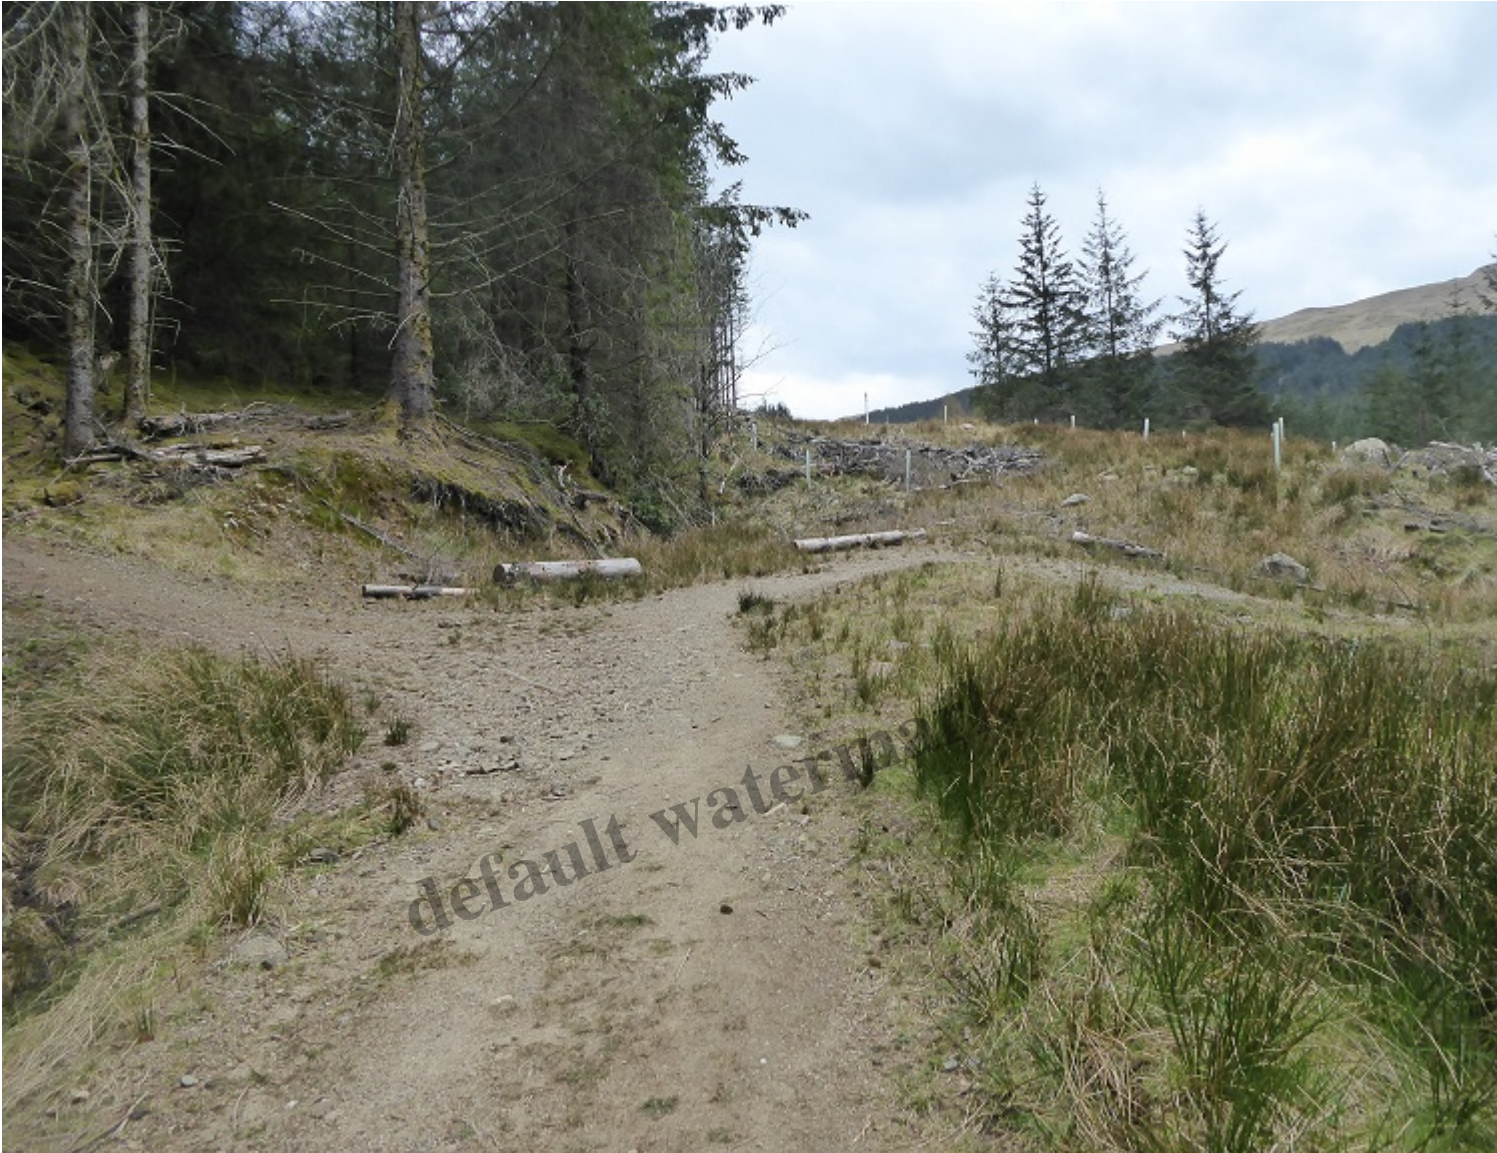
The pipeline then diverges from the path, taking a fairly direct line to the intake through a felled forest plantation while the core path bends to the right and descends to the Eas Garbh.

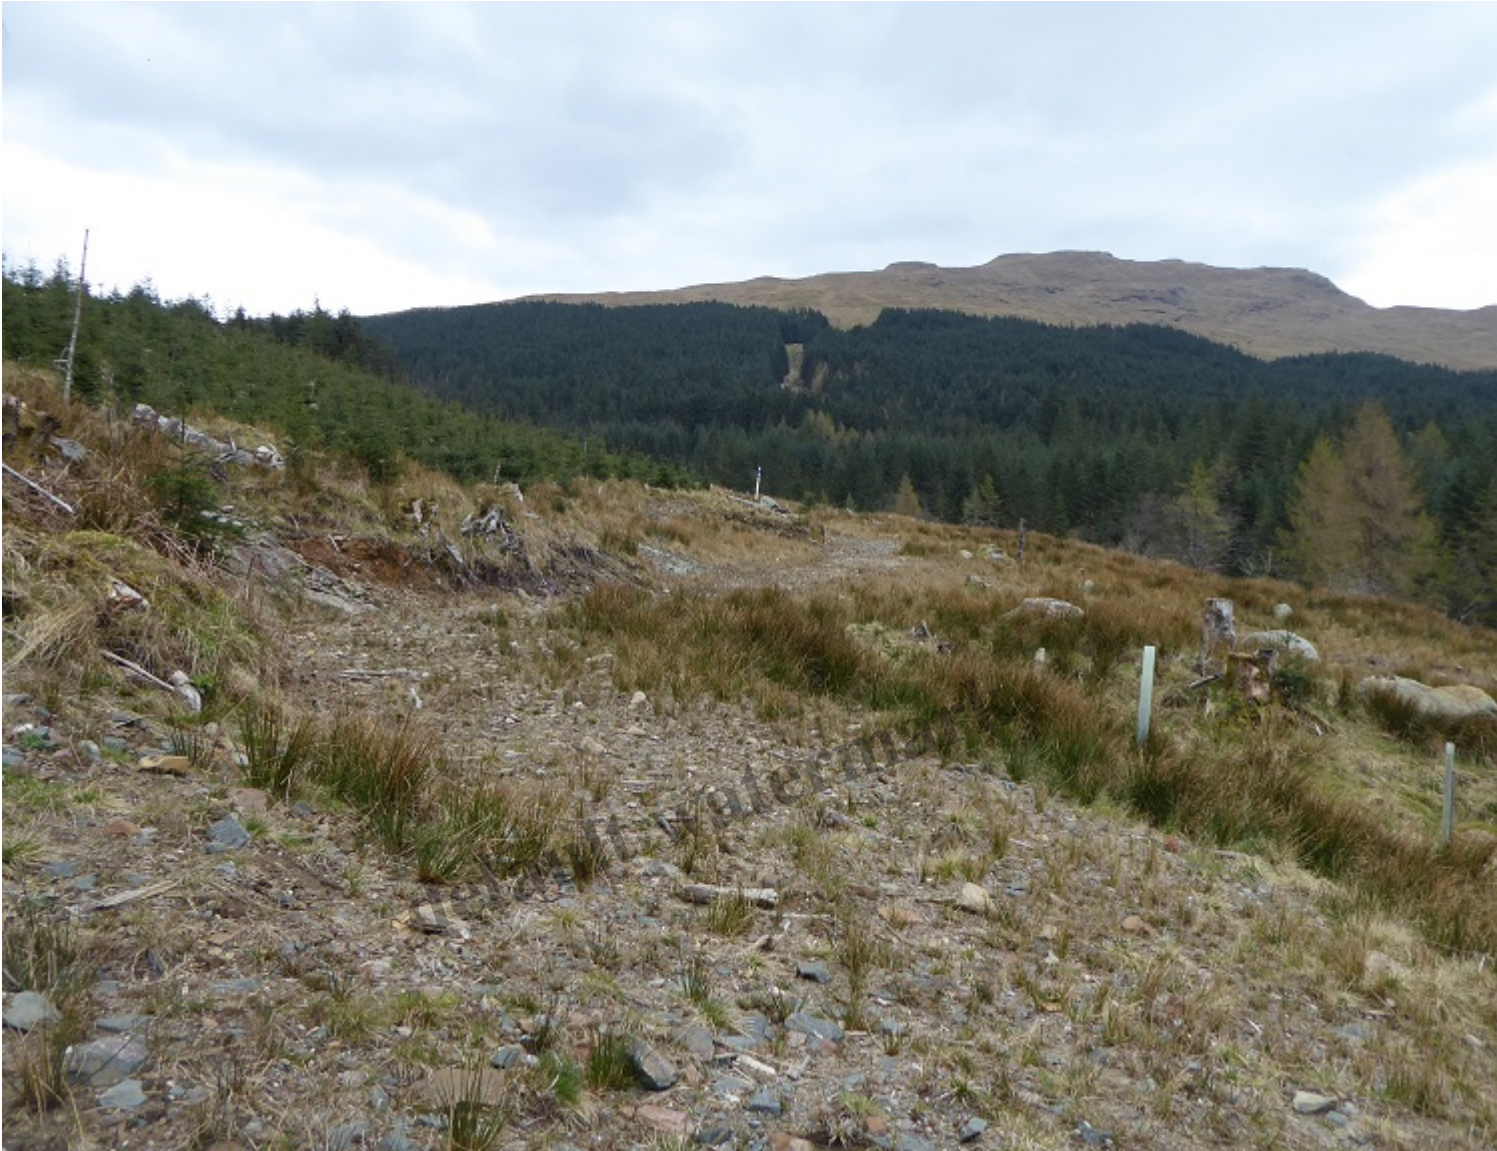
Apart from at Conic Hill ([see here](#)) I don't think I have seen a worse example of pipeline "restoration" in the National Park. There has been no attempt to restore the landforms and the flat bench above the pipe has in effect created a permanent road across the hillside.

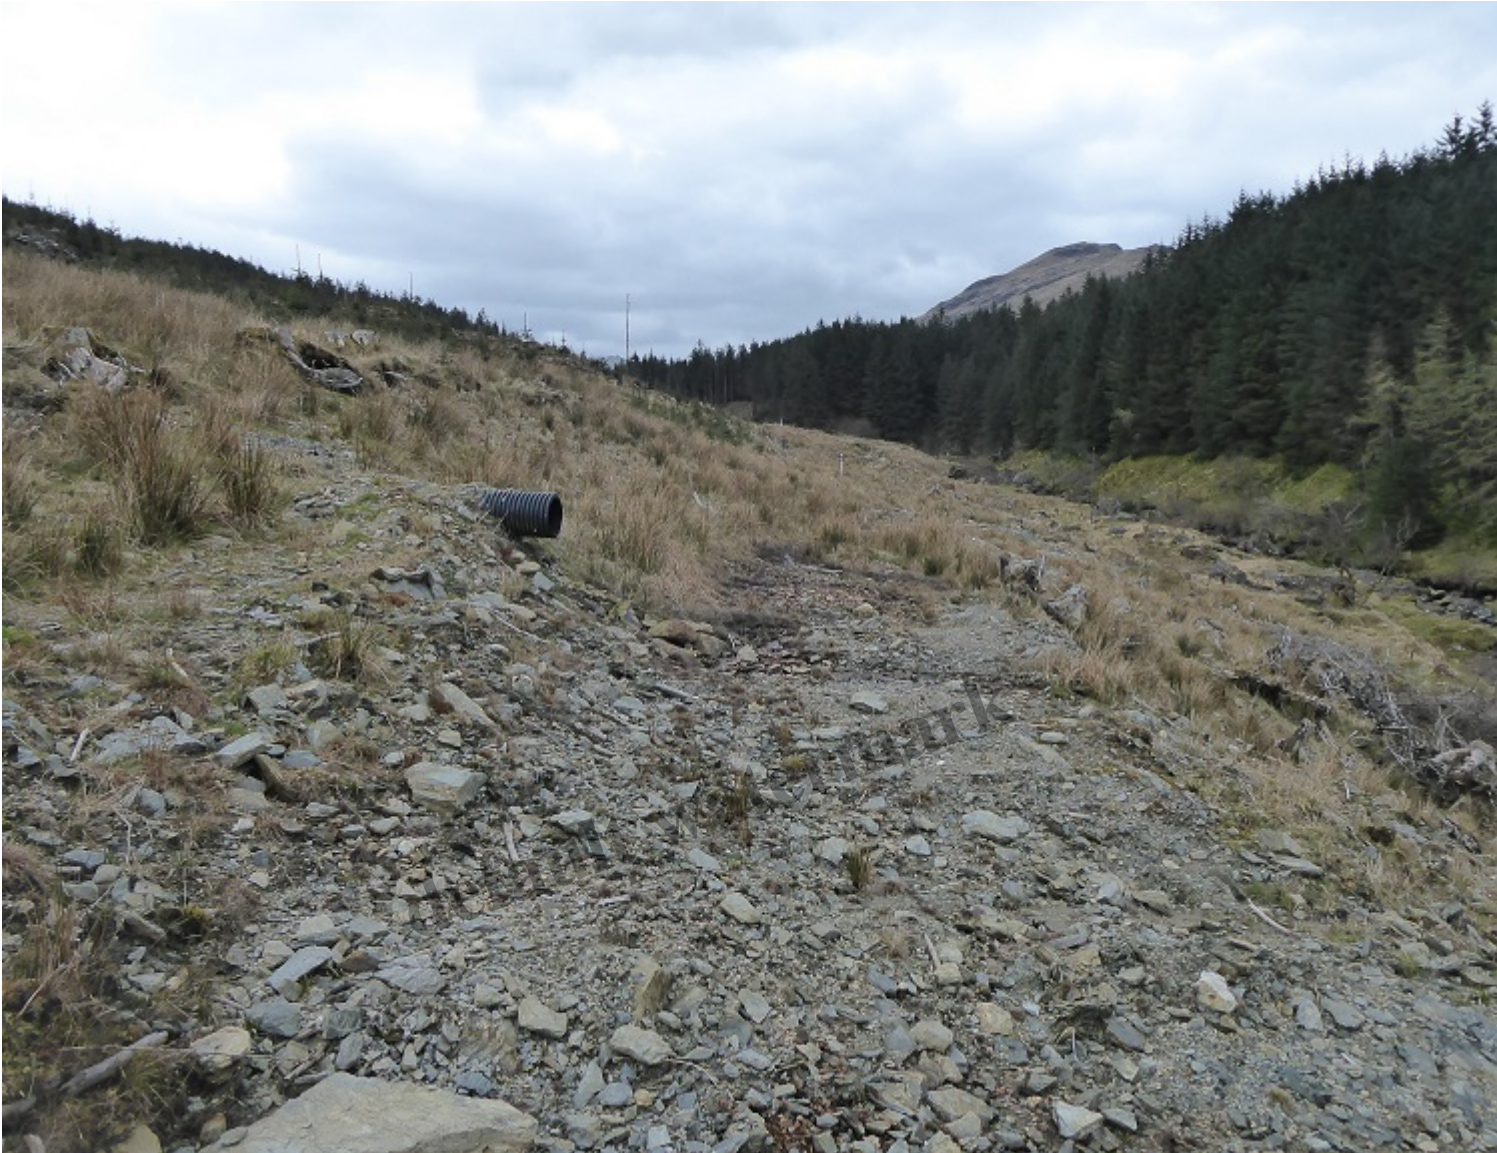
The National Park has simply been treated as industrial wasteland. What's clear is that the LLTNPA has abandoned any attempt to enforce its normal standards on land owned by the former Forestry Commission.

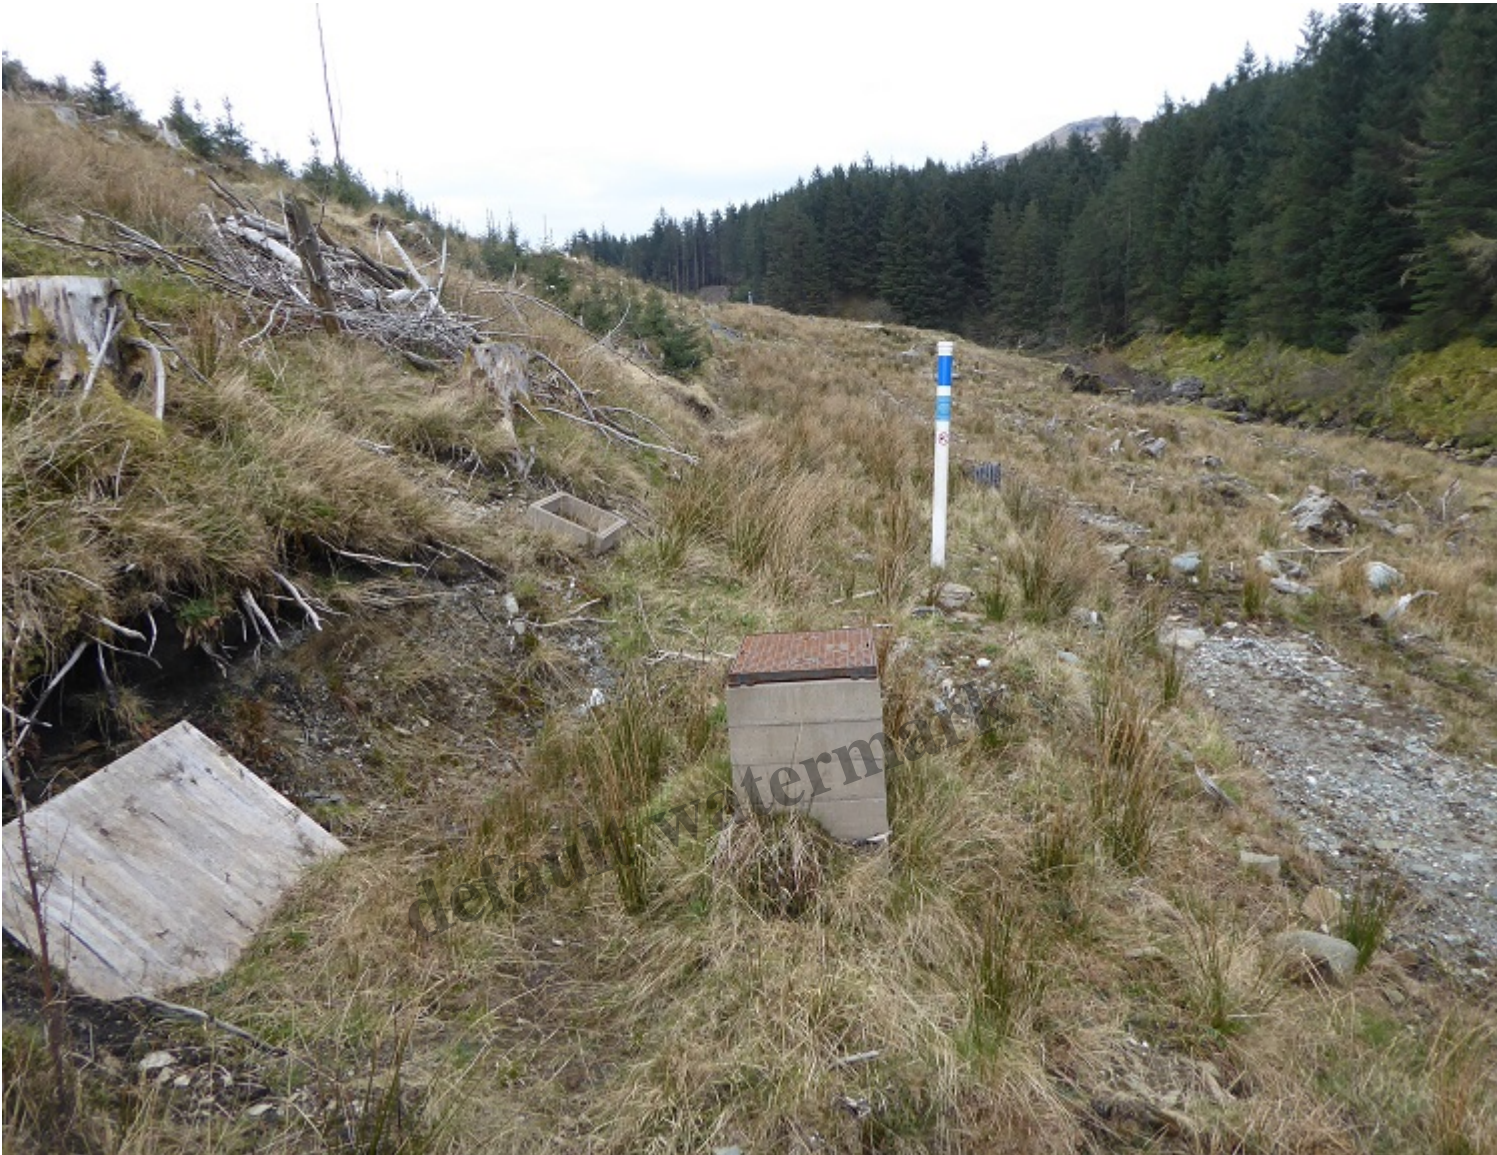
The hydro scheme could have provided an opportunity to rescue the west bank of the Donich Water from the ravages of industrial forestry but has instead has made it worse.
