The Donich Water hydro scheme and industrial forestry – out of sight, out of mind?

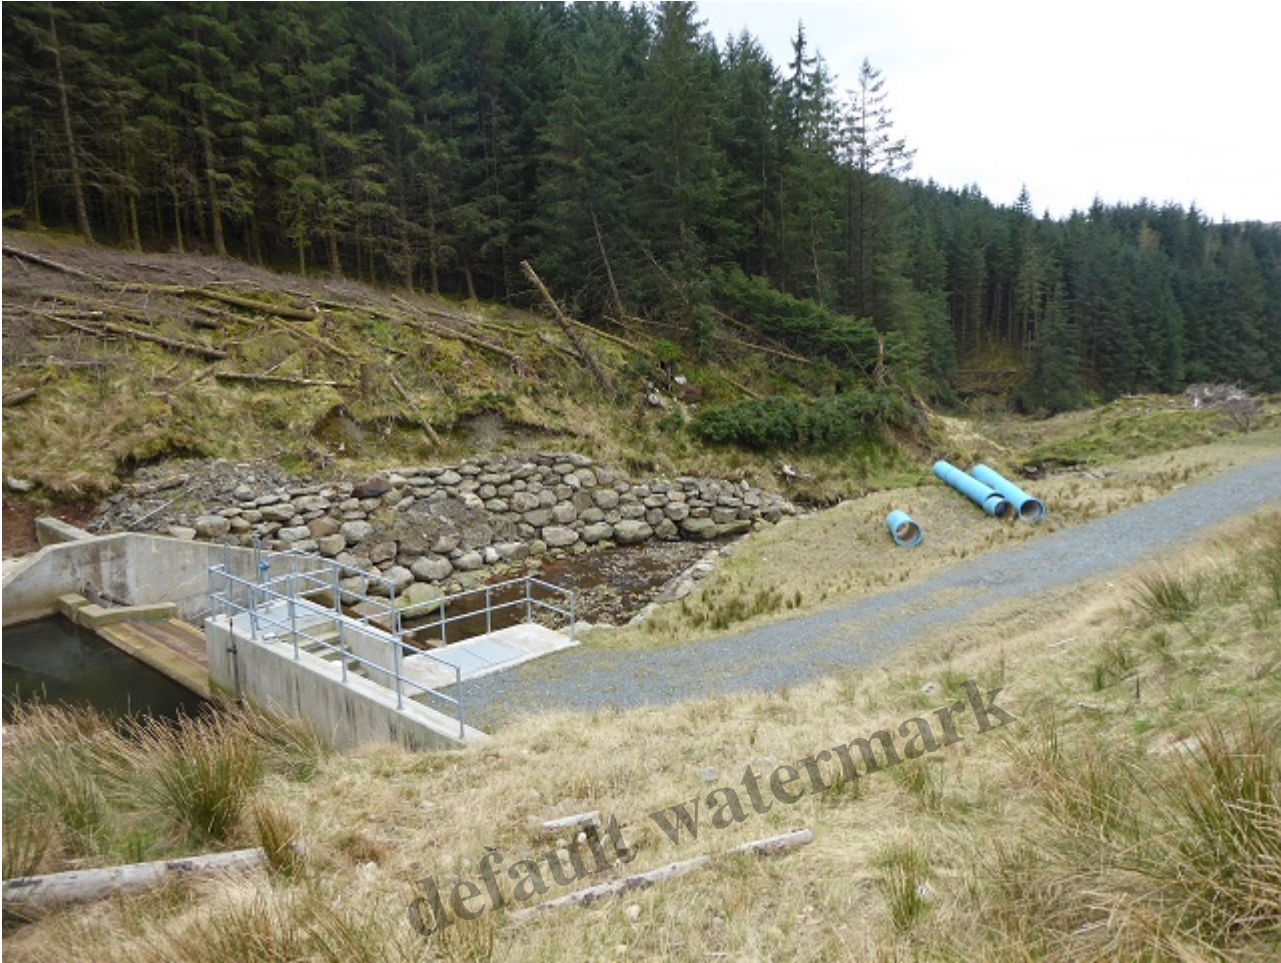
The intake was supposed to be screened but there has been little attempt to do so and the rip rap bouldering along either side of what remains of the river below presents the usual mess. Note how there has been no attempt to make use of the trees felled on the far bank because of the hydro construction.

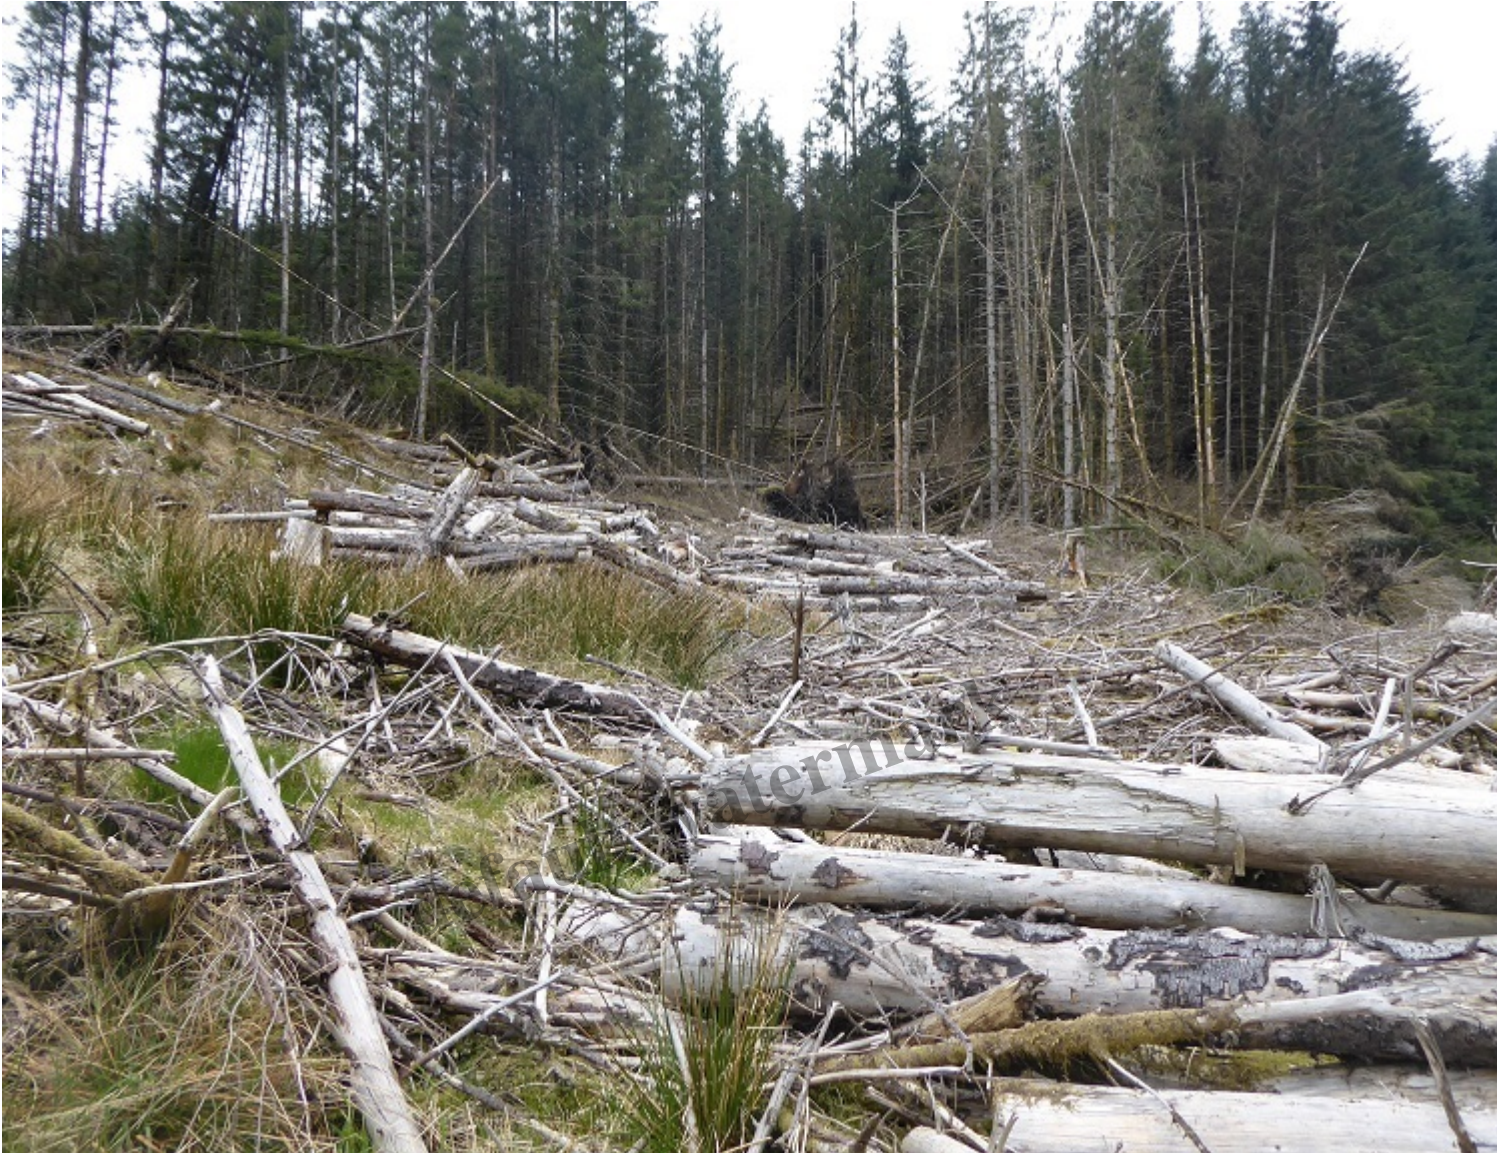
The wasteful practices of industrial forestry are also clearly visible just above the intake. Instead of trying to improve forestry within the National Park – and using planning applications such as this one to influence what Forest and Land Scotland does – the LLTNPA's draft woodland strategy has endorsed the UK Forestry Standards under which this destruction and waste is allowed to happen ([see here](#)).

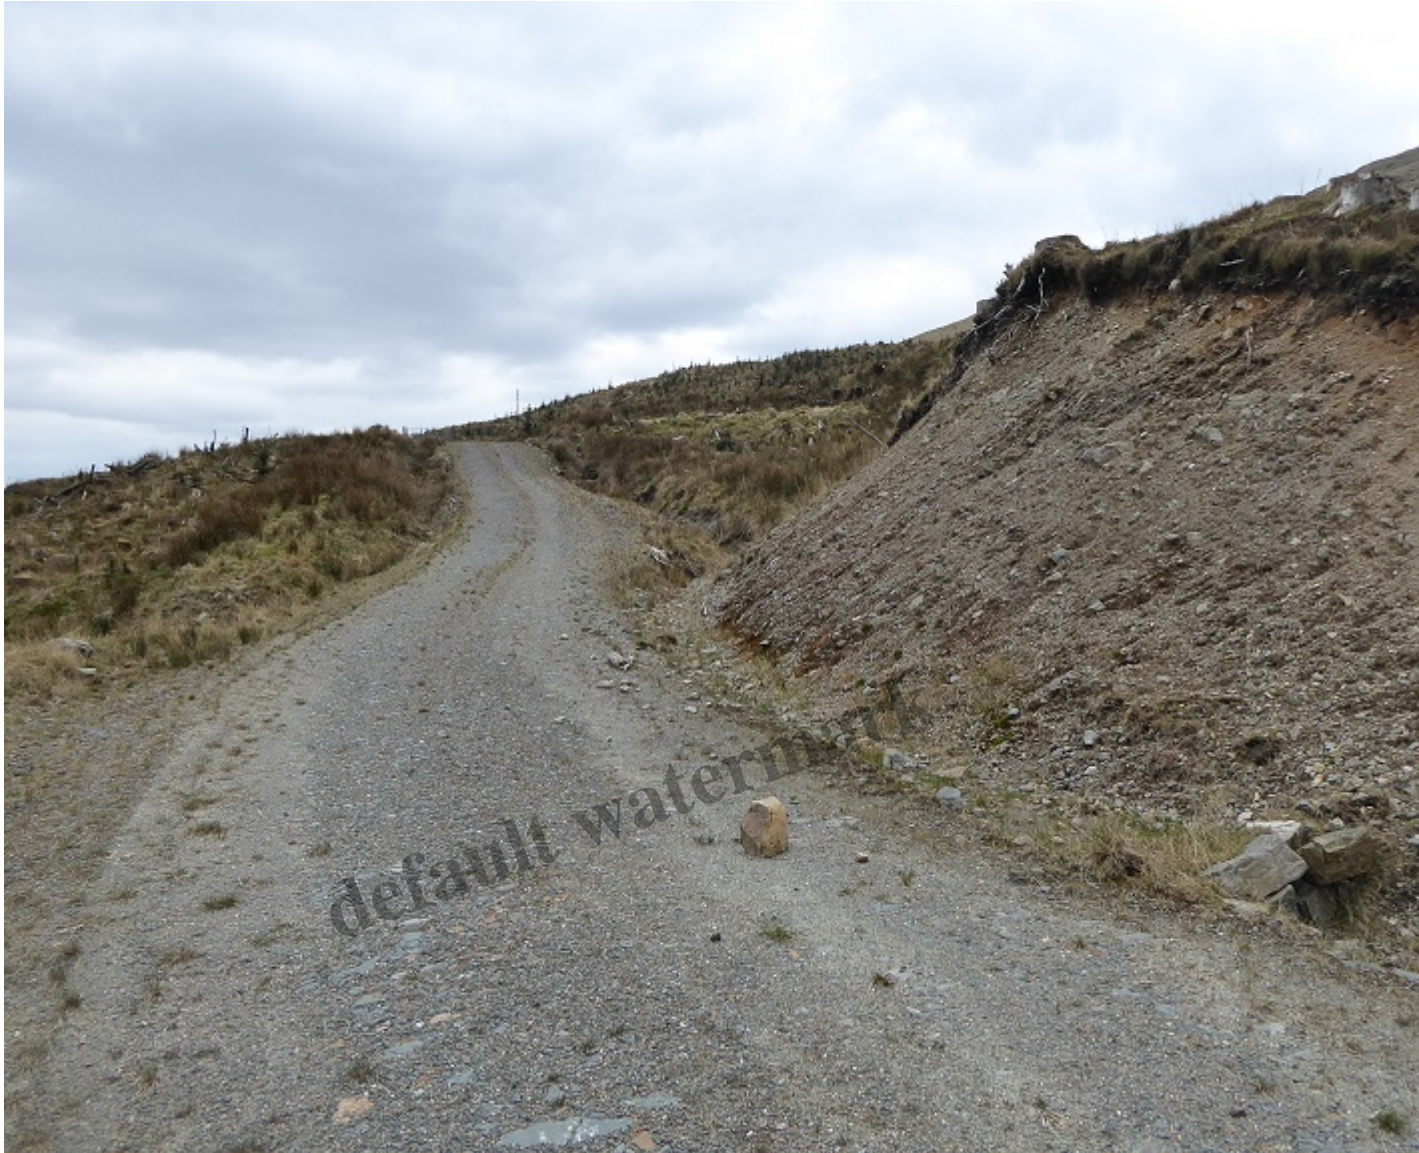
The top spur to the intake – there has been no attempt to restore the bank which is now eroding

As part of the Planning Application the LLTNPA approved two new permanent forest track spurs built according to UK forest standards. No consideration was given as to whether those standards are compatible with the Park's own best practice guidance on renewables which states that steep batters (as above) should be avoided completely and the width of new roads should be limited to 2.5m. This provides further proof that that the UK Forestry Standards are totally inappropriate for National Parks in
