The Donich Water hydro scheme and industrial forestry – out of sight, out of mind?

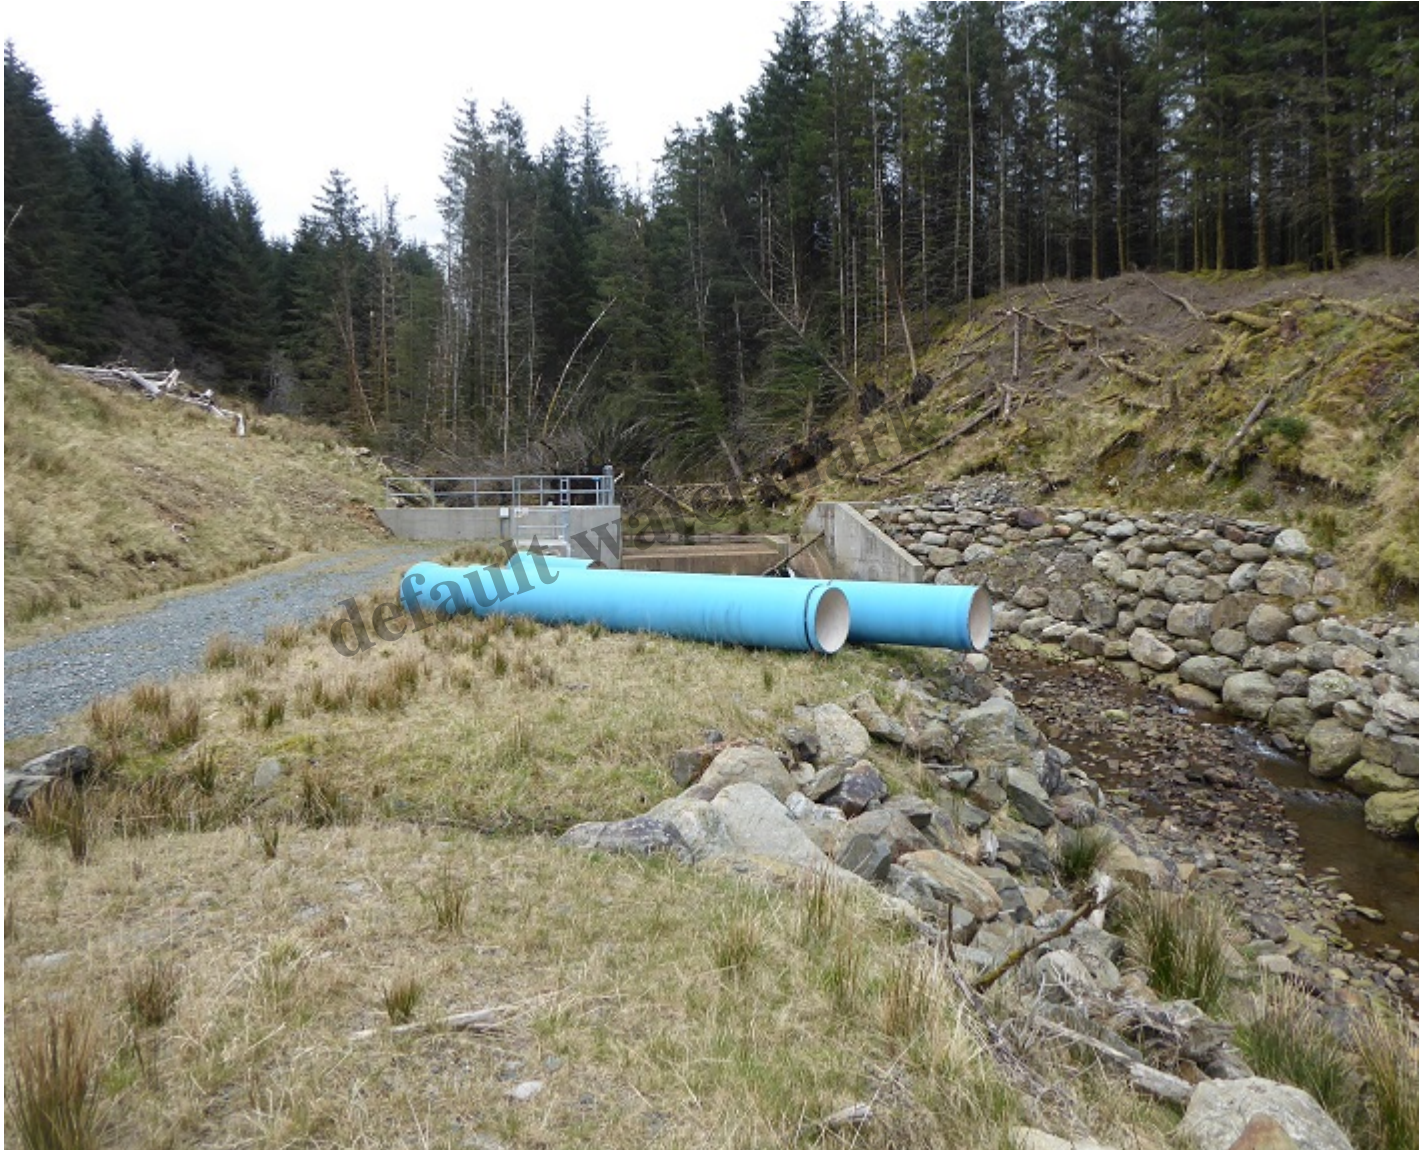
Almost three years after the Donich Water hydro scheme was commissioned, the spare penstock has not been removed, a symptom of the Park's failure to ensure basis planning standards are met. The forestry, bare wing walls and rip rap bouldering add to the landscape mess.

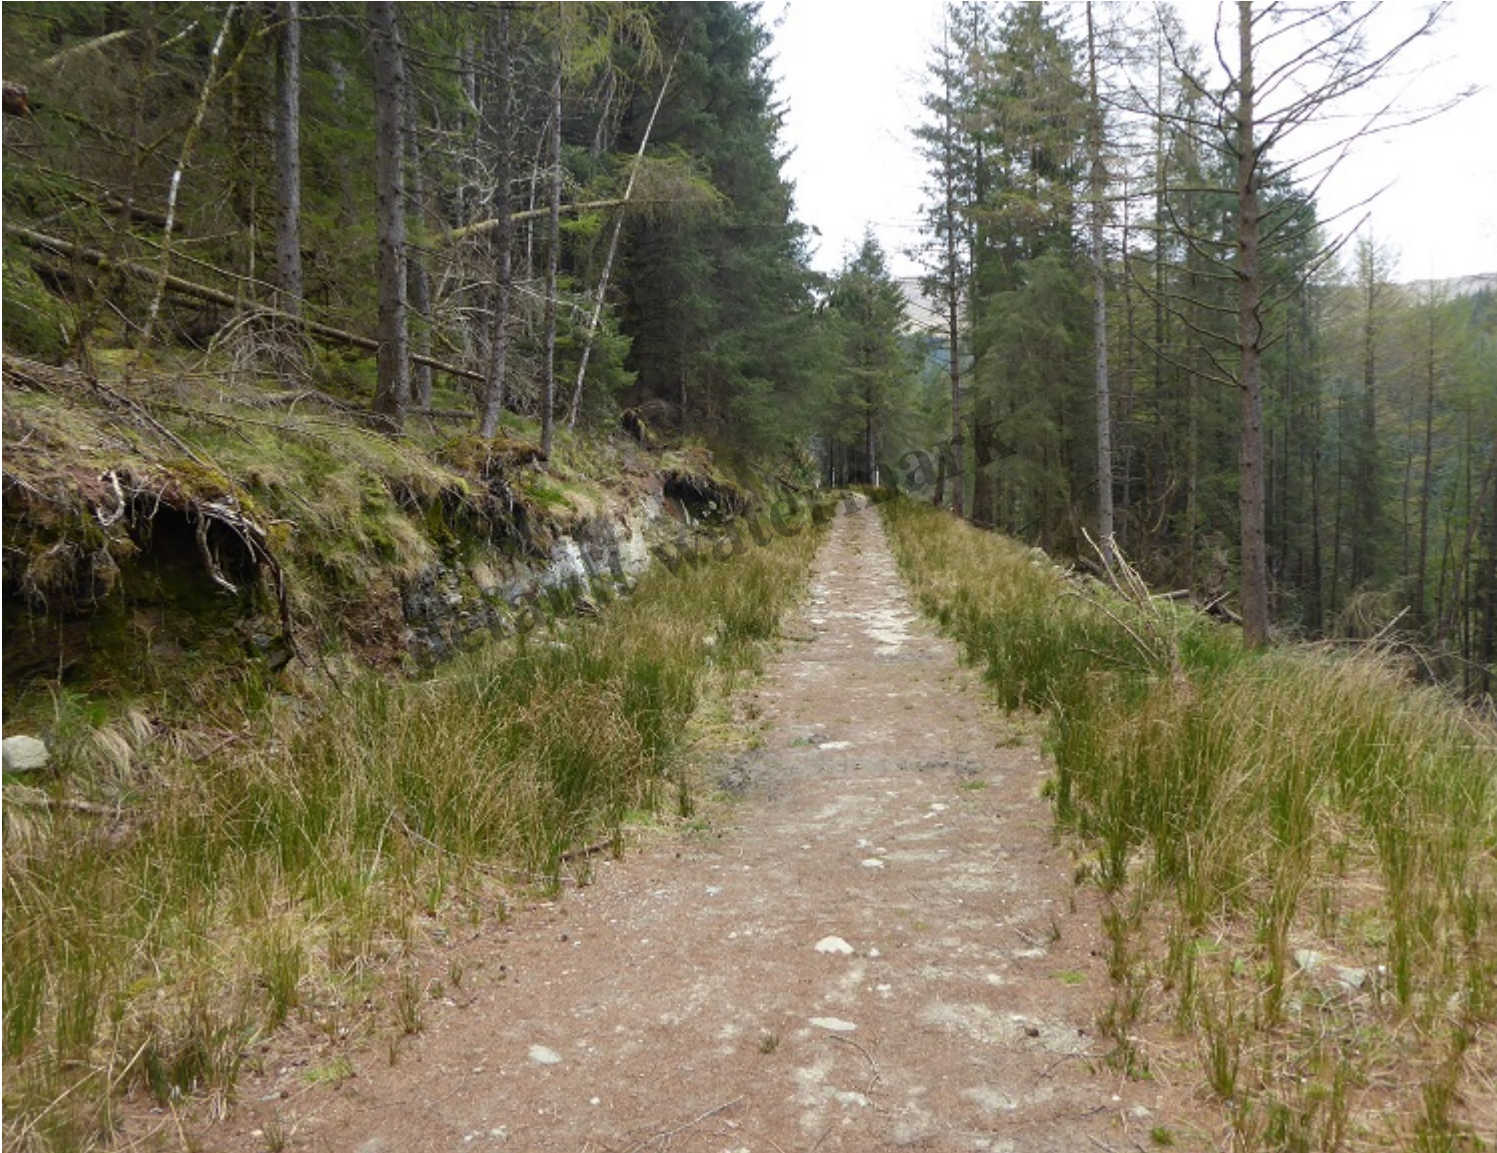
After the steep section, the pipeline follows the line of the core path. No attempt has been made to restore the prominent bench which has now been cut across the hillside. It has been left to revegetate itself and consequently has been colonised with rush. Some of the steep bank on the left may have been created by the original path but its contrary to the Park's best practice guidance, being too steep to vegetate, and there has been no attempt to restore it. An opportunity to improve the walking experience – an open woodland ride with grasses and flowers would be good for butterflies etc – has been lost and the “restored” path has very little to commend it.

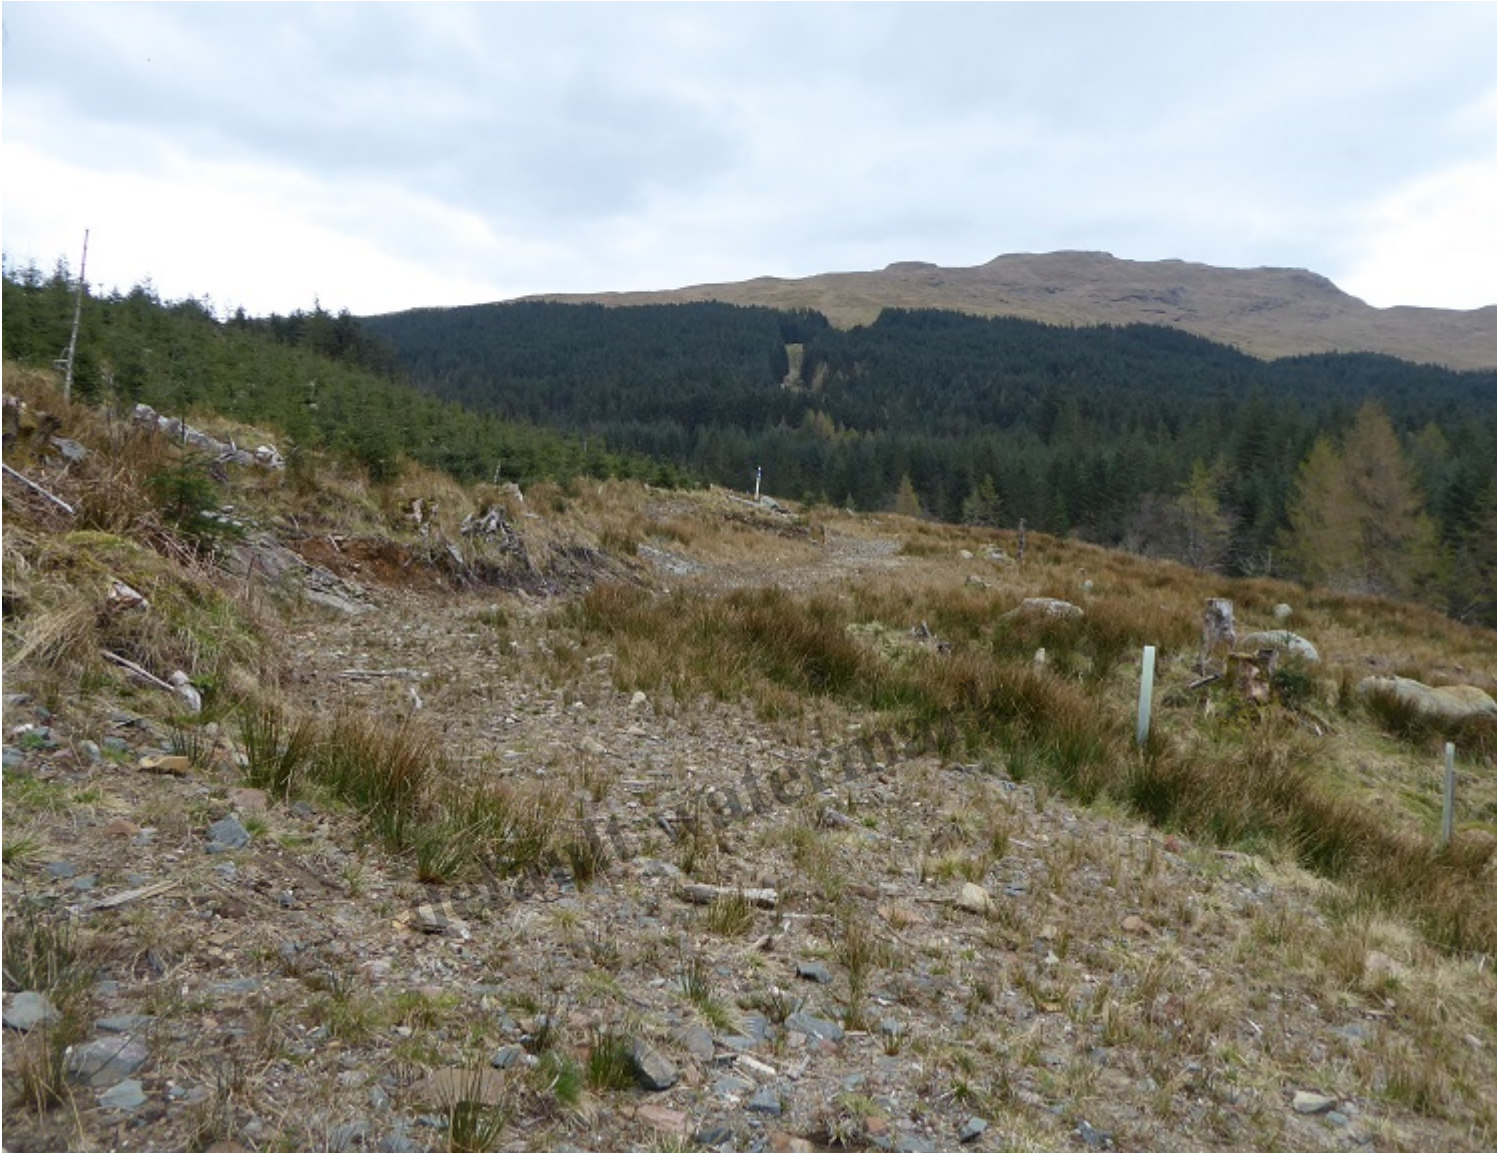
Apart from at Conic Hill ([see here](#)) I don't think I have seen a worse example of pipeline "restoration" in the National Park. There has been no attempt to restore the landforms and the flat bench above the pipe has in effect created a permanent road across the hillside.

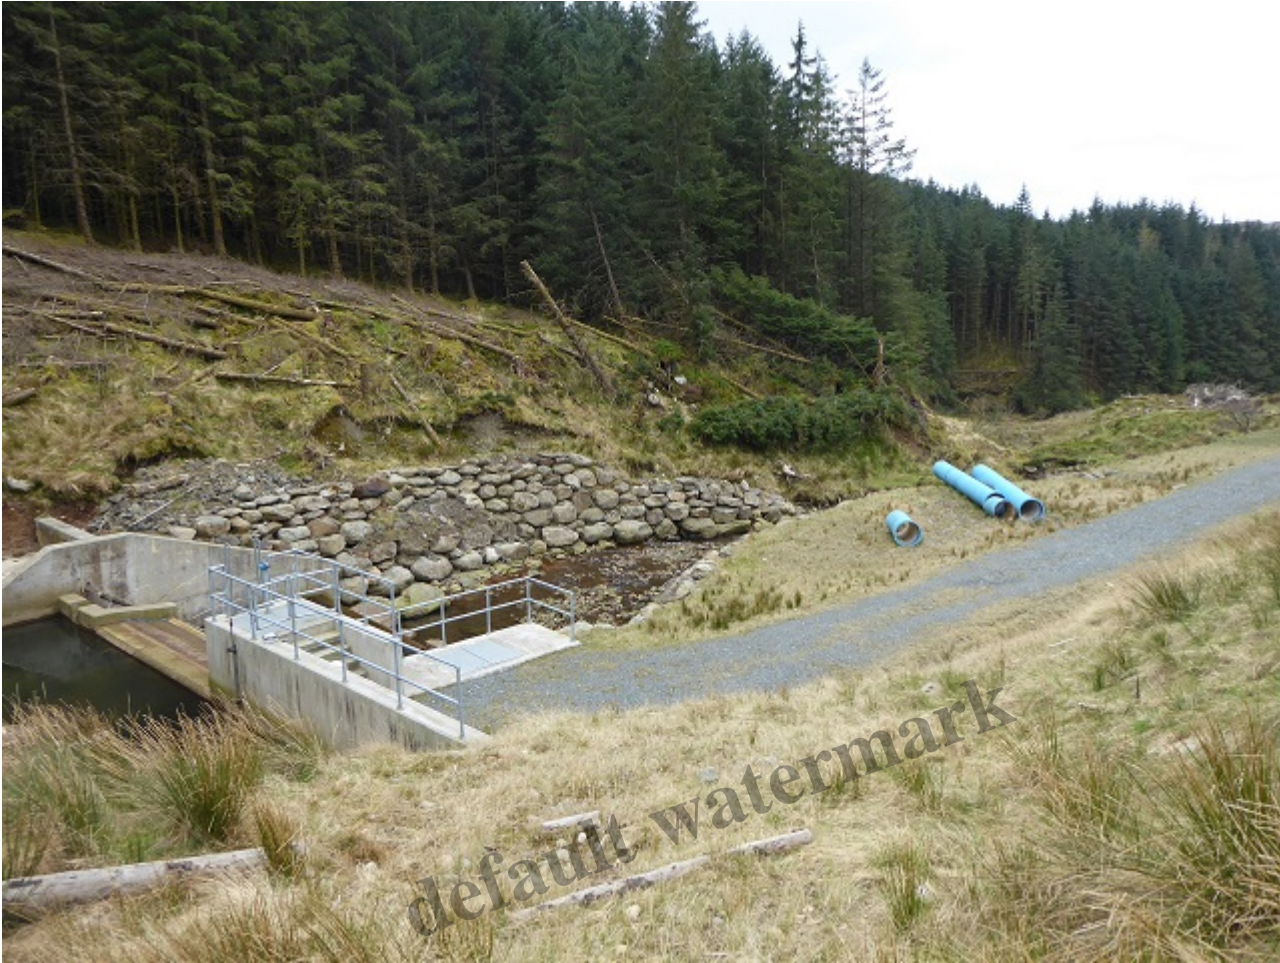
The intake was supposed to be screened but there has been little attempt to do so and the rip rap bouldering along either side of what remains of the river below presents the usual mess. Note how there has been no attempt to make use of the trees felled on the far bank because of the hydro construction.

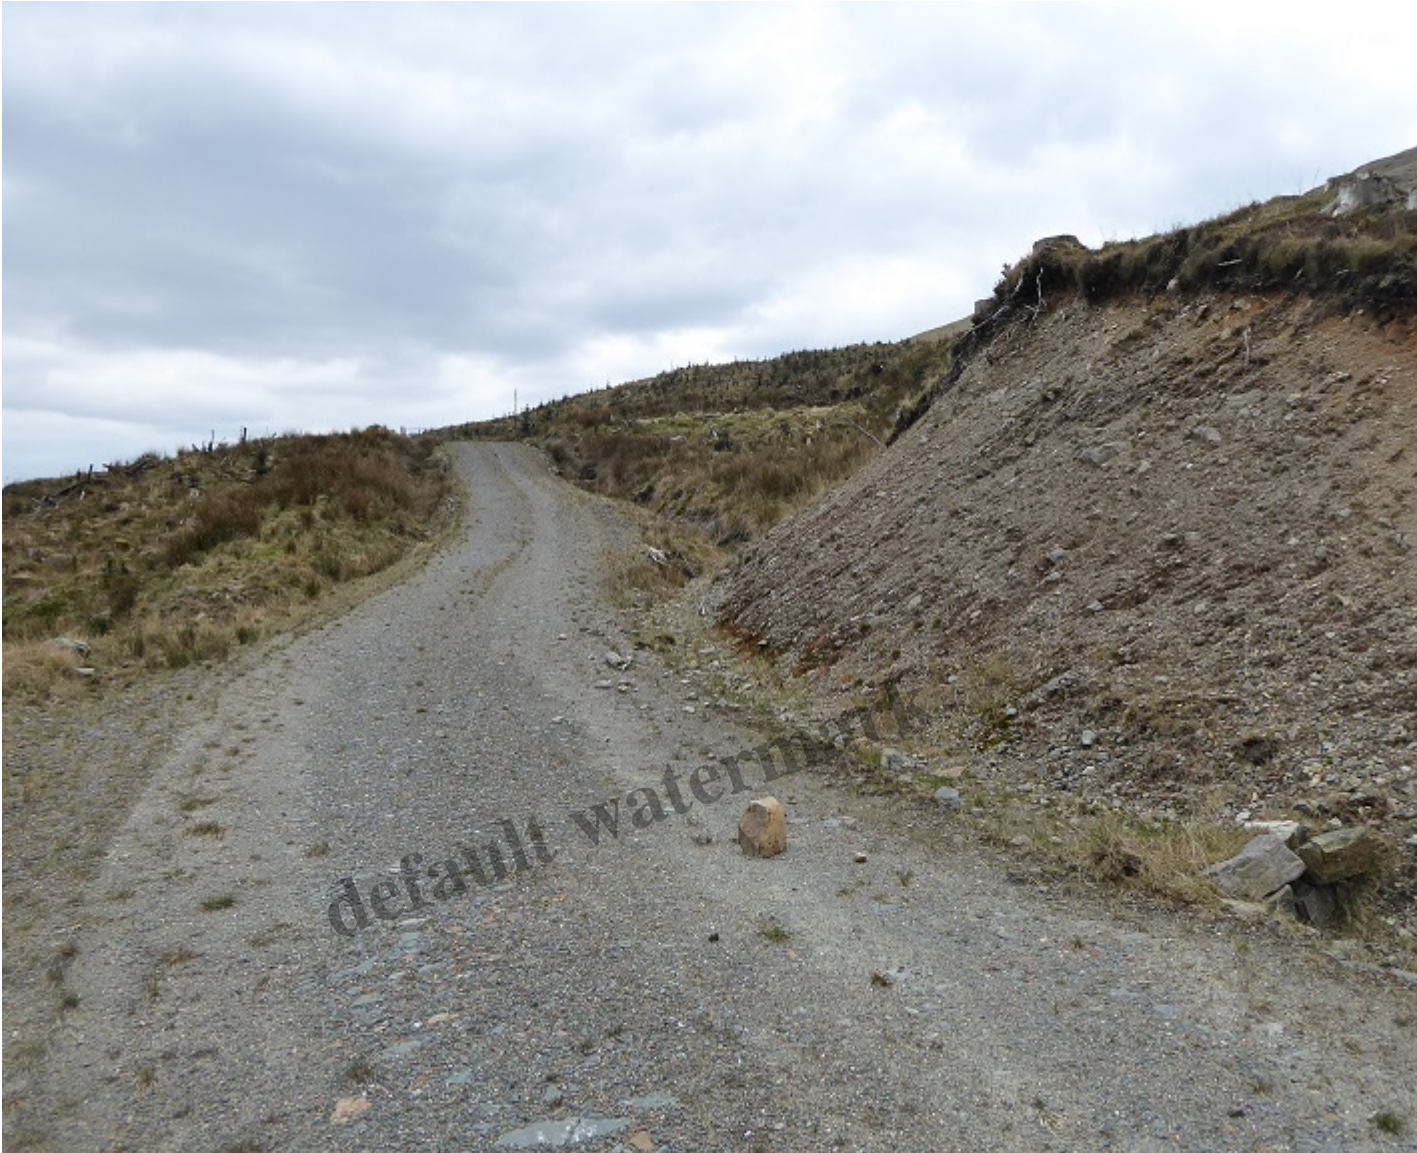
The top spur to the intake – there has been no attempt to restore the bank which is now eroding

As part of the Planning Application the LLTNPA approved two new permanent forest track spurs built according to UK forest standards. No consideration was given as to whether those standards are compatible with the Park's own best practice guidance on renewables which states that steep batters (as above) should be avoided completely and the width of new roads should be limited to 2.5m. This provides further proof that that the UK Forestry Standards are totally inappropriate for National Parks in
