The Donich Water hydro scheme and industrial forestry – out of sight, out of mind?

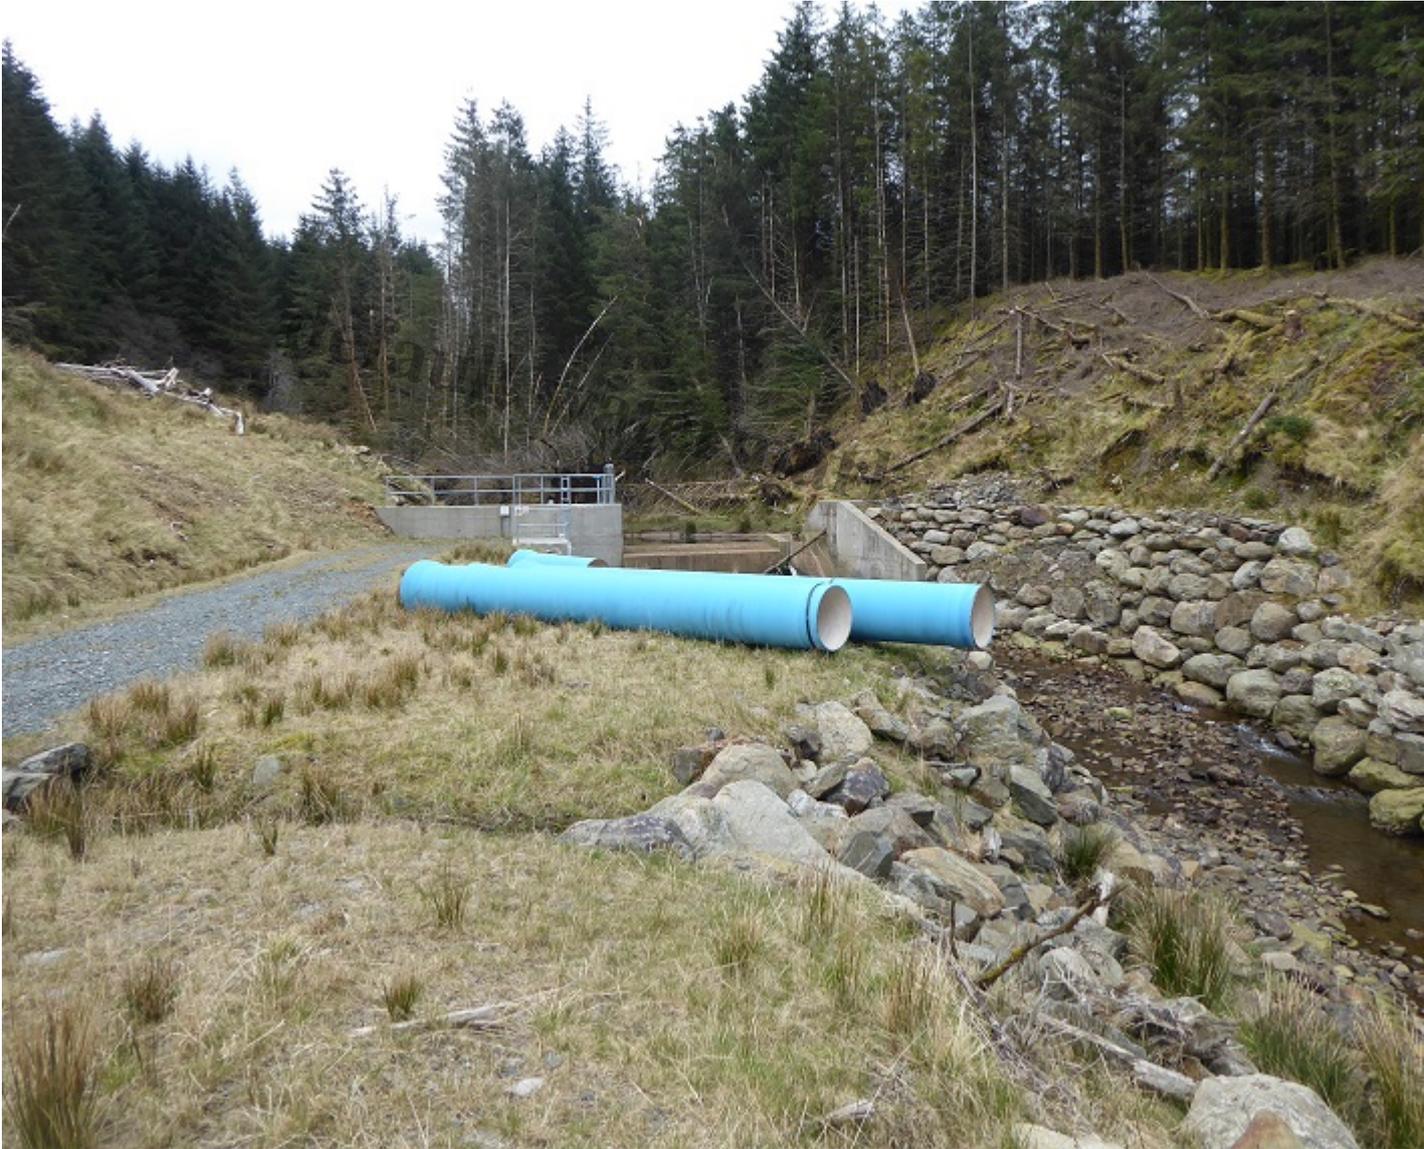
Almost three years after the Donich Water hydro scheme was commissioned, the spare penstock has not been removed, a symptom of the Park’s failure to ensure basic planning standards are met. Felled forestry, bare wing walls and rip rap bouldering add to the landscape mess.

enforcement action to remove these pipes. This post takes a look at the wider failures with the Donich Water Scheme which the LLTNPA needs to address.

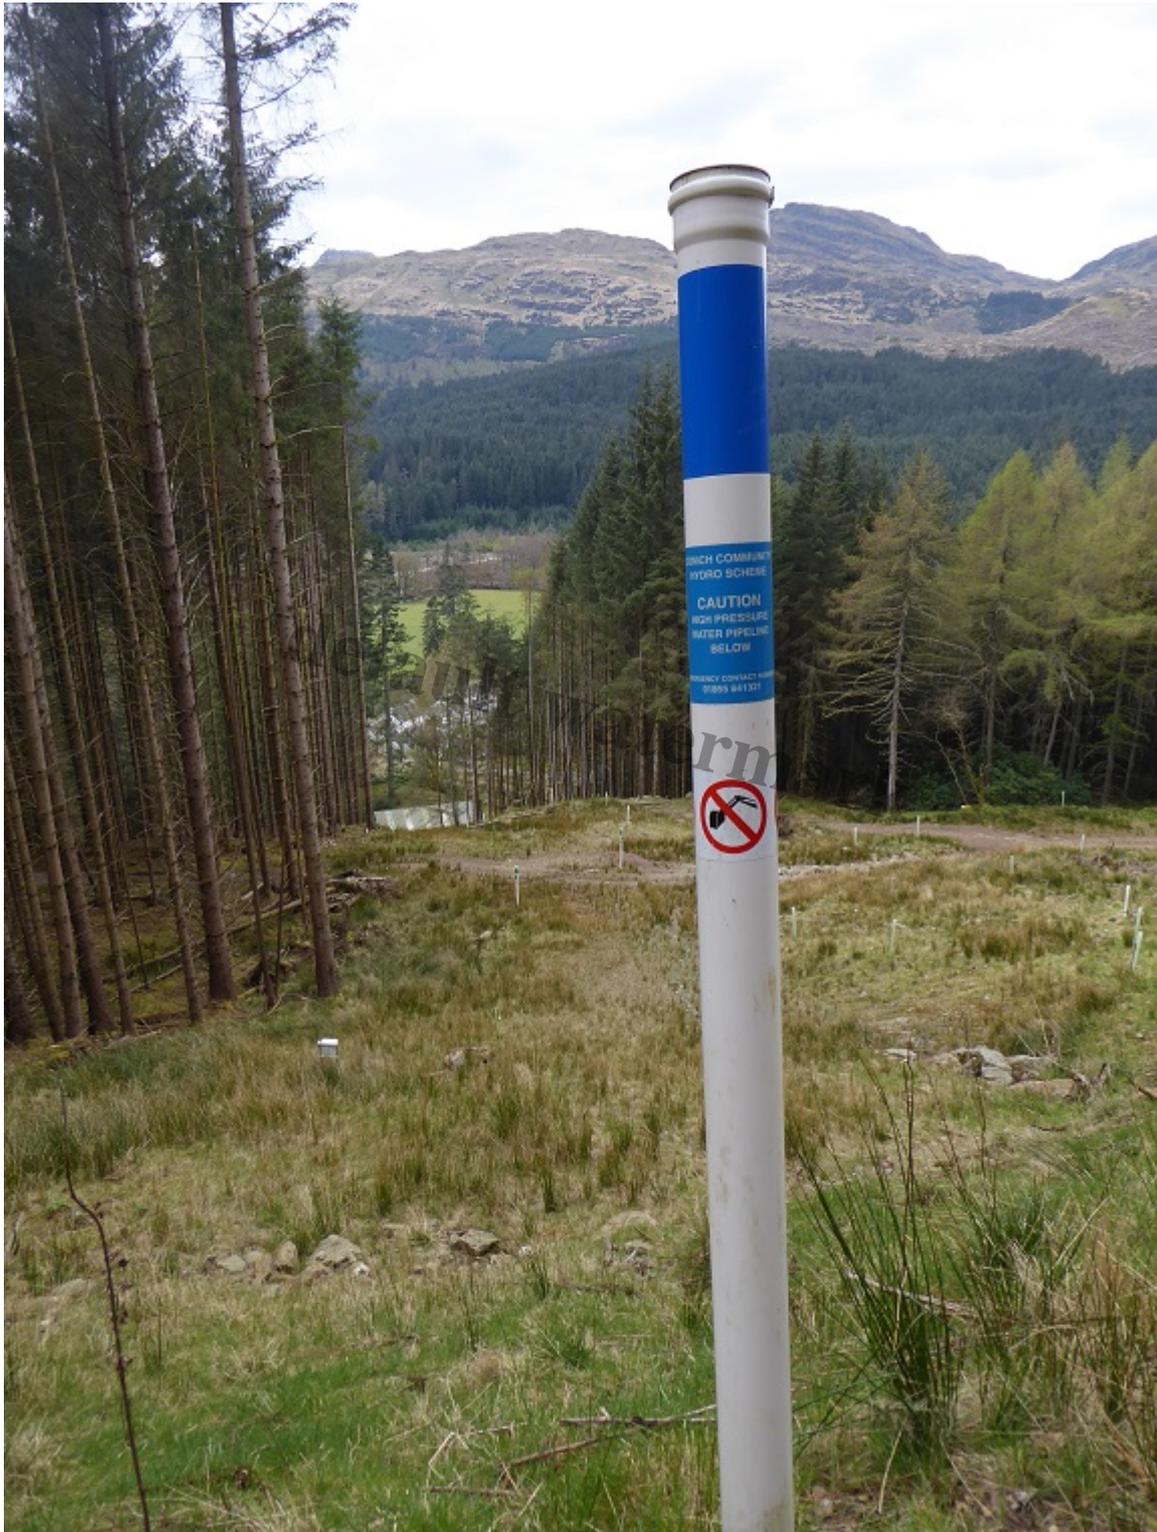
While the path existed before the hydro scheme was approved, trees were felled to make way for the steepest section of pipeline above the powerhouse

30 months after construction, the vegetation above the steepest section of the pipeline has hardly recovered. There appears to have been only minimal attempts at restoration, with a few trees planted. In most hydro schemes within the National Park, the most effective restoration work has involved the ground above pipelines. In this case too the LLTNP required the land to be restored, requiring a

ture management plan for example, but appears to have done nothing to enforce this. It appears that because this land is within industrial forestry and owned by the Forestry Commission/Forest and Land Scotland the LLTNPA has not enforced its usual standards.

I also wondered whether the prominent ugly marker poles are really necessary and whether the LLTNPA could not have insisted on something a little more sympathetic to the natural environment?

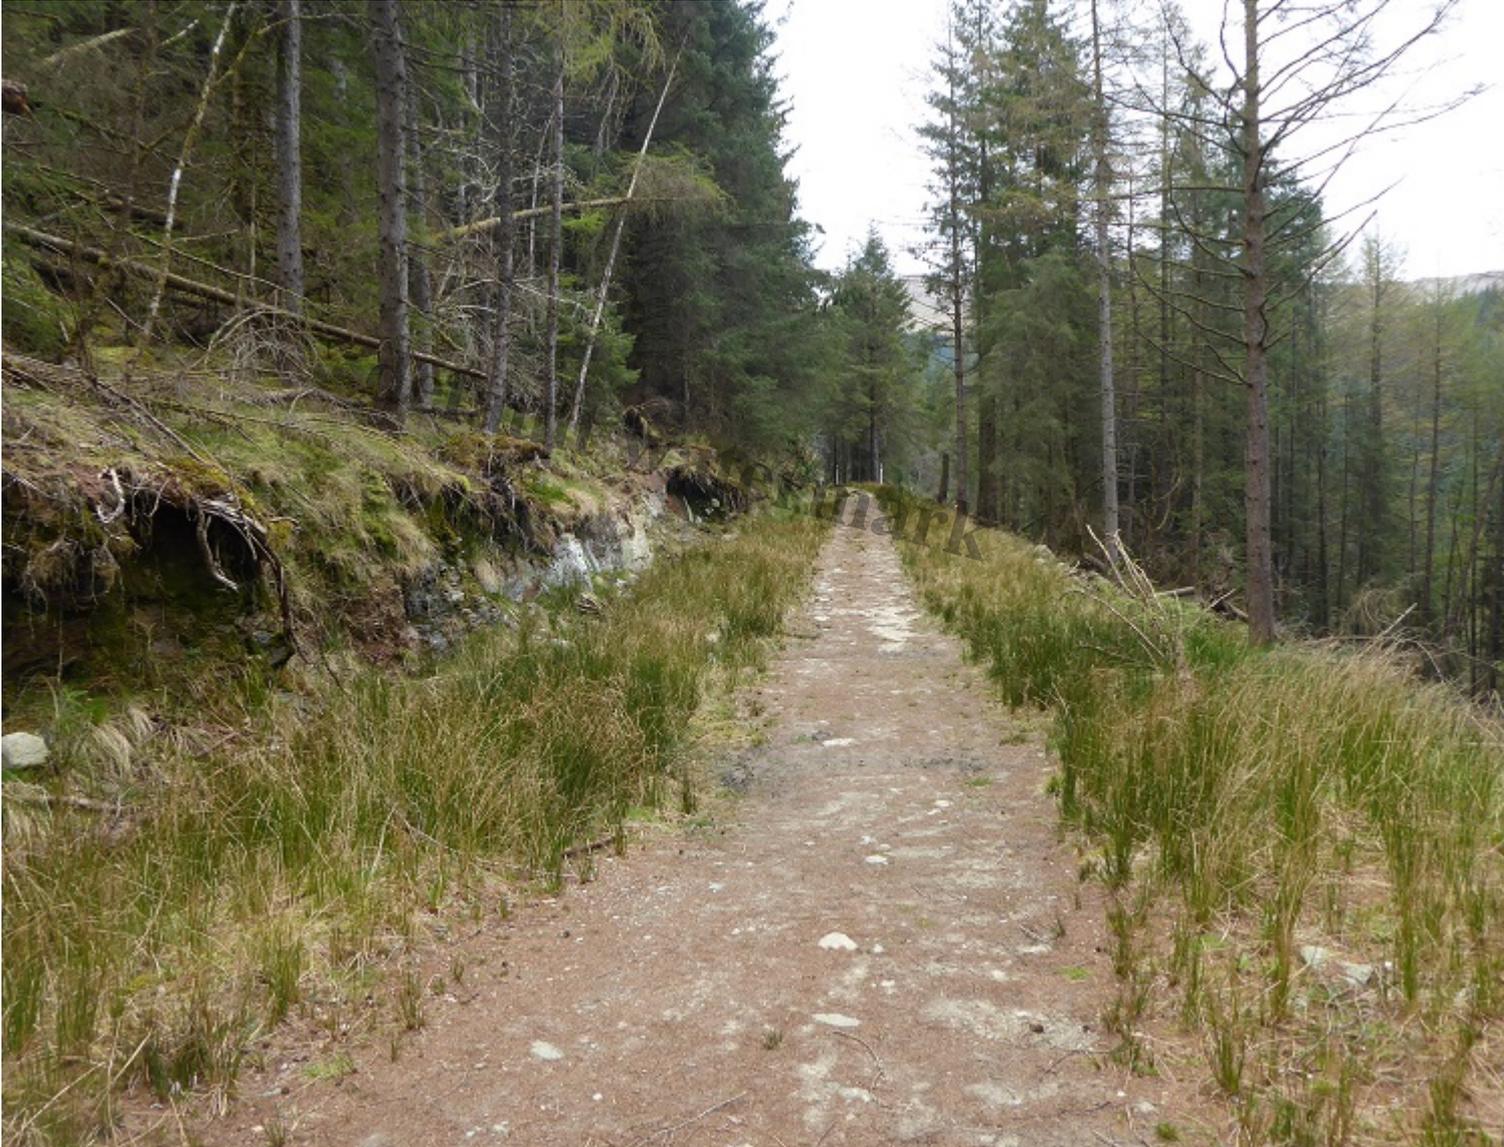
After the steep section, the pipeline follows the line of the core path. No attempt has been made to restore the prominent bench which has now been cut across the hillside. It has been left to revegetate itself and consequently has been colonised with rush. Some of the steep bank on the left may have been created by the original path but its contrary to the Park's best practice guidance, being too steep to vegetate, and there has been no attempt to restore it. An opportunity to improve the walking experience – an open woodland ride with grasses and flowers would be good for butterflies etc – has been lost and the 'restored' path has very little to commend it.

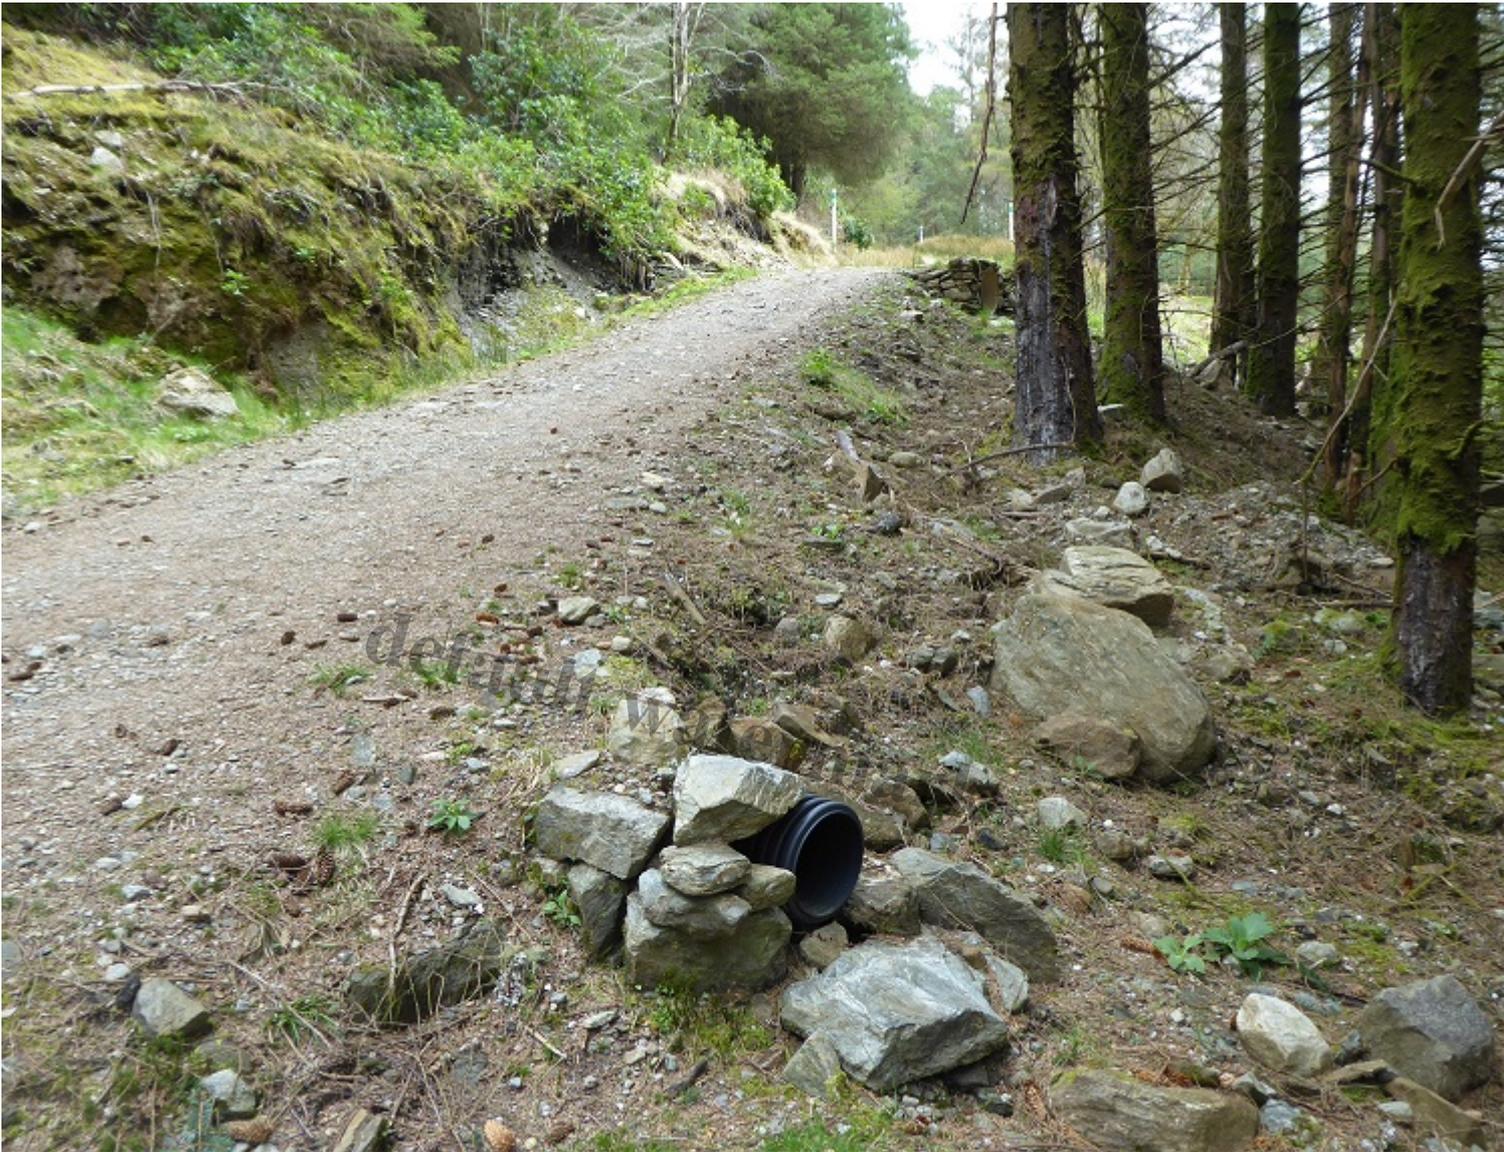
The quality of the culvert finishing was very poor and in this case the stone facing had already collapsed revealing the plastic pipe.

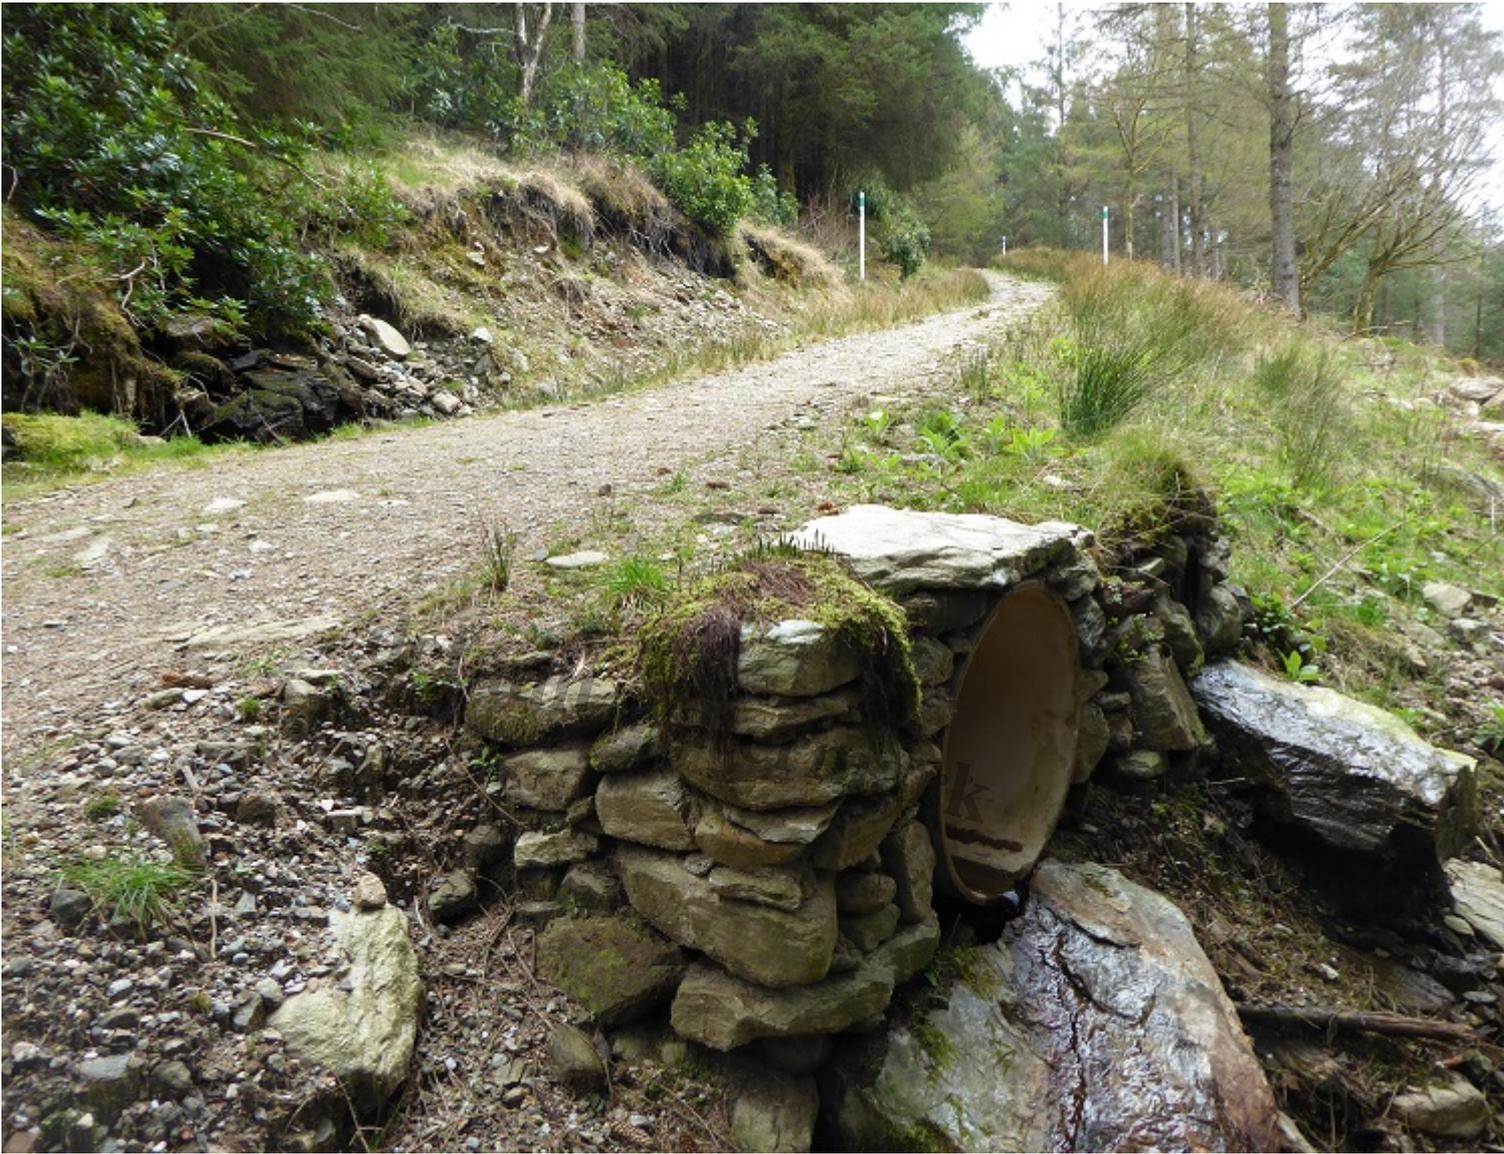
Its hard to see this culvert wall facing, built without any foundations, surviving long either. Note the bare banks and multiple pipe markers behind. Are these the standards we should expect in a National Park?

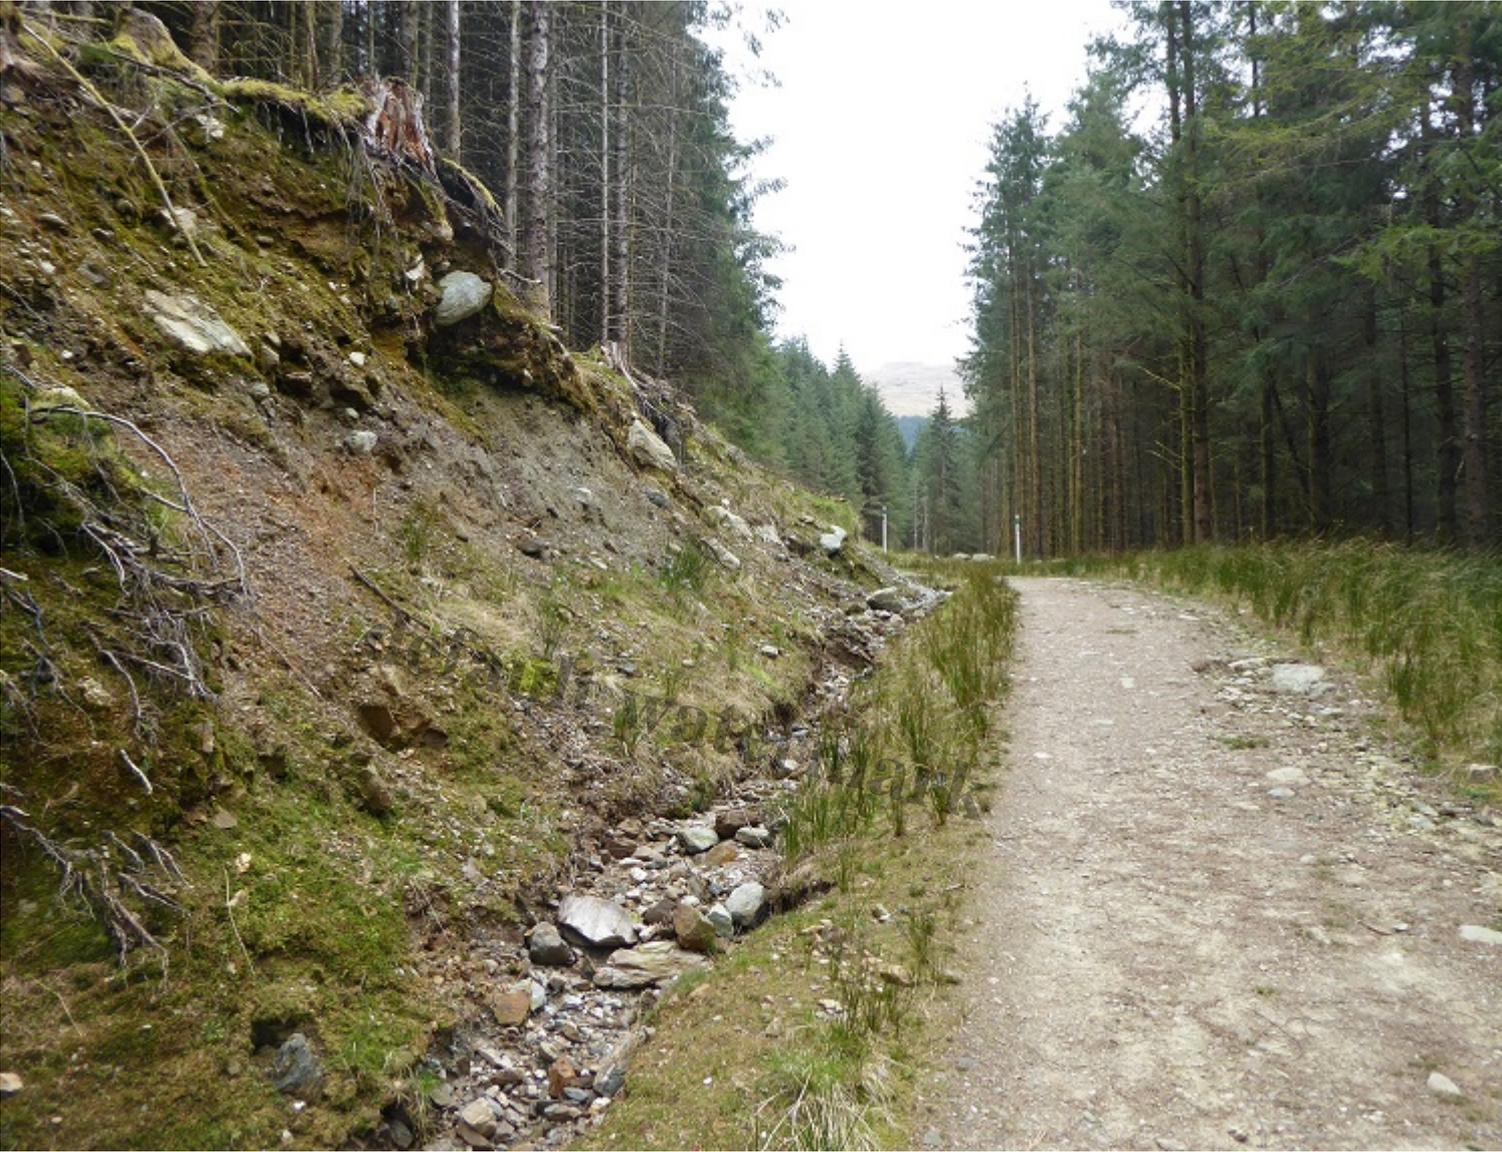
Further along the cuttings are even worse. Does no-one in Forestry and Land Scotland or the LLTNPA consider what sort of recreational experience this offers?

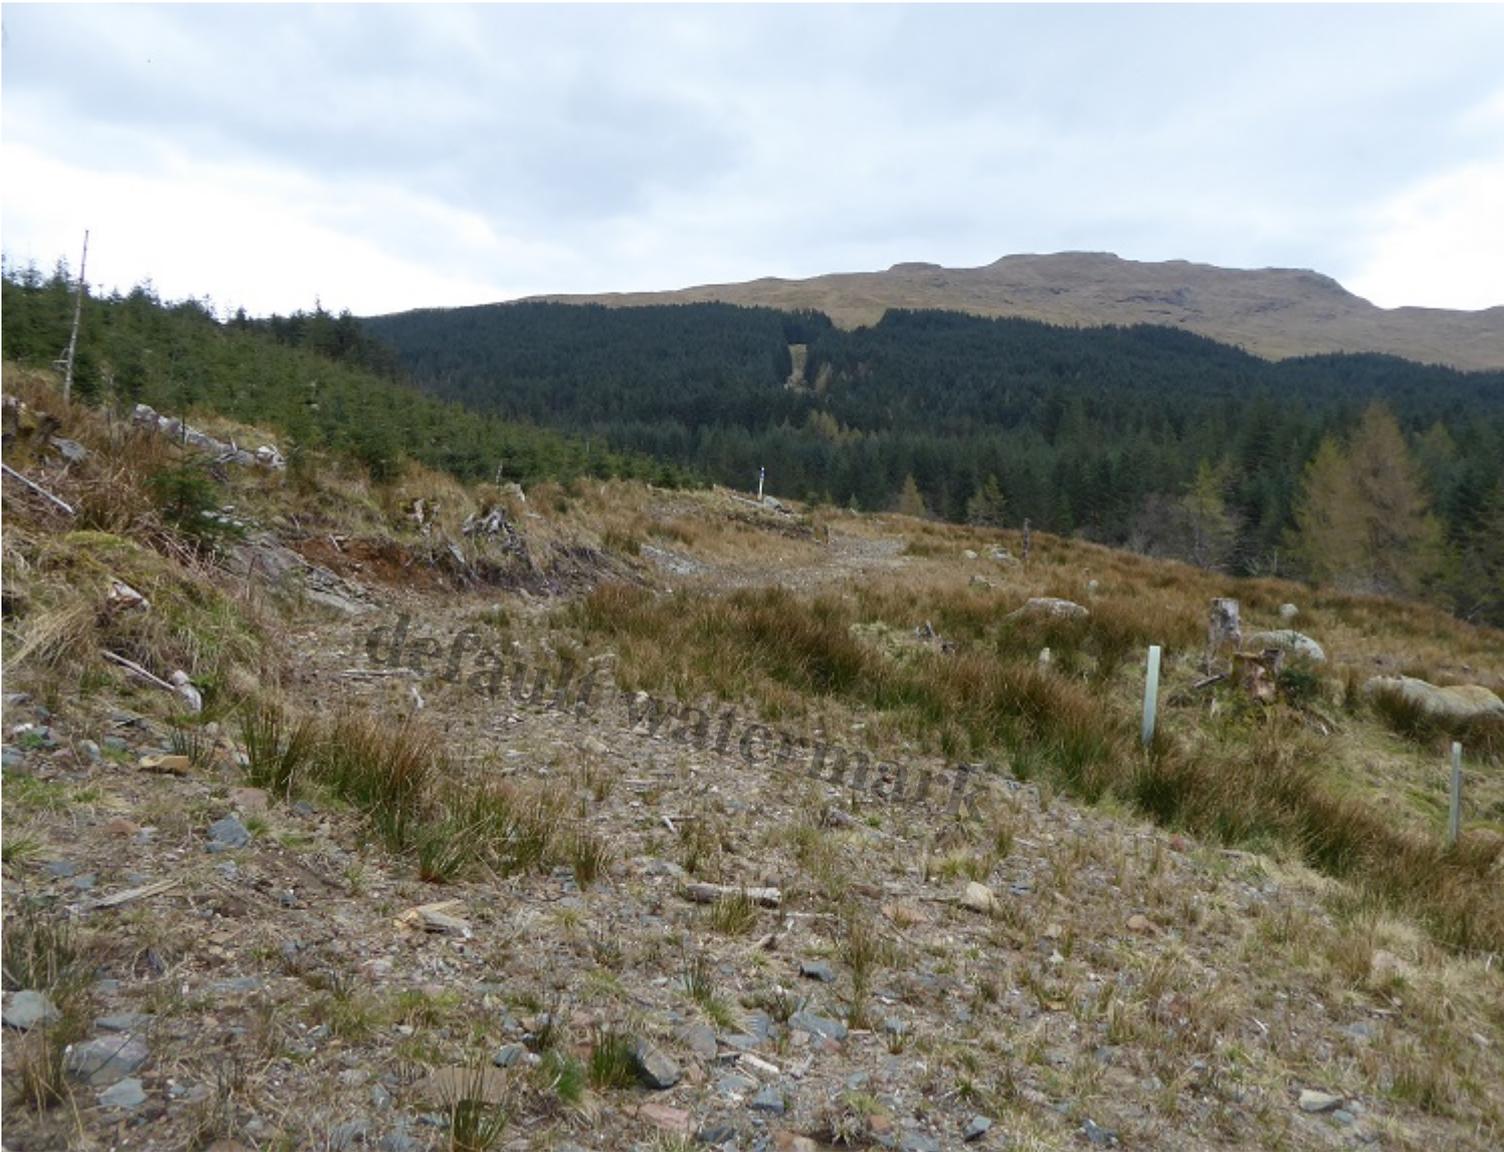
Apart from at Conic Hill ([see here](#)) I don't think I have seen a worse example of pipeline restoration in the National Park. There has been no attempt to restore the landforms and the flat bench above the pipe has in effect created a permanent road across the hillside.

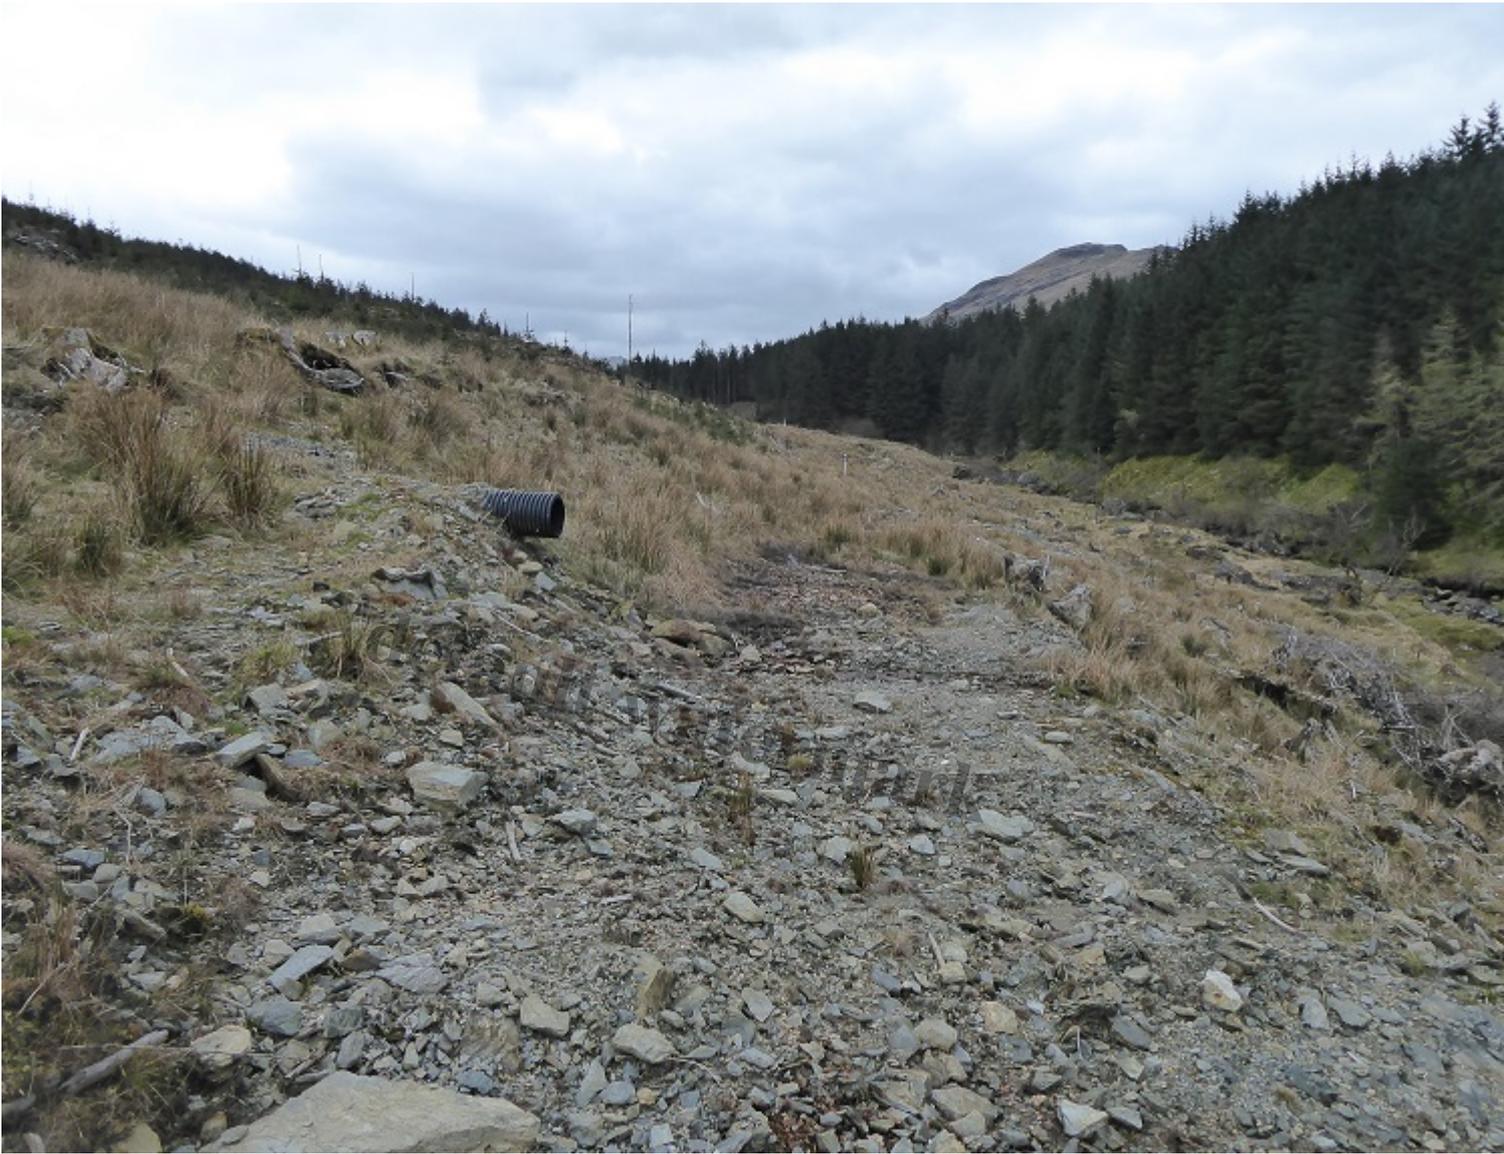
The National Park has simply been treated as industrial wasteland. What's clear is that the LLTNPA has abandoned any attempt to enforce its normal standards on land owned by the former Forestry Commission.

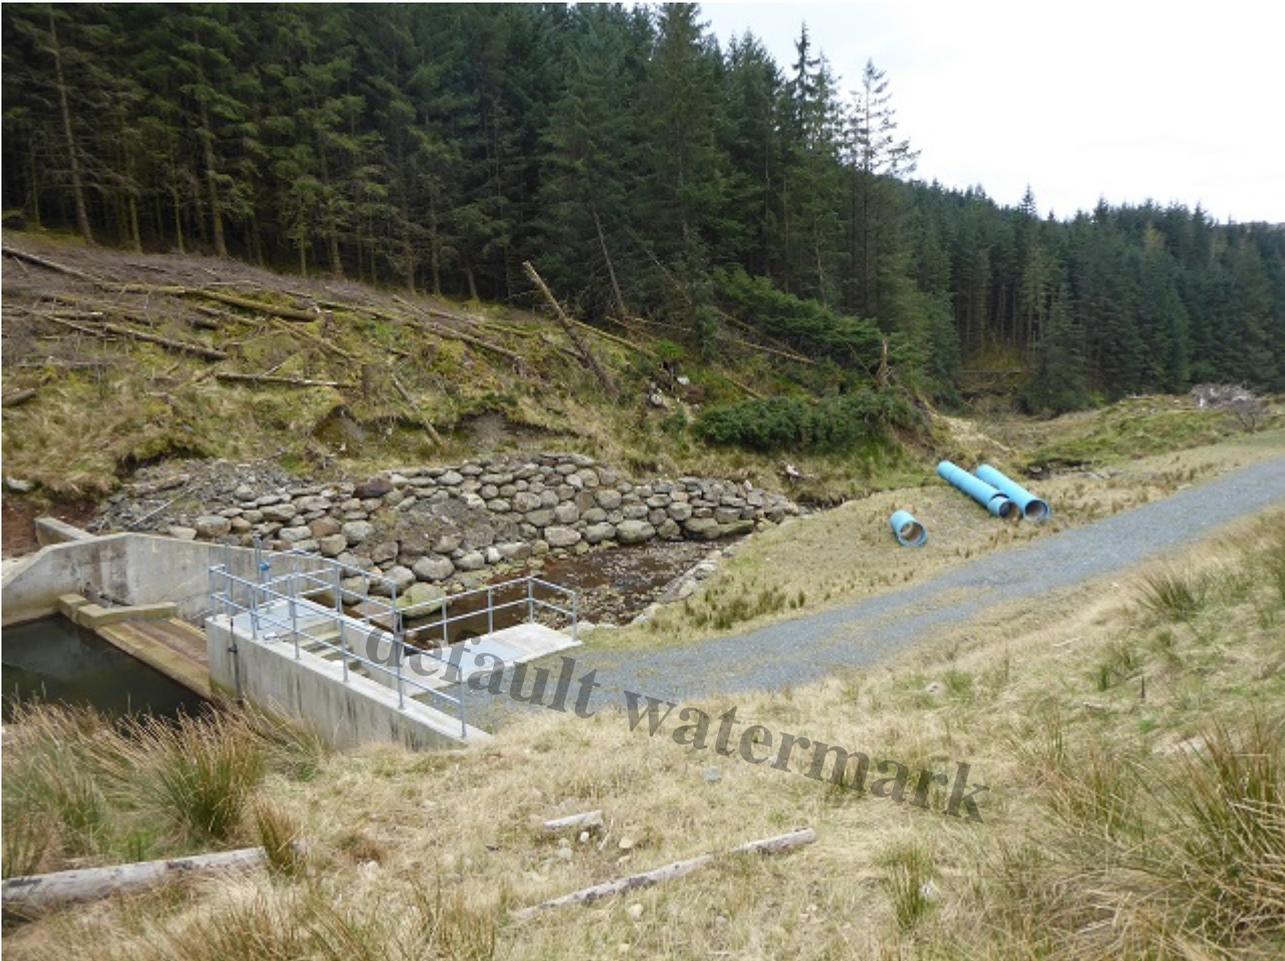
The intake was supposed to be screened but there has been little attempt to do so and the rip rap bouldering along either side of what remains of the river below presents the usual mess. Note how there has been no attempt to make use of the trees felled on the far bank because of the hydro construction.

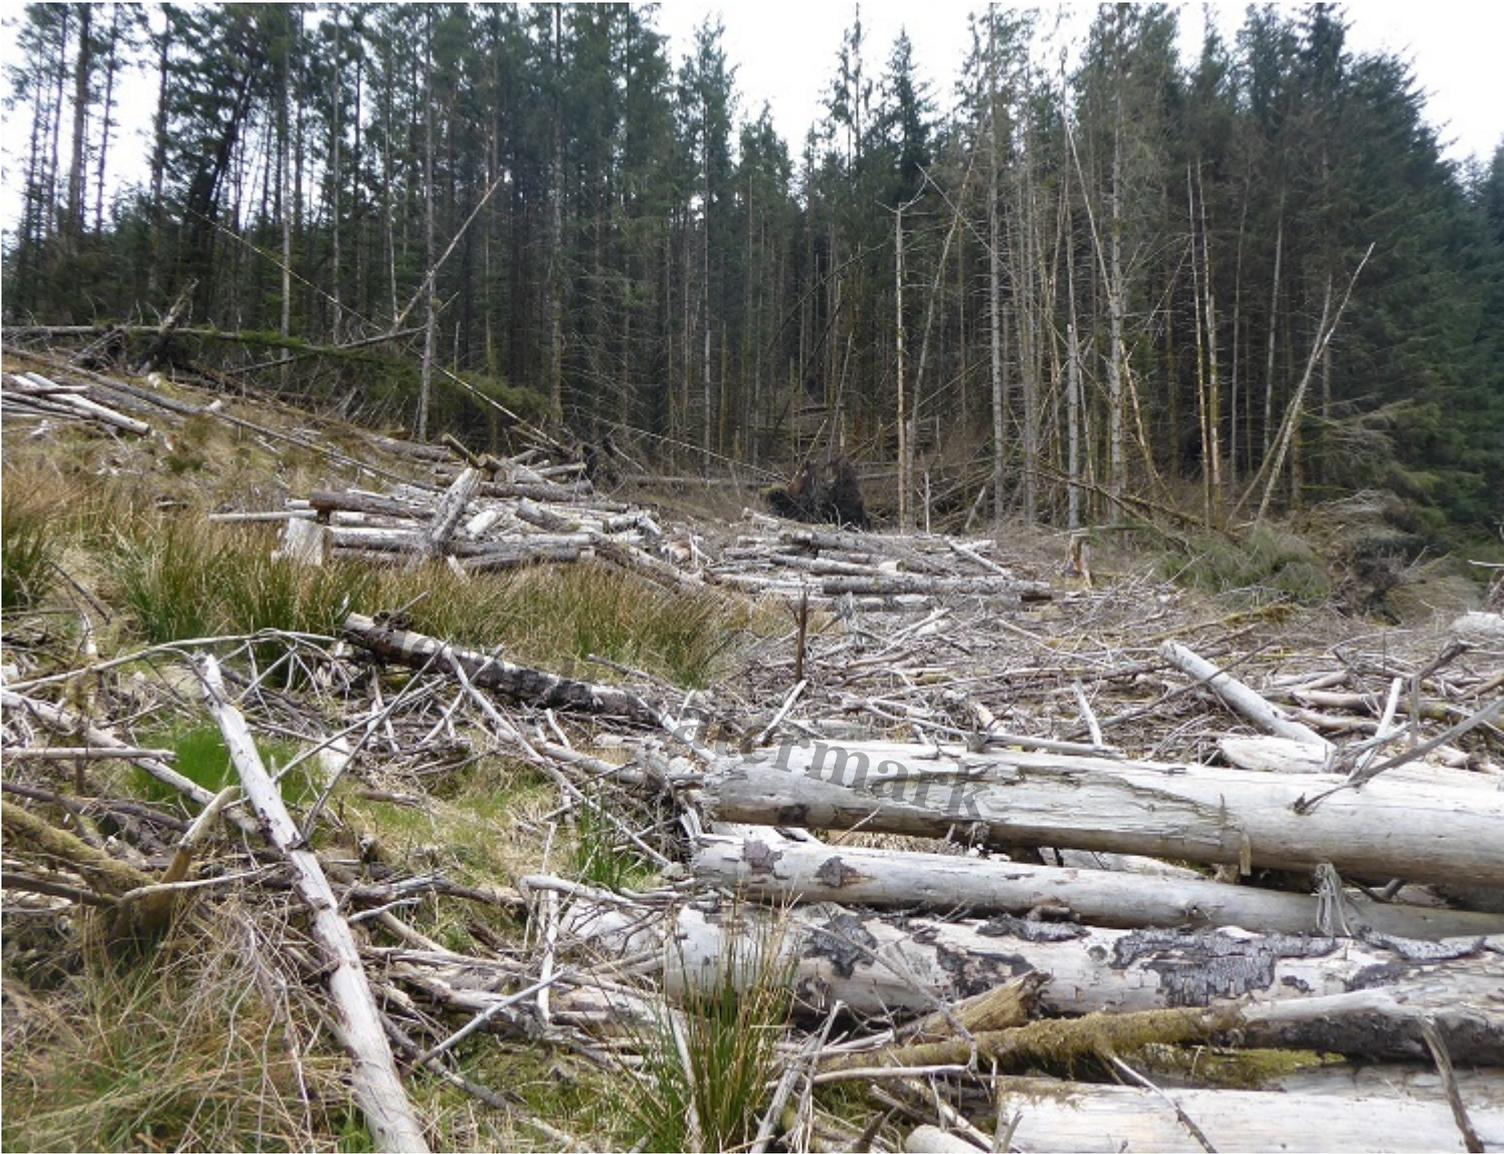
The wasteful practices of industrial forestry are also clearly visible just above the intake. Instead of trying to improve forestry within the National Park â?? and using planning applications such as this one to influence what Forest and Land Scotland does â?? the LLTNPAâ??s draft woodland strategy has endorsed the UK Forestry Standards under which this destruction and waste is allowed to happen ([see here](#)).

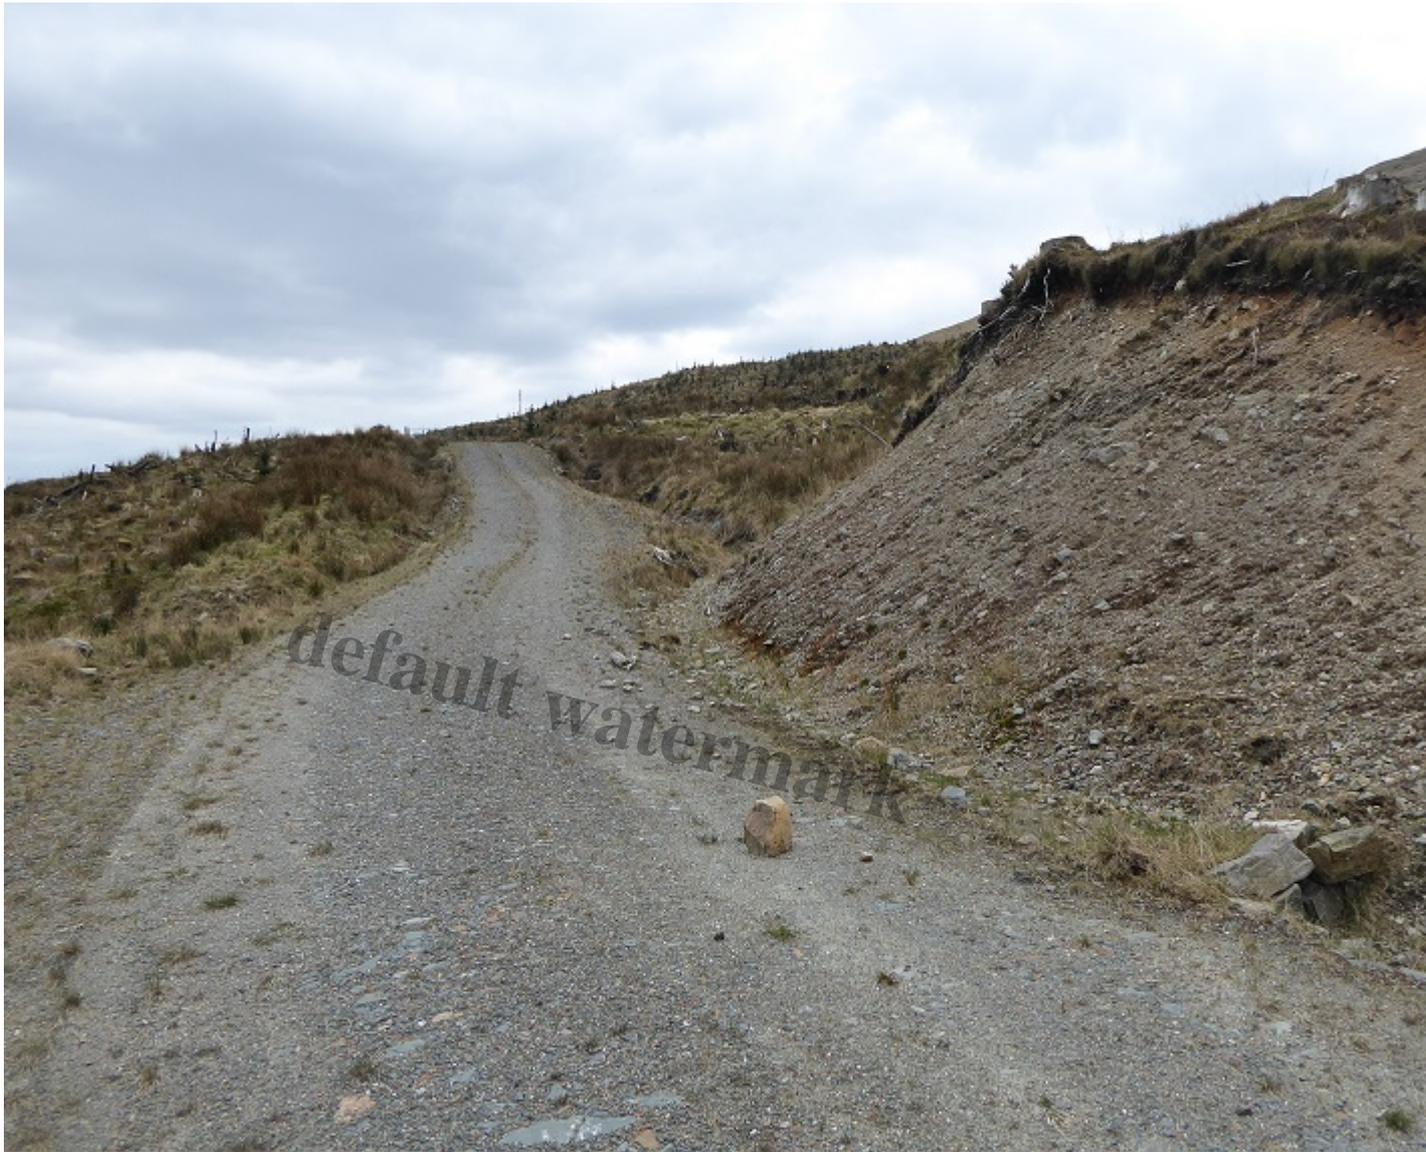
The top spur to the intake â?? there has been no attempt to restore the bank which is now eroding

As part of the Planning Application the LLTNPA approved two new permanent forest track spurs built according to UK forest standards. No consideration was given as to whether those standards are compatible with the Parkâ??s own best practice guidance on renewables which states that steep batters (as above) should be avoided completely and the width of new roads should be limited to 2.5m. This provides further proof that that the UK Forestry Standards are totally inappropriate for National Parks in Scotland.
