## Climate Change and Glen Falloch (4) – hydro failures and their impact

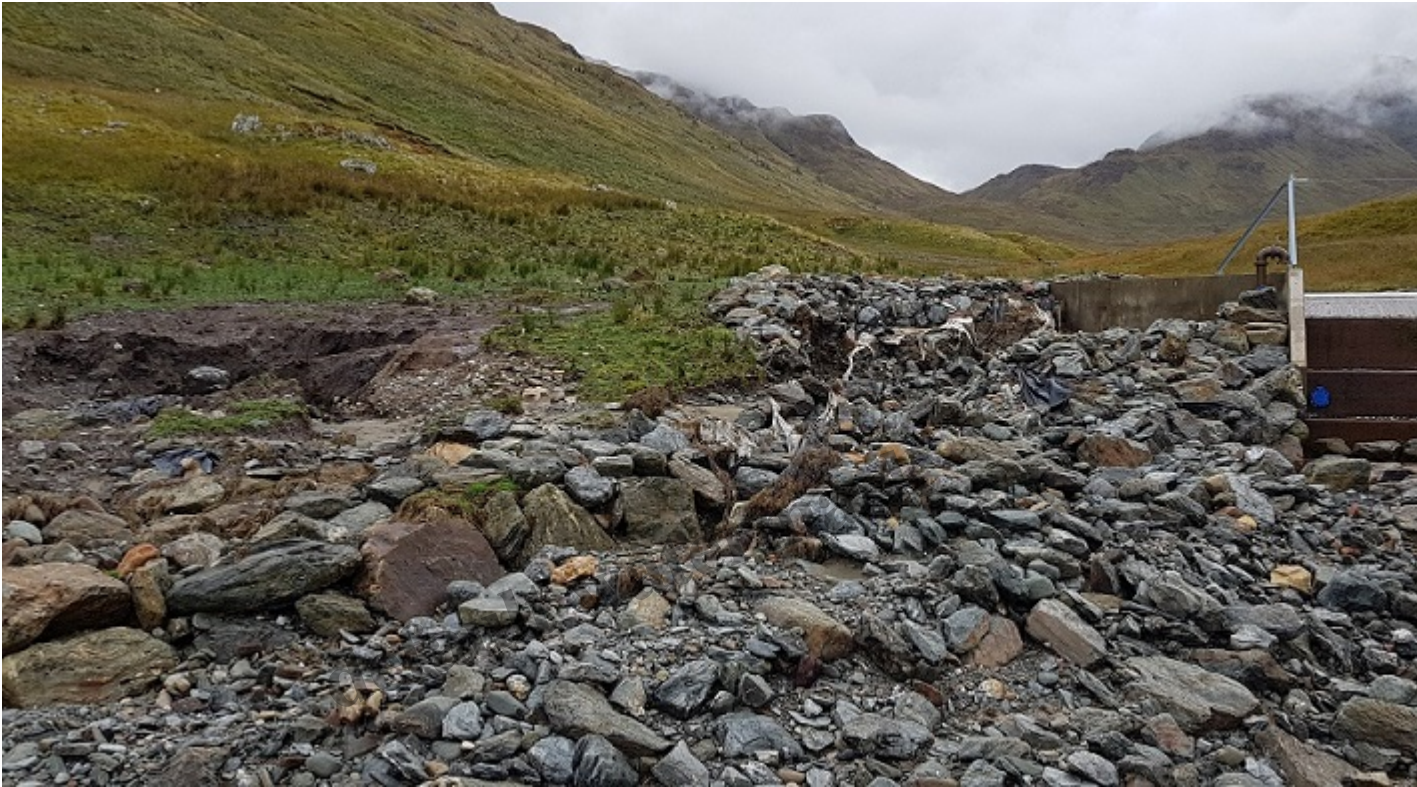
Upper Glen Falloch hydro intake 25th September 2019 – photo credit Kevin McGrath

Compare the two photos above taken just four months apart. A large proportion of the rip-rap bouldering which had been placed against the dam wall to the left of the intake has been removed by the flood, along with much of the bouldering along the bank of the river below.

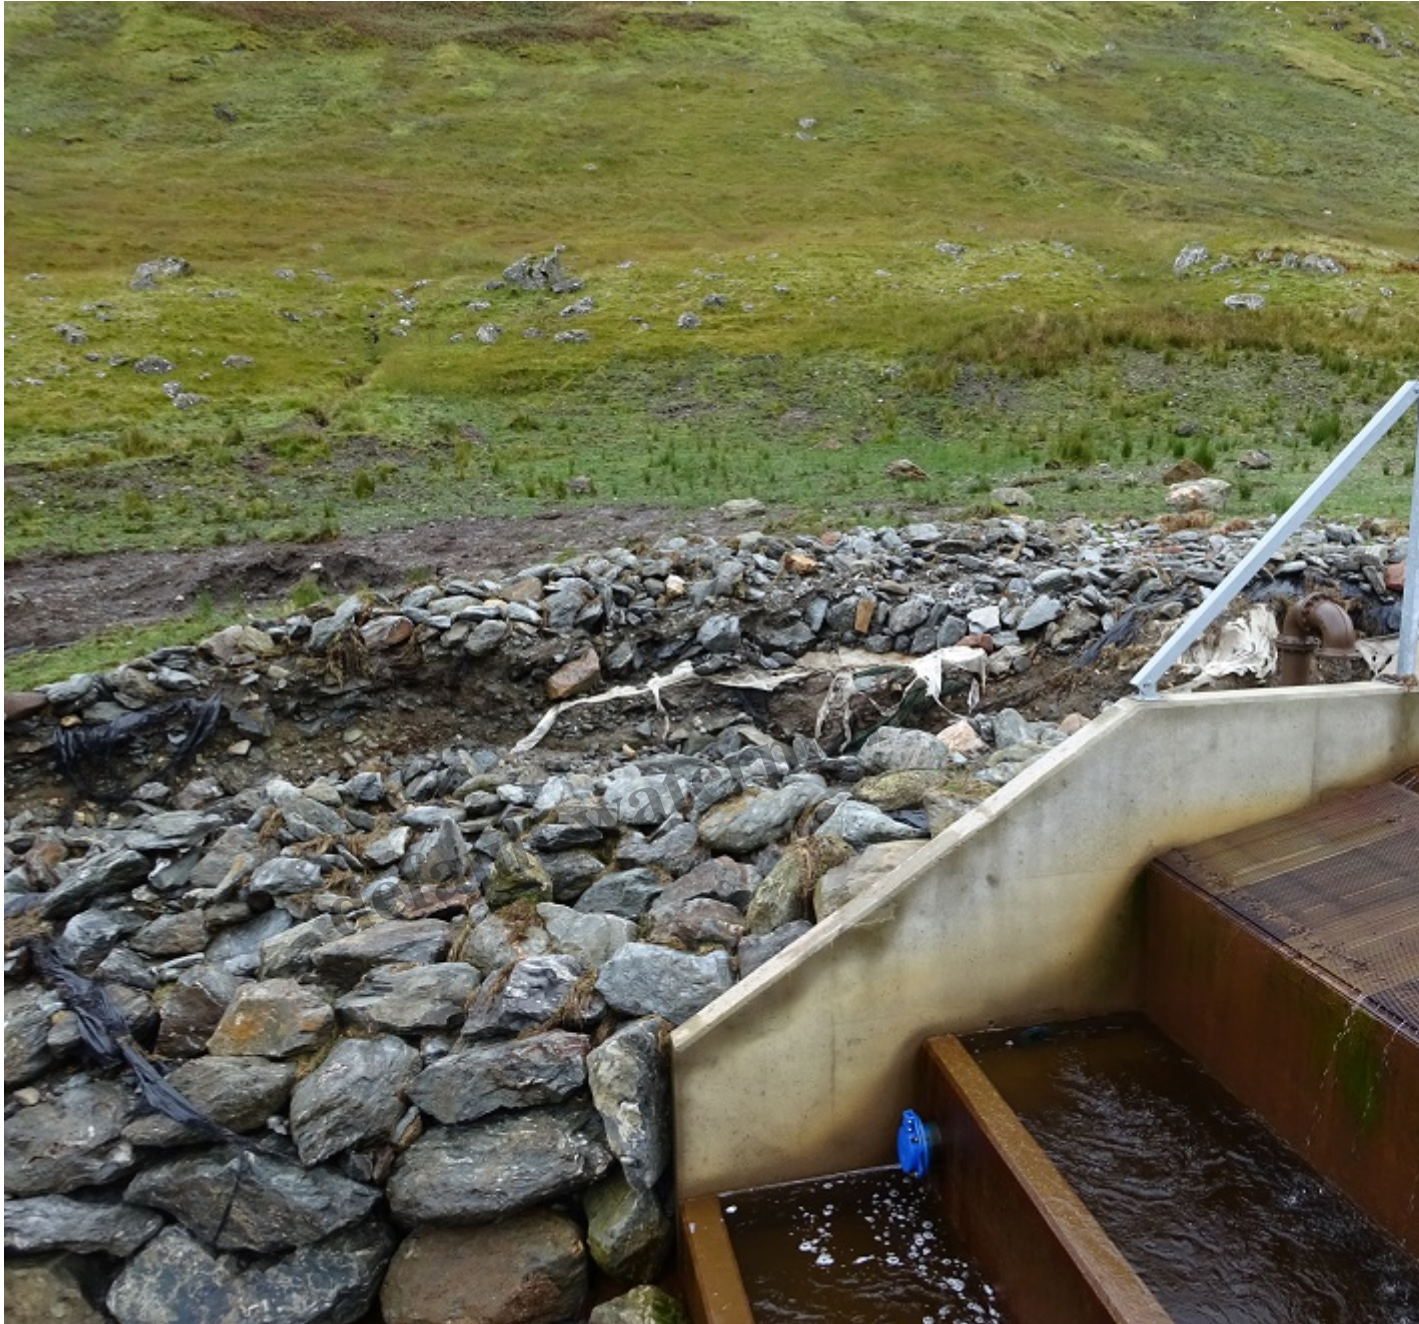
The artificial embankment at the Upper Falloch intake used to reach the top of the concrete walls and away from between them to the new bank opposite. Photo credit Kevin McGrath

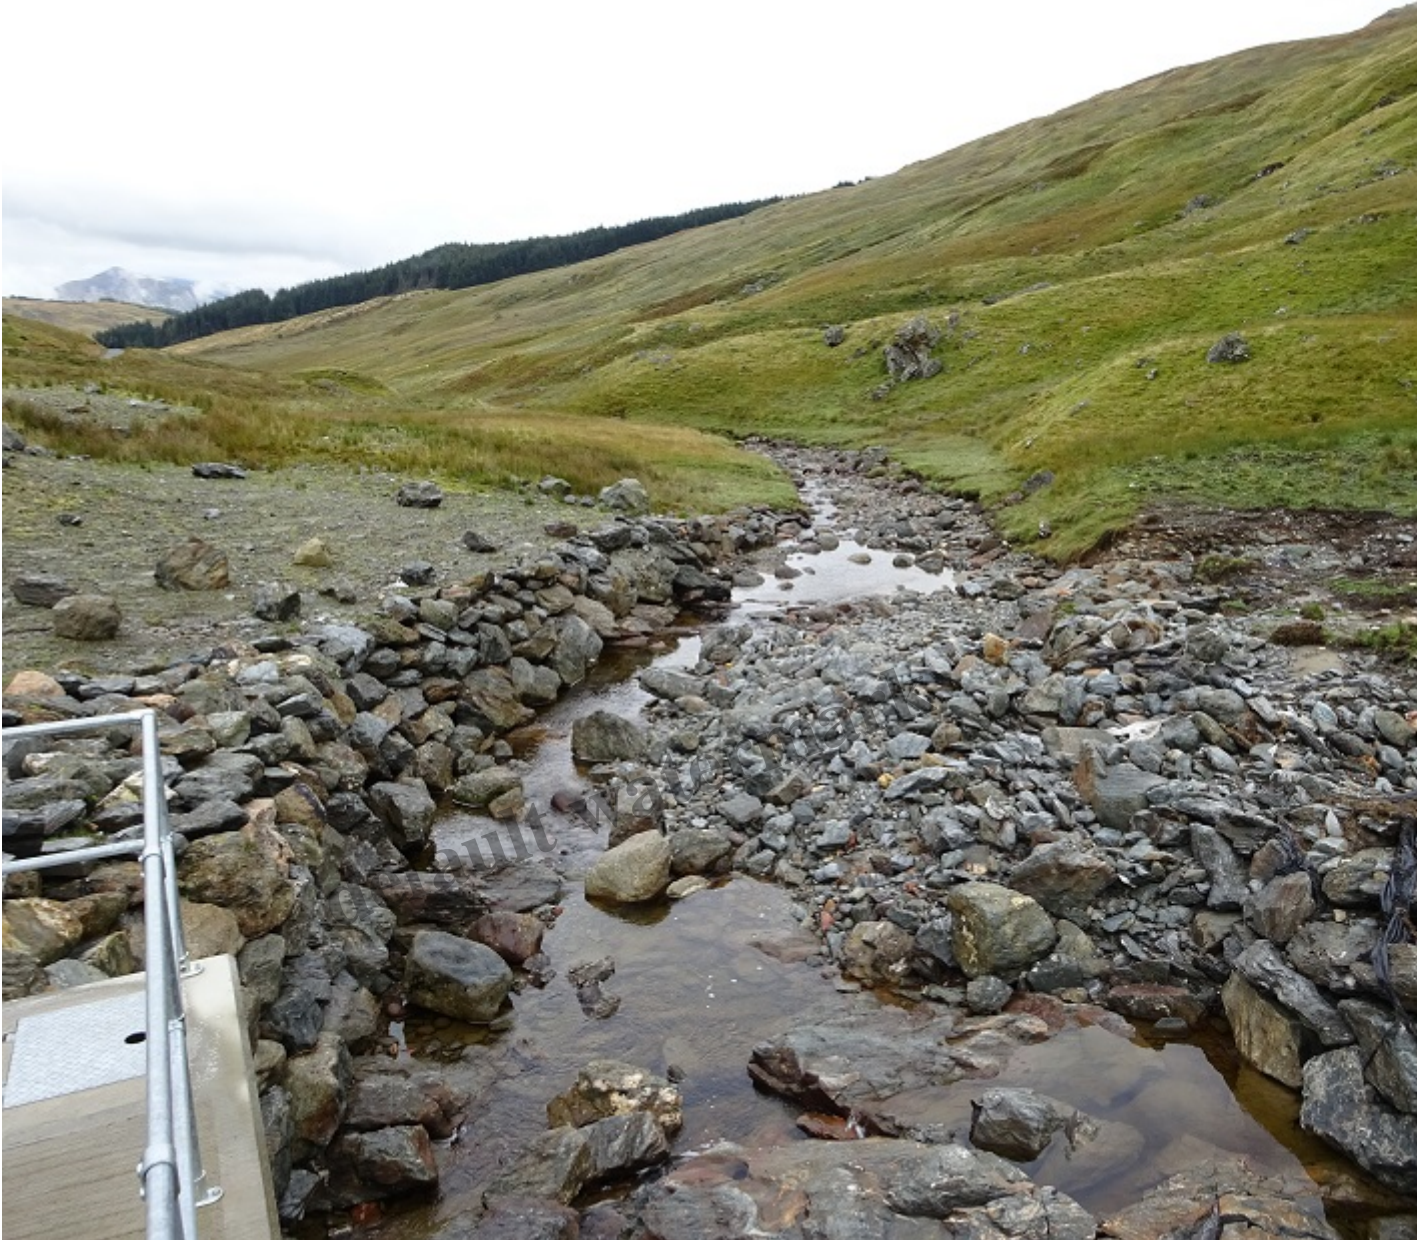
Looking downstream from the intake the rip rap bouldering on the right bank, which used to mirror the left bank, has mostly been swept away making this side of the river appear far more natural. Photo Credit: C. McGrath.

The force of the flood water to remove the rip rap bouldering must have been quite something. The boulders were placed here to protect the river bank after the construction of the intakes but have failed. And it's not just on the Upper Falloch where this has happened, but on four of the other eight Glen Falloch intakes.

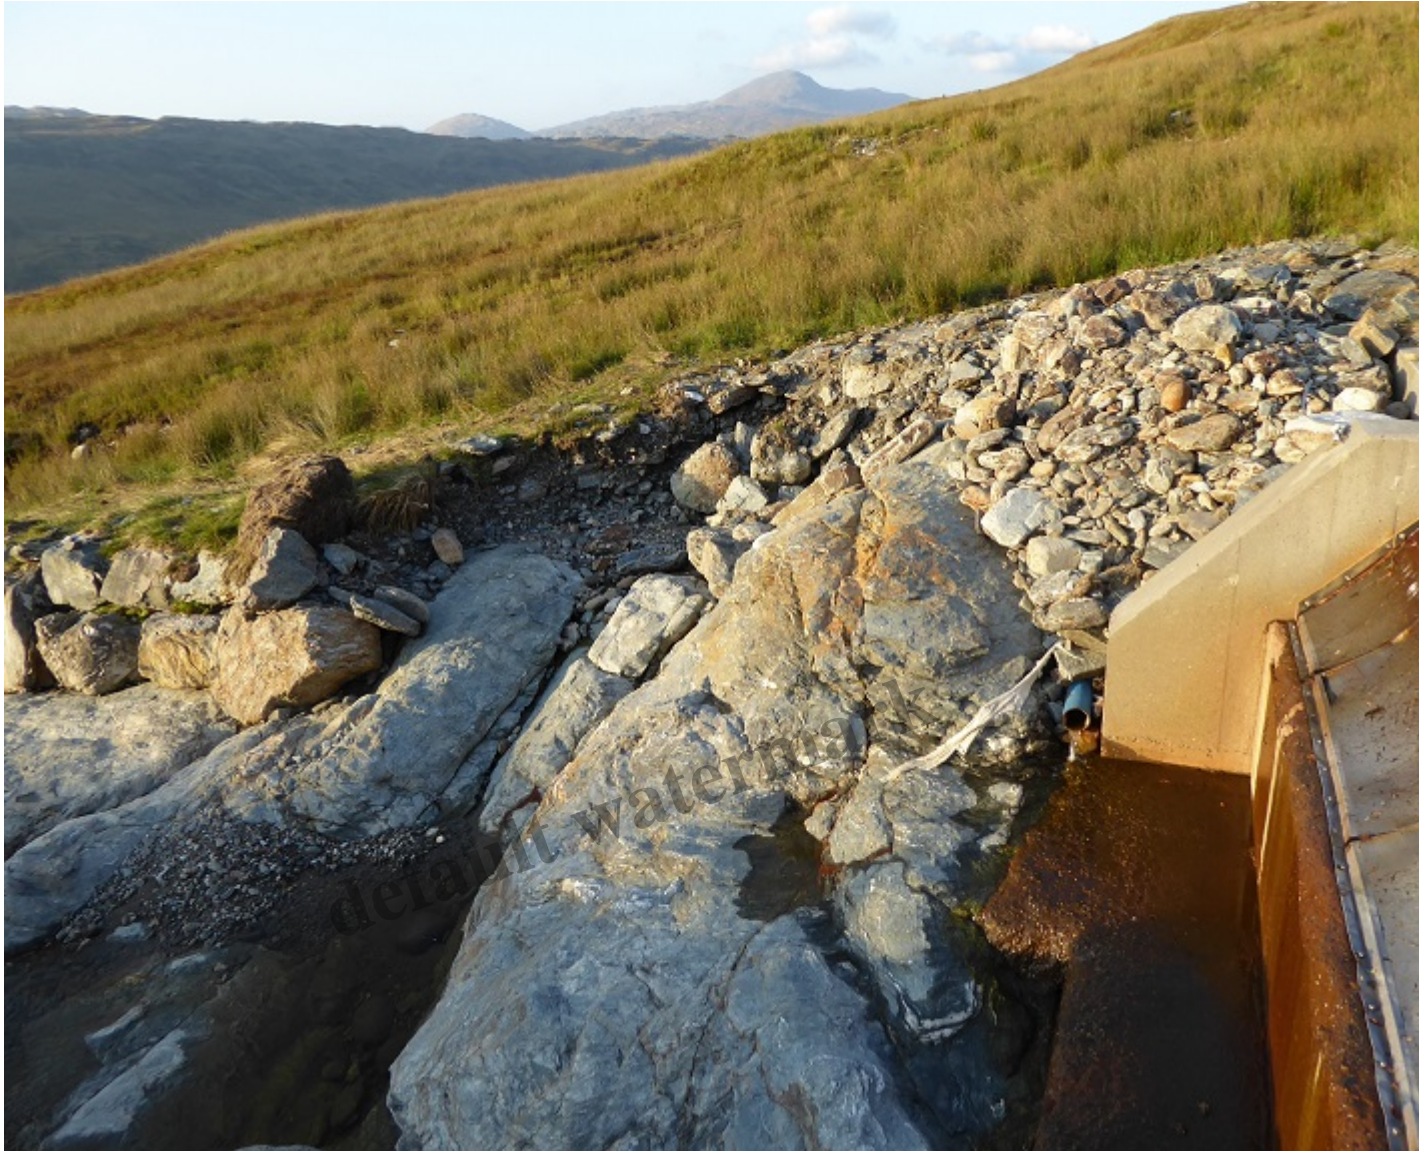
Large chunk of restored bank removed from below Allt Andoran Intake, leaving bare bank behind – E Chalum in distance. Both banks below this intake have been seriously damaged. Photo Author.

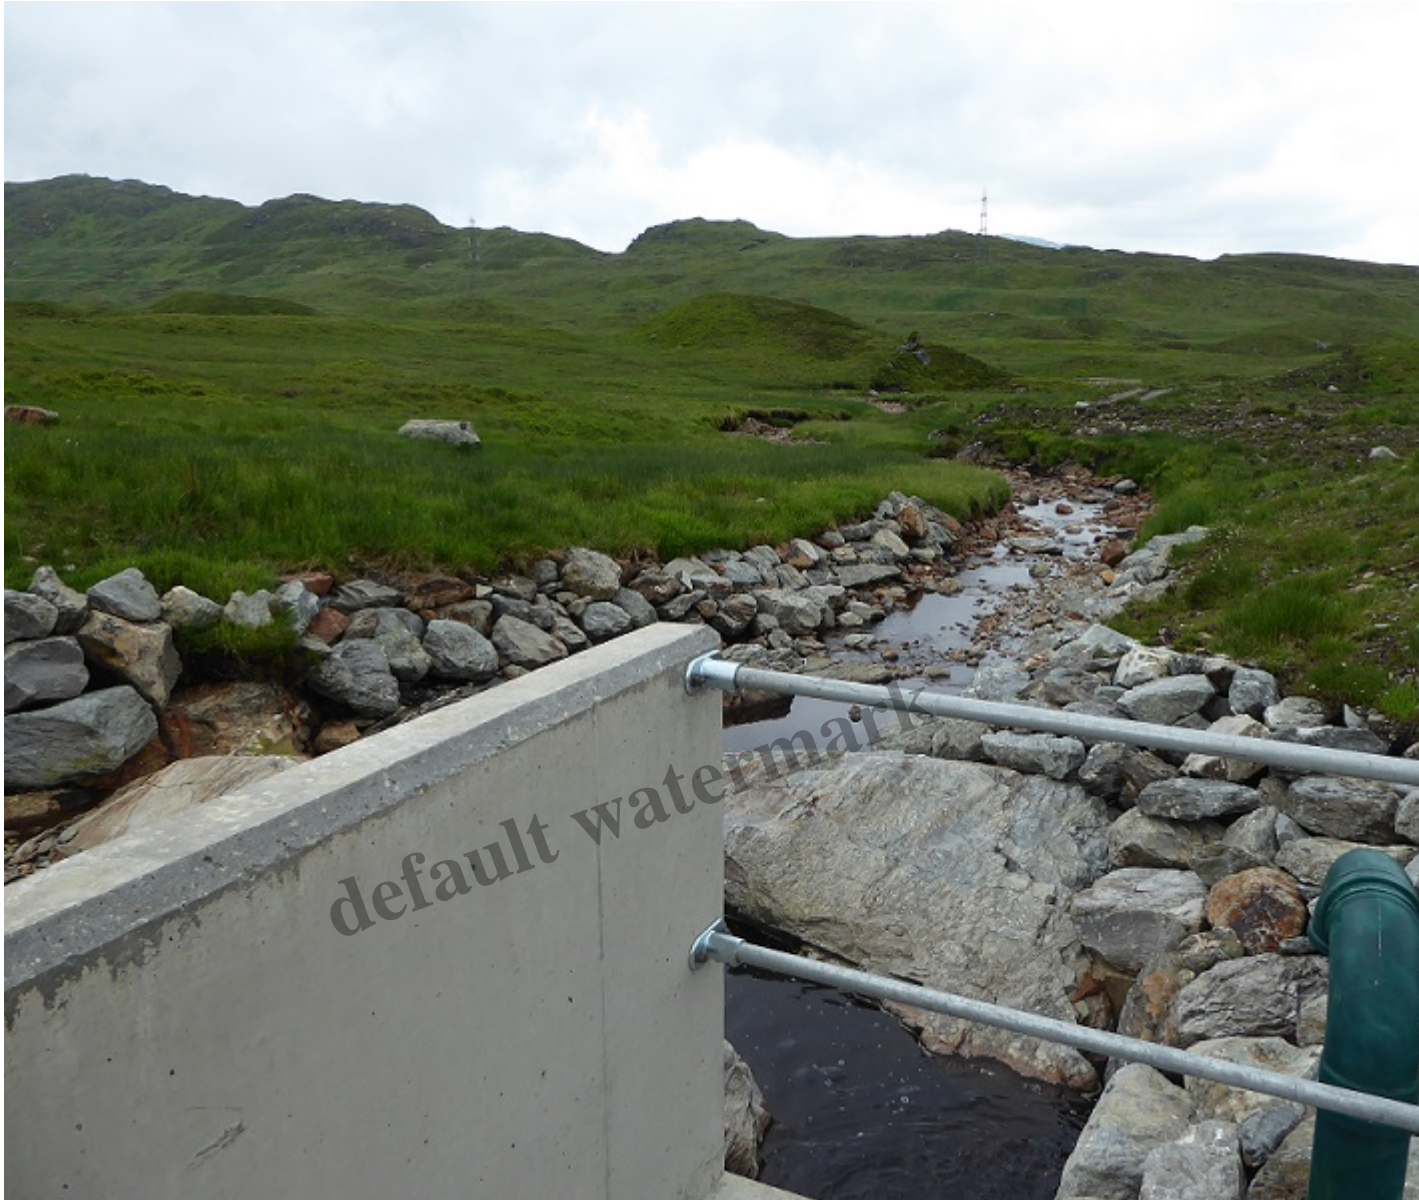
A comparison with a photo taken in 2016 confirms the extent of bouldering which has been washed from the banks

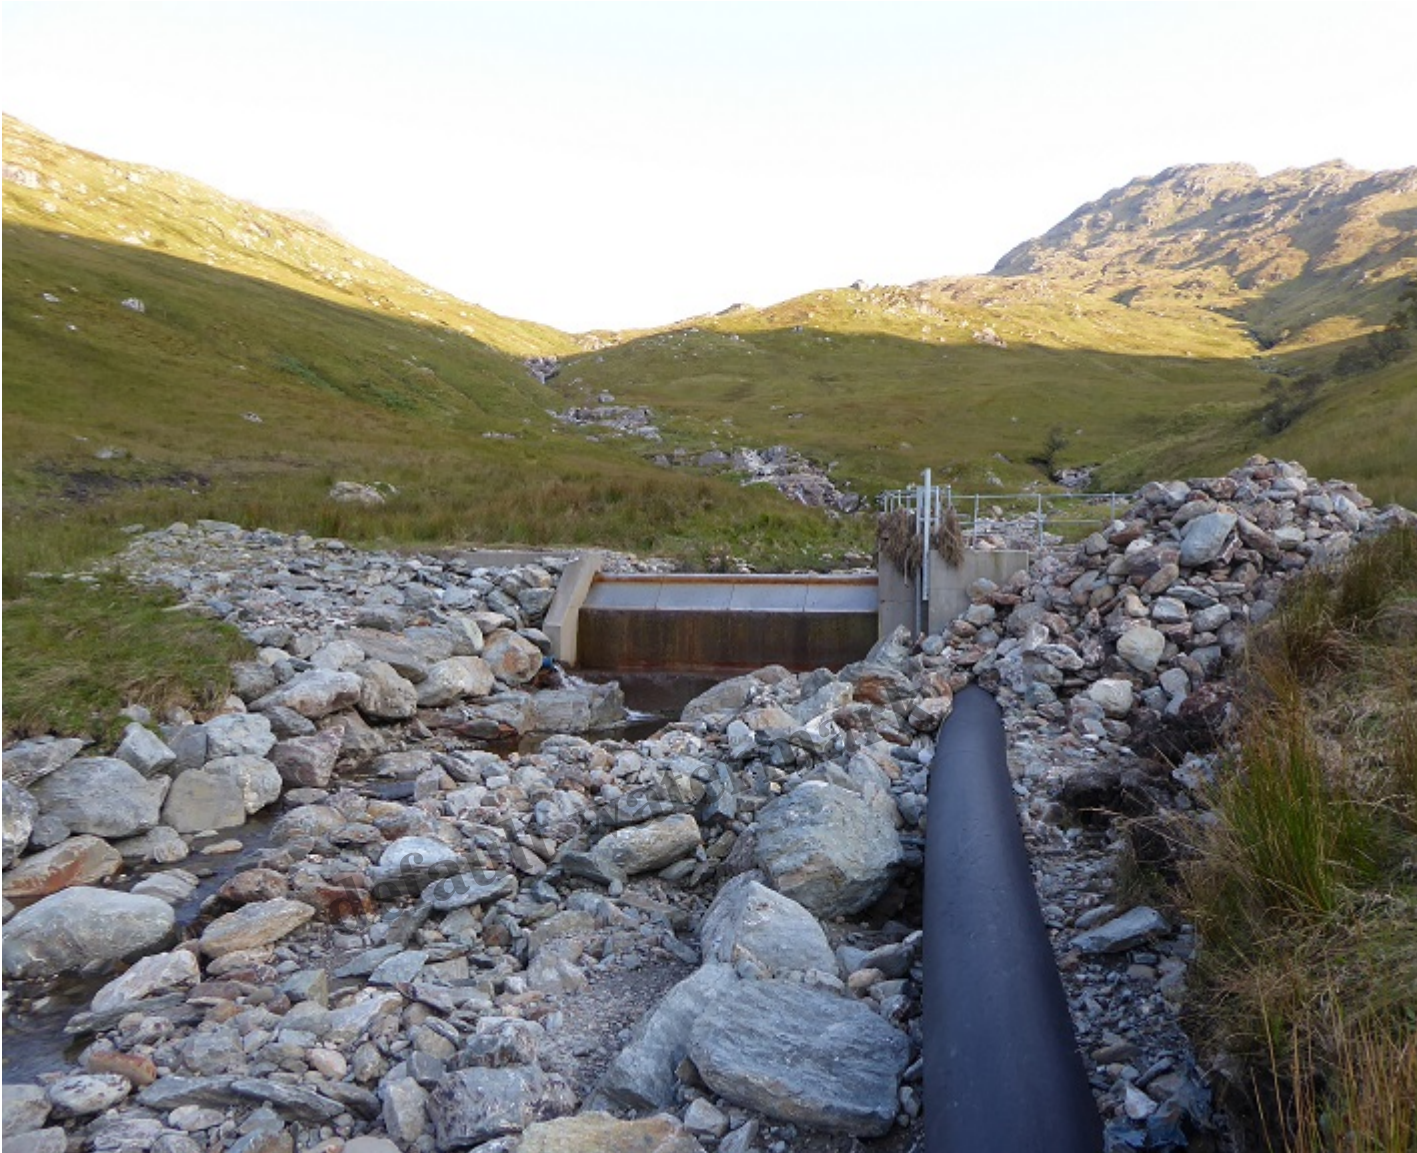
Looking up to Allt a Chuillin main intake along section of pipeline that was, until recently, under the “restored” bank of the river (photo of this from above featured in my last post). The pile of boulders on right appears to have been excavated from the pool and is perhaps intended for use to cover up this pipeline again. Unlikely to work!

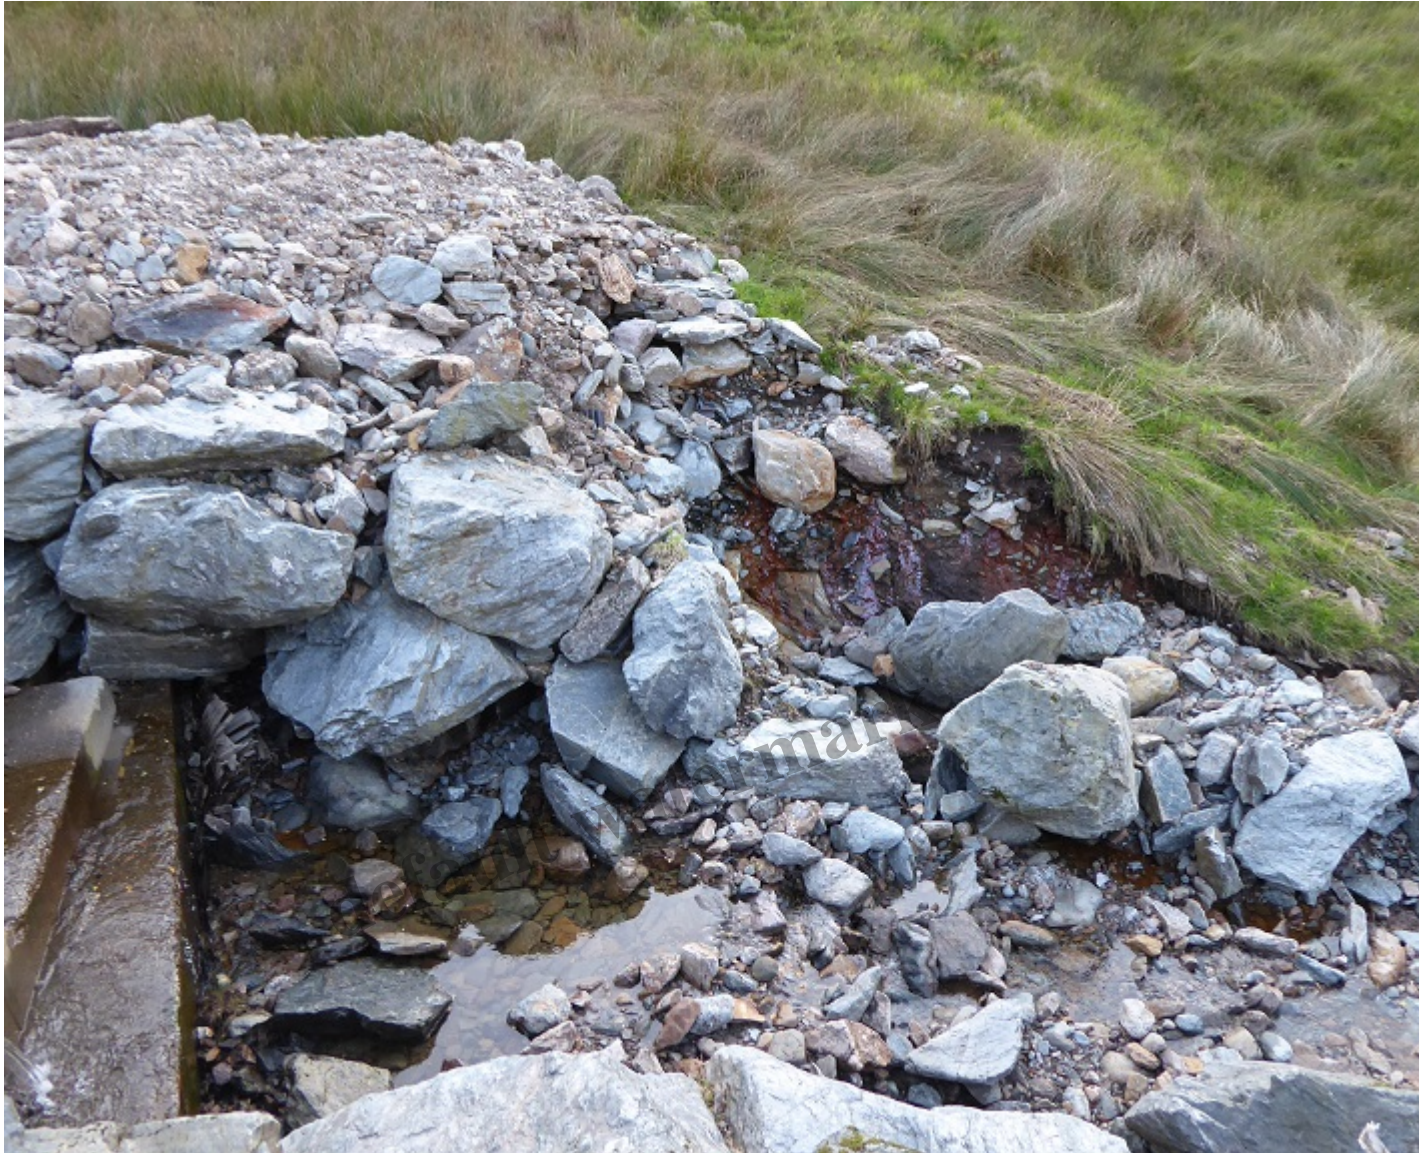
Damaged bank below the second of the Allt a Chuillin intakes

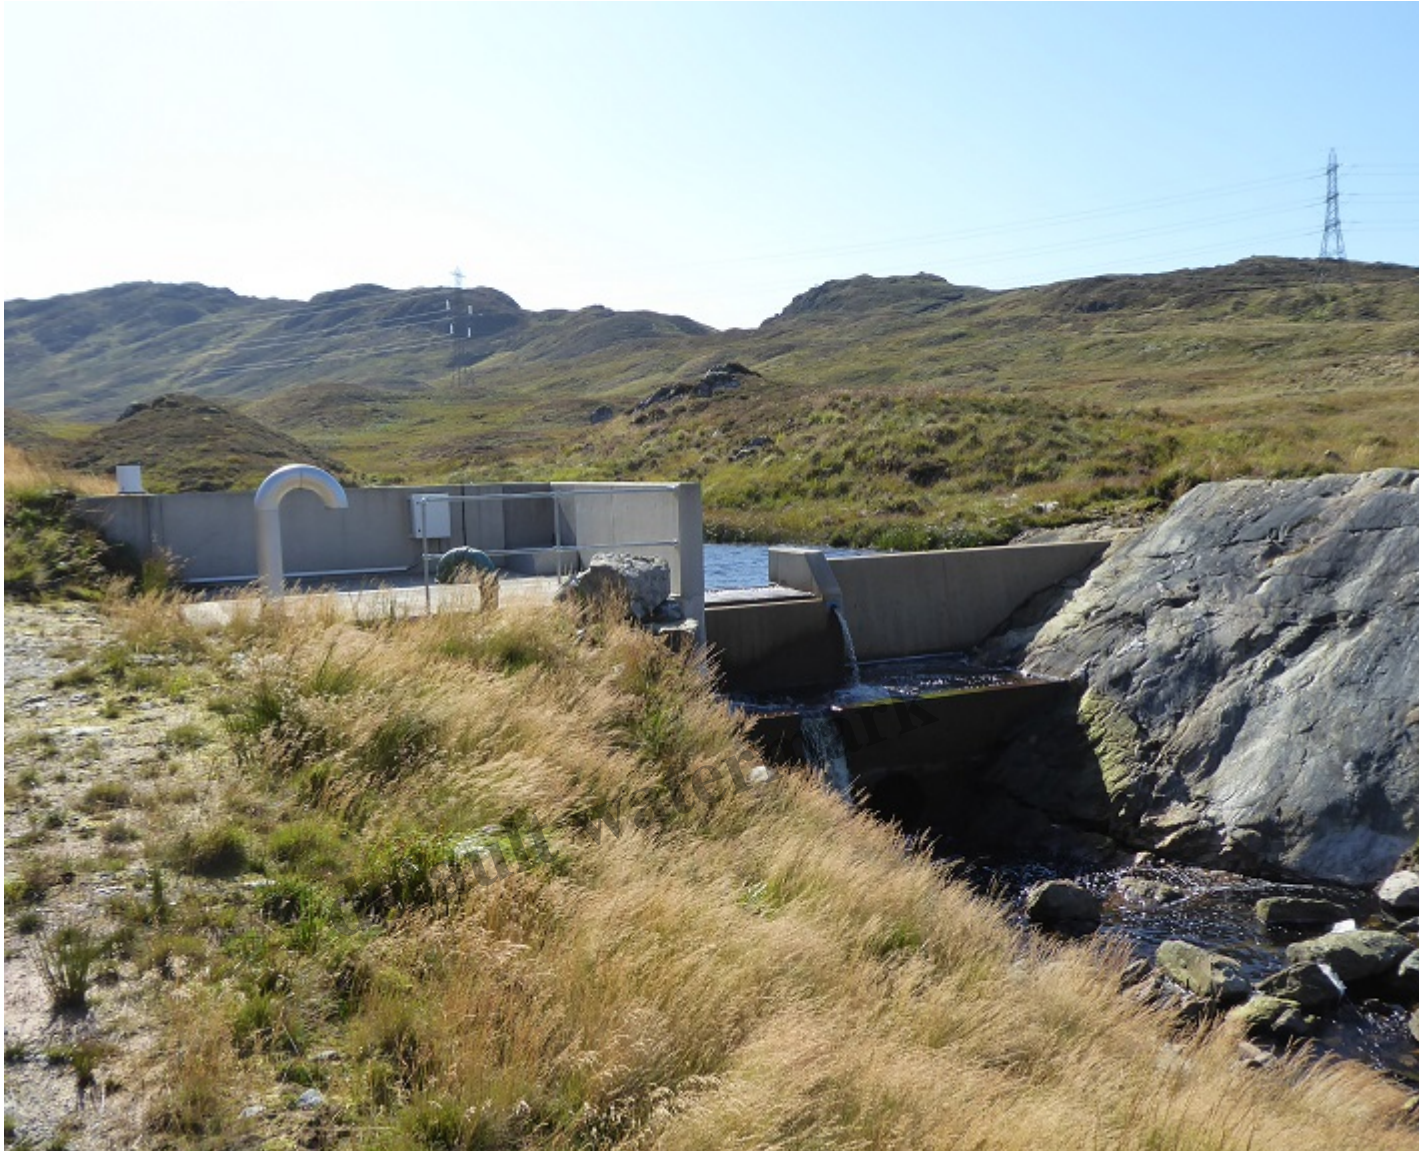
The other Ben Glas intake (see above), with a large pool and constructed into rock, is little damaged compared to its neighbour. Had the highest section of concrete retaining wall be faced with stone, a Park Best Practice Guidance, the landscape impact of this impact would have been reduced further.

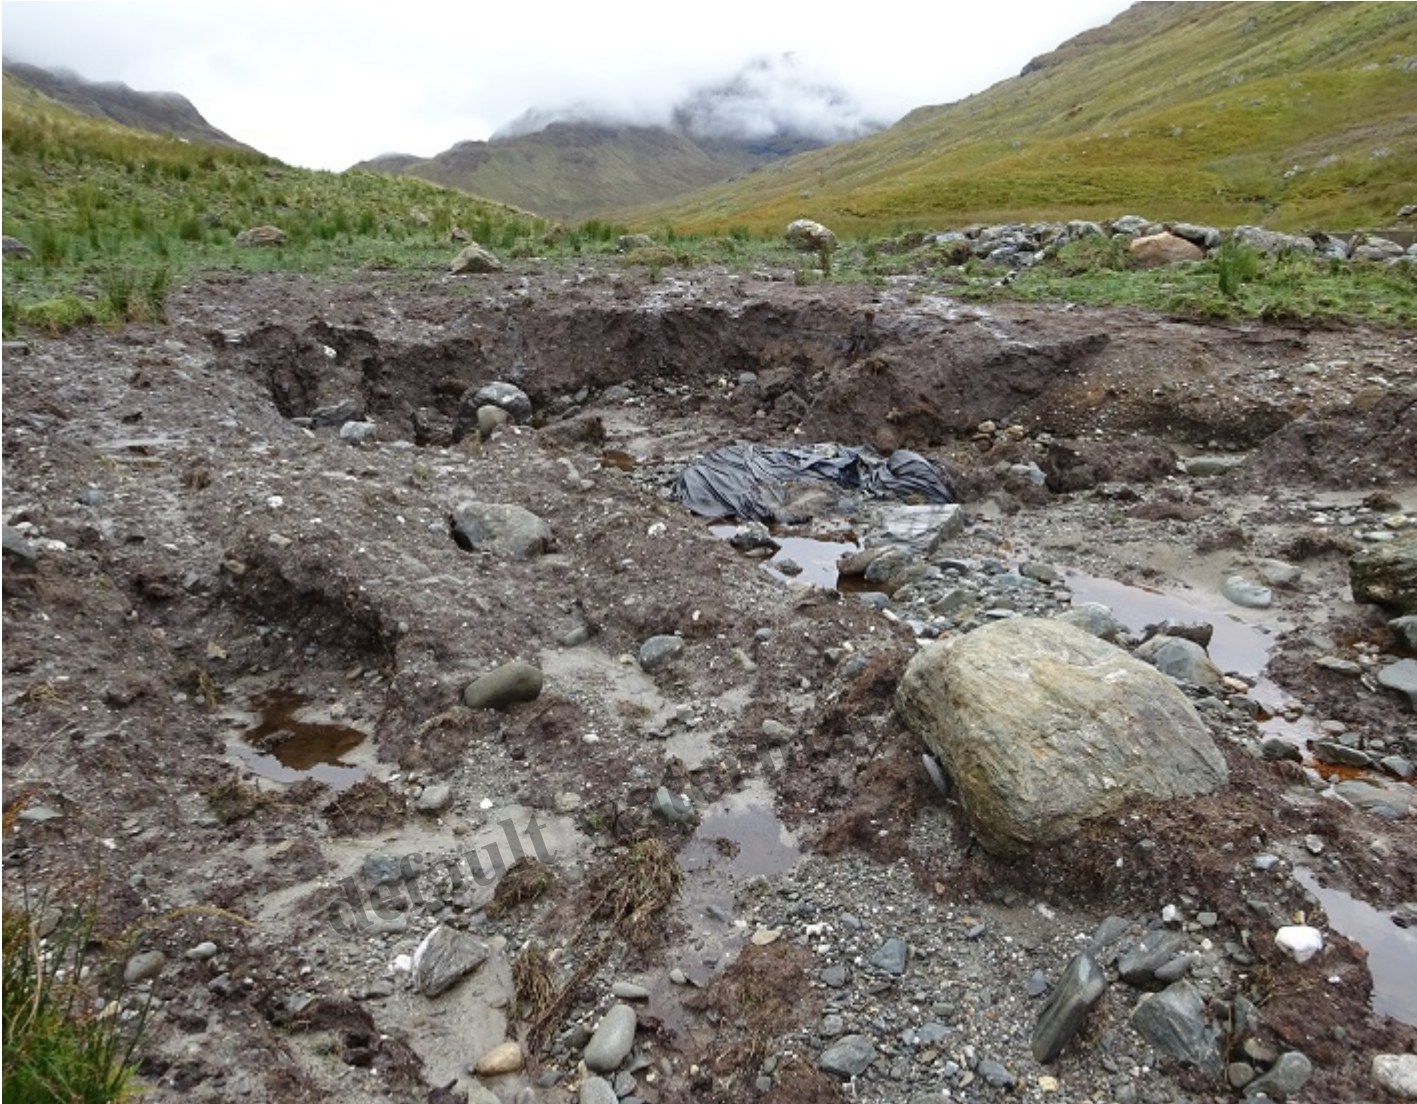
New river formation on the Upper Falloch (intake pool just visible to right)? The erosive impact of the river overflowing here has been accentuated because this a diversionary channel was constructed on this line while the intake was being built. This section of ground is not “natural” and helps explain the where peat has just been placed on the surface its been washed away. Destruction of peat of course releases yet more carbon into the atmosphere.

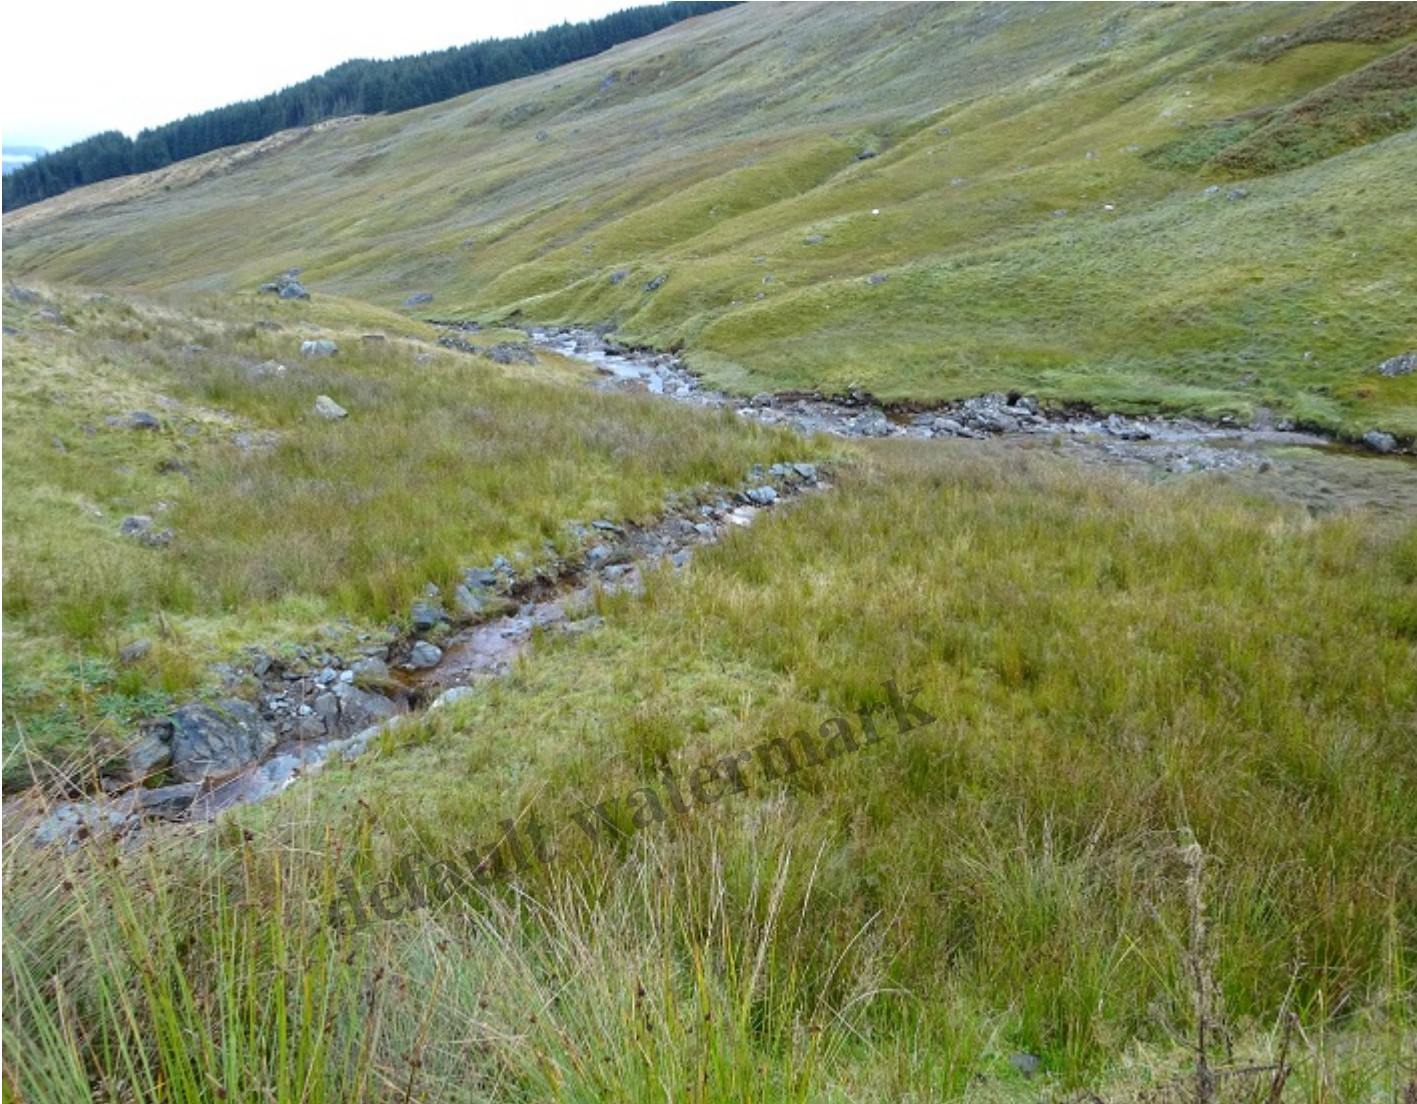
Looking down the Upper River Falloch where relatively little damage is evident to the river banks. The hydro pipeline has been dug UNDER the burn in the foreground and the banks by the rush are the work of humans not of nature. Photo credit Kevin McGrath.

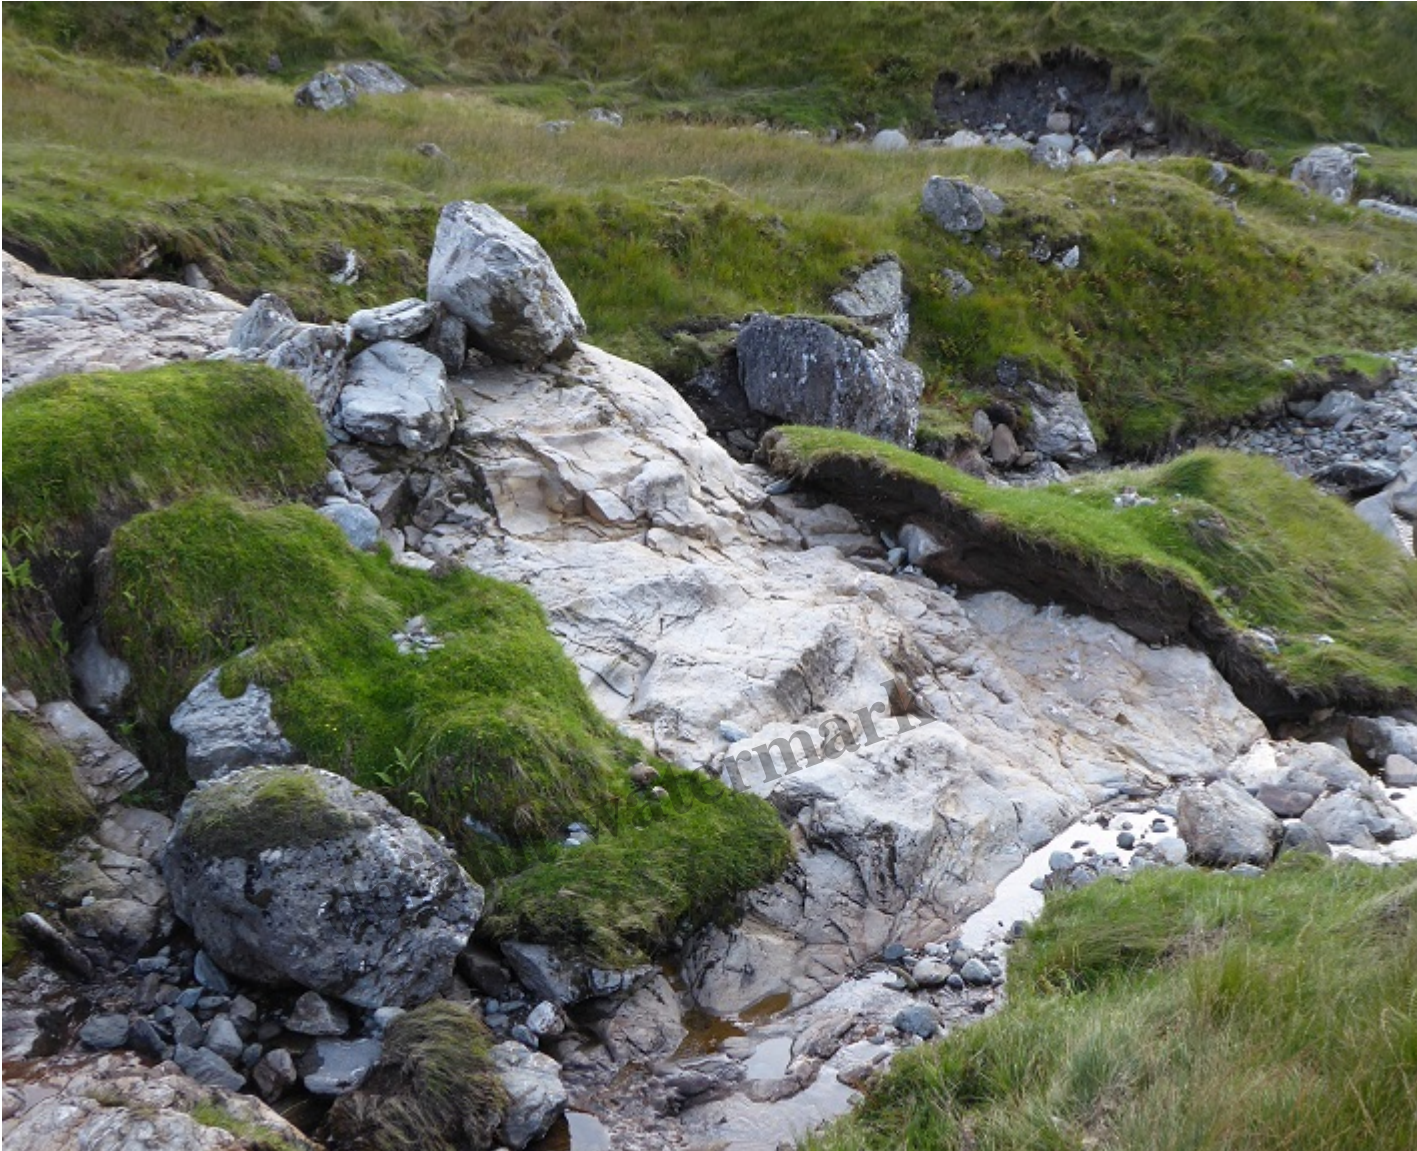
Vegetation has been swept clean off this island in the middle of the Allt a Chuillinn well above the main intake

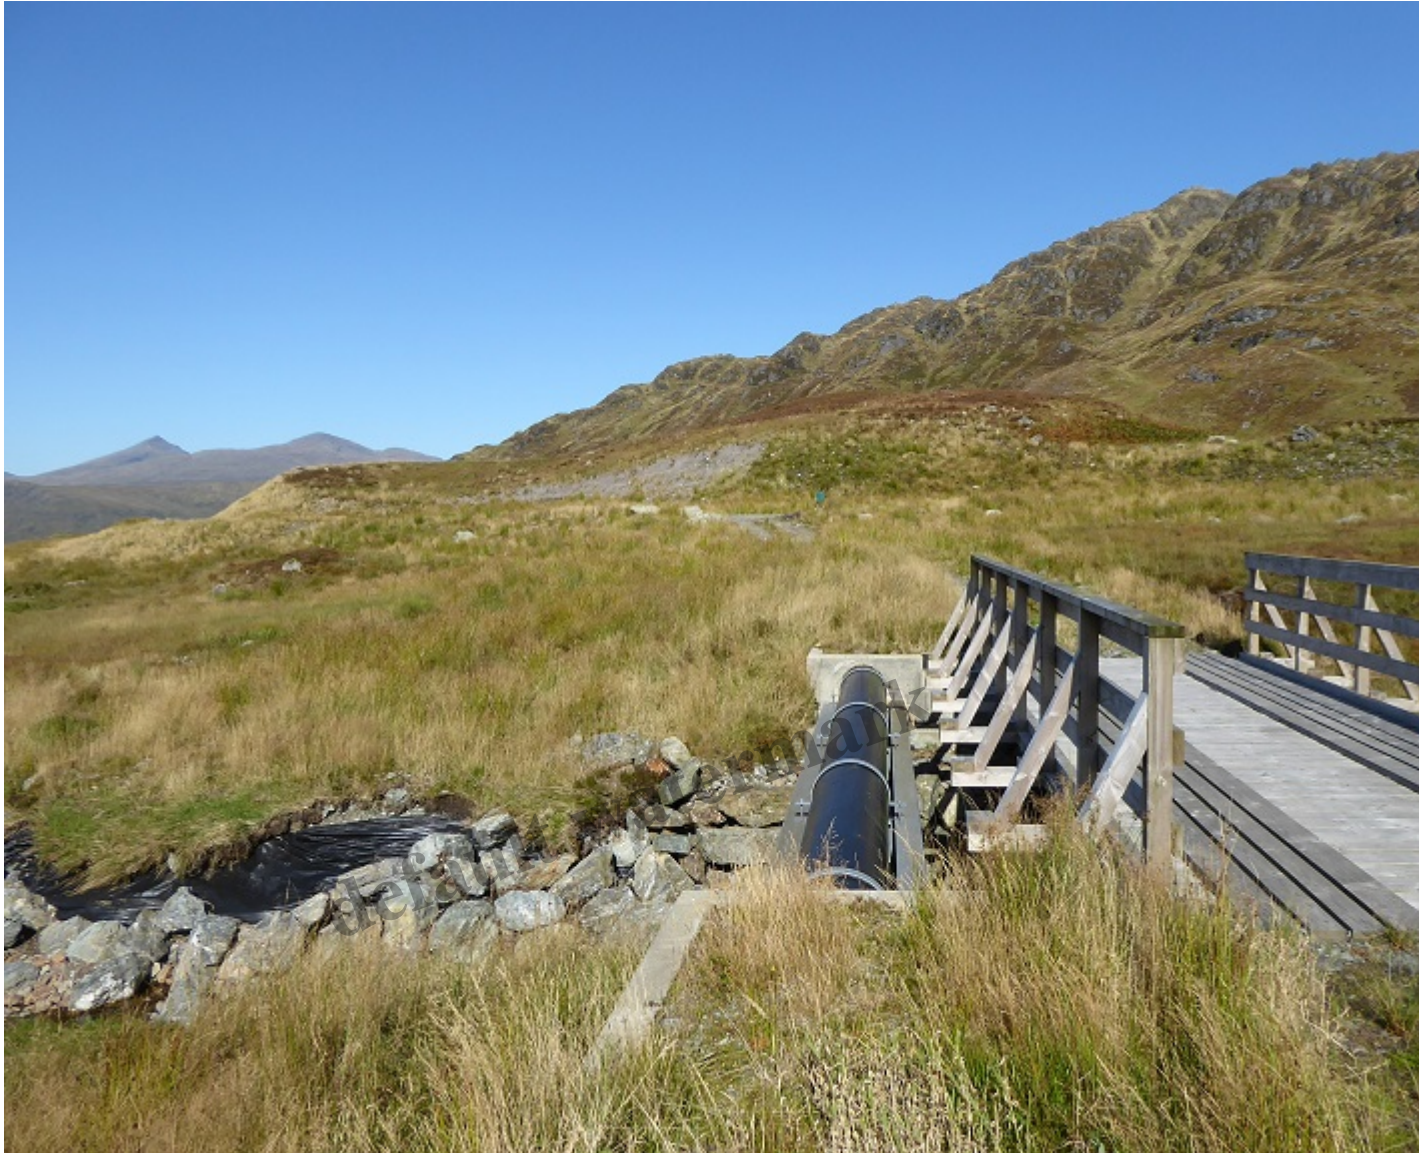
Plastic sheeting on bank below Ben Glas intake bridge. The level of the flood here reached the bottom of the bridge – as you could tell from vegetation left high and dry after the flood.

At first glance I thought, how ugly! Then I realised the top of the bank has been swept away. The problem is as soon as water gets between whatever is on the surface and the sheeting, its much easier for whatever is on the surface, whether boulders or turf, to get swept away.

Perhaps its time to put a moratorium on any plastic sheeting being used to line the ground as part of the restoration of hydro schemes? Whether that will address the whole problem, however, is another question. What wouldn't be acceptable is a solution that involves embedding the boulders in concrete.

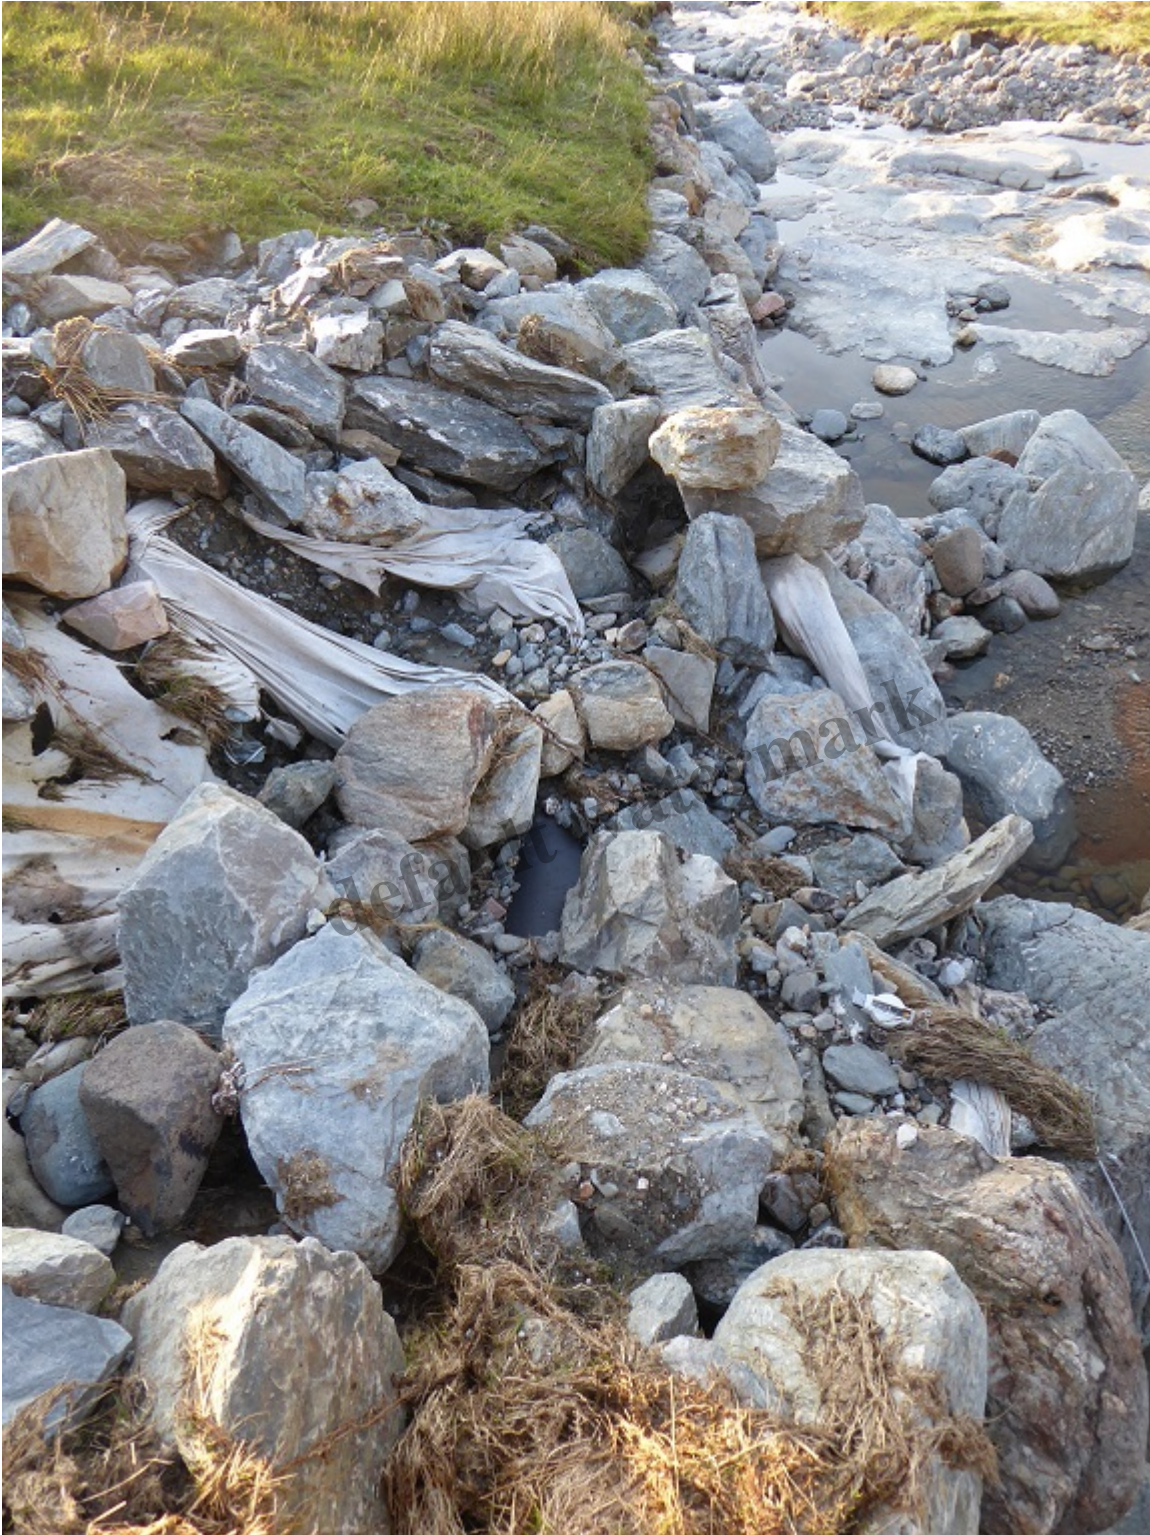
Left bank below Allt Andoran, with cloth sheeting and section of pipe visible centre

This is not, however, just a problem about plastic sheeting. Water forced through the boulders by the flood then collides and bounces off the intake pipes which form an erosion surface. I don't think its coincidence that two different sections of intake pipe have been revealed by the flood event in Glen

Falloch. It appears from the photo above that even permeable membranes may facilitate erosion of material placed on them.
