Climate Change and Glen Falloch (4) â?? hydro failures and their impact

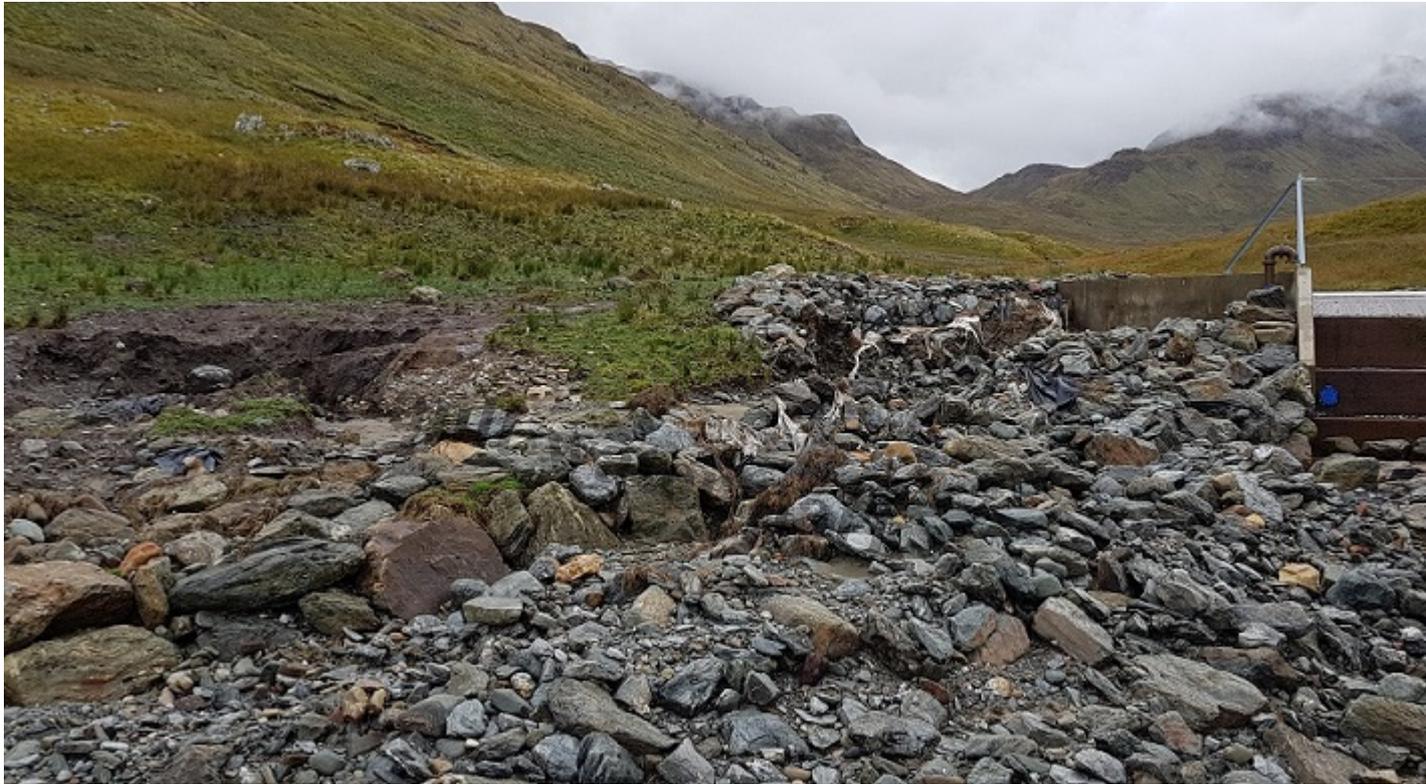
Upper Glen Falloch hydro intake 25th September 2019 â?? photo credit Kevin McGrath

Compare the two photos above taken just four months apart. A large proportion of the rip-rap bouldering which had been placed against the dam wall to the left of the intake has been removed by the flood, along with much of the bouldering along the bank of the river below.

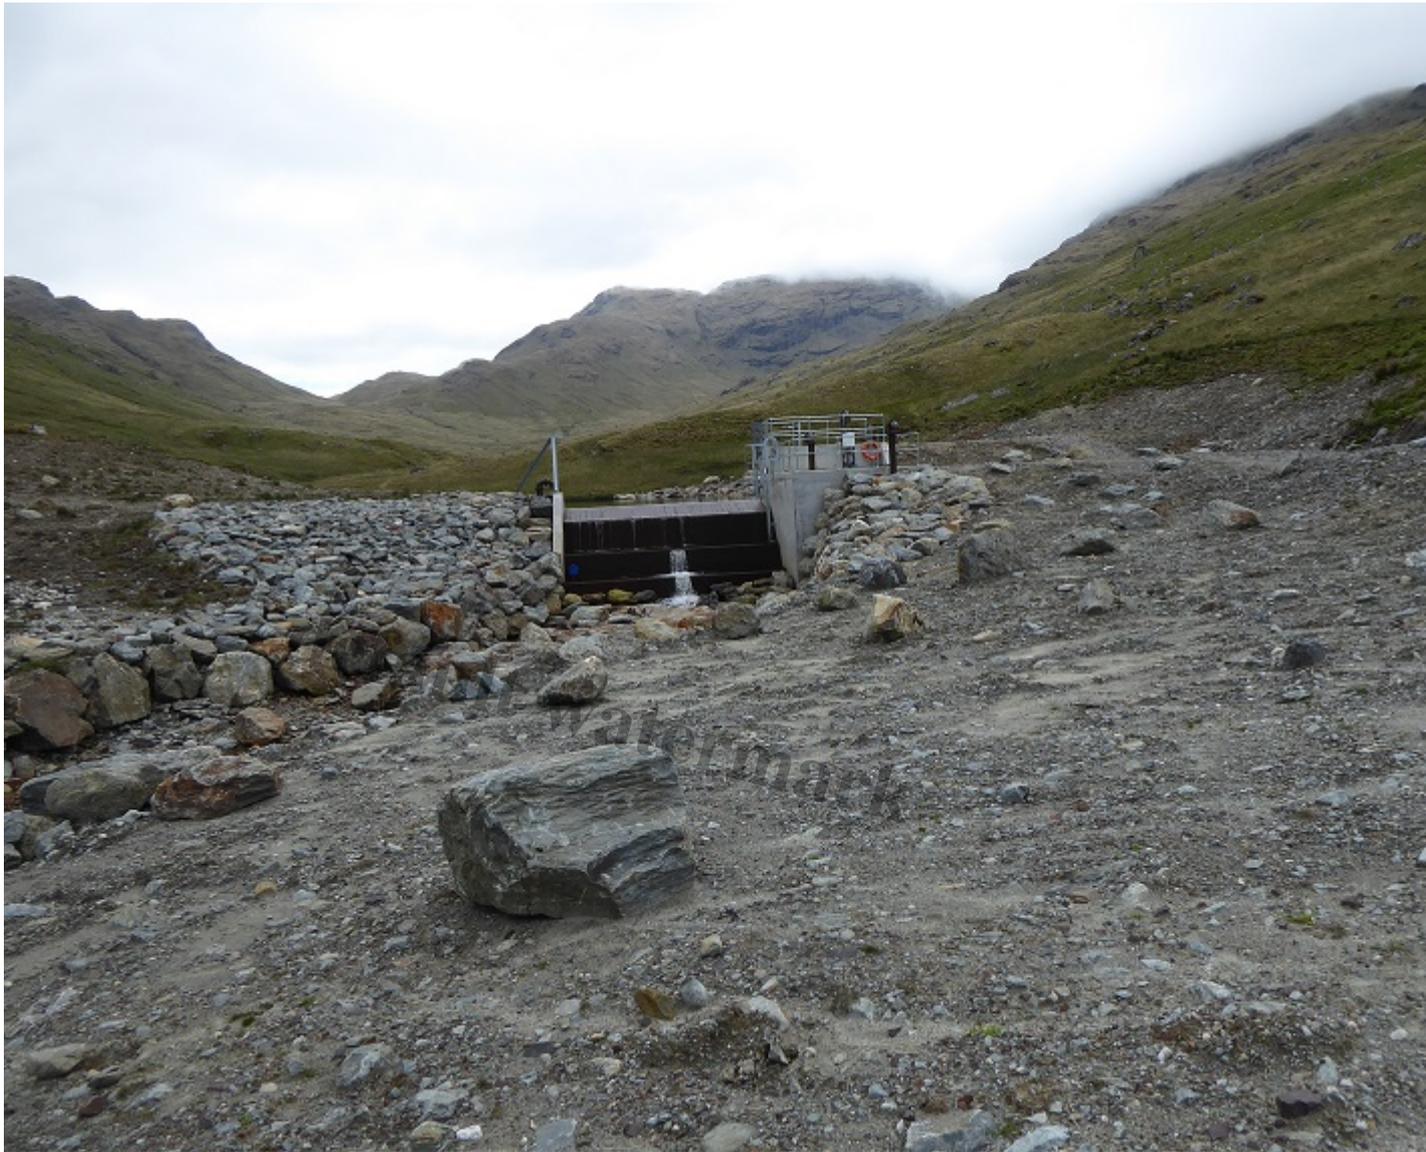
View up to intake May 2019. The bare foreground is a consequence of further work the Park approved in 2018 (see below). Photo Author.

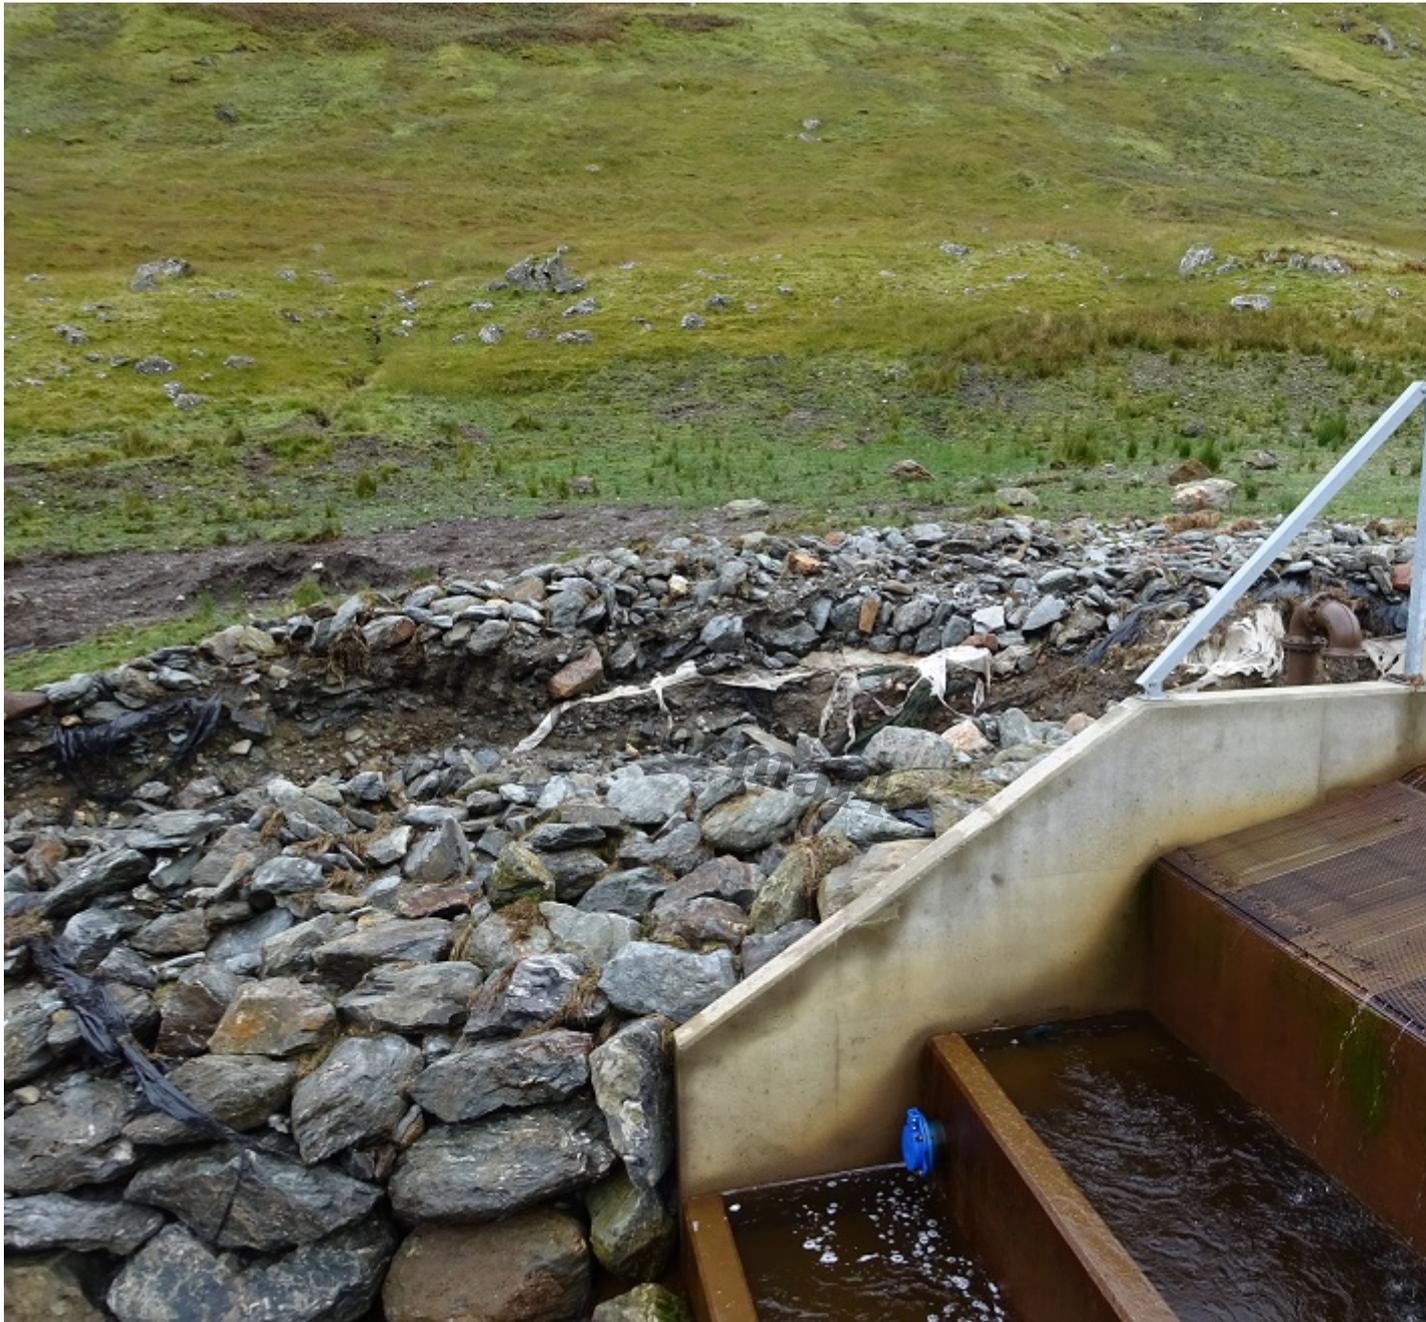
The artificial embankment at the Upper Falloch intake used to reach the top of the concrete walls and away from between them to the new bank opposite. Photo credit Kevin McGrath

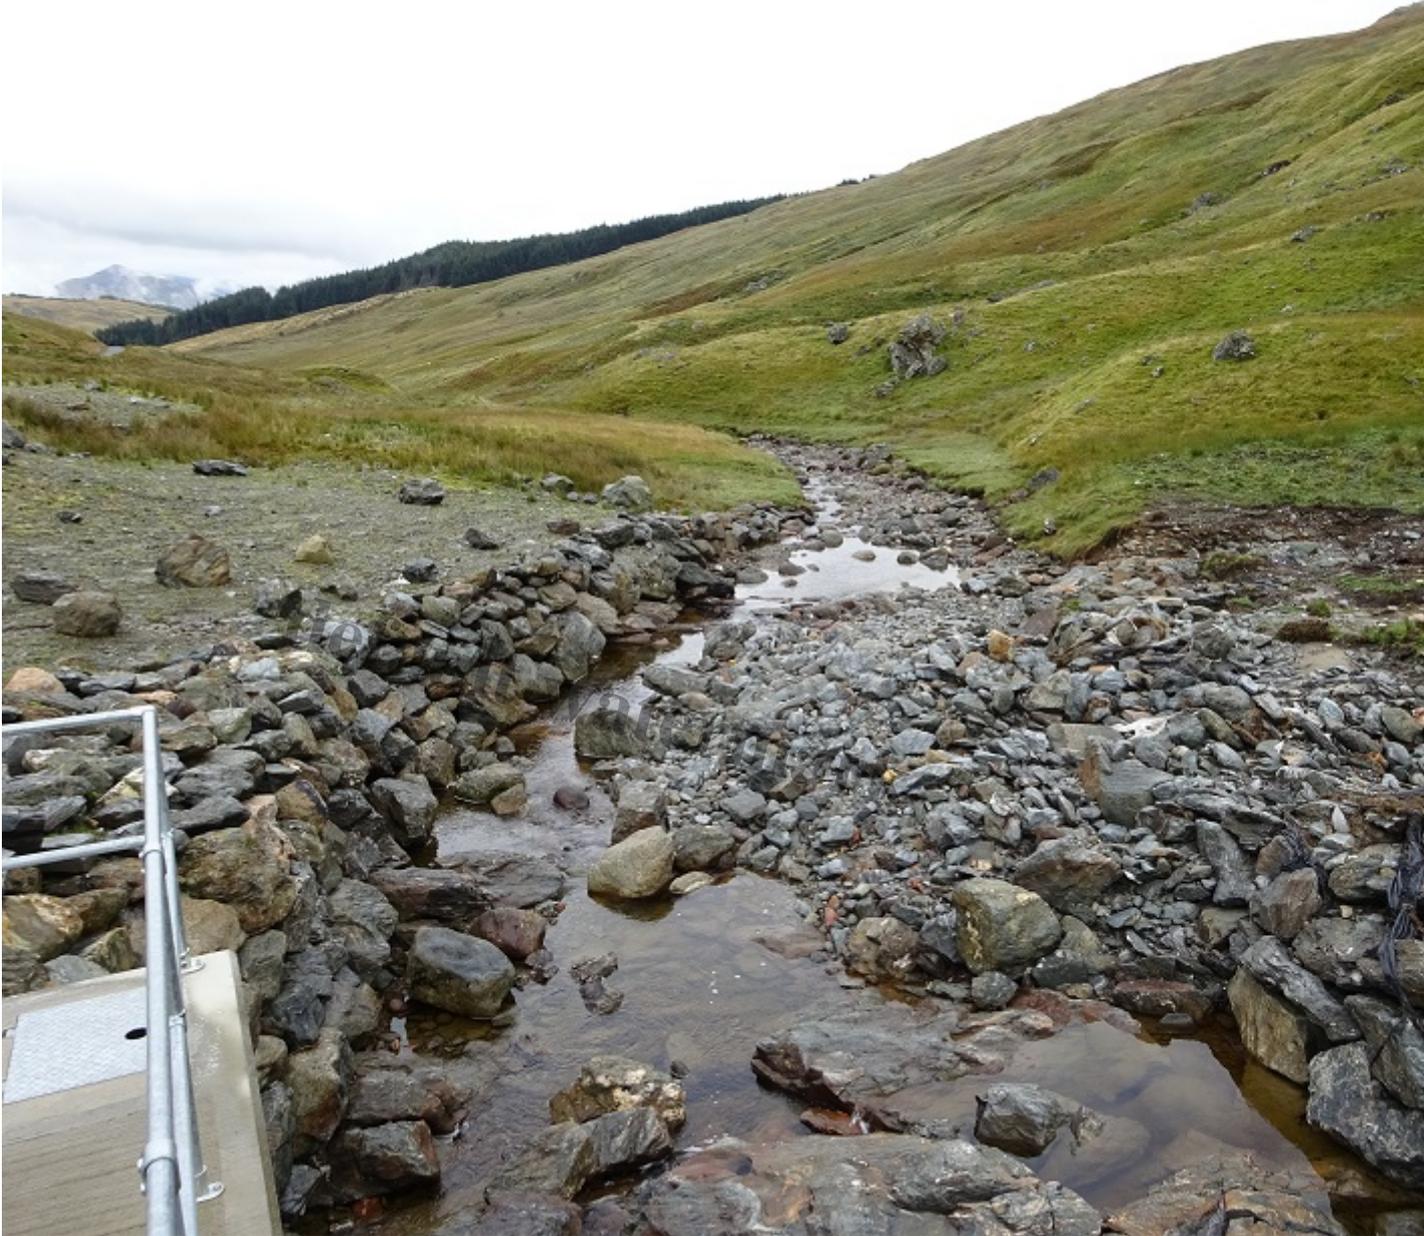
Looking downstream from the intake the rip rap bouldering on the right bank, which used to mirror the left bank, has mostly been swept away making this side of the river appear far more natural. Photo Credit: Creag MeGrath.

The force of the flood water to remove the rip rap bouldering must have been quite something. The boulders were placed here to protect the river bank after the construction of the intakes but have failed. And it's not just on the Upper Falloch where this has happened, but on four of the other eight Glen Falloch intakes.

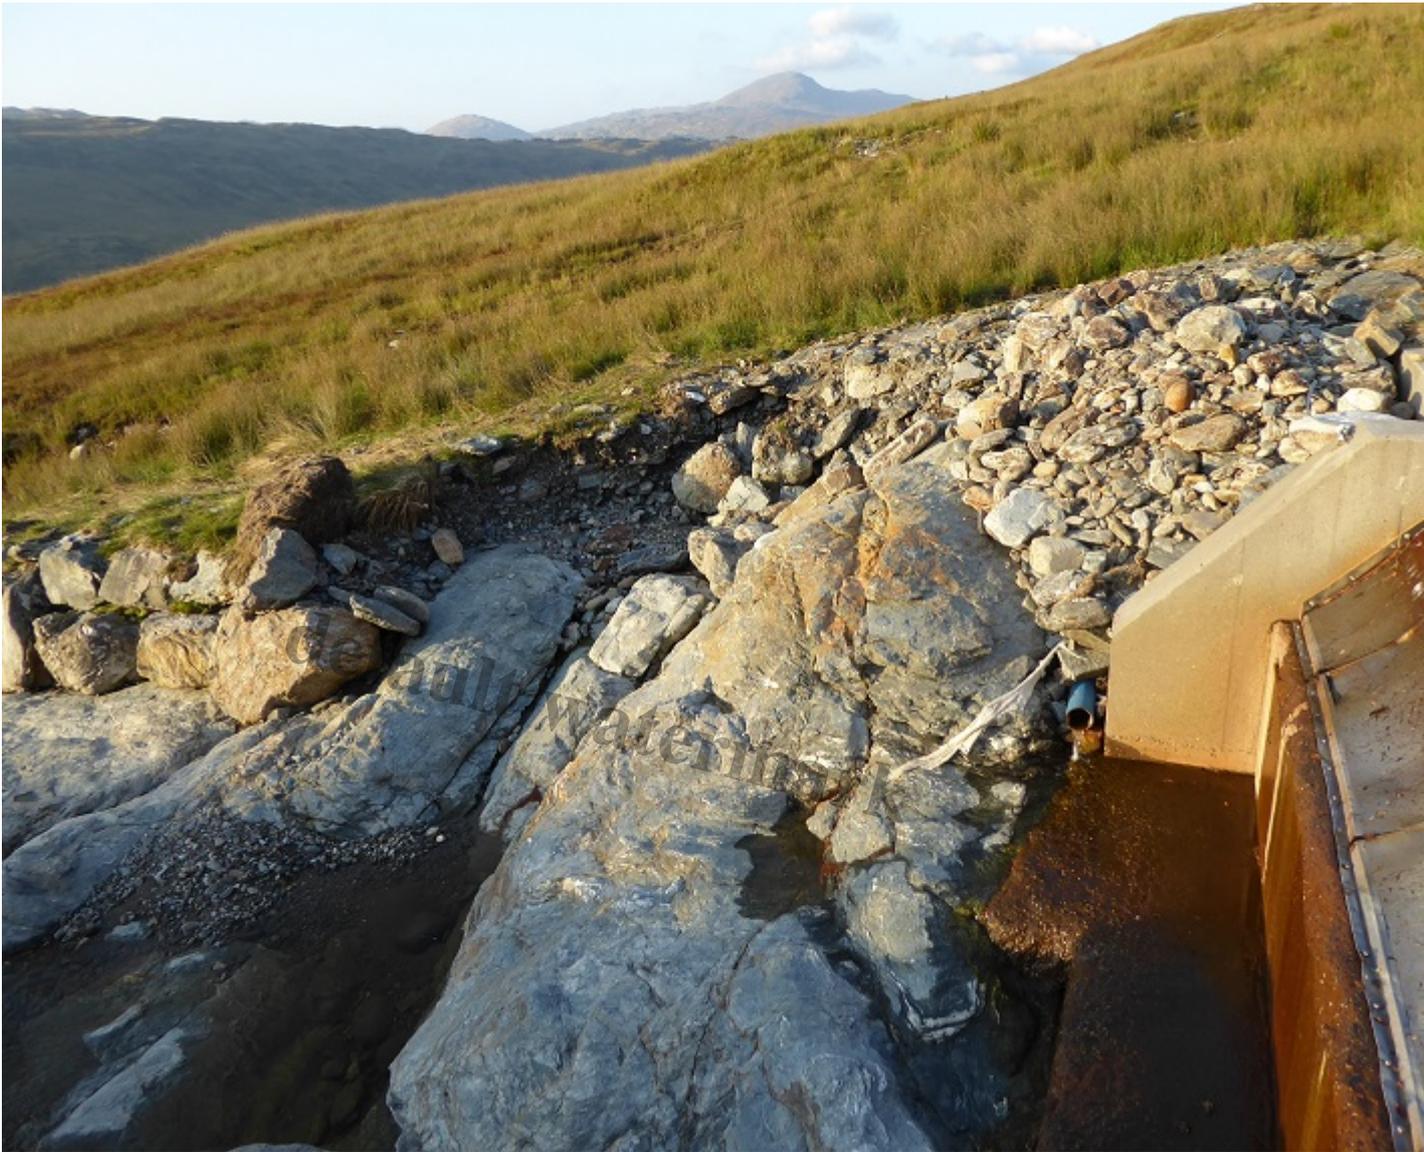
Large chunk of restored bank removed from below Allt Andoran Intake, leaving bare bank behind & Chalum in distance. Both banks below this intake have been seriously damaged. Photo Author.

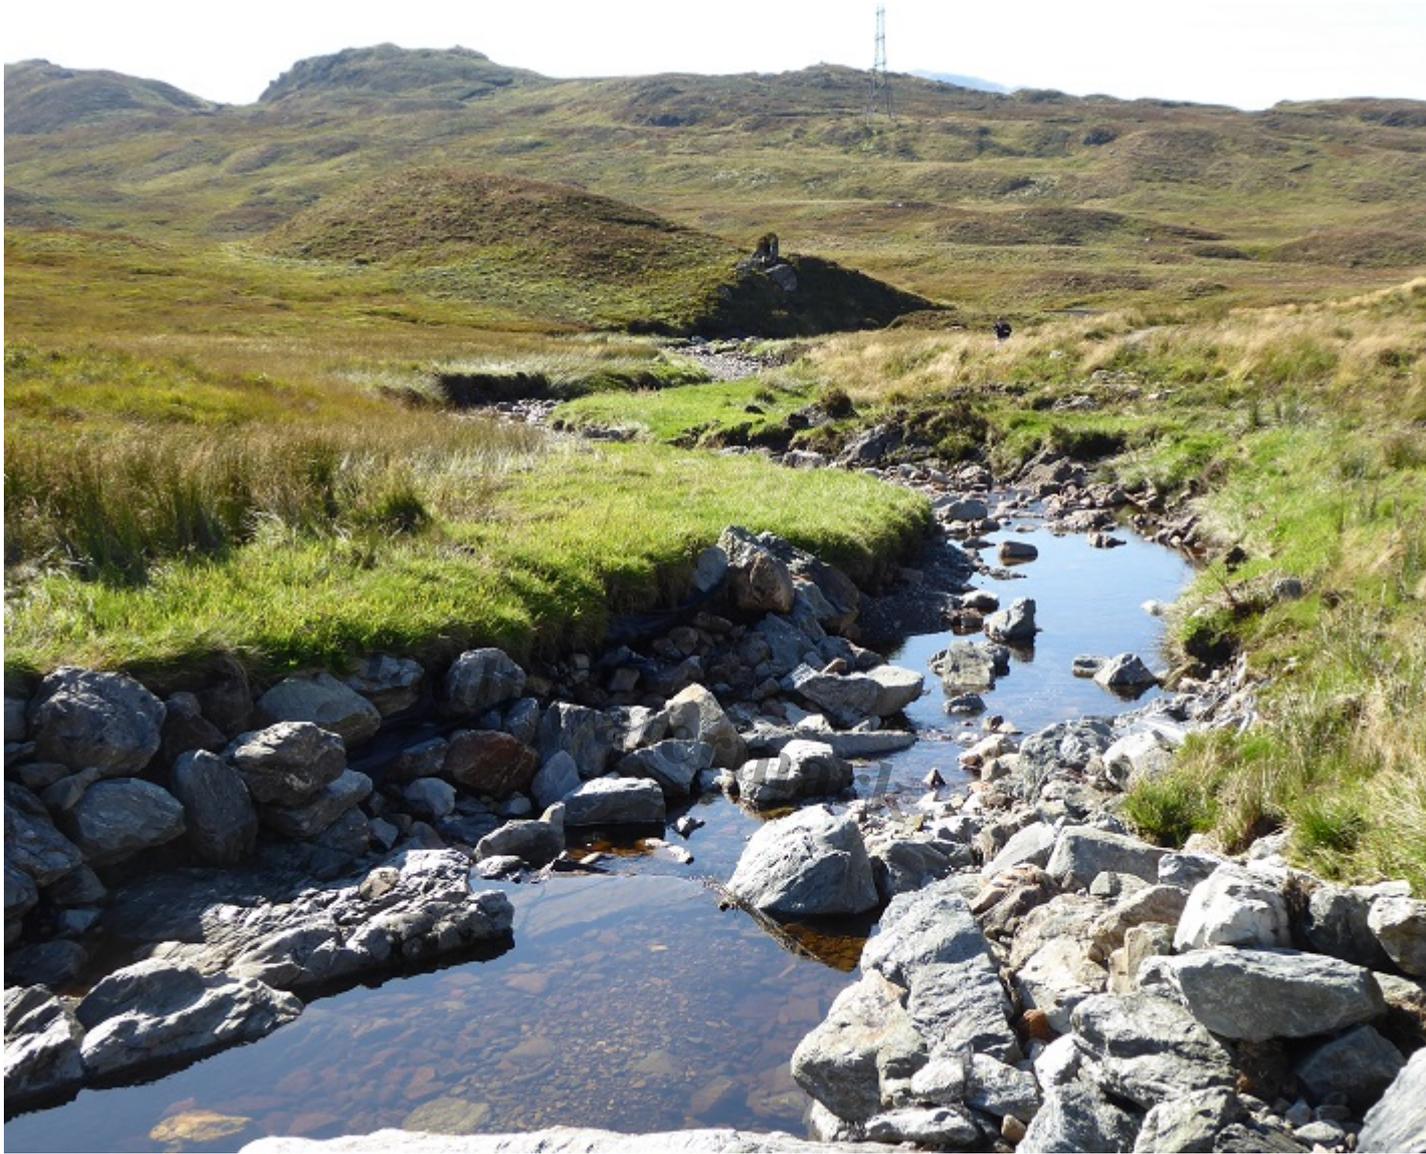
View down from Ben Glas intake on walkers path to Beinn Chabhair Sept 2019. It looked to me like boulders had been stripped from the left bank mid-photo.

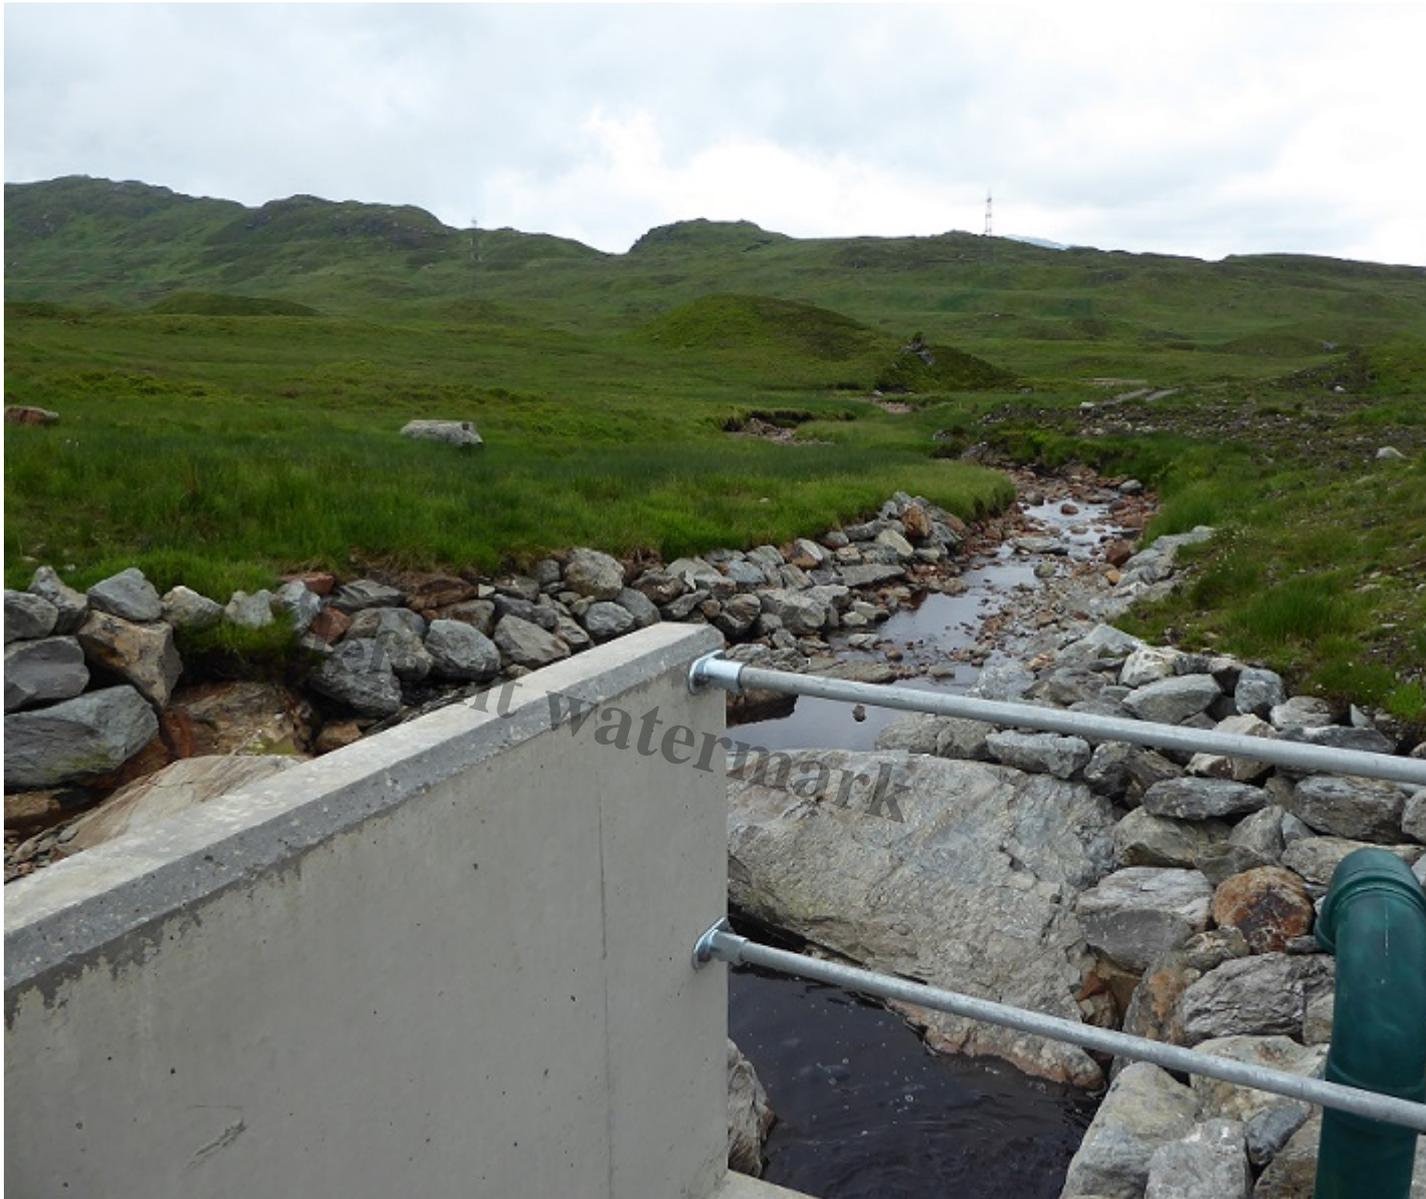
A comparison with a photo taken in 2016 confirms the extent of bouldering which has been washed onto the banks

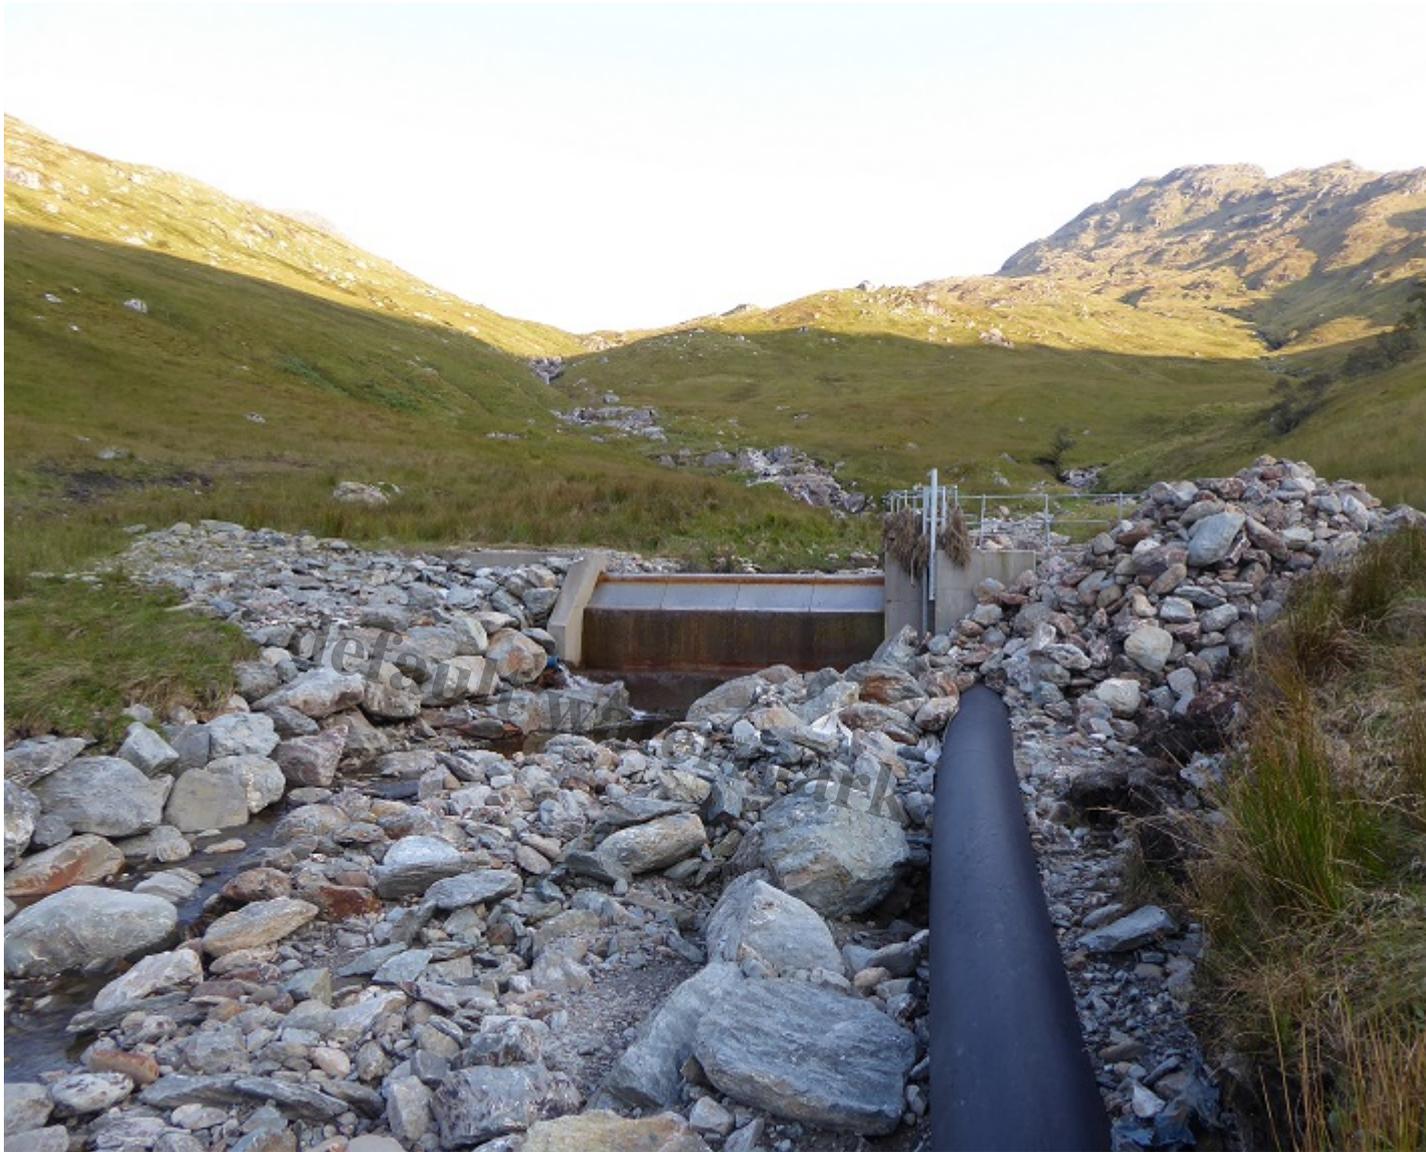
Looking up to Allt a Chuillin main intake along section of pipeline that was, until recently, under the "restored" bank of the river (photo of this from above featured in my last post). The pile of boulders on the right appears to have been excavated from the pool and is perhaps intended for use to cover up the pipeline again. Unlikely to work!

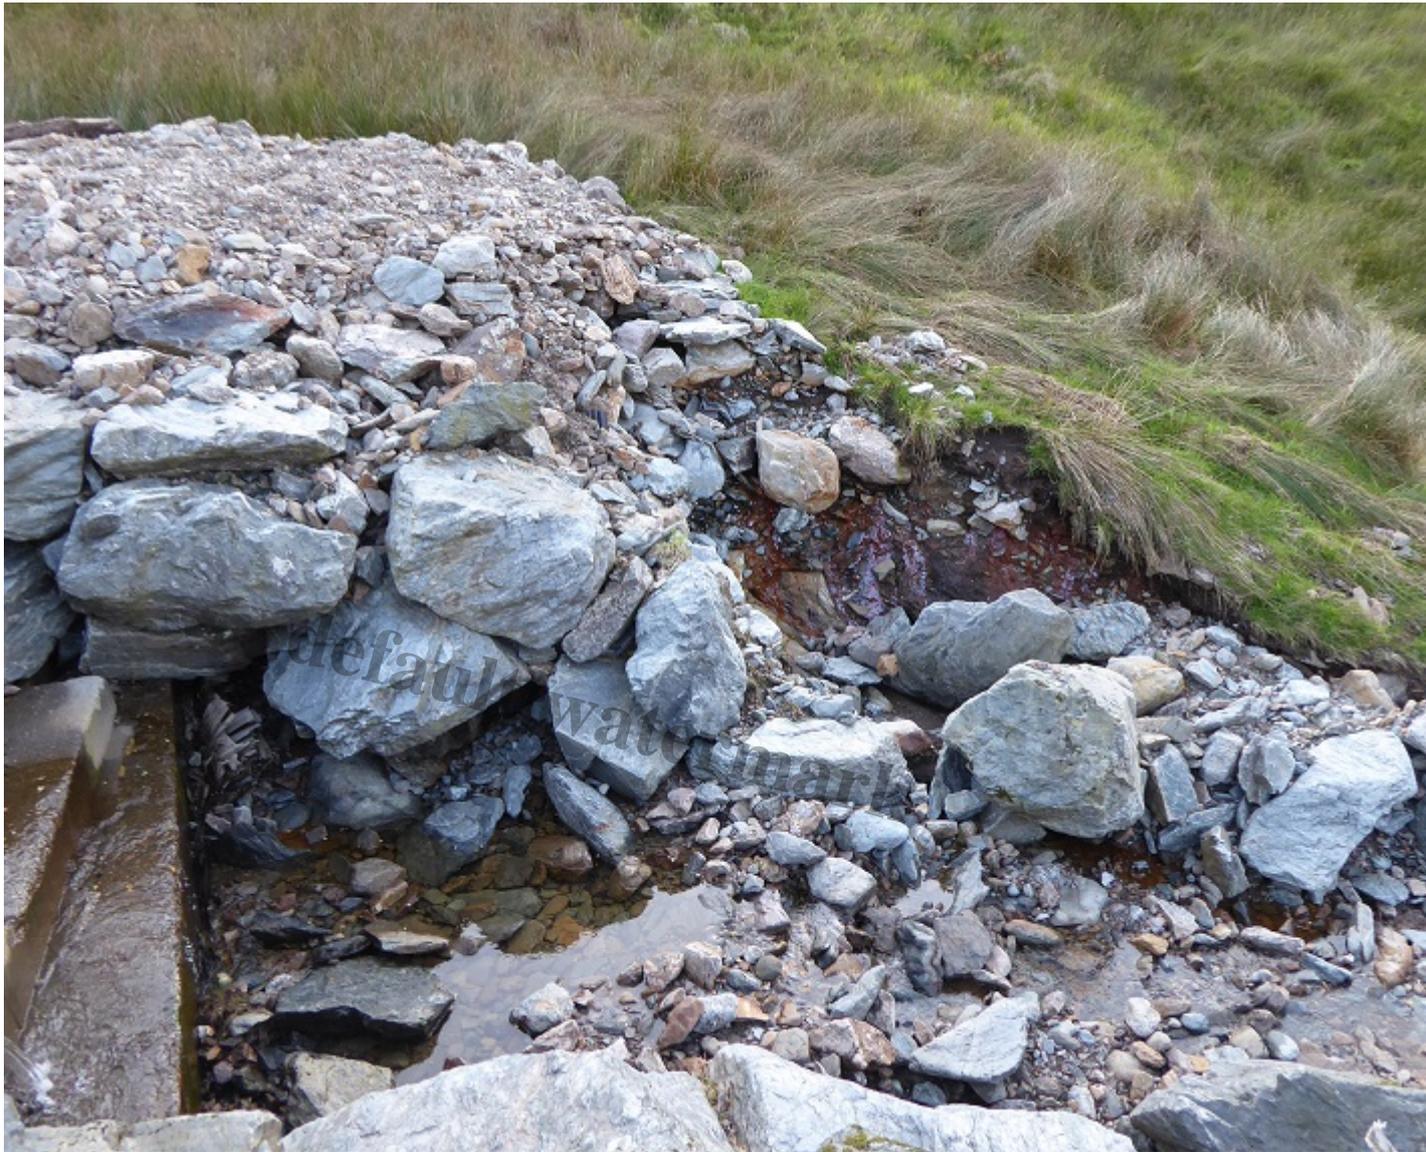
Damaged bank below the second of the Allt a Chuillin intakes

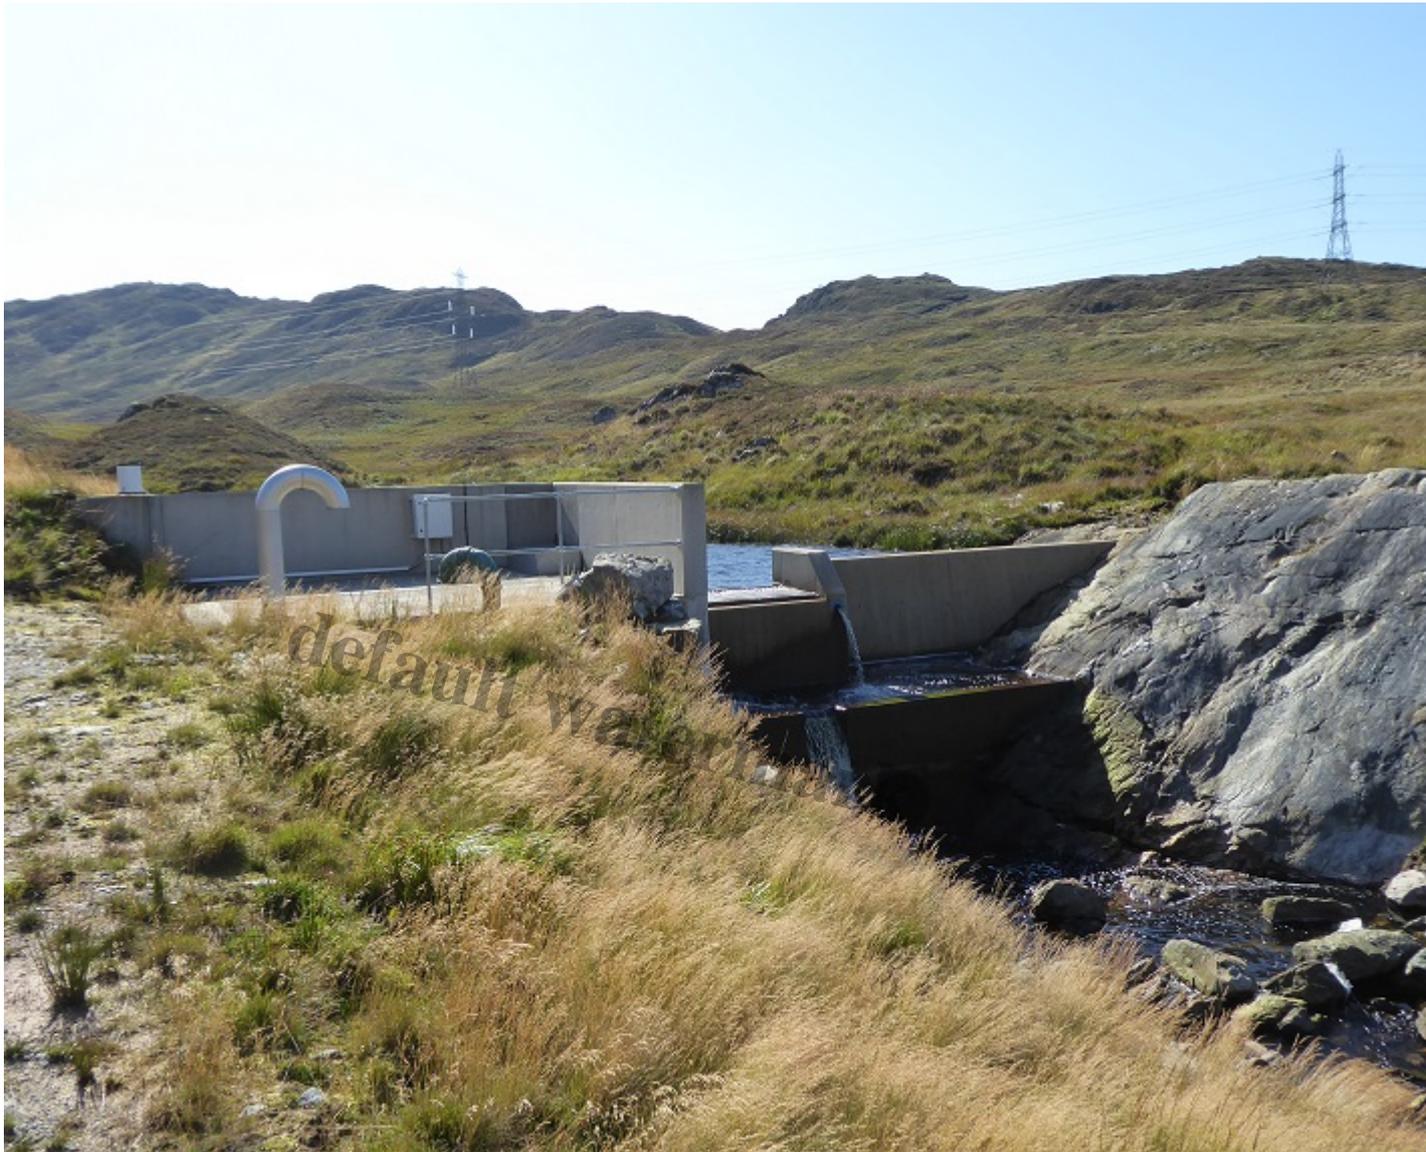
The other Ben Glas intake (see above), with a large pool and constructed into rock, is little damaged compared to its neighbour. Had the highest section of concrete retaining wall be faced with stone, a Park Best Practice Guidance, the landscape impact of this impact would have been reduced further.

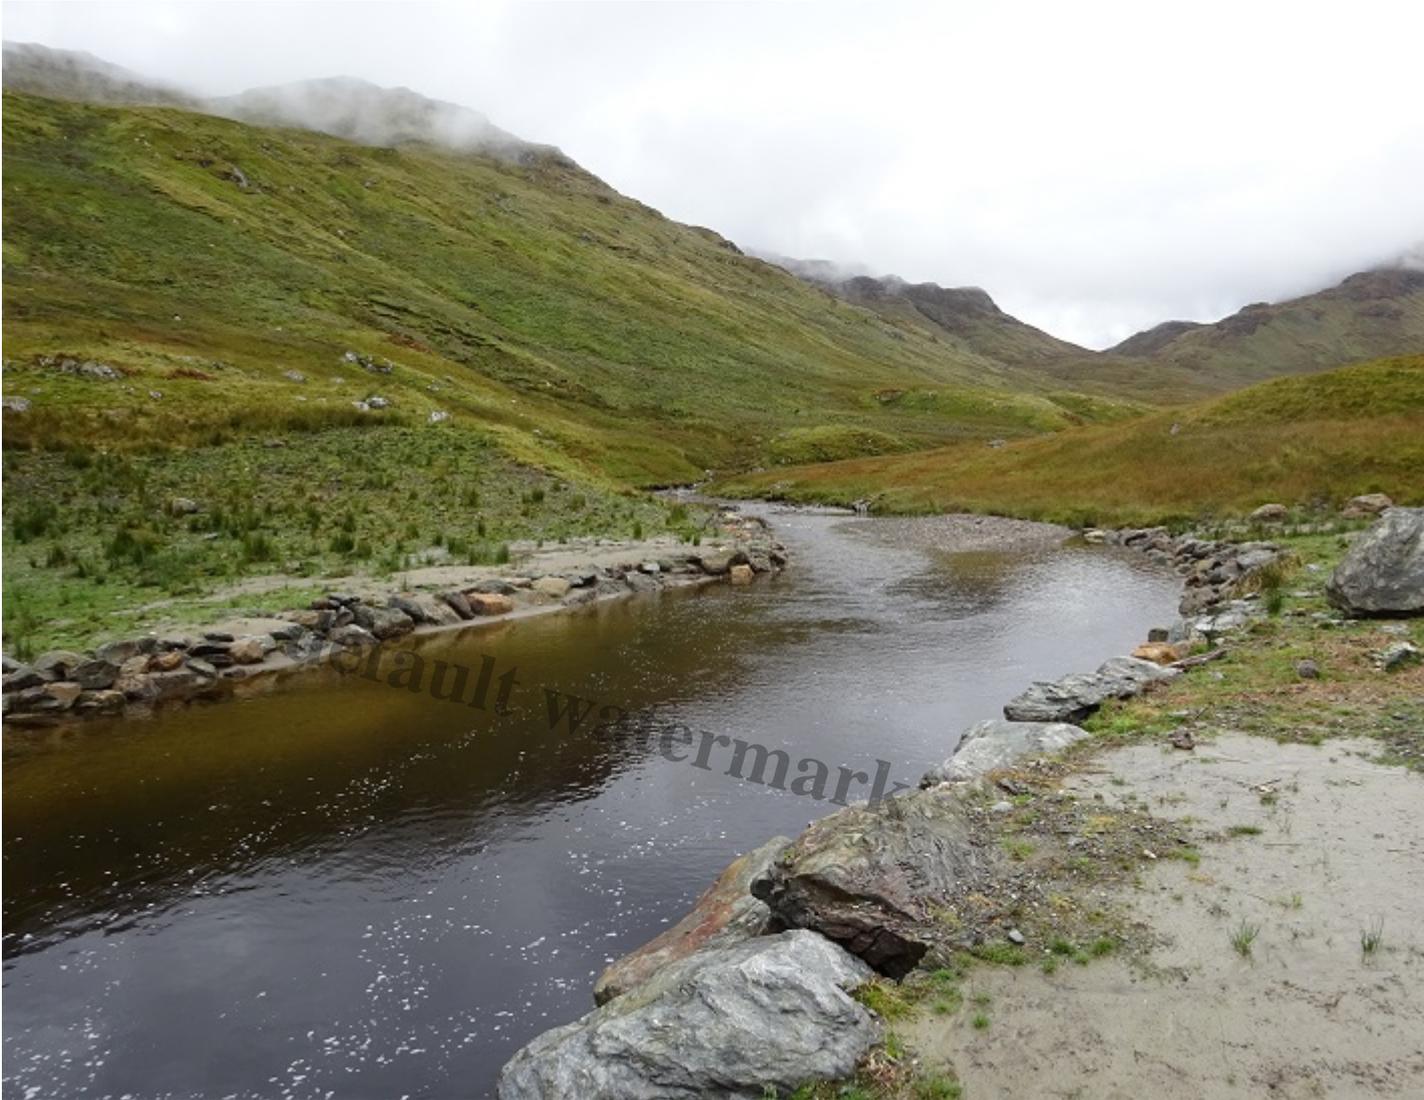
Looking across the intake pool to the rip rap bouldering embankment September 2019 – it now looks far more natural than it did four months ago. Photo credit Kevin McGrath.

Besides the large amount of silt washed over the bank in the top photo – which could help it eventually revegetate and stabilise – many of the boulders visible in the earlier photo are no longer there and appear to have been washed away (I blew both photos up to compare them).

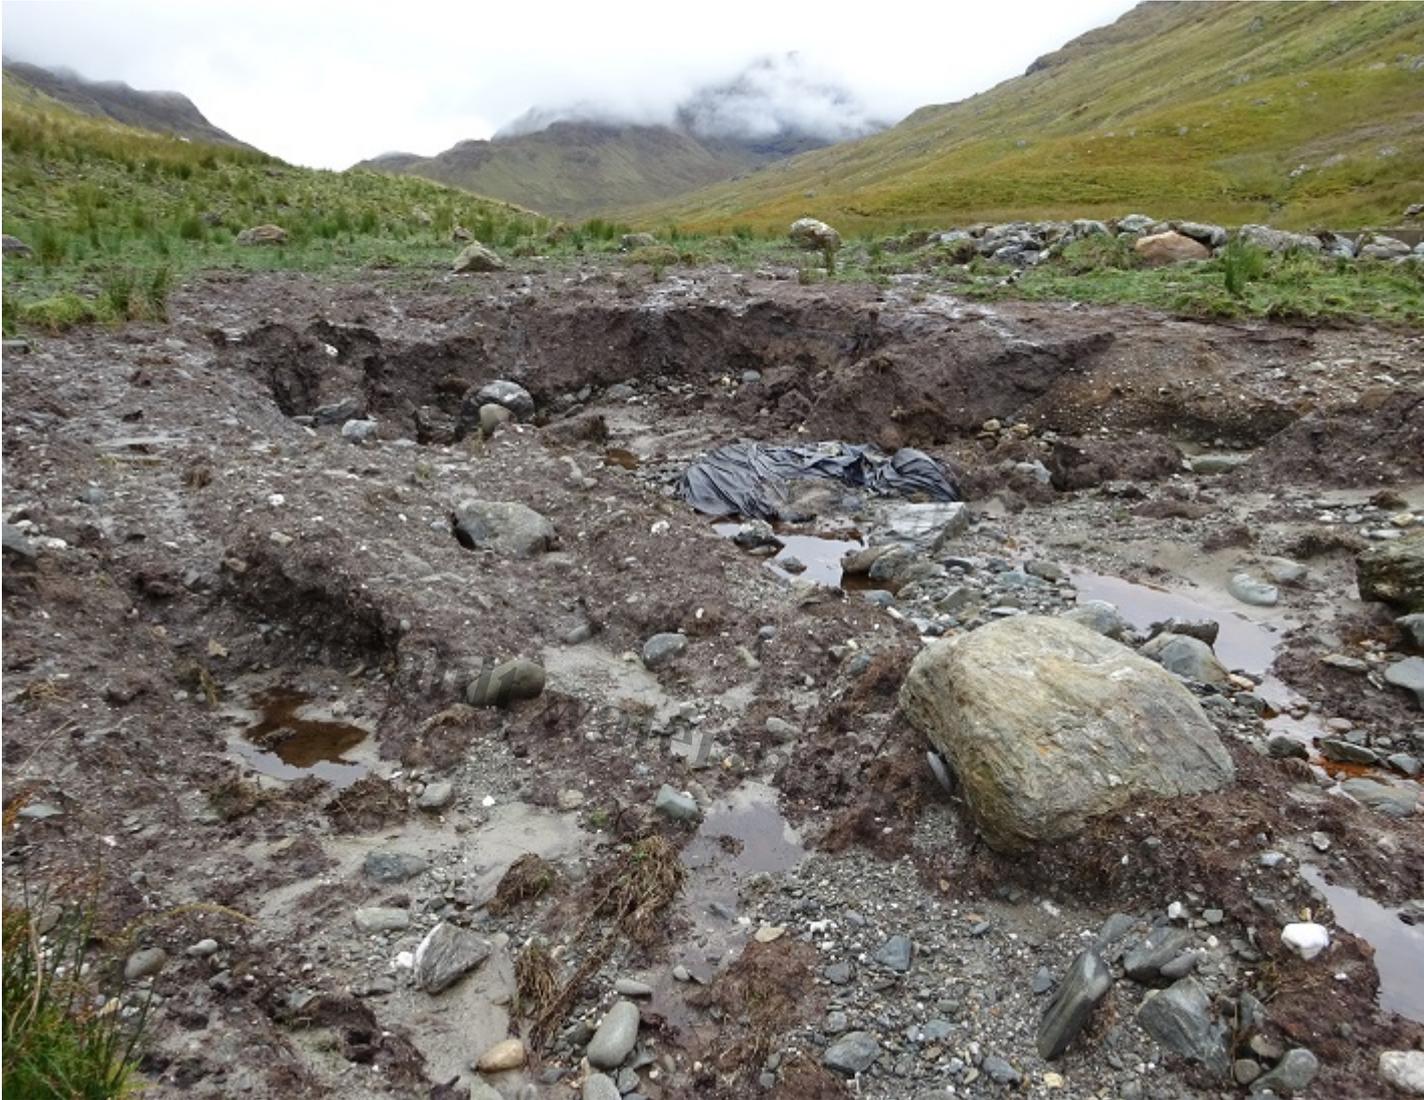
New river formation on the Upper Falloch (intake pool just visible to right)? The erosive impact of the river overflowing here has been accentuated because this a diversionary channel was constructed on this line while the intake was being built. This section of ground is not "natural" and helps explain that where peat has just been placed on the surface its been washed away. Destruction of peat of course releases yet more carbon into the atmosphere.

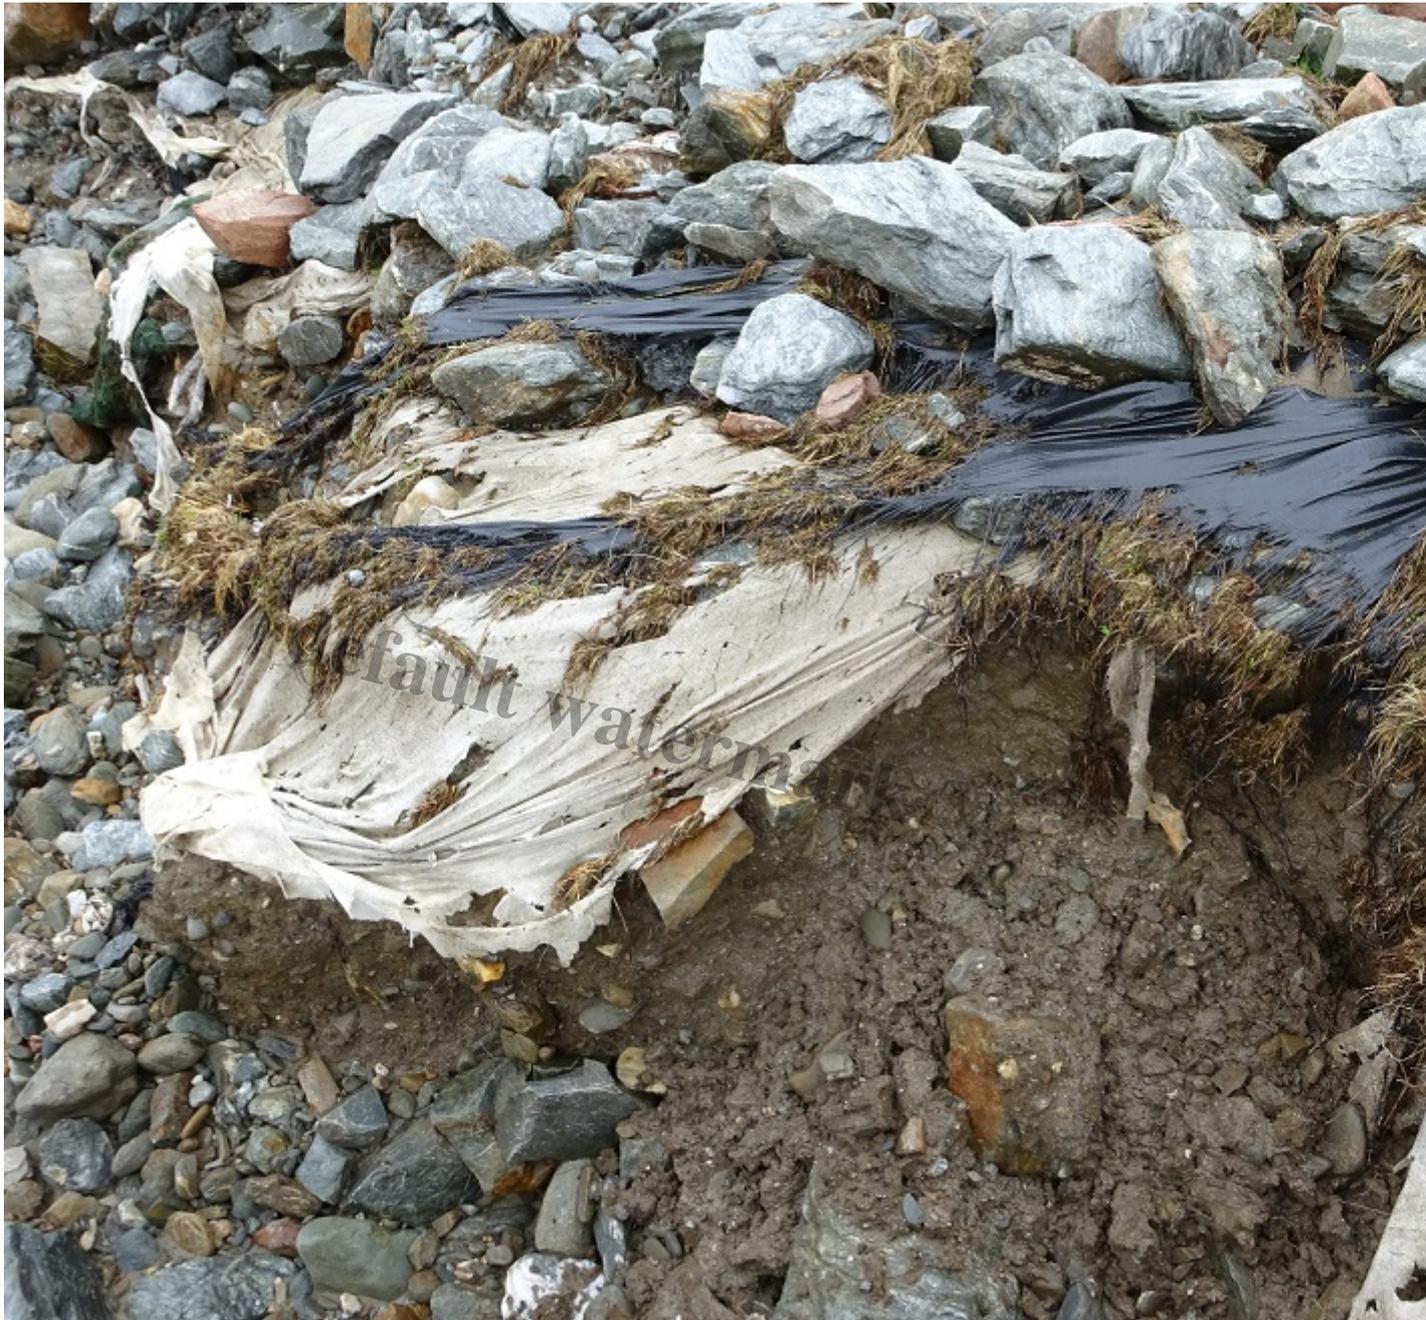
Eroded bank and ripped up sheeting below the Upper Falloch intake. Photo Credit Kevin McGrath
